INSPECTION REPORT

| Type of Inspection | Focused Compliance Inspection (FCI) | | | |
| Facility or Site Name | Enbridge Ingleside Oil Terminal | | | |

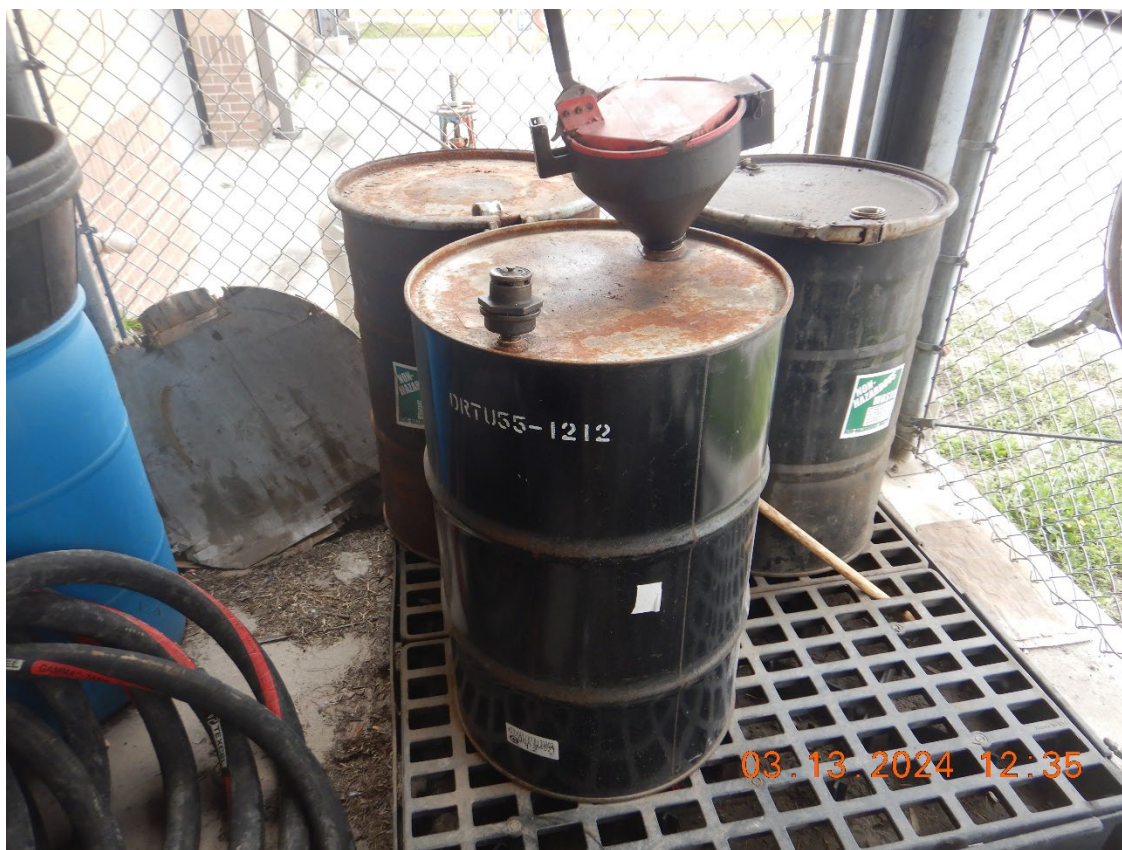
Photo No. 1

Description: View of three used oil drums outside of lab which were not labeled with the words 'Used Oil' in the storage area outside the lab.

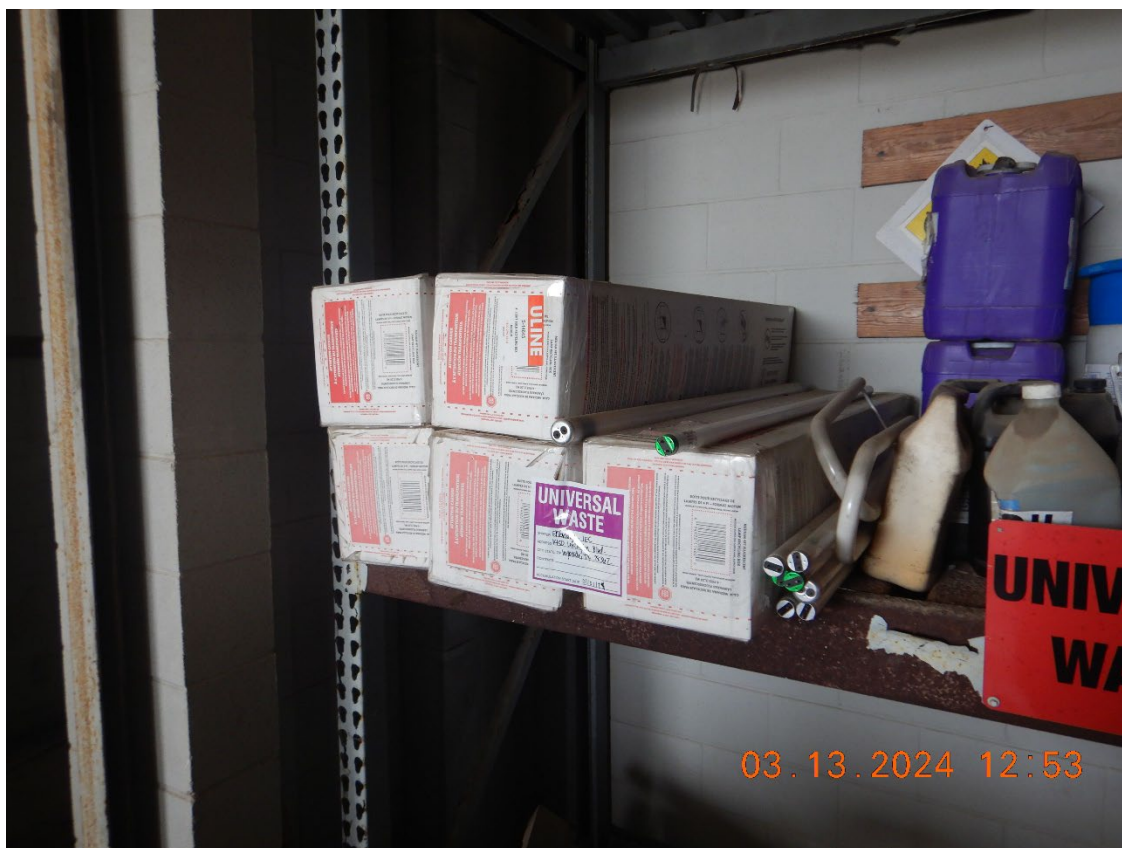
Photo No. 2

Description View of several universal waste lamps not stored inside a container in the waste building.

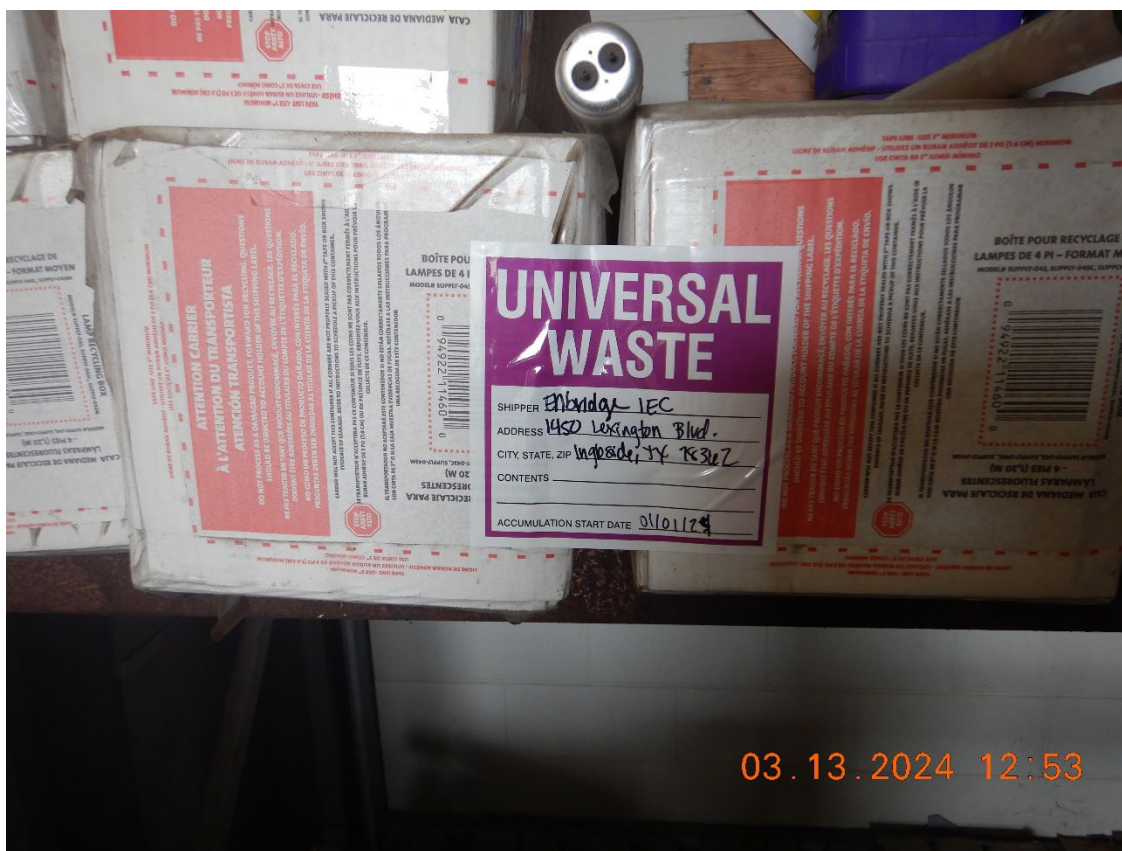
## Photo No. 3

Description: View of label for universal waste lamps missing waste name inside the waste building.

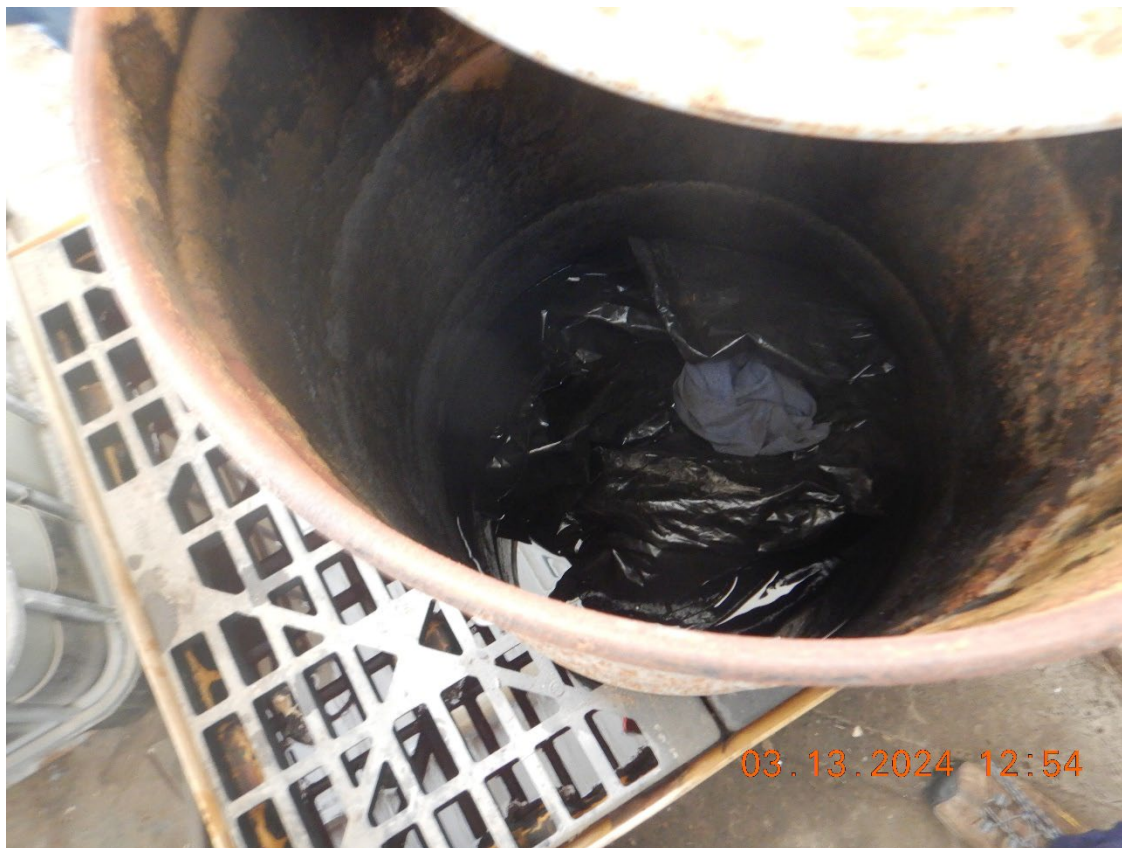
Photo No. 4

Description: View of free-flowing oil in waste drum that was not labeled as "Used Oil" inside of the waste building.

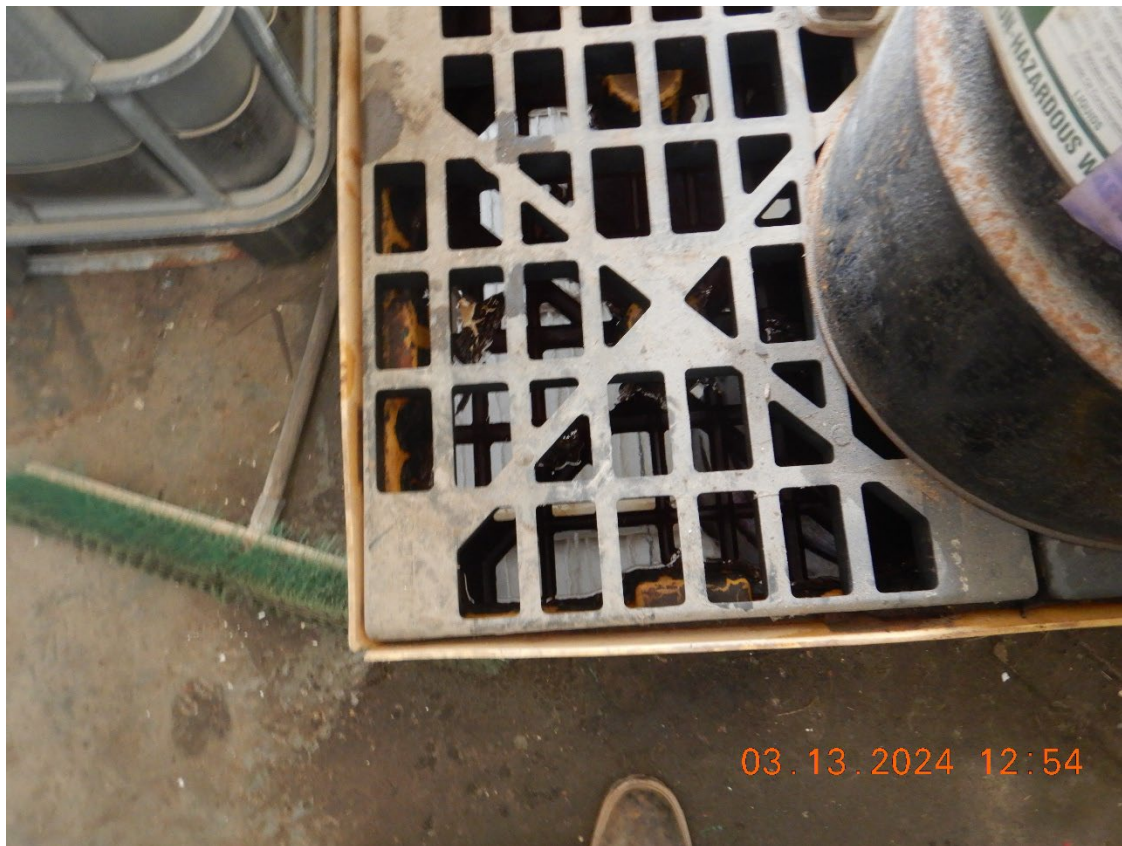
Photo No. 5

Description: View of spilled oil in secondary containment that was not removed inside the waste building.

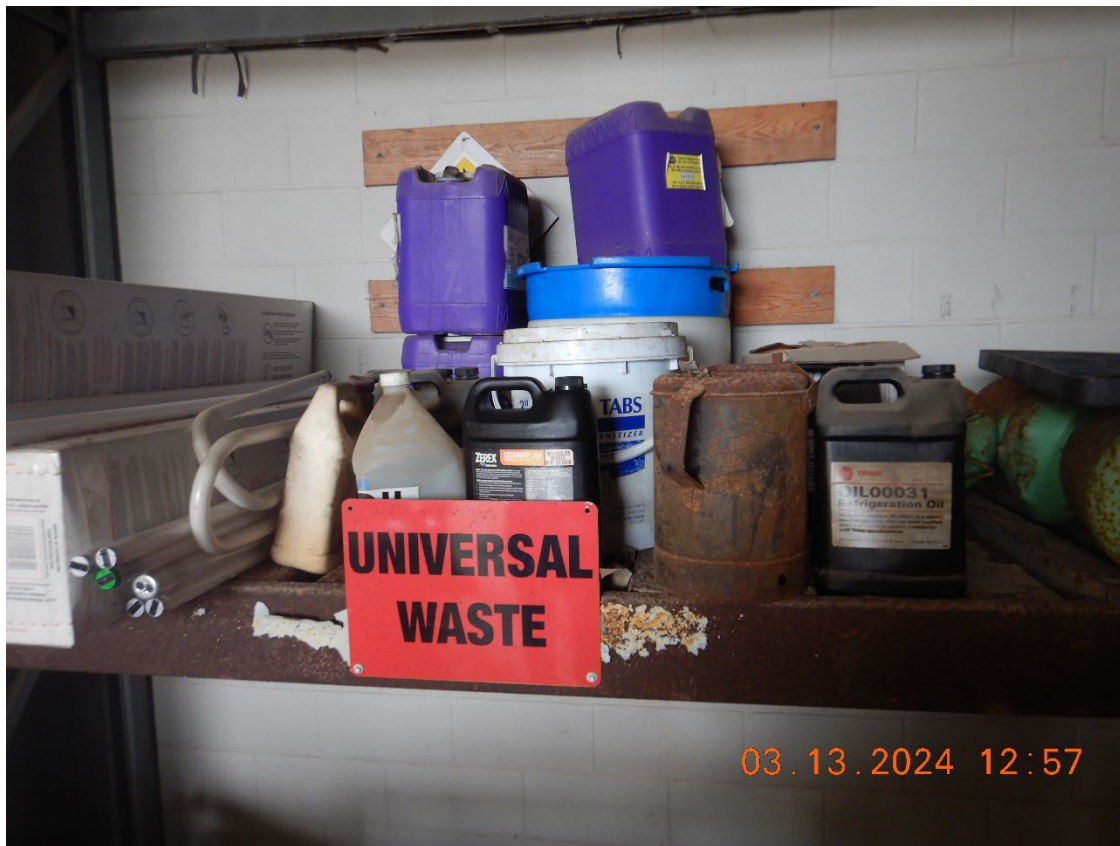
Photo No. 6

waste building. The inspection team did not verify the amount in each container due to time and accessibility constraints, but a spot check on several containers determined they were not RCRA empty (see Appendix 1 – Photos 6, 7, 10, and 11).

Description: View of several unlabeled undetermined waste containers in the waste building.

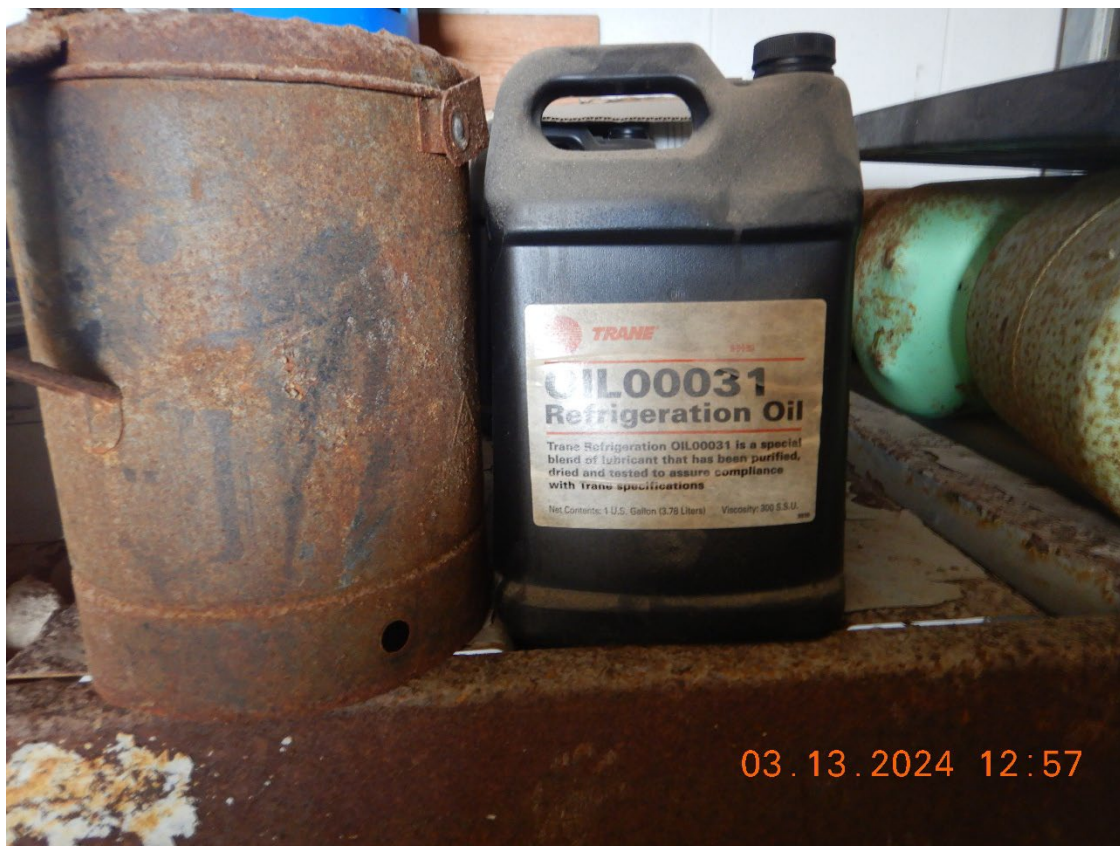
Photo No. 7

Description: View of a refrigeration oil waste container found inside of the waste building.

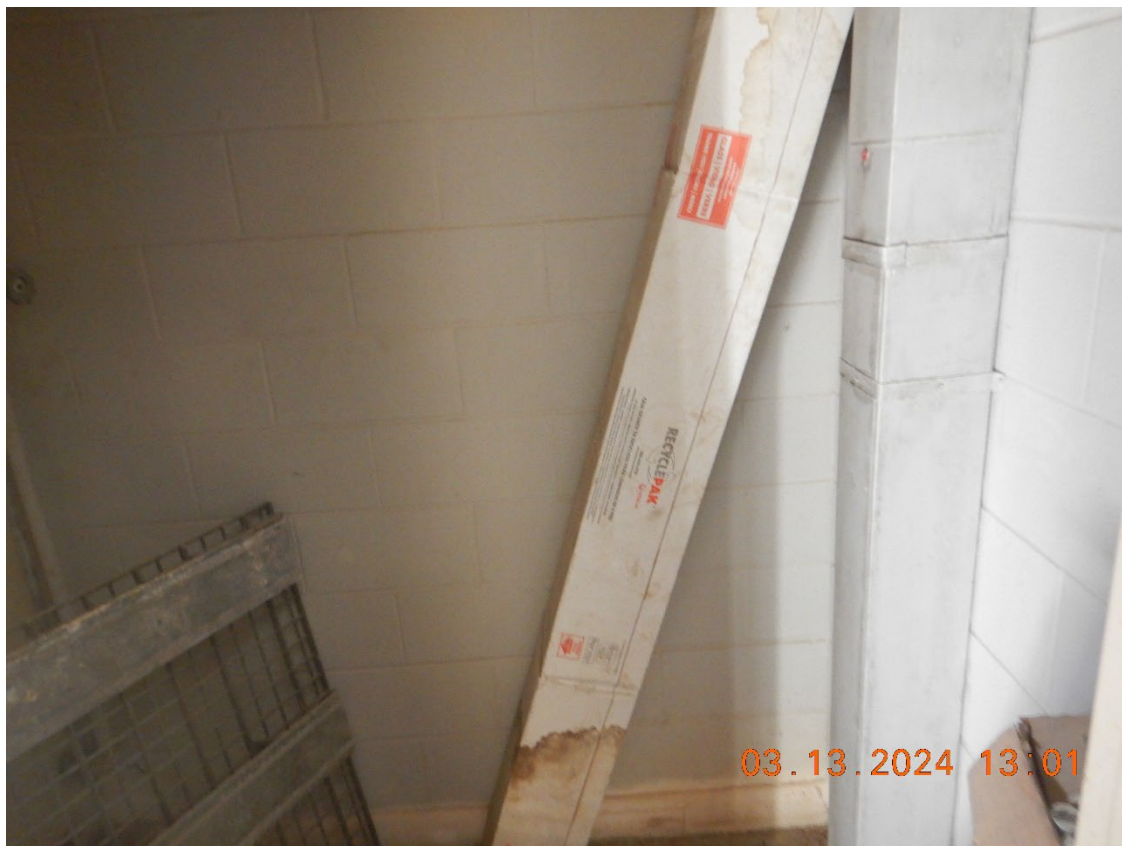
Photo No. 8

Description: View of two boxes of universal waste lamps with no labels found in the waste building.

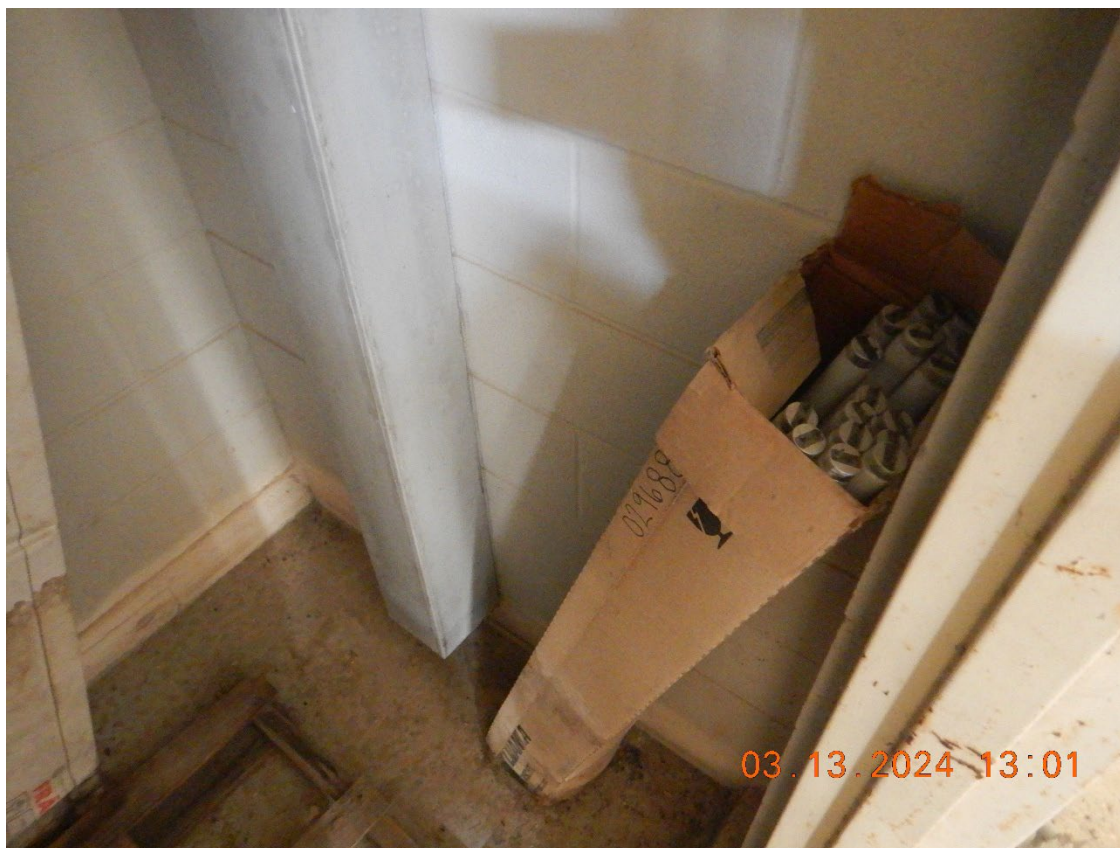
Photo No. 9

Description: View one of the boxes of universal waste lamps with no labels not closed found in the waste building.

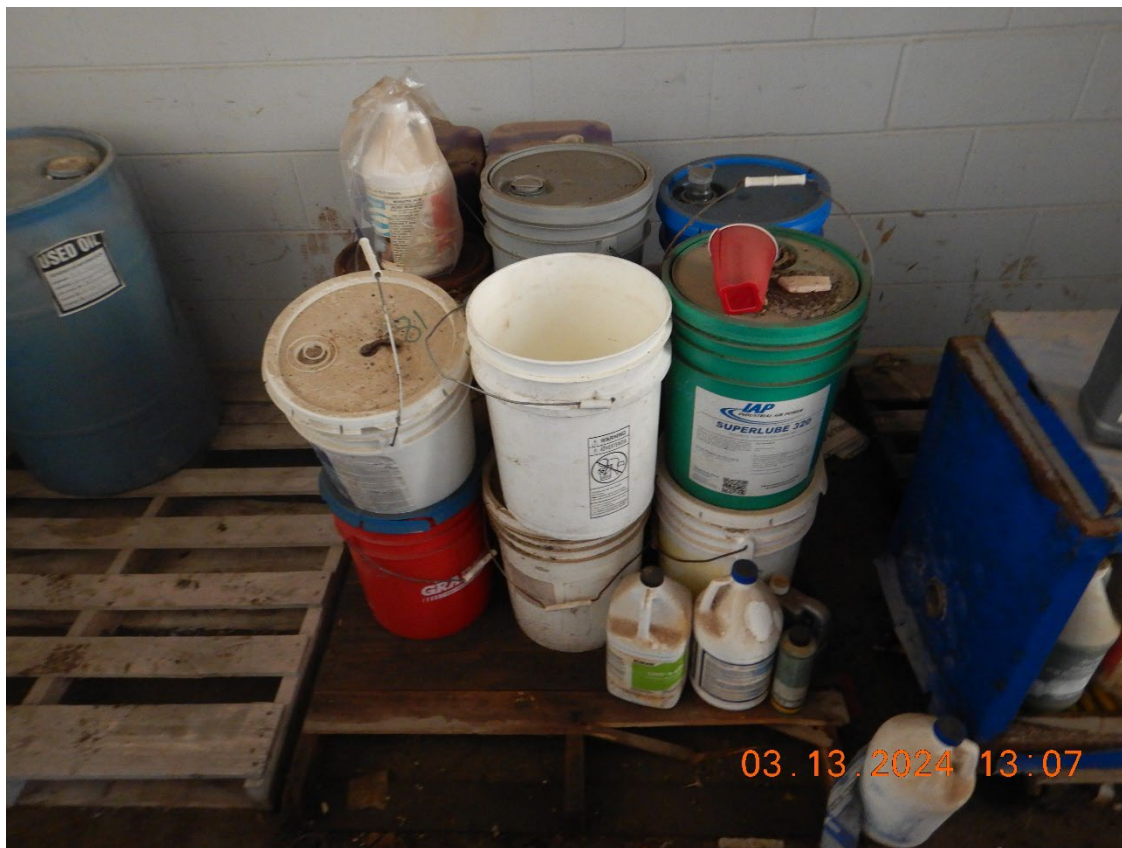
Photo No. 10

Description: Several unlabeled and open 5-gallon waste drums; contents unknown inside the waste building.

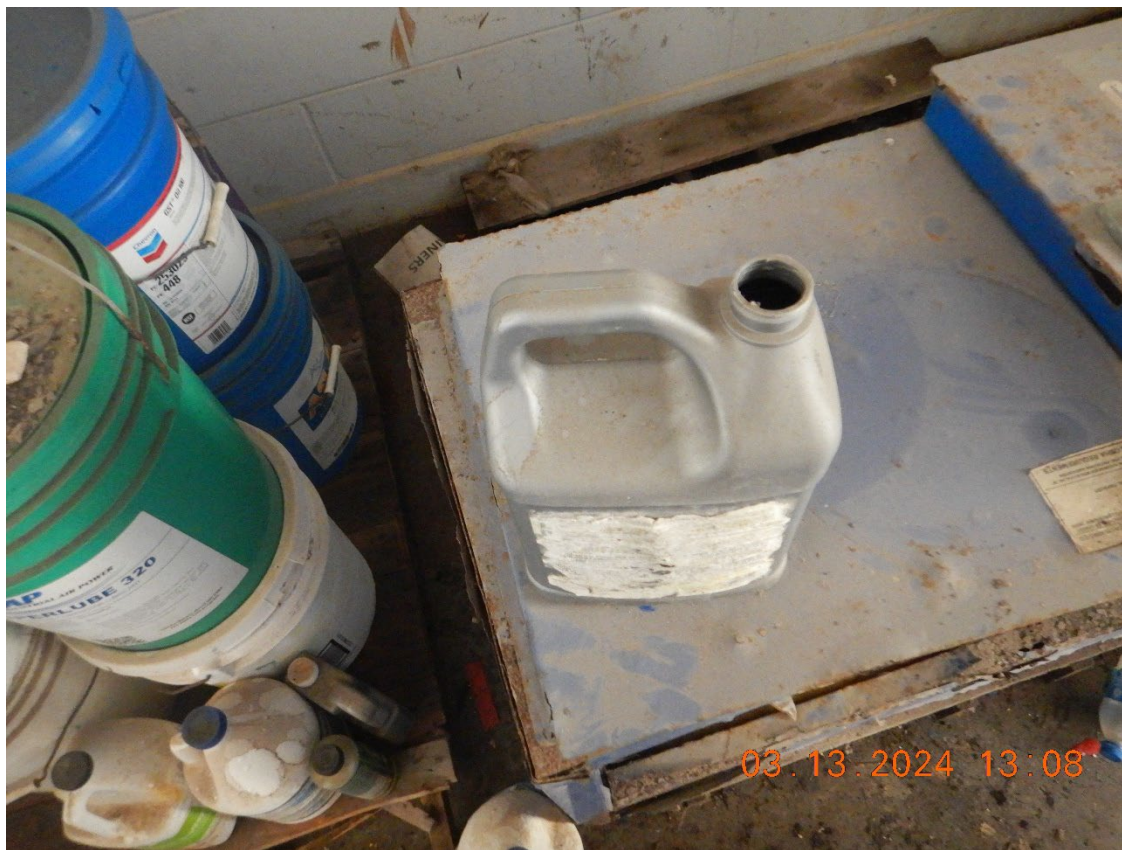
Photo No. 11

Description: One of the unlabeled and open containers seen in Photo 72 inside the waste building.

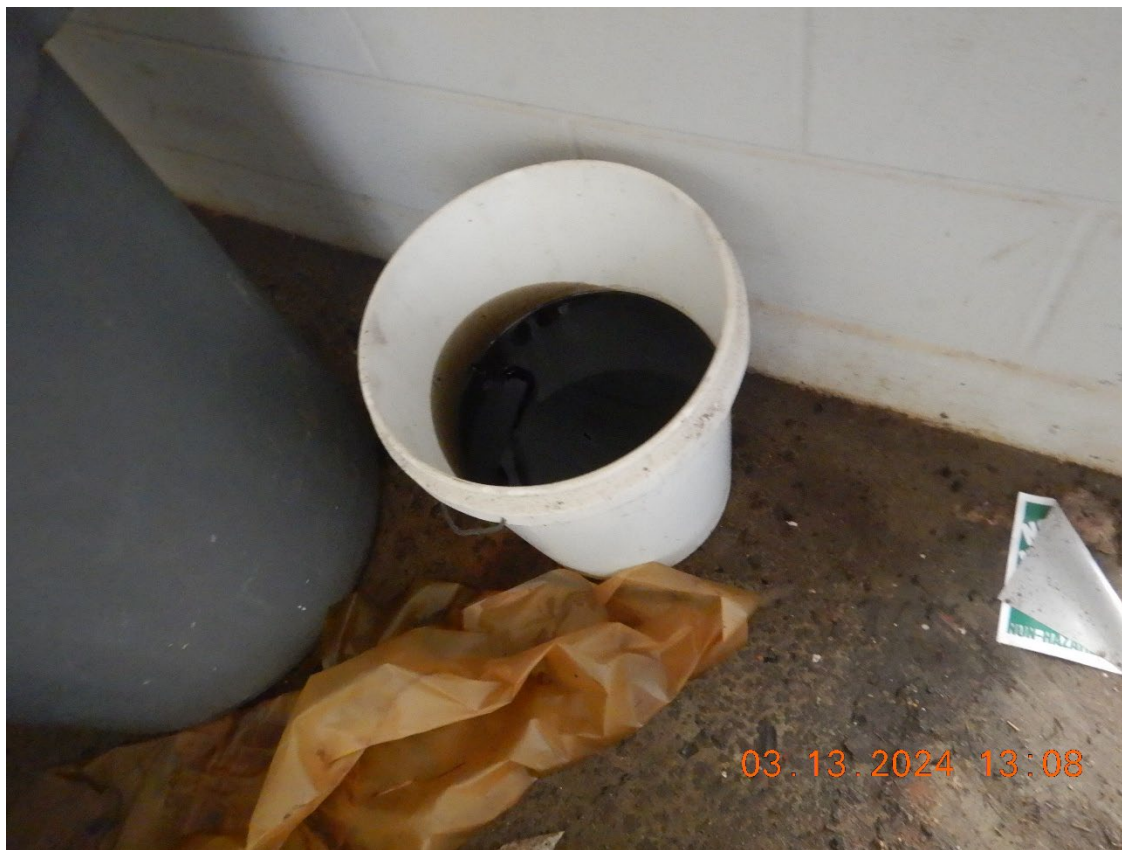
Photo No. 12

Description: View of open and unlabeled 5-gallon container of used oil inside of the waste building.

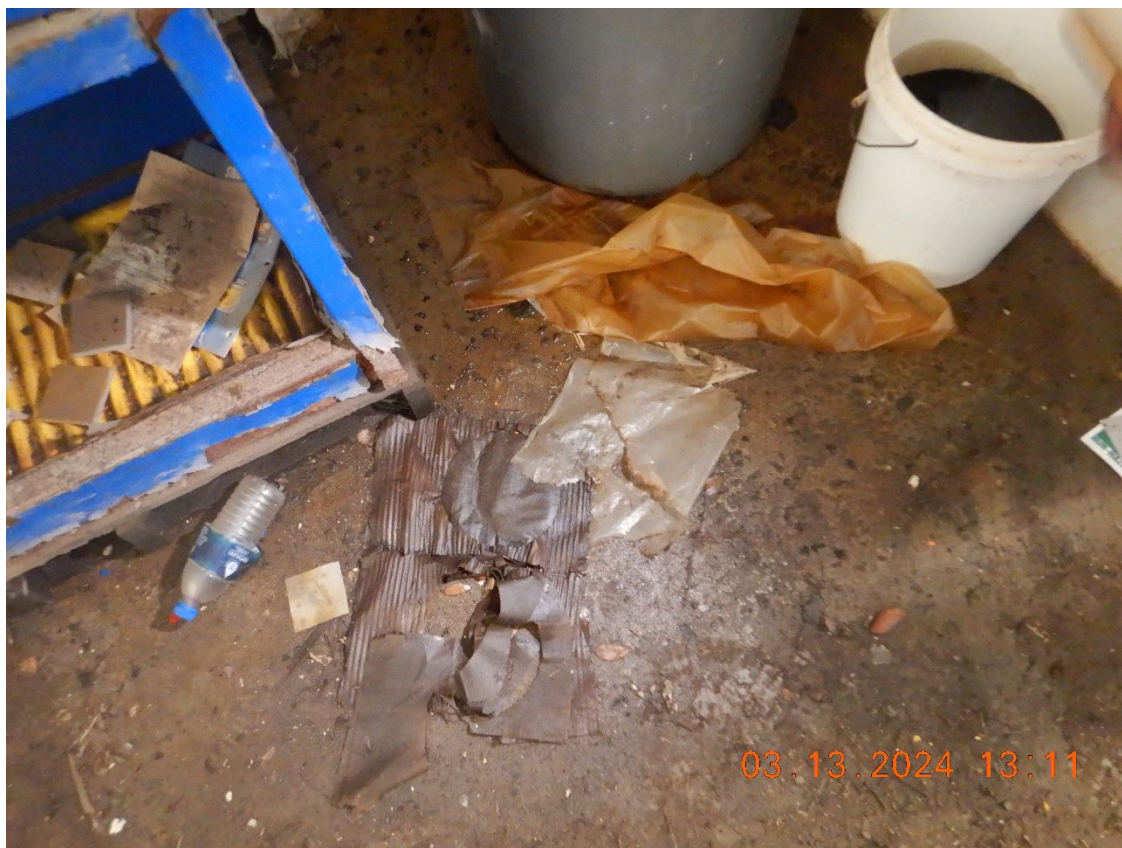
Photo No. 13

Description: View of oil residue on the floor in the waste building.

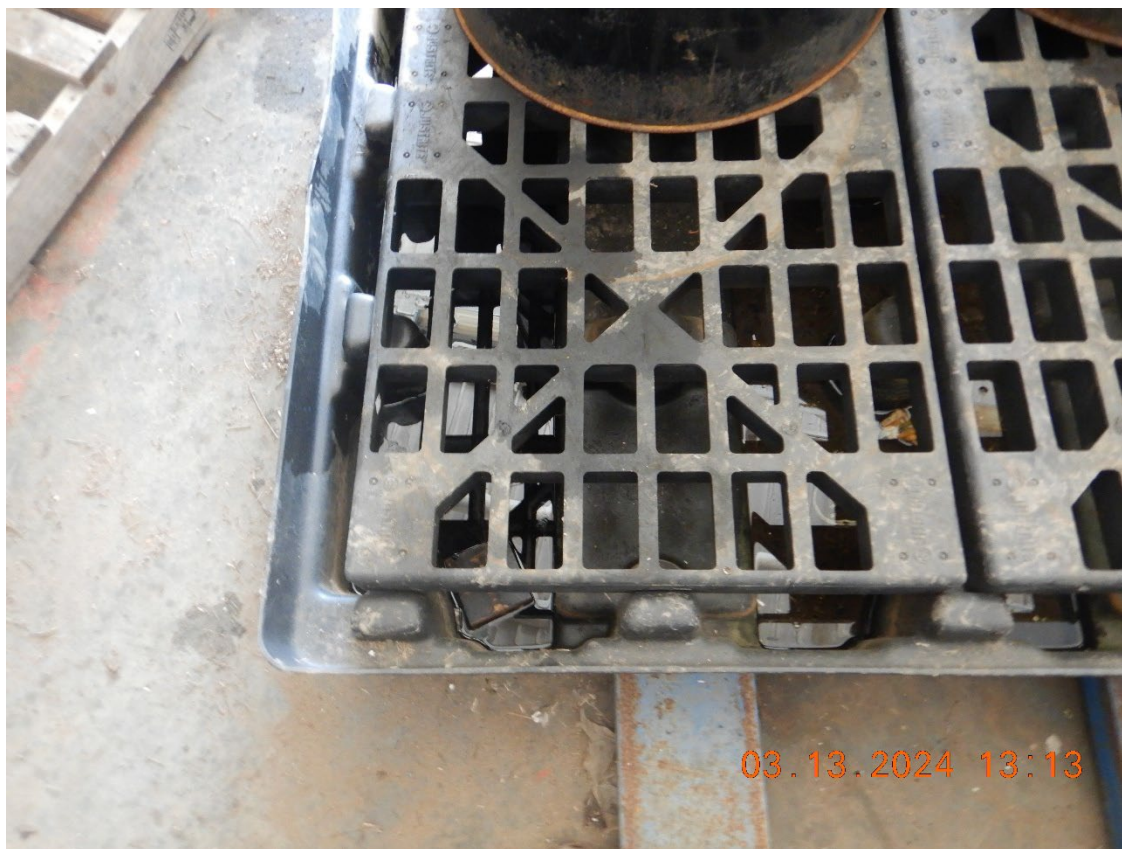
Photo No. 14

Description: View of spilled oil in secondary containment that was not removed in the waste building.

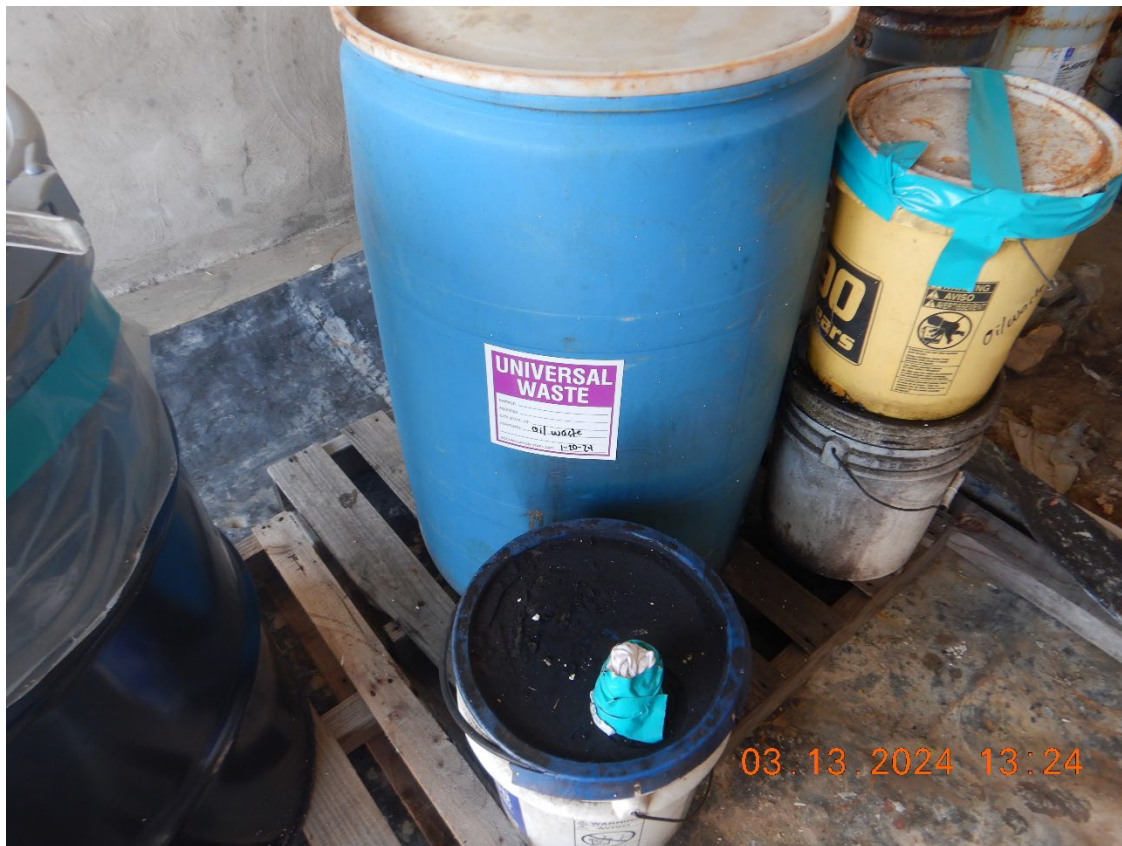
Photo No. 15

In the paint waste area, the inspection team observed one full 55-gallon drum and three full 5-gallon containers of used oil that were not properly labeled with the words “Used Oil” (see Appendix 1 – Photo 15). [See **AOC #1** listed above – Enbridge did not clearly label containers used to store used oil with the words “Used Oil” - 40 CFR 279.22(c)(1)]. The inspection team also observed three non-empty 55-gallon drums and four pallets of 5-gallon drums of paint and paint related waste that were improperly labeled (see Appendix 1 – Photos 16 through 18). [**AOC #7** – *Enbridge did not clearly label containers used to store waste paint with the words “Universal Waste: Paint and Paint Related Waste – 30 TAC 335.262(c)(2)(F)*].

Description: View of 55-gallon drum and three 5-gallon containers of used oil that are not properly labeled in the Paint Waste Storage Area.

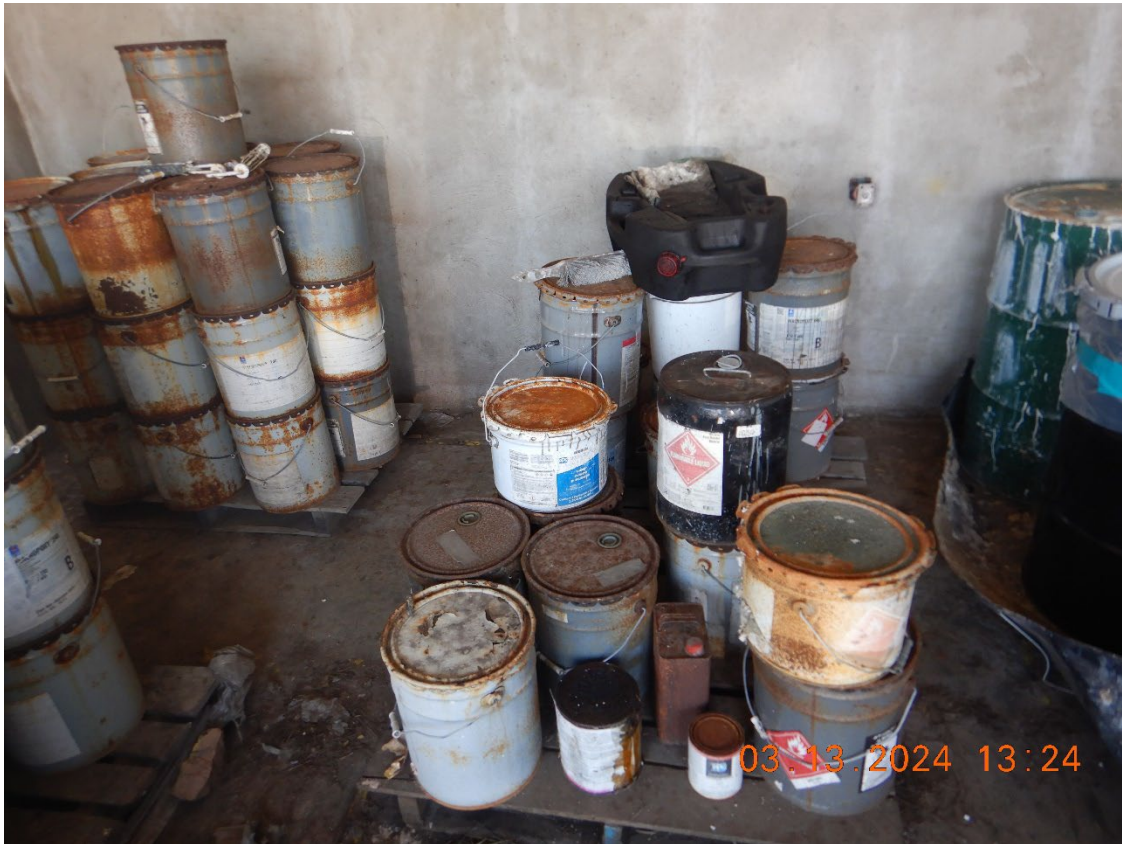
Photo No. 16

Description: View of many 5-gallon containers of paint waste found unlabeled in the Paint Waste Storage Area.

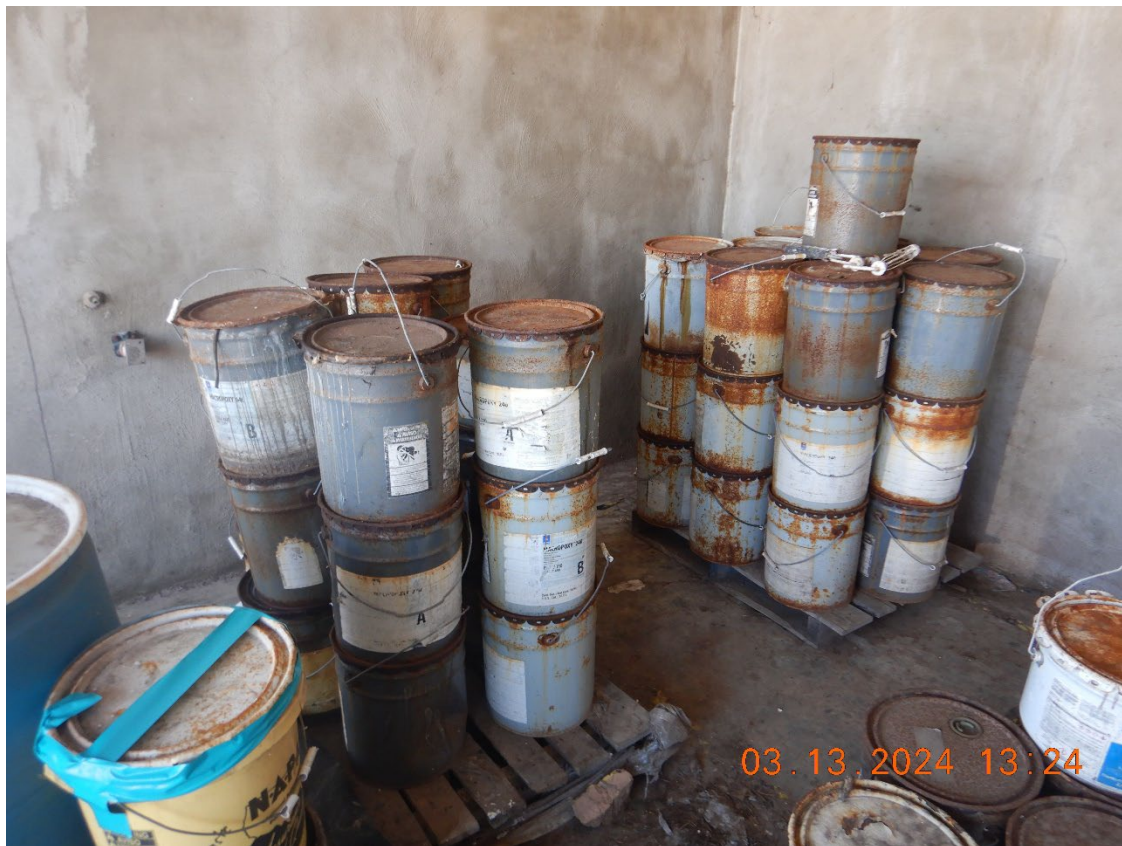
Photo No. 17

Description: View of many 5-gallon containers of paint waste found unlabeled in the Paint Waste Storage Area.

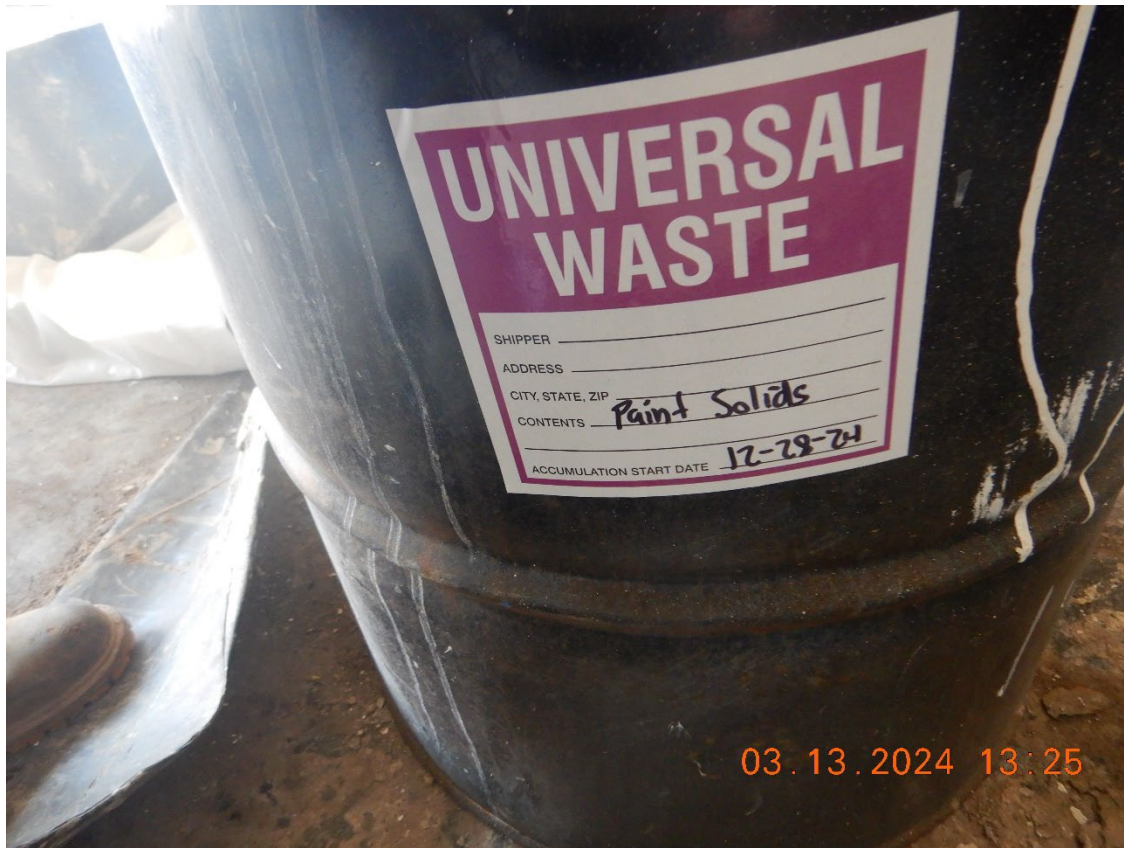
Photo No. 18

Description: Example of most universal waste paint labels found in the Paint Waste Storage Area.

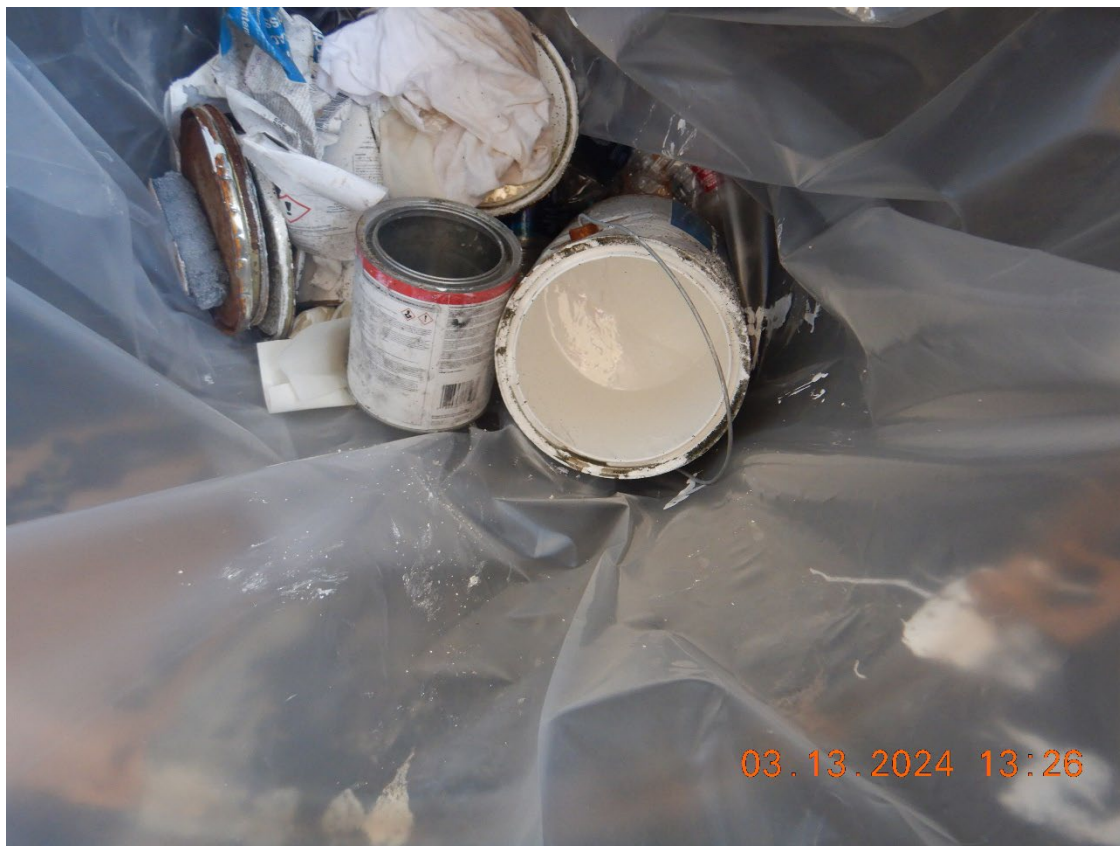
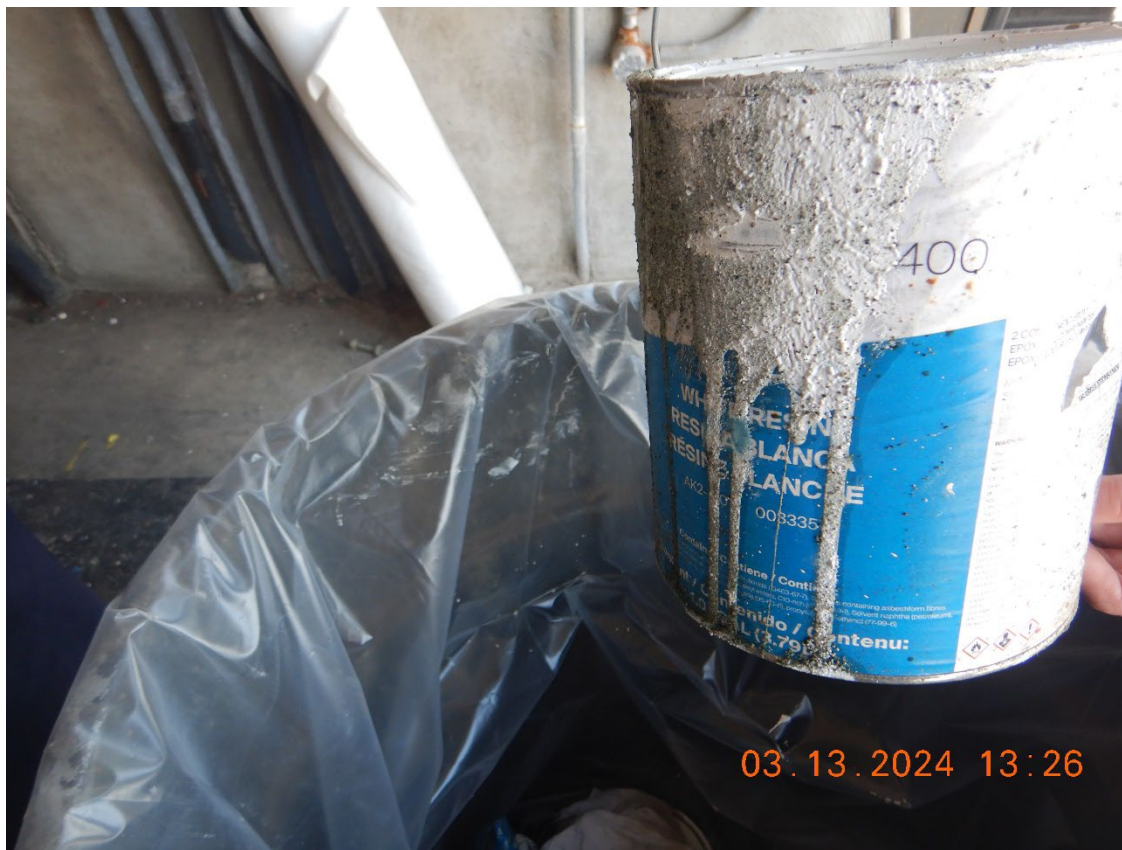
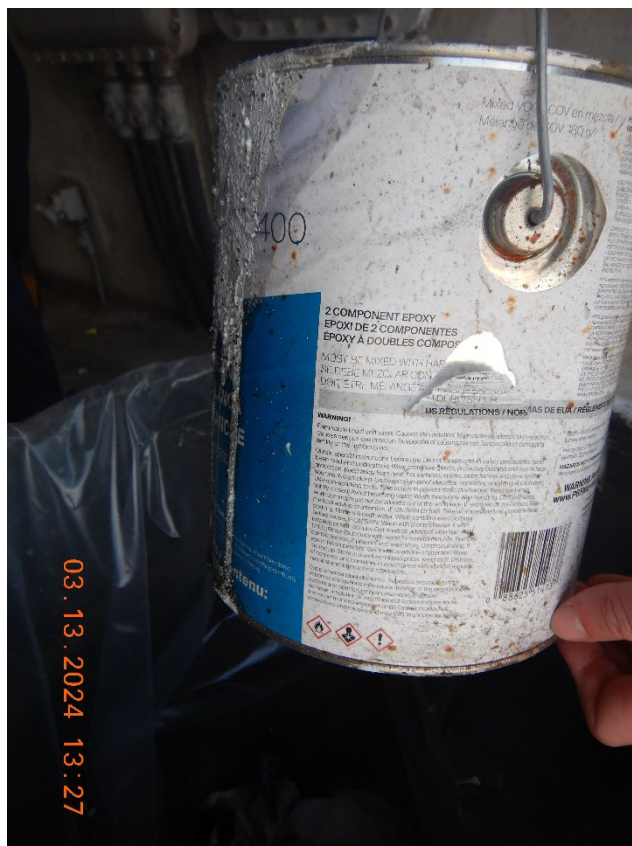
The inspection team observed a 1-gallon container of two-part epoxy paint with liquid paint residue, approximately one quarter full, still inside in a 55-gallon bin labeled as ‘General Trash’ (see Appendix 1 – Photos 19 to 21). [See **AOC #6** listed above – *Enbridge did not make a hazardous waste determination for a solid waste it generated – 40 CFR 262.11*]

Description: View of 1-gallon can of 2-part epoxy paint with residual liquid paint still inside found in an open trash can labeled "General Trash" in the Paint Waste Storage Area.

In the follow-up email sent on 03/29/2024, Enbridge explained the staff has reorganized and properly labeled the paint and paint-related waste storage area, ensuring all containers were sealed and positioned correctly, while also removing any potential paint waste from the general plant trash can and ordering signs to enhance identification of the area (see Appendix 2).

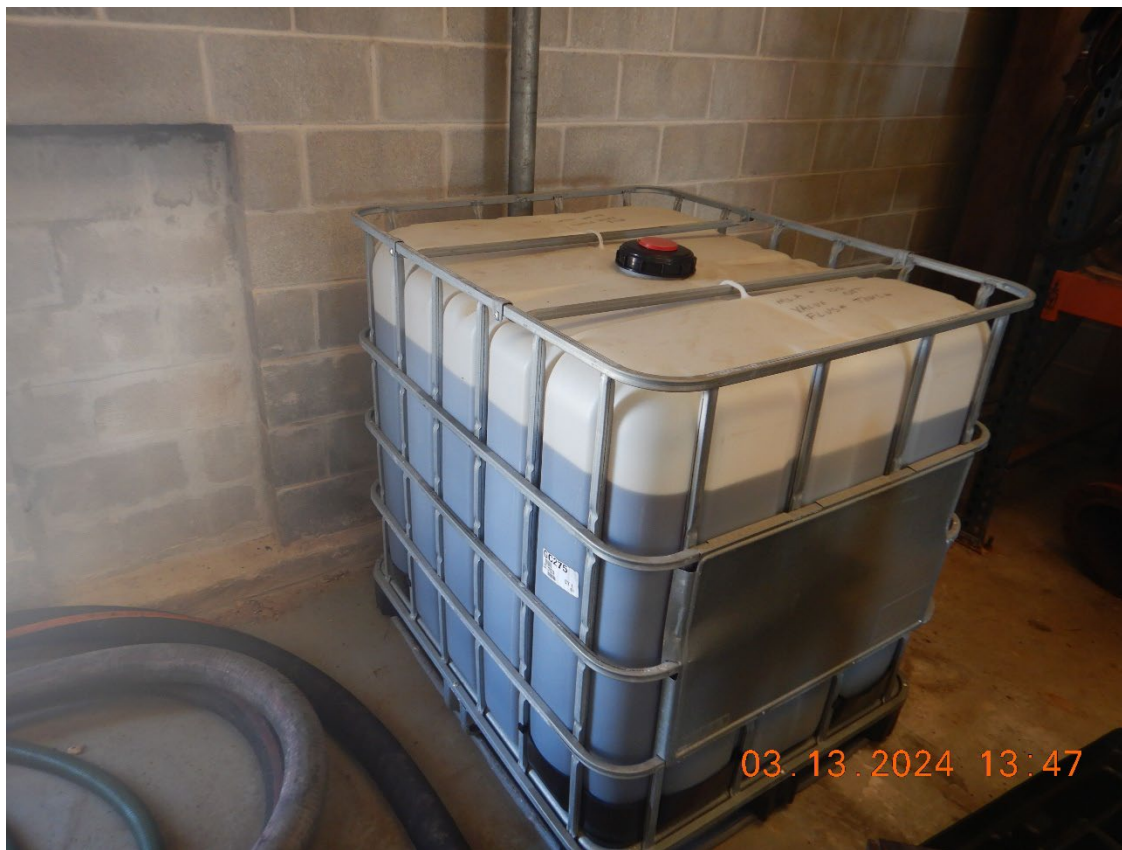
Photo No. 22

The inspection team observed the dock areas and the dock storage area where a 275-gallon tote was found, which initially was thought to be waste, but was determined to be good diesel product by Enbridge staff (see Appendix 1 – Photo 22). No apparent AOCs were noted at the dock storage area.

Description: View of unlabeled 275-gallon tote that was determined to be product in the Dock Storage Area.
