**RE: ALCOA BUILDING ENVIRONMENTAL ASSESSMENT  
MODIFIED PHASE I FINAL REPORT**

**RE: ALCOA BUILDING - MODIFIED PHASE I  
ENVIRONMENTAL ASSESSMENT DRAFT REPORT**

Subject: Phase I Environmental Assessment  
Alcoa Building  
Color Photos from Final Report

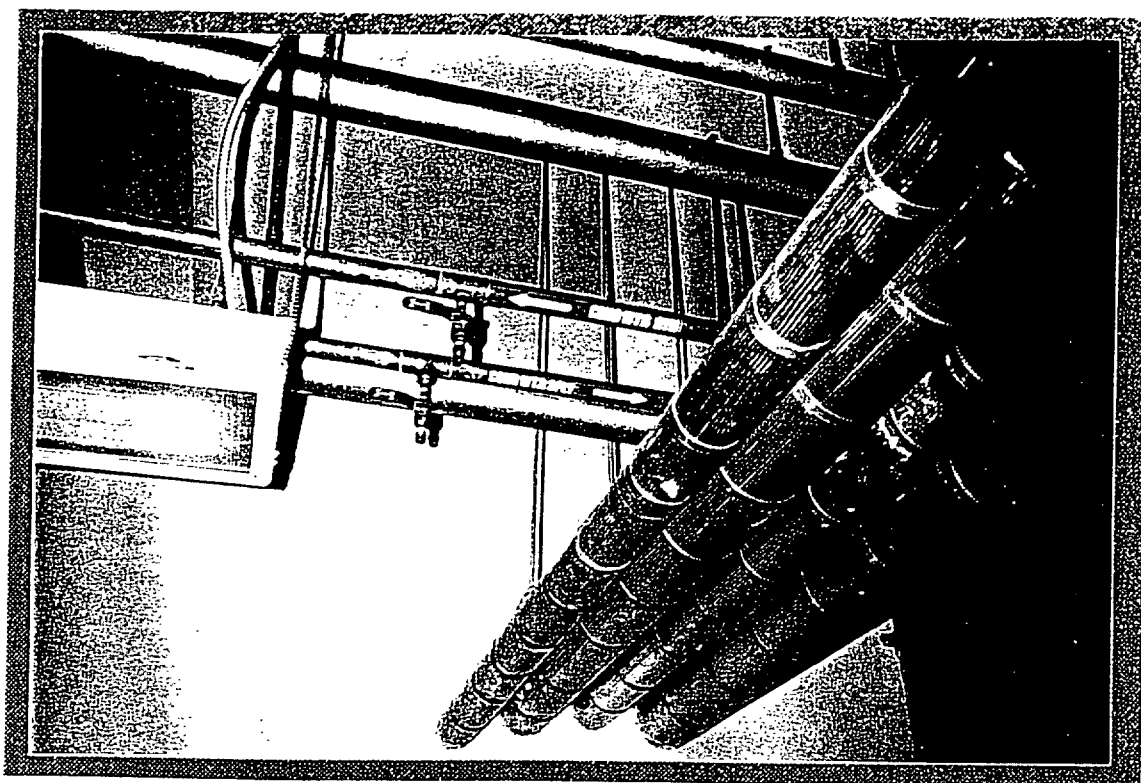
*Cooling tower conditioned water piping, room SB-65.*

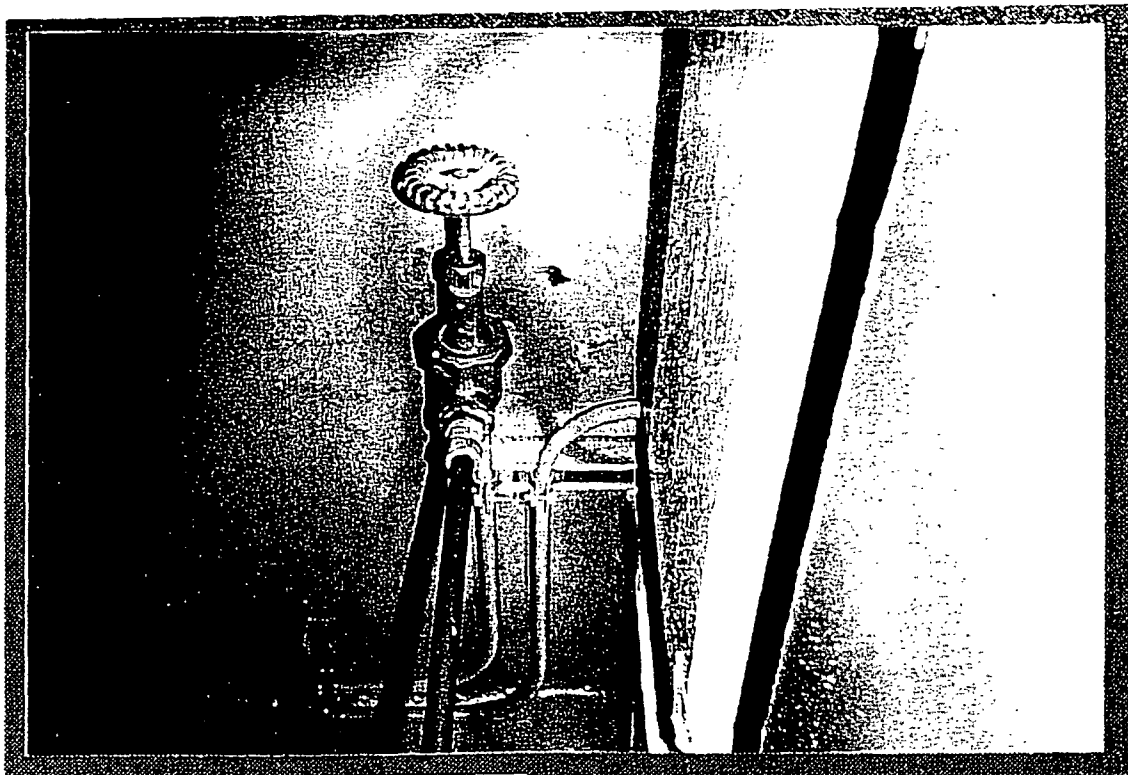
*Slight diesel leak at fuel line  
valve in generator room.*

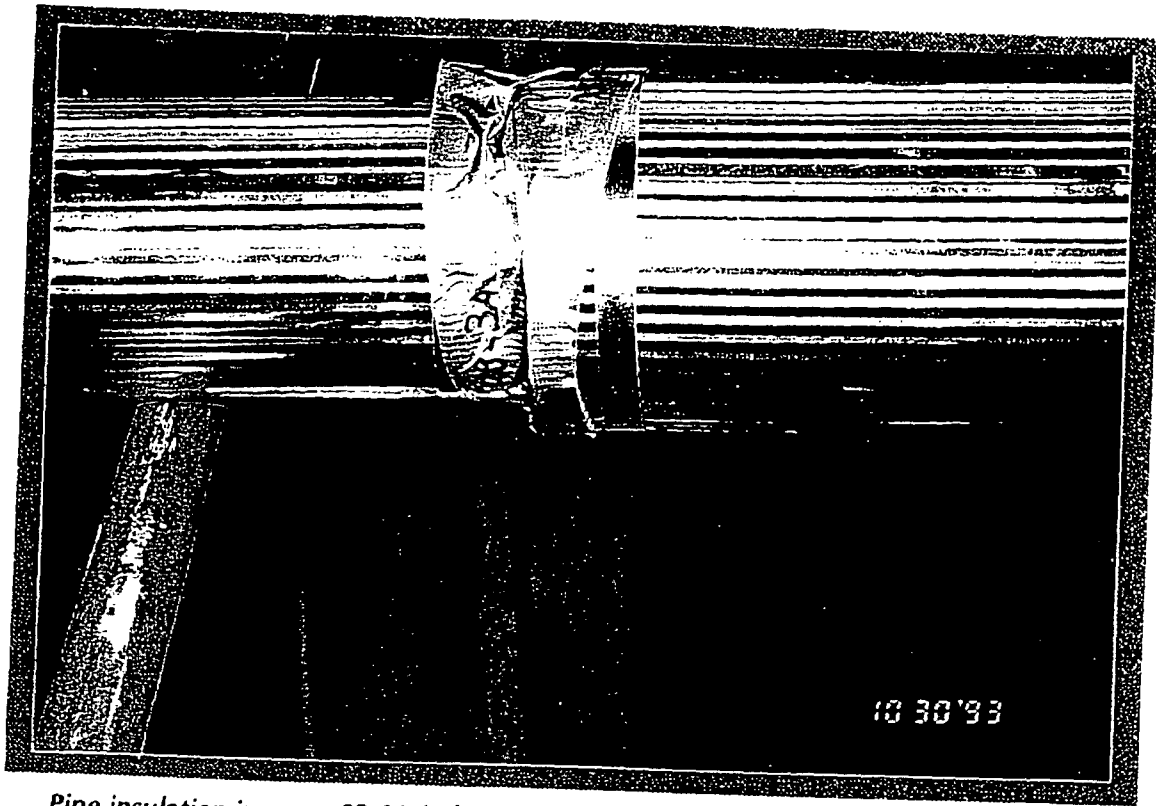
*Pipe insulation in room SB-82 (asbestos sample SB-3A).*

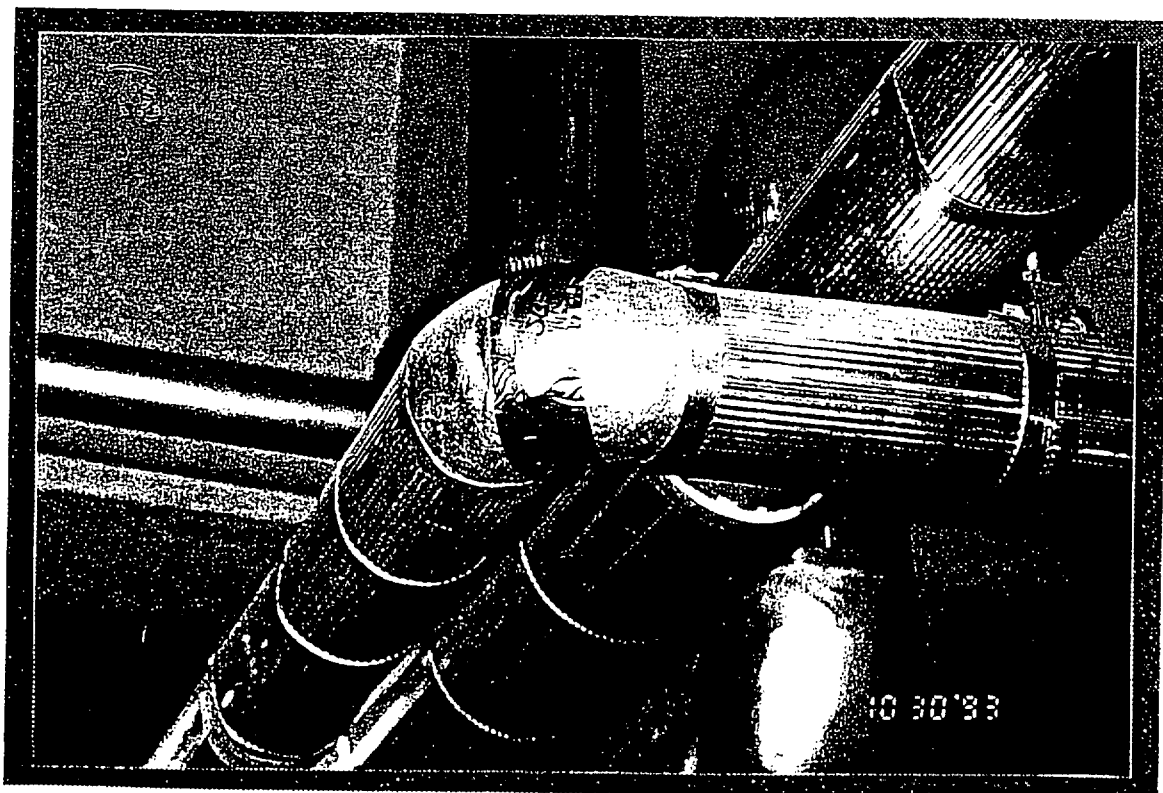
*Pipe elbow insulation in room SB-65 (asbestos sample SB-5B).*

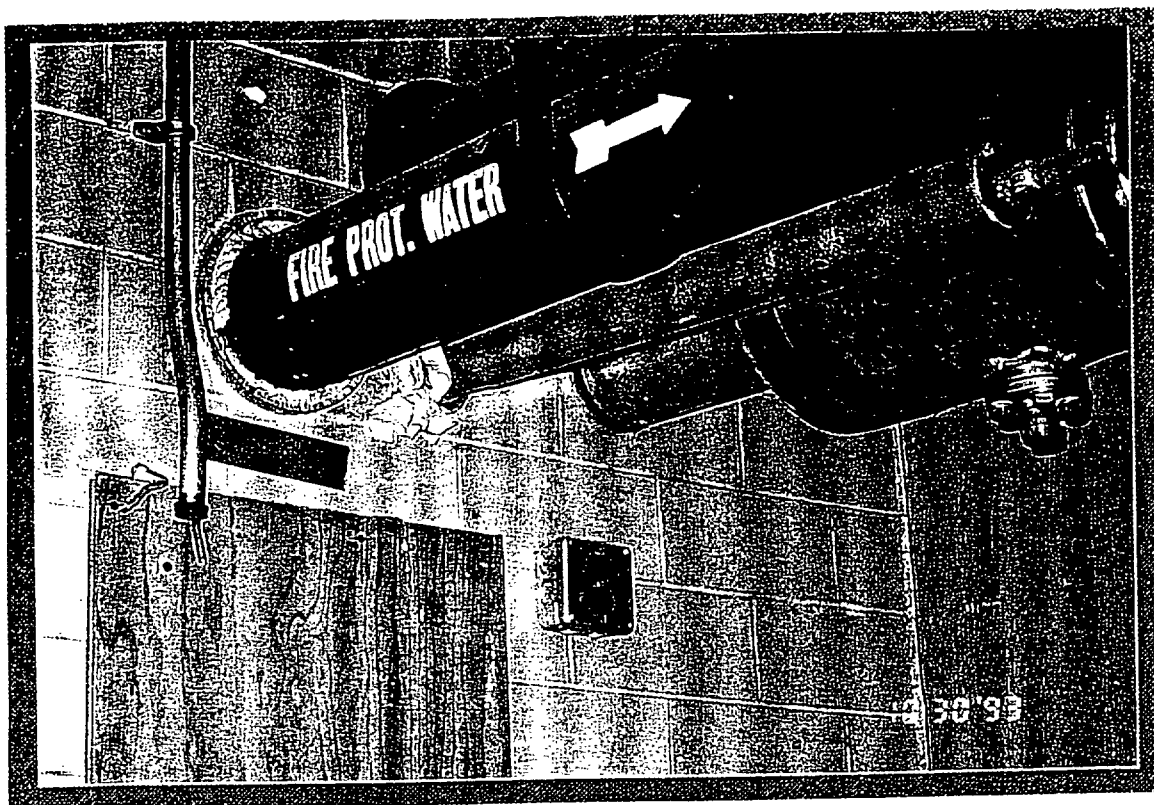
*Rope packing around fire protection water line (asbestos sample SB-6) and pipe insulation on city water line (asbestos sample SB-7A) in room SB-65.*

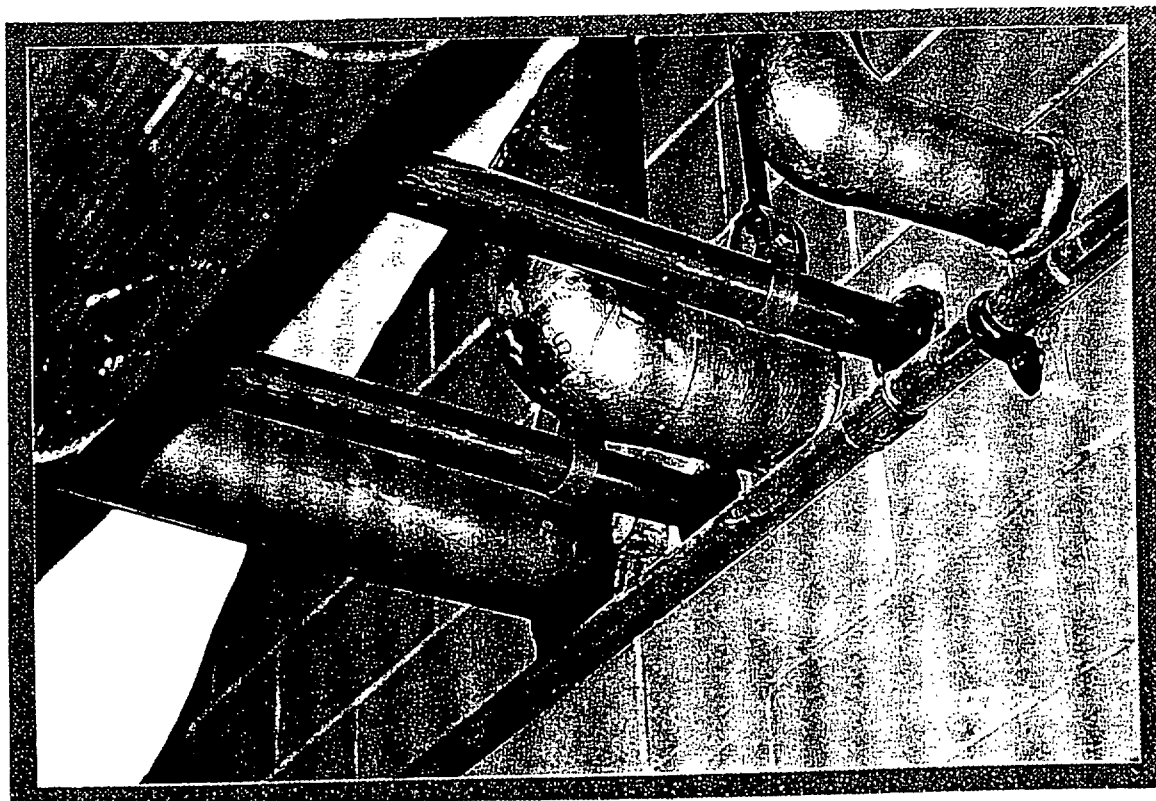
*Pipe elbow insulation in room SB-65A (asbestos sample SB-8B).*

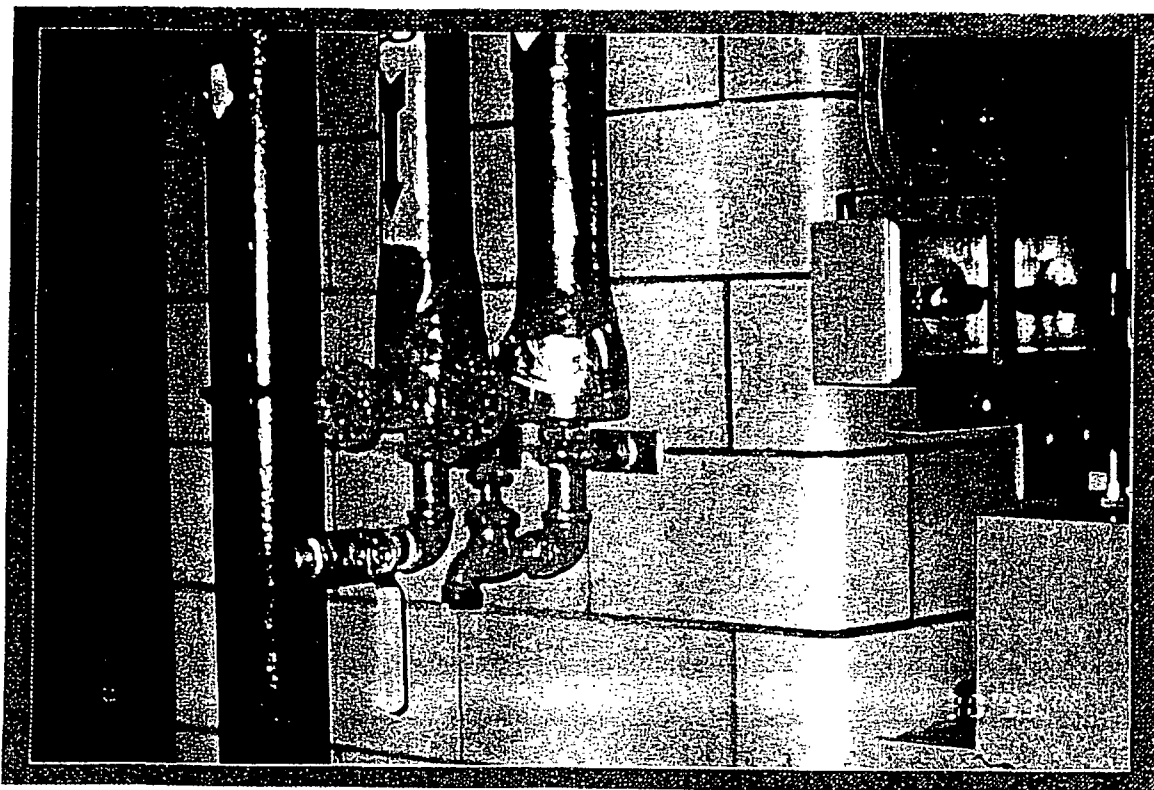
*Pipe insulation on city water line in subbasement in engine room (asbestos sample SB-11B).*

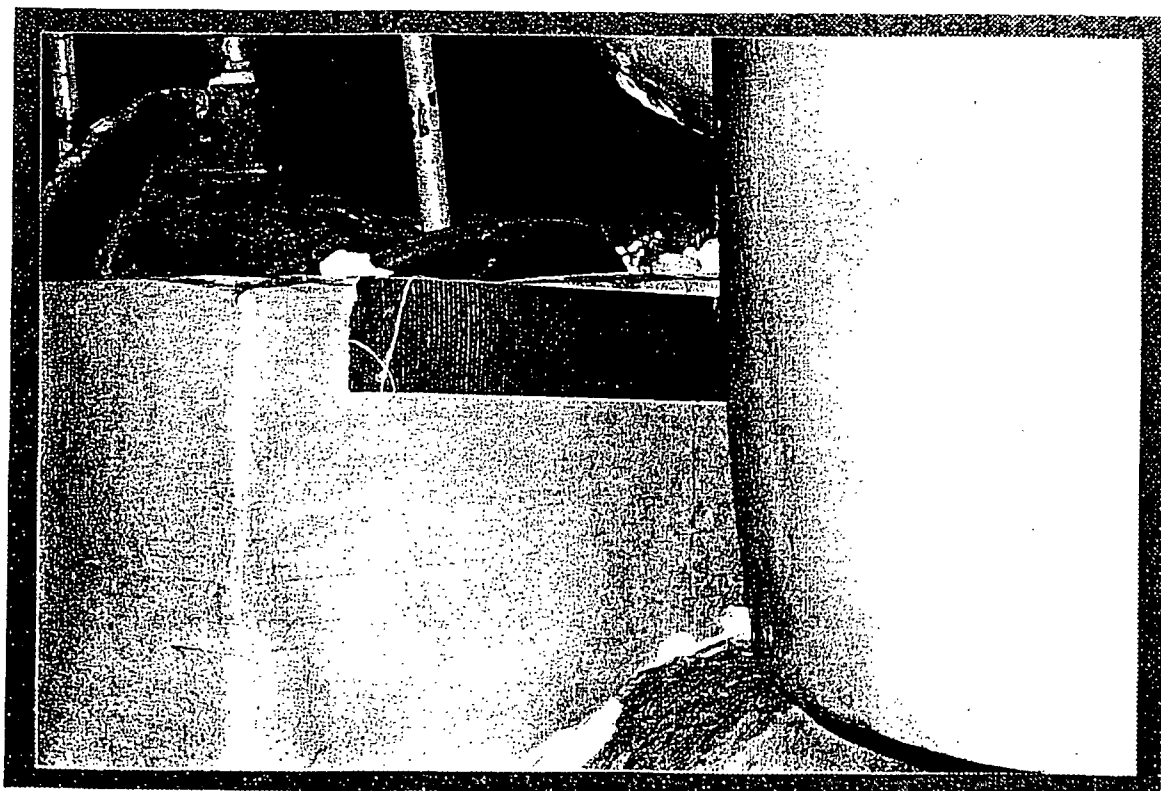
*Pipe elbow insulation on chillers in subbasement engine room (asbestos sample SB-12).*

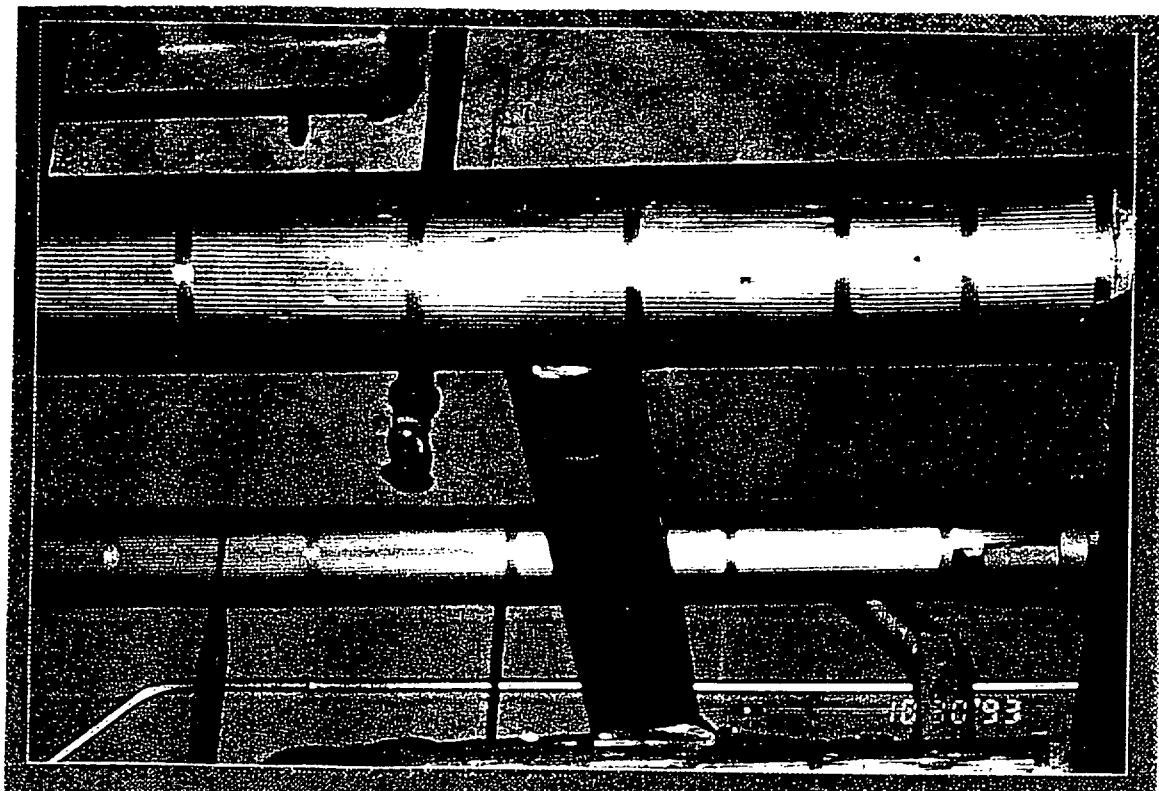
*Pipe insulation in room B-61  
(asbestos sample B-1).*

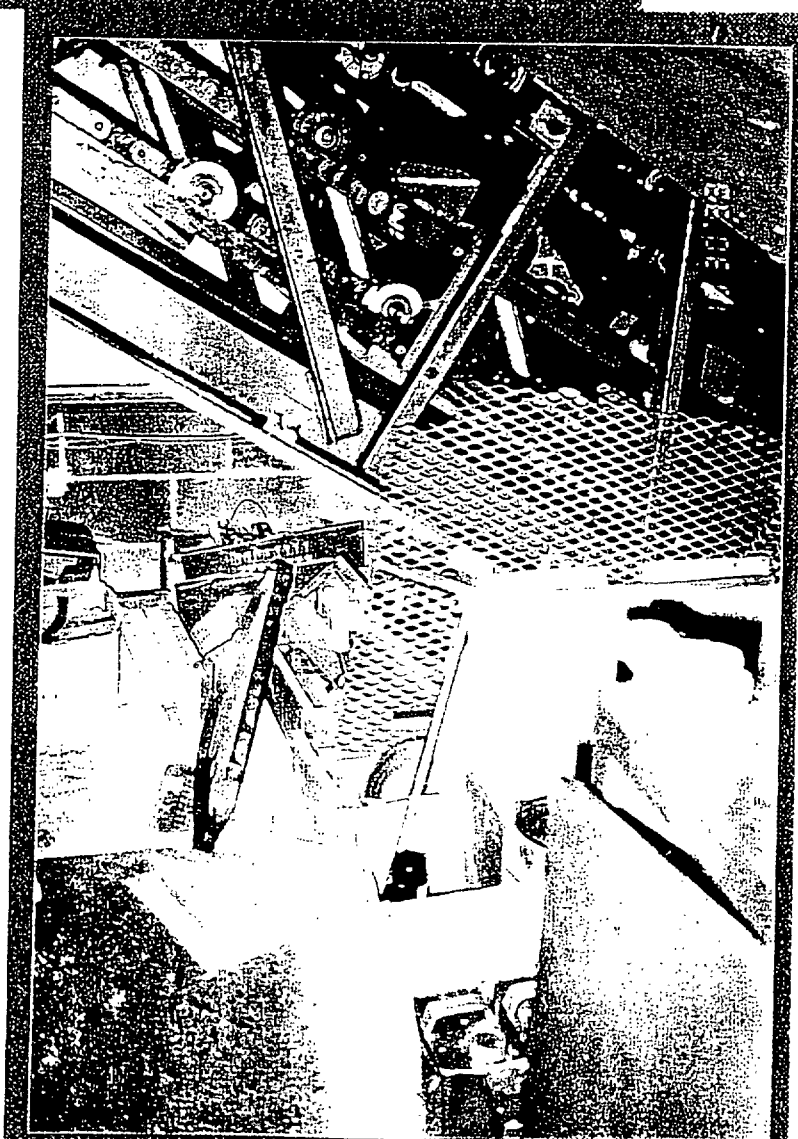
*Underside of escalator at  
basement level (above stained  
area in subbasement corridor).*

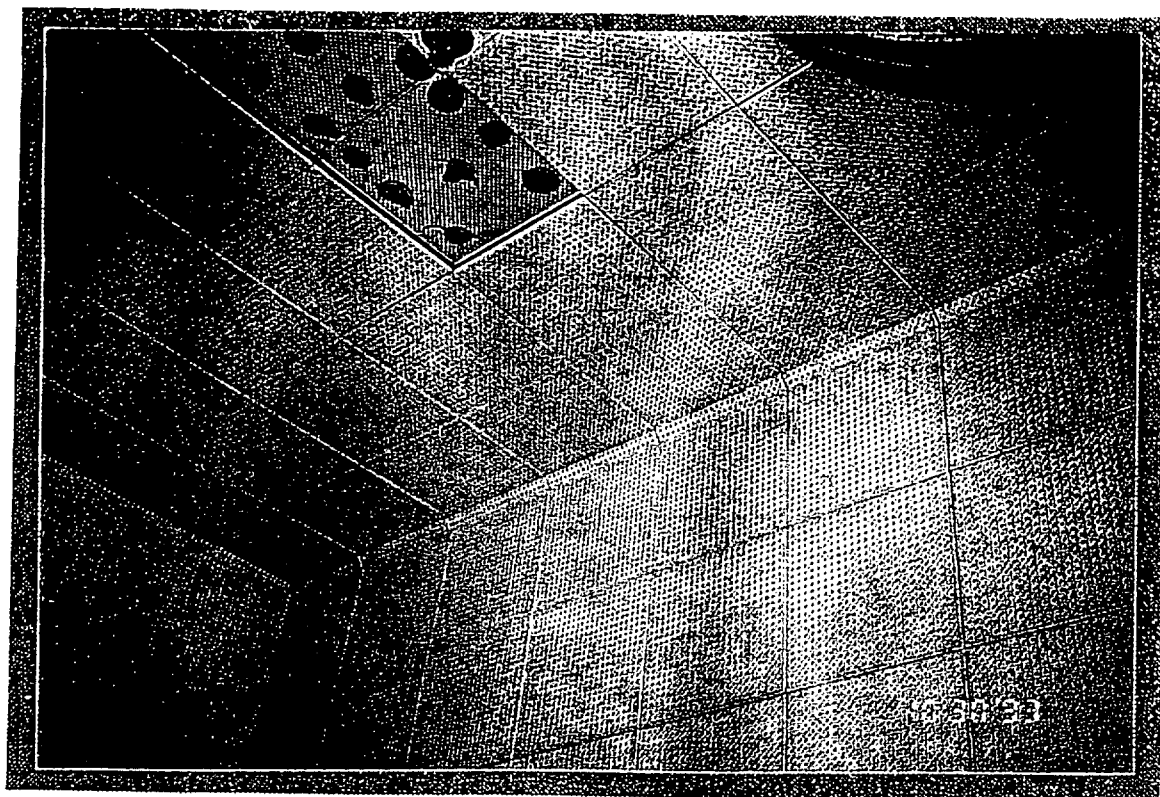
*Acoustical tile in recording studio, room B-51E (asbestos sample B-4).*

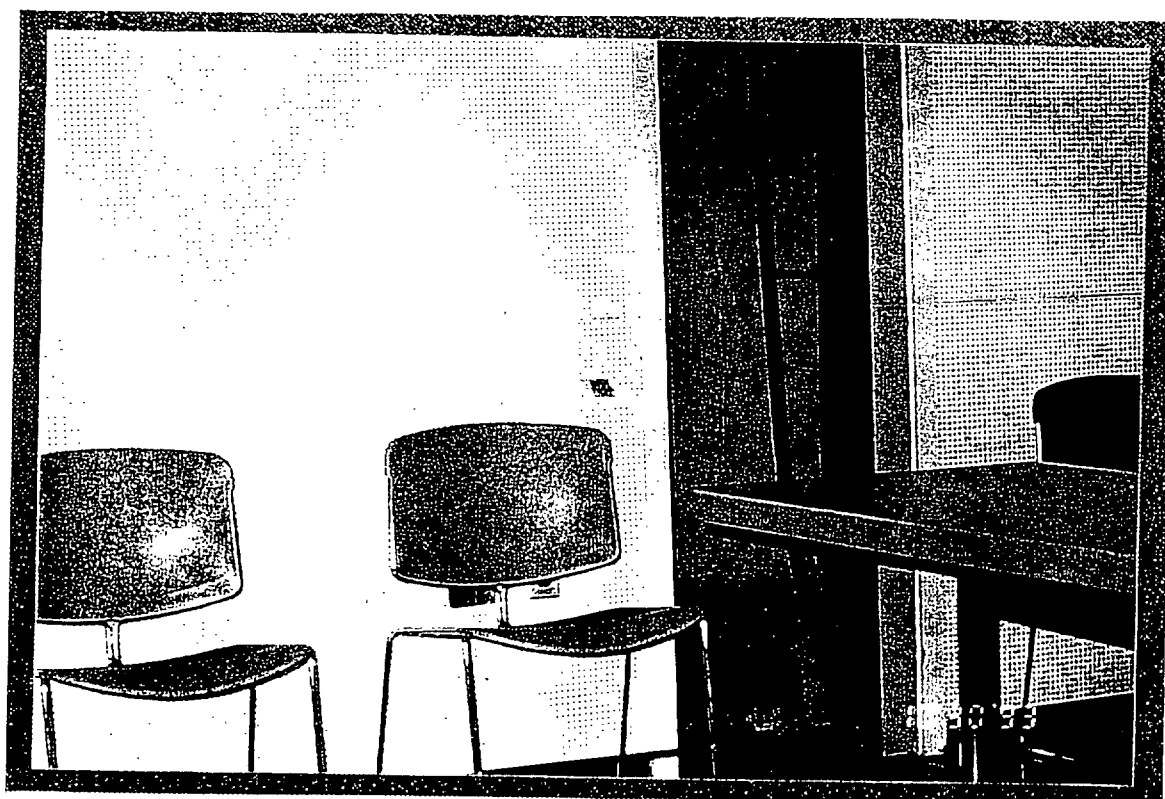
*Wallboard in duplication center, room B-48 (asbestos sample B-3).*

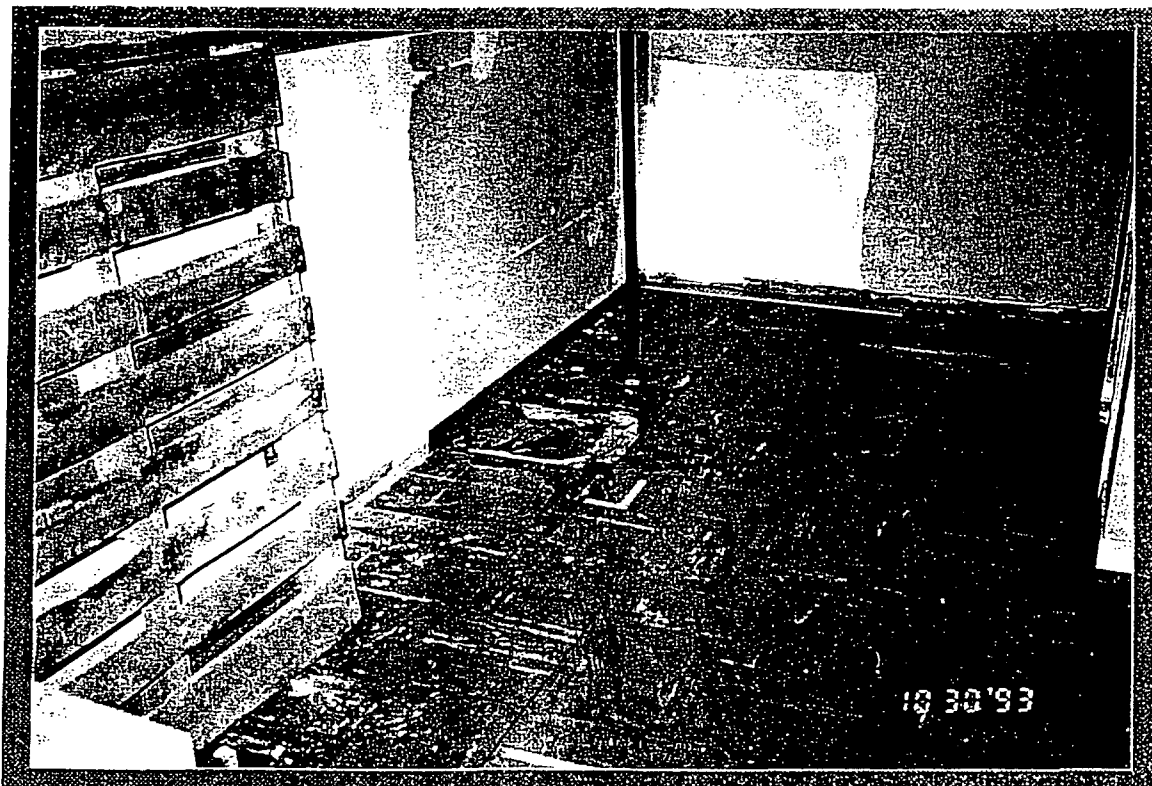
1. Chemically stained shelves and floor tile were observed in the old darkroom located in the former duplication center in the basement. This would be a minor finding that could be easily remedied.

*Stained floor tile in former basement darkroom, room B-51.*

3. Don Burrell has informed me that the problem with the stained shelves and floor tile in the basement has been corrected.
4. The hydraulic lift in the Executive Annex is inspected regularly and has not presented a problem. Future building owners would be responsible for proper maintenance.

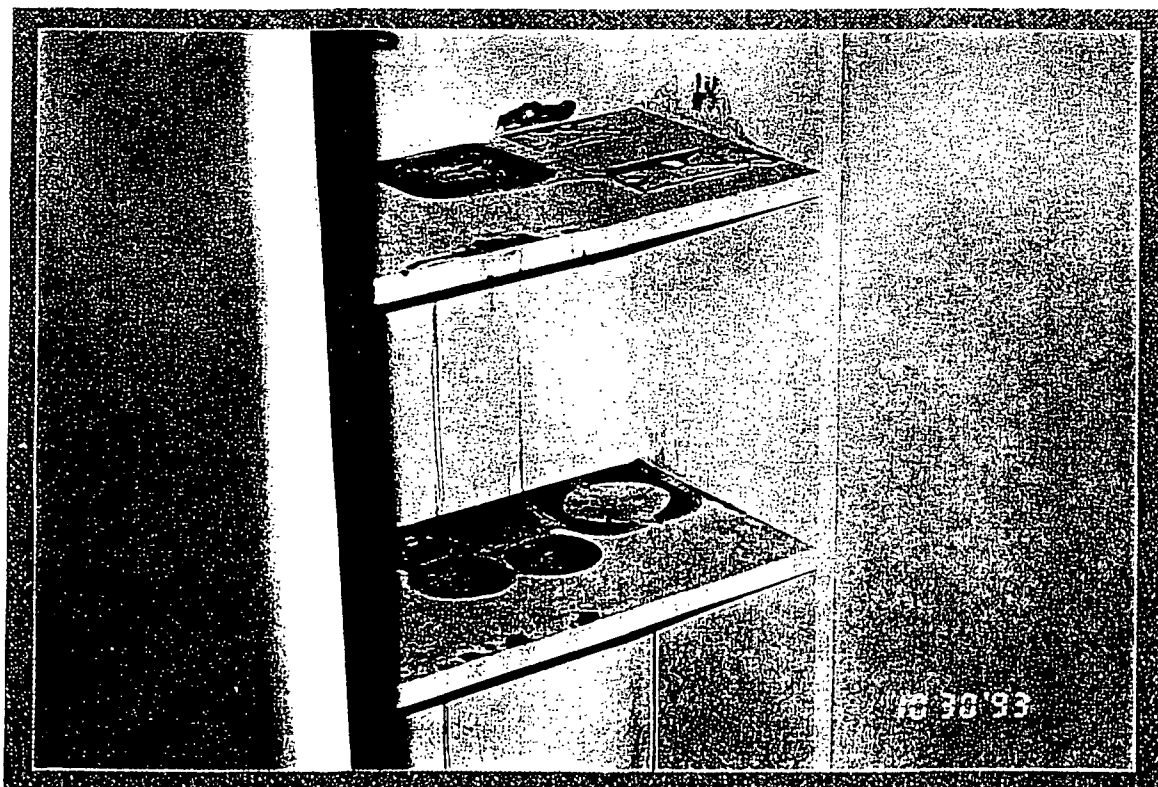
*Stained shelves in former basement darkroom, room B-51.*

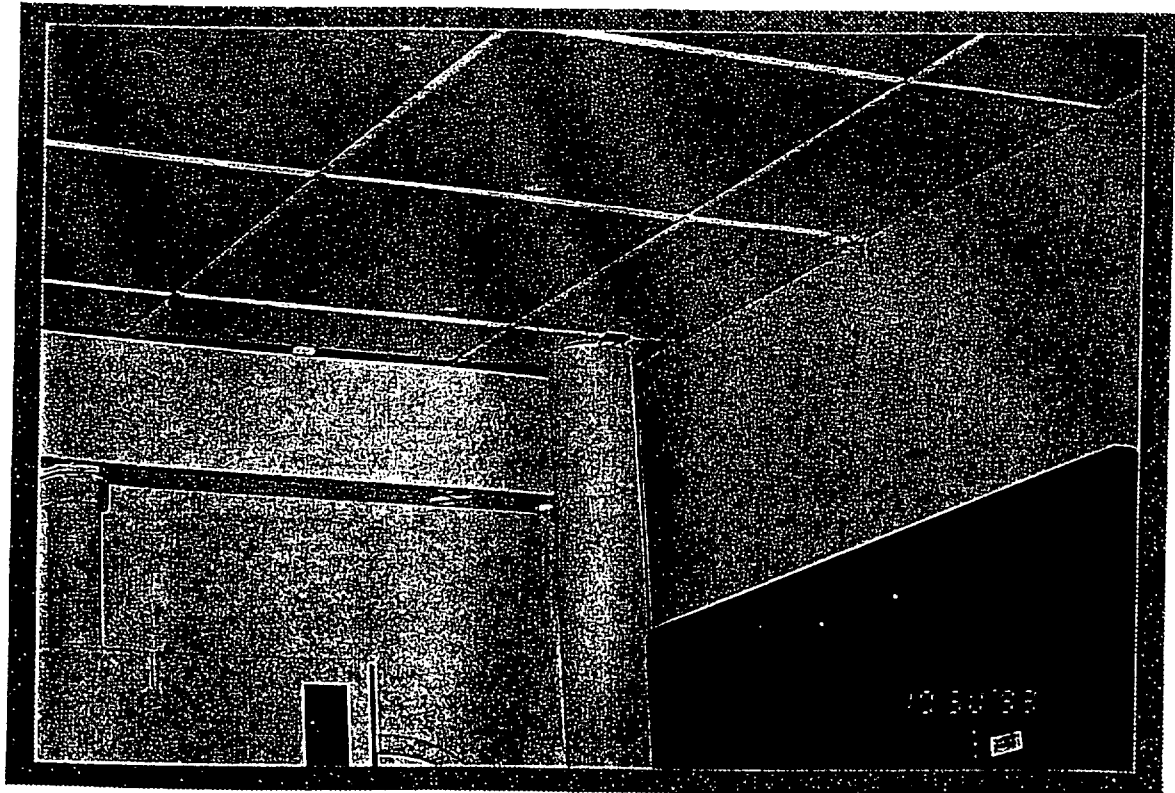
*Ceiling tile in basement guardroom, room B-26 (asbestos sample B-7).*

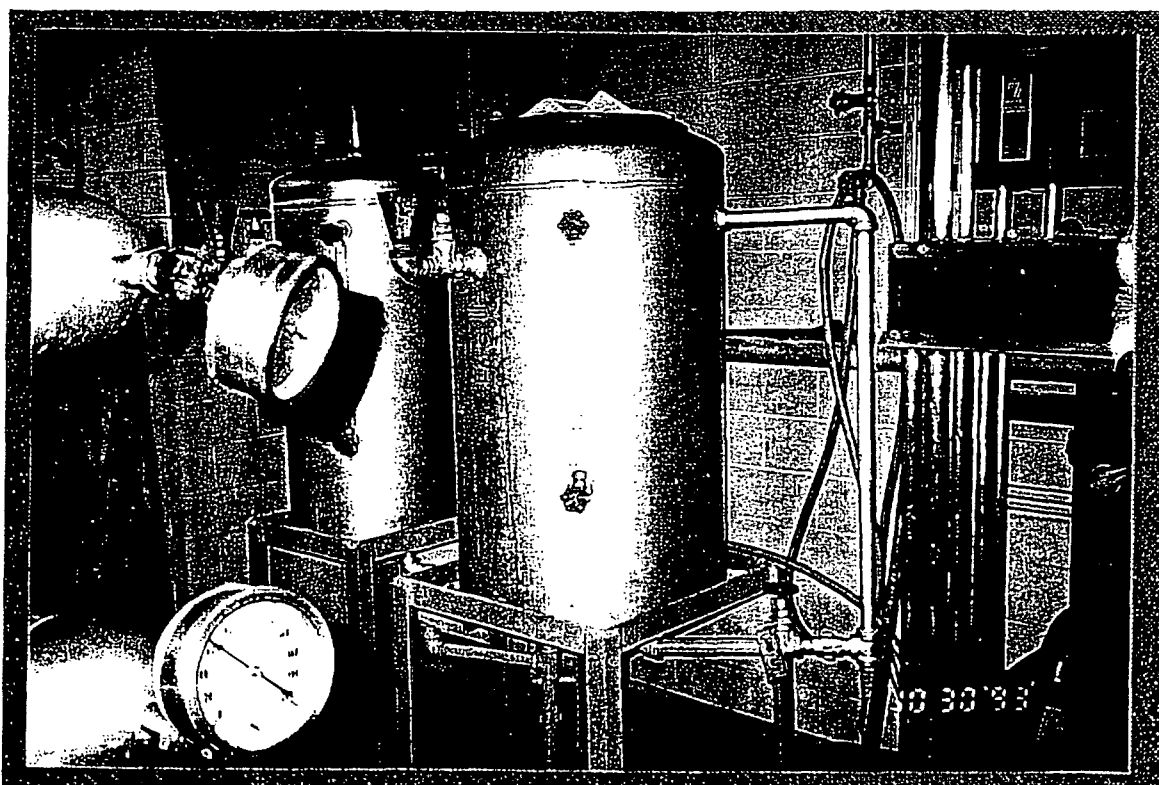
3. The consultant's investigation indicated a possible leakage of a ethylene glycol solution (antifreeze) from the snow melt system installed beneath the sidewalks outside the building. The snow melt system was in use between 1987 and 1990. There may be a need to conduct testing of the soil/groundwater beneath the sidewalk to determine the significance of this release. This however, should not be a major issue.

*Reservoir tank for former snow melt system in 2nd floor fan room.*

1. Based on my conversations with I. C.F. Kaiser and others within Alcoa (Gary Crouth & John George), I do not feel that soil and groundwater sampling is warranted due to past problems with leaks in the snow melt system. The leakage did not appear to be major and the heat exchange fluid would be very biodegradable and most likely would not be present at this point in time. Perhaps the only reason to conduct any sampling would be to take a "belt & suspenders" approach. I would recommend not conducting sampling and to wait until a buyer is found to see if testing is an issue in the transfer.

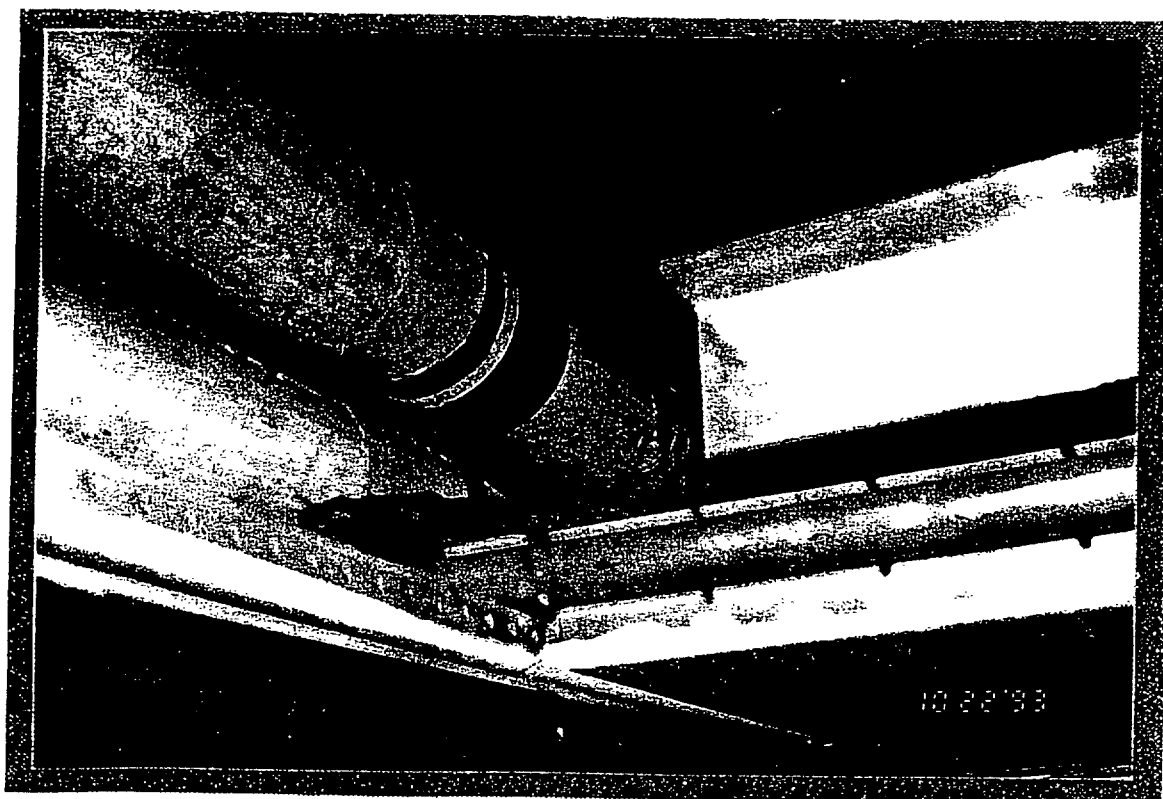
*Pipe insulation in Cigar Shop, above ceiling (asbestos sample 1-CS-01A).*

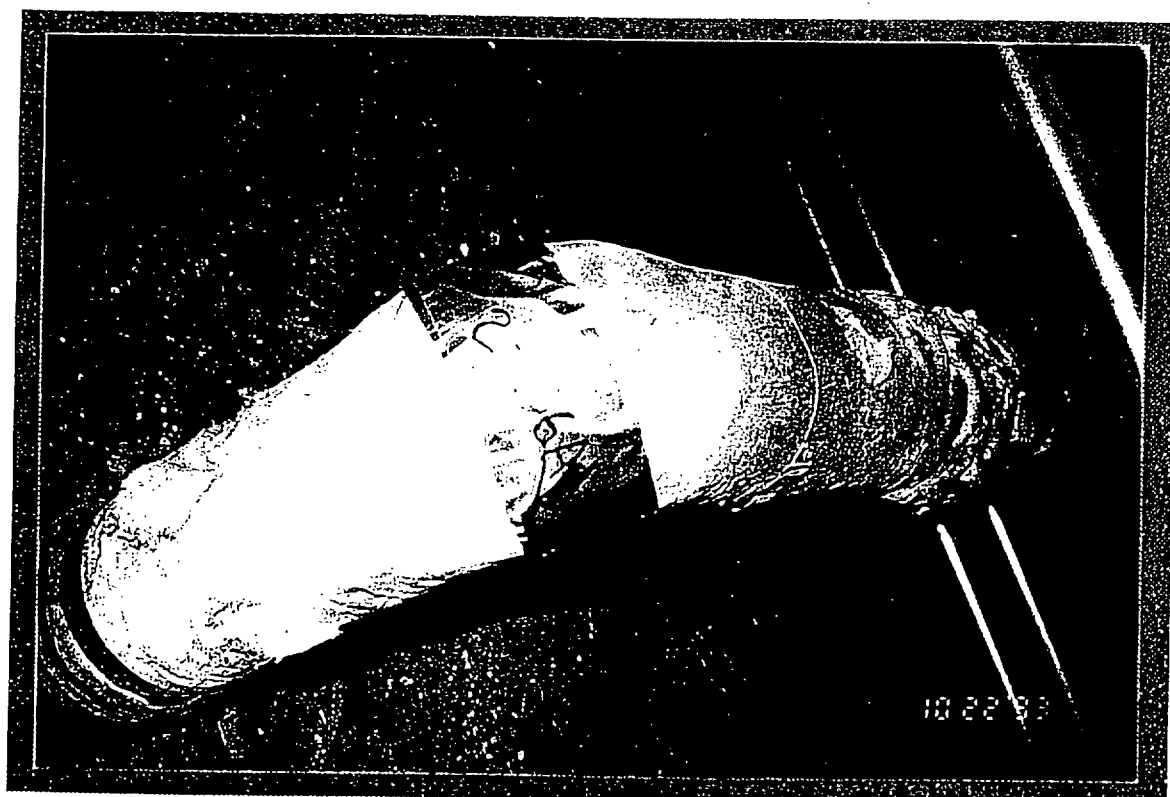
*Pipe insulation on 2nd floor (asbestos sample 2-6A).*

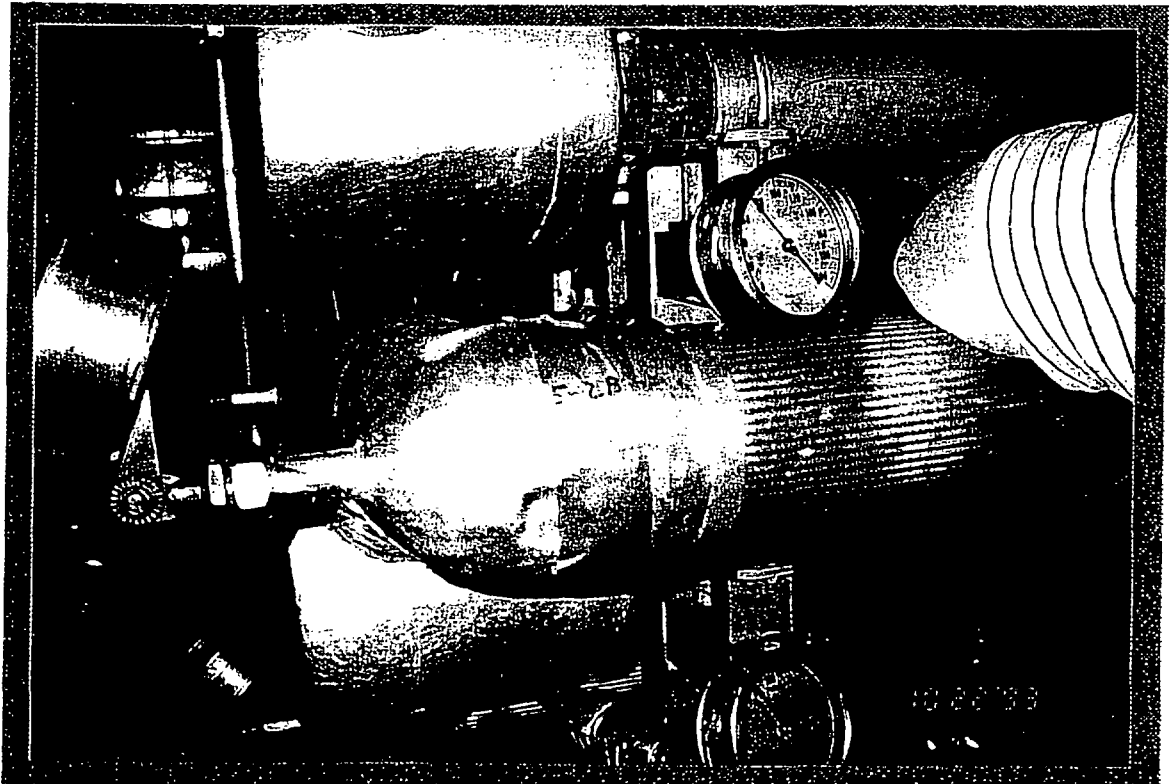
*Pipe elbow insulation in 5th floor fan room (asbestos sample 5-2B).*

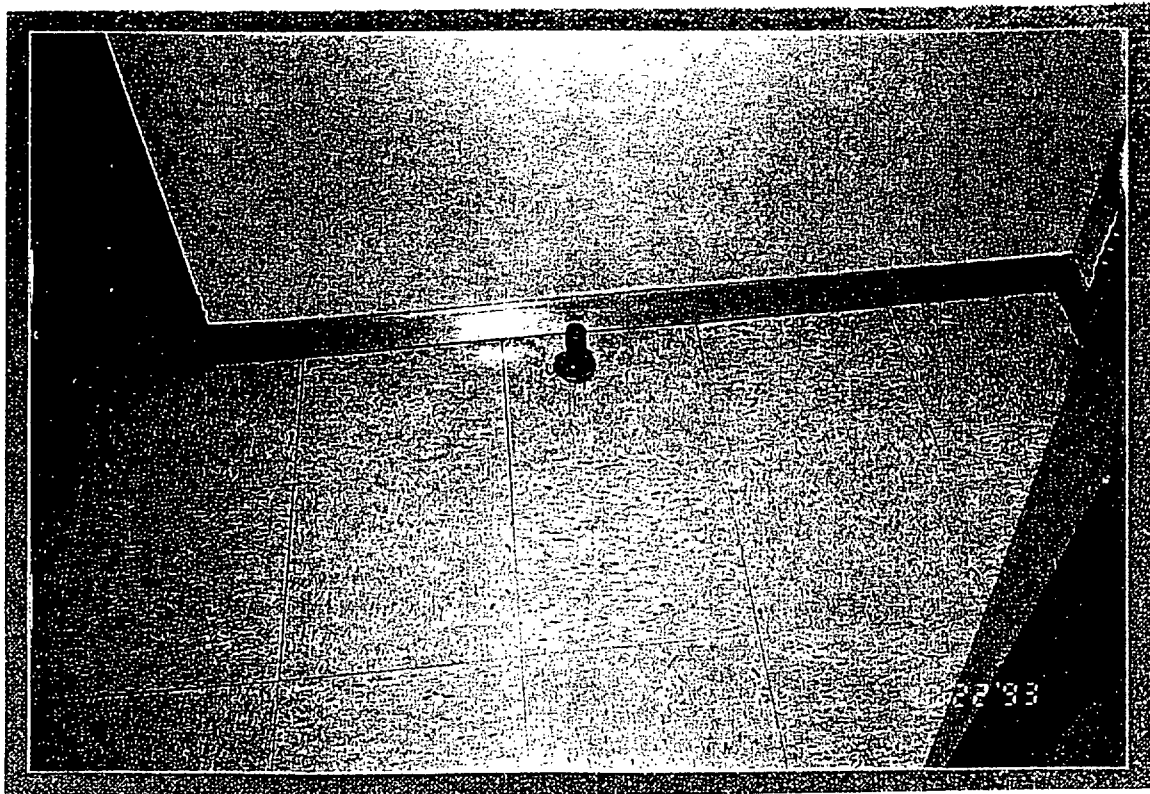
*Beige floor tile in room 1570E, 15th floor (asbestos sample 15-2).*

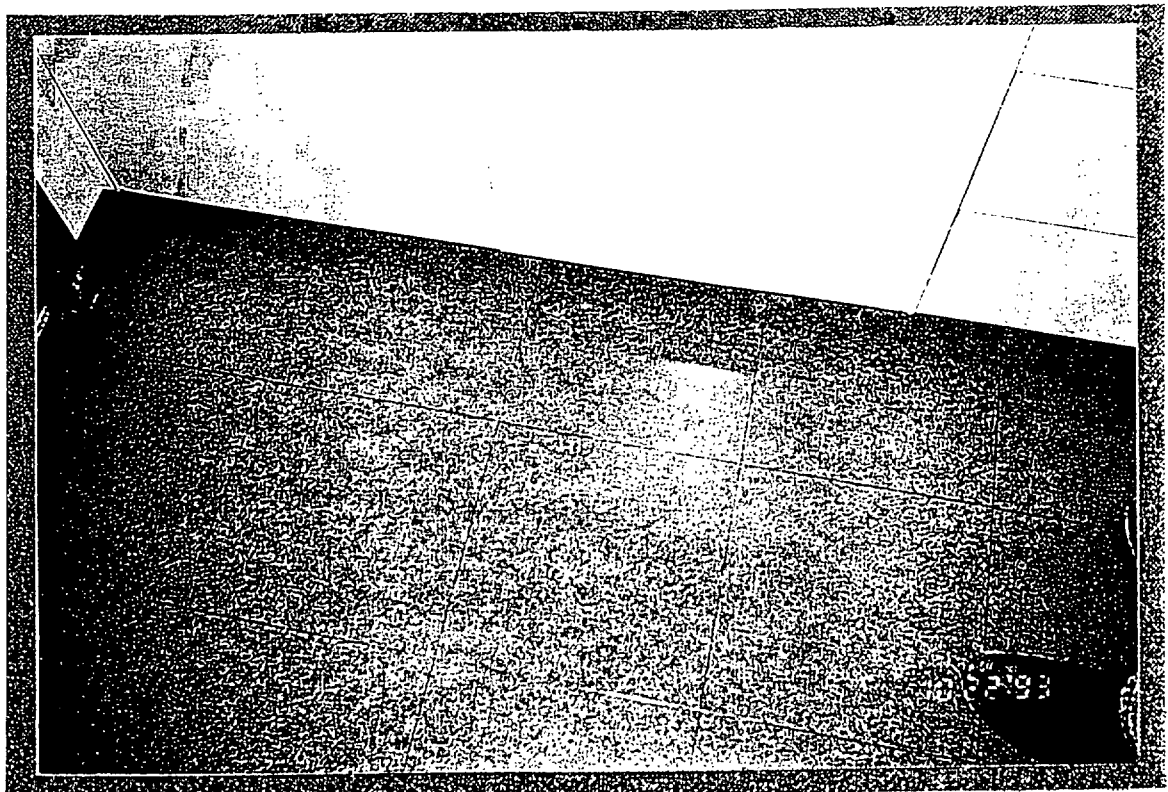
*Green and black floor tile in room 1570D, 15th floor (asbestos sample 15-3).*

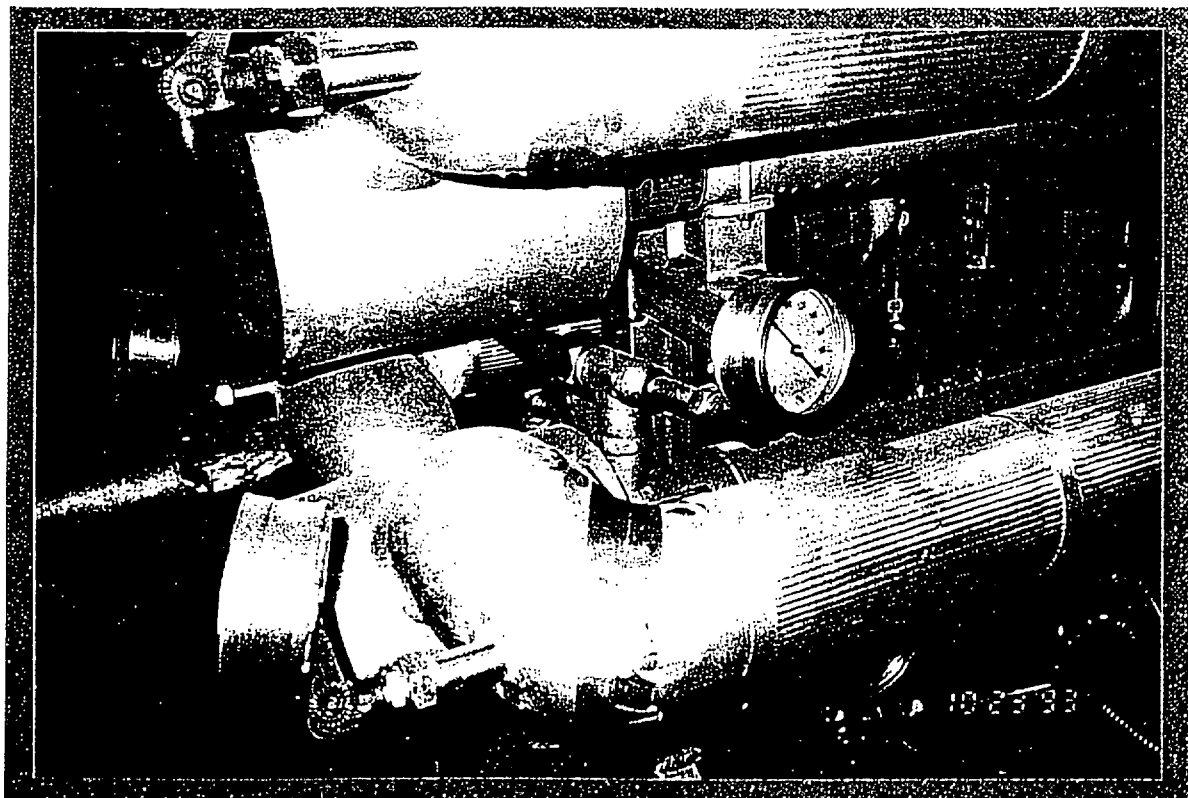
*Fan room on 21st floor (asbestos sample 21-03B).*

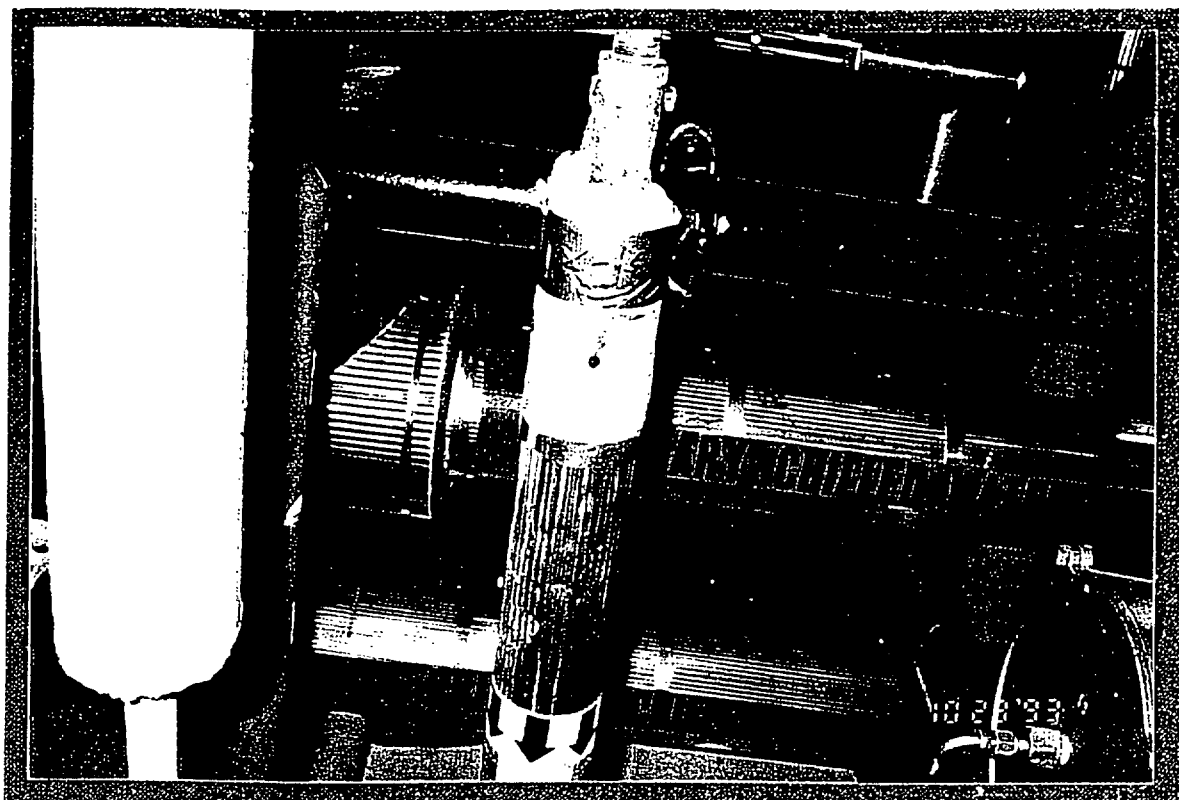
*Pipe insulation in fan room on 31st floor (asbestos sample 31-7A).*

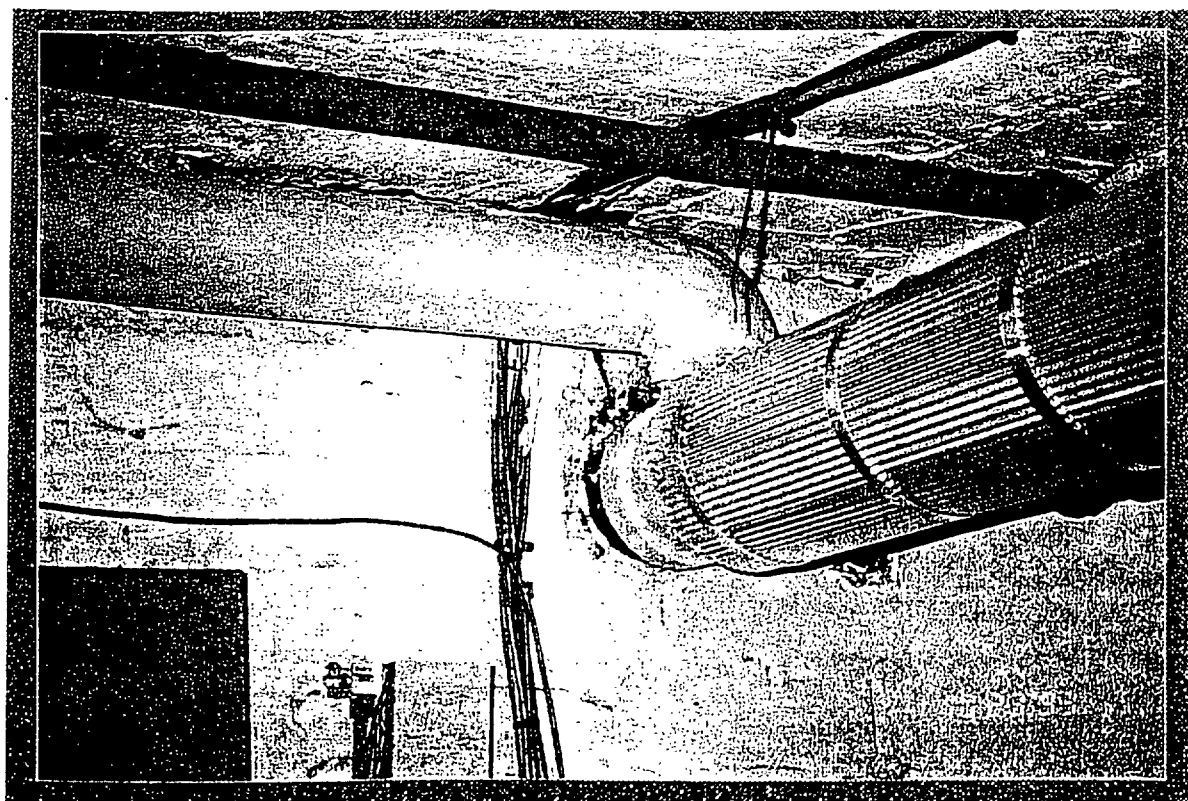
*Pipe elbow insulation in basement of Harvard/Yale/Princeton Club  
(asbestos sample HYP-1-6B).*
