**Region 6 Compliance Assurance and Enforcement Division  
INSPECTION REPORT**

| Inspection Date(s): | 02/07/2018 | | |
| Company Name: | <b>FF&amp;N Oil Company</b> | | |
| Facility Name: | <b>Diffey No1 Manville No5 SWD</b> | | |

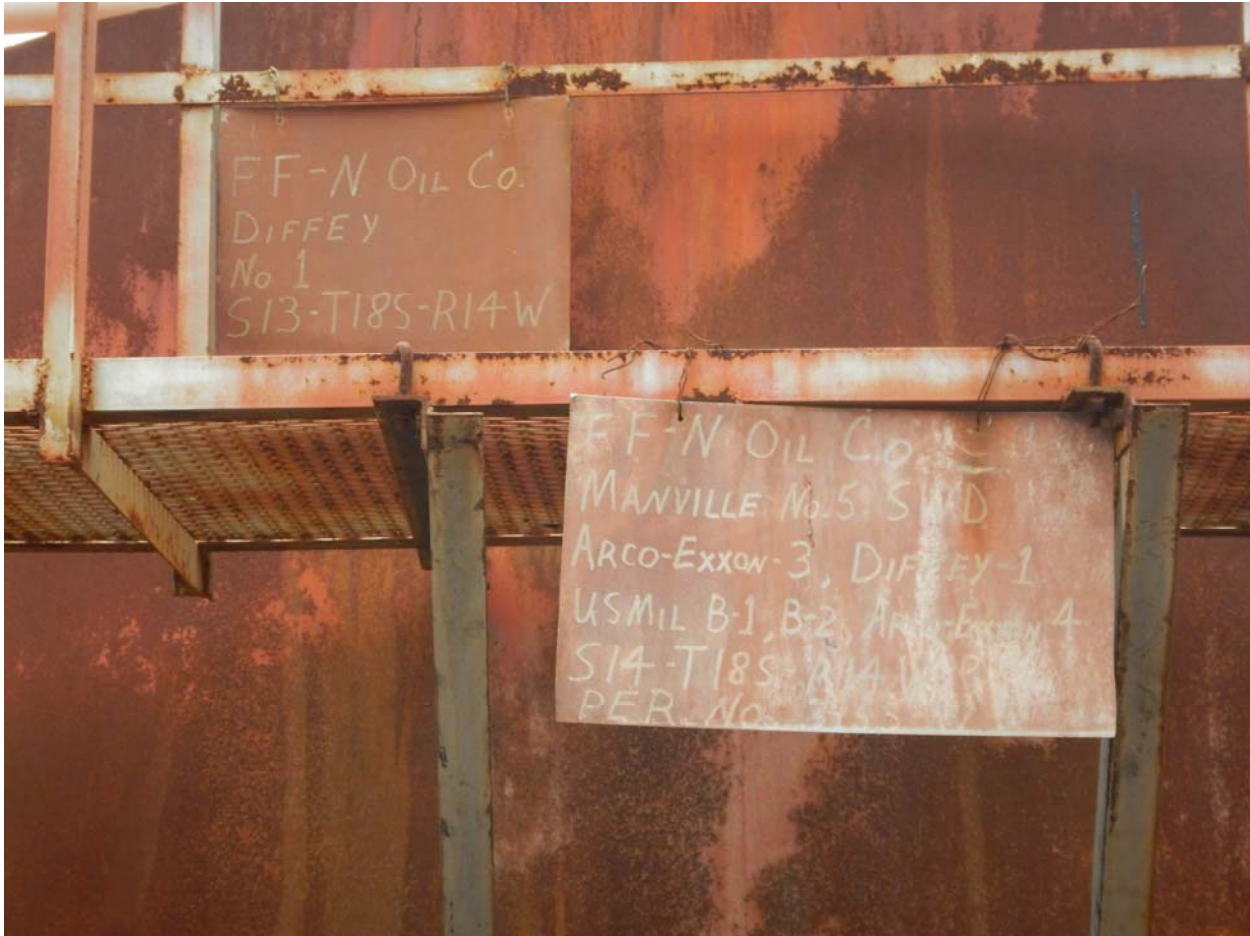
Photo No. 1

Photograph File Name: DSCN3110.JPG  
Date of Photograph: 02/07/2018  
Latitude: 33.157155 N  
Longitude: -92.512298 W  
Orientation: N  
Map Datum: WGS-84  
Time of Photo: 03:14 AM  
Photographer: Jack Arias  
Description: This image shows the sign and tank at FF&N Oil Company – Diffey No. 1 Manville No. 5 SWD.

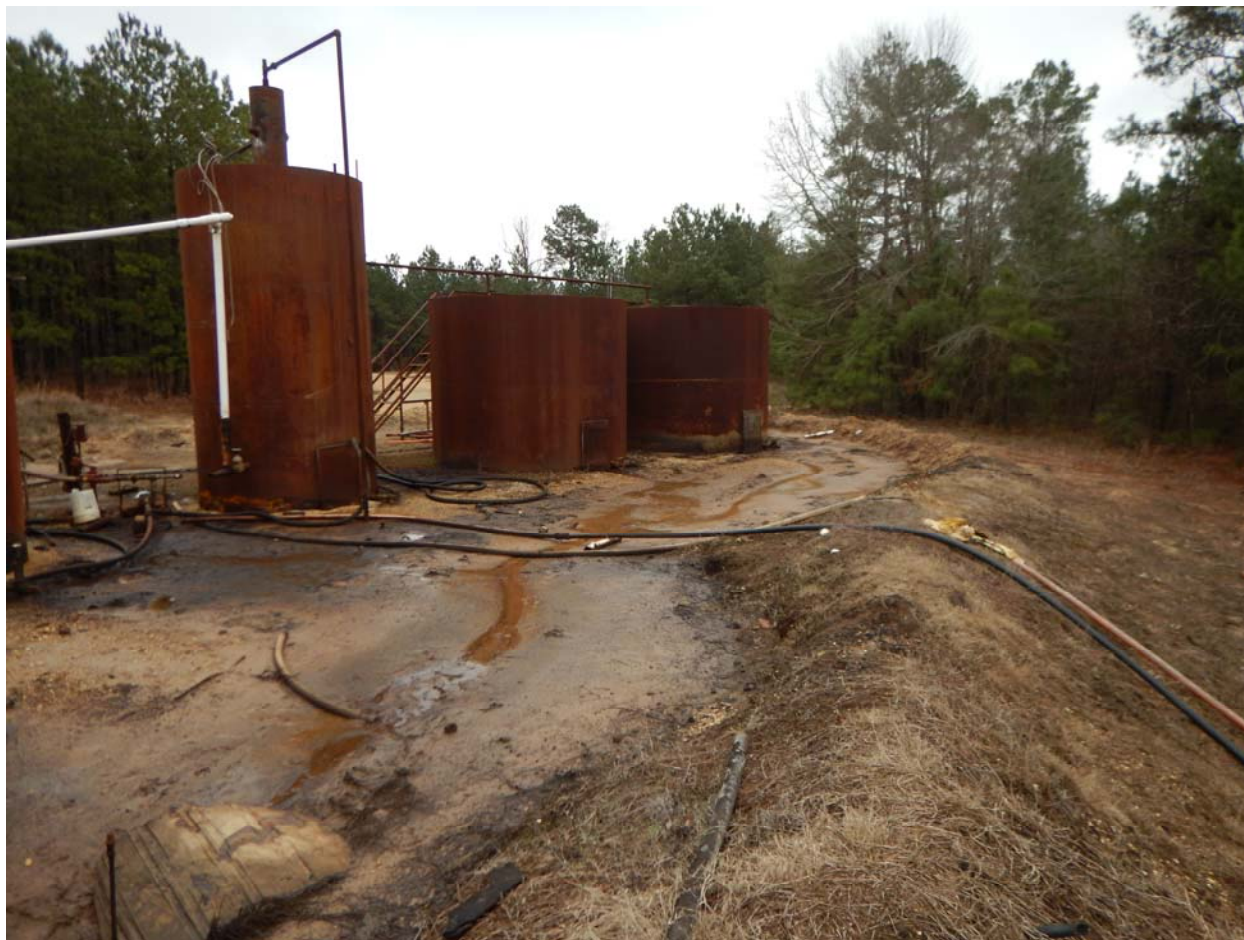
Photo No. 2

Description: This image shows part of the facility's two oil storage tanks, two produce water tanks, and two heater treater separators. The tanks were not surrounded by a secondary containment wall. The tanks were connected to production wells, vessels, flow lines, collection points, and other equipment used for the production of crude oil and disposal of produced water.

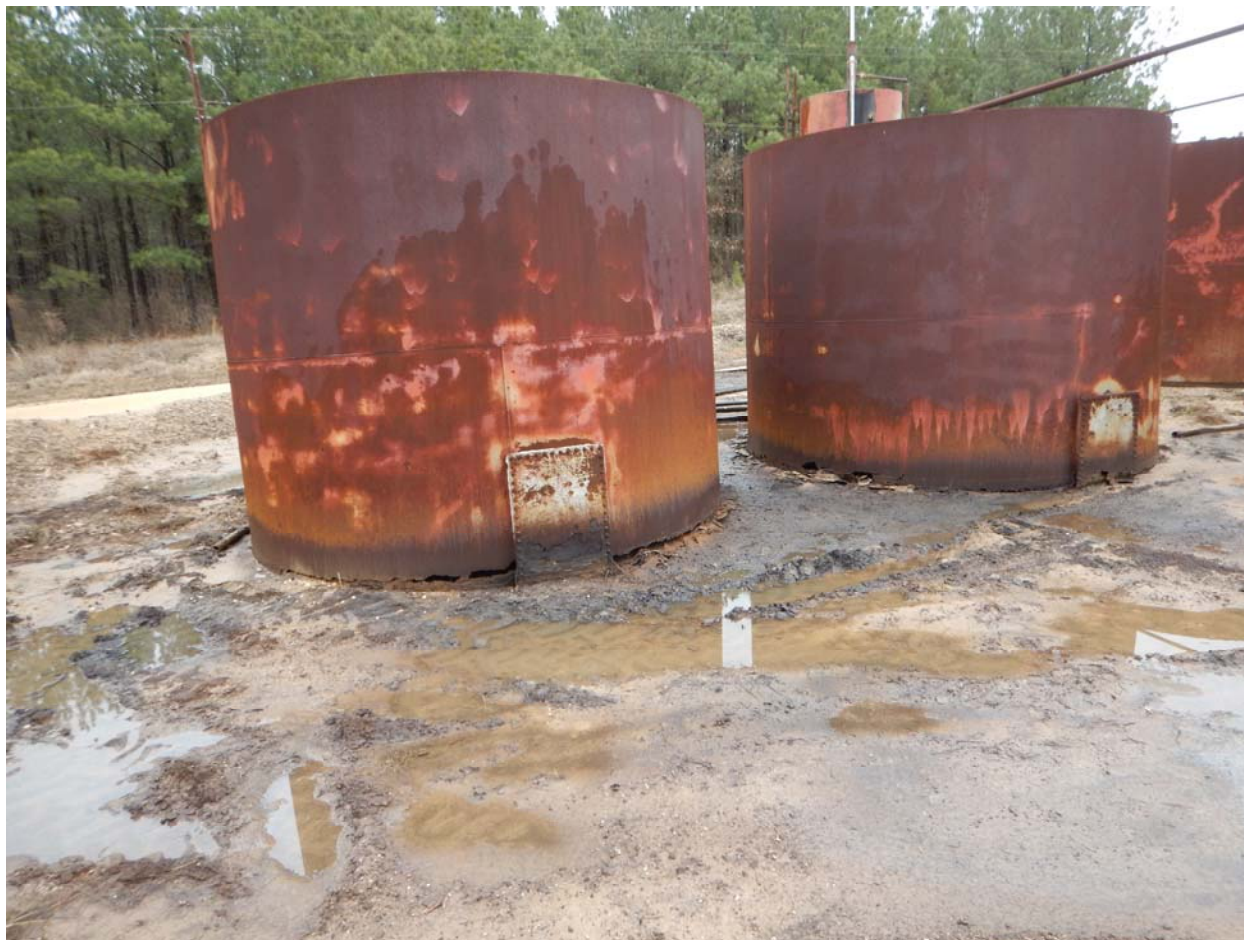
Photo No. 3

Description: This image shows an oil storage tank, fluids pooled inside the containment area, oil staining inside the containment area and on the tank(s), visible erosion on the containment wall, and corrosion on tanks and flowlines.

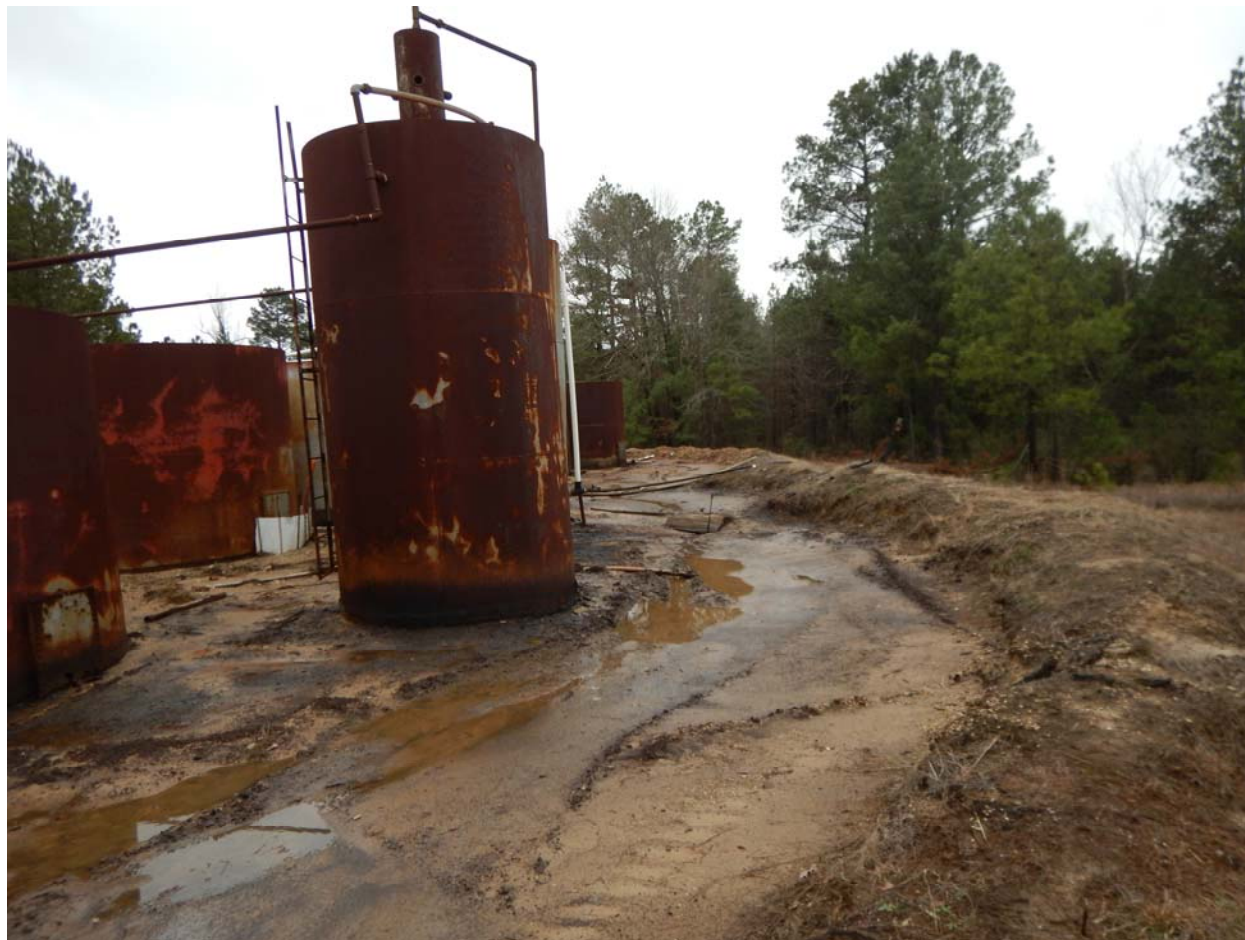
Photo No. 4

Description: This image shows the existence of fluids inside the containment area near the tanks. Also, I observed that the facility had an inadequate raised secondary containment wall around the tanks.

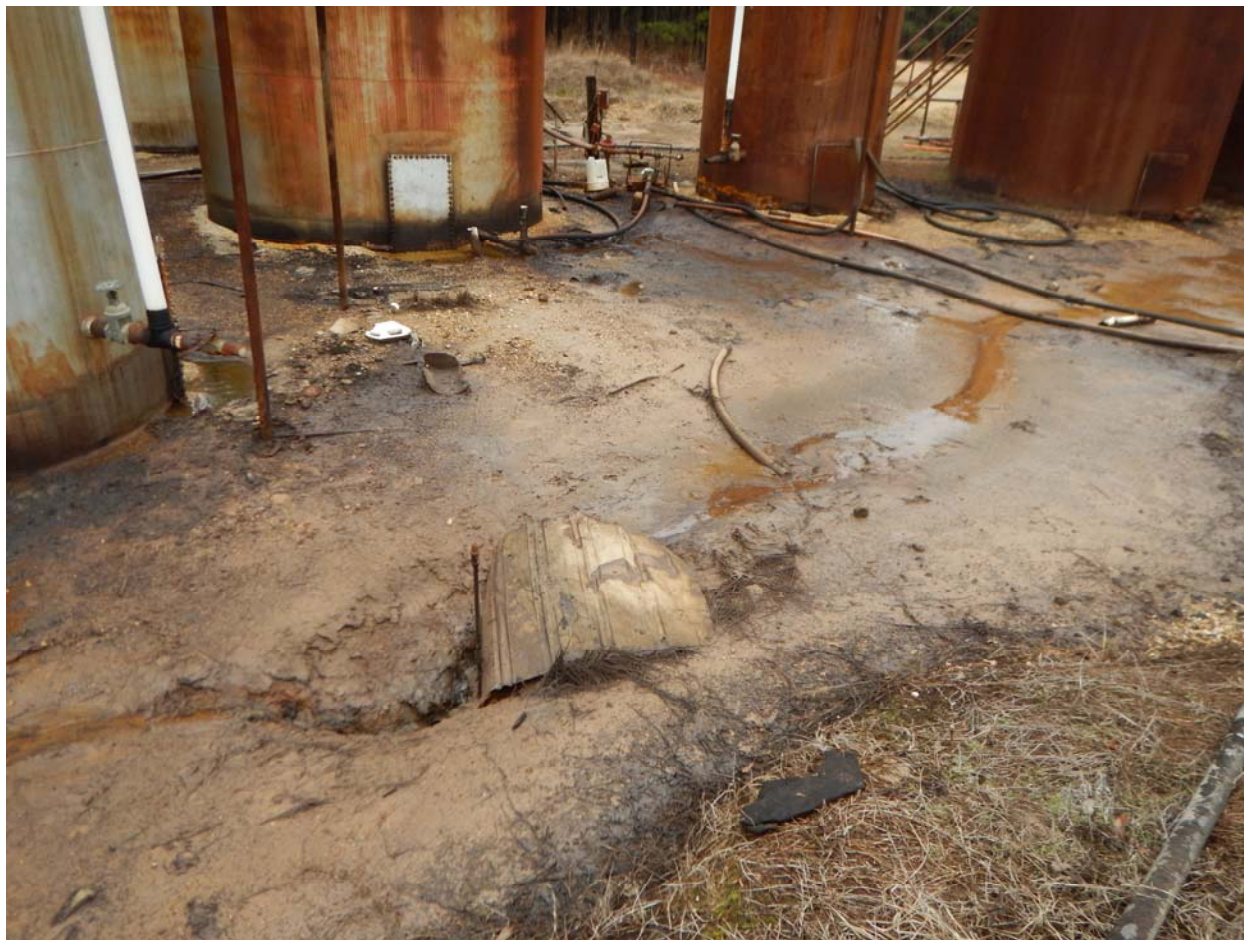
Photo No. 5

Description: This image shows the existence of fluids inside the containment area near the tanks. Also, I observed that the facility had inadequate secondary containment wall around the tanks, produced water pools, sediments fully saturated with oil, and a flow path of fluids in the containment area.

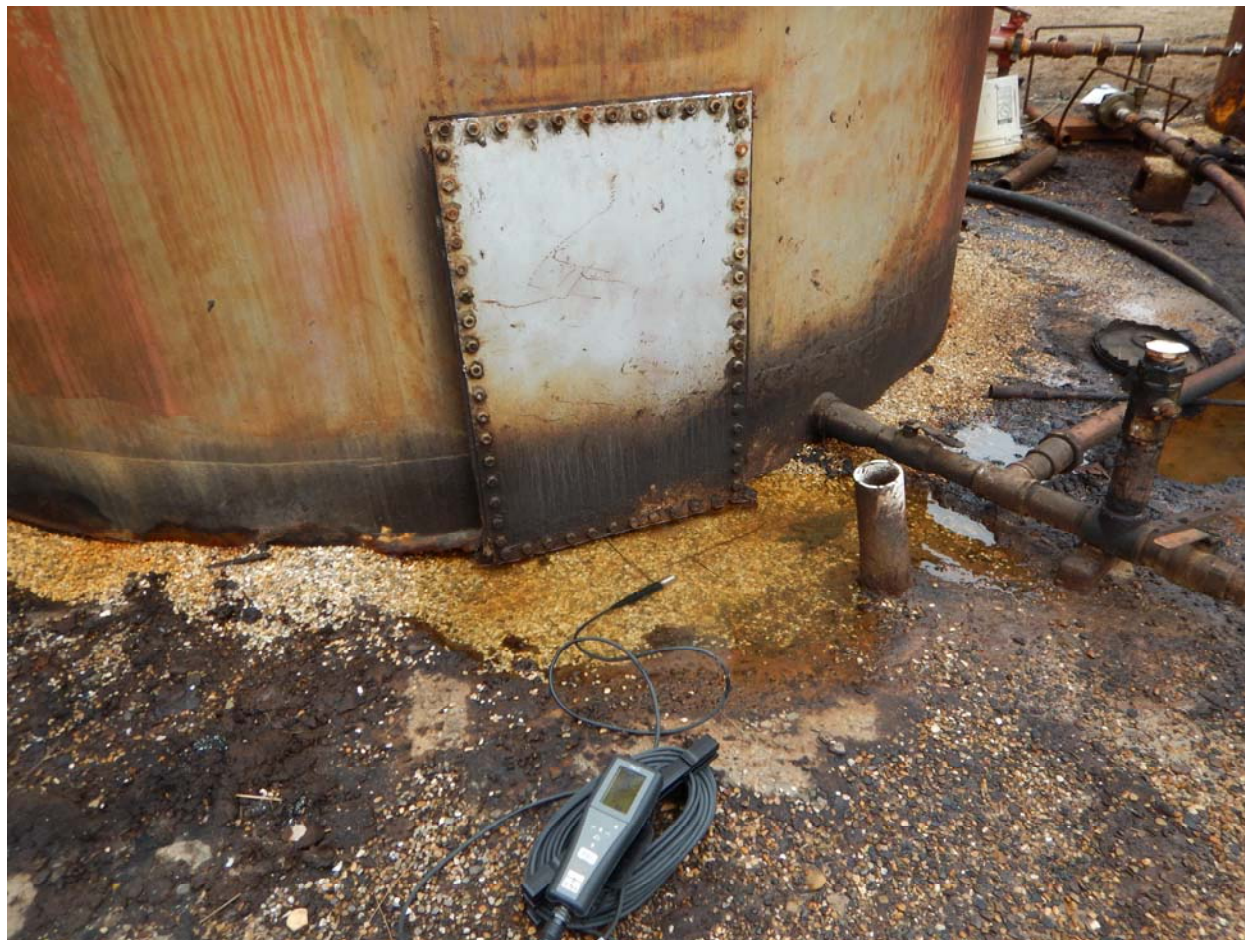
Photo No. 6

downgradient from the facility to the tributary of Ward Creek. Also, I observed debris, flowlines, visible oil staining and dead vegetation downstream along the flow path (See Photo Nos. 2 – 12 in Appendix 1). Using a calibrated YSI 30 Pro Conductivity Meter, at the point source of contamination (next to the facility's tanks and separators), at latitude 33.157155 N and longitude -92.512298 W, I took a Total Dissolved Solids (TDS) measurement of 11,732 parts-per-million (ppm) inside the containment area near the produced water tank. I observed oil staining and pool of fluids inside and outside the containment area (See Photo Nos. 6 – 7 in Appendix 1).

Description: This image shows the YSI 30 Pro Conductivity Meter at the point source of contamination next to the facility's tanks and separators.

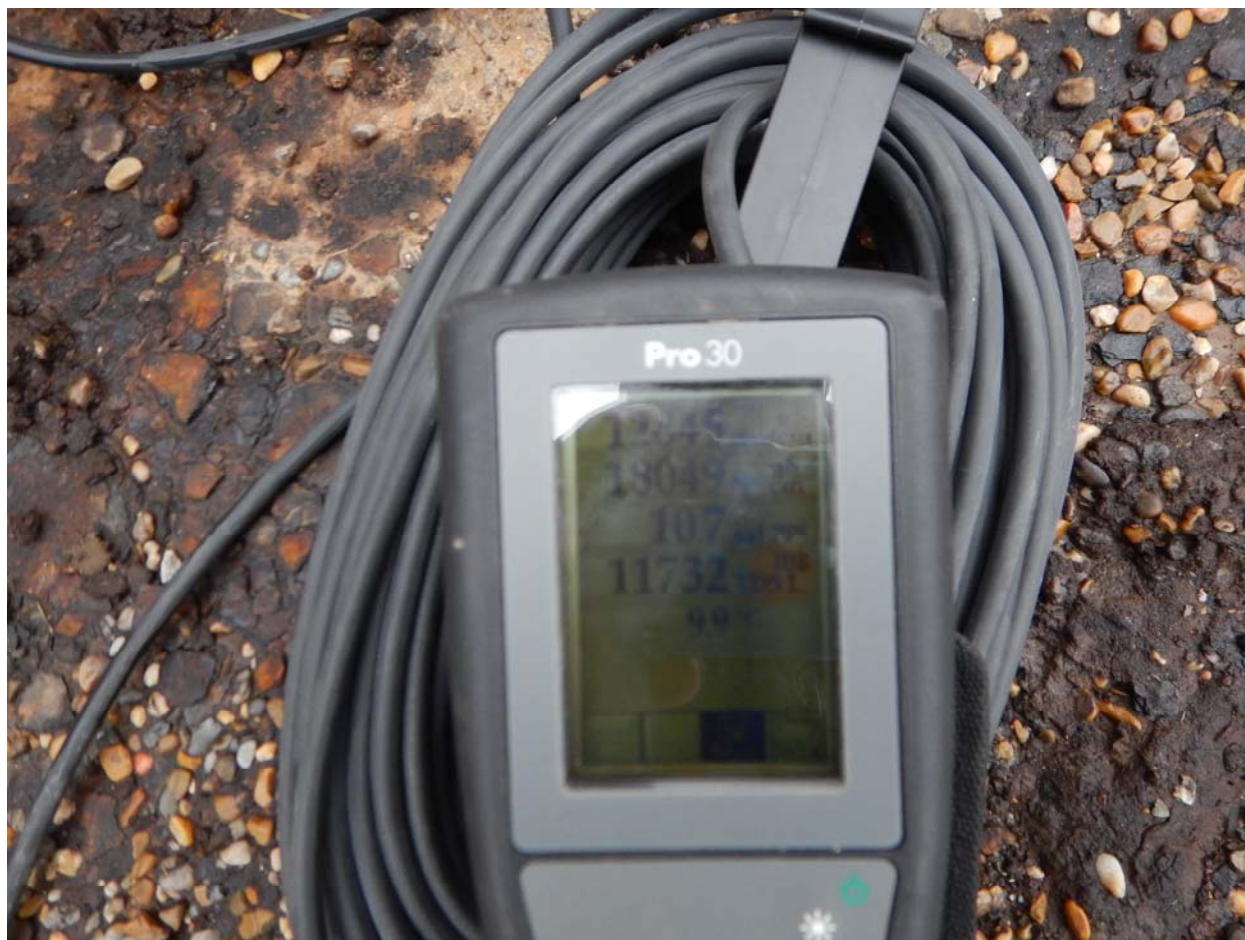
Photo No. 7

Photograph File Name: DSCN3124.JPG  
Date of Photograph: 02/07/2018  
Latitude: 33.157155 N  
Longitude: -92. 512298 W  
Orientation: NW  
Map Datum: WGS-84  
Time of Photo: 03:37 PM  
Photographer: Jack Arias  
Description: This image shows a Total Dissolved Solids (TDS) measurement of 11,732 ppm next to the facility's tanks and separators.

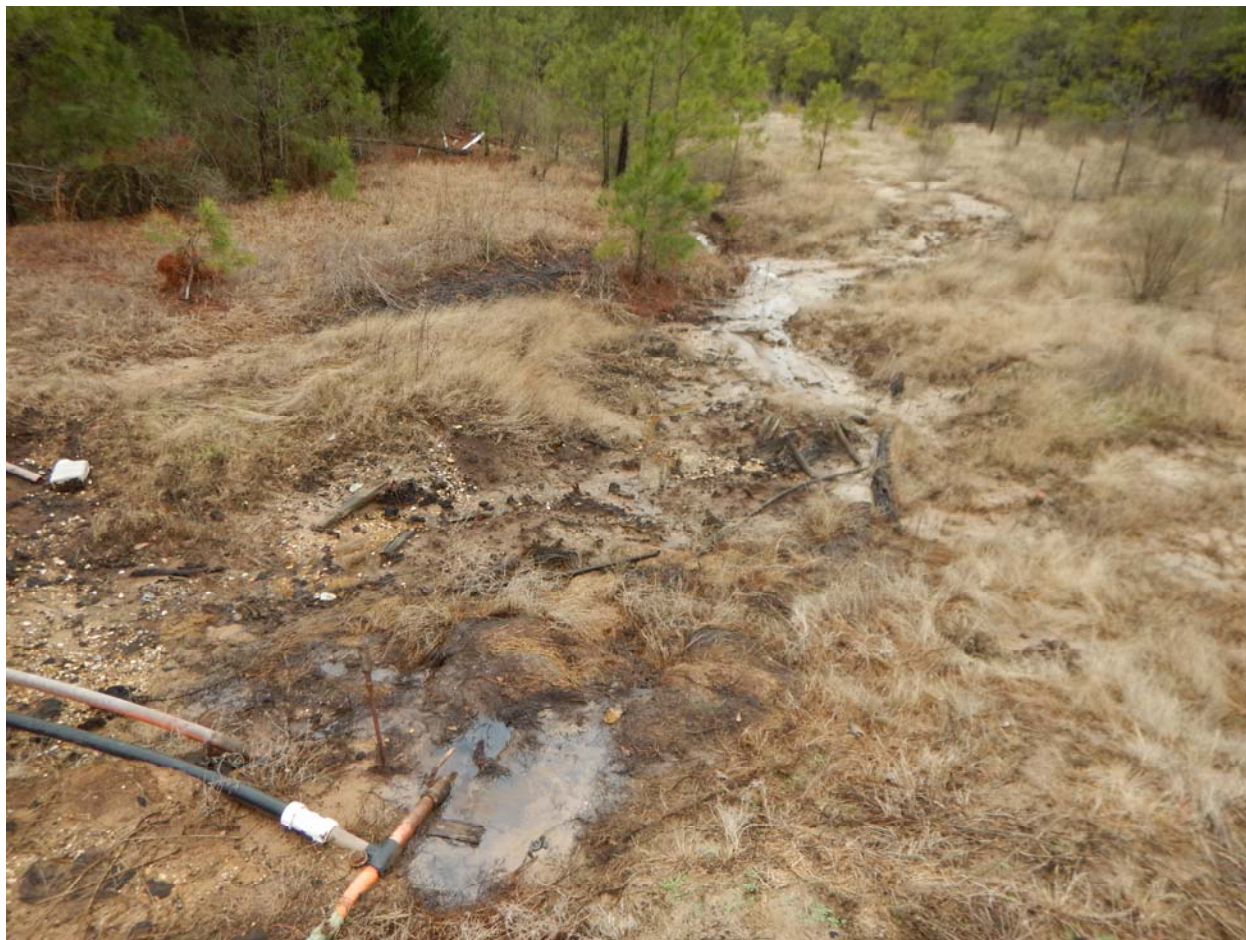
Photo No. 8

Also using a calibrated YSI 30 Pro Conductivity Meter, I took another reading at the drain pipe's outfall point at latitude 33.157083 N and longitude -92.512444 W, I took a Total Dissolved Solids (TDS) measurement of 1,505 parts-per-million (ppm) outside the containment area near the containment wall. I observed oil staining and pool of fluids inside and outside the containment area. (See Photo Nos. 8 – 10 in Appendix 1).

Description: This image shows the existence of a drain pipe located on the western edge of the containment wall. I observed oil staining and pooled fluids inside and outside the containment area.

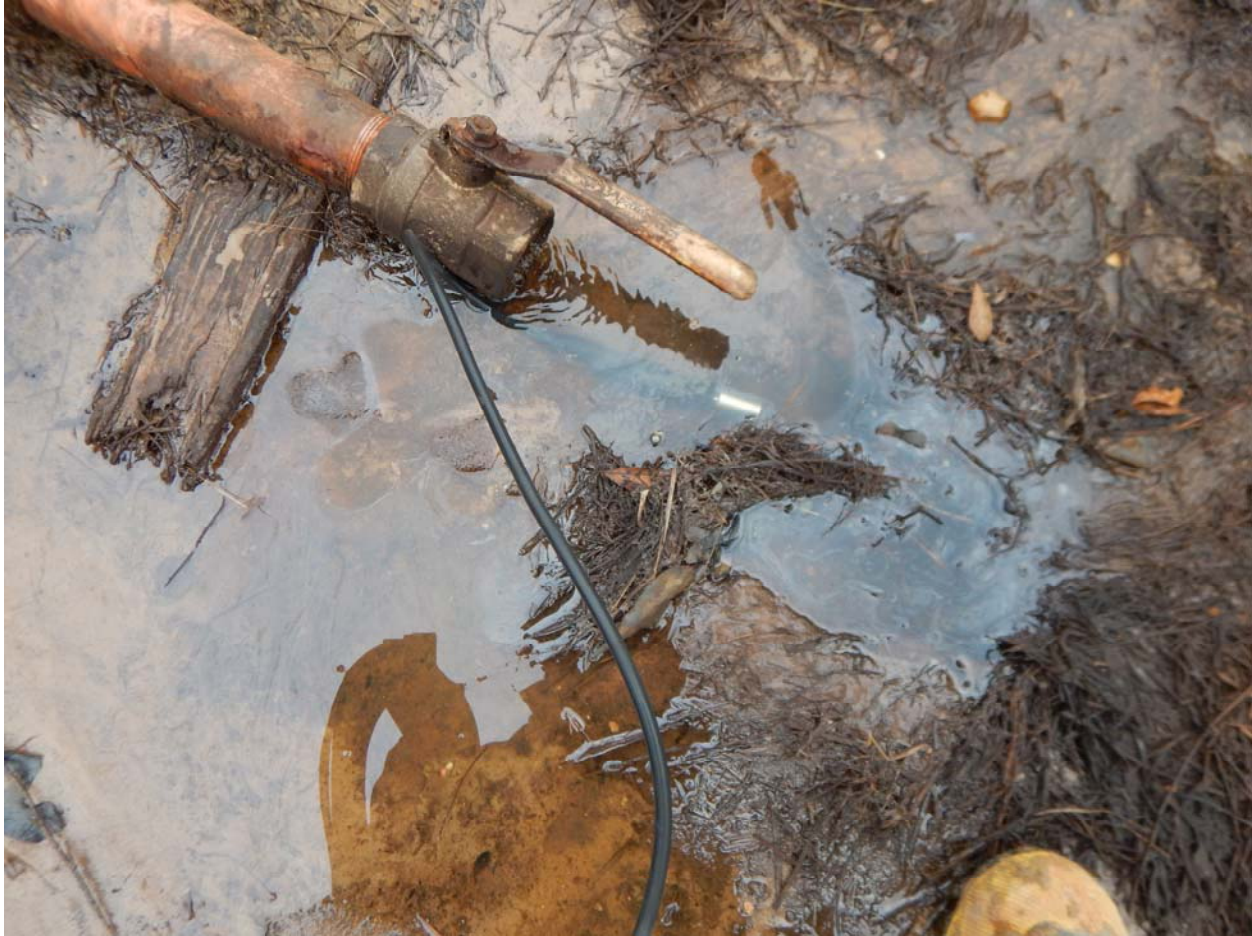
Photo No. 9

Description: This image shows the drain pipe and fluids being discharge from the drain pipe (outfall) . The valve at the end of the drain pipe appeared to be open at the time of the inspection.

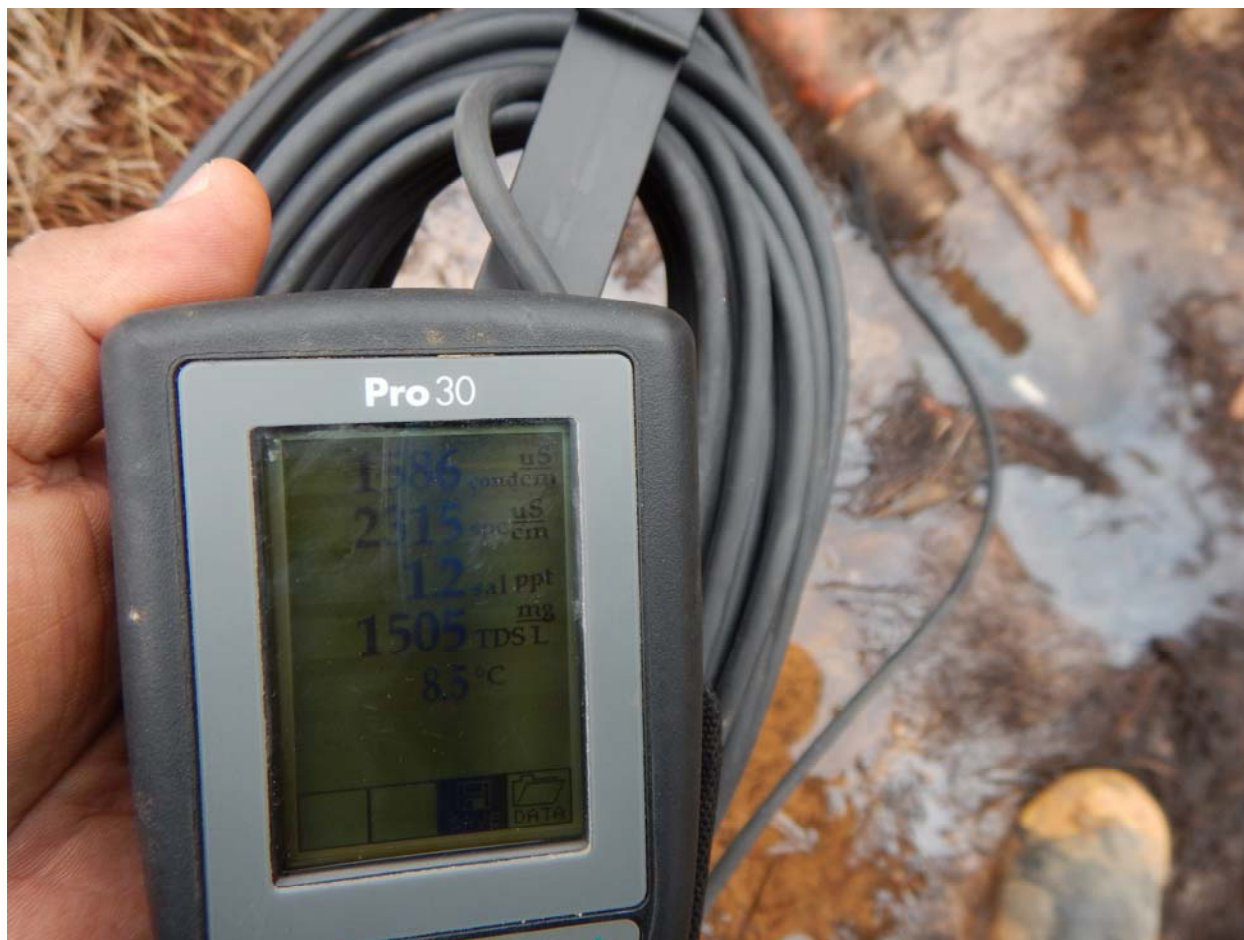
Photo No. 10

Description: This image shows a Total Dissolved Solids (TDS) measurement of 1,505 ppm at the drain pipe (outfall).

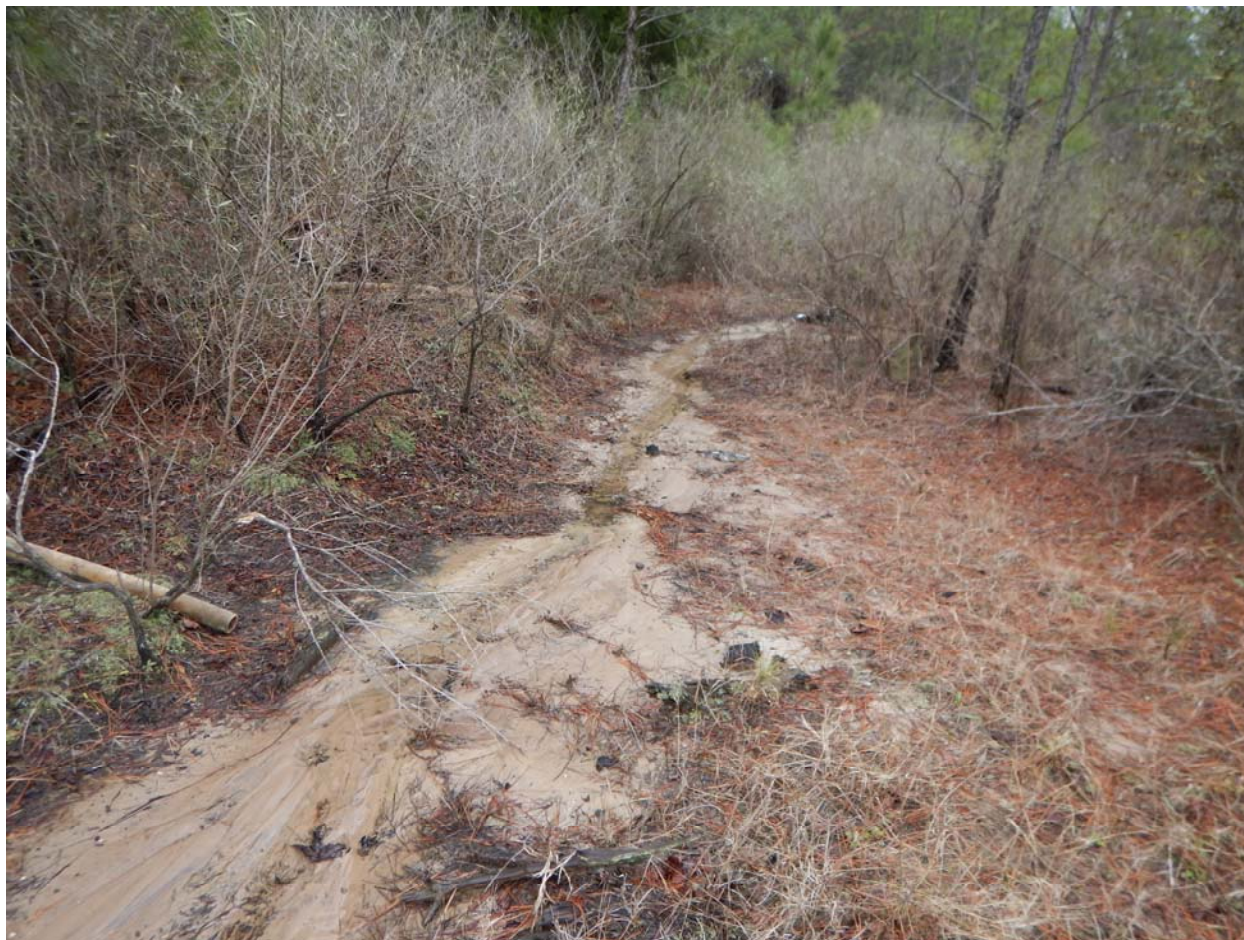
I followed the flow path of fluids downstream from the facility to the tributary of Ward Creek and at approximately 166 feet from the facility to the tributary of Ward Creek, I identified the Point of Entry (POE) of fluids at latitude 33.156806 N and longitude -92.512761 W. At this point, using a calibrated YSI 30 Pro Conductivity Meter, I took a TDS measurement of 3,794 ppm. At the POE, I observed a flowpath of fluids, dead vegetation, erosion, defined bed and bank, high water marks, and debris along the tributary of Ward Creek (See Photo No. 11 - 13 in Appendix 1).

Description: This image shows visible downstream flowpath of fluids, dead vegetation, defined bed and bank, high water marks, and debris along the tributary of Ward Creek. It also identified the flow path leading to the Point of Entry (POE) of fluids.

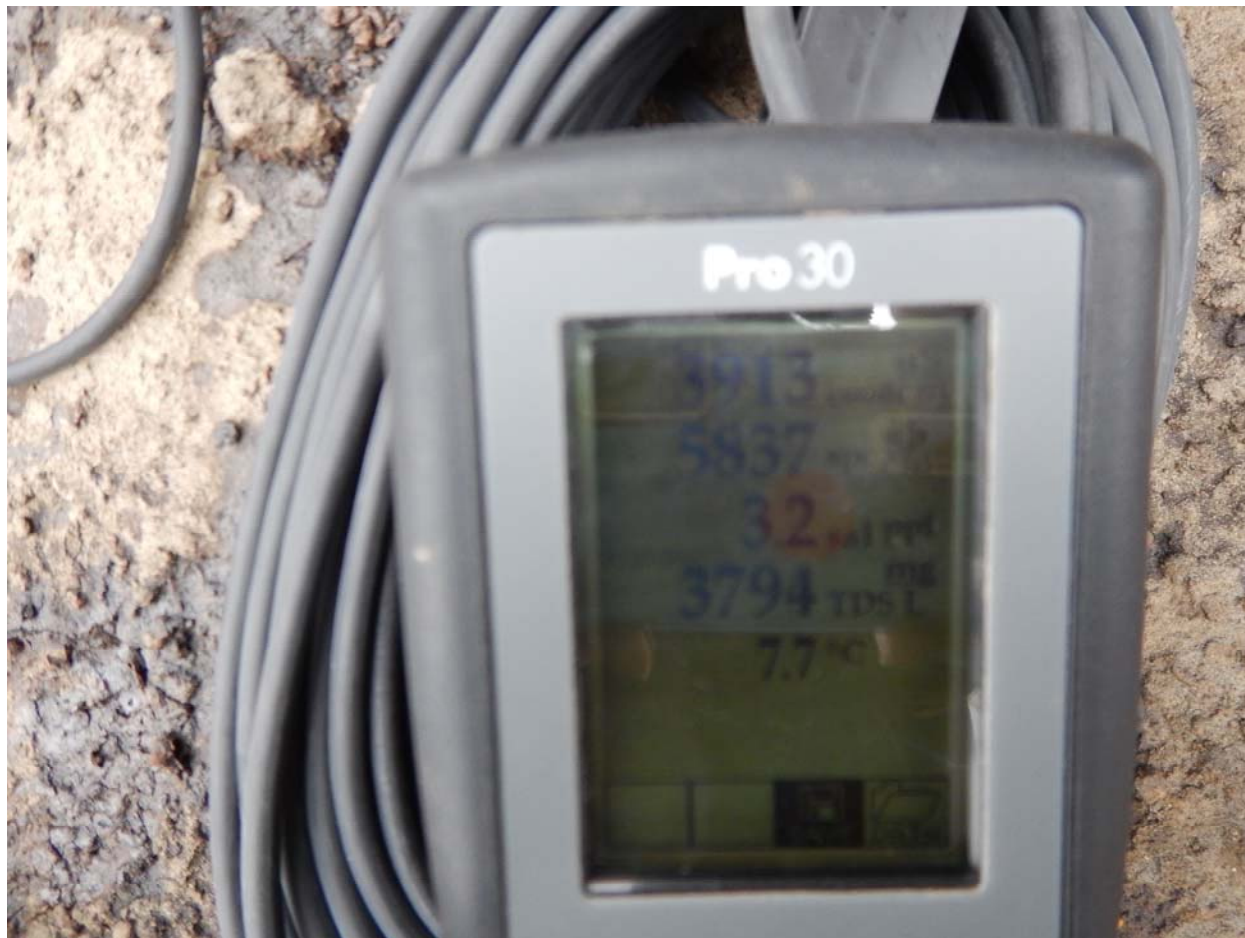
Photo No. 12

Description: This image shows a Total Dissolved Solids (TDS) measurement of 3,794 ppm. It also identified the Point of Entry (POE) of fluids.

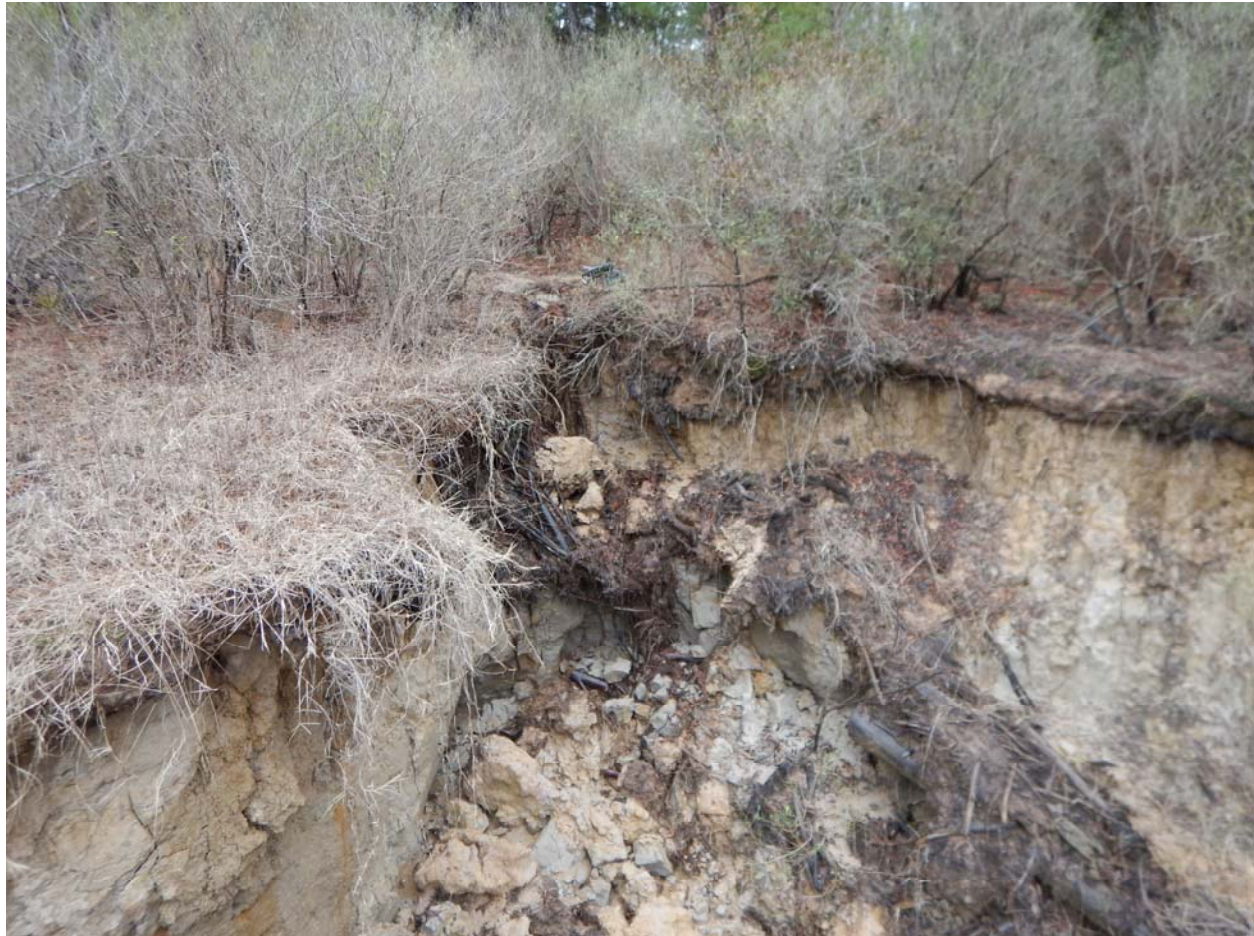
Photo No. 13

Photograph File Name: DSCN3121.JPG  
Date of Photograph: 02/07/2018  
Latitude: 33.156806 N  
Longitude: -92.512761 W  
Orientation: N  
Map Datum: WGS-84  
Time of Photo: 03:33 PM  
Photographer: Jack Arias  
Description: This image shows a downstream flowpath of fluids, dead vegetation, erosion, defined bed and bank, high water marks, and debris from POE and along the tributary of Ward Creek

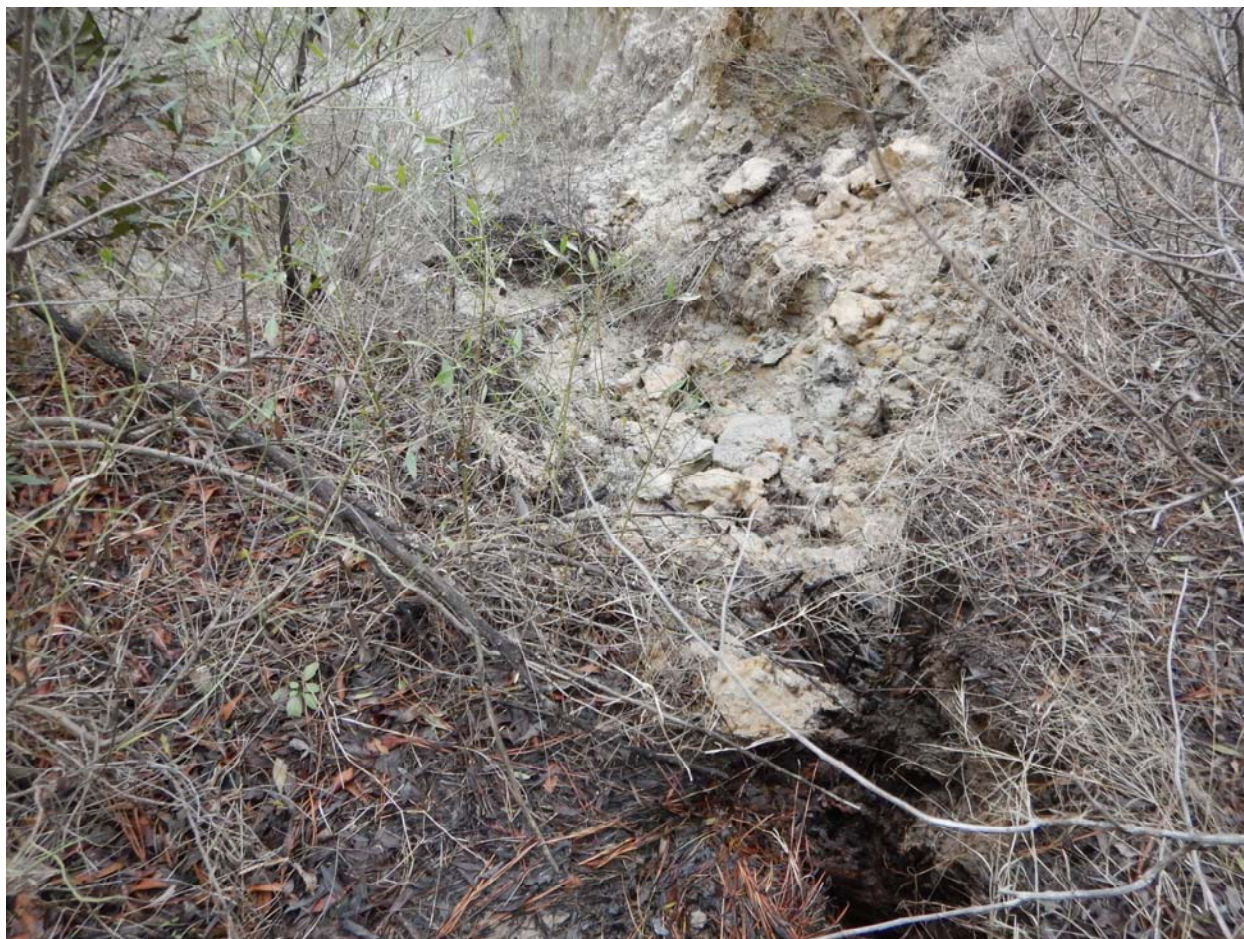
Photo No. 14

Photograph File Name: DSCN3117.JPG  
Date of Photograph: 02/07/2018  
Latitude: 33.156806 N  
Longitude: -92.512761 W  
Orientation: S  
Map Datum: WGS-84  
Time of Photo: 03:32 PM  
Photographer: Jack Arias  
Description: This image shows a downstream flowpath of fluids, dead vegetation, erosion, defined bed and bank, high water marks, and debris along the tributary of Ward Creek

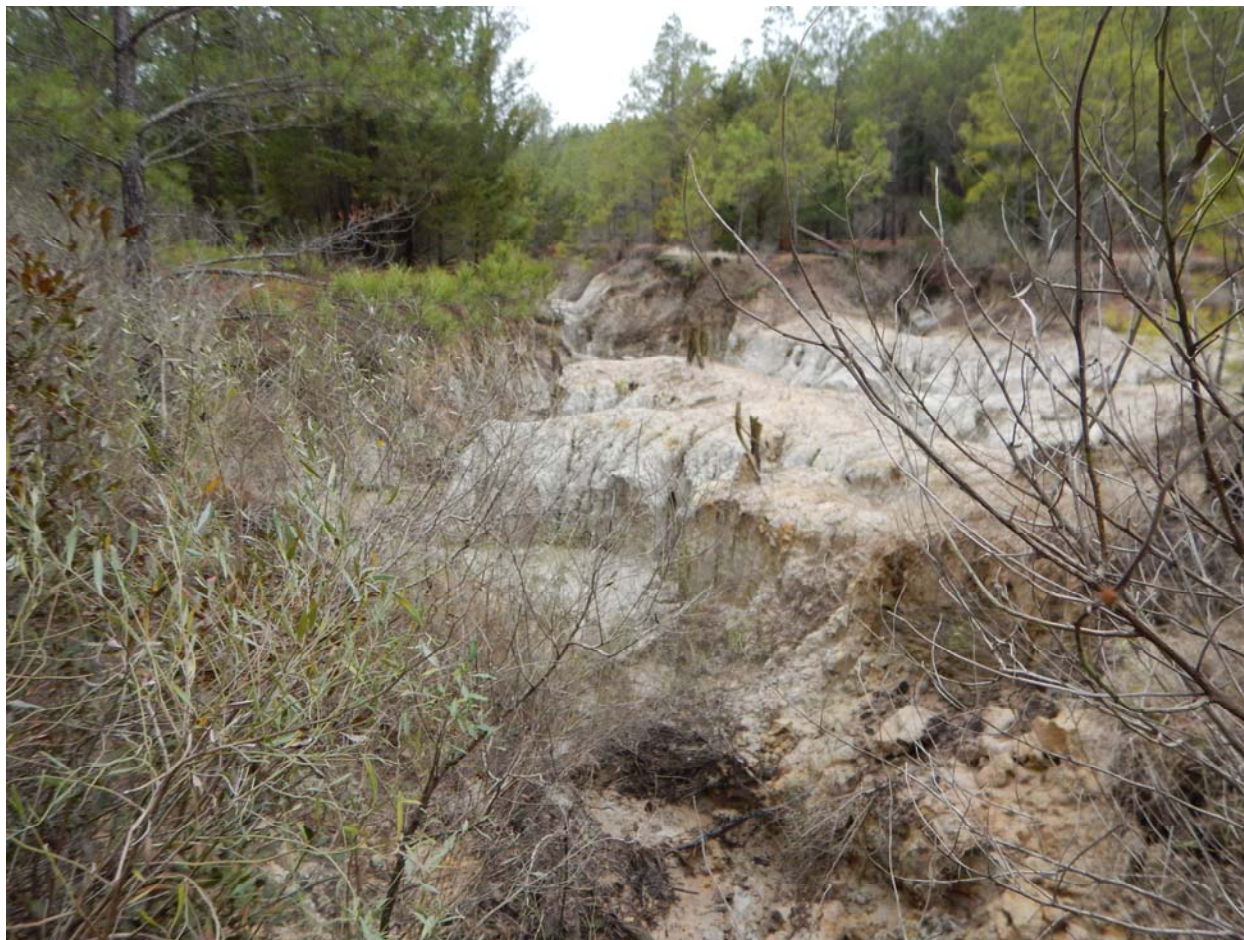
Photo No. 15

Description: This image shows a downstream flowpath of fluids, dead vegetation, erosion, defined bed and bank, high water marks, and debris along the tributary of Ward Creek

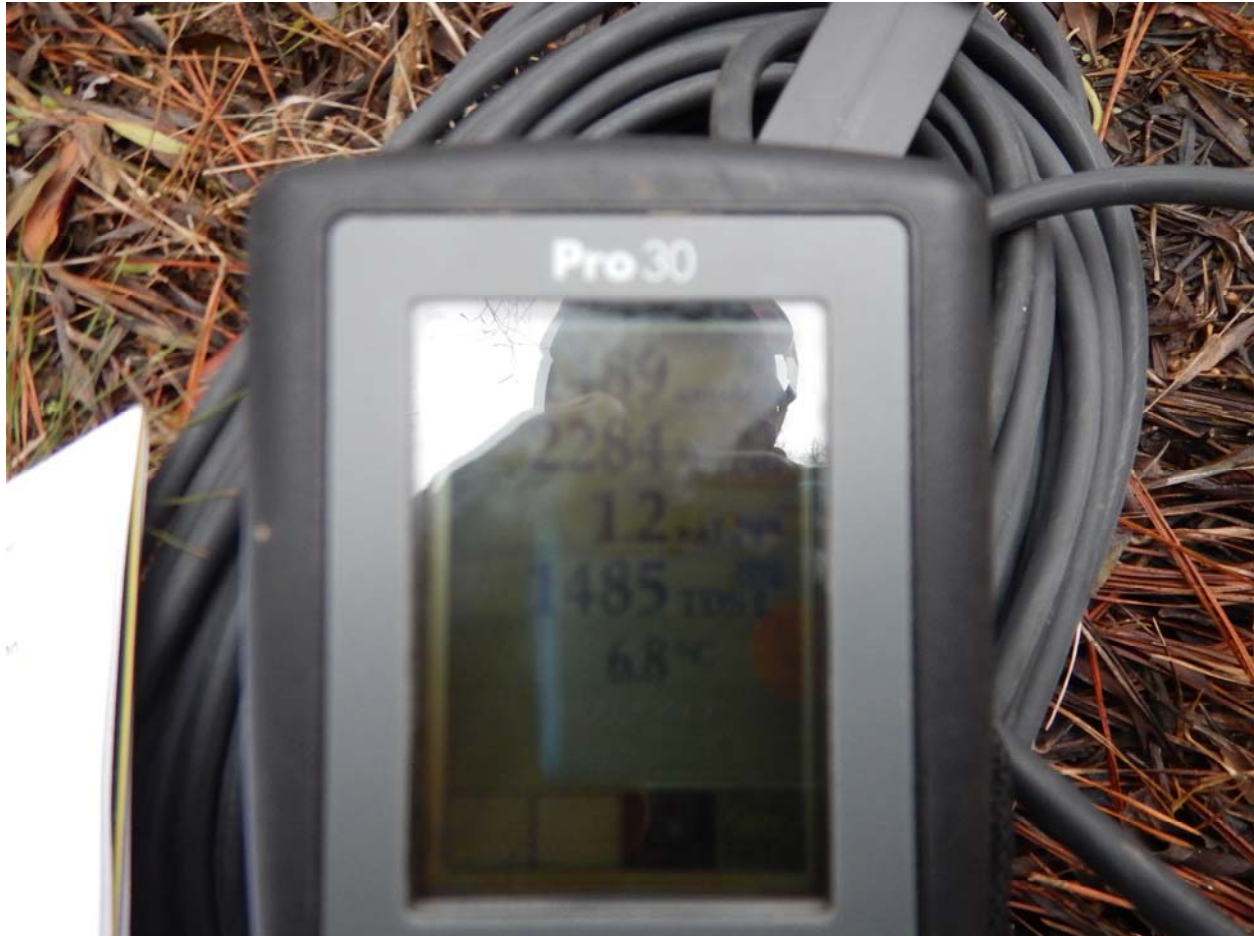
Photo No. 16

I followed the tributary downstream to determine if low lying areas and potential vegetation along the tributary were impacted by oil and produced water discharges. At approximately 162 feet downstream from the POE at latitude 33.156611 N and longitude -92.513167 W, I found a flow path of fluids with defined bed and bank, ordinary high water marks, erosion, and debris. At this point, using a calibrated YSI 30 Pro Conductivity Meter, I took a TDS measurement of 1,485 ppm (See Photo Nos. 14 - 16 in Appendix 1).

Description: This image shows a Total Dissolved Solids (TDS) measurement of 1,485 ppm at the tributary of Ward Creek.

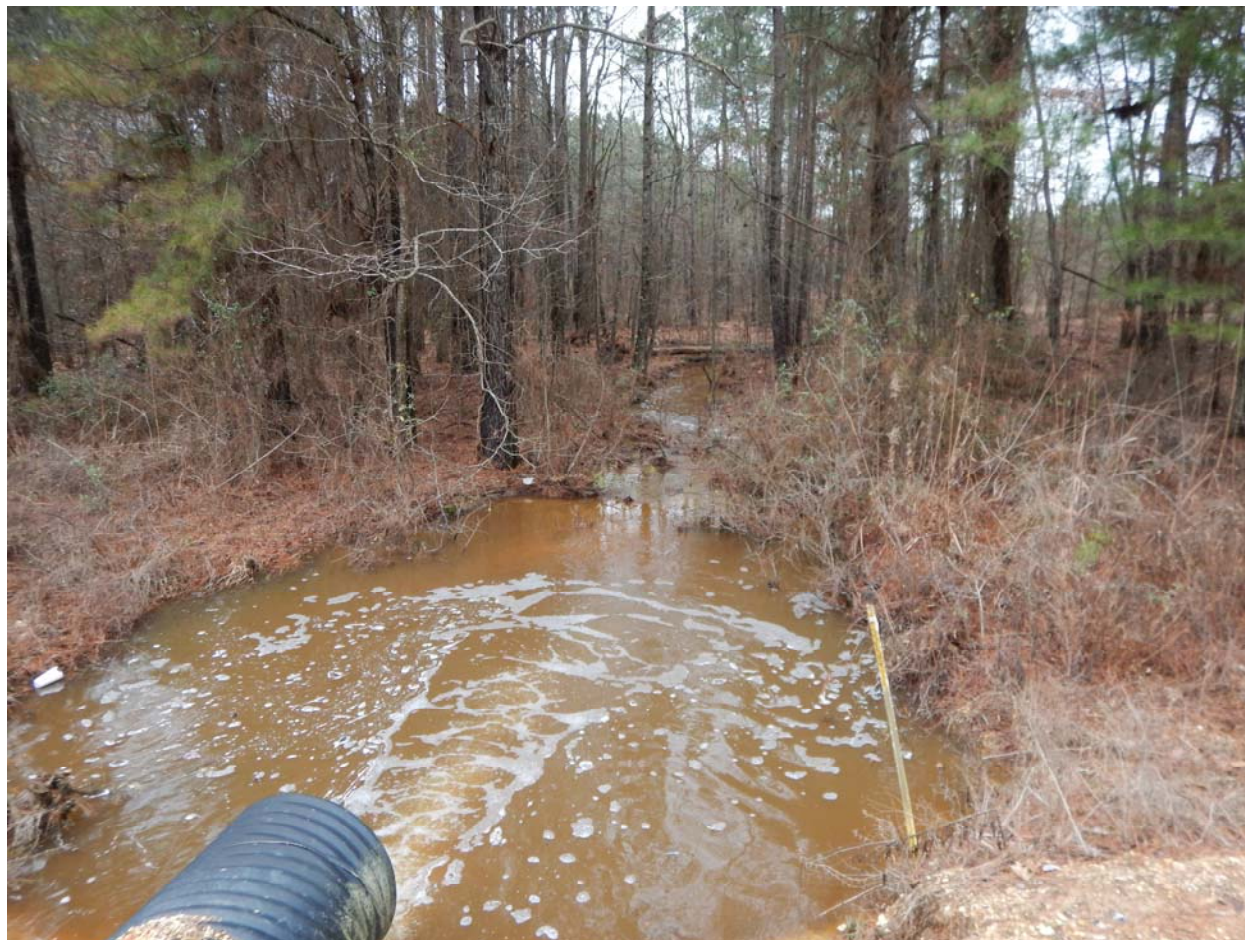
Photo No. 17

Description: This image is Ward Creek approximately 0.66 miles upstream of where the tributary of Ward creek enters into Ward Creek. Ward Creek here shows a well defined bed and bank, an ordinary high water mark, debris, riparian vegetation and plants growing along Ward Creek.

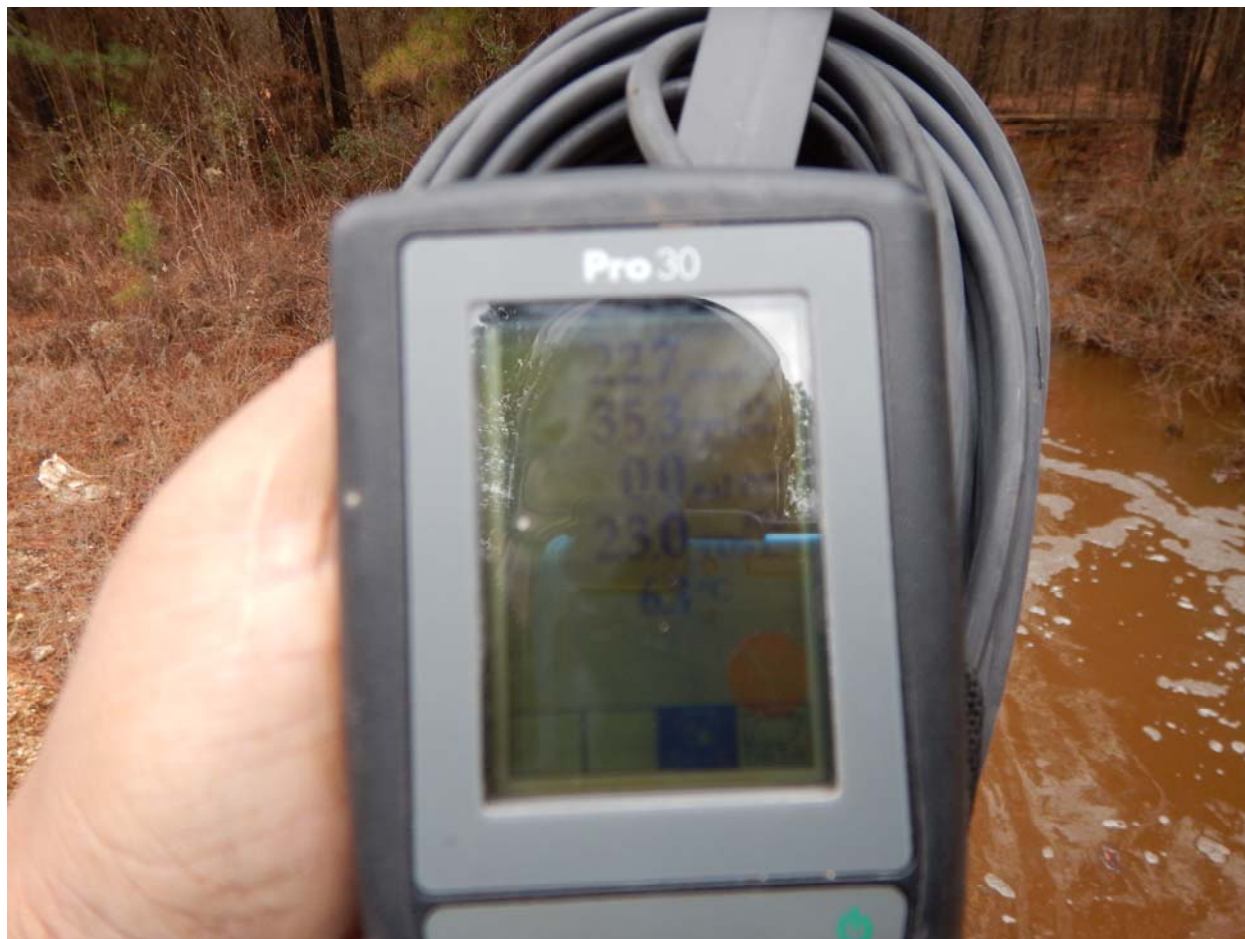
Photo No. 18

33.160866 N and longitude -92.512116 W, I took a TDS reading of 23.0 ppm. I observed defined bed and bank, high water marks, debris, and riparian vegetation and plants growing along the tributary (See Photo Nos. 17 - 18 in Appendix 1).

Description: This image shows a Total Dissolved Solids (TDS) measurement of 23 ppm at 0.66 miles upstream from the point between tributary of Ward creek and Ward creek. I am standing at the same approximate location as Photo 17.
