**Region 6 - Enforcement & Compliance Assurance Division**  
**INSPECTION REPORT**

| Inspection Date(s): | 03/10/2022 | |
| Media Program: | Water | |
| Company Name: | <b>Town of Flower Mound</b> | |

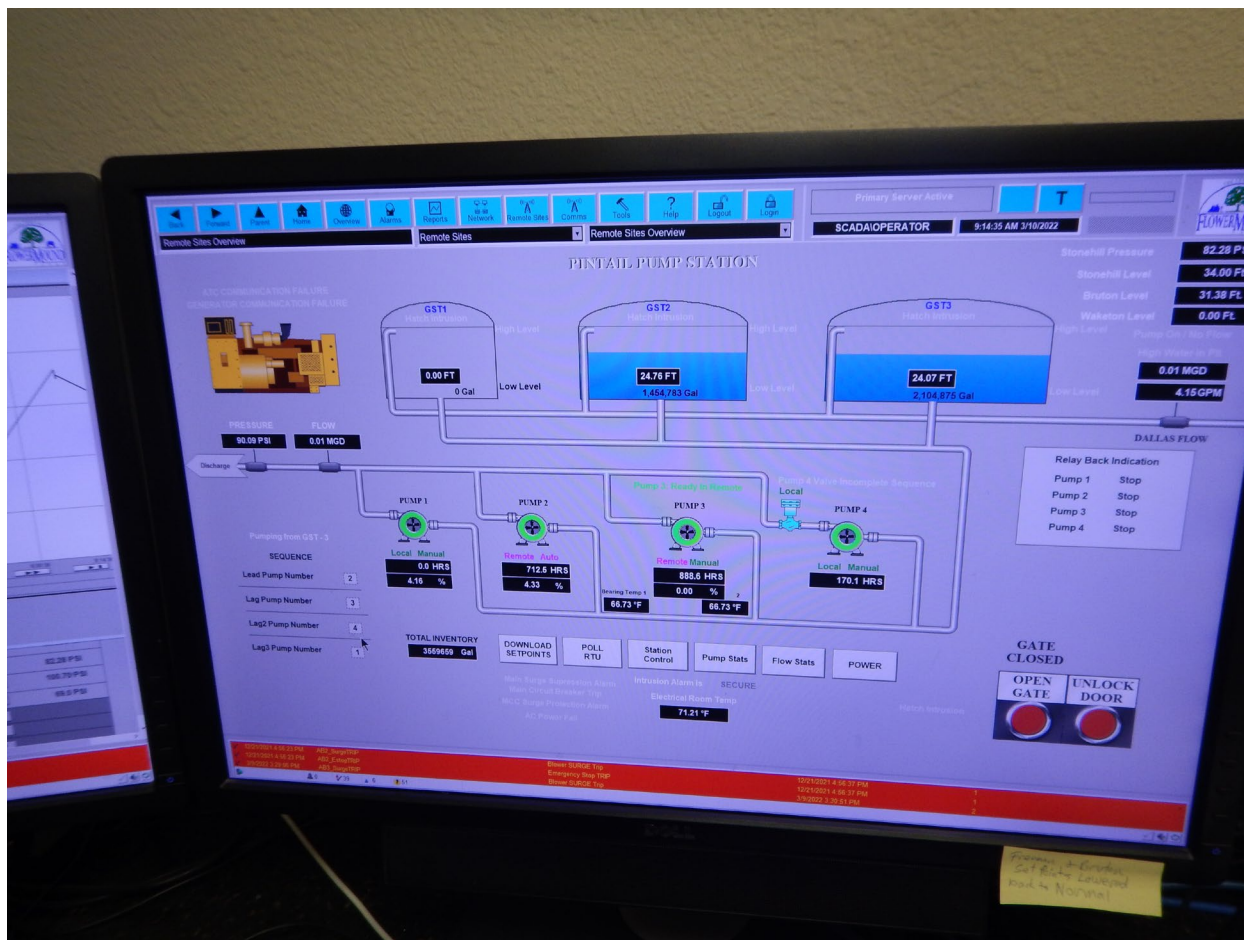
Photo No. 1

- The SCADA system is manned 24/7. Two computers have access to SCADA and a third computer is a read-only monitor. Operators communicate via radios on a dedicated radio frequency. The SCADA system has a seconds-counter as a cybersecurity measure (Appendix 1, Photo 1). We were informed that only one person mans the SCADA system during the night shift, however the system is working to budget for two in the future. When an alarm goes off, the person manning the SCADA system then notifies necessary personnel. Every SCADA operator has the same log-in information to access into the system (AOC 1).

1. Every operator that has access to the water system's SCADA system shares the same login (username and password). We recommend unique login usernames and passwords for each operator with access to SCADA for enhanced cybersecurity.
2. The wall surrounding the water entry pipe had visible cracking and previous repair. We recommend installing the pressure regulator and repairing any remaining wall damage.
3. The fence is broken at the Pintail Pump Station. We recommend repairing the broken fence to keep the pump station and two ground storage tanks secure.
4. Sediment build-up at the base of the 2.0 MG ground storage tank at the Pintail Pump Station. Erosion control is recommended.

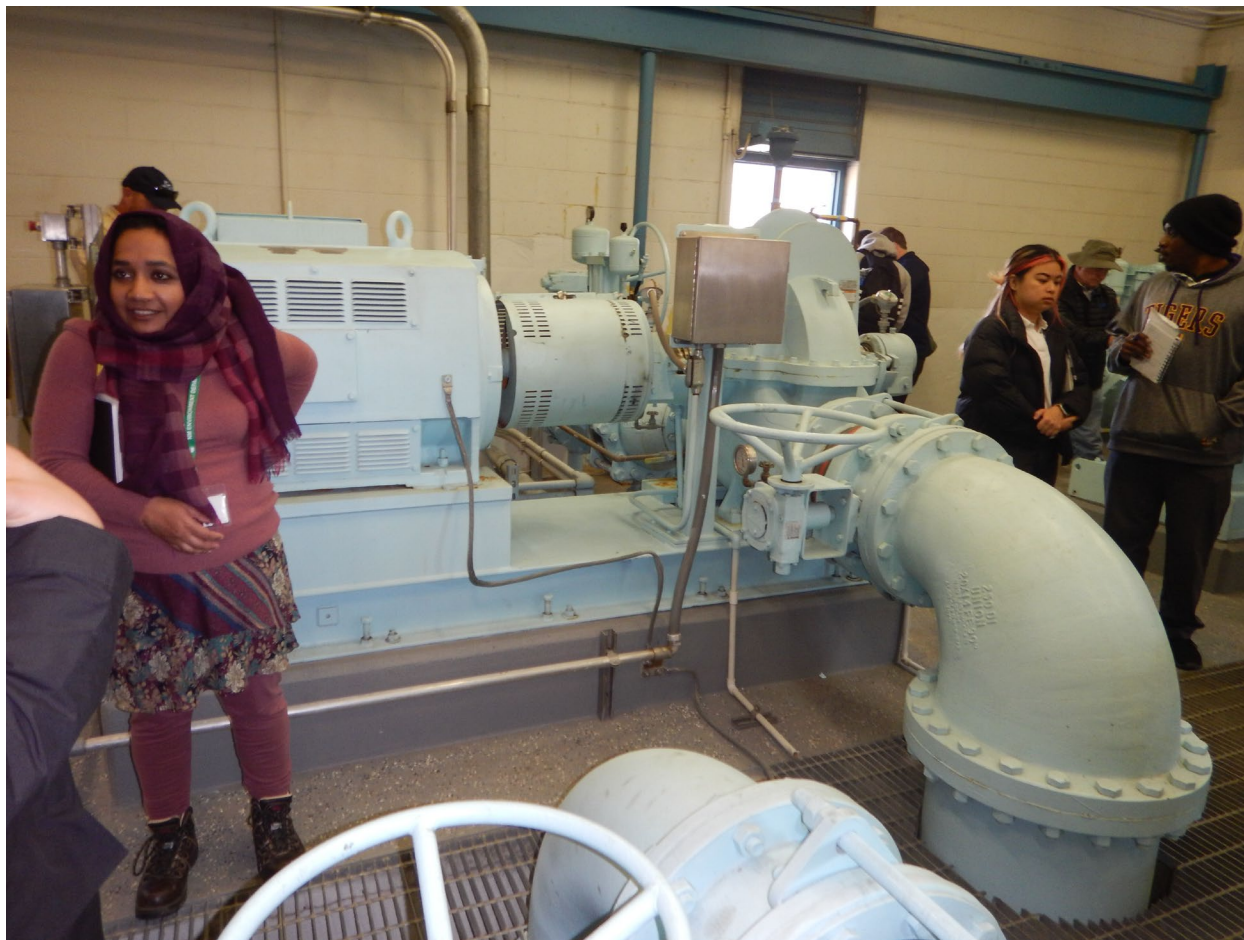
Photo No. 2

Description: Pintail Pump Station pump in good condition

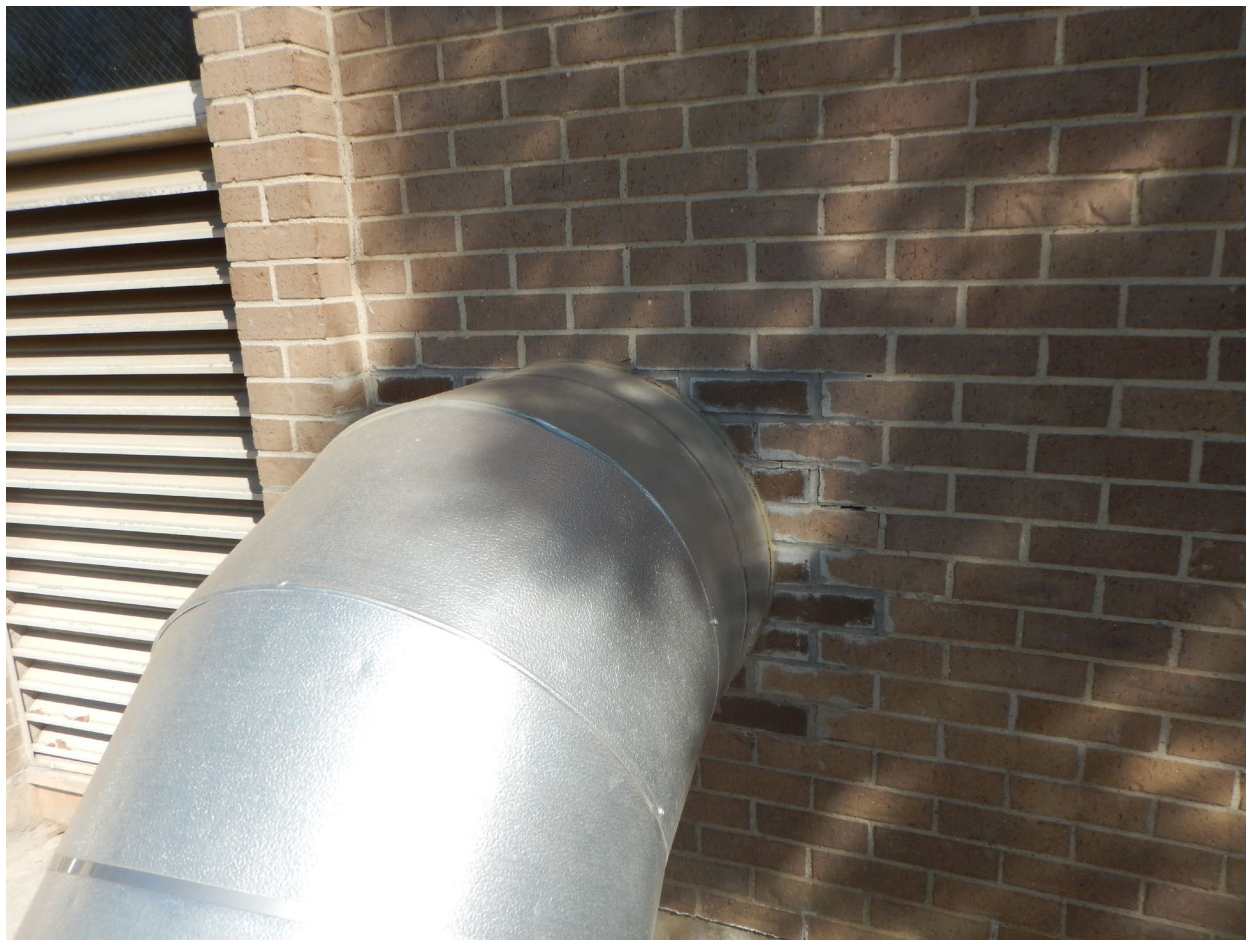
Photo No. 3

- The pump station and three ground storage tanks are located within a residential neighborhood. We were informed that no noise complaints have been made from neighboring residents. Two of the four pumps were online at the time of the inspection. A third pump may go online during peak season demand. Three pumps are variable speed controlled and one is a soft start. We were informed that one of the pumps that was offline at the time of the inspection was undergoing maintenance and waiting on replacement parts. The other three pumps were observed to be in good condition, free of rust and leaks (Appendix 1, Photo 2). The wall surrounding the water entry pipe had visible cracking and previous repair (Appendix 1, Photos 3-4; AOC 2). We were informed that the pipe vibrates and damaged the wall, and the system is working to install a pressure regulator to stop the movement of the pipe.

Description: Repaired wall surrounding the entry pipe into the Pintail Pump Station taken from outside of the pump building

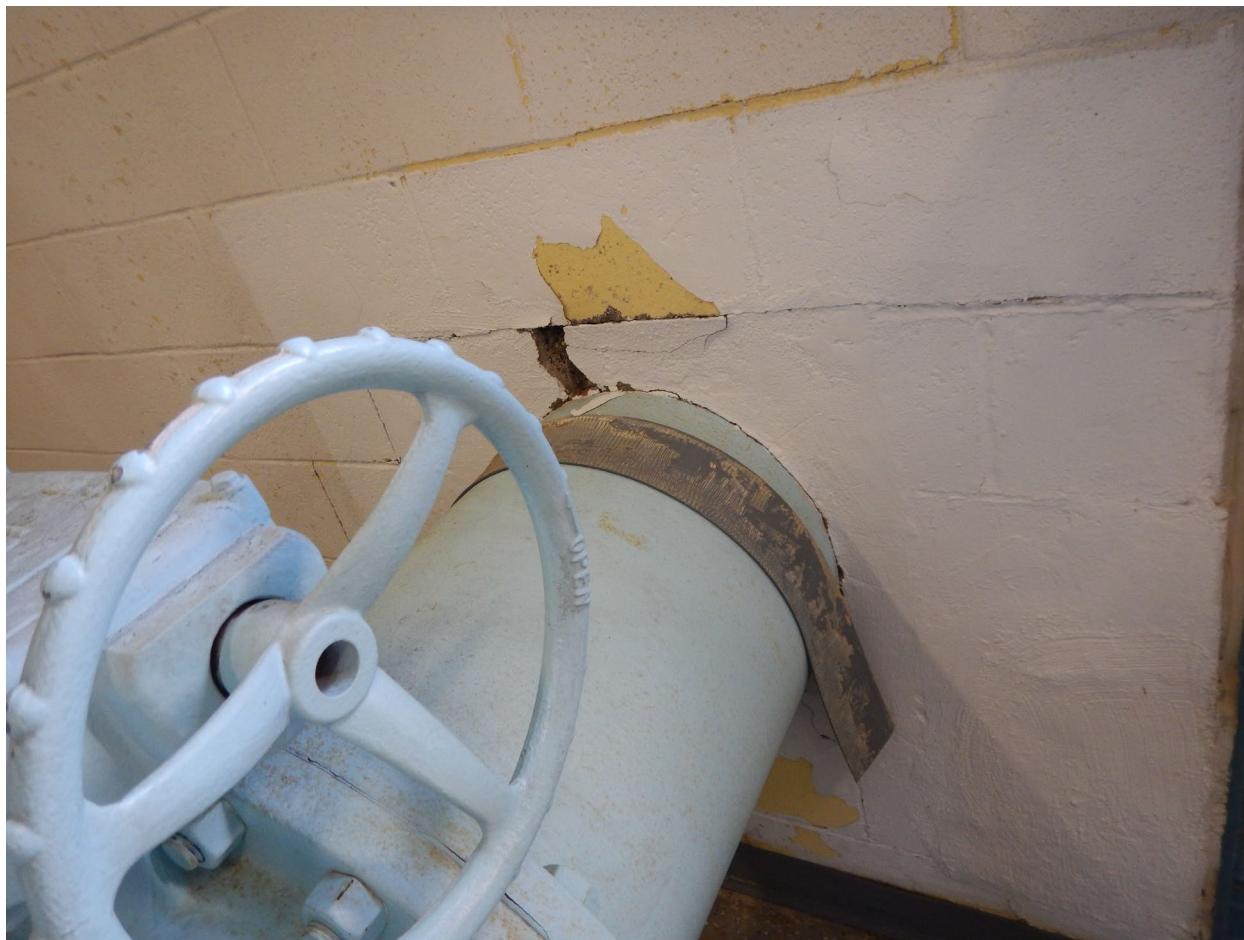
Photo No. 4

Description: Damaged wall surrounding the entry pipe into the Pintail Pump Station taken from inside the pump building

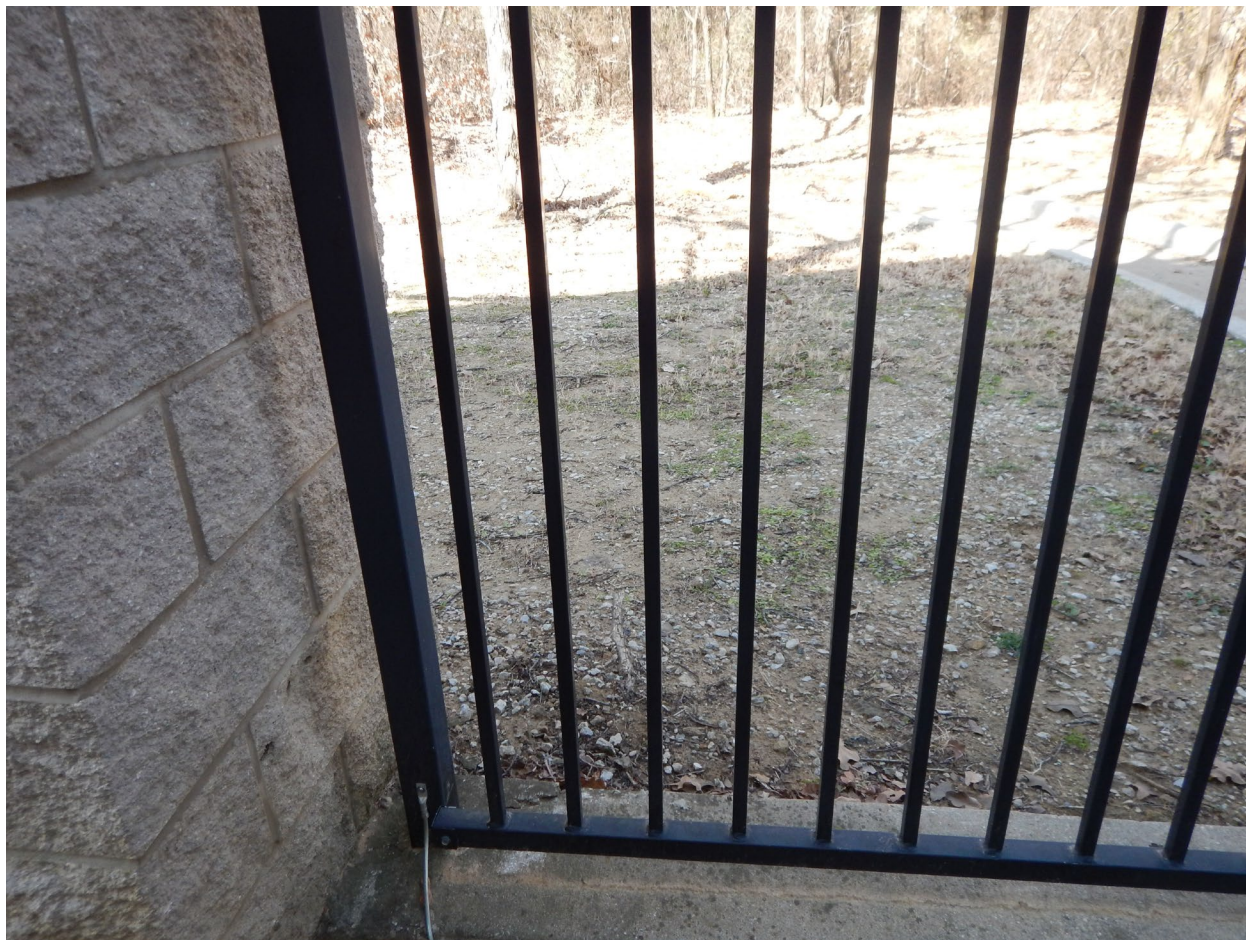
Photo No. 5

- 1.0 MG ground storage tank: Tank was observed to be in good condition at the time of the inspection.
- 2.0 MG ground storage tank: The fence located between the tank and the adjacent creek was broken (Appendix 1, Photo 5; AOC 3). We observed soil and sediment accumulated above the tank's concrete pad (Photo 6, AOC 4). Tank was otherwise in good condition.

Description: Broken fence behind Pintail Pump Station 1.0 and 2.0 MG ground storage tanks

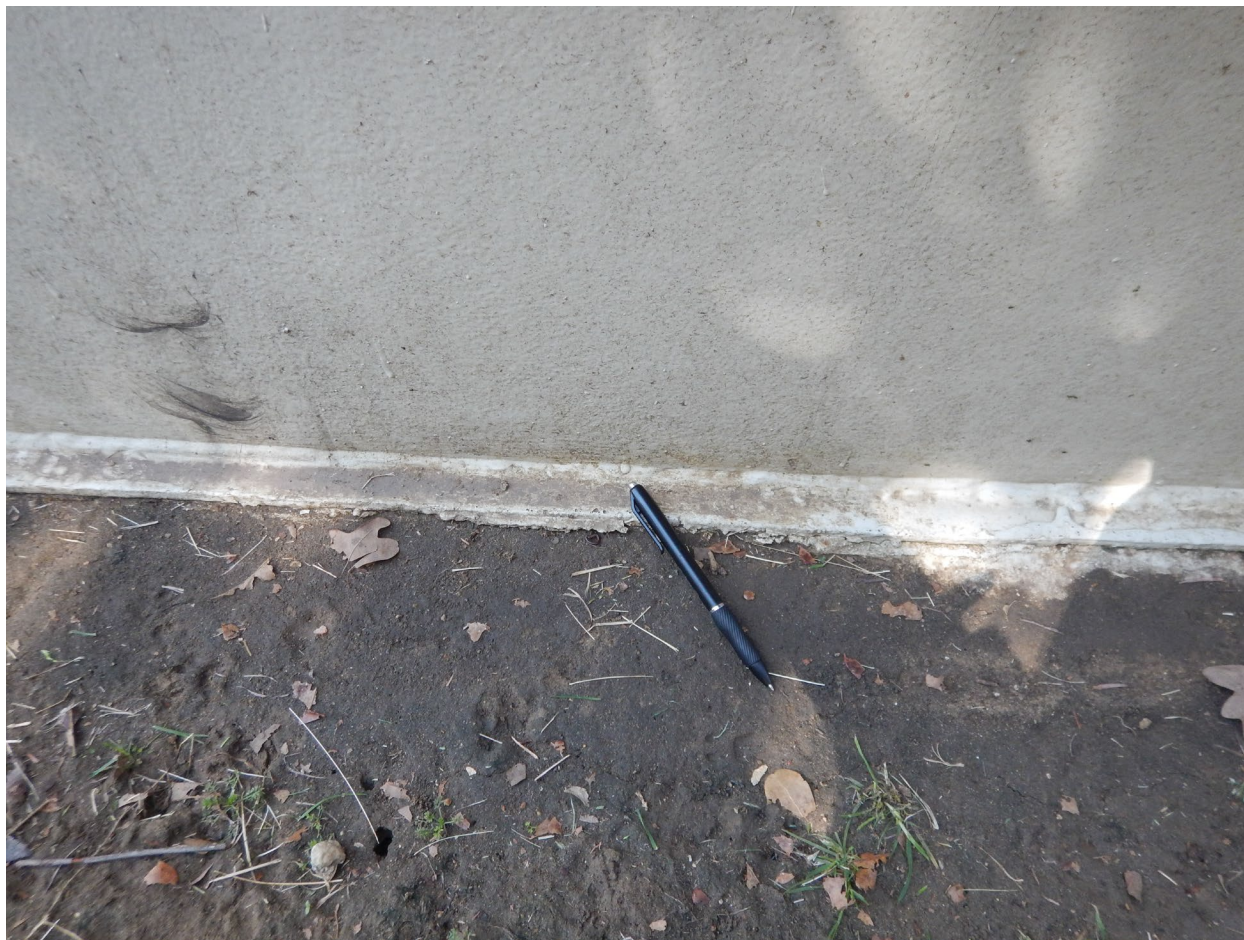
Photo No. 6

Description: Sediment deposition on top of Pintail Pump Station 2.0 MG ground storage tank concrete base

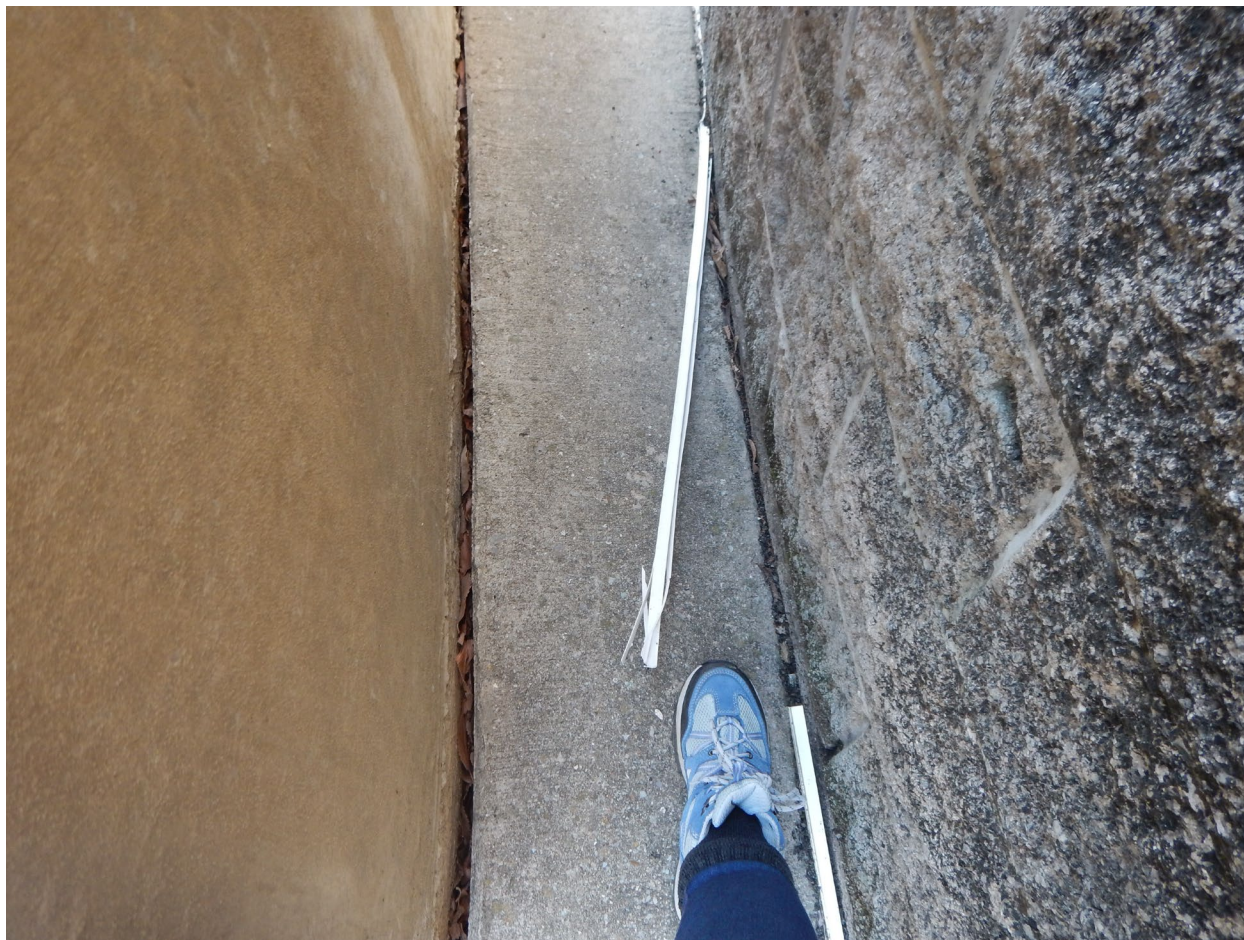
Photo No. 7

- 3.0 MG ground storage tank: We observed broken and missing shims along the sidewalk at the base of the tank (Appendix 1, Photo 7; AOC 5) and erosion beneath the sidewalk (Appendix 1, Photo 8; AOC 5). The tank itself was observed to be in good condition.

Description: Broken sidewalk shim surrounding Pintail Pump Station 3.0 MG ground storage tank

5. Erosion beneath the sidewalk and missing/degrading shims at the 3.0 MG ground storage tank at the Pintail Pump Station. We recommend repairing the erosion beneath the concrete, implementing erosion control, and replacing missing/degrading shims.

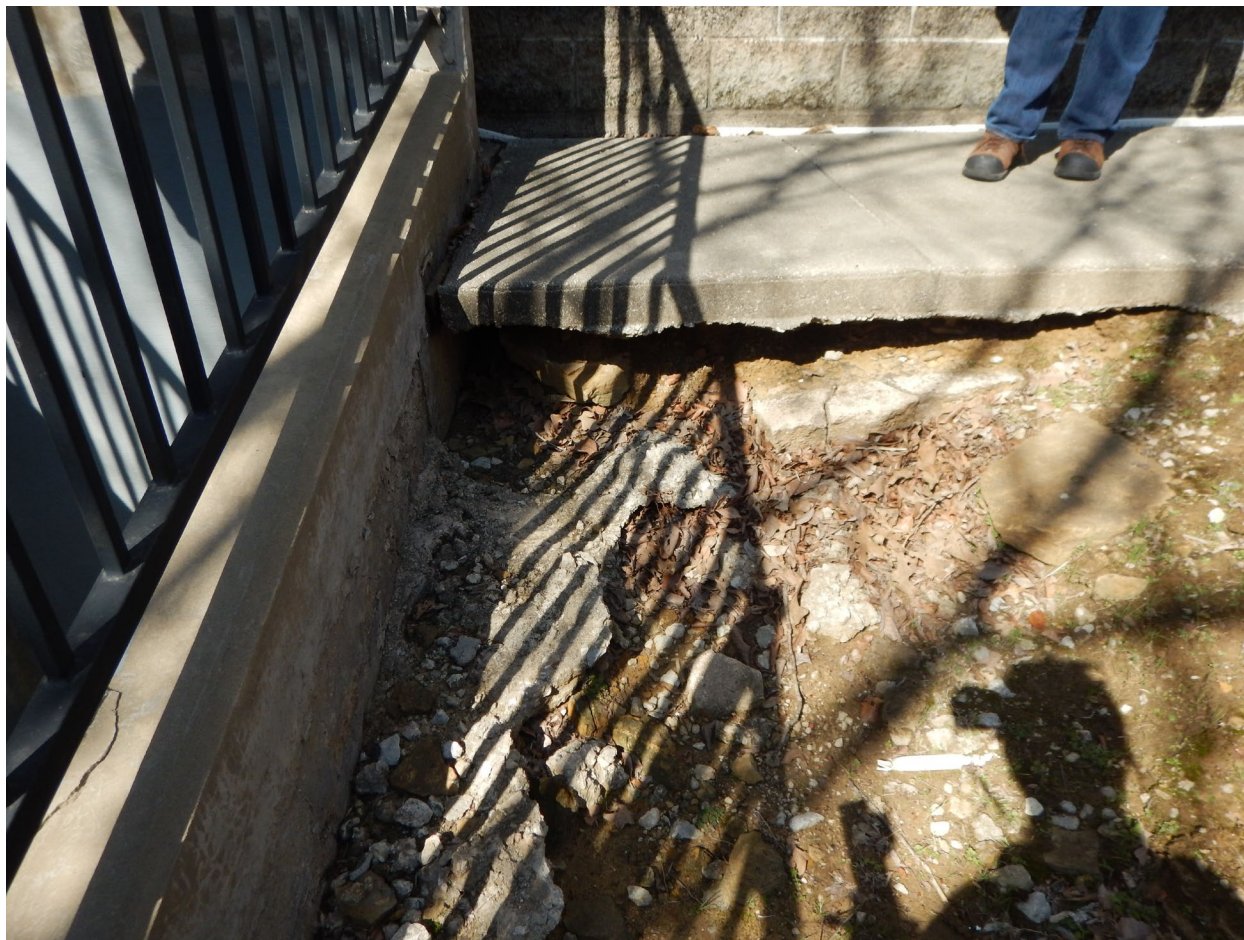
Photo No. 8

Description: Erosion beneath the sidewalk surrounding Pintail Pump Station 3.0 MG ground storage tank

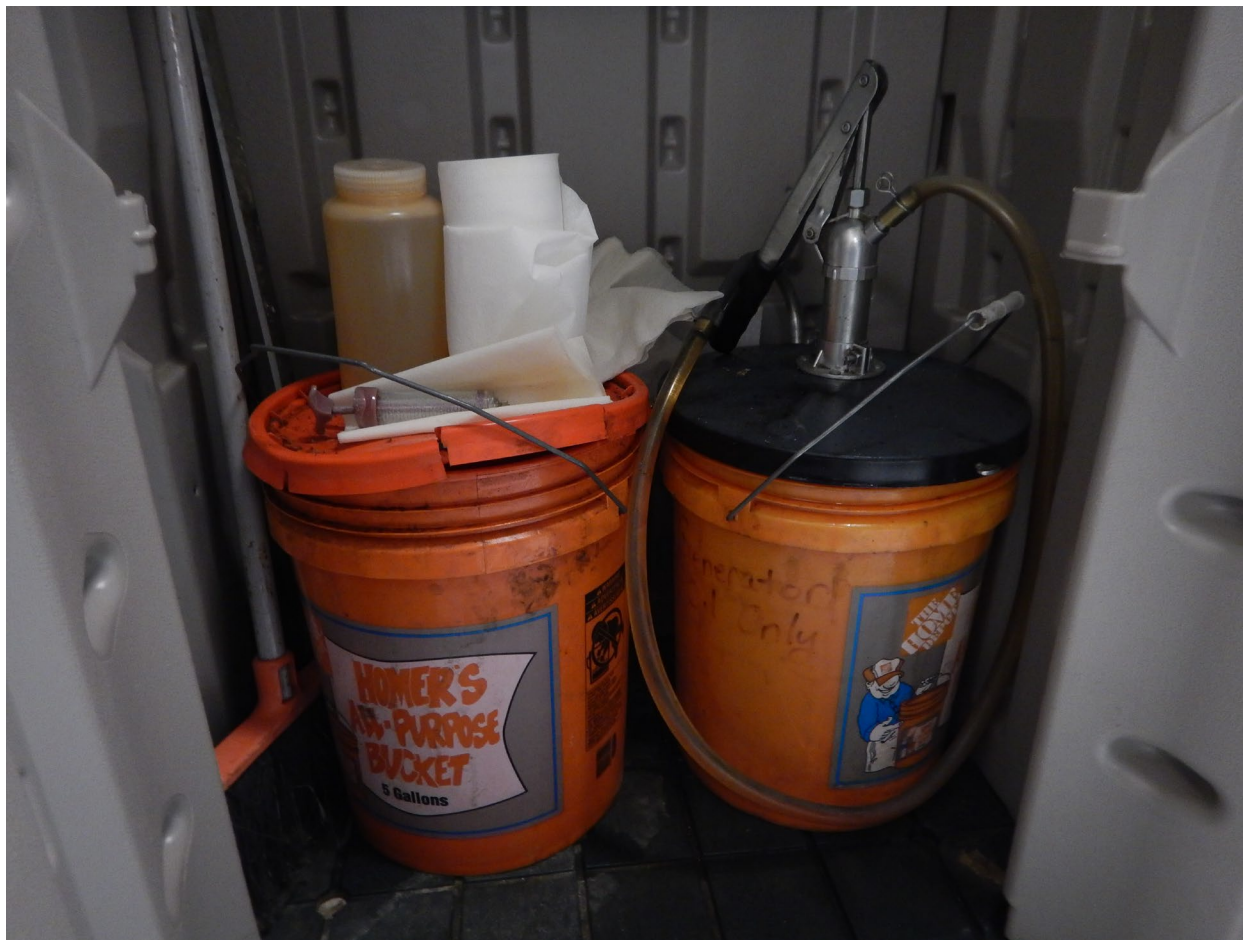
Photo No. 9

- One of the five pumps was online during the time of the inspection. We were informed that the pumps rotate operation every month. A second pump may go online during peak season demand. Pumps were free of rust and no leaks were observed. The lubricating oil for the pumps was in an unlabeled 5-gallon bucket in a storage closet (Appendix 1, Photo 9; AOC 6). The original packaging and label was missing at the time of the inspection.
- The storage tank was observed to be in good condition at the time of the inspection.

Description: Unlabeled pump lubricating oil containers at Stonehill Pump Station

6. Lubricating oil in an unlabeled container at the Stonehill Pump Station. We recommend keeping lubricating oil in its original container with label or applying the original label to the current container.

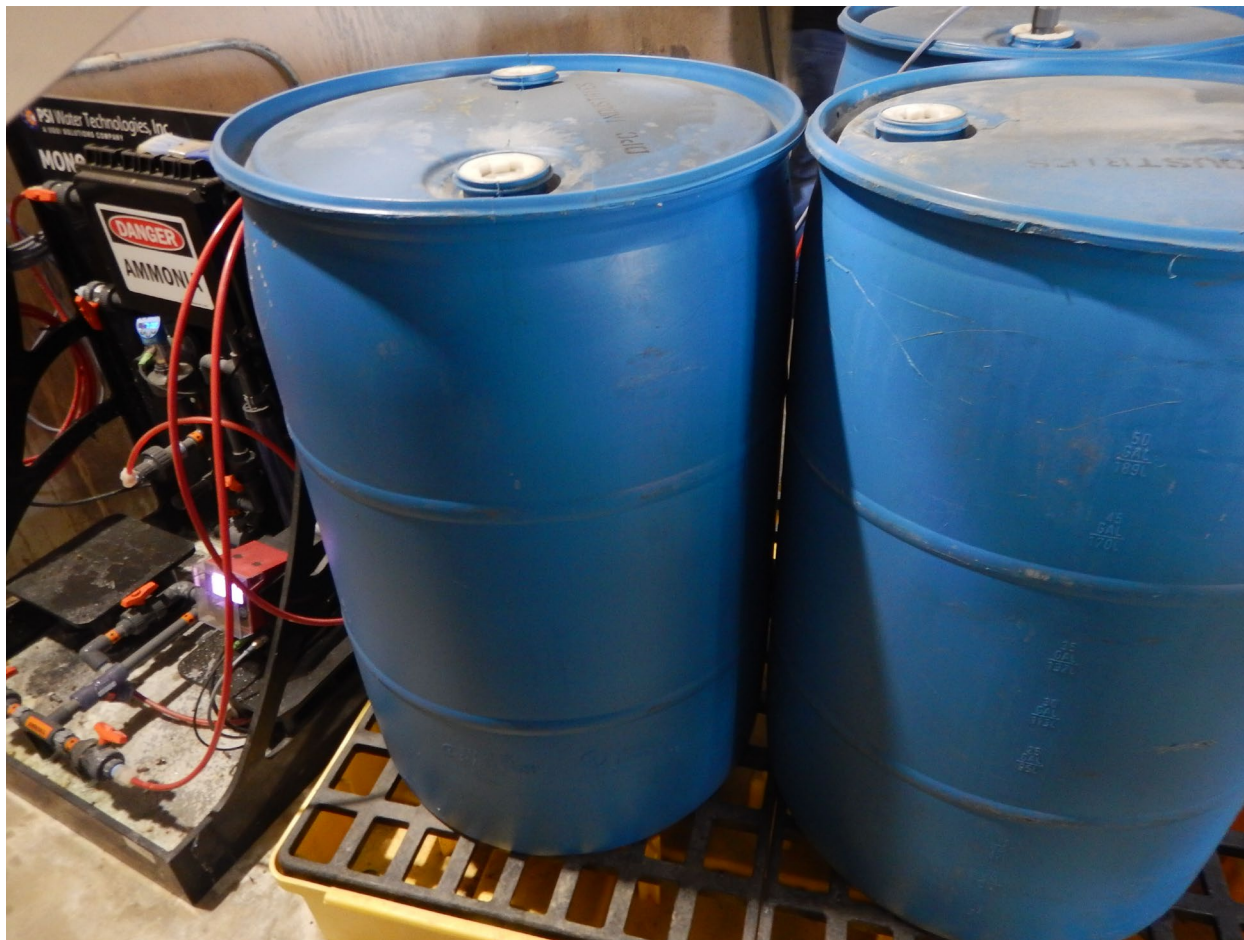
Photo No. 10

- The liquid ammonium sulfate (LAS) barrels for the chloramine booster had adequate secondary containment. LAS barrels were missing original labels (Appendix 1, Photo 10; AOC 7).
- We observed deteriorating seals on the tank entry (Appendix 1, Photo 11; AOC 8), and a leak coming from the actuator arm (Appendix 1, Photo 12; AOC 9). Water from the leak was pooling in a joint on either side of the actuator (Appendix 1, Photo 13; AOC 9).

Description: Unlabeled LAS barrels at Bruton Orand Tower Chloramine Booster

7. LAS barrels missing/deteriorating labels at the Bruton Orand Tower Chloramine Booster. We recommend new labels for all three LAS barrels.
8. Deteriorating seals on the tank entry at Bruton Orand Tower. We recommend replacing deteriorating seals.

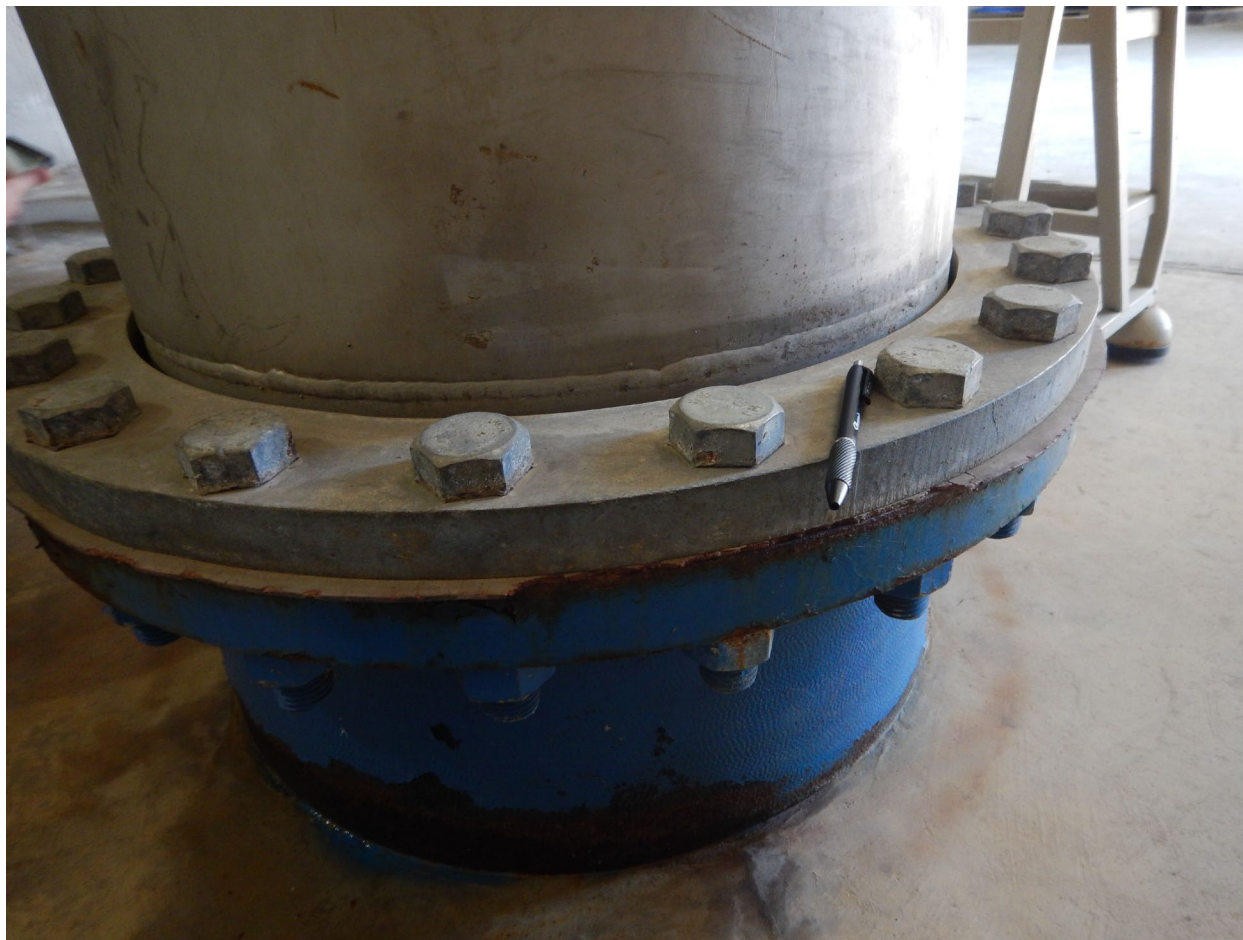
Photo No. 11

Description: Deteriorating seal on the tank entry at Bruton Orand Tower

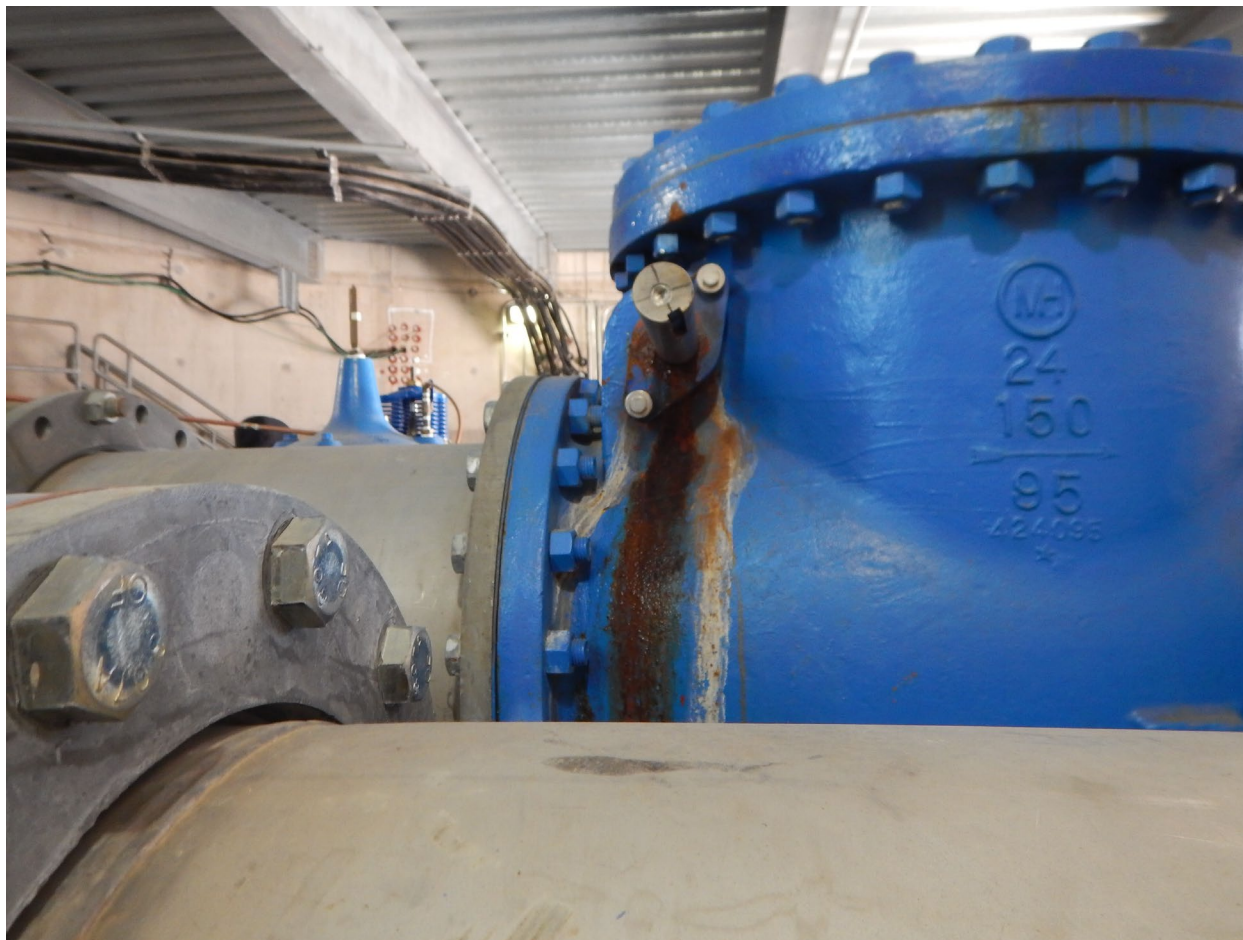
Photo No. 12

Description: Active leak from tank entry actuator arm at Bruton Orand Tower

9. Active leak and water pooling from the actuator arm on the tank entry at the Bruton Orand Tower. We recommend fixing the observed leak and inspecting the areas where water had pooled for rust and repair any damage.
