## REGION 10 Enforcement Division

### INSPECTION REPORT

| <b>Company Name:</b> | Delta Western, LLC | | |
| <b>Facility or Site Name:</b> | Delta Western, LLC - Juneau Bulk Facility | | |

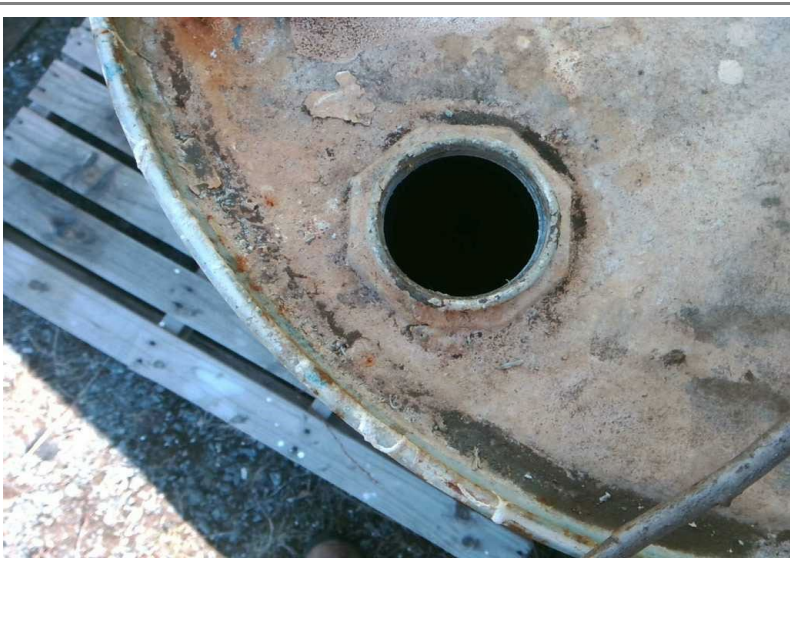
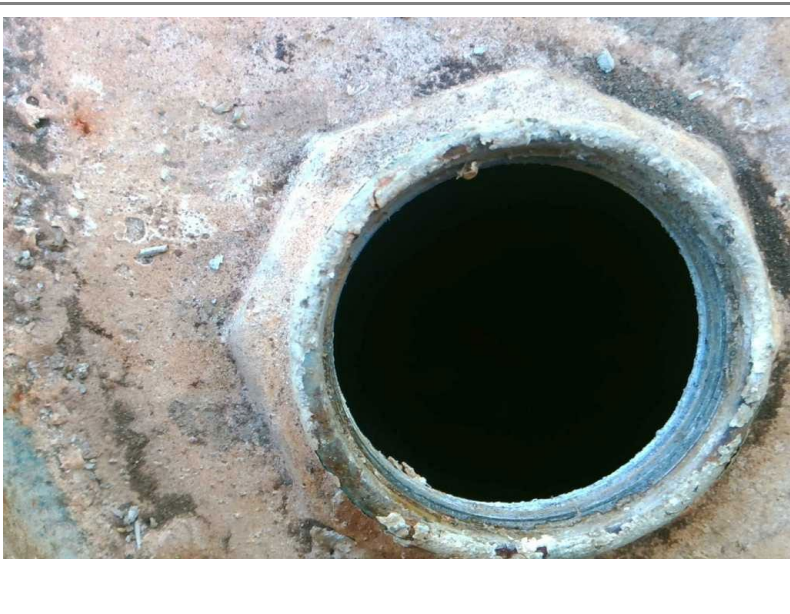
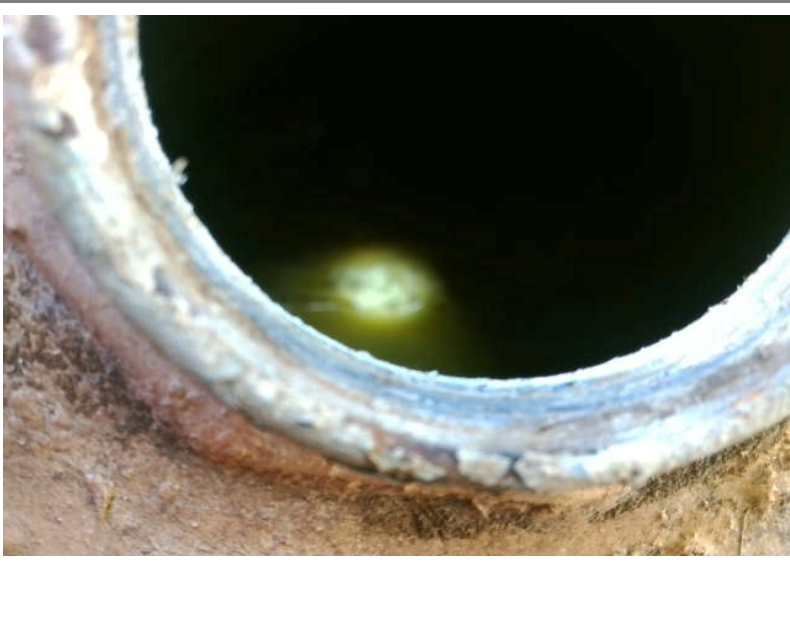
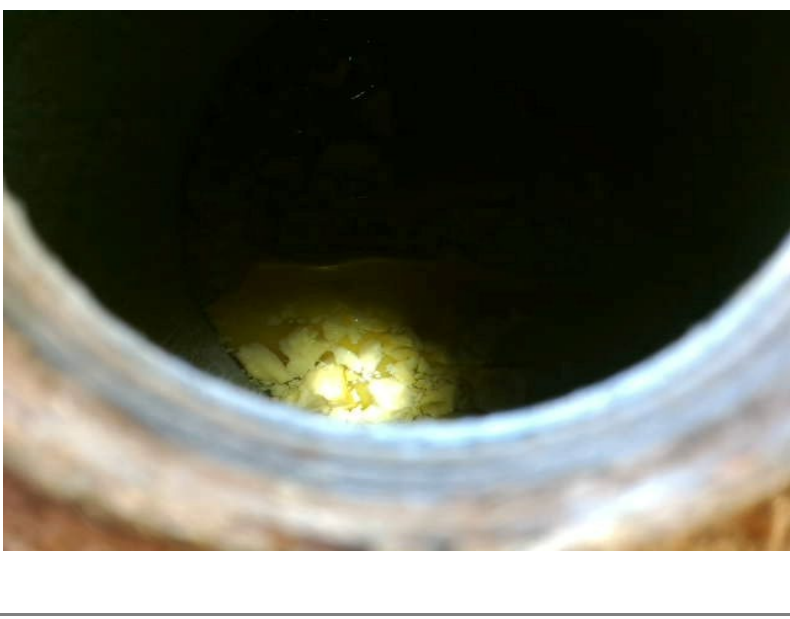
He went back to the office to ask Mr. Comstock about the container. Mr. Bjork returned and opened the bung on the container to determine what the container held. He used the light on his iPhone to see what was in the container and said it appeared to be white paint. He waved his hand over the opening and at that point I could smell a solvent odor. Mr. Bjork concurred that it was some type of solvent that was mixed with paint/coating.

| <p>[Title]</p> <p>IMG-2022041411195919591206201.jpg</p> <p>04/14/2022 11:19 AM (AKT)</p> <p>Jon Jones</p> <p>Tank Farm/Southwest side of the facility, just outside the tank farm perimeter.</p> <p>No CBI</p> <p>No PII</p> <p>View of the container bung opening (Photographed while Mr. Bjork attempted to view the contents of the container).</p> | |
| <p>[Title]</p> <p>IMG-2022041411201720171168177.jpg</p> <p>04/14/2022 11:20 AM (AKT)</p> <p>Jon Jones</p> <p>Tank Farm/Southwest side of the facility, just outside the tank farm perimeter.</p> <p>No CBI</p> <p>No PII</p> <p>Close-up view of the container bung opening (Photographed while Mr. Bjork attempted to view the contents of the container).</p> | |

| <p>[Title]</p> <p>IMG-20220414113906396160320.jpg</p> <p>04/14/2022 11:39 AM (AKT)</p> <p>Jon Jones</p> <p>Tank Farm/Southwest side of the facility, just outside the tank farm perimeter.</p> <p>No CBI</p> <p>No PII</p> <p>Close-up view looking into the container through the bung opening (Photographed while Mr. Bjork attempted to view the contents of the container using an iPhone light).</p> | |
| <p>[Title]</p> <p>IMG-202204141139143914107154.jpg</p> <p>04/14/2022 11:39 AM (AKT)</p> <p>Jon Jones</p> <p>Tank Farm/Southwest side of the facility, just outside the tank farm perimeter.</p> <p>No CBI</p> <p>No PII</p> <p>View of the container contents, illuminated by Mr. Bjork's iPhone light.</p> | |

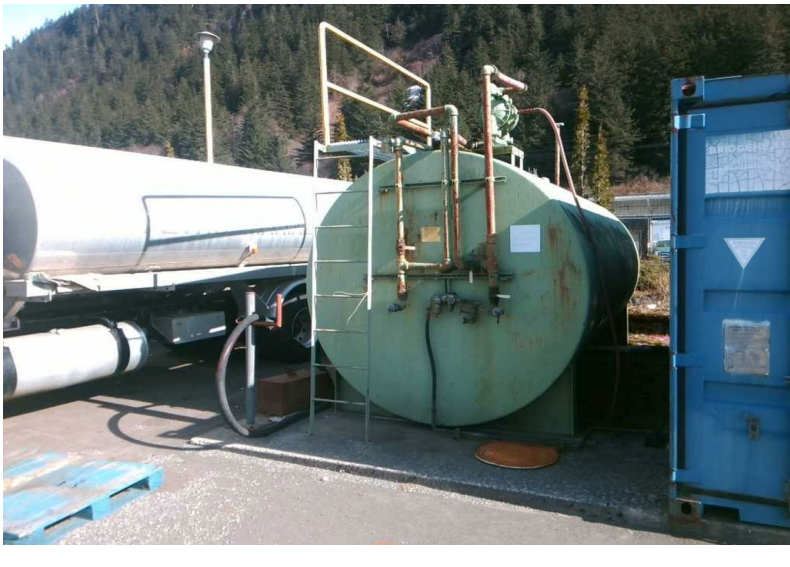
| While inspecting the area, I saw a Used Oil storage tank. According to Mr. Bjork the tank has a capacity of 6,000 gallons. The container was labeled with the words "Used Oil." | |

| <p>[Title]</p> <p>IMG-202204141029012911074586.jpg</p> <p>04/14/2022 10:29 AM (AKT)</p> <p>Jon Jones</p> <p>Load rack and tank farm</p> <p>No CBI</p> <p>No PII</p> <p>View of used oil storage tank.</p> | |

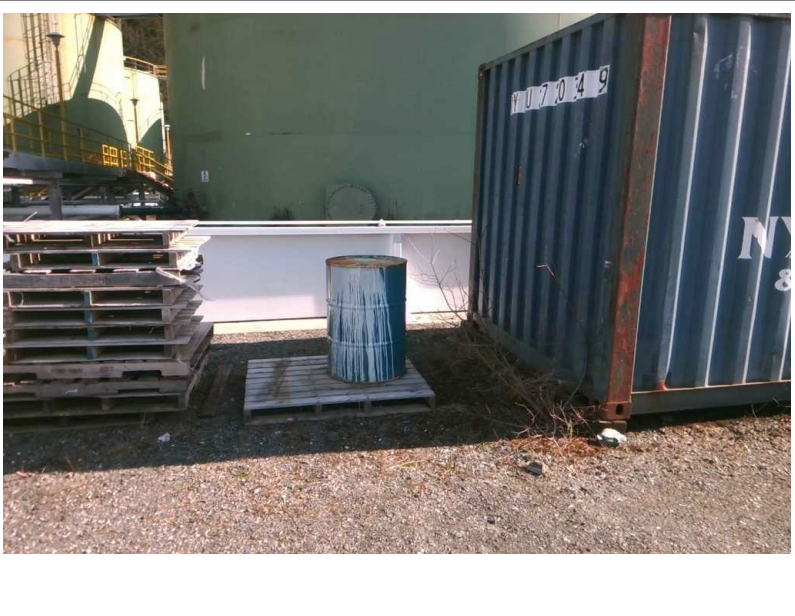
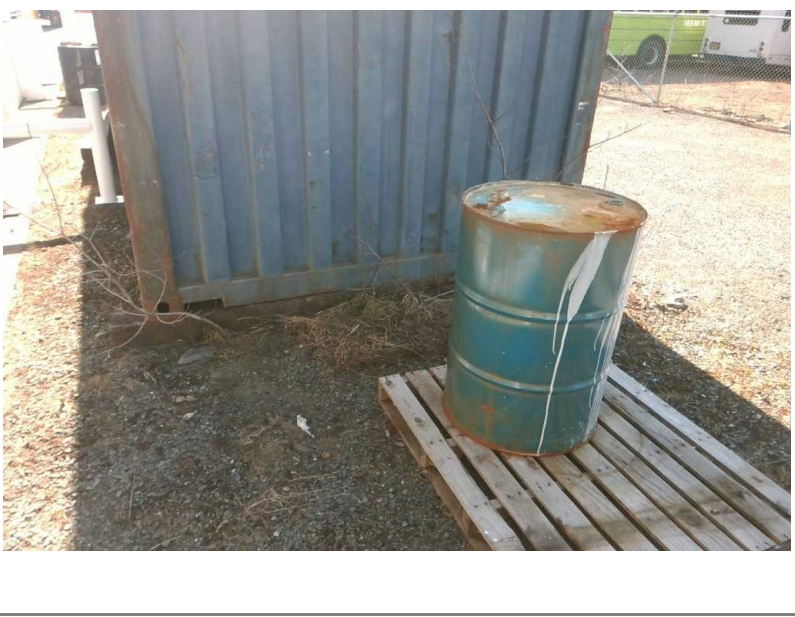
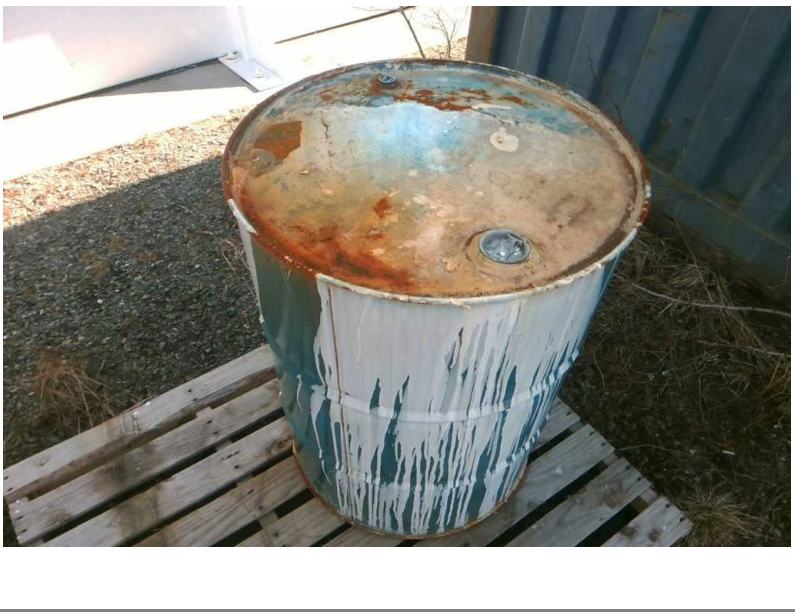
While inspecting the area outside the bermed perimeter of the tank farm, I saw a blue, 55-gallon container that was on a pallet. The container had some sort of white liquid staining that appeared to have been splashed on or run down the exterior surface of the container. I jostled the container back and forth and could hear the contents sloshing back and forth. It felt as though it was approximately half full of a liquid. The exterior of the container was void of any markings or labeling and I asked Mr. Bjork if he knew what kind of liquid the container held. Mr. Bjork told me he thought it was leftover waste paint and solvent from a previous project in which a contractor came out and applied a sealer to the interior of the tank farm's secondary containment.

Mr. Comstock confirmed that the container held some waste paint related material. Mr. Comstock contacted the contractor that had performed the job and he said the contractor told him it was a mix of the product that had been used to seal the surface of the tank farm's secondary containment and Methyl Ethyl Ketone (MEK) used to clean the paint guns.

During the inspection, I explained to Mr. Bjork that my concern was the amount of waste in the container and that if more than 220 pounds had been generated, his facility's generator category would have moved up to Small Quantity Generator.

Following the inspection, on 4/14/2022, Mr. Bjork worked with AML to have a forklift scale brought over to weigh the container. Mr. Bjork called me on the afternoon of 4/14/2022 to tell me that the weight of the container, after subtracting the weight of the pallet, was 215 pounds, including the weight of the container. . Mr. Bjork followed up with an email on 4/14/2022 that included a description of what he spoke to me about as well as photo documentation of weighing the container, the container weight, and verification that the scale used was certified.

| <p>[Title]</p> <p>IMG-2022041410453945391077819.jpg</p> <p>04/14/2022 10:45 AM (AKT)</p> <p>Jon Jones</p> <p>Tank Farm/Southwest side of the facility, just outside the tank farm perimeter.</p> <p>No CBI</p> <p>No PII</p> <p>View of the 55-gallon container that held waste paint related material (Mix of MEK/coating from paint gun cleaning).</p> | |
| <p>[Title]</p> <p>IMG-2022041410455345531263325.jpg</p> <p>04/14/2022 10:45 AM (AKT)</p> <p>Jon Jones</p> <p>Tank Farm/Southwest side of the facility, just outside the tank farm perimeter.</p> <p>No CBI</p> <p>No PII</p> <p>Another view of the 55-gallon container that held waste paint related material (Mix of MEK/coating from paint gun cleaning).</p> | |
| <p>[Title]</p> <p>IMG-2022041410472047201105380.jpg</p> <p>04/14/2022 10:47 AM (AKT)</p> <p>Jon Jones</p> <p>Tank Farm/Southwest side of the facility, just outside the tank farm perimeter.</p> <p>No CBI</p> <p>No PII</p> <p>Another view of the 55-gallon container that held waste paint related material (Mix of MEK/coating from paint gun cleaning).</p> | |
