INSPECTION REPORT

| Type of Inspection | Compliance Evaluation Inspection (CEI) | | |
| Company Name | North Slope Borough (NSB) | | |
| Facility or Site Name | Oxbow Landfill | | |

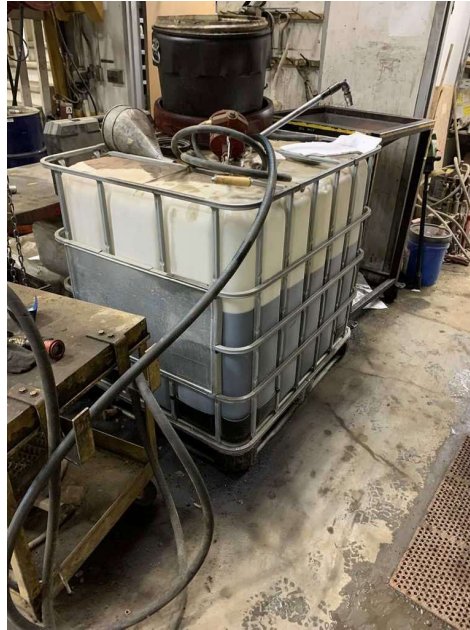
| [Title] | | | IMG_1585.jpg |

| <p>While in the Maintenance Shop, we saw a 275-gallon tote that appeared to contain used oil. I asked Mr. Lervig if the tote contained used oil and he told us that it did. At the time of the inspection, the tote contained approximately 225-gallons of used oil and was not labeled with the words "Used Oil." I explained the regulation requiring that all used oil storage units be labeled, and Mr. Lervig labeled the tote with the words "Used Oil" during the inspection.</p> <p>At the time of the inspection, there was also a 55-gallon container that was being used to accumulate used oil from filter draining. This container was labeled with the words used oil.</p> | | | |

| <b>Building:</b> Maintenance Shop | <b>Area:</b> | <b>Sub-area:</b> |
|---|---|---|
| A tote containing approximately 225-gallons of used oil was not labeled with the words "Used Oil." Mr. Lervig labeled the tote with the words "Used Oil" during the inspection. | <b>Regulations:</b> | <b>Sections:</b> |

| View of 275-gallon used oil tote that is not labeled with the words "Used Oil." | | | |

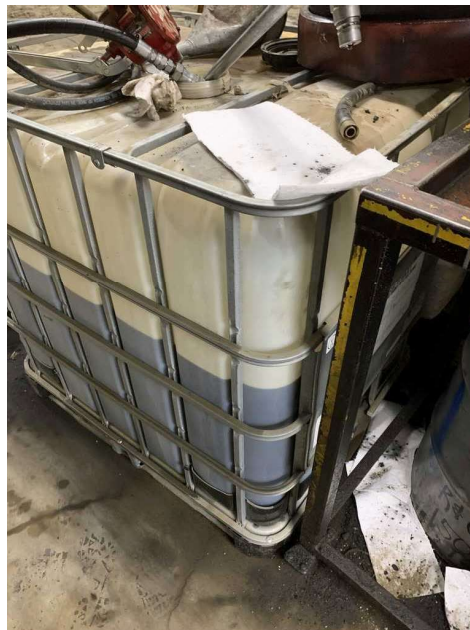
| [Title] | | | IMG_1586.jpg |

| Another view of the used oil tote, showing that it is not labeled with the words "Used Oil." | | | |

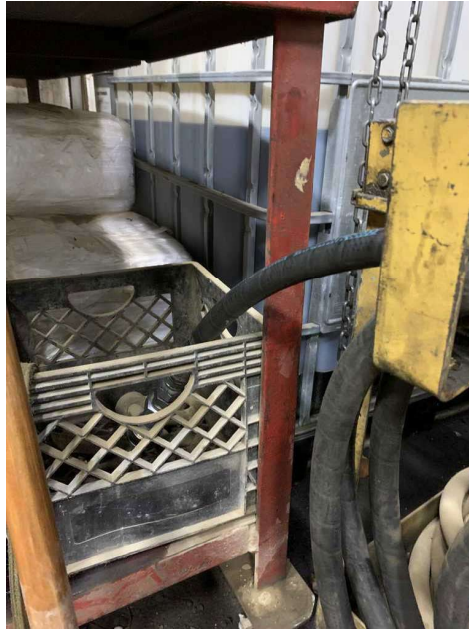
| [Title] | | | IMG_1587.jpg |

| Close-up view of the used oil tote, showing that it is not labeled with the words "Used Oil." | | | |

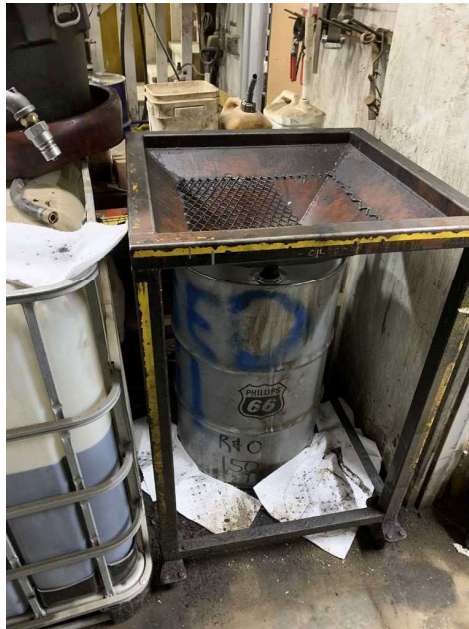
| [Title] | | | IMG_1588.jpg |

| View of a 55-gallon container being used to accumulate used oil. At the time of the inspection, this container was labeled with the words "Used Oil." | | | |

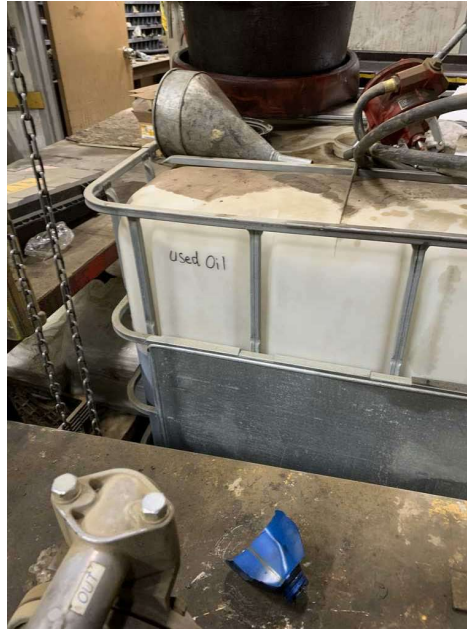
| [Title] | | | IMG_1589.jpg |

| View of the used oil tote after being labeled with the words "Used Oil," during the inspection. | | | |

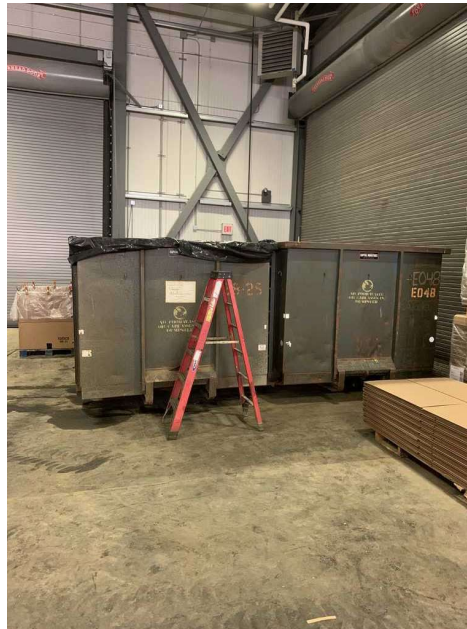
| [Title] | | | IMG_1590.jpg |

| View of the roll-off containers in the oily waste sorting area. Container on the left contains oily waste from Hilcorp's Milne Point facility. Container on the right contains less contaminated oily waste that will be landfilled. | | | |

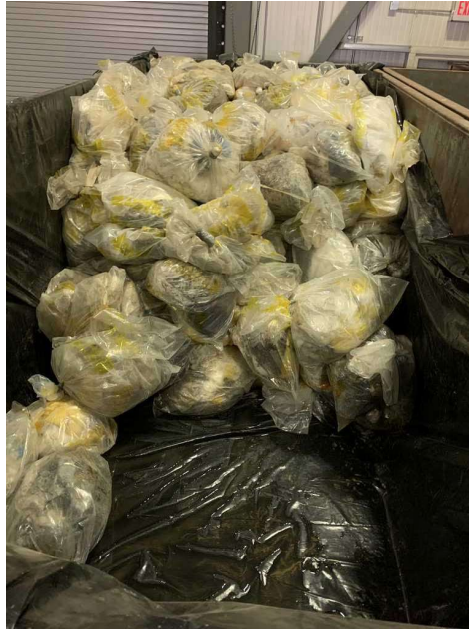
| [Title] | | | IMG_1591.jpg |

| View of the bags of oily waste that come into the facility prior to sorting. | | | |

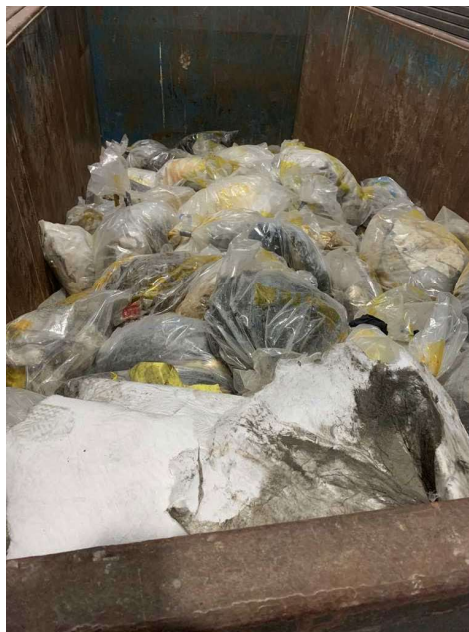
| [Title] | | | IMG_1592.jpg |

| View inside of the roll-off that contains sorted oily waste that will be landfilled. | | | |

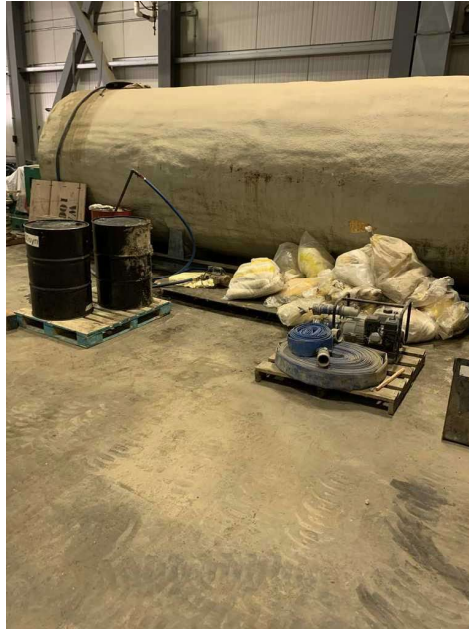
| [Title] | | | IMG_1593.jpg |

| View of less oily absorbents, that came in with oily waste, that will be used to soak up liquids in the bags of heavily contaminated oily waste. | | | |

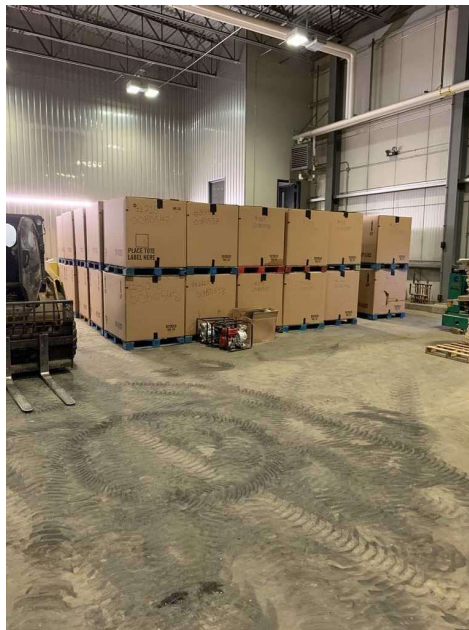
| [Title] | | | IMG_1594.jpg |

| View of the boxed bags of oily waste that will be sent to the City of Spokane, WA. Waste to Energy facility. | | | |

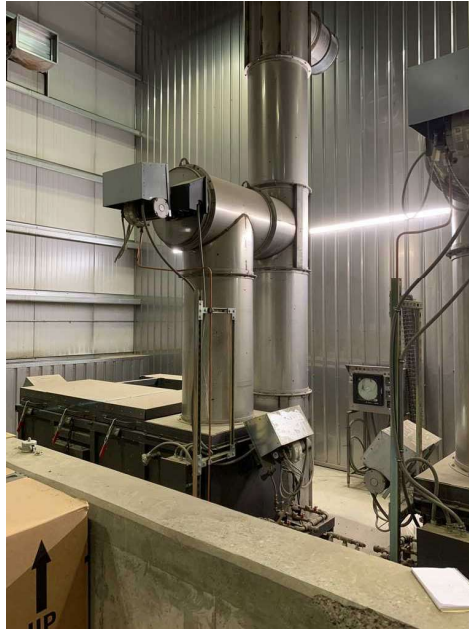
| [Title] | | | IMG_1595.jpg |

| View of the incinerators that were shut down and are not in operation. | | | |

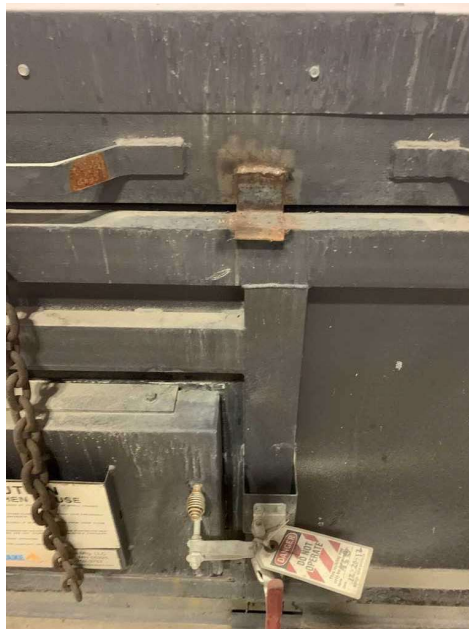
| [Title] | | | IMG_1596.jpg |

| Close-up view of the incinerator, showing that the door had been welded shut. | | | |

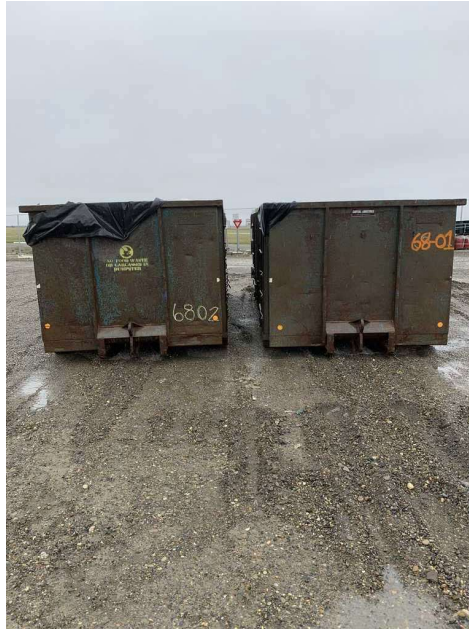
| [Title] | | | IMG_1597.jpg |

Just outside the Incinerator building, we saw two additional roll-off containers of oily waste that required sorting. According to Mr. Lervig, the roll-off marked #6802 came in from Hilcorp's Prudhoe Bay Unit (PBU) Pad 9 and the other marked #6801 came in from Hilcorp's PBU Flow Station 1 (FS-1).

| View of additional roll-off containers holding bags of oily waste that require sorting. The roll-off on the left contains oily waste from Hilcorp's PBU Pad 9 and the roll-off on the right contains oily waste from Hilcorp's PBU Flow Station 1. | | | |

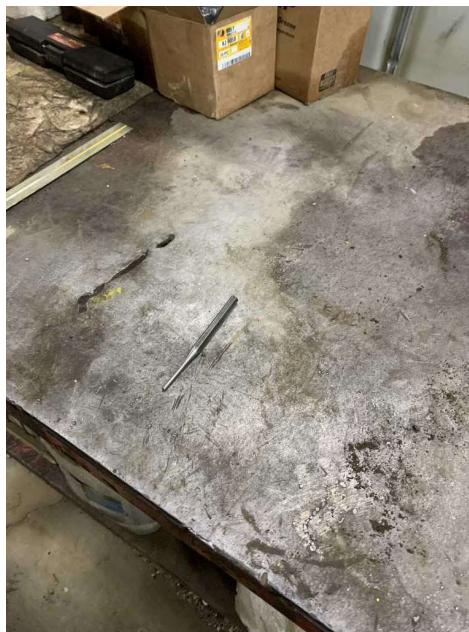
| [Title] | | | IMG_1602.jpg |

| <p>We returned to the Maintenance Shop after inspecting the Incinerator building. Mr. Lervig mentioned during the opening conference that his facility generates several waste aerosol cans each month that get punctured in the Maintenance Shop. Upon our return, I asked Mr. Lervig to show me where and how the waste aerosol cans were being punctured. Mr. Lervig told me that the waste aerosol cans were being punctured, using a hammer and a punch, on a bench in the shop. I asked him how the punctured aerosol cans were being managed and he told us that they were being disposed of into the scrap metal pile. I asked Mr. Lervig for the name of the scrap metal recycler that the landfill was using. Mr. Lervig told us that most of the time it was cost prohibitive for the metal to go to a recycler. He told us that, most of the time, the scrap metal gets landfilled onsite. I explained that VSQGs were required to manage their waste properly and suggested that they make a waste determination and either manage them as a hazardous waste or a universal waste without puncturing the aerosol cans.</p> | | | |

| <b>Building:</b> Maintenance Shop | <b>Area:</b> | <b>Sub-area:</b> |
|---|---|---|
| Mr. Lervig told me that the waste aerosol cans were being punctured, using a hammer and a punch, on a bench in the shop. | <b>Regulations:</b> | <b>Sections:</b> |

| View of the bench and the punch used to puncture waste aerosol cans. | | | |

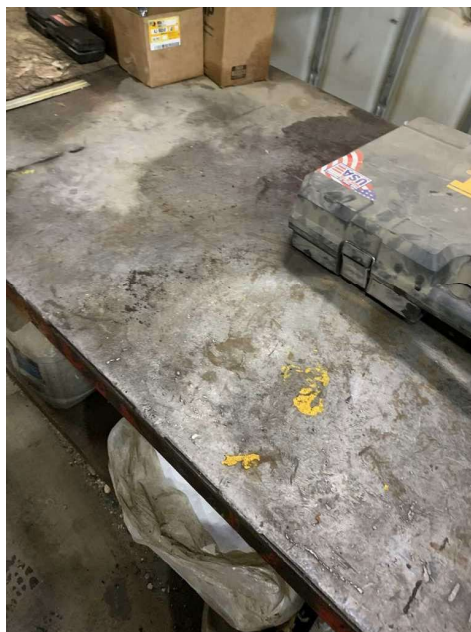
| [Title] | | | IMG_1603.jpg |

| View of yellow paint on the bench where waste aerosol cans are punctured using a hammer and punch. | | | |
