**Region 6 - Enforcement & Compliance Assurance Division**  
**INSPECTION REPORT**

| Inspection Date(s): | 8/16/2023 | |
| Company Name: | <b>Osage Pipe Line Company, LLC</b> | |
| Facility Name: | <b>Skull Creek</b> | |

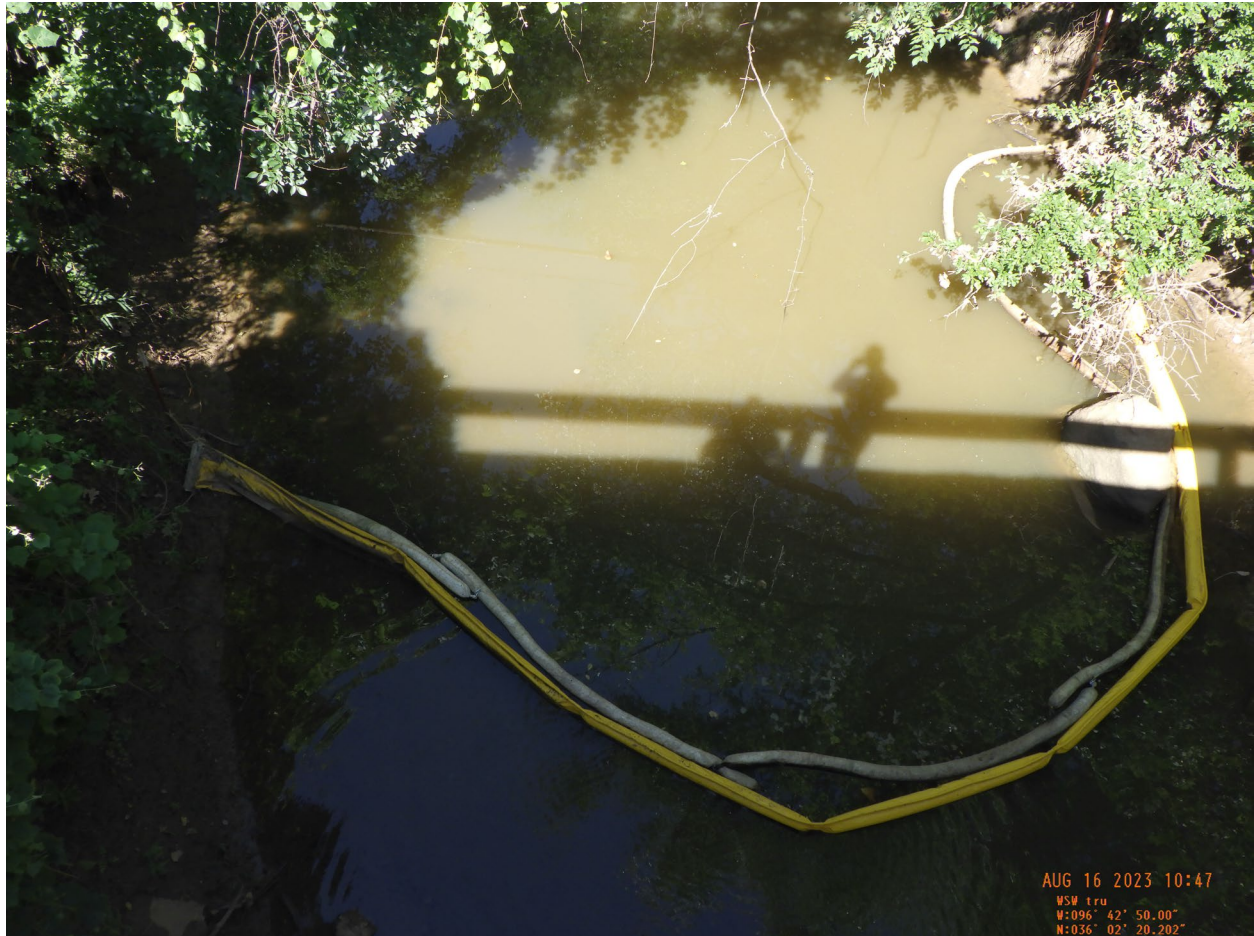
Photo No. 1

I observed sheen at the lowermost containment and boom site located on the west side of N Norfolk Road, see Appendix 1 (photo log), photos No. 1 and No.2. For additional GPS location and photo metadata, see Appendix 1.

My primary area of concern was the oil sheen observed at the lowermost boom site located just west of N Norfolk Road, which was downstream of all ongoing cleanup and restoration activities being conducted.

**Description:** Lowermost containment and absorbent boom located off N Norfolk Road with sheen present.

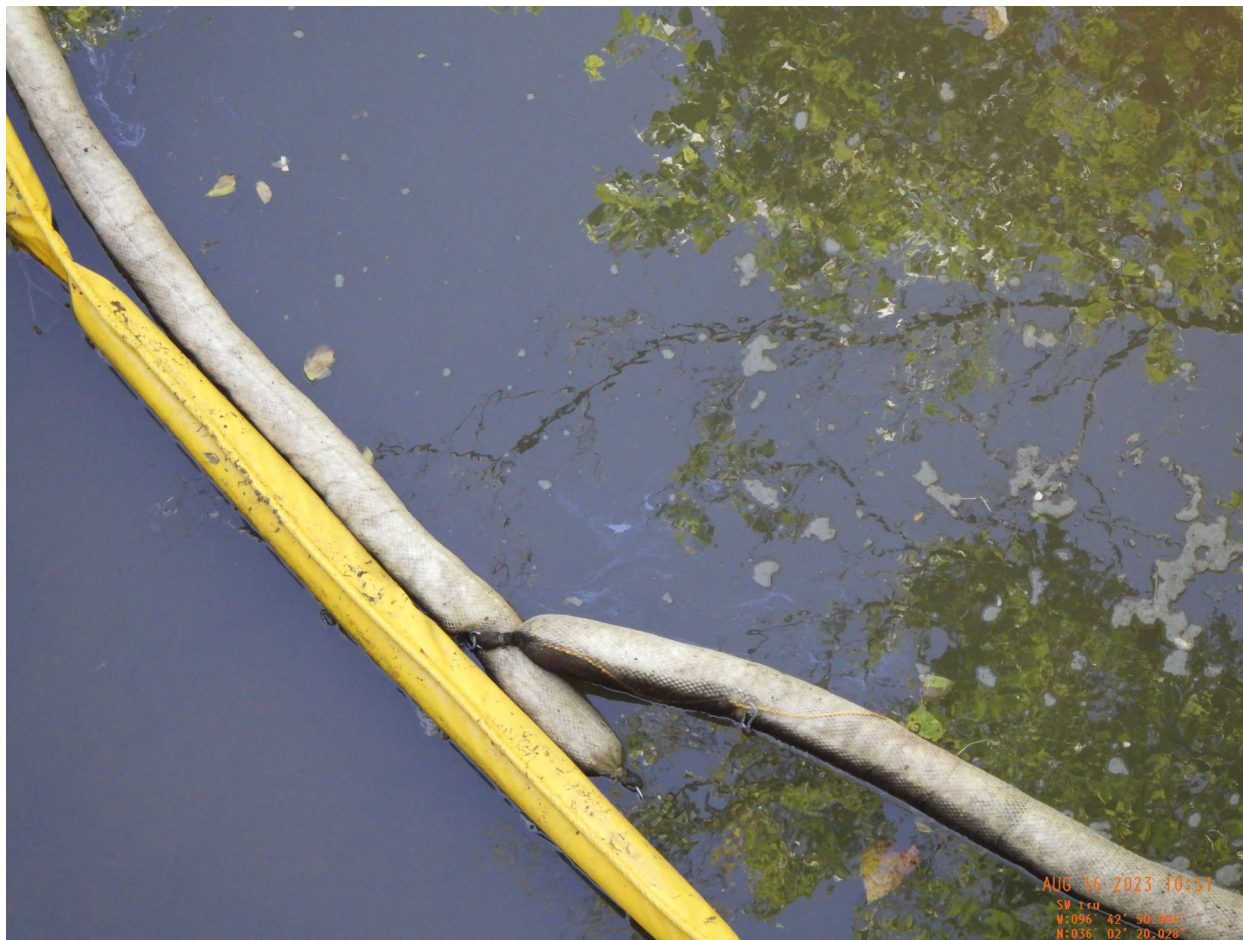
Photo No. 2

**Description:** Zoomed in photo of oil sheen present at the boom site off N Norfolk Road.

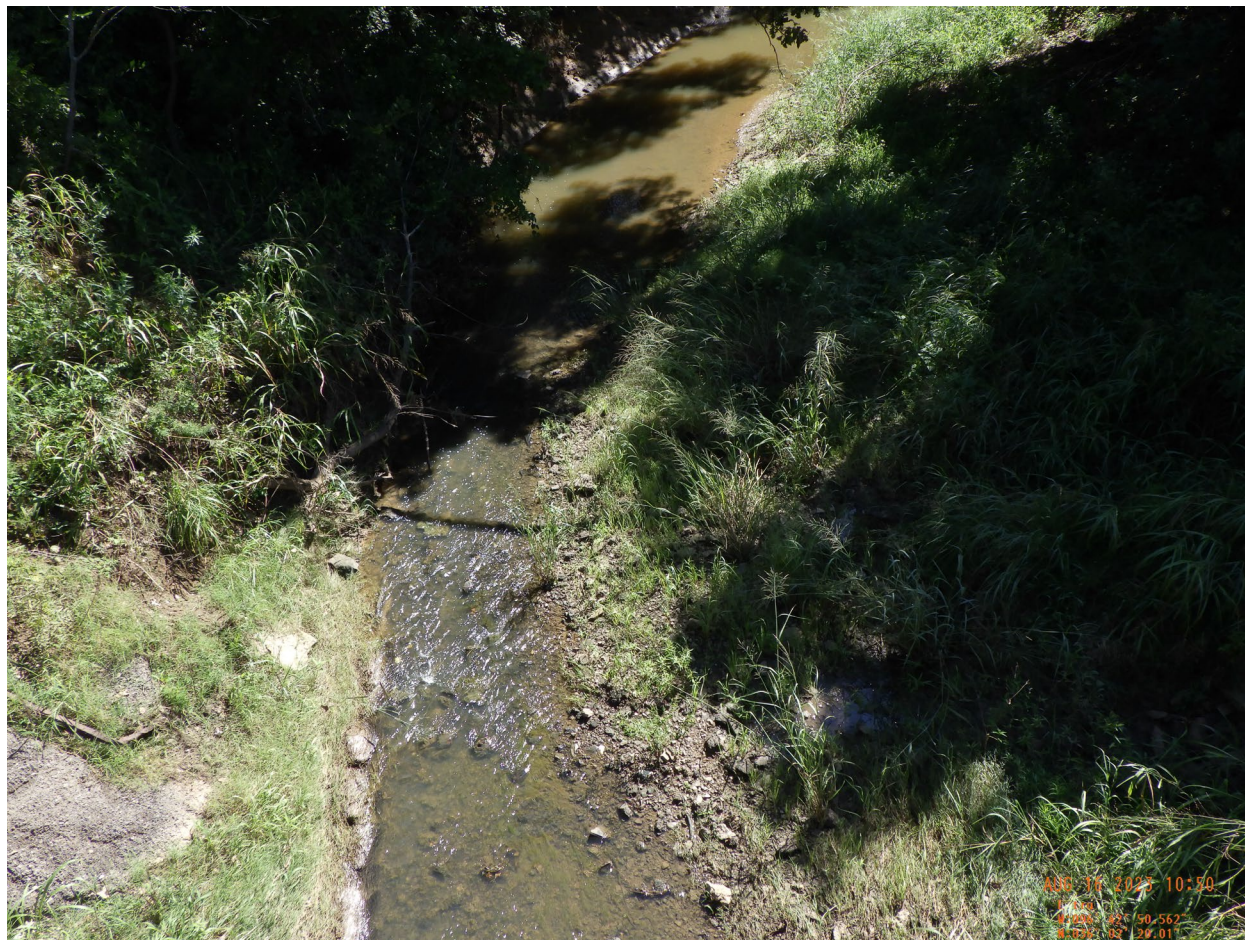
Photo No. 3

**Description:** This photo was taken at the boom off N Norfolk Road, with a view looking downstream.

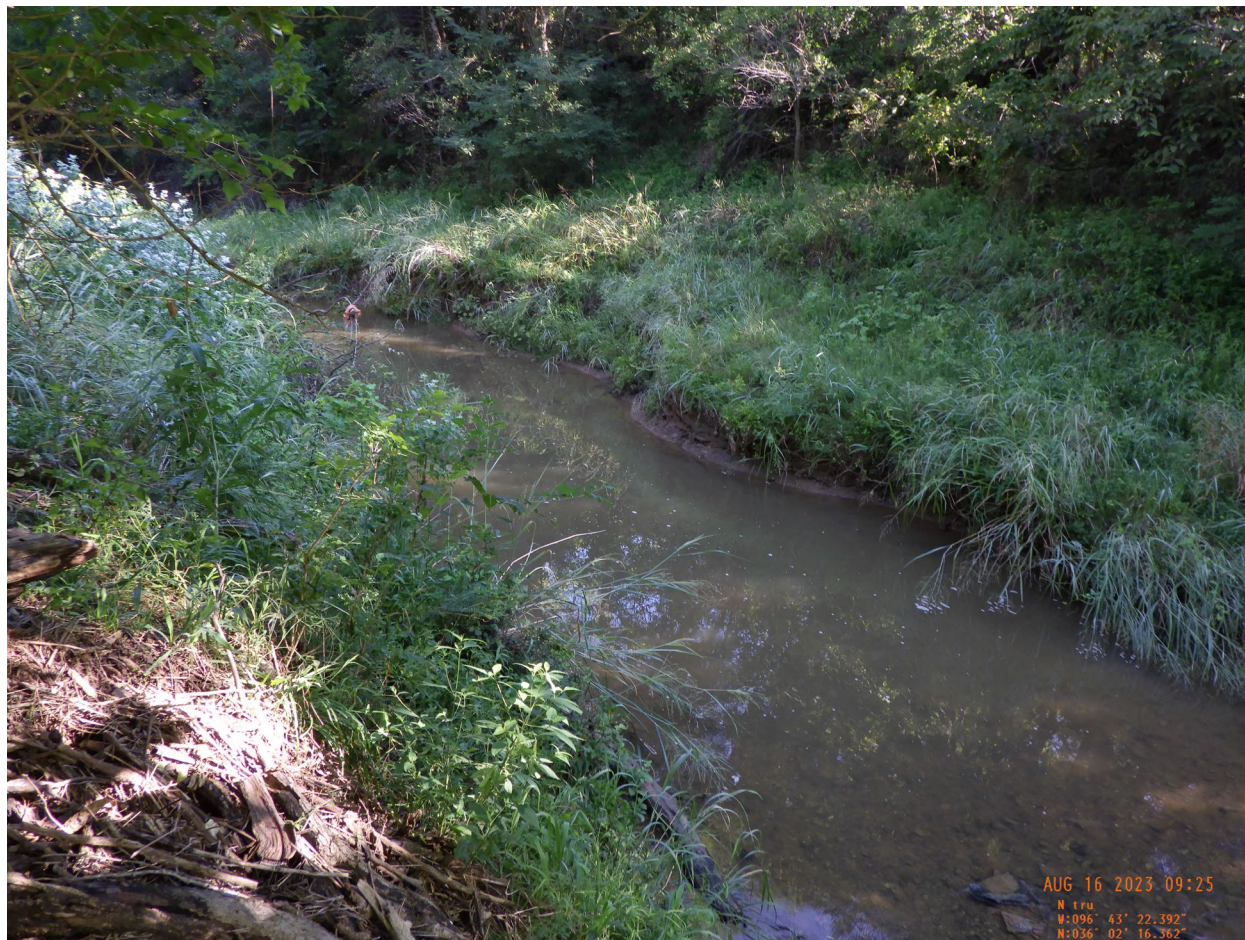
Photo No. 4

**Description:** This was a photo with a N or upstream view, showing the topography and vegetation of the tributary.

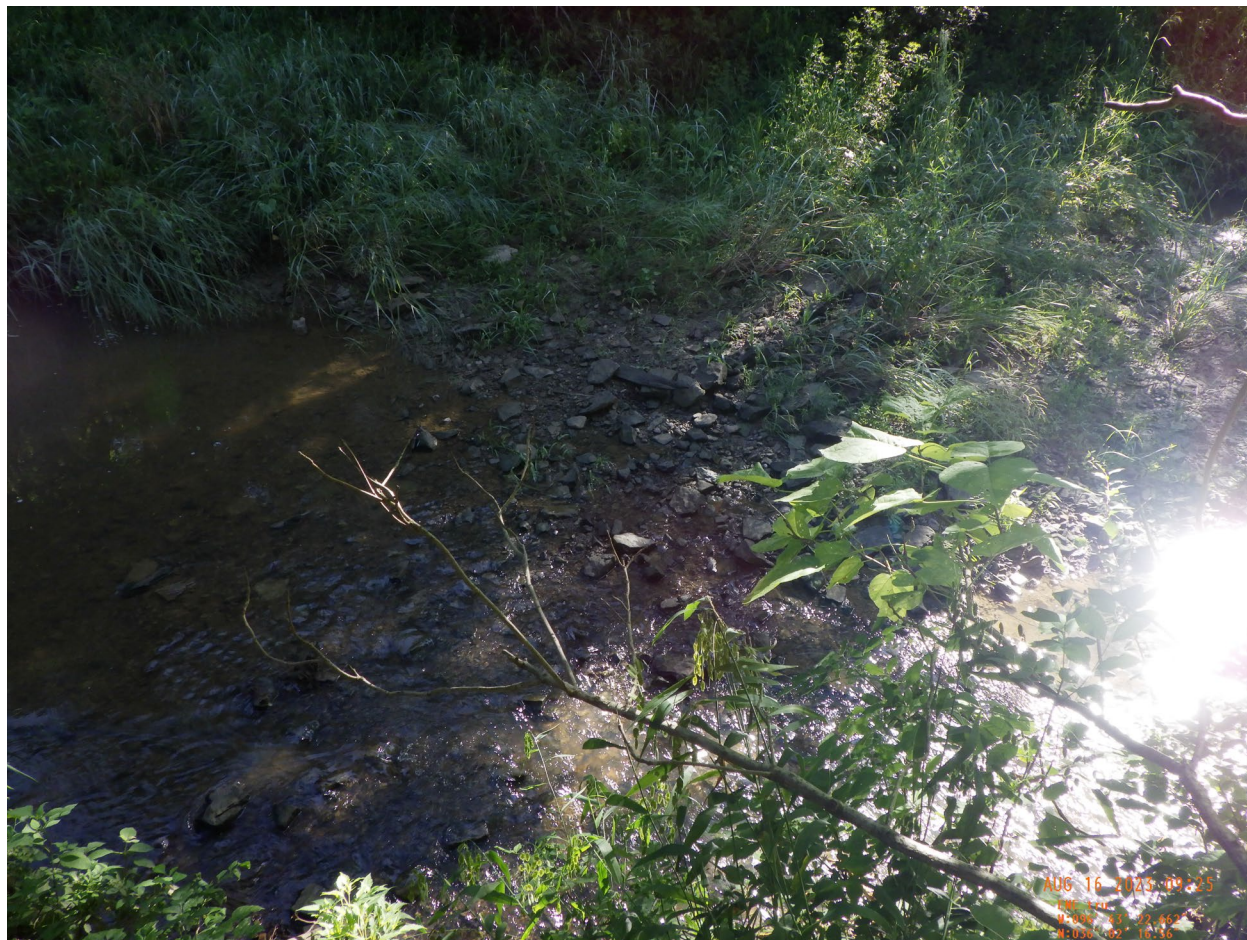
Photo No. 5

**Description:** This was a photo of a shallow point, showing the topography and vegetation of the tributary.

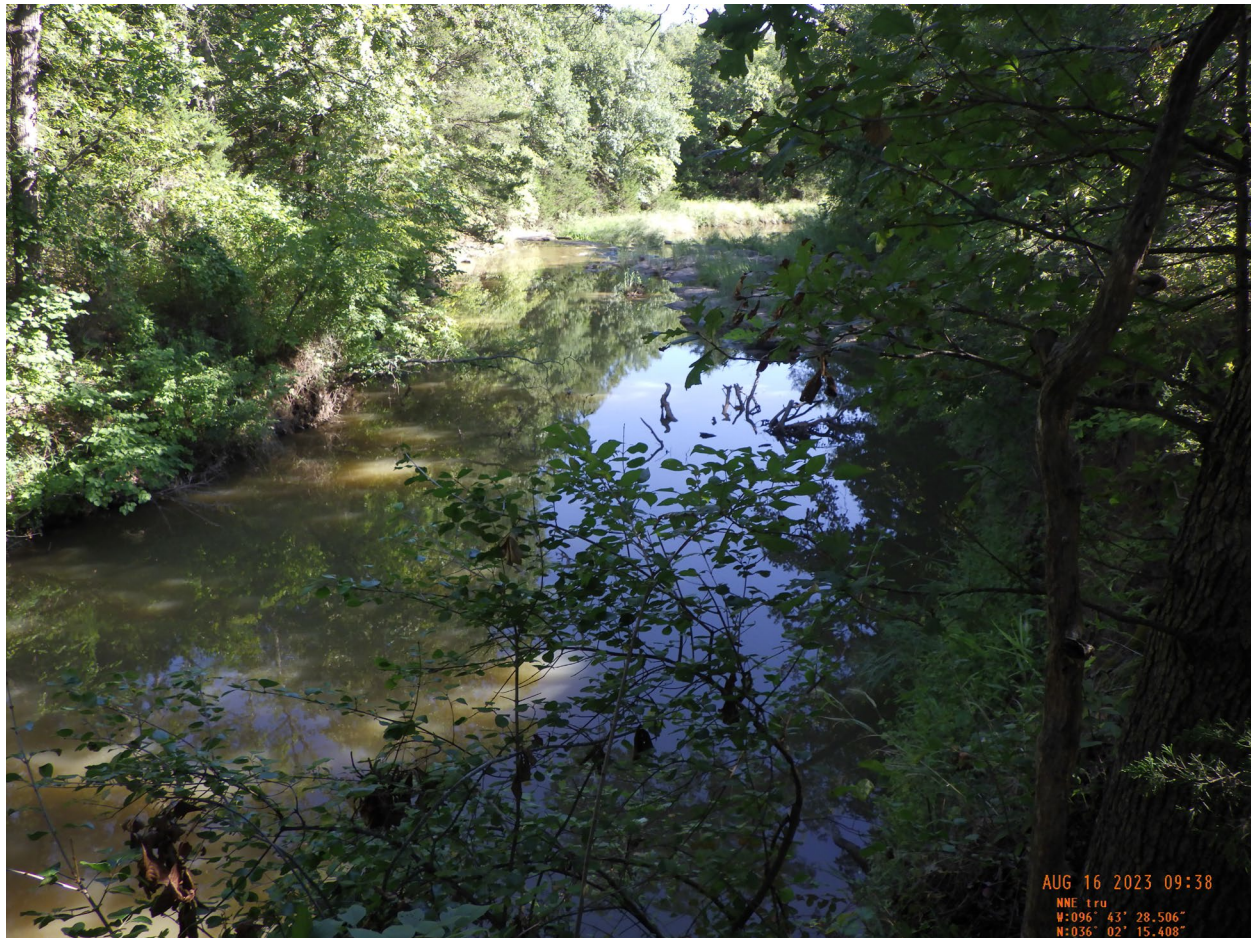
Photo No. 6

**Description:** This was a photo with a NNE or downstream view, showing the topography and vegetation of the tributary.

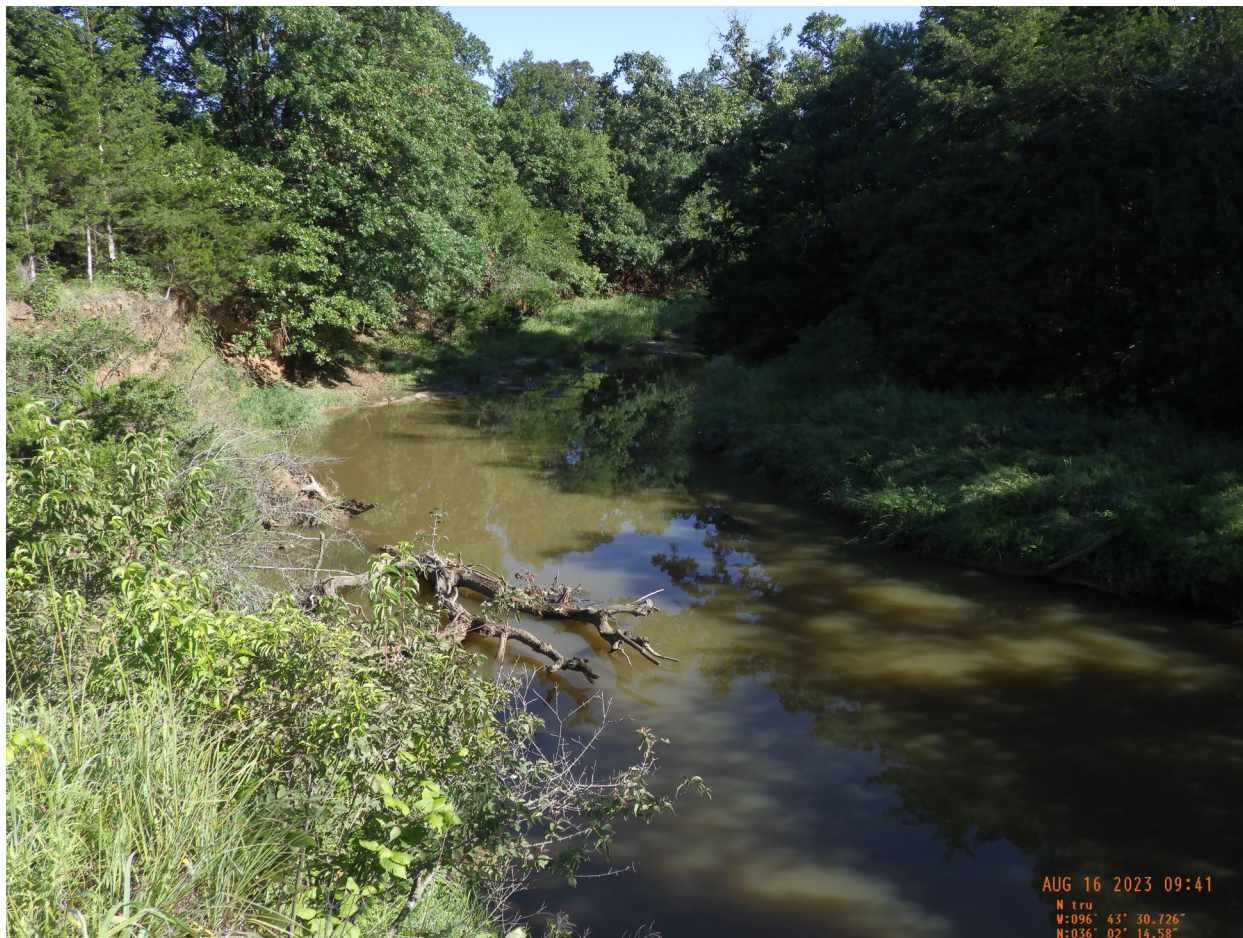
Photo No. 7

**Description:** This was a photo with a N or upstream view, showing the topography and vegetation of the tributary taken at the same location as photo 6.

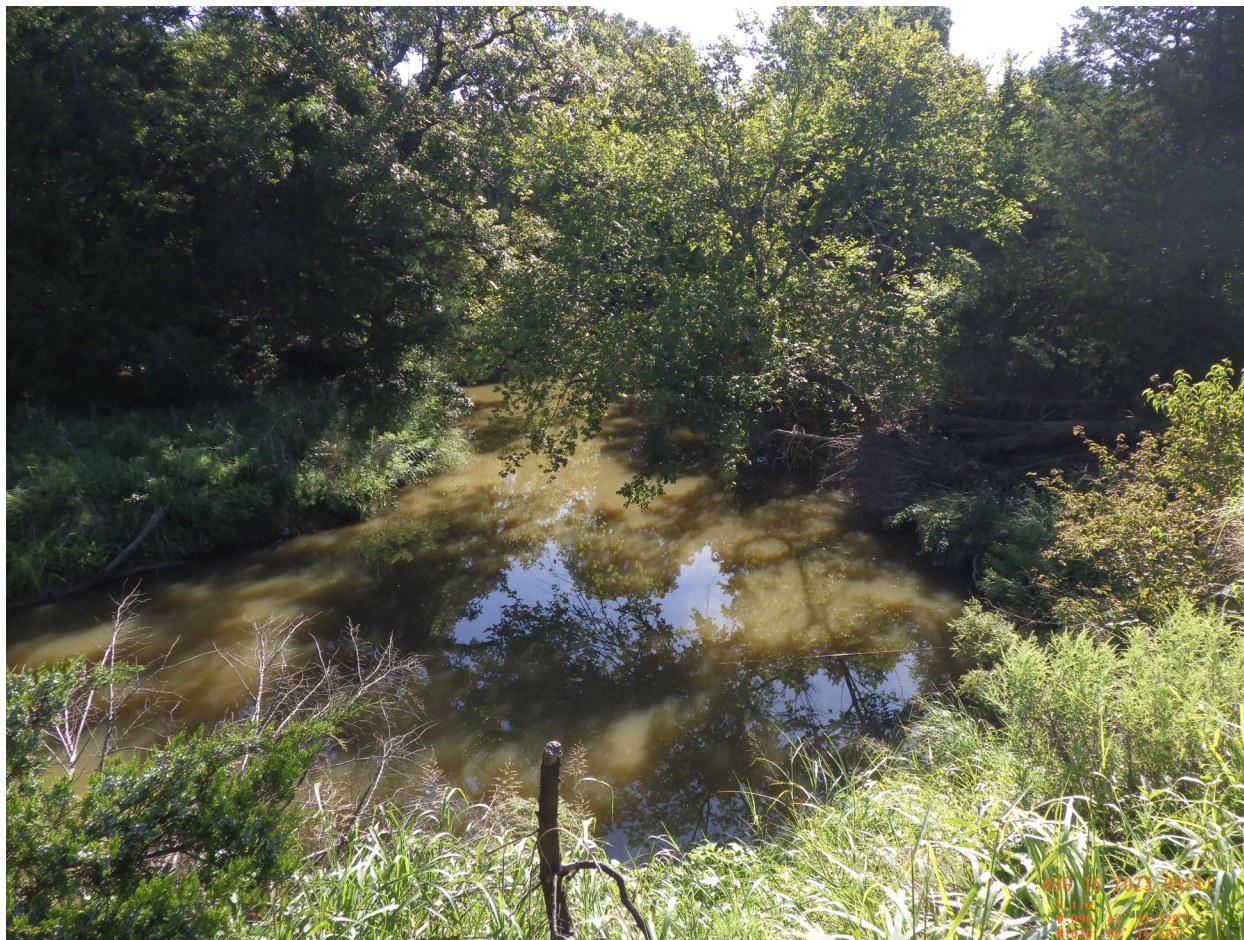
Photo No. 8

**Description:** This was a photo with a E or downstream view, showing the topography and vegetation of the tributary.

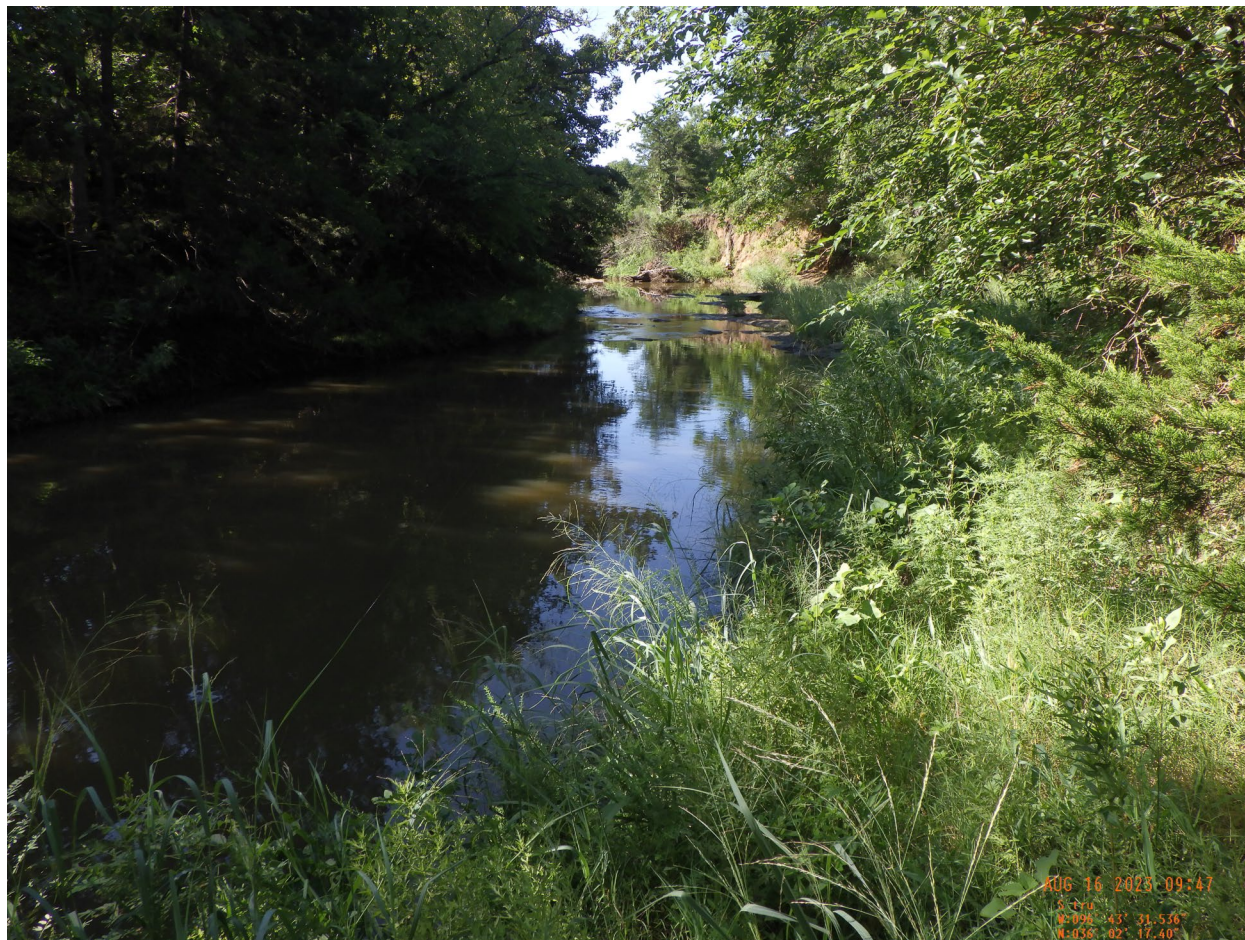
Photo No. 9

**Description:** This was a photo with a S or downstream view, showing the topography and vegetation of the tributary.

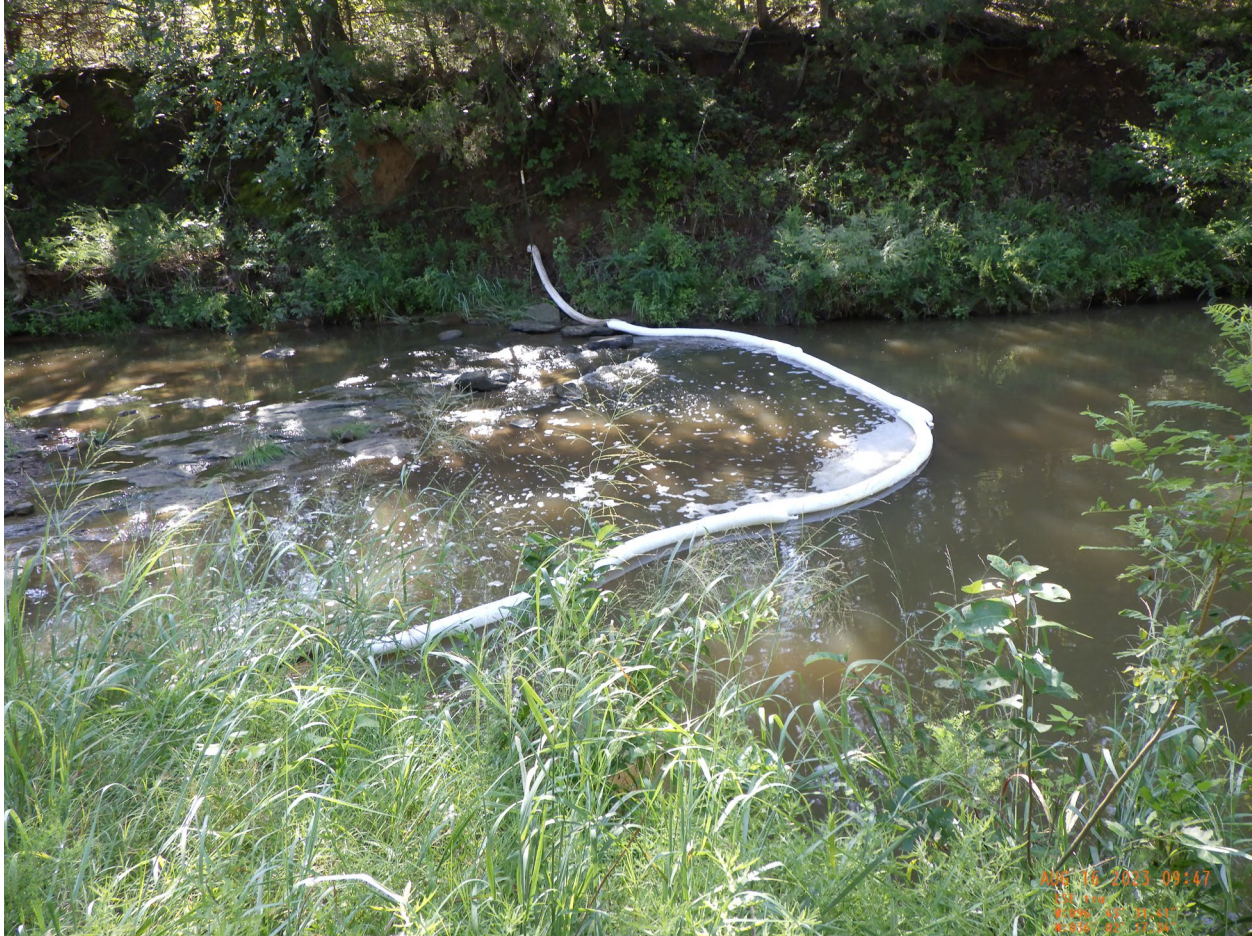
Photo No. 10

I observed an absorbent boom with foam approximately 30 yards downstream from the dam, see photo No. 10.

**Description:** This was a photo taken downstream from the lowermost containment dam location. At the time of the inspection, the containment dam was no longer present. This was a photo with ESE view, showing an absorbent boom and foam floating on the surface of the impacted tributary.

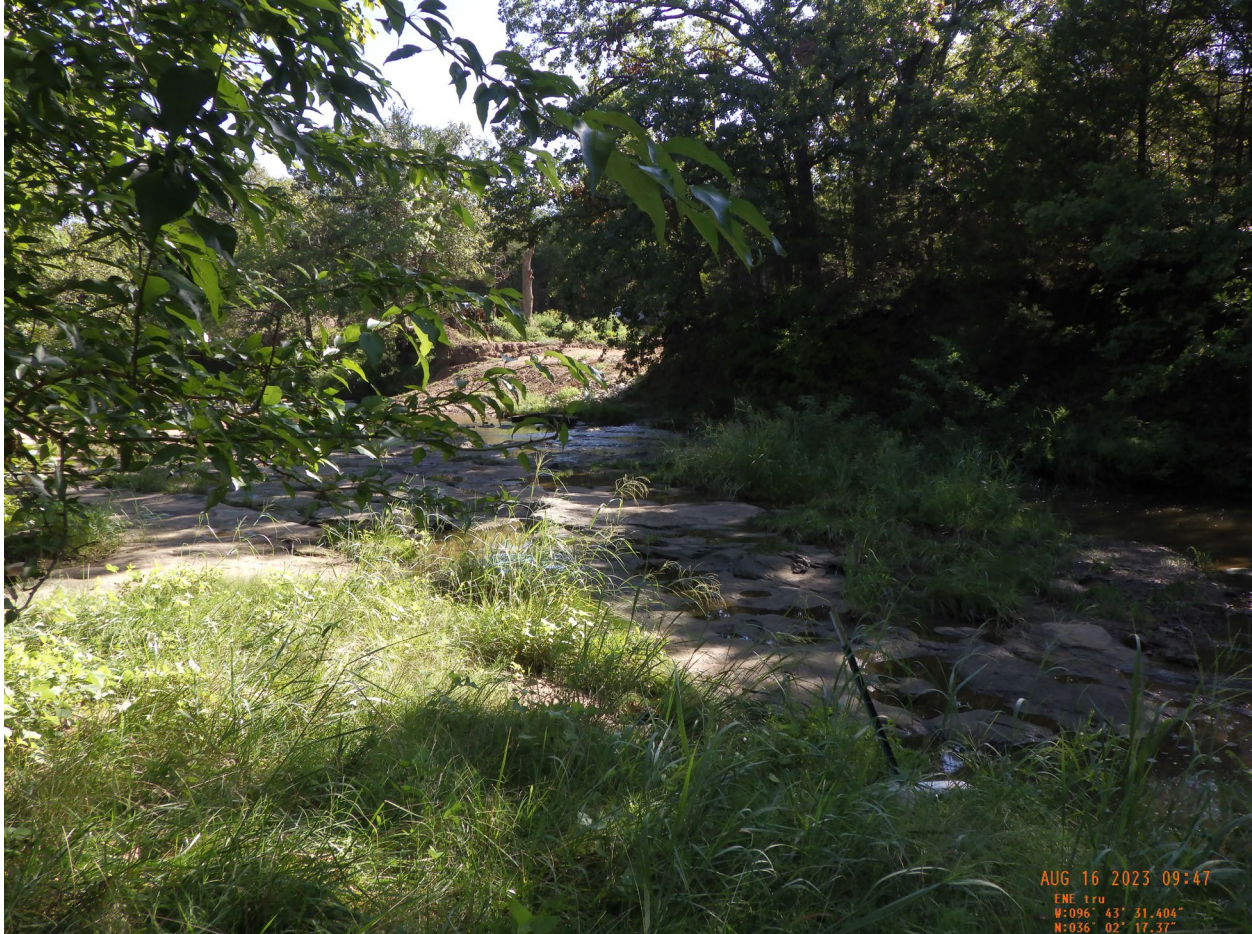
Photo No. 11

**Description:** This was a photo taken immediately downstream from the lowermost containment dam, the dam was no longer present at the time of the inspection. This was a photo with ESE/upstream view, showing the location where the dam was previously located.

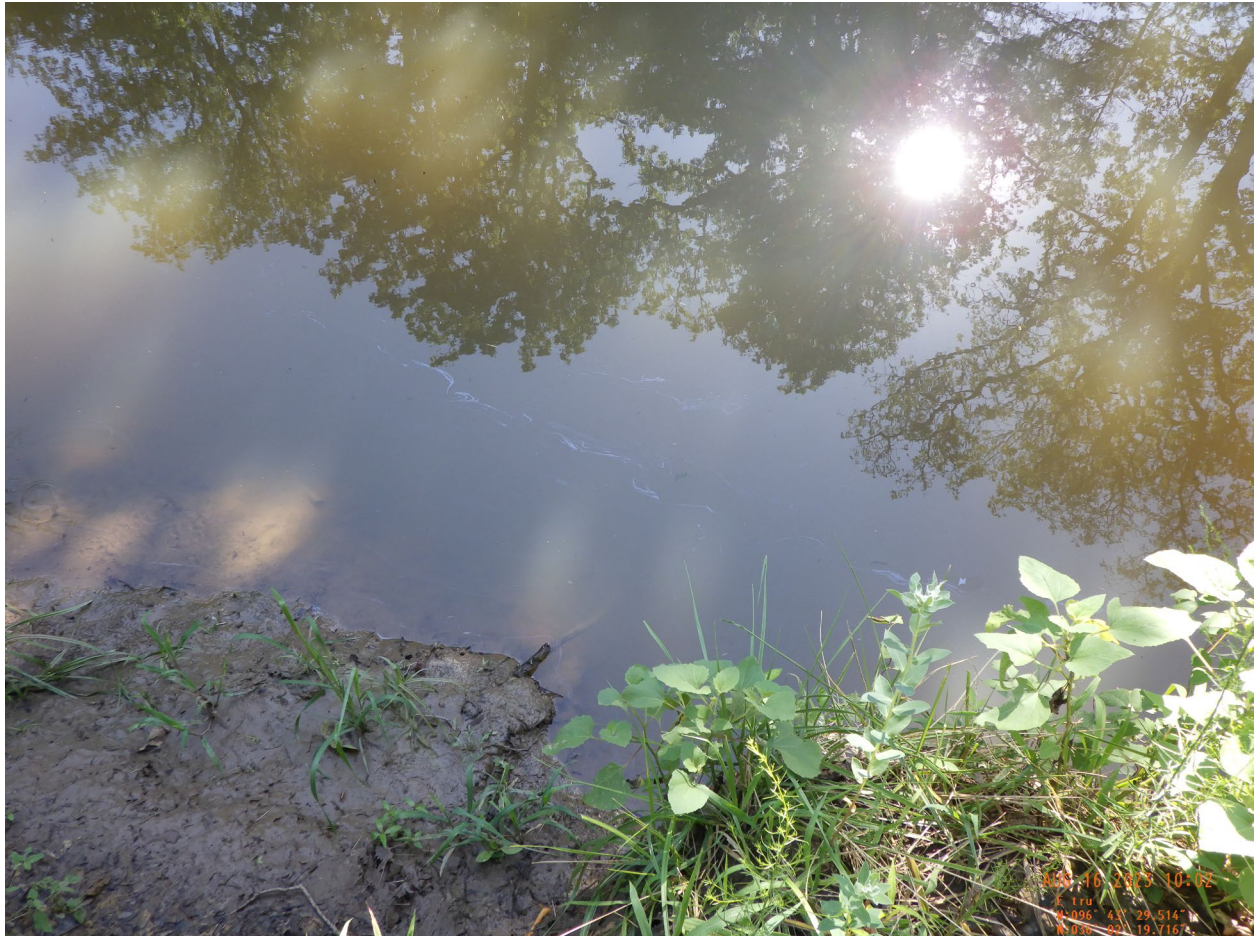
Photo No. 12

I observed oil sheen approximately 20 yards upstream from where the lowermost containment dam was previously located. At the time of the inspection, the containment dam was no longer present. See photo No. 12.

**Description:** This was a photo taken upstream from the dam location, showing sheen caught between the absorbent and containment booms.
