United States  
Environmental Protection  
Agency

United States  
Occupational Safety and  
Health Administration

EPA 550-F-97-002F  
September 1997

# SHAFT BLOW-OUT HAZARD OF CHECK AND BUTTERFLY VALVES

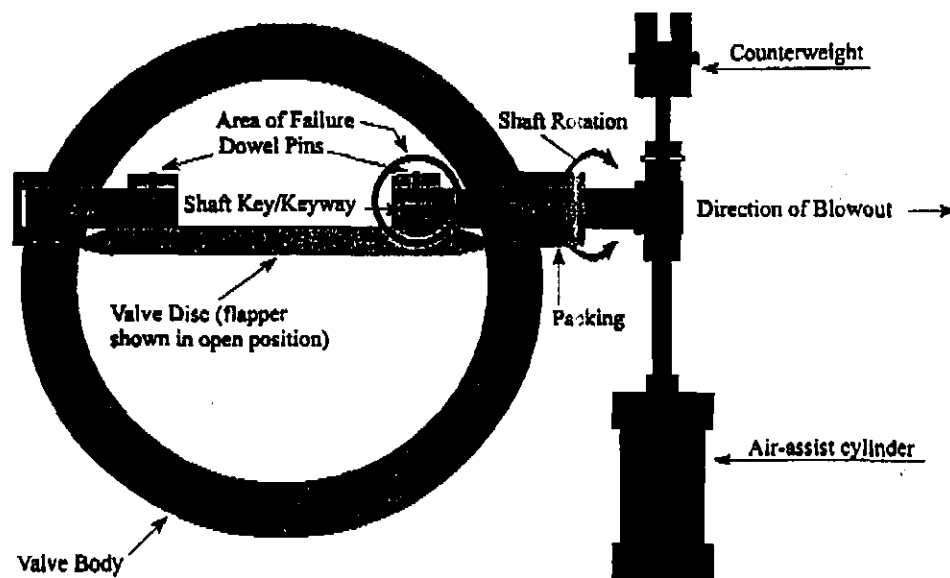
Simplified cross-sectional view of check valve (flow direction is into page)

The check valve was designed with a drive shaft that connects the internal valve disk to an external pneumatic cylinder (see diagram on next page). The valve failed when a dowel pin designed to fasten the drive shaft to the disk sheared and a key designed to transfer

torque from the drive shaft to the disk fell out of its keyway, disconnecting the drive shaft from the disk. System pressure was high enough to eject the unrestrained drive shaft from the valve, carrying with it the external counterweight assembly, weighing over 200 lbs., a distance of 43 feet away.

Valves subject to this hazard may be designed with a two-piece valve stem (sometimes referred to as a "stub-shaft" design). In each of the cases described above, the malfunctioning component was a Clow stub-shaft Model GMZ pneumatically assisted swing check valve (see diagram below). In these check valves, one stem piece functions as a drive shaft that connects the internal valve disk to an external air-assist cylinder and counterweight assembly. The drive shaft penetrates the pressure boundary through a stuffing box. The exterior portion of the drive

shaft is connected to a pneumatic piston and counterweight, and the interior portion of the shaft is coupled directly to the valve disk using a cylindrical hardened steel dowel pin and a rectangular bar key. This arrangement provides a power-assist to close the valve during compressor shut down, preventing reverse flow of compressed gases. These particular valves have probably not been produced since 1985, but still exist in some process facilities constructed before that date. Similar valves currently or previously produced and sold by other valve manufacturers may also be subject to this hazard.

Facilities should review their process systems to determine if they have valves installed that may be subject to this hazard. If so, facilities should conduct a detailed hazard analysis to determine the risk of valve failure. Check valves or butterfly valves which are subject to several or all of the above design and operational factors are at high risk for shaft blow-out. Detailed internal inspections may be necessary in order to identify high-risk valves. Facilities should consider replacing high-risk valves at the earliest opportunity with a blow-out resistant design. Several blow-out resistant designs of check and butterfly valves are available. If immediate valve replacement is impossible or impractical, facilities should consider immediately modifying the valves to prevent shaft blow-out. Valve manufacturers should be consulted in order to ensure that any modifications made are safe.
