# US POSTAL SERVICE SPRINGFIELD VMF CLEAN WATER ACT PHOTOGRAPH LOG

*ALL PHOTOGRAPHS WERE TAKEN BY MICHAEL PRESCOTT USING A HEWLETT  
PACKARD PHOTOSMART M547*

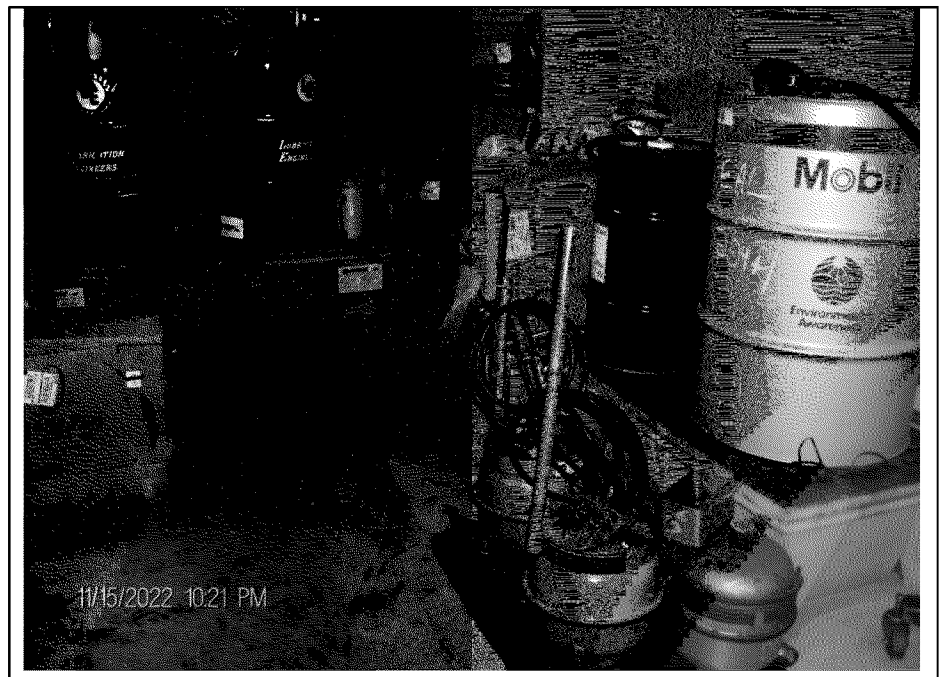
**PHOTO #:** 1

**COMMENTS:** An oil storage room showing 55-gallon drums of oil and transmission fluid on secondary containment pallets.

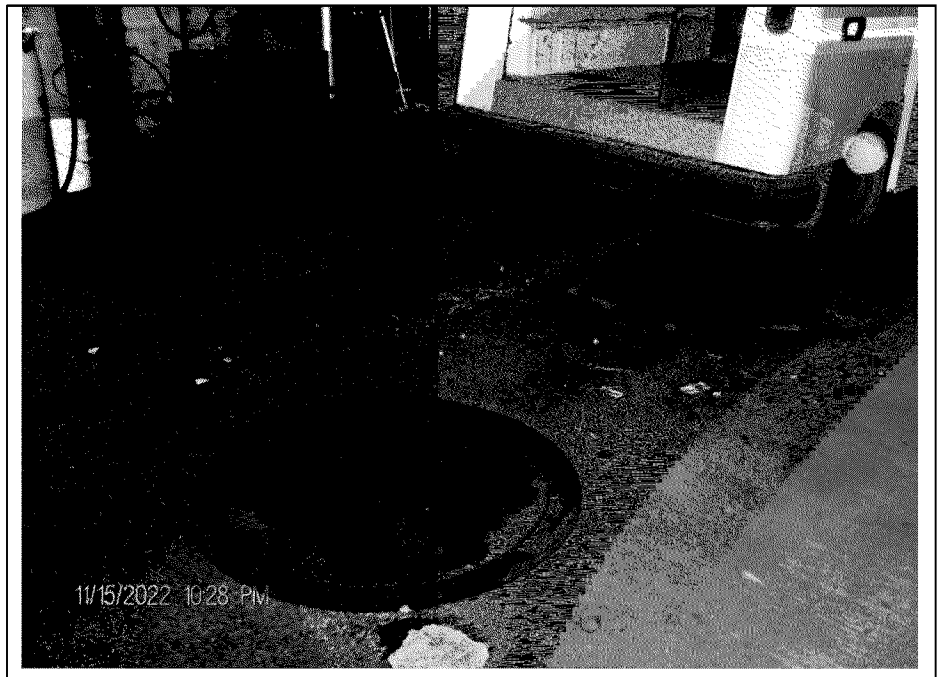
**PHOTO #:** 3

**COMMENTS:** Maintenance bay for washing vehicles and two manhole covers for the two 2000-gallon USTs that collect the washwater for pumping out by a truck for off-site disposal.

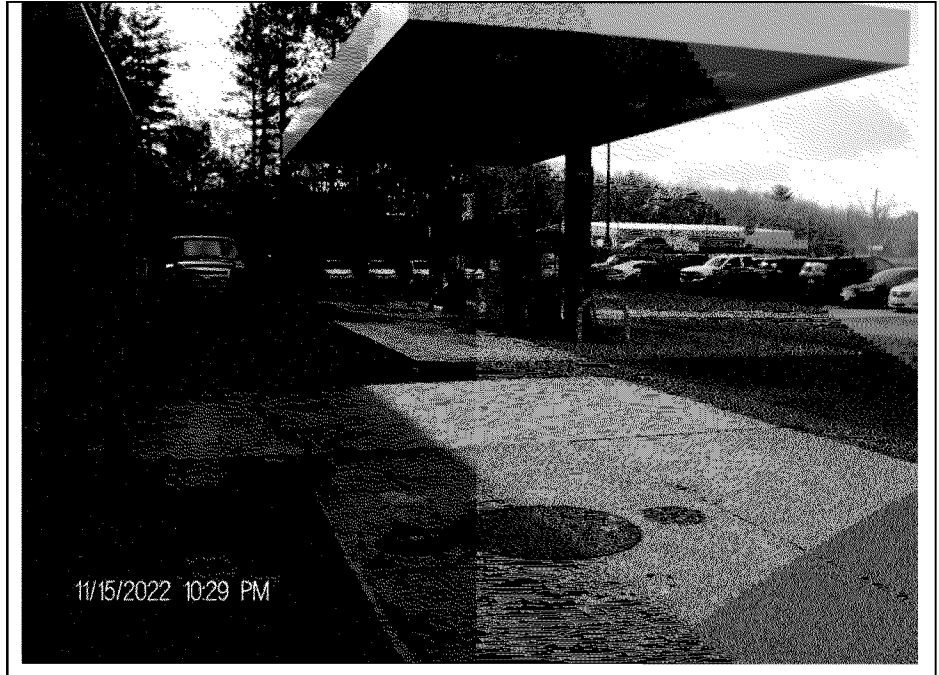
**PHOTO #:** 4

**COMMENTS:** Views of fuel island with dispensers and the covers to the used oil underground storage tank (UST) in the foreground and oil water separator next to the building.

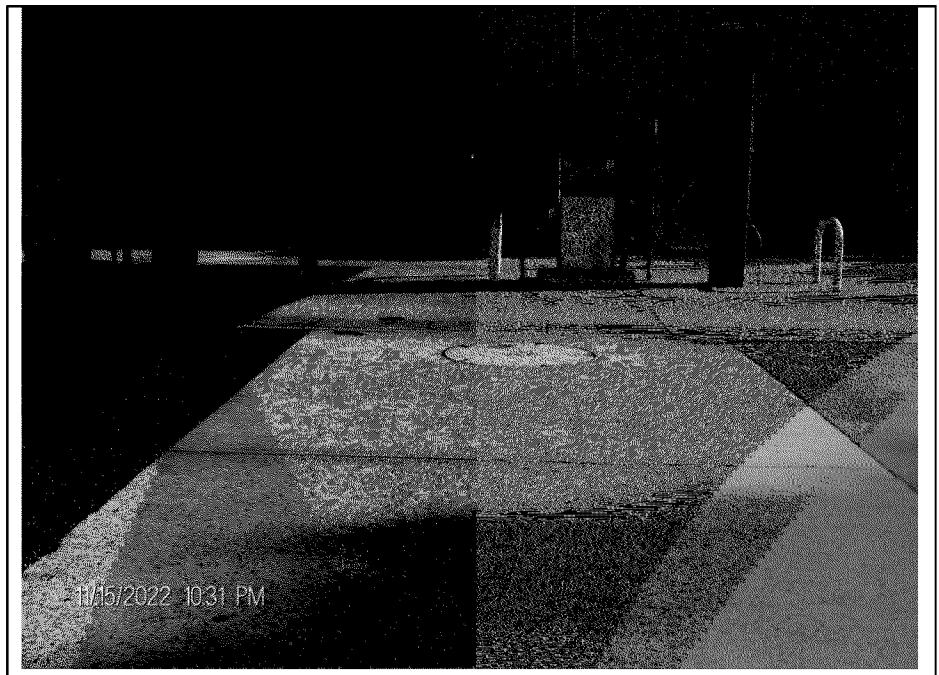
**PHOTO #:** 5

**COMMENTS:** Top of diesel UST and fuel dispensers in background.

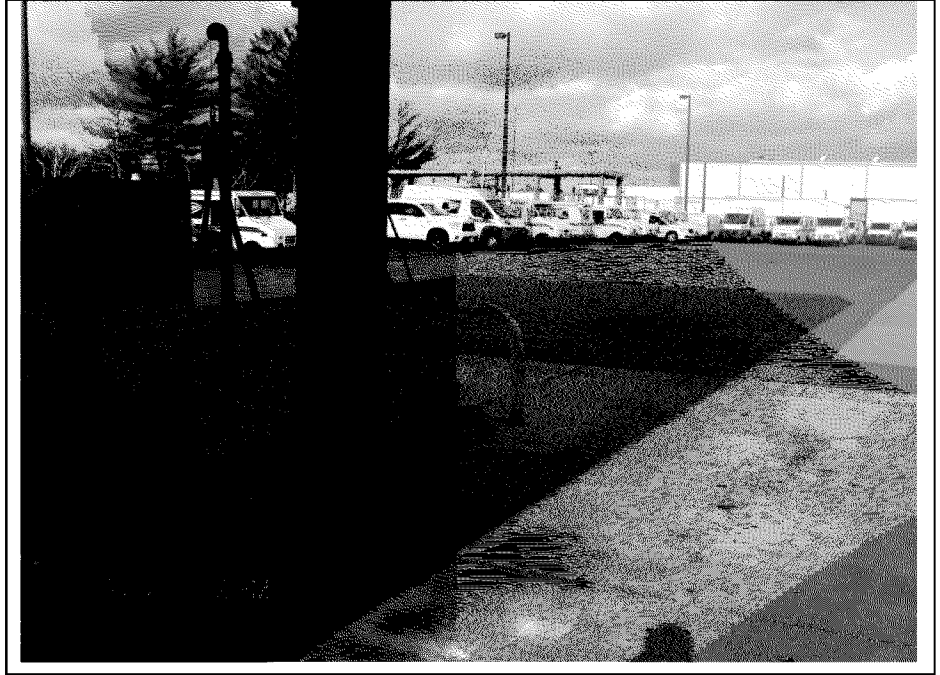
**PHOTO #:** 6

**COMMENTS:** Oil and diesel stains around one of the fuel dispensers.

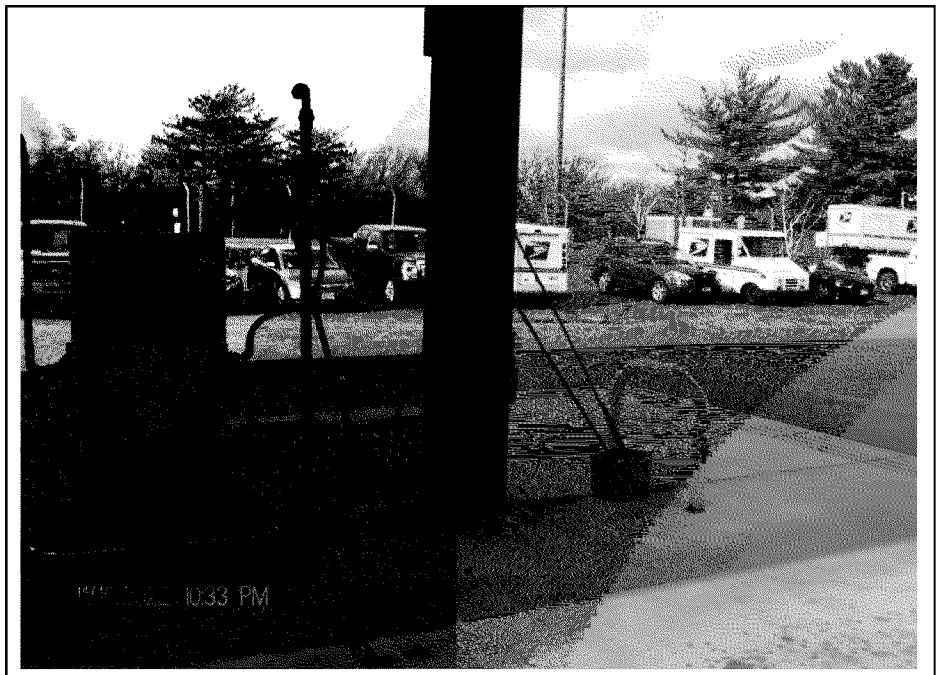
**PHOTO #:** 7

**COMMENTS:** Another view of the oil and diesel stains around one of the fuel dispensers looking toward the stormwater drain in the background.

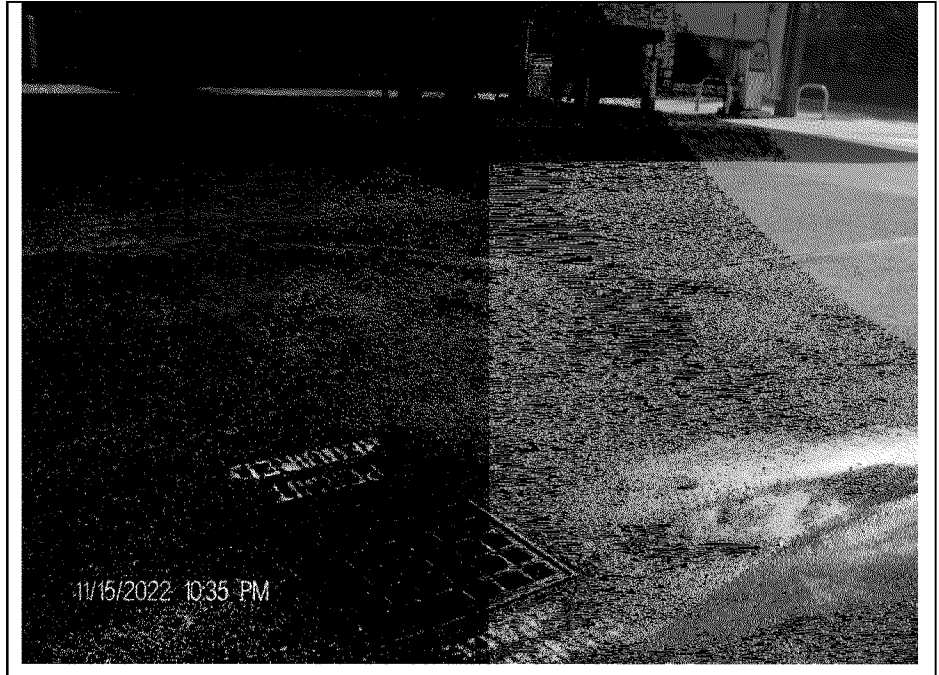
**PHOTO #:** 8

**COMMENTS:** View of drain where stormwater from the fueling area flows to. There was no oil sheen visible on the surface of the water in the drain.

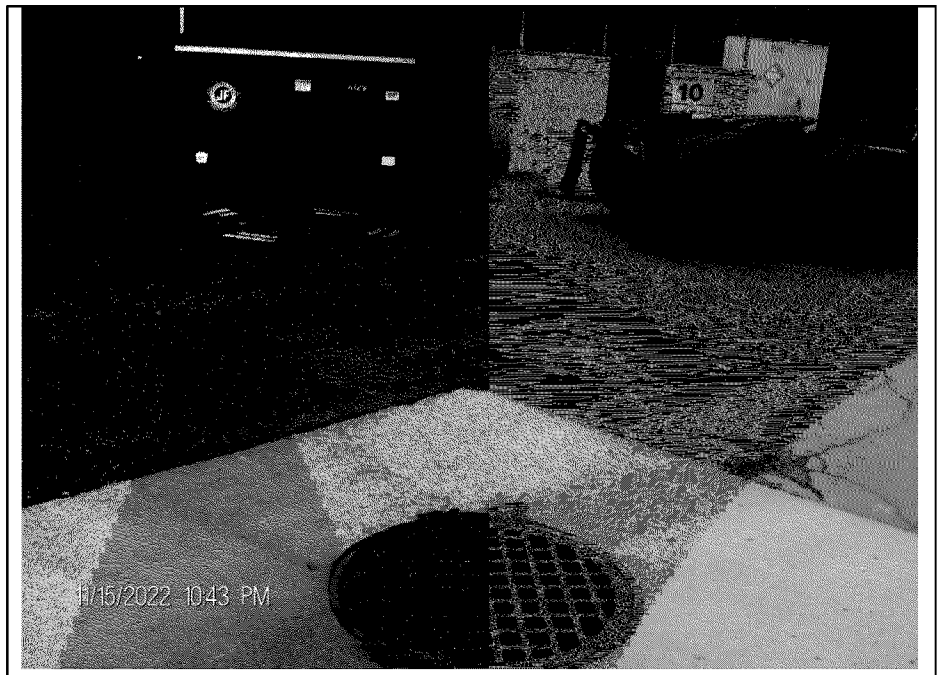
**PHOTO #:** 9

**COMMENTS:** View of storm drain in the foreground and the covered metal parts dumpster and adjacent covered storage area for tires and empty containers.

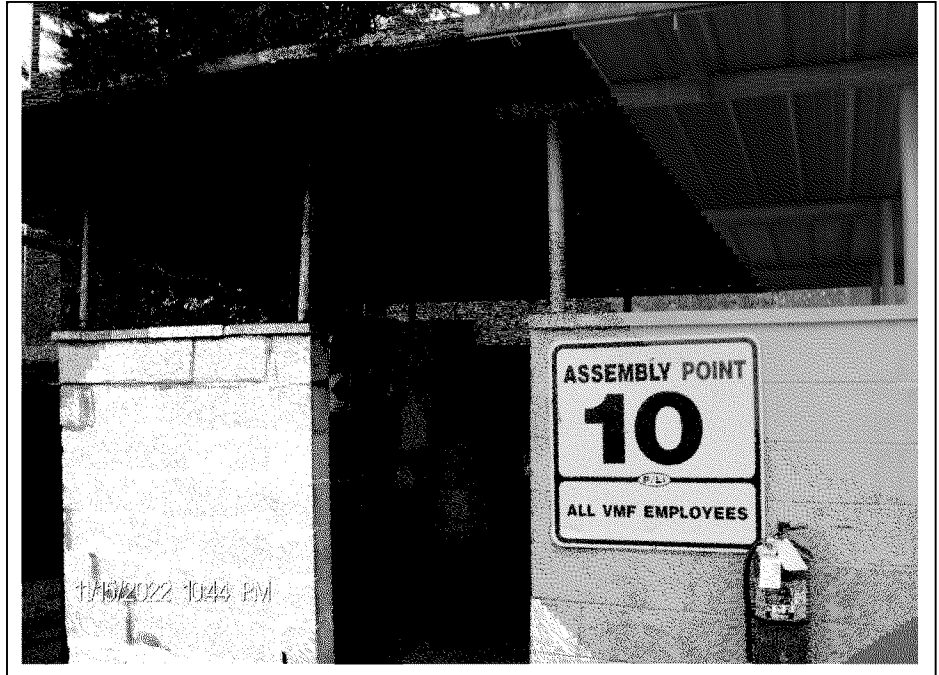
**PHOTO #:** 10

**COMMENTS:** Covered storage area  
for tires and empty containers.

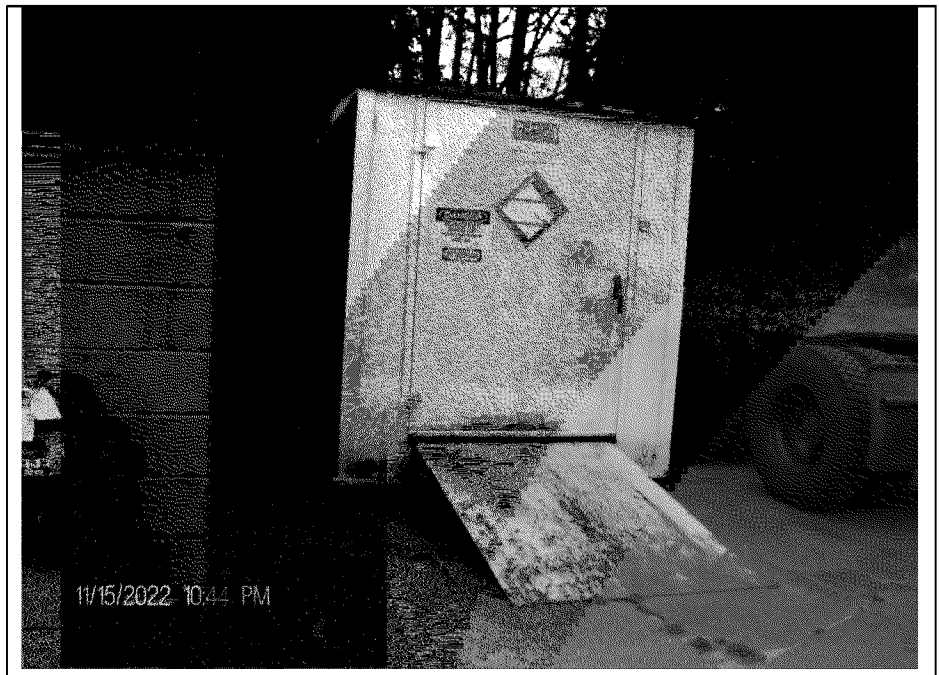
**PHOTO #:** 11

**COMMENTS:** HAZMAT locker for  
hazardous materials and wastes.

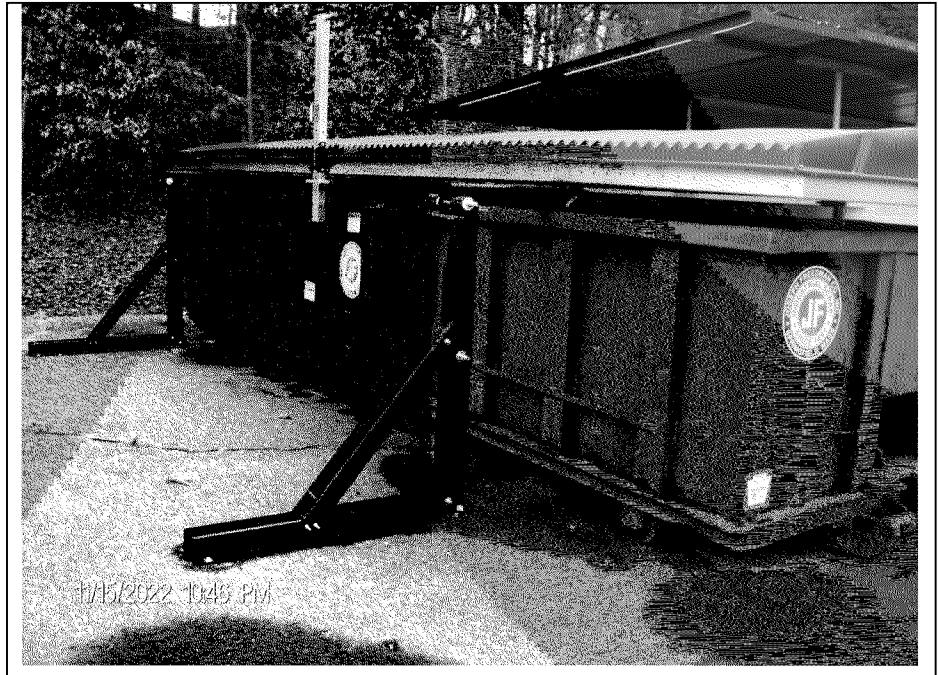
**PHOTO #:** 12

**COMMENTS:** Closer view of covered dumpster for used metal parts.

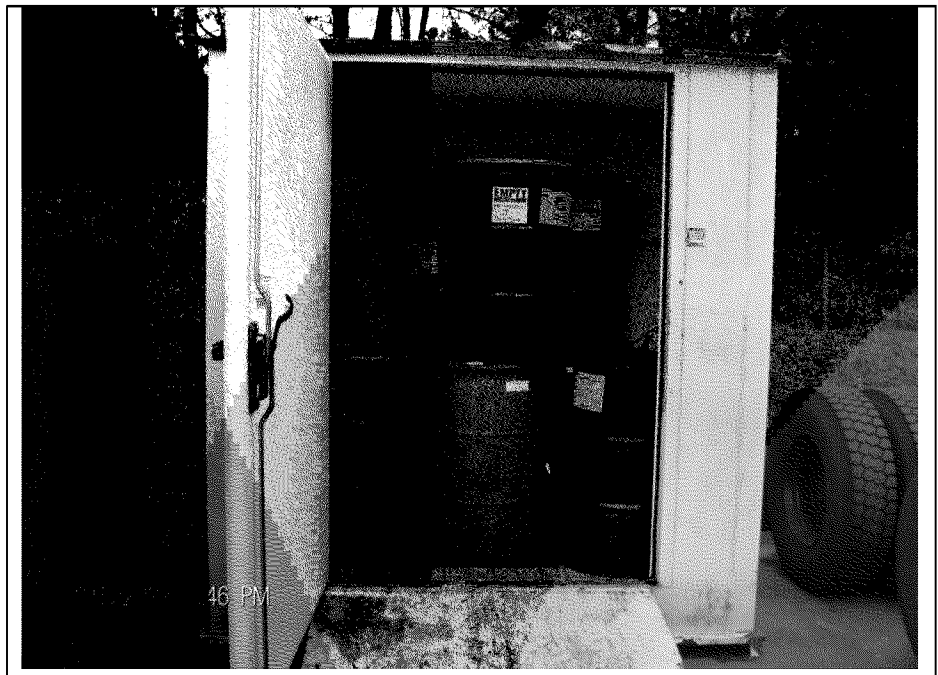
**PHOTO #:** 13

**COMMENTS:** View inside opened HAZMAT locker for hazardous materials and wastes.

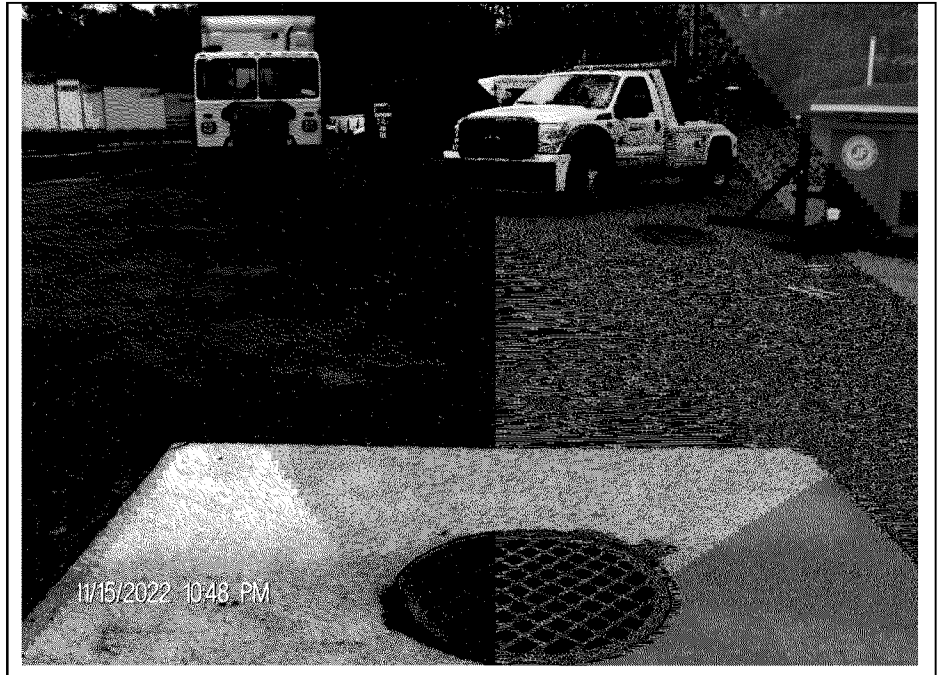
**PHOTO #:** 14

**COMMENTS:** Another view of the stormwater drain in the foreground and the covered metal parts dumpster to the right and the covered trash dumpster and vehicle parking straight ahead.

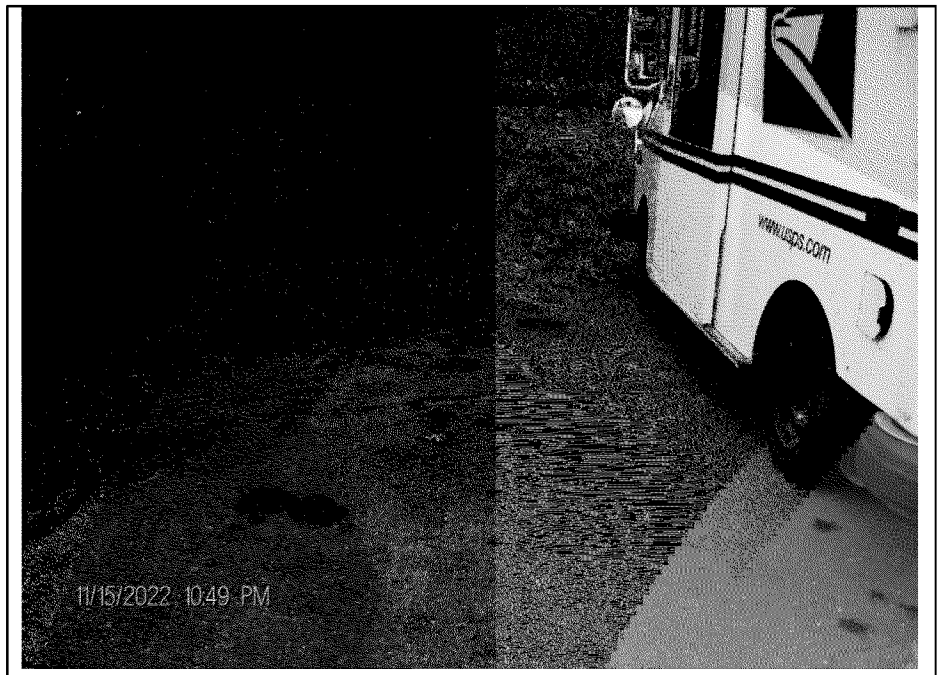
**PHOTO #:** 15

**COMMENTS:** Some oil stains where vehicles were parked.
