**Region 6 Compliance Assurance and Enforcement Division  
INSPECTION REPORT**

| Inspection Date(s): | 04/26/2017 | | |
| Company Name: | Addison, Town of – Trinity River Authority (TRA) Member City | | |
| Facility Name: | Addison Wastewater Collection System | | |

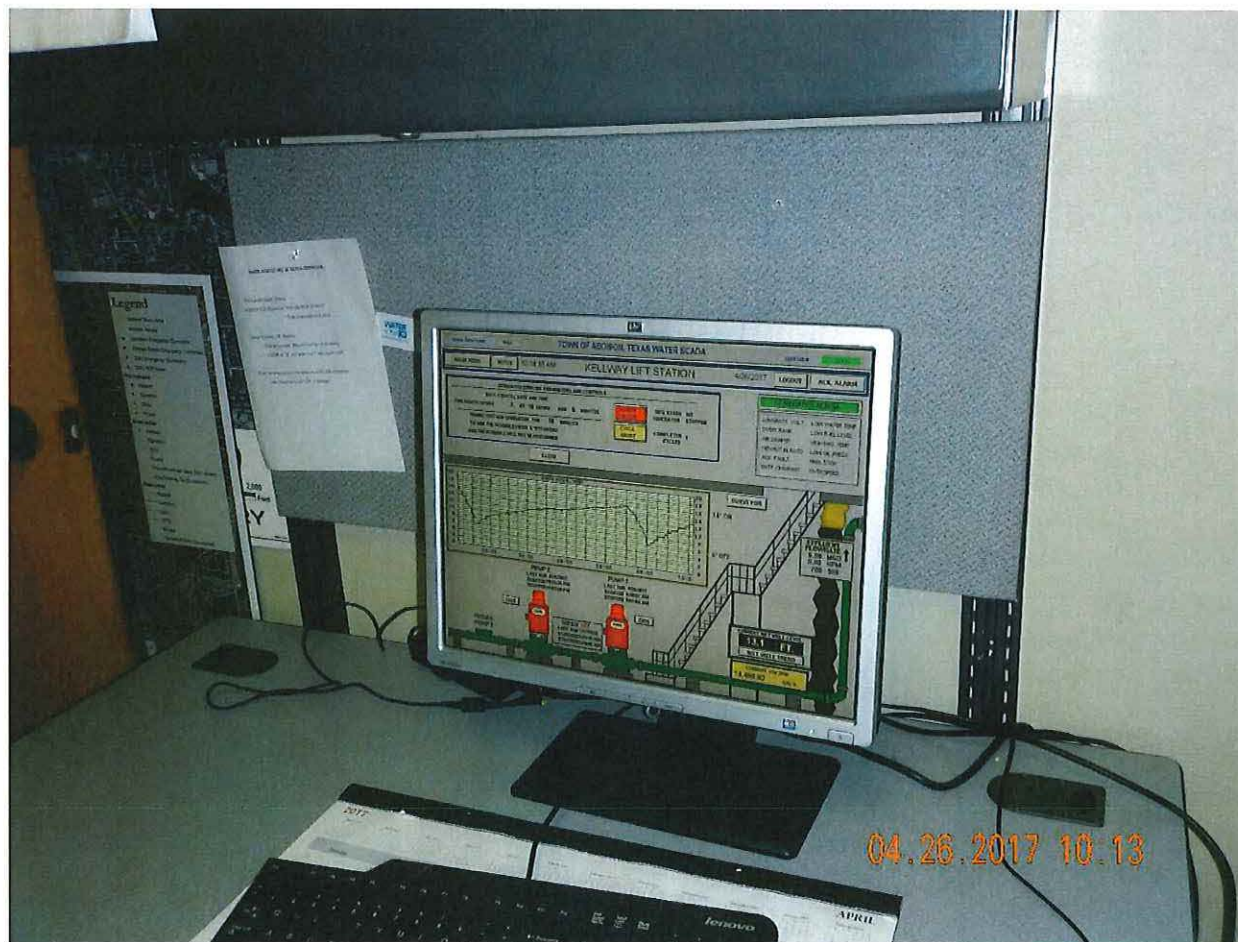
Photo No. 1

| Comments: SCADA system showing the Kellway lift station. Addison has a duplicate SCADA system located at the Celestial Pump Station, 5510 Celestial Rd. | | |

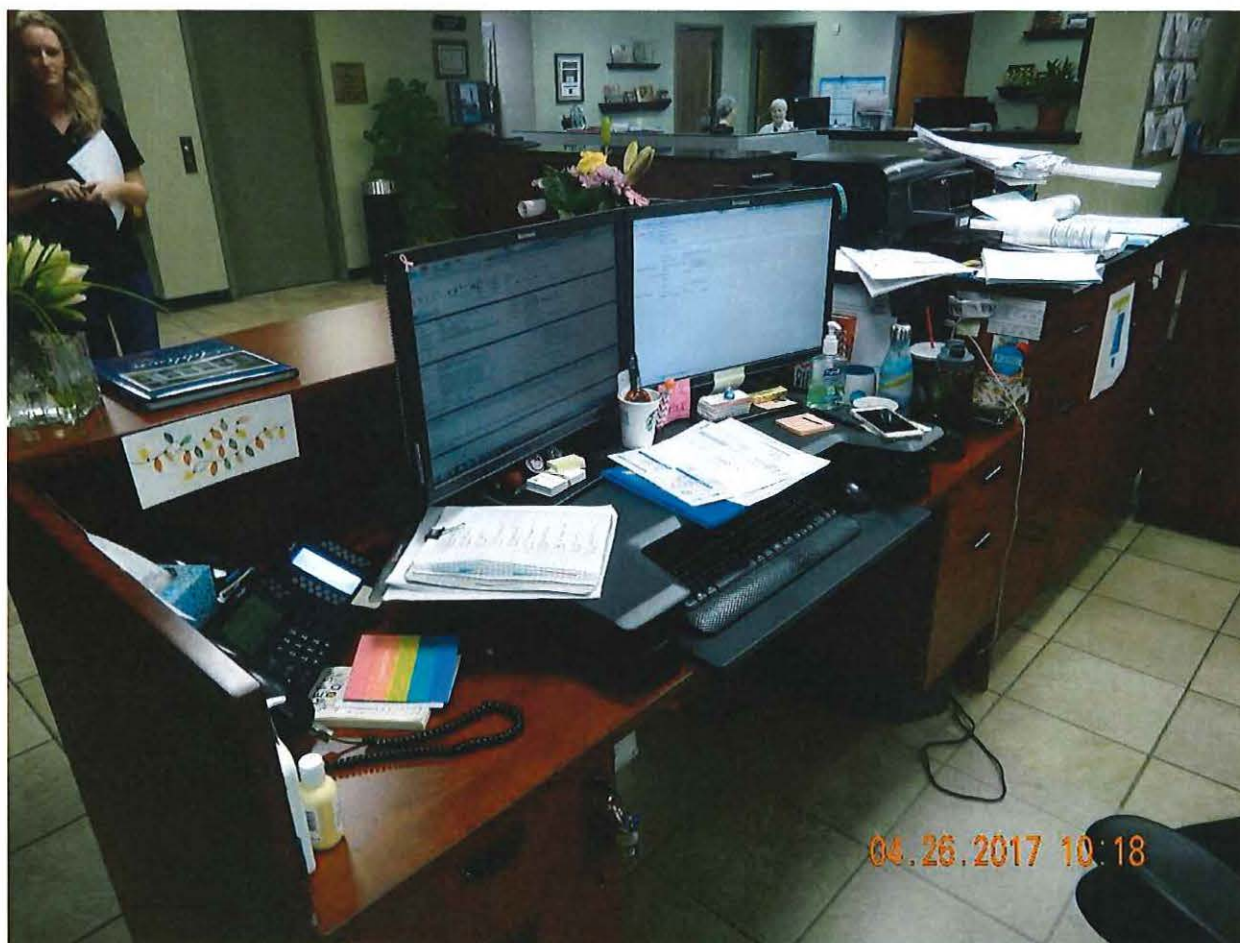
Photo No. 2

| Location: Reception / Dispatch, Service Center, 16801 Westgrove Dr., Addison TX | | |

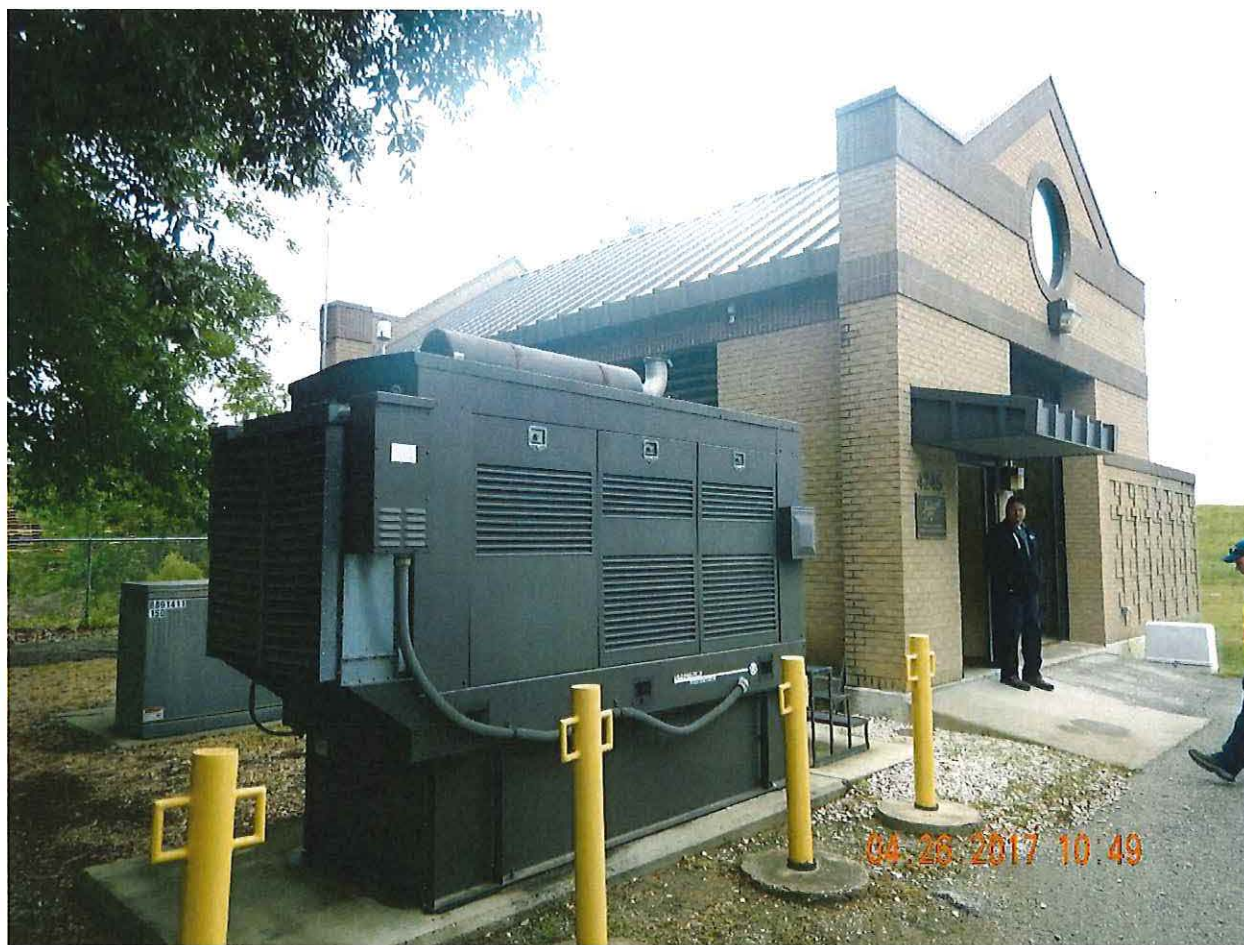
Photo No. 3

| Comments: Backup Diesel Generator with double walled above ground fuel tank, located in the foreground.<br>Note: Vegetation was noted growing up and over security fencing on the northeast quadrant.<br>Vegetation is to be cleared from fencing. | | |

6. Develop and adopt an automated asset management program.
7. Repair / replace damaged security fencing and clear / remove vegetation away from security fencing at the Kellway lift station.

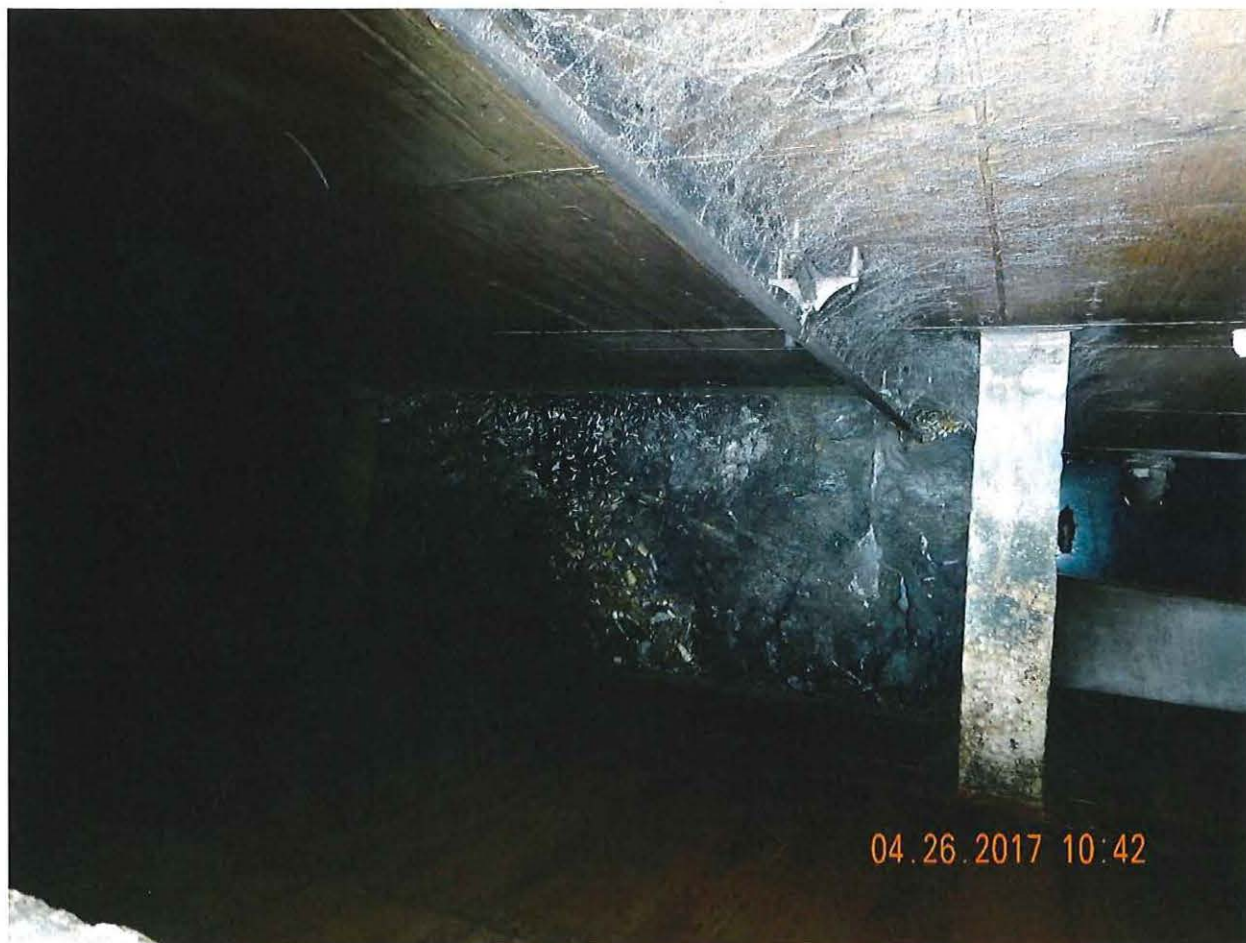
Photo No. 4

| Comments: Wet well with large amount of debris and some grease floating on top. | | |

8. Increase inspection / cleaning frequency of the wet well at the Kellway lift station. At the time of this inspection, the wet well was in need of cleaning (Appendix 1; photo #4.)

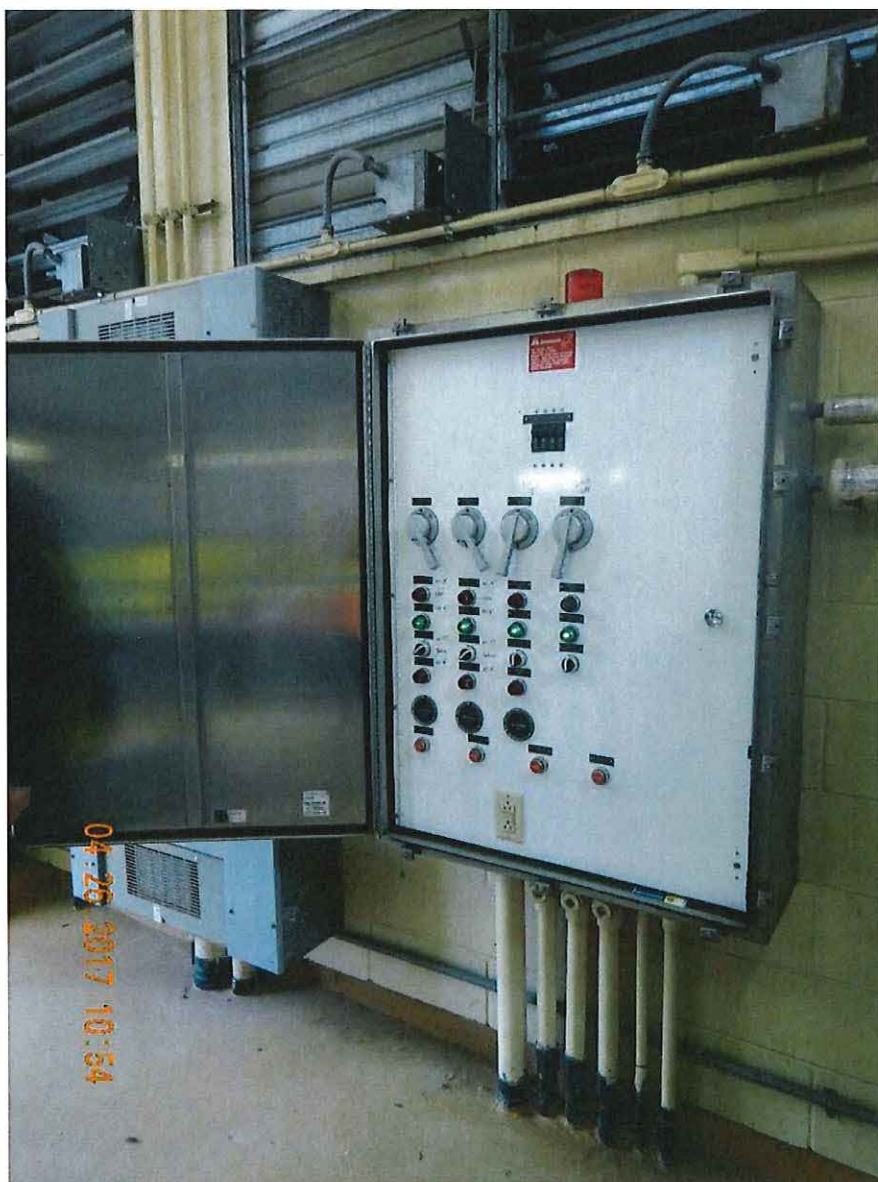
Photo No. 5

| Comments: Electrical panel with red light / visual alarm located on top. | | |

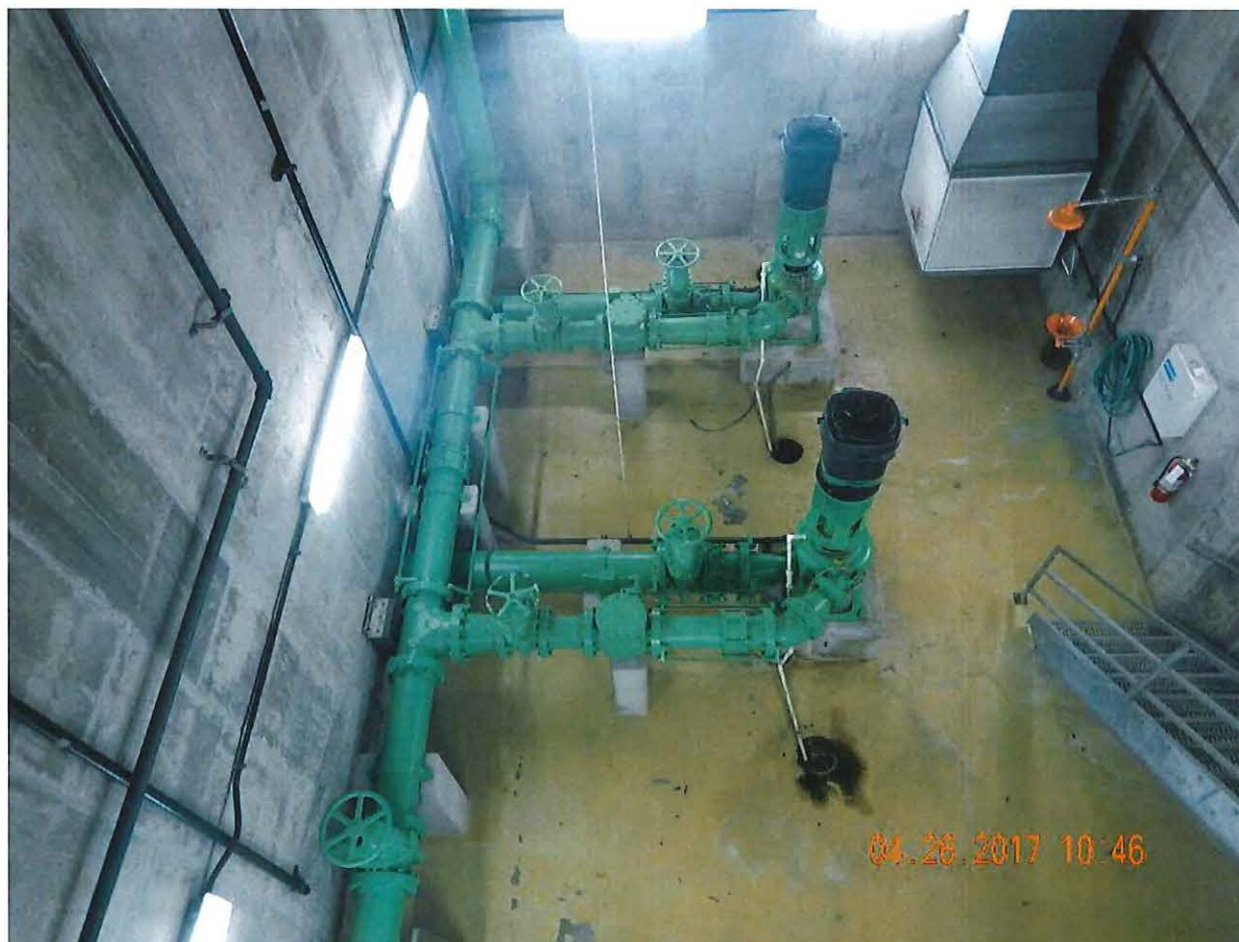
Photo No. 6

| Comments: Dry well. | | |

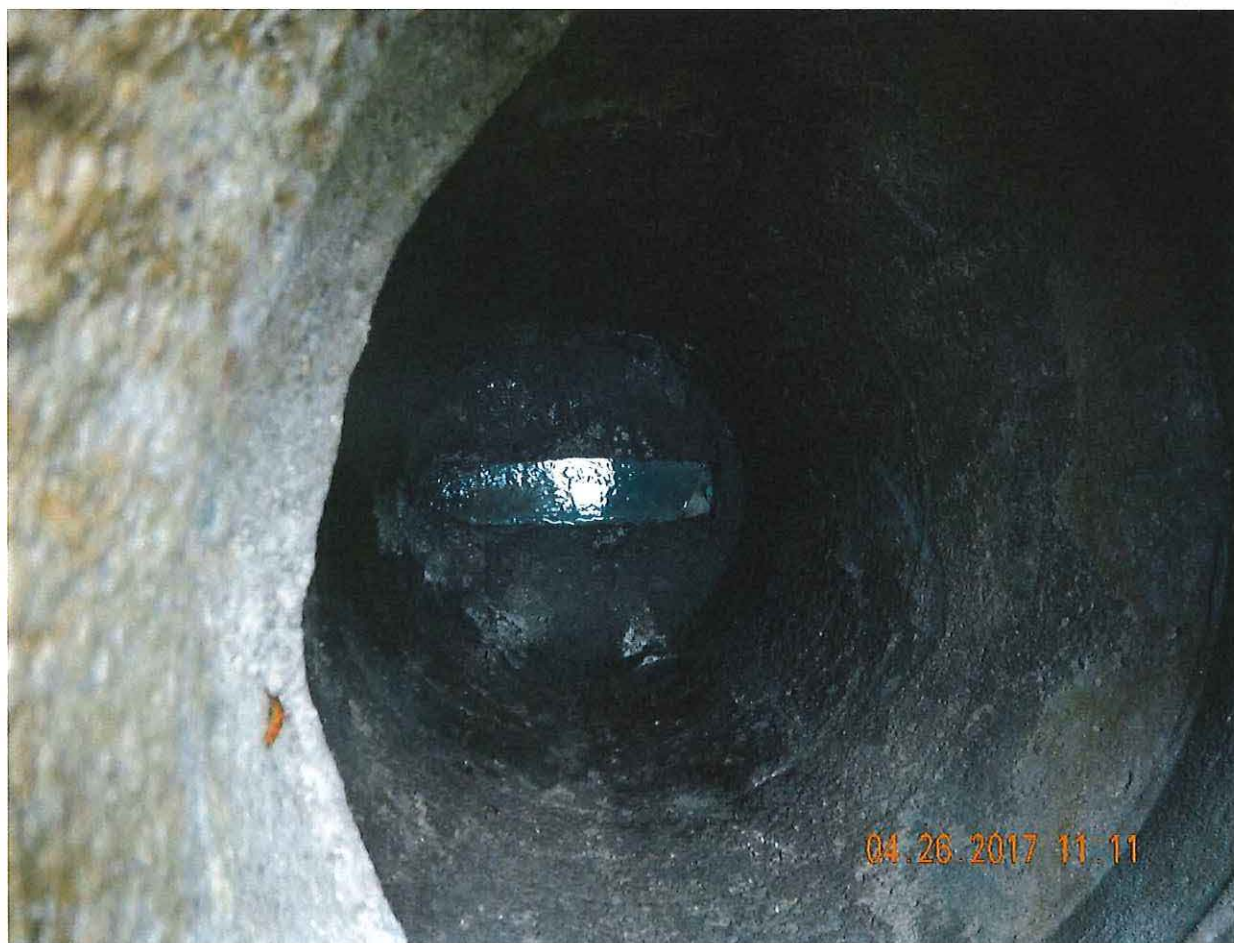
Photo No. 7

| Comments: Manhole behind restaurant row which is routinely maintained by Town of Addison.<br>Evidence of grease in line and floor of manhole. | | |

9. Increase inspection / degreasing frequency at the Tokyo1 manhole. At the time of inspection there was evidence of grease buildup (Appendix 1; photo #7.)
10. As part of the Town's FOG / Grease Trap programs, expand efforts to inspect liquid wastehauler grease trap pumping efforts, Trip Tickets and occasional follow up with approved grease trap waste disposal sites.

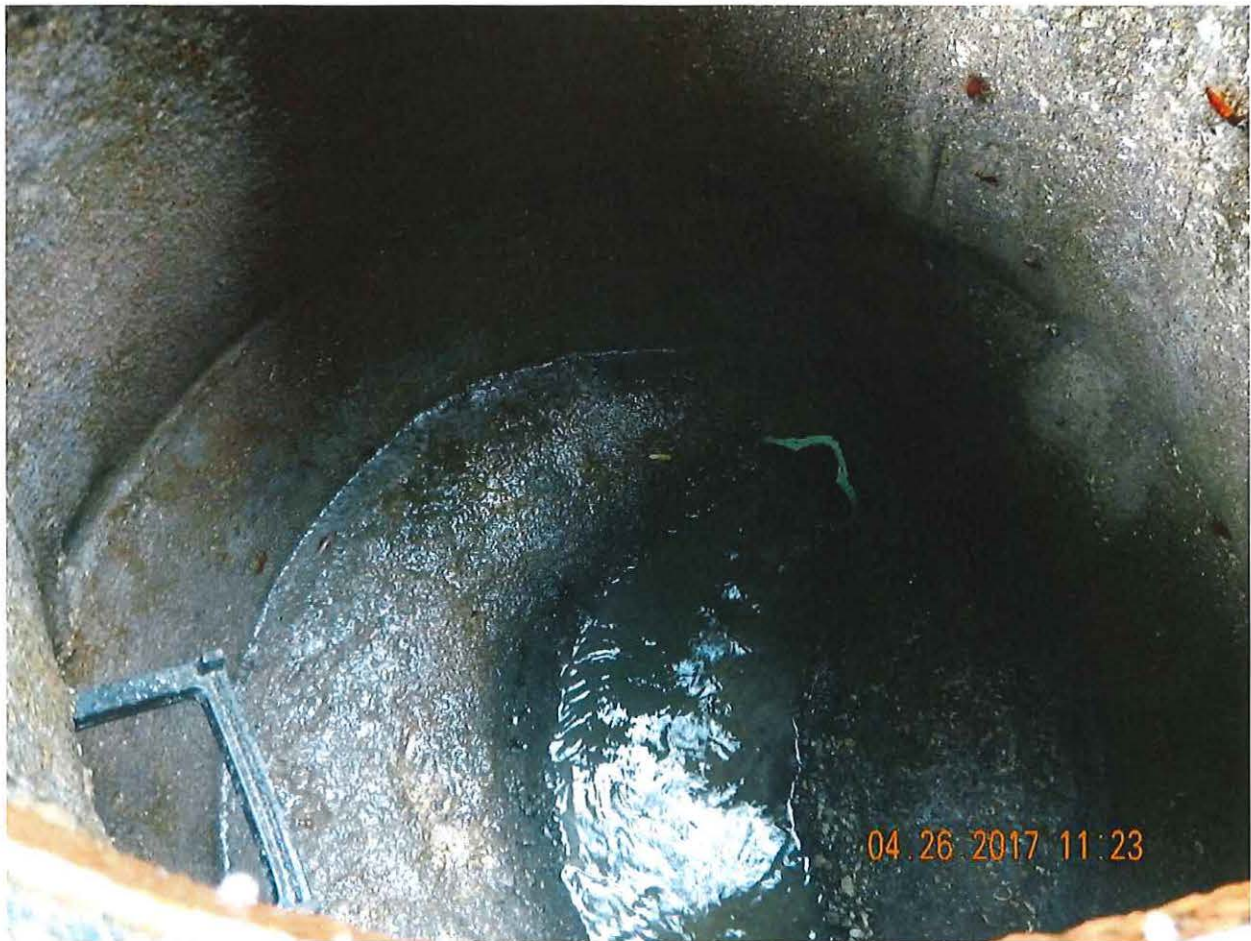
Photo No. 8

| Comments: Manhole appears to be relatively clean and in good working order. | | |

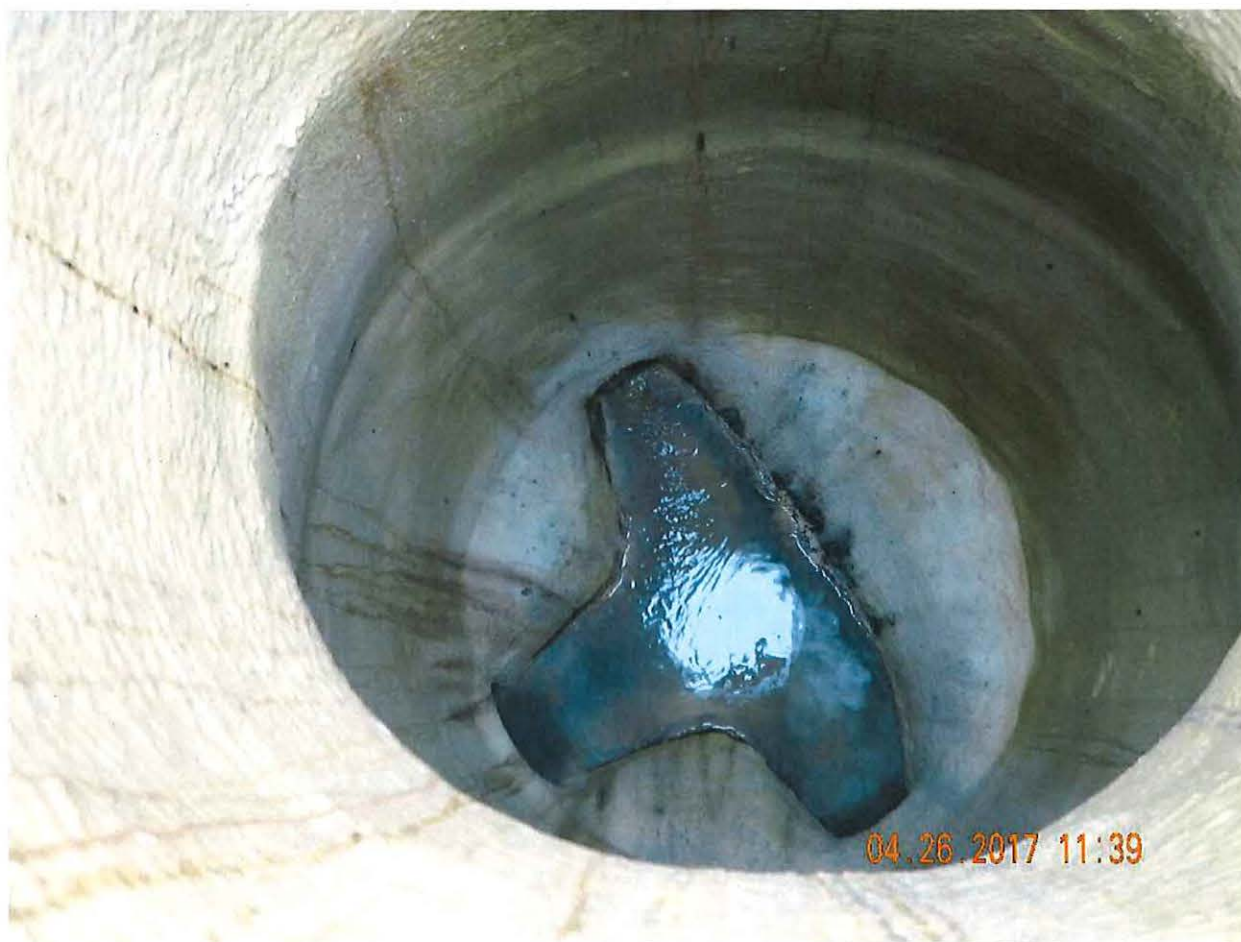
Photo No. 9

| Comments: Recently rehabbed manhole with epoxy coating. On Landmark, just south of Belt Line, in the middle of the street, adjacent to Stadium Café. Manhole appears to be well sealed, clean, and in good working order. | | |

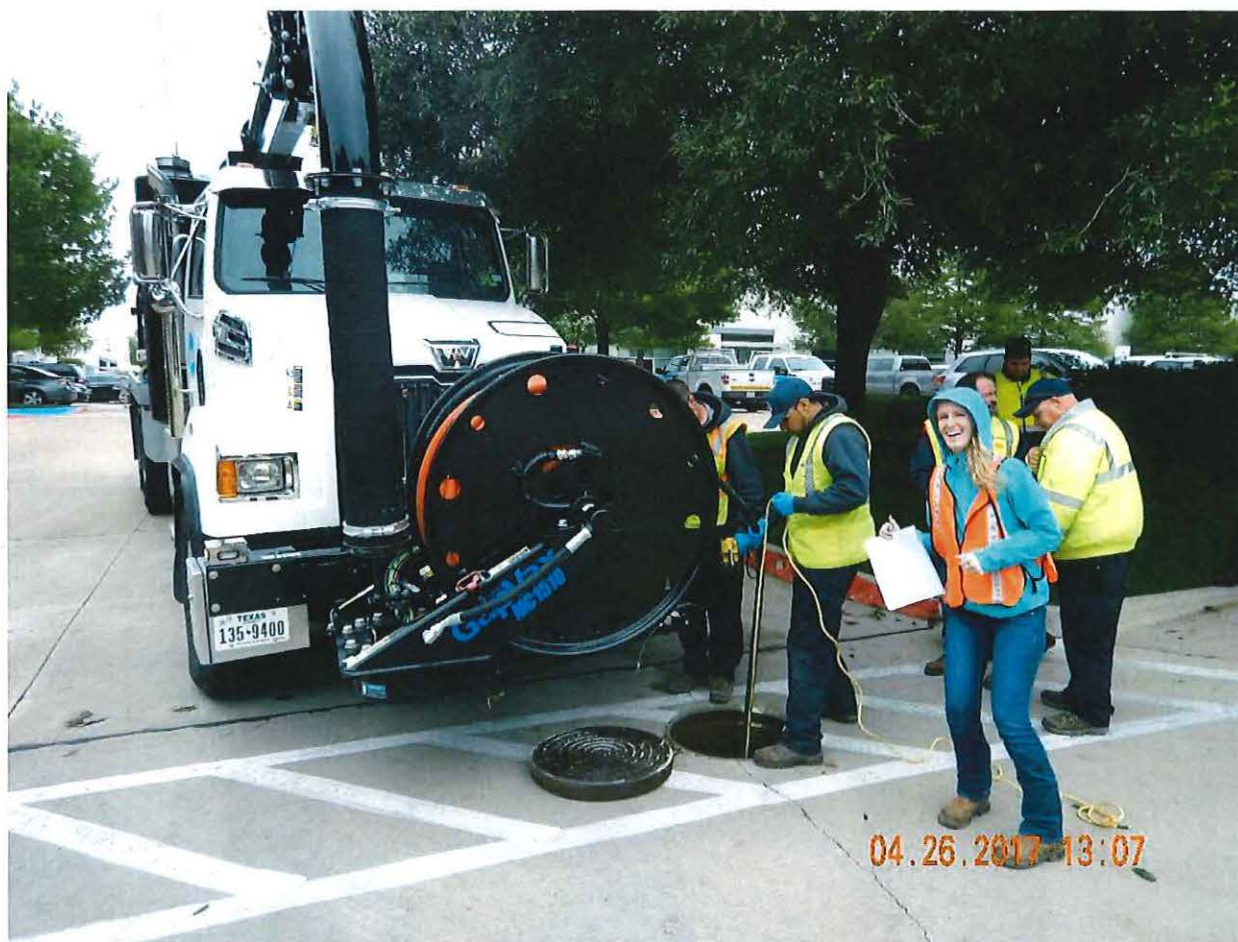
Photo No. 10

| Comments: Jet Vac Truck cleaning line prior to CCTVing. | | |

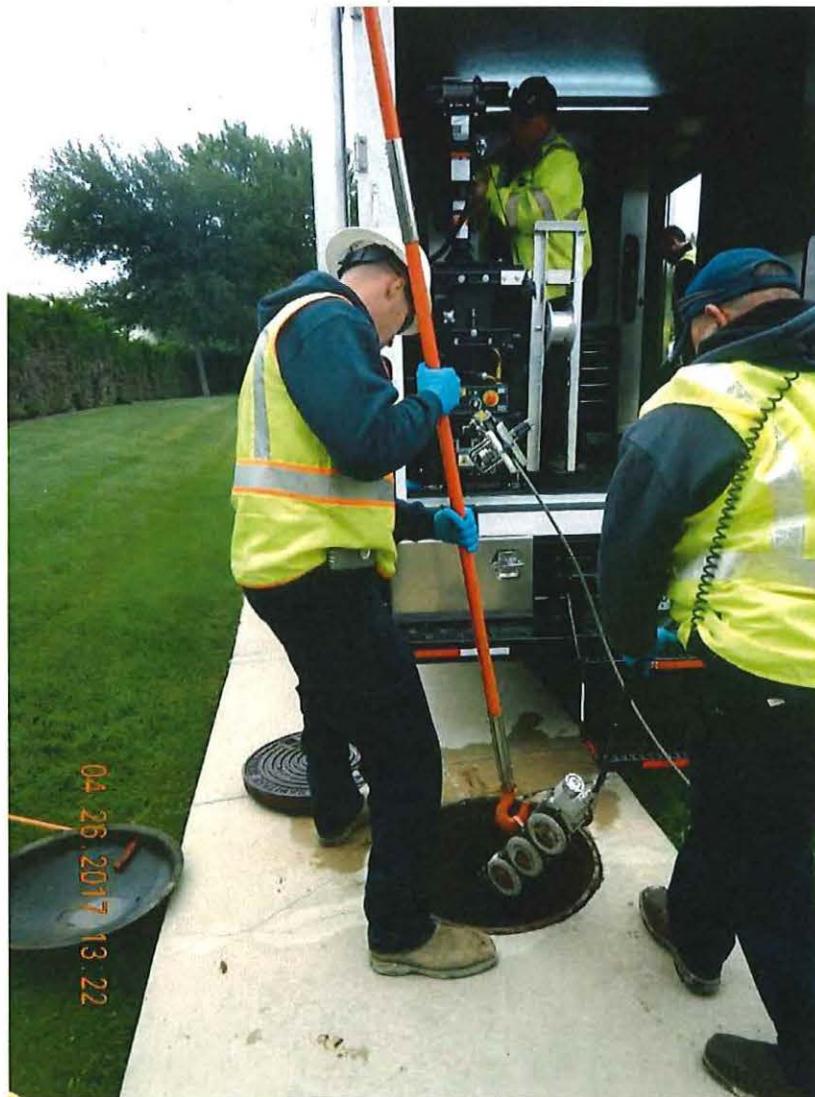
Photo No. 11

| Comments: CCTVing of sewer main. | | |

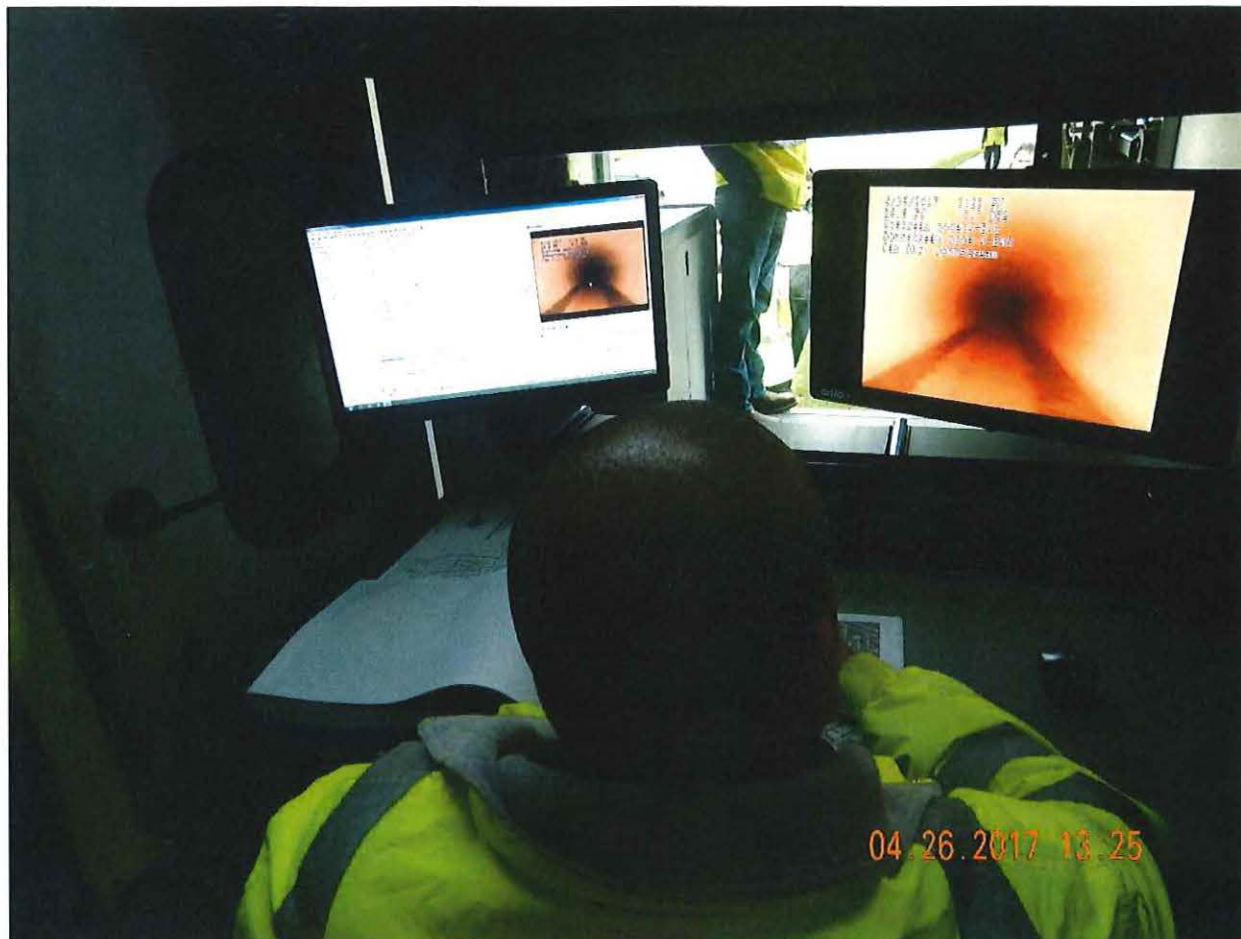
Photo No. 12

| Comments: CCTV operator evaluating condition inside of sewer main. | | |
