**Region 6 - Enforcement & Compliance Assurance Division**  
**INSPECTION REPORT**

| Inspection Date(s): | 7/31/2023 – 8/2/2023 | |
| Company Name: | Clean Harbors Environmental Services, Inc. | |
| Facility Name: | Clean Harbors Environmental Services, Inc. (CHESI) | |

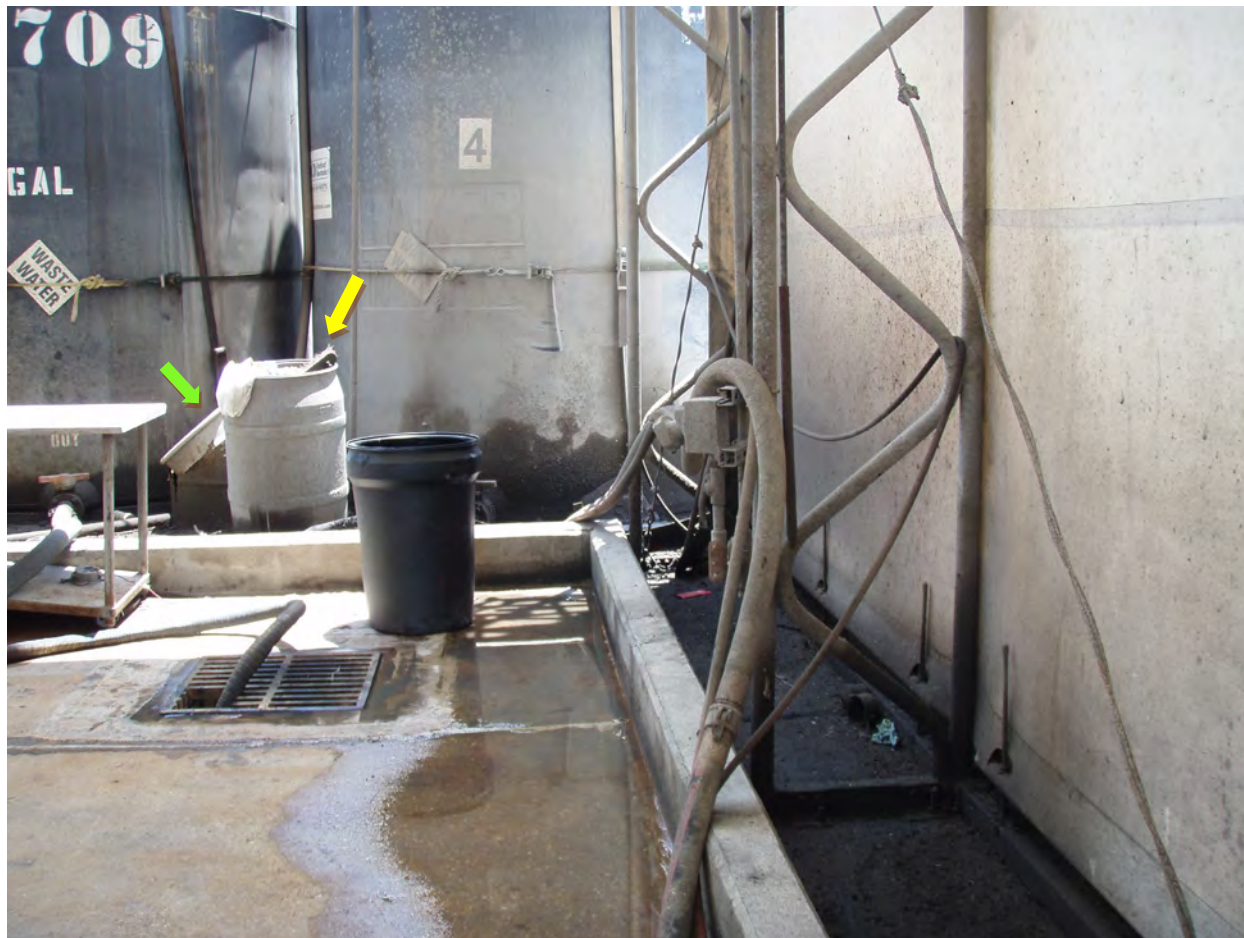
**PHOTO No. 3**

| Sum of<br>Photos in<br>Report | Photo #<br>Referenced<br>in Report | Photo # | Description / Direction Facing | Direction (see<br>attached<br>maps) | File Name<br>PXXXXXXX.JPG | Time | Date |
|---|---|---|---|---|---|---|---|
| 3 | 3 | 3 | CHESI Tank Wash Area - Wash pad sump close up. Liquid on pad from wash down. Residue and glove observed outside of west containment berm. Open, unlabeled plastic drum approximately full of spent PPE/general trash (yellow arrow), poor condition drum empty (green arrow), and black drum empty. | S | 7310003 | 2:03 PM | 7/31/2023 |

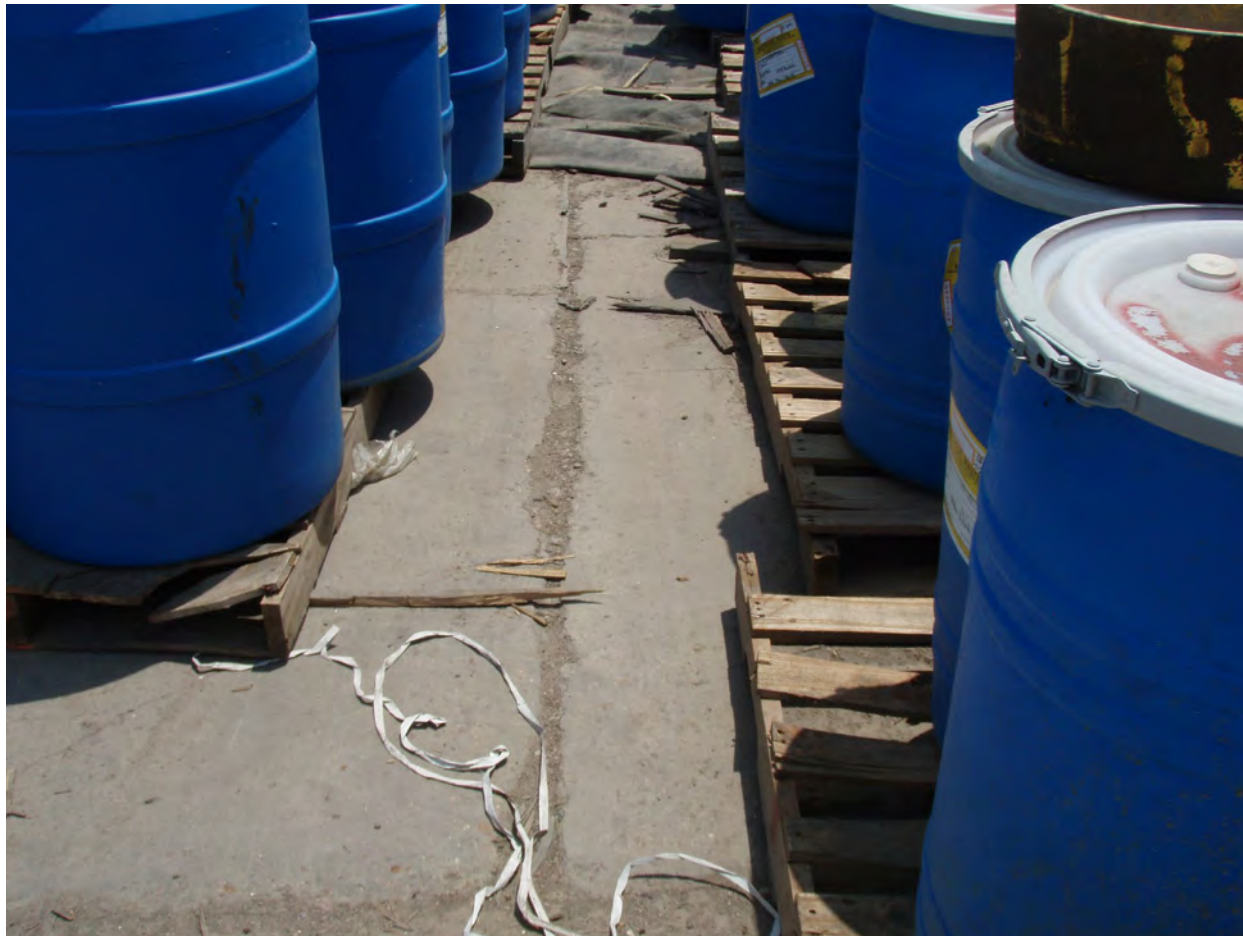
**PHOTO No. 42**

- v. At least 144 drums of hazardous waste being stored over 10 days. [30 TAC 335.94(a) for a transfer facility]
  - vi. Cracks and spalling in the Central Storage Area that appeared uncoated/unsealed. [40 CFR 264.175(b)(1) for a permitted facility]

| Sum of<br>Photos in<br>Report | Photo #<br>Referenced<br>in Report | Photo # | Description / Direction Facing | Direction (see<br>attached<br>maps) | File Name<br>PXXXXXXX.JPG | Time | Date |
|---|---|---|---|---|---|---|---|
| 21 | 42 | 42 | CHESI Tank Wash Area - CSA - Close up of cracks and spalling along concrete seams in area. | S | 7310042 | 2:18 PM | 7/31/2023 |

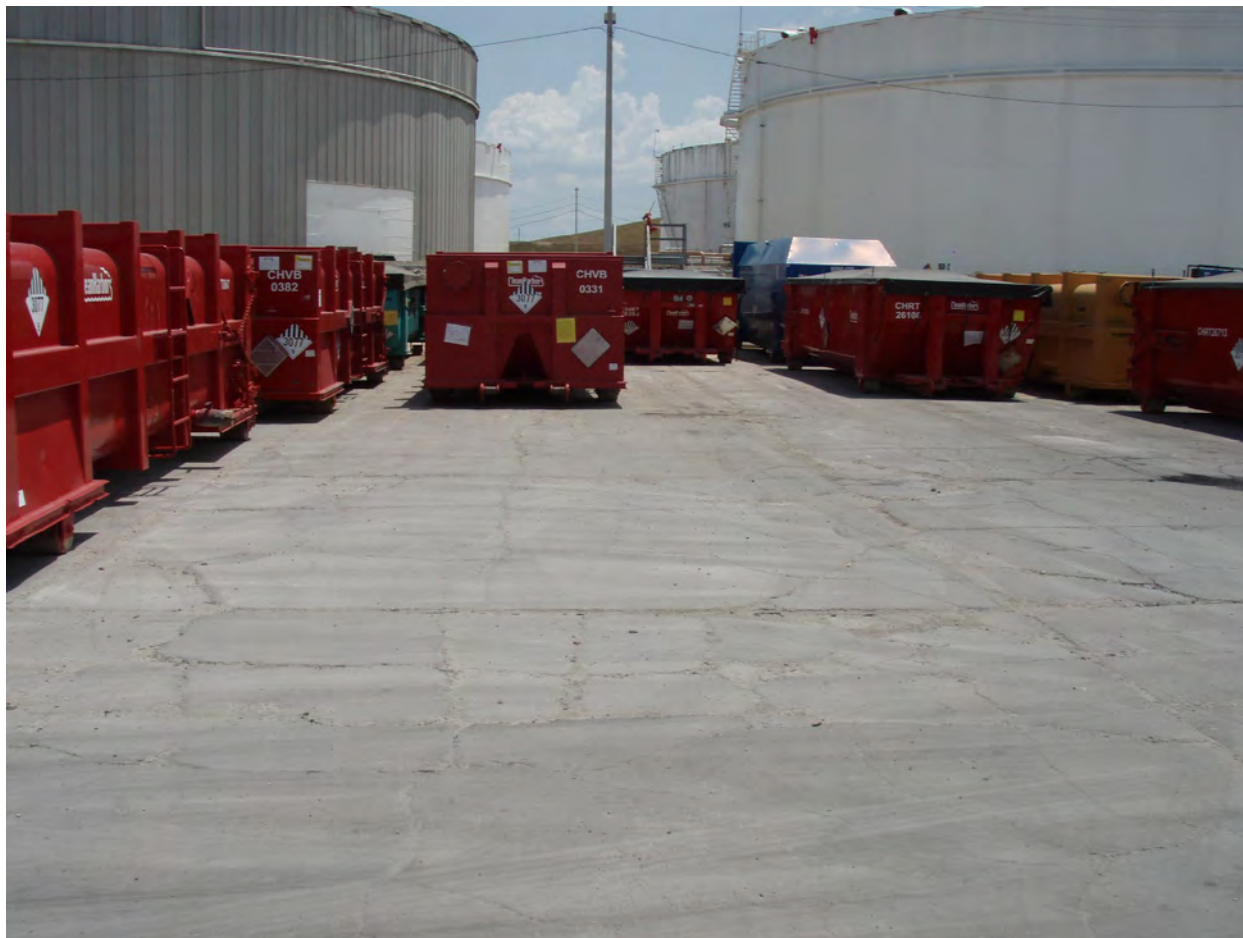
**PHOTO No. 46**

- Less Than 10-Day Storage Areas Conditions – I observed numerous containers of off-site generated hazardous waste being stored less than 10 days in the three container storage areas (i.e., roll-offs, tankers, and trailers). Also, I observed cracks and spalling in these areas. See Photos 46, 49, 112, 114, and 120. **(AOC #1.a)**.

- a. **AOC #1.a** – I observed cracks and spalling in the less than 10-day roll-off, tanker, and trailer storage areas. [40 CFR 264.175(b)(1) for a permitted facility]
- b. **AOC #1.b** – I observed one 1-cubic yard satellite accumulation box (containing less than 55-gallons) of spent PPE opened and not labeled with the indication of hazards. [40 CFR 262.15(a)(4) and (5) for a SQG or LQG]
- c. **AOC #1.c** – CHESI Transfer did not notify as a generator of hazardous waste. [30 TAC 335.6 for a SQG or LQG]

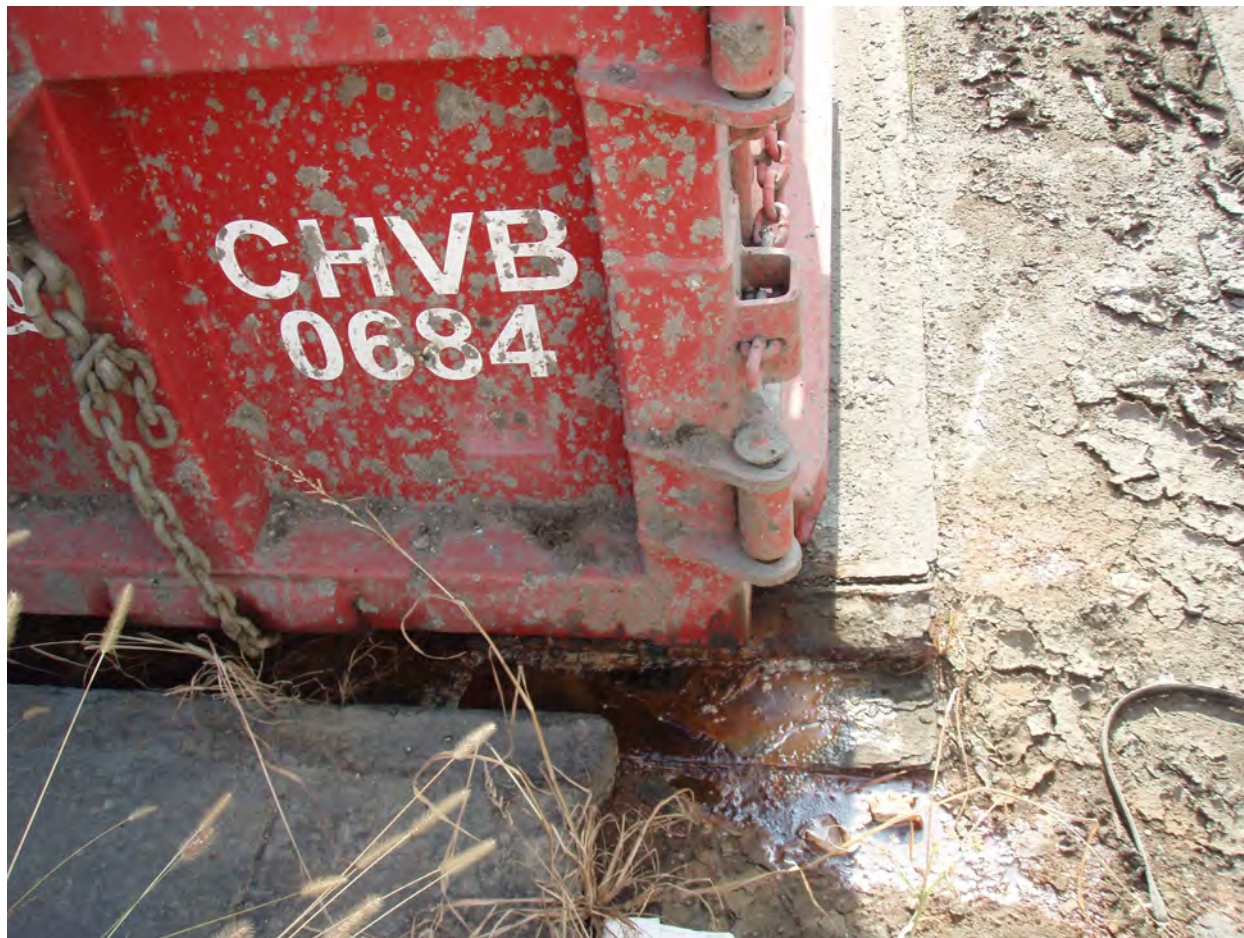
**PHOTO No. 66**

- I selected the following roll-offs to review related manifests and waste profiles:
  - Container #VB12007 – randomly selected for tracking.
  - Container #CHVB0684 – leaking, labeled PCBs, and believed to be empty (see Photos 66 and 70). Since it was leaking, I noted it as a concern to verify that it did not contain a hazardous waste since roll-offs are reused and PCBs could be mixed with hazardous waste. **(AOC #3.b)** A catch container was placed underneath to catch any leaks/spills until cleaned up (see Photos 135).

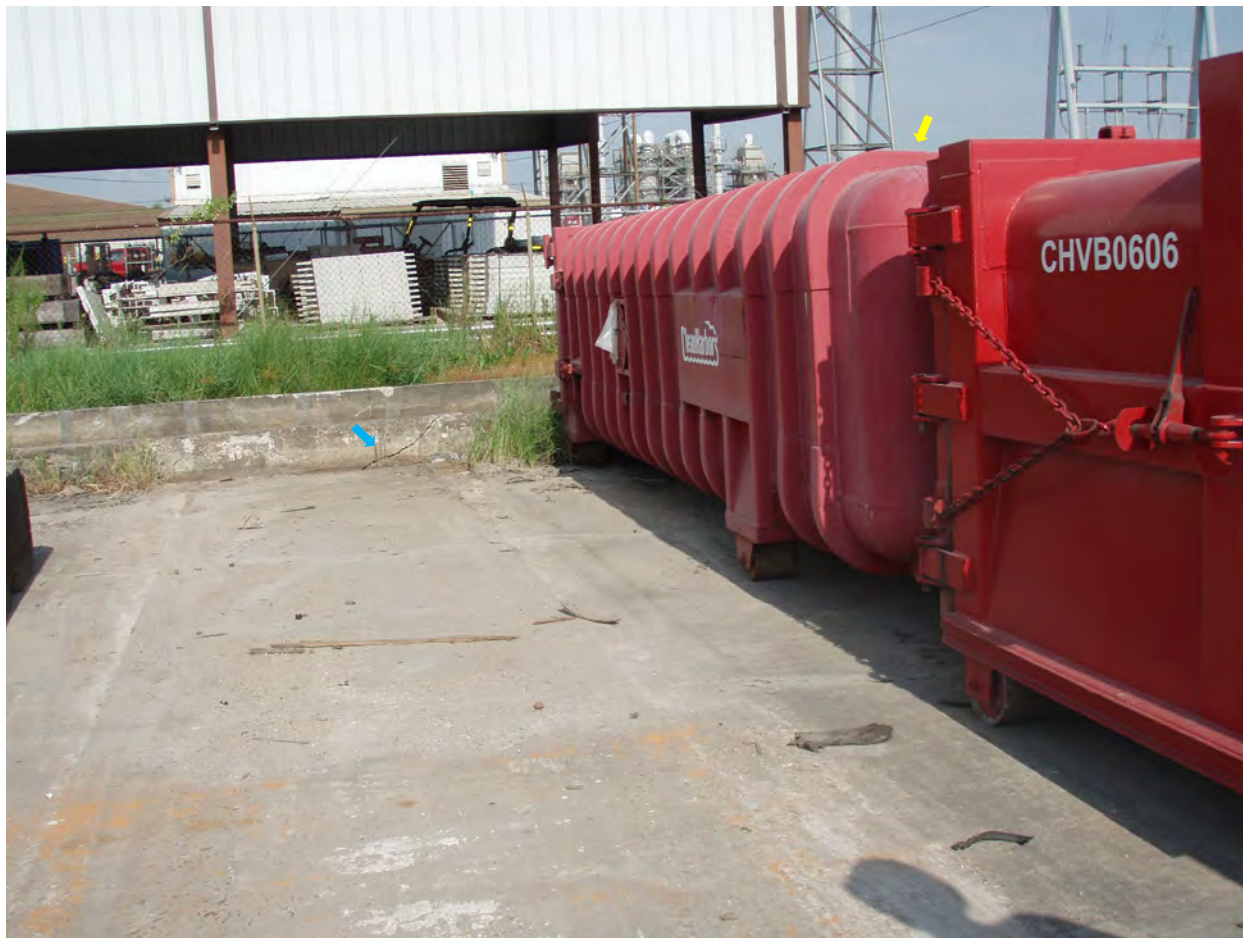
**PHOTO No. 75**

- I observed in the drainage collection area cracks in a wall along with weeds, algae, residue, accumulated liquid, and little fish swimming (see Photos 72, 75, 77, and 78). Also, I observed a crack on the south end, stains as stated below, and residue throughout the containment that Mr. Riffles stated was dirt being blown/tracked in (see Photos 66, 75 - 77, 122, 125, and 135). **(AOC #3.a)** During the inspection, CHDP started cleaning out this containment area (see Photo 140).

- Container #RT-251988 – labeled with manifest #024041343JJK and randomly selected for tracking.
  - Container #CHVB0230 – dated 5/8/23 and labeled construction debris, but I observed a stain underneath it (see Photos 75 and 76). **(AOC #3.c)**

- a. **AOC #3.a** – I observed cracks in the Waste Receiving Pad's drainage collection area wall along with weeds, algae, residue, accumulated liquid, and little fish swimming. [40 CFR 264.175(b) for a permitted facility]
- b. **AOC #3.b** – I observed a roll-off labeled PCBs leaking that needed its non-hazardous waste determination verified since it was believed to be empty. Roll-offs are reused, and PCBs could be mixed with hazardous waste. [30 TAC 335.504 (40 CFR 262.11) all generators]
- c. **AOC #3.c** – I observed two storage containers on the Waste Receiving Pad with stains underneath. [40 CFR 264.171 for a permitted facility]

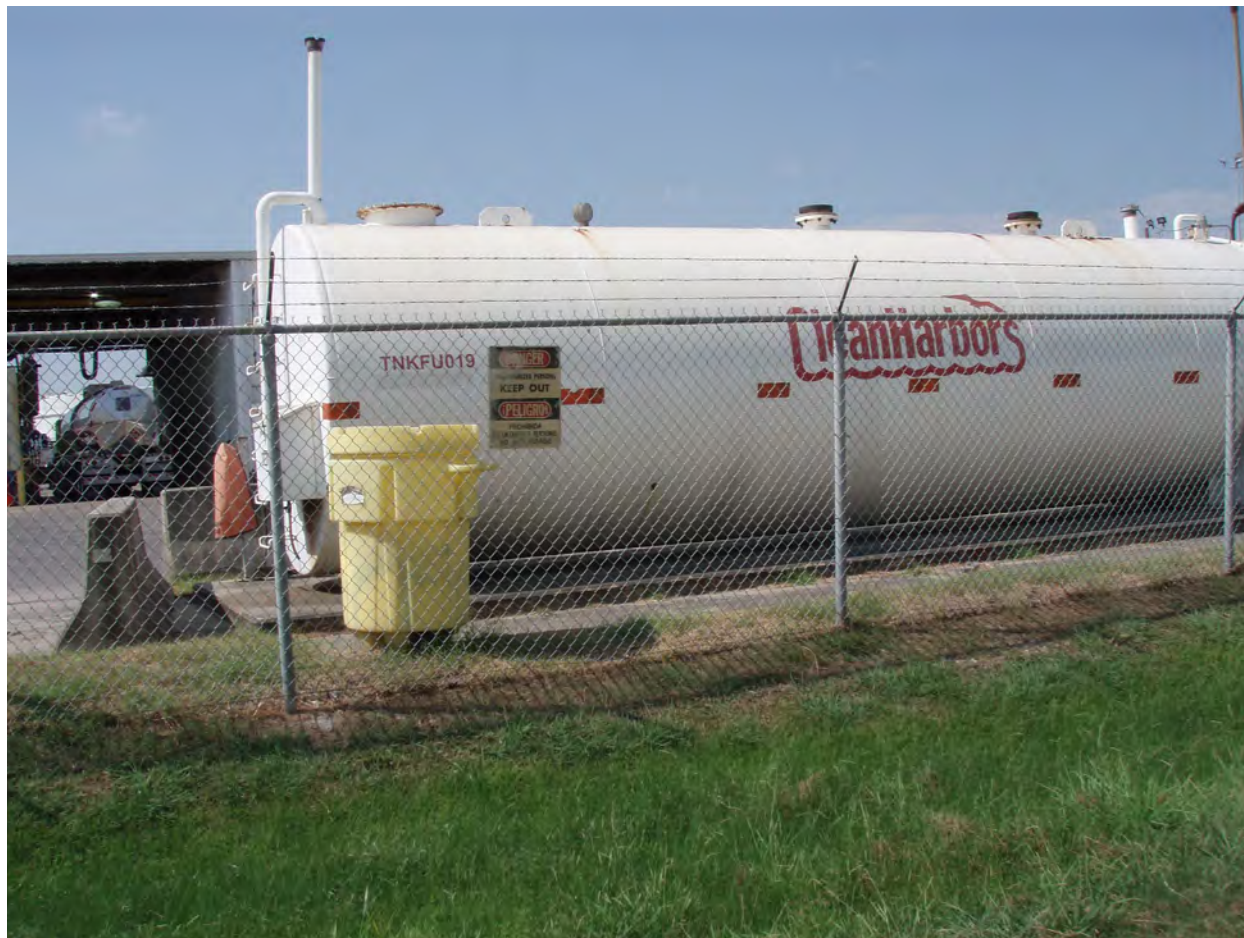
**PHOTO No. 118**

- The north security fence has three openings of which two have gates that remain open. The other opening near the transportation office has no gate and I observed no warning signs near it (see Photos 116 - 118, 129, 136 and 139). Also, I observed warning signs posted on the north, south, and east fences but spaced far apart (see Photos 18, 100, 108, 112, 114, and 125). **(AOC #1.d)** Mr. Riffel stated that they have ordered more warning signs to be posted around the facility.

- d. **AOC #1.d** – I observed insufficient warning signs posted. [30 TAC 335.94 for a transfer facility or 40 CFR 265.14(c) for a permitted facility]
