## SURVEY REPORT

| REPORT NO.<br>NN8687 | NAME OF VESSEL<br>SS "ESSO BOSTON" | PORT OF ISSUE<br>Newport News, Va. |
| <div style="text-align: center;">DESCRIPTION OF SURVEY</div> <div style="text-align: right; font-size: 1.2em;">H &amp; M X &amp; RPR</div> <div style="text-align: center;"> DRYDOCKING AND REPAIRS<br/> SPECIAL SURVEY NO. 2 OF HULL<br/> ANNUAL SURVEY &amp; LOAD LINE INSPECTION<br/> RENEWAL OF L.L. CERT. BY ABS-NEW YORK<br/> SPECIAL SURVEY OF MACHINERY<br/> TAILSHAFT SURVEY<br/> ANNUAL BOILER SURVEY </div> <div style="text-align: right; border: 1px solid black; border-radius: 50%; width: 40px; height: 40px; line-height: 40px; margin: 10px auto;">M</div> | | |

Newport News, Va., Sept. 1, 1970

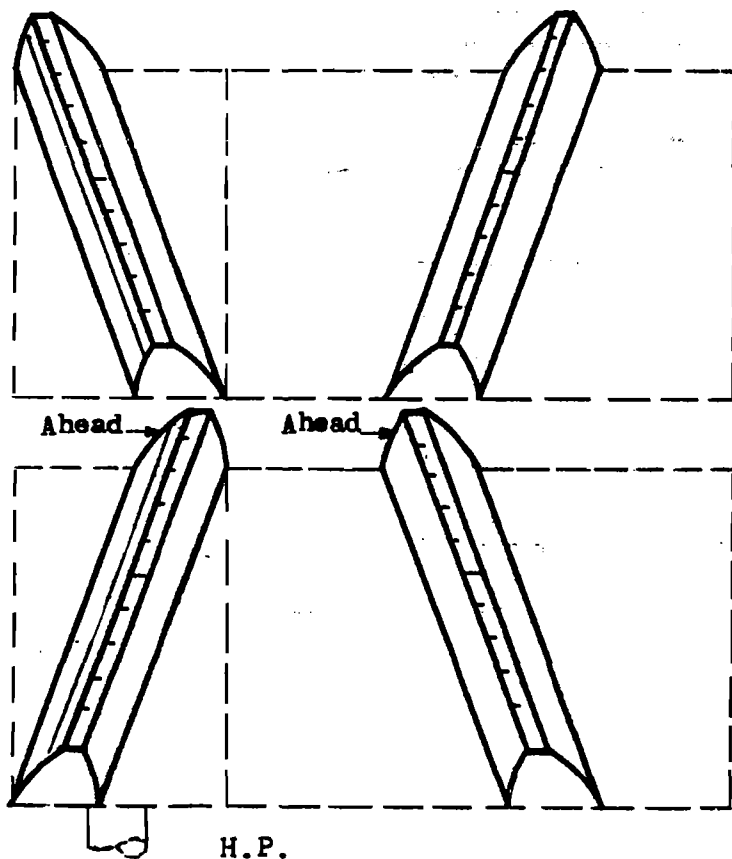
H.P.

Remarks Reduction gears examined thru inspection covers of gear casing.
