## RCRA Compliance Evaluation Inspection Report

United States Postal Service - Vehicle Maintenance Facility  
6707 Winton Blount Boulevard  
Montgomery, Alabama 36119-9351  
Montgomery County  
(334) 244-7533

EPA ID No.: ALR000018507

April 20, 2021, 9:30 a.m.

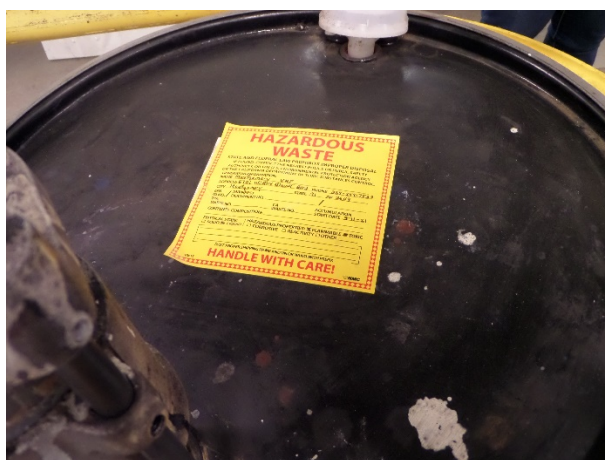
vehicles under repair and maintenance in the various service bays at the time of inspection. The inspectors observed an aerosol can puncturing device and a filter cannister mounted on a 55-gallon drum in secondary containment in the satellite accumulation area (SAA) (Picture-1). The drum was observed to be closed and labeled as "Hazardous Waste." The hazard indication on the drum was observed to be "Flammable" and "Toxic." The inspectors also observed a closed 55-gallon drum containing punctured aerosol cans located next to the 55-gallon SAA drum. According to Mr. Clardy, the punctured cans were managed as scrap. The inspectors observed a spill kit near the SAA.

*Picture 1: SAA Drum, VMF*

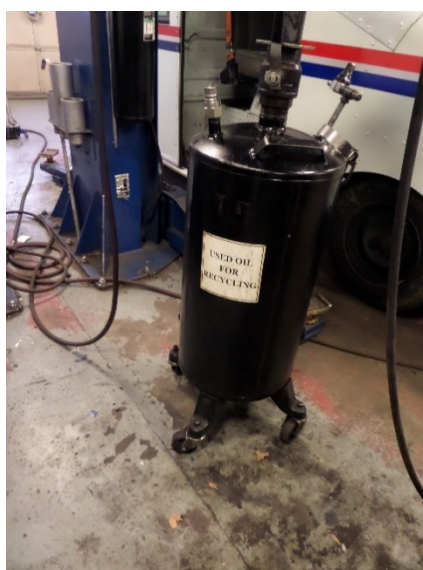
The inspectors observed floor drains in the service bays with liquid in them that required cleaning. Mr. Clardy mentioned that Safety-Kleen was contracted to clean the drain trough once a year. According to Mr. Clardy, the floor drains located inside the VMF including the Lube Room, Service Bays and the Wash Bays are routed through an oil/water separator prior to release into the municipal sanitary sewer system. The drain oil/water separator was located outside near the southwest corner of the VMF building. The inspectors observed a parts washer in the service area. The equipment was not in use at the time of inspection. Mr. Clardy stated that the equipment was not in service. The inspectors observed a Model 26.1, Aqueous Brake Cleaner equipment. The equipment was not in service at the time of inspection. Mr. Clardy mentioned that the equipment was serviced by Safety-Kleen periodically. The inspector observed a 55-gallon used oil drum (Picture-2) on skids near one of the service bays. The drum was closed and labeled as "Used Oil for Recycling". Mr. Clardy said that Safety Kleen Inc. picked up their used oil for recycling purposes.

*Picture 2: Used Oil Container on Skids, VMF*

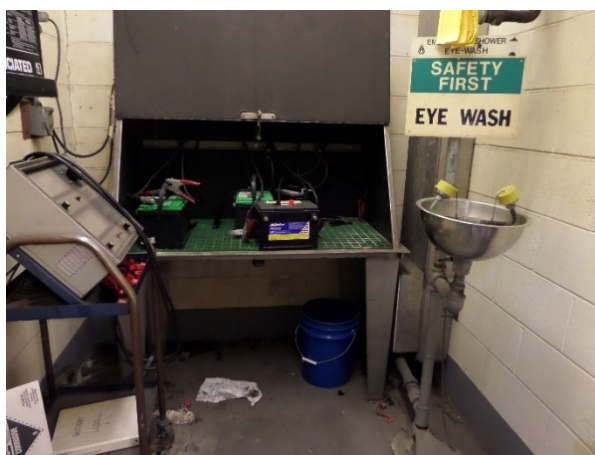
The next area inspected was the Battery Charging Room. The inspectors observed three automotive batteries being charged during the inspection at the battery charging terminal (Picture-3). There were three additional batteries waiting to be serviced in secondary containment. According to Mr. Clardy, spent lead-acid batteries are recycled through reclamation. The spent batteries are placed on the charger to see if they are rechargeable. Once charged the batteries are put back in service, if not, they are placed in storage until they are picked up by Interstate Battery Company for a one-to-one swap for rebuilding and reuse. The inspectors observed an eye wash station near the battery charging terminal. Mr. Clardy mentioned that the eye wash station was checked on a weekly basis.

*Picture 3: Battery Charging Room*

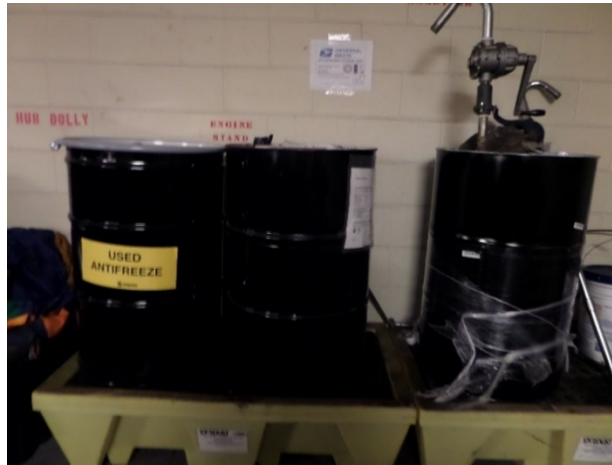
The inspectors observed used tires and used antifreeze storage area adjoining the Battery Charging Room. The inspectors observed two 55-gallon drums labeled as "Used Antifreeze" in secondary containment (Picture-4). According to Mr. Clardy, Safety Kleen picked up their used Antifreeze. Used tires were picked up by a local company called "Day and Night". No hazardous waste was observed in this area.

*Picture 4: Used Antifreeze in Secondary Containment*

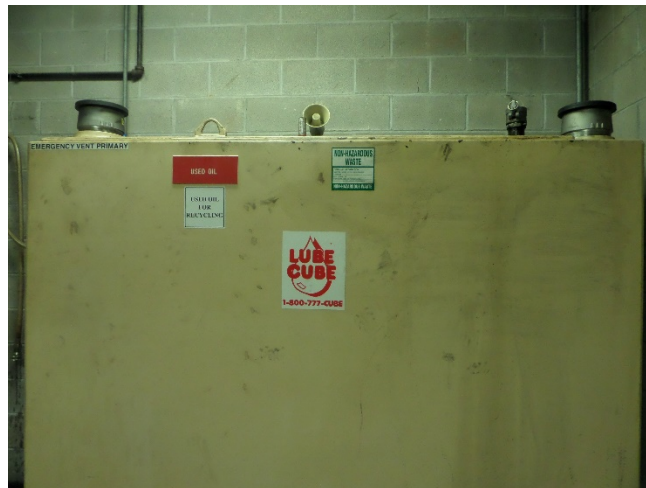
*Picture 5: 650-gallon Used Oil Tank*

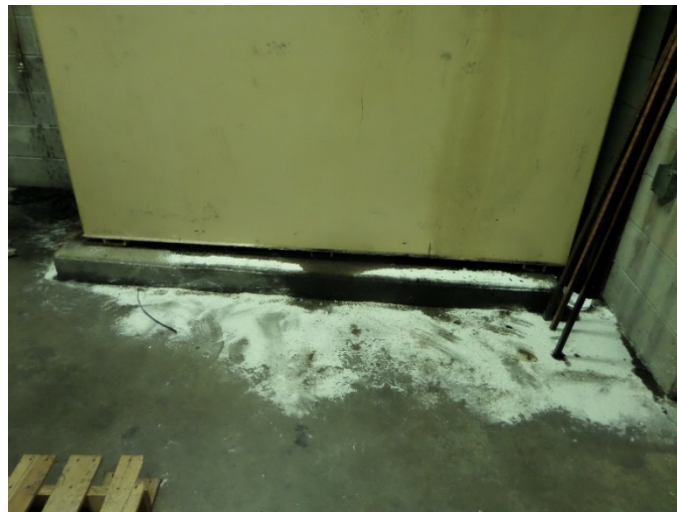
observed the 650-gallon used oil tank labeled as “Used Oil” and the tank containing new oil labeled as “Virgin Oil”. The inspectors observed oil stains in the floor covered by the shop absorbent- “Stardust” (Picture-6) near the base of the used oil tank. Mr. Clardy mentioned that there was an accidental spill during a routine pick up of used oil from the Lube Room last week. Mr. Clardy mentioned that spill was in the process of being cleaned up.

*Picture 6: Absorbent material covering the used oil spill*

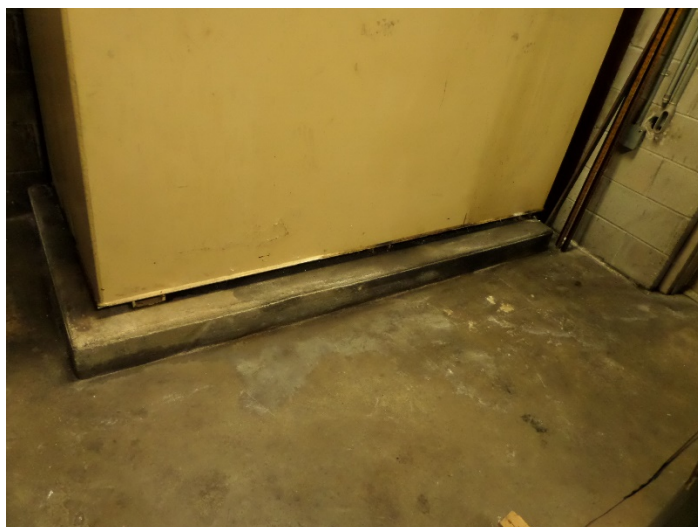
*Picture 7: Used Oil Spill Cleaned during Inspection*

The inspectors observed several closed and labeled 55- gallon drums containing products also stored in the Lube Room. There was no leaks and spills near the product drums. The inspectors also observed a spill kit in the Lube Room. The spill near the used oil tank was later cleaned up before the inspection was concluded. The inspectors later verified the cleanup in the Lube Room prior to concluding the inspection.
