## MULTI-SECTOR GENERAL PERMIT NON-FILER INSPECTION CHECKLIST

| <b>Inspection Date(s):</b> | 2/7/2023 | |
| <b>Operator Name:</b> | Price's Auto Salvage (formerly B F Leidy & Sons Inc.) | |

**Appendix A. Aerial Map**  
**Clean Water Act Inspection**  
**Price's Auto Salvage**

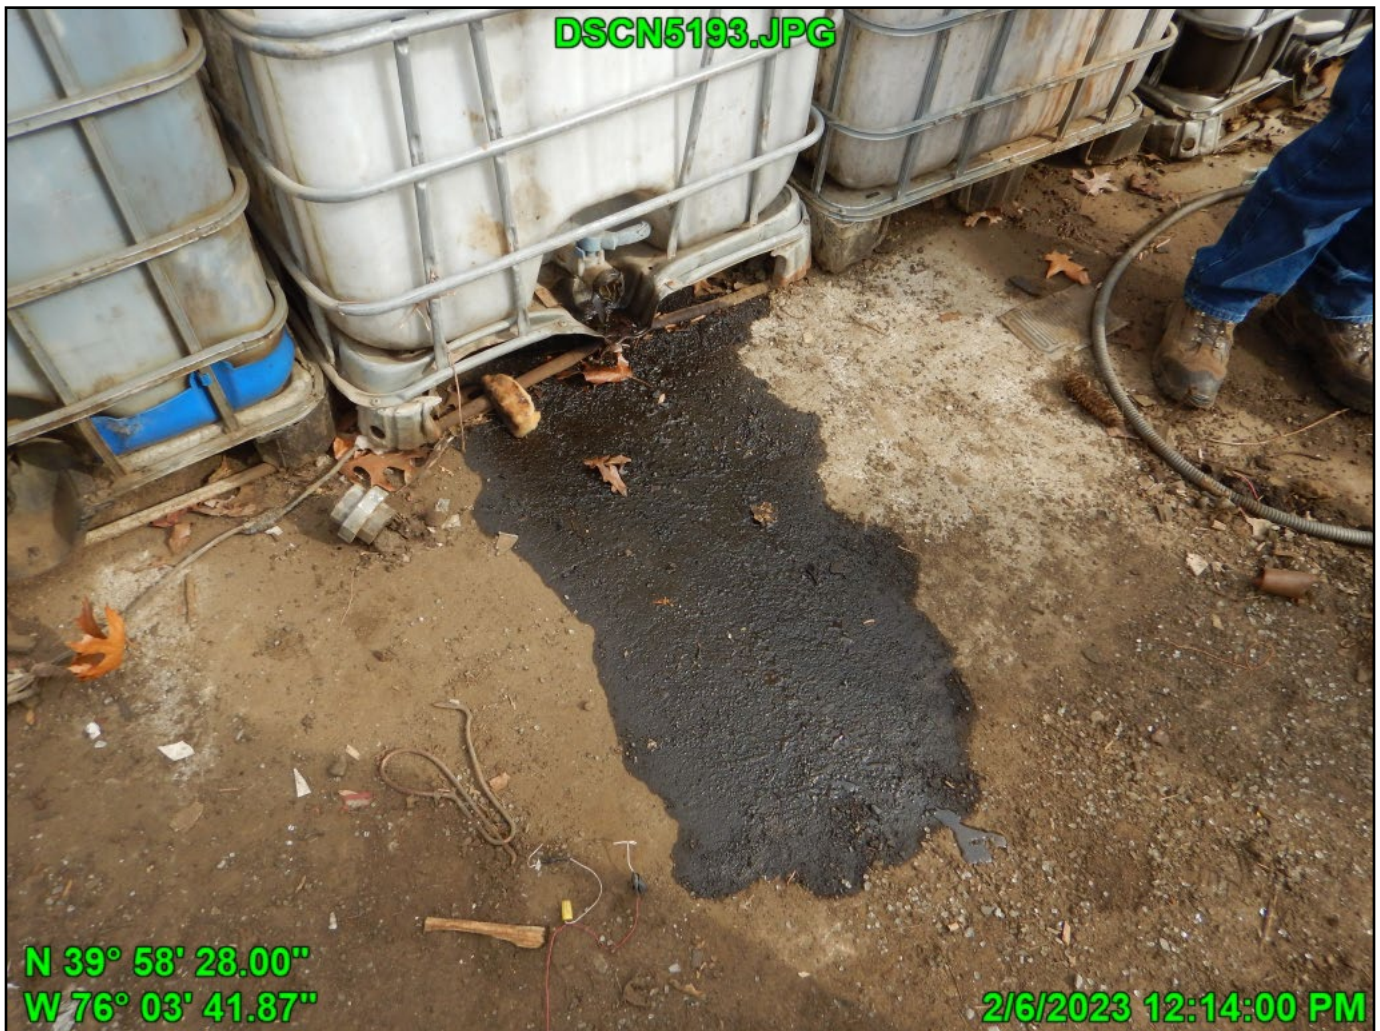
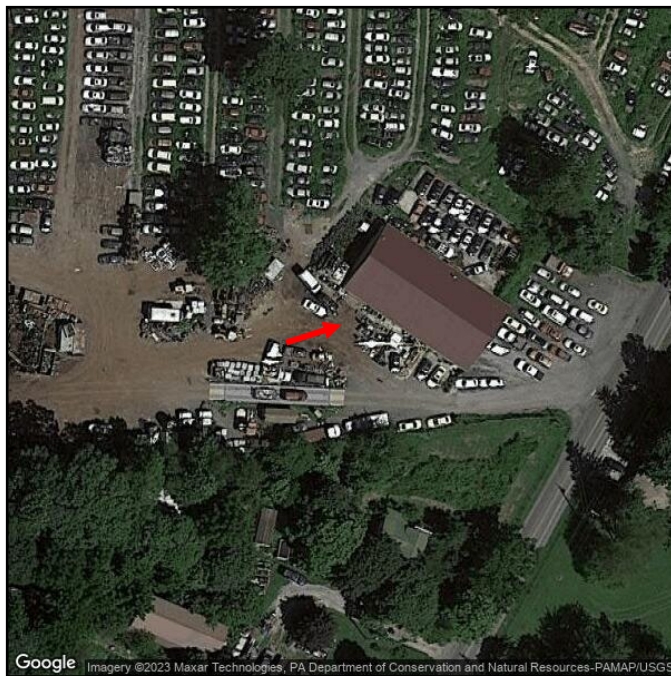
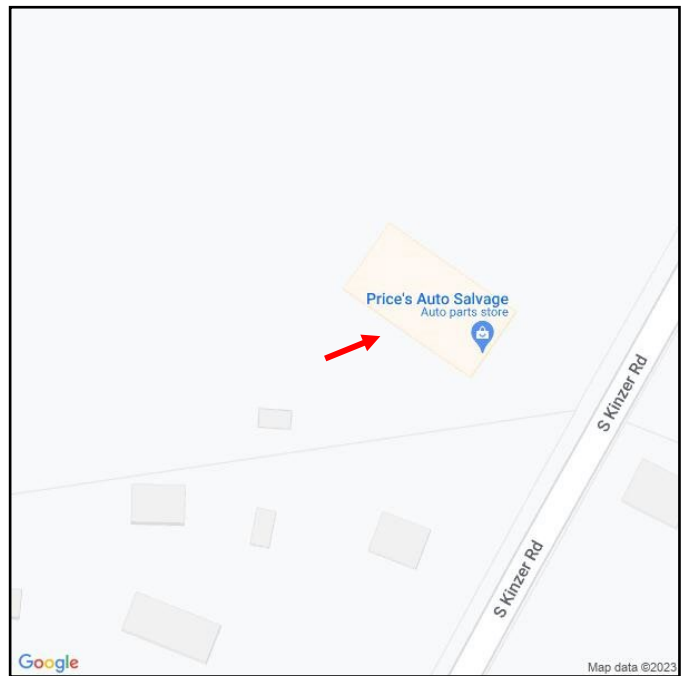
| Description | Leaking oil from the automotive parts storage container shown in Photograph DSCN5192. |

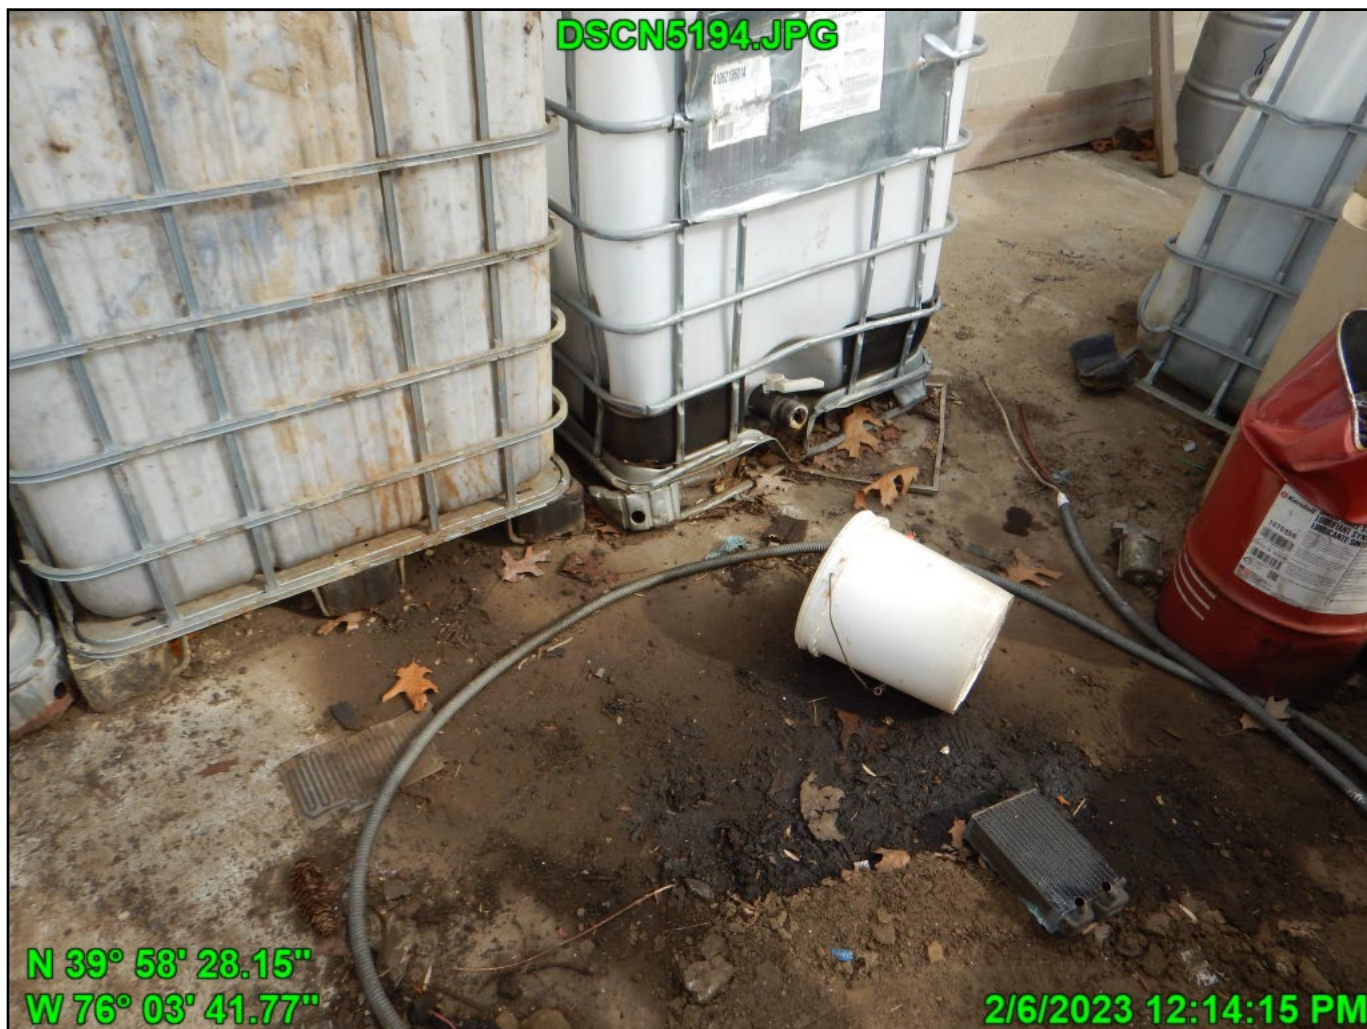
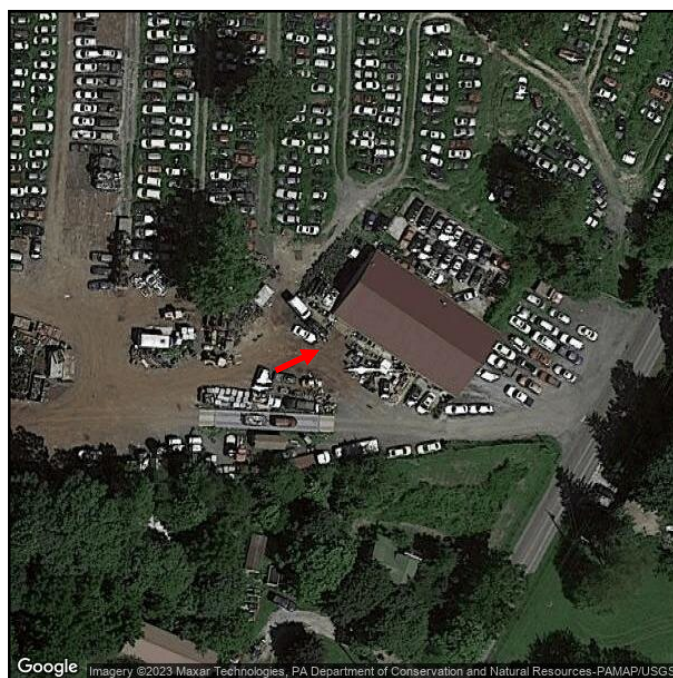
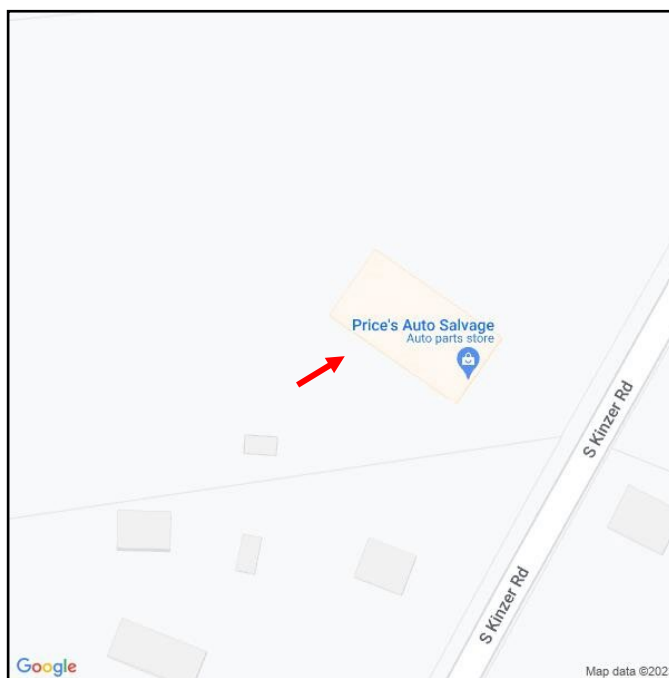
| Description | Petroleum staining on the ground adjacent to vehicle parts stored outside without cover. |

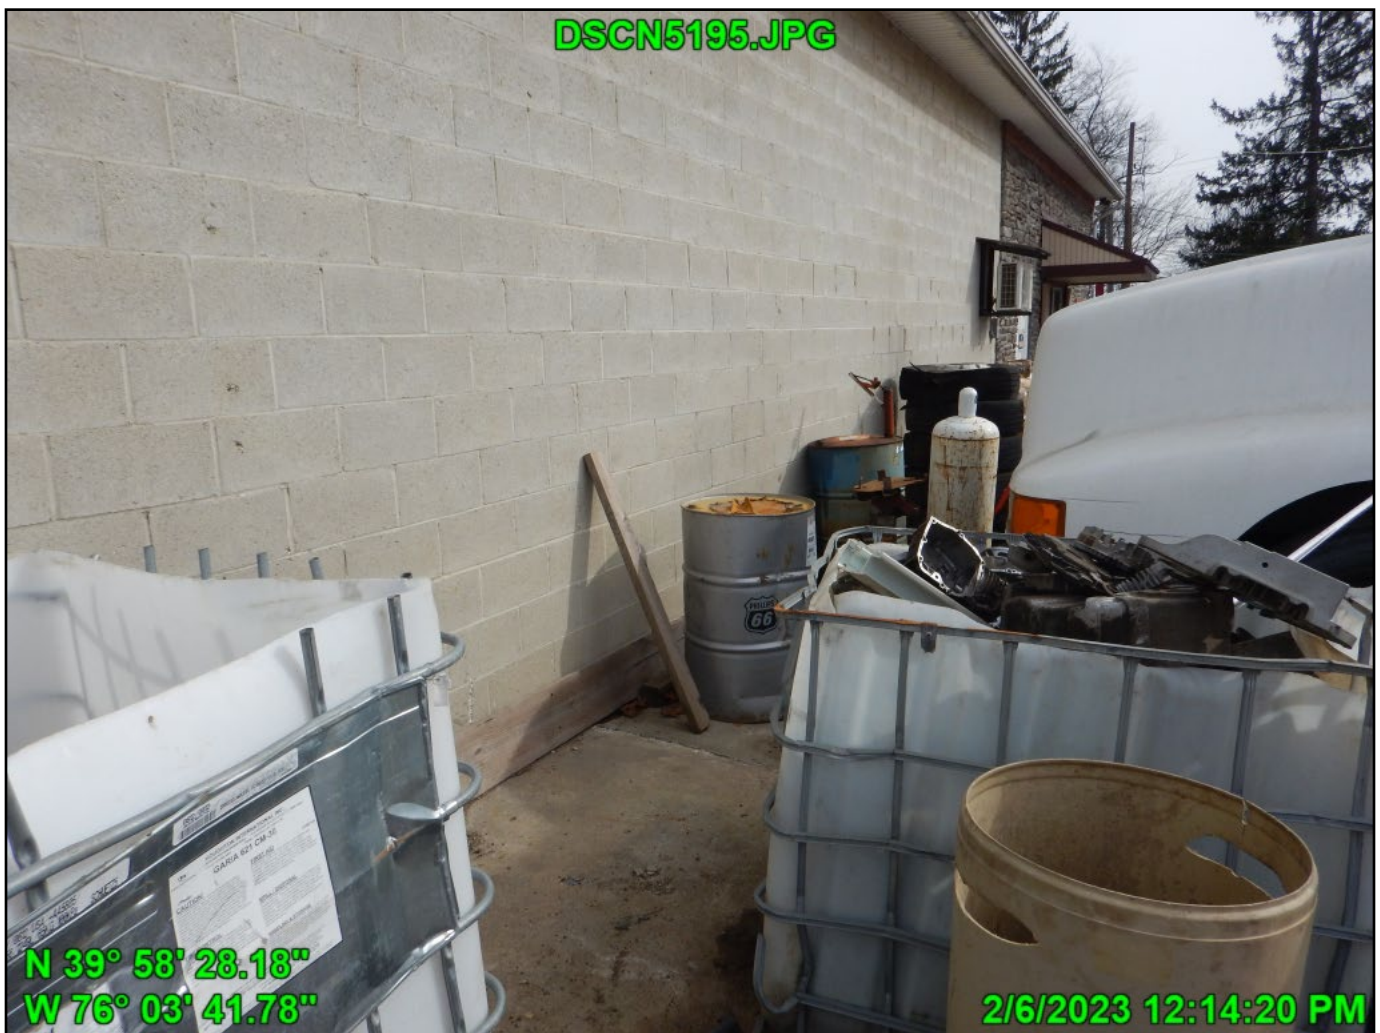
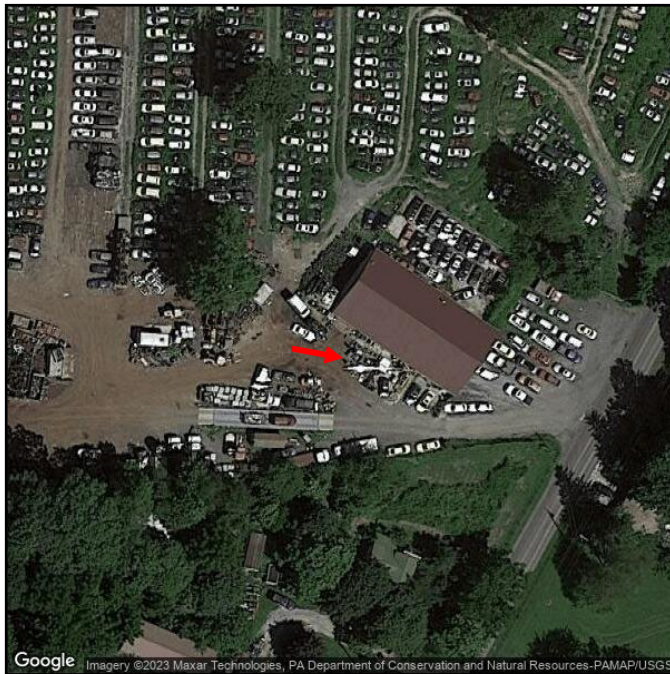
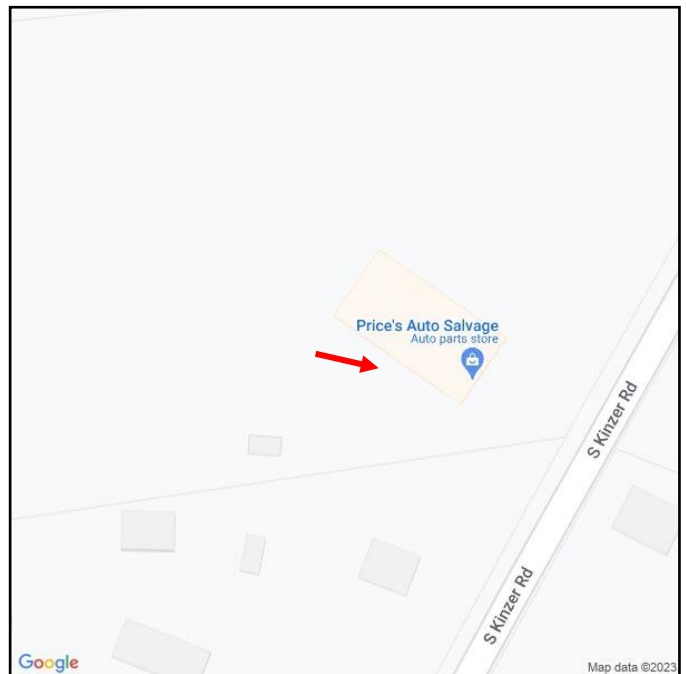
| Description | Vehicle parts stored outside without cover adjacent to the primary Facility building. |

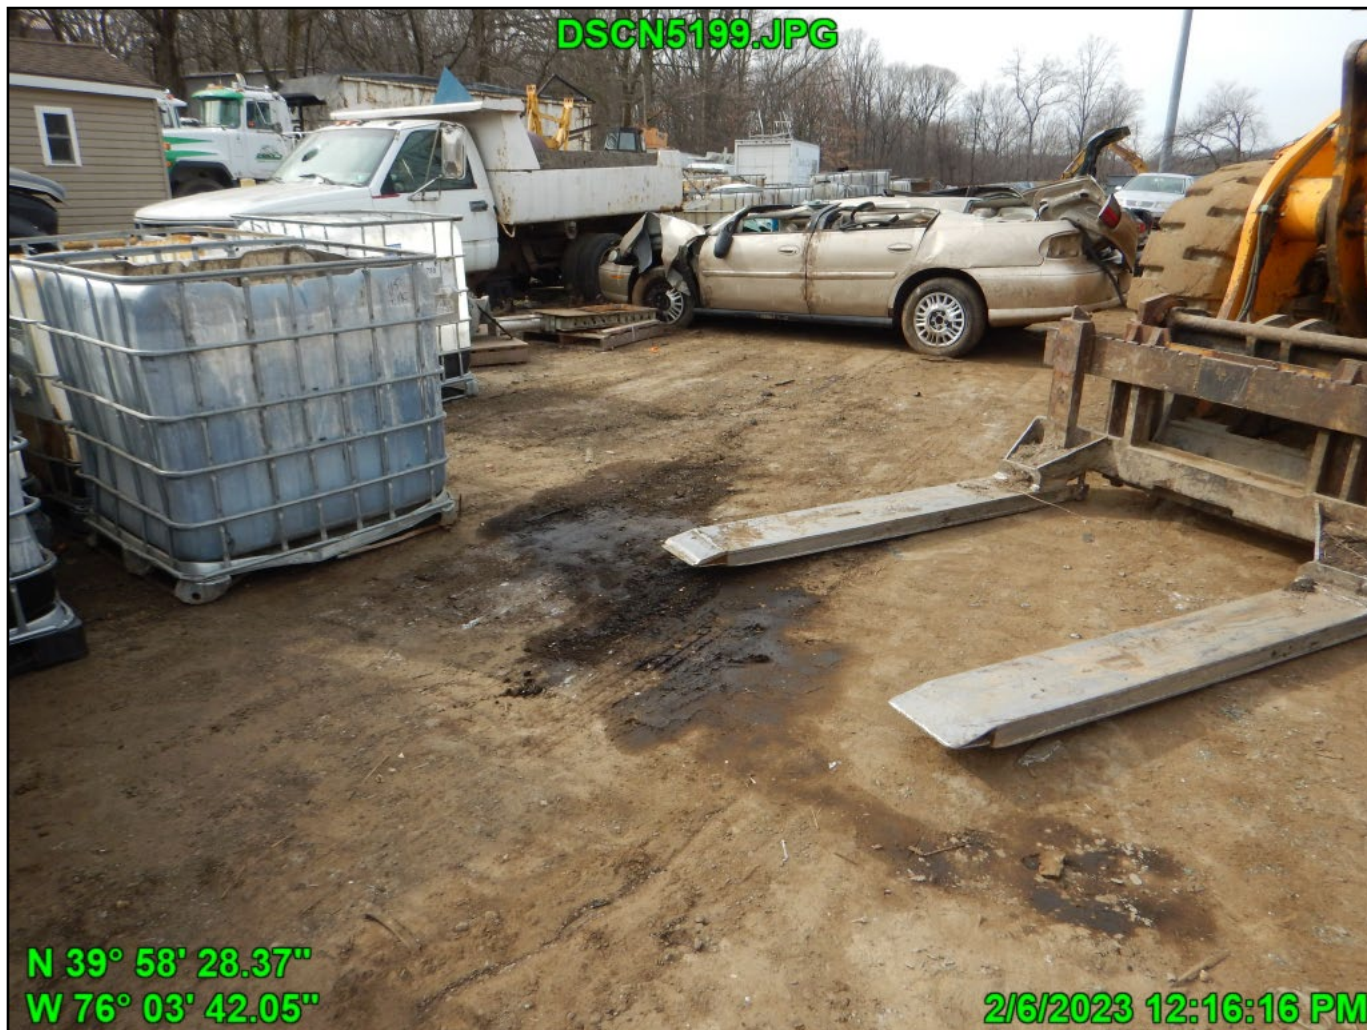
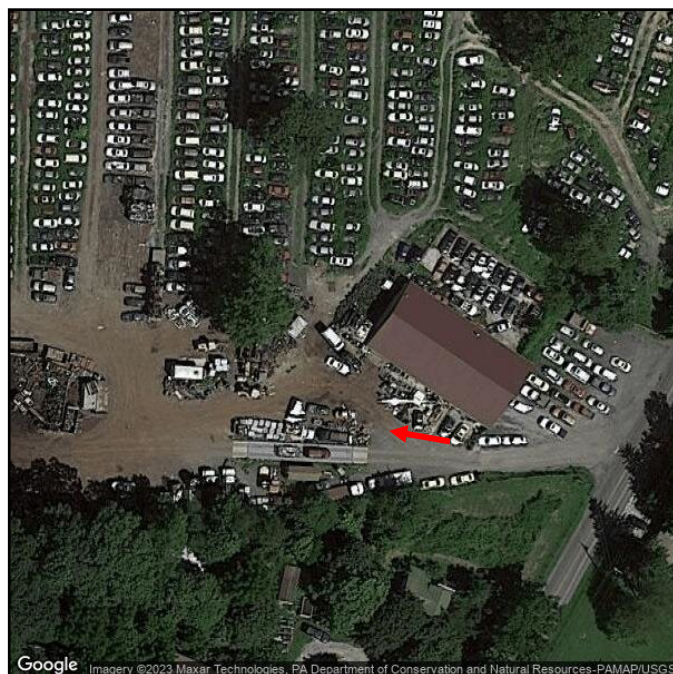
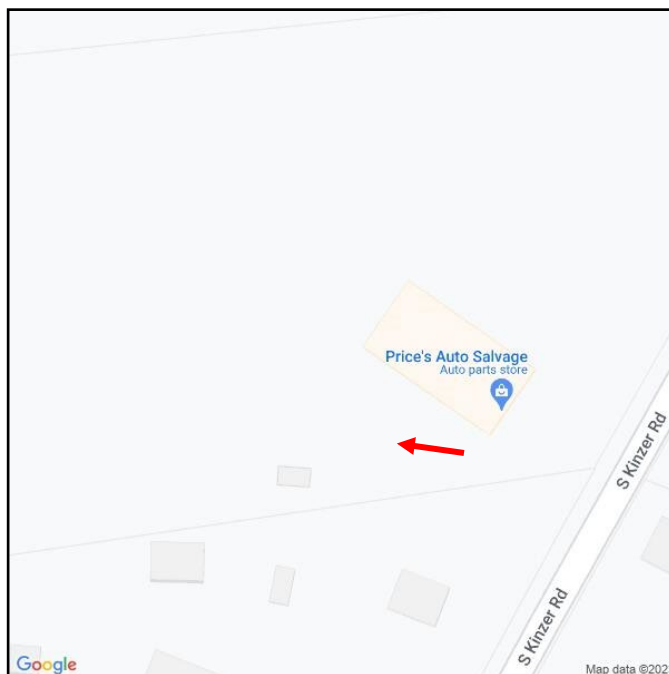
| Description | Petroleum stain on the compacted dirt near the primary Facility building. |

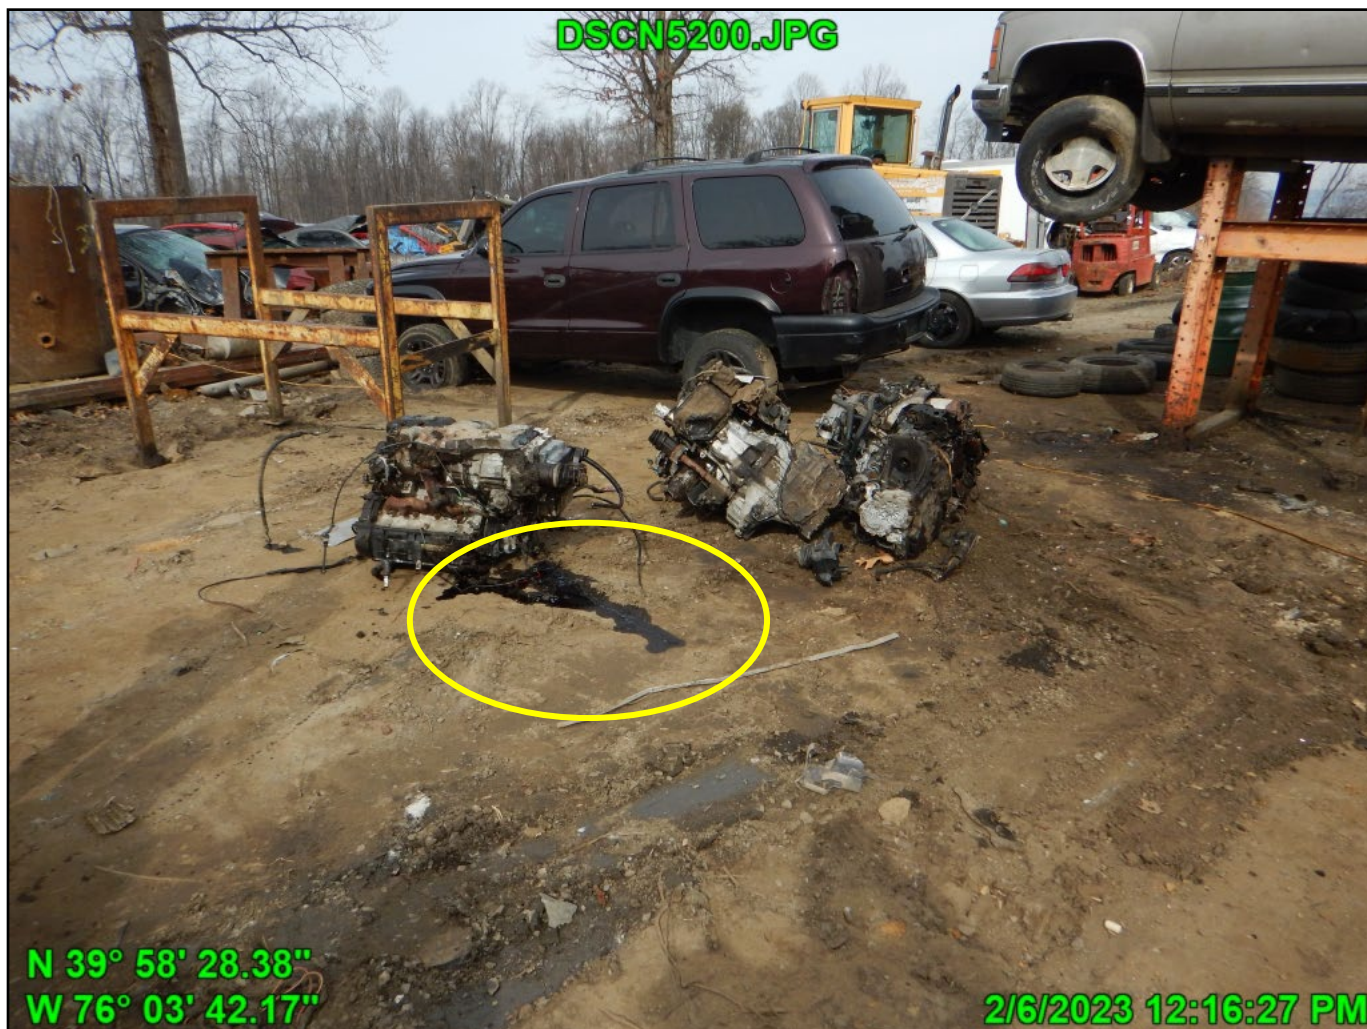
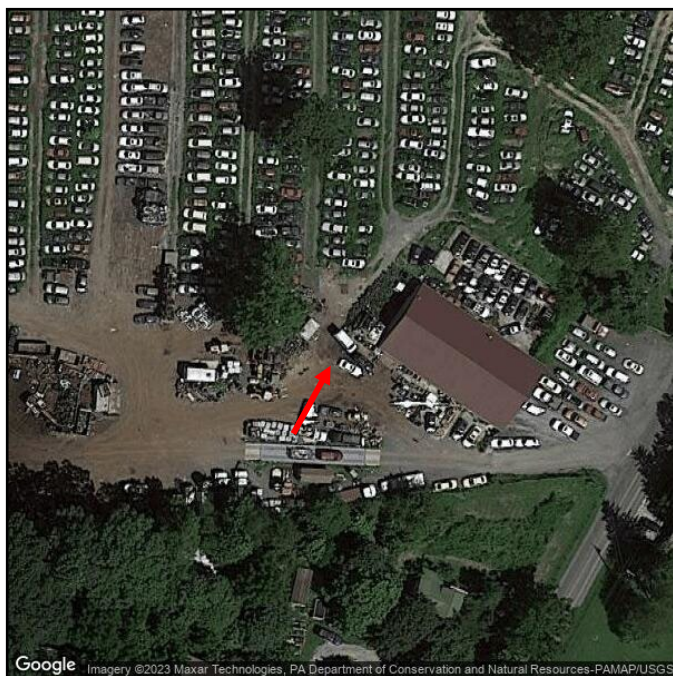
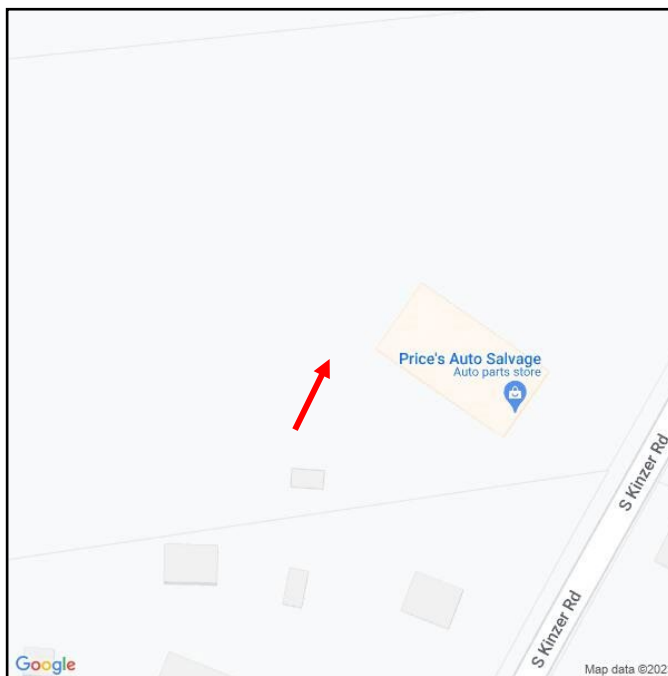
| Description | Used engines leaking oil on the adjacent compacted dirt ground surface. |

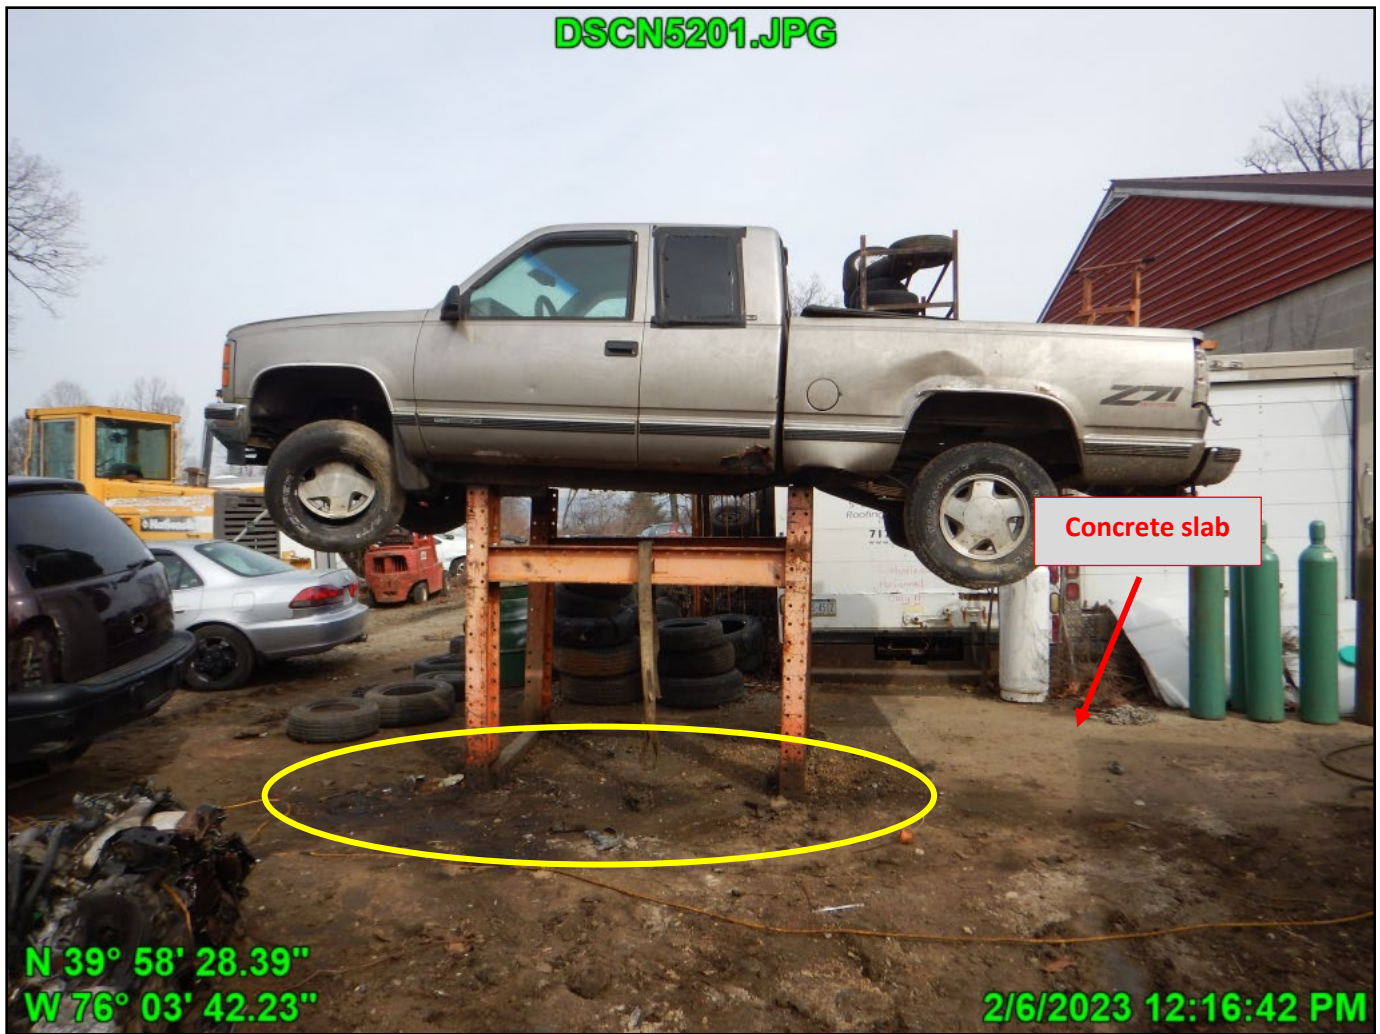
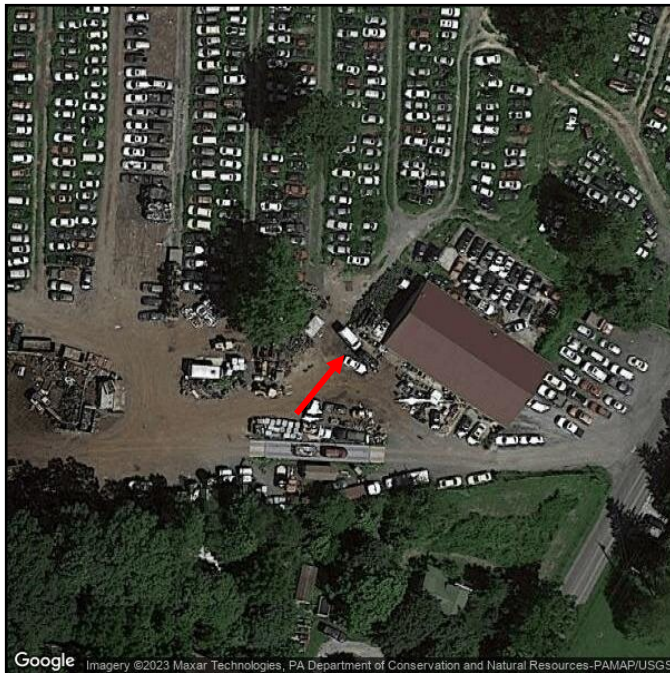
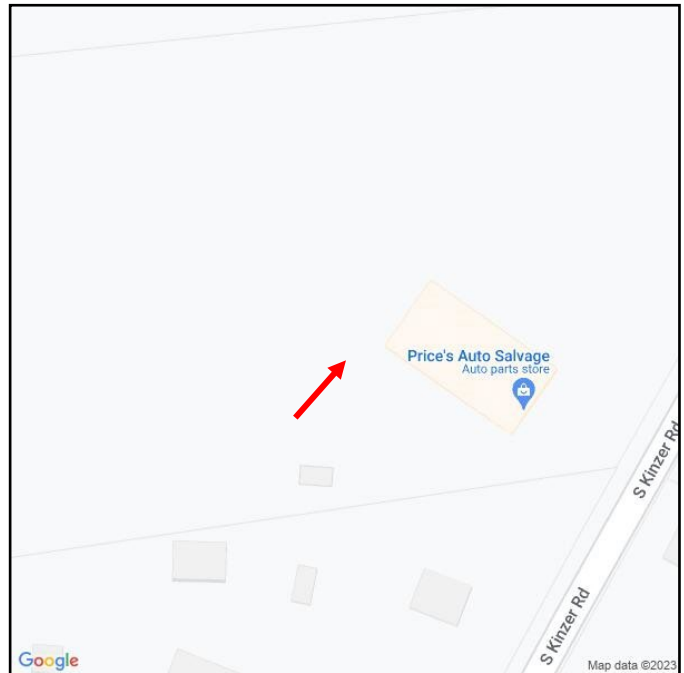
DSCN5201.JPG

- 5) The EPA Inspection Team observed that the Facility was conducting maintenance activities (including changing/draining fluids) on used vehicles outside without cover or containment (refer to Appendix B, Photograph DSCN5201).

Facility fluid removal station that, according to the Facility representative, is sometimes moved to the adjacent concrete slab. Note the petroleum staining around the station. The fluid removal station did not have cover or containment for spills and leaks.

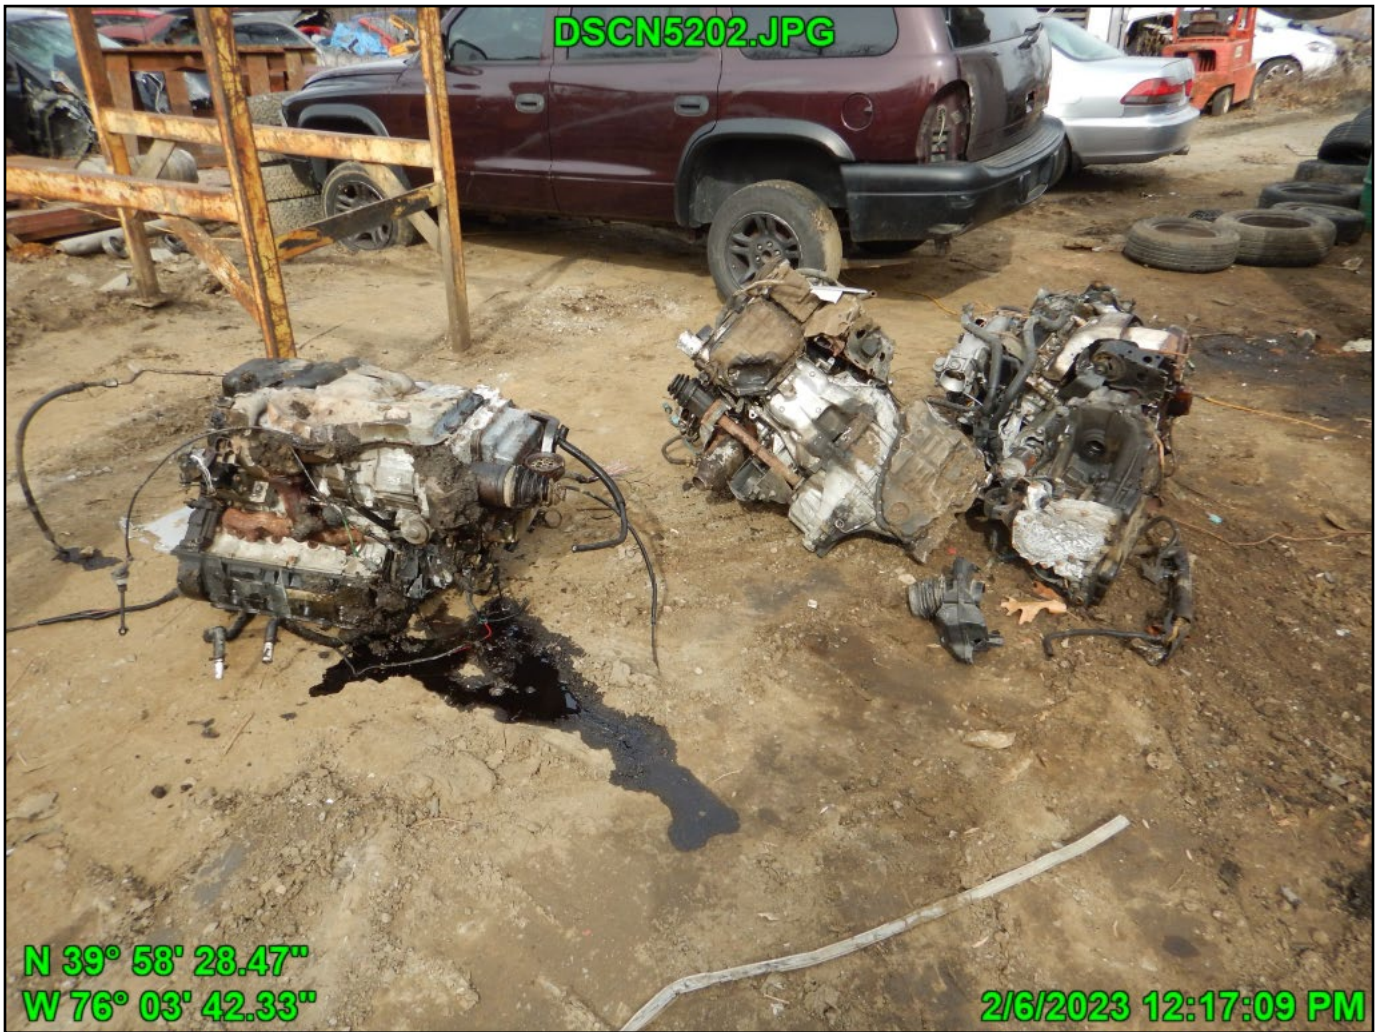
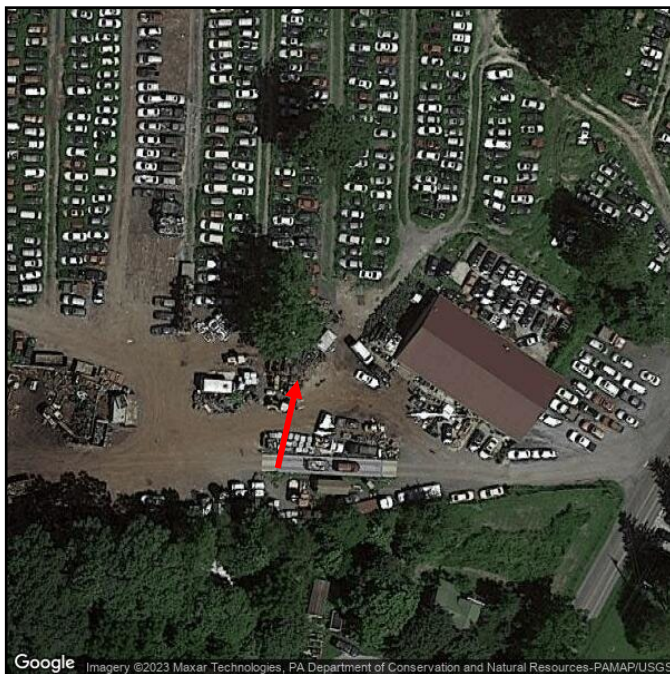
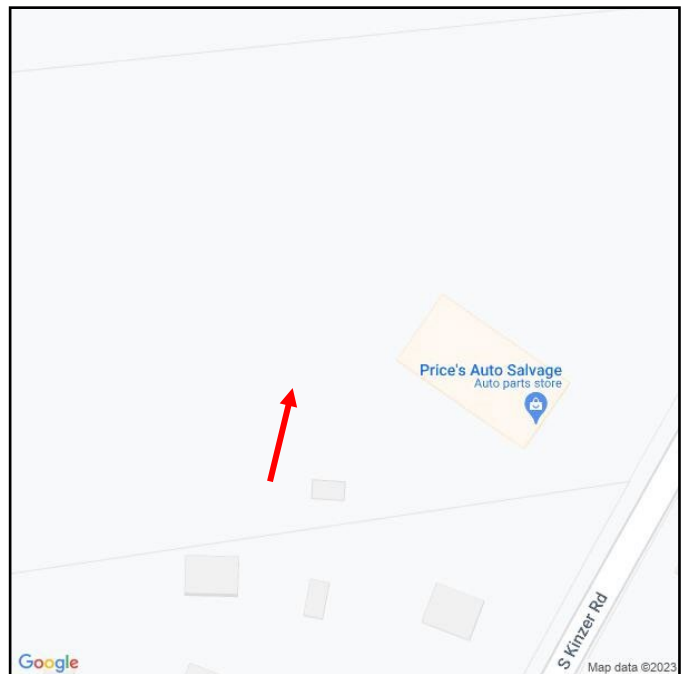
| Description | Used engines leaking oil to the ground next to the fluid removal station shown in Photograph DSCN5200. |

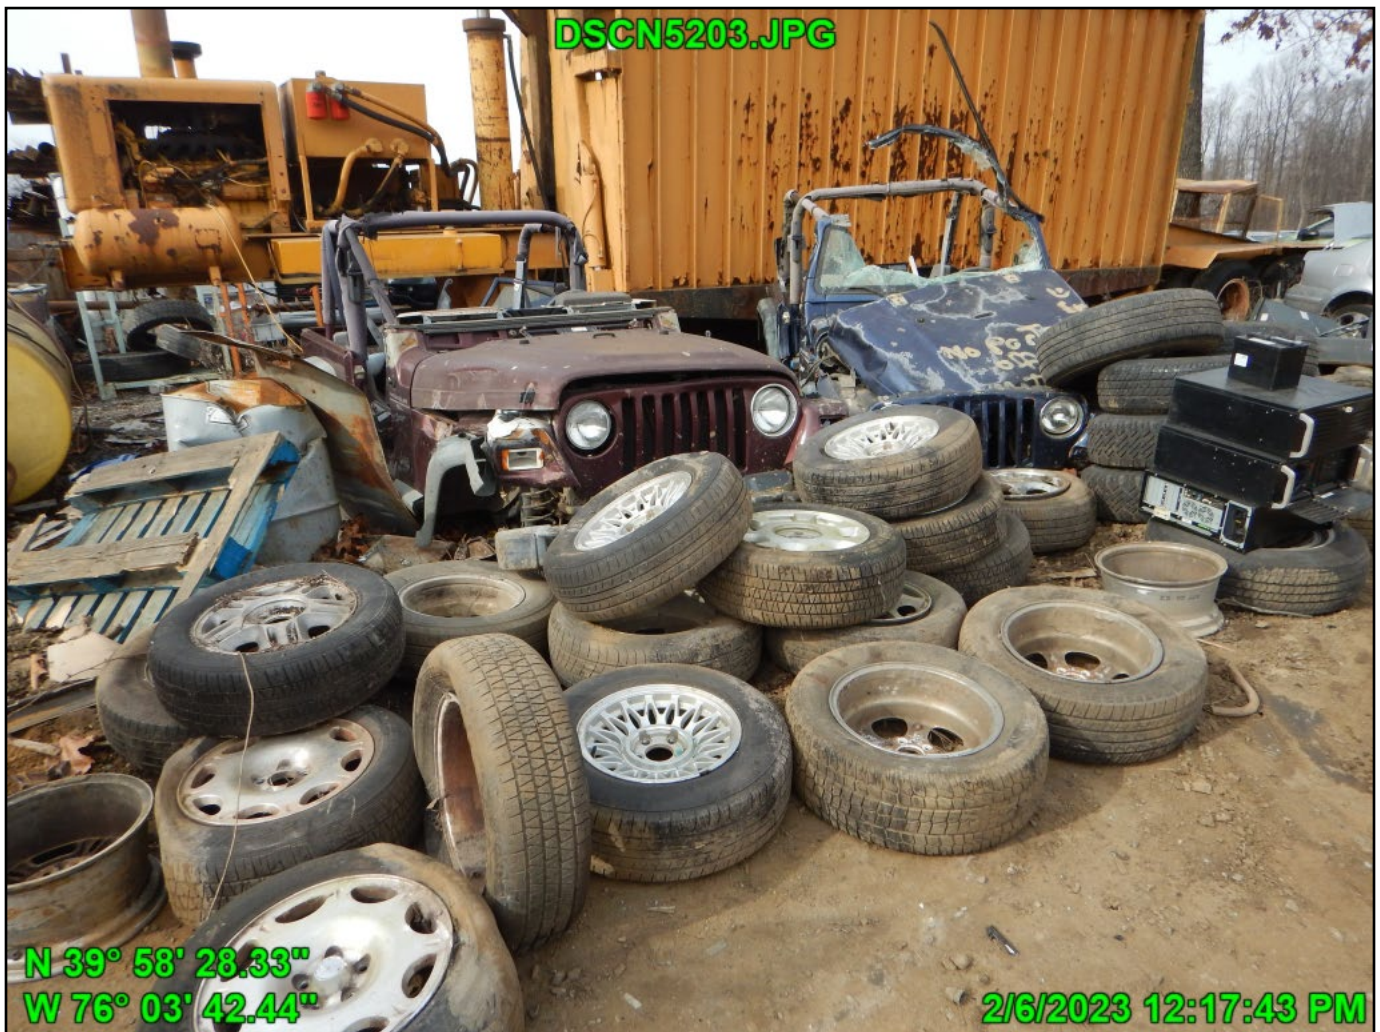
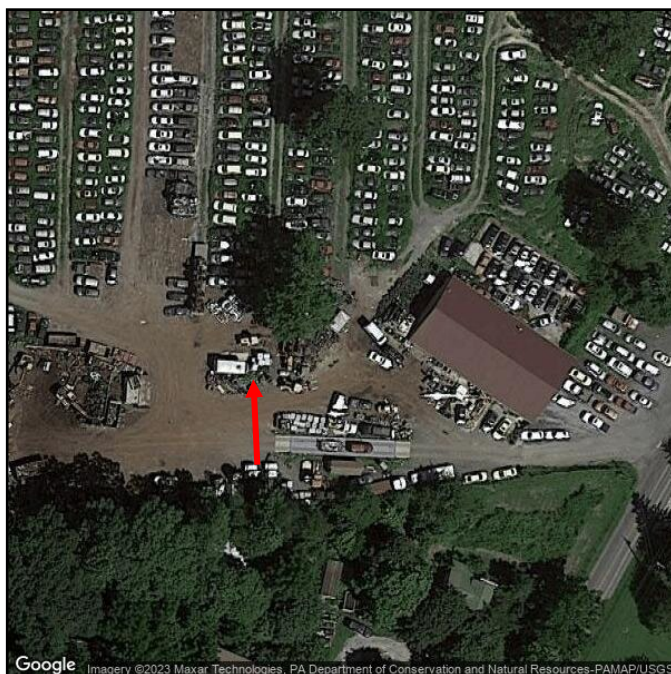
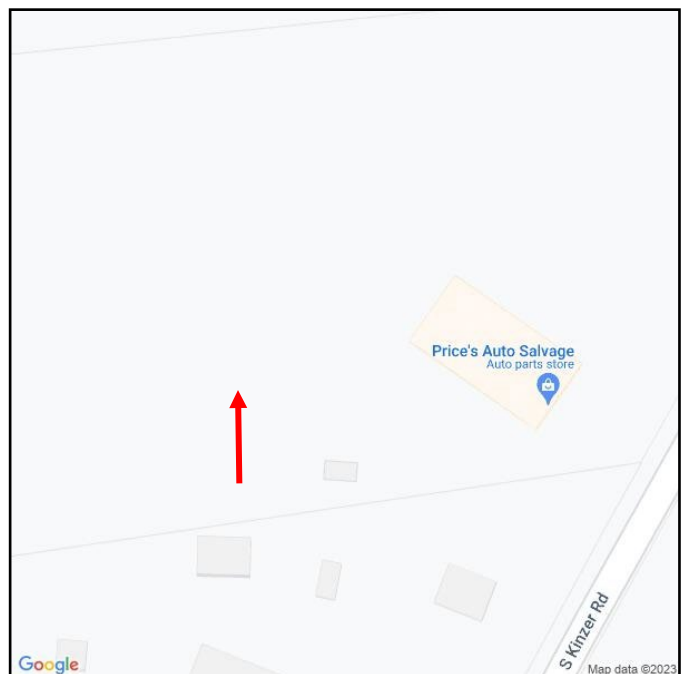
| Description | Used vehicle tires and rims being stored outside without cover in the middle of the Facility. |

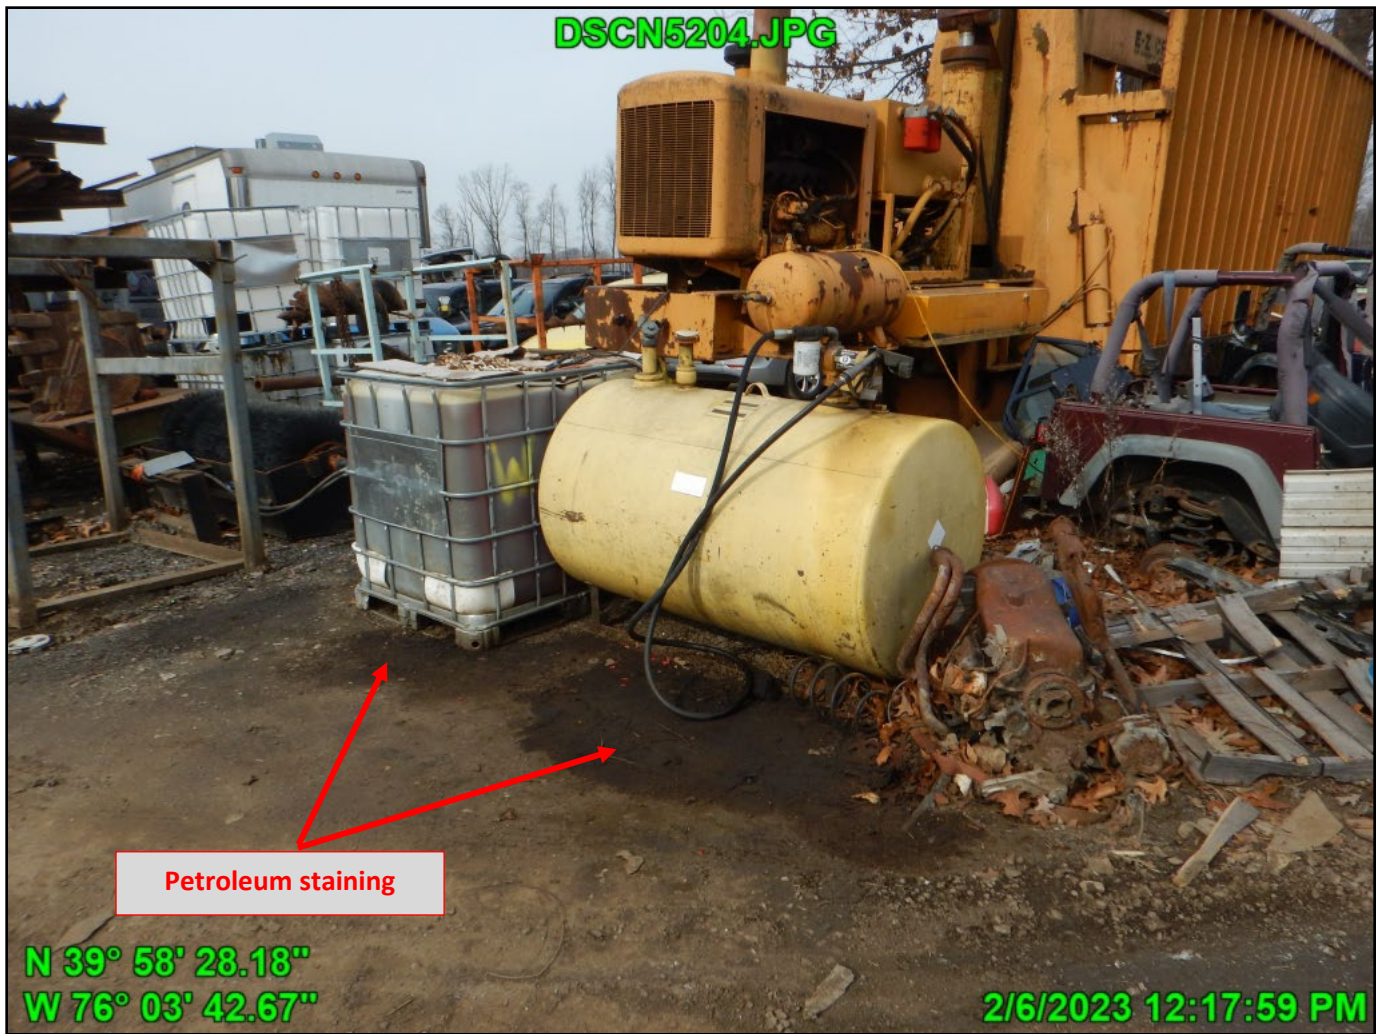
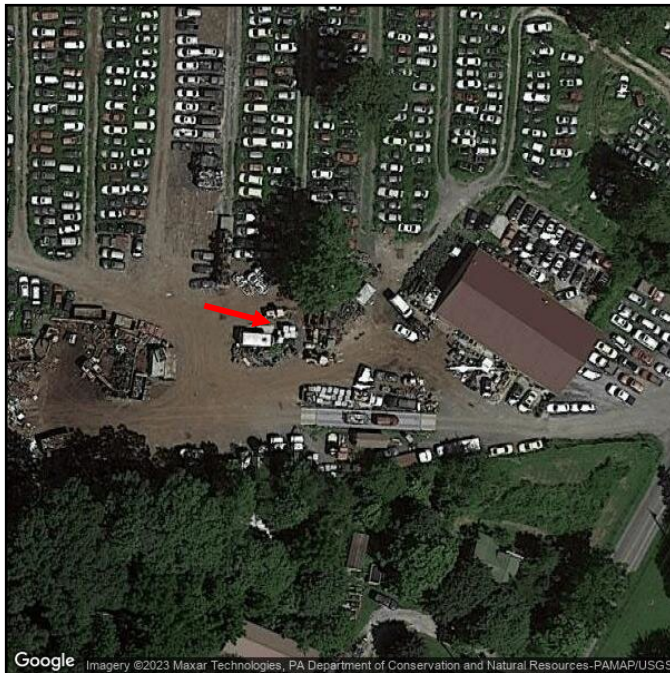
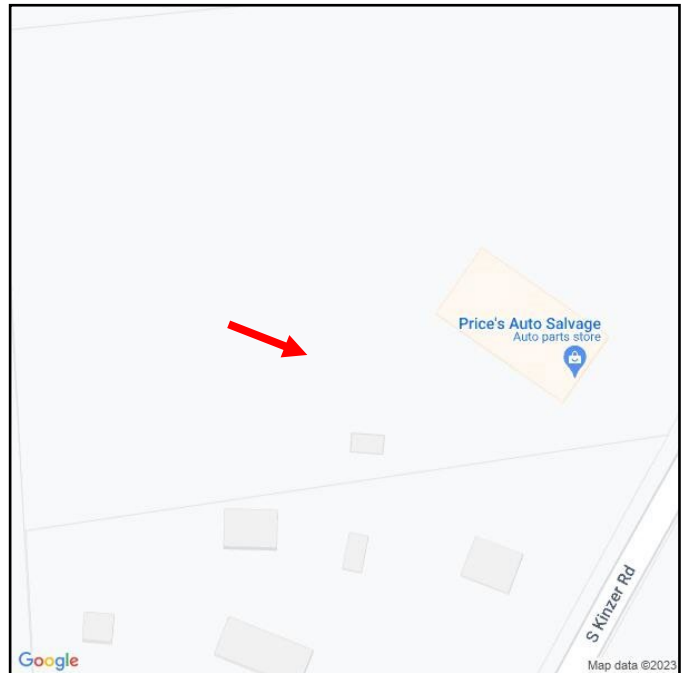
Approximately 250-gallon tank of off-road diesel and a tote of waste oil. Note the staining on the adjacent ground surface. It was unclear if the tank was double-walled and secondary containment was not provided for the waste oil tote.
