## MULTI-SECTOR GENERAL PERMIT NON-FILER INSPECTION CHECKLIST

| <b>Inspection Date(s):</b> | 2/7/2023 | |
| <b>Operator Name:</b> | Price's Auto Salvage (formerly B F Leidy & Sons Inc.) | |

**Appendix A. Aerial Map**  
**Clean Water Act Inspection**  
**Price's Auto Salvage**

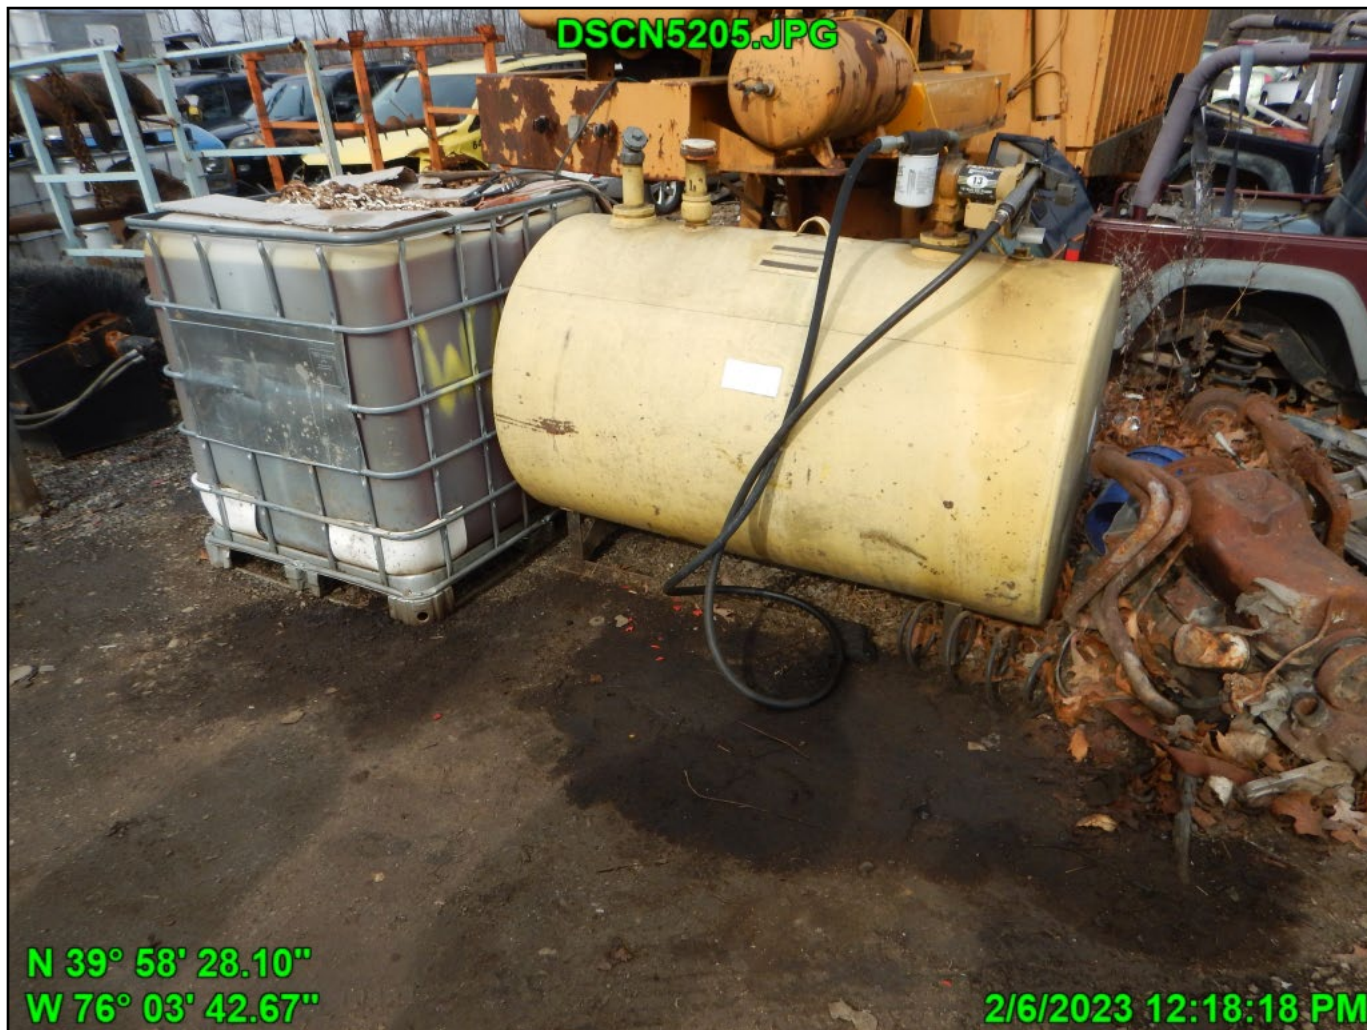
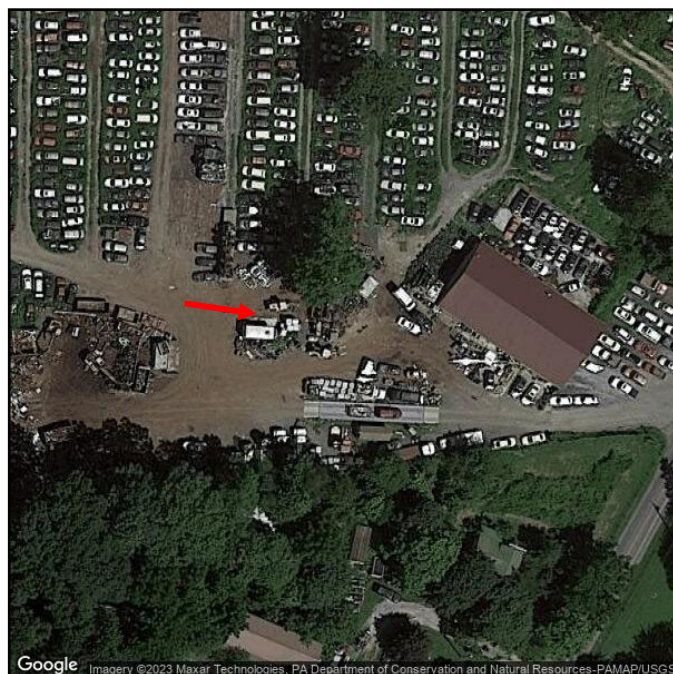
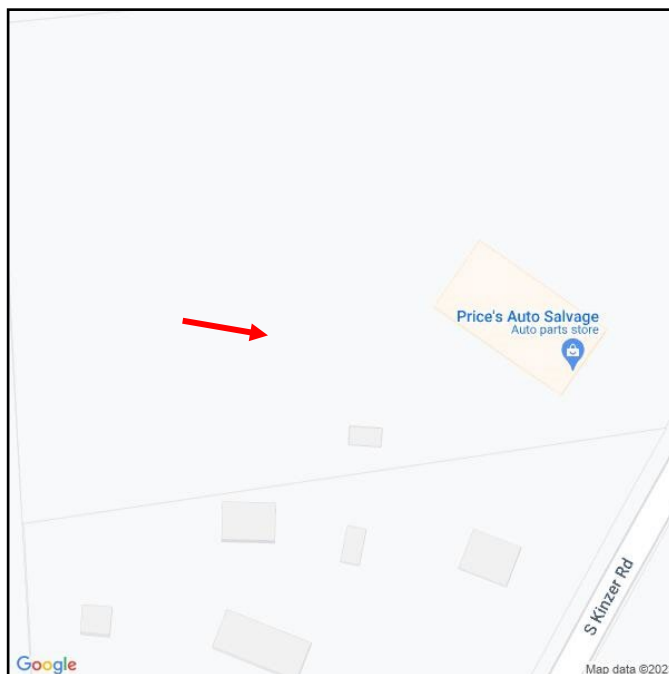
| Description | Closer view of the petroleum staining shown in Photograph DSCN5205. |

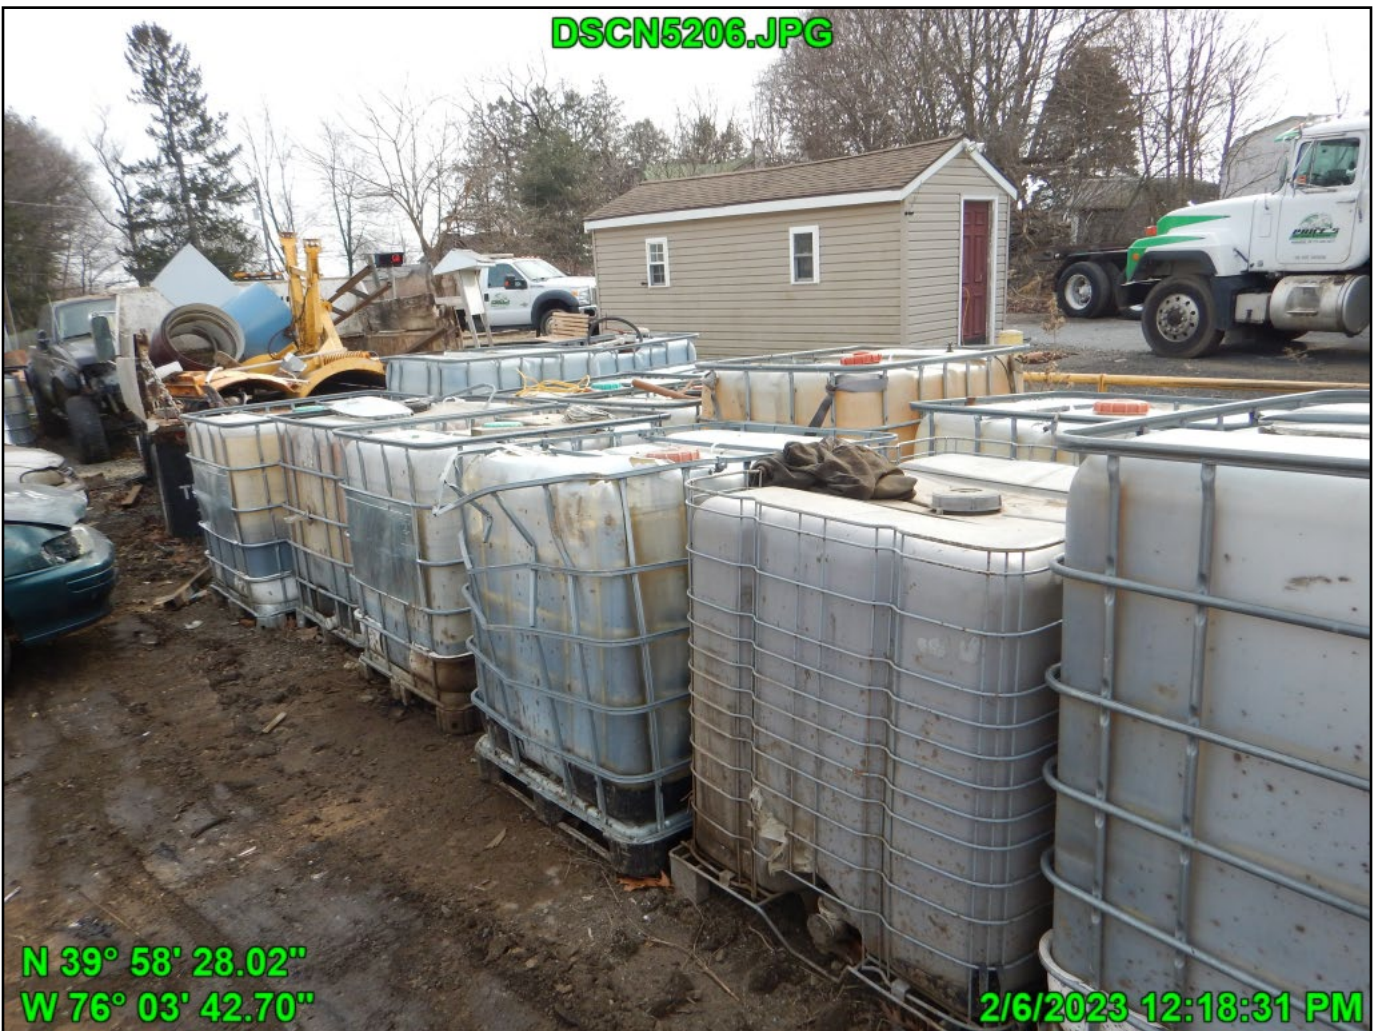
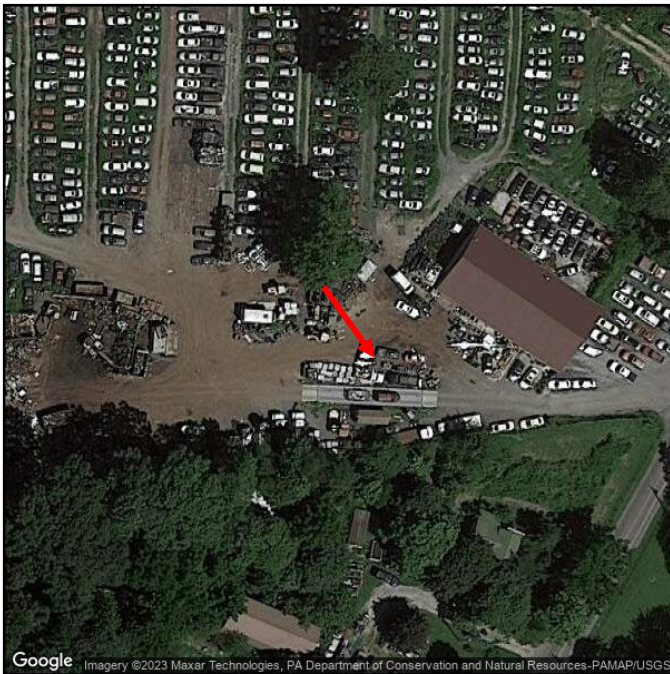
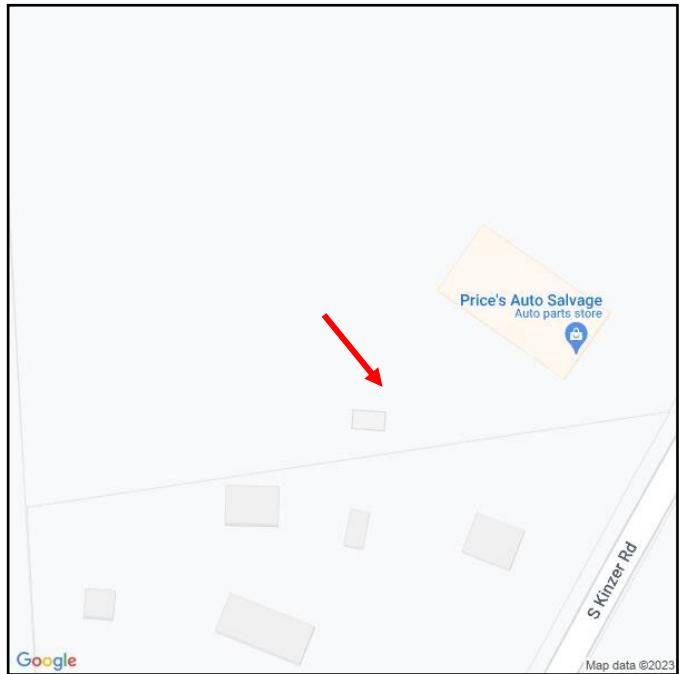
DSCN5206.JPG

- 3) The EPA Inspection Team observed waste oil totes stored outside without cover or secondary containment (refer to Appendix B, Photographs DSCN5206 and DSCN5207).

Approximately eleven 275-gallon waste oil totes, of which 7 appeared to be full at the time of the inspection. None of the totes had secondary containment.

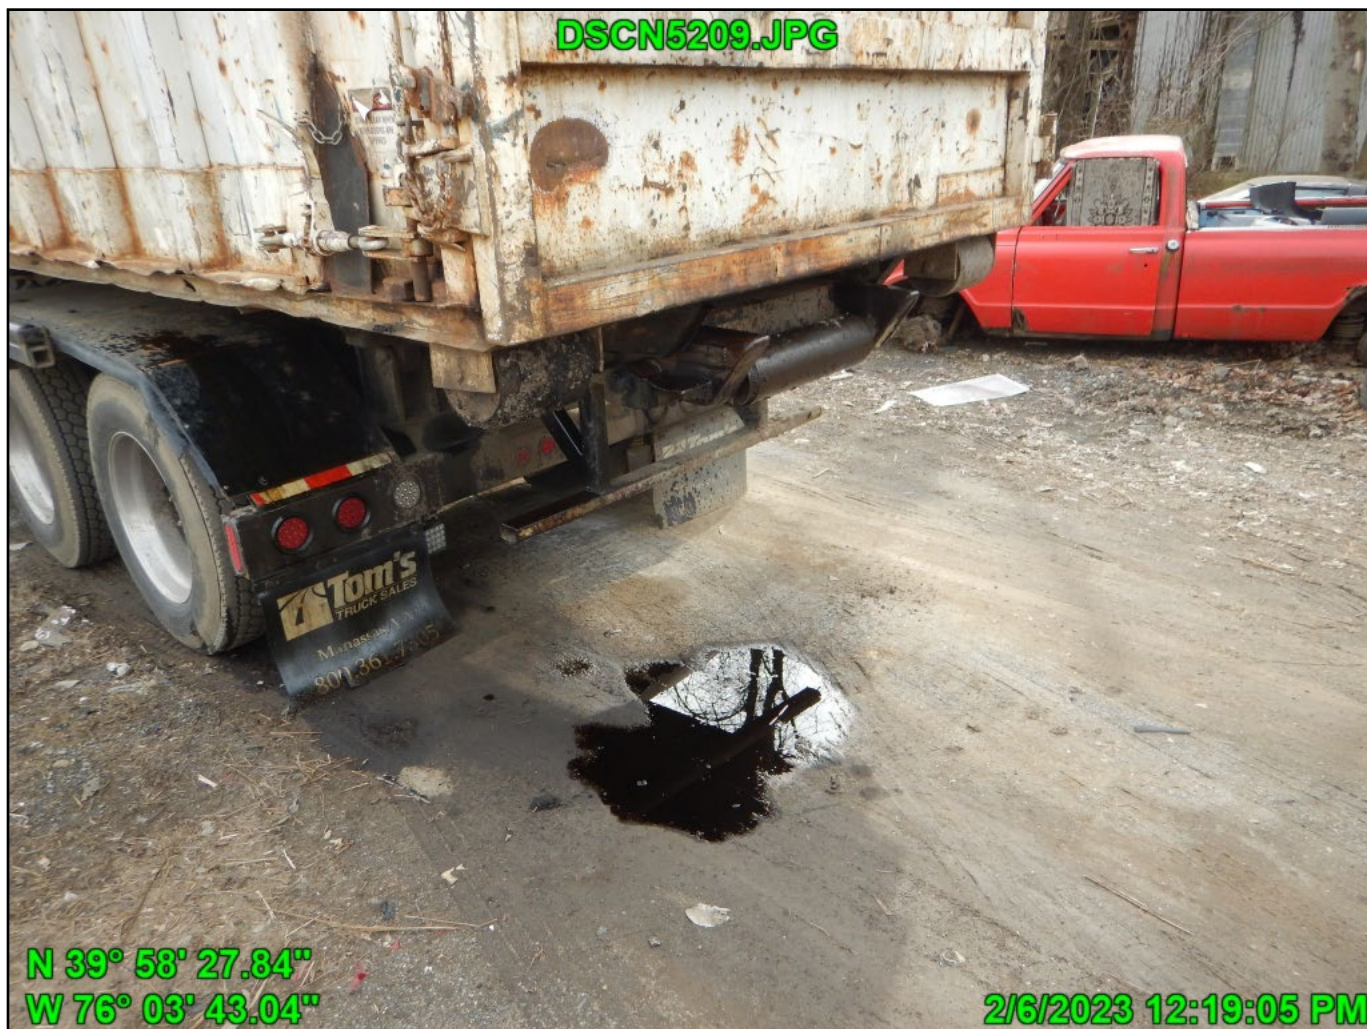
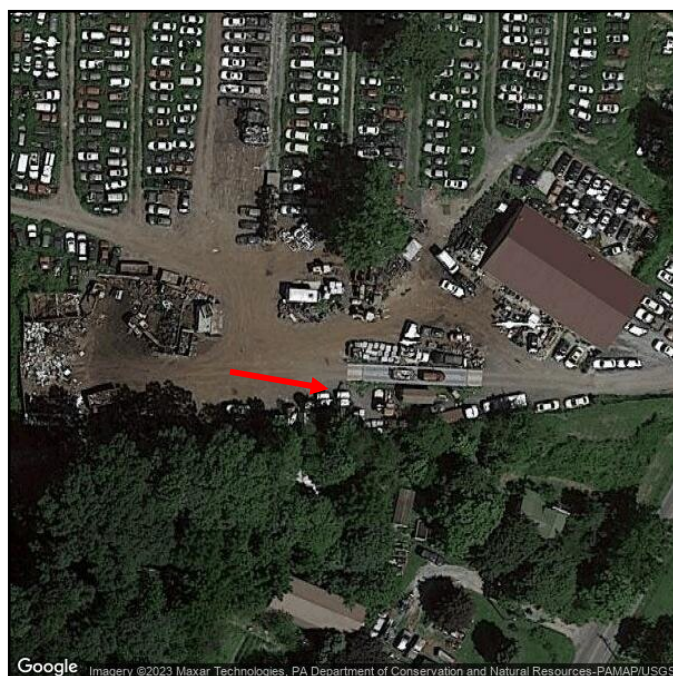
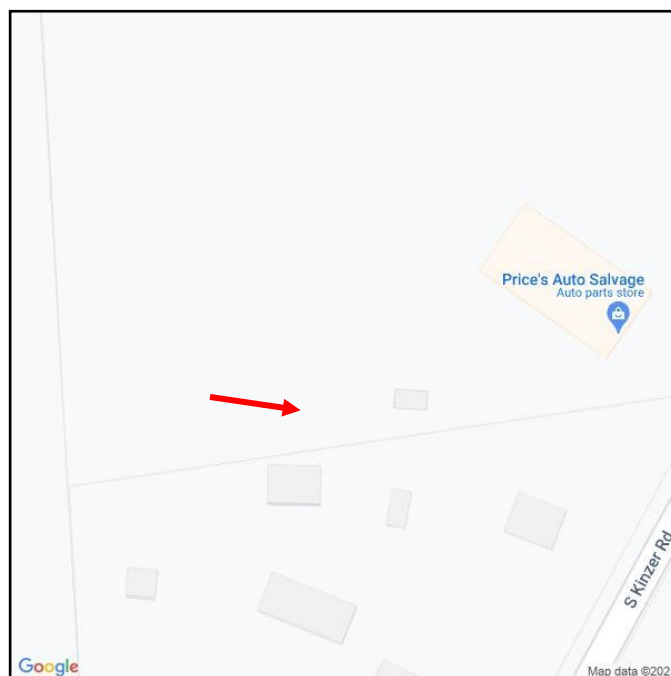
| Description | Petroleum product leak on the ground surface in the south area of that Facility. |

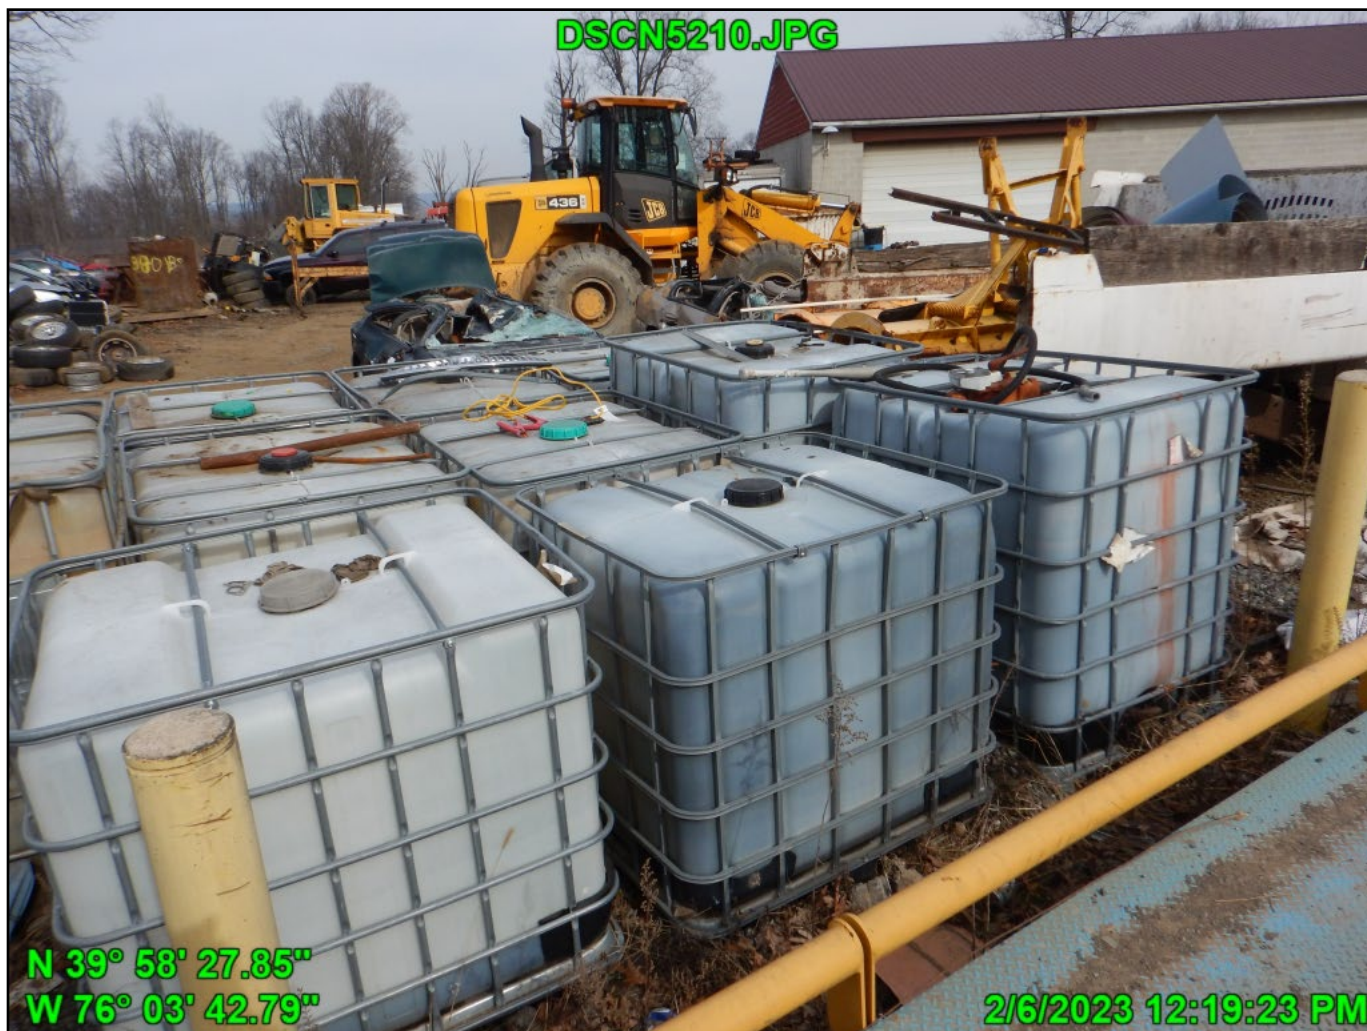
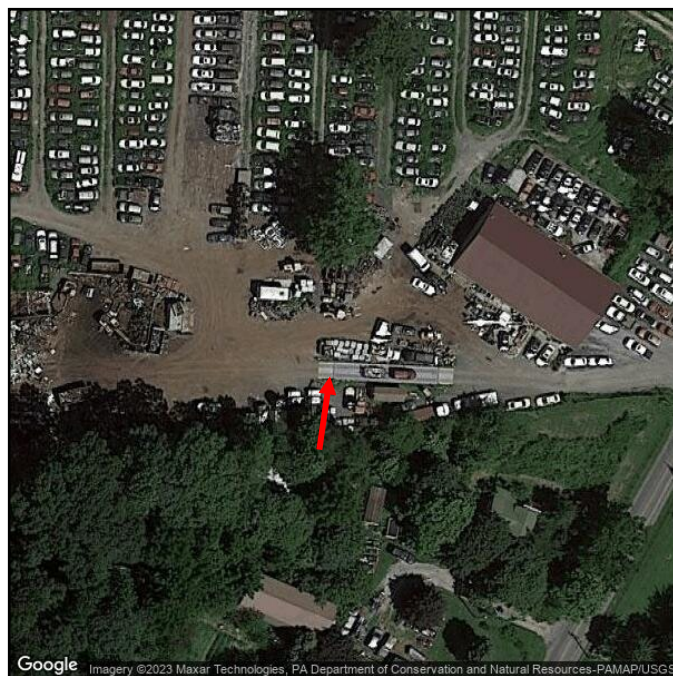
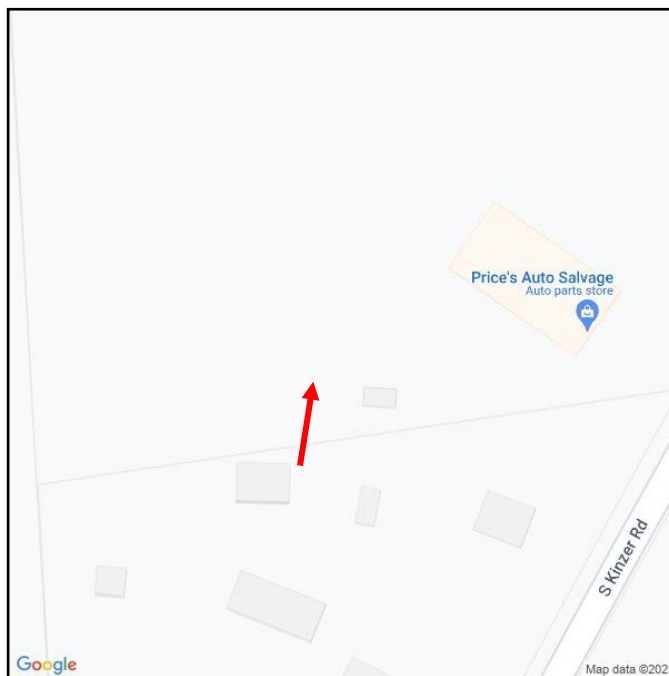
| Description | Approximately eleven 275-gallon waste oil totes shown in Photographs DSCN5206 and DSCN5207, of which 7 appeared to be full. None were equipped with secondary containment. |

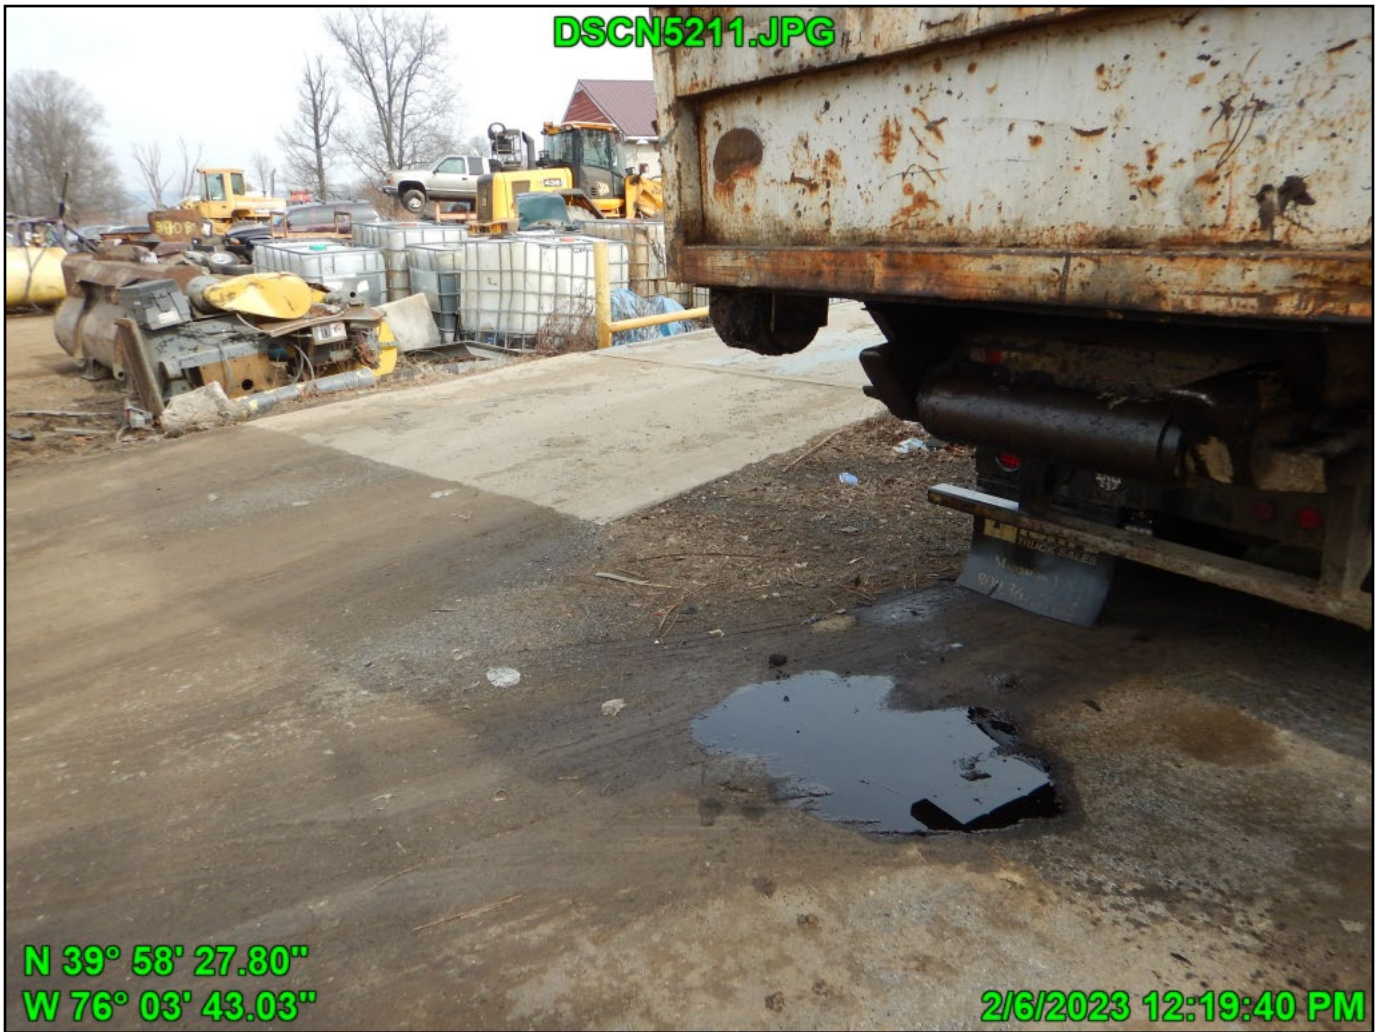
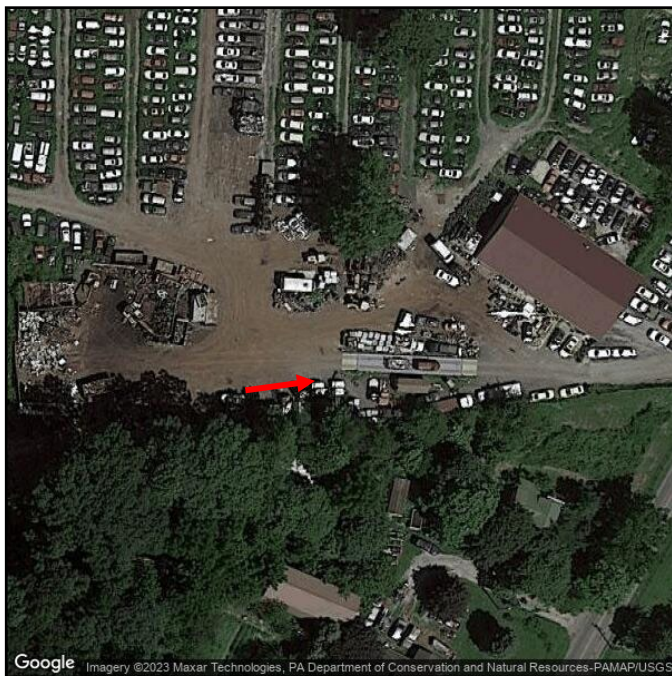
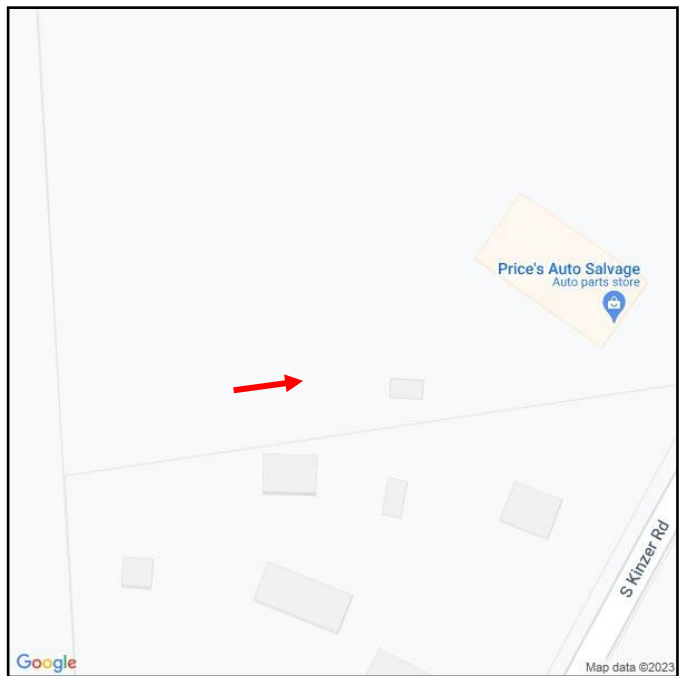
| Description | Petroleum product leak onto the ground surface in the south area of the Facility, shown in Photograph DSCN5209. |

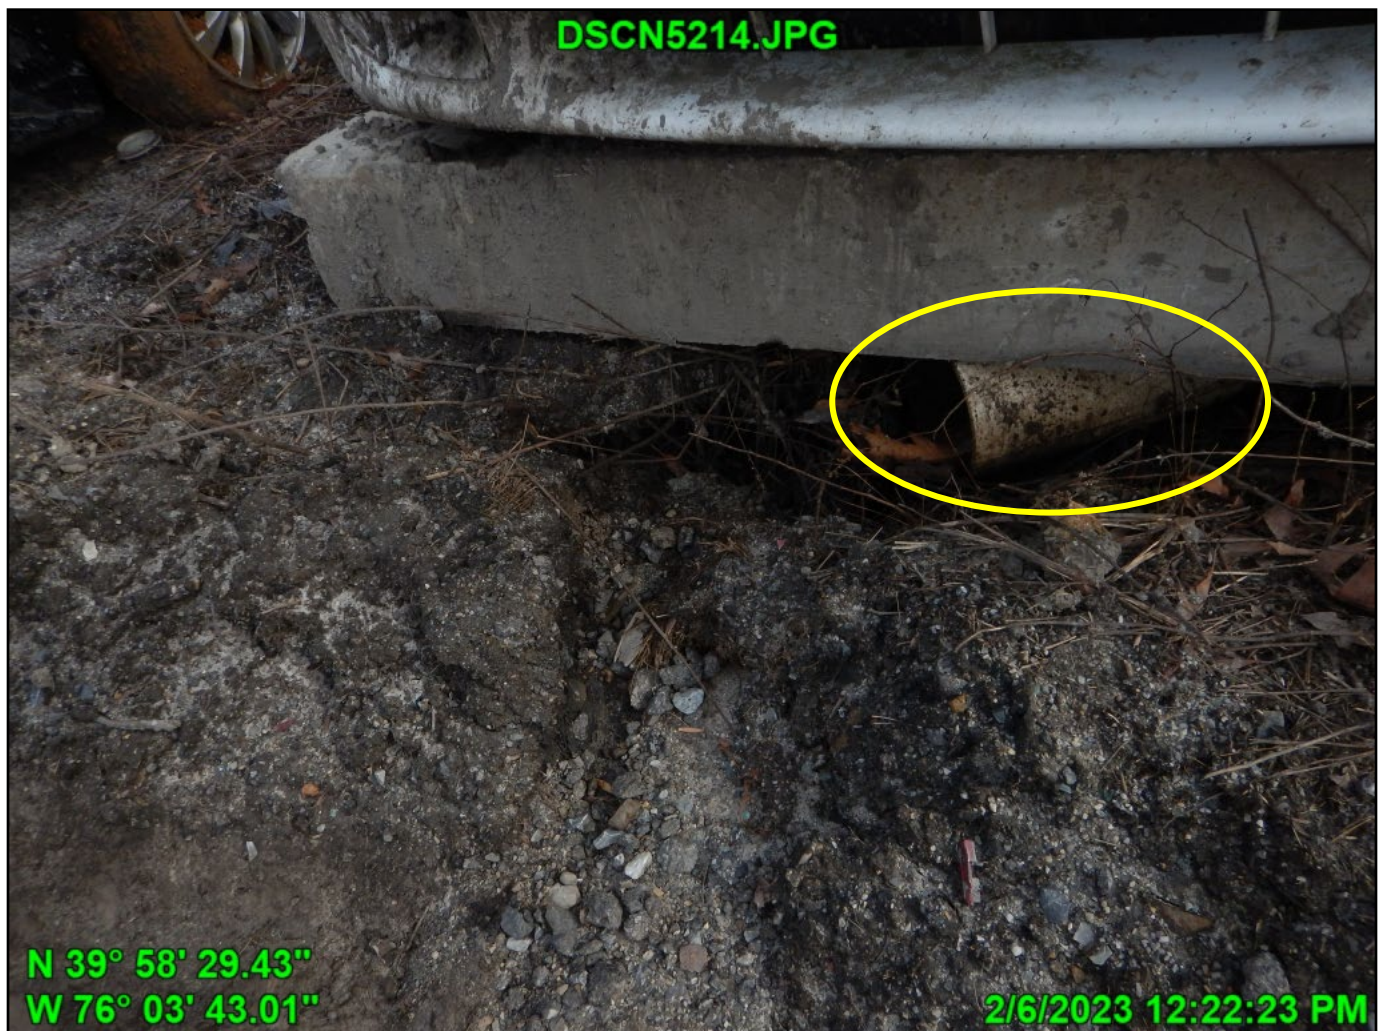
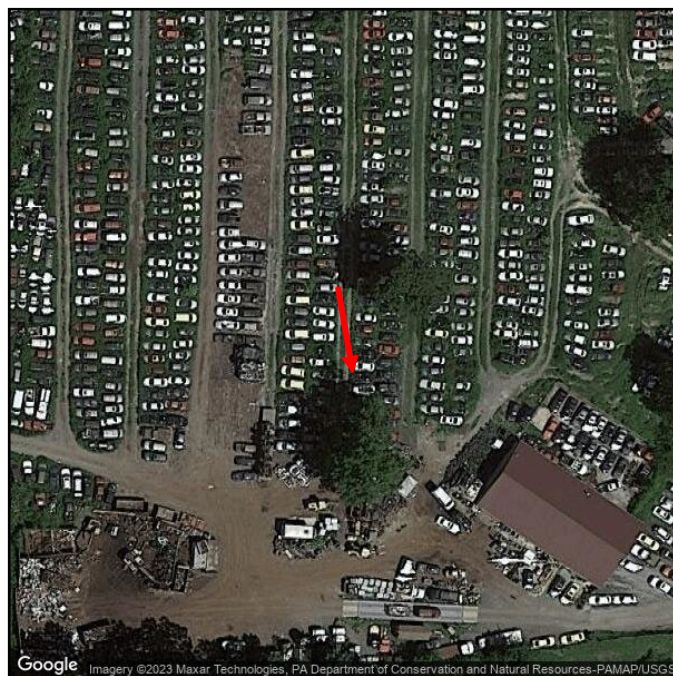
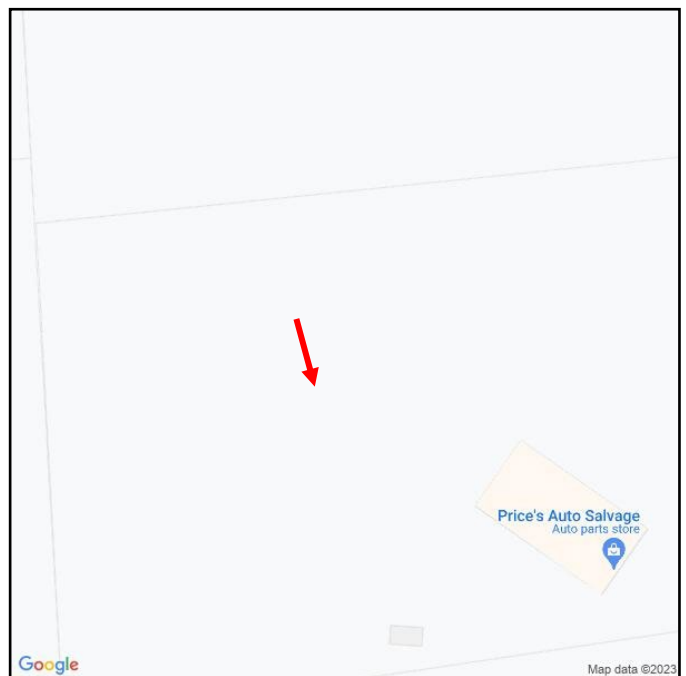
| Description | Petroleum staining from flow from the adjacent pipe. This pipe connects to the inlet shown in Photograph DSCN5198. |

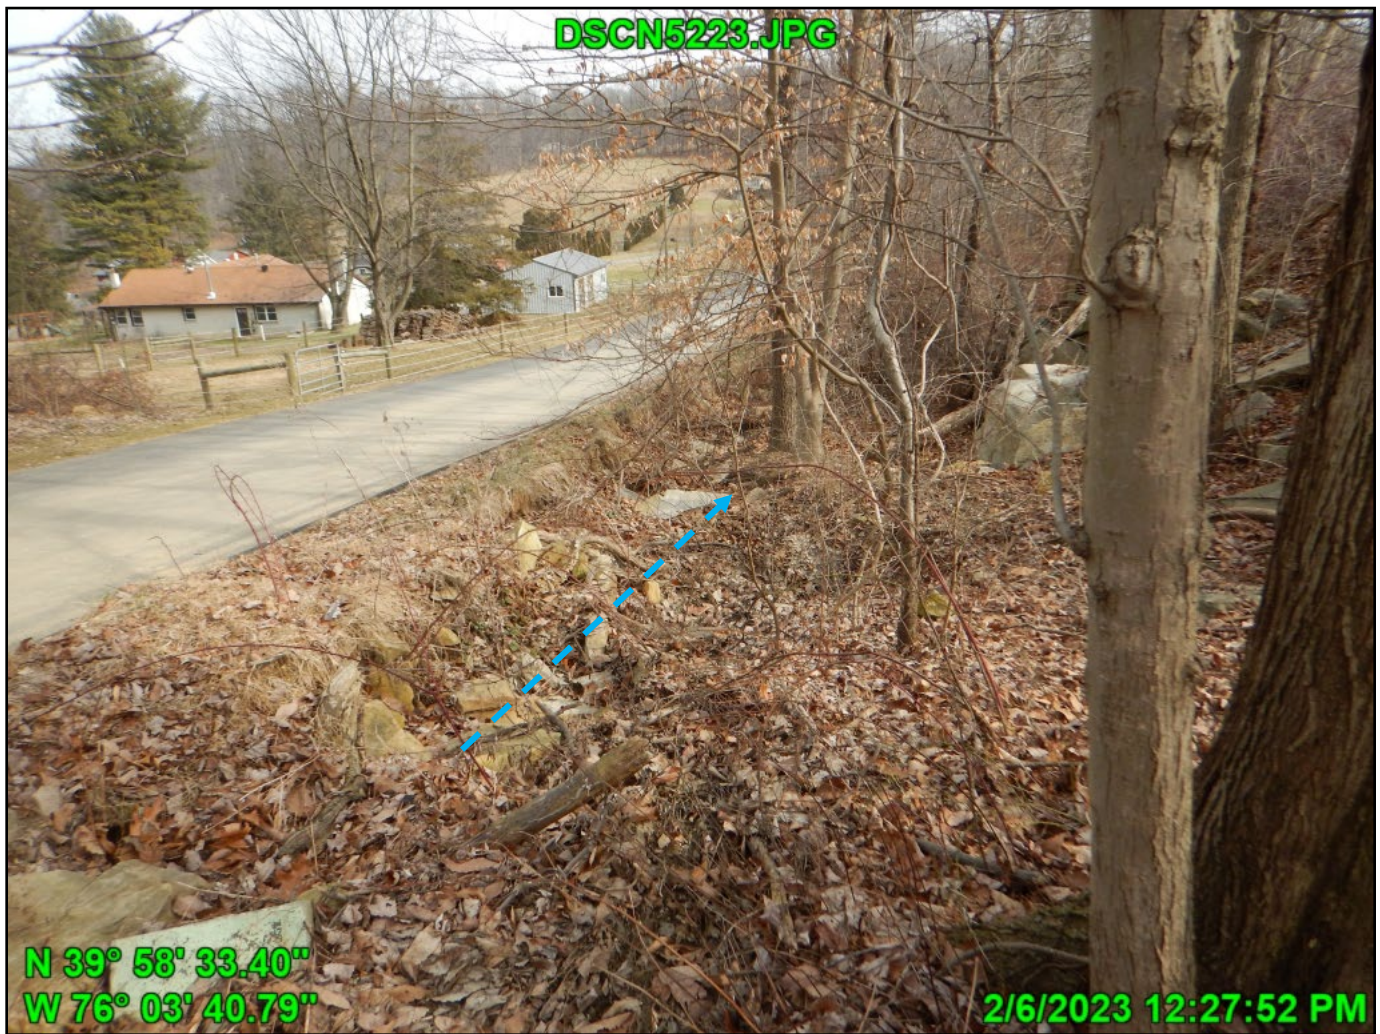
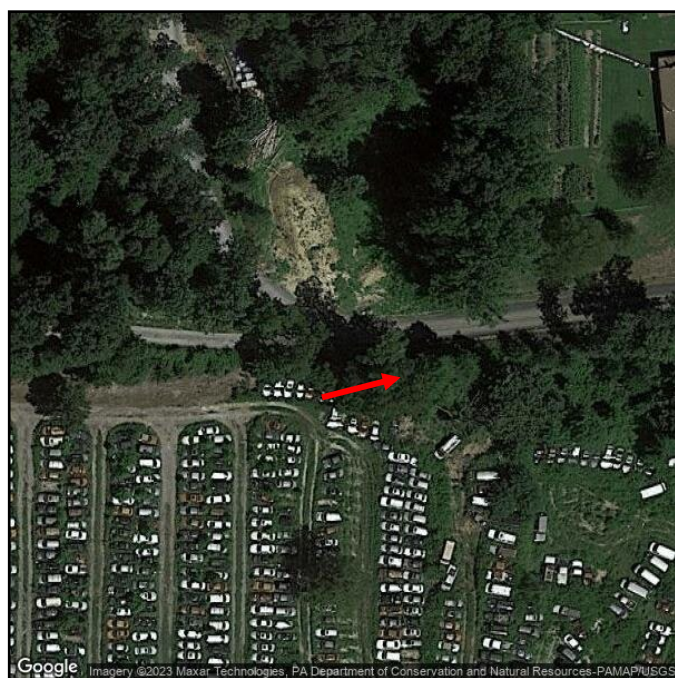
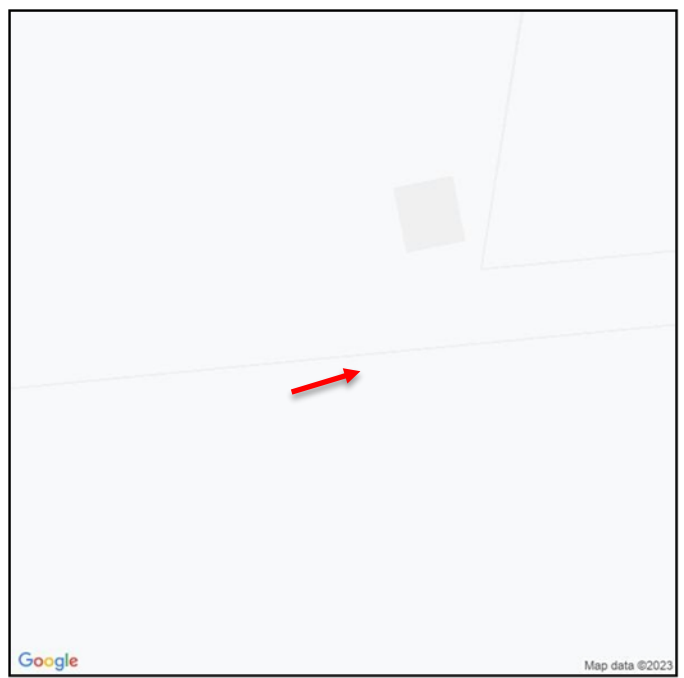
| Description | Observed entrance to the ravine located on the Facility's northern boundary. Note the estimated direction of stormwater flow. |

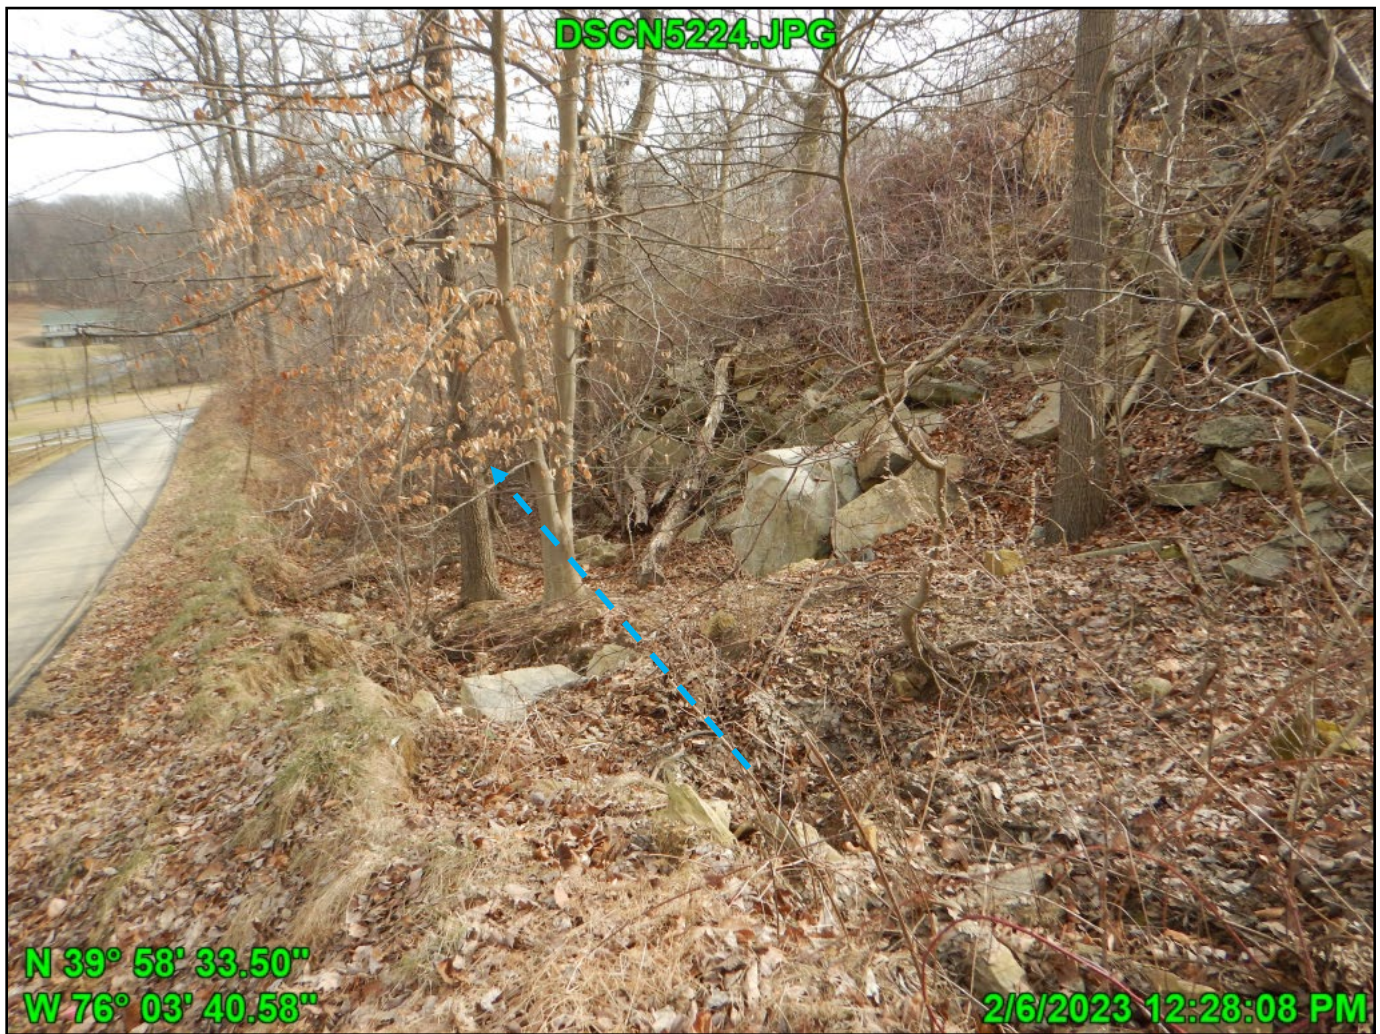
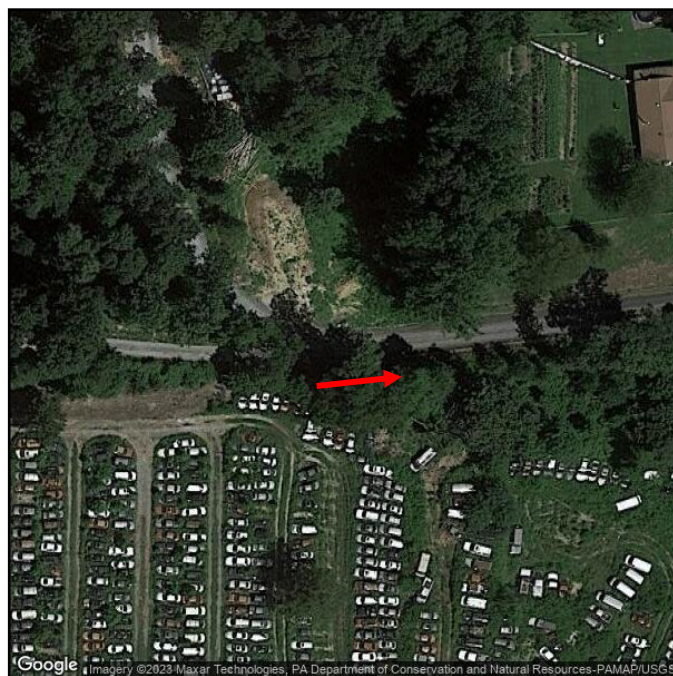
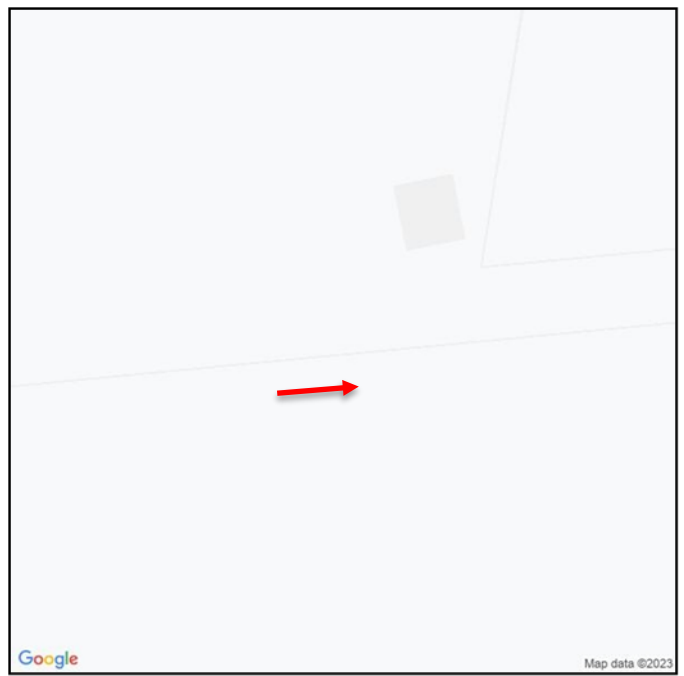
| Description | Ravine located on the Facility's northern boundary shown in Photograph DSCN5223. Note the direction of stormwater path. |

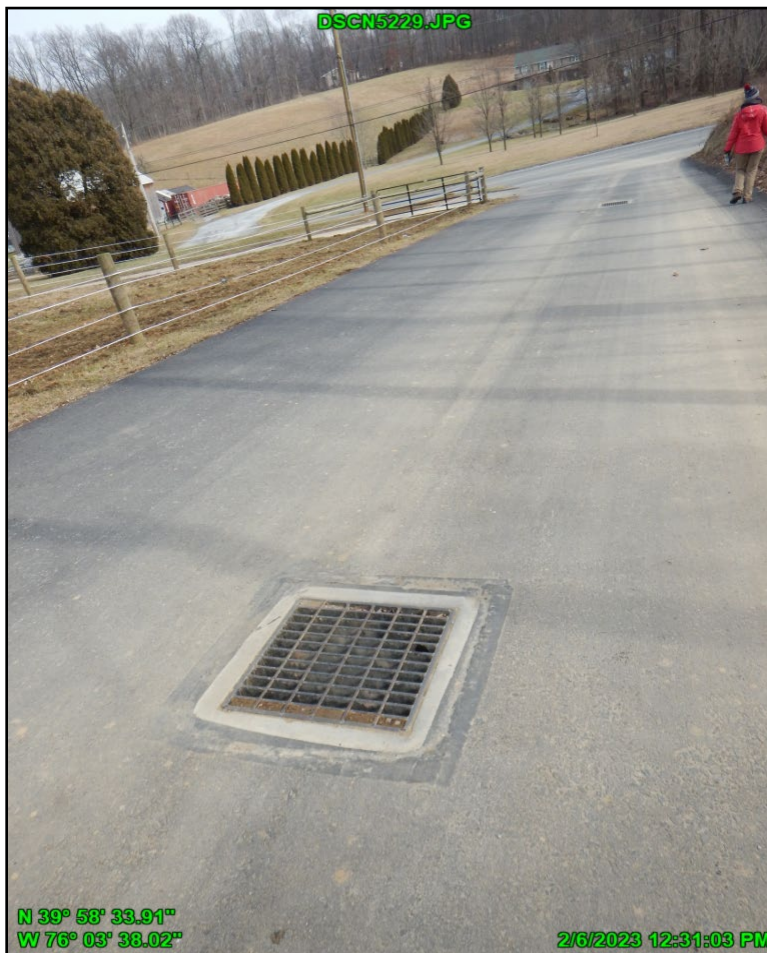
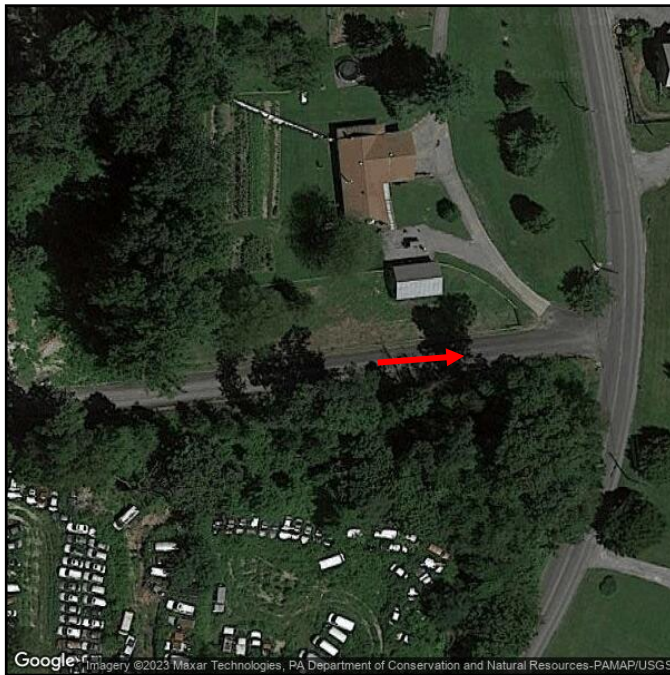
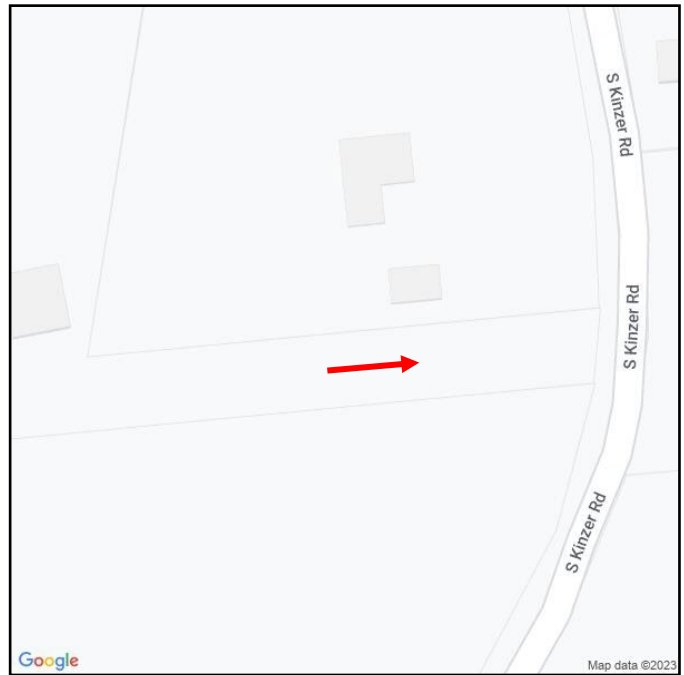
| Description | Catch basins on a road adjacent to the Facility. The Facility representative stated that the catch basins drain to a swale located on private property across South Kinzer Road. The inspectors observed that it would be unlikely that a Facility stormwater discharge would enter these catch basins. |

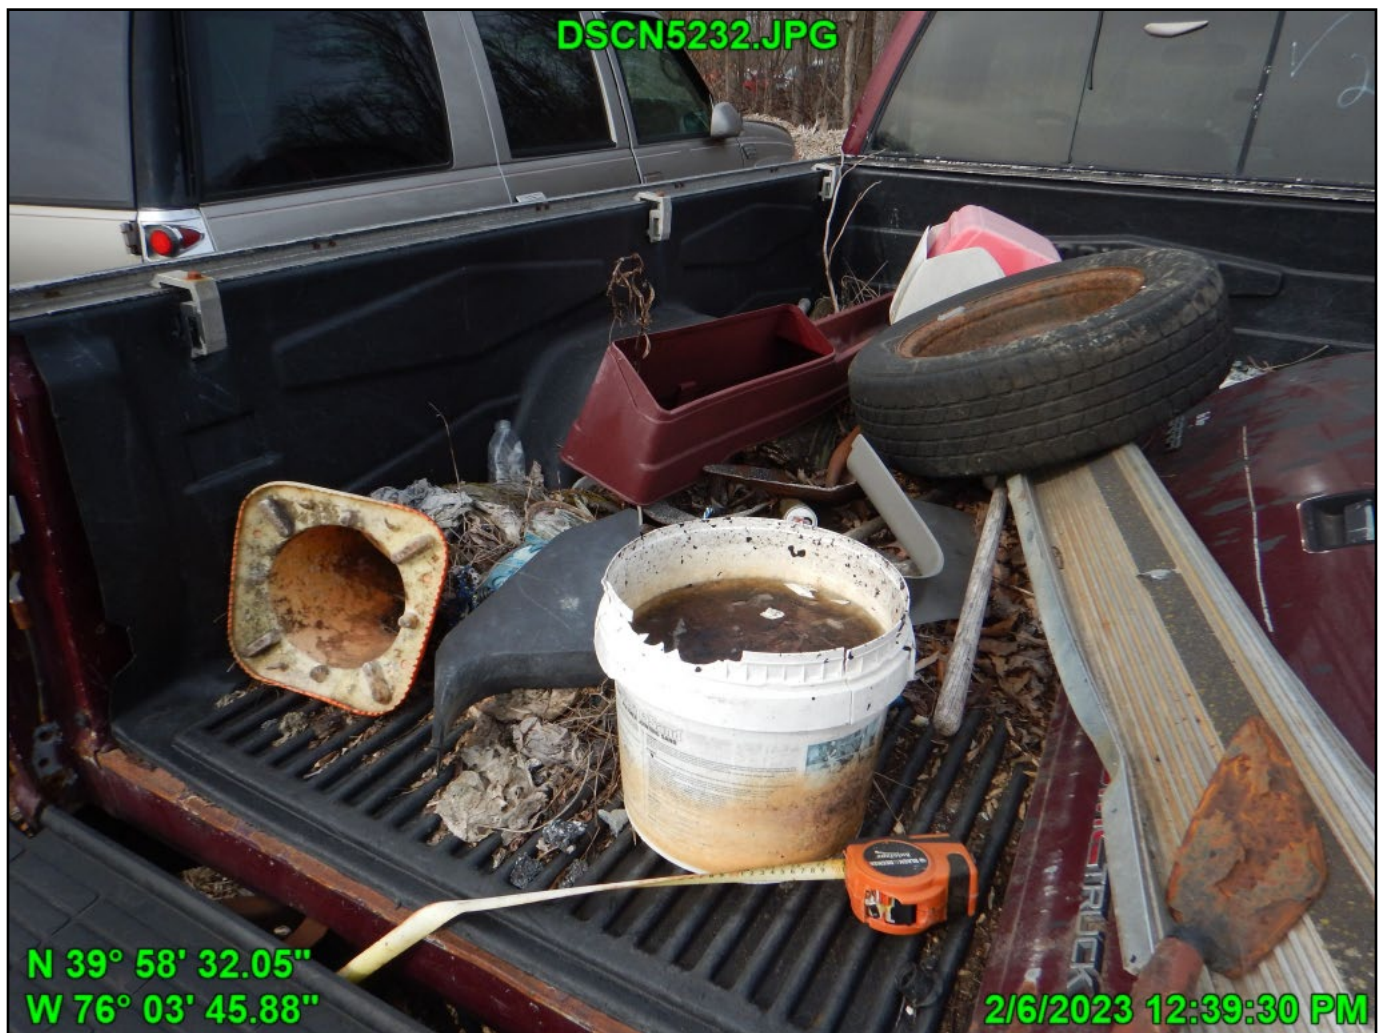
| Description | Open bucket containing an unknown liquid in the north part of the Facility. |
