## Region 6 - Enforcement & Compliance Assurance Division

### INSPECTION REPORT

| Inspection Date(s): | 10/07/2024 | |
| Company Name: | <b>H &amp; H Tank Cleaning</b> | |

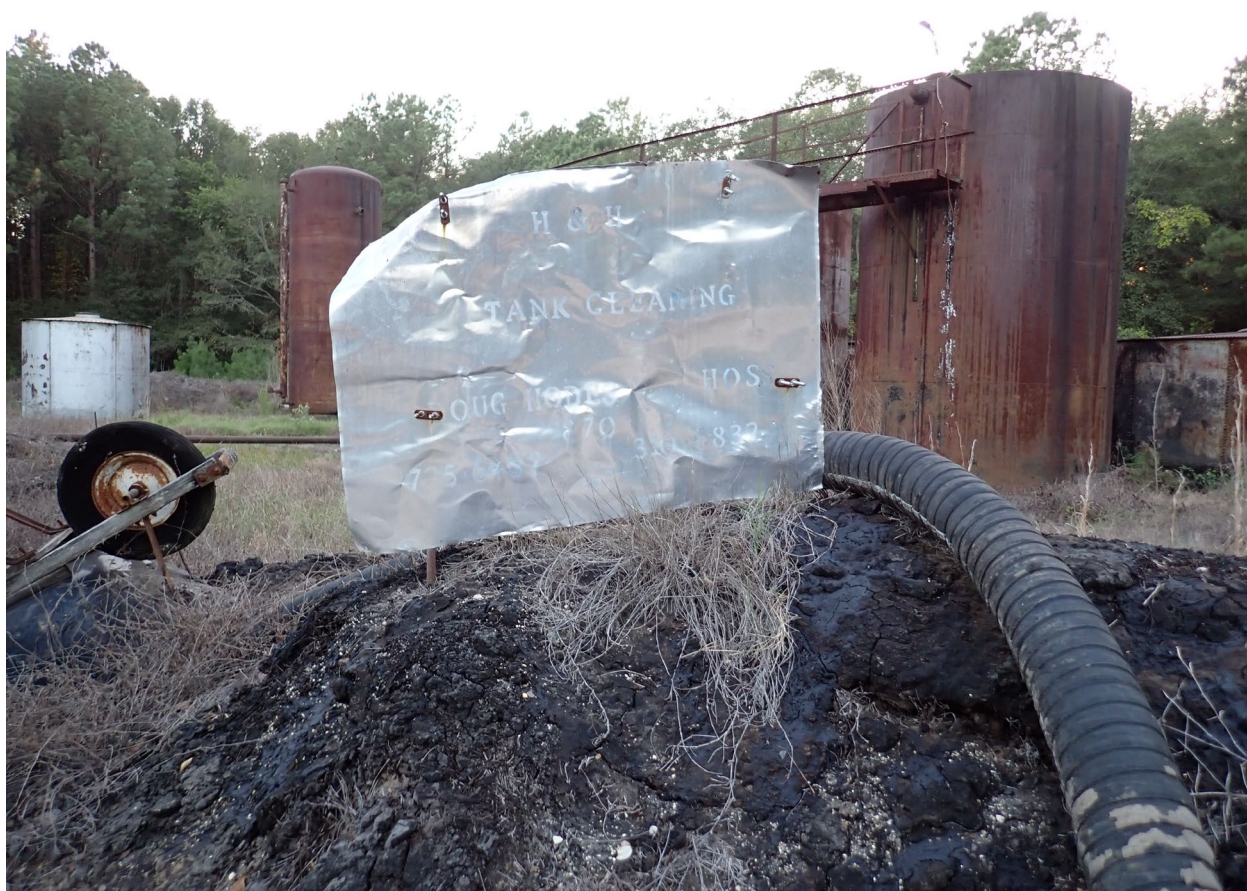
Photo No. 1

I observed the facility sign, secondary containment, pipes, valves, and storage tanks located at the facility; see Appendix 1 (photo log), photo No. 1 and No. 2. For additional GPS location and photo metadata, see Appendix 1.

**Description:** This photo was taken looking west and shows the facility sign.

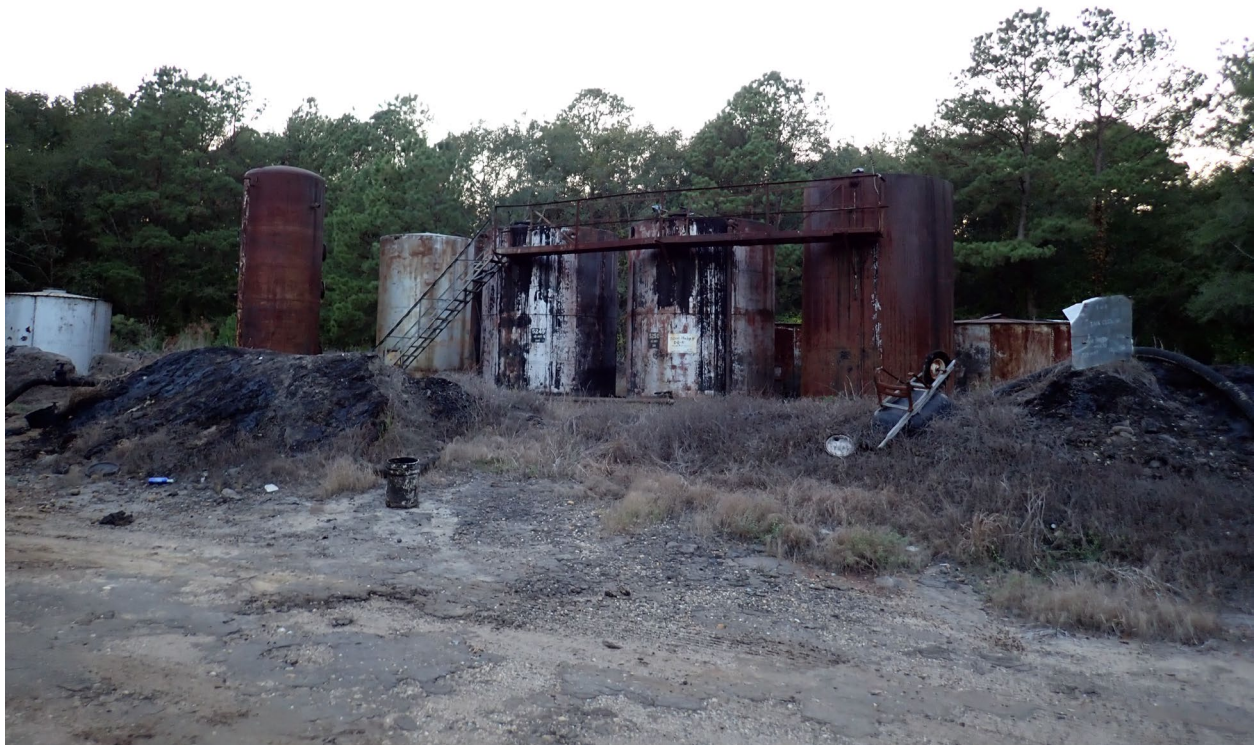
Photo No. 2

**Description:** This photo was taken looking west and shows an overview of the facility.

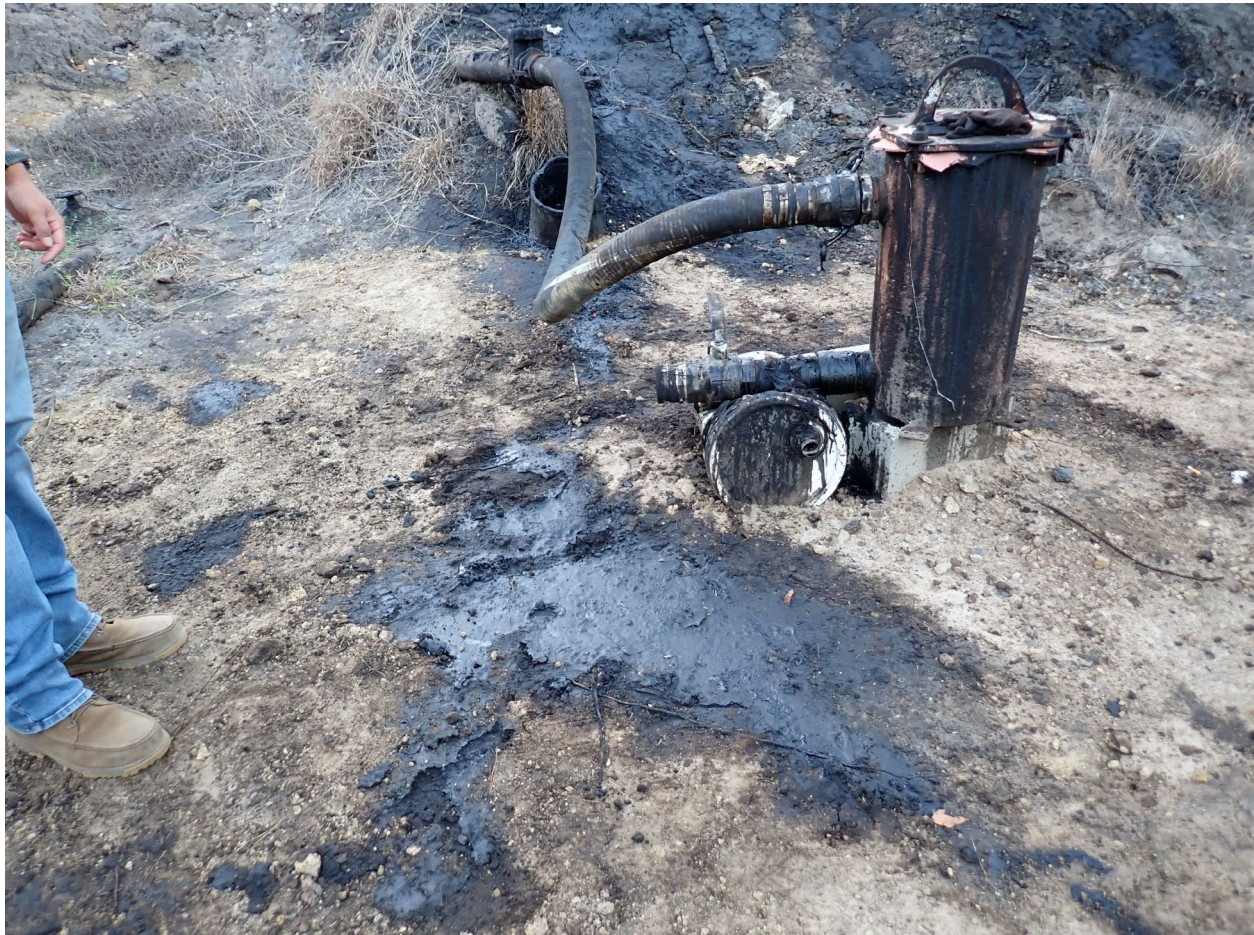
Photo No. 3

I observed loose oil from discharge valves outside of secondary containment, see photo No. 3 - 4. I also observed a discharge pipe connected to a storage tank, see photo No. 5.

No closing conference was held due to no H & H Tank Cleaning staff being present during the inspection. Areas of concern at the time of the inspection include the loose oil from the discharge valves outside of secondary containment and the discharge pipe connected to the storage tank.

**Description:** This photo was taken looking west and shows a discharge valve with loose oil and no catchment.

Inspector will conduct follow-up phone calls with the company representatives over the coming weeks and months to ensure areas of concern are properly addressed.

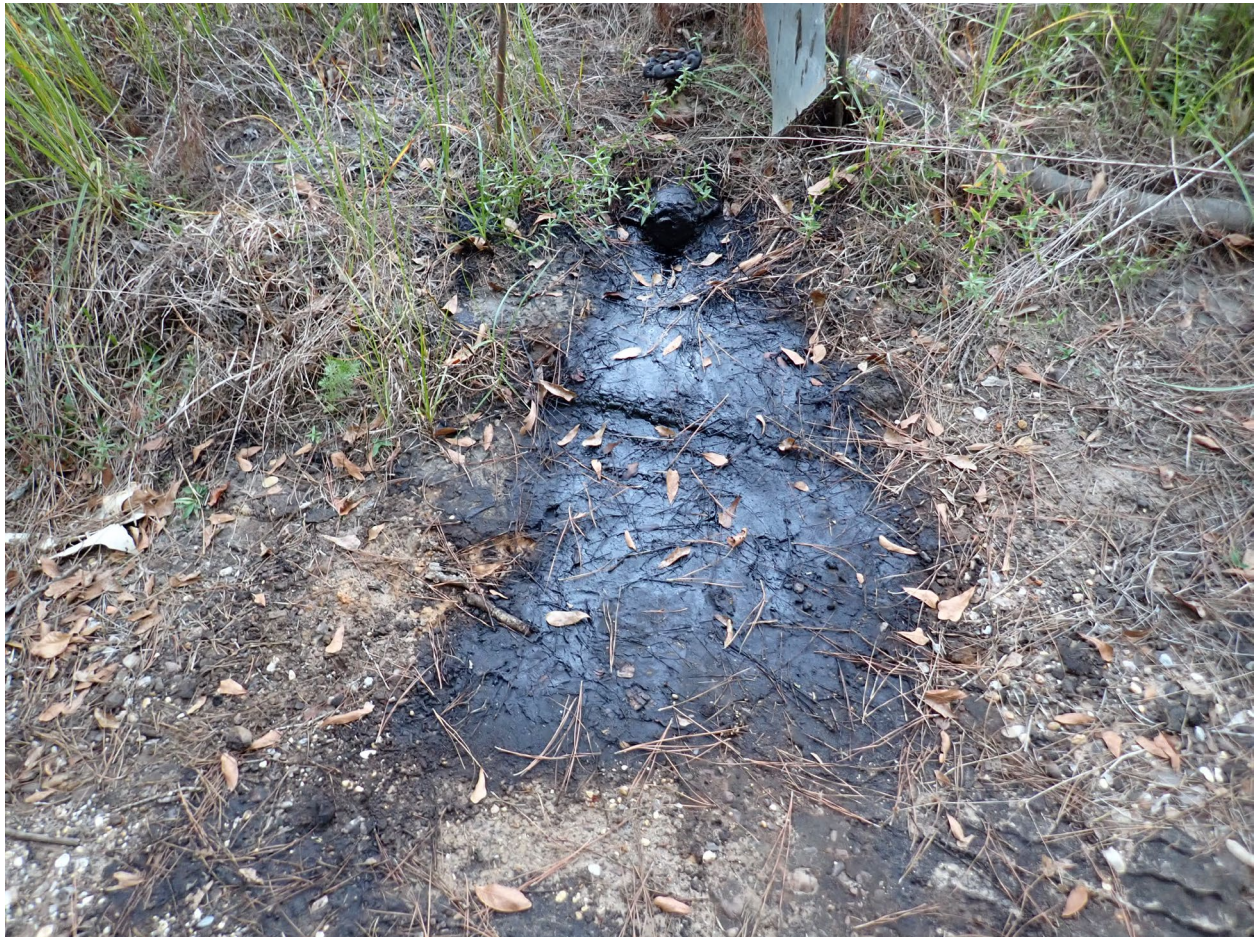
Photo No. 4

**Description:** This photo was taken looking east and shows a discharge valve with loose oil and no catchment.

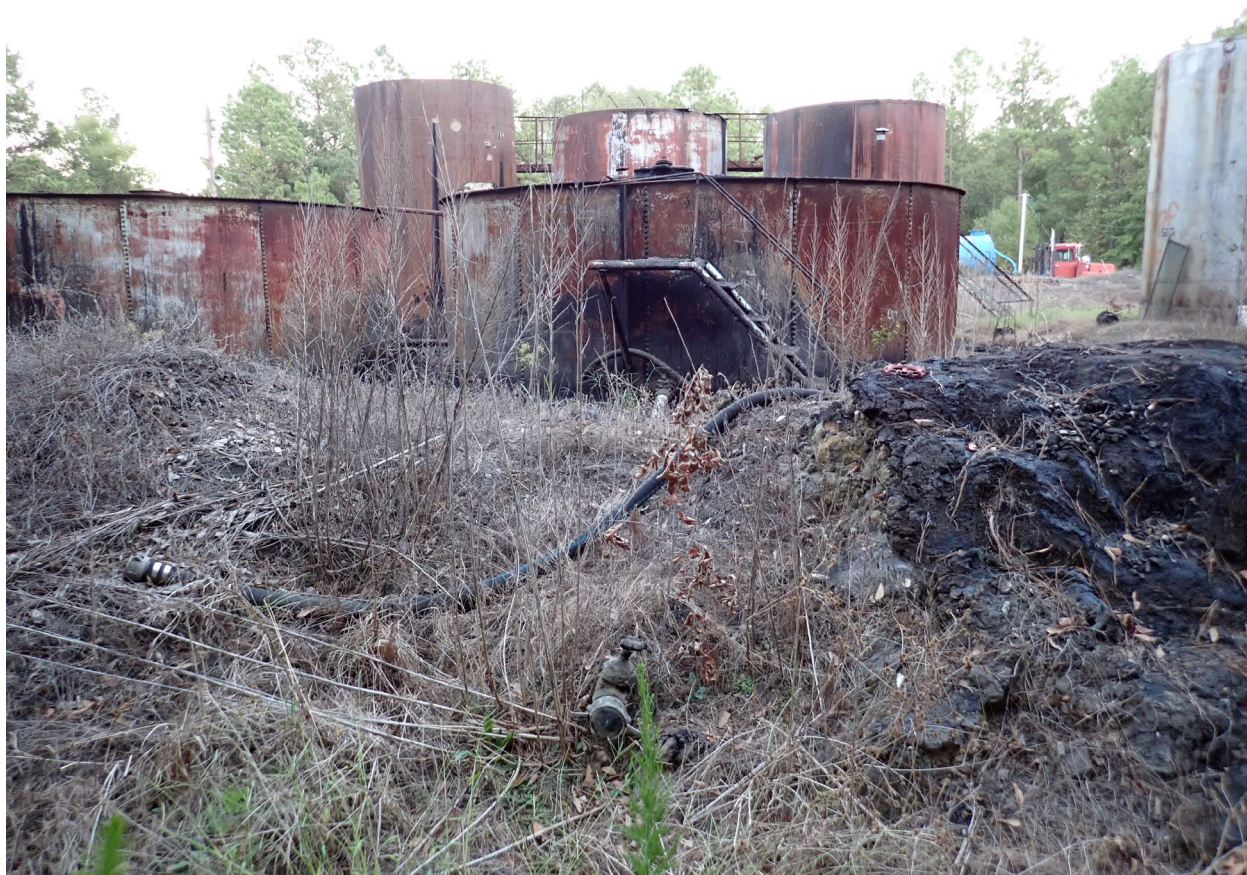
Photo No. 5

**Description:** This photo was taken looking east and shows a discharge pipe connected to a tank.
