**Region 6 - Enforcement & Compliance Assurance Division**  
**INSPECTION REPORT**

| Inspection Date(s): | 03/12/2024 | |
| Company Name: | <b>Jerry Langley Oil Company, LLC</b> | |
| Facility Name: | <b>Bertie No. D-7 SWD</b> | |

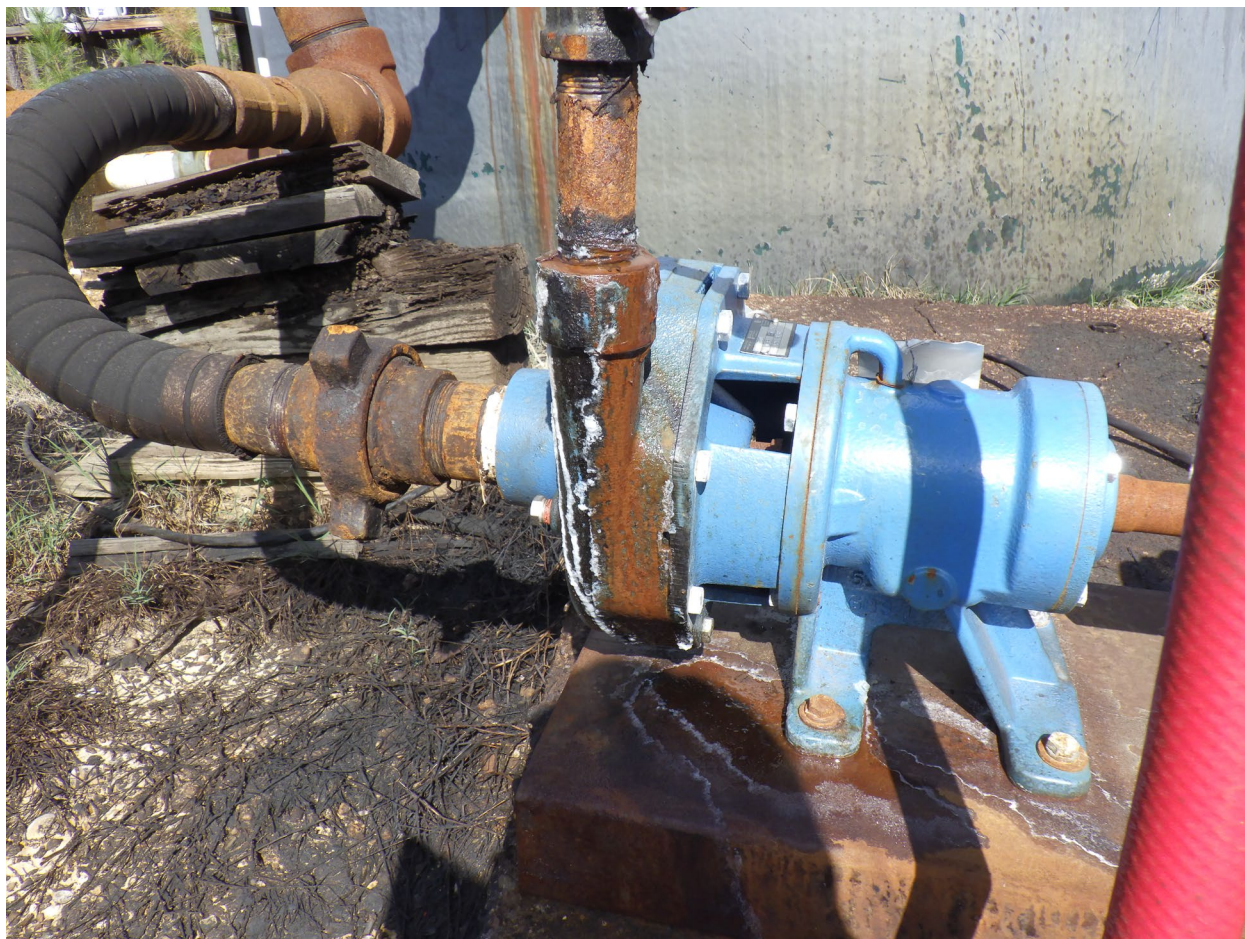
Photo No. 3

I observed fluid leaking from the motor connected to the injection well, see photo No. 3.

**Photo File Name:** R0010225**Orientation:** NW**Date of Photo:** 03/12/2024**Time of Photo:** 3:12 PM**Latitude:** 33.335688**Longitude:** -92.688423**Photographer:** Uma Lad**Description:** This photo was taken looking northwest and shows fluid leaking from a motor.

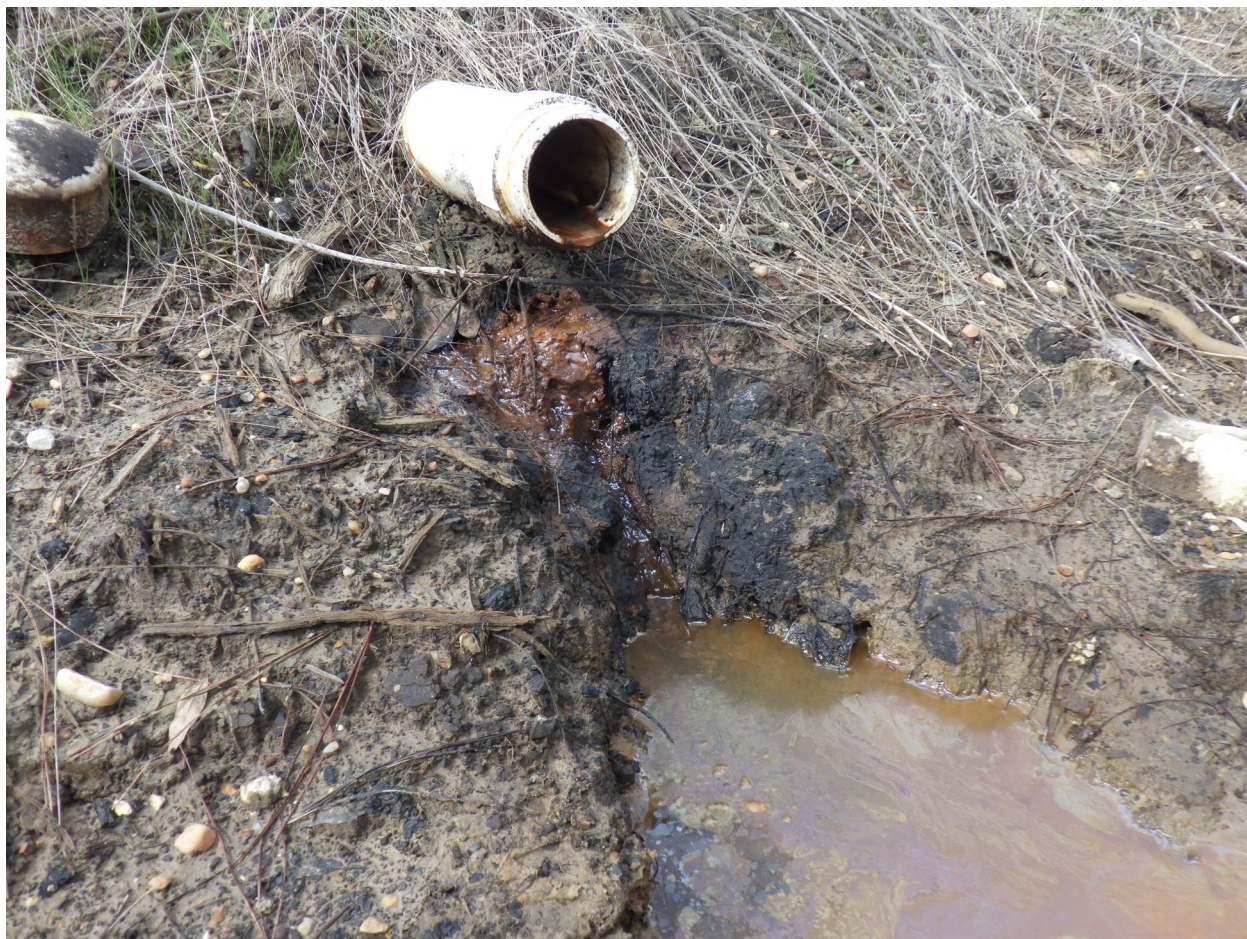
Photo No. 4

I observed a leaking, uncapped secondary containment drainage pipe. In the area below the discharge pipe, I observed oil-stained soil and oil sheen in the water, see photo No. 4.

**Photo File Name:** R0010212**Orientation:** N**Date of Photo:** 03/12/2024**Time of Photo:** 3:13 PM**Latitude:** 33.335633**Longitude:** -92.688473**Photographer:** Uma Lad**Description:** This photo was taken looking north and shows a leaking, uncapped secondary containment discharge pipe. Below the discharge pipe is oil-stained soil and water with an oil sheen.

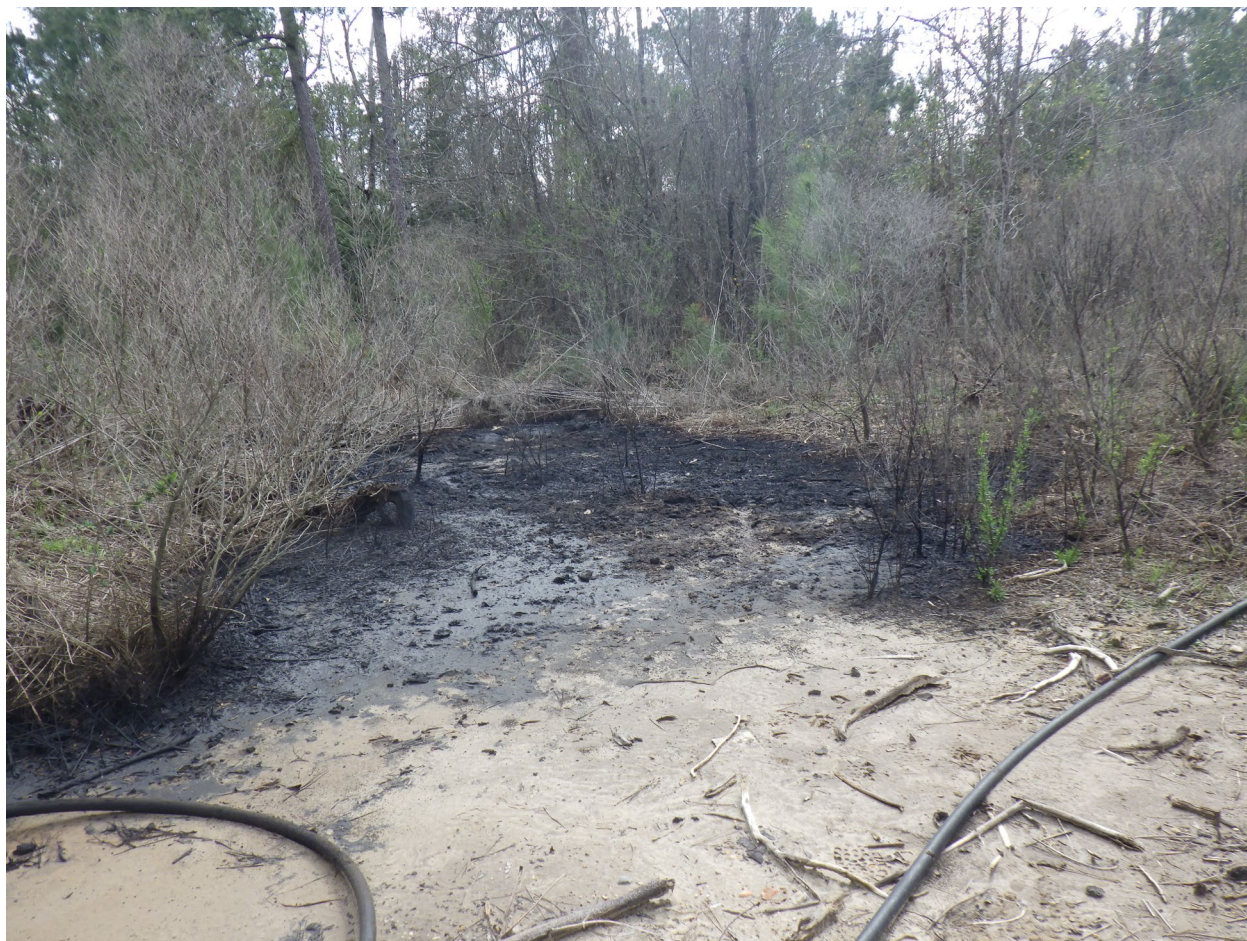
Photo No. 5

When following the impacted flowpath from the secondary containment drainage valve, I observed oil-stained soil and vegetation, see photo No. 5 through No. 6. I observed oil sheen in standing water along the flowpath, see photo No. 7 through No. 9.

**Photo File Name:** R0010213**Orientation:** SW**Date of Photo:** 03/12/2024**Time of Photo:** 3:13 PM**Latitude:** 33.335617**Longitude:** -92.688525**Photographer:** Uma Lad**Description:** This photo was taken looking southwest and shows oil-stained soil and vegetation along the impacted flowpath from the secondary containment drainage valve.

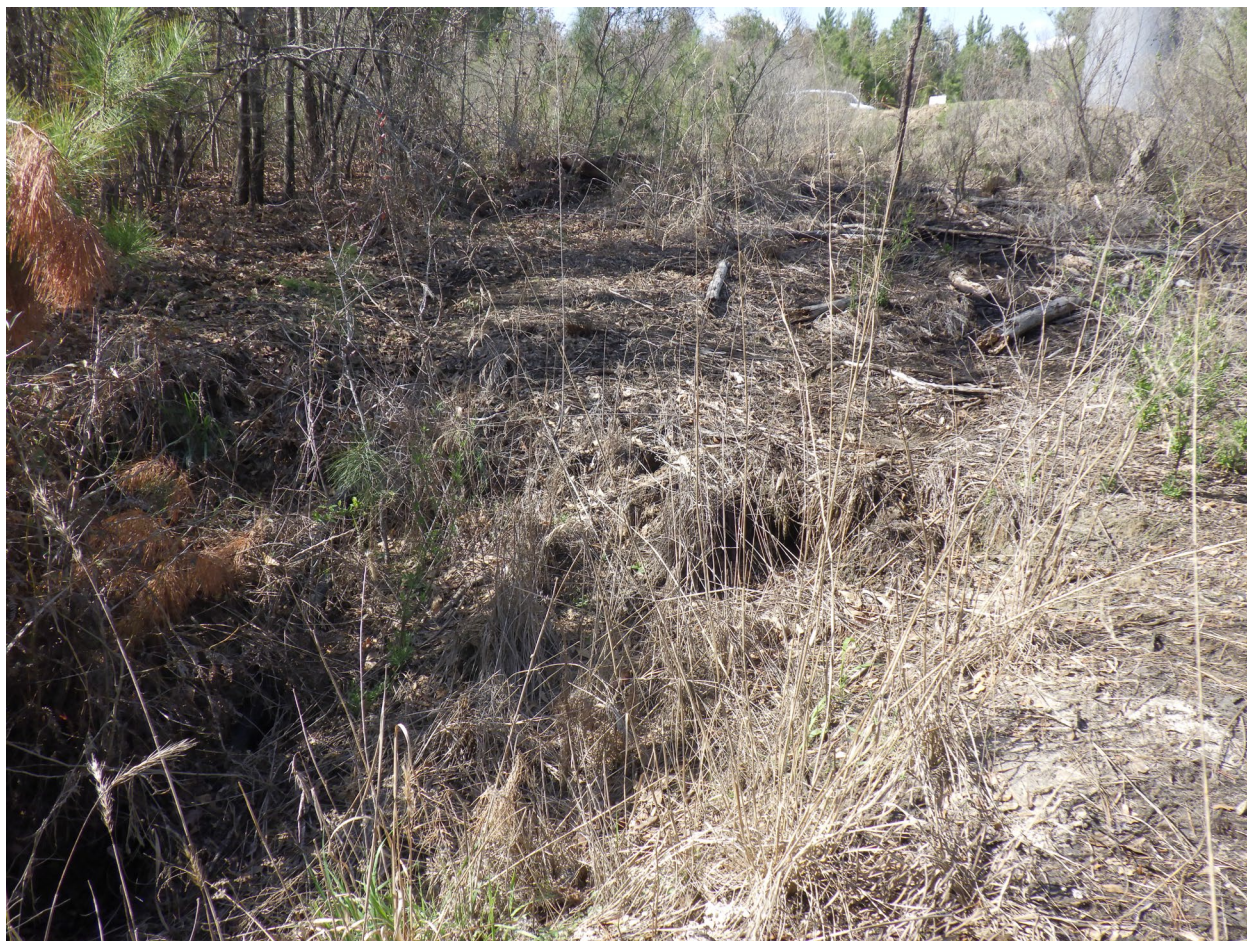
Photo No. 6

**Photo File Name:** R0010224**Orientation:** NNW**Date of Photo:** 03/12/2024**Time of Photo:** 3:53 PM**Latitude:** 33.335407**Longitude:** -92.68838**Photographer:** Uma Lad**Description:** This photo was taken looking north-northwest and shows oil-stained vegetation along the impacted flowpath.

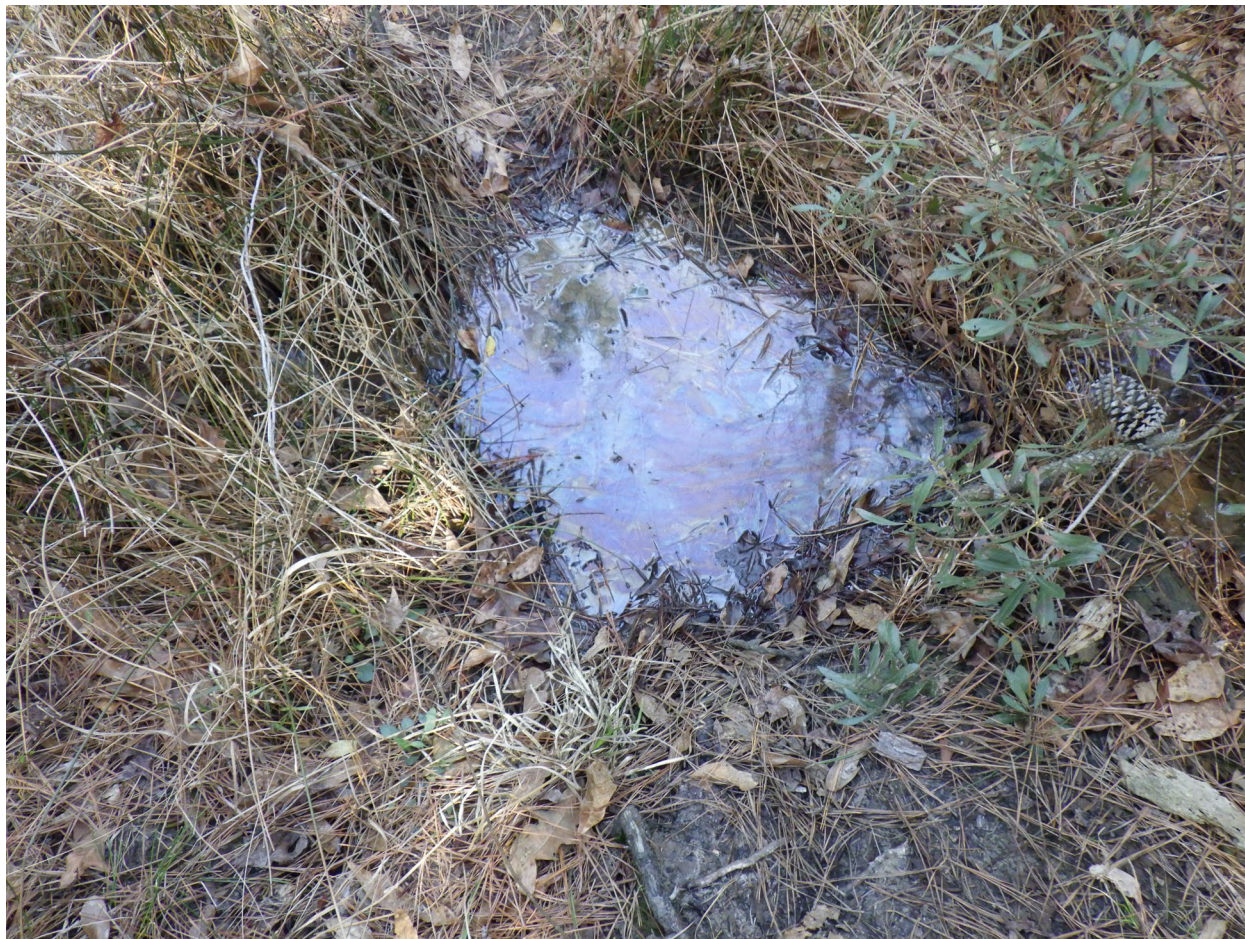
Photo No. 7

**Photo File Name:** R0010223**Orientation:** ENE**Date of Photo:** 03/12/2024**Time of Photo:** 3:51 PM**Latitude:** 33.335133**Longitude:** -92.688415**Photographer:** Uma Lad**Description:** This photo was taken looking east-northeast and shows an oil sheen along the impacted flowpath.

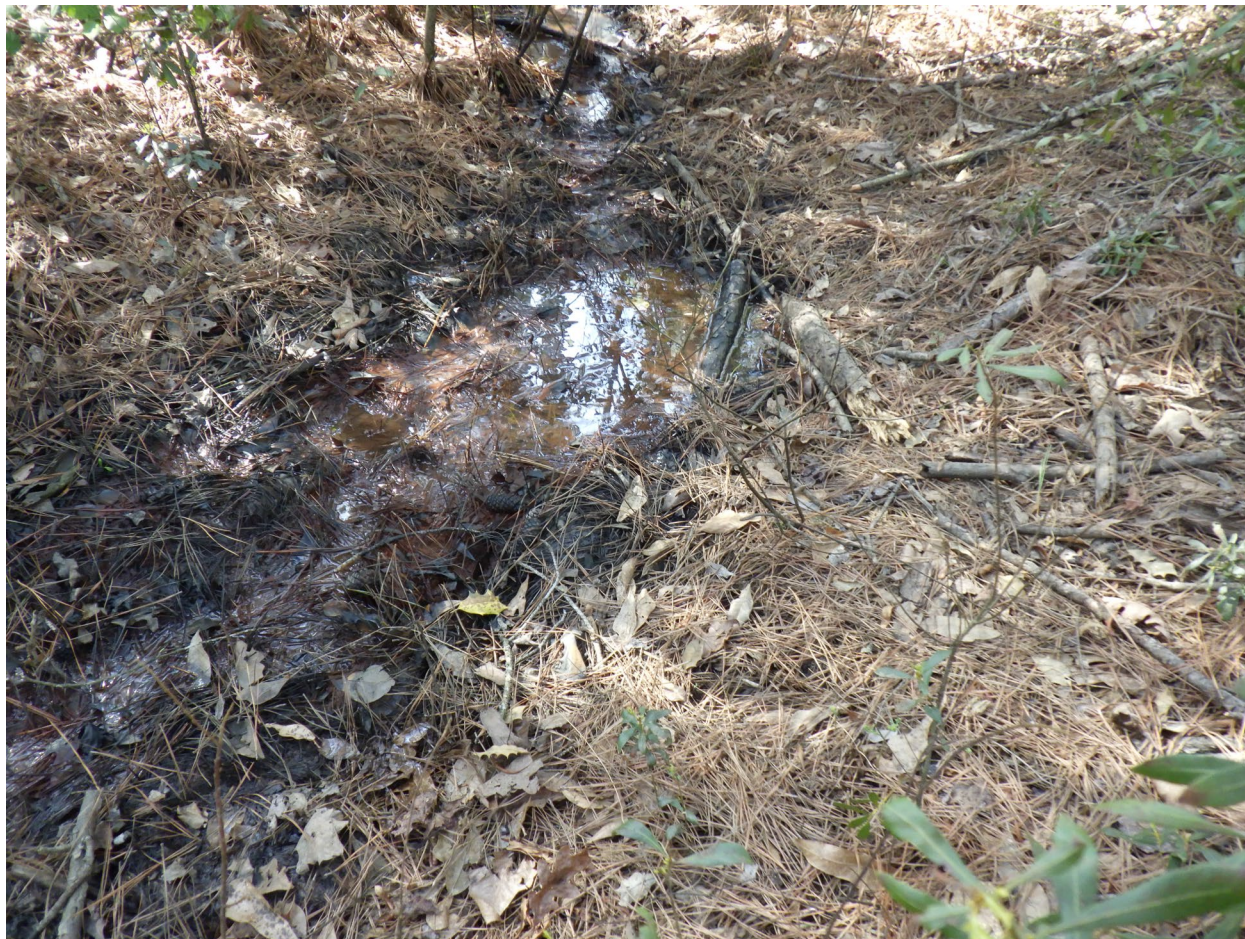
Photo No. 8

**Photo File Name:** R0010218**Orientation:** WNW**Date of Photo:** 03/12/2024**Time of Photo:** 3:46 PM**Latitude:** 33.334673**Longitude:** -92.688083**Photographer:** Uma Lad**Description:** This photo was taken looking west-northwest and shows an oil sheen along the impacted flowpath.

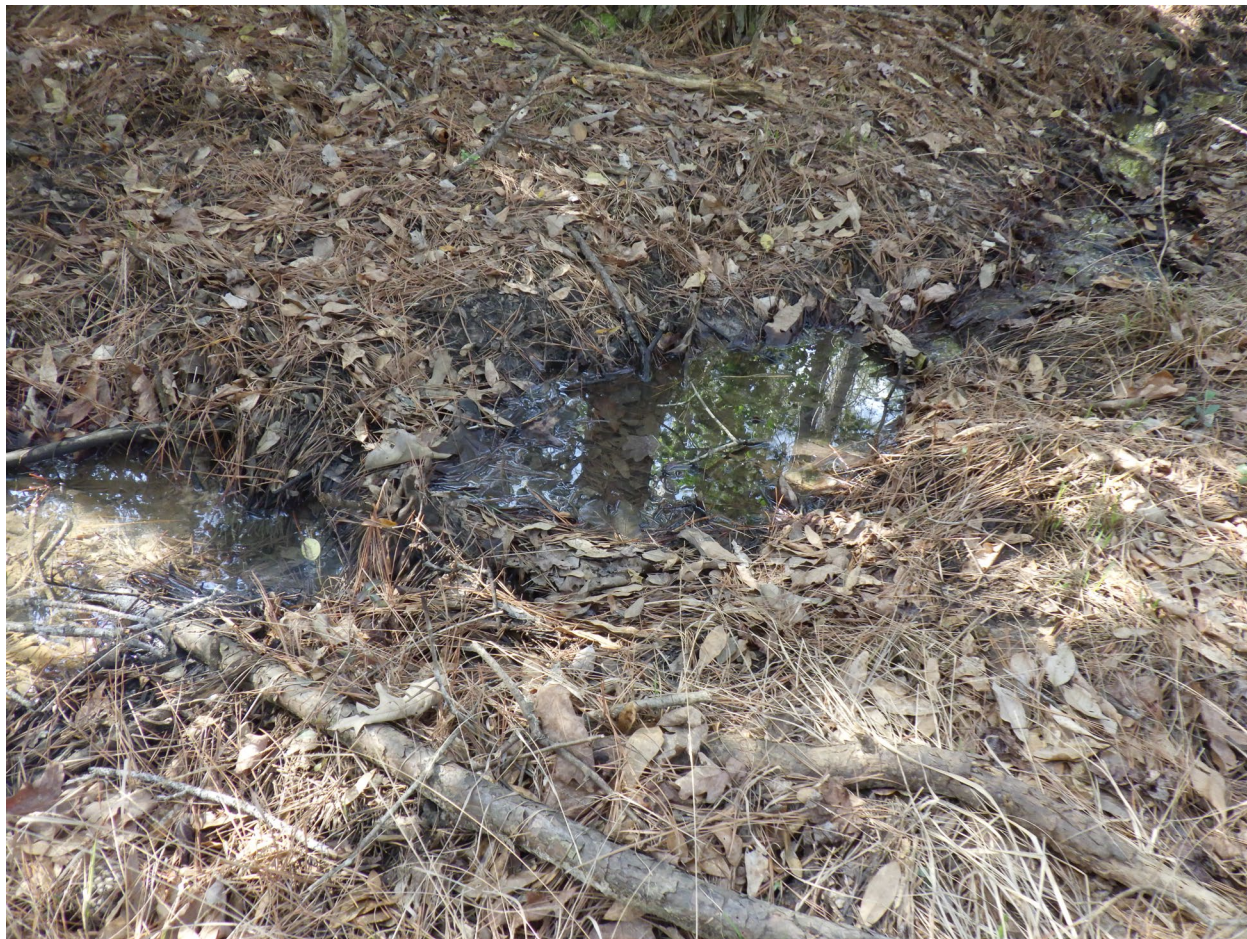
Photo No. 9

**Photo File Name:** R0010220**Orientation:** NW**Date of Photo:** 03/12/2024**Time of Photo:** 3:46 PM**Latitude:** 33.334933**Longitude:** -92.688453**Photographer:** Uma Lad**Description:** This photo was taken looking northwest and shows an oil sheen along the impacted flowpath.

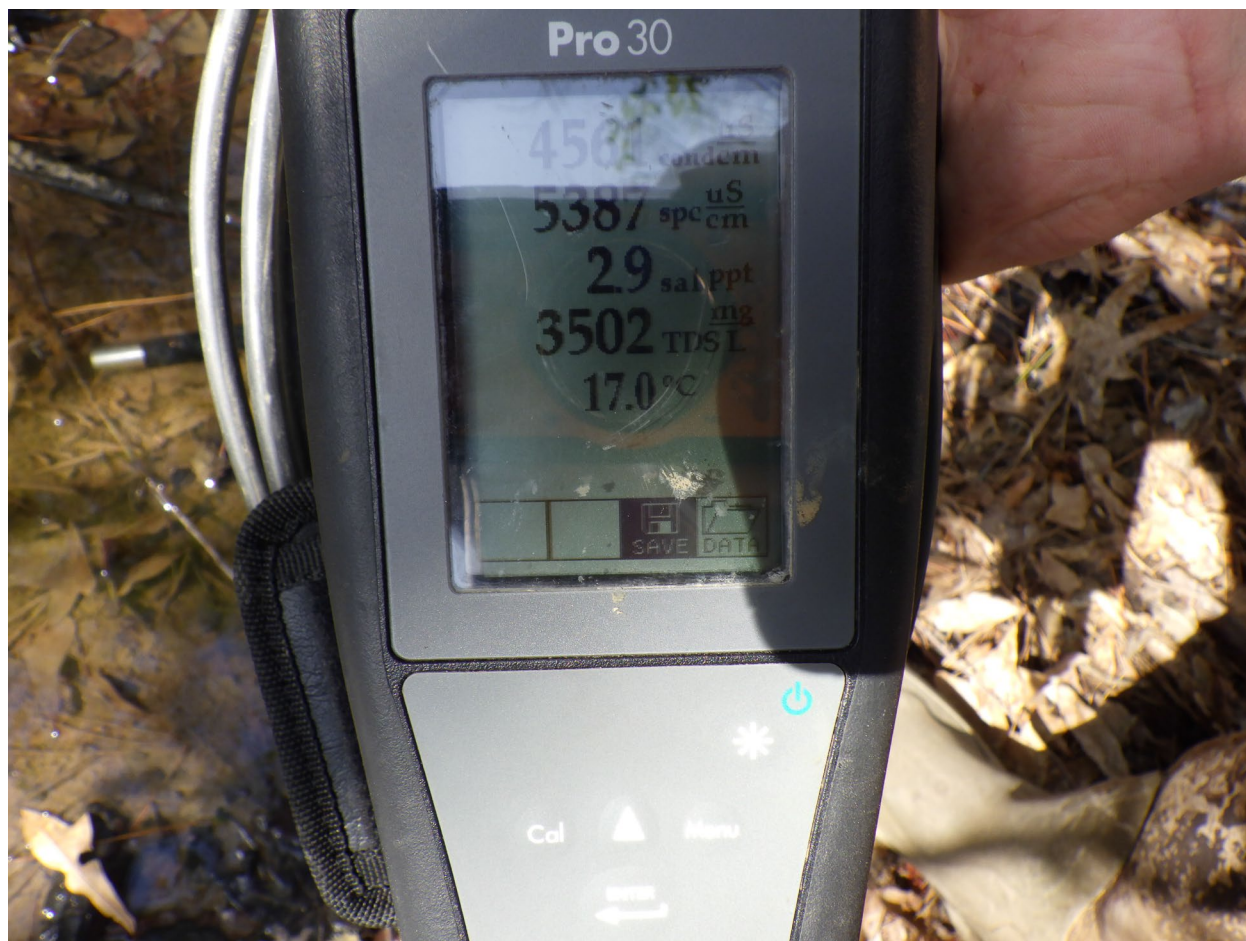
Photo No. 10

In water near the point of entry into an unnamed tributary of Smackover Creek, I observed a total dissolved solids (TDS) reading of 3,502 mg/L, see photo No. 10. This was the highest TDS field reading observed during the inspection. Further along the flowpath, I observed a TDS reading of 955 mg/L, see photo No. 11.

**Photo File Name:** R0010219**Orientation:** N/A**Date of Photo:** 03/12/2024**Time of Photo:** 3:46 PM**Latitude:** 33.334735**Longitude:** -92.688317**Photographer:** Uma Lad**Description:** This photo shows a TDS reading of 3,502 mg/L in water along the impacted flowpath.

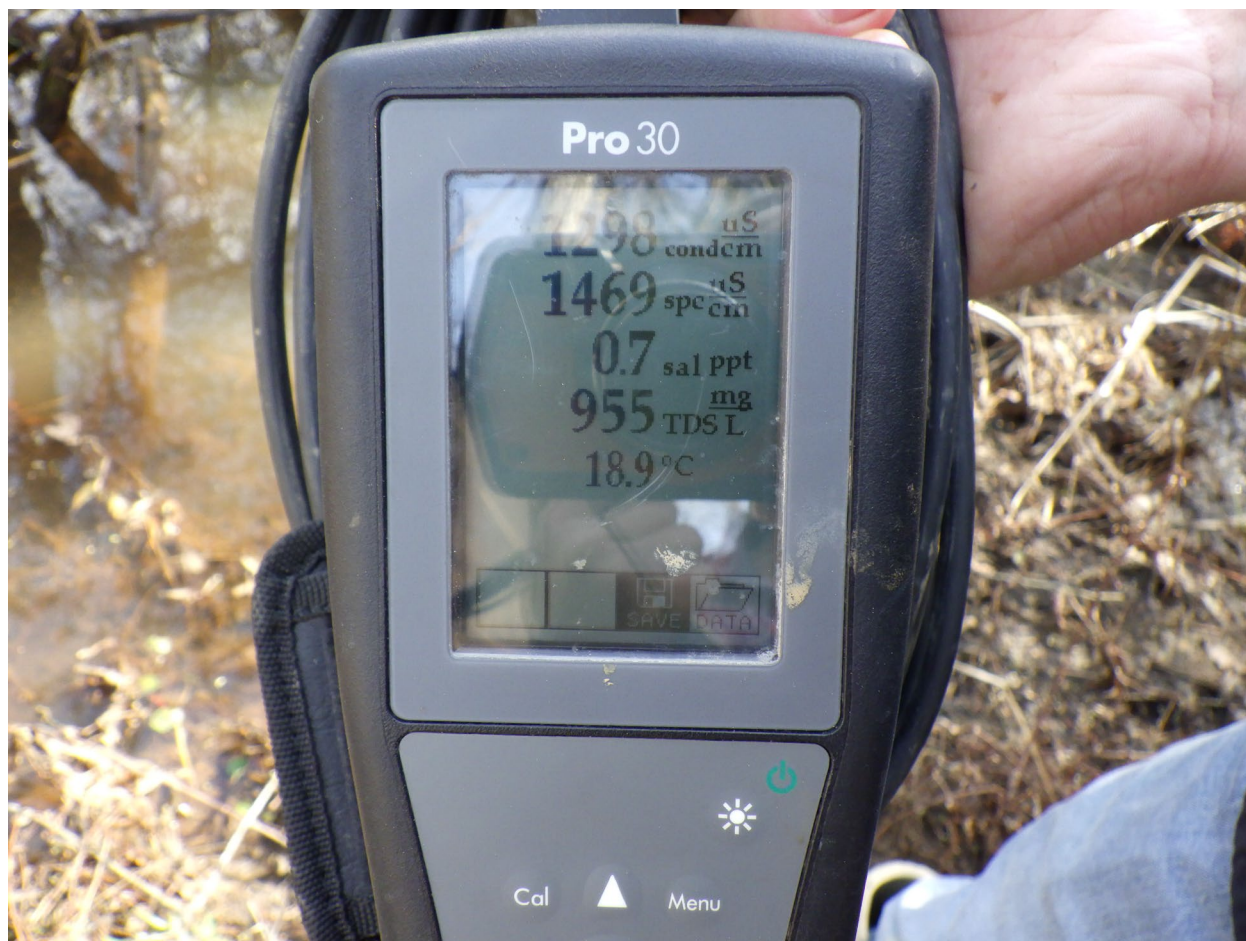
Photo No. 11

**Photo File Name:** R0010221**Orientation:** N/A**Date of Photo:** 03/12/2024**Time of Photo:** 3:48 PM**Latitude:** 33.334730**Longitude:** -92.688215**Photographer:** Uma Lad**Description:** This photo shows a TDS reading of 955 mg/L in water along the impacted flowpath.

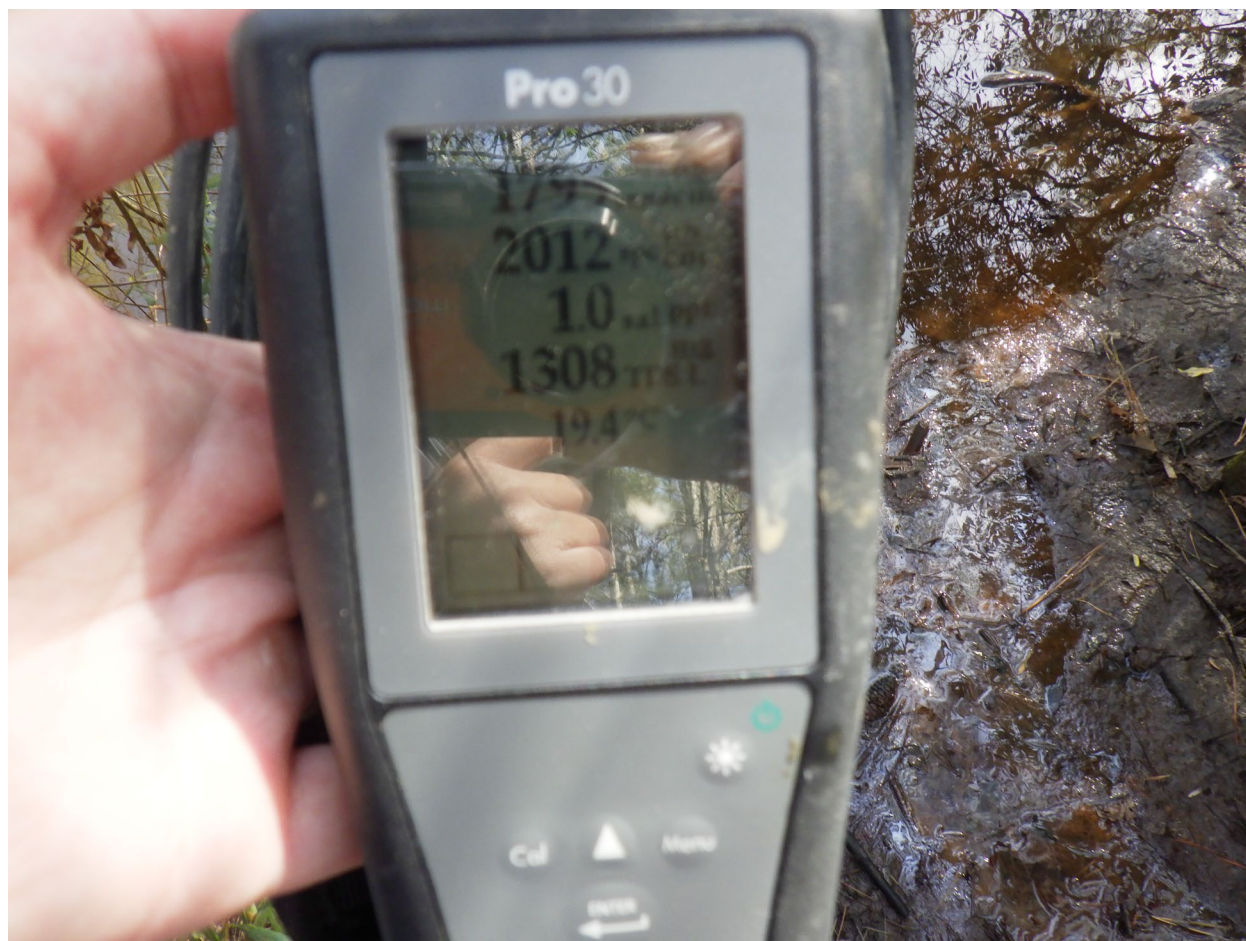
Photo No. 12

At the point of entry into an unnamed tributary of Smackover Creek, I observed a TDS reading of 1,308 mg/L as well as vegetation and bed and bank features, see photo No. 12 through No. 15.

**Photo File Name:** R0010215**Orientation:** N/A**Date of Photo:** 03/12/2024**Time of Photo:** 3:43 PM**Latitude:** 33.334633**Longitude:** -92.688143**Photographer:** Uma Lad**Description:** This photo shows a TDS reading of 1308 mg/L at the point of entry to the unnamed tributary of Smackover Creek.

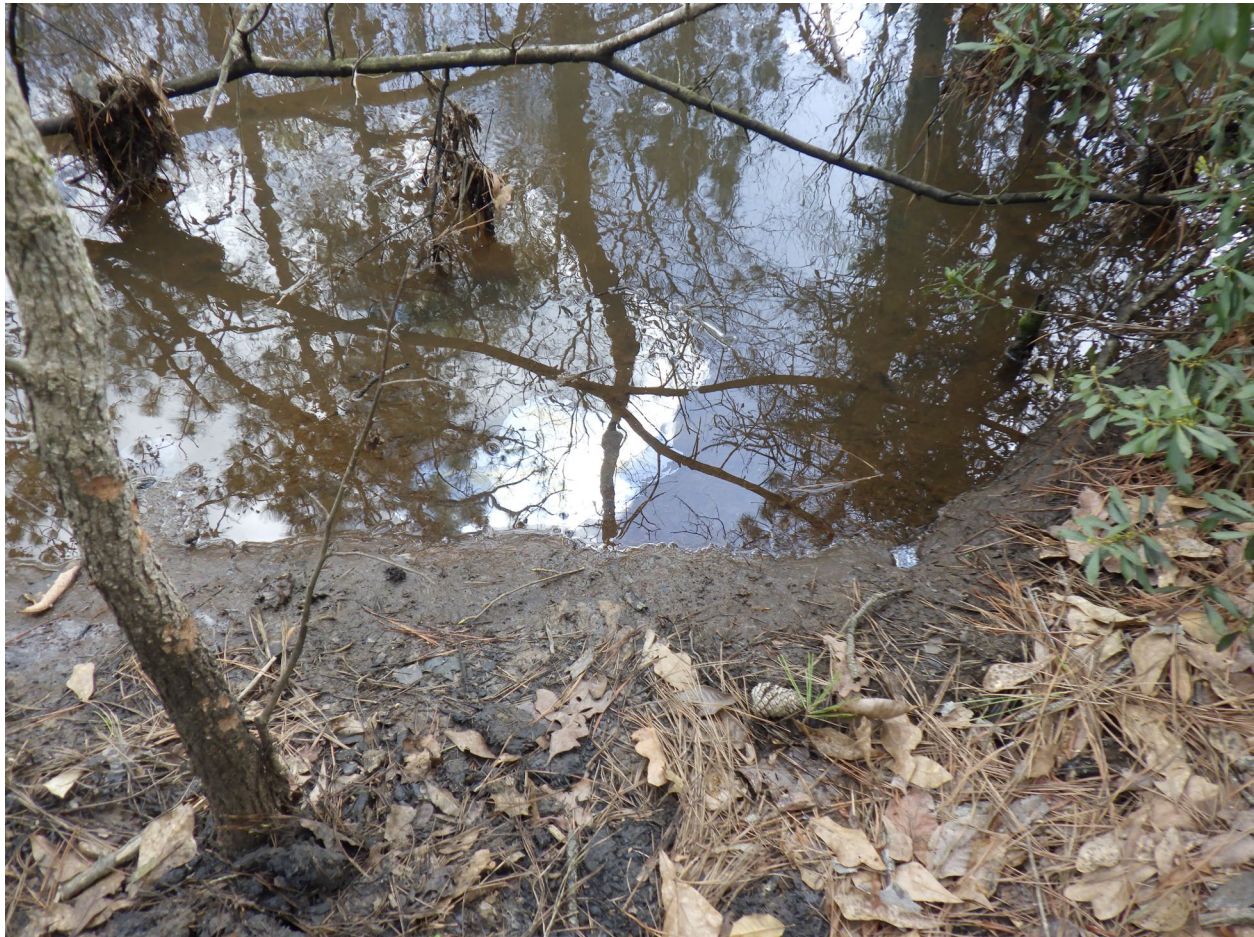
Photo No. 13

**Photo File Name:** R0010214**Orientation:** S**Date of Photo:** 03/12/2024**Time of Photo:** 3:23 PM**Latitude:** 33.334625**Longitude:** -92.688165**Photographer:** Uma Lad**Description:** This photo was taken looking south and shows point of entry to the unnamed tributary of Smackover Creek.

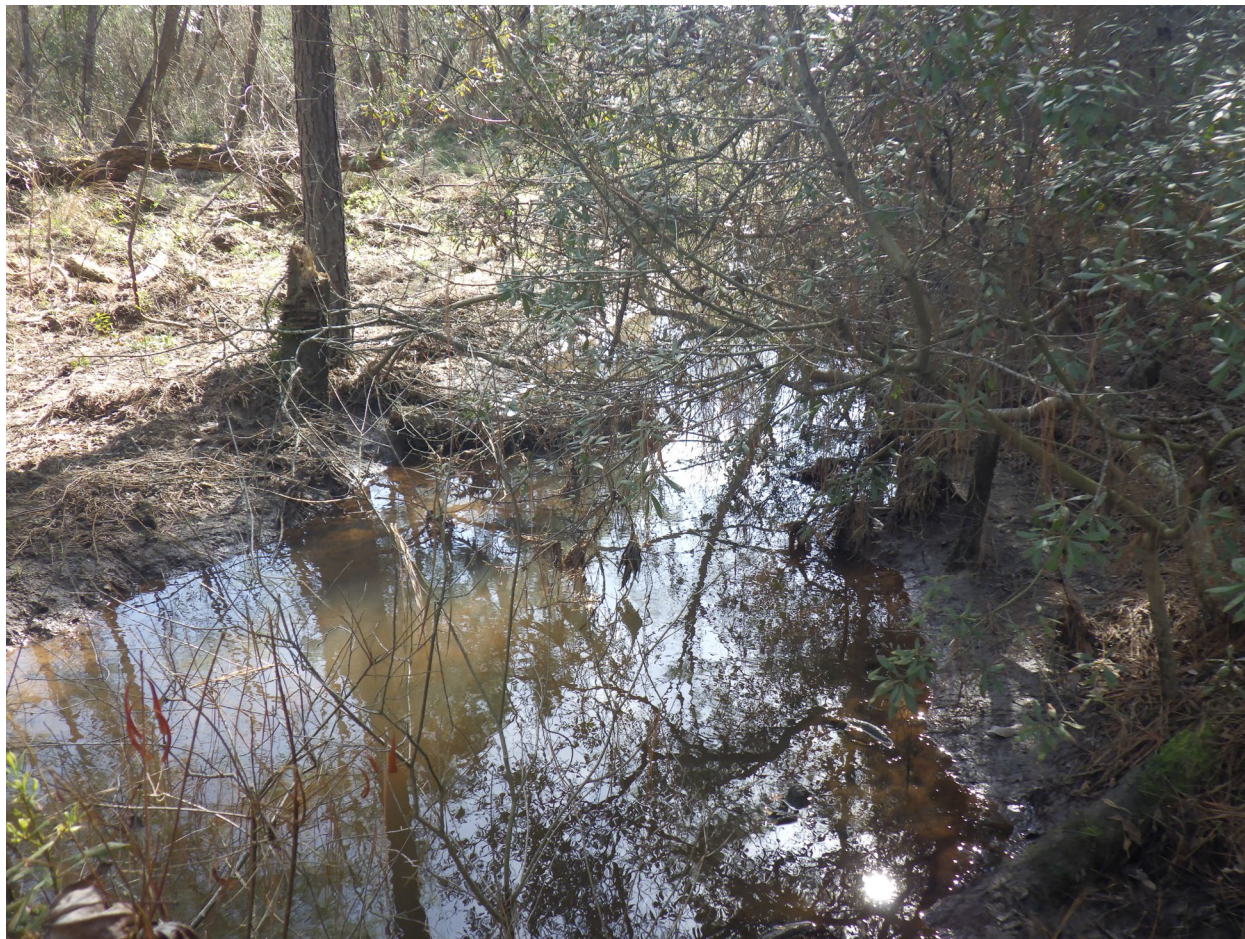
Photo No. 14

**Photo File Name:** R0010216**Orientation:** W**Date of Photo:** 03/12/2024**Time of Photo:** 3:53 PM**Latitude:** 33.335407**Longitude:** -92.68838**Photographer:** Uma Lad**Description:** This photo was taken looking west or upstream from the point of entry to the unnamed tributary of Smackover Creek.

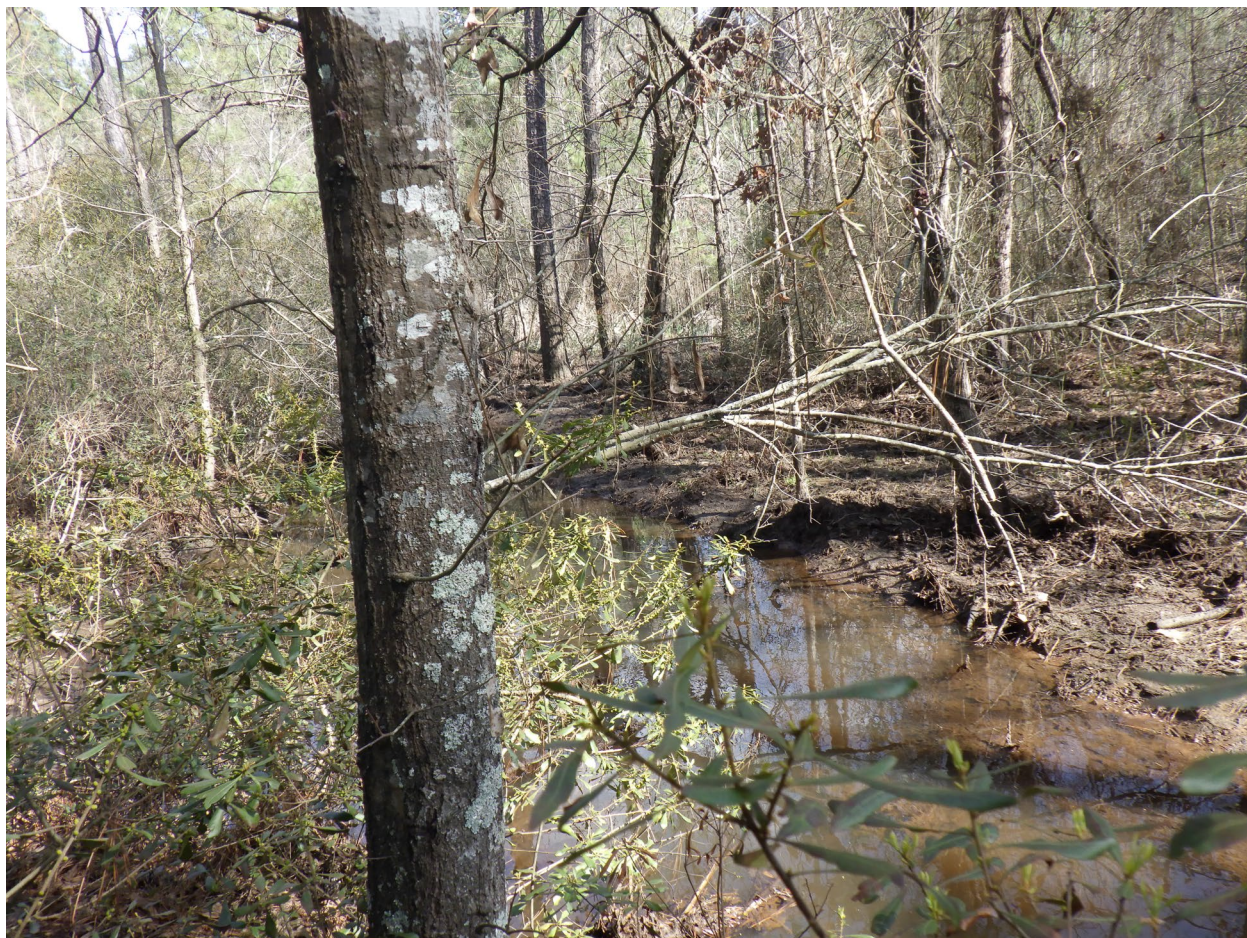
Photo No. 15

**Photo File Name:** R0010217**Orientation:** E**Date of Photo:** 03/12/2024**Time of Photo:** 3:44 PM**Latitude:** 33.334571**Longitude:** -92.688152**Photographer:** Uma Lad**Description:** This photo was taken looking east or downstream from the point of entry to the unnamed tributary of Smackover Creek.

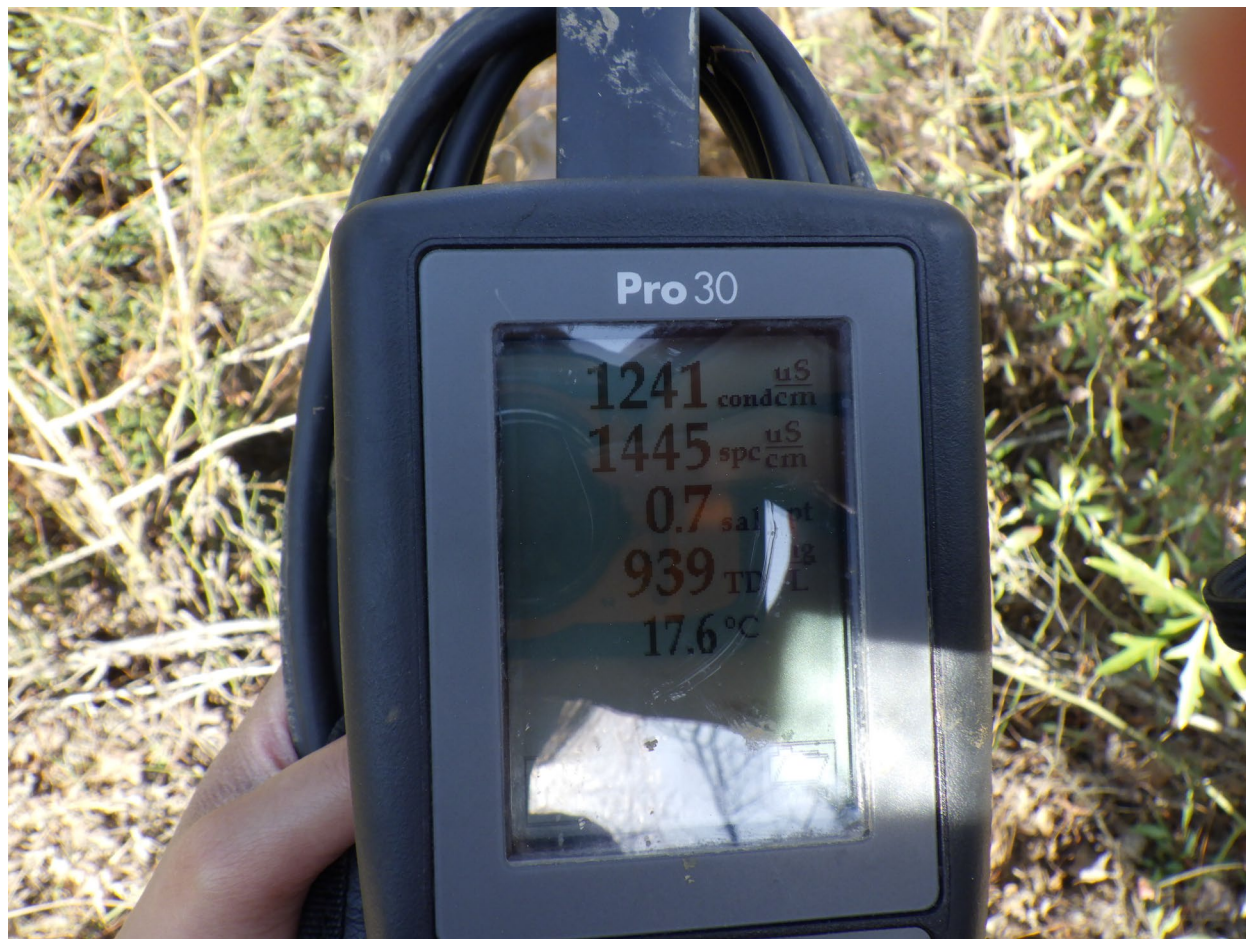
Photo No. 16

I observed a “background” TDS field reading of 939 mg/L taken upstream of the point of entry at the unnamed tributary of Smackover Creek, see photo No. 16.

**Photo File Name:** R0010226**Orientation:** N/A**Date of Photo:** 03/12/2024**Time of Photo:** 3:53 PM**Latitude:** 33.33435**Longitude:** -92.688658**Photographer:** Uma Lad**Description:** This photo shows a background TDS reading of 939 mg/L, which was measured upstream to the point entry of the unnamed tributary of Smackover Creek.
