**Subj:** Clean Water Act Inspection Report for Republic Services Inc.

A. *Facility Name:* Republic Services Inc. (AKA Allied Waste of MA - Revere)

A. *Date(s) of inspection:* Oct. 7, 2024

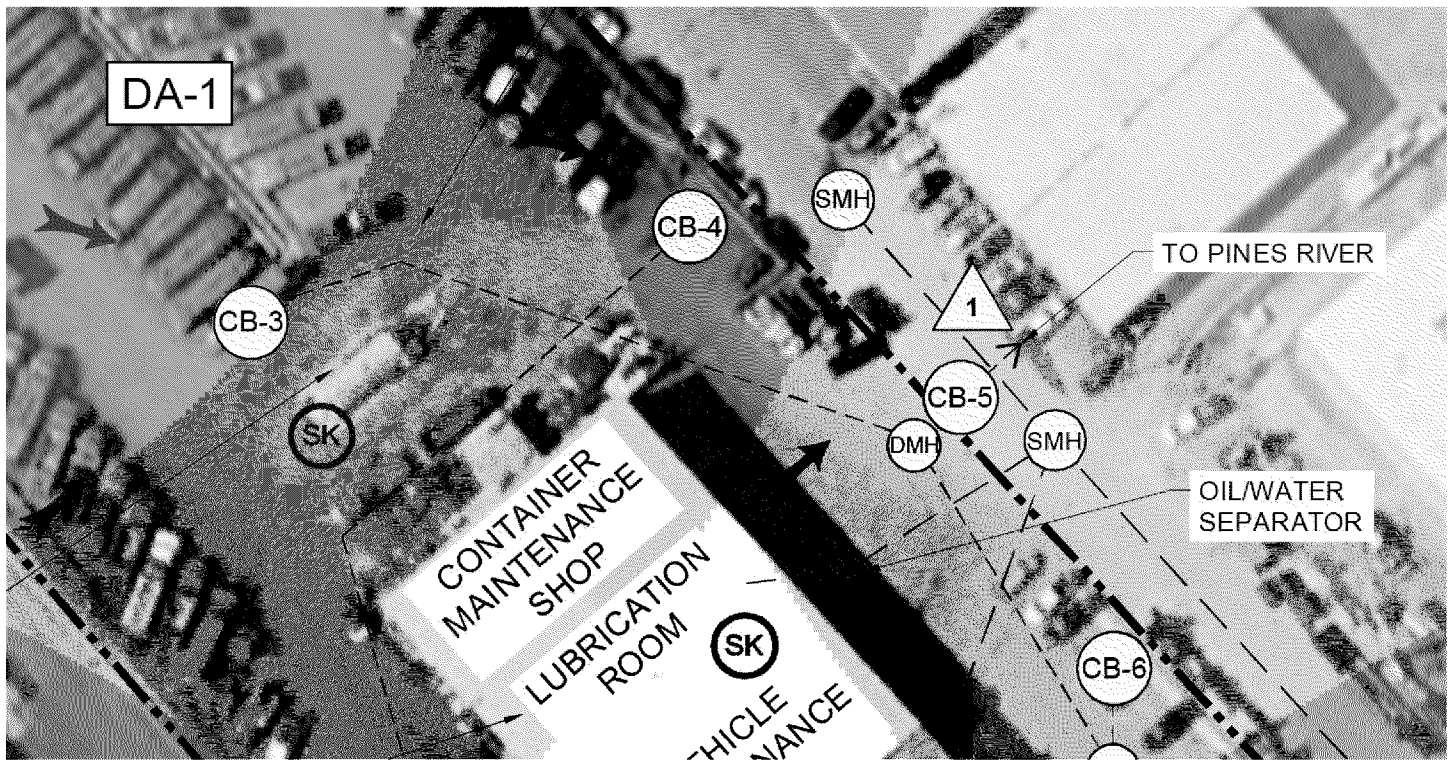
Figure 1 – Portion of Site Map from 5/28/21 SWPPP

On October 8, 2024, the day following the inspection, Mr. Atkins submitted an unsigned electronic copy of a SWPPP dated May 28, 2021, which he stated is the current SWPPP. The site map from the 2021 SWPPP (see a clipped portion below in Figure 1.), does not depict the outdoor OWS downstream of CB-04.

The outdoor OWS described is also omitted from within the narrative description of Structural Control Measures in the 2021 SWPPP. Section 2.0 of the 2021 SWPPP describes the stormwater conveyance system as all draining to CB-05, without mention of an OWS.

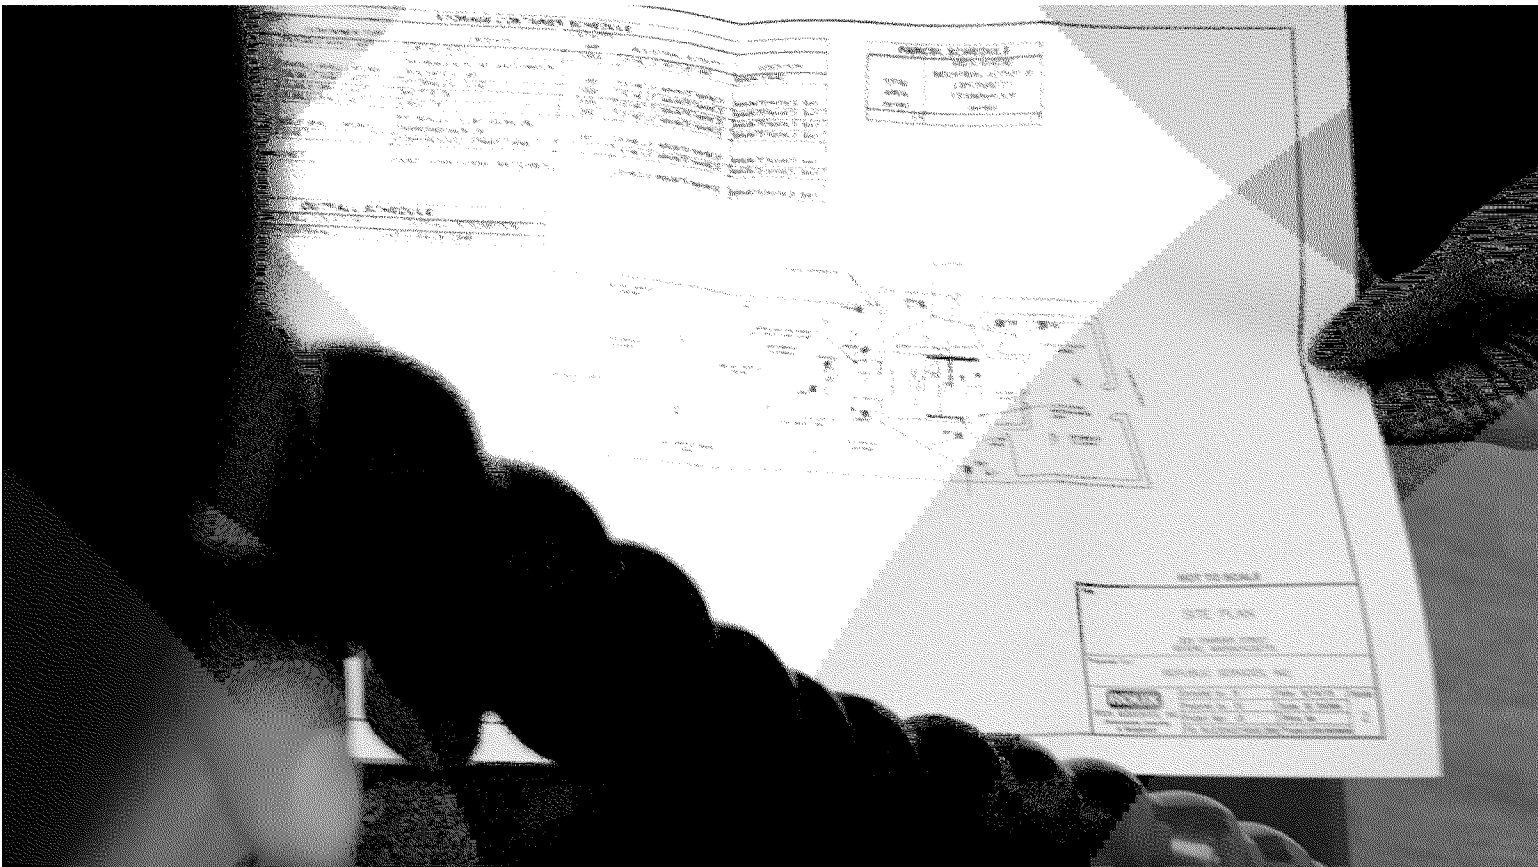
*Photo 1: 2012 SWPPP MAP*

Upon initial questioning, Facility representatives were uncertain about whether the holding tank discharges into the sanitary sewer system. I pointed out that the site map from the 2012 SWPPP has a line indicating the discharge flow path from the holding tank into the sanitary sewer. The line is labeled as "covered". After seeing that, Facility representatives came to the consensus that the holding tank is now a tight tank (does not discharge). This conclusion aligns with the additional information provided by Facility representatives which is that the tank is pumped out by a third-party contractor on a semi-regular frequency (approximately every few months). Daily visual inspection of the water level within the tank made through a floor grate (photo 9) determines when the contractor is called to pump-out the contents.

The site map within the 2012 SWPPP (Photo 1) depicts the flow path of discharge from CB-04 as flowing through an Oil Water Separators (OWS) and then towards a junction manhole where it confluent with flow

from CB-01, CB-02 and CB-03 before flowing to a drain manhole and then into CB-05, the Facility's sole discharge point.

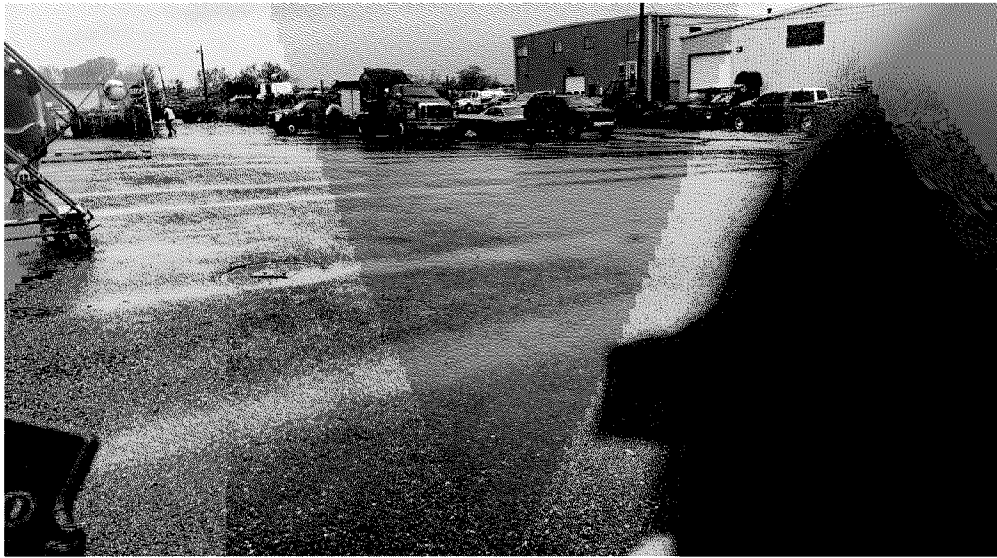
*Photo 3*

Facility representatives stated that stormwater samples are collected by an outside contractor from a metal 6-inch diameter sampling port in between the northern entrances to the maintenance garage bays (Photo 12) and CB-05, the sole discharge point permitted at the Facility. The sample port is located approximately 5 ft south of a sewer drain cover (Photo 3).

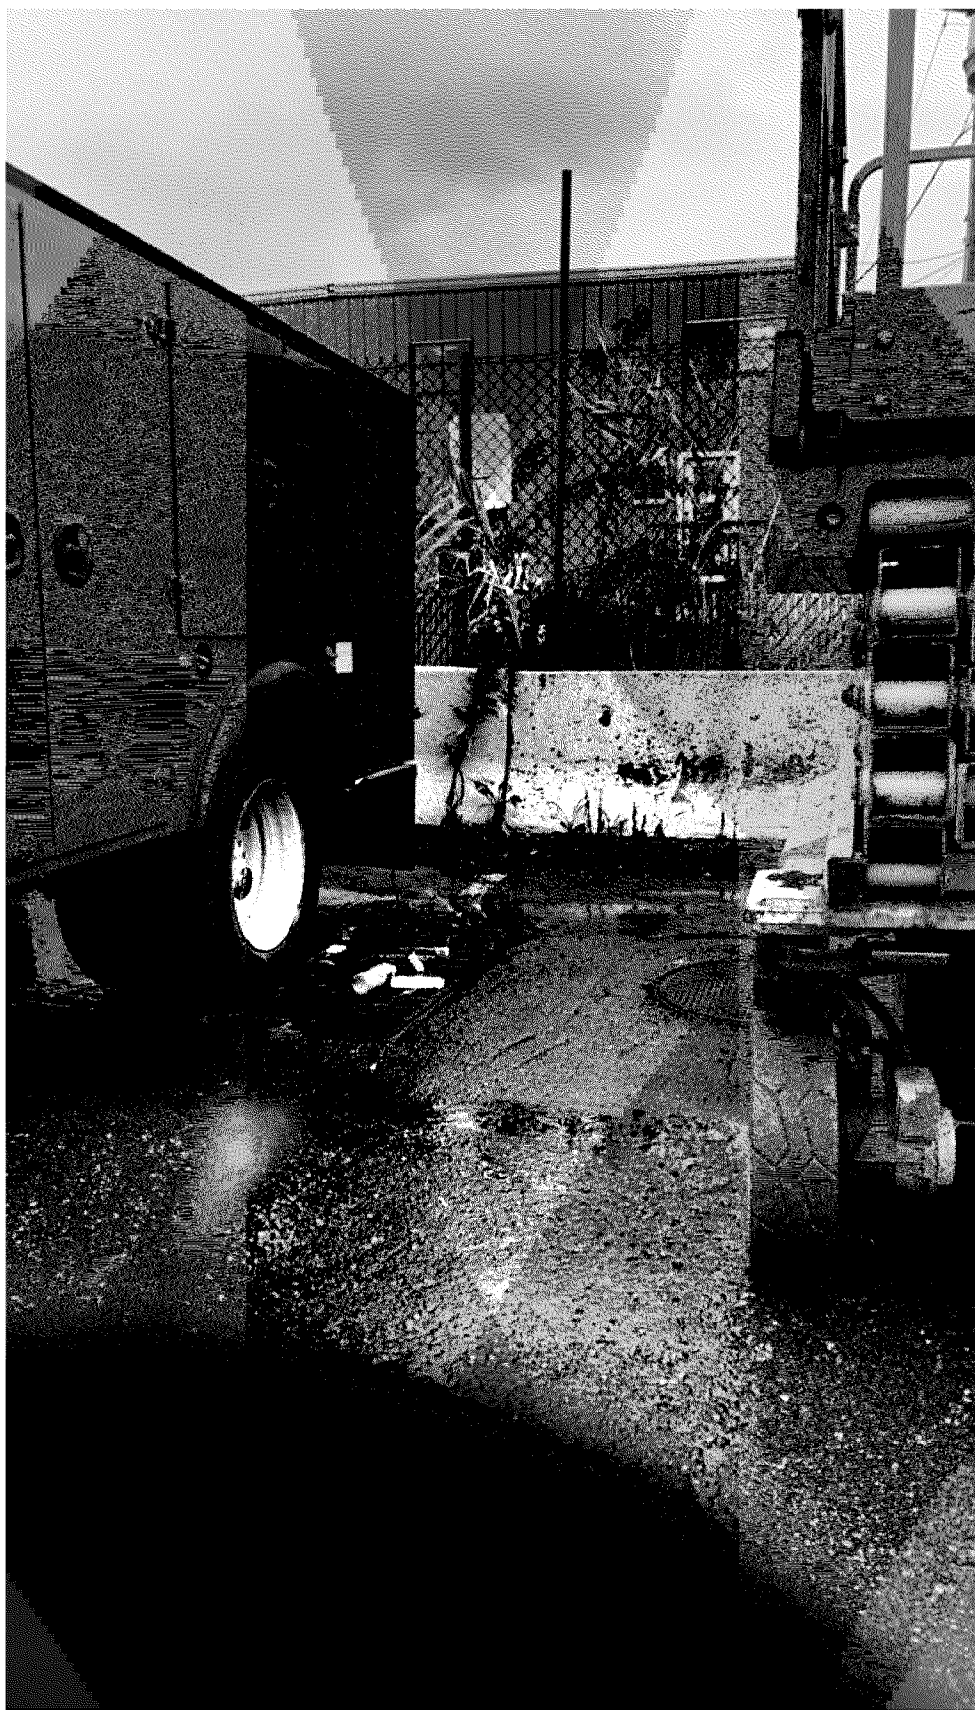
*Photo 4*

Catch basin CB-04 (Photo 4) has two solid metal drain grates approximately 5 feet to its' east (Photos 4, 5, 9 and 10). The water surface within the compartment under the closest of the two drain covers was covered by approximately half an inch of oily white scum. When the surface was agitated by a metal stick, water below the scum appeared slightly opaque. Water within the compartment under the second drain cover, located approximately 10 feet from to CB-04, and 5 feet from the first drain cover, had no visible sheen and lower opacity.

During the Facility Tour, Facility representatives stated that the OWS downstream of CB-04 has never been inspected or maintained.

Facility representatives were unaware of the existence of the outdoor oil water separator downstream of CB-04 (photo 4).

Facility representatives explained that regular clean-out of the holding tank down-gradient of the indoor OWS's is conducted, but no maintenance or inspection of the outdoor OWS has been conducted in their time working at the Facility, which began before 2012.

I stated that Part 2.1.2.3 of the MSGP requires the Facility to maintain all structural control measures so that they remain effective, to minimize pollutant discharges. This includes but is not limited to all industrial equipment and systems.

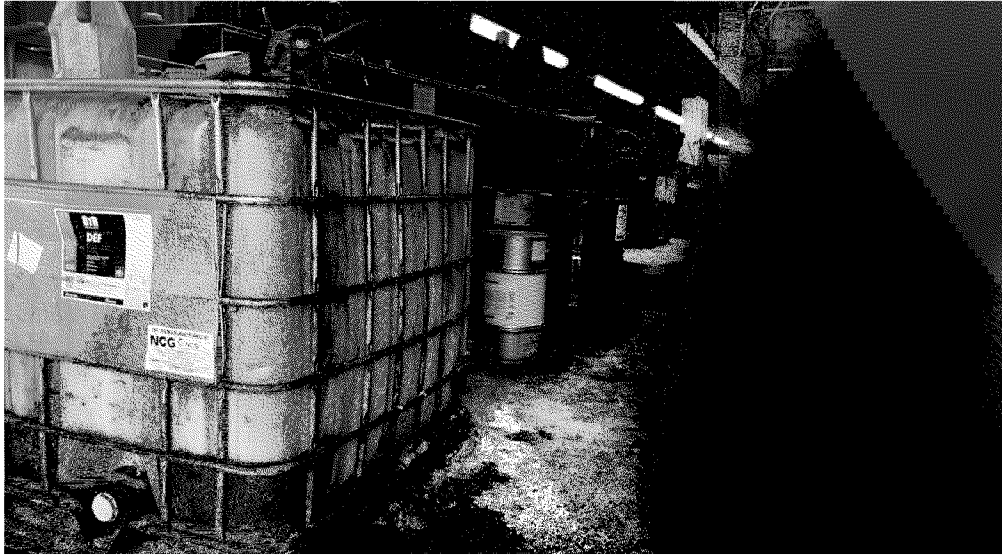
*Photo 8*

According to information provided during the opening conference, the Facility consists of one building containing offices, a Vehicle Maintenance Shop, a Lubrication Room, and a Container Maintenance Shop. The Vehicle Maintenance Shop has seven vehicle bays, the Container Maintenance Shop has four bays, and the lubrication room has two vehicle bays. The Lubrication Room (photo 8) was previously used as a vehicle washing area (wash bay) but is now used to store oil-based fluids.

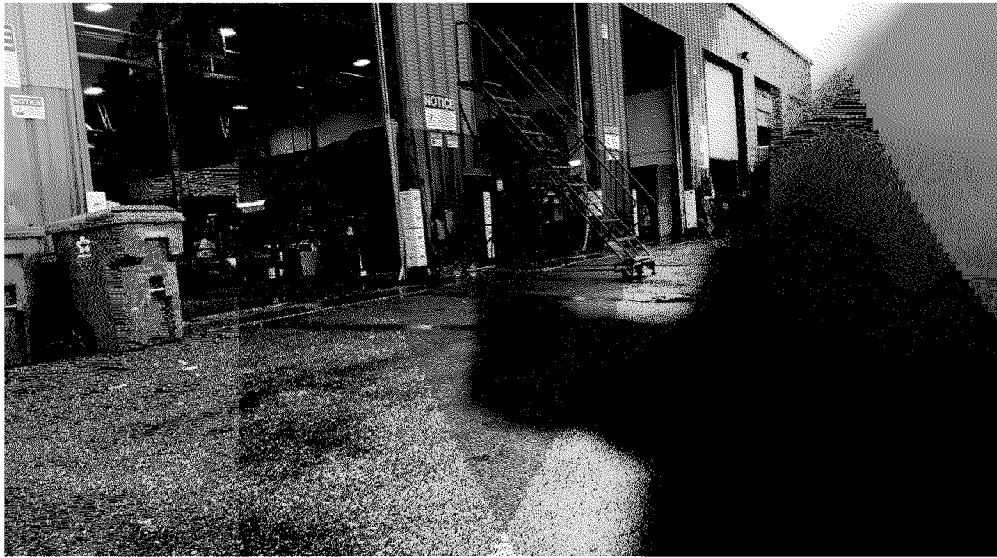
*Photo 12*

Facility representatives stated that the Facility has seven catch basins which all contribute flow through CB-05 before discharging off-site into the Pines River. Considering catch basins capture stormwater from areas with unique industrial activities (i.e. vehicle storage, refueling areas, maintenance, etc.) it is a requirement of the MSGP that monitoring captures combined flow from all catch basins. It is unclear due to inadequate mapping of stormwater infrastructure whether the sample point is representative of the combined flow from all seven catch basins on site.
