CHRONOLOGICAL SUMMARY OF EMERGENCIES INVOLVING

TENNECO CHEMICALS INC. VCM CARS

VISIT TO SITE OF KCS RAILROAD WRECK  
INVOLVING FIVE 38,000 GALLON TANK CARS OF VCM

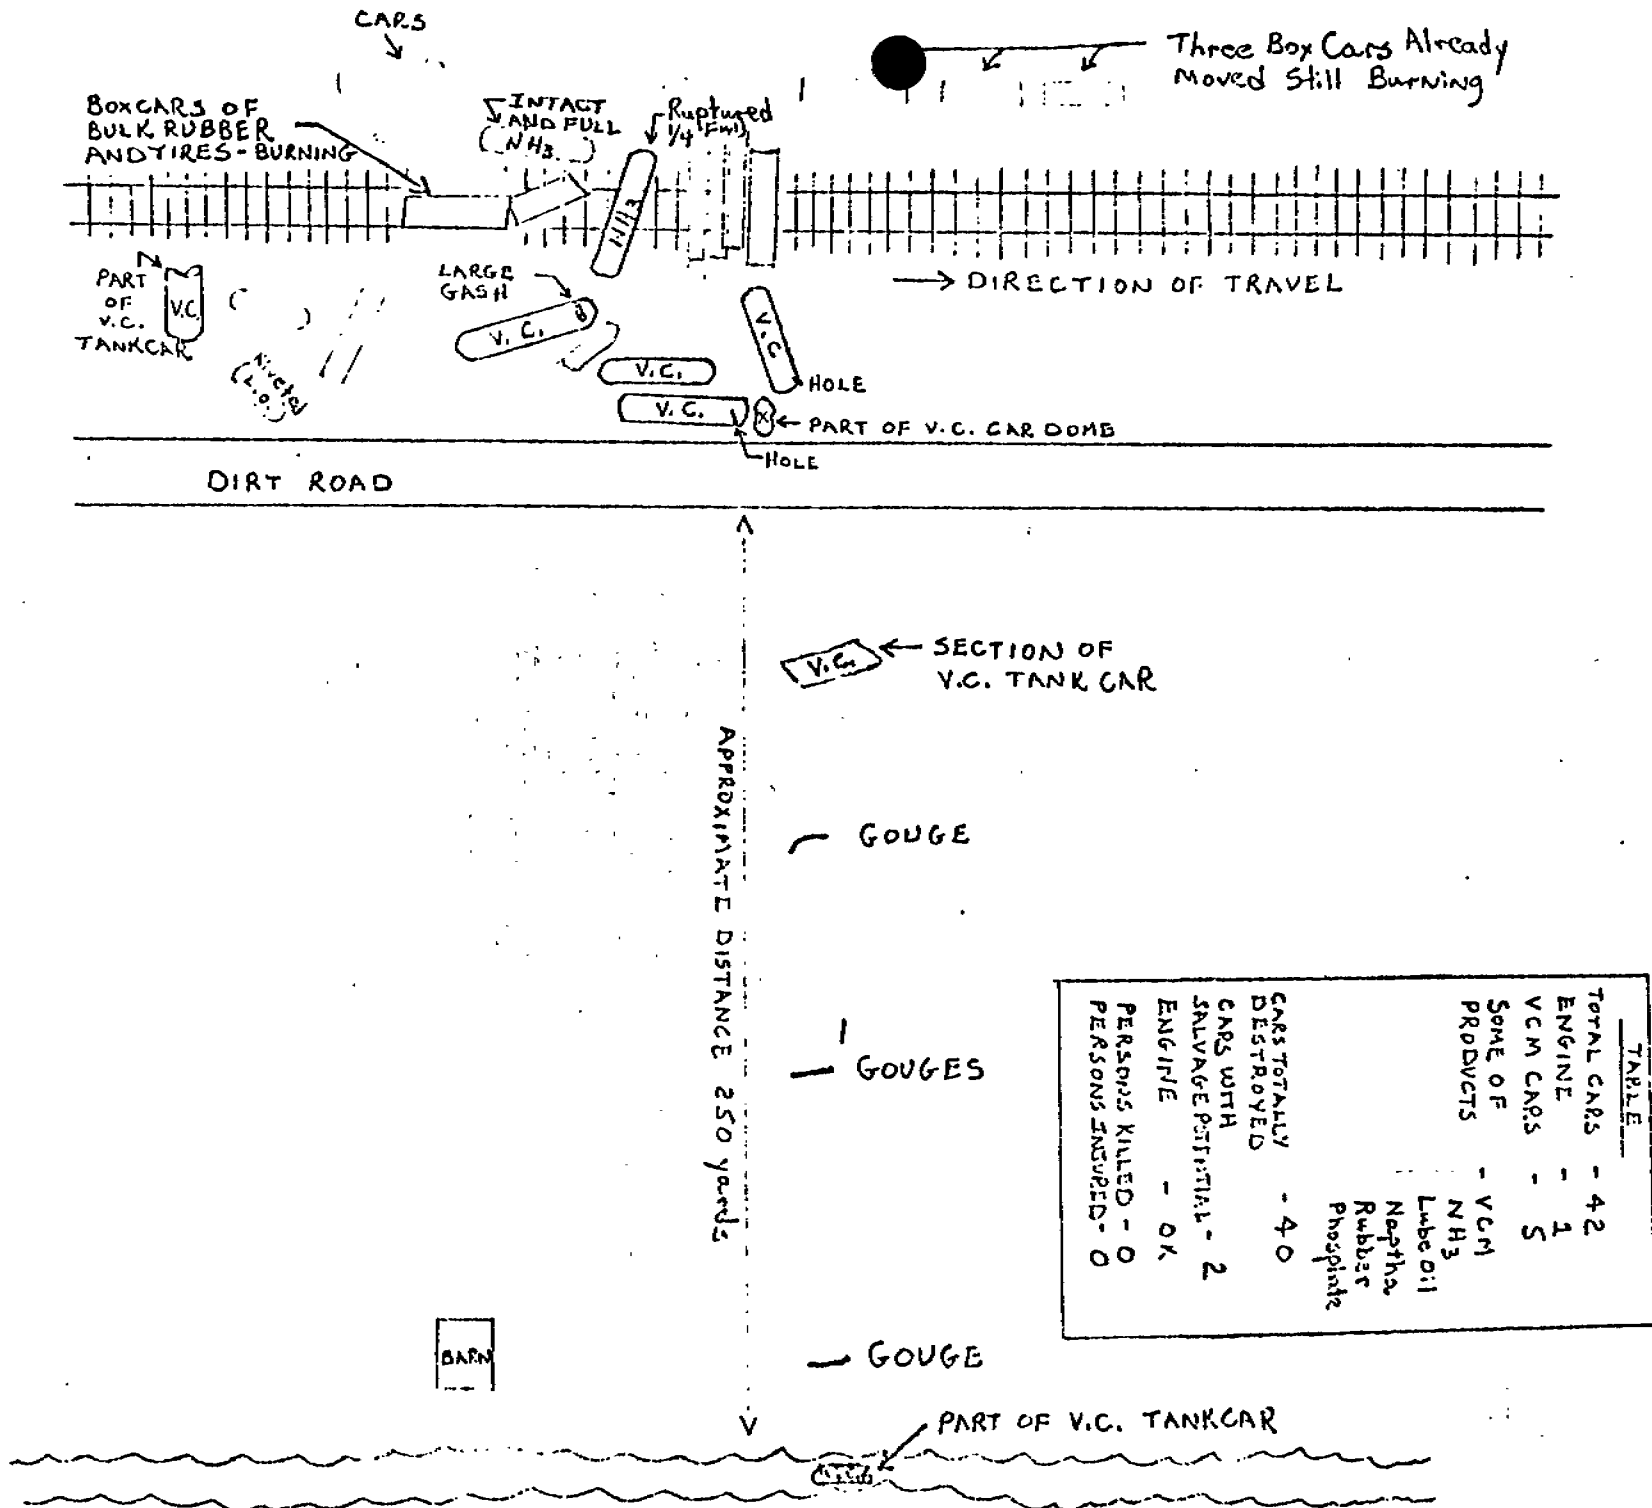
SKETCH OF SCENE

1. The wreck occurred early Thursday morning (about 5:00 or 6:00 A.M.).
2. The cause is still speculative, however, the most universal theory is a broken or split rail.
3. On impact, tremendous damage was inflicted on all 42 cars. Of the 42 cars and the engine, only the engine, one anhydrous  $\text{NH}_3$ , and a flat car had salvage potential.
4. The five VCM cars were located and identified by KCS personnel as per the attached diagram. The fact they were 38,000 gallon cars made them identifiable. The specific cars were:

5. The four VCM cars still in one piece (the tank portion) each had large punctures of a type likely to be inflicted on impact. The fifth car was scattered over a wide area (see sketch). It is considered likely that this separation occurred within a few minutes of the initial impact.
