**UNITED STATES ENVIRONMENTAL PROTECTION AGENCY  
REGION 8  
RESOURCE CONSERVATION AND RECOVERY ACT**

**Facility Name:** Safety-Kleen Systems, Inc. – **Facility Location:** 2801 S Tejon St.  
Englewood Englewood, Colorado 80110

**Type and Purpose of Inspection:** Focused Compliance Inspection

Inspection focused on compliance with RCRA air regulations in 40 C.F.R. Part 264, Subparts AA, BB and CC [6 CCR 1007-3 Part 264, Subparts AA, BB and CC]

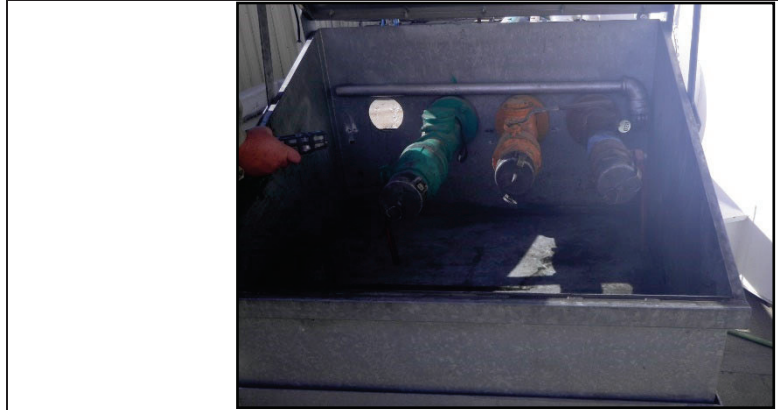
| Attributes | |
|---|---|
| Title | Photo 2 |

**Data Collected and Observations:** As part of the on-site portion of the inspection, the inspection team conducted a comparative monitoring campaign using Method 21 and audio, visual and olfactory inspections for equipment associated with the return and fill station and the hazardous waste tank that is subject to 6 CCR 1007-3 Part 264, Subpart BB. The inspection team identified one leaking component, a check valve with tag number 028. The leak was identified visually. (See photos 2-4 in Appendix B.)

| Attributes | |
|---|---|
| Description | Loading and<br>unloading area: left<br>two valves connect<br>to product tanks,<br>right goes to waste<br>tank. Inspection<br>team identified a<br>leaking component<br>on the waste tank<br>connection line. |

- Shipping documents from June 29, 2020 for generators without a generator ID
- Repair document for leak identified by the EPA inspection team

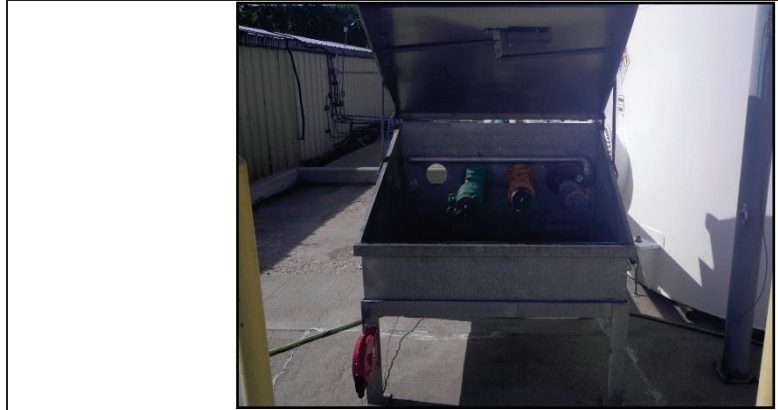
| Attributes | |
|---|---|
| Title | Photo 3 |

| Attributes | |
|---|---|
| Description | Loading and unloading area: left two valves connect to product tanks, right goes to waste tank. Inspection team identified a leaking component on the waste tank connection line. |

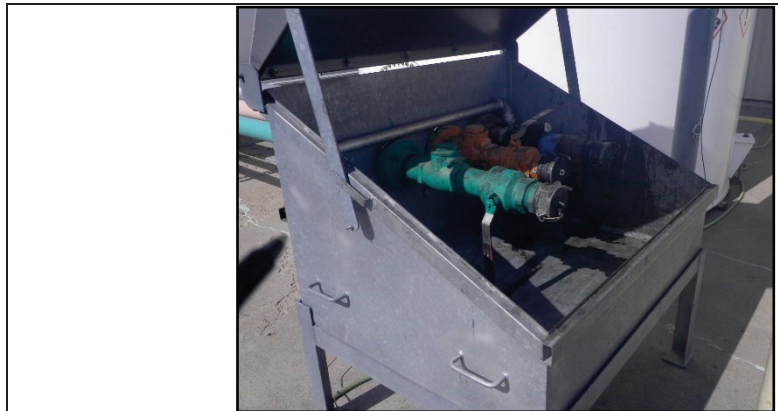
| Attributes | |
|---|---|
| Title | Photo 4 |

| Attributes | |
|---|---|
| Description | Loading and unloading area: left two valves connect to product tanks, right goes to waste tank. Inspection team identified a leaking component on the waste tank connection line. |

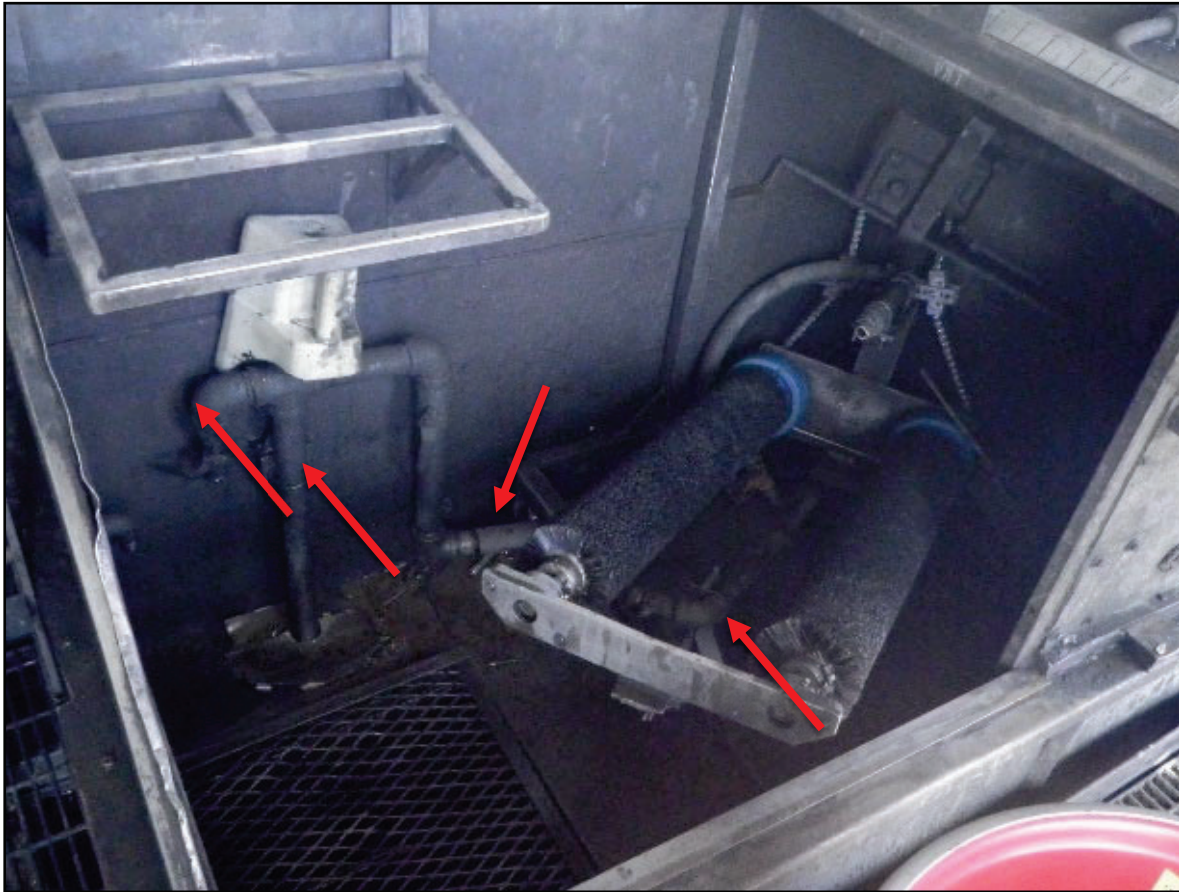
**Deficiencies or Concerns:** During the on-site portion of the inspection, the EPA inspection team noted that there are four valves inside both the north and south return and fill station that are not included on the Subpart BB monitoring component list. These components are in heavy liquid service and should be monitored per to 6 CCR 1007-3 § 264.1058. (See Attachment 1.)

**Figure 1:** Inside the north return and fill station at the Safety-Kleen Englewood facility. Arrows point to valves that are in heavy liquid service and should be included in the Subpart BB monitoring plan. The south return and fill station is **identical and has the same valves missing** from the Subpart BB monitoring plan.

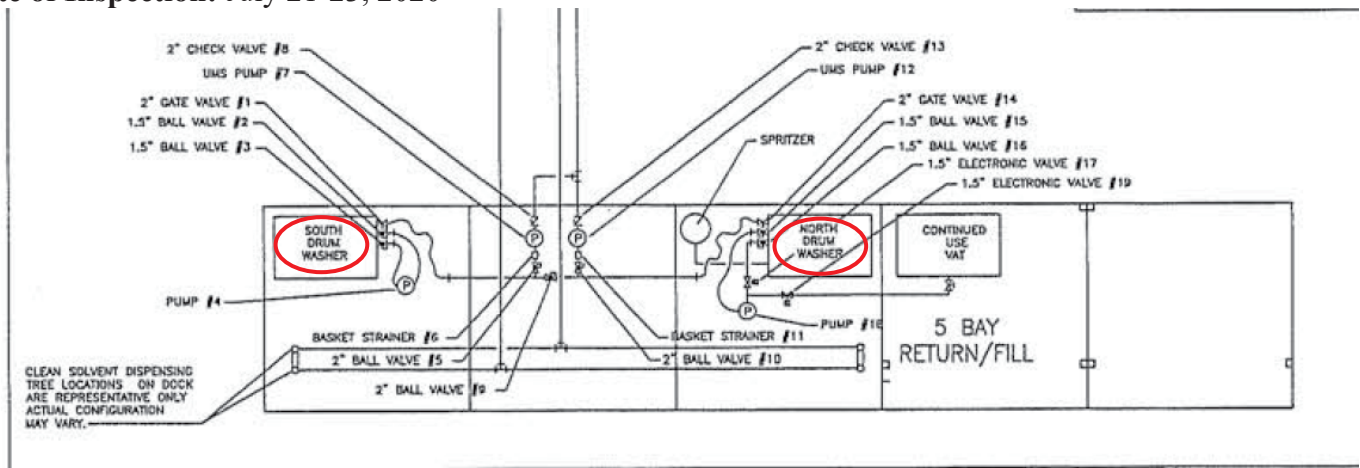
**Figure 2:** Snippet of the Subpart BB monitoring plan from the Safety-Kleen Englewood RCRA permit, Attachment 3 which shows the locations of the valves included on the Subpart BB monitoring plan. The red ovals indicate the general location of the valves missing from the Subpart BB monitoring plan.

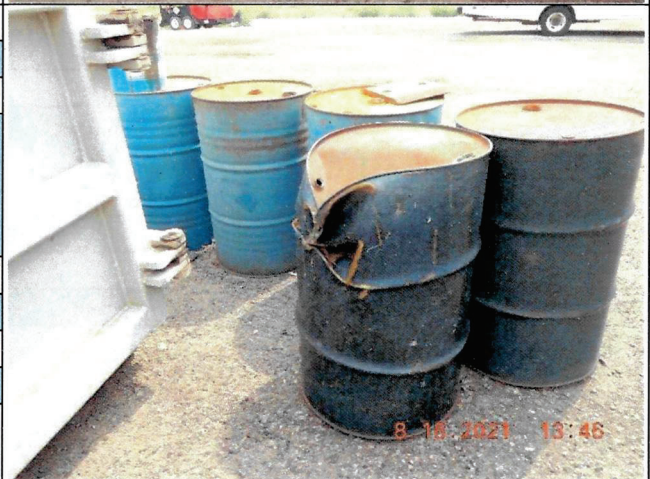
| Attributes | |
|---|---|
| Title | Photo 6 |

- Six containers, each was a 55-gallon drum, were located on the east side of the garage; none were labeled and they were in poor condition with rust and dents visible. There was no evidence of any leaks. Tim Payne did not know what the contents of the drums were. The containers were not within secondary containment.

| Attributes | |
|---|---|
| Description | Damaged container on east side of the garage. The container is located behind the row of containers in Photo 5. |

**Deficiencies or Concerns:** There were unlabeled containers in the Waste Collection area, on the east side of the garage, on the southwest side of the garage, and the northwest side of the Facility. These containers need to be labeled with the contents of the containers. Used oil containers must contain the label "Used Oil". Hazardous waste containers, if present, must contain the label "Hazardous Waste" and an indication of the hazard. e.g., flammable, corrosive, toxic, etc.
