**Region 6 Compliance Assurance and Enforcement Division  
INSPECTION REPORT**

| Inspection Date(s): | November 15–18, 2021 | | |
| Company Name: | <b>Total Environmental Solutions, Inc. (TESI)</b> | | |

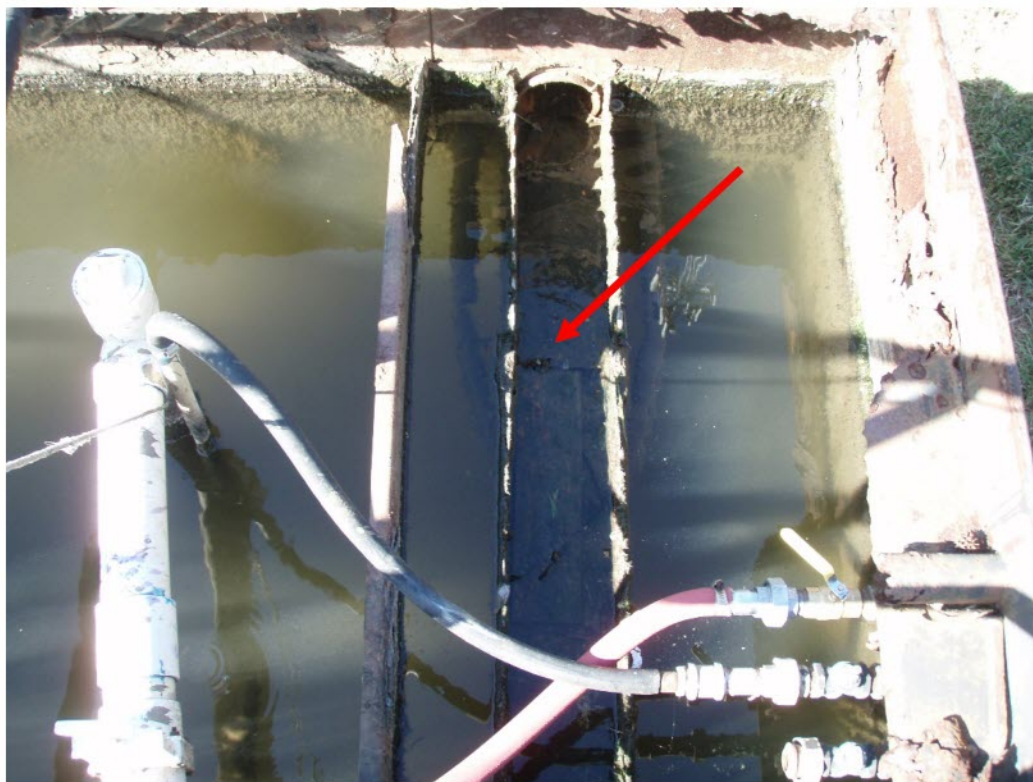
1. Weir was being bypassed as flow was from under the weir structure and in need of repair (see picture below)

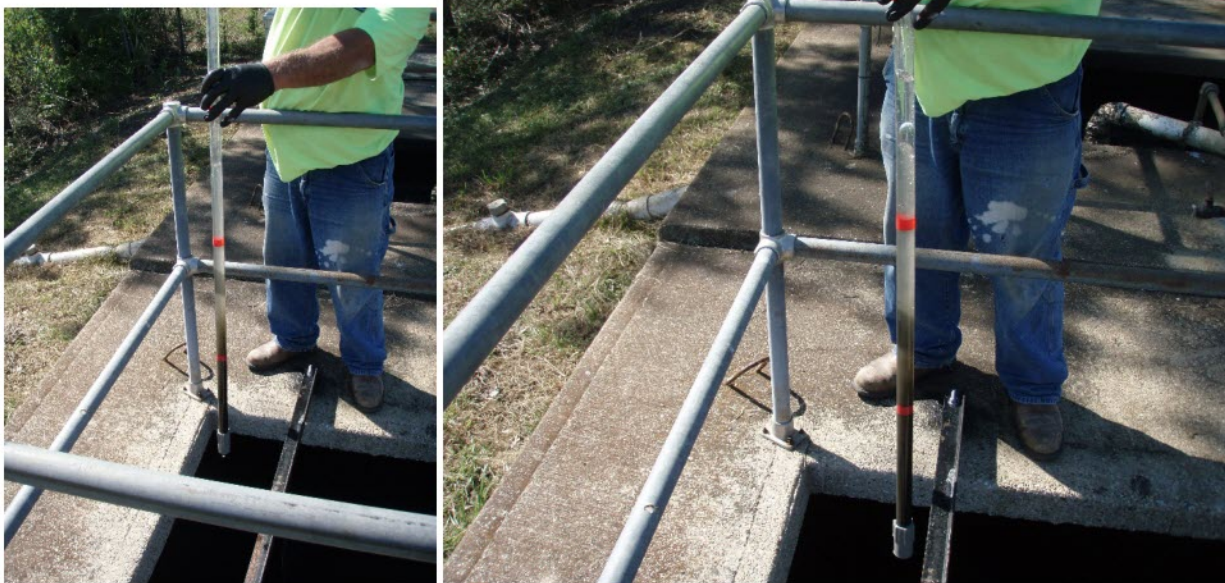
1. Solids in the Chlorine Contact Chamber (see pictures below).

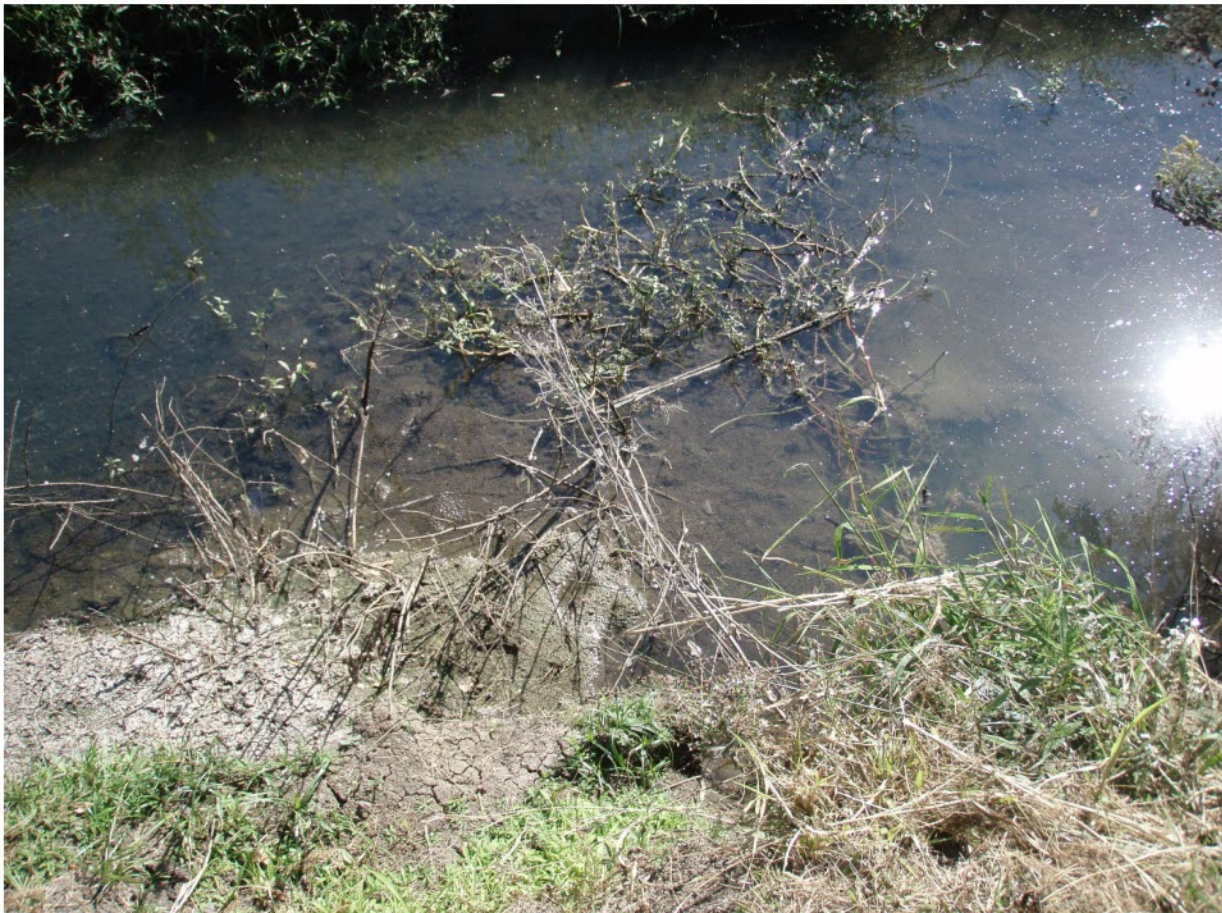
2. Sludge observed in the receiving ditch (see picture below).

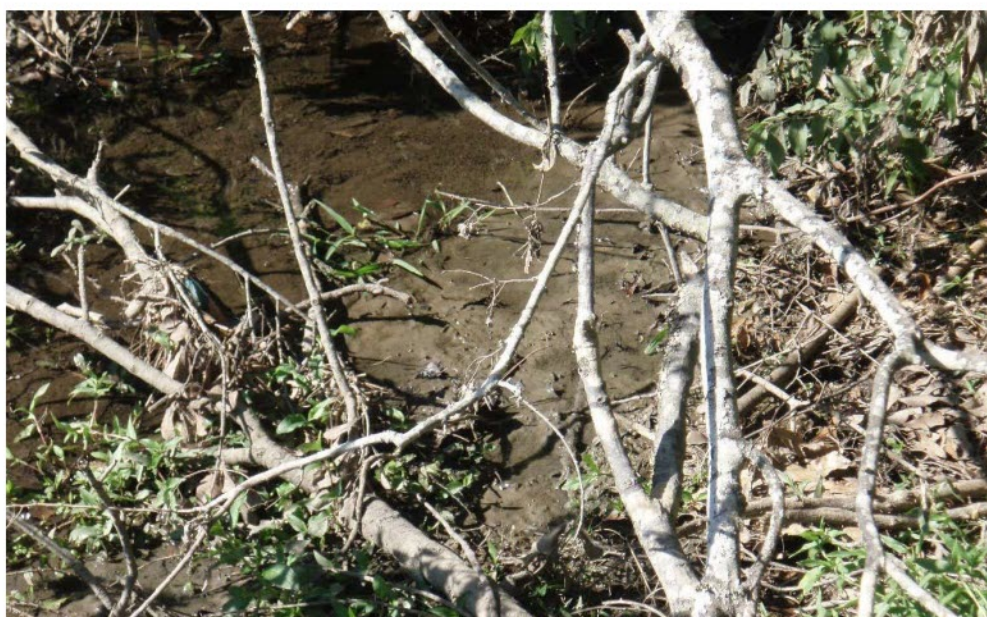
1. Sludge observed in the receiving ditch from Eureka #1 discharge (see picture below).

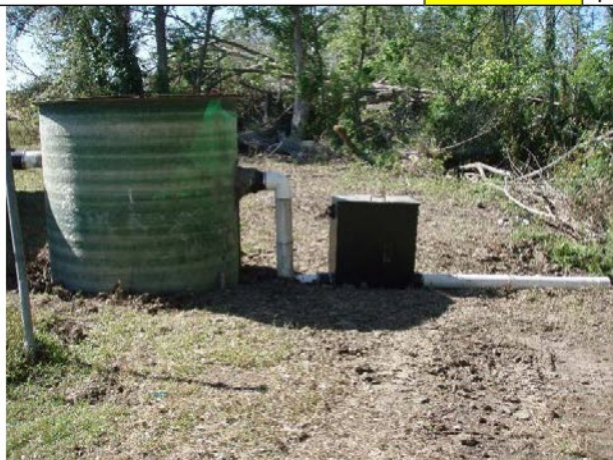
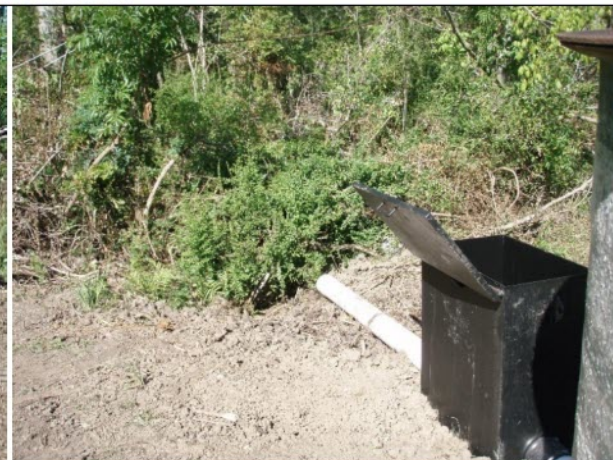
| Job to complete | Date completed | Job completion Information |
|---|---|---|
| Discharge Install v-notch sample box or other flow measurement system | 11/15/21 | Delayed due to weather and Contractor Scheduled for 5-1-21. Unknown date confirmed on Audit date/ completed. See picture below |

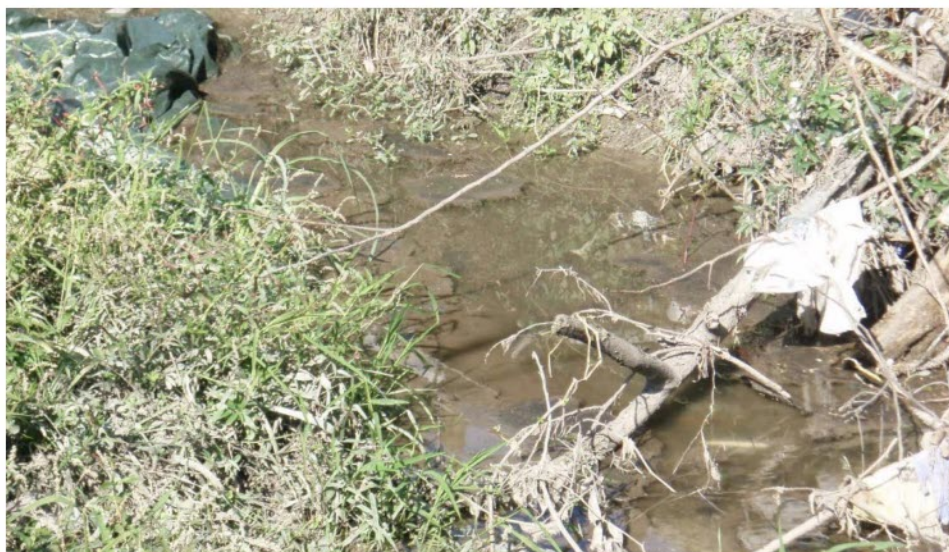
1. Sludge observed in the receiving ditch (see picture below).

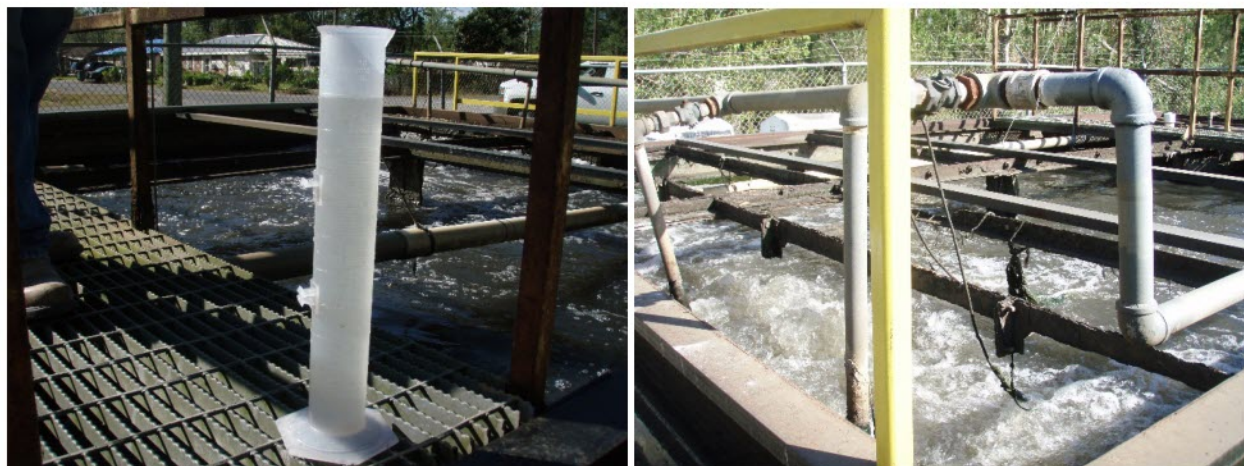
1. No solids in the aeration basin, Sludge Volume Index - 0 - (see picture below of 30-minute set test and aeration basin).

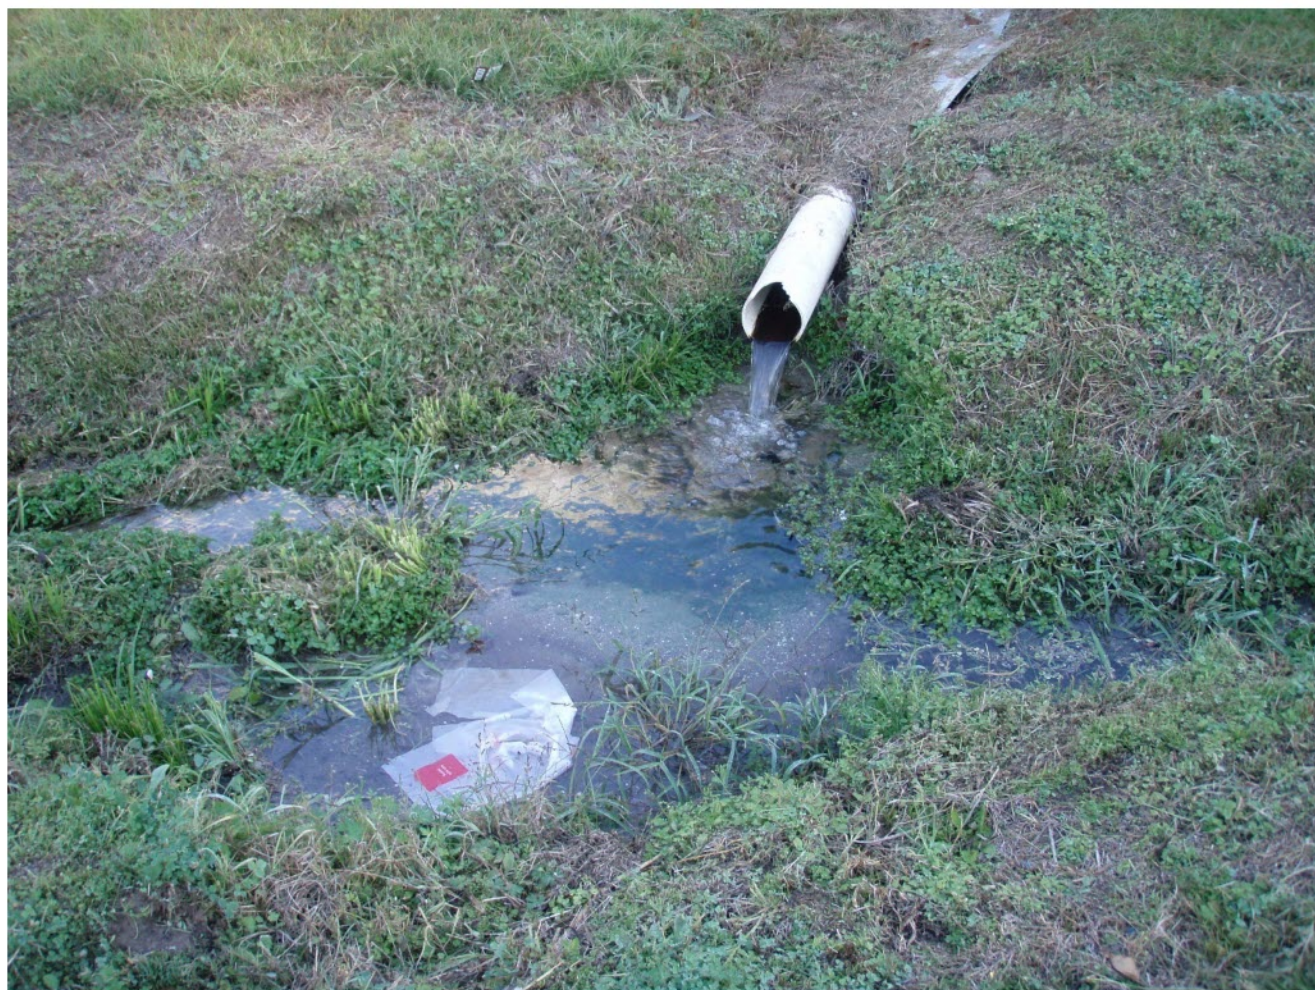
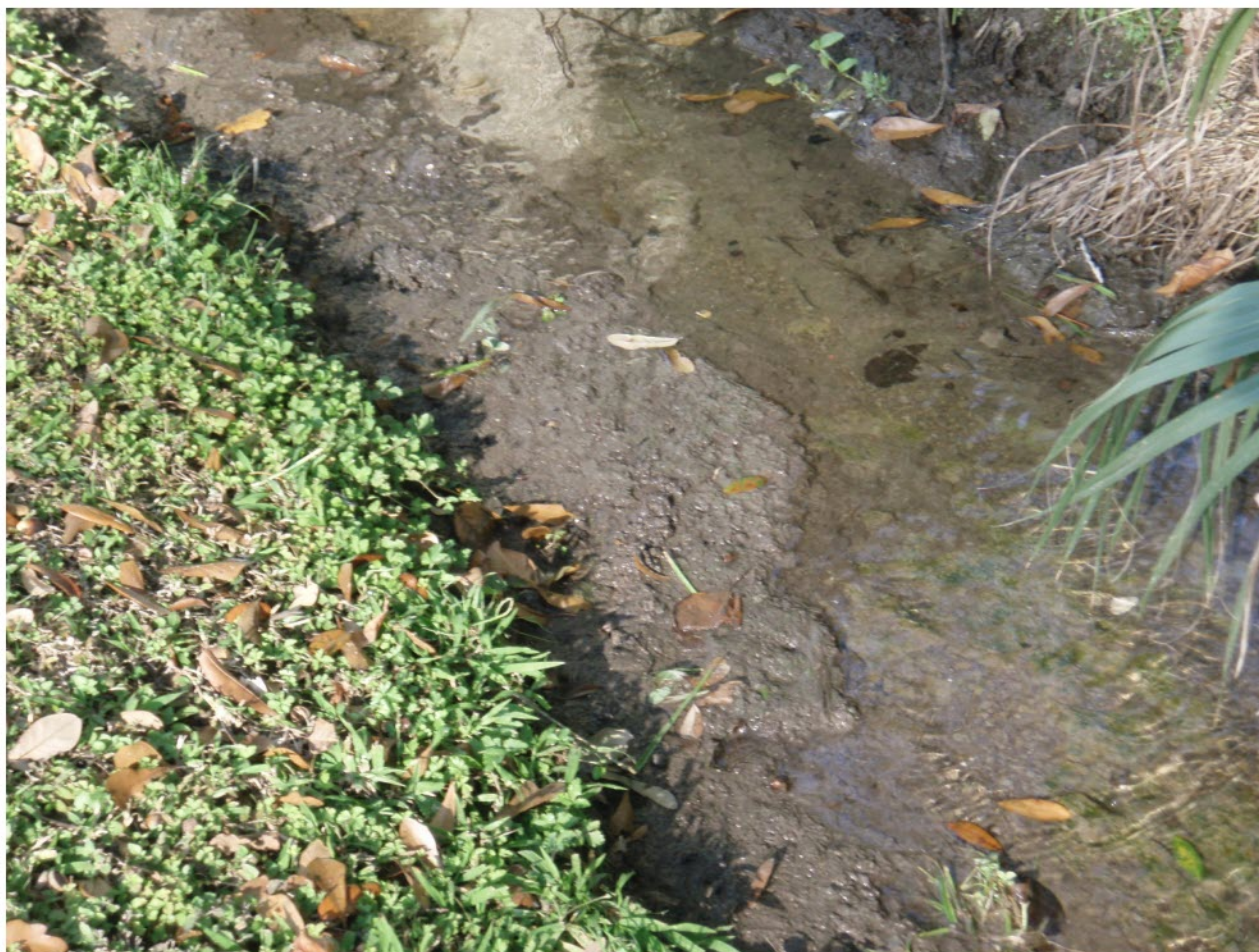
1. Sludge observed in the receiving ditch (see the following pictures below).

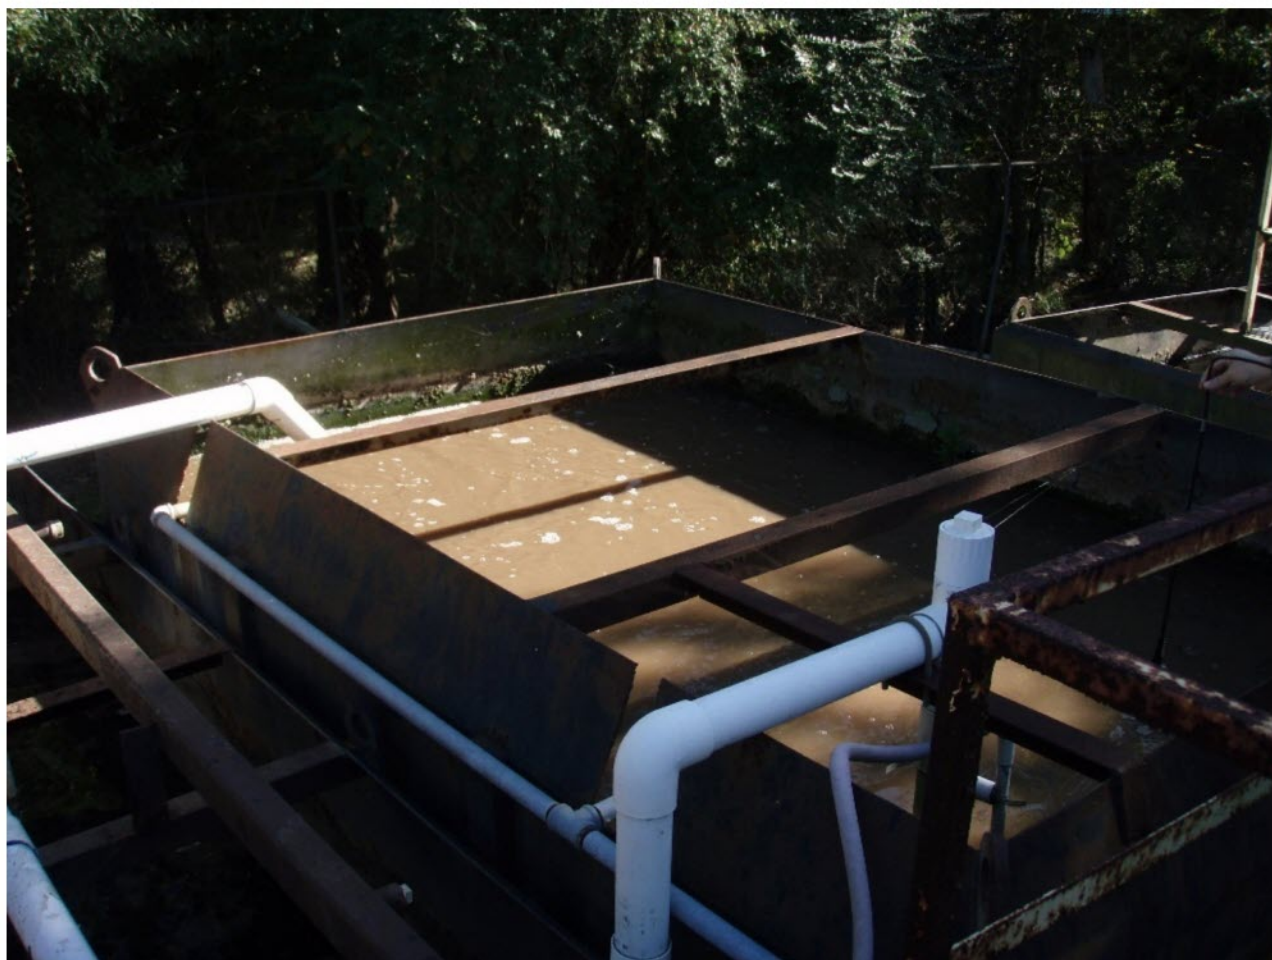
1. The digester that is installed for both plants is not being utilized or properly operated as required. The digester was reported to be repaired and utilize on 9/12/2018 per the DOJ consent decree required jobs for Avies Knoll 1 & 2. The digester's utilization with proper operations is part of the plants design.

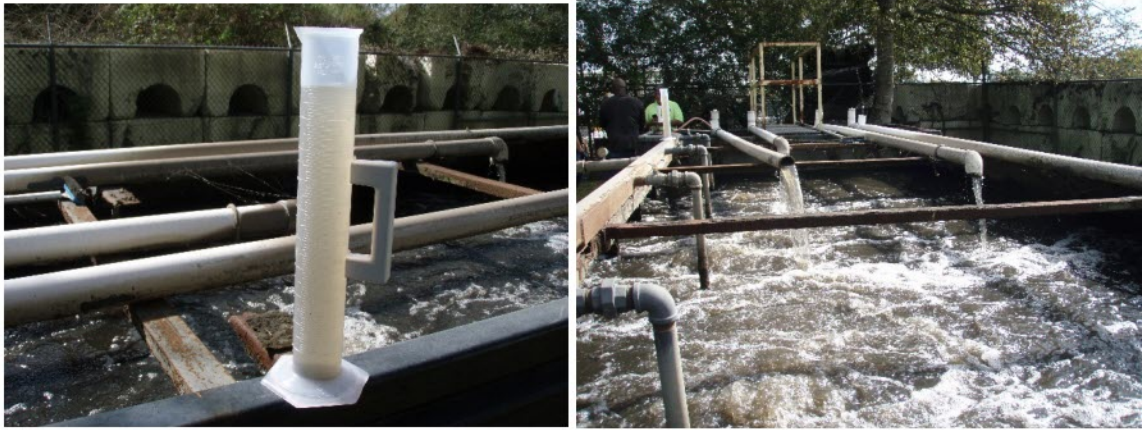
1. No solids in the aeration basin, Sludge Volume Index - 0 - (see picture below of 30-minute set test and aeration basin).

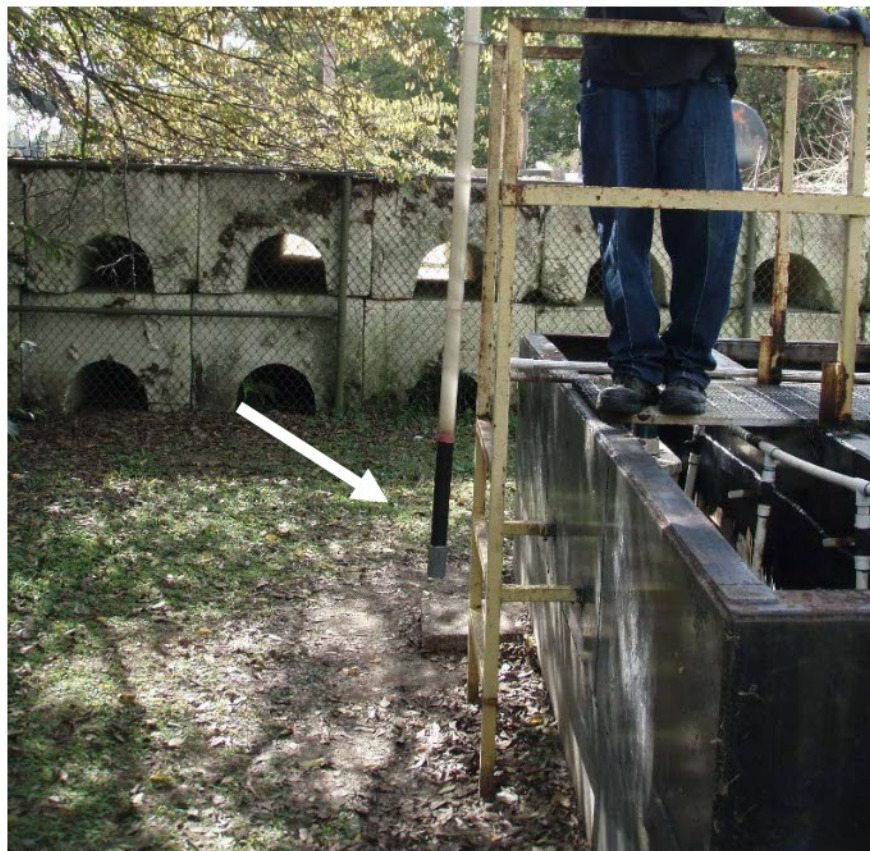
2. Solids in the Chlorine Contact Chamber (see picture below).

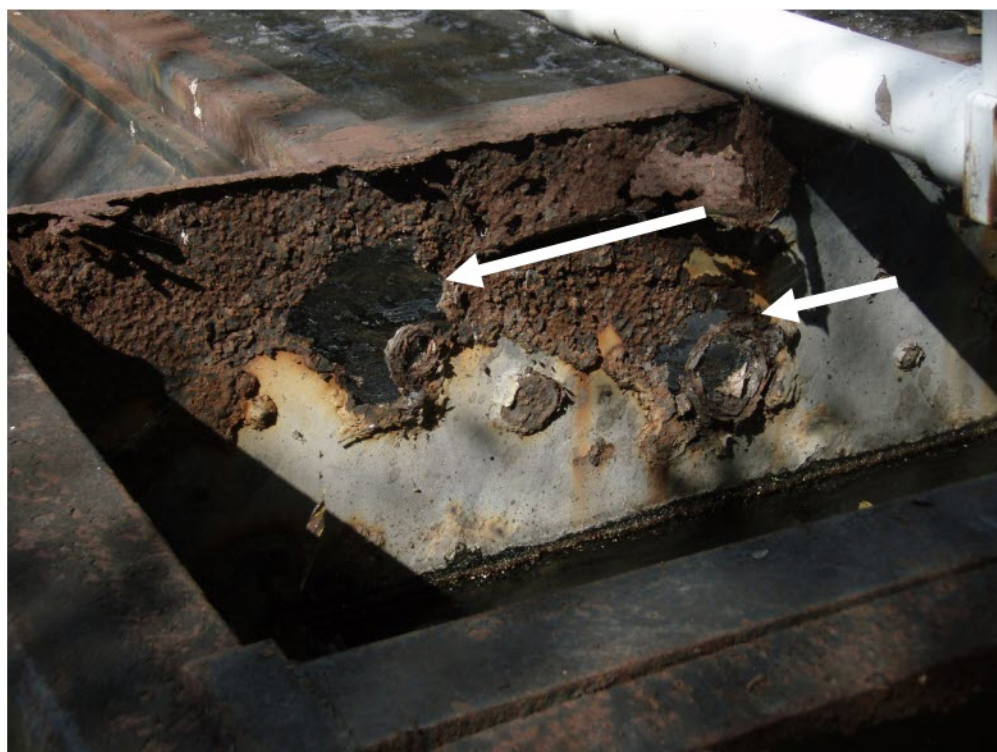
3. Rusted and deteriorated structure needs to be repaired (see picture below).

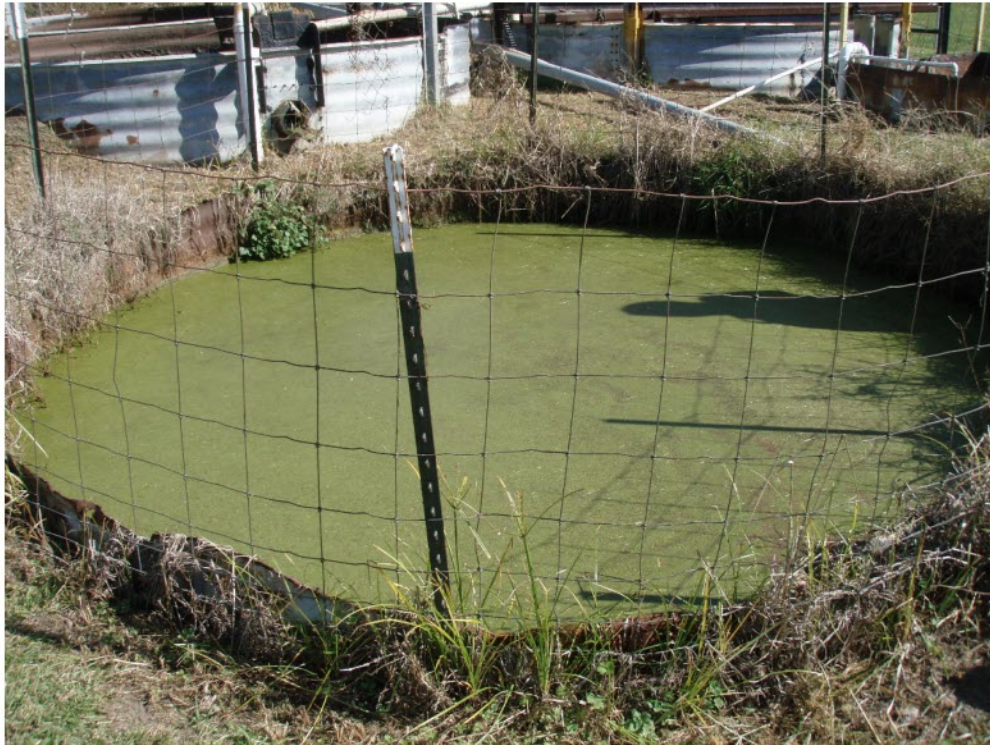
1. Abandoned treatment tank needs to be properly remediated and closed (see picture below).

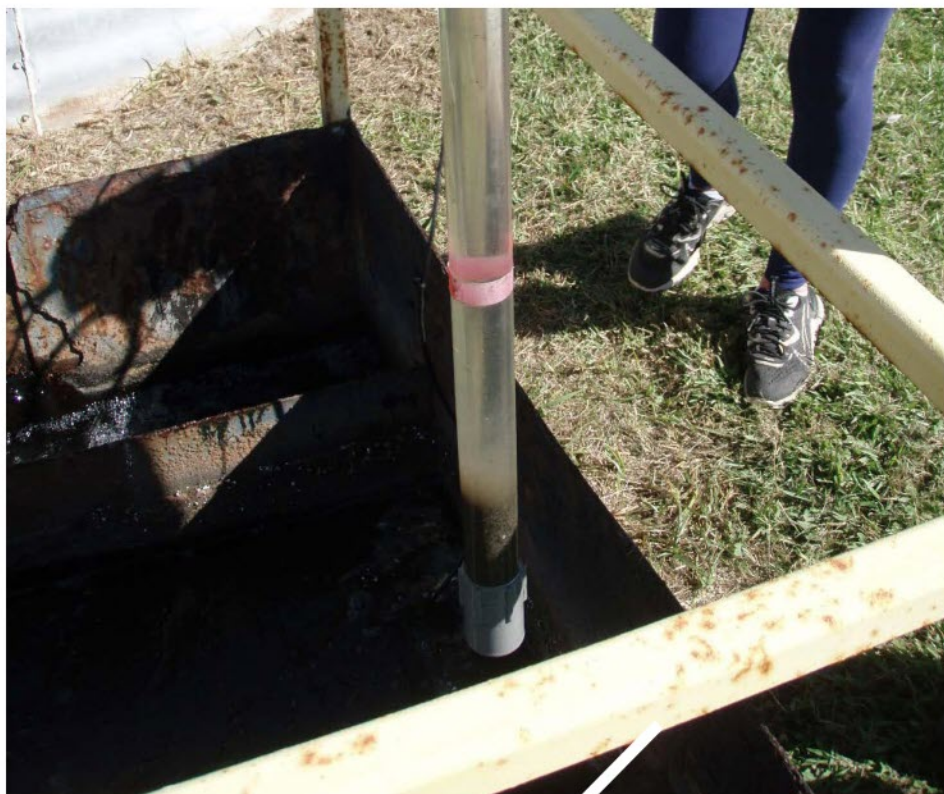
2. Solids in the Chlorine Contact Chamber (see picture below).

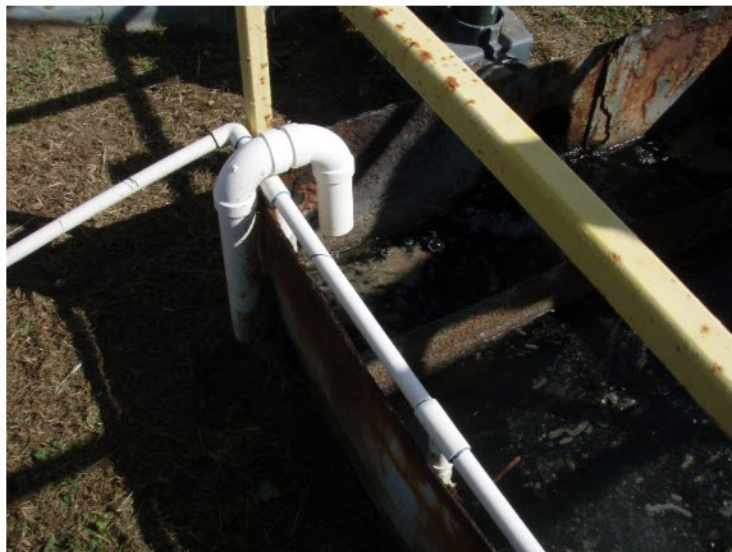
3. Observed unknown 2-inch pipe at the Chlorine Contact Chamber (see picture below).

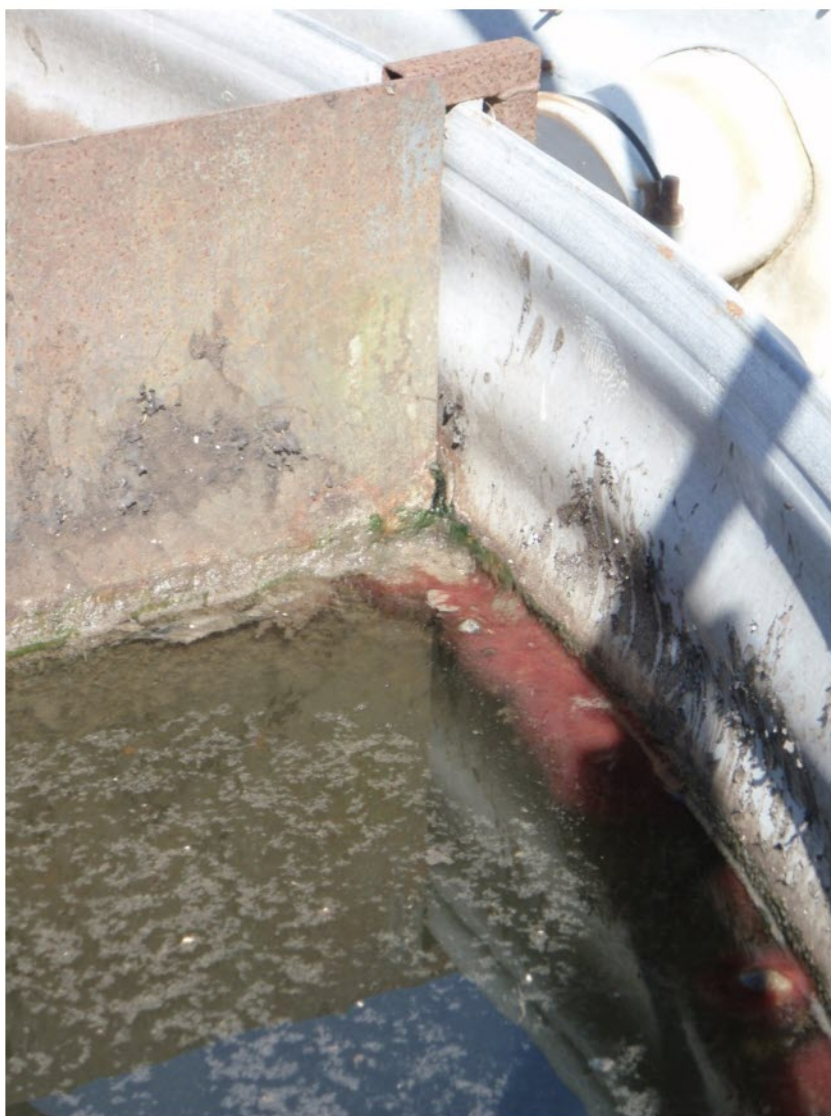
4. Observed Bloodworms in the clarifier at the time of the inspection (see picture below).

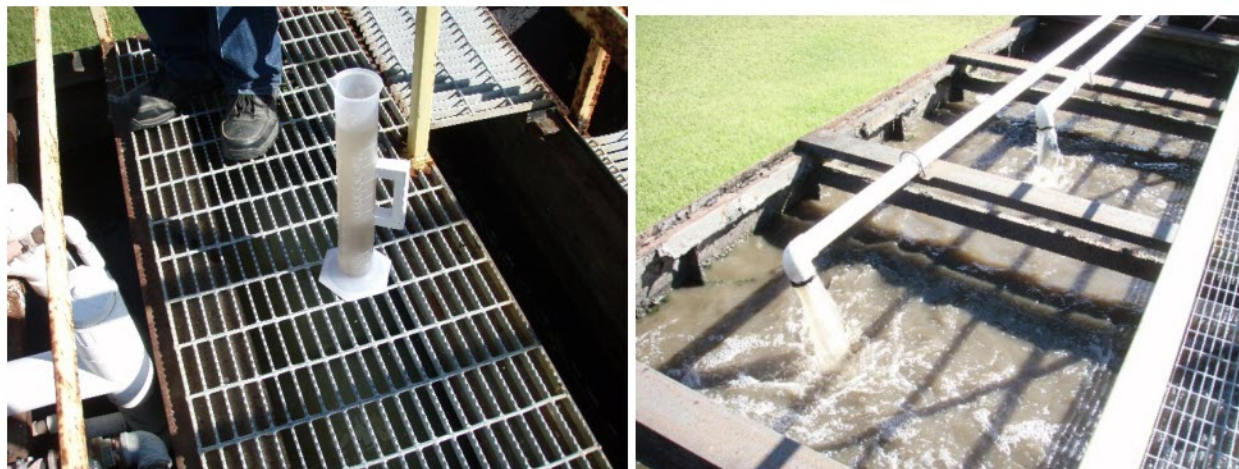
1. No solids in the aeration basin, Sludge Volume Index - 0 - (see picture below of 30-minute set test and aeration basin).

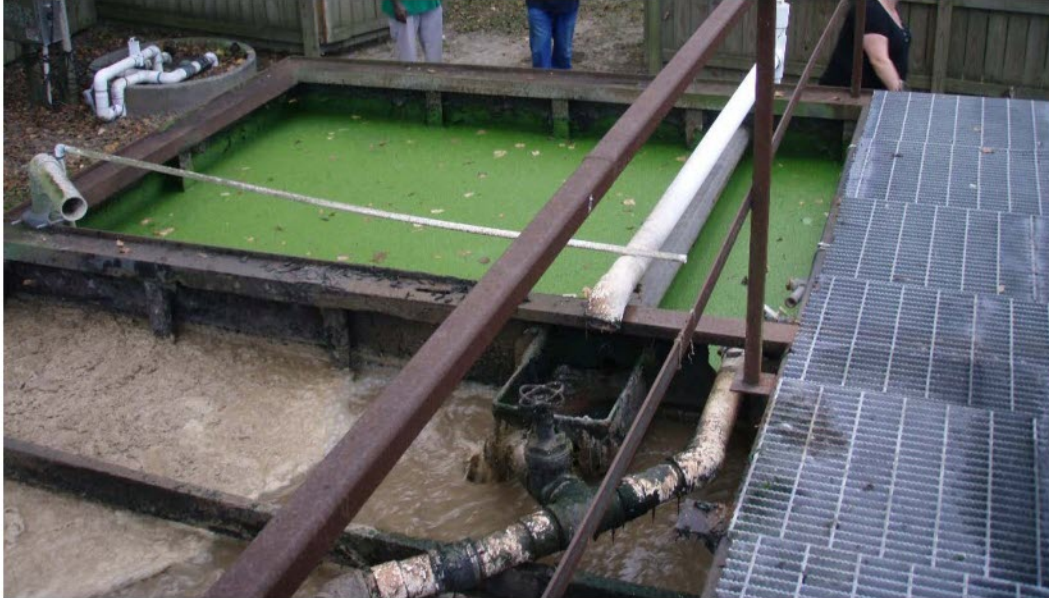
1. The digester is not operational or being utilized. The digester's utilization with proper operations is part of the plants design.

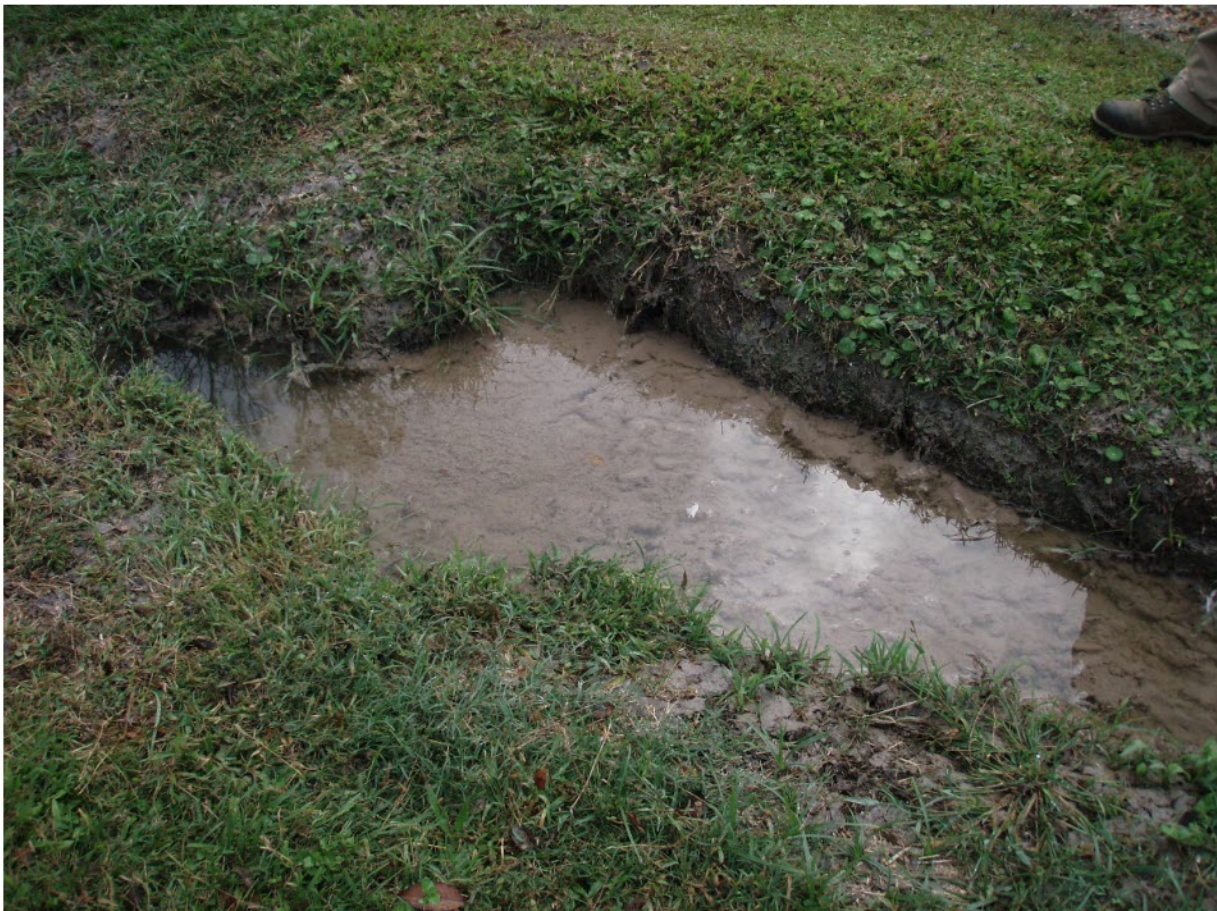
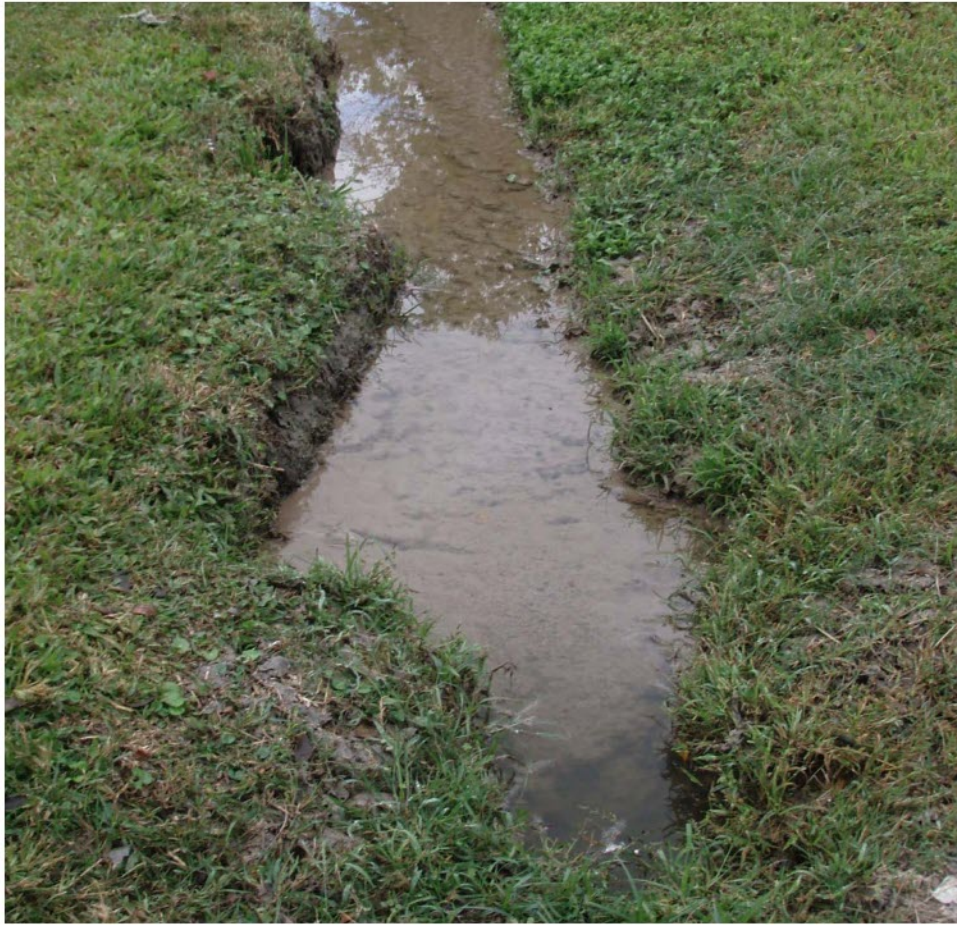
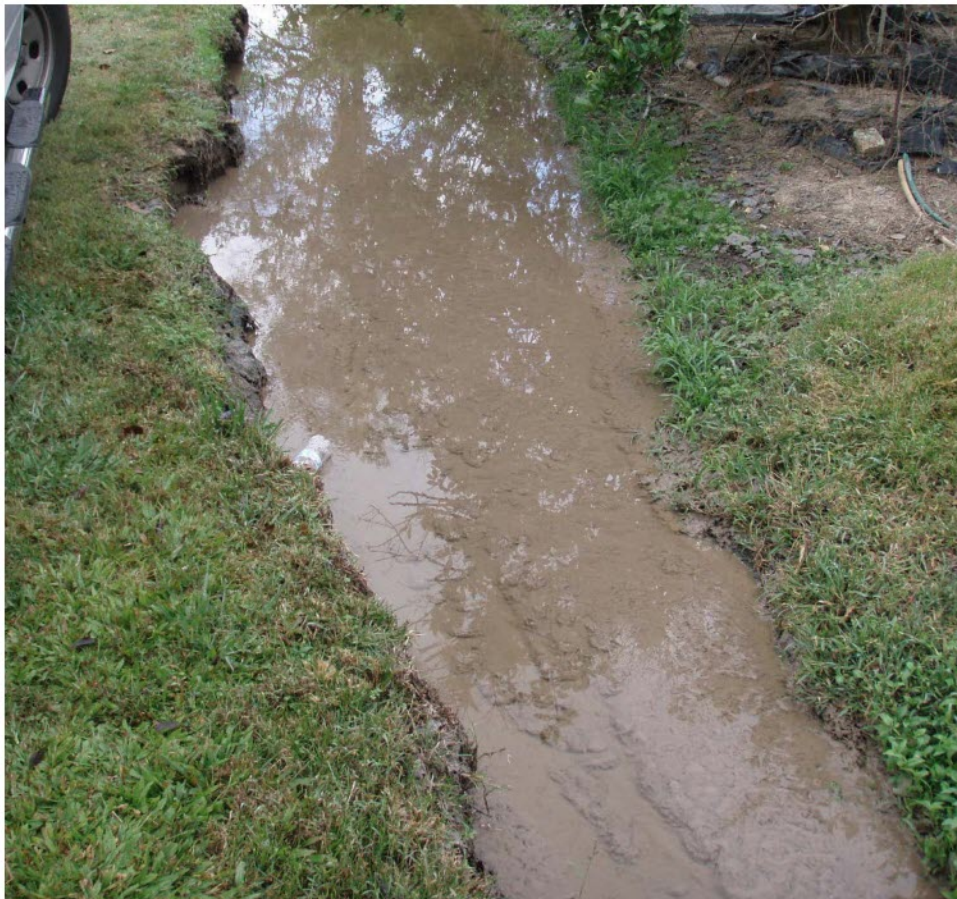
2. Sludge observed in the receiving ditch (see pictures below).

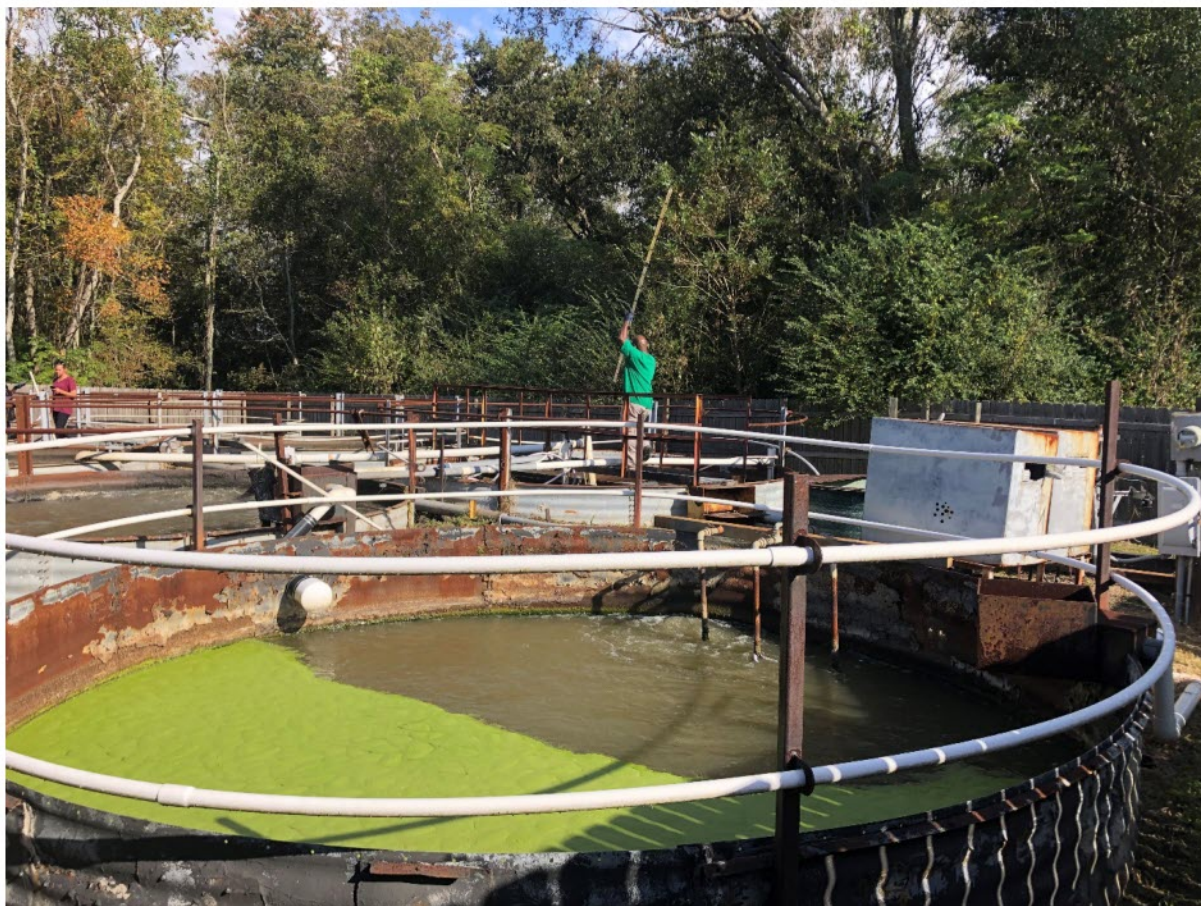
1. The first aeration cell was not being utilized or properly operated as required. The first aeration cell was reported to be online and providing additional treatment capacity on 10/01/2016. The aeration cell's utilization with proper operations is part of the plants design.

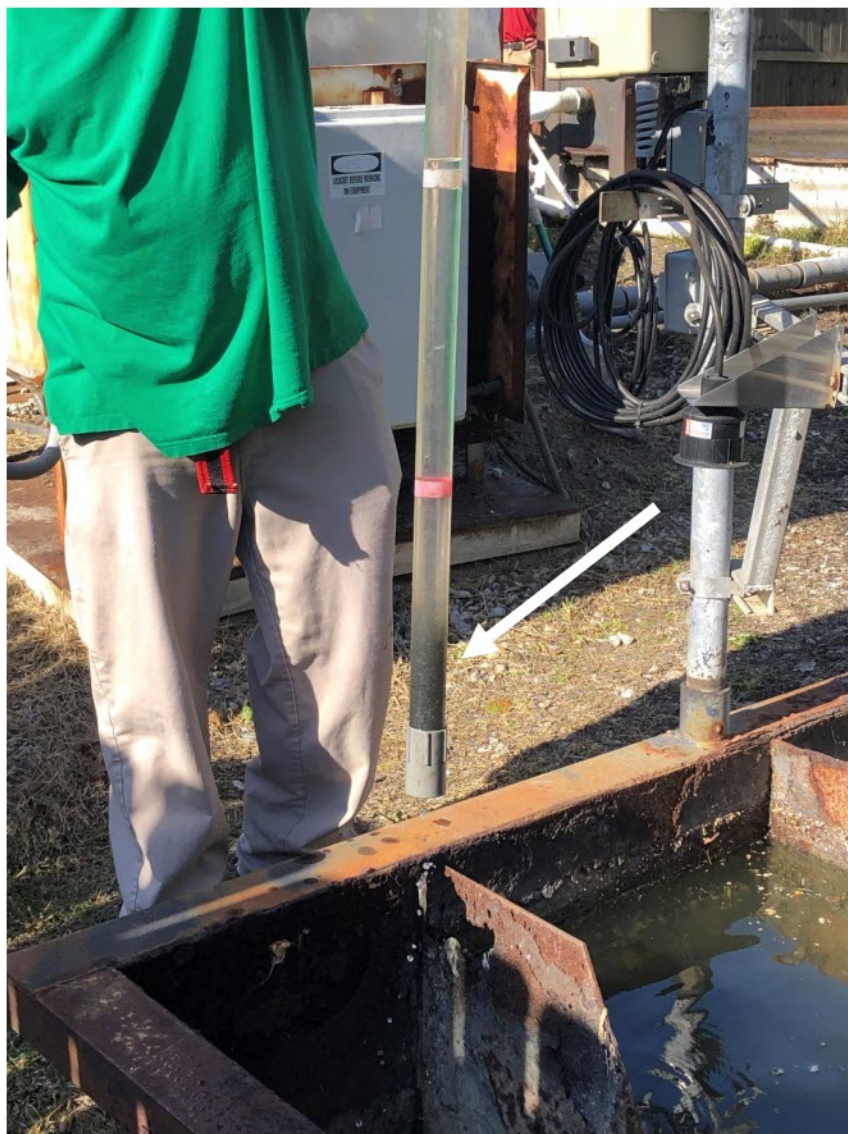
2. Solids in the Chlorine Contact Chamber (see pictures below).

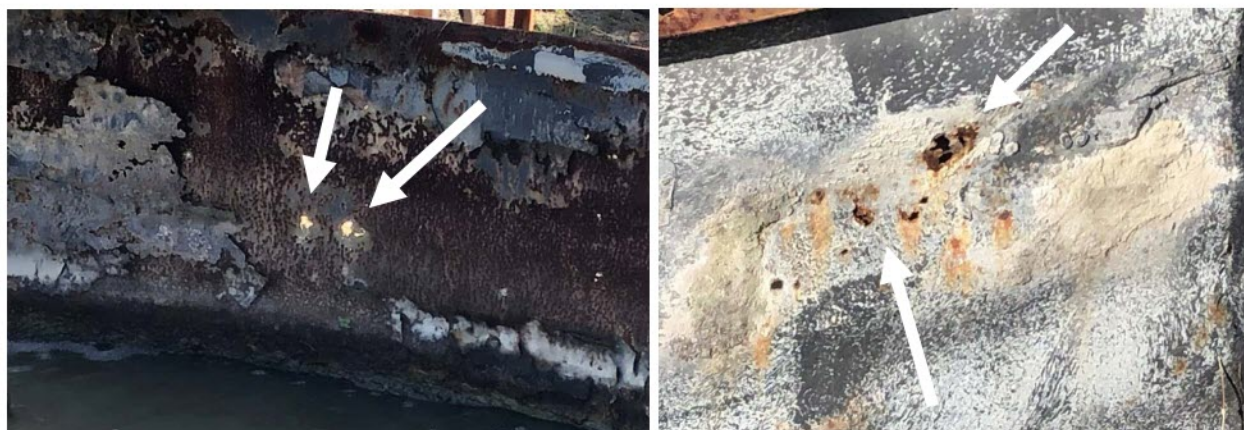
3. Rusted and deteriorated structure needs to be repaired (see pictures below).

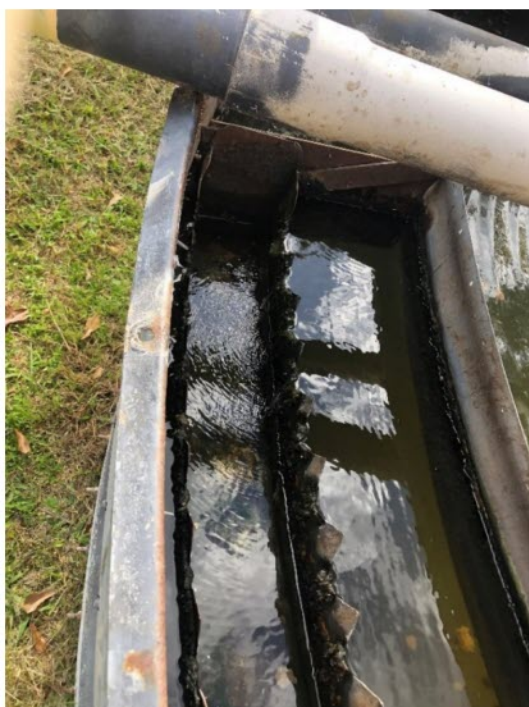
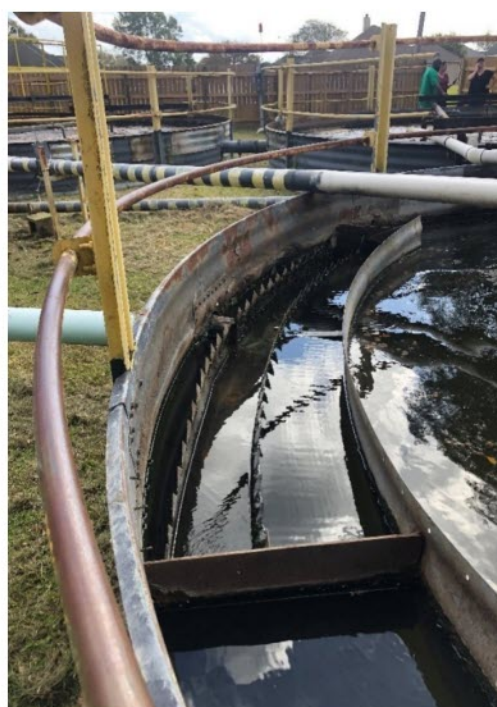
1. Weirs were being bypassed due to the uneven weir structure (see pictures below).

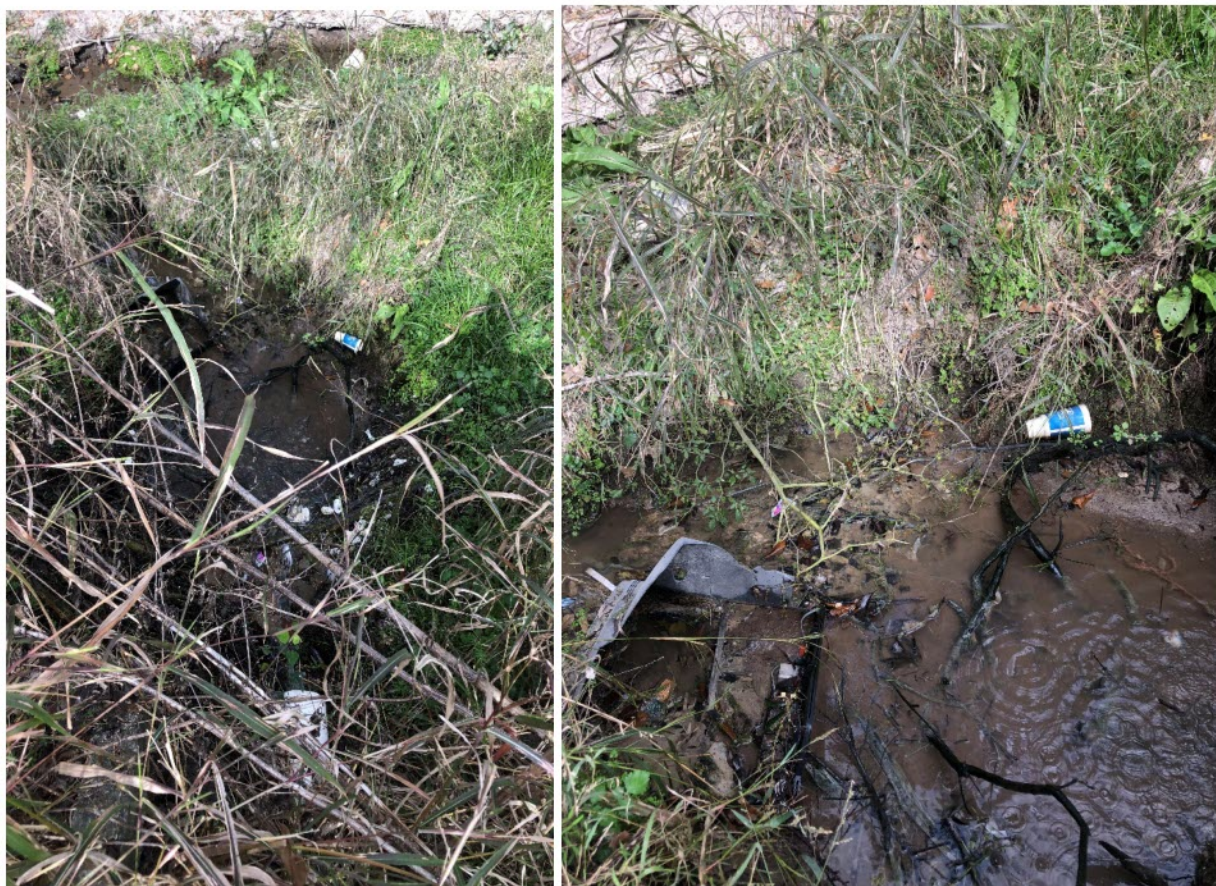
2. Sludge observed in the receiving ditch (see pictures below).
