**Region 6 Compliance Assurance and Enforcement Division  
INSPECTION REPORT**

| Inspection Date(s): | November 15–18, 2021 | | |
| Company Name: | <b>Total Environmental Solutions, Inc. (TESI)</b> | | |

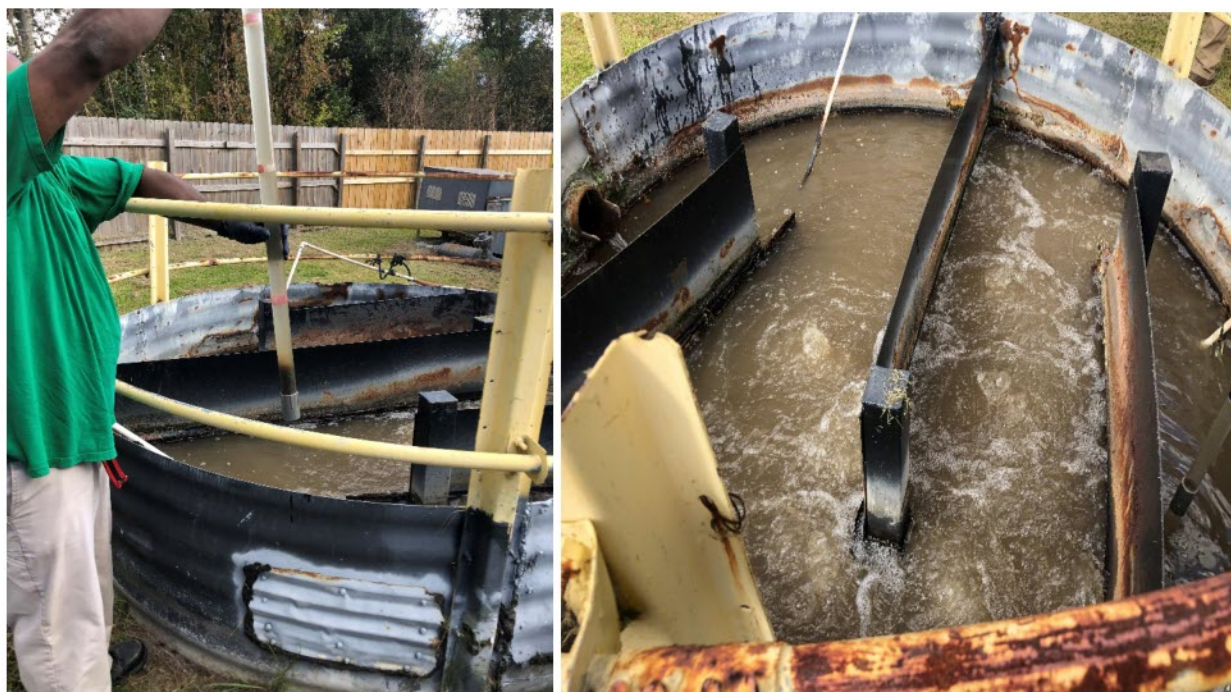
3. Solids in the Chlorine Contact Chamber (see pictures below).

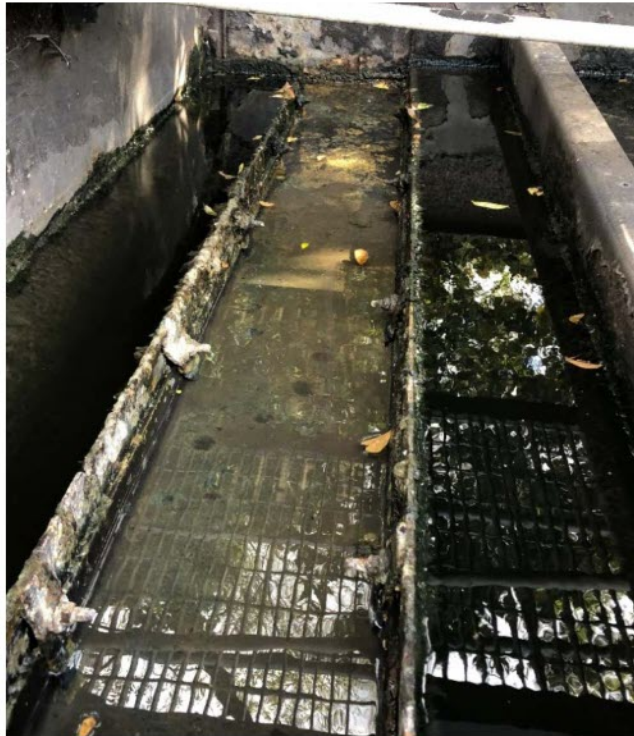
1. Weirs were being bypassed due to the uneven weir structure (see picture below).

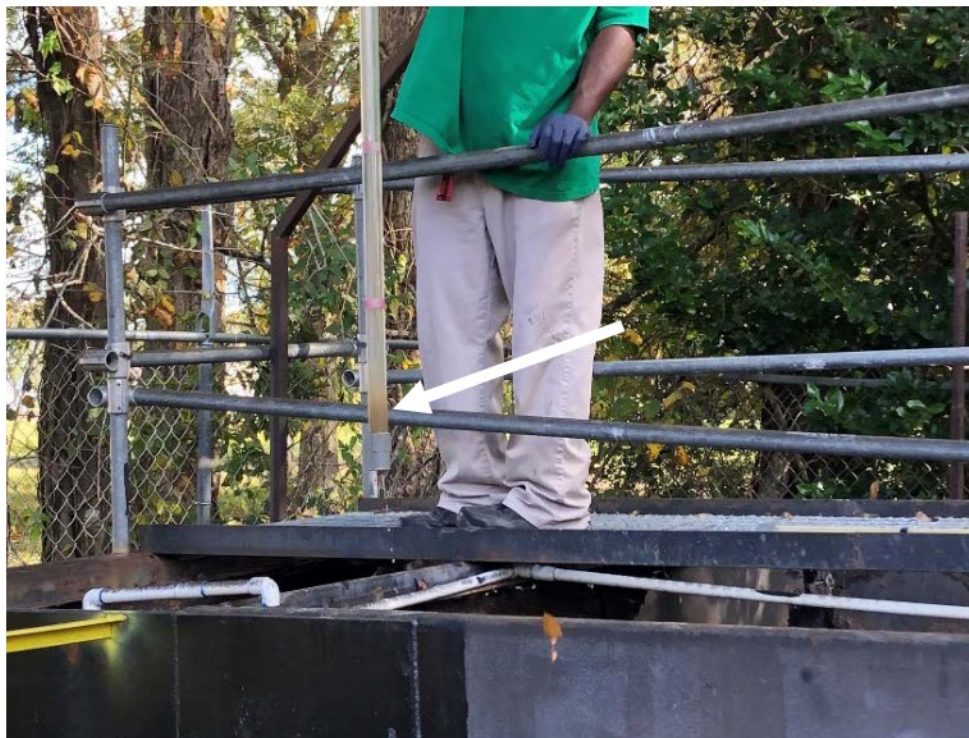
2. Solids in the Chlorine Contact Chamber (see pictures below).

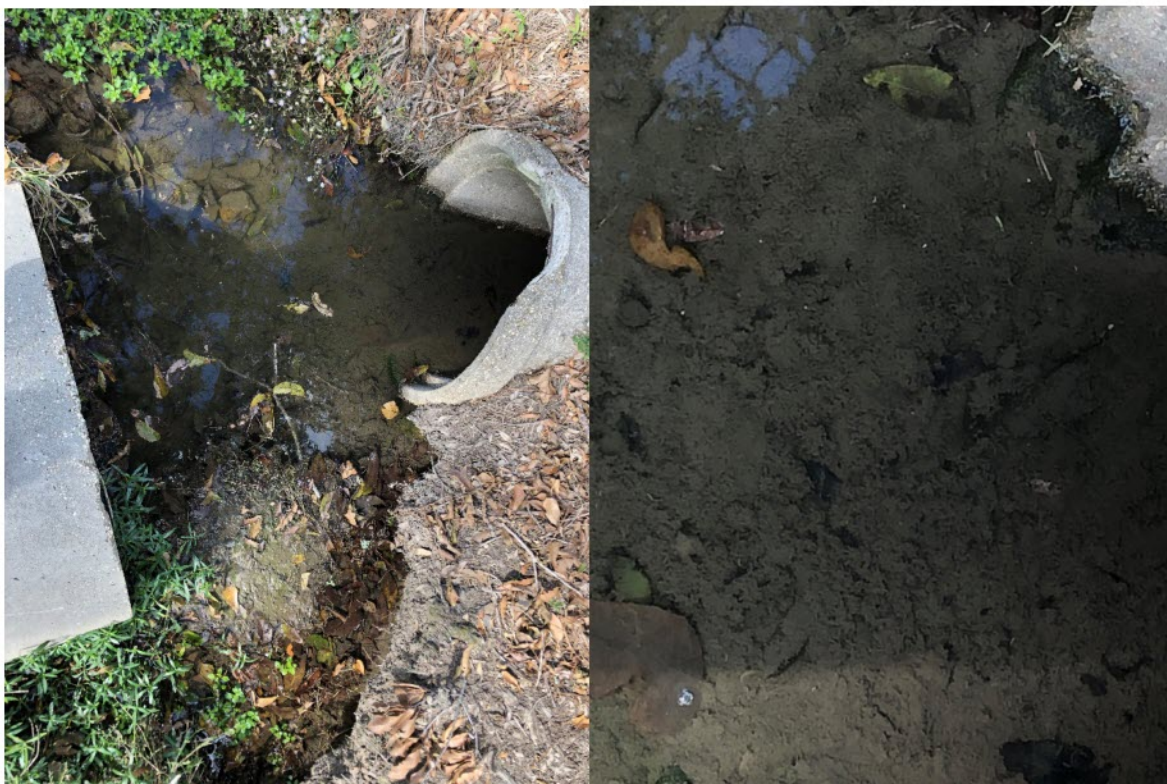
3. Sludge observed in the receiving ditch (see pictures below).

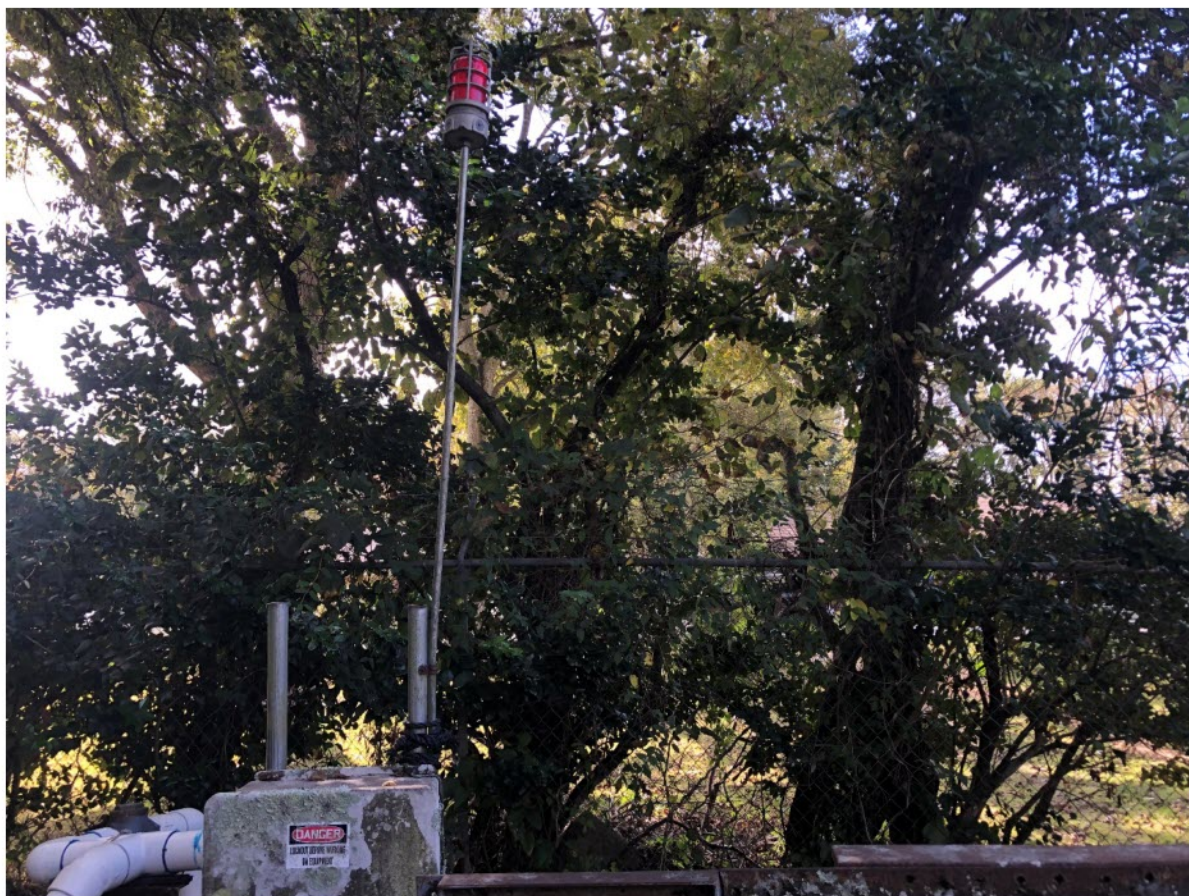
4. Warning light is not visible from the road due to trees (see picture below).

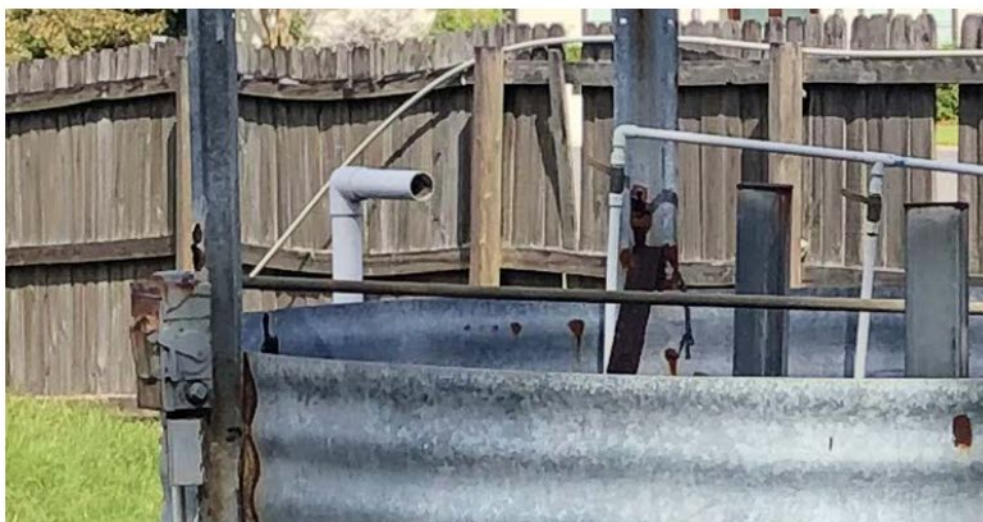
1. Observed unknown 2-inch pipe at the Chlorine Contact Chamber (see picture below).

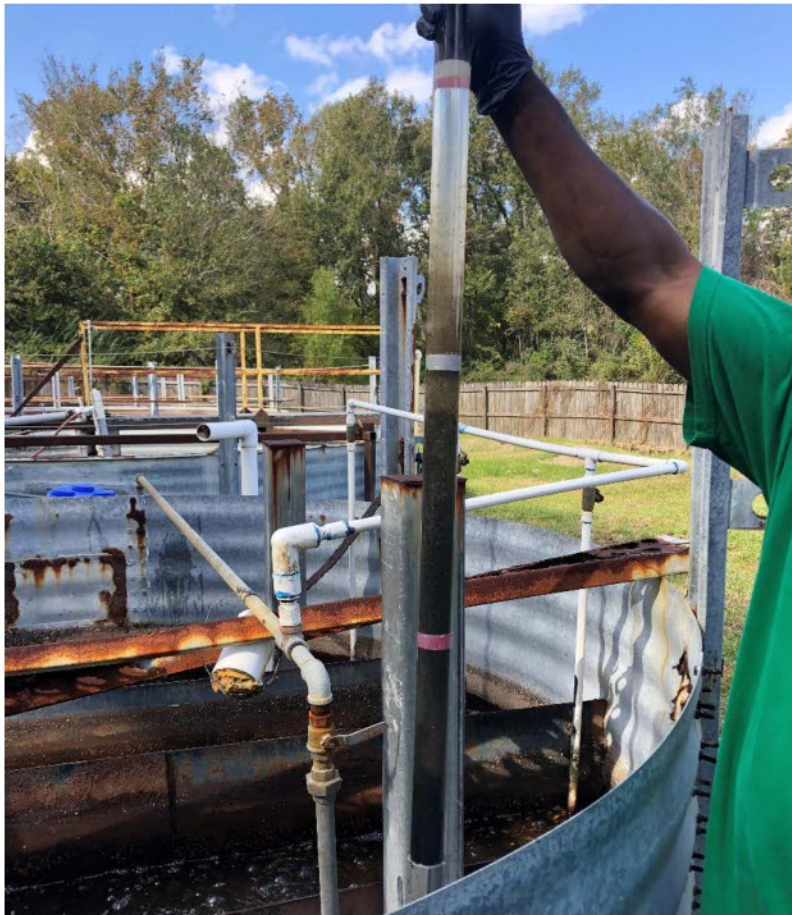
2. Solids in the Chlorine Contact Chamber (see pictures below).

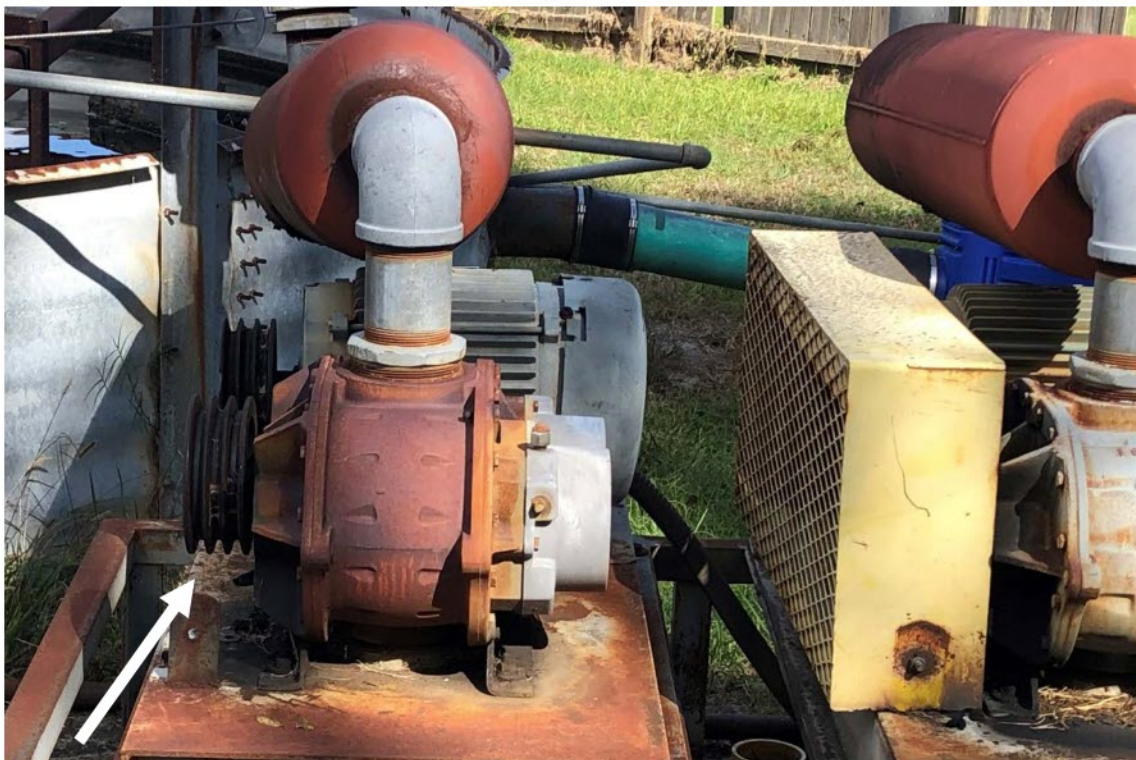
3. Aeration blow was not in working condition due to missing belt (see picture below).

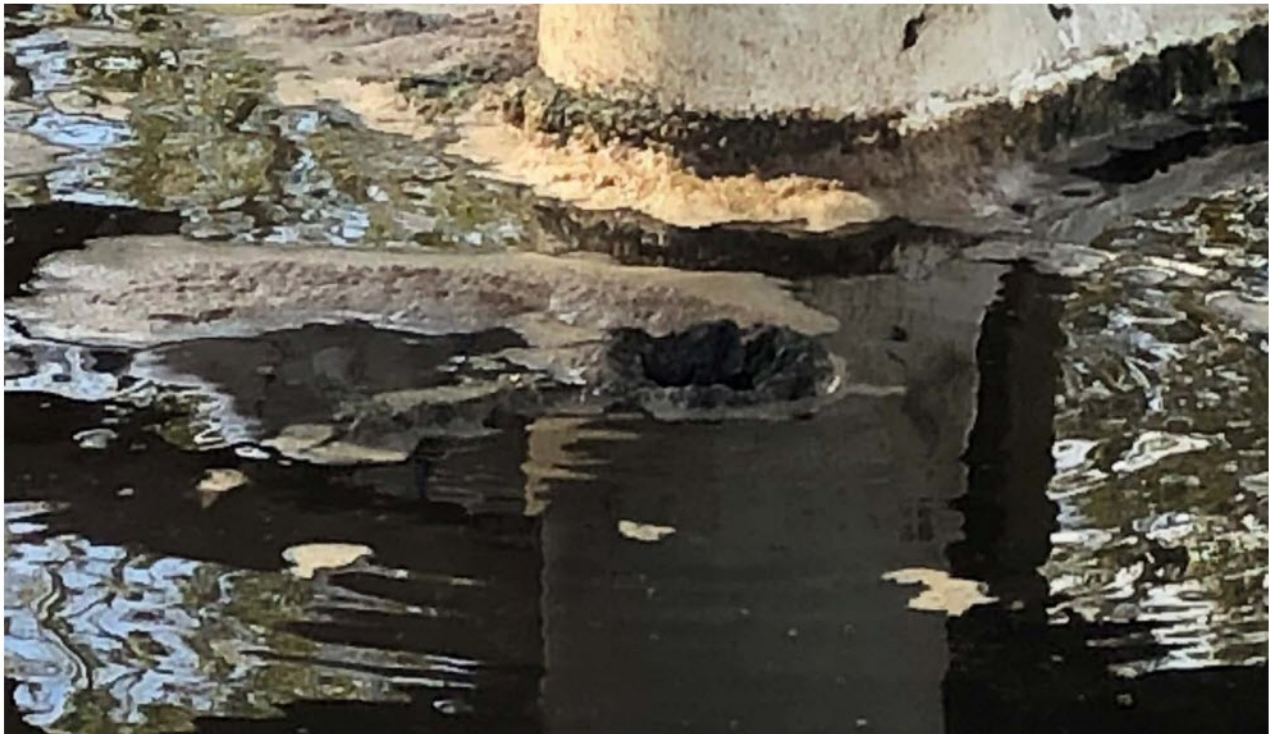
4. Skimmer not functioning correctly due to buildup of debris (see pictures below).

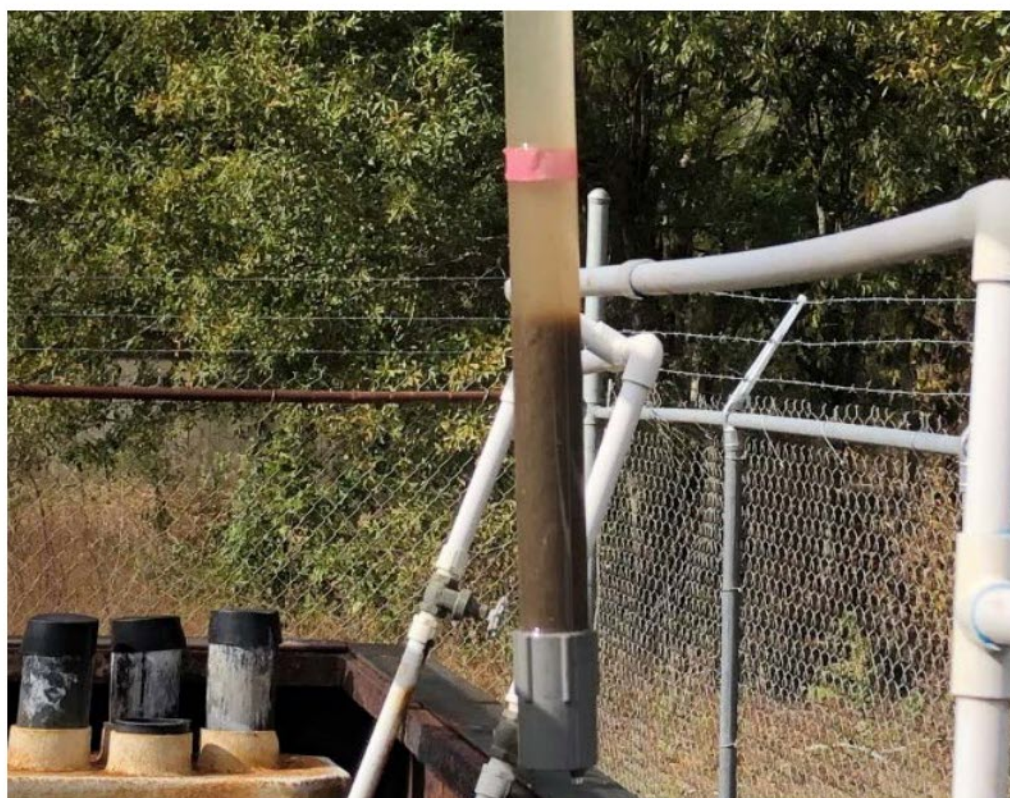
1. Solids in the Chlorine Contact Chamber of Arrowhead #2 STP (see picture below).

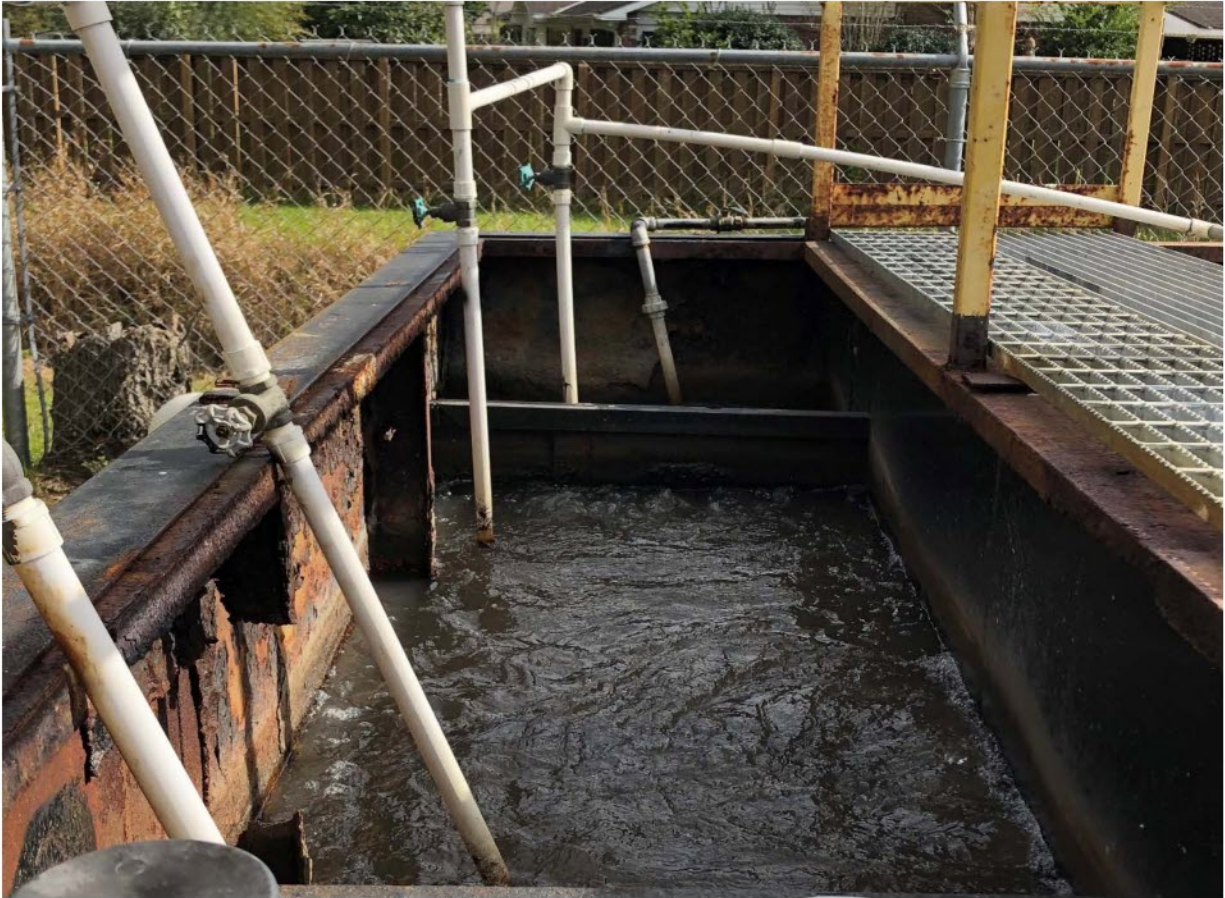
2. Solids in the Chlorine Contact Chamber of Arrowhead #1 STP. Chamber was cloudy with solids due to aeration (see picture below).

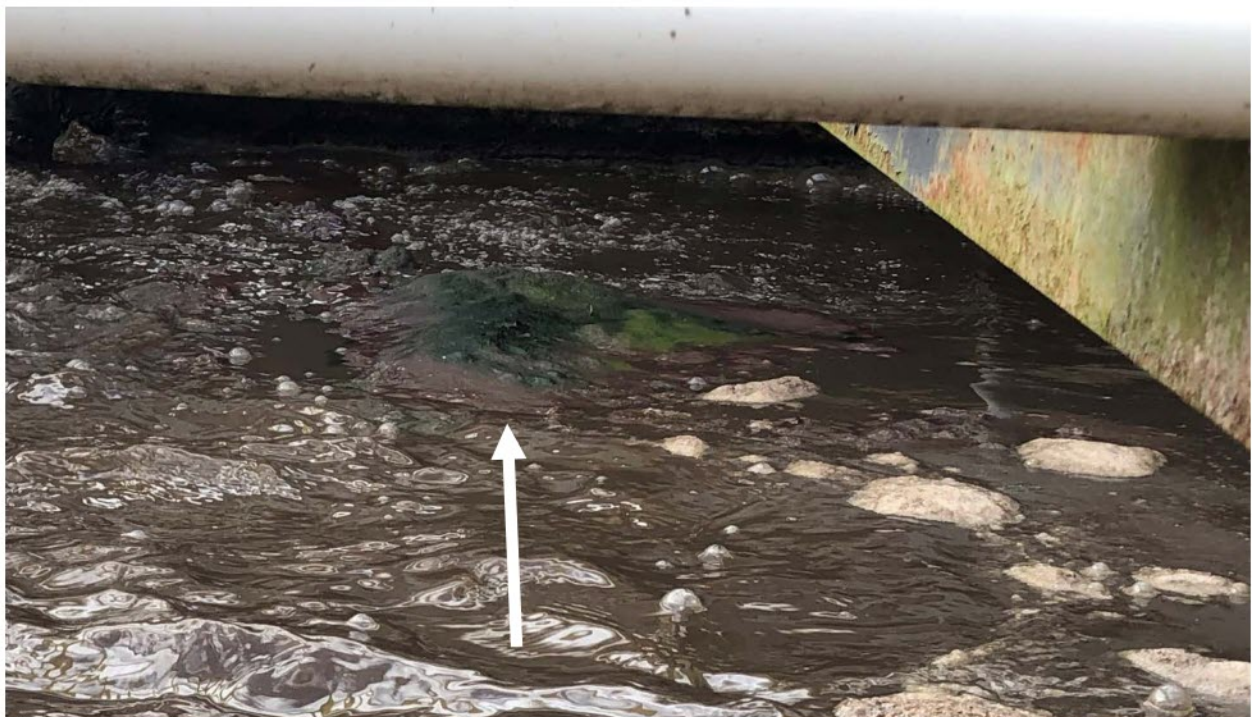
3. Large mass of debris observed in the aeration chamber of Arrowhead #1 STP (see picture below).

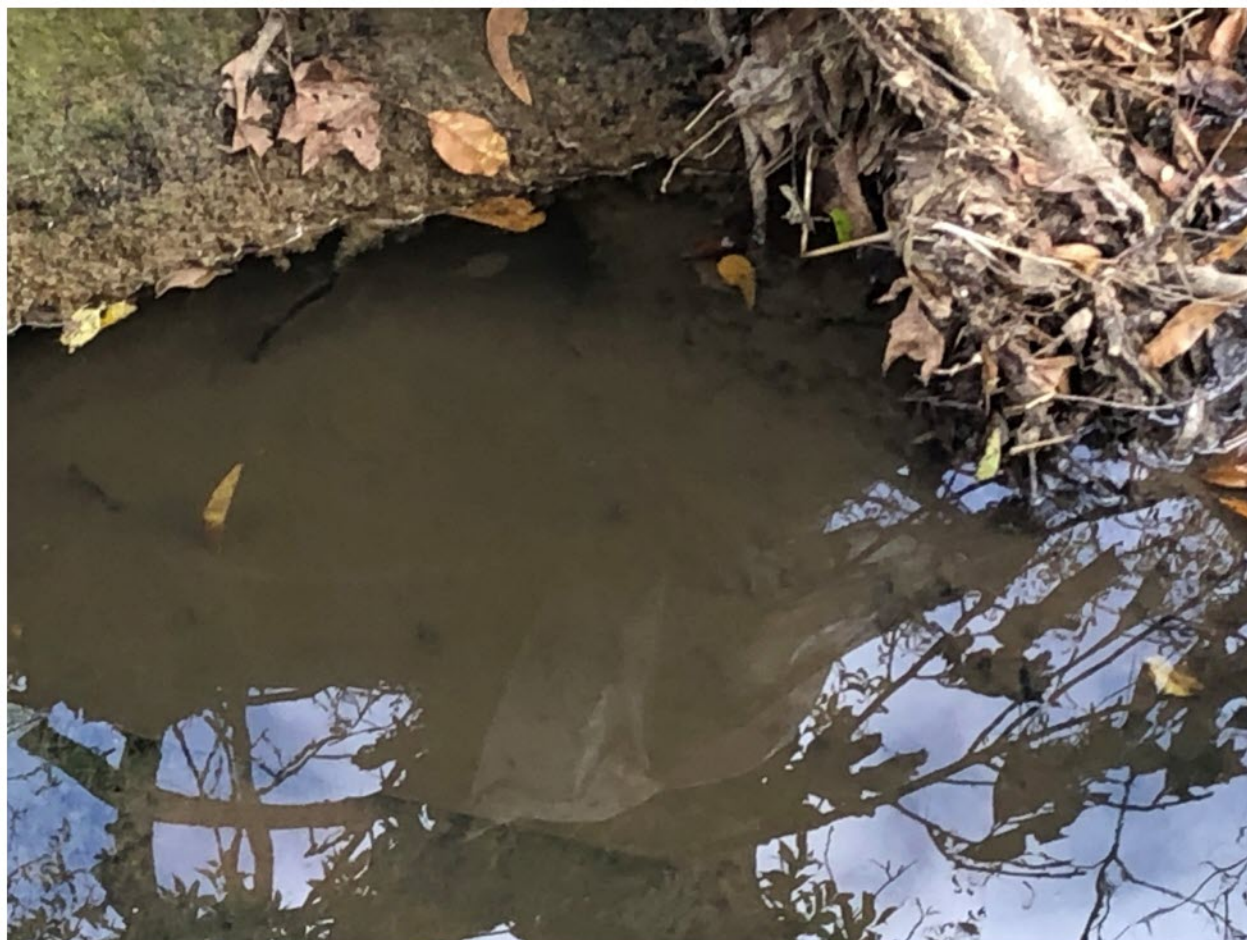
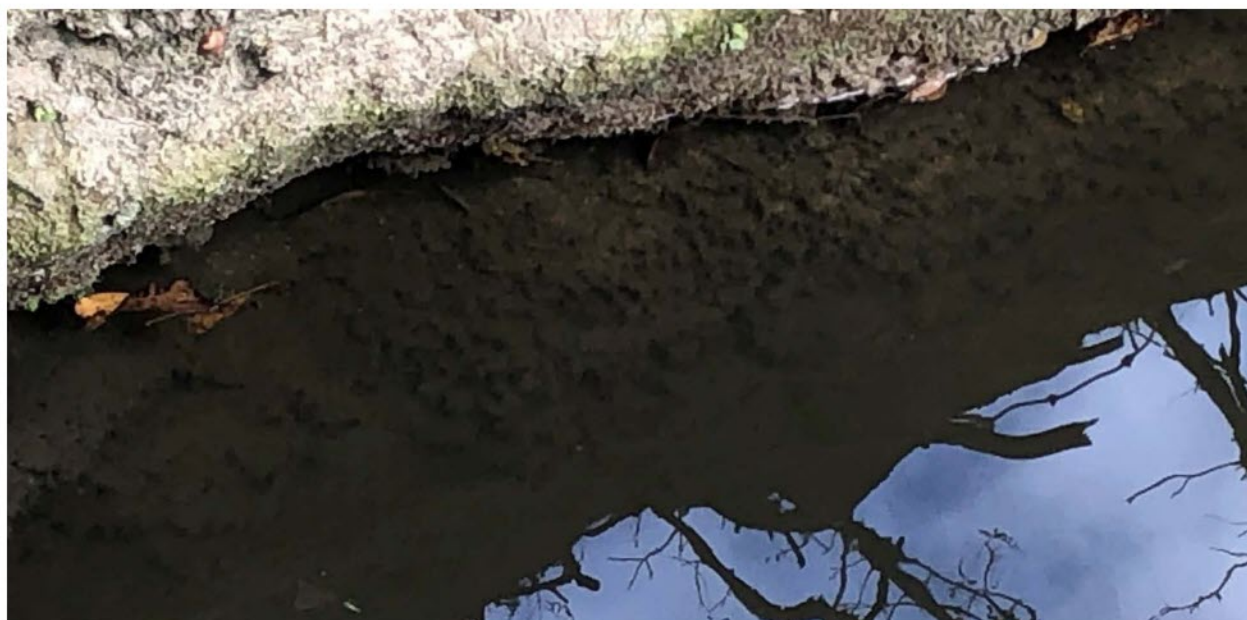
4. Sludge observed in the receiving ditch (see pictures below).

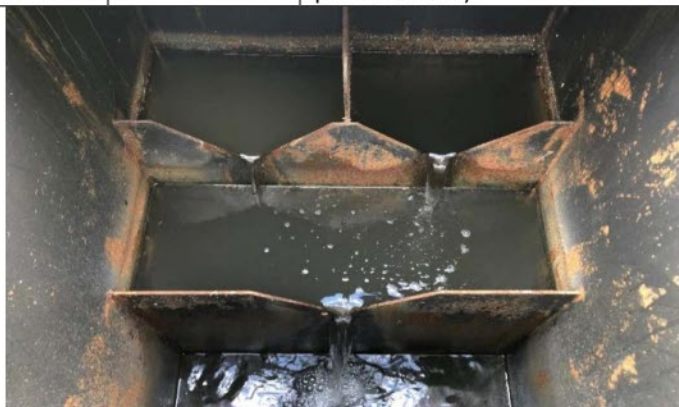
| Job to complete | Date completed | Job completion Information |
|---|---|---|
| Discharge Install v-notch sample box or other flow measurement system | 1/27/2021 | Delayed due to weather and Contractor Scheduled for 5-1-21. Unknown date completed/confirmed on date of Audit (see picture below) |

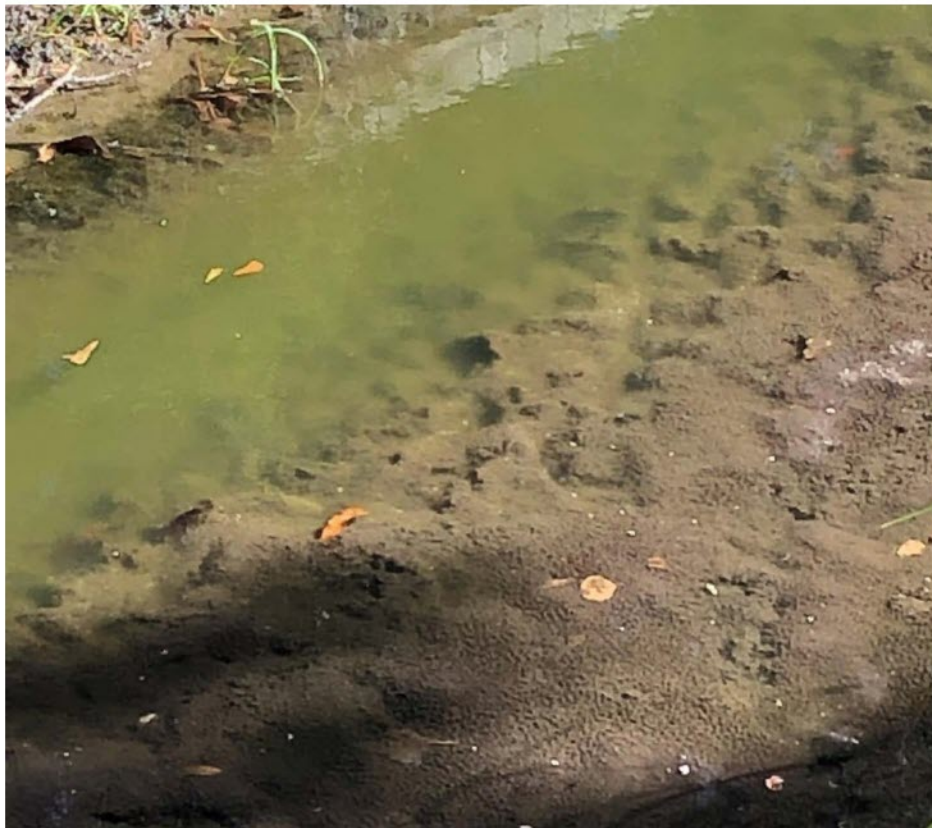
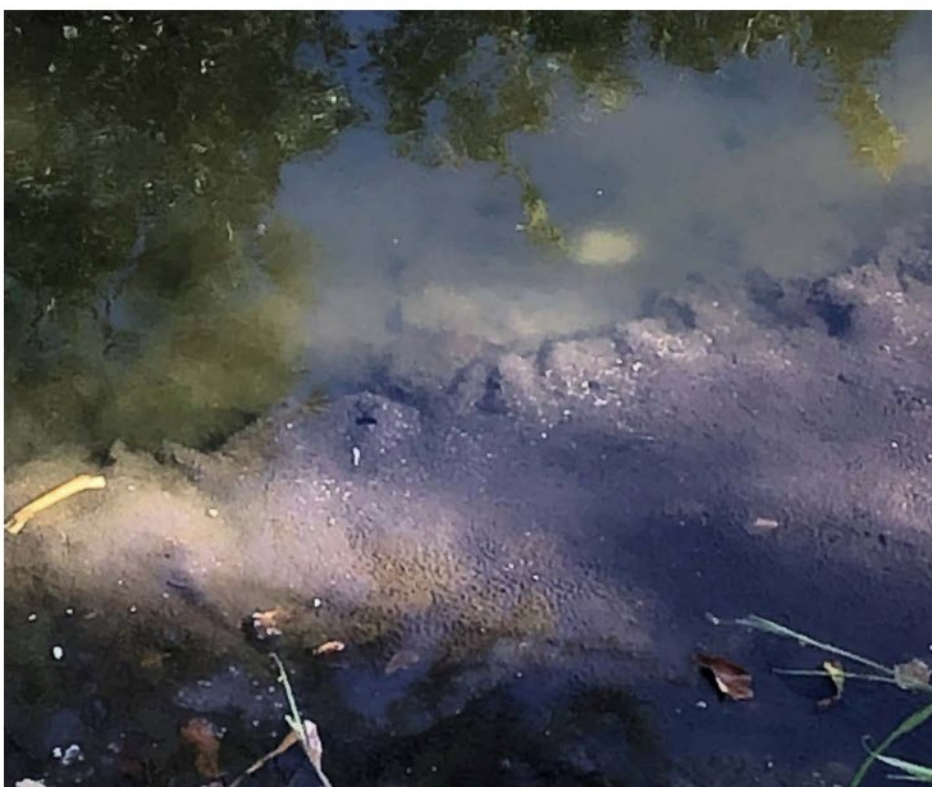
1. Sludge observed in the receiving ditch (see pictures below).

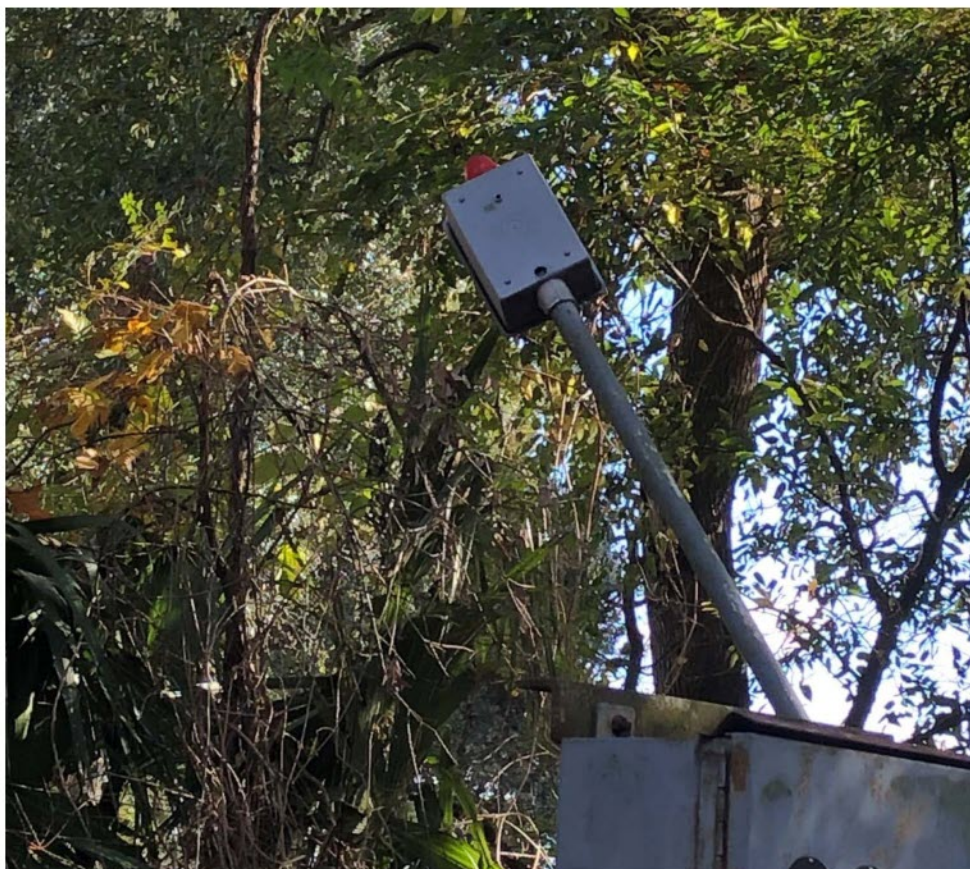
2. Warning light is not visible from the road due to trees (see picture below).

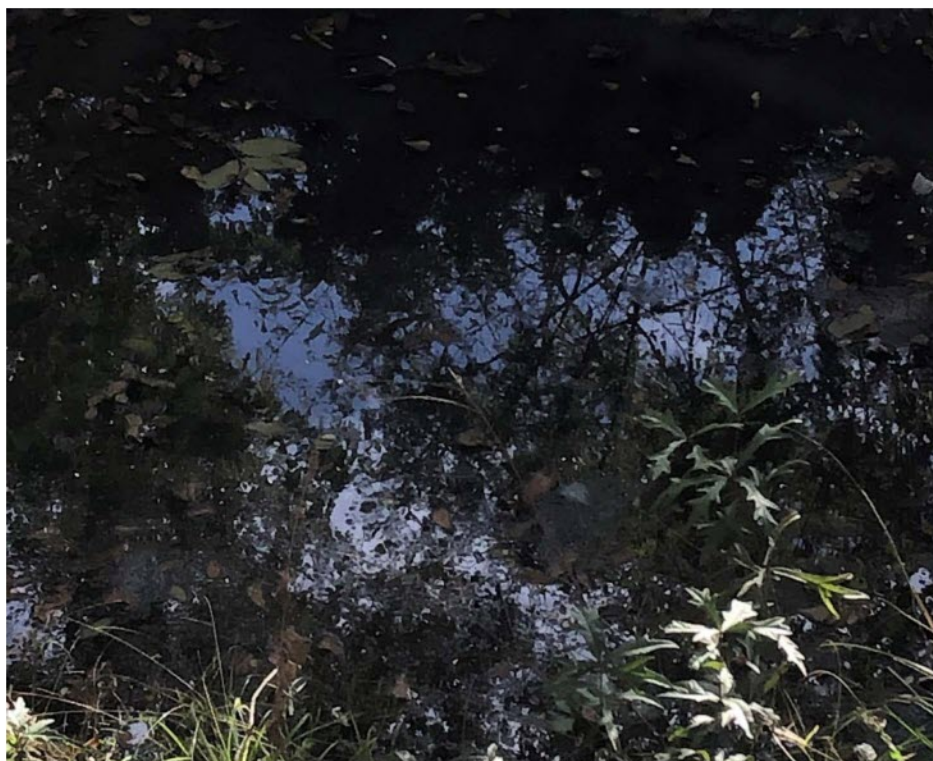
1. Sludge observed in the receiving ditch (see picture below).

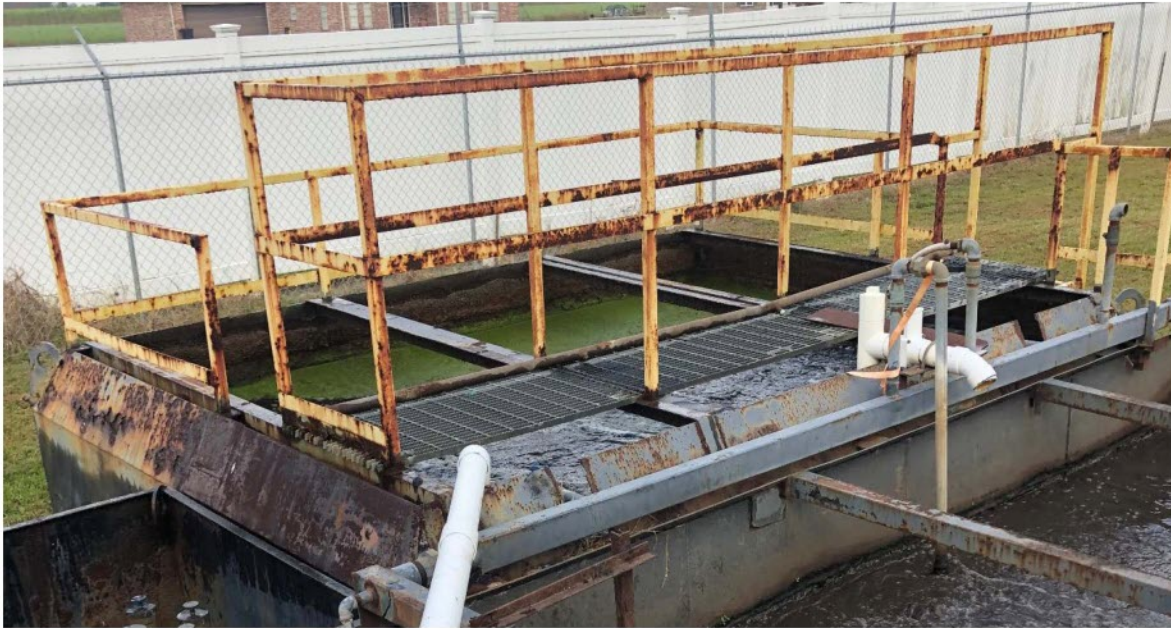
1. The digester is not being utilized or properly operated as required. The digester was reported to be repaired and utilize on 3/9/2020 per the DOJ consent decree required jobs for Abadie Oaks STP. The digester's utilization with proper operations is part of the plants design.

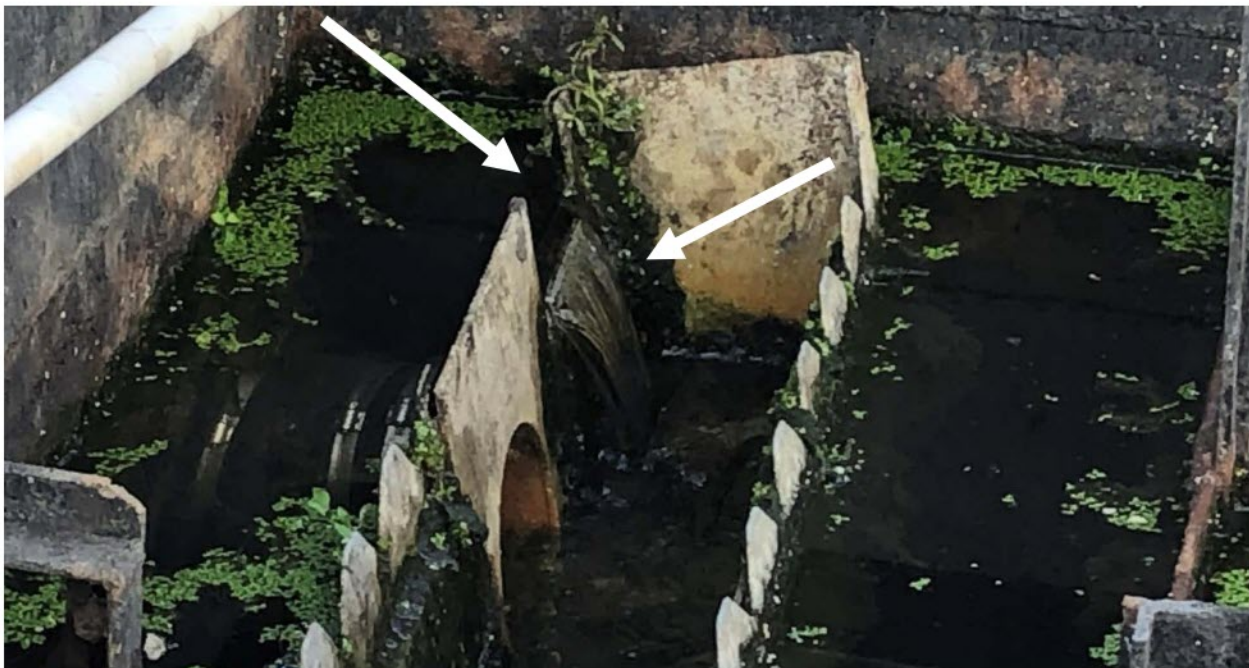
2. Weir was being bypassed from a section of the weir structure that has been removed and in need of repair (see picture below).eirs were

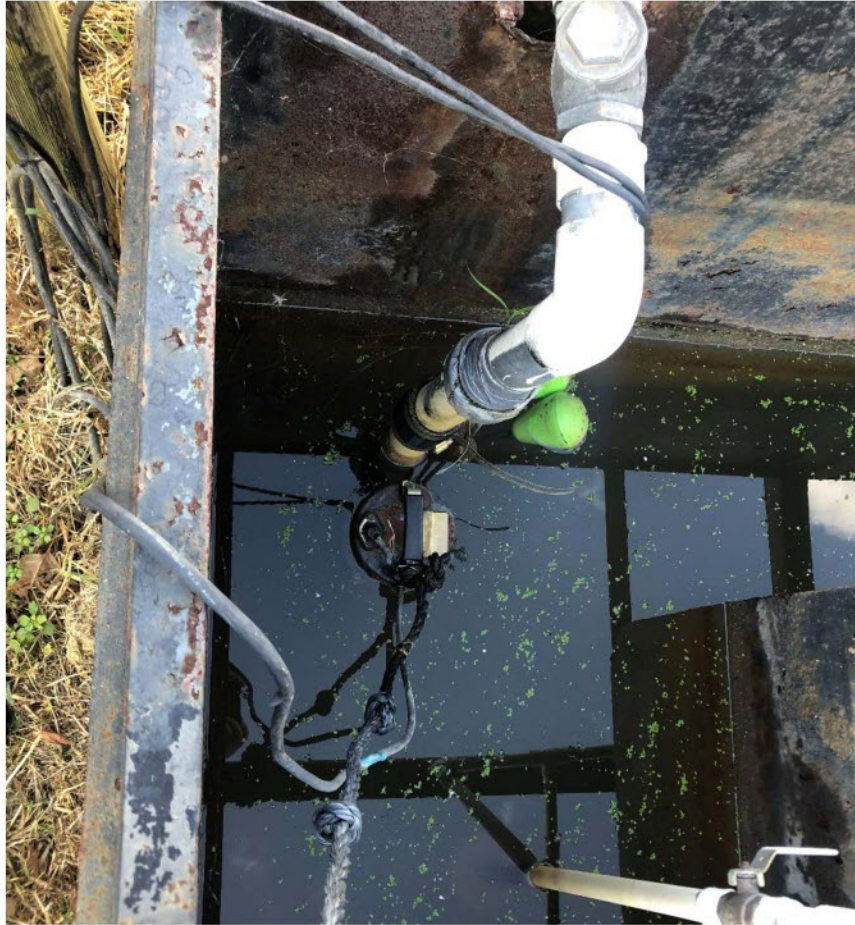
3. The facility is using a pump to discharge to the receiving ditch. DOJ required a discharge V-notch sampling box and an external effluent lift station to be installed per the DOJ consent decree required jobs for Abadie Oaks STP (see picture below).

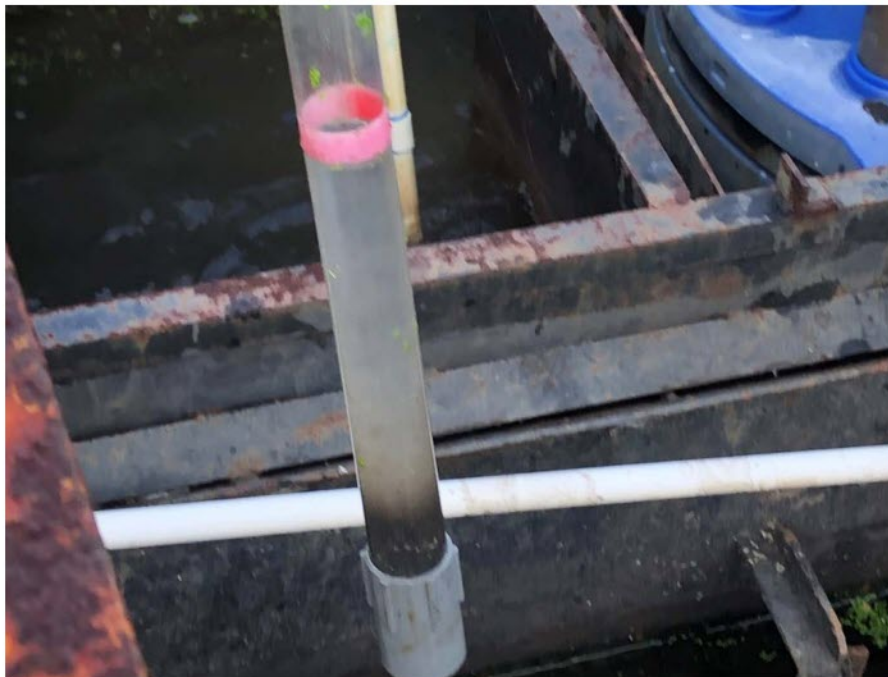
4. Solids in the Chlorine Contact Chamber of Arrowhead #2 STP (see picture below).

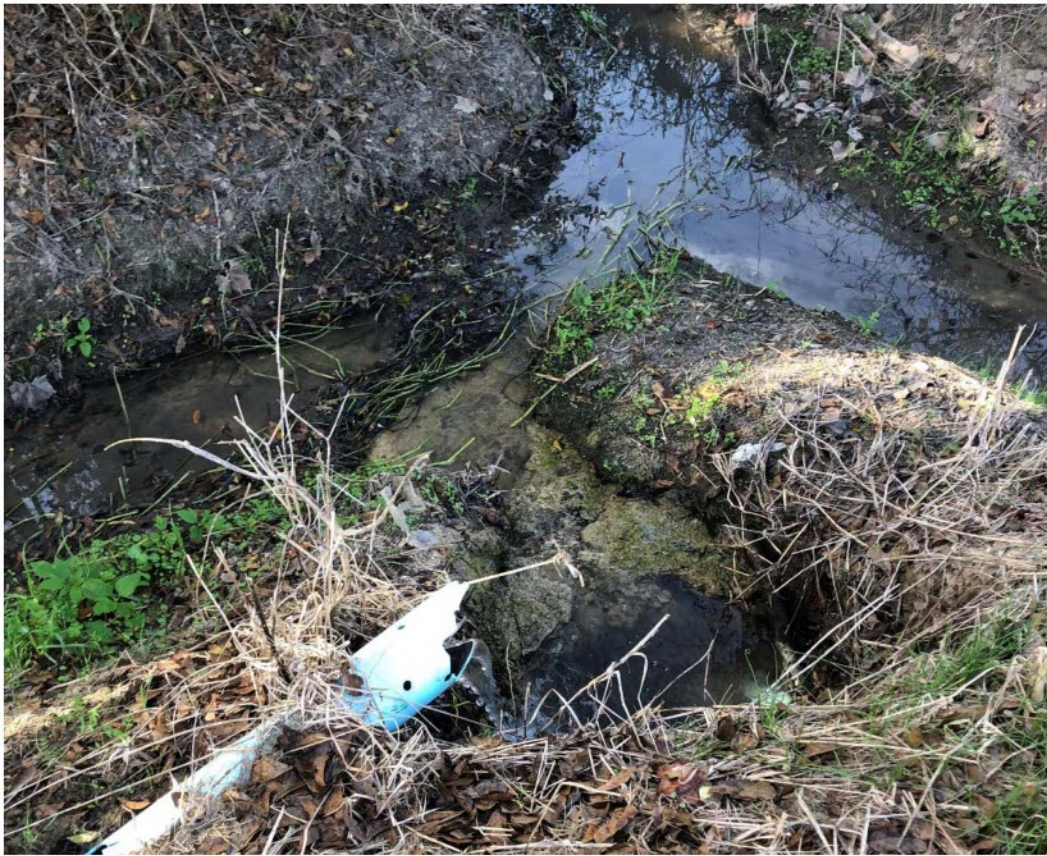
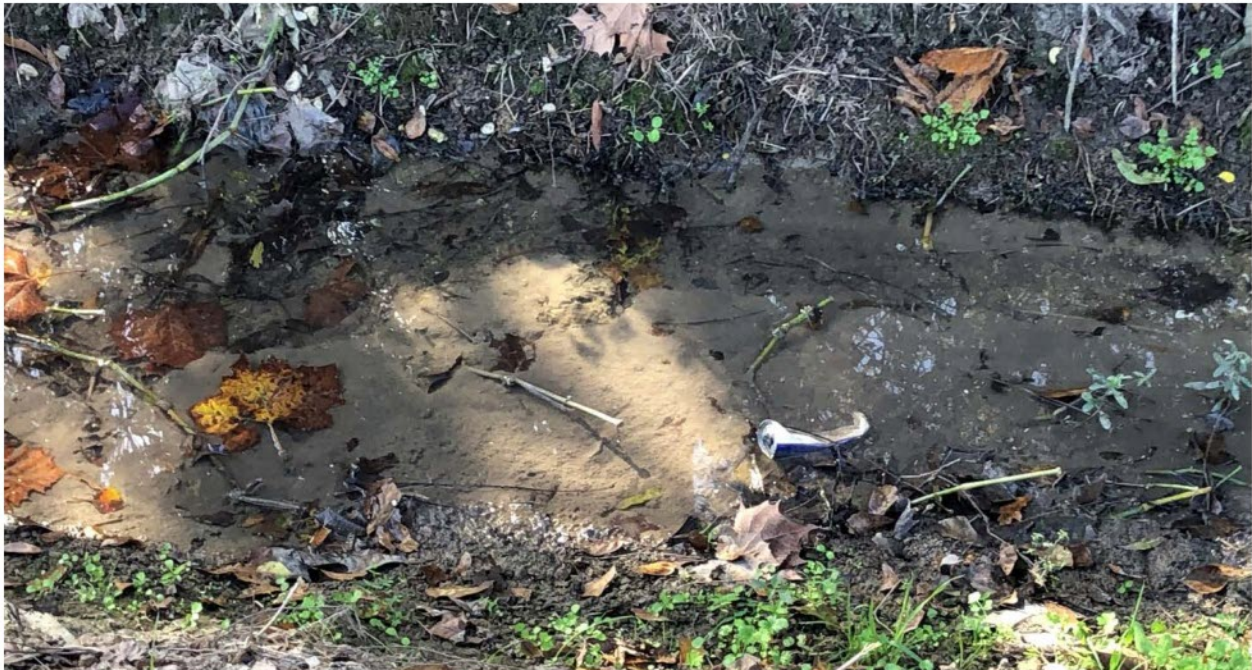
5. Sludge observed in the receiving ditch (see pictures below).

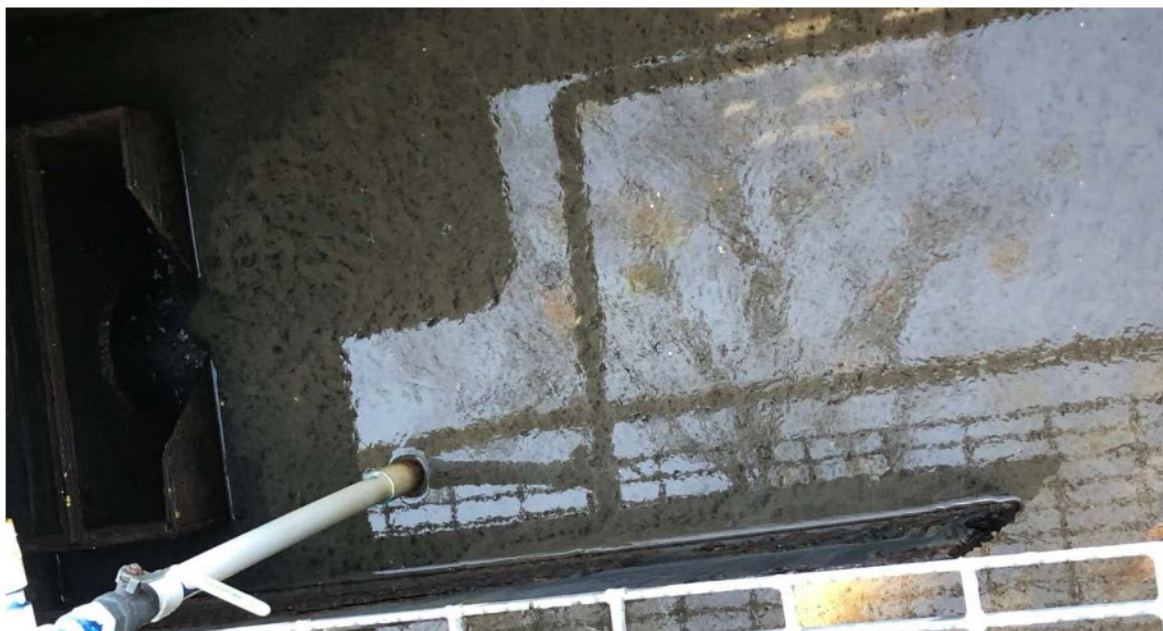
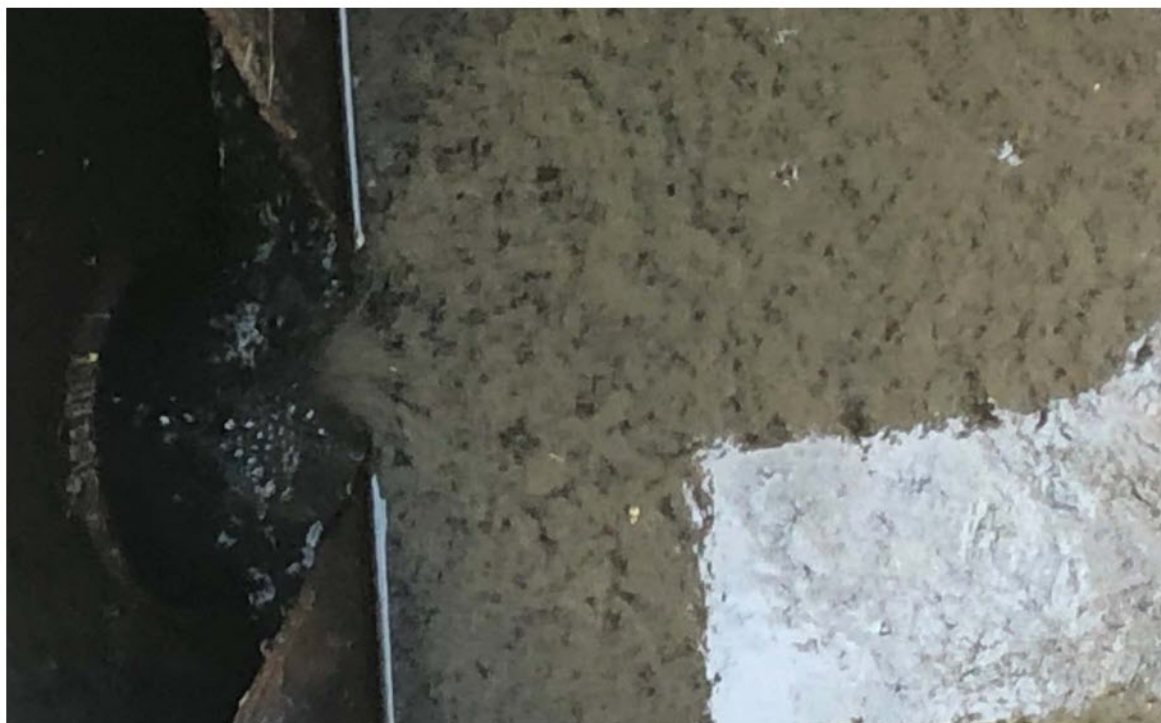
1. Solids were being discharged over the v-Notch weir into the receiving ditch at the time of the inspection (see pictures below).

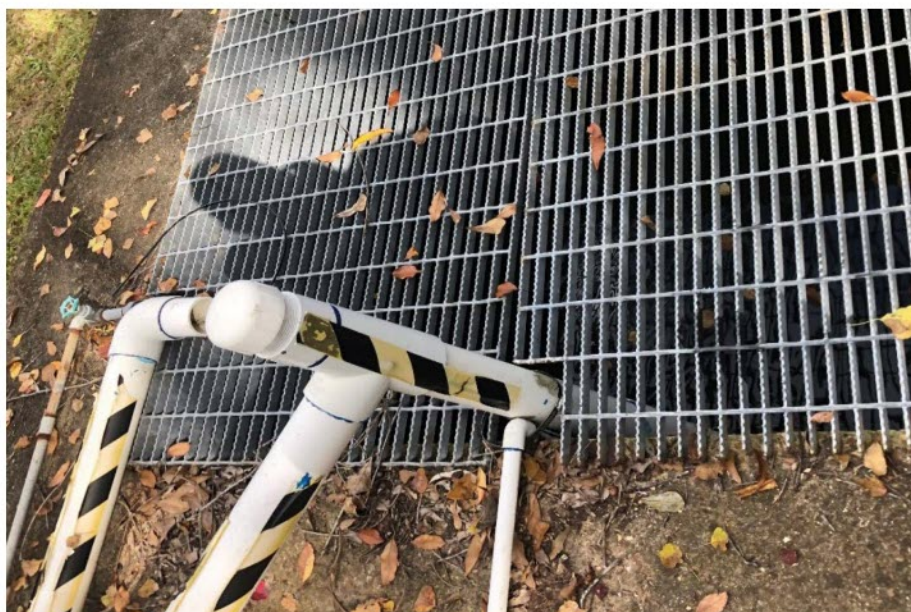
1. The digester is not being utilized or properly operated as required. The digester was reported to be repaired and utilize on 6/6/2017 per the DOJ consent decree required jobs for Abadie Oaks STP. The digester's utilization with proper operations is part of the plants design.
