**Region 6 Compliance Assurance and Enforcement Division  
INSPECTION REPORT**

| Inspection Date(s): | November 15–18, 2021 | | |
| Company Name: | <b>Total Environmental Solutions, Inc. (TESI)</b> | | |

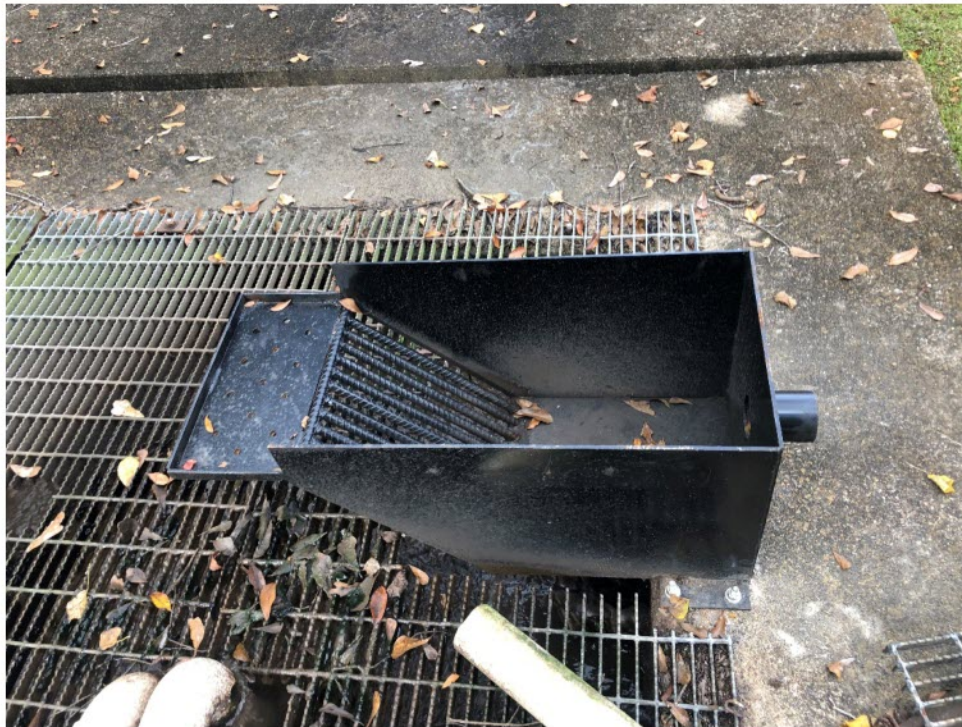
2. New bar-screen structure built and in place, not currently hooked up (see picture below).

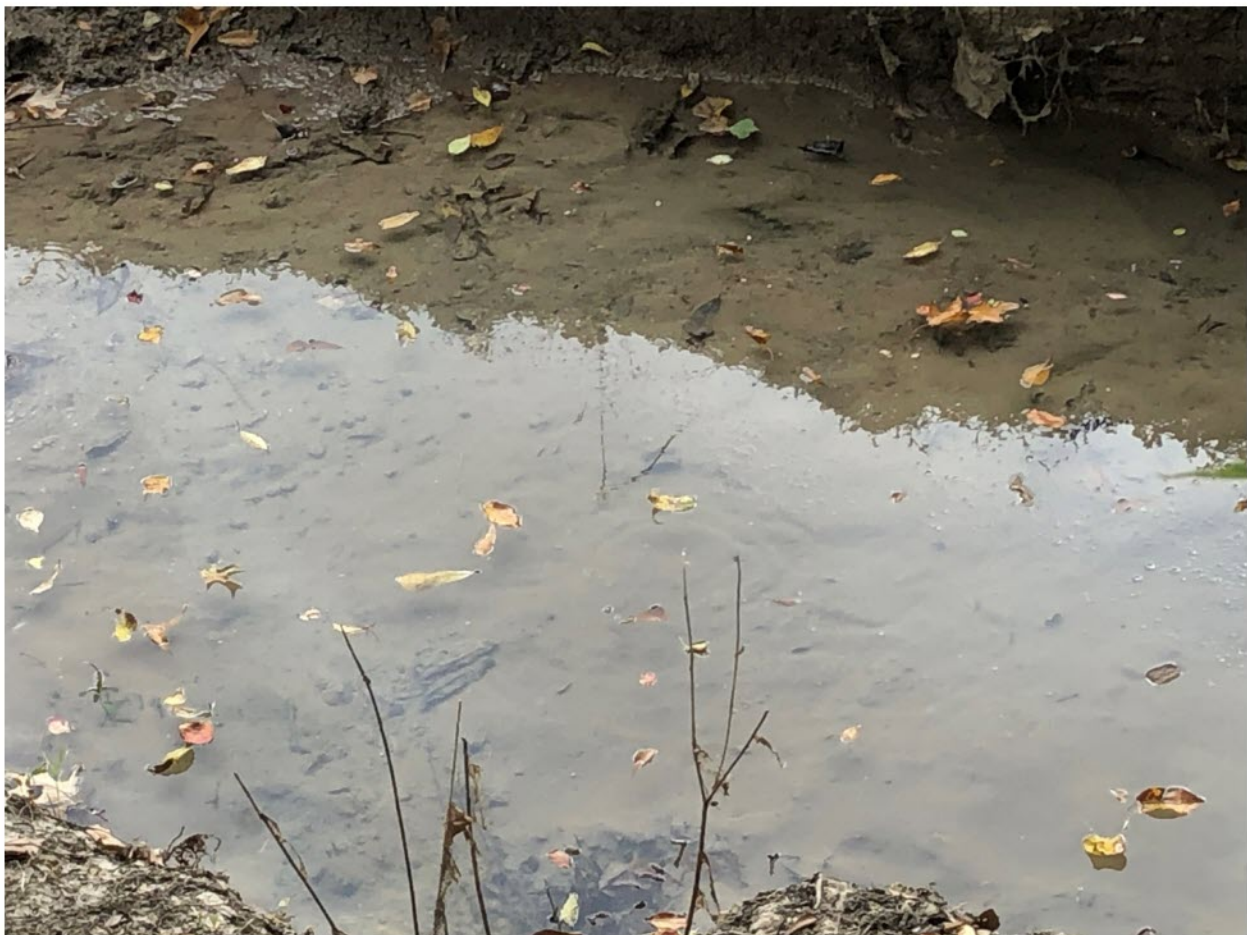
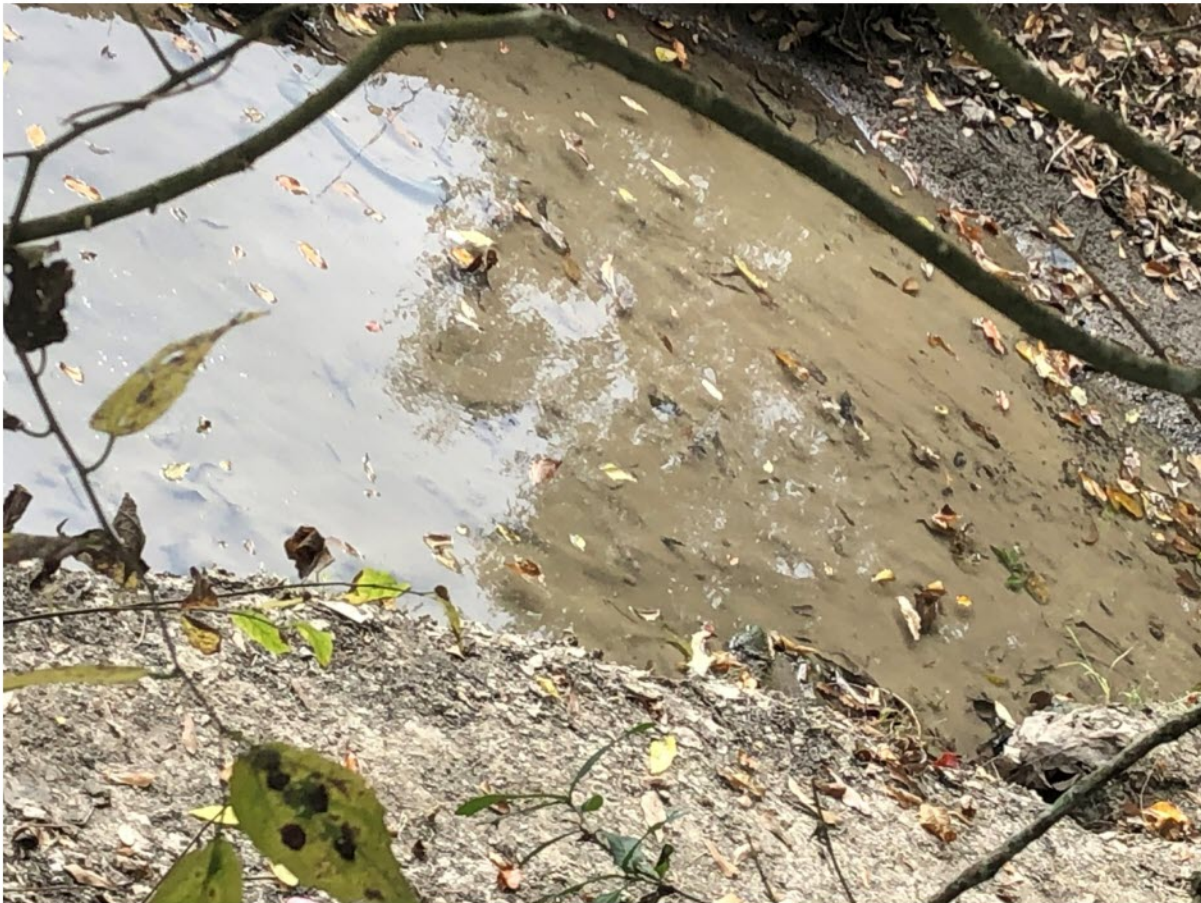
3. Sludge observed in the receiving ditch (see pictures below).

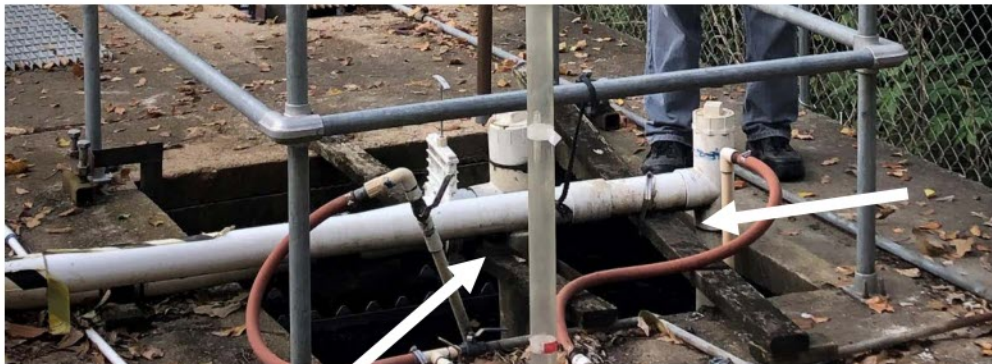
4. Wood supports are worn and need to be replaced with metal supports (see picture below).
