**U.S. ENVIRONMENTAL PROTECTION AGENCY  
REGION III WATER BRANCH, ENFORCEMENT  
AND COMPLIANCE ASSURANCE DIVISION  
CLEAN WATER ACT  
COMPLIANCE INSPECTION REPORT**

**Name of Facility:** Borough of Terre Hill MS4  
**Facility Address:** 300 Broad Street PO Box 250, Terre Hill, PA 17581  
**Mailing Address:** 300 Broad Street PO Box 250, Terre Hill, PA 17581

| <b>Type of Inspection:</b> | MS4 Compliance Inspection |

**Unique Project Identifier (UPI):** 3E21WN074A

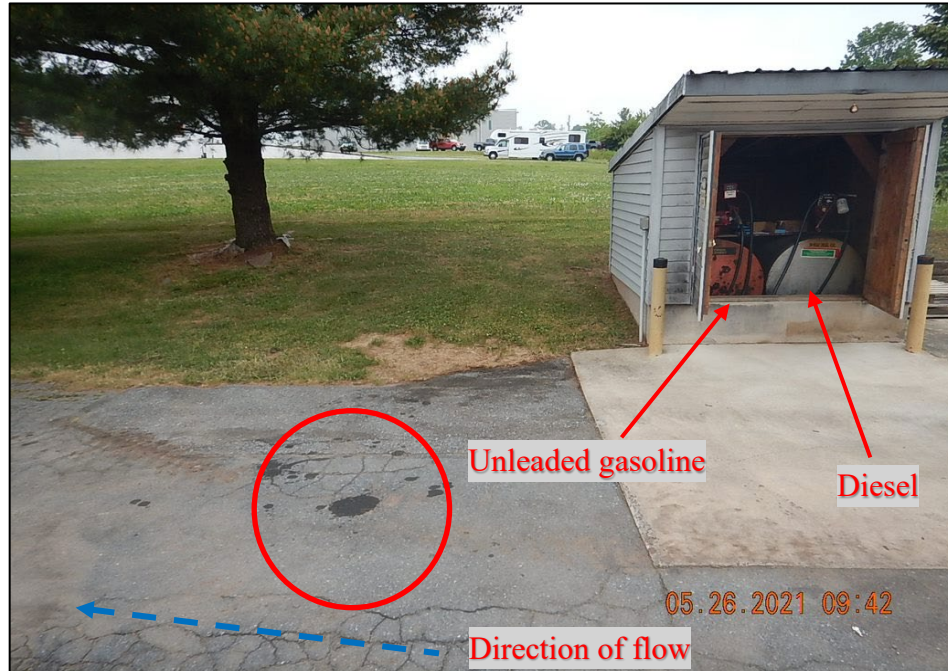
- 2) The EPA Inspection Team observed small petroleum stains on the pavement adjacent to the aboveground fuel storage tank building (refer to Photograph 1). Absorbent materials for spill cleanup were observed in the building.

- 3) The EPA Inspection Team observed two 250-gallon aboveground fuel storage tanks (one diesel, one regular unleaded). The tanks did not appear to be double-walled but were located under cover and within secondary containment (refer to Photographs 1 and 2).

**Photograph 1. Municipal Garage: (DSCN5083)** View, facing west, of petroleum stains on the pavement adjacent to the aboveground fuel storage tank building. The tanks did not appear to be double-walled, but were located under cover and within secondary containment.

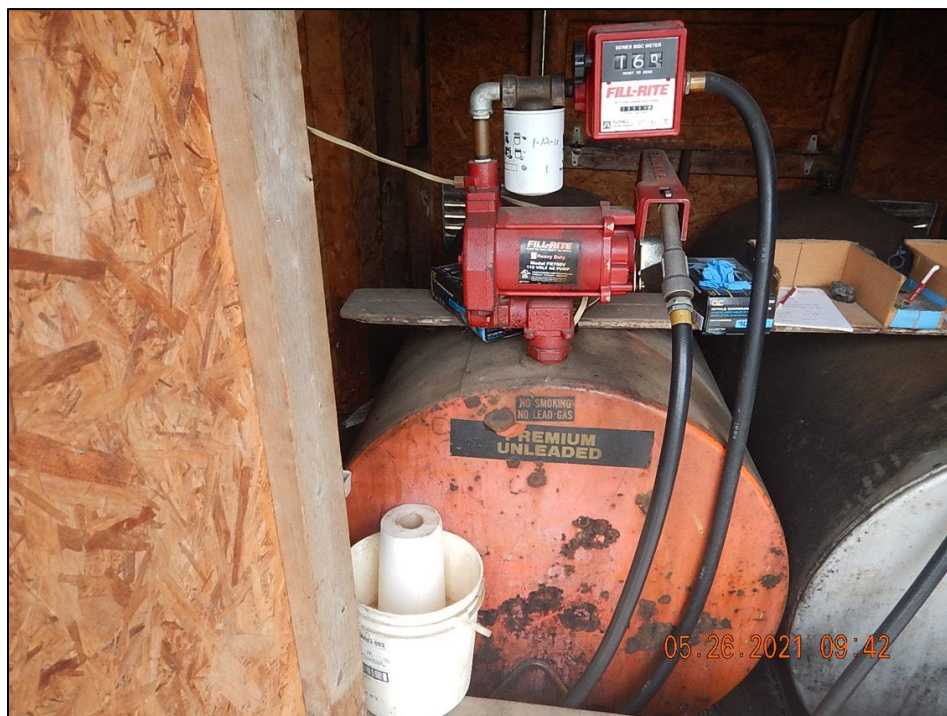
**Photograph 2. Municipal Garage: (DSCN5084)** Closer view of the aboveground unleaded fuel storage tank from Photograph 1. Note the bucket of absorbent material next to the tank.

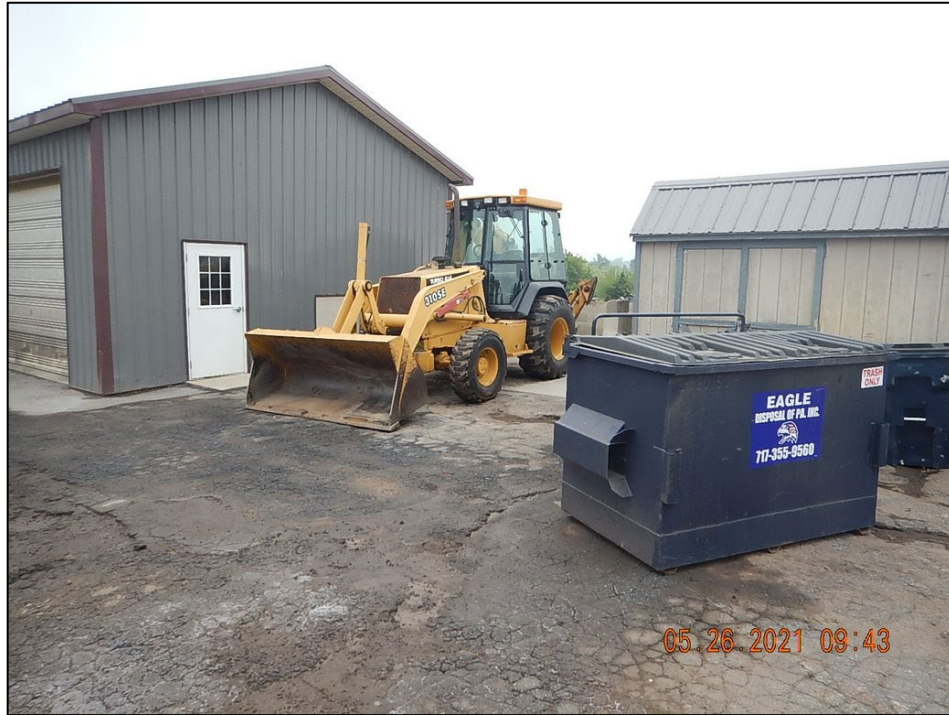
- 4) The EPA Inspection Team observed a covered waste dumpster in the middle of the Municipal Garage property (refer to Photograph 3). The EPA Observation Team did not observe any trash or refuse near the dumpster or onsite.

**Photograph 3. Municipal Garage: (DSCN5087)** View, facing northeast, of several Borough vehicle and tool storage buildings and a covered dumpster.

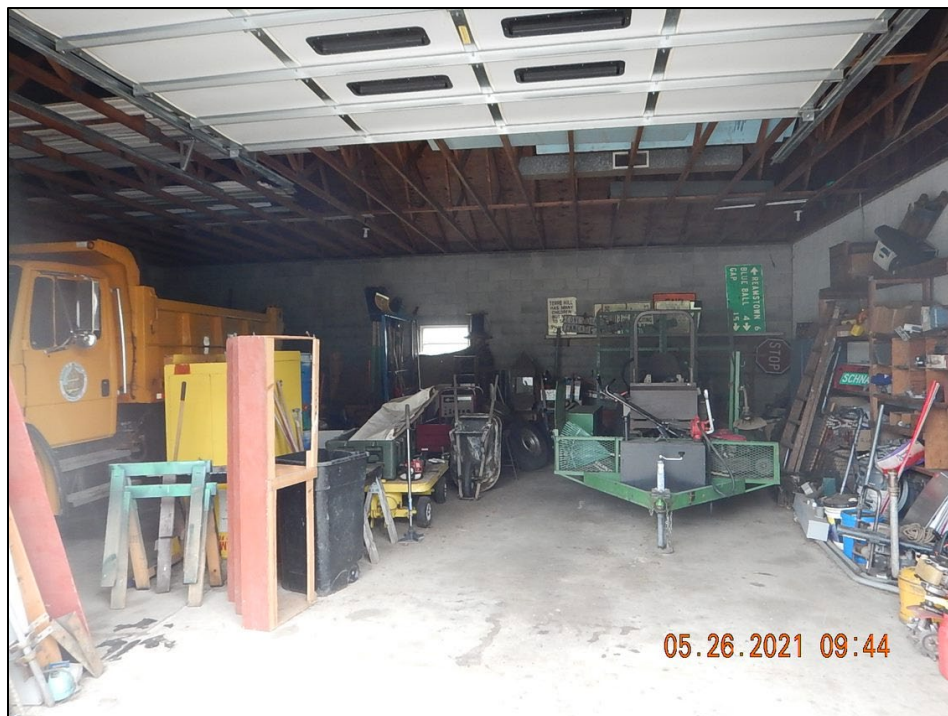
- 5) The EPA Inspection Team observed inside the primary vehicle and tool storage garage (refer to Photograph 4). The garage did not contain any floor drains.

**Photograph 4. Municipal Garage: (DSCN5088)** View inside one of the main enclosed garages that stores vehicles and tools. No floor drains were installed in this building.

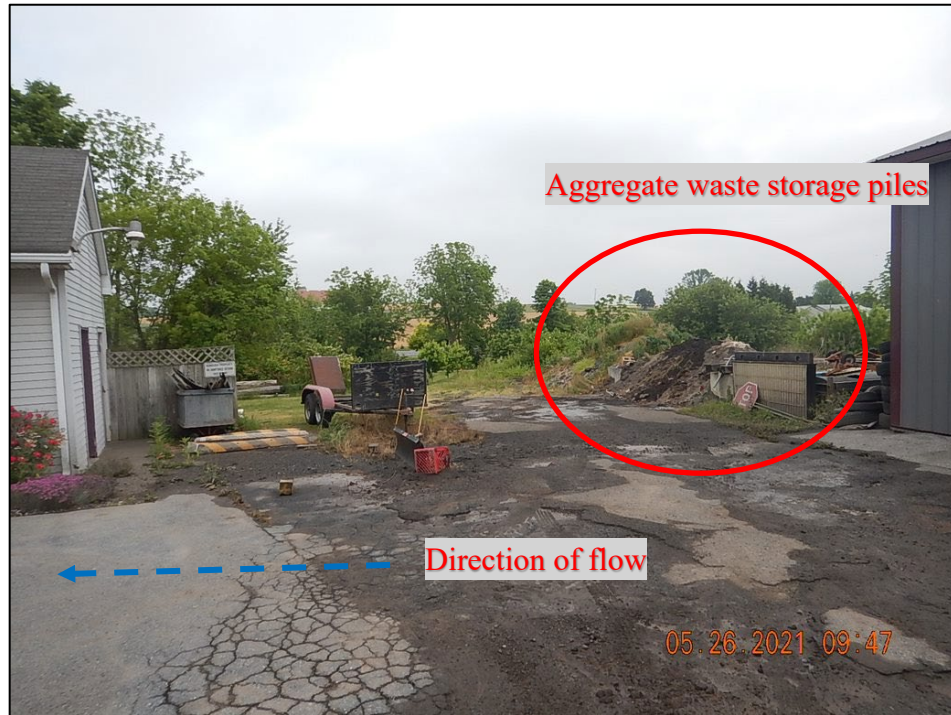
- 6) The EPA Inspection Team observed several aggregate storage areas in the northern portion of the Municipal Garage property. These aggregate piles appeared to mostly comprise dirt and crushed stone. The EPA Inspection Team observed the migration of materials from these aggregate containment areas (refer to Photographs 5, 6, and 7).

**Photograph 5. Municipal Garage: (DSCN5091)** View, facing north, of more storage buildings and aggregate waste storage in the northern portion of the property.

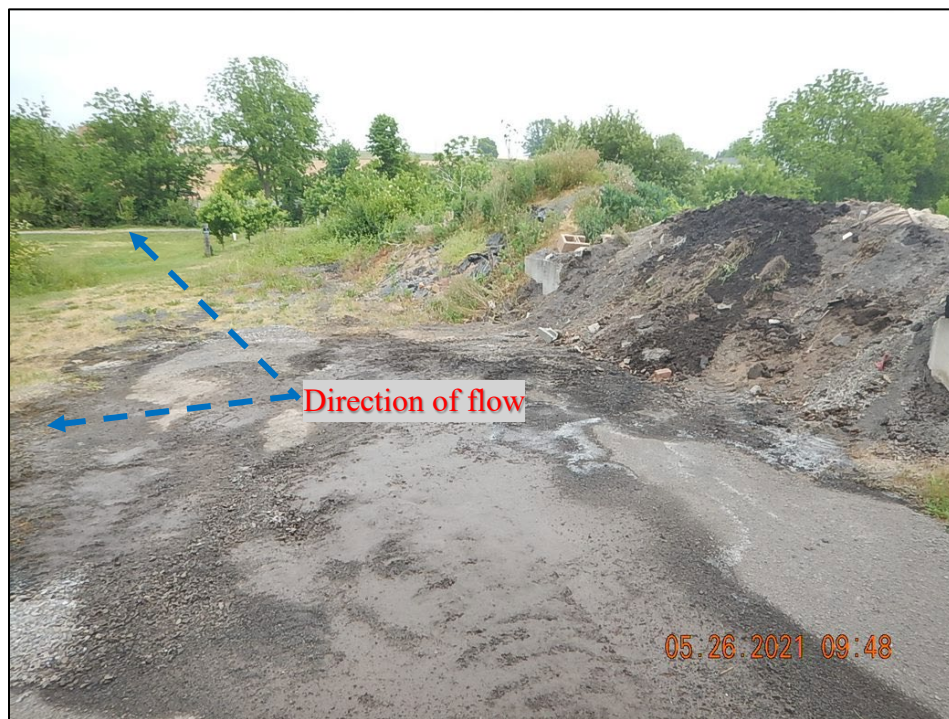
**Photograph 6. Municipal Garage: (DSCN5092)** Closer view of Photograph 5, facing north, of aggregate waste storage piles in the northern portion of the property. Note the migration of materials from the containment area. Stormwater from this area flows north offsite to a grass field.

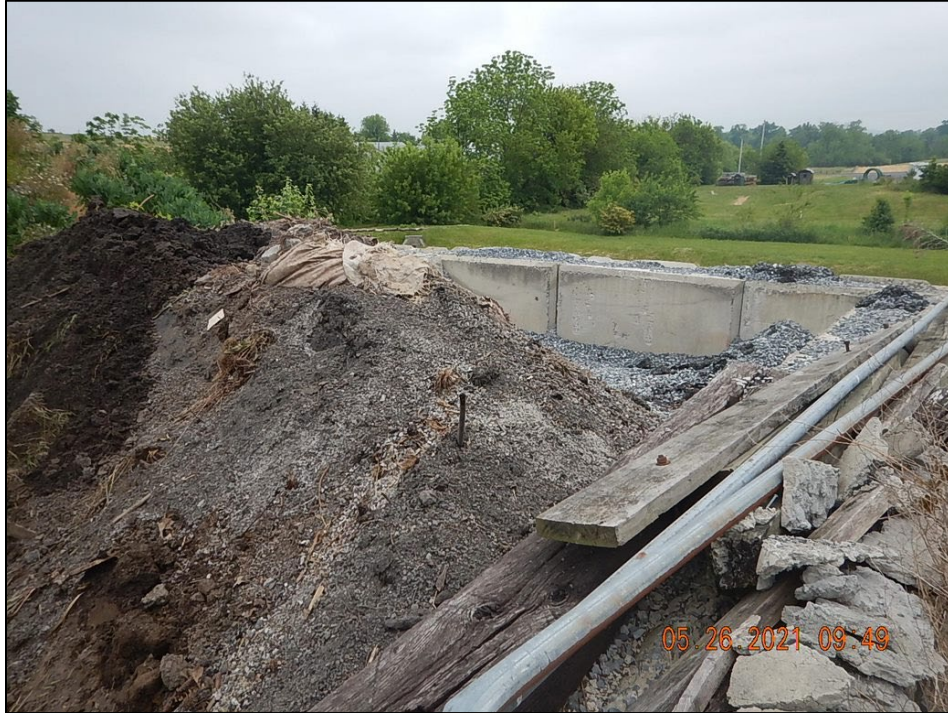
**Photograph 7. Municipal Garage: (DSCN5093)** Closer view of Photograph 6, facing east, of the wasted aggregates (primarily comprising dirt and crushed stone).

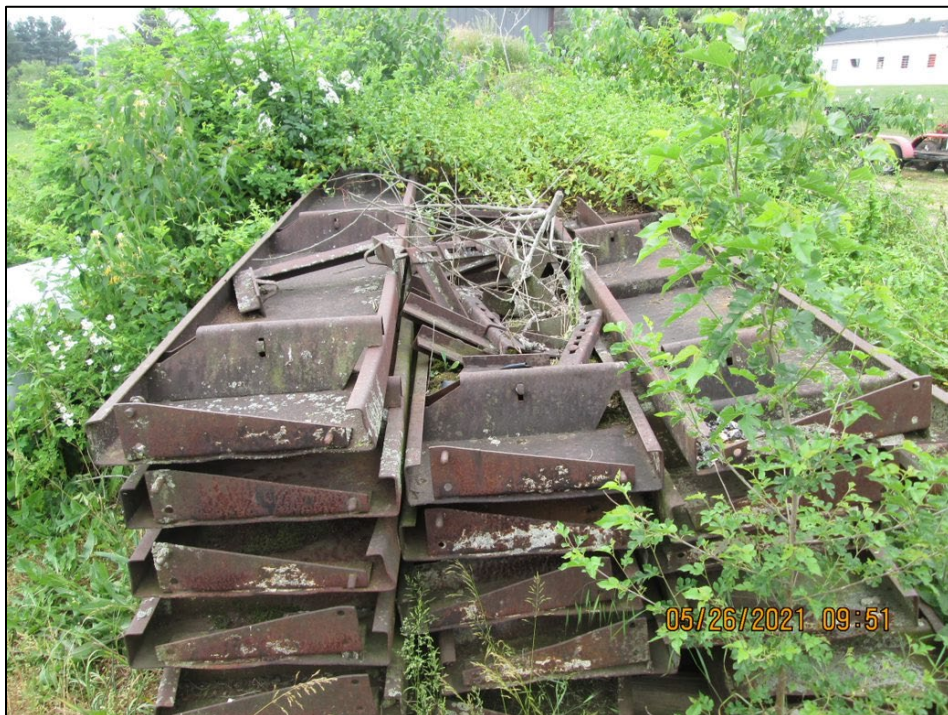
- 7) The EPA Inspection Team observed metal scrap materials, stored uncovered along the northern portion of the Municipal Garage property (refer to Photograph 8).

**Photograph 8. Municipal Garage: (IMG\_1784)** View, facing north, of uncovered scrap metal materials in the northern portion of the property.

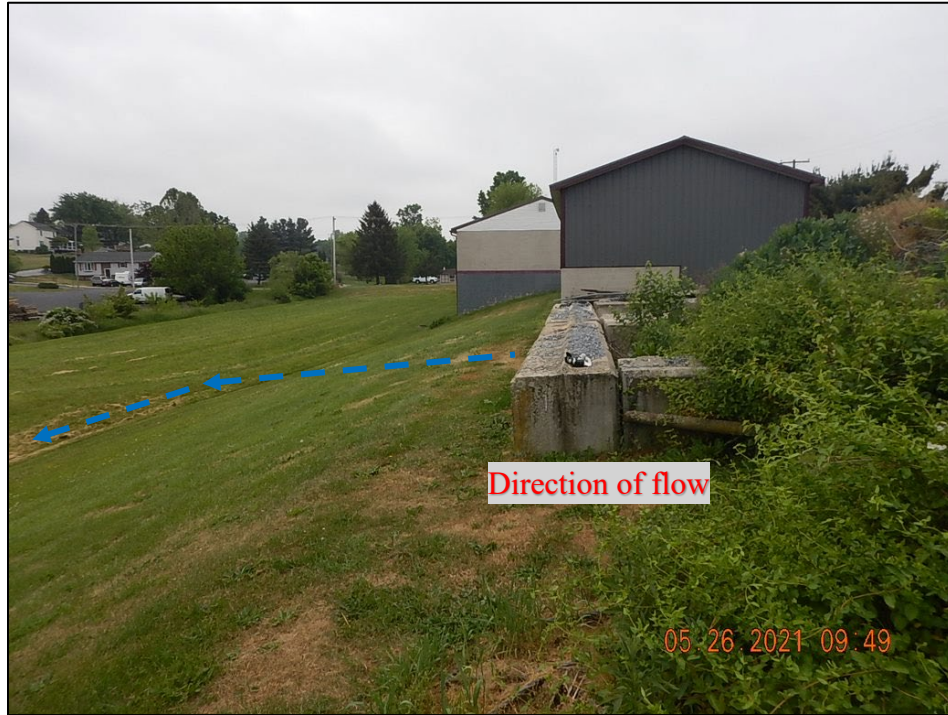
- 8) The EPA Inspection Team observed an infiltration swale located on private land to the east of the entire Municipal Garage property (refer to Photograph 9). This swale collects stormwater from the eastern portion of the property.

**Photograph 9. Municipal Garage:** (DSCN5095) View, facing south, of an infiltration swale located on private land to the east of the entire property. This swale collects stormwater from the eastern portion of the property.

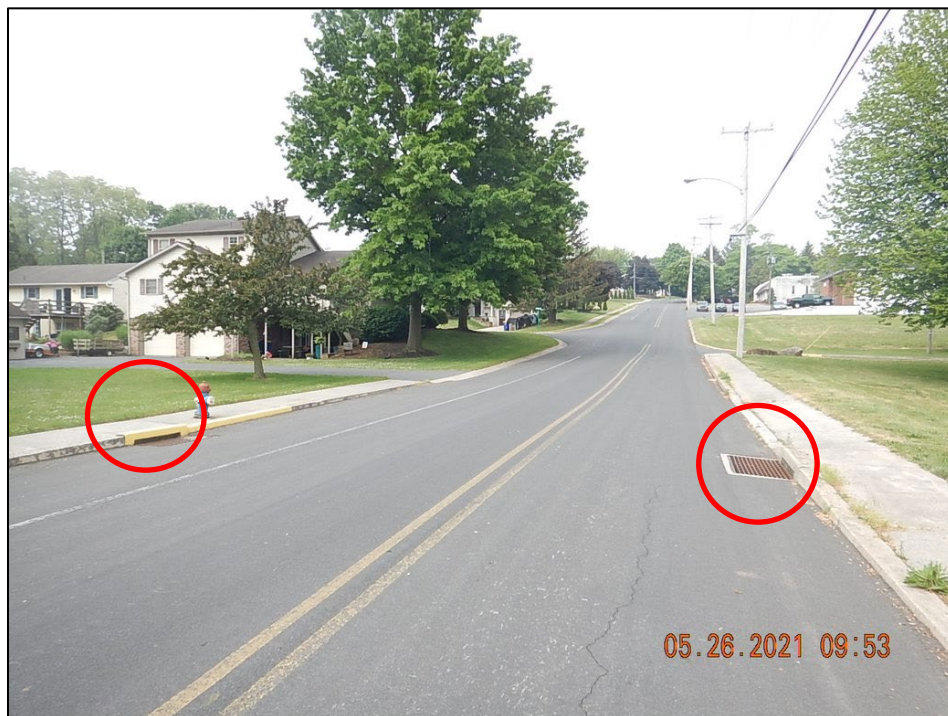
- 1) The EPA Inspection Team observed two catch basins on the north and south sides of Willow Street that convey stormwater to the outfall location (refer to Photograph 10).

**Photograph 10. Outfall #12:** (DSCN5100) View, facing east along Willow Street, of the catch basins that collect roadway stormwater and convey it to Outfall #12.

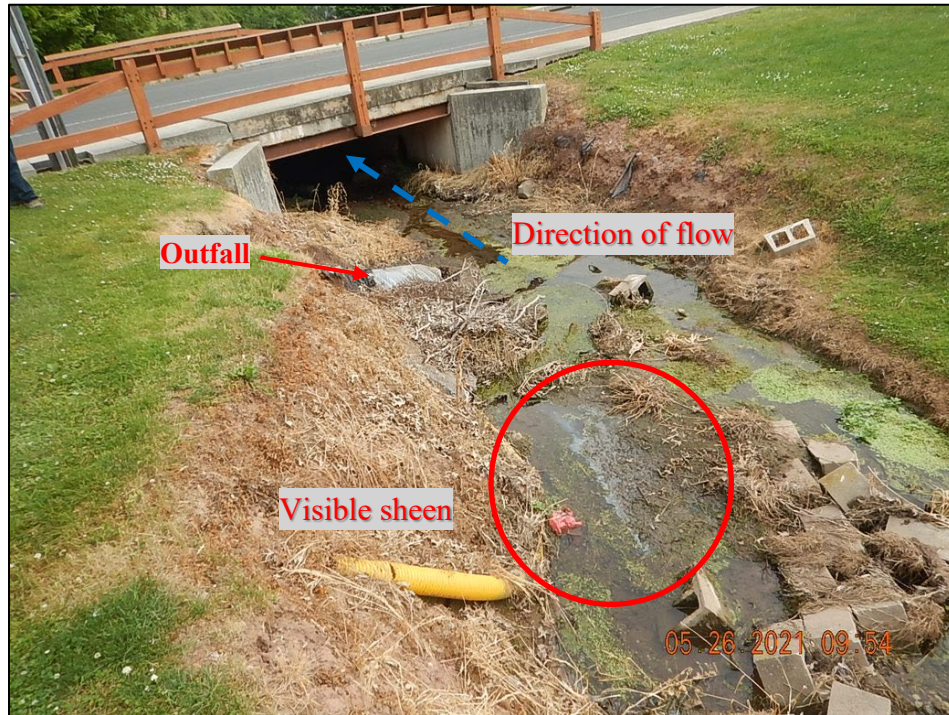
- 2) The EPA Inspection Team observed a visible sheen in the unnamed stream upstream of the outfall (refer to Photographs 11 and 12). The sheen did not appear to be coming from any of the outfalls.

**Photograph 11. Outfall #12:** (DSCN5102) View, facing north, of the box culvert outlet structure for Outfall #12. There was debris and a visible sheen in the water upstream from the outfall. The adjacent embankments were located on private property.

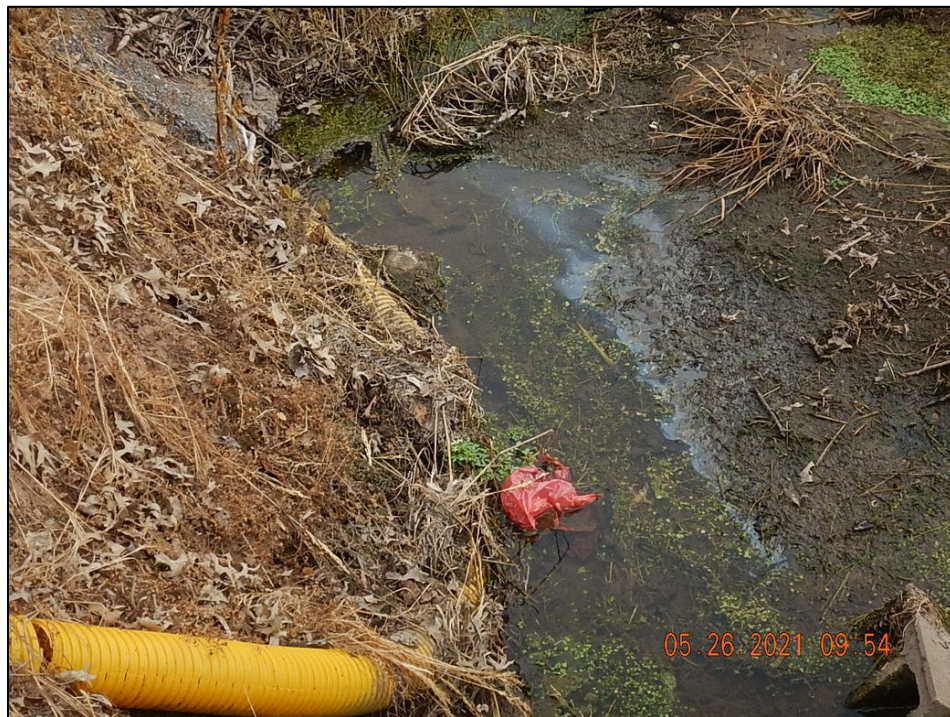
**Photograph 12. Outfall #12:** (DSCN5103) Closer view of Photograph 11 of the visible petroleum sheen in the water upstream from the outfall.

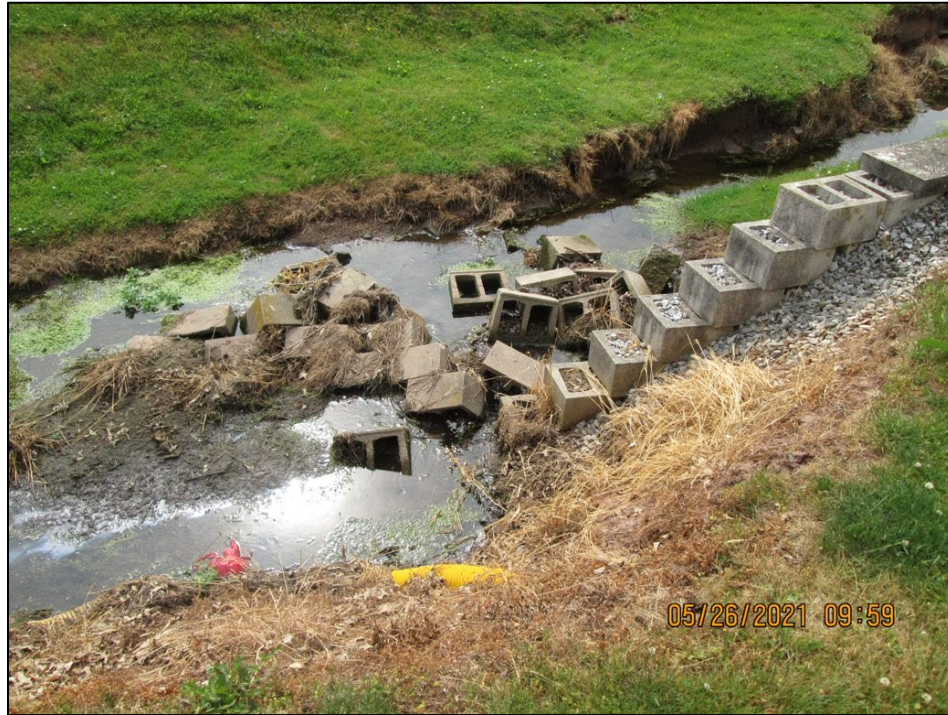
- 3) The EPA Inspection Team observed cinder blocks and other debris in the channel, originating from a retaining wall from the adjacent private lot that had collapsed (refer to Photograph 13).

**Photograph 13. Outfall #12: (IMG\_1797)** View, facing east, of cinder blocks in the channel upstream of the outfall. These materials originated from the adjacent private property's retaining wall.

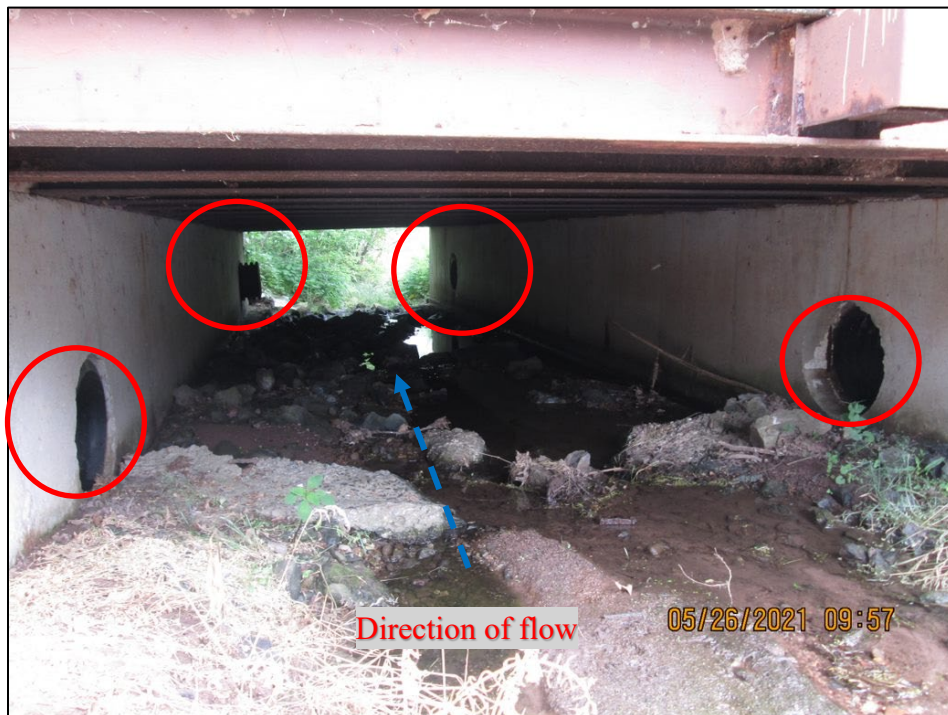
- 4) The EPA Inspection Team observed four separate pipes leading into the culvert structure where Borough representatives stated Outfall #12 was located (refer to Photograph 14) as well as one corrugated metal pipe outfall, just upstream of the culvert. The Borough provided outfall maps that show five separate outfalls in this location; however, none are identified as Outfall #12 (refer to Appendix B, Exhibit 3). The outfalls shown on the map at this location are 009, 015, 016, 017, and 018. It is unclear why Borough representatives referred to this location as Outfall #12.

**Photograph 14. Outfall #12: (IMG\_1795)** View inside outlet structure for Outfall #12. Note the four separate pipes leading into the structure that convey stormwater from both directions of Willow Street.

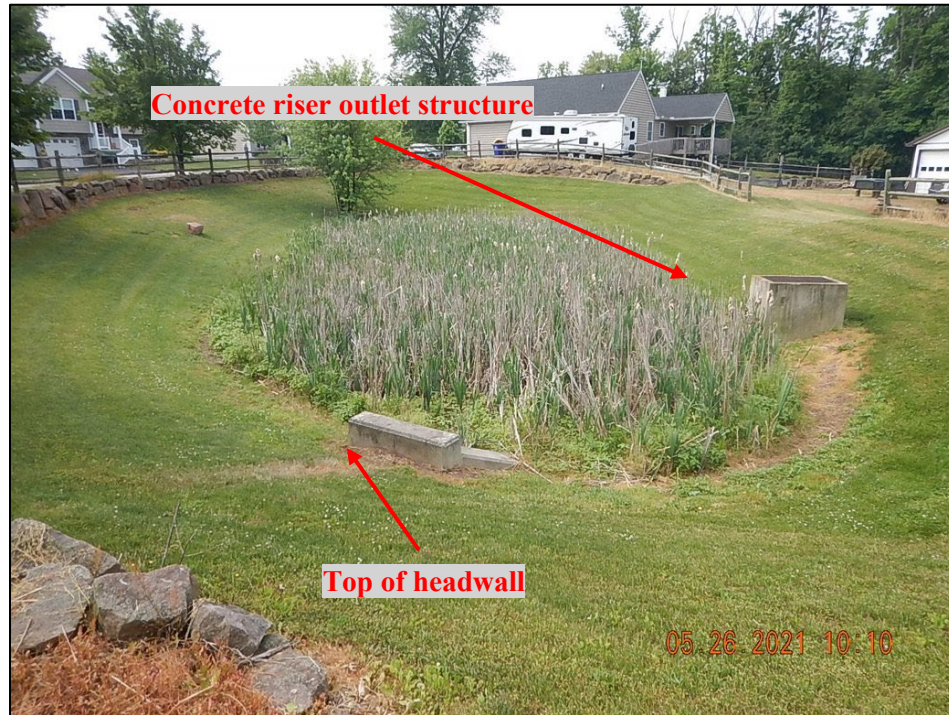
**Photograph 15. Randall Drive Detention Basin:** (DSCN5108) View, facing west, of the privately-owned and operated detention basin. This basin collects stormwater from the adjacent Randall Drive.

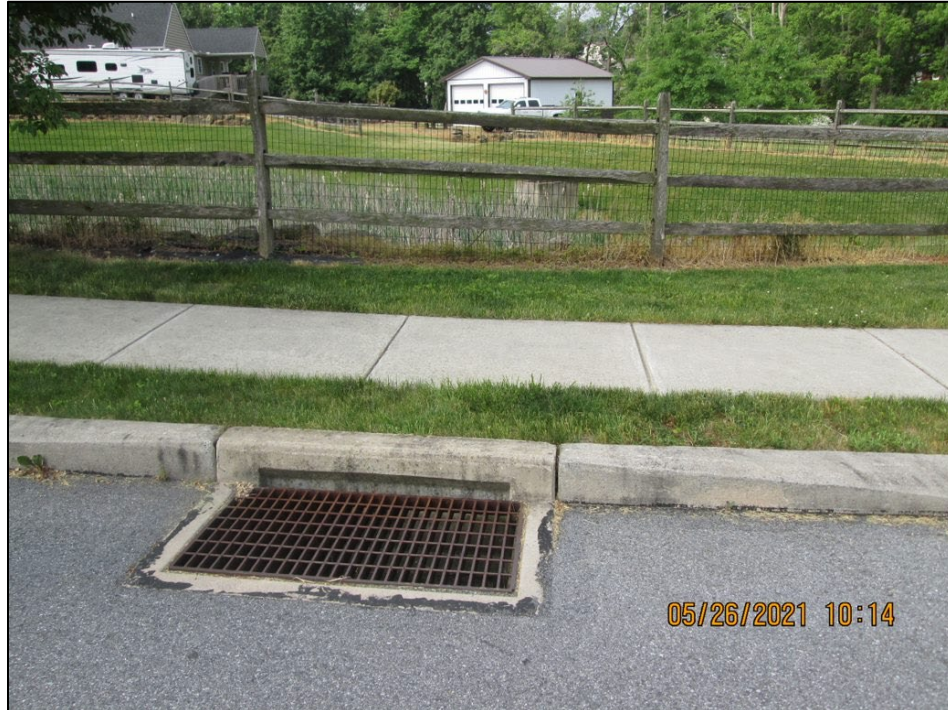
**Photograph 16. Randall Drive Detention Basin:** (IMG\_1801) View of the primary catch basin along Randall Drive that conveys stormwater to the detention basin. Note the basin visible in the background.

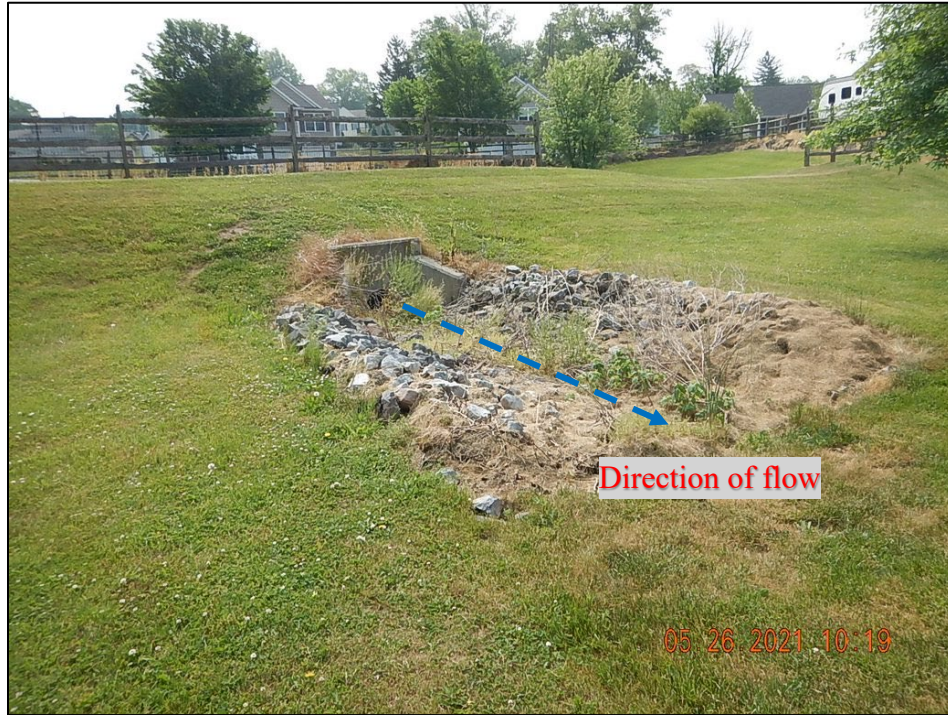
**Photograph 17. Randall Drive Detention Basin: (DSCN5110)** View, facing east, of the outlet structure for the detention basin.

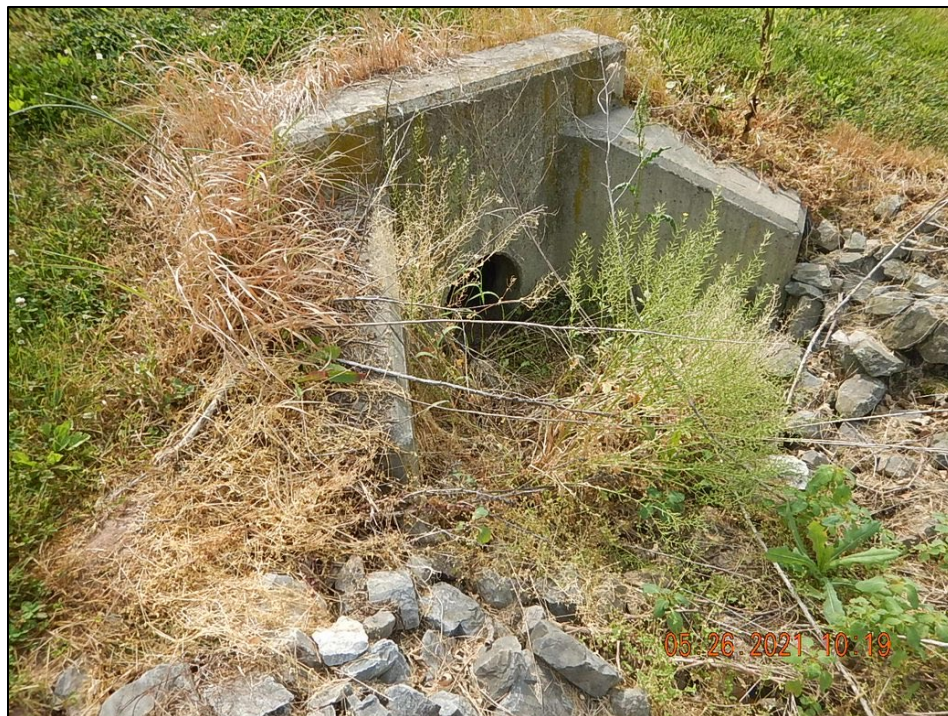
- 1) Borough representatives stated that they inspect the BMP approximately annually and may take pictures, but they do not generate a formal inspection report.
- 2) The EPA Inspection Team observed the detention basin perimeter had recently been mowed. From what was visible, the structures within the basin appeared to be in good condition and no trash was observed (refer to Photograph 15).
- 3) The EPA Inspection Team observed the primary catch basin on Randall Drive that conveys stormwater to the detention basin (refer to Photograph 16).
- 4) Stormwater is discharged from the stormwater basin, through the concrete riser outlet structure, through a low flow orifice, and across the privately-owned field and towards a grassy area west of the basin (refer to Photograph 17).
- 5) The EPA Inspection Team observed vegetation growing in and around the outlet structure (refer to Photograph 18).

**Photograph 18. Randall Drive Detention Basin: (DSCN5111)** Closer view of Photograph 17, of the outlet structure for the detention basin. Note the excess vegetation in and around the structure.

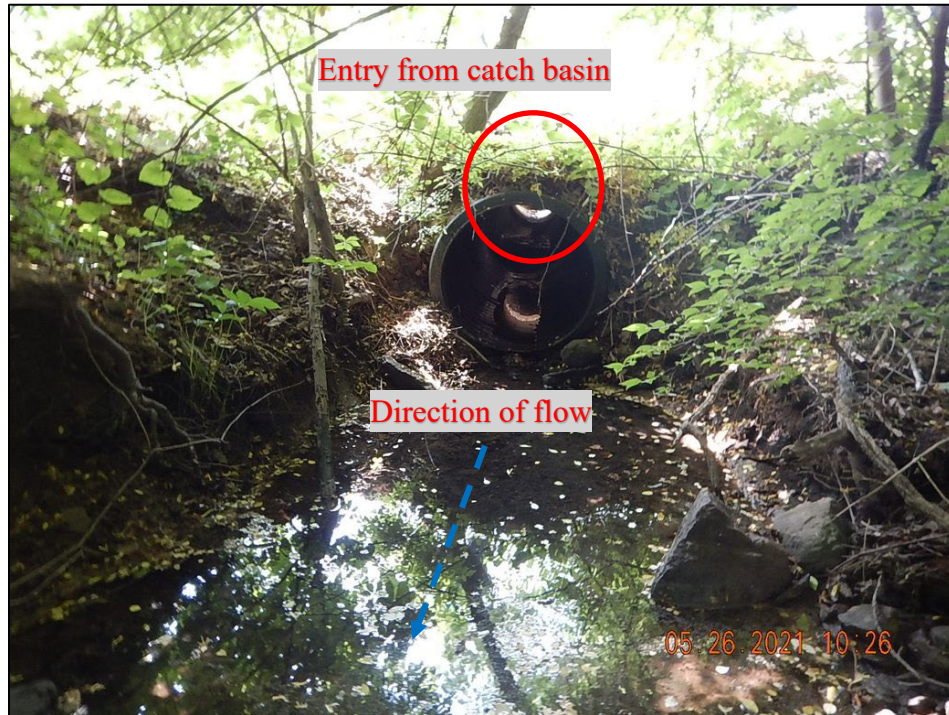
- 1) The EPA Inspection Team observed the outlet structure for Outfall #7 and observable dry weather flow at the time of the inspection (refer to [Photograph 19](#)). Borough representatives stated that the culvert where the outfall discharges is in a spring fed stream, and that moisture and flow during dry weather is a regular occurrence. Borough representatives did not formally document the dry weather flow during the EPA inspection.

**Photograph 19. Outfall #7:** (DSCN5115) View, facing southeast, of the culvert under Center Avenue where Outfall #7 is located. Dry weather flow was visible at the time of the inspection. Borough representatives stated that the location is part of a spring-fed stream and flow is normal.

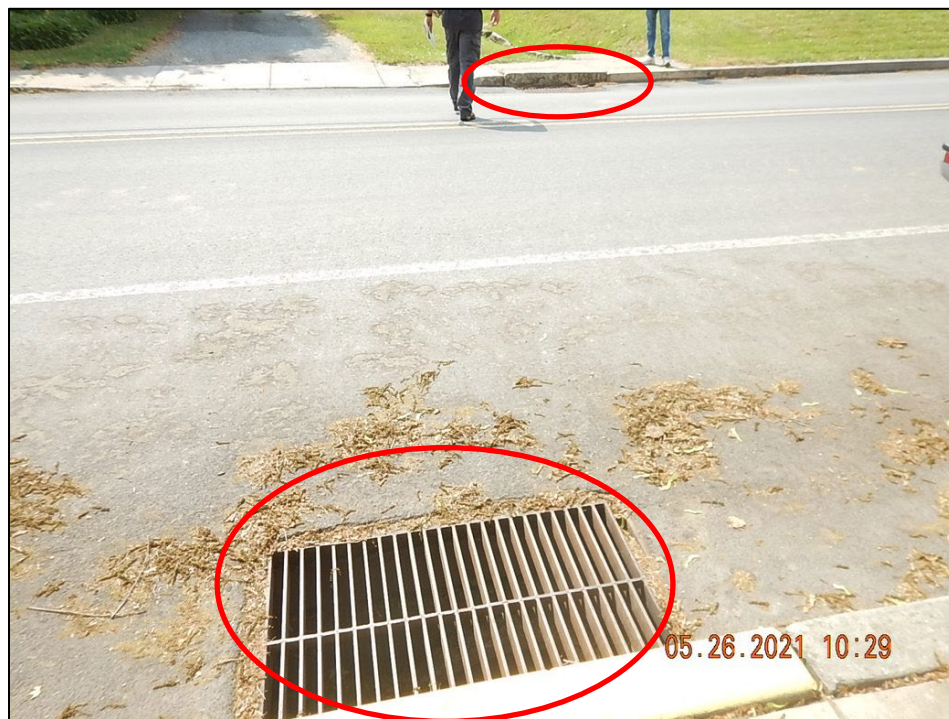
- 2) The EPA Inspection Team observed two catch basins on the north and south sides of Center Avenue that convey stormwater to Outfall #7, located in a culvert under Center Avenue (refer to Photograph 20).
- 3) The EPA Inspection Team observed a drainage channel from a private stormwater basin located on the southern side of Center Avenue that discharges into the same culvert as Outfall #7 (refer to Photographs 21 and 22).

**Photograph 20. Outfall #7:** (DSCN5118) View, facing southeast, of the two catch basins on Center Avenue that drain into Outfall #7.

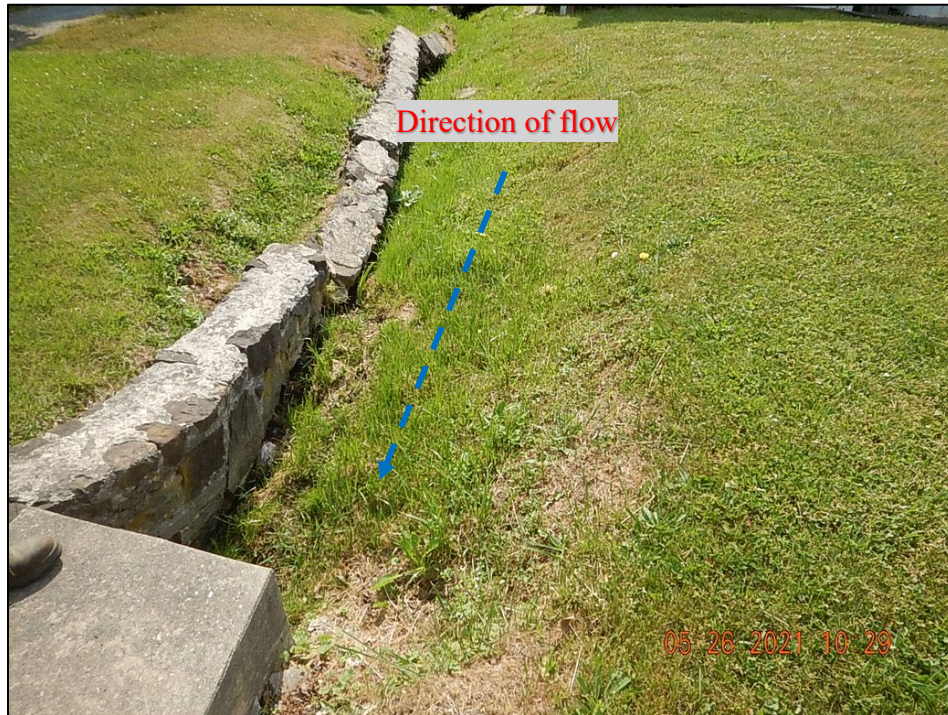
**Photograph 21. Outfall #7:** (DSCN5120) View of the channel from the private basin located on the southern side of Center Avenue that channels flow into Outfall #7.

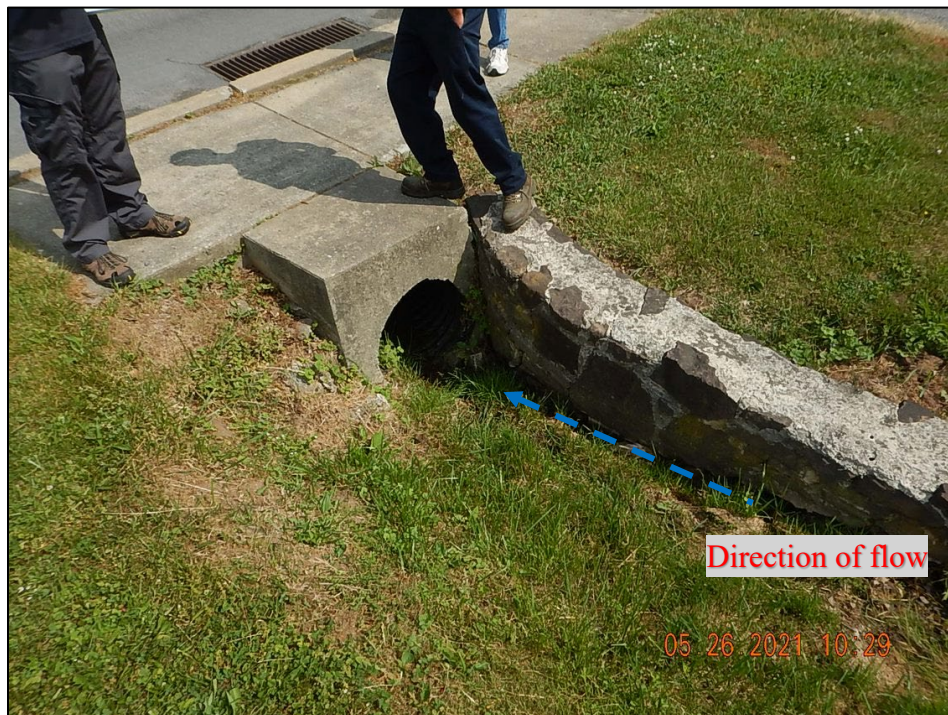
**Photograph 22. Outfall #7:** (DSCN5121) View, facing north, of the headwall at the end of the private basin channel that flows into Outfall #7.

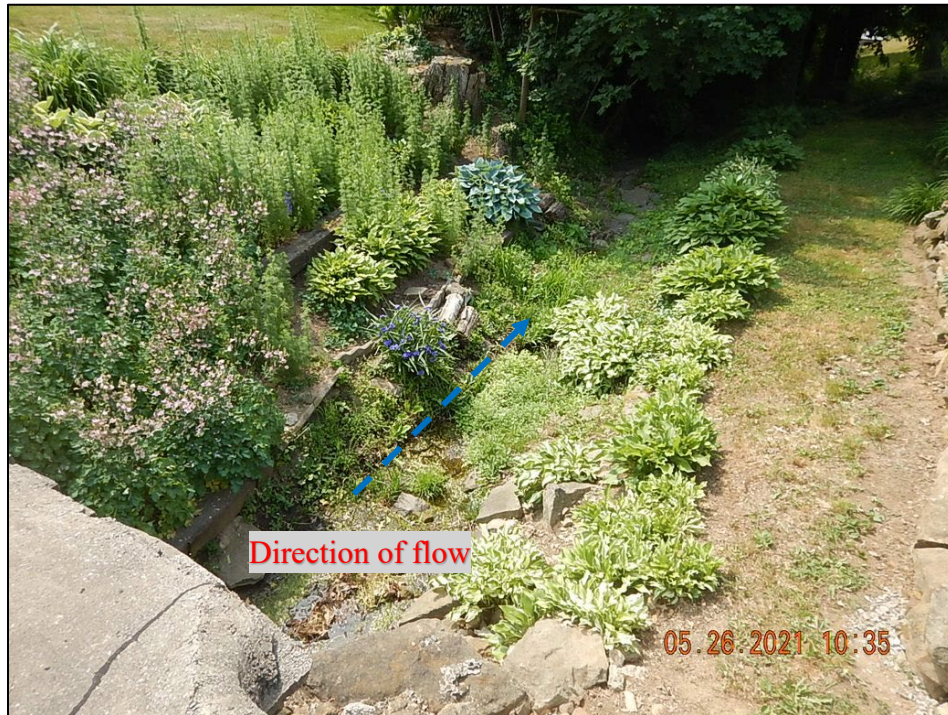
- 1) The EPA Inspection Team observed the outlet structure for Outfall #4 (refer to [Photograph 23](#)). The concrete pipe for Outfall #4 appeared to be 36 inches in diameter. However, an outfall map kept at the Borough office identified the outlet structure for Outfall #4 to be a 48-inch pipe (refer to [Photograph 24](#)). Borough representatives agreed there was an error on the map. Maps provided to the EPA Inspection Team by the Borough did not indicate outfall pipe diameters.
- 2) The EPA Inspection Team observed the catch basin and conveyance culvert on the north side of Fairview Street that channels water towards Outfall #4 (refer to [Photographs 25 and 26](#)). The structure was free of debris and appeared to be in good condition.

**Photograph 23. Outfall #4: (DSCN5122)** View, facing south, of the top of the headwall for Outfall #4 along Fairview Street.

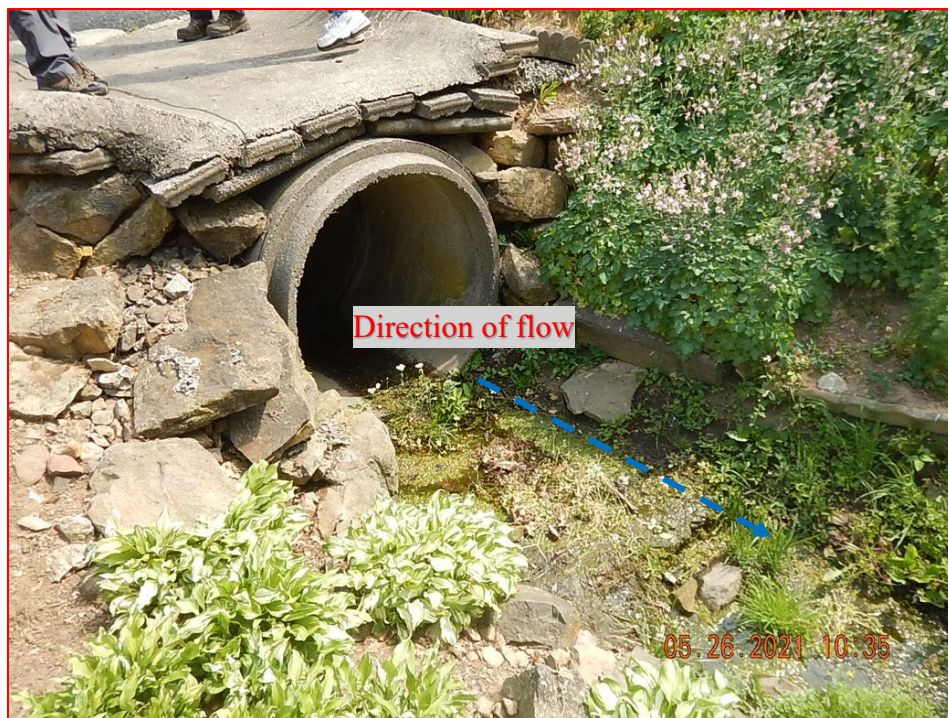
**Photograph 24. Outfall #4: (DSCN5123)** View, facing north, of the outlet pipe for Outfall #4. The structure appeared to be a 36-inch concrete pipe.

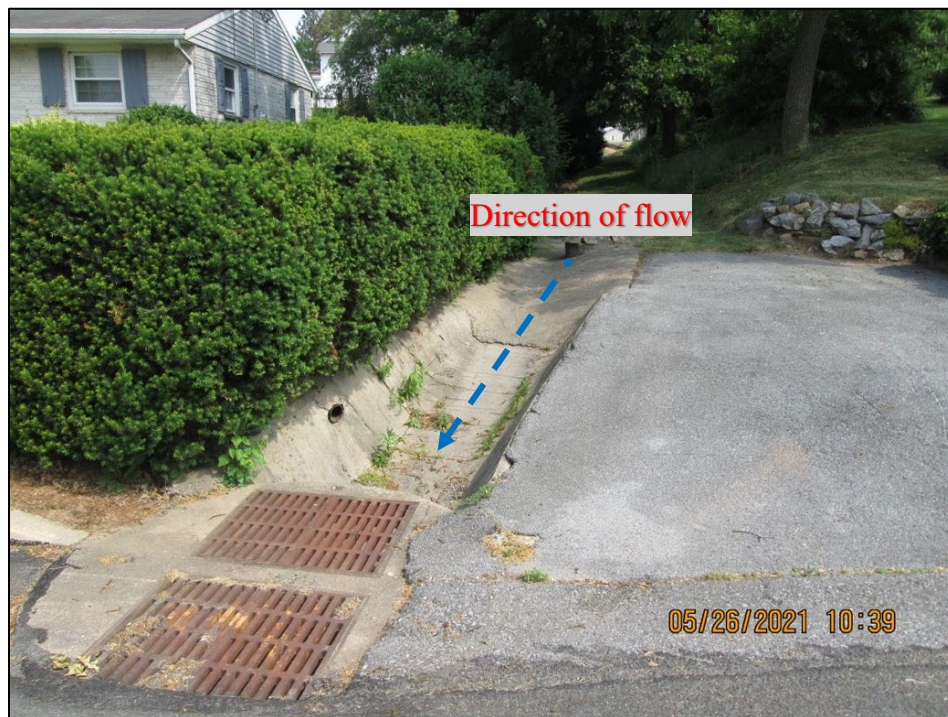
**Photograph 25. Outfall #4: (IMG\_1817)** View, facing north, of culvert that flows into Outfall #4.

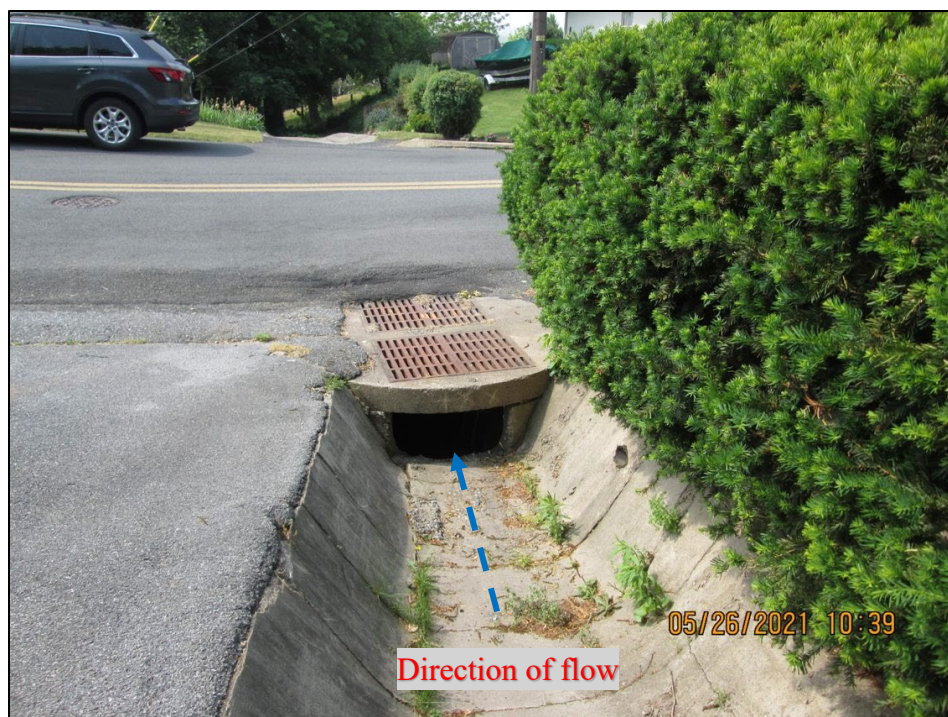
**Photograph 26. Outfall #4: (IMG\_1819)** View, facing north, of culvert in Photograph 25 that flows to Outfall #4.

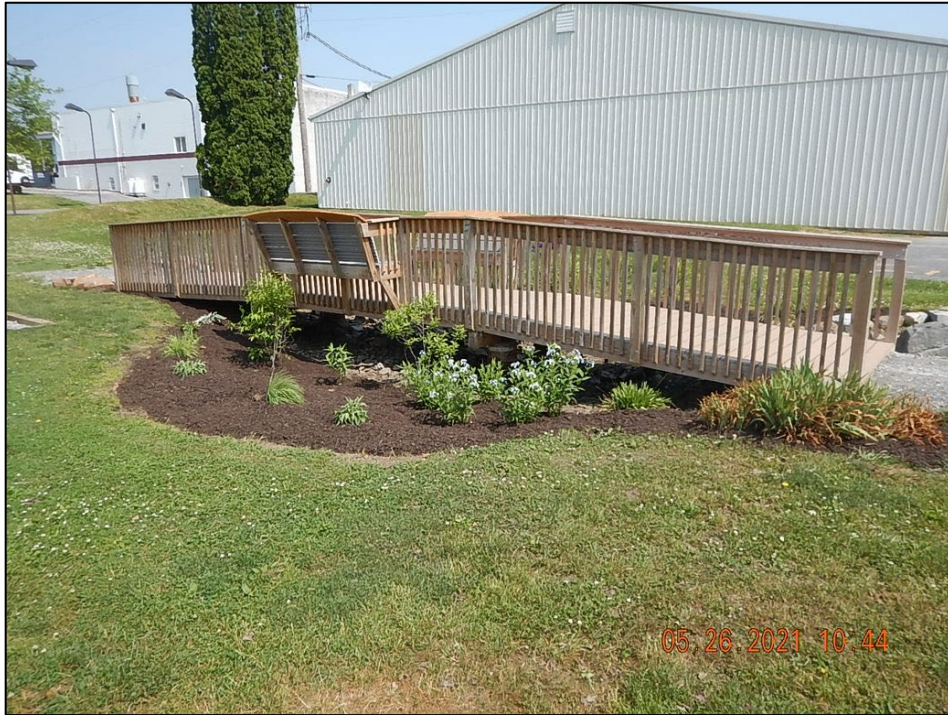
- 1) The EPA Inspection Team observed the primary areas that convey stormwater runoff to Rain Garden #1 (refer to Photograph 27); the adjacent parking lot to the north and east, and the field to the west. Though Rain Garden #1 was installed recently, in 2020, the rock swale was saturated with leaves and debris, potentially limiting the function of the BMP (refer to Photographs 28 and 29).

**Photograph 27. Memorial Park Rain Garden #1: (DSCN5127)** View, facing north, of Rain Garden #1 at the Terre Hill Community Memorial Park.

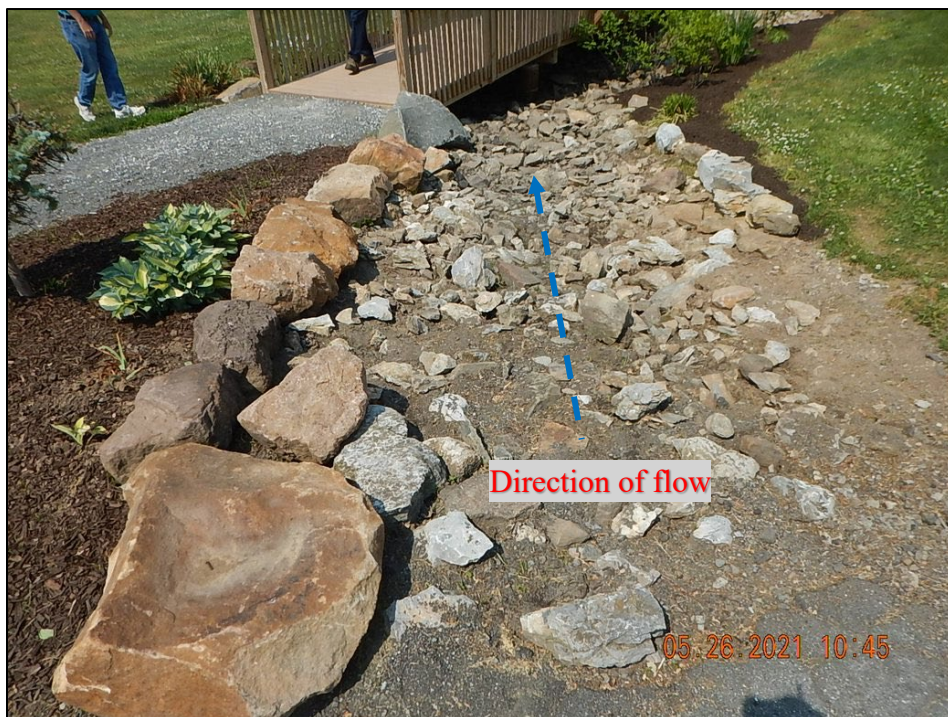
**Photograph 28. Memorial Park Rain Garden #1: (DSCN5130)** View, facing north, of Rain Garden #1 at the Terre Hill Community Memorial Park. This portion of the rain garden receives sheet flow from the adjacent parking lot. Note the accumulation of leaves and debris within the rain garden.

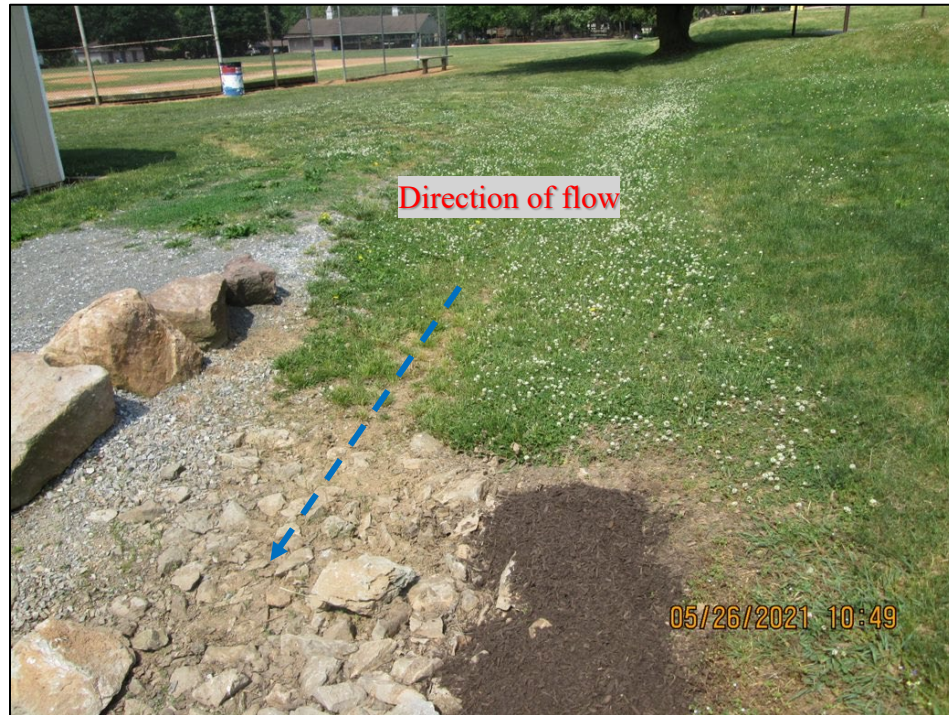
**Photograph 29. Memorial Park Rain Garden #1: (IMG\_1825)** View, facing west, of the field that also conveys flow into Rain Garden #1. Note the accumulation of leaves and debris within the rain garden.
