**U.S. ENVIRONMENTAL PROTECTION AGENCY  
REGION III WATER BRANCH, ENFORCEMENT  
AND COMPLIANCE ASSURANCE DIVISION  
CLEAN WATER ACT  
COMPLIANCE INSPECTION REPORT**

**Name of Facility:** Borough of Terre Hill MS4  
**Facility Address:** 300 Broad Street PO Box 250, Terre Hill, PA 17581  
**Mailing Address:** 300 Broad Street PO Box 250, Terre Hill, PA 17581

| <b>Type of Inspection:</b> | MS4 Compliance Inspection |

**Unique Project Identifier (UPI):** 3E21WN074A

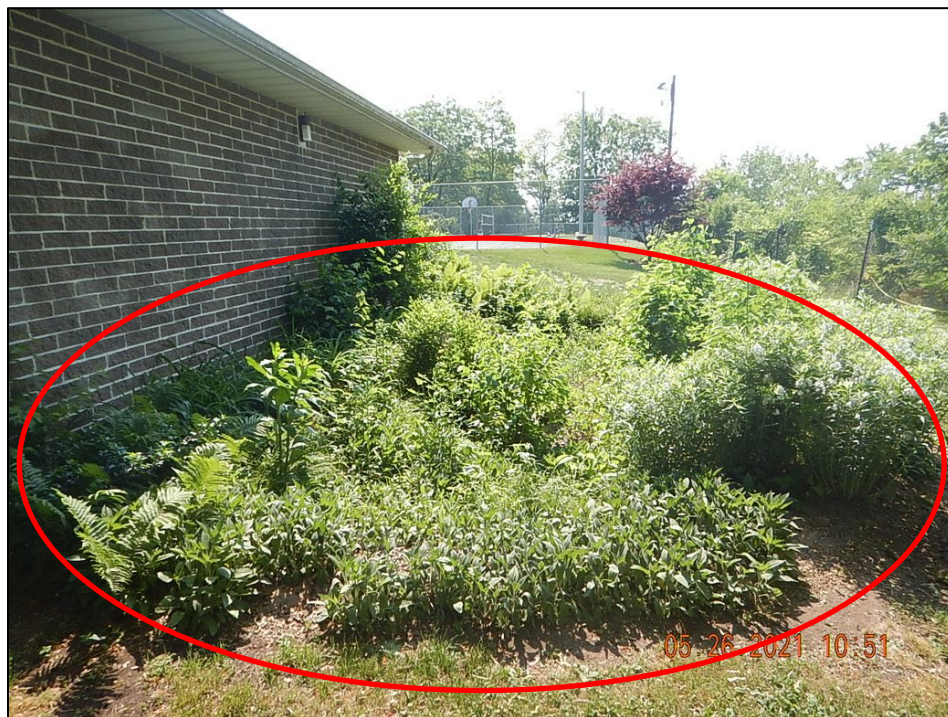
- 1) The EPA Inspection Team observed that Rain Garden #2 was in need of maintenance at the time of the inspection. Specifically, the EPA Inspection Team observed an abundance of weeds within the garden. Borough representatives stated that the garden was last trimmed/cut in 2020, though some of the vegetation was permanently damaged or inadvertently removed from the maintenance (refer to Photographs 30 and 31). Borough representatives stated that the local soil conservation district has provided some training on rain gardens to Borough staff in the past; however, it is unclear when the training occurred, who attended, and what the focus was.

**Photograph 30. Memorial Park Rain Garden #2: (DSCN5135)** View of Rain Garden #2 at the Terre Hill Community Memorial Park which collects stormwater from the nearby grassy areas and adjacent building. Note the excessive weeds and vegetation within the rain garden.

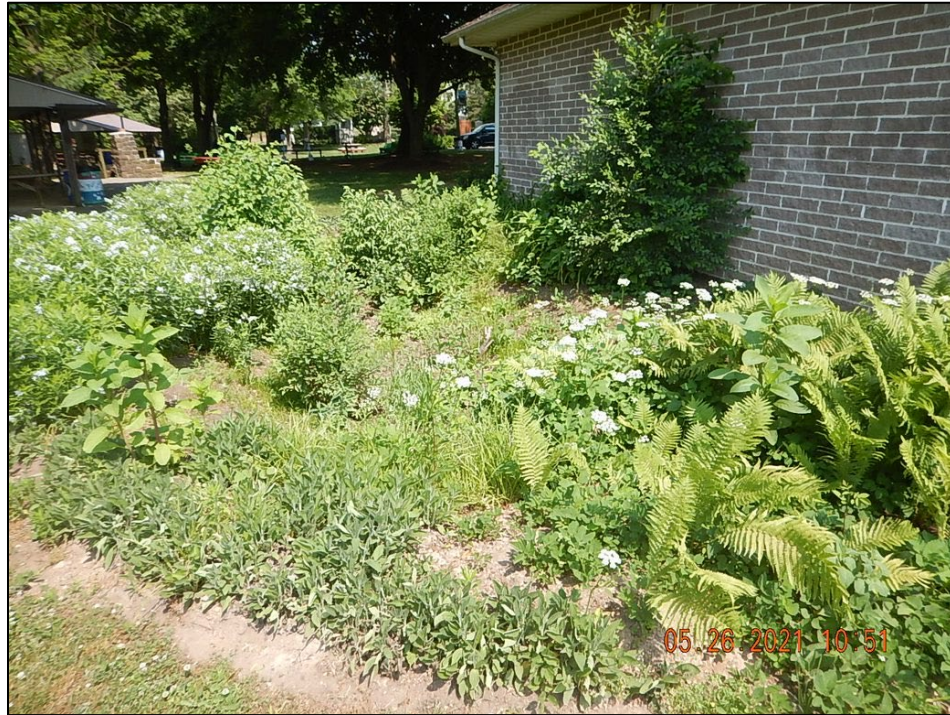
**Photograph 31. Memorial Park Rain Garden #2: (DSCN5137)** An additional view of Rain Garden #2. Note the excessive weeds and vegetation within the rain garden.

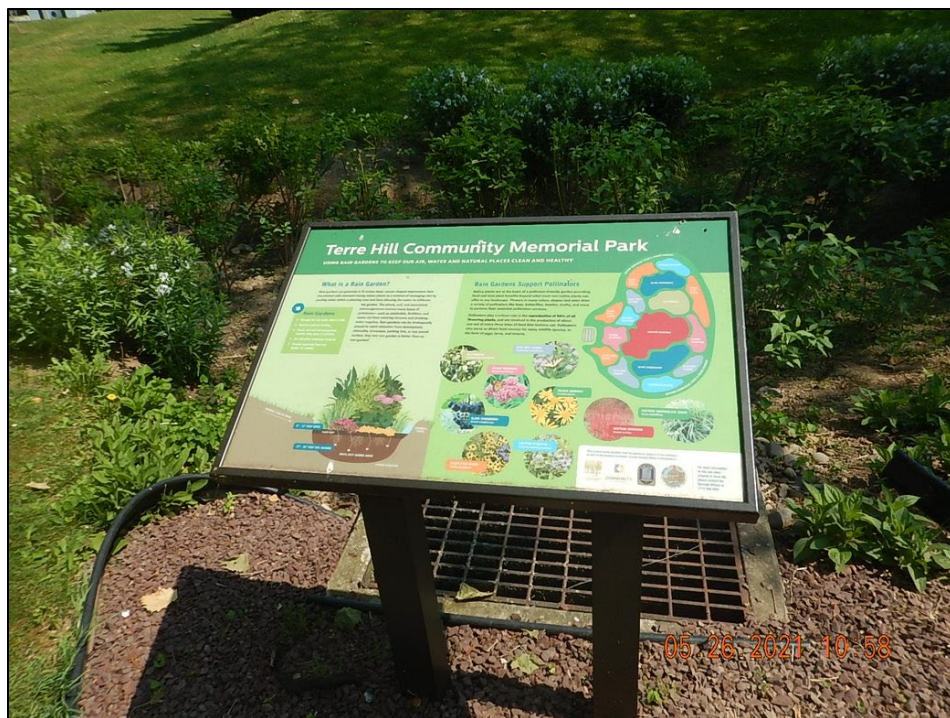
- 1) Overall, the rain garden appeared to be in good condition at the time of the inspection.
- 2) The EPA Inspection Team observed an inlet within Rain Garden #3 that collects stormwater (refer to Photograph 32). Overflow from Rain Garden #3 is conveyed to Outfall 025, south of the park (refer to Photograph 33 and Appendix B, Exhibit 3).
- 3) The EPA Inspection Team observed the adjacent tennis court and parking lot from which stormwater runoff drains to the rain garden (refer to Photographs 34 and 35).

**Photograph 32. Memorial Park Rain Garden #3: (DSCN5140)** View, facing north, of Rain Garden #3 and attached inlet at the Terre Hill Community Memorial Park. This rain garden collects stormwater from an adjacent parking lot and tennis court.

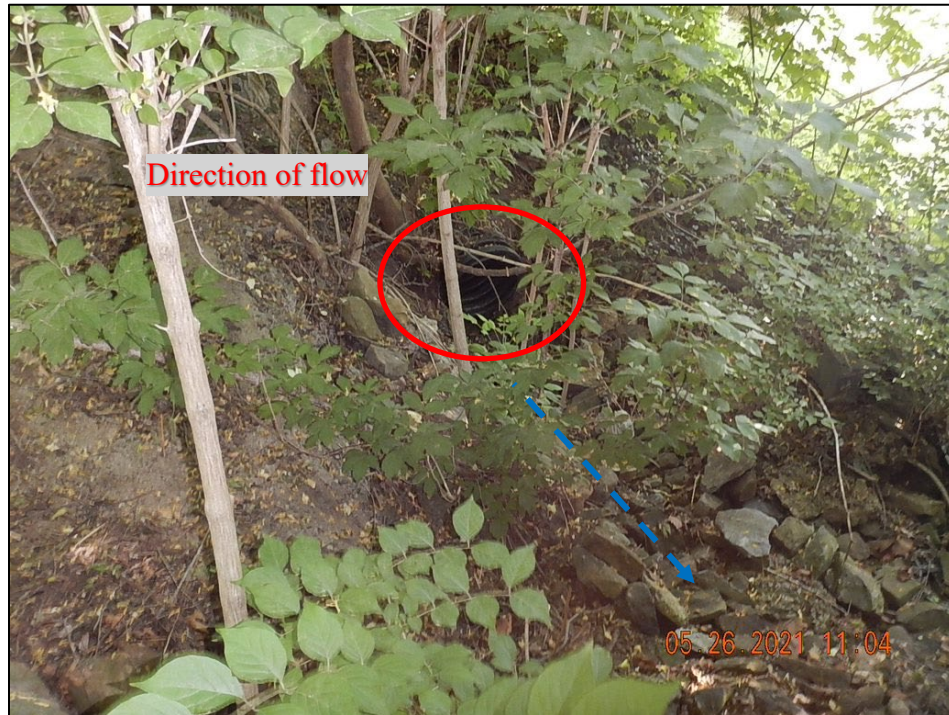
from the tank conveys excess volume to Outfall 025, south of the park (refer to Photograph 33 and Appendix B, Exhibit 3).

**Photograph 33. Memorial Park Rain Garden #3: (DSCN5148)** View of the overflow outlet pipe from Rain Garden #3 and the stormwater tank. The channel leads to Outfall 025.

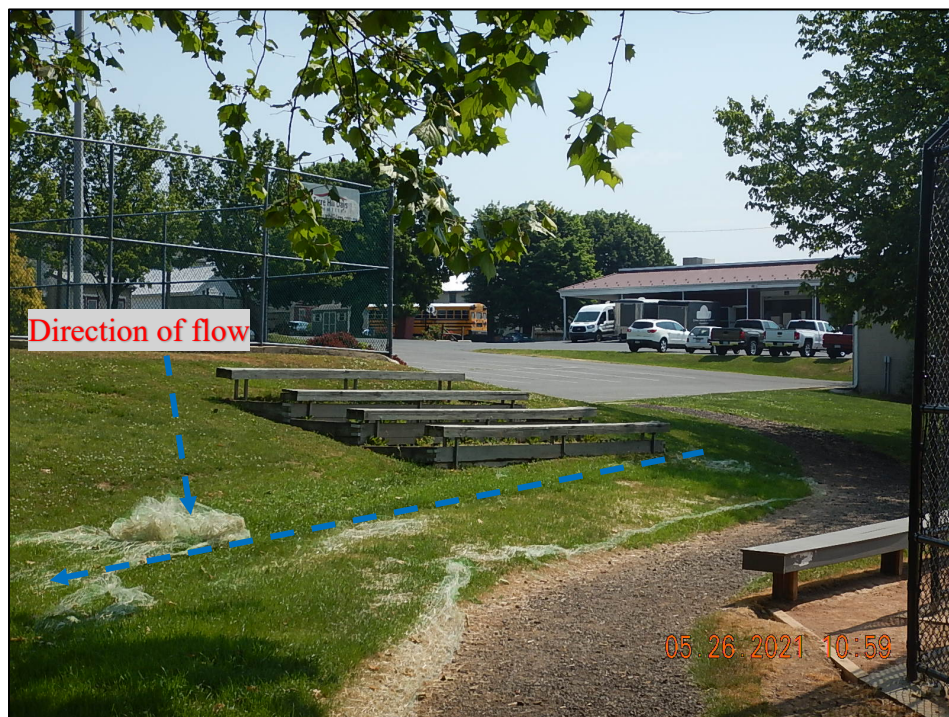
**Photograph 34. Memorial Park Rain Garden #3: (DSCN5143)** View, facing northeast, of the parking lot and tennis court that runoff and drain into the rain garden.

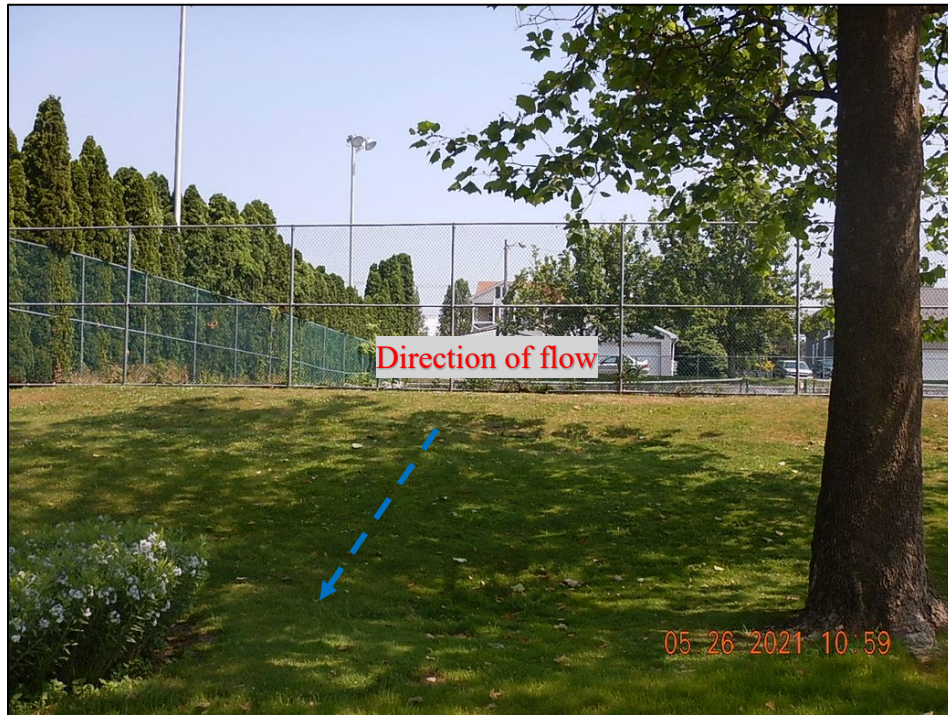
**Photograph 35. Memorial Park Rain Garden #3:** (DSCN5144) View, facing north, of the adjacent tennis court which flows into the rain garden.

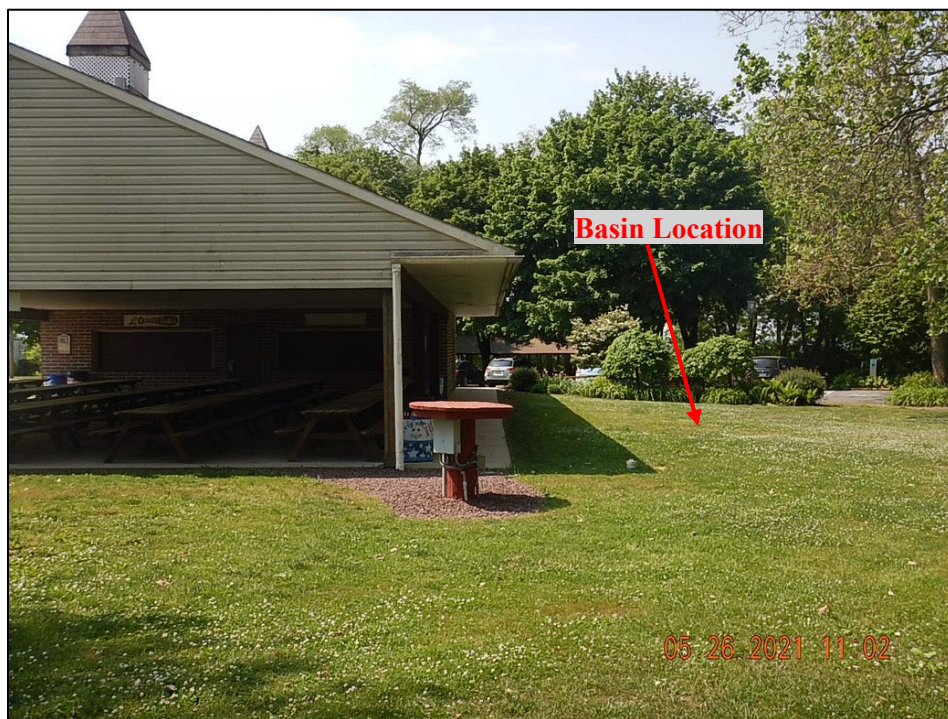
- 1) The EPA Inspection Team observed a drainage inlet for a 2,000-gallon underground rainwater storage tank near Memorial Park Pavilion #1 (refer to [Photographs 36 and 37](#)). An overflow pipe

**Photograph 36. Memorial Park Underground Storage Tank:** (DSCN5145) View of Pavilion #1 at Terre Hill Community Memorial Park. Rainwater from the roof of the pavilion is stored in an underground 2,000-gallon storage tank. Some stormwater is also able to collect through the inlet drain to the tank.

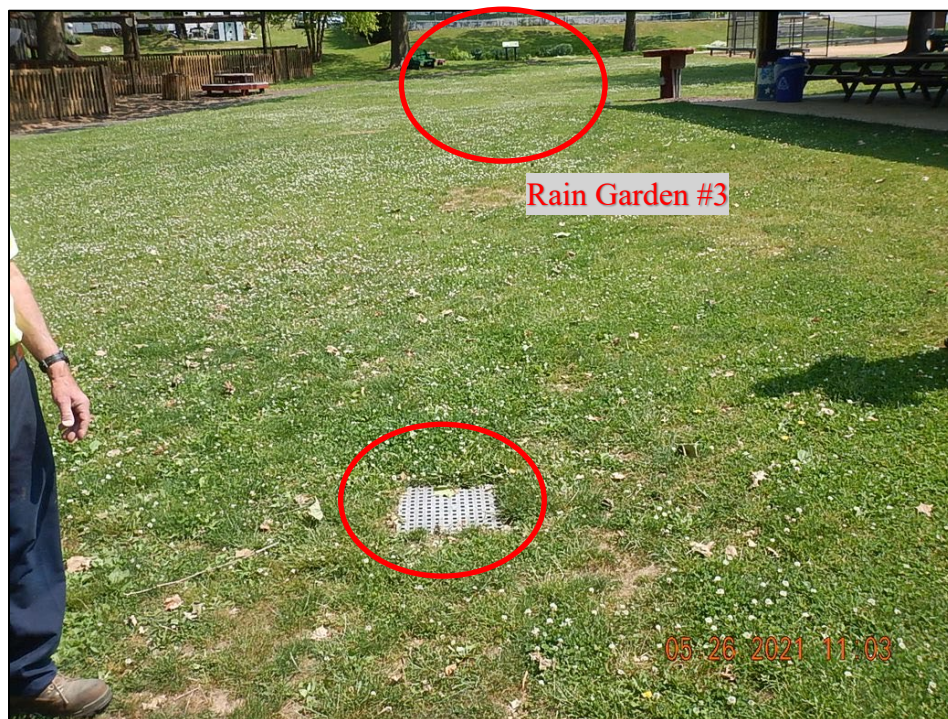
**Photograph 37. Memorial Park Underground Storage Tank:** (DSCN5147) View, facing north, of the drain into the underground storage tank that collects rainwater from park pavilion and surrounding area.
