## Attachment C

**Pit Worx, Inc.  
Pearson Pit  
Site Inspection Photographic Log**

Autaugaville, Autauga County, Alabama

April 17, 2024

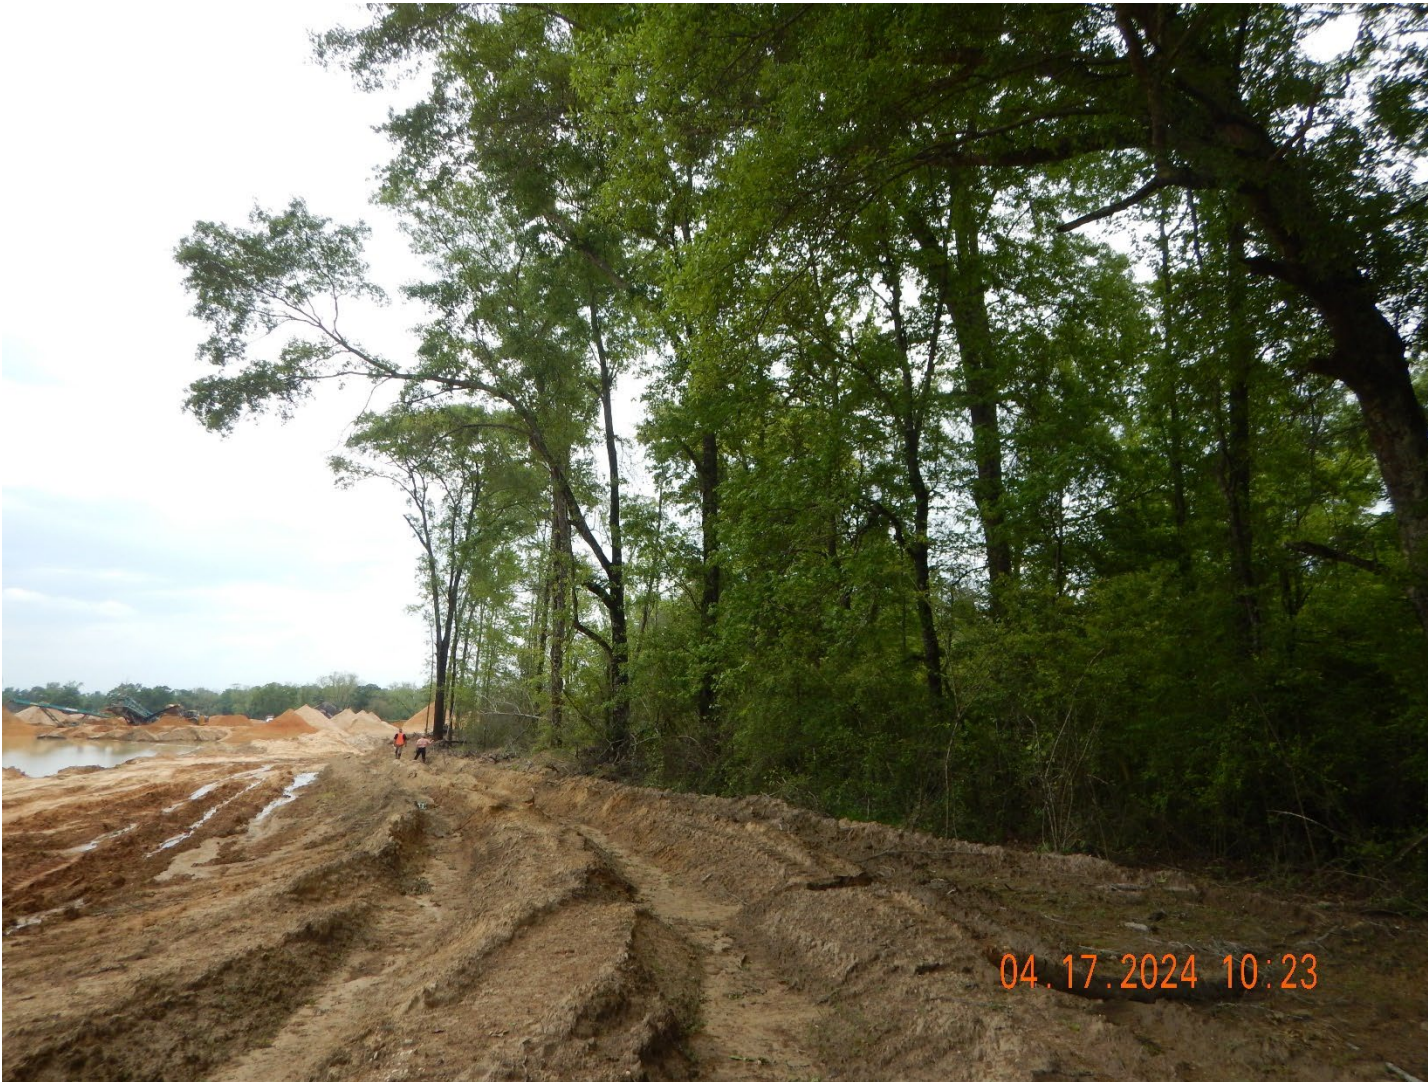
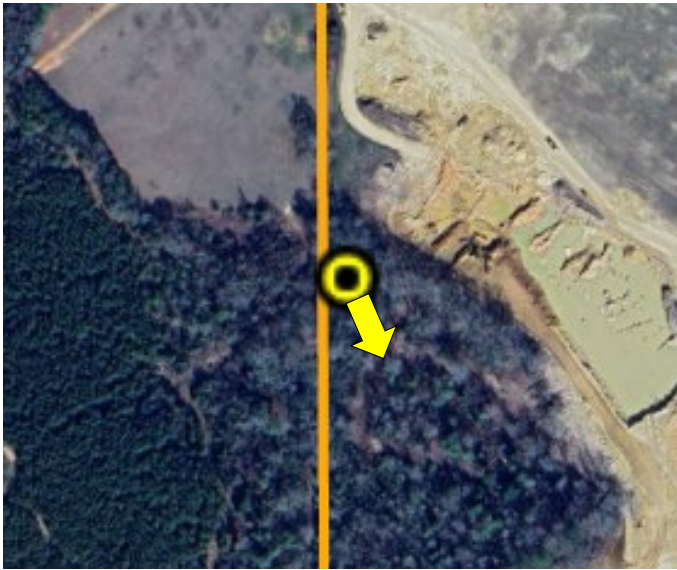
| Title | Photo 1 |

| Description | Striking toward remaining trees where potentially jurisdictional wetlands are located. Additional clearing has potentially occurred since the aerial imagery was taken.<br>*Camera clock was set to Eastern Standard Time. |

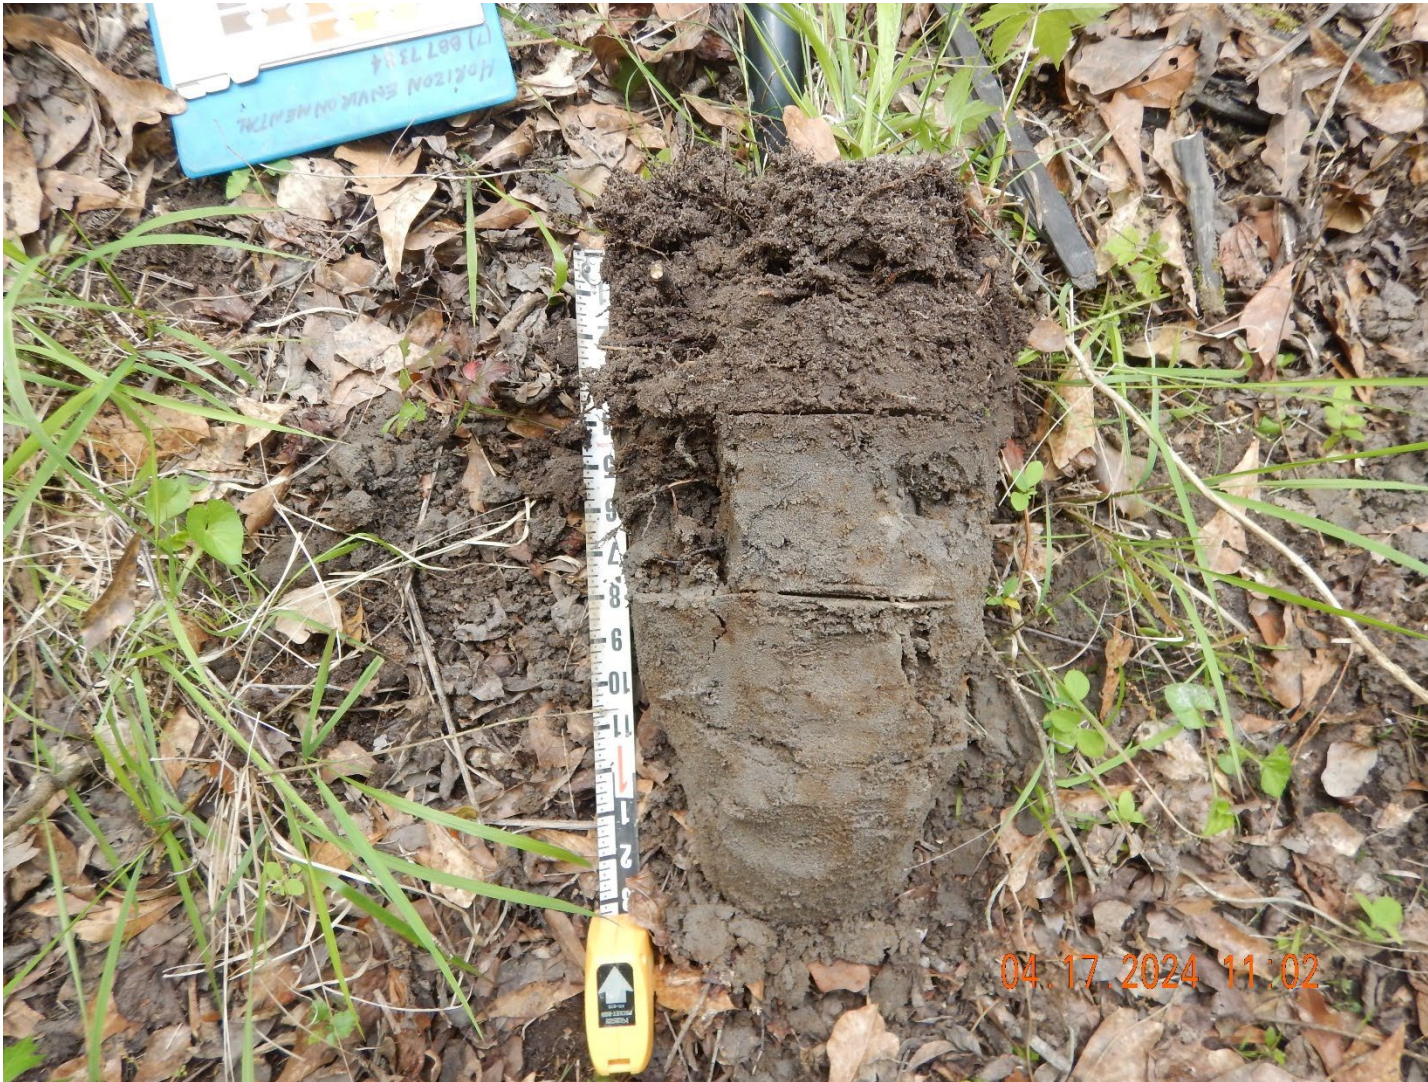
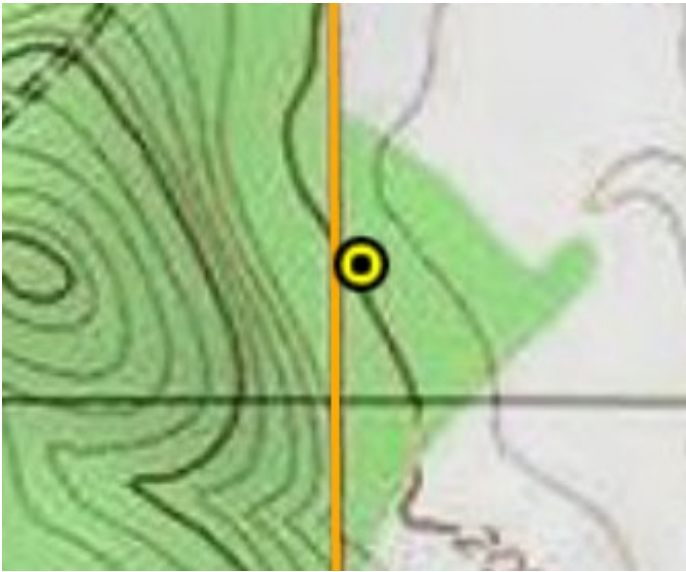
| Title | Photo 2 |

| Description | Soil profile, S1. Location where BioResources documented wetland conditions (November 2023 WOTUS report). |

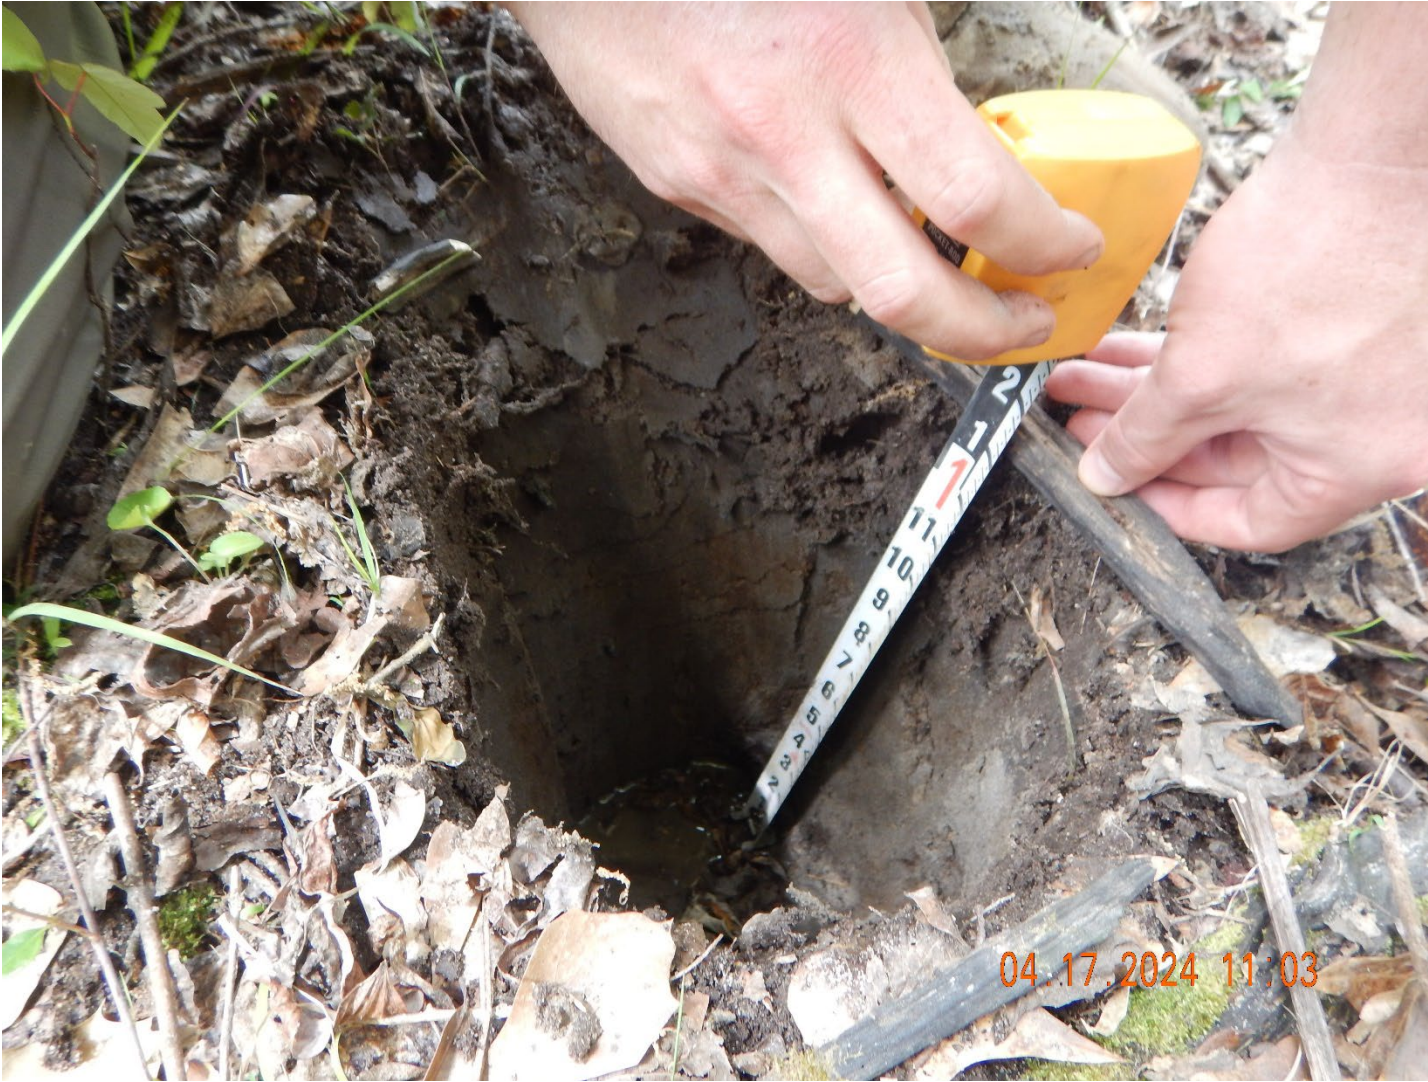
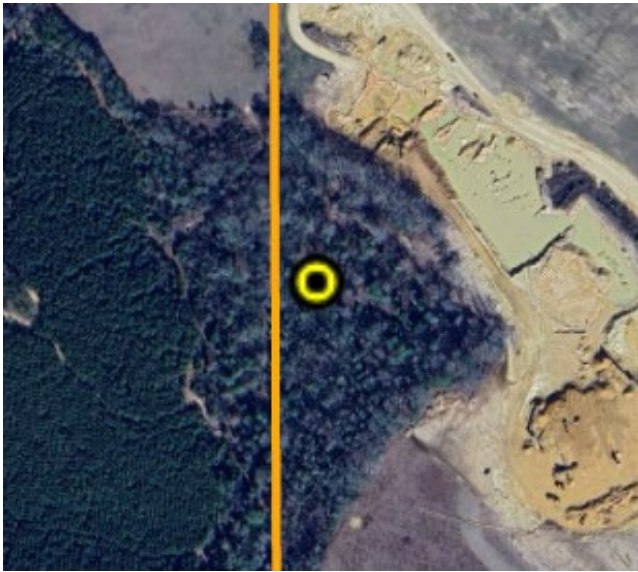
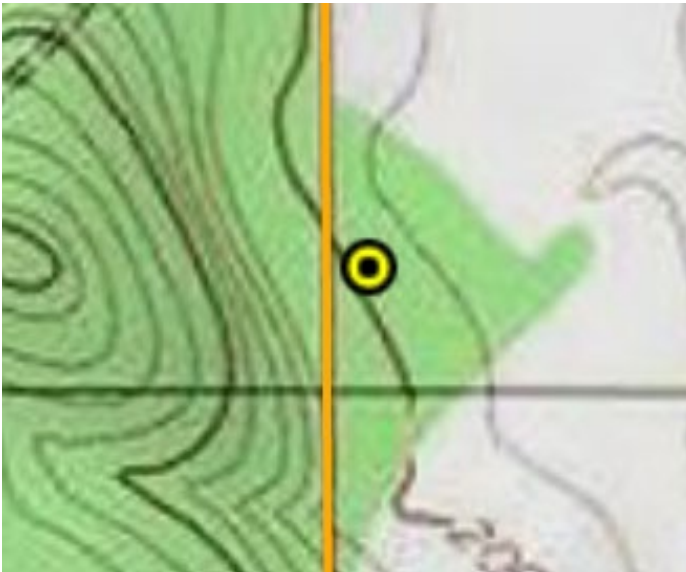
| Title | Photo 3 |

| Description | Location of soil profile, S1. Notice water within 12 inches from the soil surface. |

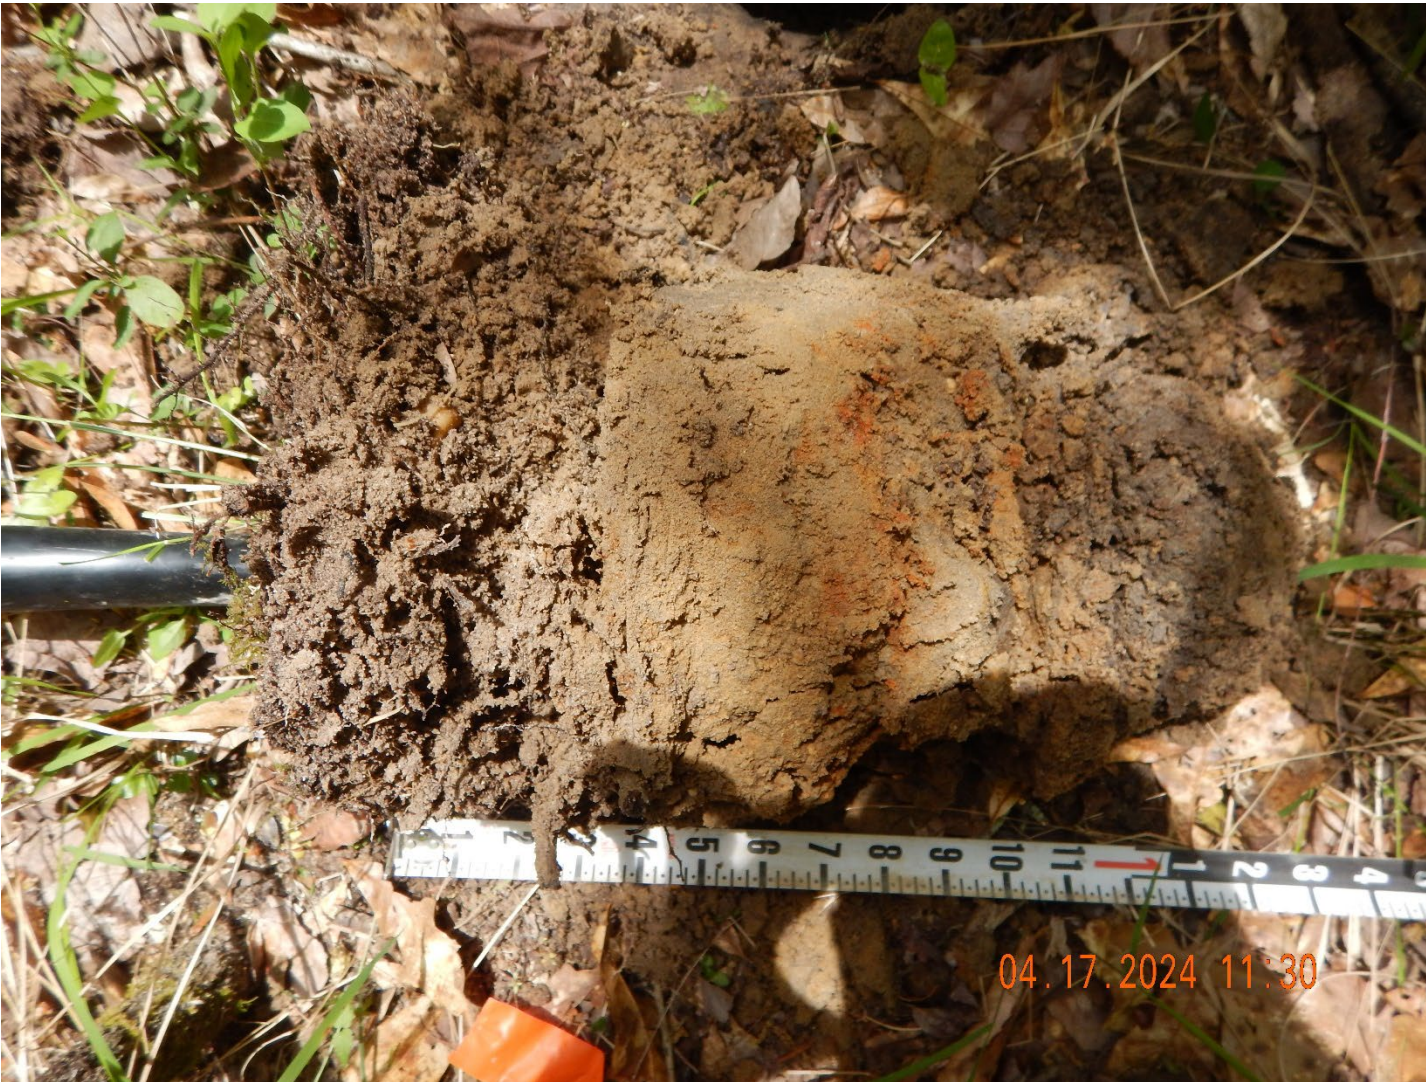
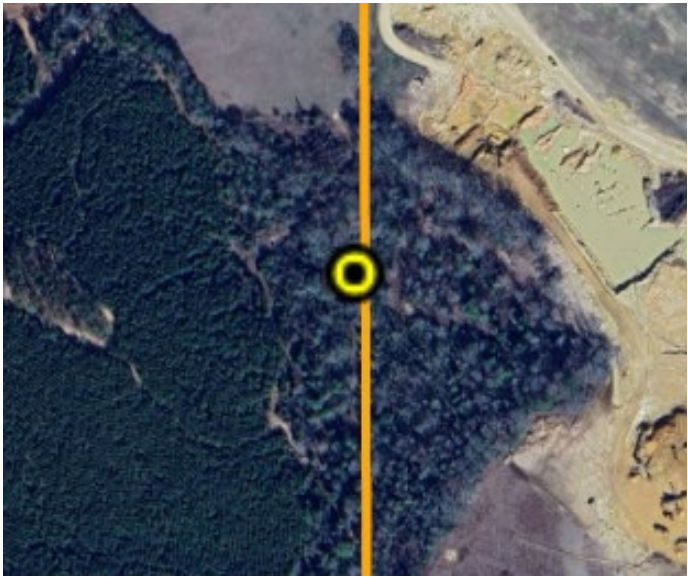
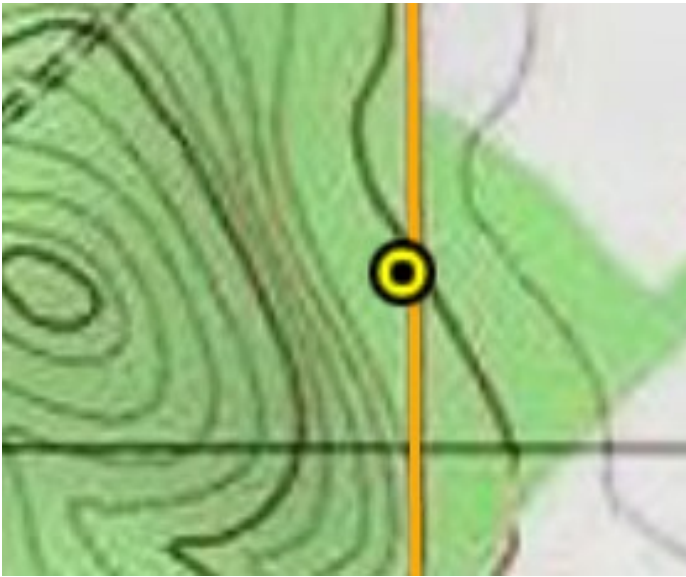
| Title | Photo 4 |

| Description | Soil profile, S2. |

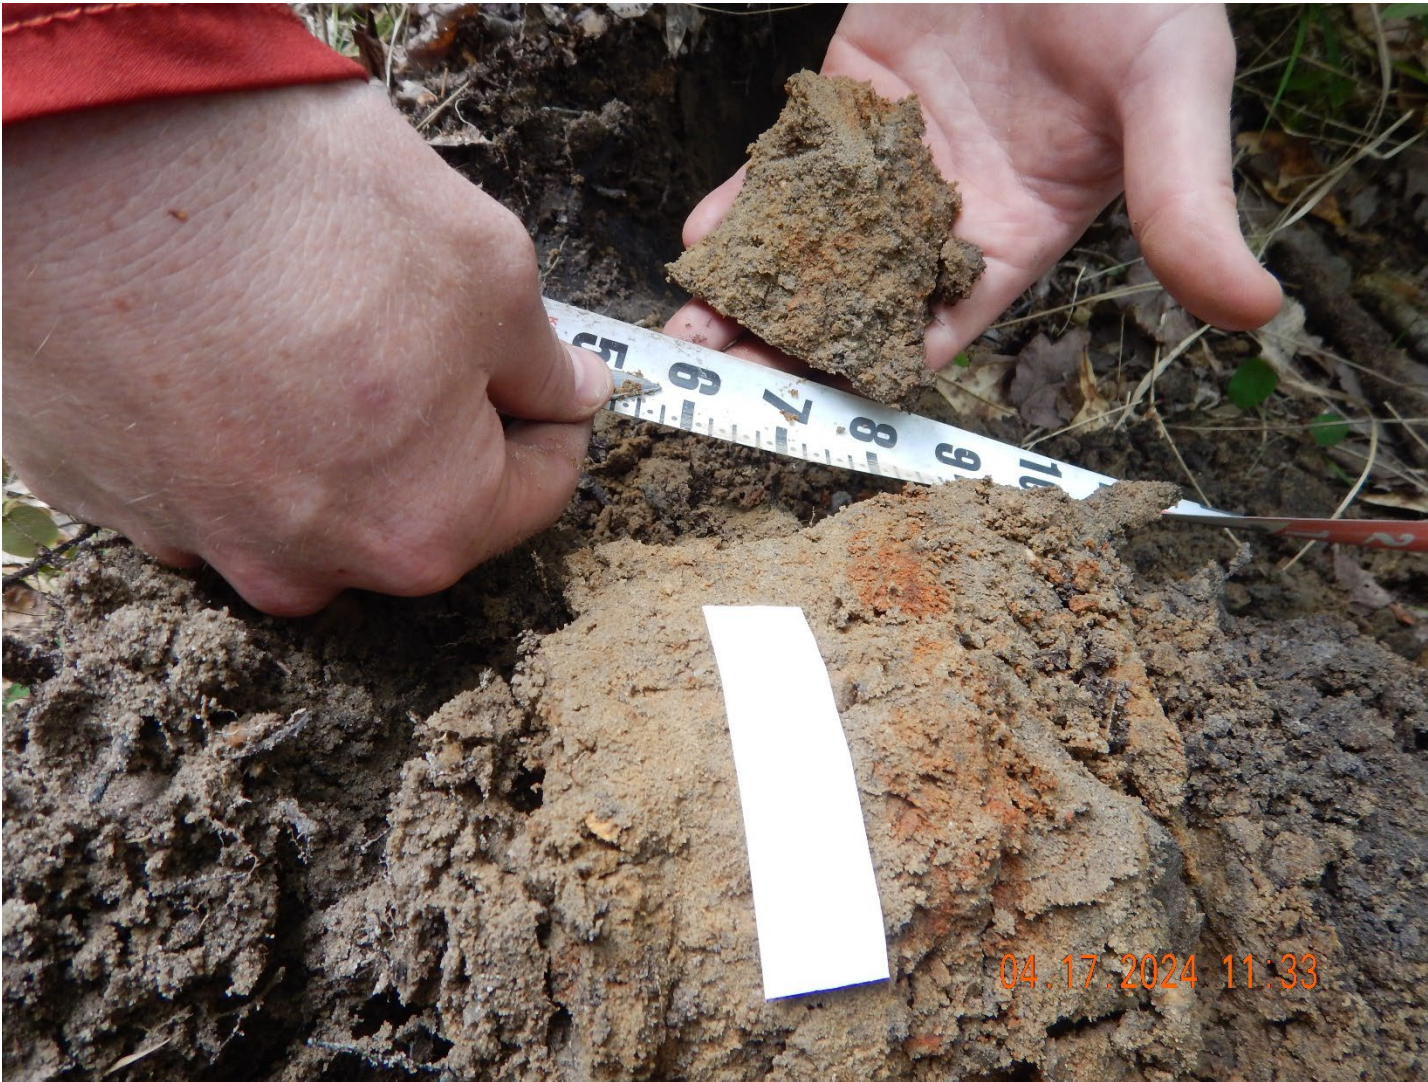
| Title | Photo 5 |

| Description | Additional angle of S2. |

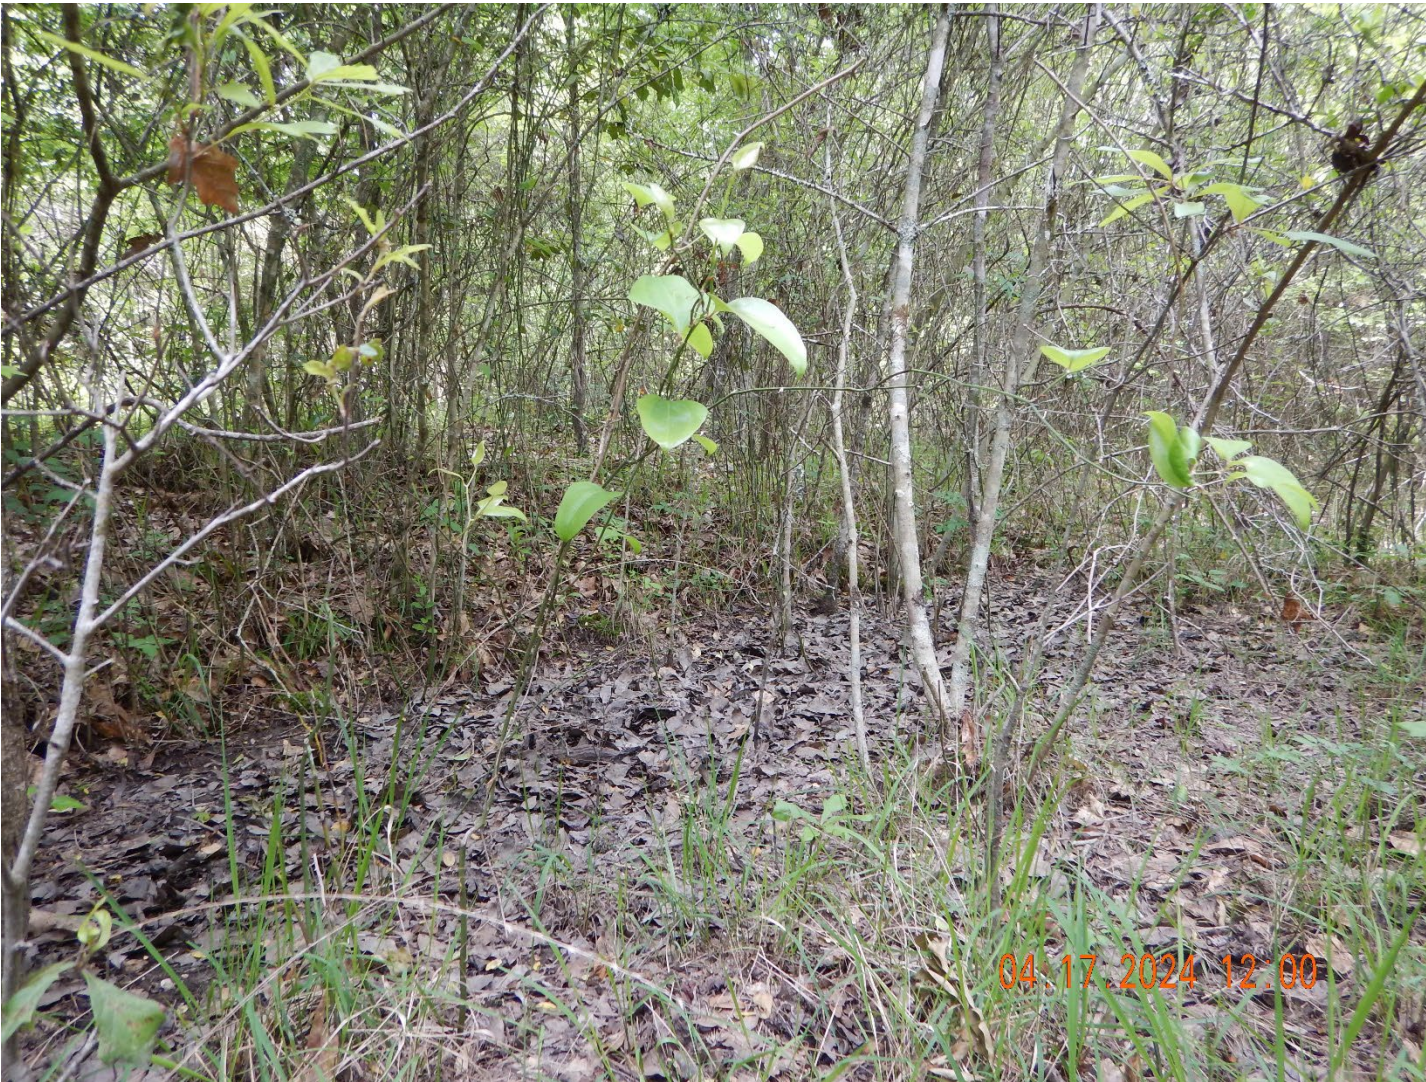
| Title | Photo 6 |

| Description | Landscape, taken approximately 10 feet from S2. |

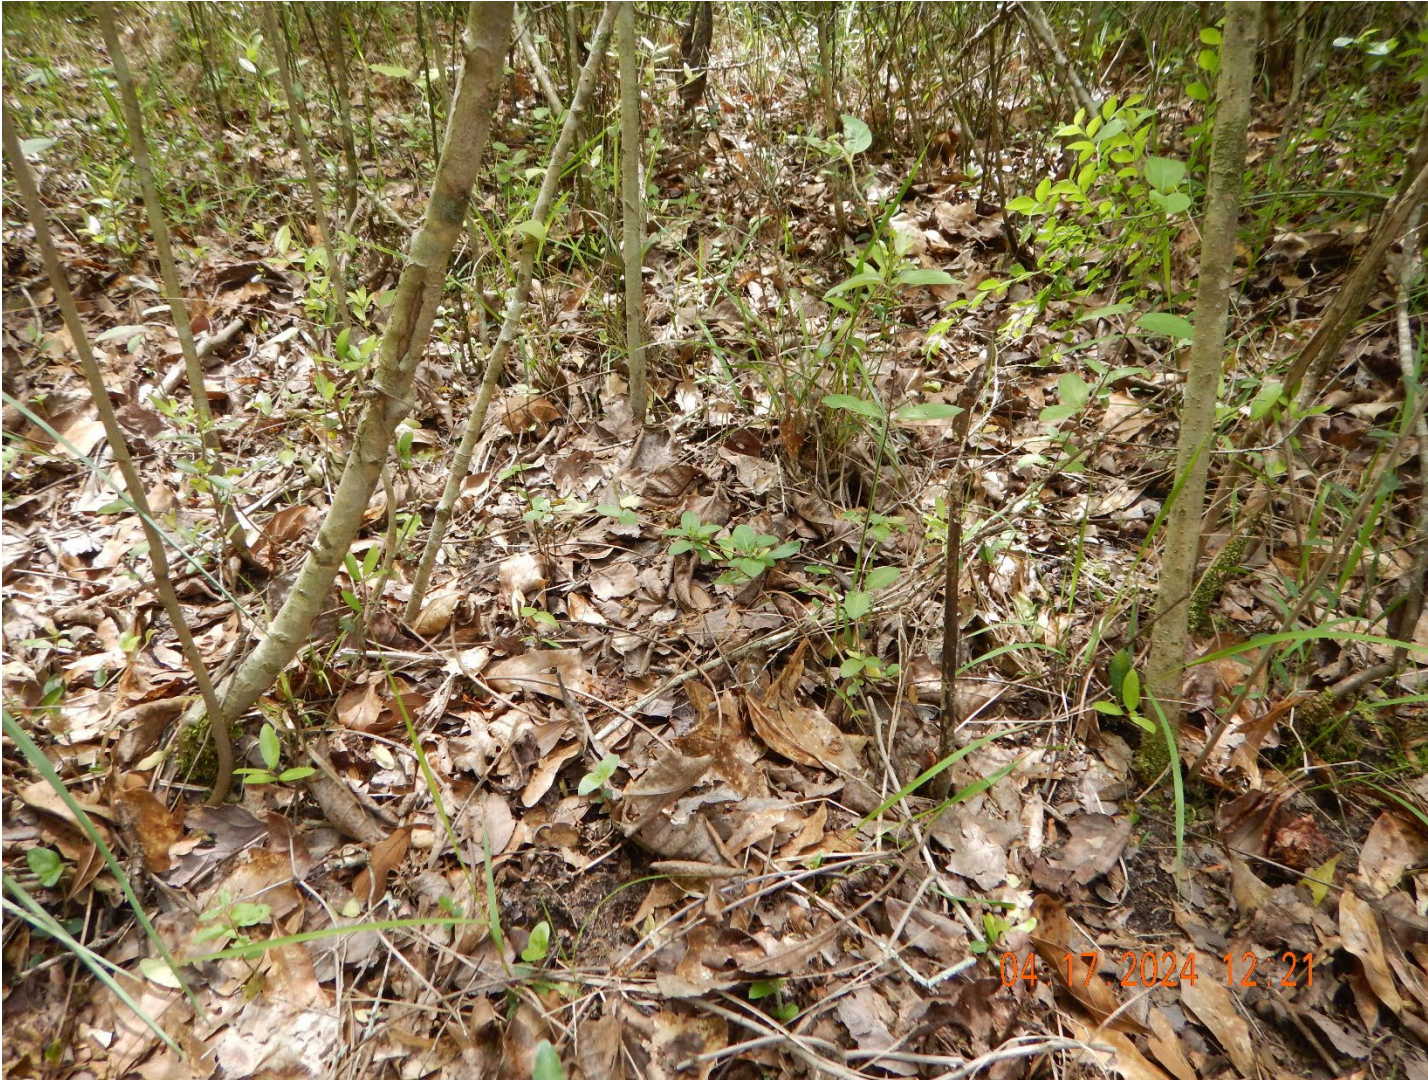
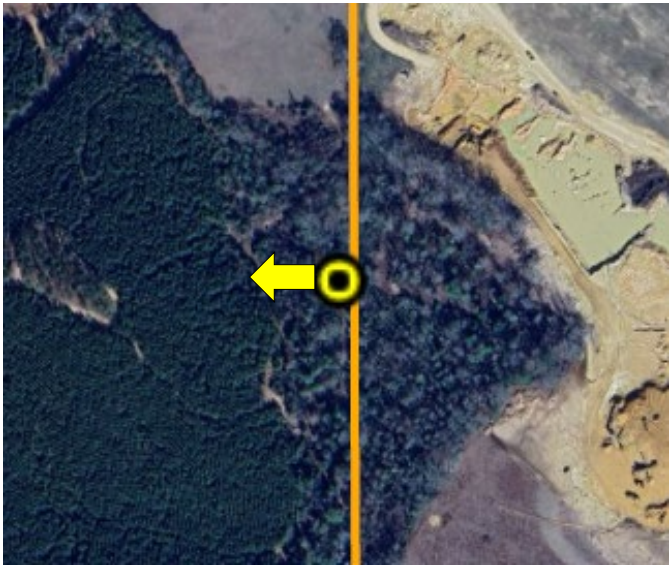
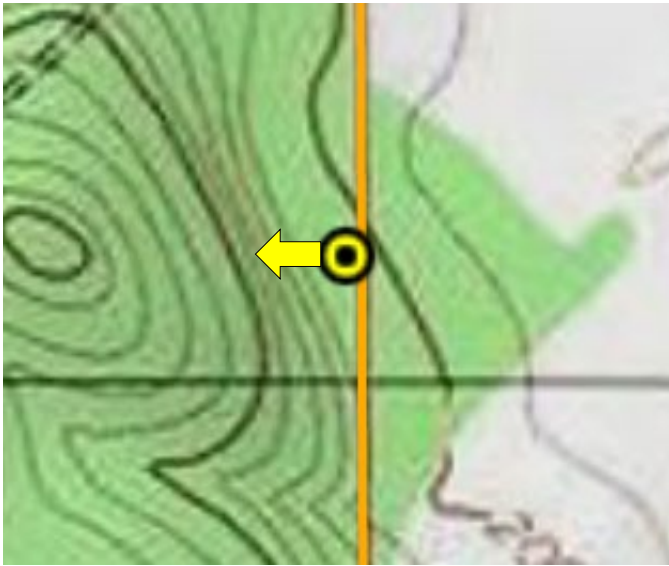
| Title | Photo 7 |

| Description | Landscape, taken approximately 3 feet from S2. |

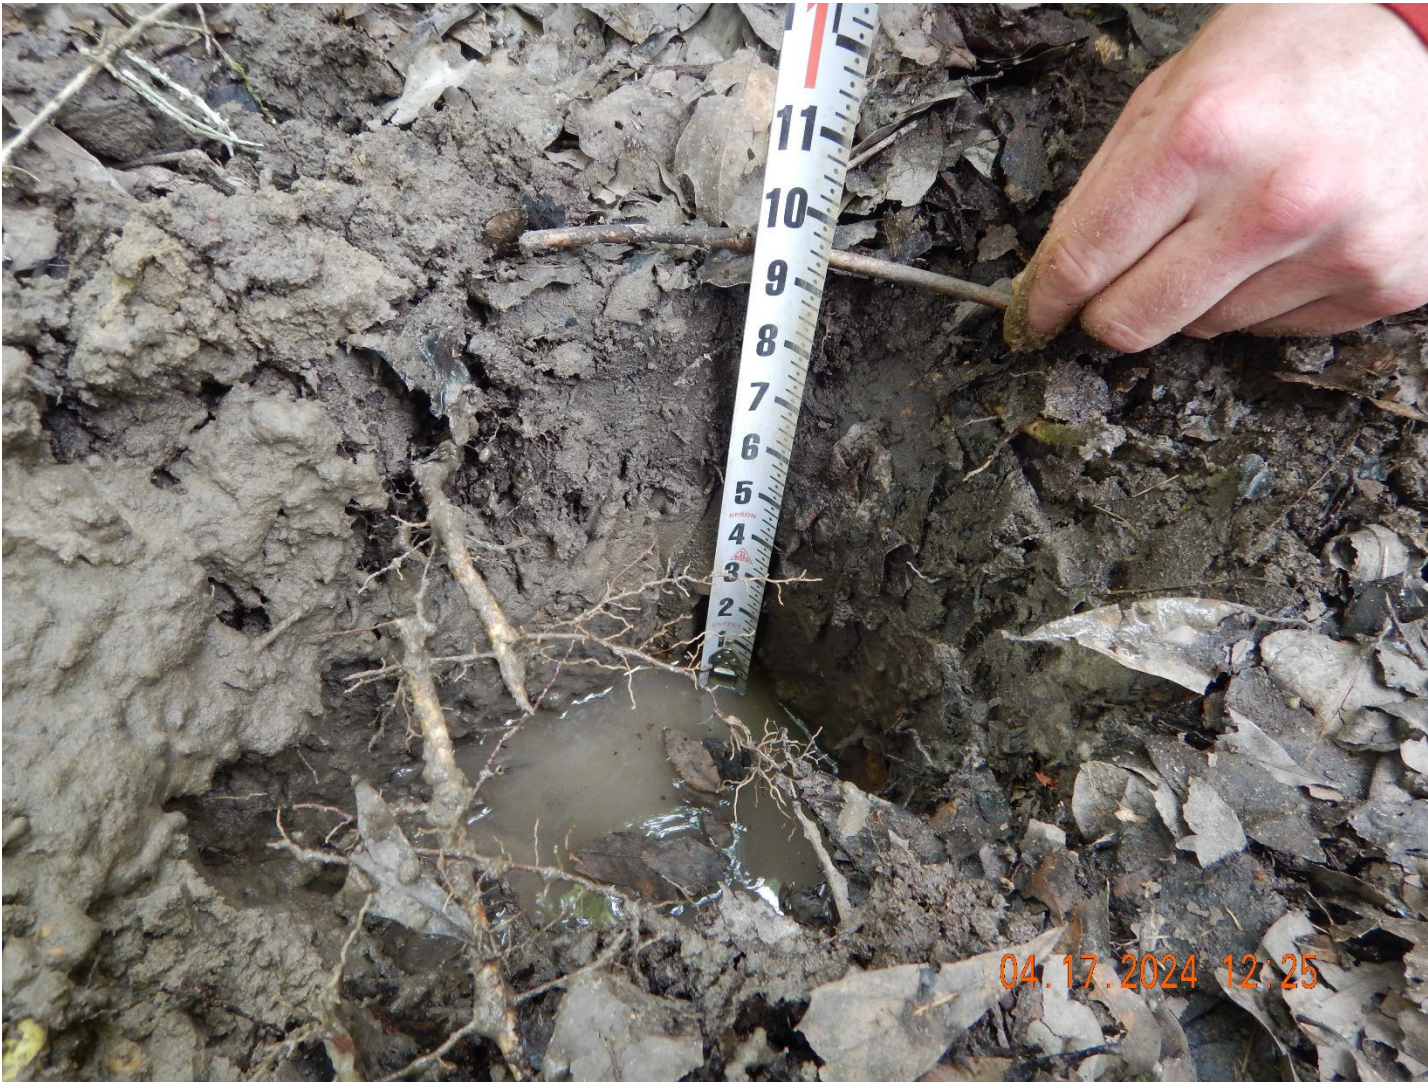
| Title | Photo 8 |

| Description | Location of soil profile S3. Notice water within 12 inches from the soil surface. |

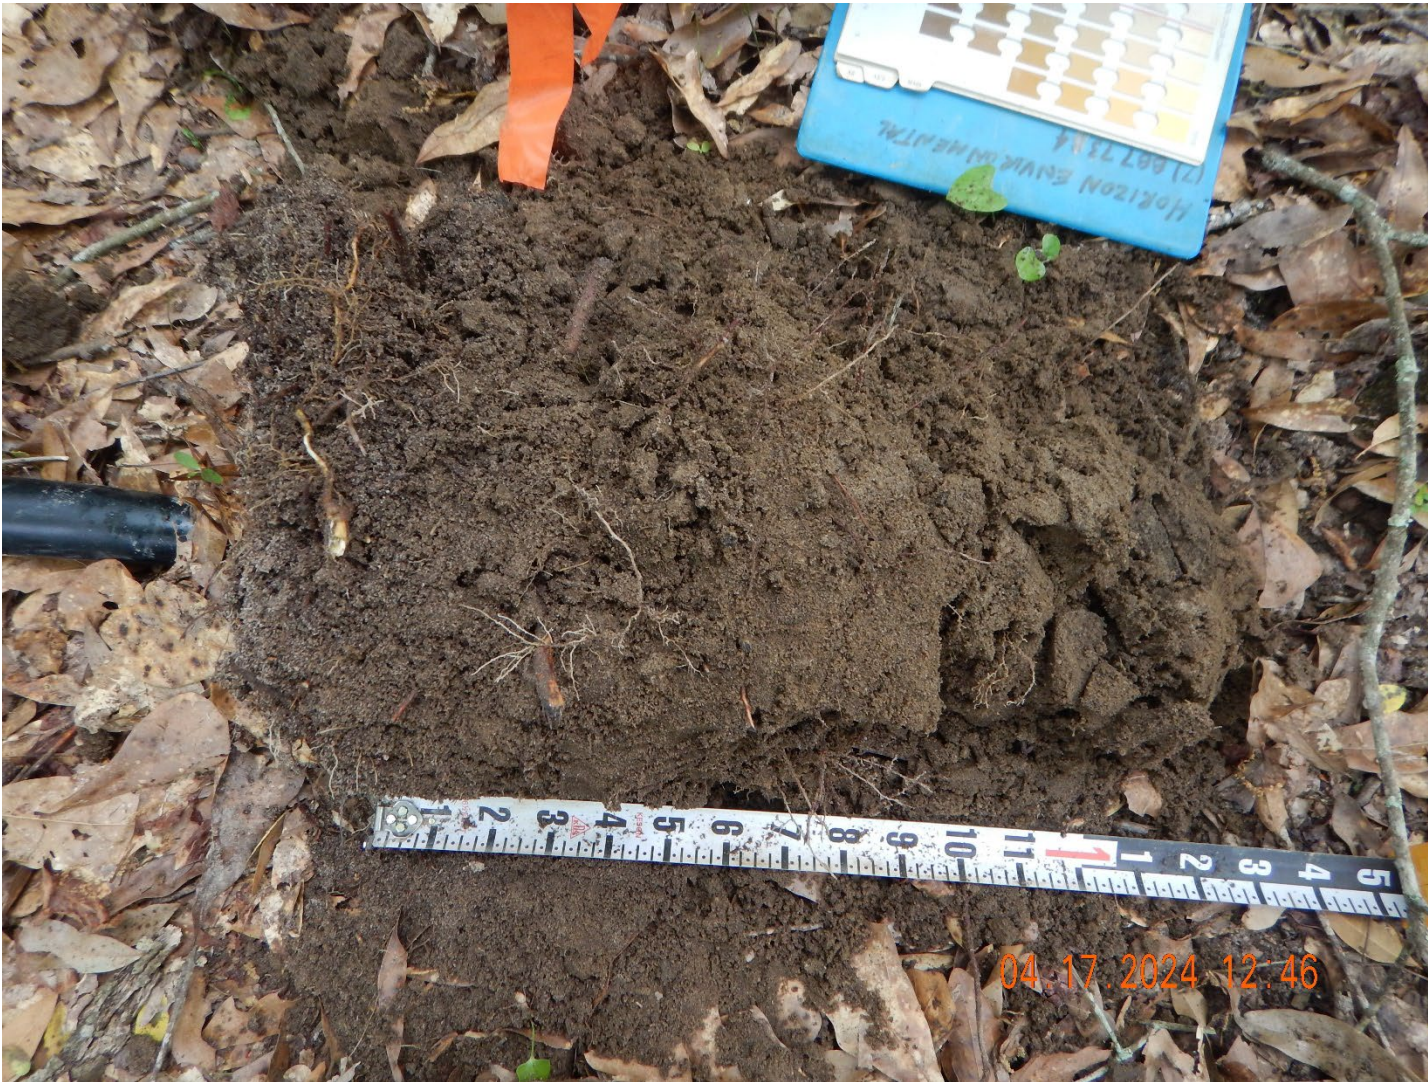
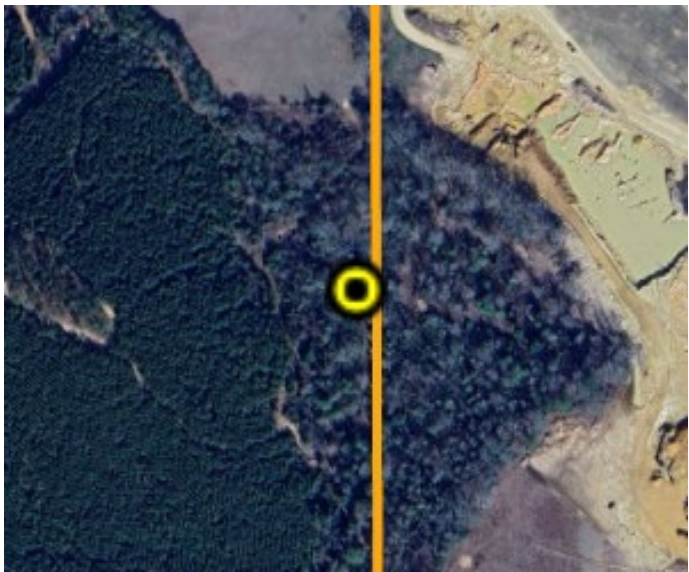
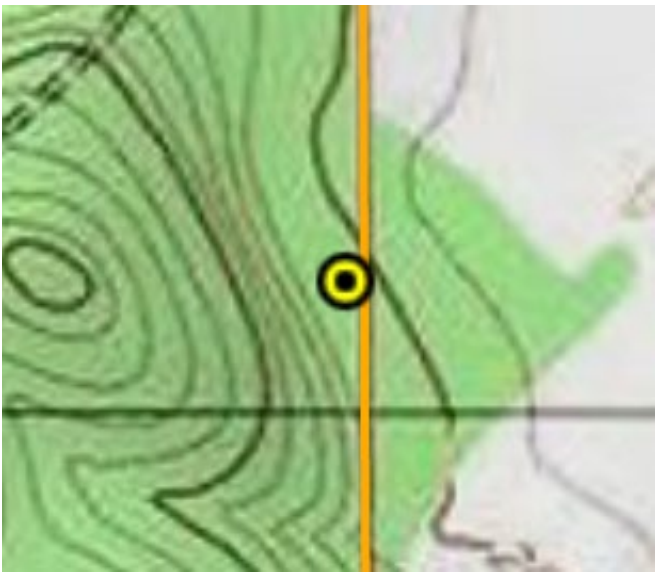
| Title | Photo 9 |

| Description | Soil profile, S4. |

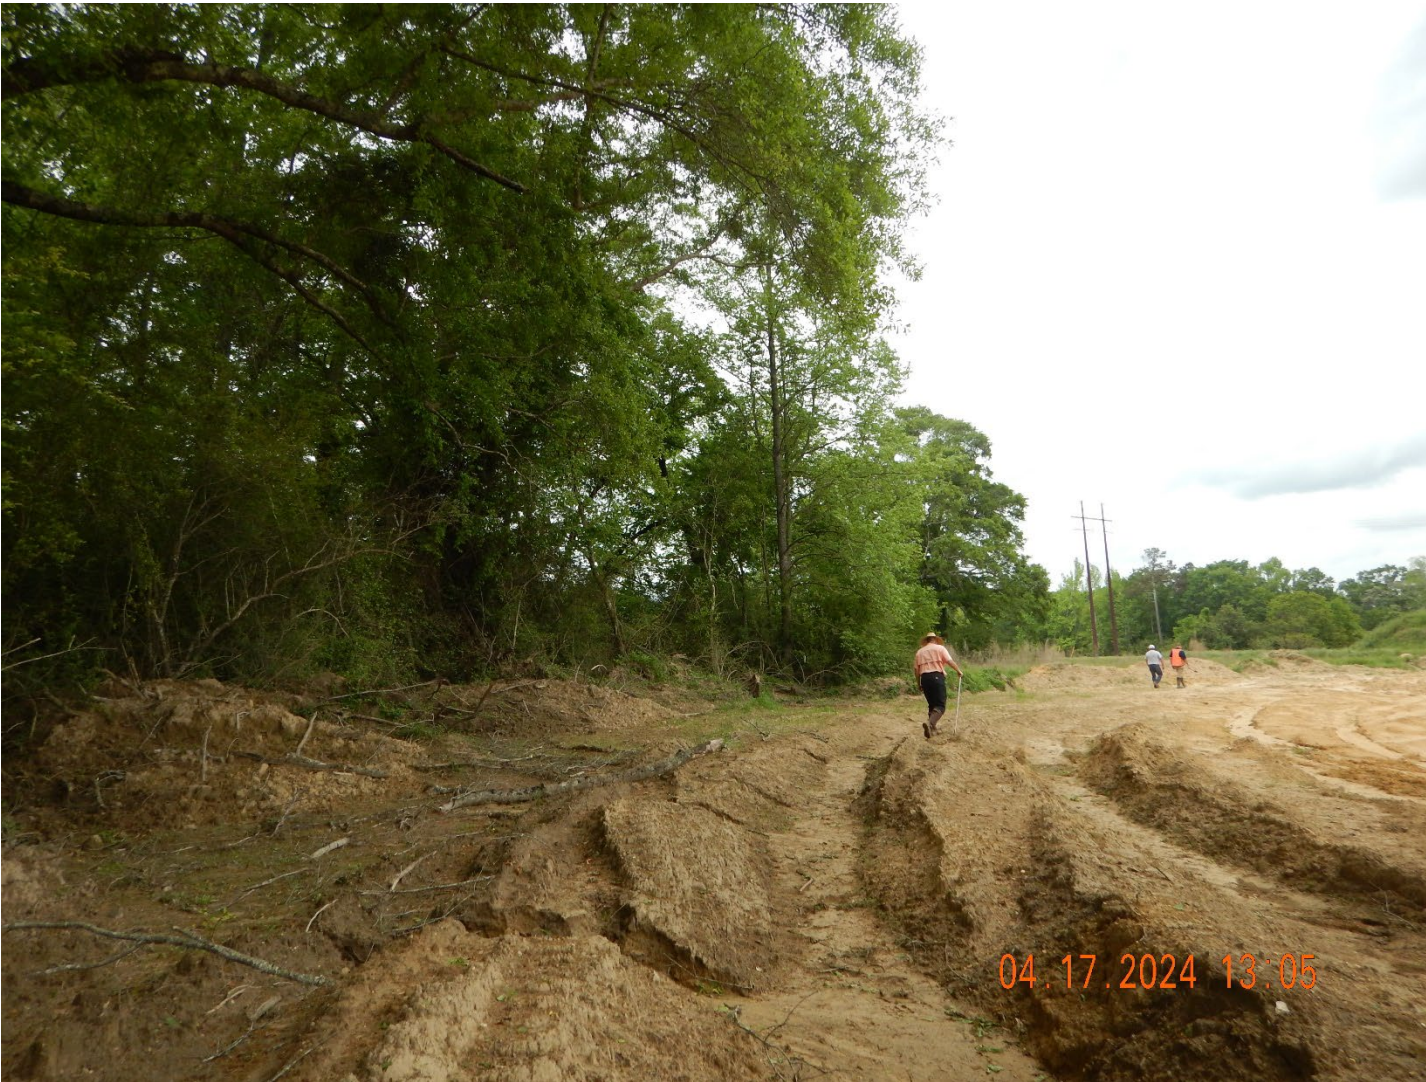
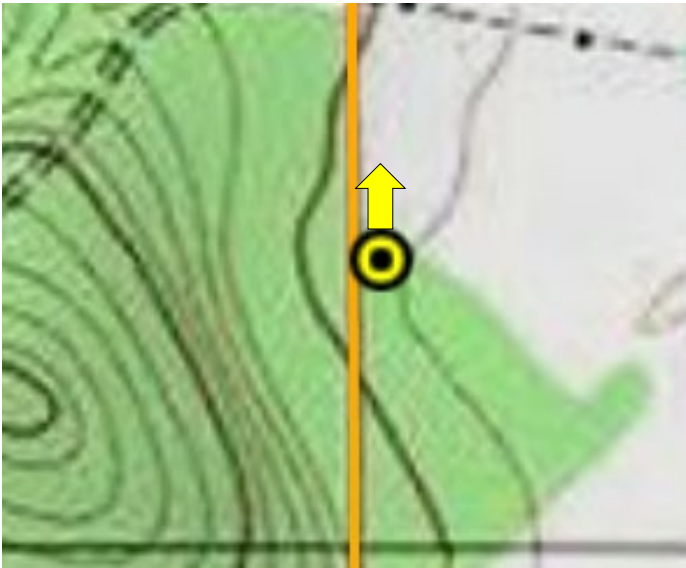
| Title | Photo 10 |

| Description | Coming out of the forested area, notice evidence of mechanized earth-moving equipment. |

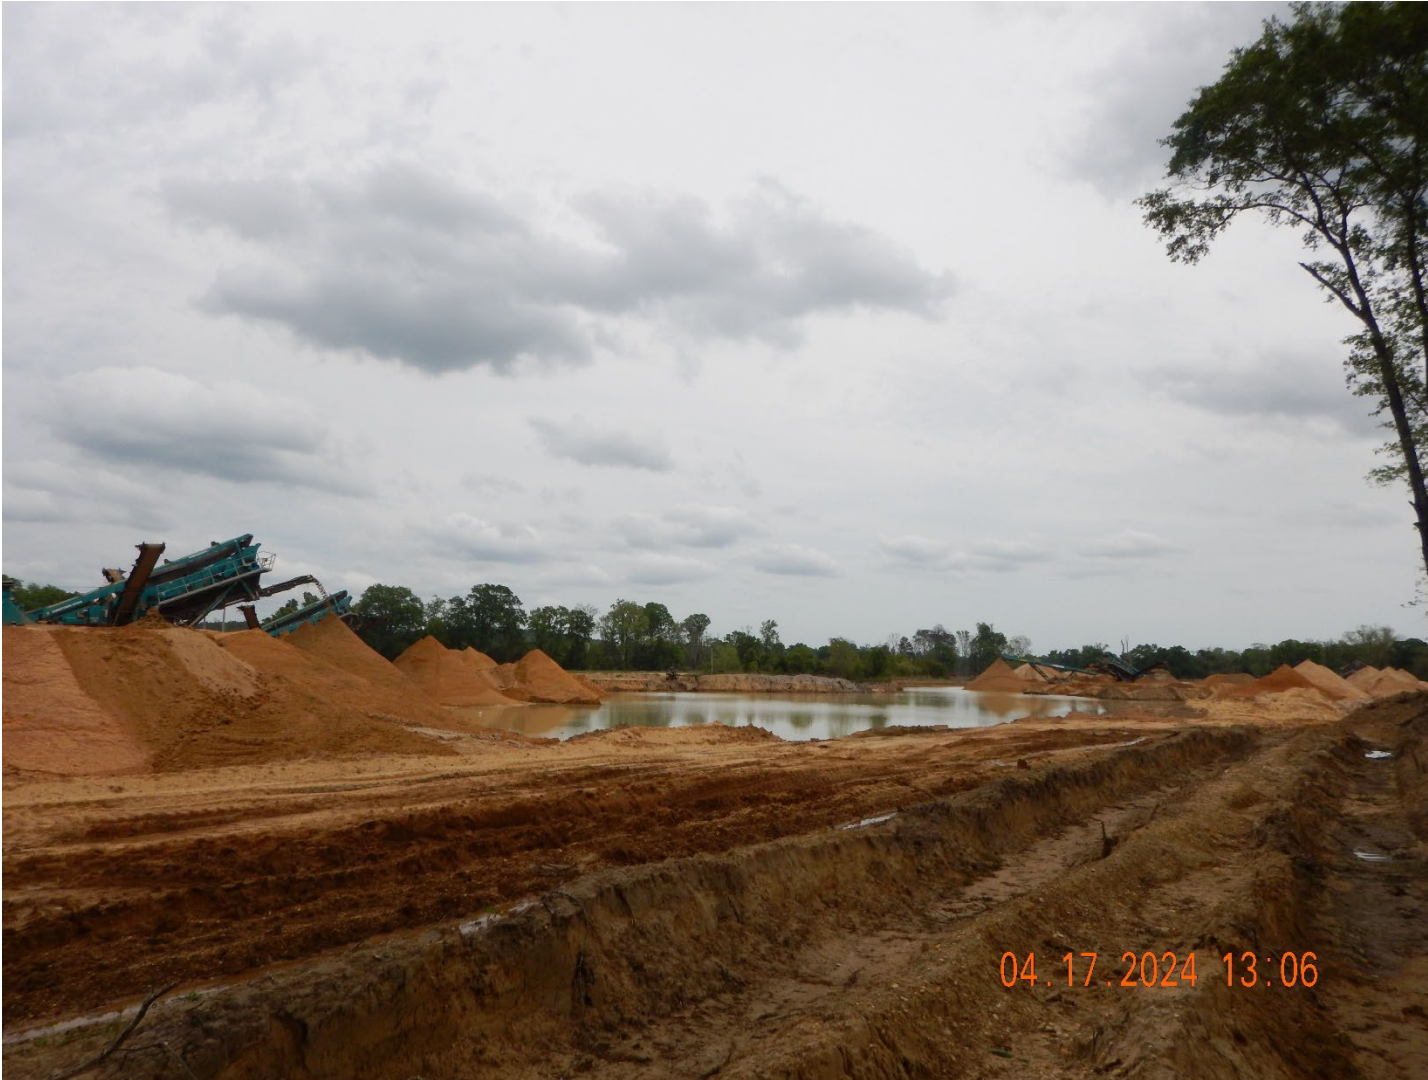
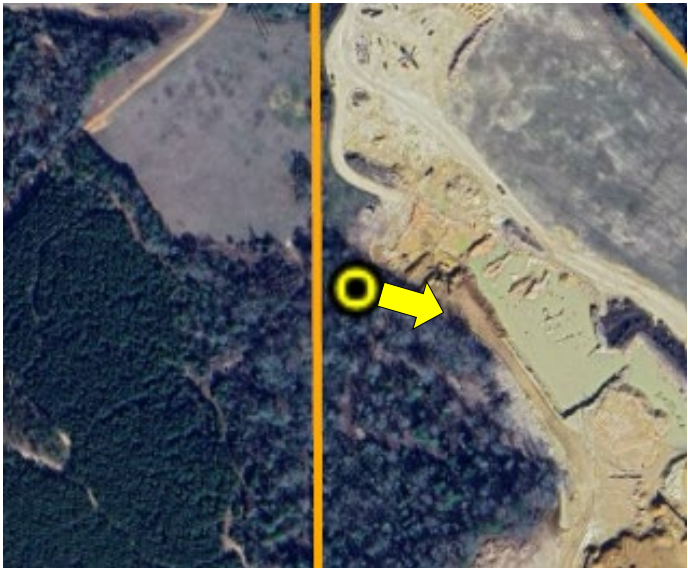
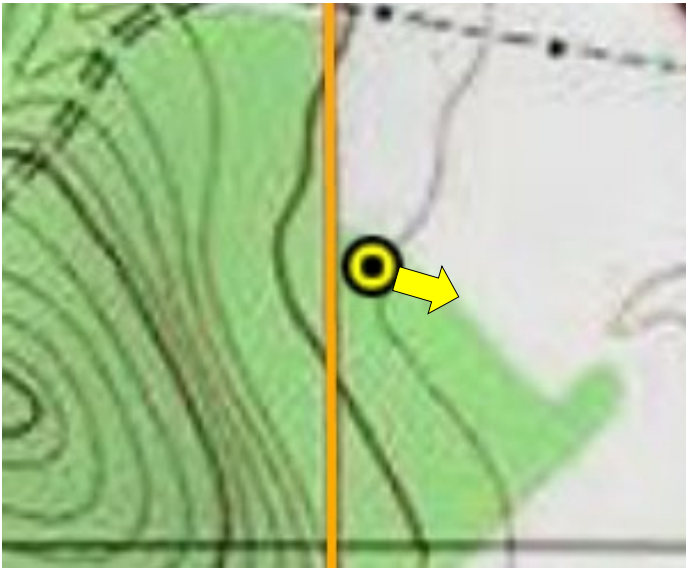
| Title | Photo 11 |

| Description | Striking toward sand/gravel dredging and sorting operations. |
