## Attachment C

**Pit Worx, Inc.  
Pearson Pit  
Site Inspection Photographic Log**

Autaugaville, Autauga County, Alabama

April 17, 2024

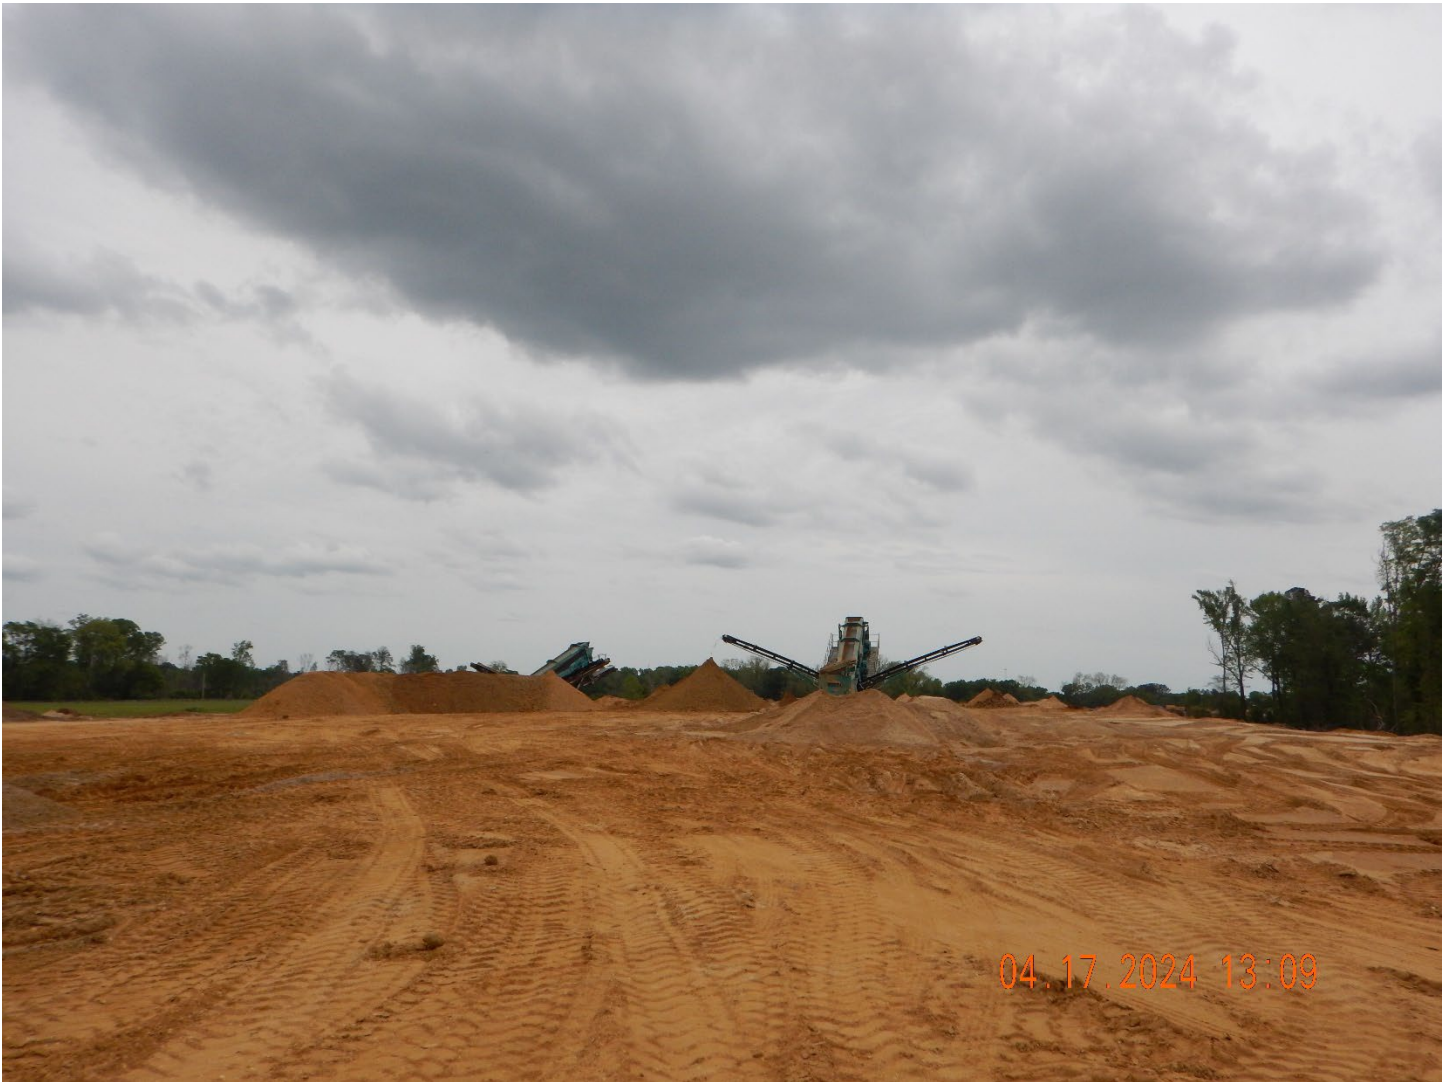
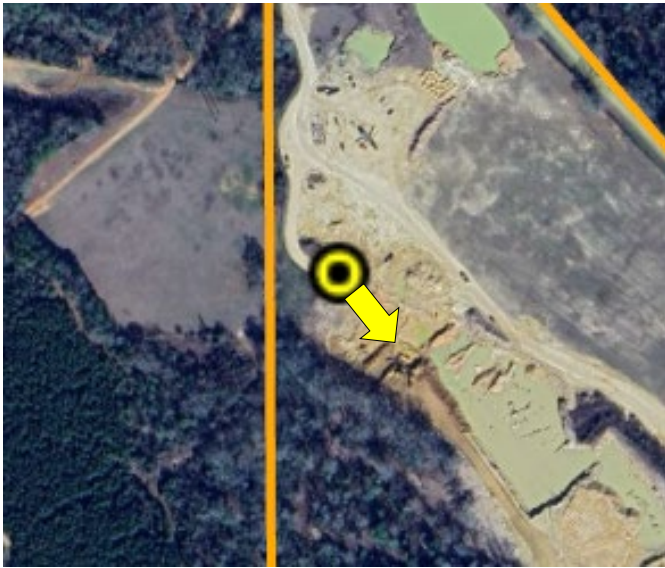
| Title | Photo 12 |

| Description | Same description as Photo 11, different view. |

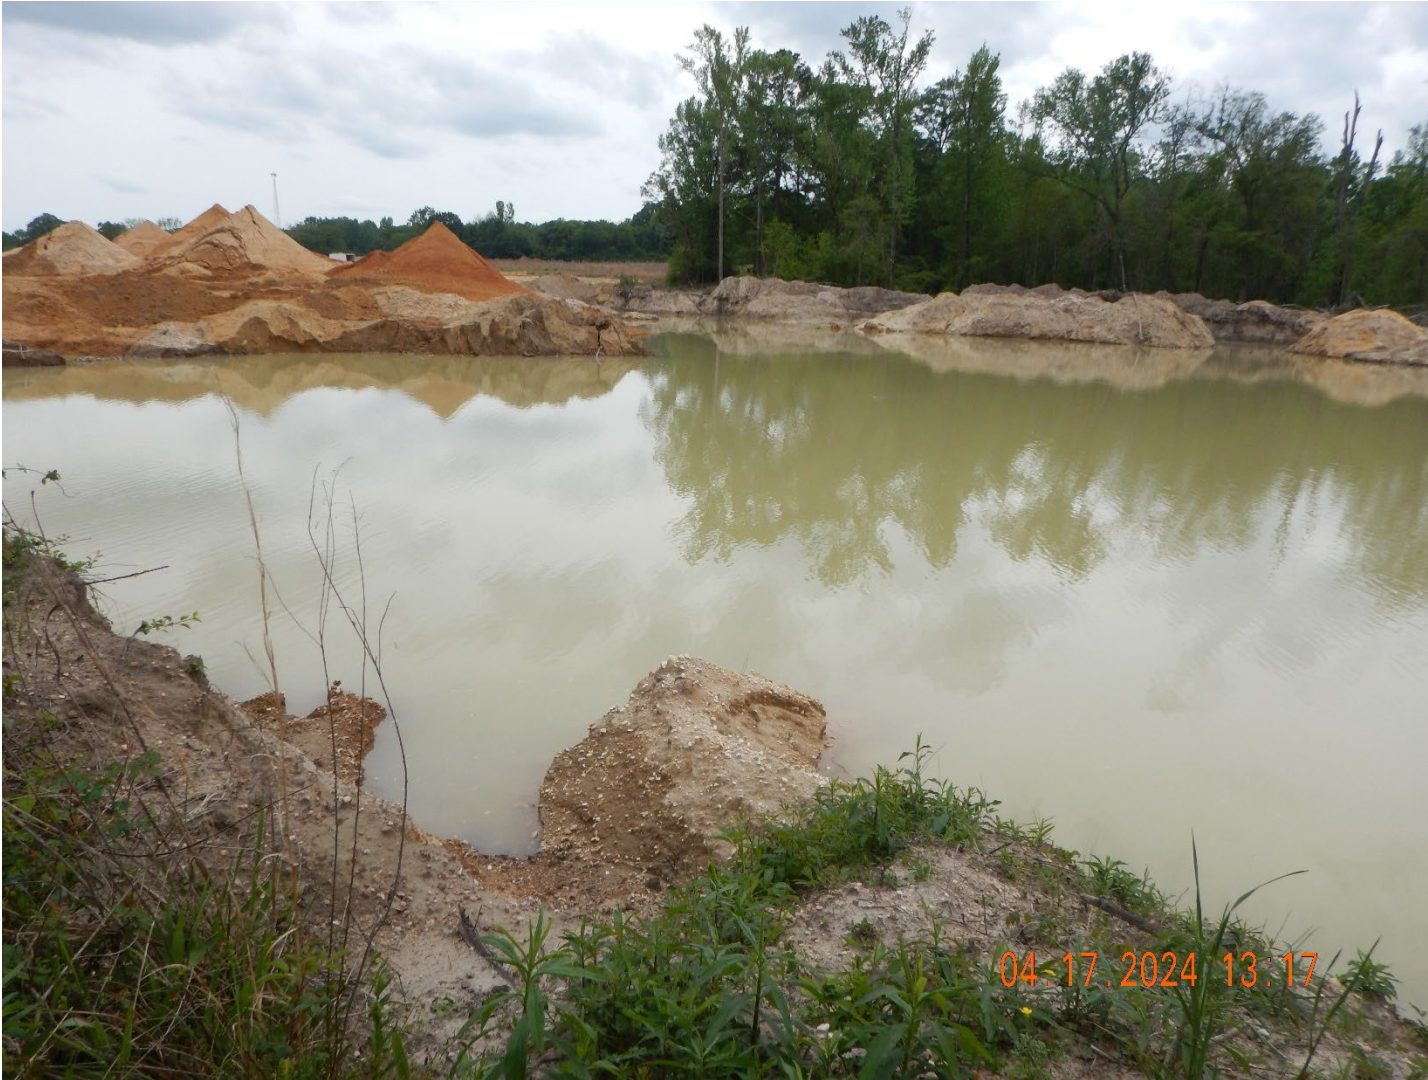
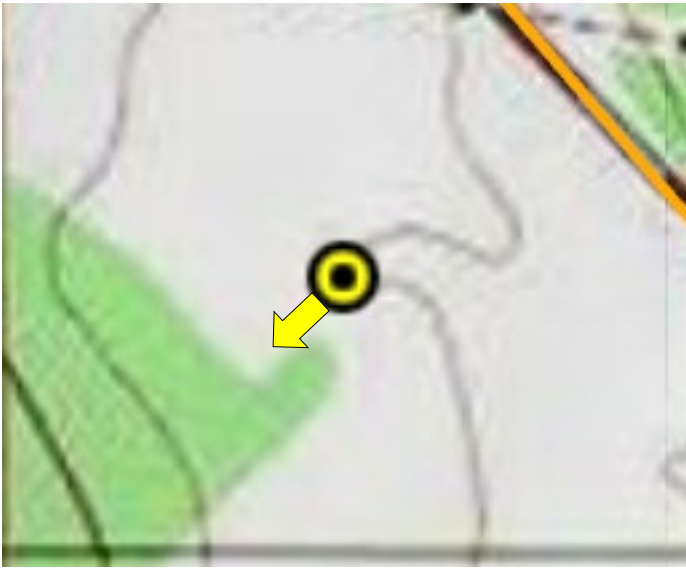
| Title | Photo 13 |

| Description | Overlooking a past vegetated oxbow feature that has since been excavated circa late 2023/early 2024, per operator. Approximately 600 feet northwest from Stream 1, delineated by BioResources in their 2023 WOTUS report. |

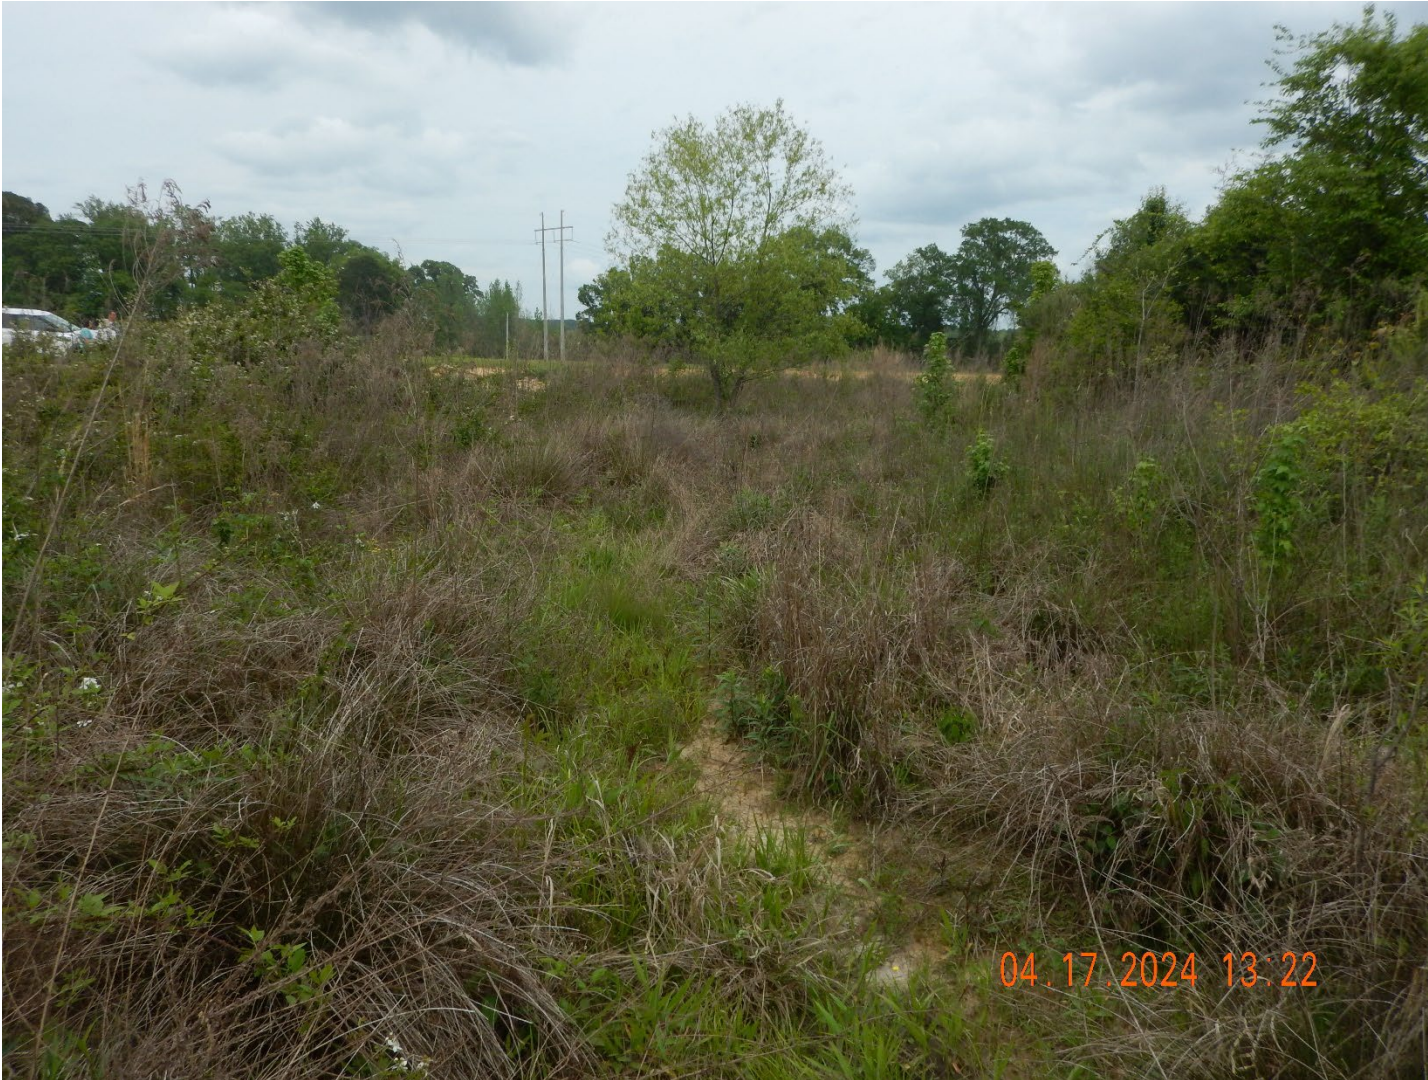
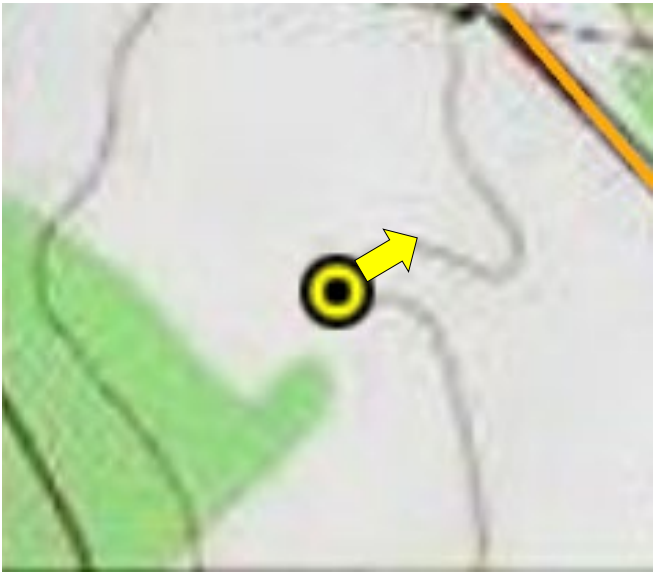
| Title | Photo 14 |

| Description | Standing in the vegetated channel, striking in the opposite direction in relation to Photo 13. Observed <i>Juncus effusus</i> , <i>Panicum hemitomon</i> , <i>Salix caroliniana</i> . |

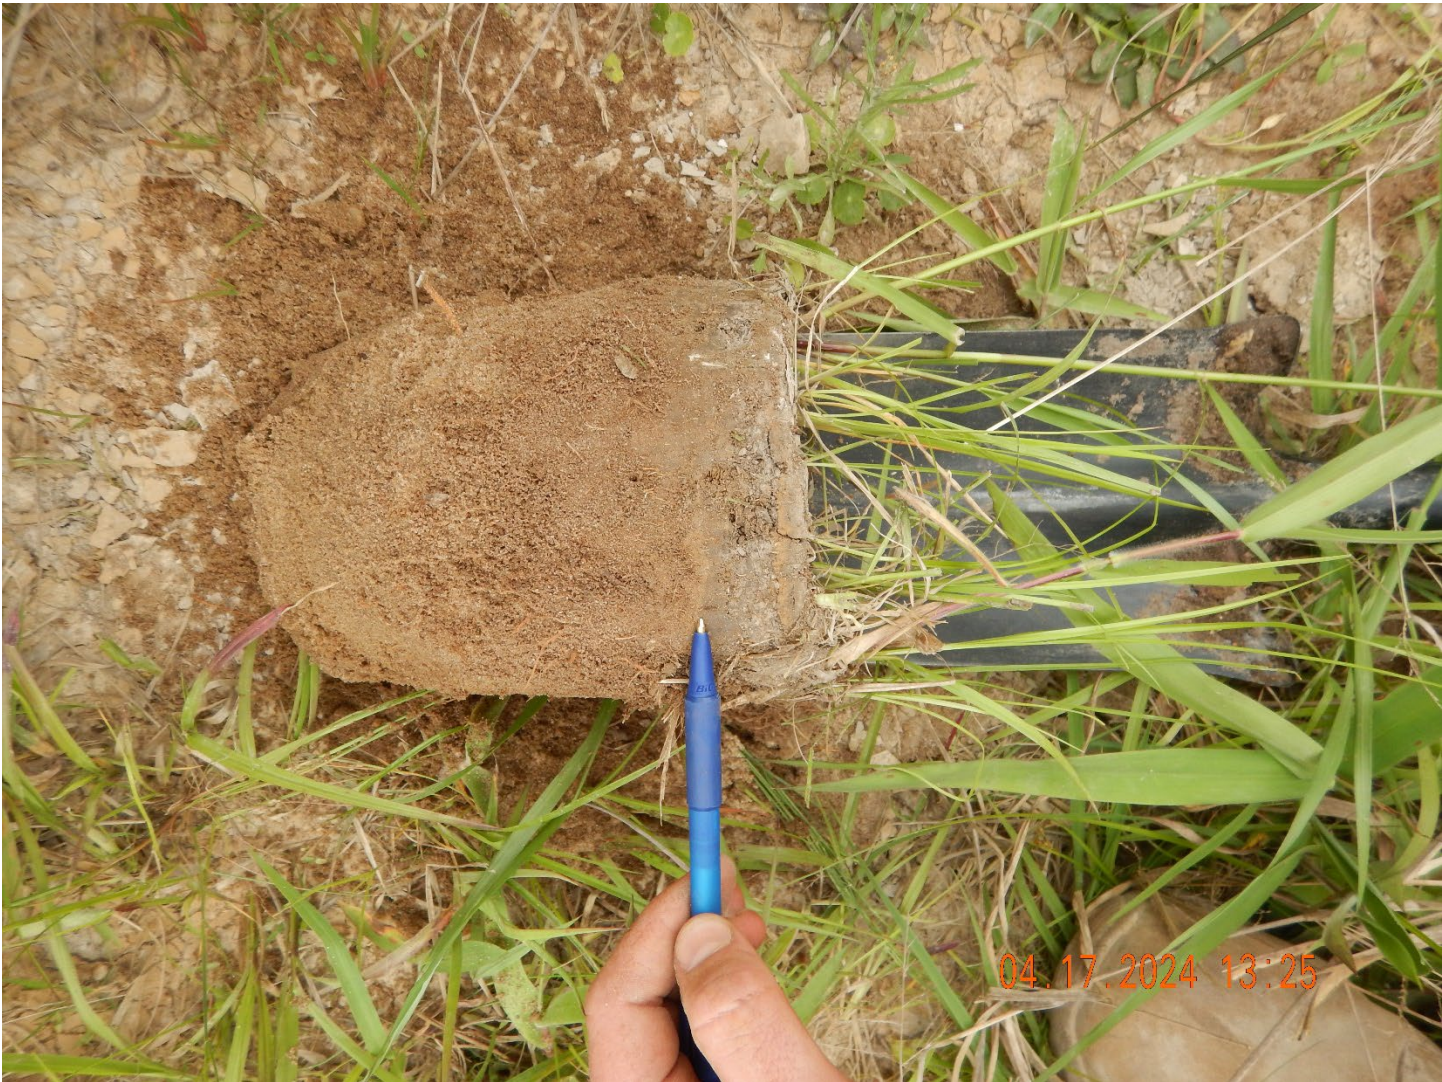
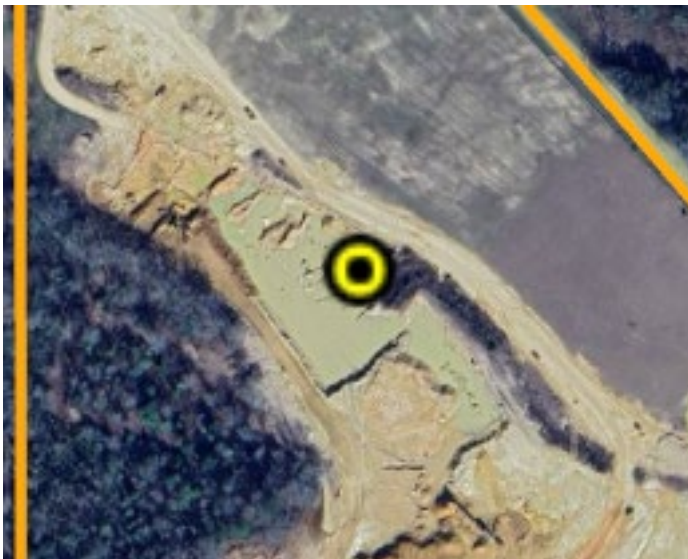
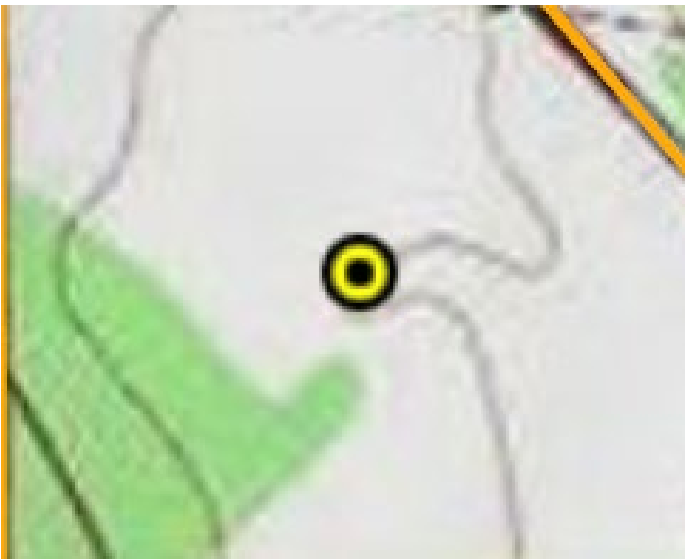
| Title | Photo 15 |

| Description | Soil profile, S5; where Photos 13/14 were taken. |

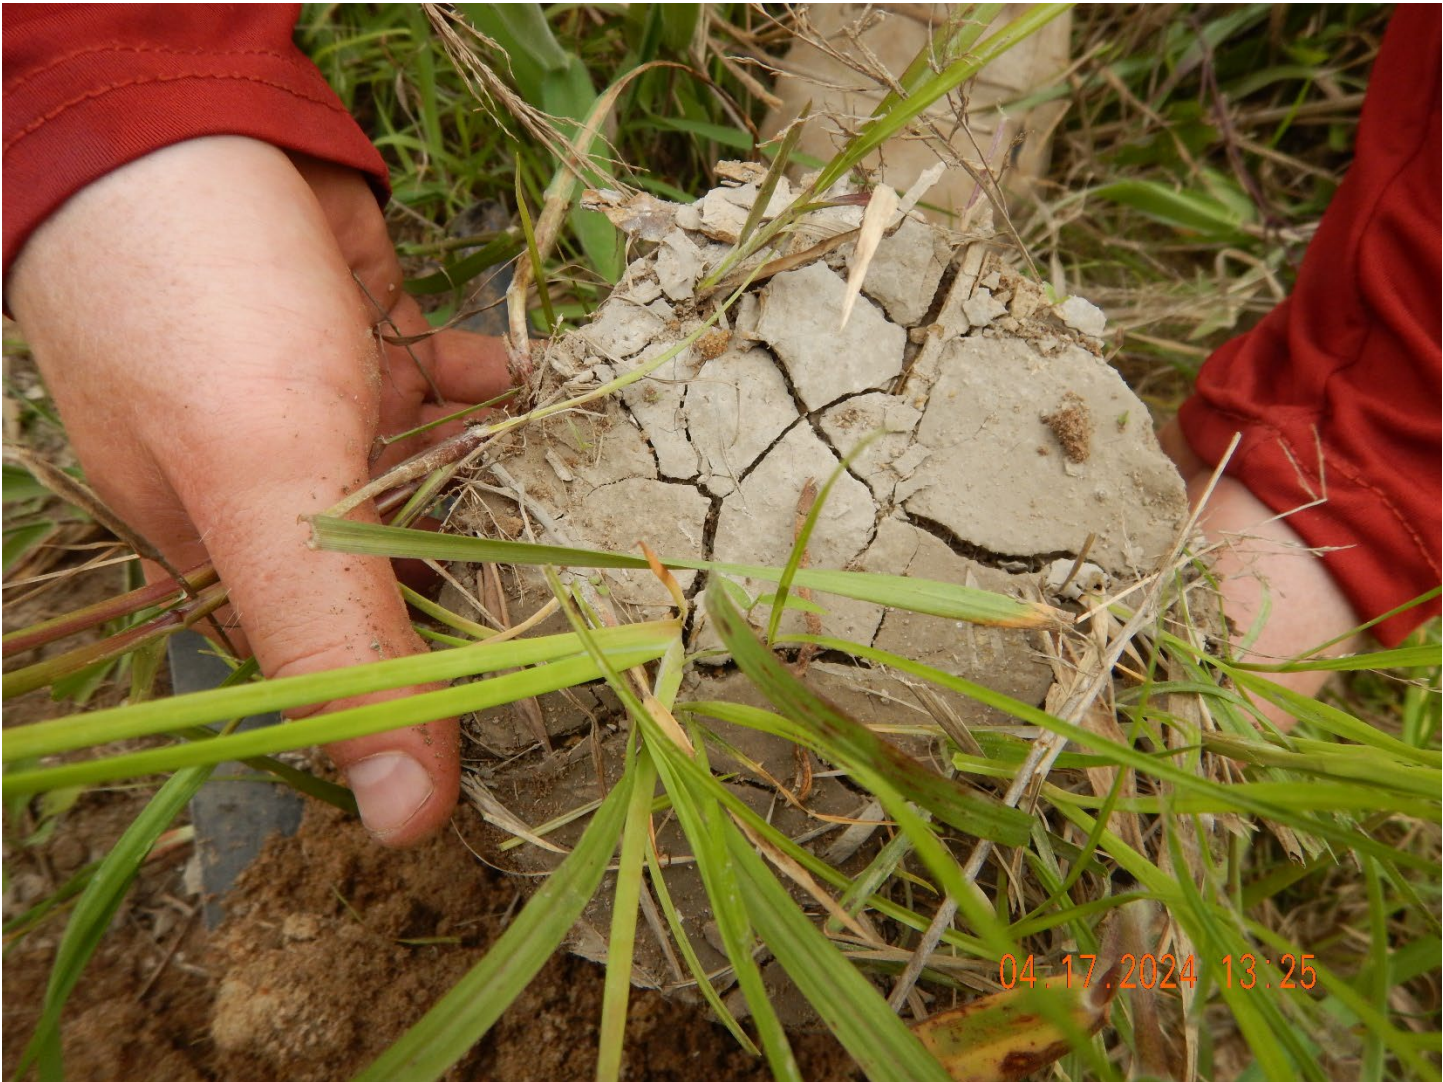
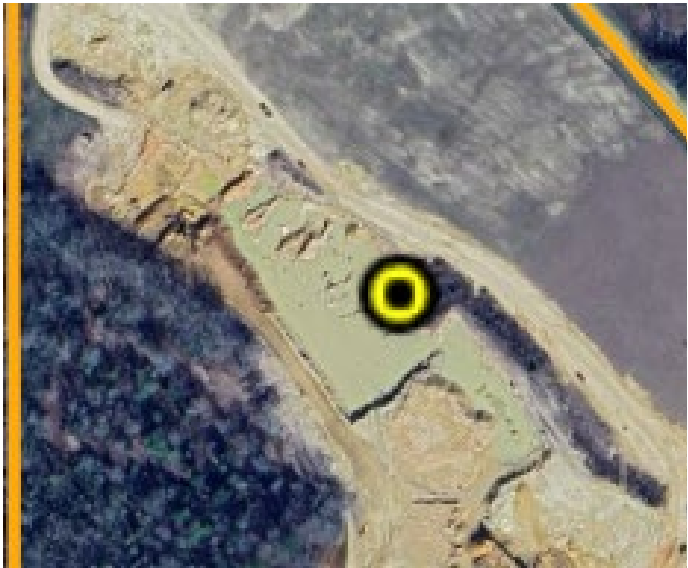
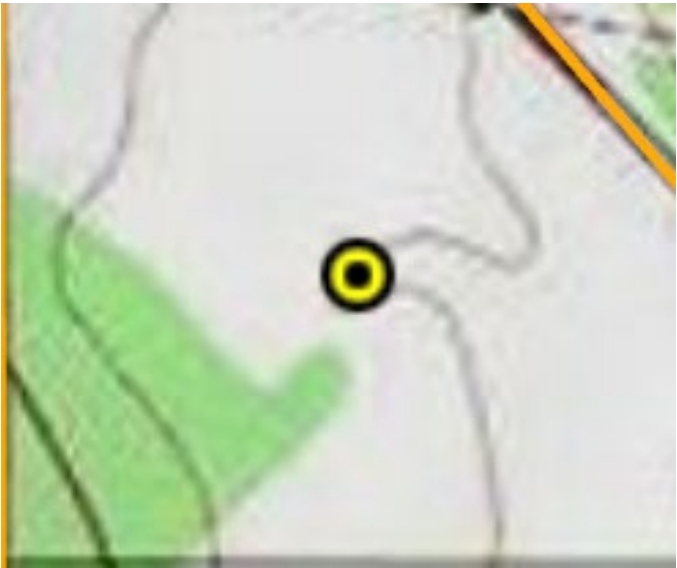
| Title | Photo 16 |

| Description | Surface of S5. |

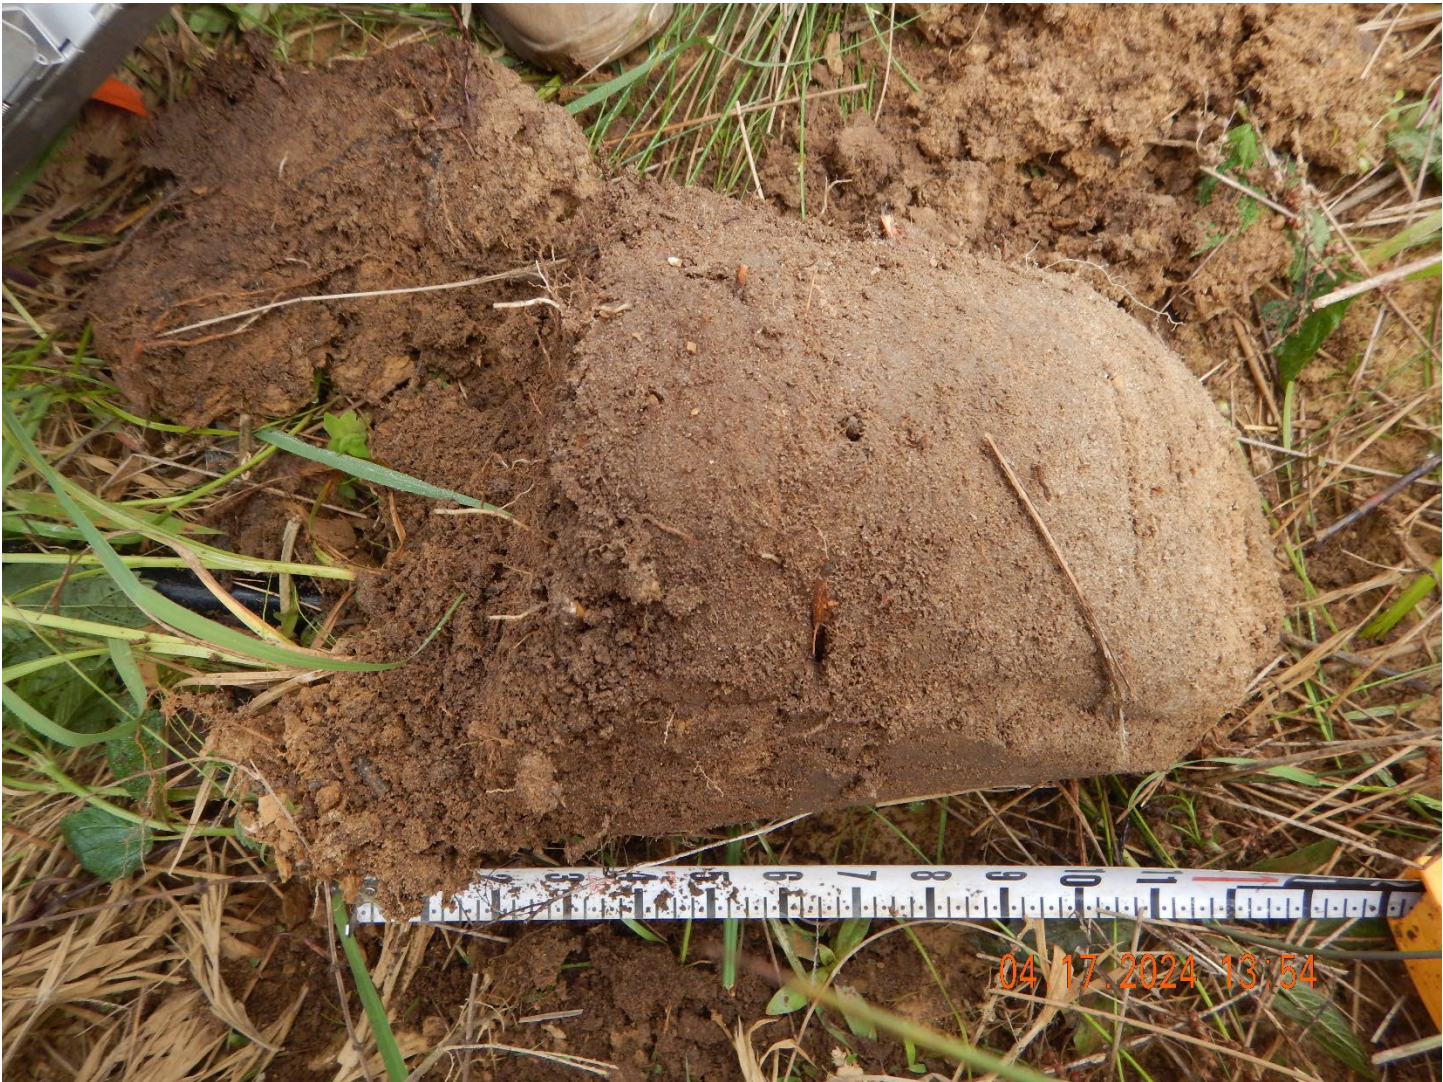
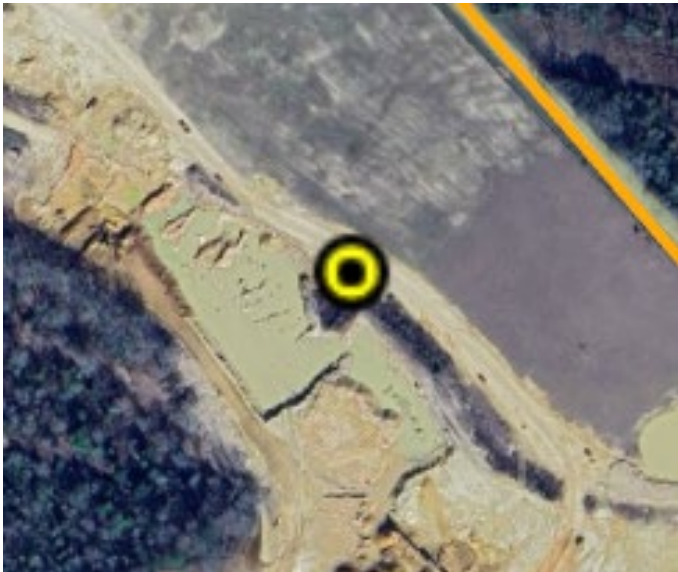
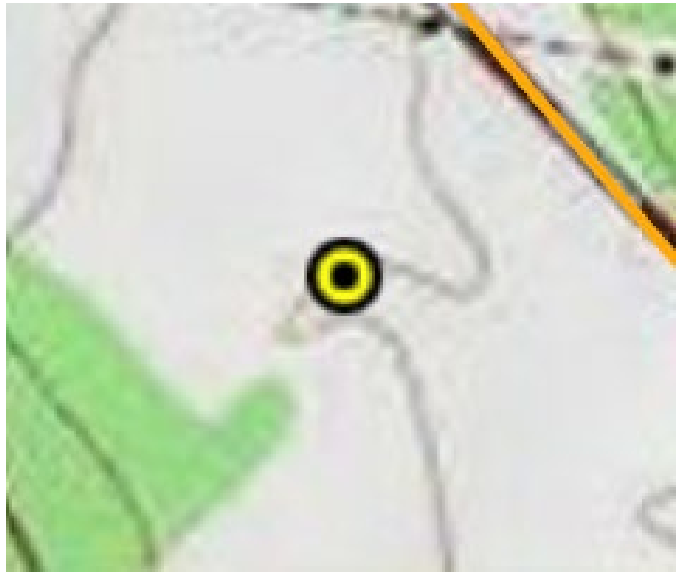
| Title | Photo 17 |

| Description | Soil profile, S6. |

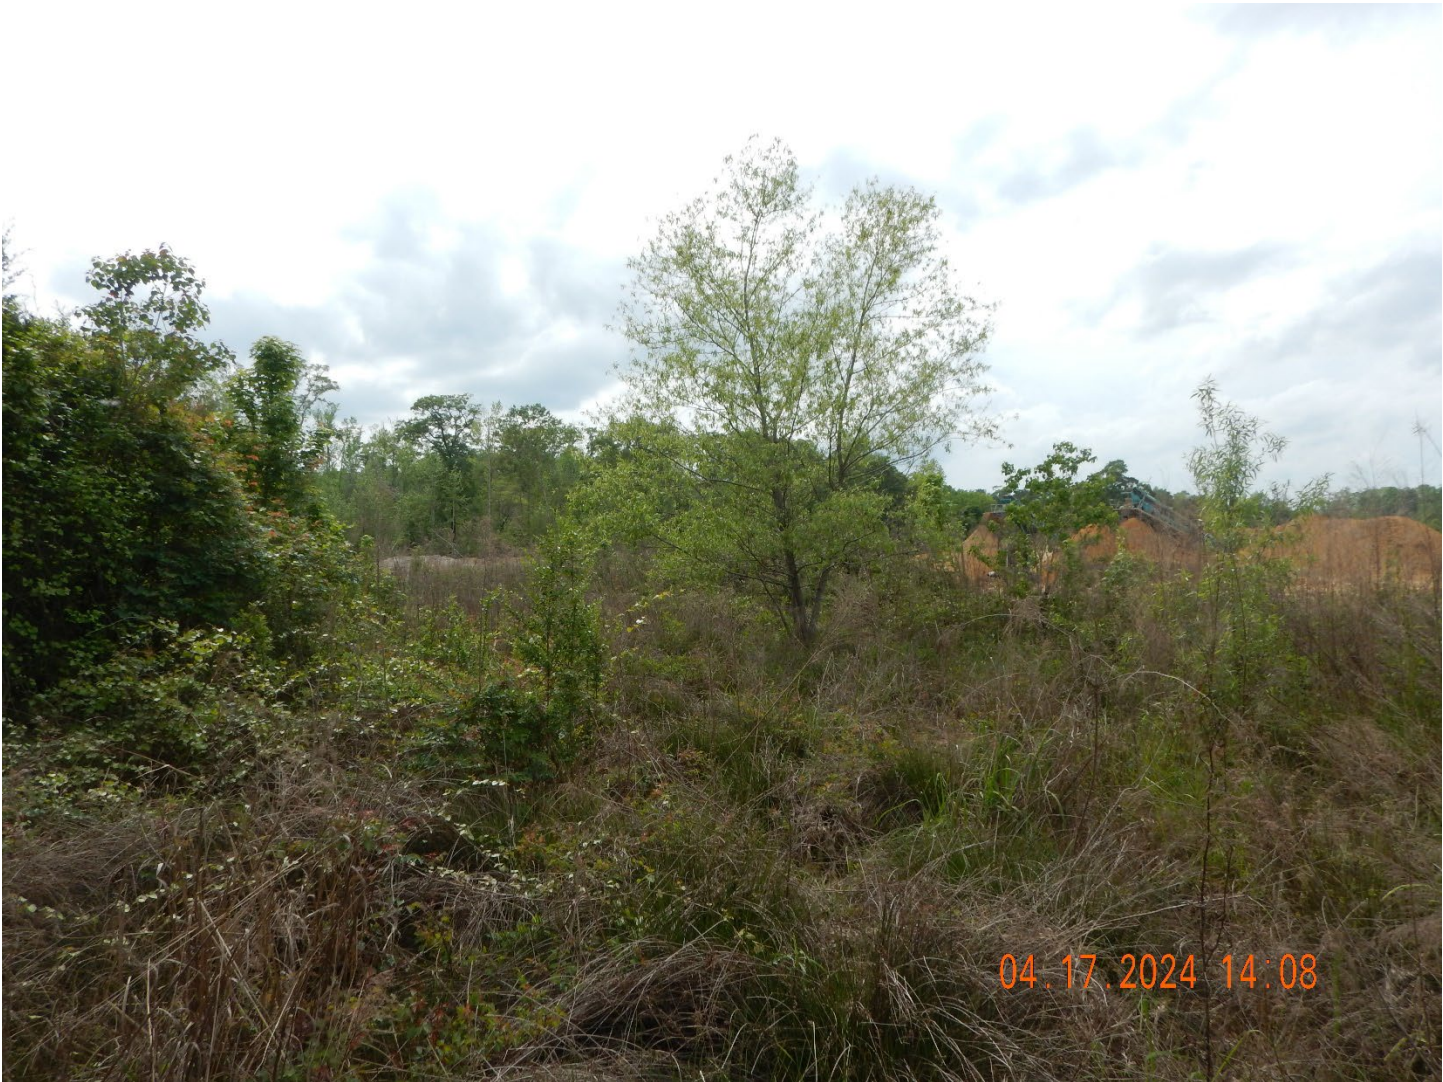
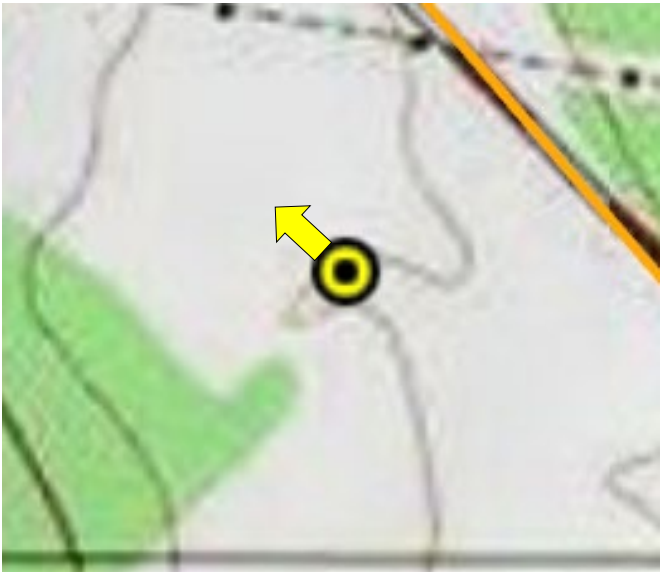
| Title | Photo 18 |

| Description | Standing over location of S6. |

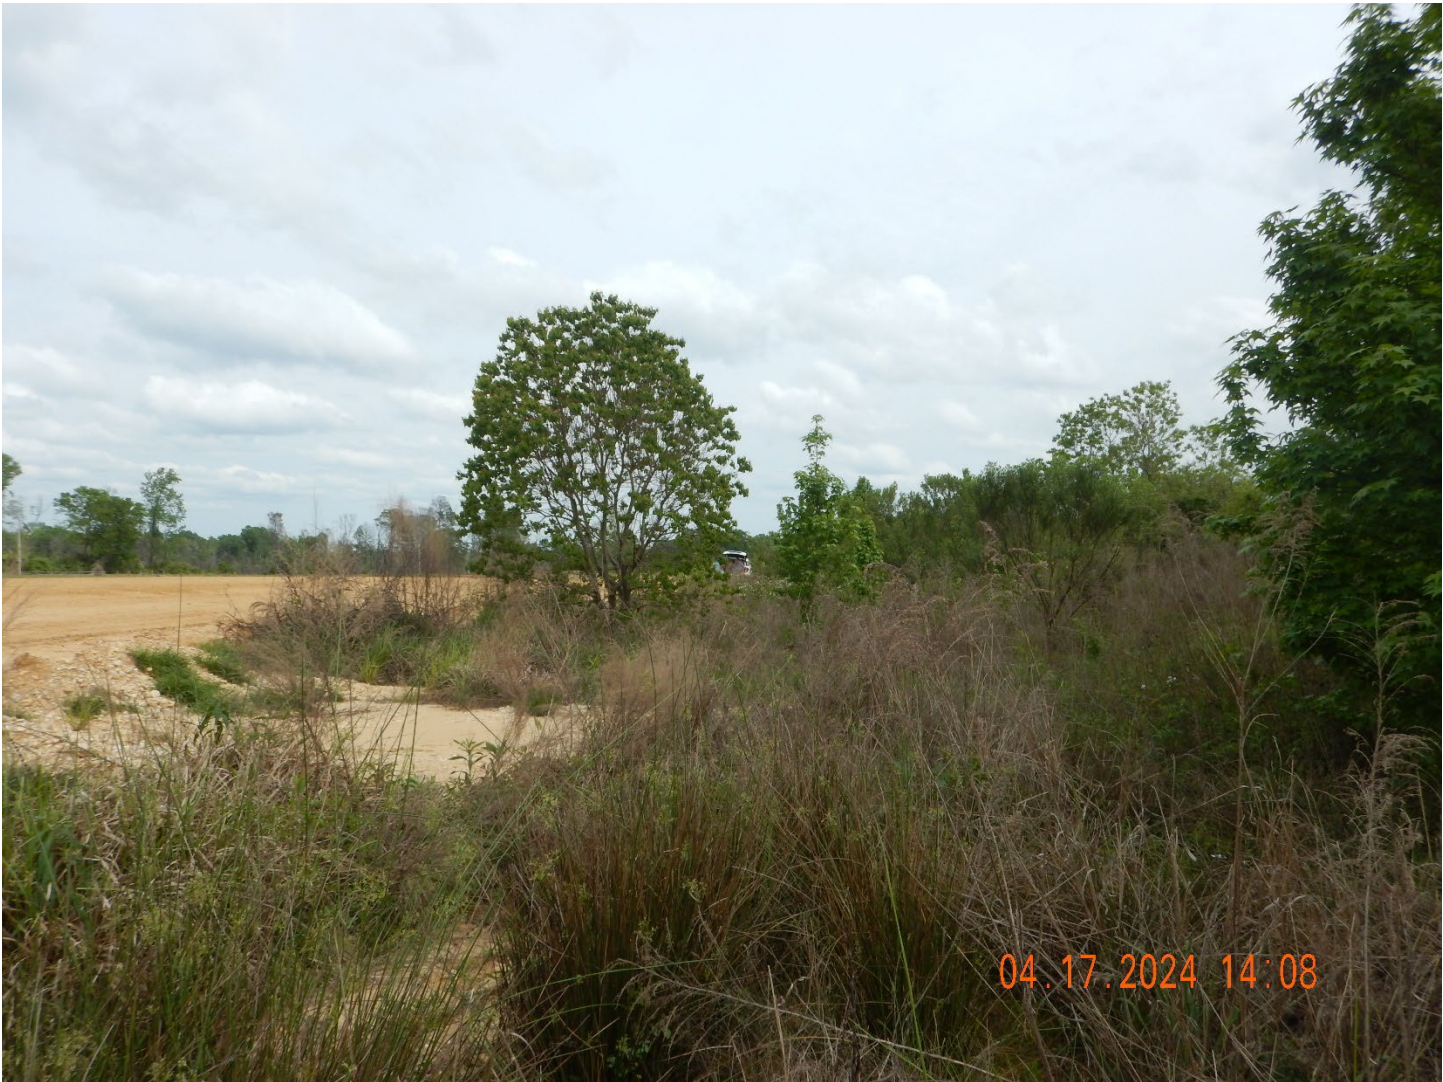
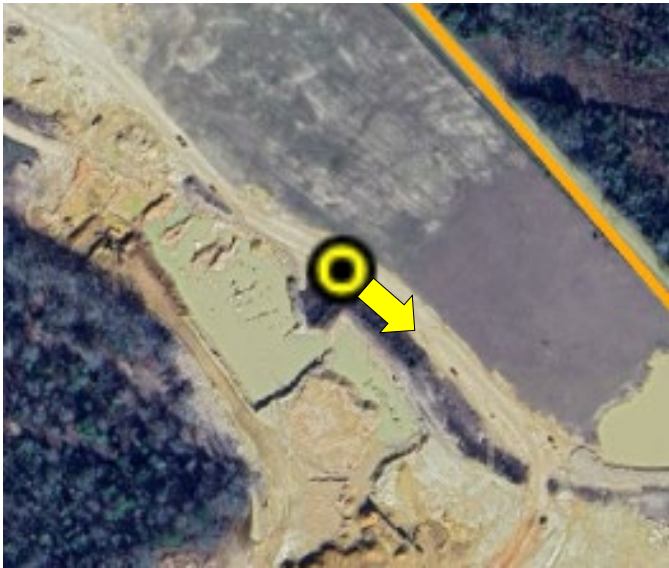
| Title | Photo 19 |

| Description | Opposite direction in relation to Photo 18. |

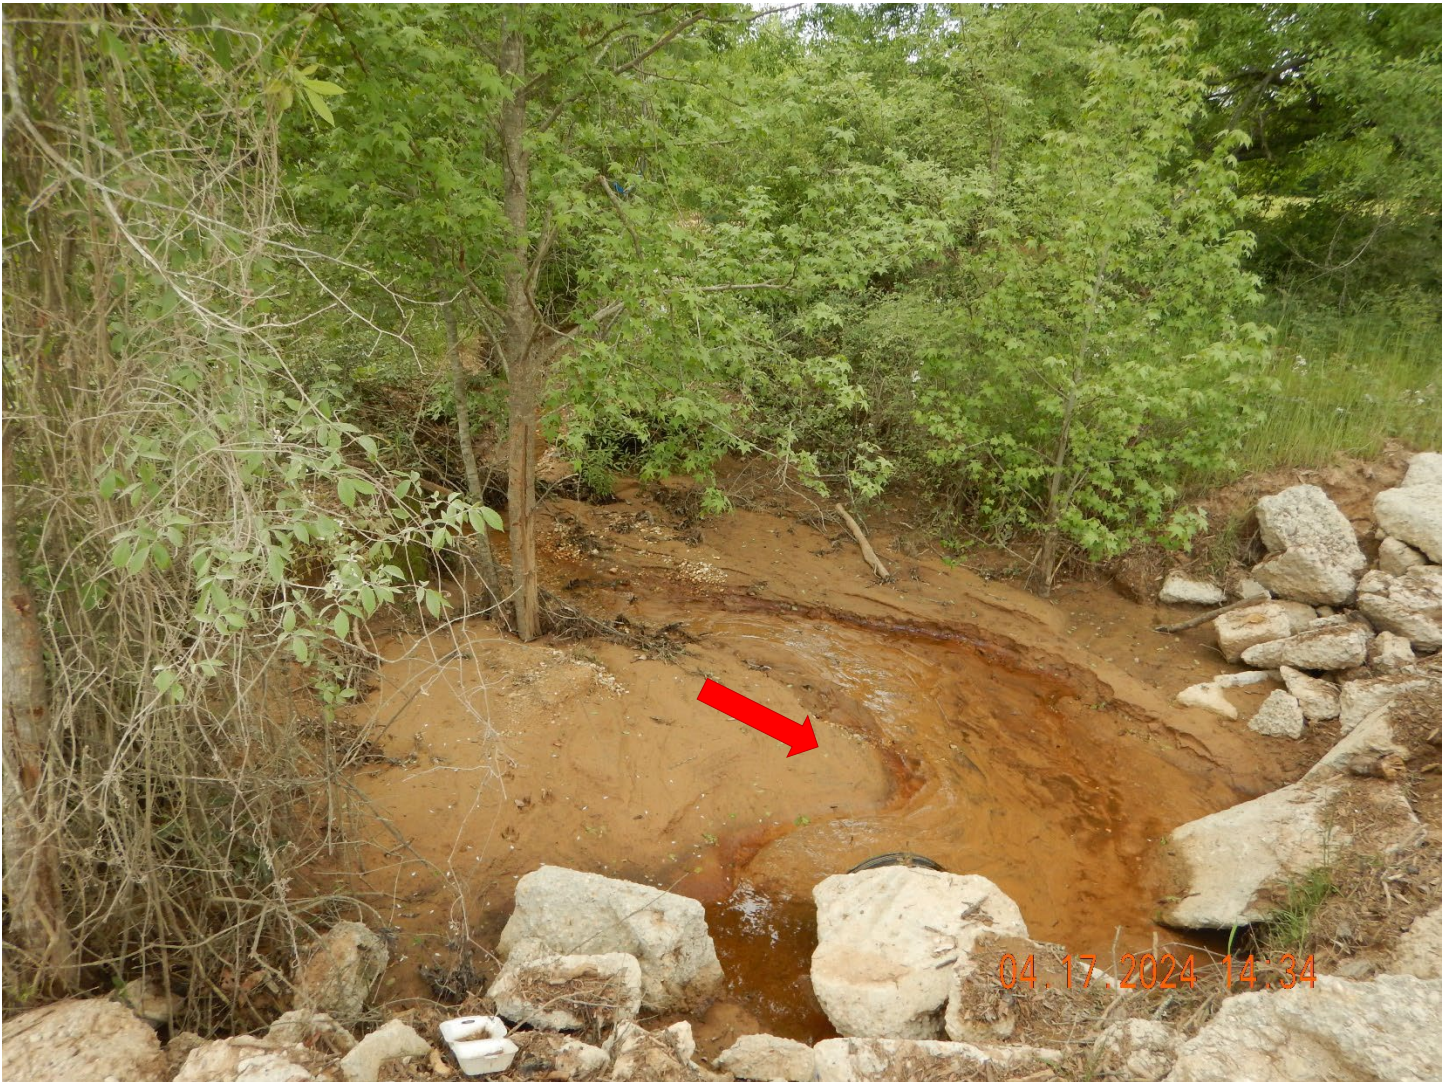
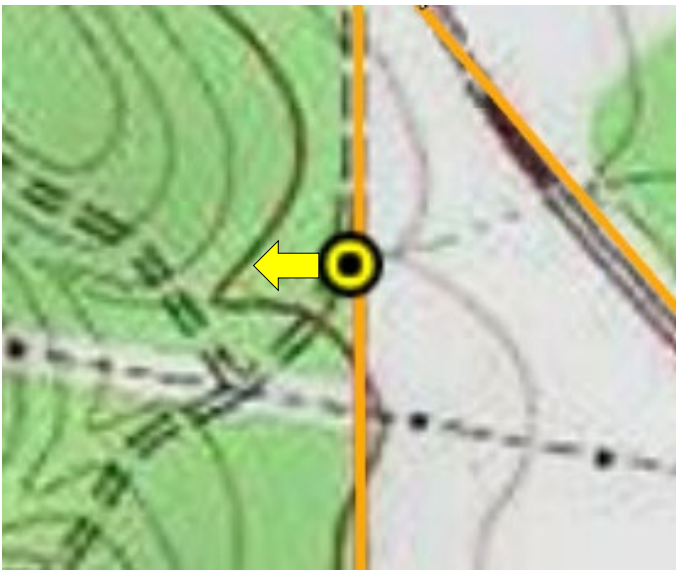
| Title | Photo 20 |

| Description | Striking upstream of flow coming from adjacent property to the west of the orange Pit Worx property lines. Red arrow in top photo indicates the direction of flow. |

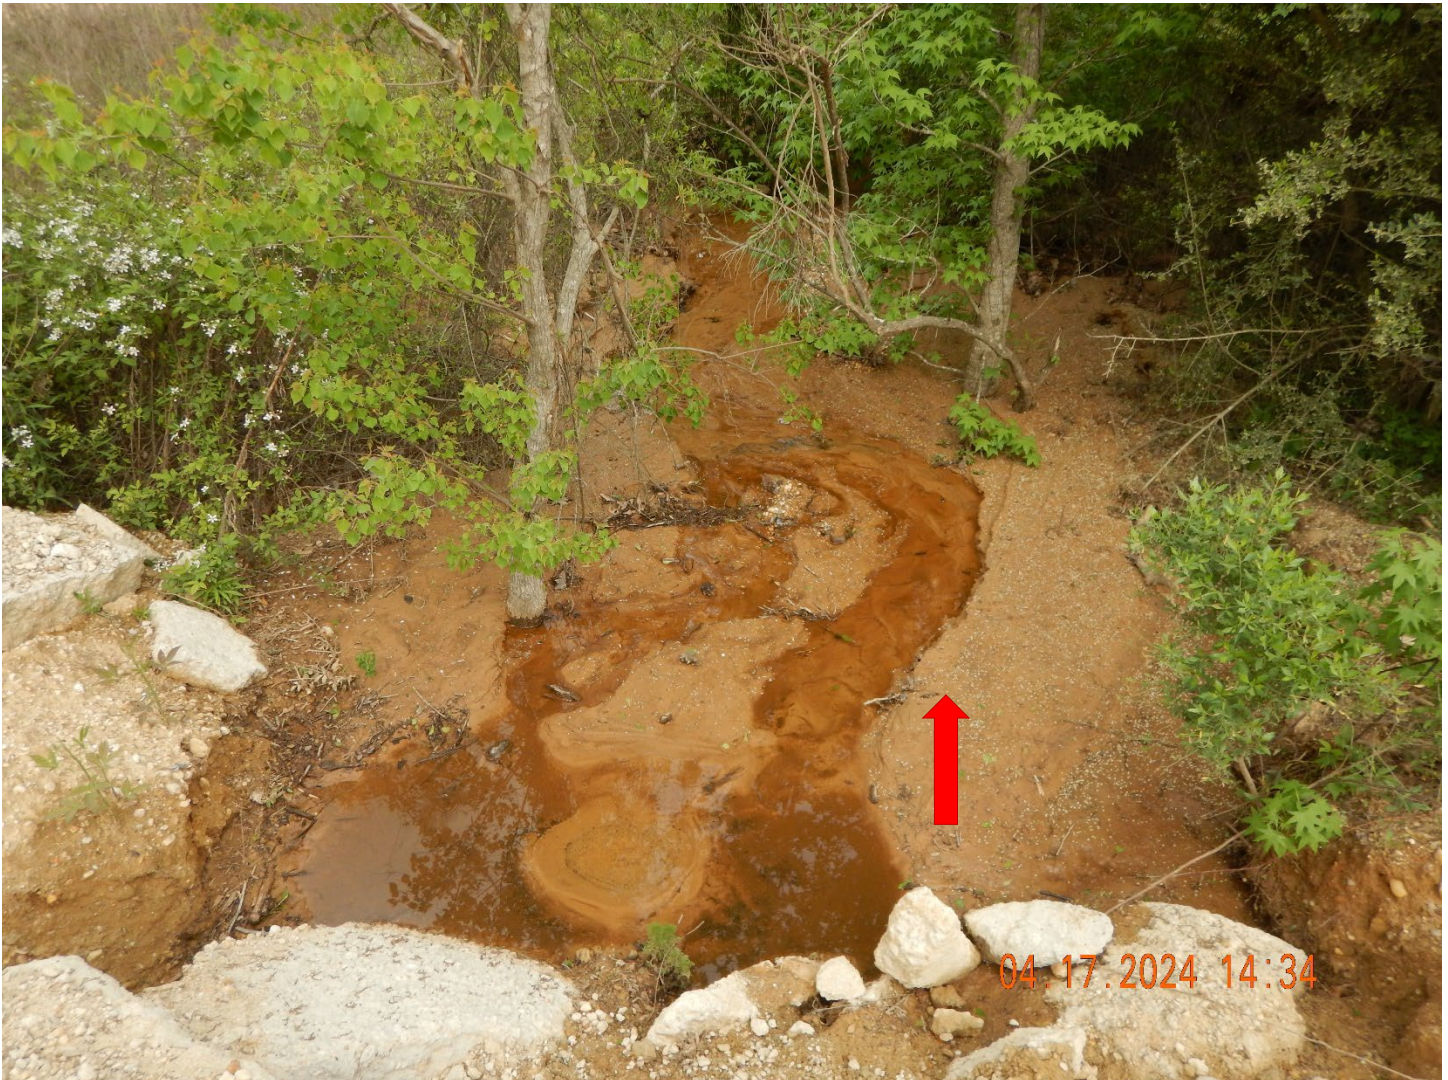
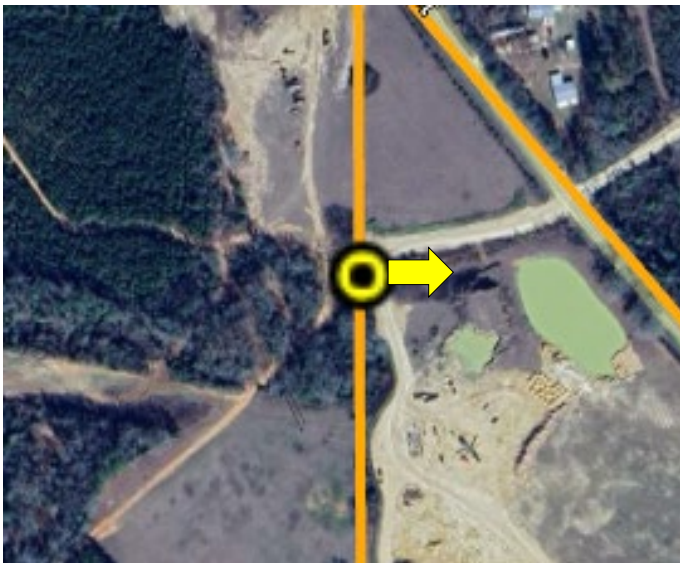
| Title | Photo 21 |

| Description | Striking from the opposite side of the road, following the flow downstream. Red arrow in top photo indicates the direction of flow. |

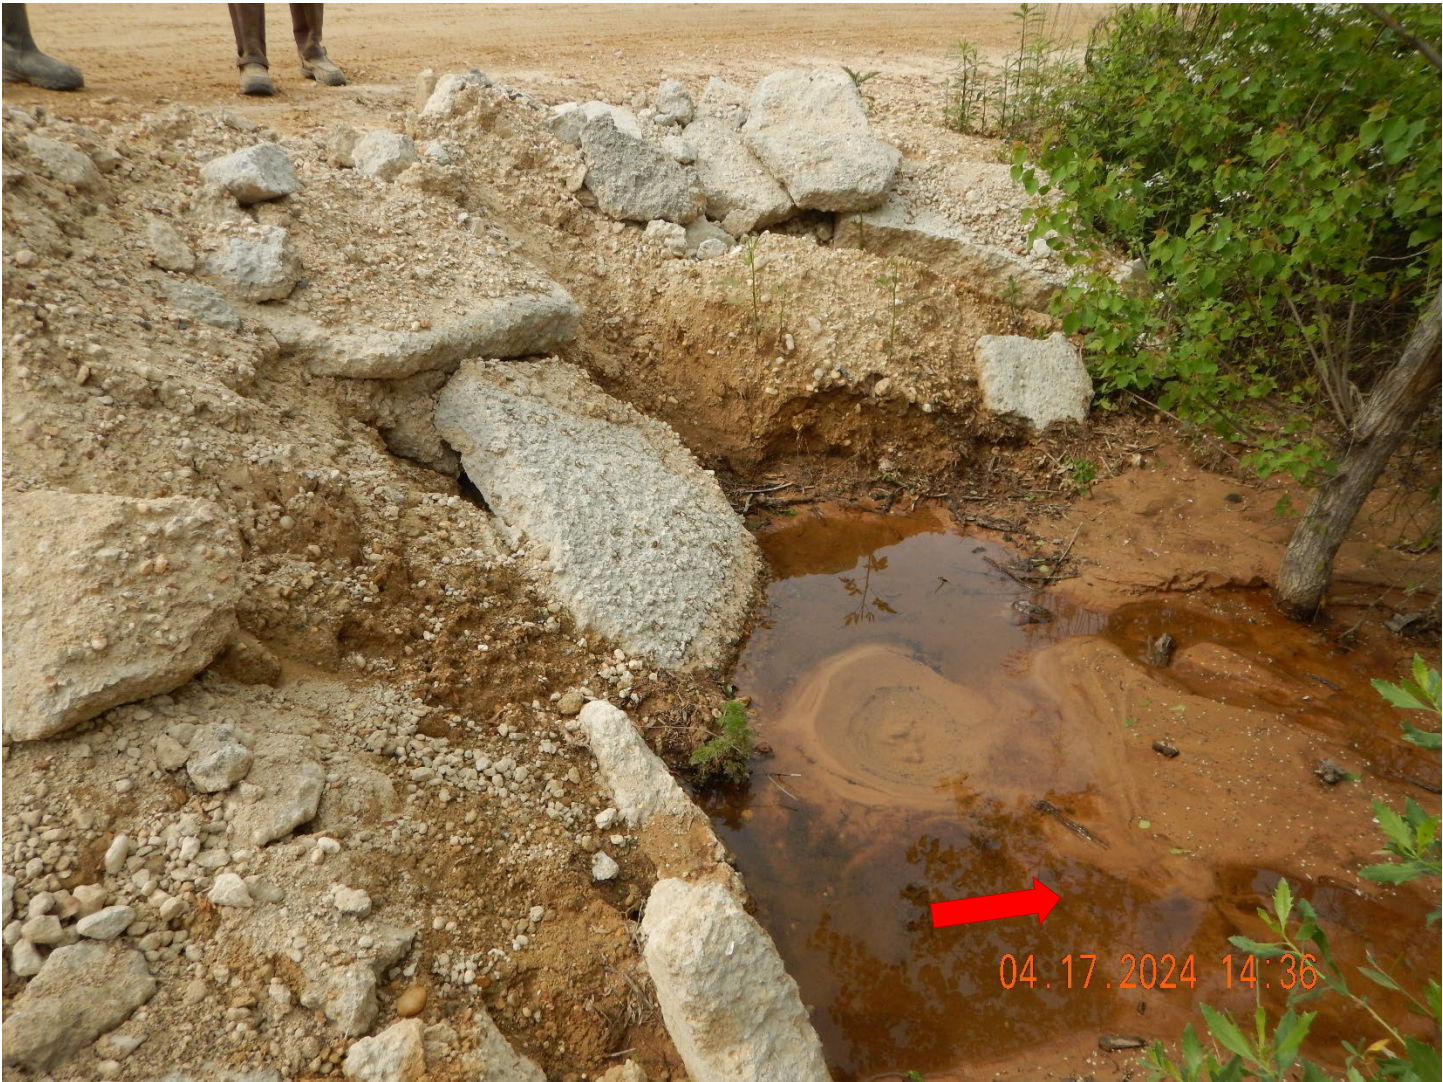
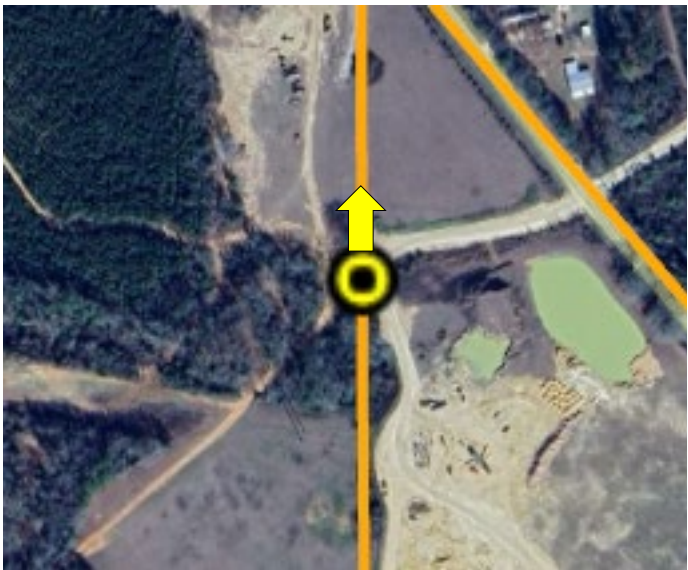
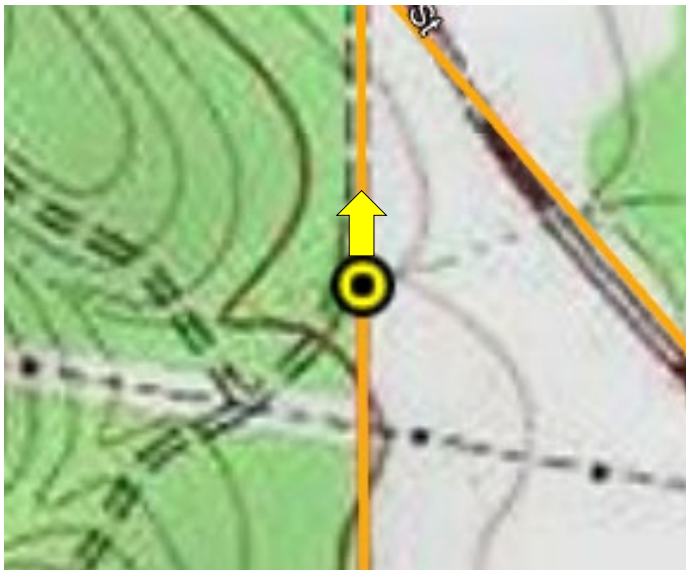
| Title | Photo 22 |

| Description | More direct shot of the culvert that can be partially seen in Photo 21. Notice excessive sediment load inhibiting flow. Red arrow in top photo indicates the direction of flow. |
