## Attachment C

**Pit Worx, Inc.  
Pearson Pit  
Site Inspection Photographic Log**

Autaugaville, Autauga County, Alabama

April 17, 2024

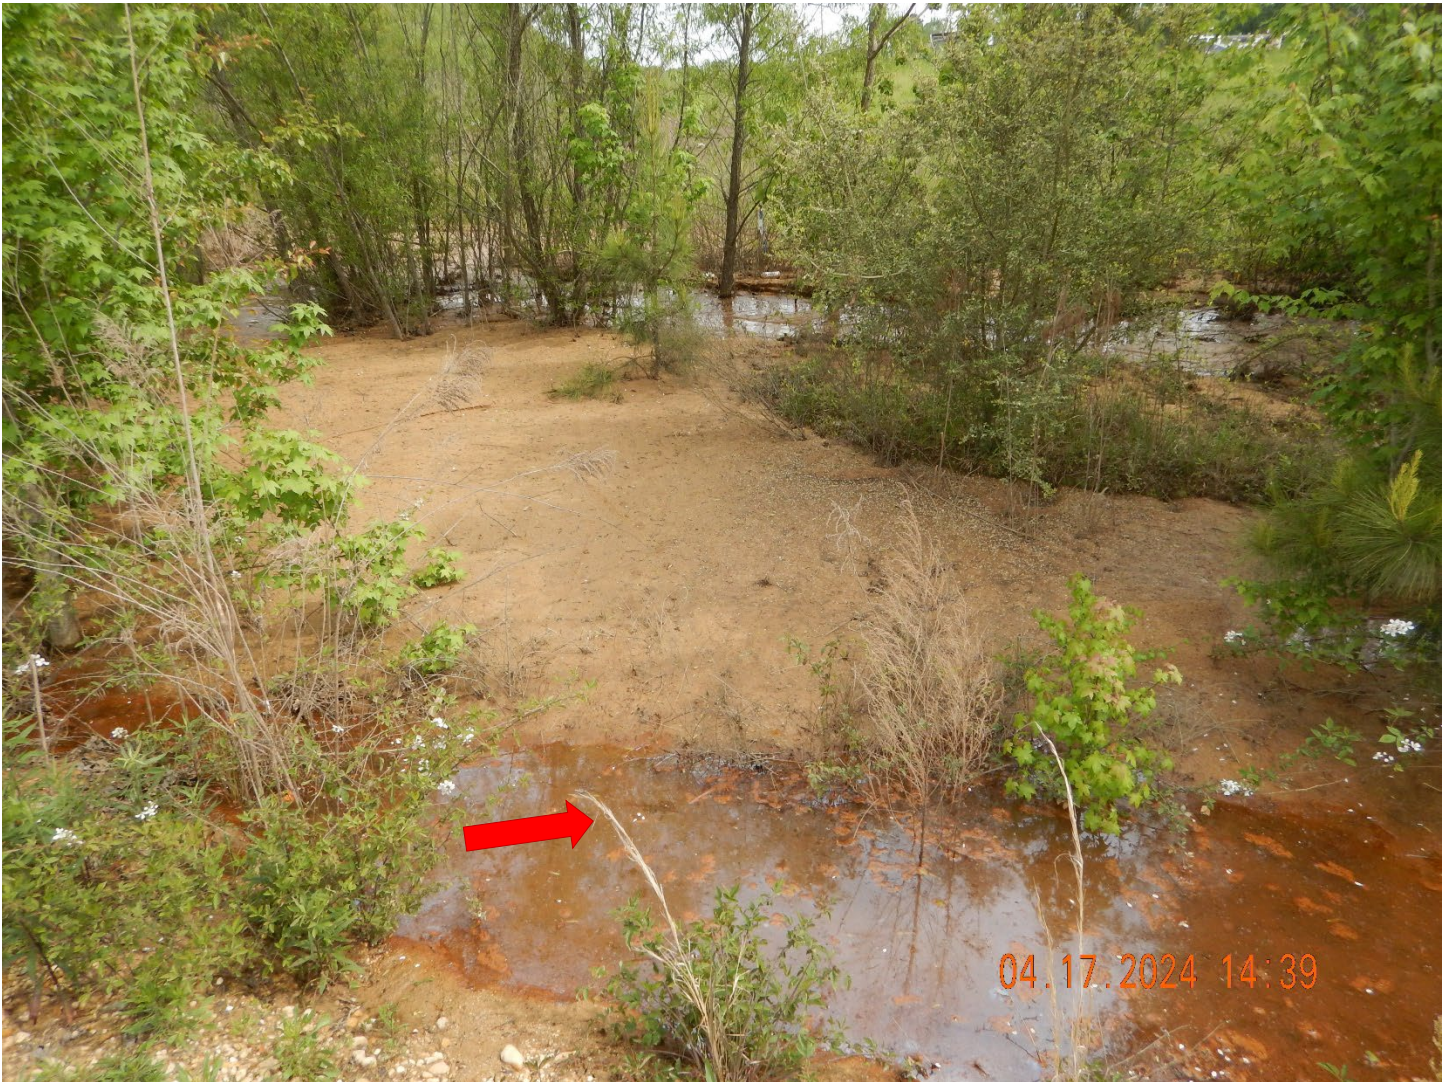
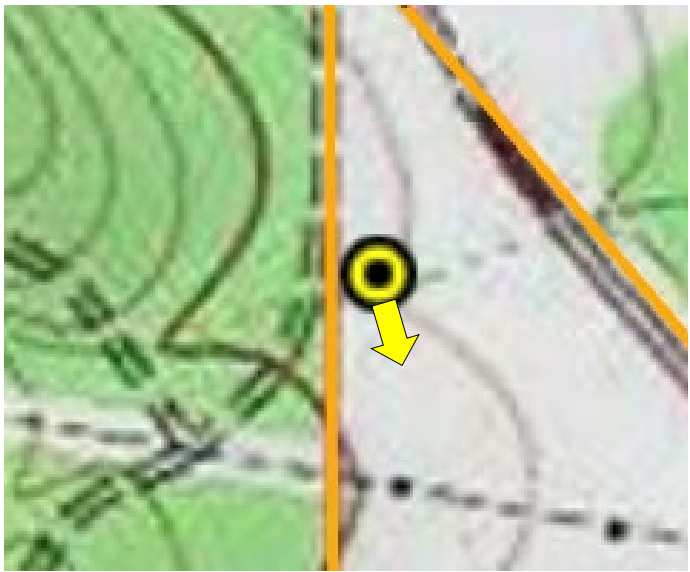
| Title | Photo 23 |

| Description | Continuing to follow the flow/ponding created by the blocked culvert to the west. Notice iron flocculation in water. Red arrow in top photo indicates the direction of flow. |

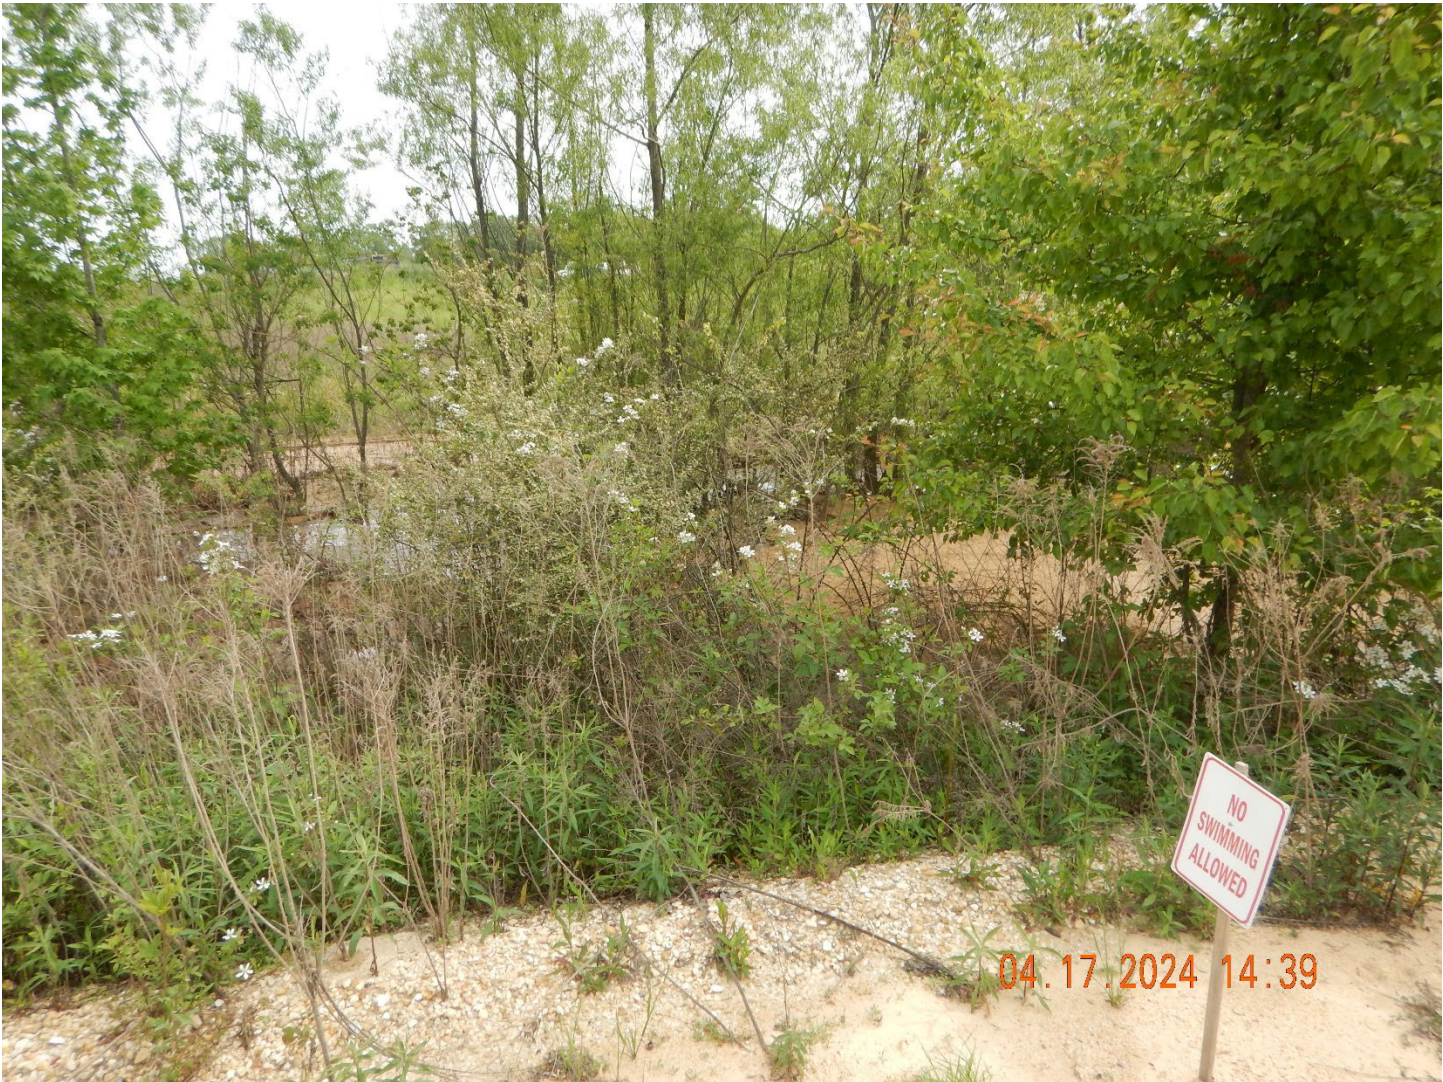
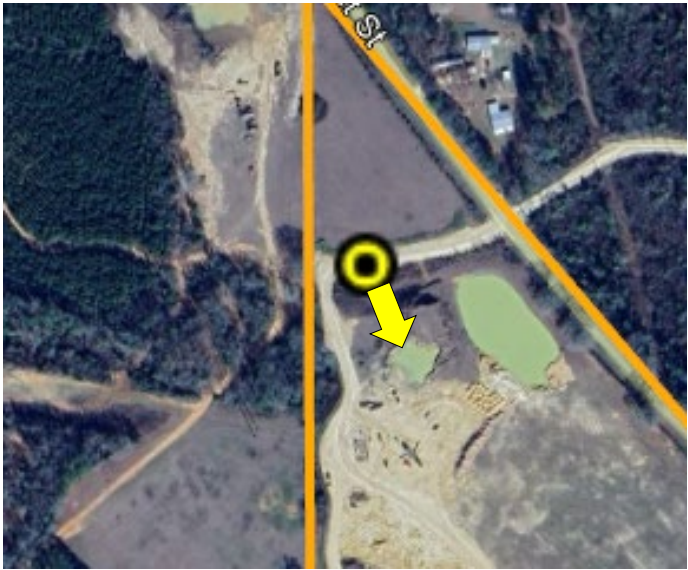
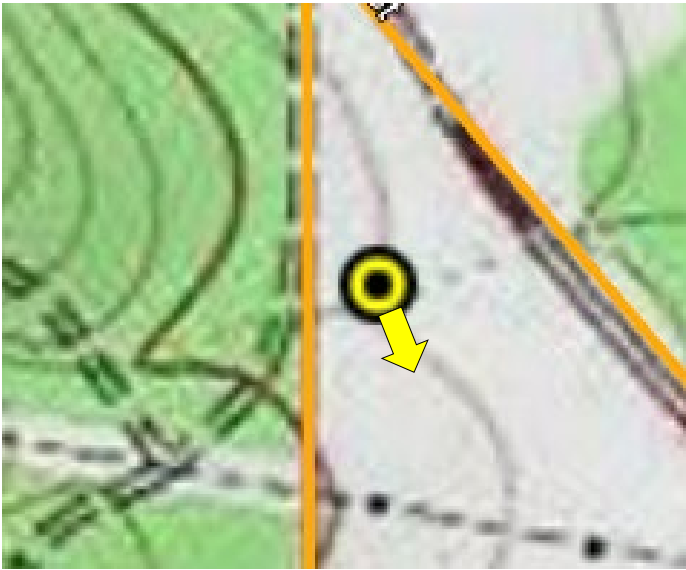
| Title | Photo 24 |

| Description | Continuing to follow the flow/ponding created by the blocked culvert to the west. |

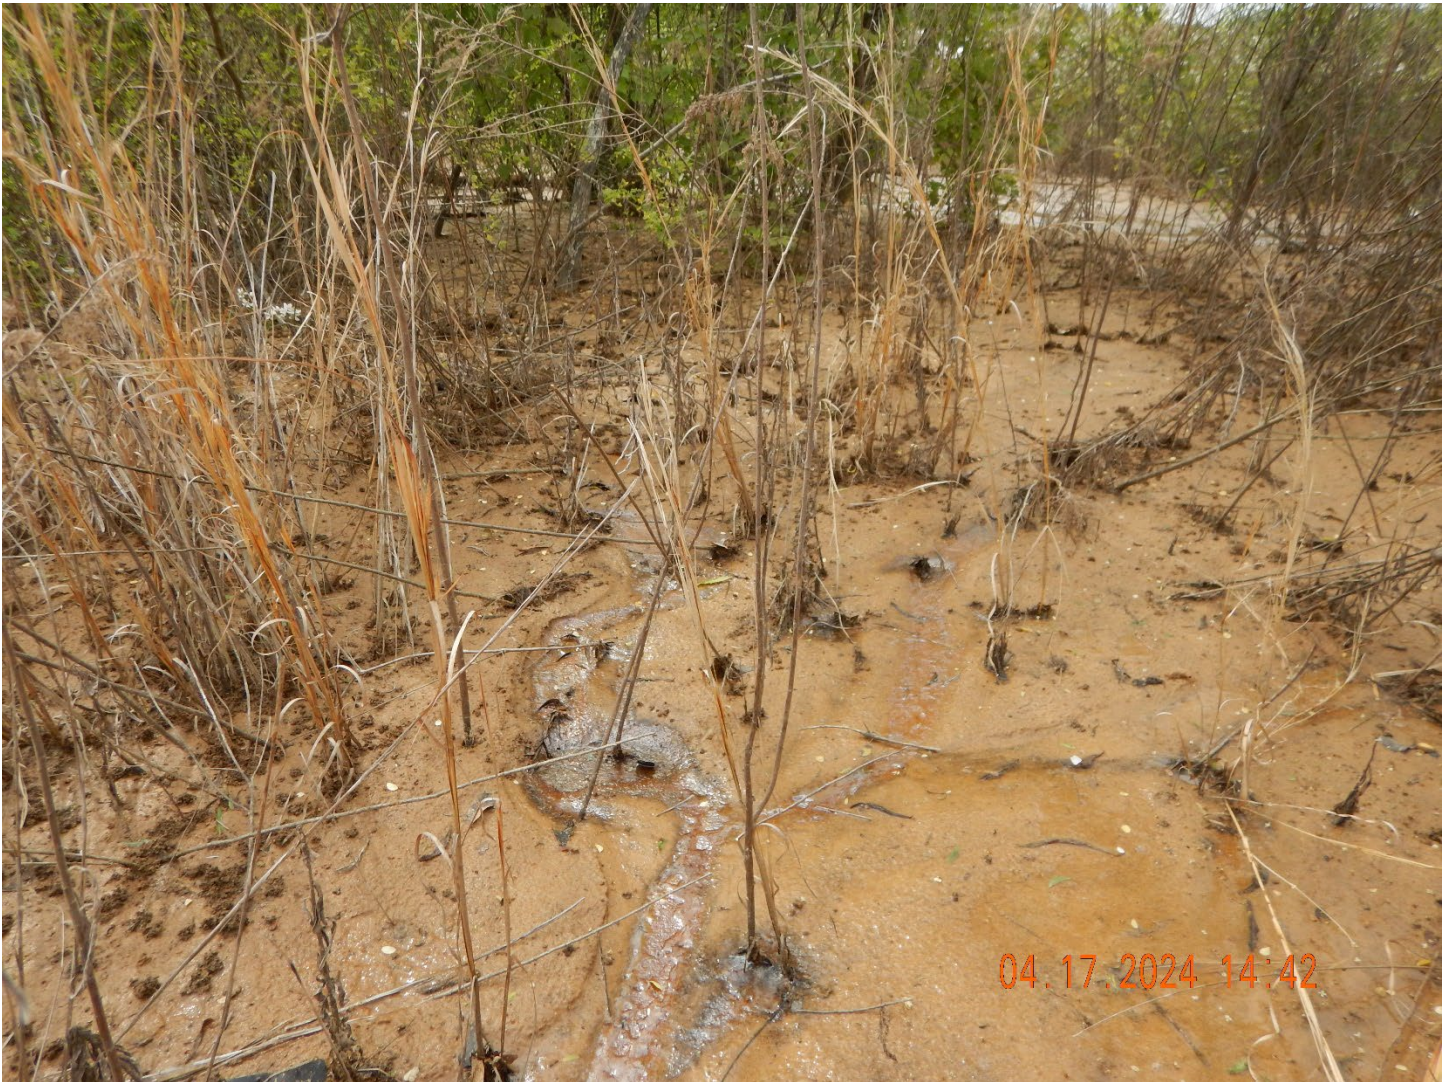
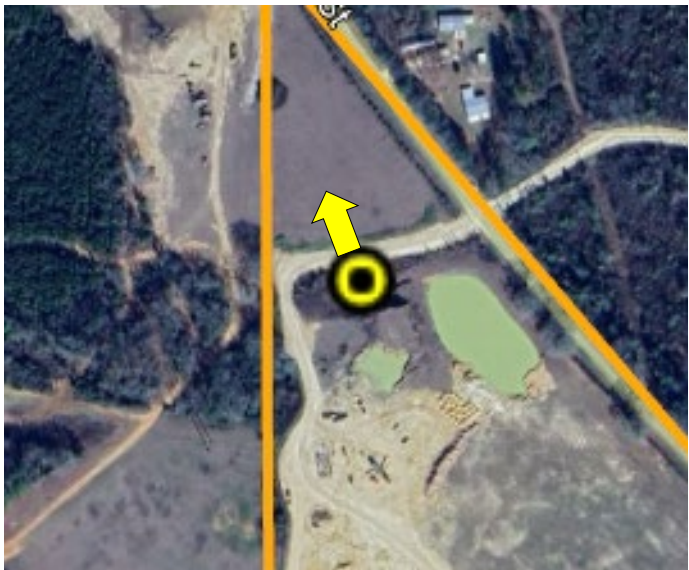
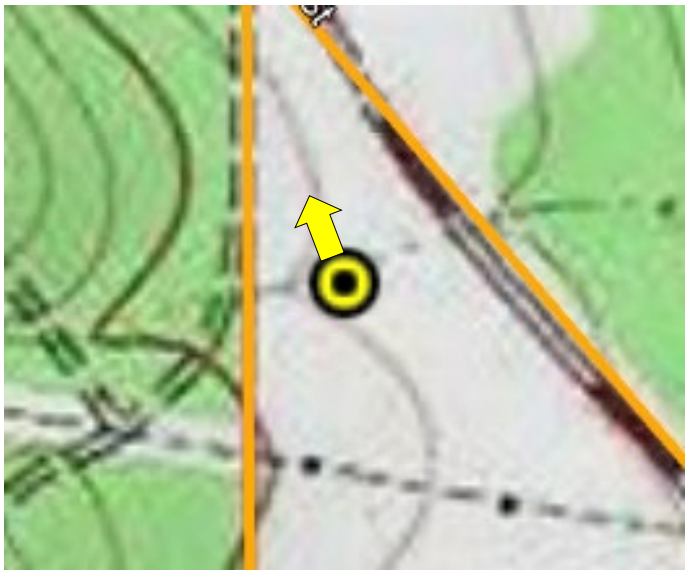
| Title | Photo 25 |

| Description | Continuing to follow the flow/ponding created by the blocked culvert to the west. Notice the formation of seeps in the foreground and midground. |

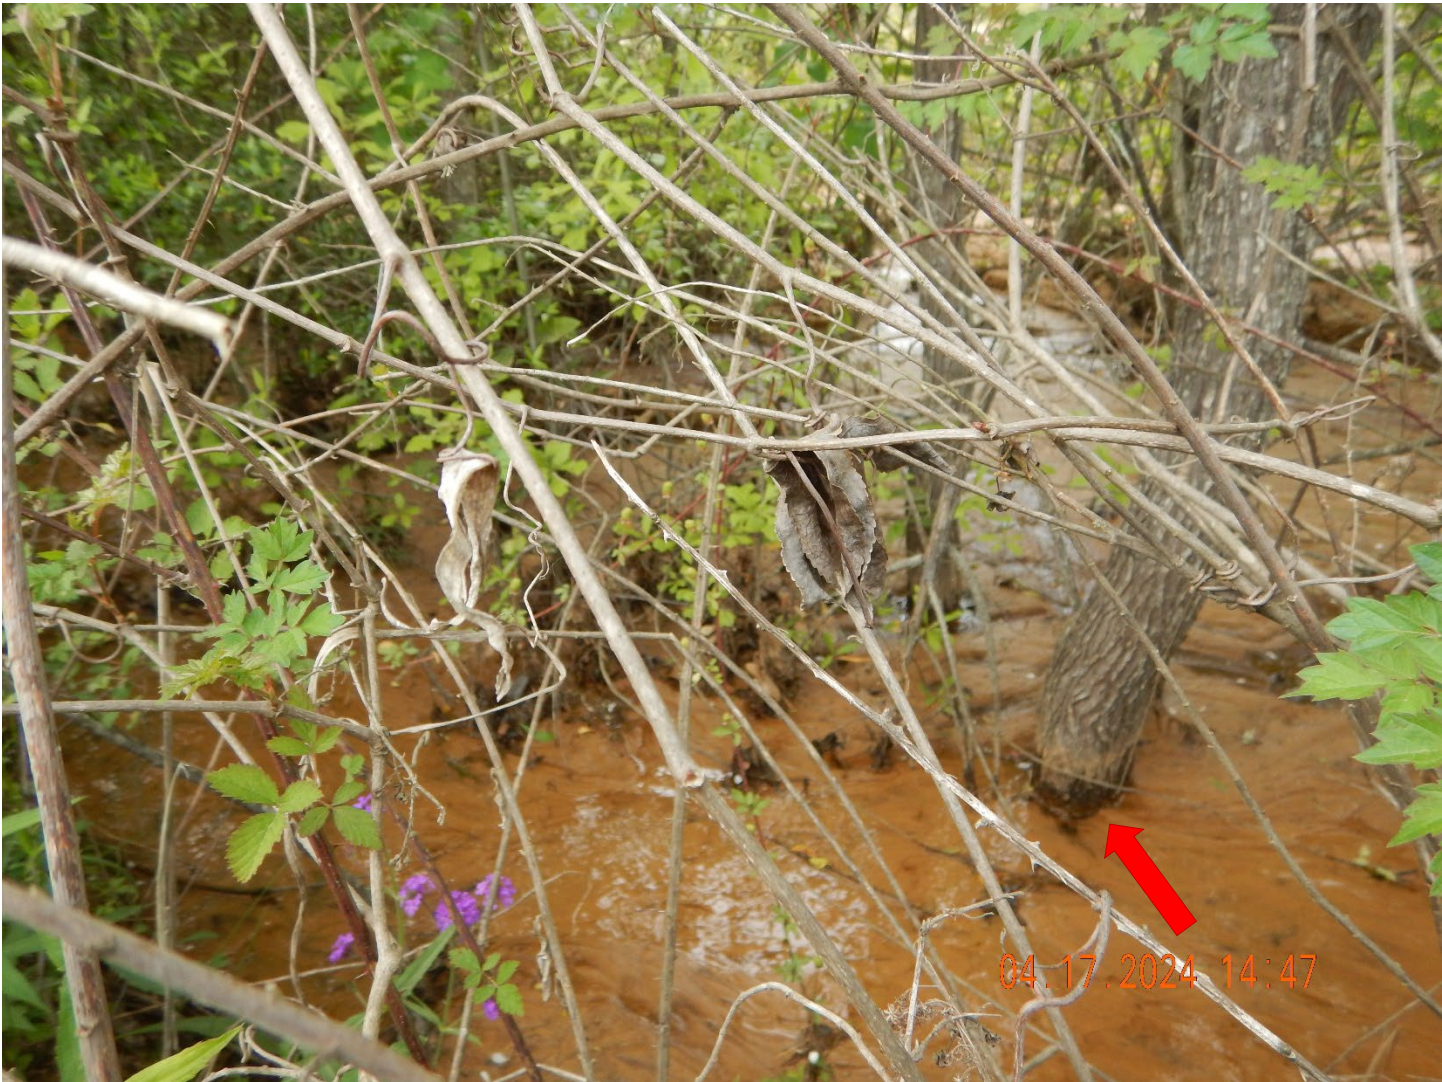
| Title | Photo 26 |

| Description | Continuing to follow the flow/ponding created by the blocked culvert to the west. Red arrow in top photo points out new high water marks on trees in the vicinity. |

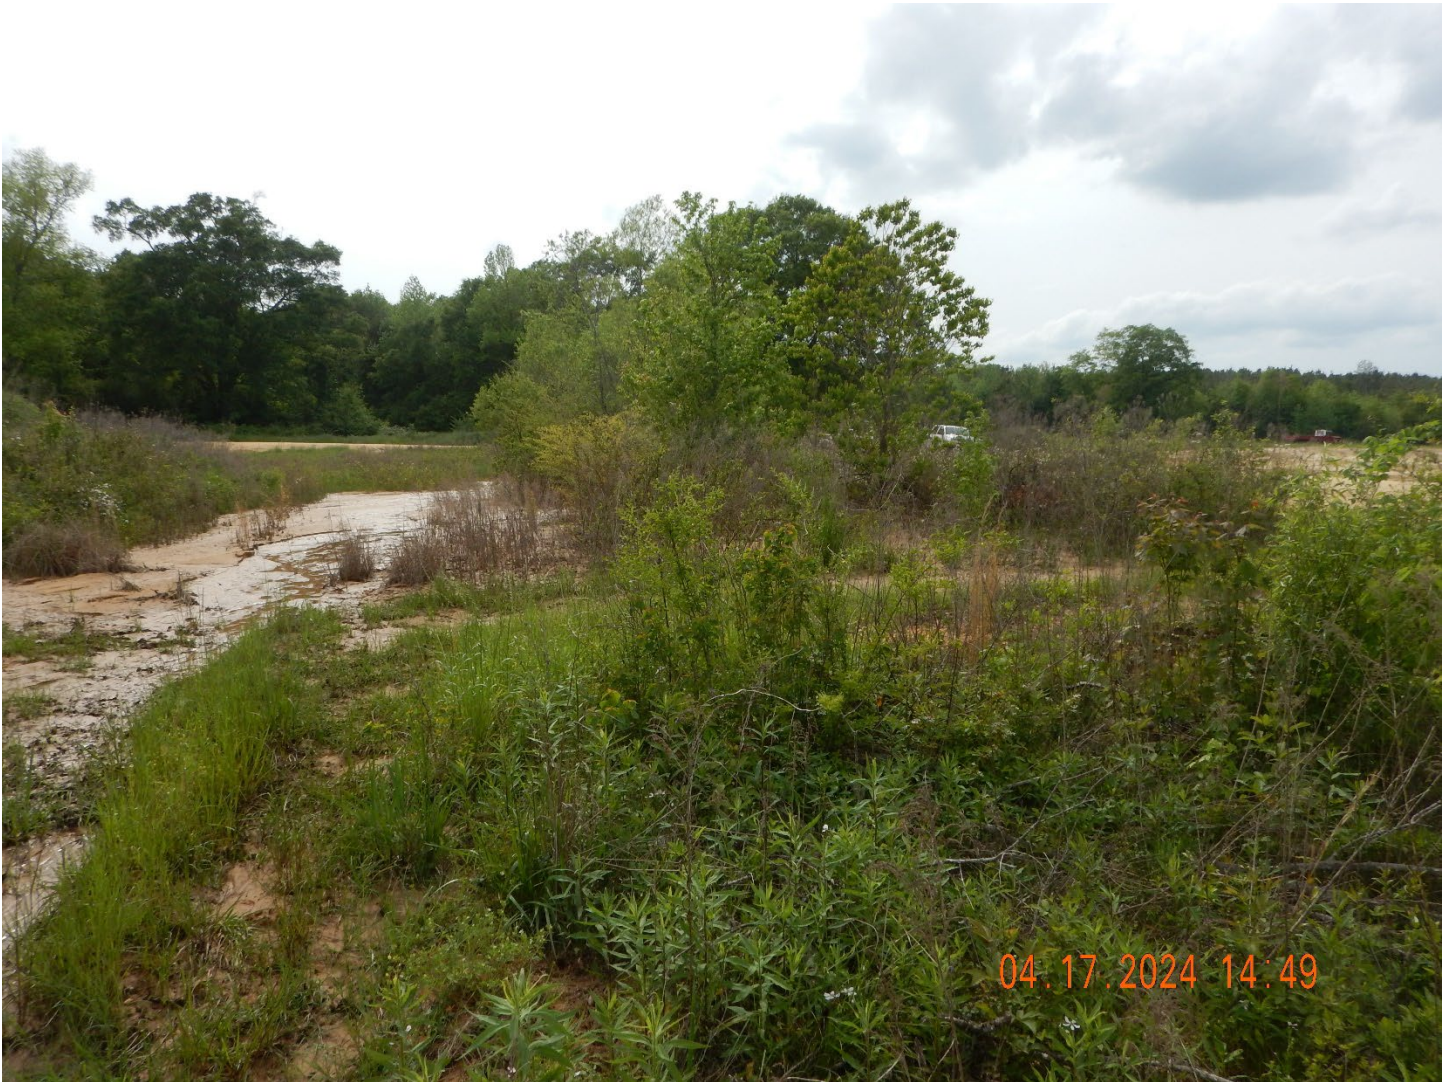
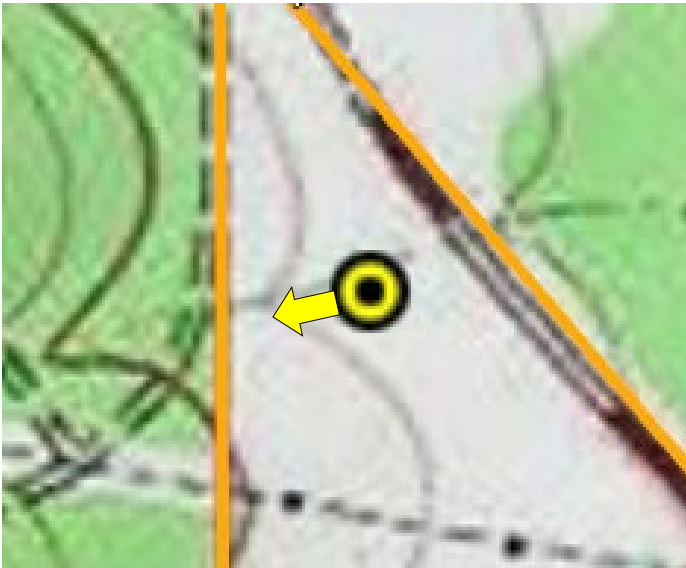
| Title | Photo 27 |

| Description | Continuing to follow the flow/ponding created by the blocked culvert to the west. |

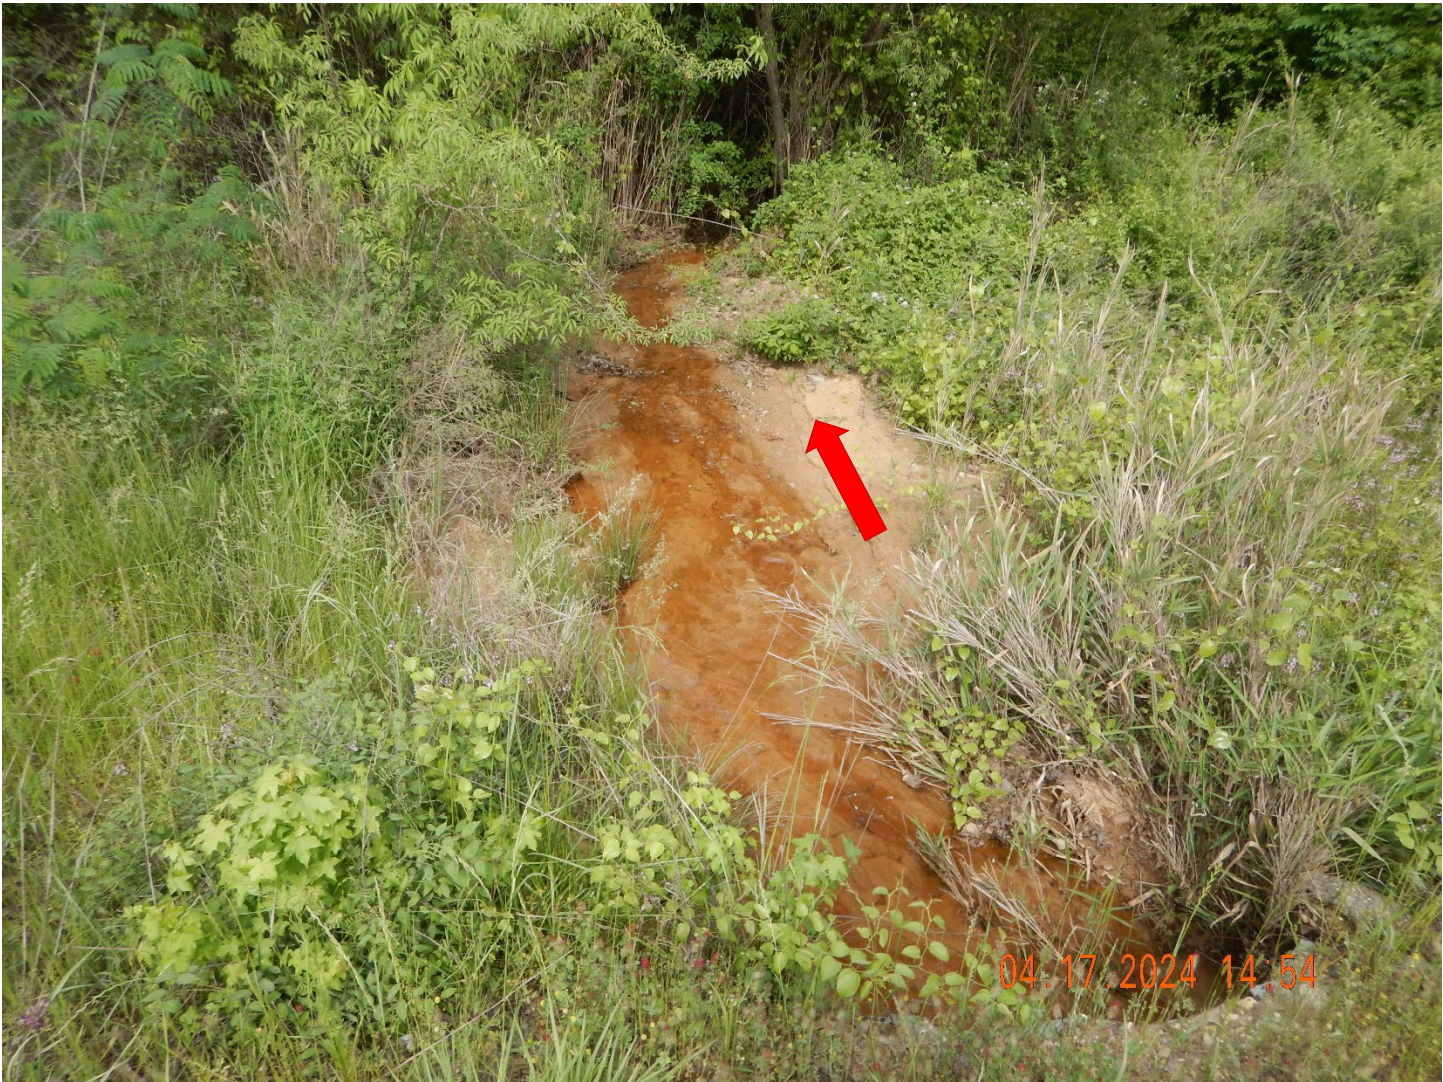
| Title | Photo 28 |

| Description | Flow after it has traveled under County Road 19 North, toward Pit Worx property to the east. |

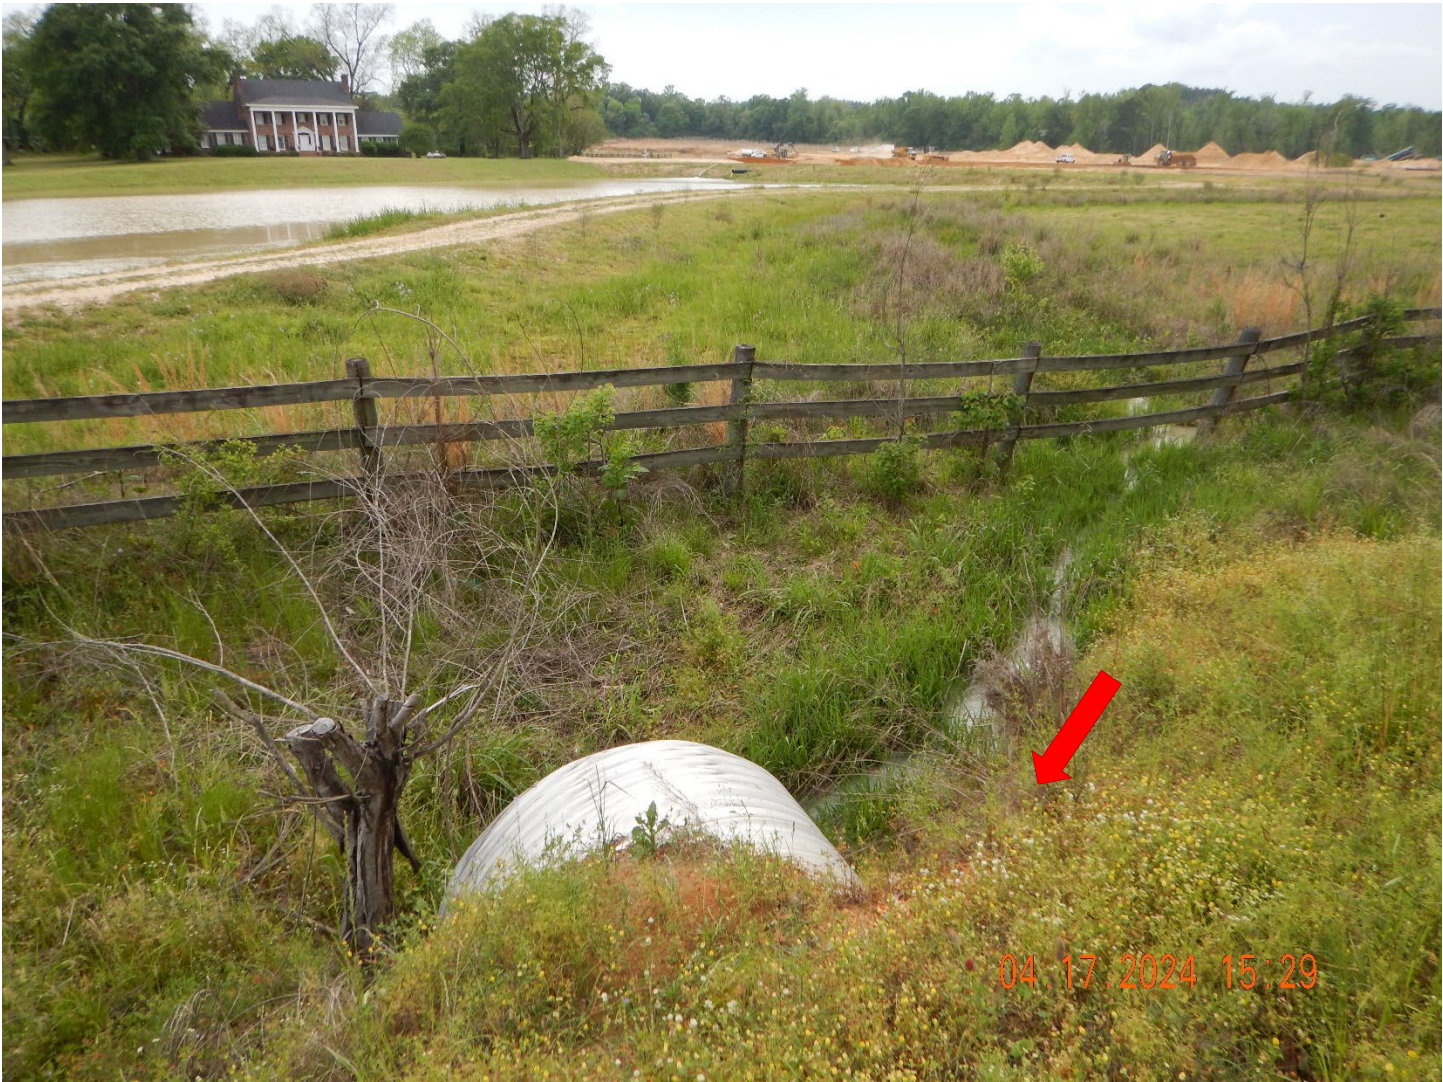
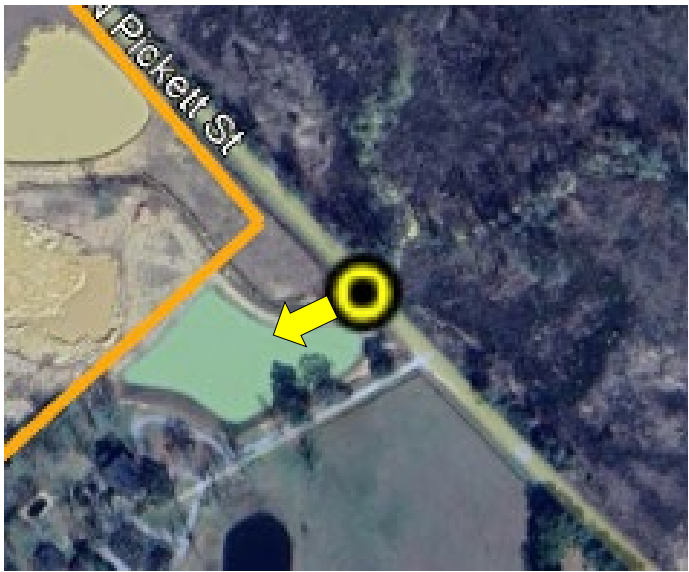
| Title | Photo 29 |

| Description | Striking toward Pickett Pond, with flow from the vegetated channel meeting a culvert that conveys it across County Road 19 North. Red arrow in top photo indicates the direction of flow. |

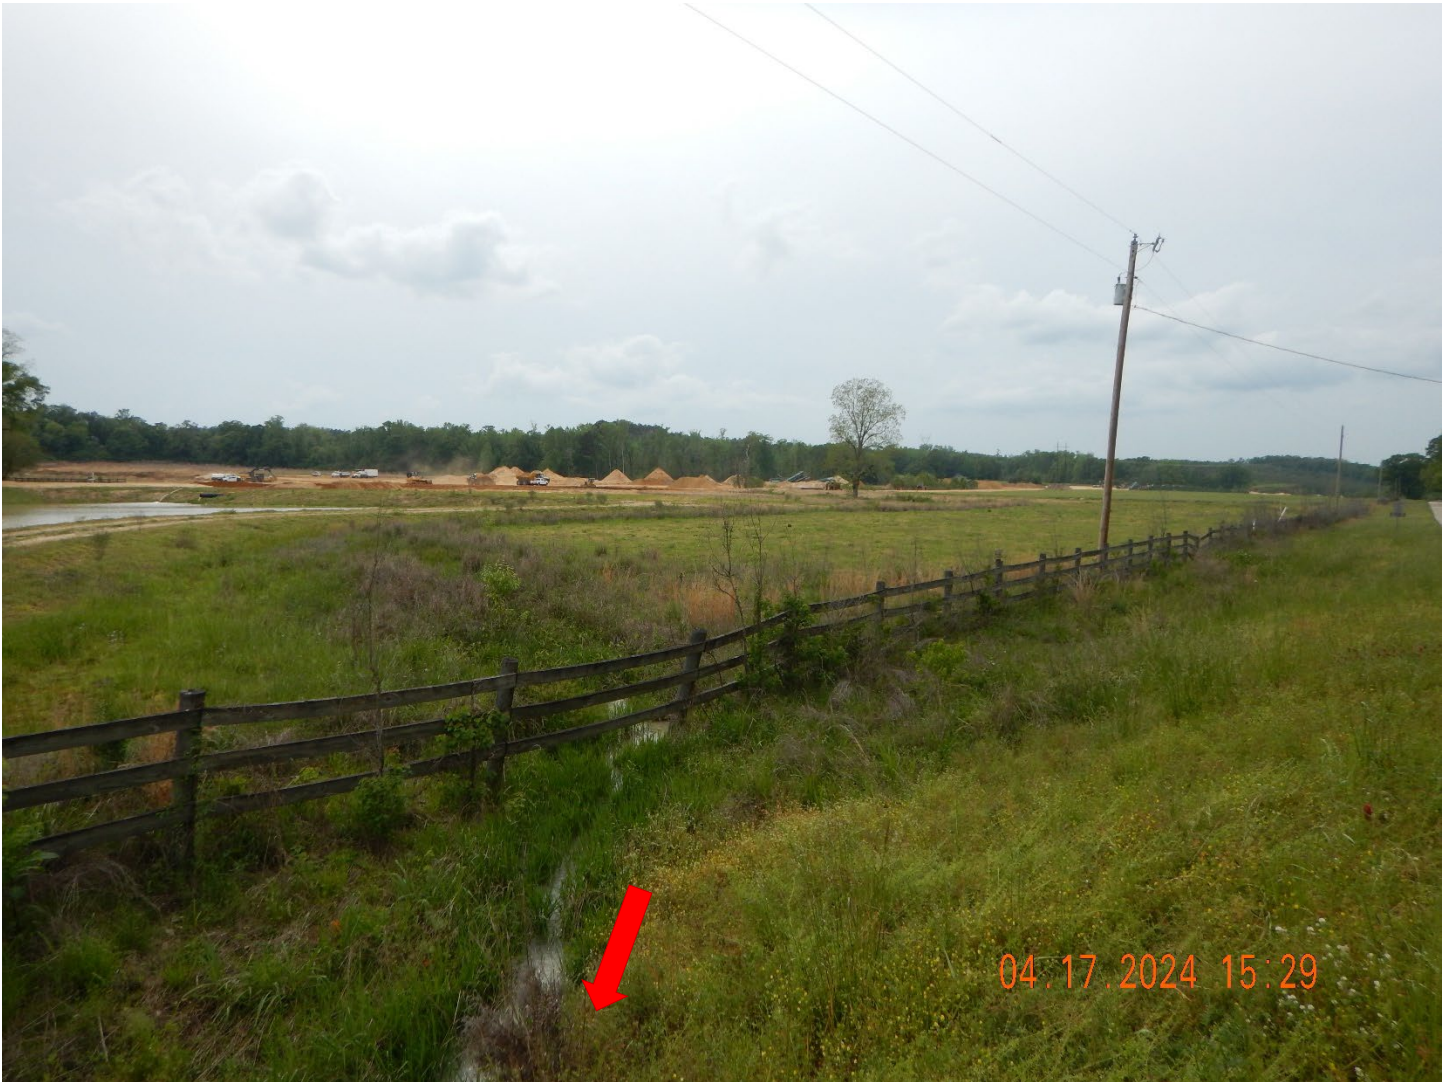
| Title | Photo 30 |

| Description | The landscape/channel northwest of Pickett Pond. Red arrow in top photo indicates the direction of flow. |

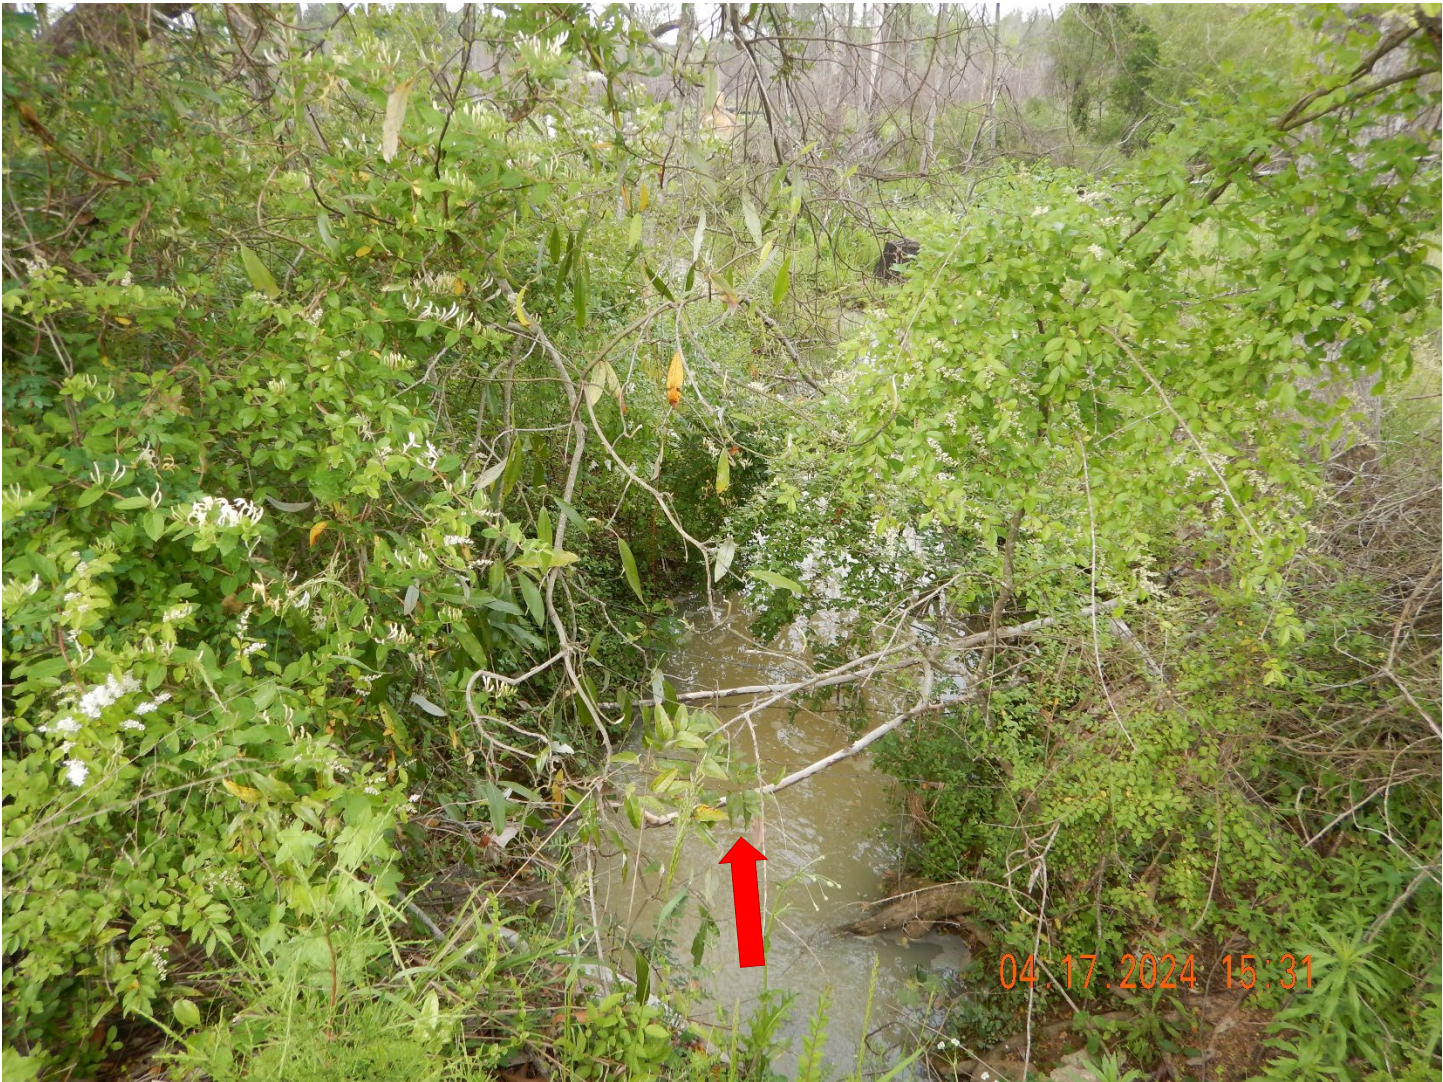
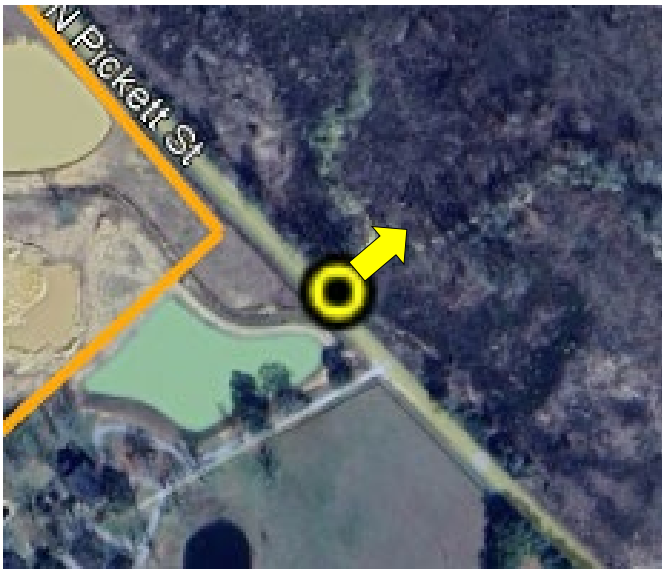
| Title | Photo 31 |

| Description | Flow from vegetated channel across the road from the Site; Swift Creek lies to the east. Red arrow in top photo indicates the direction of flow. |

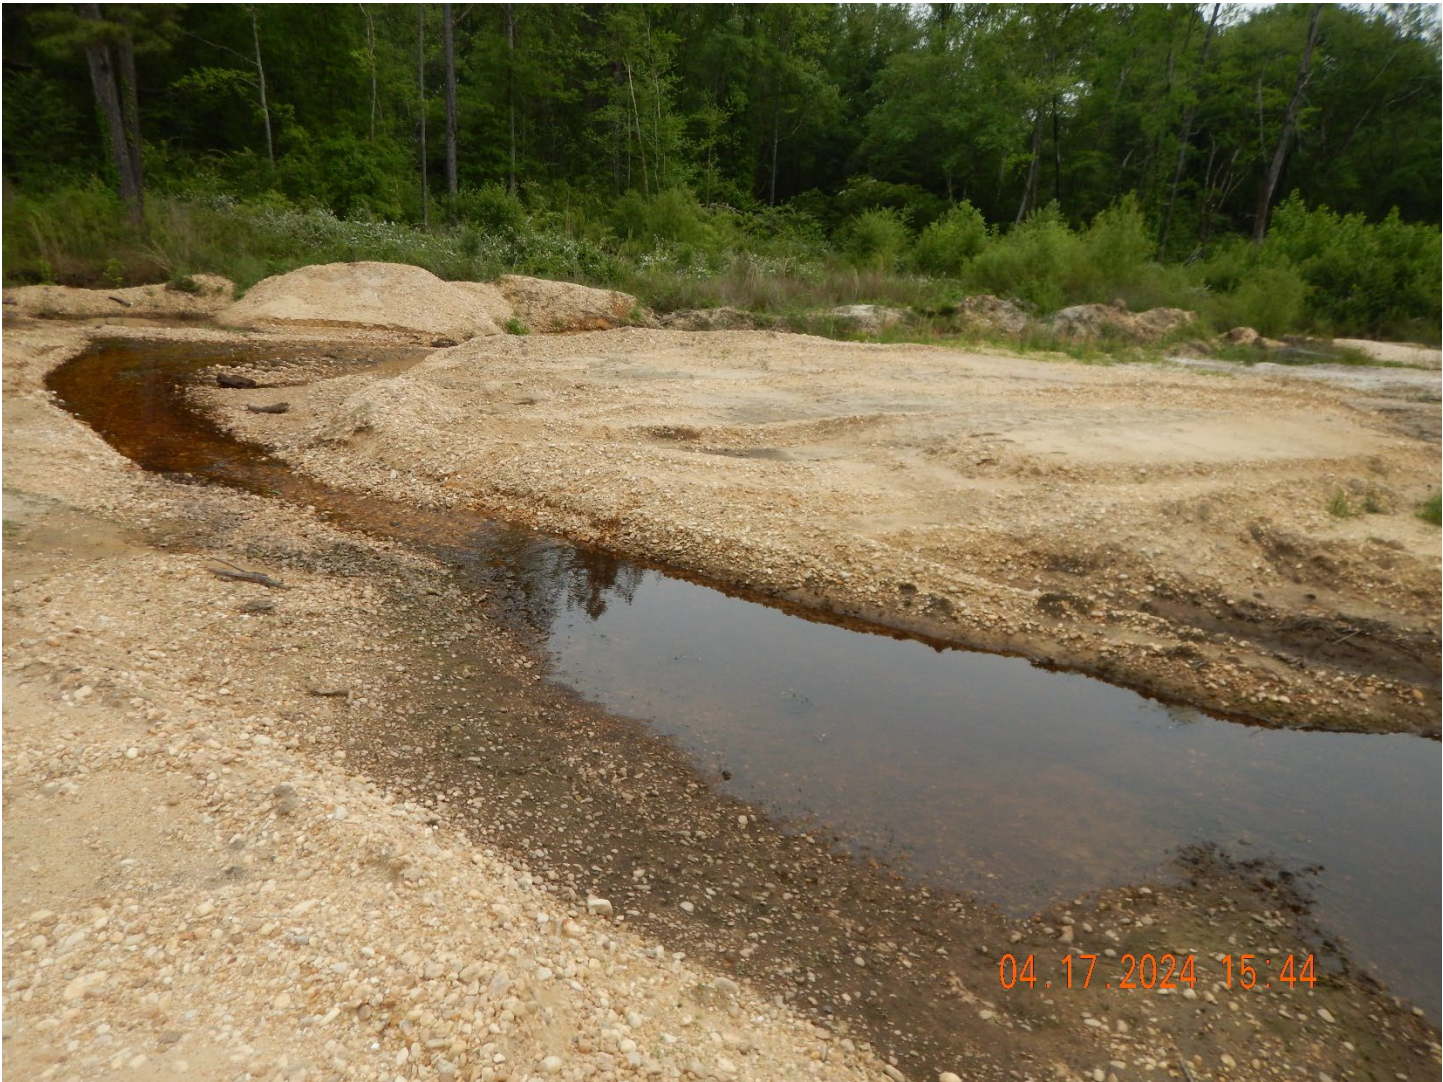
| Title | Photo 32 |

| Description | Unnamed tributary at the Meeks' property and its new flowpath post-impact. *EPA inspection team visited this current enforcement action due to its proximity to the Site (i.e., east of County Road 19 North). |

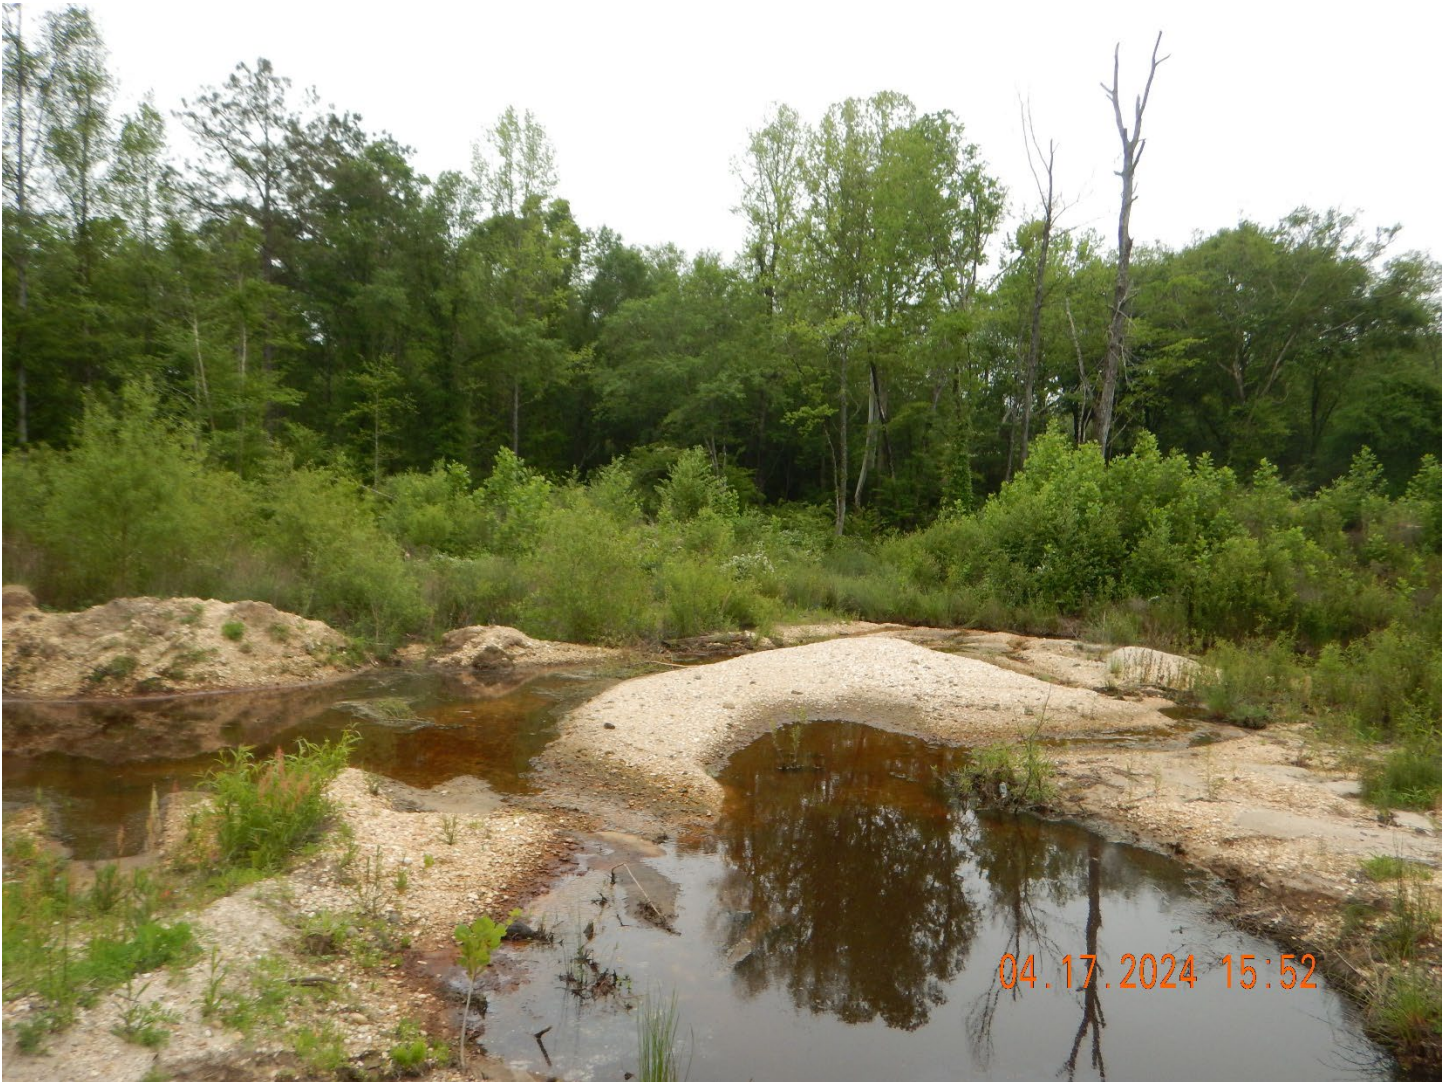
| Title | Photo 33 |

| Description | The unnamed tributary as it pools as part of its new flowpath, looking toward its confluence with Swift Creek. *EPA inspection team visited this current enforcement action due to its proximity to the Site. |
