**UNITED STATES ENVIRONMENTAL PROTECTION AGENCY  
REGION 2, ECAD-WCB  
290 Broadway, 21<sup>st</sup> Floor, New York, NY 10007**

<b>Program:</b> Sanitary Sewer System		<b>Inspection Type:</b> Compliance Evaluation Inspection	
<b>Permittee Name:</b> East Windsor MUA		<b>NPDES/ICIS No.:</b> NJ0023787, PID NO. 95449	
<b>Inspection Entry Date:</b> September 20, 2022 <b>Inspection Entry Time:</b> 8:00 AM		<b>Inspection Exit Date:</b> September 20, 2022 <b>Inspection Exit Time:</b> 5:30 PM	
<b>Facility Information:</b> East Windsor Municipal Utilities Authority <b>Lat, Long:</b> 40.294641°, -74.563824° 147 Millstone Road, East Windsor NJ <b>NAICS / SIC Code:</b> SIC Code 4952, sewer systems			
<b>EPA Representative(s):</b> Murray Lantner, P.E. Environmental Engineer, EPA Region 2, ECAD-WCB. (212) 637-3976			
<b>State Representative(s):</b>			
<b>On-Site Facility Representative</b> Angel Perez, Collections Operator Bryan Laurendeau, Collections Operator Nick Pietrefesa, Supervisor EWMUA, npietrefesa@eastwindsormua.com, 908-797-2532

## **A. Background and Findings and Opening Conference**

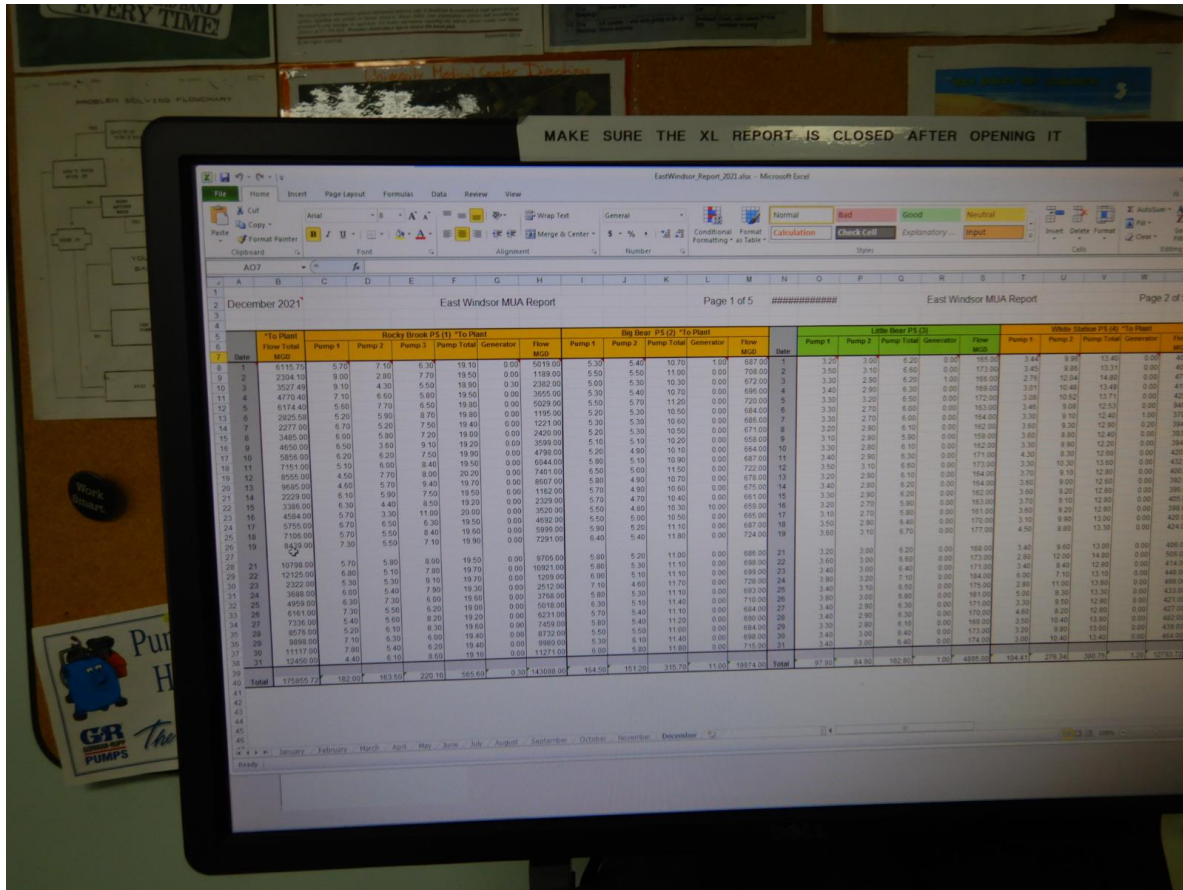
system in place for the pump stations. During the inspection, a photo taken of the SCADA system flow monitoring for December 2021 identified that the SCADA system is not accurate and the flow numbers are off by several orders of magnitude. For example as shown below on December 1, 2021 the flow to the WWTP, Rocky Brook PS (1), Big Bear PS(2), Little Bear PS (3), and White Station PS (4) was recorded as 6115, 5019, 687, 165, and 409 MGD, respectively for this plant that typically treats about 2.3 to 2.7 MGD. EWMUA said that they would work to get the SCADA system operating properly.

1. As described in paragraph in paragraph 8 above the SCADA system was reporting inaccurate flows from the WWTP and the pump stations. EWMUA said that they would work to get the SCADA system working properly.

DSCN1910 – SCADA System

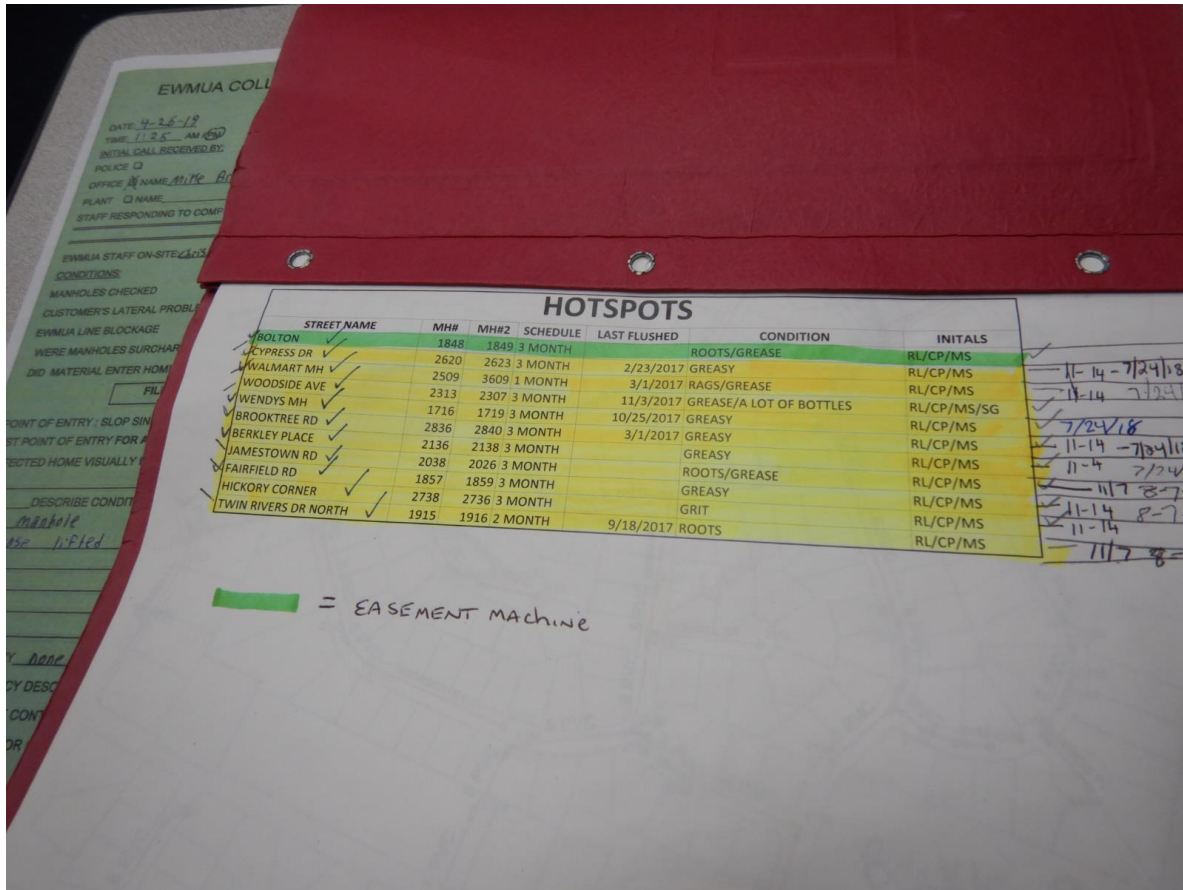
13. EWMUA does maintain a sewer system hot spot list that it jets on a routine basis as shown below. However, based on the entries its unclear if the jetting schedule is being maintained. EPA recommends keeping a database or work order system with the hot spot cleaning records.

DSCN1922 – Hot Spots

3. As described in paragraph 13 above, provide a list of the current hot spots and cleaning frequencies and indicate whether this frequency is being maintained. EPA recommends keeping a database or work order system with the hot spot cleaning records.

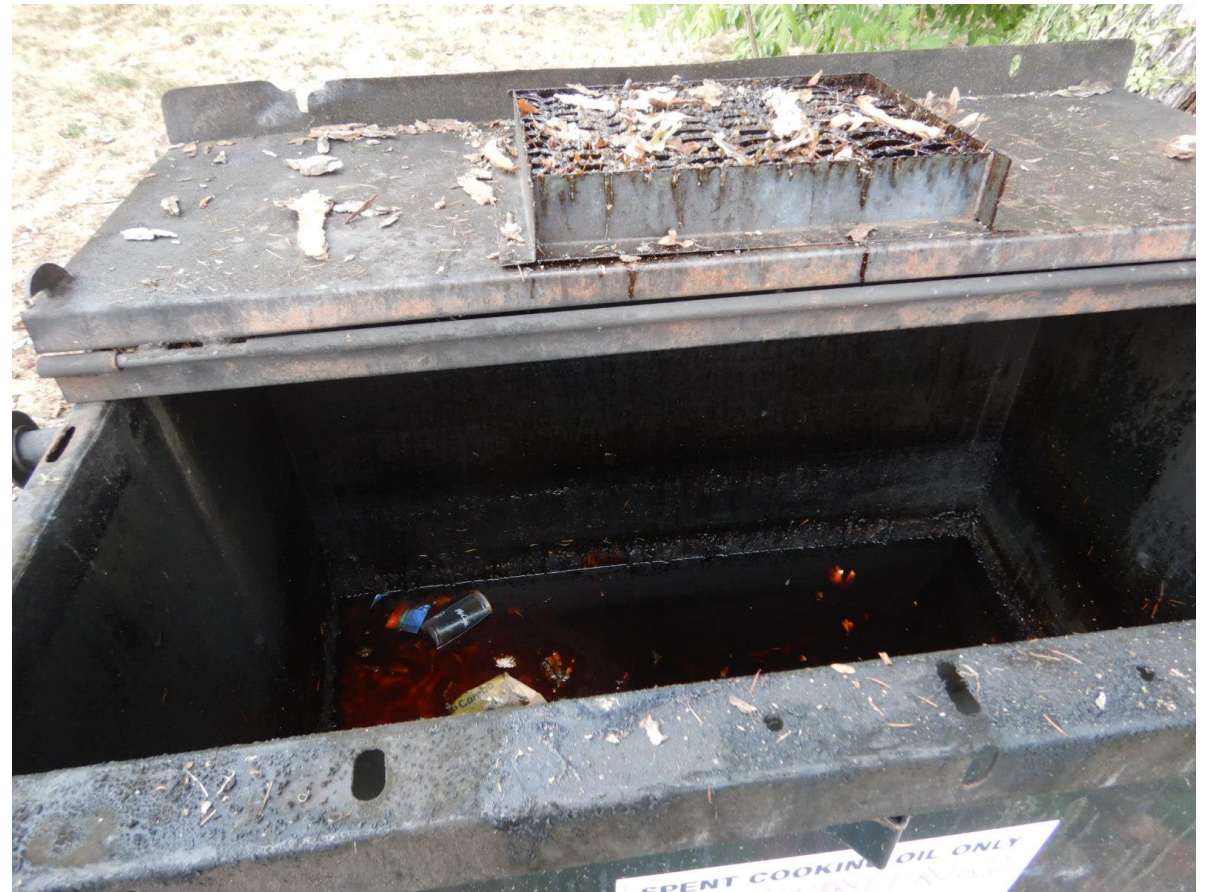
d.	Royal Plaza	Open grease dumpsters outside and grease seen on the ground around the grease dumpster (Photos 1935-1943, Att. 1)	Yes - East Windsor needs to contact MS4 (DPW) and/or health dept. to ensure properly managed grease. Provide Status

DSCN1935 – Open grease dumpster at Royal Plaza

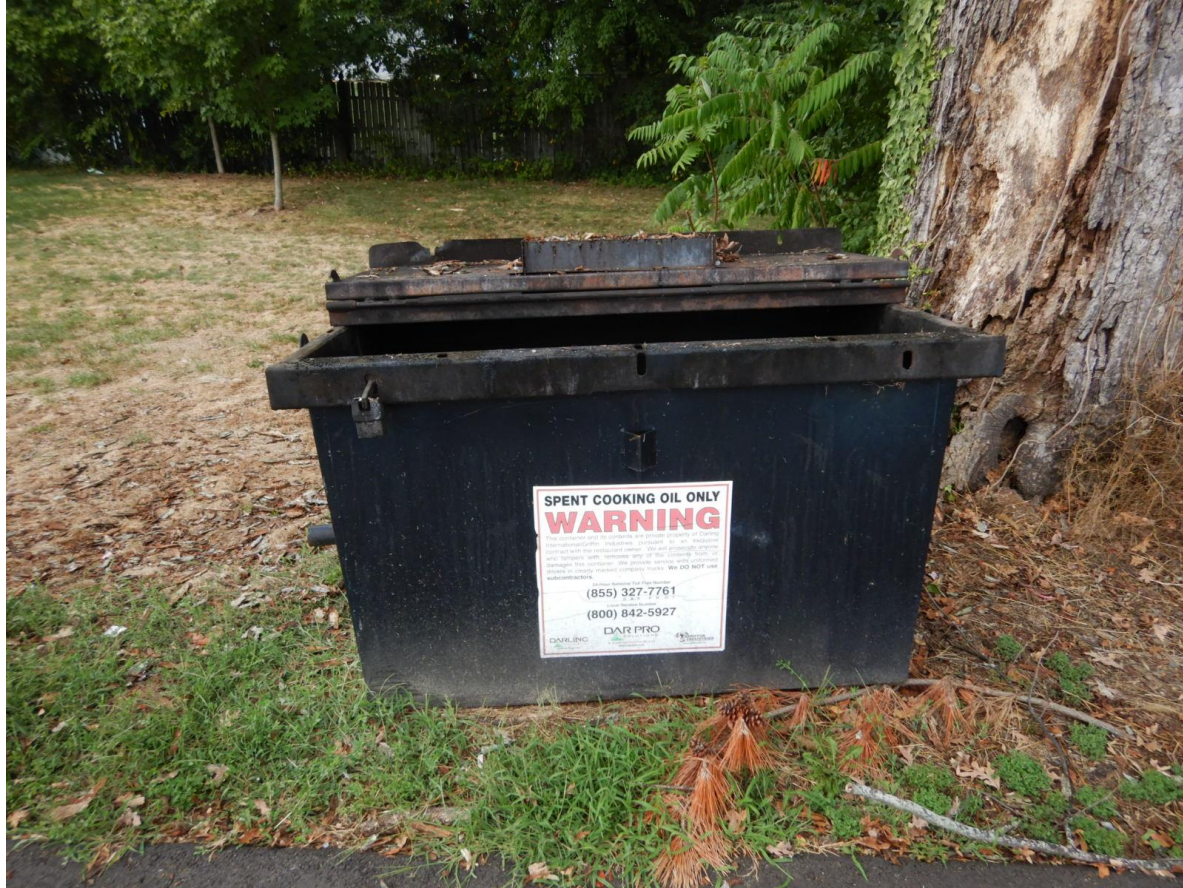
DSCN1936 - Open grease dumpster at Royal Plaza

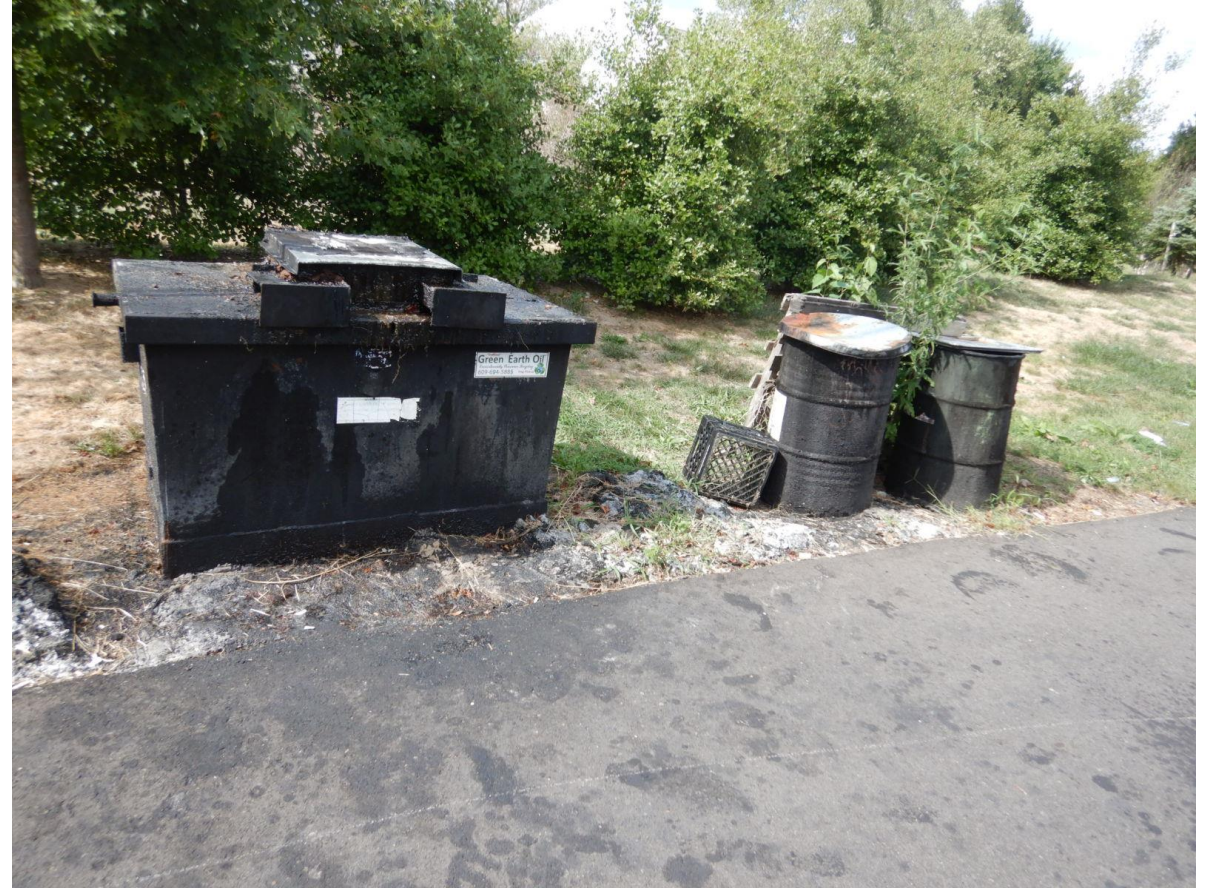
DSCN1937 - Grease outside of a grease dumpster at Royal Plaza

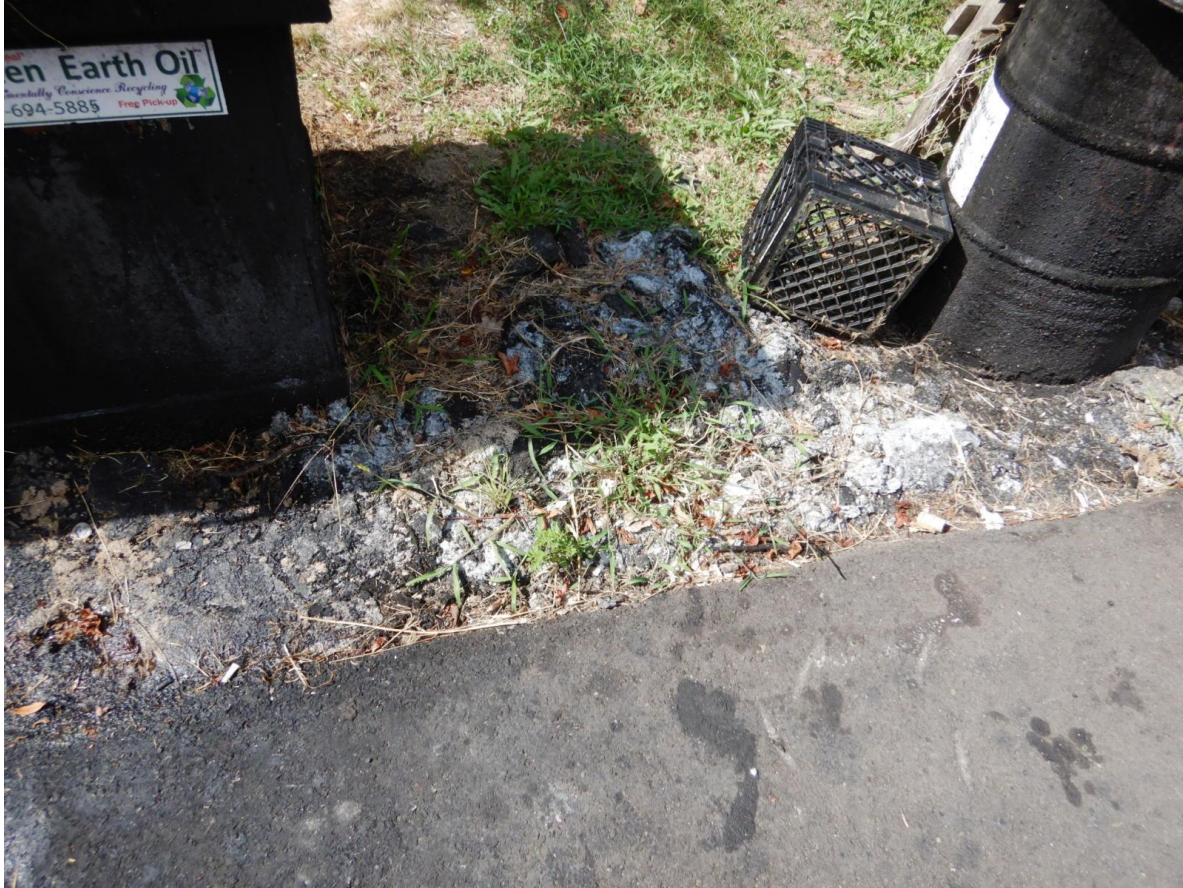
DSCN1938 - Grease outside of a grease dumpster at Royal Plaza

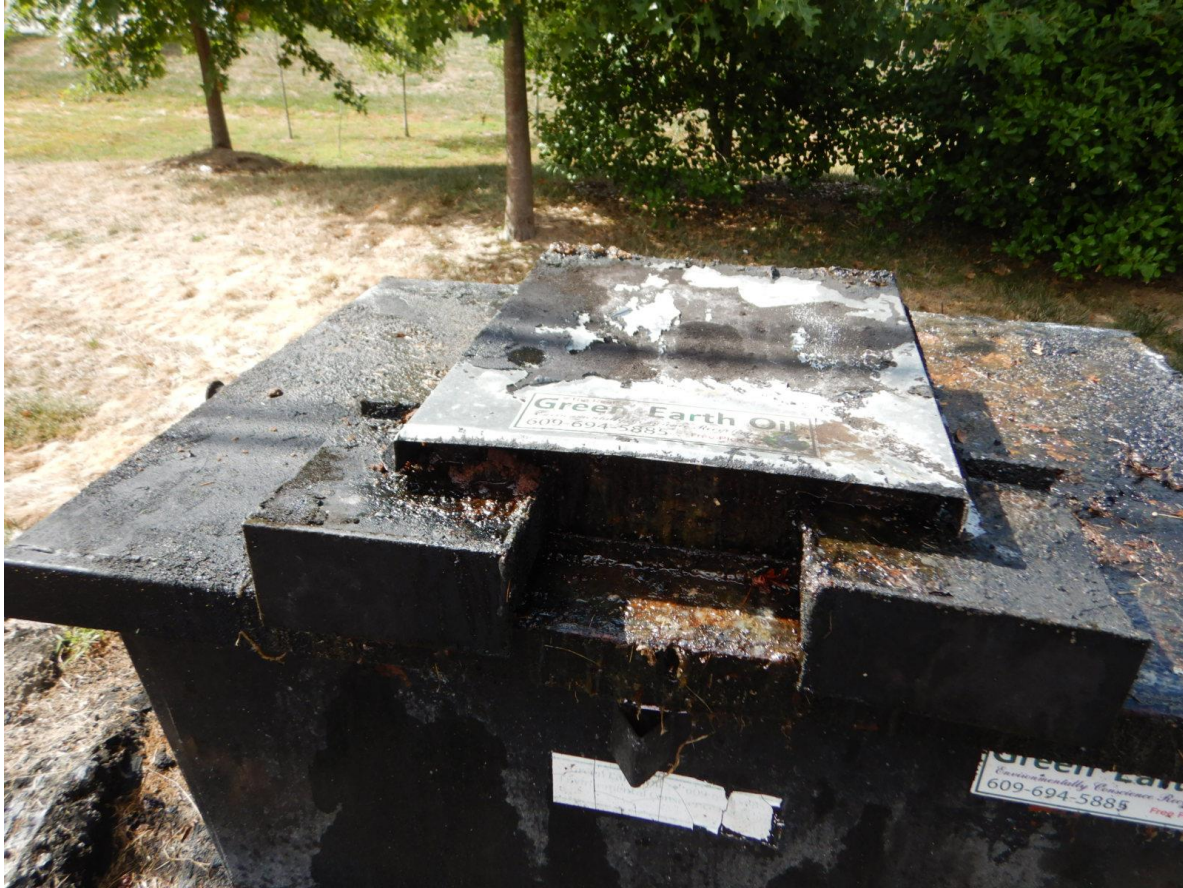
DSCN1940 – grease on top of the dumpster outside at Royal Plaza

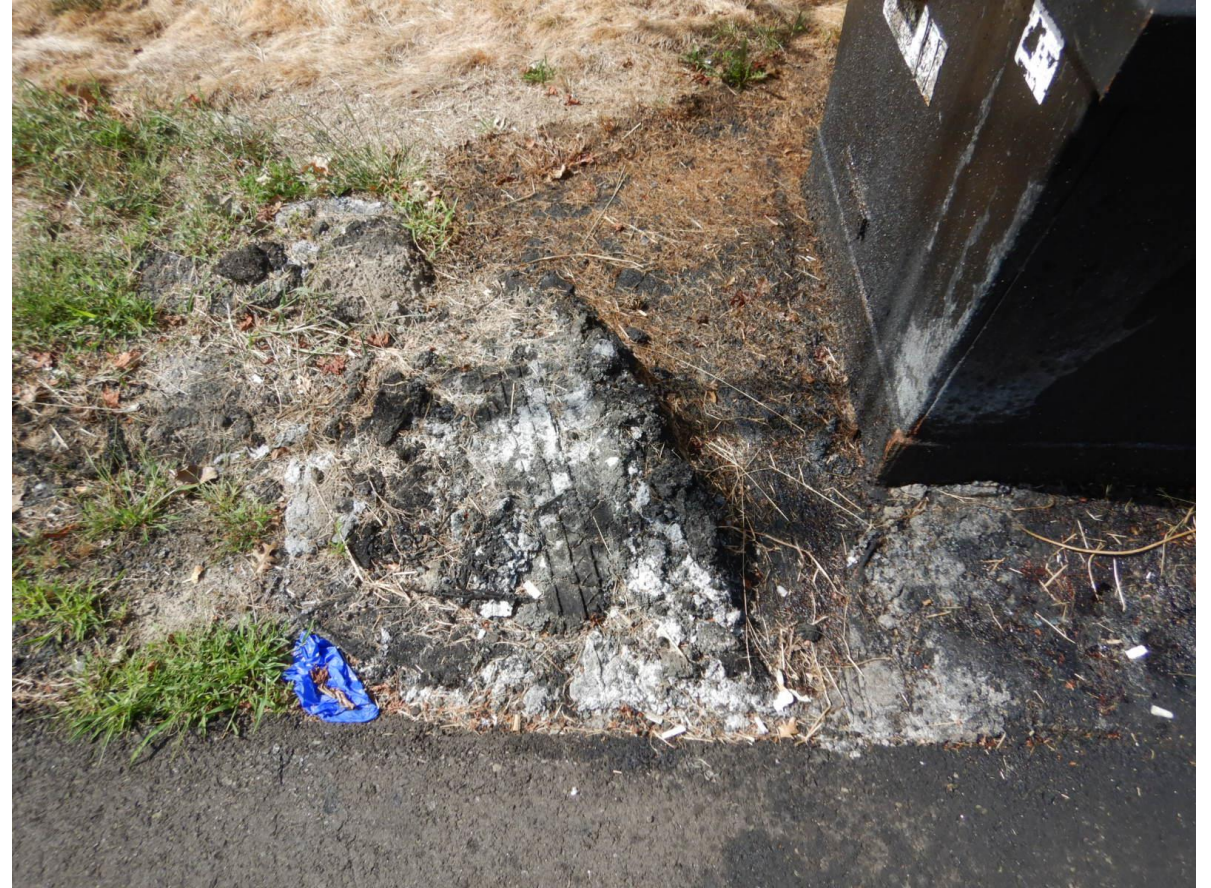
DSCN1941 - Grease outside of a grease dumpster at Royal Plaza

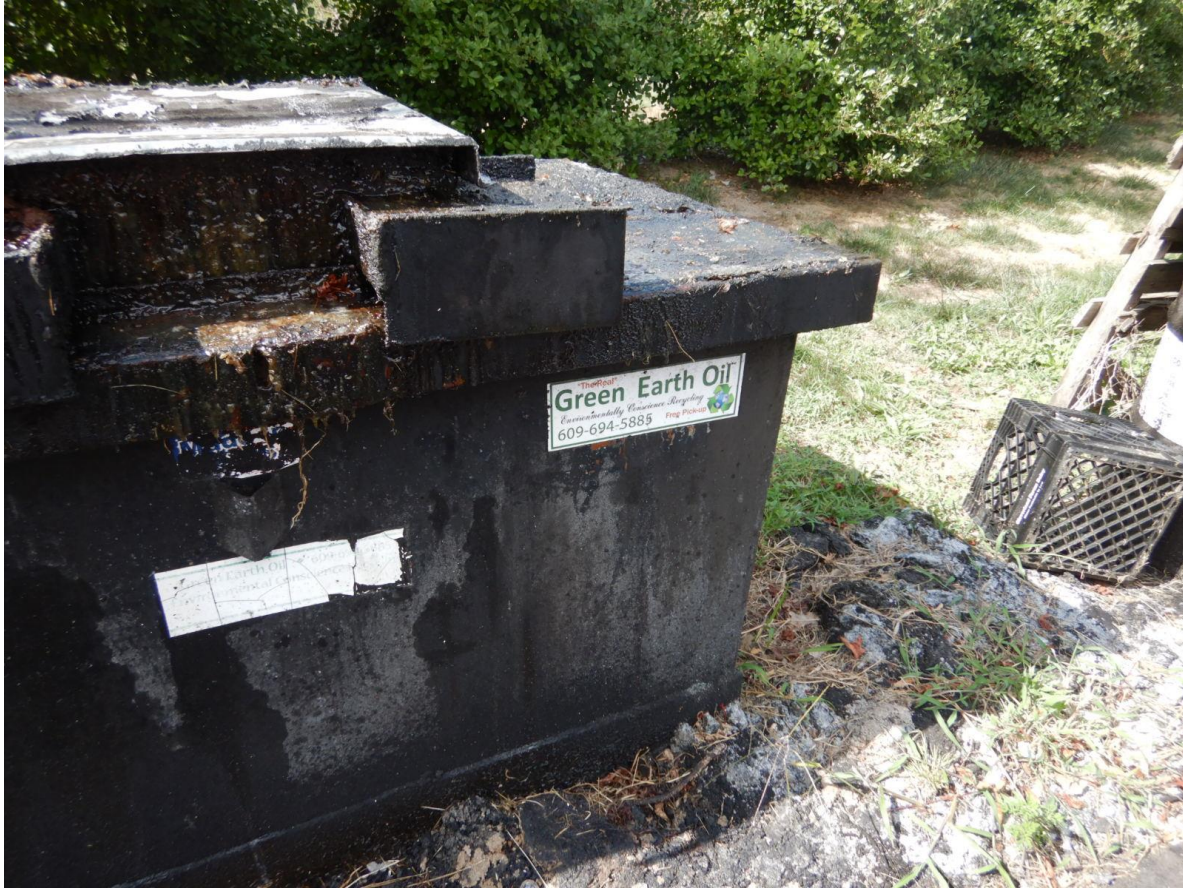
DSCN1942 Grease outside of a grease dumpster at Royal Plaza

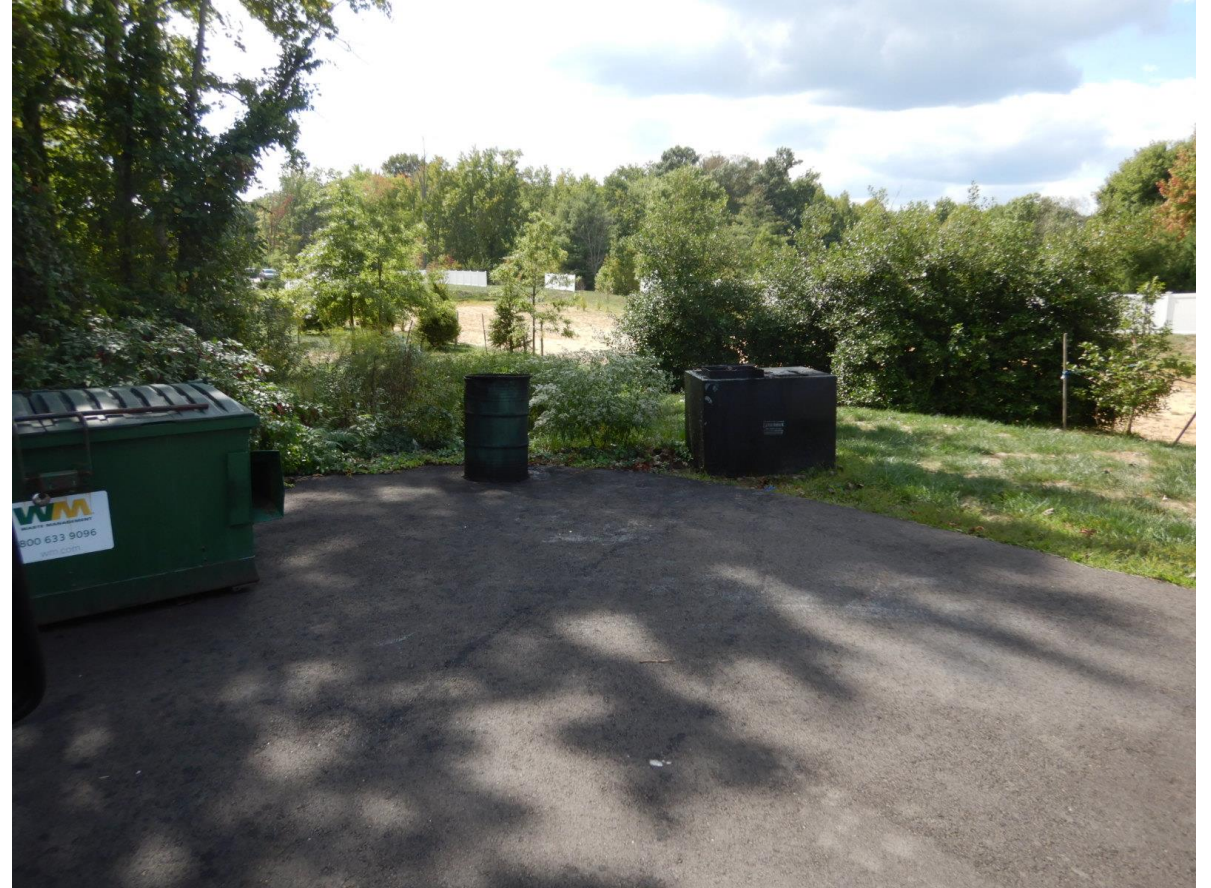
DSCN1943 Grease outside of a grease dumpster at Royal Plaza
