**Region 6 - Enforcement & Compliance Assurance Division**  
**INSPECTION REPORT**

| Inspection Date(s): | 09/13/2022 | |
| Facility Name: | <b>Casa Blanca Wastewater Treatment Plant (WWTP)</b> | |
| Identification/Permit Number: | NM0030678 | |

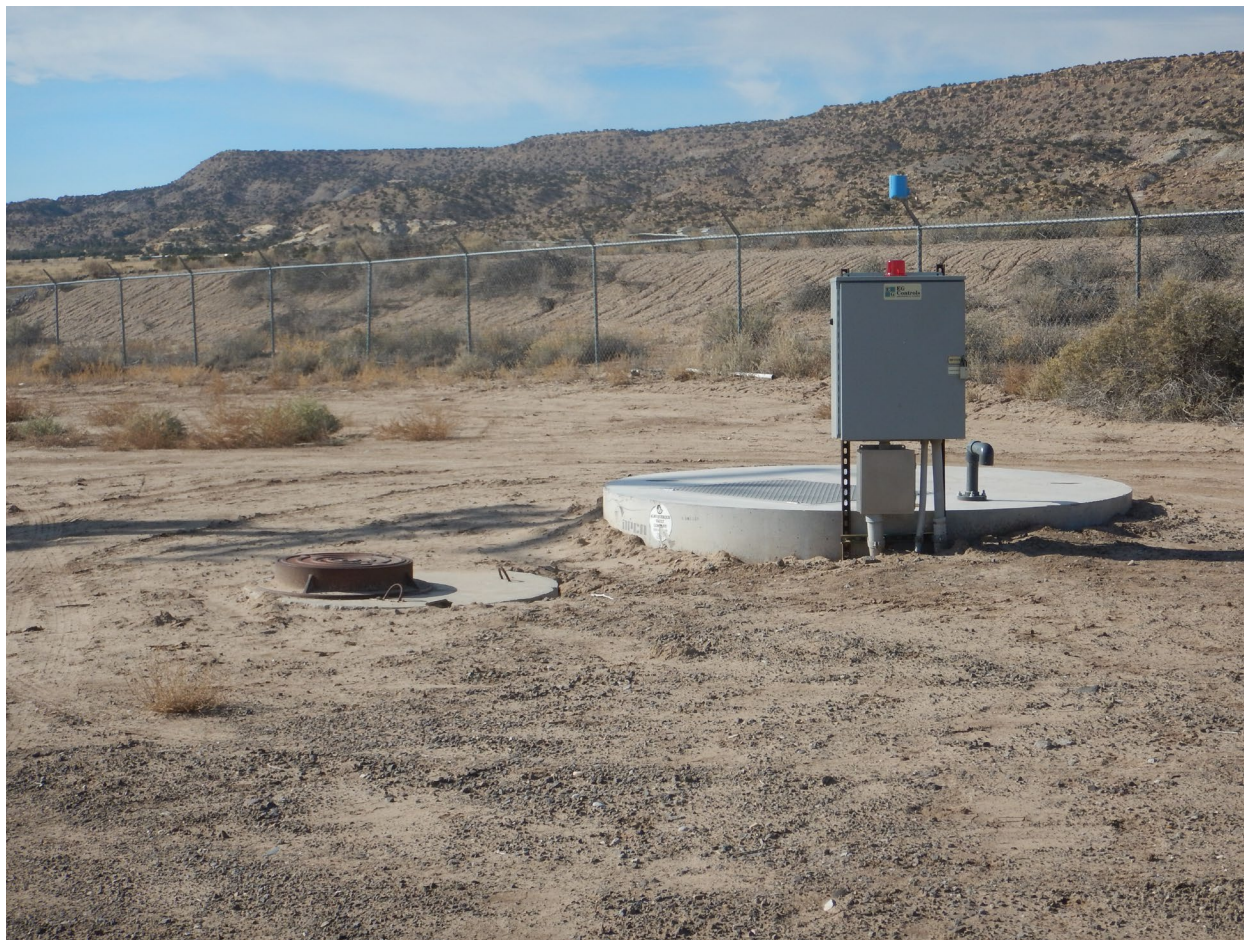
Photo No. 1

| Name | Location | Comment |
|---|---|---|
| WWTP #1 | Northwest corner inside WWTP fenced perimeter | Vault (concrete) was replaced, and LS was serviced circa early 2020. Locked hatchway w/ safety gate. |

View of Lift Station (LS) WWTP#1 located at the approximate Northwest corner inside WWTP fenced perimeter. (DSCN1653). September 13, 2022. Photographed by D. Esparza

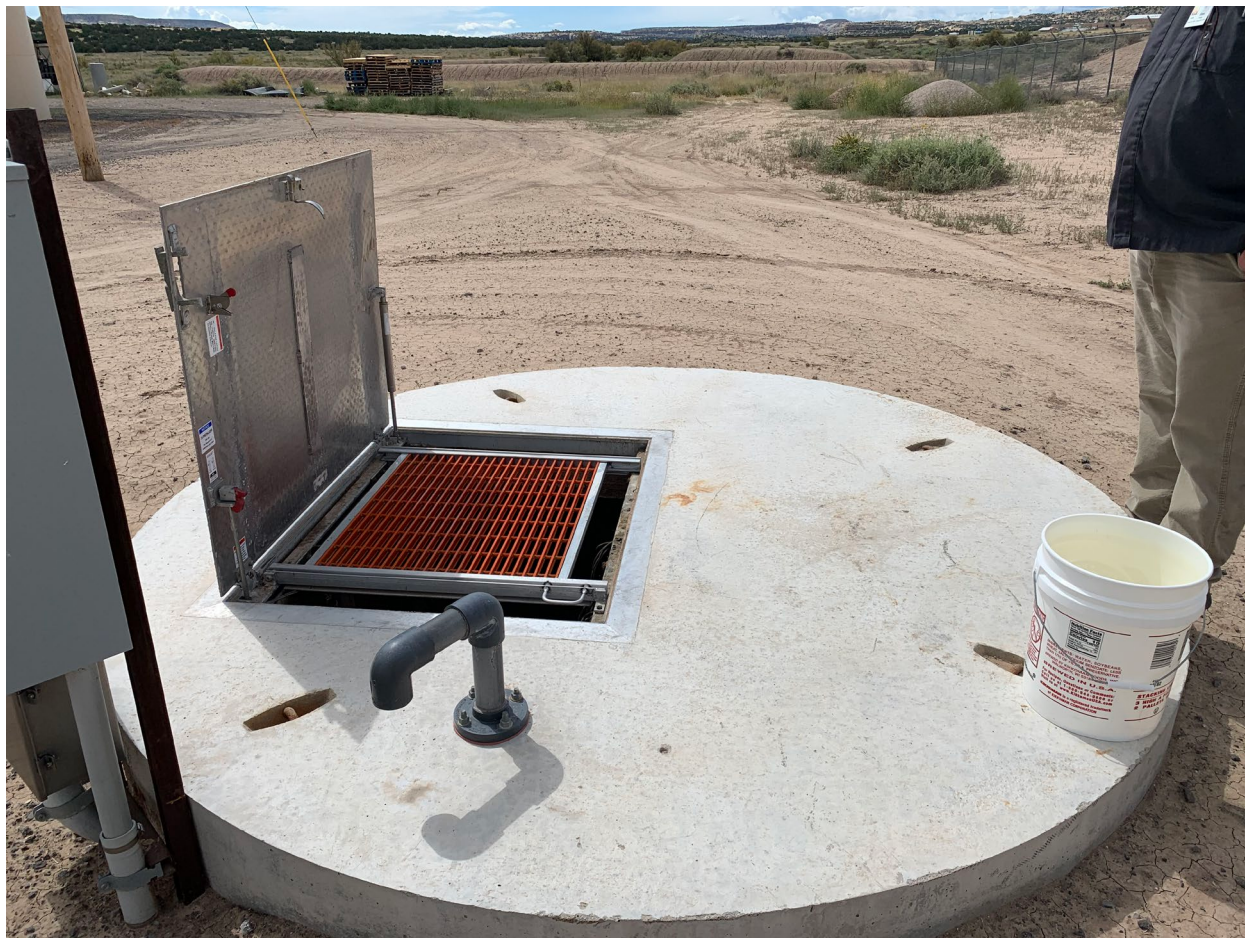
Photo No. 2

View of LS WWTP#1 with hatchway open and safety gate in-place. (IMG0138). September 13, 2022.  
Photographed by D. Esparza

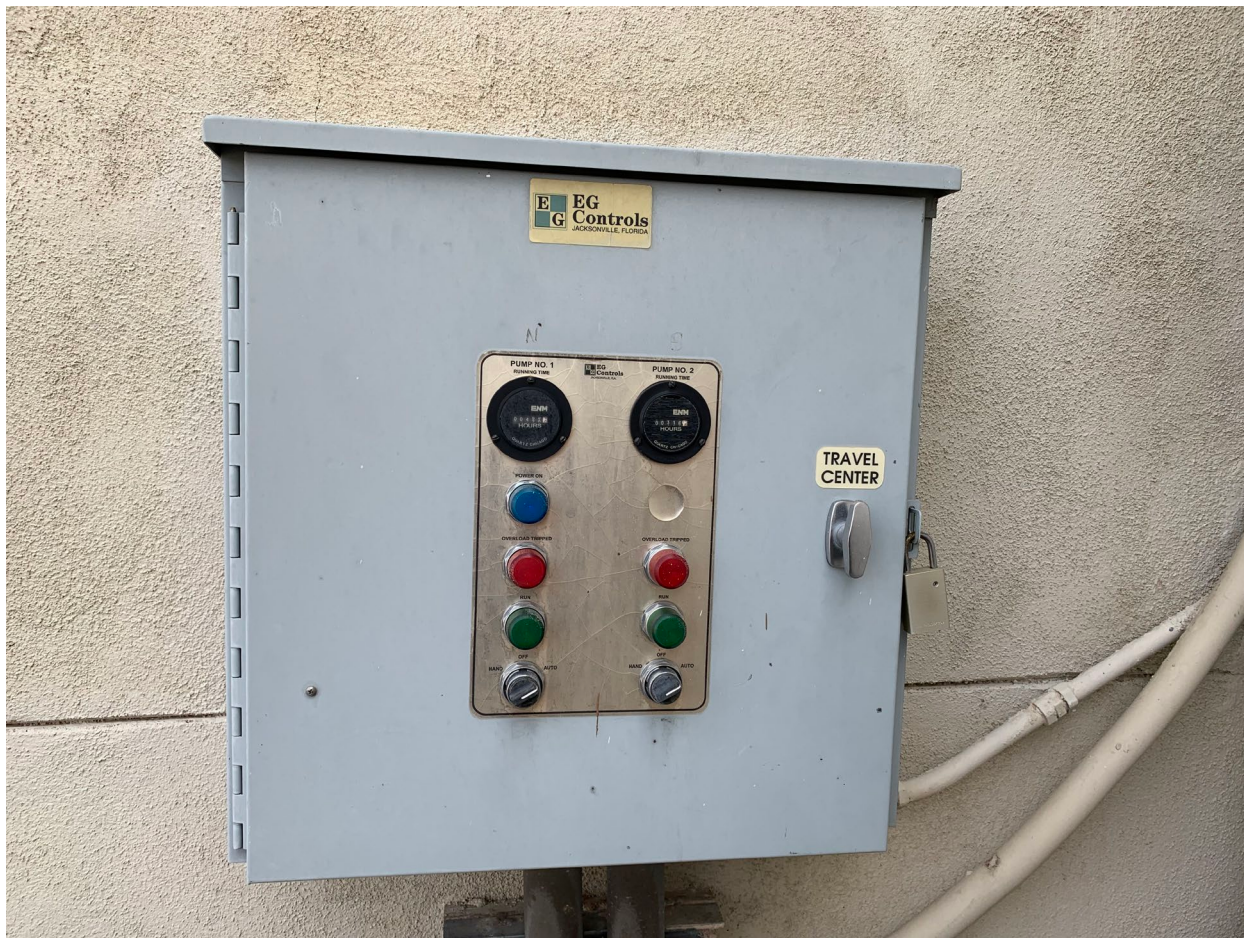
Photo No. 3

| Name | Location | Comment |
|---|---|---|
| Burger King | West side of drive-thru next to building | Vaults were cleaned, serviced and new pumps were installed circa early 2020. |

View of control panel of the Burger King Lift Station located along the West side of drive-thru next to the building. (IMG0140). September 13, 2022. Photographed by D. Esparza

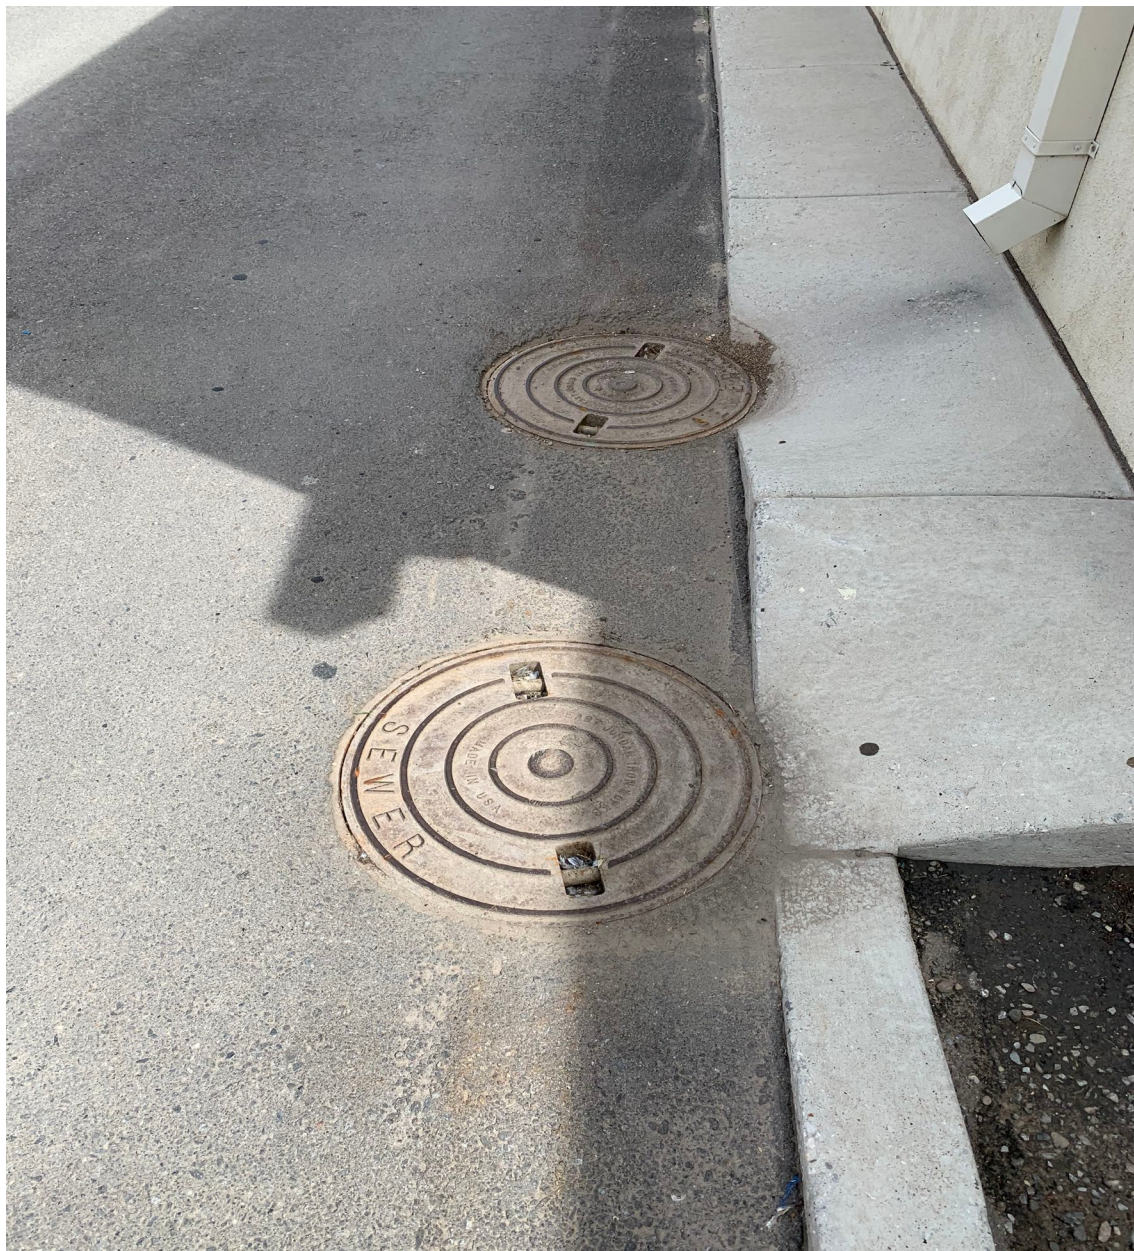
Photo No. 4

- The operator (Mr. Trotter) oversees this facility Casa Blanca WWTP (NM0030678) and Rio Puerco (NM0030686) on an individual employee basis full-time 24-hour per day 365 days per year.
- Additionally, he (Trotter) is responsible for sample collection and operation and maintenance (O&M) associated with both facilities.
- Lift Station WWTP#2 located approximately North and outside the fenced perimeter lacks secure perimeter fencing, alarms (either audible or flashing light) or signage.
- Lift Station-Burger King located within the restaurant drive-thru lacks ready access for servicing and/or routine maintenance.

View of the Burger King Lift station vaults located within the drive-thru next to the building. (IMG0142).  
September 13, 2022. Photographed by D. Esparza West side of drive-thru next to building

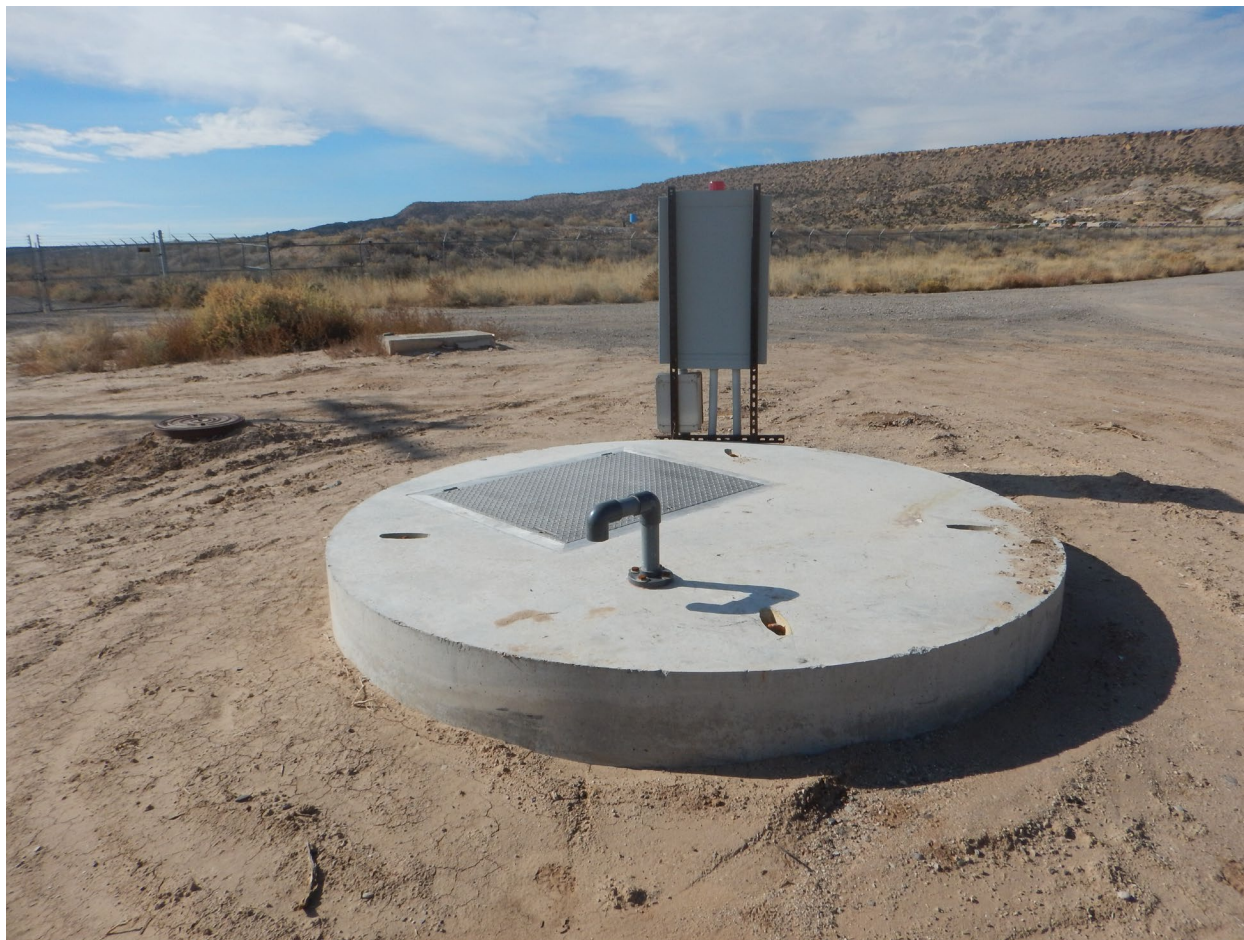
Photo No. 5

| Name | Location | Comment |
|---|---|---|
| WWTP #2 | North outside of WWTP fenced perimeter | Vault (concrete) was replaced, and LS was serviced circa early 2020. Locked hatchway w/ safety gate. Lacks secure perimeter fencing, alarms (either audible or flashing light) or signage. |

View of Lift Station (LS) WWTP#2 located approximately North and outside of WWTP fenced perimeter (DSCN1658). September 13, 2022. Photographed by D. Esparza
