INSPECTION REPORT

Inspection Entry Date/Time	11/08/2022 11:46 AM (ET)	Announced: Yes
Inspection Exit Date/Time	11/08/2022 02:10 PM (ET)	Access: Granted
Weather	Sunny, dry	
Media	Water	
Statute(s)/Program(s)	Clean Water Act, NPDES, WWTP	
Type of Inspection	CEI - Compliance Evaluation Inspection	
Permittee Name		
	Scioto County Commissioners (West Portsmouth WWTP)	
Facility or Site Name		
	West Portsmouth WWTP	
Facility/Site Physical Address		
	27 Hygean Run Rd	
City, State, Zip Code		
	West Portsmouth, OH 45663	
County/Borough/Parish		
	Scioto	
Facility GPS Coordinates

West Portsmouth WWTP

APPENDIX 1: PHOTO LOG

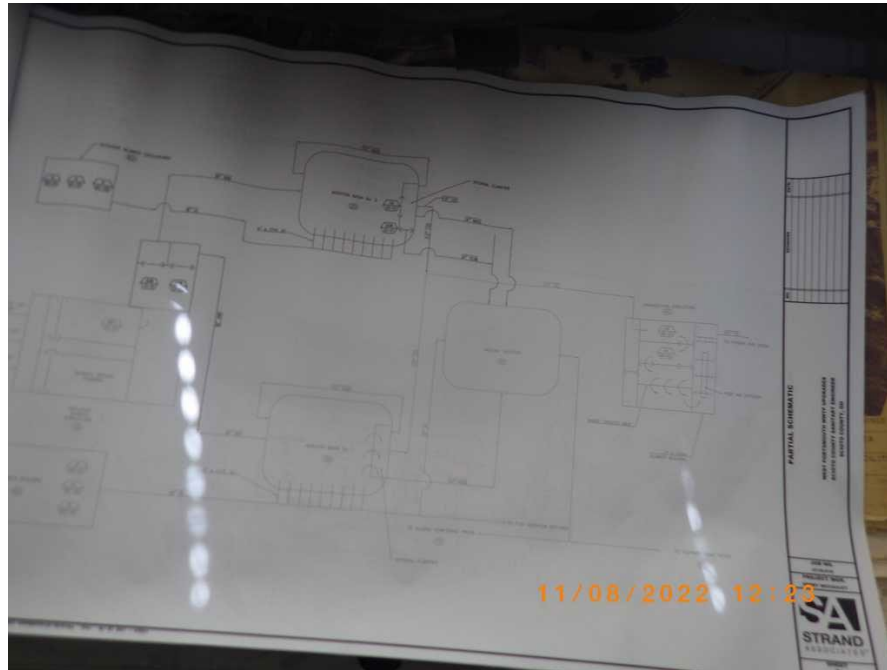
WWTP Schematic	RIMG2895.JPG	
11/08/2022 12:23 PM	Photographer: Andi Hodaj	
[Location/Area]	No CBI	No PII
Photo of the West Portsmouth WWTP schematic that includes both the old and the new WWTP.

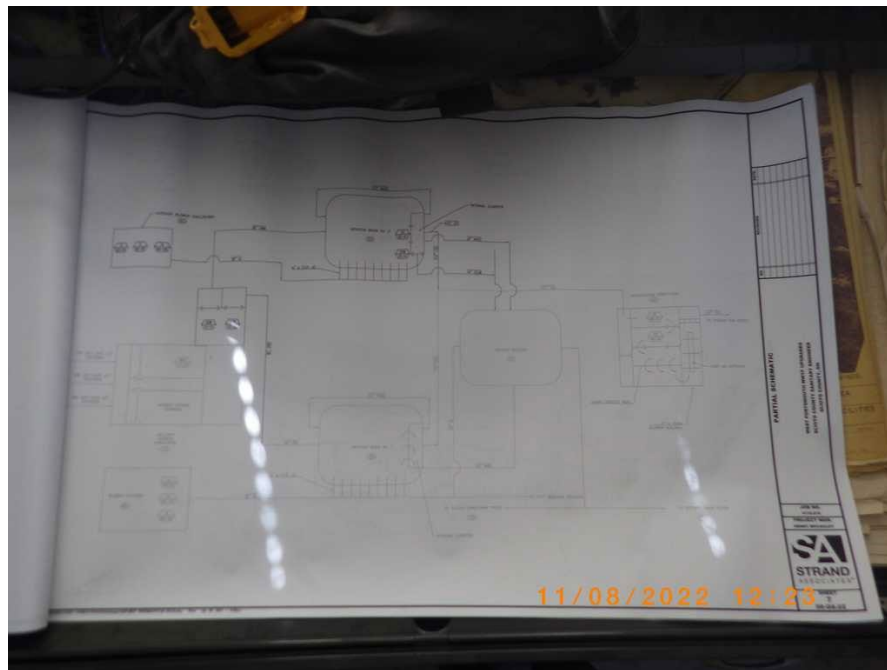
WWTP Schematic	RIMG2896.JPG	
11/08/2022 12:23 PM	Photographer: Andi Hodaj	
[Location/Area]	No CBI	No PII
Schematic of the new and old treatment plant.

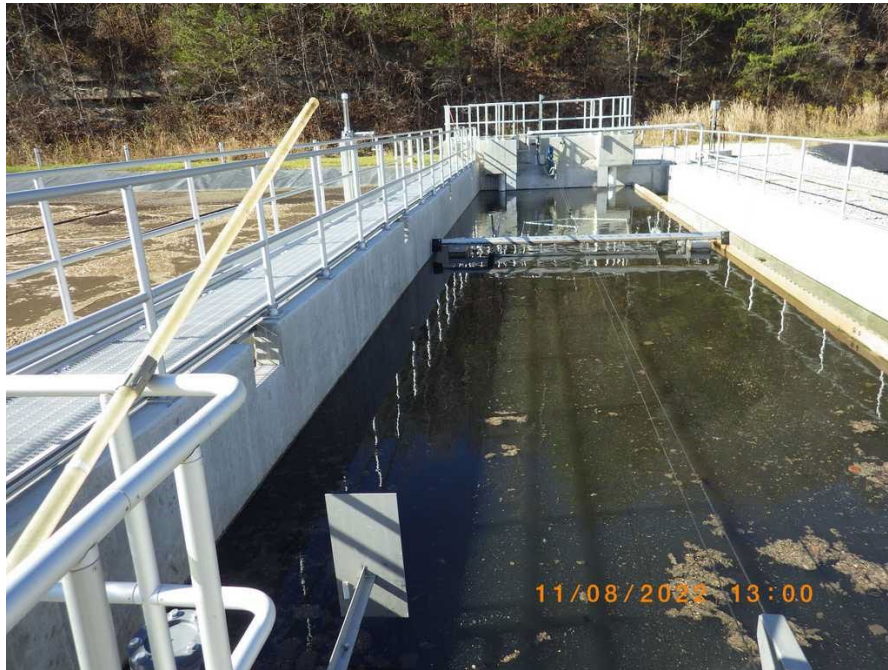
New clarifier	RIMG2906.JPG	
11/08/2022 01:00 PM	Photographer: Andi Hodaj	
[Location/Area]	No CBI	No PII
View of the new clarifier. Camera looking west.

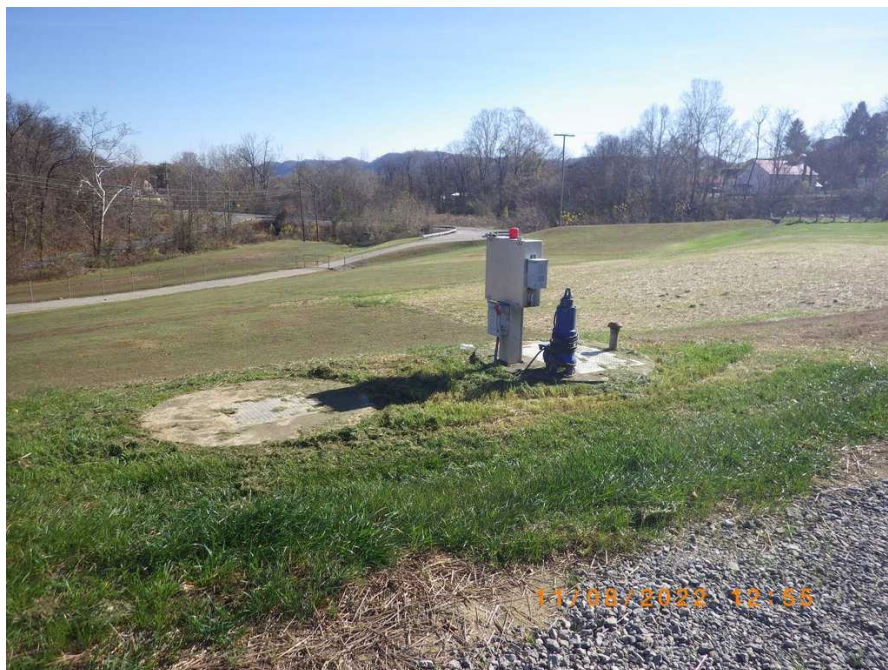
Pump station	RIMG2902.JPG	
11/08/2022 12:55 PM	Photographer: Andi Hodaj	
Digester	No CBI	No PII
Pump station and checkout pit. Camera looking southeast.

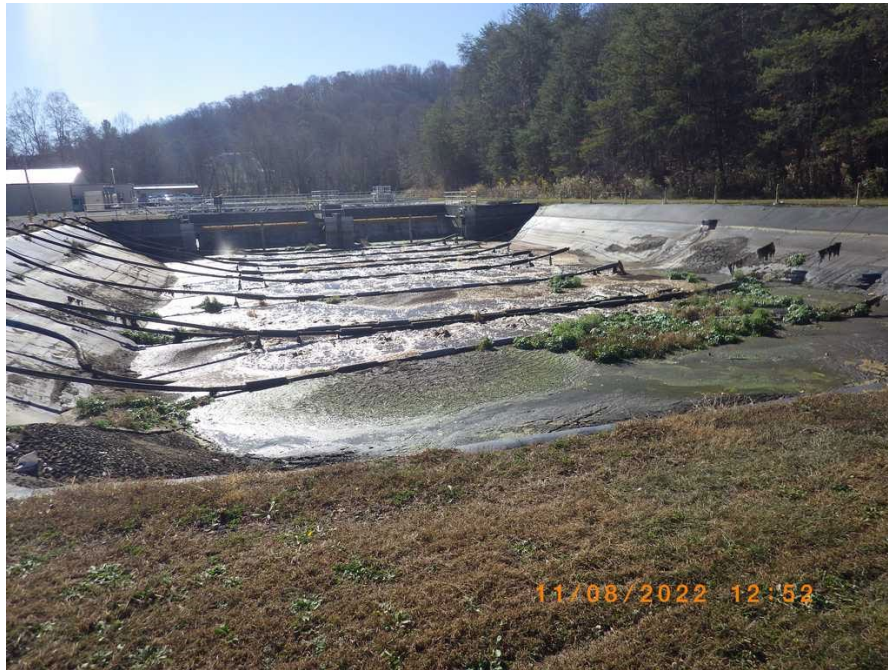
Old aeration tank	RIMG2901.JPG	
11/08/2022 12:52 PM	Photographer: Andi Hodaj	
Digester	No CBI	No PII
View of the old aeration tank. The pipe flowing in is the return flow from the clarifiers. Camera looking south.

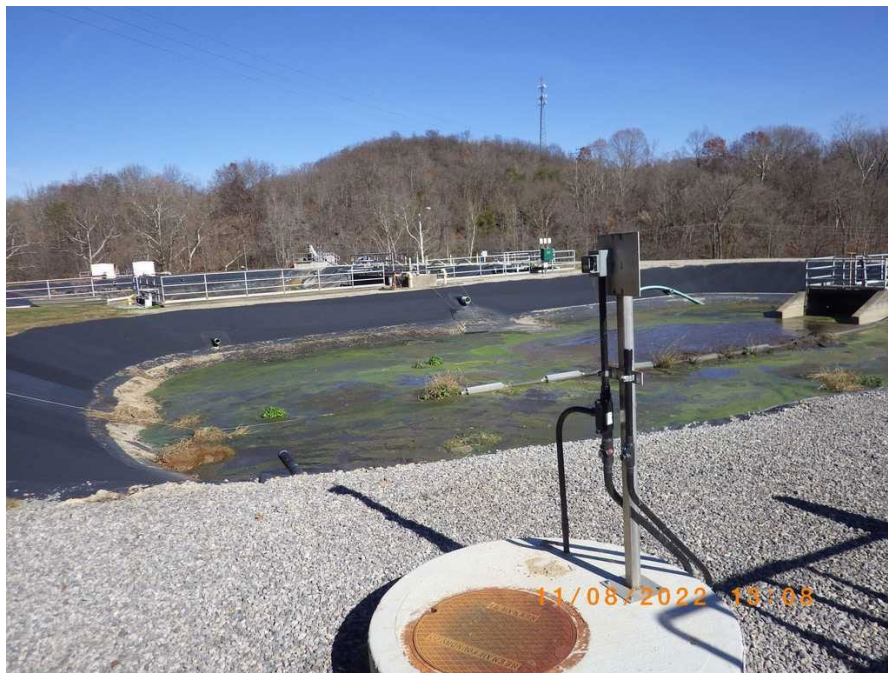
Aerobic digester	RIMG2912.JPG	
11/08/2022 01:08 PM	Photographer: Andi Hodaj	
Digester	No CBI	No PII
Aerobic digester and the valve pit that controls the flow from the clarifier. Camera looking northwest.

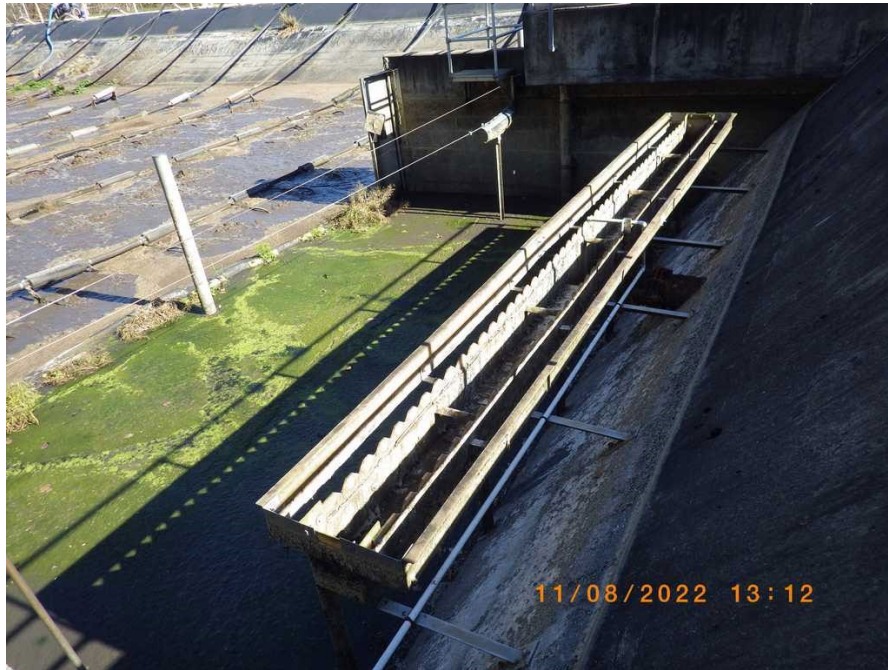
The USEPA inspectors observed Aeration Basin #1 that was currently being used as an aerobic digester during the time of the inspection. The digester's return flow was routed back into the process. The USEPA inspectors observed two built-in clarifiers in Aeration Basin #1 that were not operational at the time of inspection.

Old clarifier	RIMG2913.JPG	
11/08/2022 01:12 PM	Photographer: Andi Hodaj	
Digester	No CBI	No PII
The old clarifier next to the old aeration tank. The return flow pipe can be seen in the background. Camera looking west.

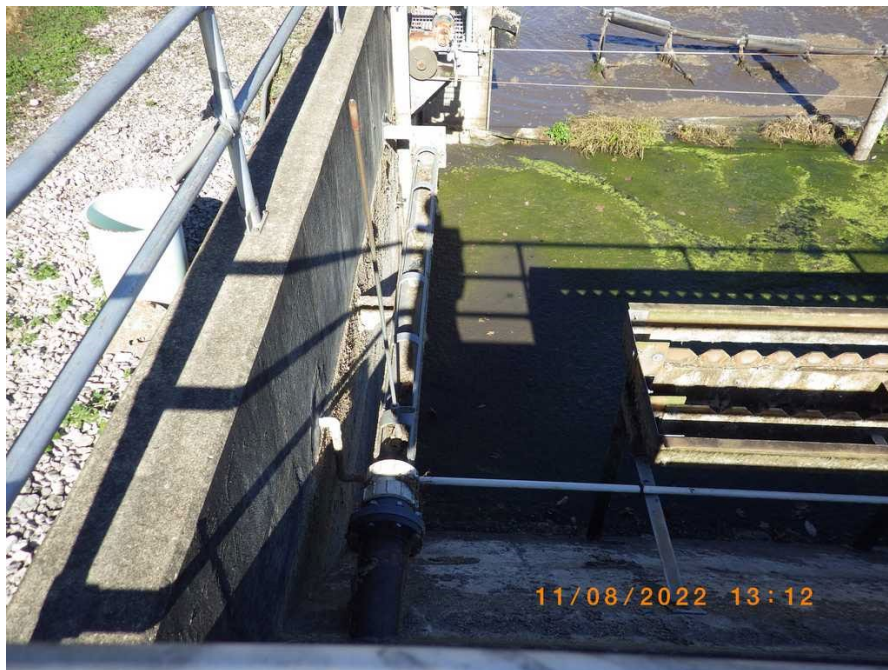
Skimmer	RIMG2914.JPG	
11/08/2022 01:12 PM	Photographer: Andi Hodaj	
Digester	No CBI	No PII
Skimmer in the old clarifier. Camera looking north.

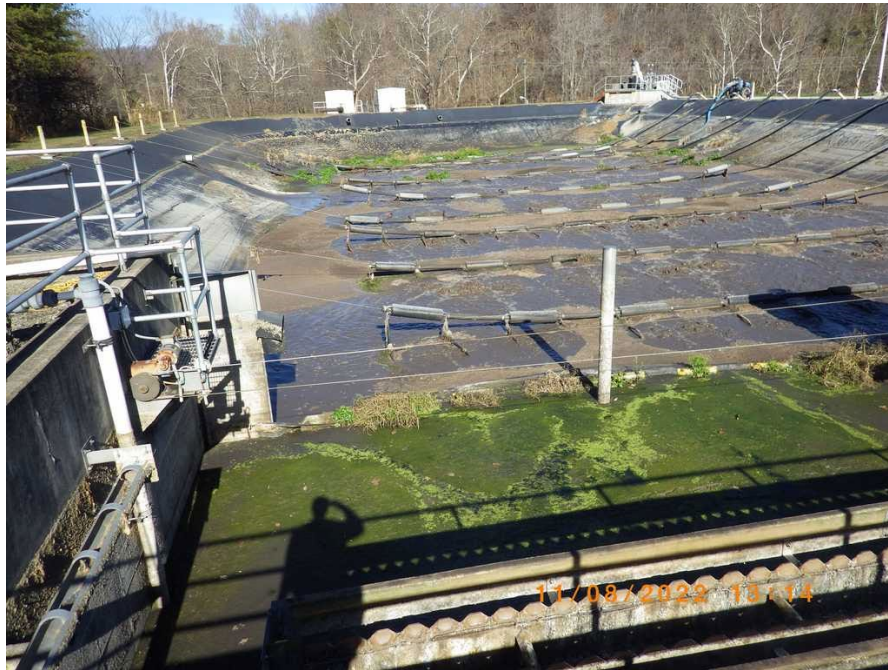
Old aeration tank	RIMG2915.JPG	
11/08/2022 01:14 PM	Photographer: Andi Hodaj	
Digester	No CBI	No PII
Overview of the old aeration tank with the aeration pipes in it. The old aeration tank was being used as an aerobic digester. Camera looking north.

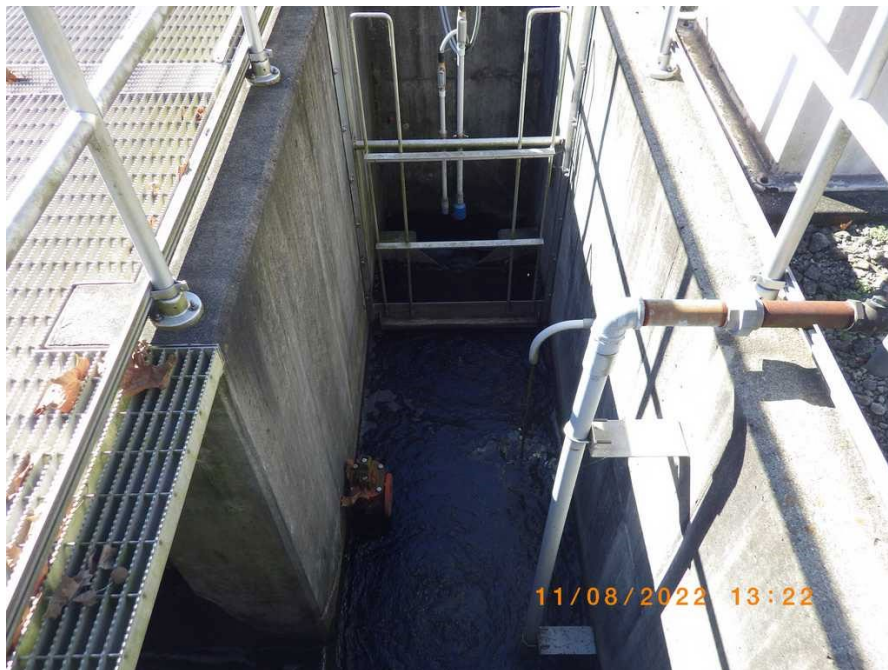
Final effluent	RIMG2918.JPG	
11/08/2022 01:22 PM	Photographer: Andi Hodaj	
Outfall 001	No CBI	No PII
Final effluent channel. The v-notch weir and depth sensor can be seen in it. Camera looking west.

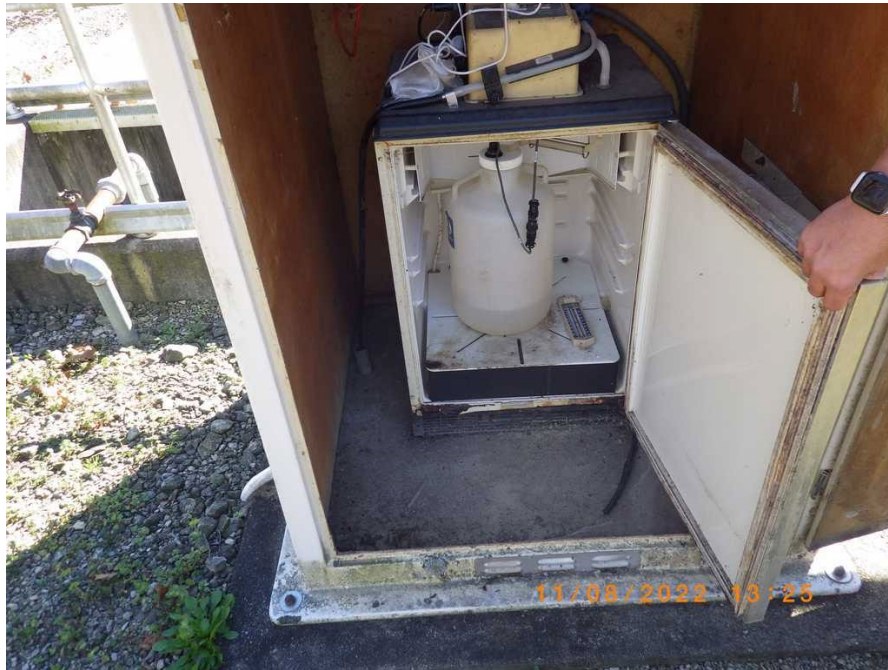
The USEPA inspectors observed a non-operational effluent autosampler at the time of the inspection. The thermometer inside the autosampler displayed 60 degrees Fahrenheit. Mr. Coleman confirmed the autosampler was not operational and grab samples were taken at the effluent instead. The USEPA inspectors observed Outfall #1 and the signage with the correct outfall number and facing the receiving stream.

Autosampler	RIMG2919.JPG	
11/08/2022 01:25 PM	Photographer: Andi Hodaj	
Outfall 001	No CBI	No PII
The autosampler at the final effluent. The bottle inside the autosampler had water in it but the operator stated that no sample was being taken that day. The thermometer in the autosampler was not working.

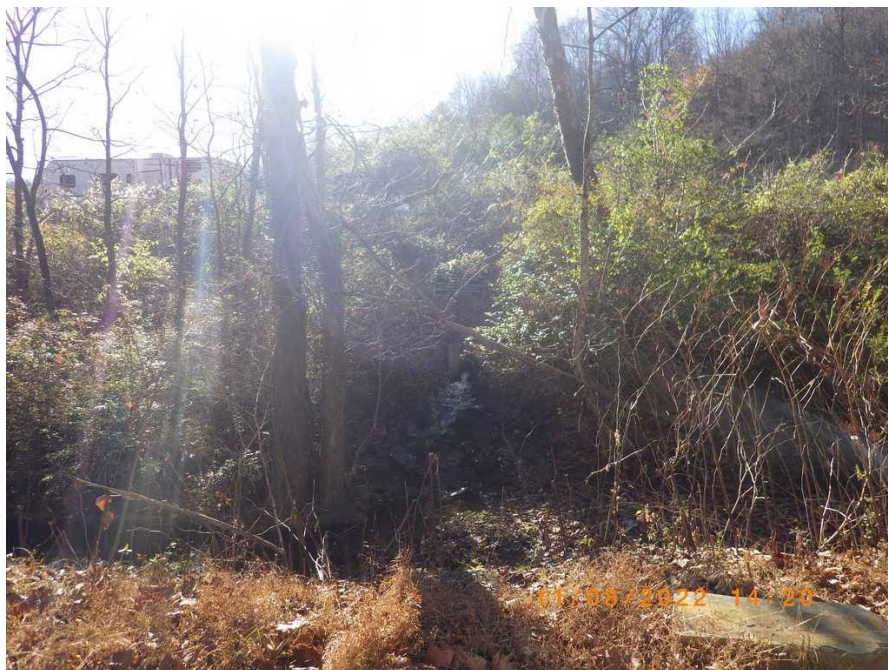
Outfall 001	RIMG2925.JPG	
11/08/2022 02:20 PM	Photographer: Andi Hodaj	
Outfall 001	No CBI	No PII
Outfall 001. Camera looking west.

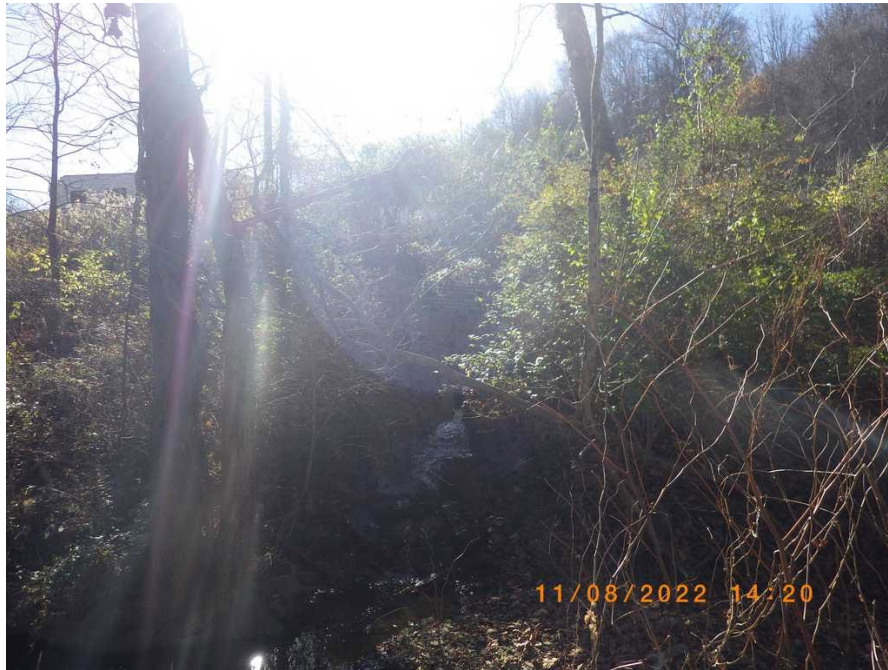
Outfall 001	RIMG2926.JPG	
11/08/2022 02:20 PM	Photographer: Danny Nguyen	
Outfall 001	No CBI	No PII
Outfall 001. Camera looking west.

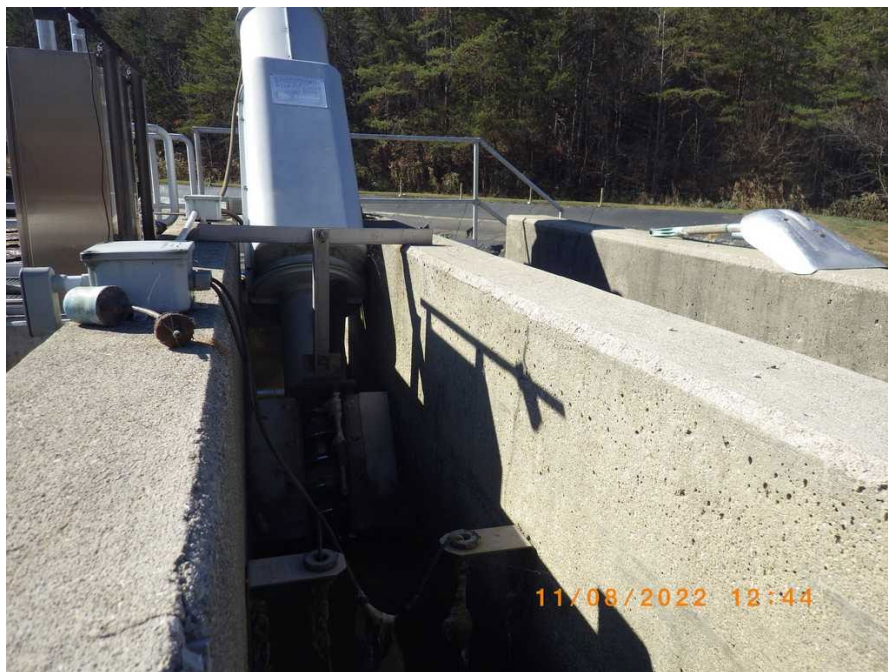
Spiral screen	RIMG2899.JPG	
11/08/2022 12:44 PM	Photographer: Andi Hodaj	
Primary Treatment	No CBI	No PII
Close-up view of the spiral screen at the headworks. Camera looking west.

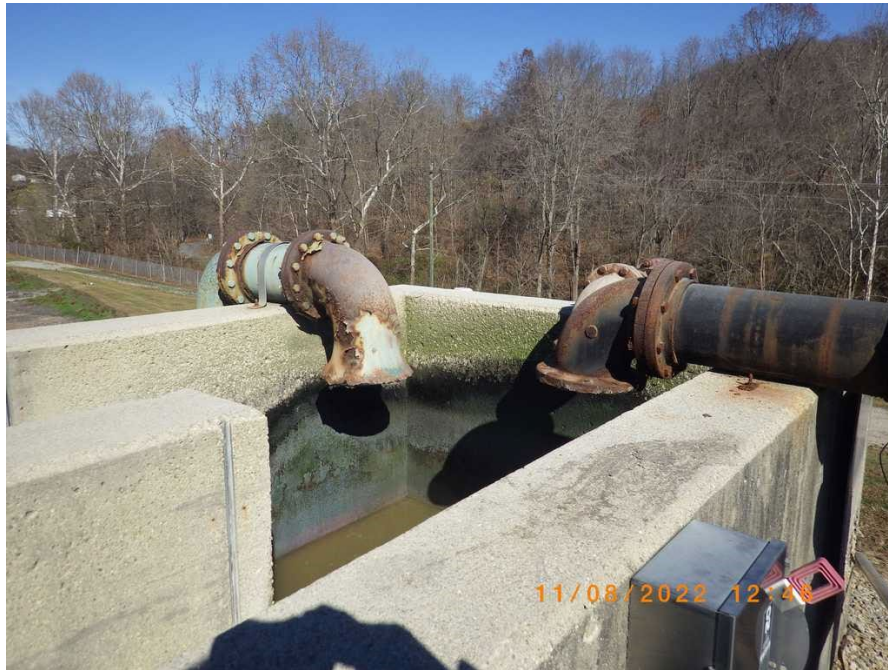
AOC Reference #: DN2-OB-001	Location: Primary Treatment
All three influent pipes were observed to be corroded.

Influent pipes	RIMG2900.JPG	
11/08/2022 12:46 PM	Photographer: Andi Hodaj	
Primary Treatment	No CBI	No PII
Three rusted influent pipes. Camera looking east.

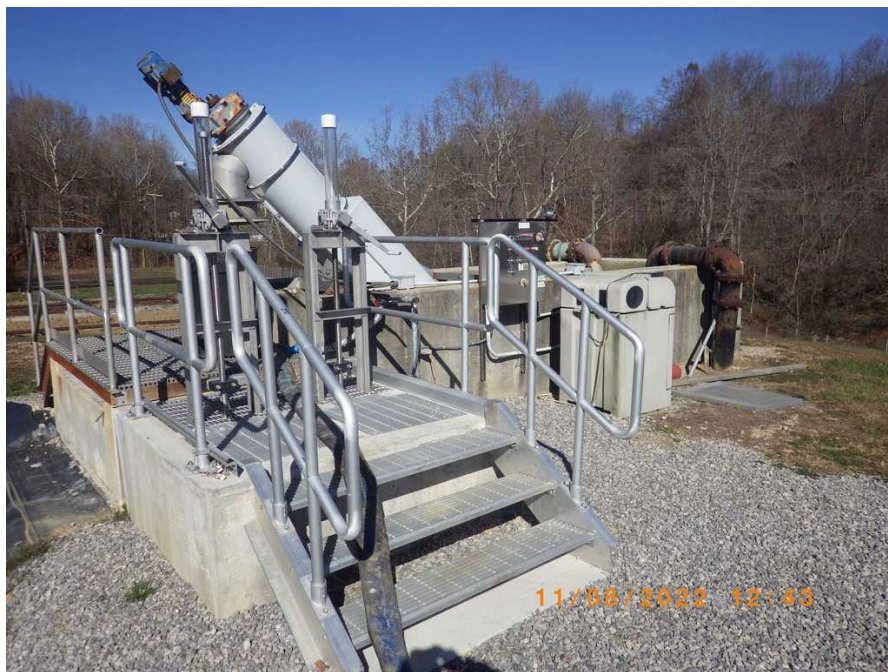
Headworks	RIMG2898.JPG	
11/08/2022 12:43 PM	Photographer: Andi Hodaj	
Primary Treatment	No CBI	No PII
Overview of the headworks. Camera looking northeast.

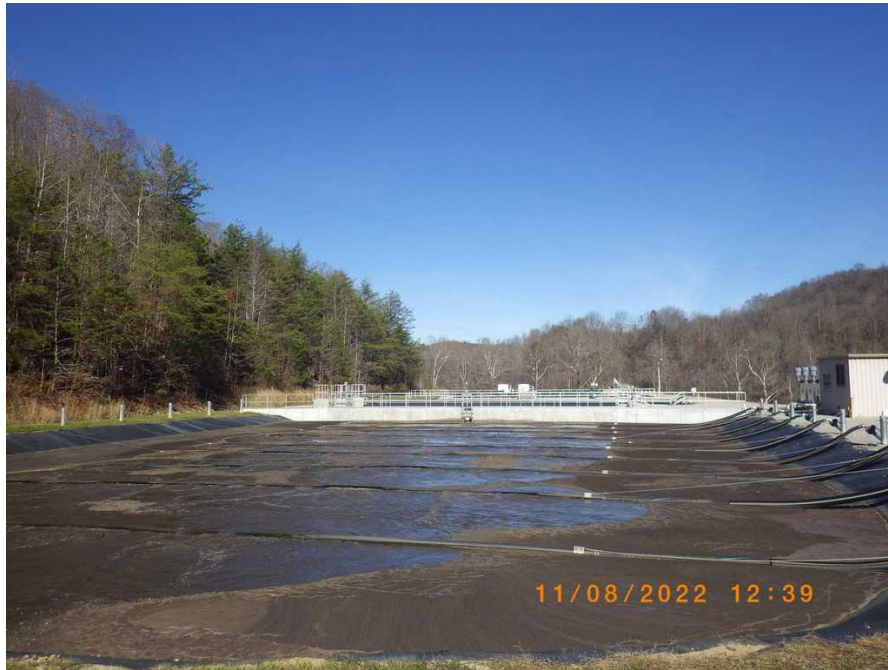
New aeration tank	RIMG2897.JPG	
11/08/2022 12:39 PM	Photographer: Andi Hodaj	
Secondary Treatment	No CBI	No PII
Overview of the new aeration tank. Camera looking north.

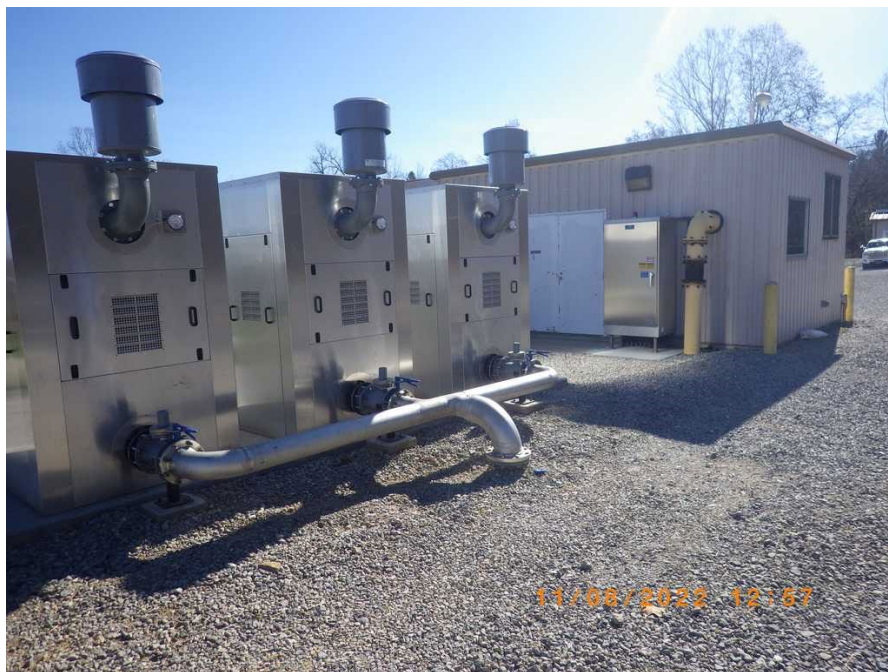
New Blowers	RIMG2903.JPG	
11/08/2022 12:57 PM	Photographer: Andi Hodaj	
Secondary Treatment	No CBI	No PII
New blowers and the blower building in the background. Camera looking south.

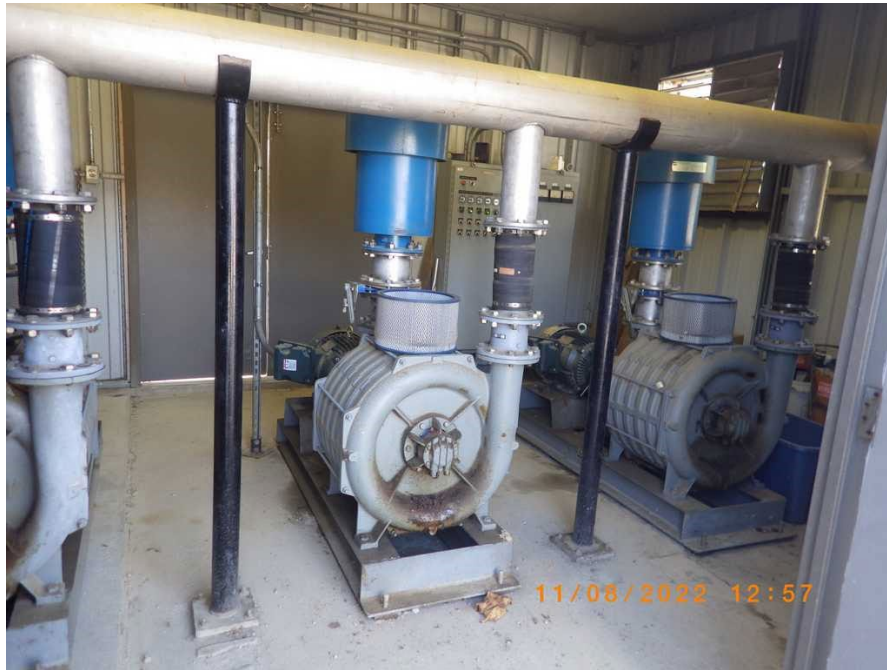
Old blowers	RIMG2904.JPG	
11/08/2022 12:57 PM	Photographer: Andi Hodaj	
Secondary Treatment	No CBI	No PII
Old blowers. Camera looking southwest.

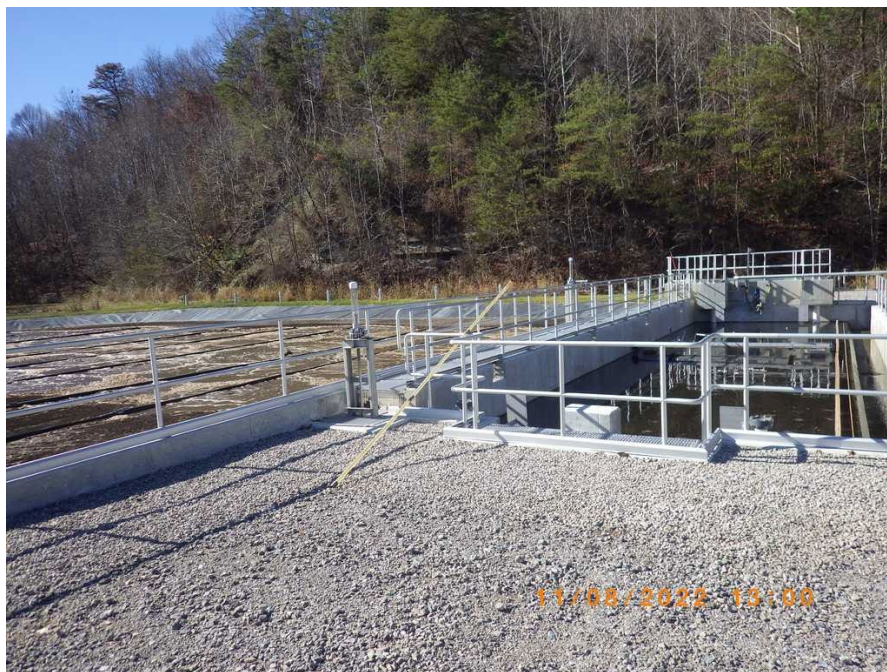
New Clarifier	RIMG2907.JPG	
11/08/2022 01:00 PM	Photographer: Andi Hodaj	
Secondary Treatment	No CBI	No PII
New clarifier next to the new aeration tank. Camera looking west.

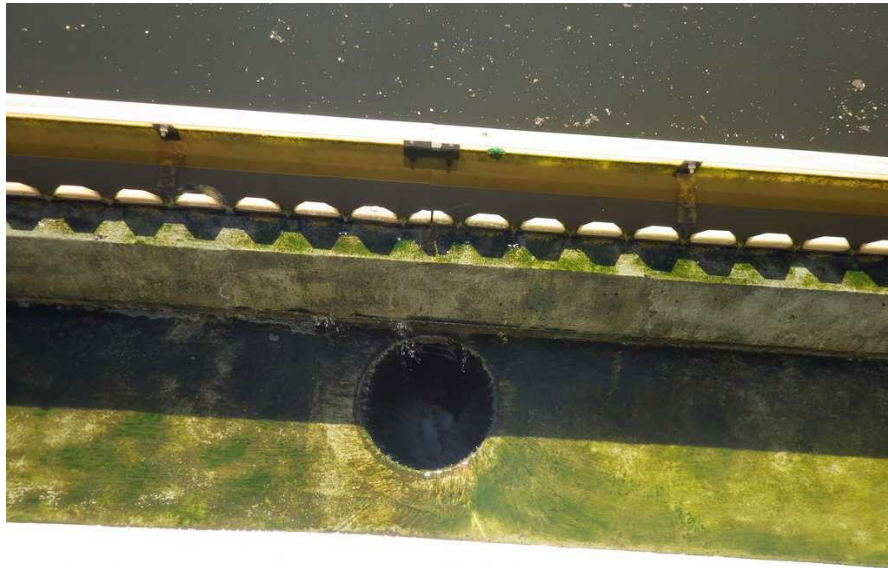
Clarifier effluent	RIMG2908.JPG	
11/08/2022 01:02 PM	Photographer: Andi Hodaj	
Secondary Treatment	No CBI	No PII
Effluent from the new clarifier.

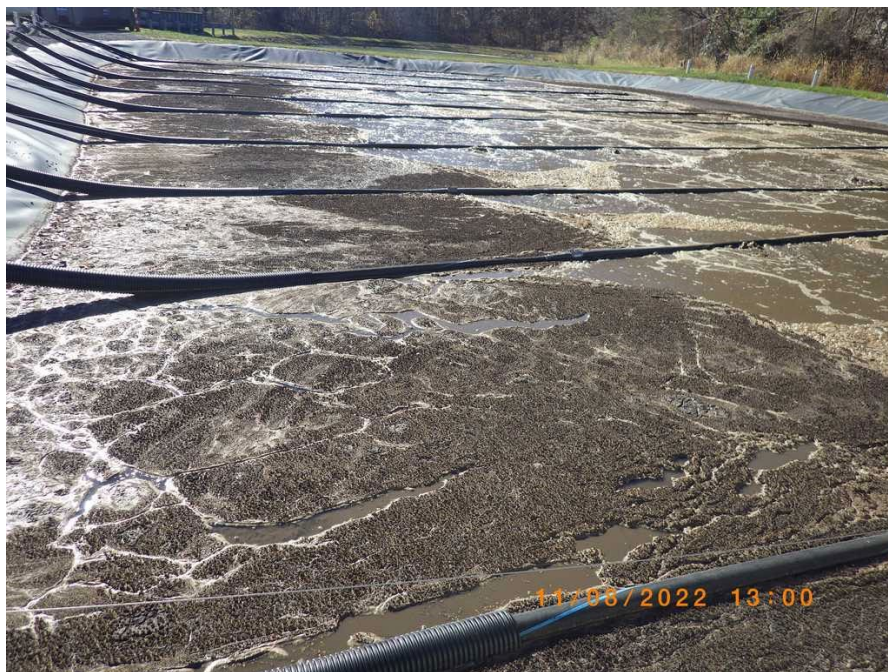
New aeration tank	RIMG2905.JPG	
11/08/2022 01:00 PM	Photographer: Andi Hodaj	
Secondary Treatment	No CBI	No PII
View of the new aeration tank. Camera looking west.

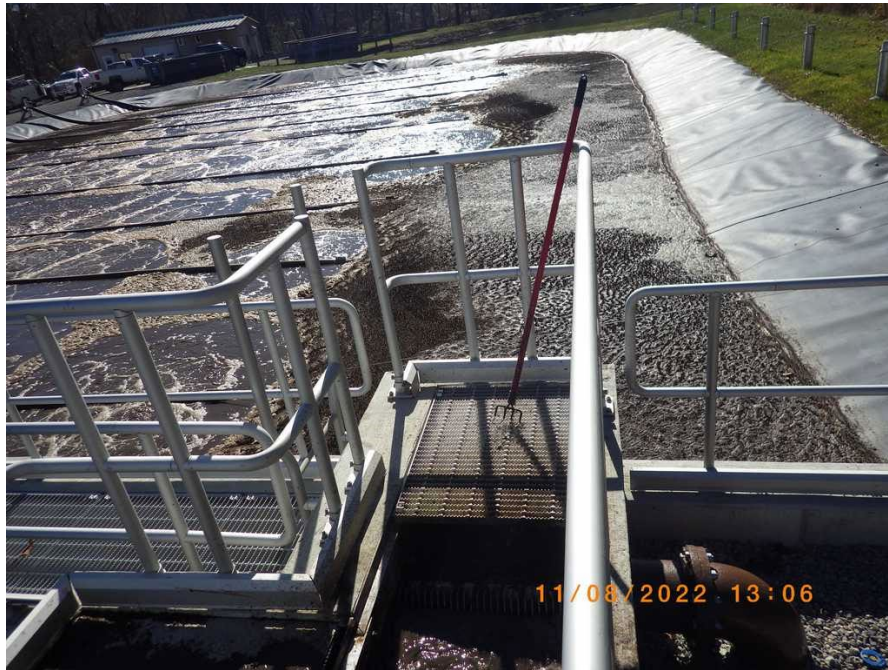
Return flow	RIMG2911.JPG	
11/08/2022 01:06 PM	Photographer: Andi Hodaj	
Secondary Treatment	No CBI	No PII
Return flow from the clarifier to the aeration basin at the east end of the clarifier. Camera looking south.

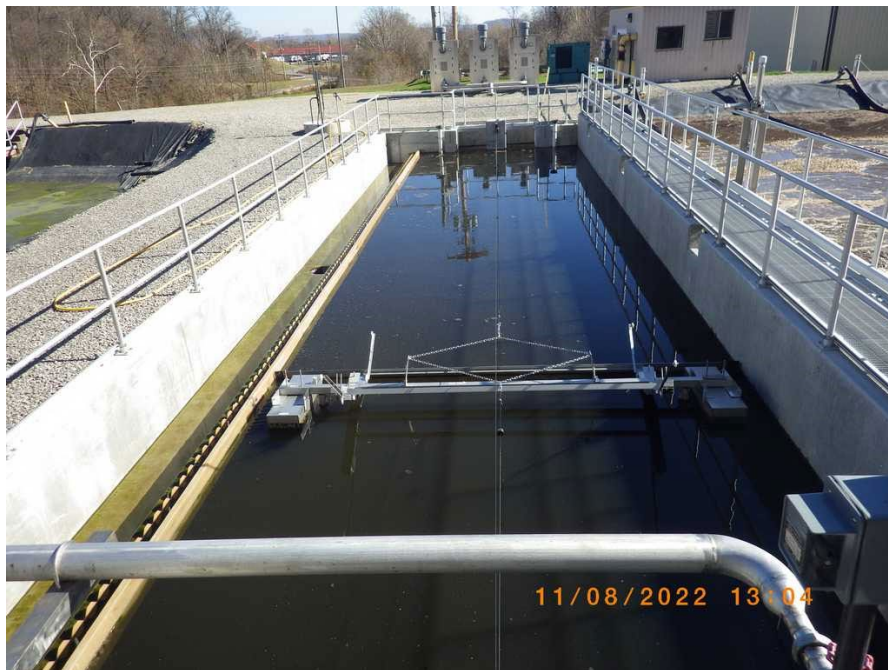
New clarifier	RIMG2910.JPG	
11/08/2022 01:04 PM	Photographer: Andi Hodaj	
Secondary Treatment	No CBI	No PII
New clarifier and the skimmer in it moving west. Camera looking west.

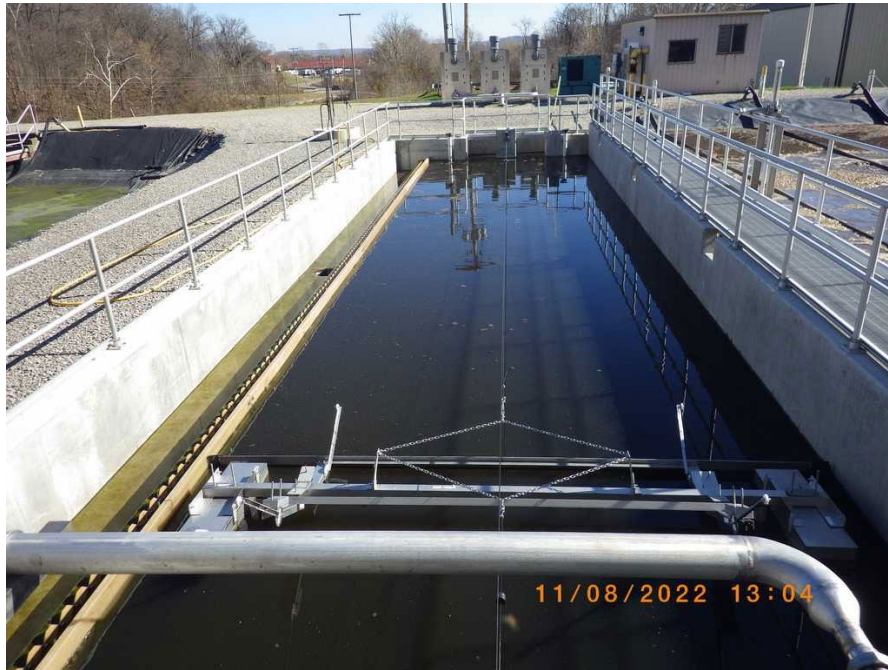
New clarifier	RIMG2909.JPG	
11/08/2022 01:04 PM	Photographer: Andi Hodaj	
Secondary Treatment	No CBI	No PII
New clarifier and the skimmer in it moving west. Camera looking west.

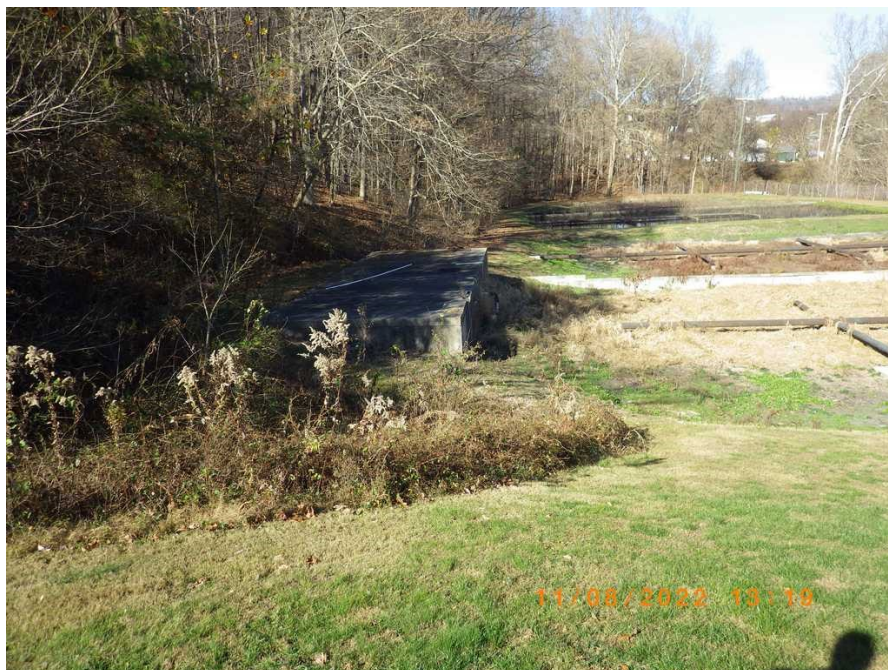
Dosage tanks	RIMG2917.JPG	
11/08/2022 01:19 PM	Photographer: Andi Hodaj	
Secondary Treatment	No CBI	No PII
Dosage tank splits the flow from the aeration tank to the sand filters. Camera looking north.

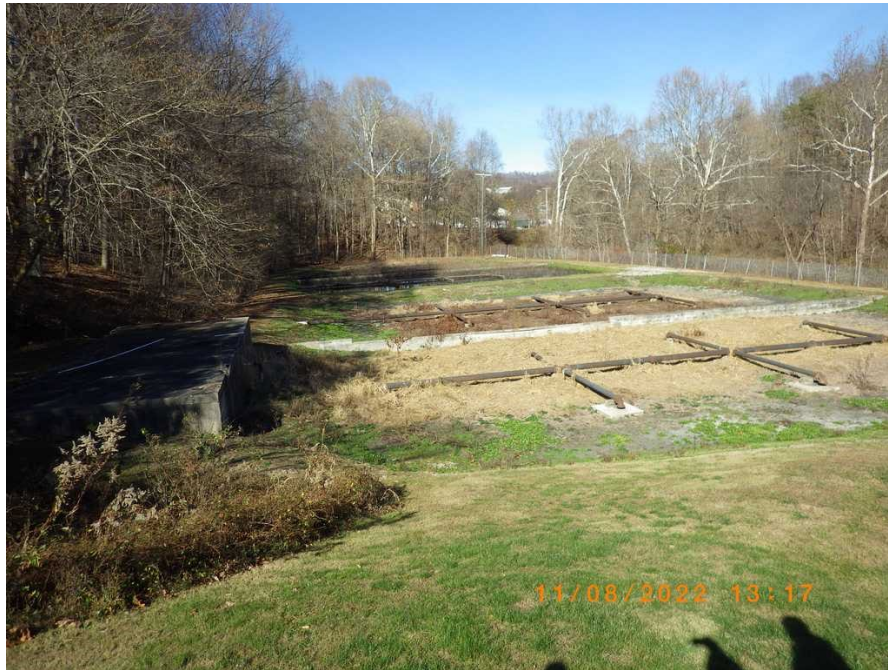
Sand filters	RIMG2916.JPG	
11/08/2022 01:17 PM	Photographer: Andi Hodaj	
Secondary Treatment	No CBI	No PII
Four sand filters. The first two in the photo had sludge in them and the third one was the only one being used. Camera looking north.

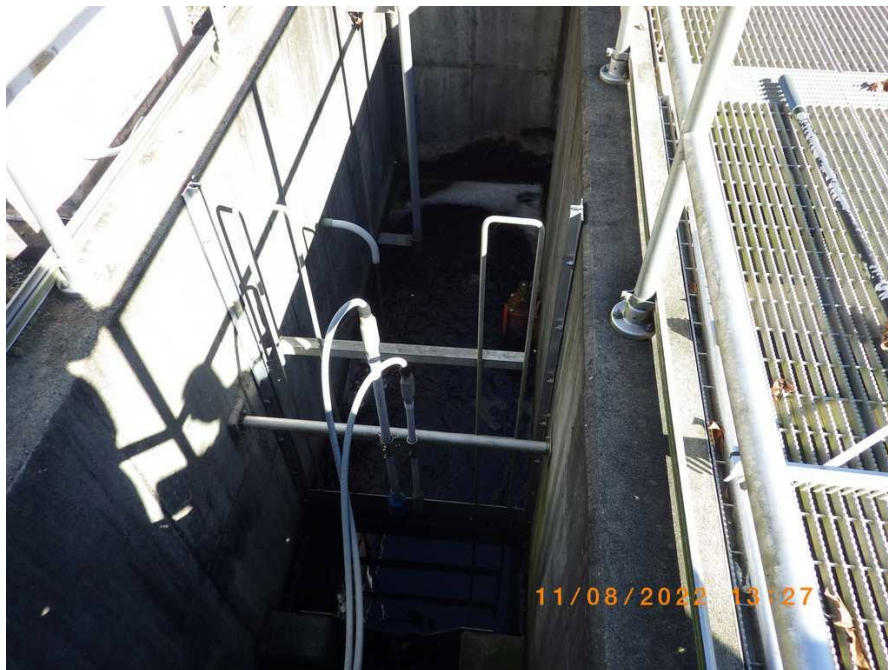
Post-aeration tank	RIMG2920.JPG	
11/08/2022 01:27 PM	Photographer: Andi Hodaj	
Secondary Treatment	No CBI	No PII
Post aeration tank and the flow meter at final tank. Camera looking east.

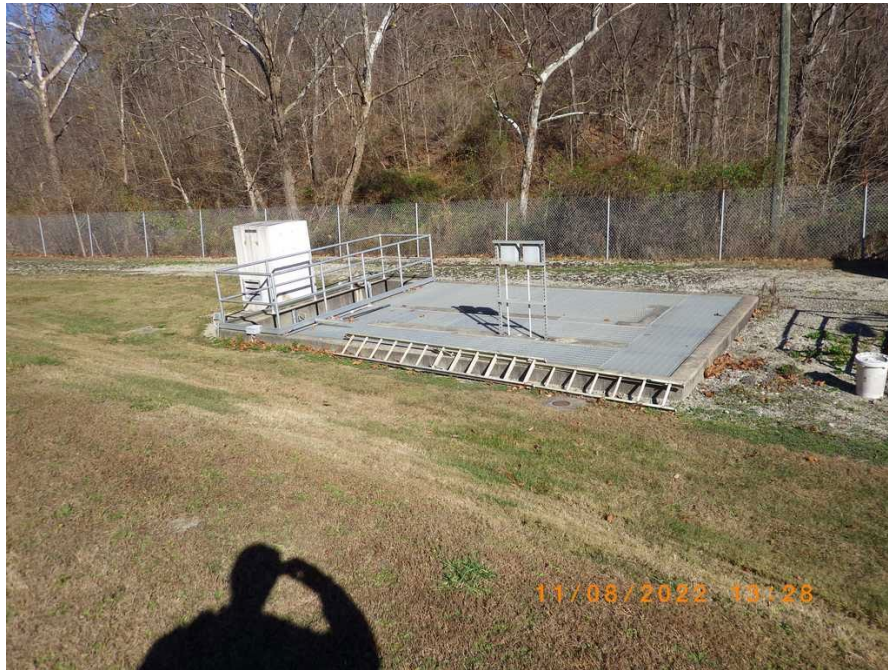
Final tank	RIMG2921.JPG	
11/08/2022 01:28 PM	Photographer: Andi Hodaj	
Secondary Treatment	No CBI	No PII
Overview of the final tank. Camera looking northeast.

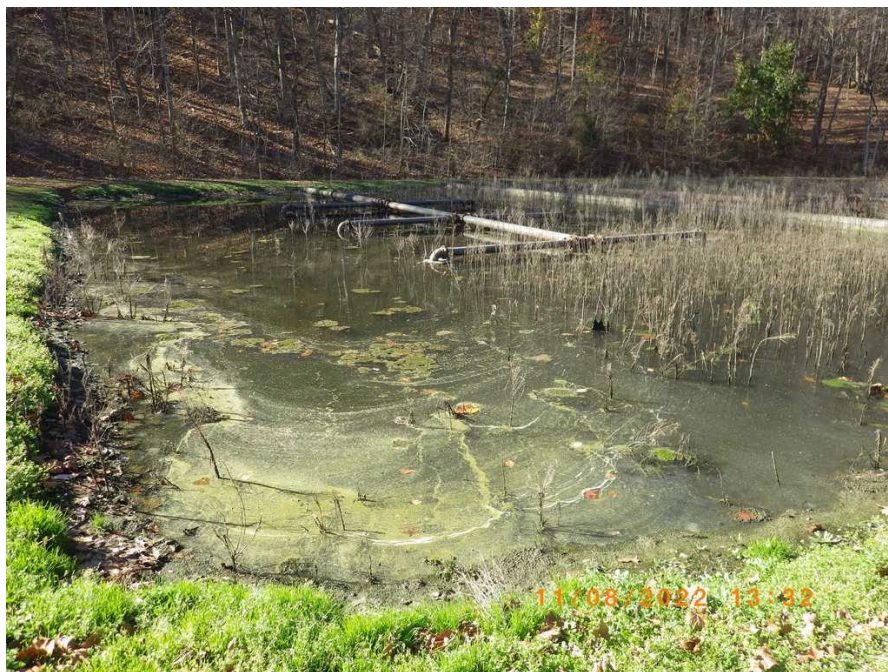
Sand filters	RIMG2922.JPG	
11/08/2022 01:32 PM	Photographer: Andi Hodaj	
Secondary Treatment	No CBI	No PII
Sand filters 3 and 4. Camera looking west.

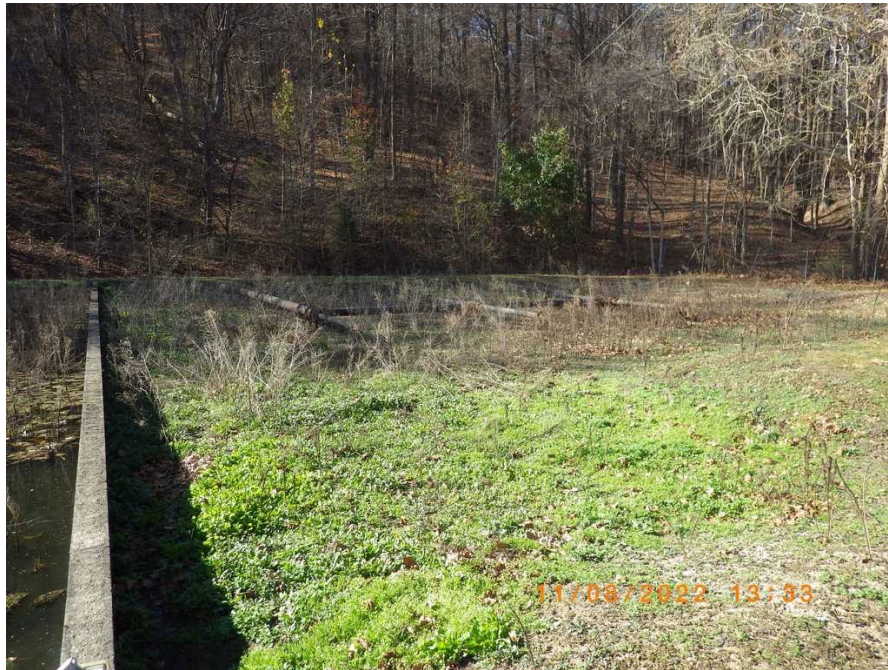
Sand filters	RIMG2923.JPG	
11/08/2022 01:33 PM	Photographer: Andi Hodaj	
Secondary Treatment	No CBI	No PII
Sand filters 3 and 4. Camera looking west.
