**INSPECTION REPORT**

| <b>Type of inspection:</b> | CEI - Compliance Evaluation Inspection | |
| <b>Facility or Site Name:</b> | Village of Bettsville WWTP | |
| <b>Permit Number:</b> | OH0058211 | |

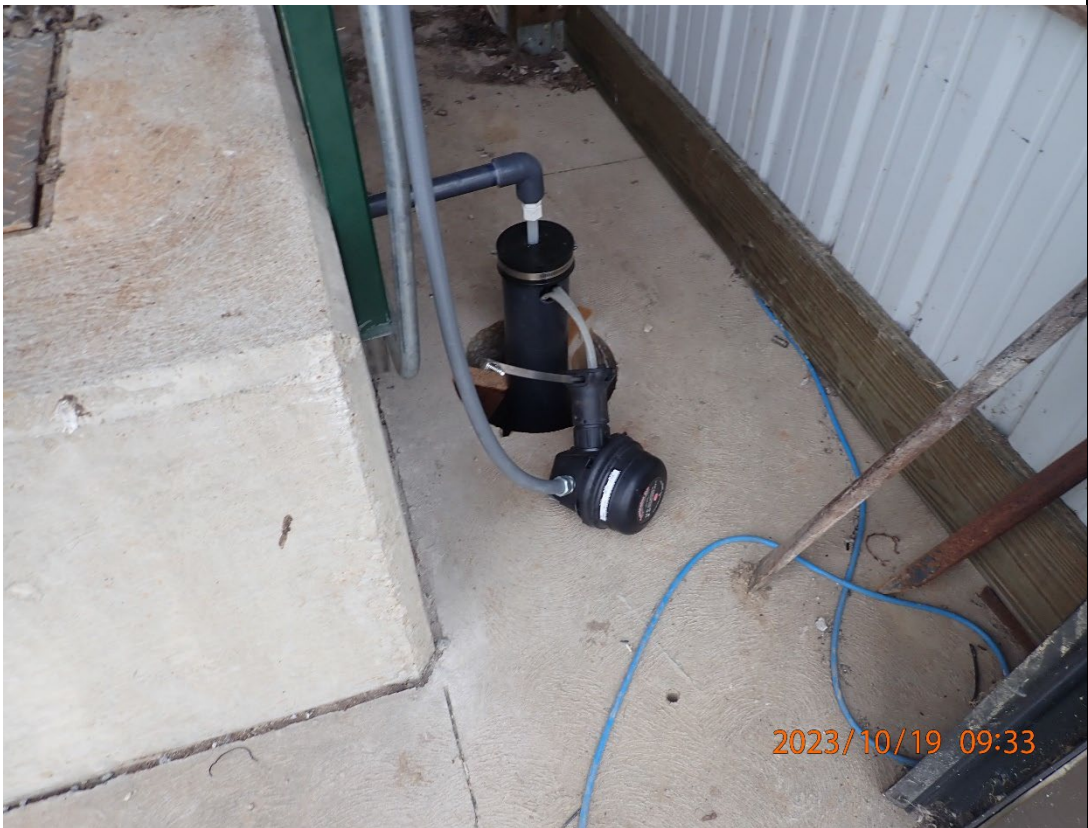
| <b>Photo No.: 1</b> | <b>Time:</b><br>9:33 a.m. | | |

| <b>Photo Description:</b><br>Alum addition point for sewage treatment. | | | |

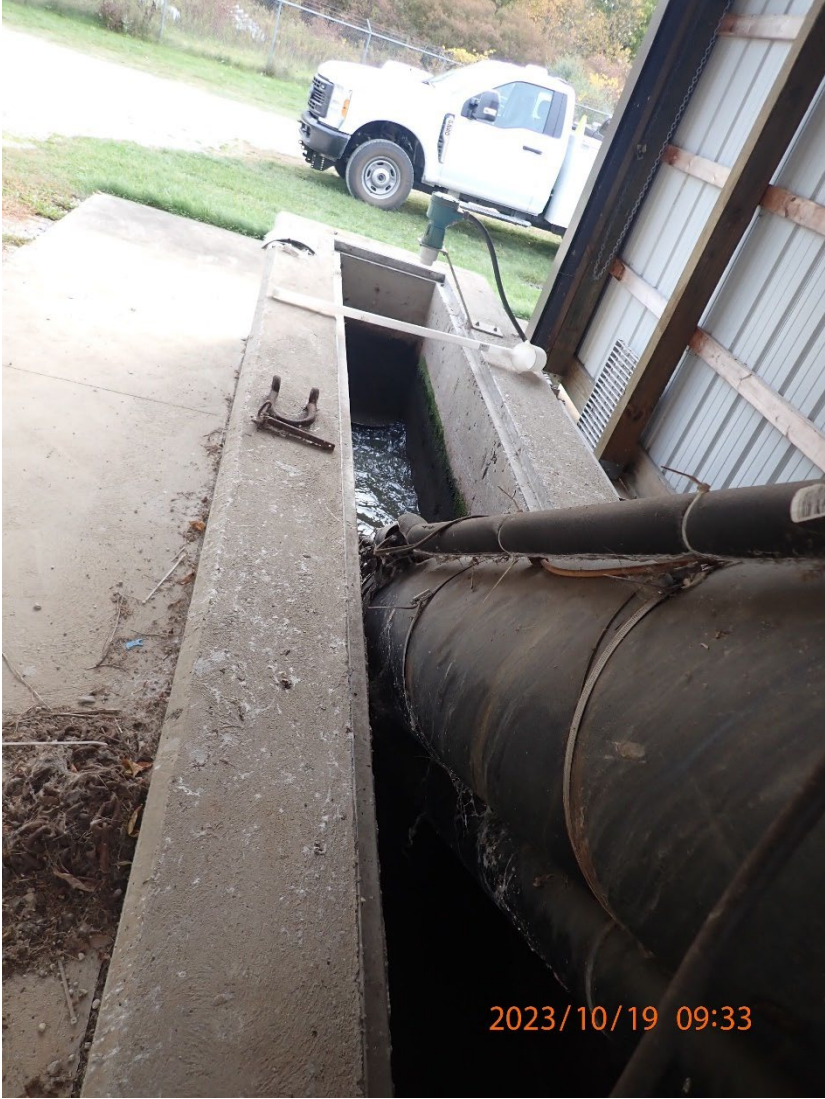
| <b>Photo No.: 2</b> | <b>Time:</b><br>9:33 a.m. | | |

| <b>Photo Description:</b><br>Screening of sewage influent. | | | |

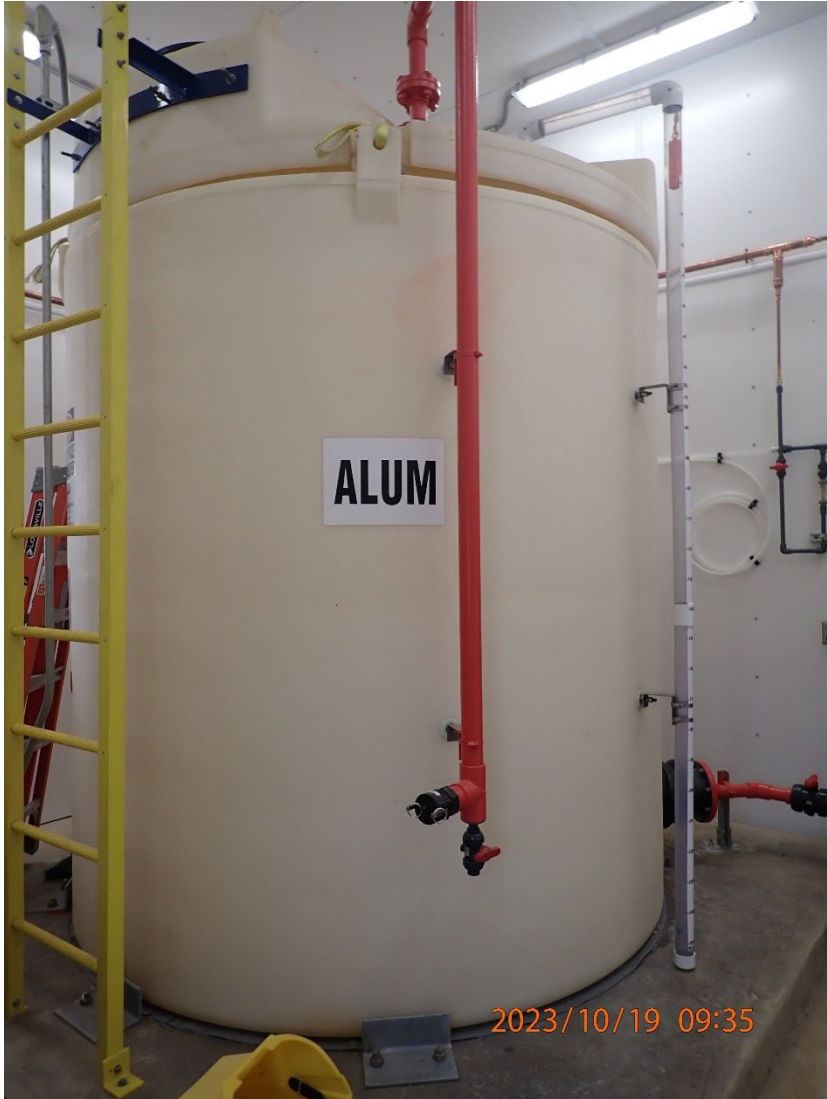
| <b>Photo No.:</b> 3 | <b>Time:</b><br>9:35 a.m. | | |

| <b>Photo Description:</b><br>Alum holding tank. | | | |

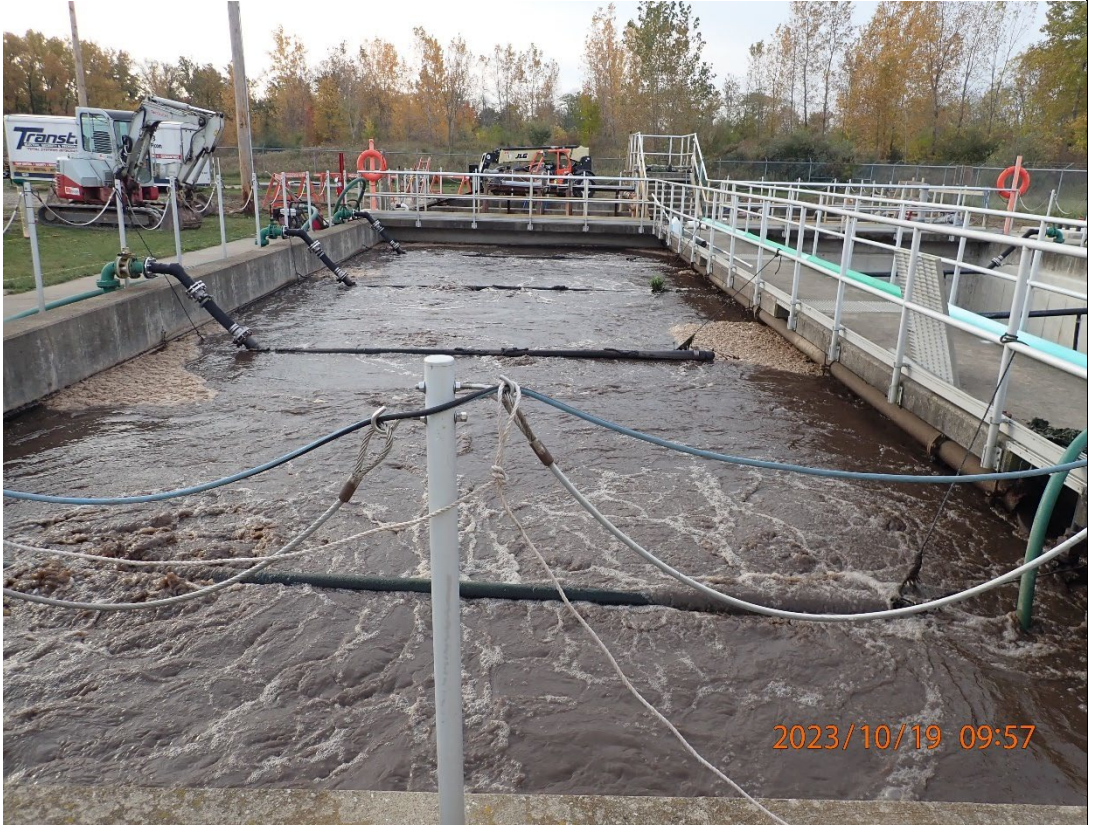
| <b>Photo No.:</b> 4 | <b>Time:</b><br>9:57 a.m. | | |

| <b>Photo Description:</b><br>Aeration Basin (east). | | | |

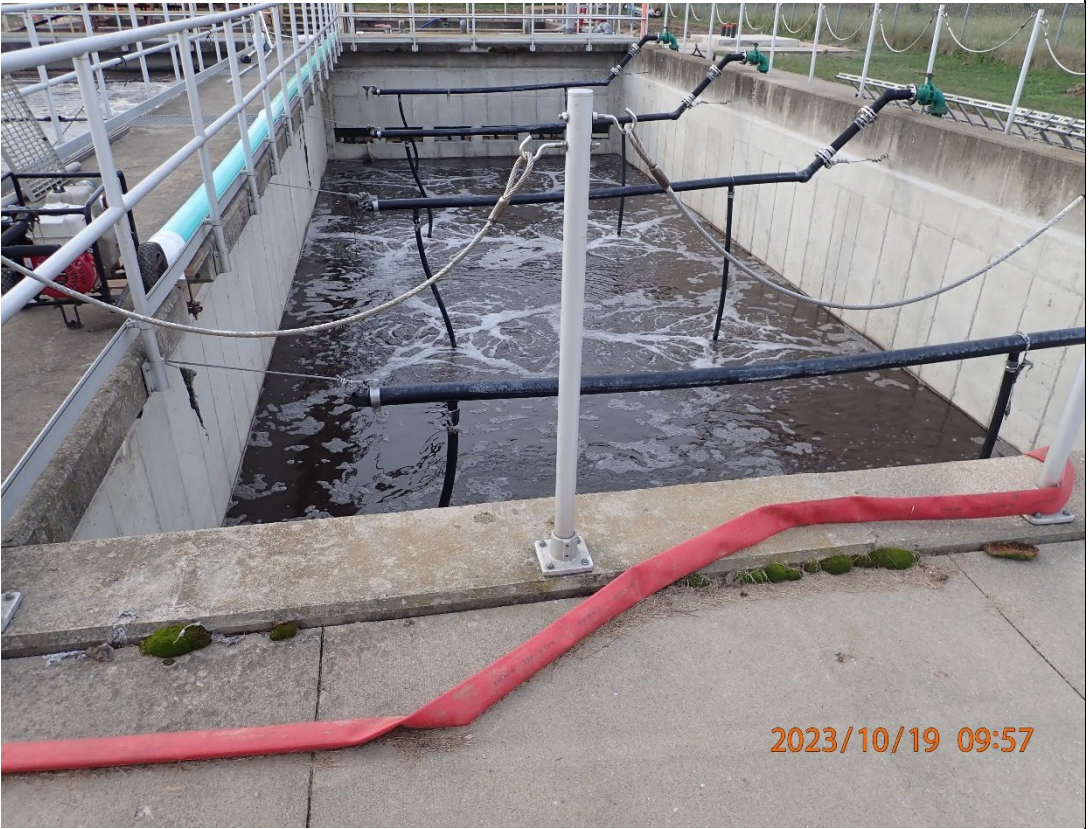
| <b>Photo No.:</b> 5 | <b>Time:</b><br>9:57 a.m. | | |

| <b>Unique Identifying No.</b> | <b>Observation</b> | <b>Area of Concern?</b> |
|---|---|---|
| <b>MS-OB-003</b> | The Facility is currently in the middle of upgrading their plant to address their effluent exceedances. Current projects are expected to be completed in January 2024 (See photos: 5, 7, and 9). | No |

| <b>Photo Description:</b><br>Aeration basin (west). | | | |

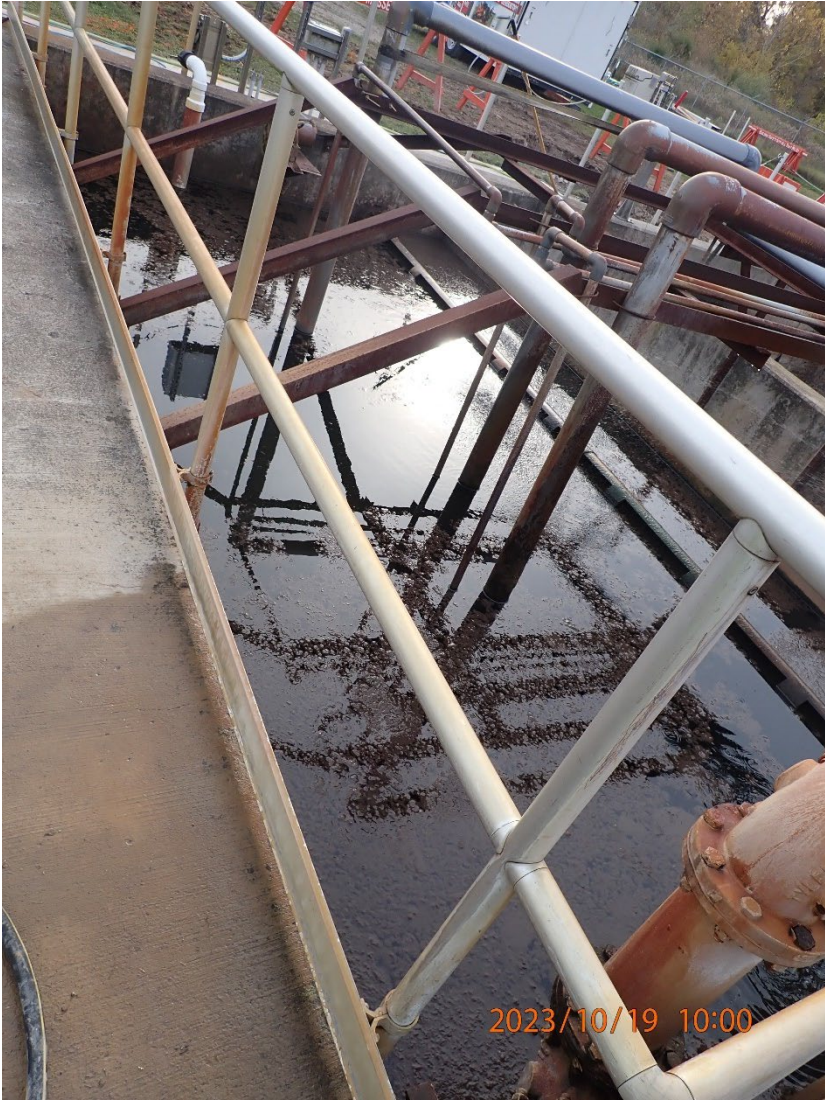
| <b>Photo No.:</b> 6 | <b>Time:</b><br>10:00 a.m. | | |

| <b>Photo Description:</b><br>Clarifier following<br>aeration basin (east). | | | |

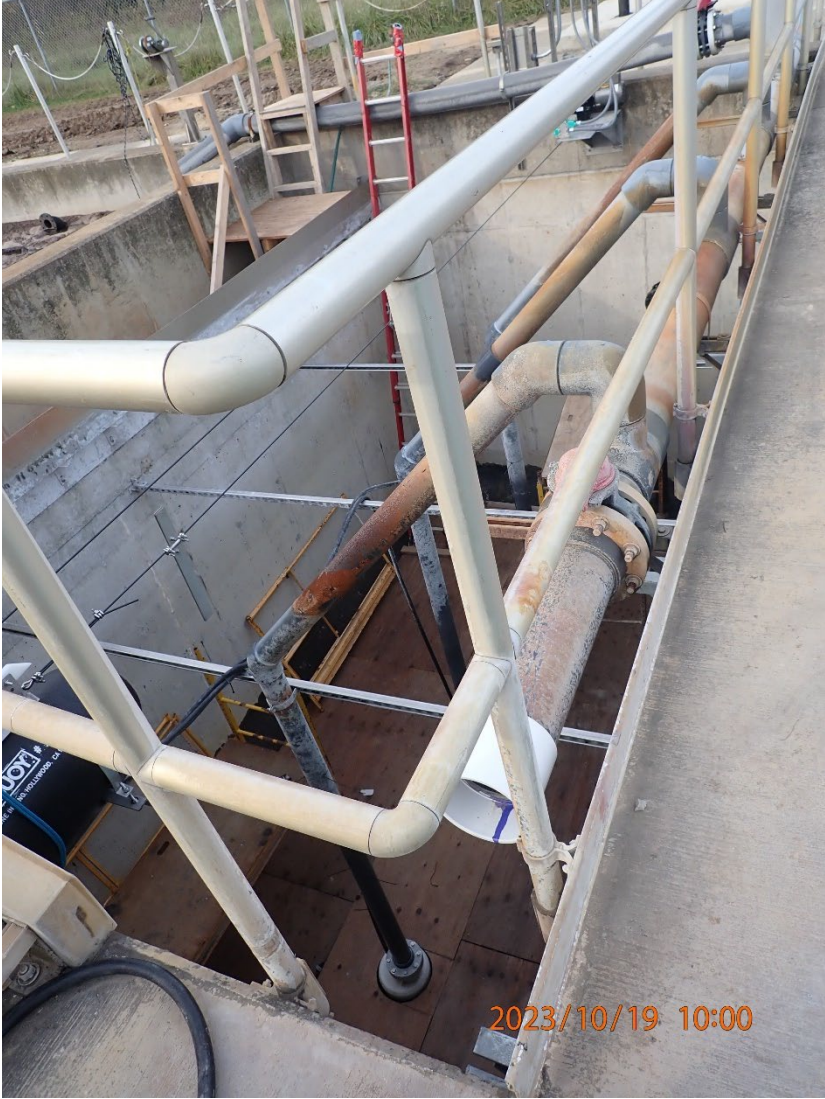
| <b>Photo No.:</b> 7 | <b>Time:</b><br>10:00 a.m. | | |

| <b>Photo Description:</b><br>Clarifier basin (west) currently under maintenance. | | | |

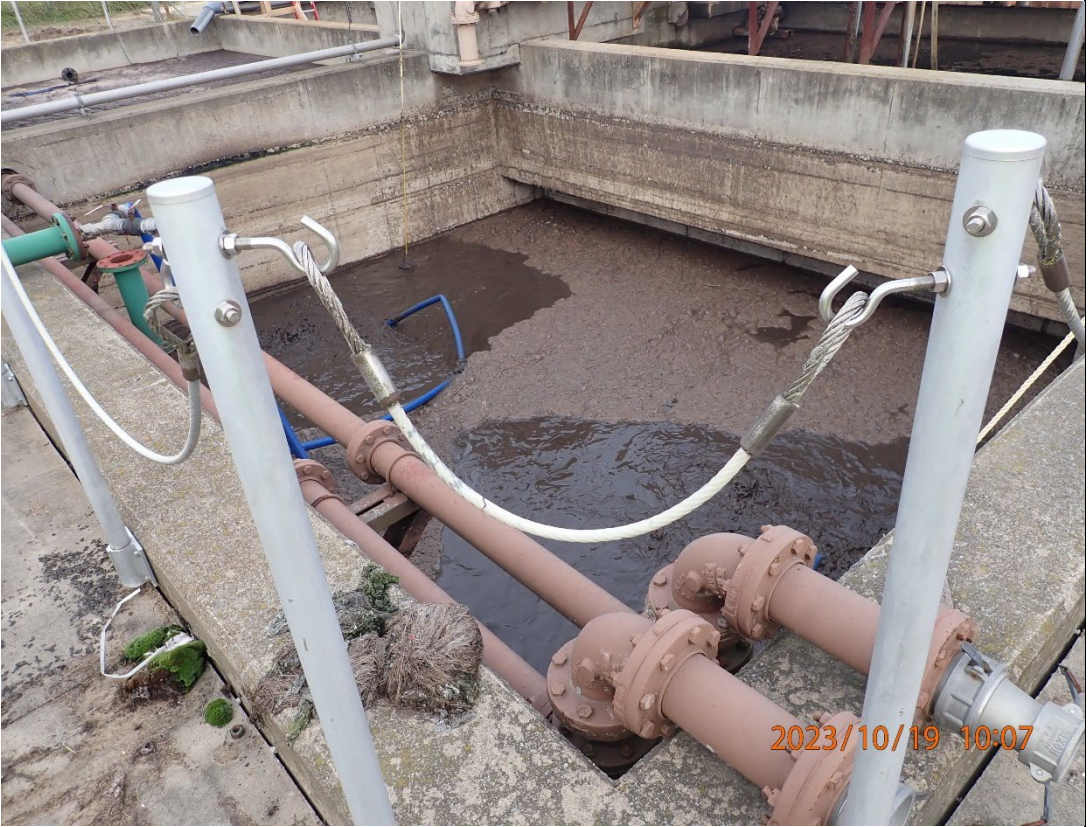
| <b>Photo No.:</b> 8 | <b>Time:</b><br>10:07 a.m. | | |

| <b>Photo Description:</b><br>Digester basin (east). | | | |

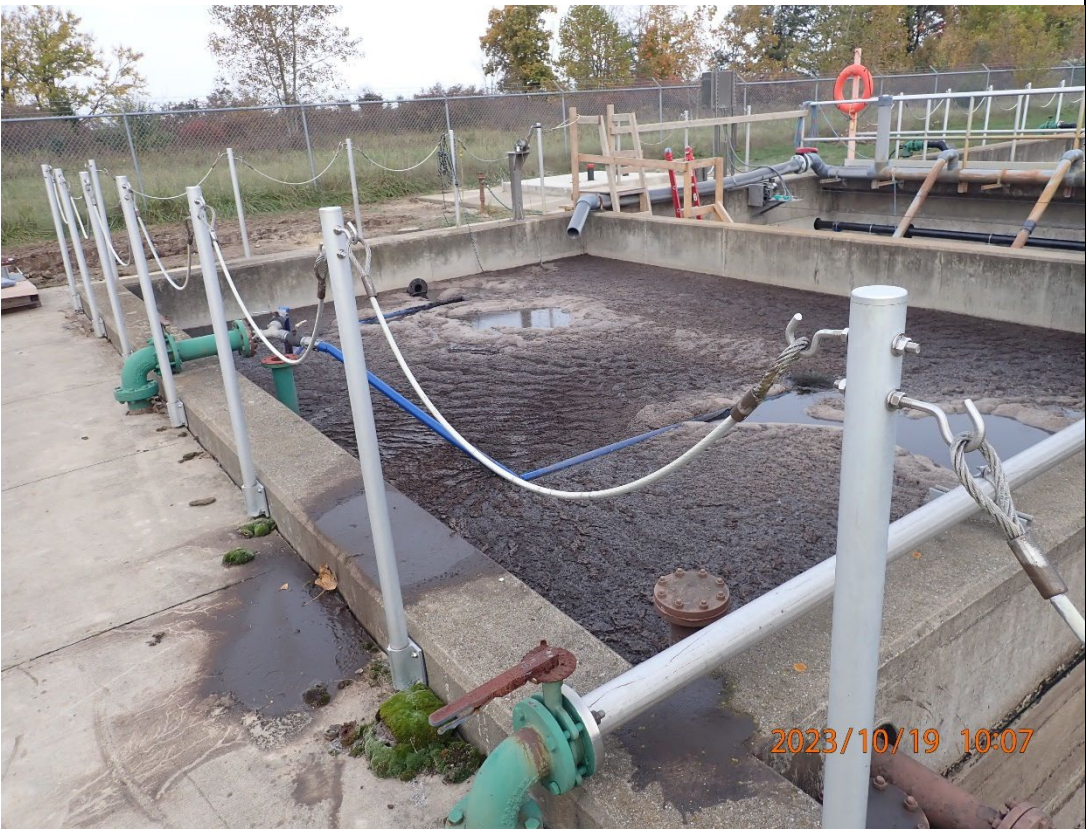
| <b>Photo Description:</b><br>Digester basin (west) currently not operating. Material directed to other digester basin for settling and treatment. | | | |

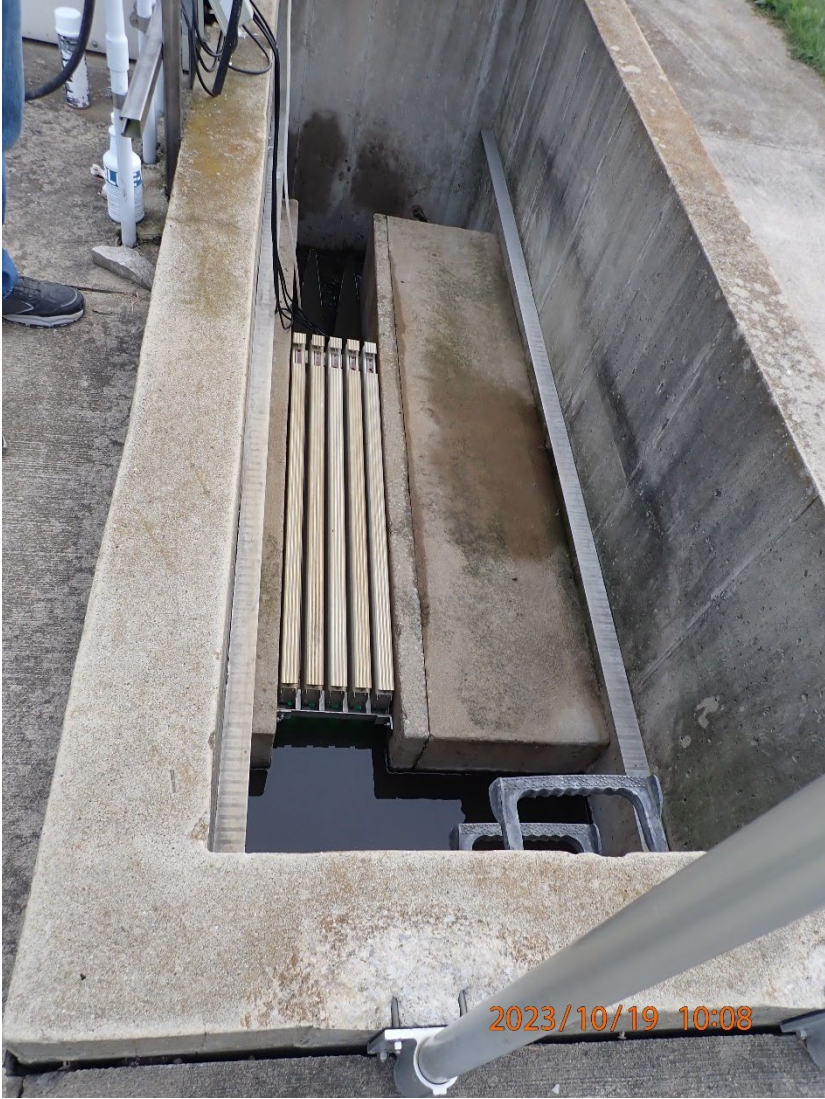
| <b>Photo No.: 10</b> | <b>Time:</b><br>10:08 a.m. | | |

| <b>Photo Description:</b><br>UV lights after digester prior to polishing basin. | | | |

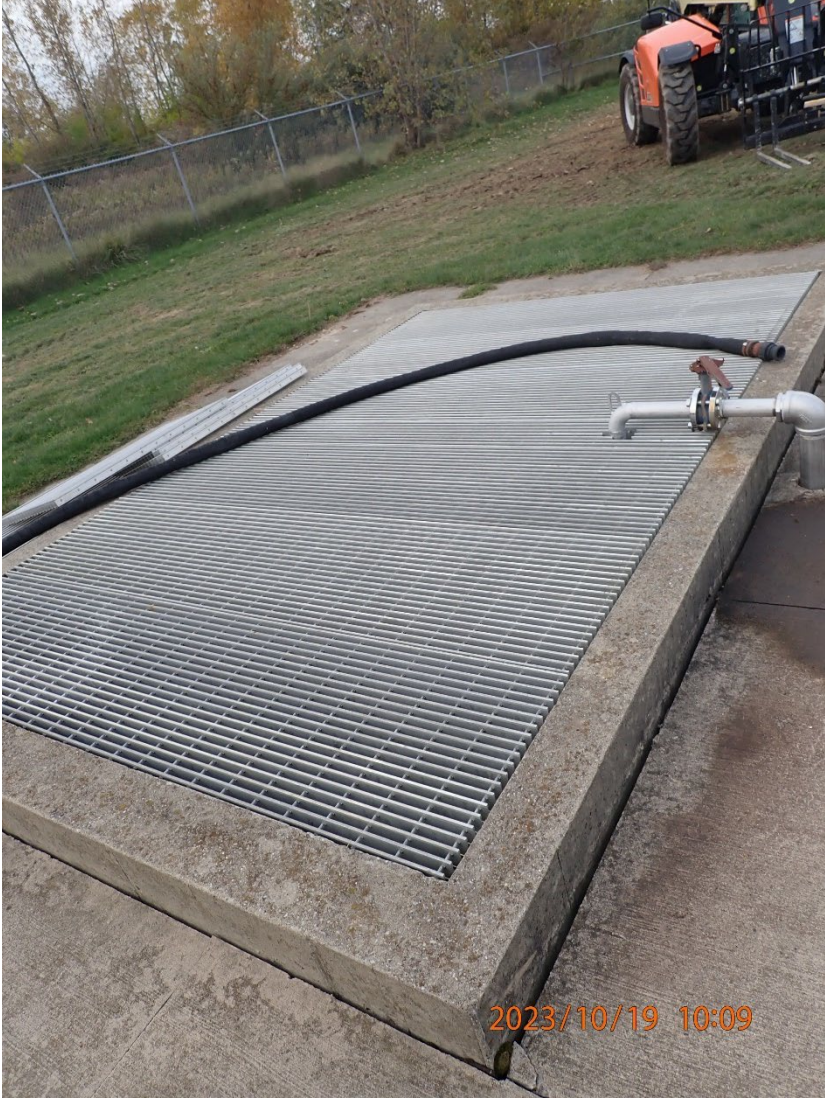
| <b>Photo No.: 11</b> | <b>Time:</b><br>10:09 a.m. | | |

| <b>Photo Description:</b><br>Polisher basin adds air to water prior to discharge. | | | |

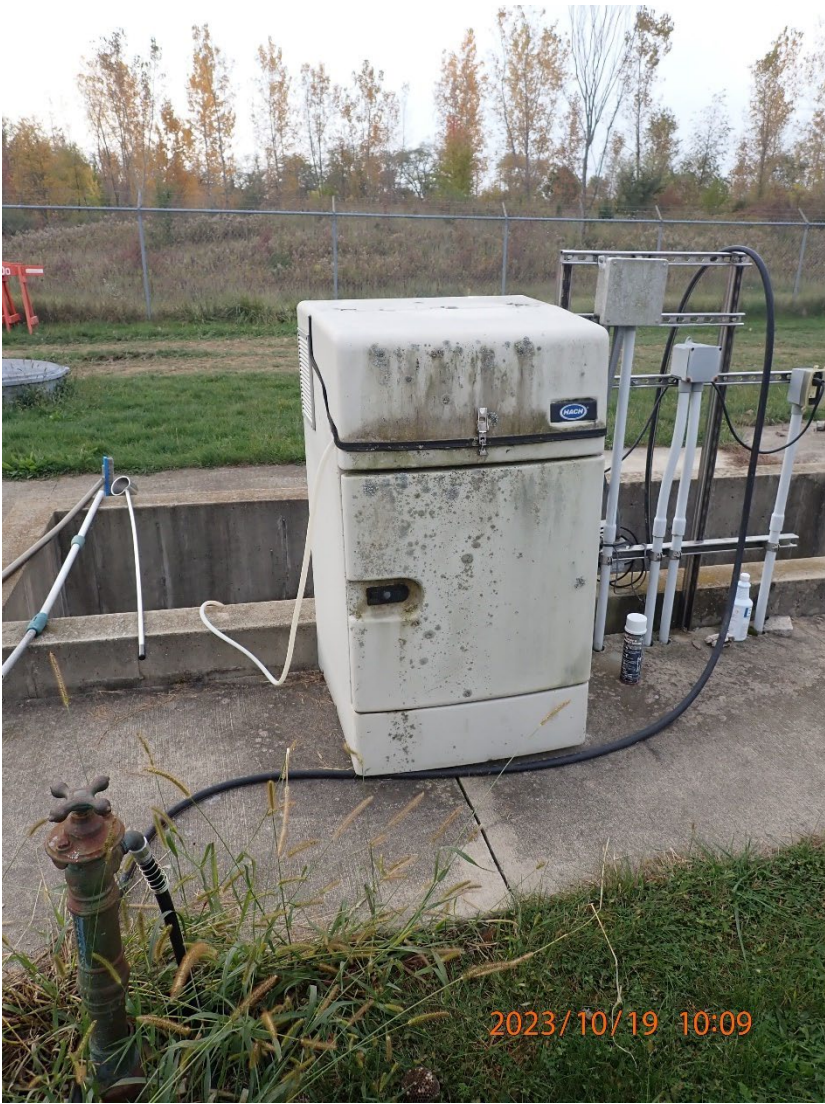
| <b>Photo No.: 12</b> | <b>Time:</b><br>10:09 a.m. | | |

| <b>Photo Description:</b><br>Composite sampler prior to discharge to Wolf Creek. | | | |
