# REPORT OF CONSTRUCTION STORM WATER INSPECTION

## **Raytown High School New Auxiliary Gym**

NPDES General Permit: **MORA23892**

**JANUARY 30, 2024**

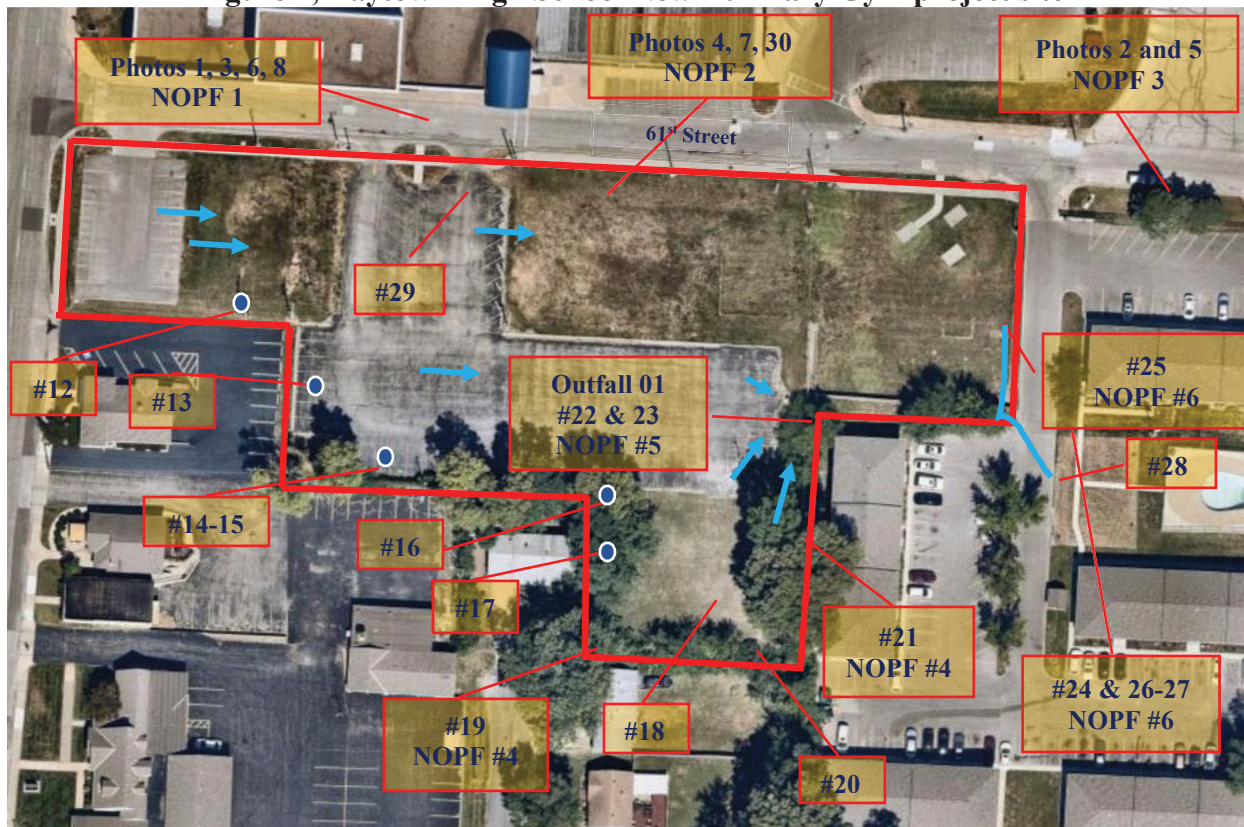
**Figure 1, Raytown High School New Auxiliary Gym project site**

10. I issued NOPF #6 because during my visual inspection of the middle southeast corner of the site (marked as NOPF #6 on figure 1 above) I noticed evidence of sediment leaving the site onto the adjacent private property. I pointed out to Mr. Gosseen that this surface runoff is a discharge point and must be identified as such on the site map and the SWPPP. I also pointed out, that the surface runoff would flow south approximately 45 feet into the Raytown MS4 underground detention basin across the street as shown in photo 24 below.

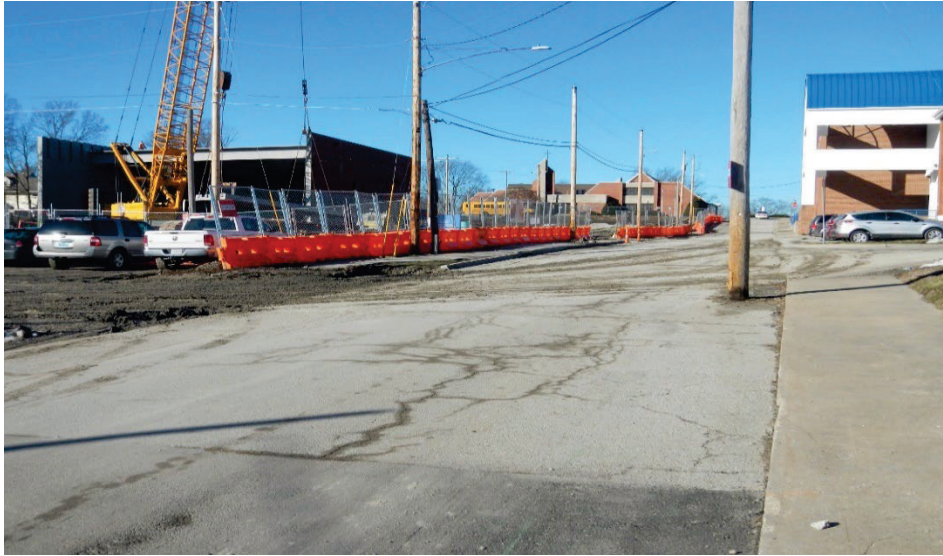
5. I issued Notice of Preliminary Finding Number 1 (NOPF #1) because I noticed a significant amount of sediment on 61<sup>st</sup> Street caused by vehicular trackout from the construction site as shown in photo 3 below.

**Photo 3, Sediment trackout onto 61<sup>st</sup> Street from the construction site**

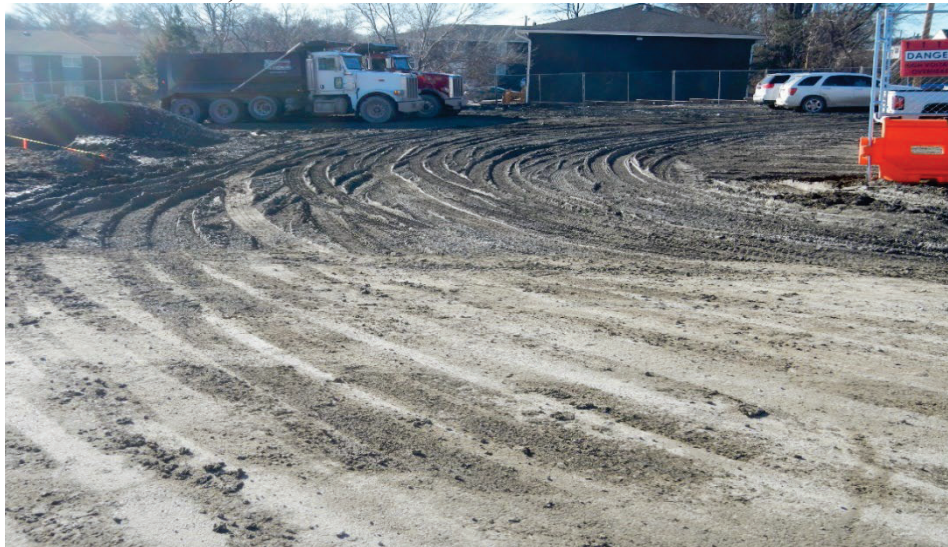
6. During the inspection I pointed out to the site operator that one of the two entrances to the site did not have any controls to prevent vehicular trackout onto the public road (61<sup>st</sup> Street). Therefore, I issued NOPF #2 because site operator failed to provide sediment controls at the site's entrance which caused sediment trackout onto 61<sup>st</sup> Street as shown in photo 4 below.

**Photo 4, Lack of BMPs at one of the site's entrances.**

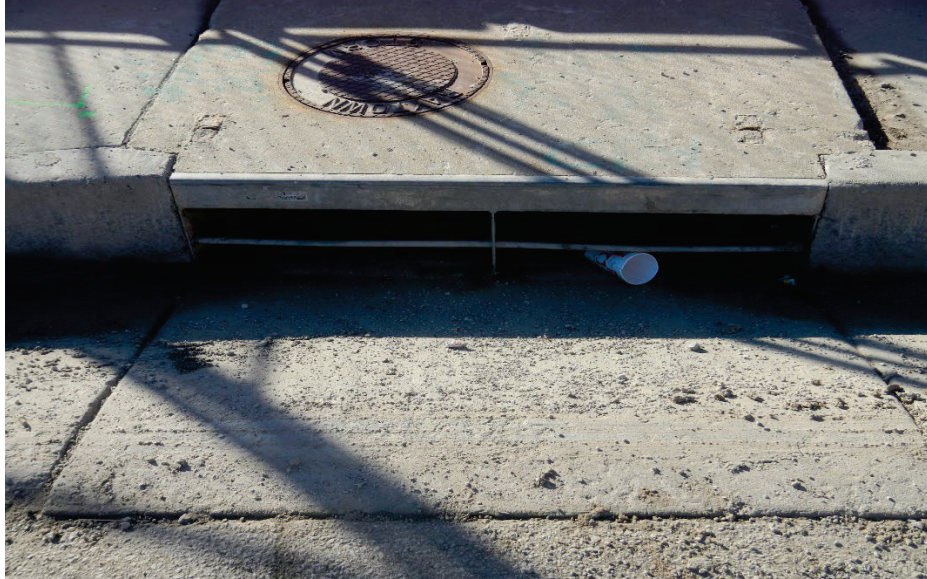
7. I issued NOPF #3 because the site operators, inspectors, and the SWPPP failed to identify the three stormwater curb inlets on the south side of 61<sup>st</sup> Street as points of concern and failed to provide sediment controls at the three inlets as shown in photo 5 below. I also noticed evidence of sediment entering the inlets. Those stormwater inlets lead to the Raytown MS4.

**Photo 5, Sediment entering the stormwater inlet curb at 61<sup>st</sup> Street.**

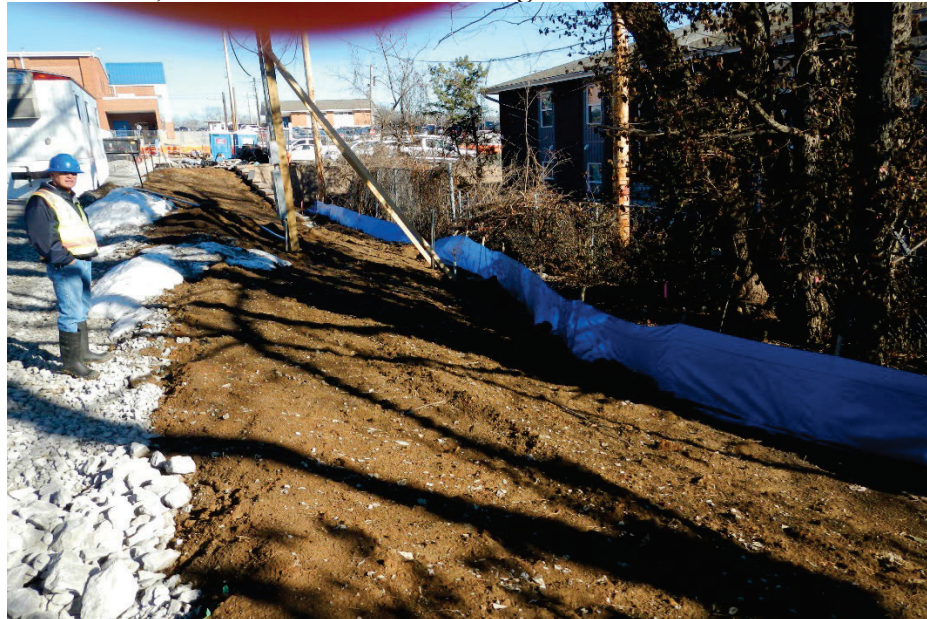
8. I issued NOPF #4 because there was a deficient section of the silt fence with sediment accumulation that overcome the fence and entered the pathway to outfall 01 on the east side of the property as shown in photo 21 below.

**Photo 21, Sediment accumulation against a section on silt fence.**

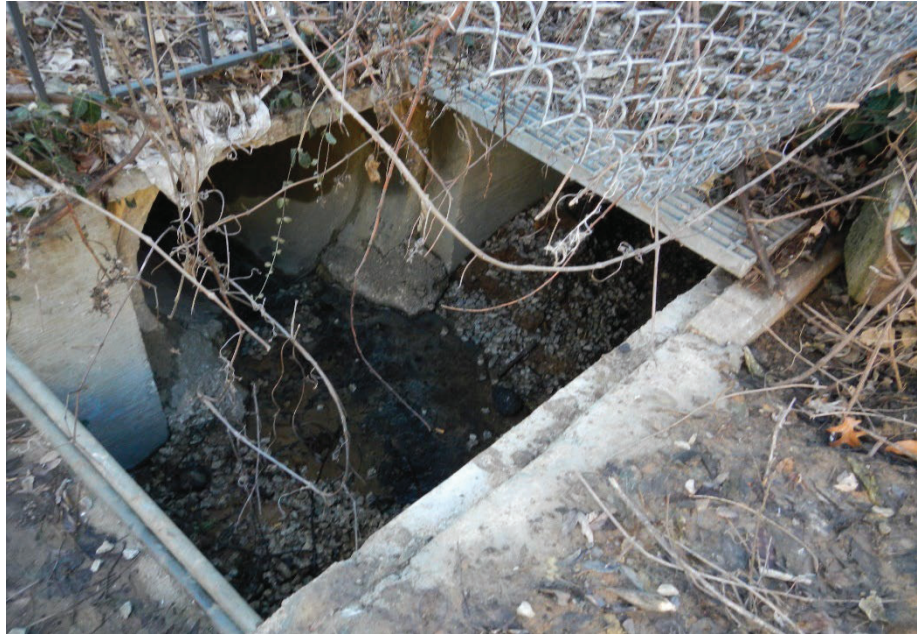
9. I also issued NOPF #5 because I observed sediment from the site entering outfall 01. The outfall did not have any controls. I observed murky discharge from outfall 01. Outfall 01 discharges into the Raytown MS4.

**Photo 23, Outfall 01 with no sediment controls.**

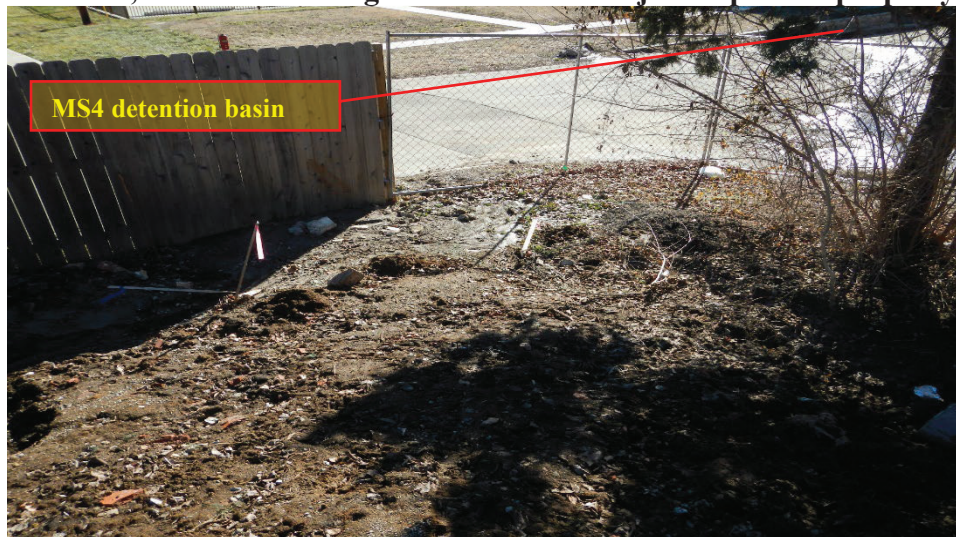
**Photo 24, Sediment leaving the site into the adjacent private property.**
