## Region 6 Compliance Assurance and Enforcement Division

### INSPECTION REPORT

| Company Name: | <b>Seven Cross Operating, LLC</b> | | |
| Facility Name: | <b>Novice Unit 8022 Battery Lease (RRC Lease No. 10904)</b> | | |

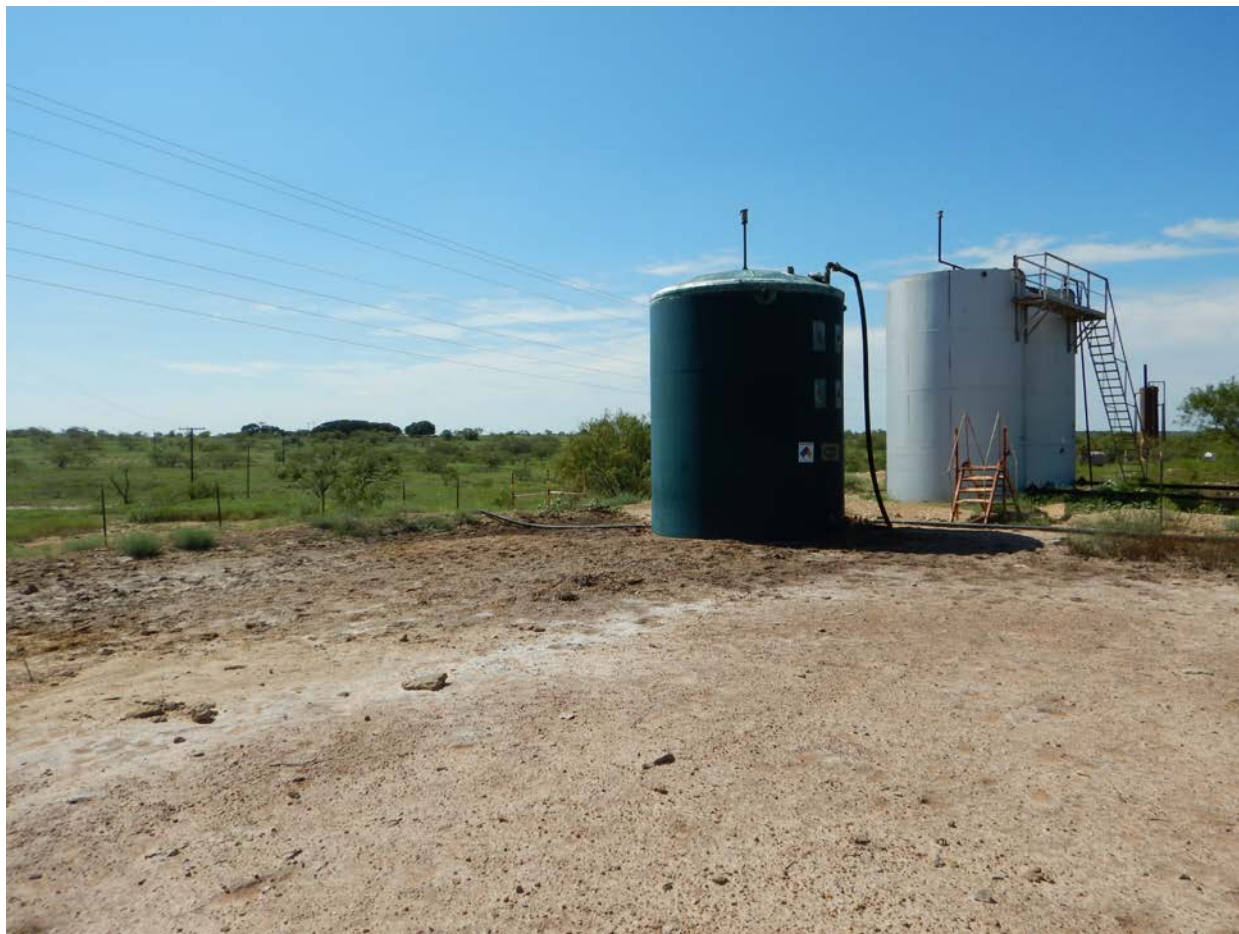
Photograph File Name: DSCN0880.JPG

Description: This image shows the south side of the tank battery, including two oil storage tanks and a produced water tank in this portion of the tank battery and lease. We observed visible salt crystals near and south of the produced water tank.

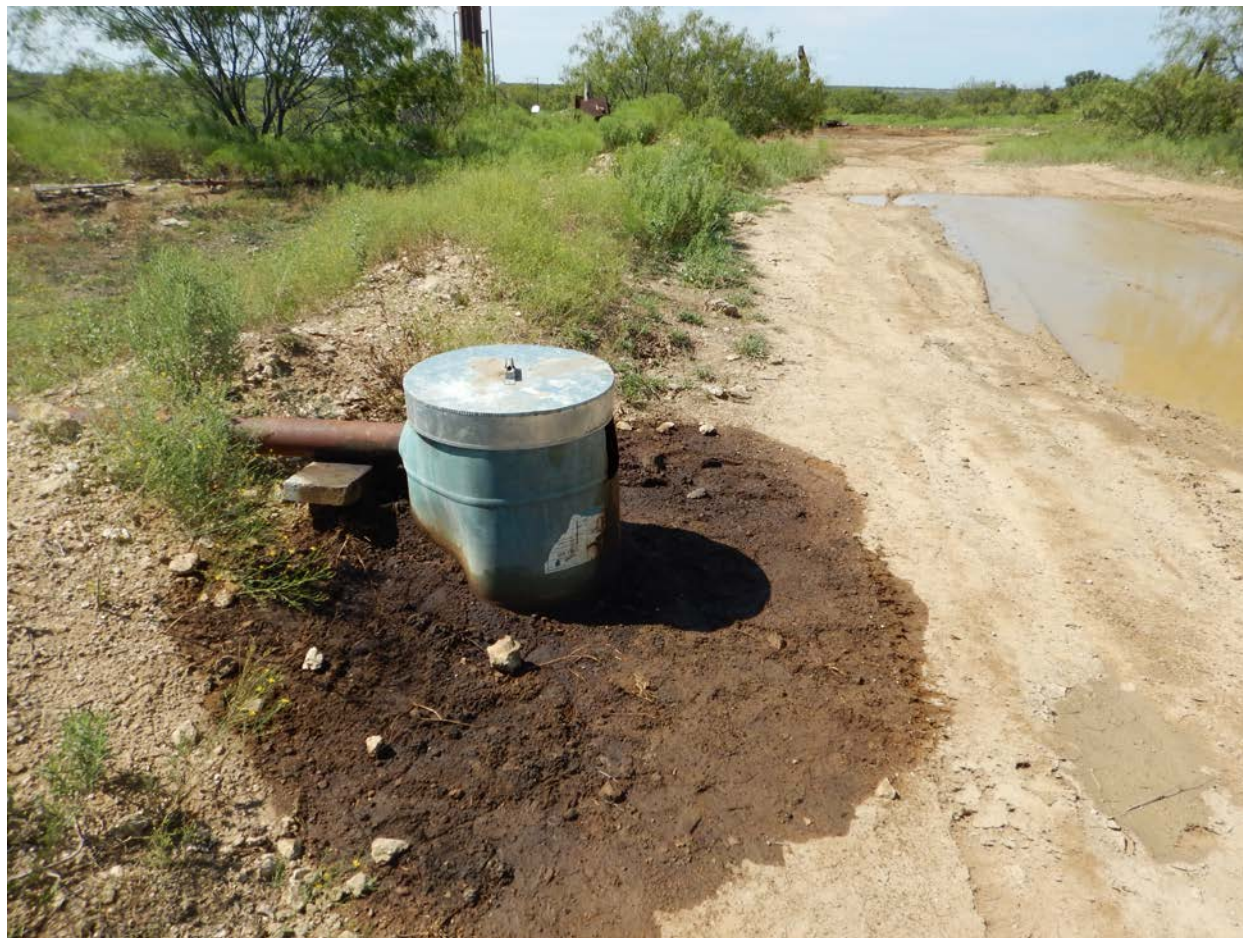
Photograph File Name: DSCN0878.JPG

Description: This image shows one of the catch boxes at the outlet line from the oil storage tanks to the connection valve area for hauling the oil from the facility. We observed oil staining around the catch box. We also observed excessive vegetation in the secondary containment and an inadequate secondary containment berms due to visible dry flow paths from the tank battery location westward towards the tributary of the South Fork of Jim Ned Creek.

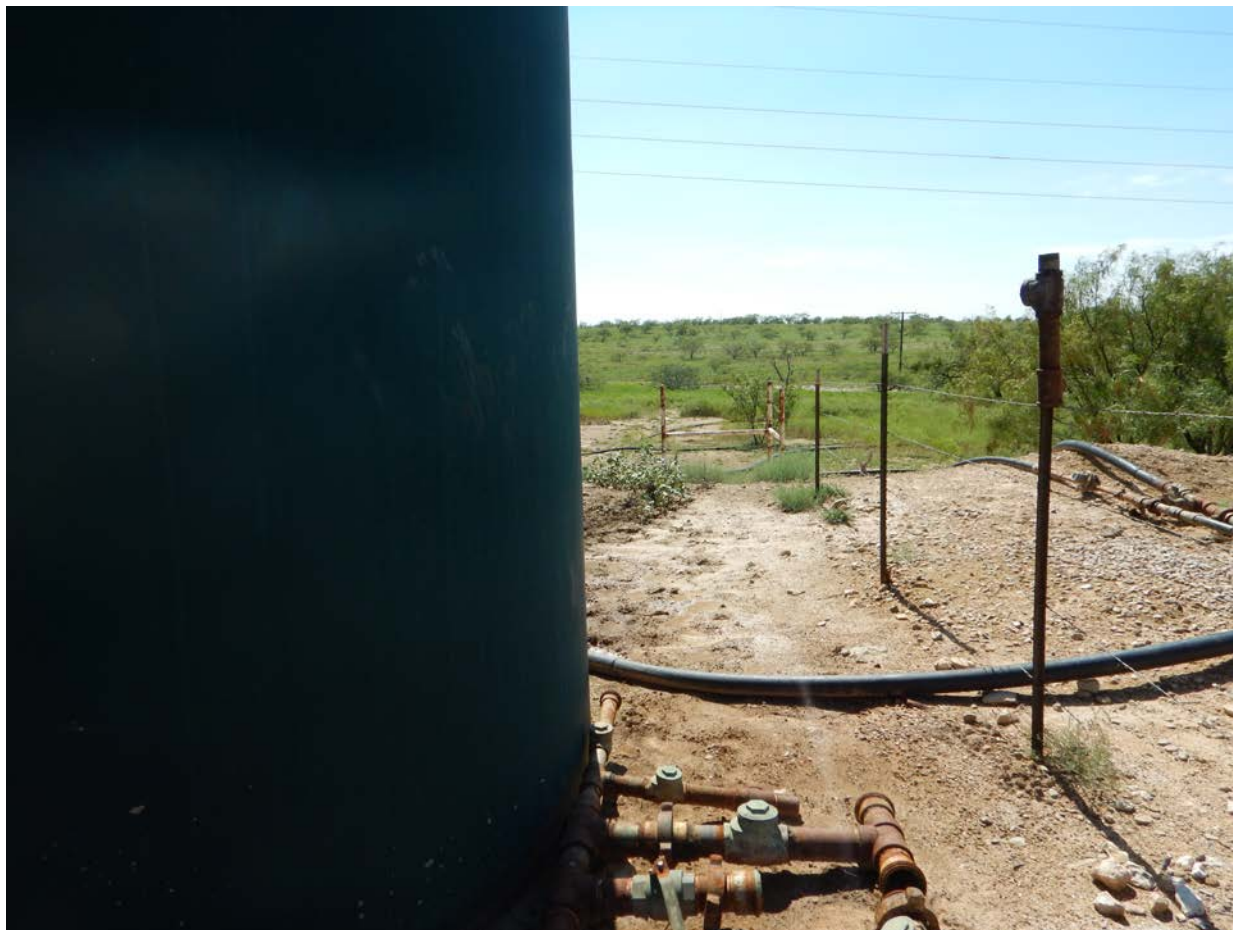
Photograph File Name: DSCN0879.JPG

Description: This image shows produced water storage tank and the secondary containment berm on the west side of the tank battery. We observed a dry flow path west towards the tributary of the South Fork of Jim Ned Creek. We observed that the berm walls of the secondary containment were compacted and had some erosion on the west side of the facility and along the visible dry flow path.

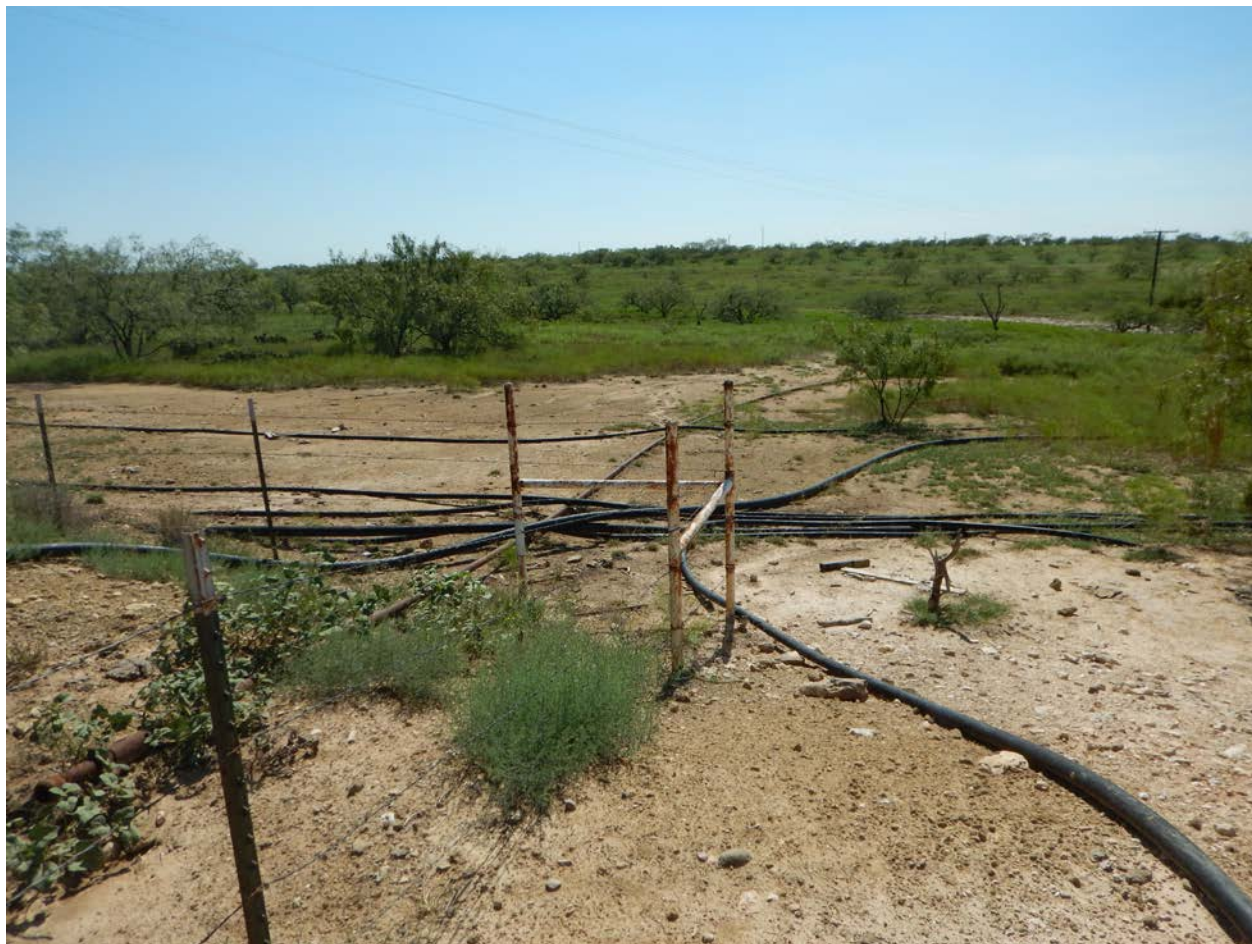
Photograph File Name: DSCN0881.JPG

Description: This image shows the west side of the tank battery near the produced water storage tank shown in Photo No. 5 of Appendix 1. We observed a visible dry flow path from the west side of the facility towards the tributary of the South Fork of Jim Ned Creek. We saw erosion along the west side of the berm as well. The flow path had no visible vegetation, while visible vegetation was around the flow path at the time of the inspection.

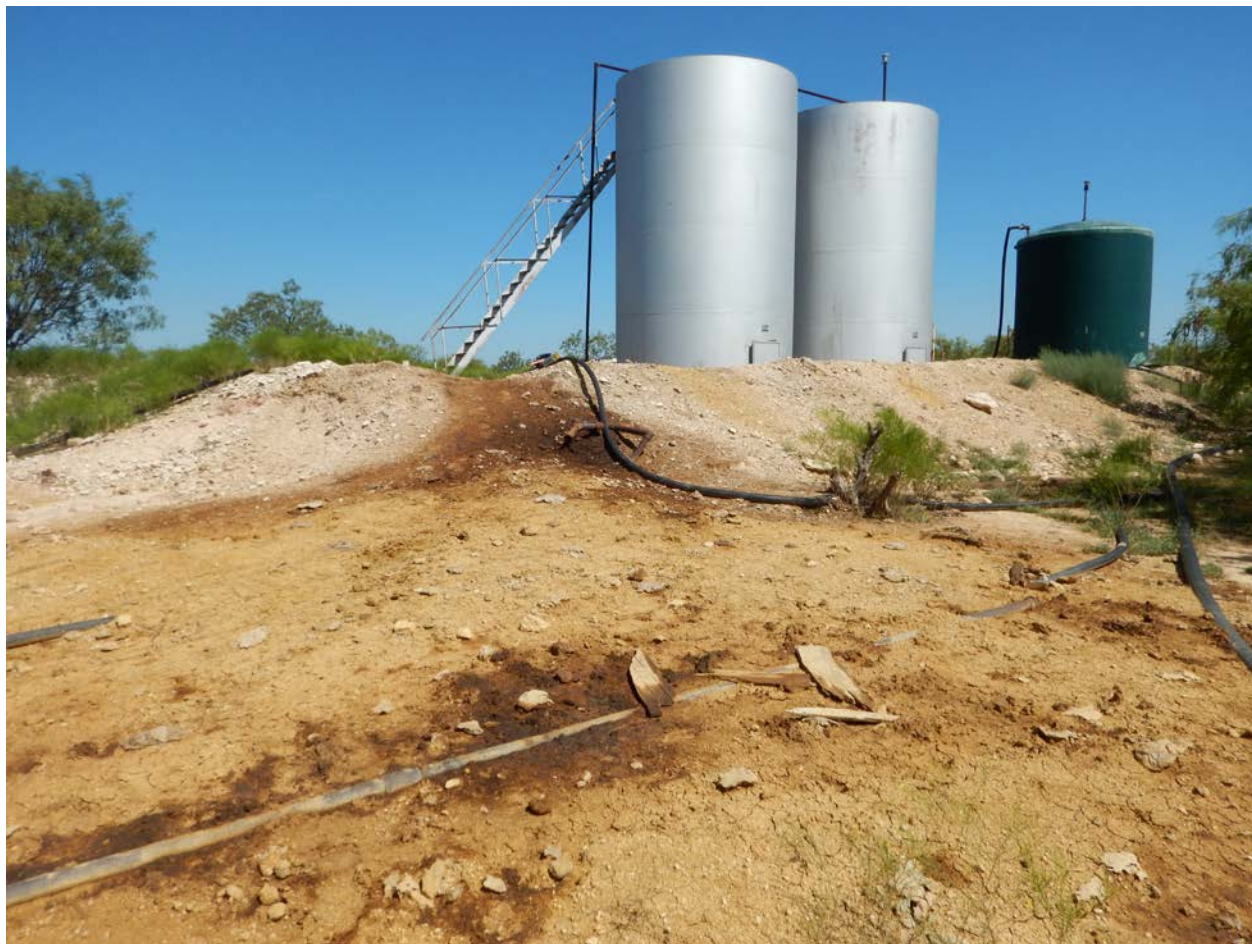
Photograph File Name: DSCN0874.JPG

Description: This image shows the west side of the tank battery, near the oil storage tanks. We observed oil staining on the secondary containment berm and outside of the secondary containment area. We observed a flow path from the west side of the tank battery towards the tributary of the South Fork of the Jim Ned Creek. There was no vegetation along the flow path at the time of the inspection. The smell of hydrocarbons was also present at the time of the inspection.

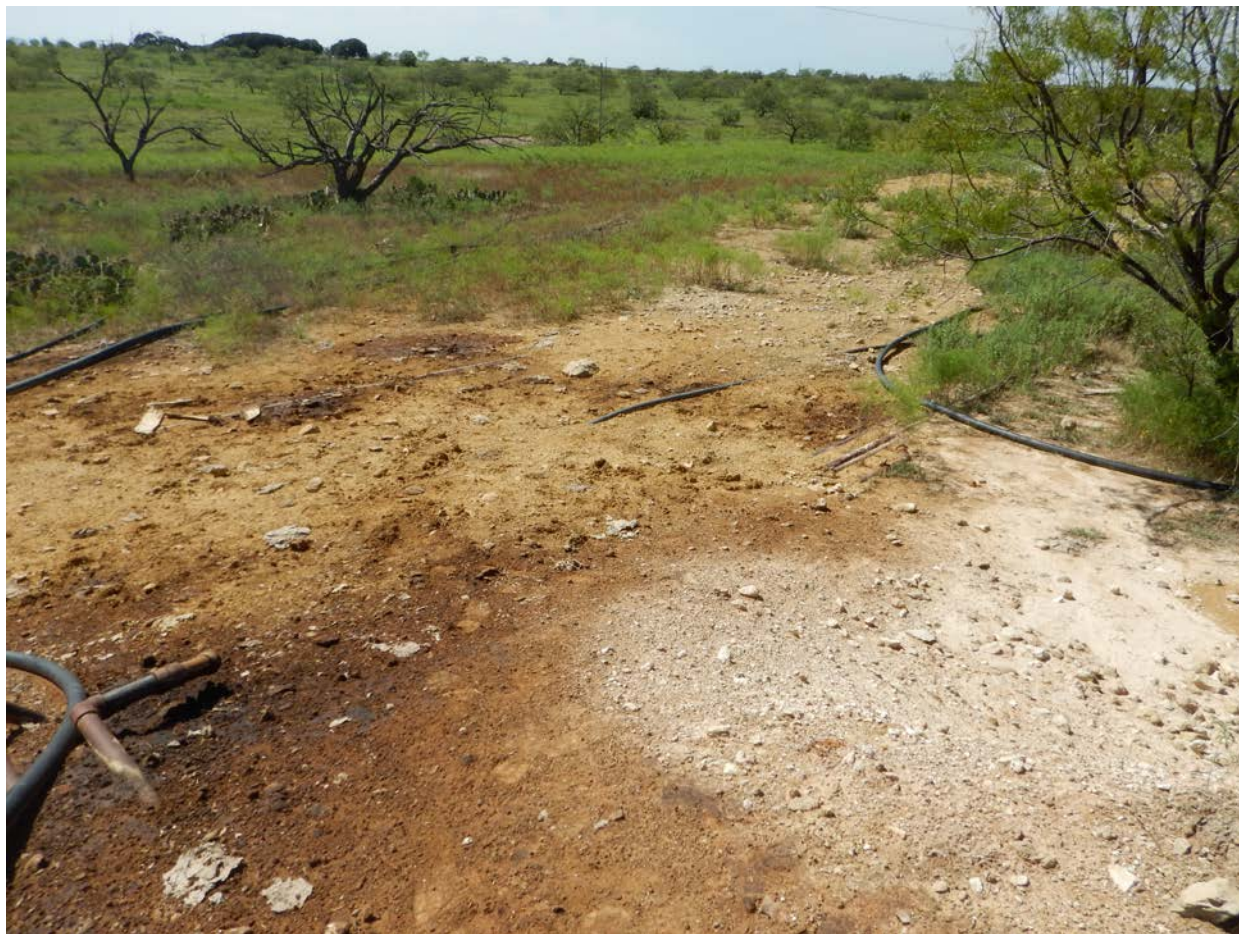
Photograph File Name: DSCN0875.JPG

Description: This image shows the visible dry flow path from the west side of the tank battery near the oil storage tanks, shown in Photo No. 7 in Appendix 1. We observed oil staining along the flow path and no vegetation along the flow path. The flow path went west towards the tributary of the South Fork of Jim Ned Creek.

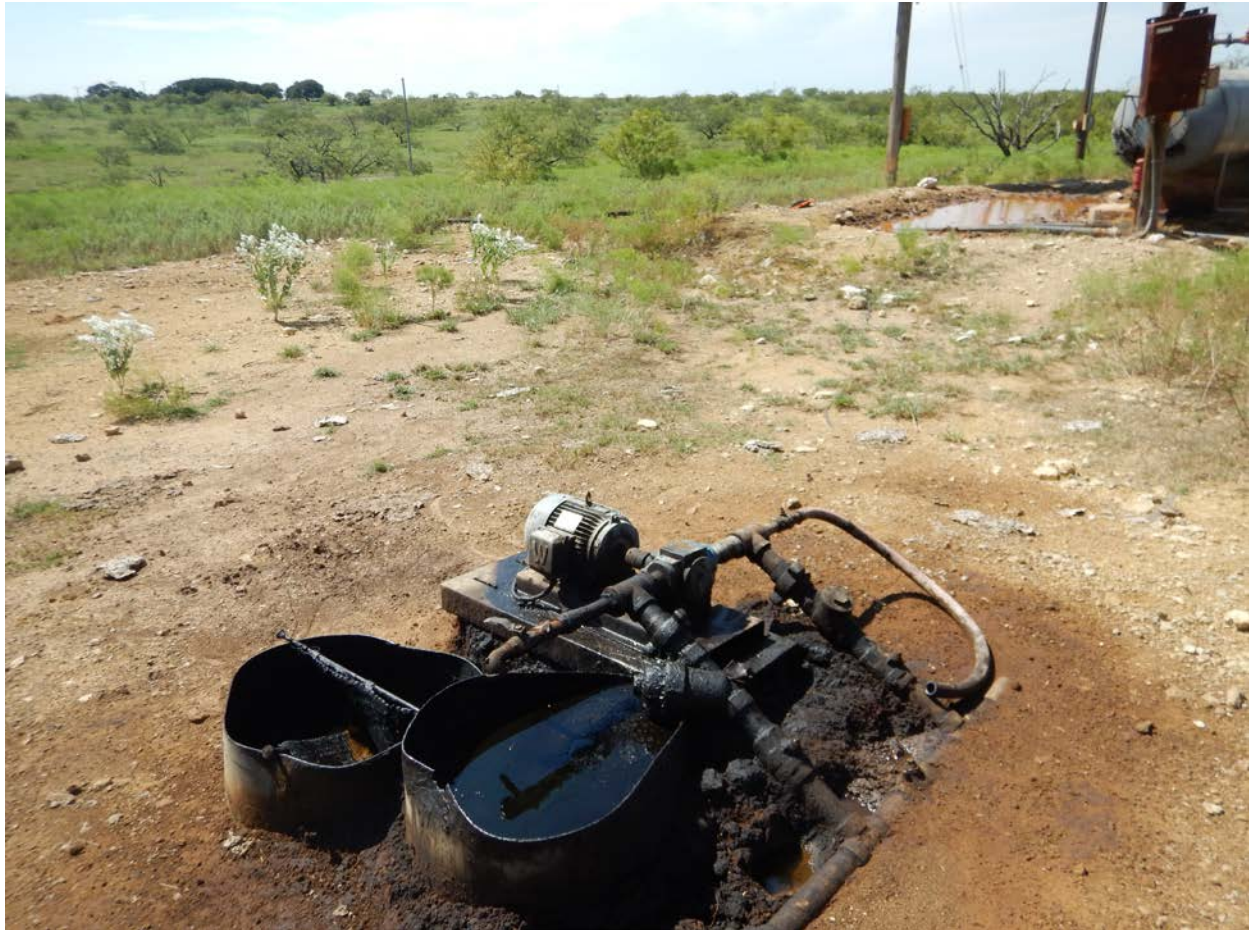
Photograph File Name: DSCN0873.JPG

Description: This image shows a transfer pump that is located between the heater treater and the oil and produced water storage tanks at the tank battery. We observed buckets of oil and fluids at the transfer pump, oil staining around the equipment, and no secondary containment for this pump. We also observed the flow path from the west side of the tank battery. North of the transfer pump, the horizontal separator was visible with an inadequate secondary containment area full of fluids.

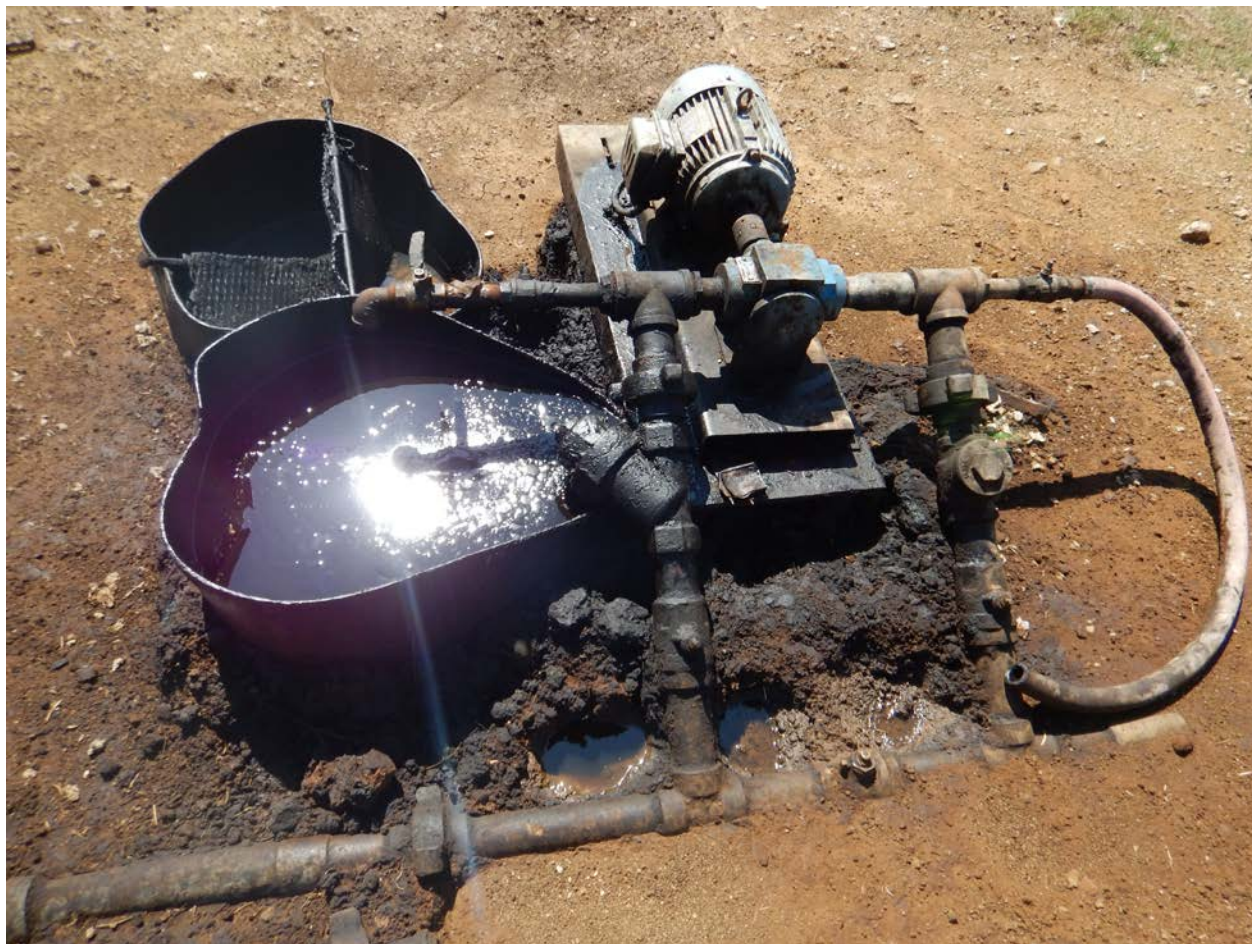
Photograph File Name: DSCN0872.JPG

Description: This image shows the leaking transfer pump from Photo No. 9 in Appendix 1. The transfer pump was pumping fluids from the heater treater to the tank battery storage tanks. We observed oil staining and the pump leaking at the time of the inspection. Fluids filled several containers and holes near the pump as well.

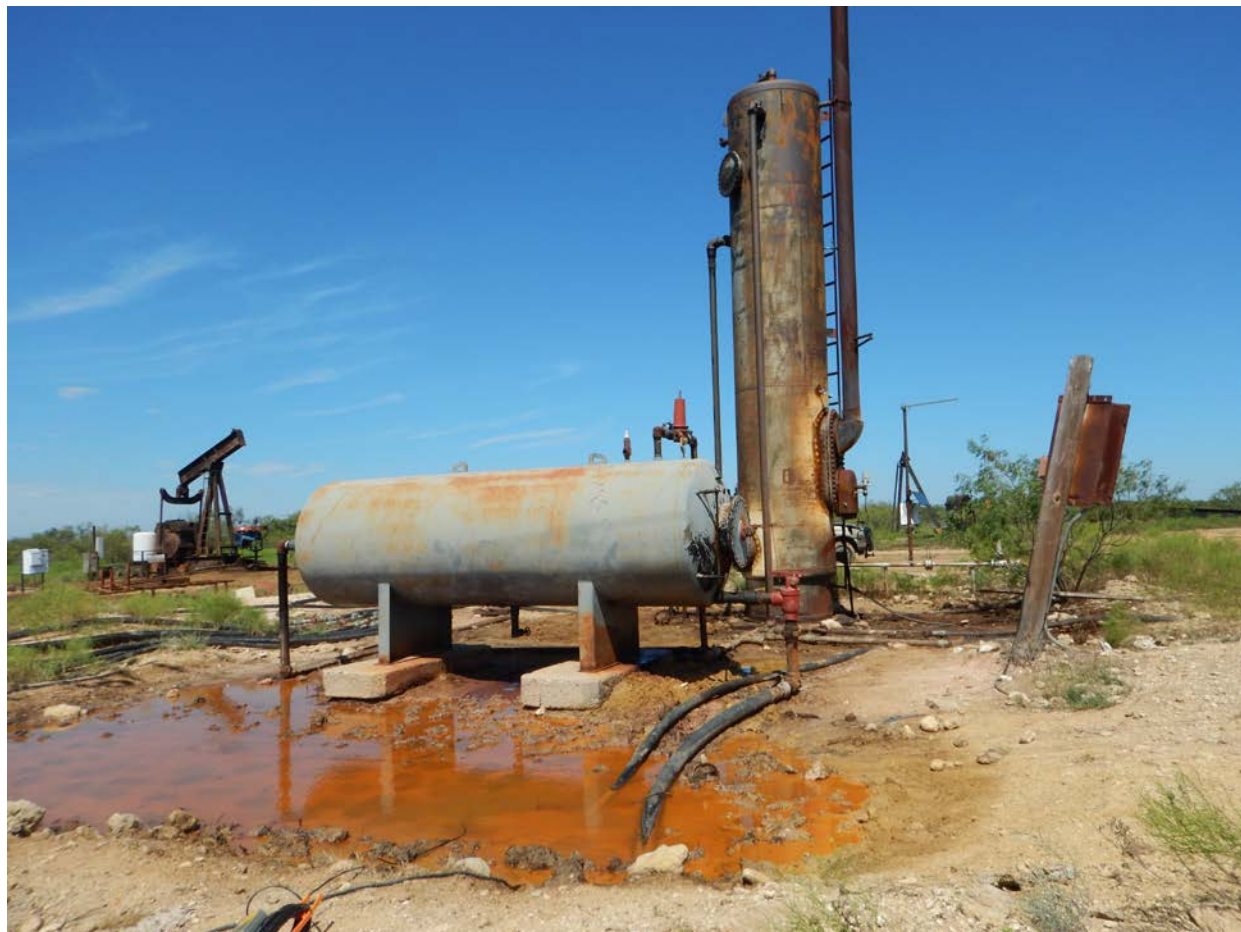
Photograph File Name: DSCN0869.JPG

Description: This image shows the horizontal separator and the heater treater at the facility, north of the oil and produced water storage tanks at the tank battery. There was an inadequate secondary containment due to fluids in the containment area and eroded berm walls. We observed significant rust on the heater treater and the separator at the time of the inspection. The fluids in the secondary containment area were from the leaking separator at the time of the inspection. Several flow lines were visible as well.

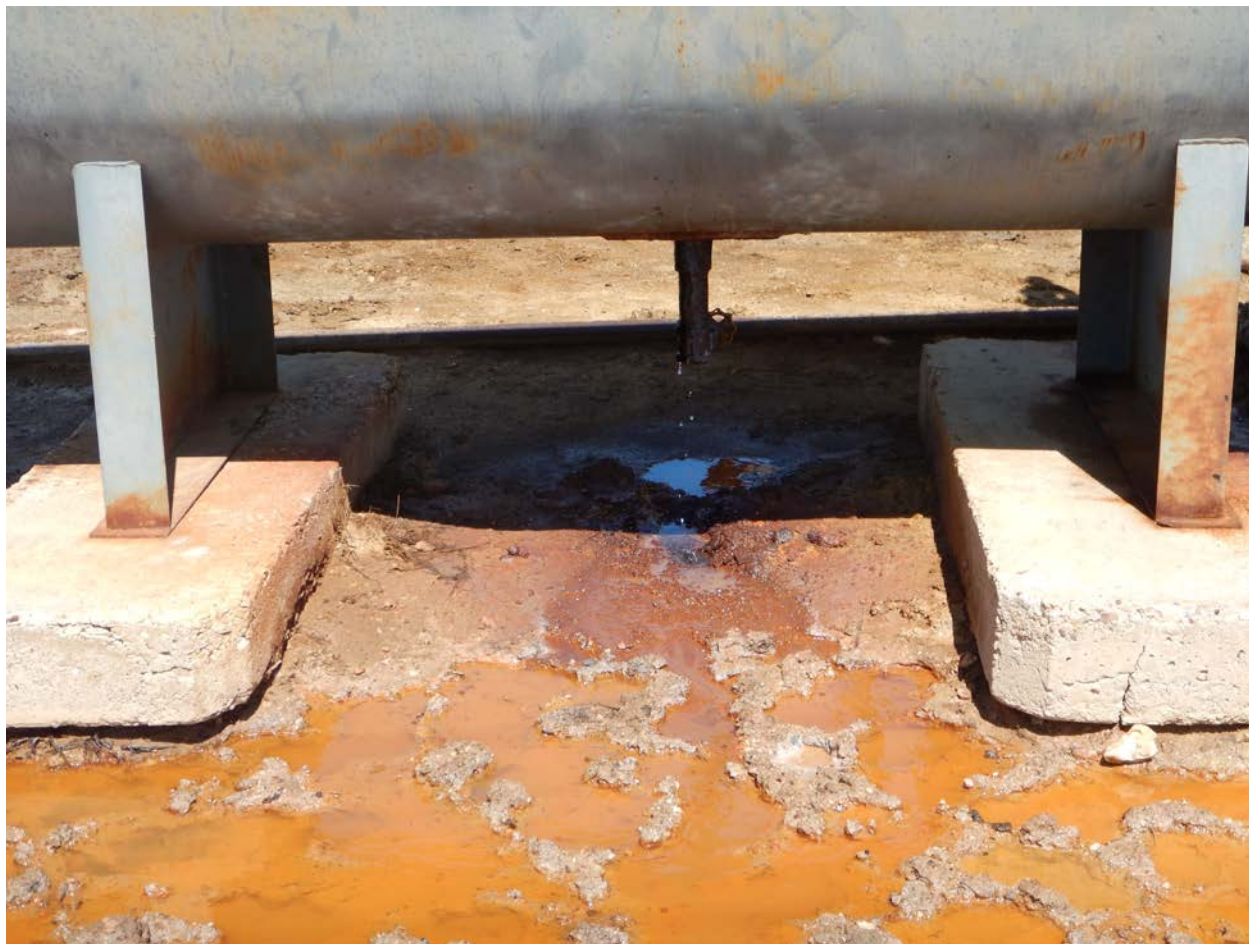
Photograph File Name: DSCN0870.JPG

- An actively leaking horizontal separator with a consistent dripping leak and fluids in the inadequate containment area that measured over 80,000 ppm TSS

Description: This image shows the horizontal separator with an active leak at the time of the inspection. We observed fluids leaking from the bottom of the separator at the time of the inspection. These fluids were inside the secondary containment of the separator, which was inadequate at the time of the inspection. We observed significant rusting on the separator as well.

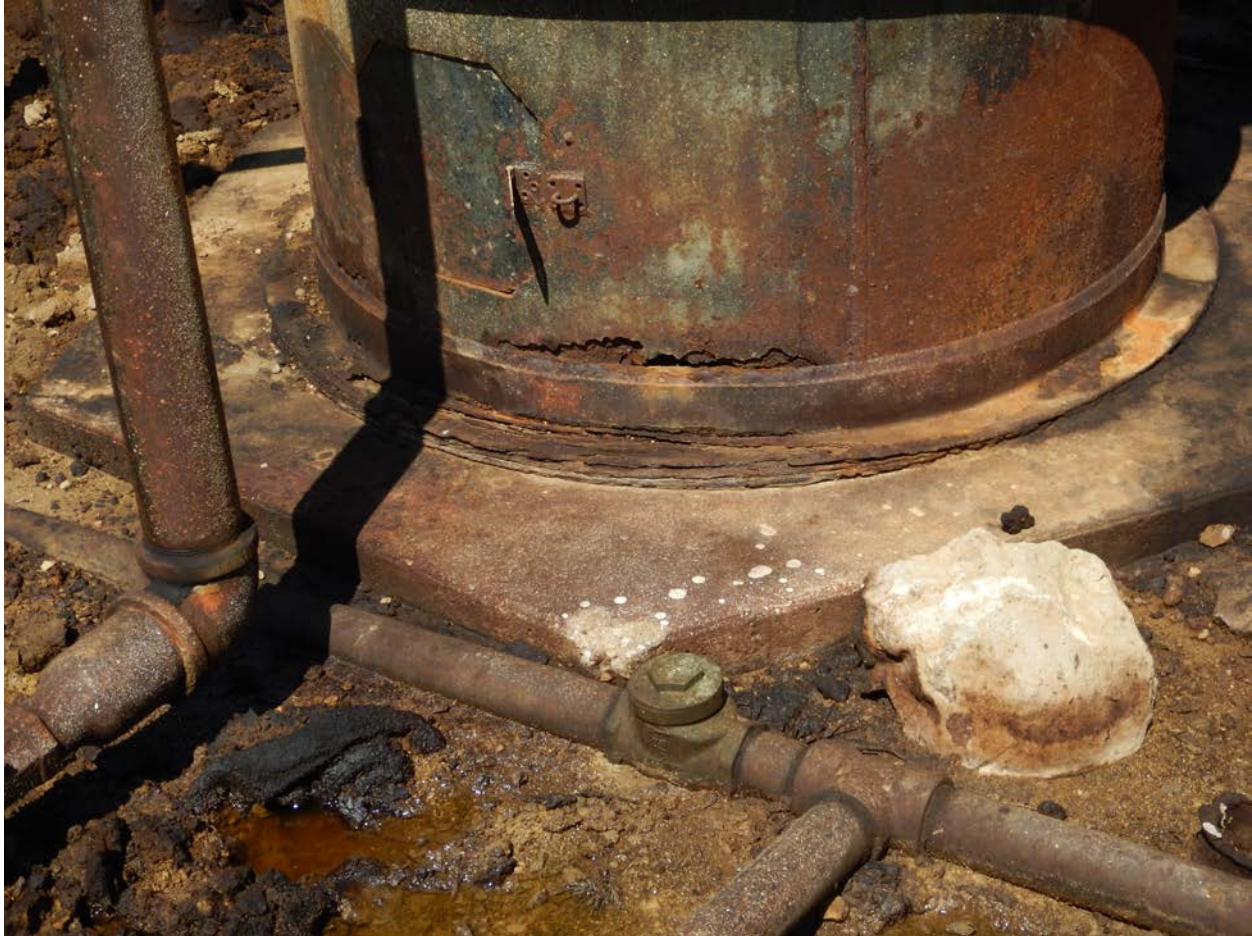
Photograph File Name: DSCN0871.JPG

- Significant corrosion on the heater treater's exterior, especially at the bottom of the heater treater, and rusting on equipment connected to the heater treater and separator

Description: This image shows the bottom of the heater treater, as shown in Photo No. 11 in Appendix 1. We observed significant corrosion and rusting on the heater treater. The heater treater had corrosion on the bottom and holes in the exterior. We observed oil staining and fluids near the heater treater in the secondary containment. The secondary containment was inadequate at the time of the inspection due to fluids being inside the secondary containment at the time of the inspection.

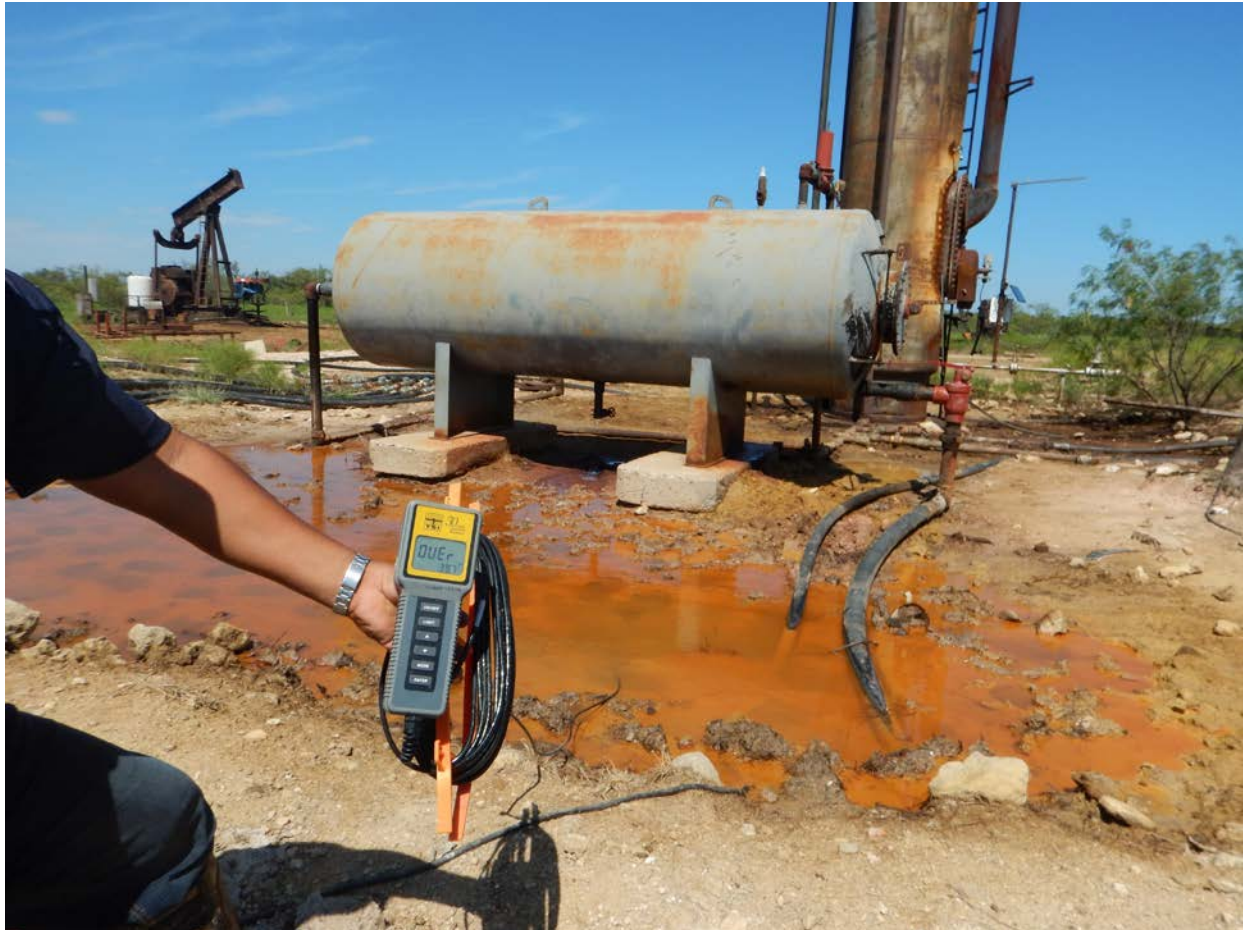
Description: This image shows the fluids in the inadequate secondary containment area of the heater treater and horizontal separator. We took a Total Soluble Salts (TSS) reading of over 80,000 parts-per-million (ppm) of the fluids in the containment area at the time of the inspection. The separator was actively leaking at the time of the inspection.

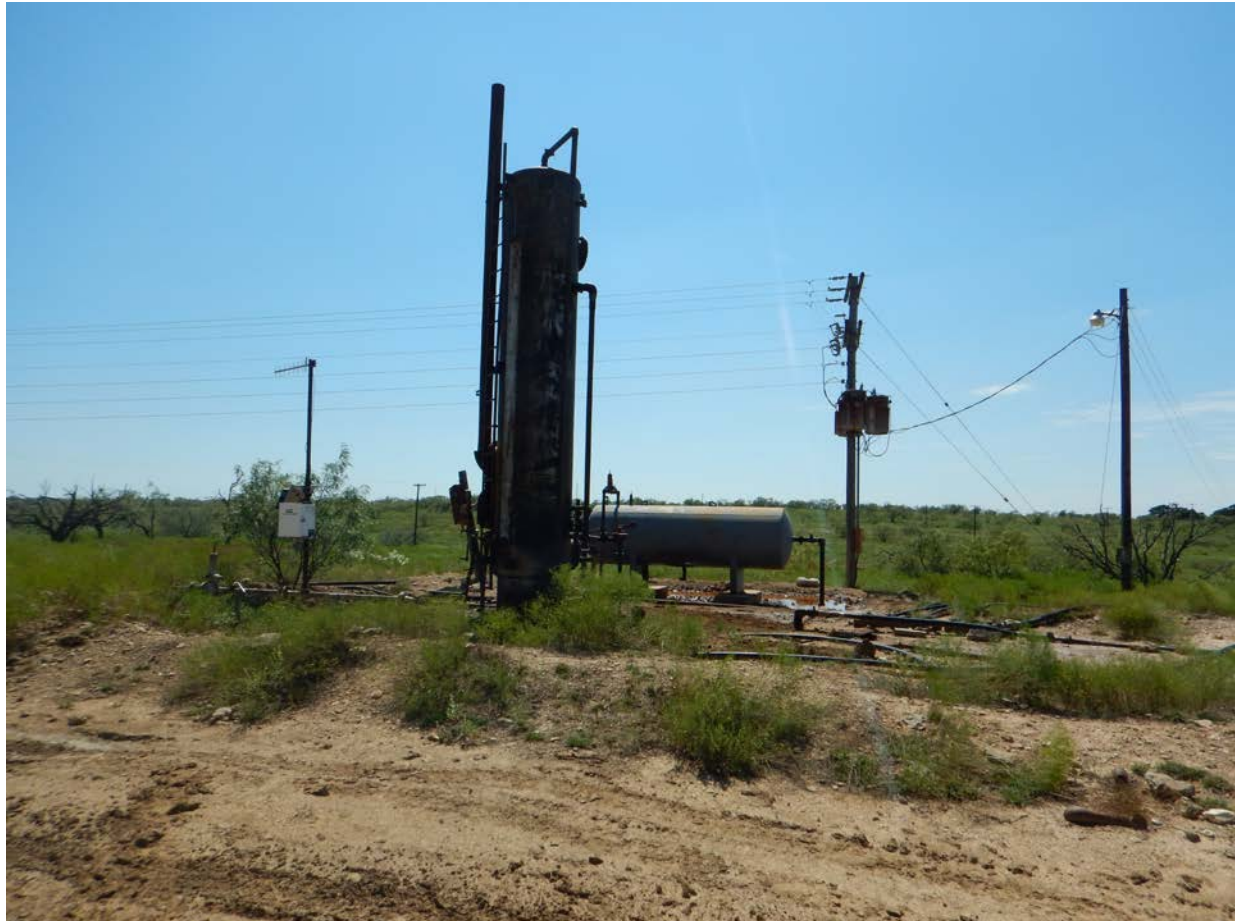
This image shows the heater treater and horizontal separator at the facility. We observed gas production equipment, including a gas pipeline was visible at the time of the inspection. At the facility approximately 7 pipes from wells were connected to the separator and heater treater. We observed fluids in the secondary containment area at this part of the facility, as shown in Photo Nos. 9, 11, 12, and 14 in Appendix 1.

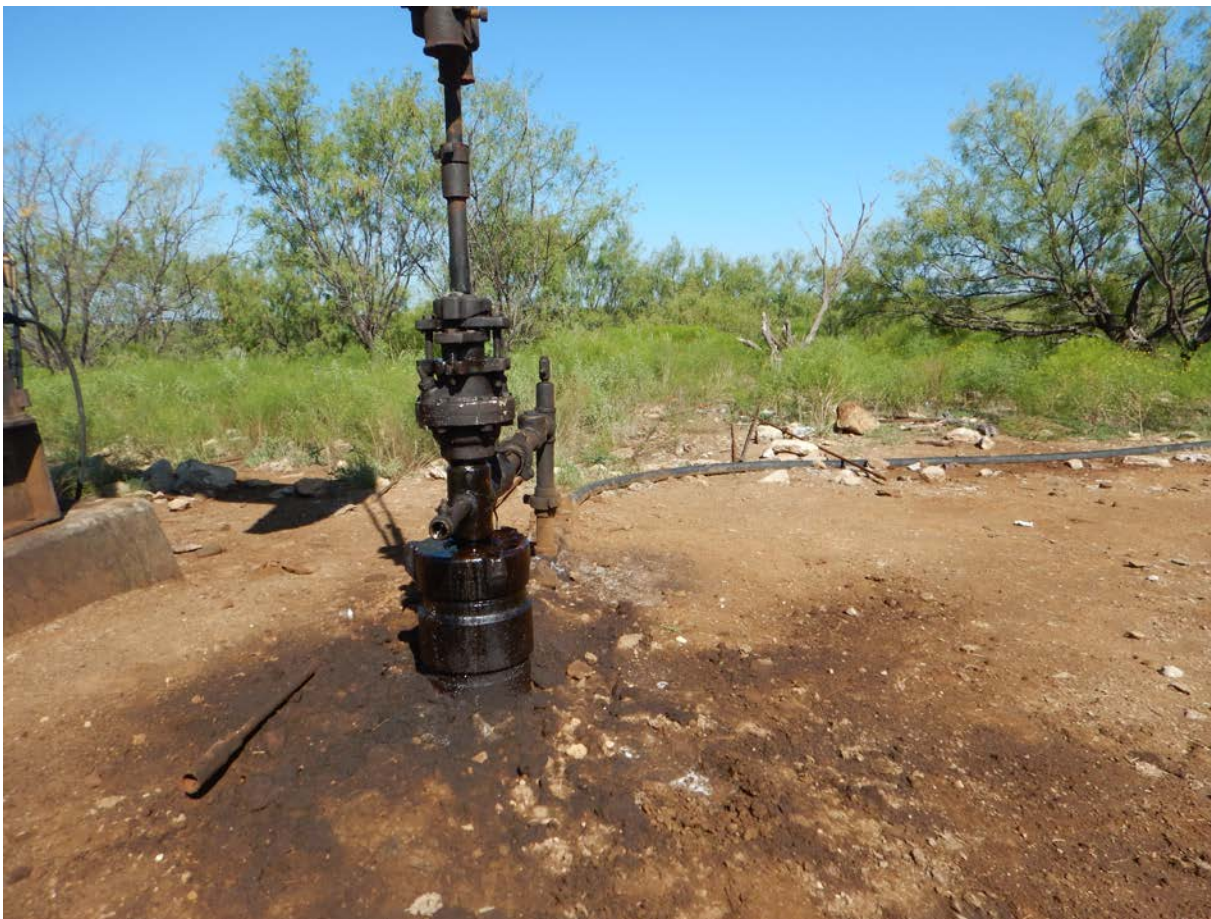
Photograph File Name: DSCN0899.JPG

Description: This image shows the Novice Unit Well No. 8026, which is associated with the Novice Unit 8022 Battery Lease. At the time of the inspection, we observed visible oil staining and a leaking well head, near the stuffing box and casing head.

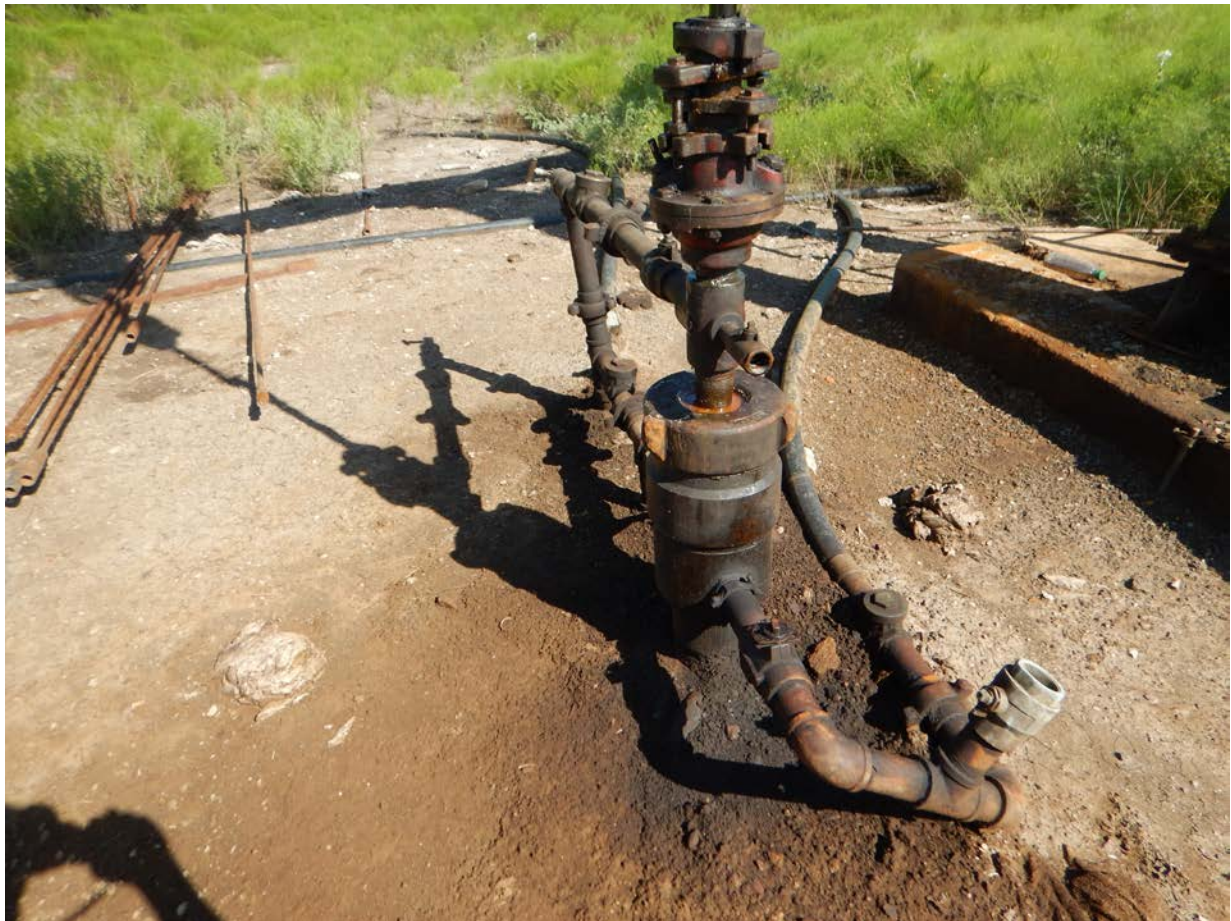
Photograph File Name: DSCN0901.JPG

Description: This image shows the Novice Unit Well No. 8028, which is associated with the Novice Unit 8022 Battery Lease. At the time of the inspection, we observed visible oil staining and a leaking well head, near the stuffing box and casing head.

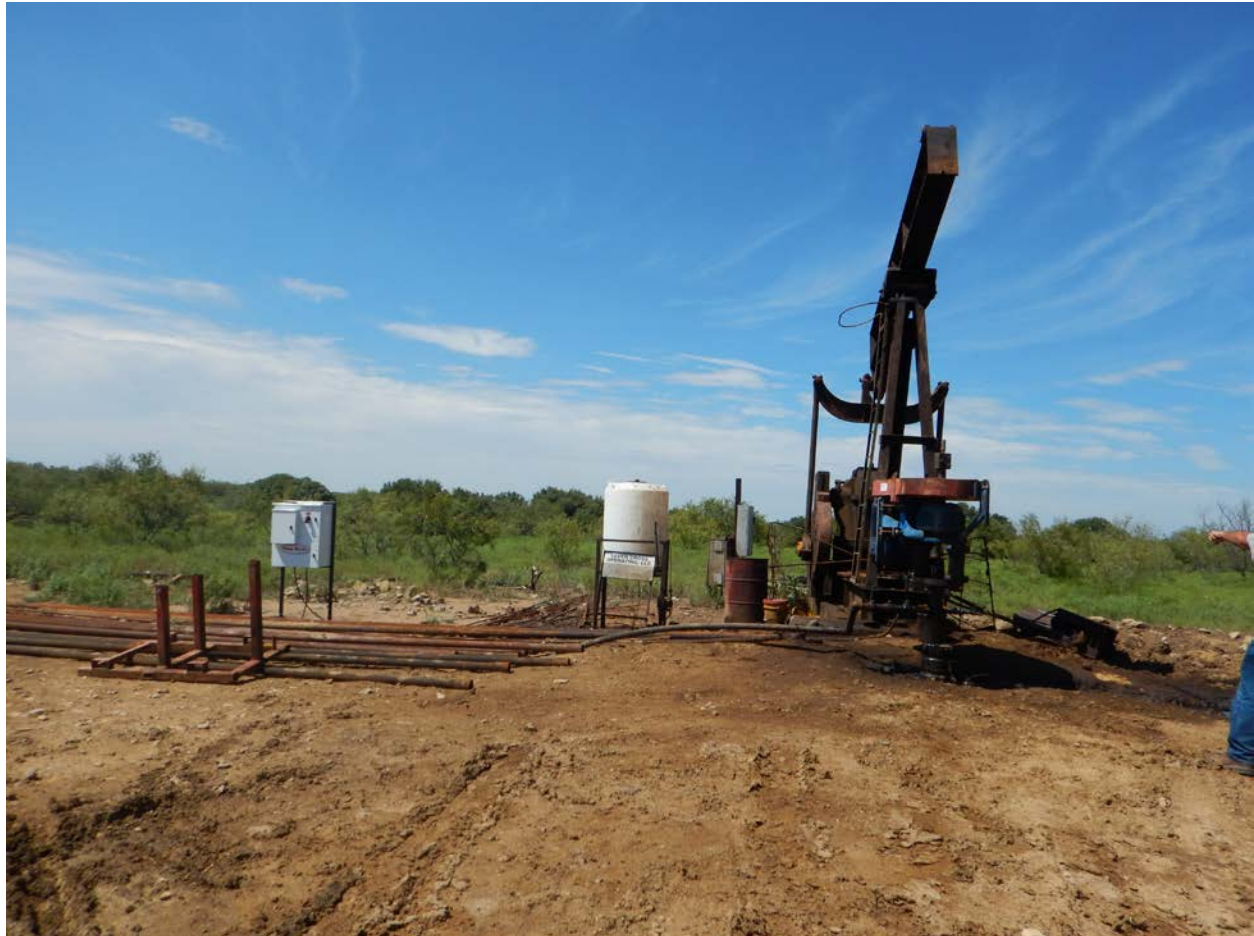
This image shows the Novice Unit Well No. 8099, which is associated with the Novice Unit 8022 Battery Lease. At the time of the inspection, we observed visible oil pooled near the well head, oil staining, and a leaking well head near the stuffing box and casing head. Fluids were also observed near the well head. A chemical storage container was at the well location and did not have a secondary containment.

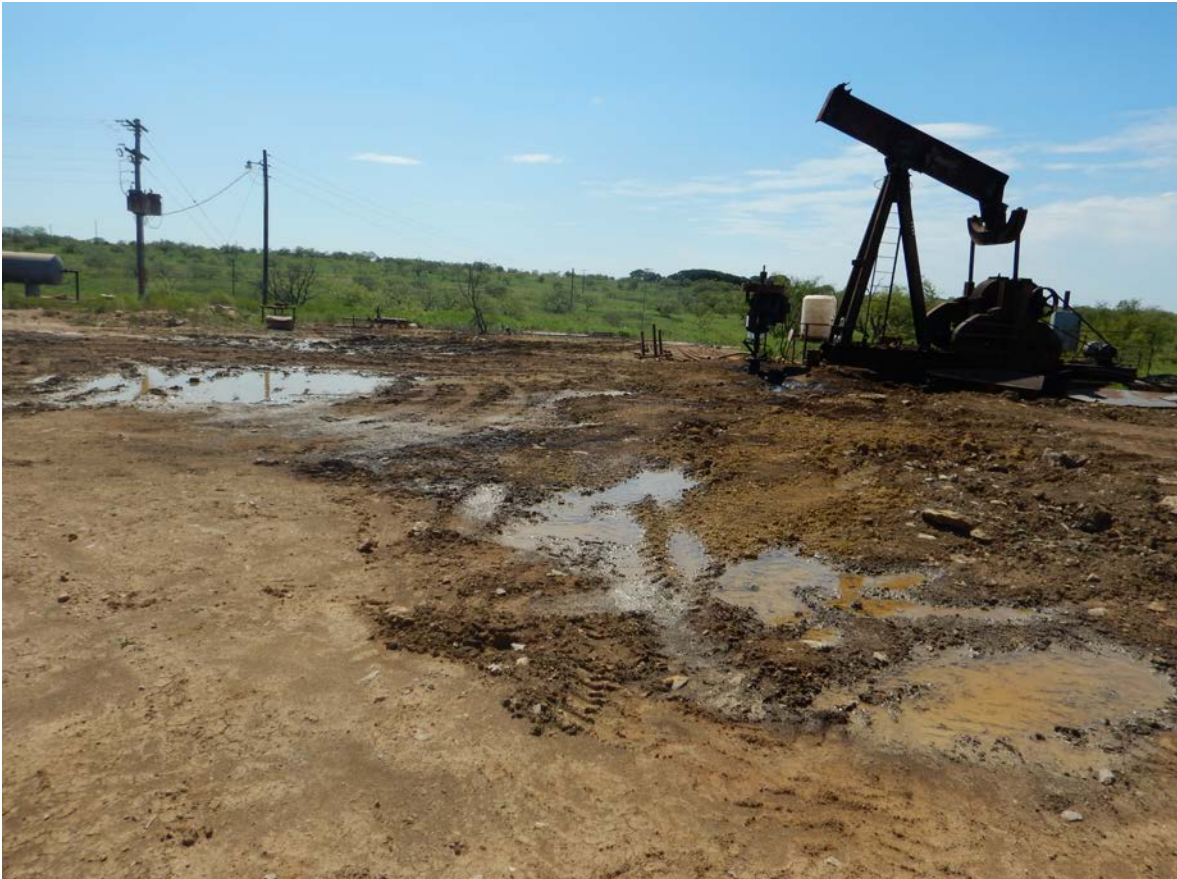
This image shows the Novice Unit Well No. 8099, which is associated with the Novice Unit 8022 Battery Lease. At the time of the inspection, we observed visible oil pooled near the well head, oil staining, and a leaking well head near the stuffing box and casing head. Fluids were also observed near the well. We observed fluids covered with soil near the well at the time of the inspection. The horizontal separator near this well associated to the tank battery, as shown in Photo No. 11, can be seen south west of the well. A dry flow path was visible west of the well site and separator area at the time of the inspection.

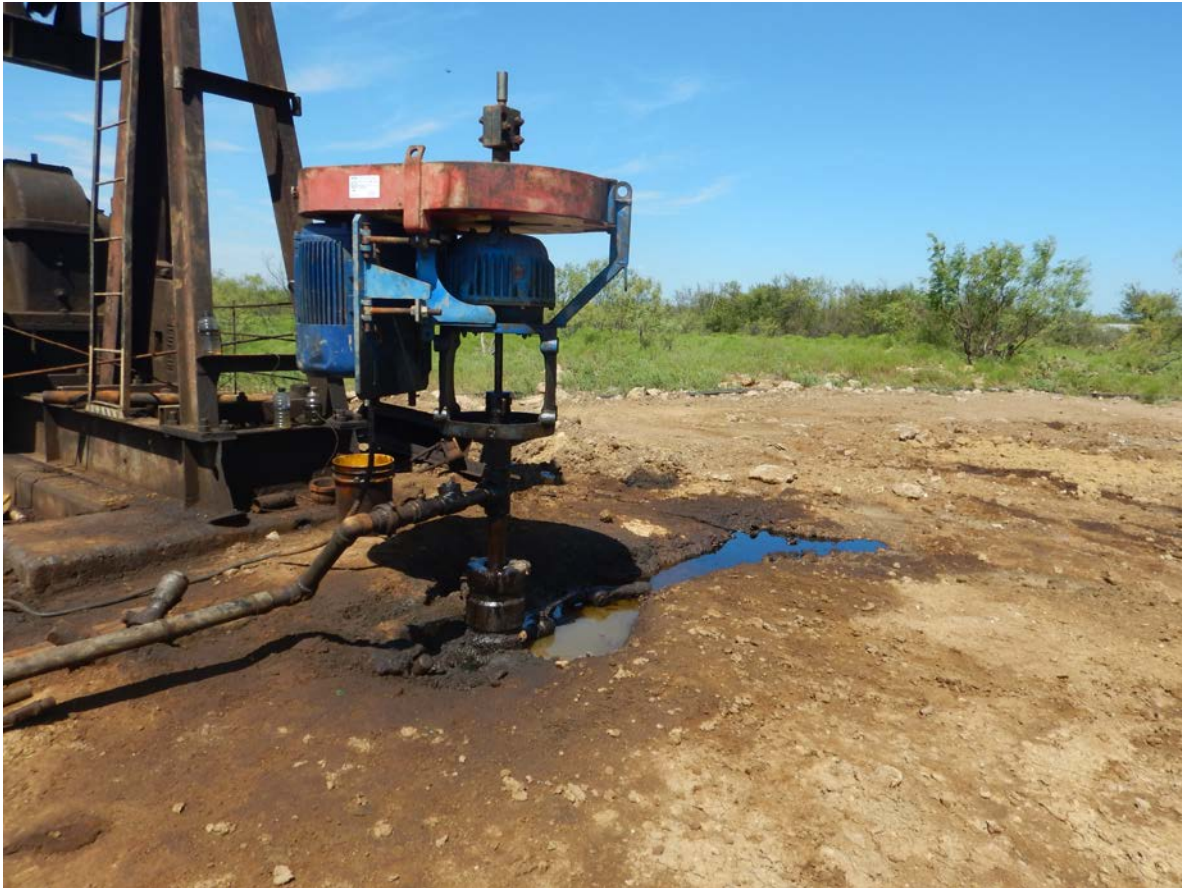
Description: This image shows the Novice Unit Well No. 8099, which is associated with the Novice Unit 8022 Battery Lease. At the time of the inspection, we observed visible oil pooled near the well head, oil staining, and a leaking well head near the stuffing box and casing head. Fluids were also observed near the well head.
