## Region 6 Compliance Assurance and Enforcement Division

### INSPECTION REPORT

| Company Name: | <b>Seven Cross Operating, LLC</b> | | |
| Facility Name: | <b>Novice Unit 8022 Battery Lease (RRC Lease No. 10904)</b> | | |

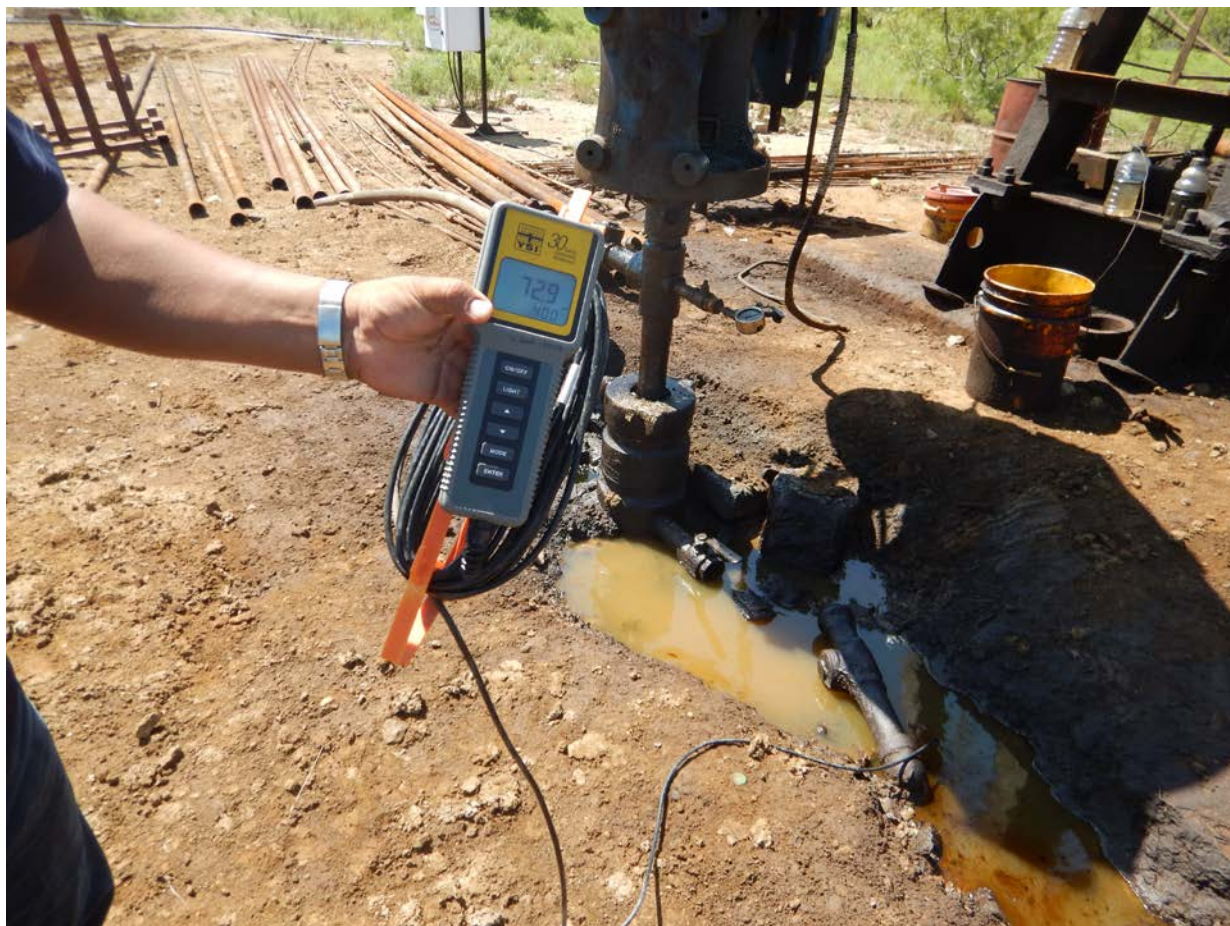
Photograph File Name: DSCN0862.JPG

Description: This image shows the Novice Unit Well No. 8099, which is associated with the Novice Unit 8022 Battery Lease. At the time of the inspection, we observed visible oil pooled near the well head, oil staining, and a leaking well head near the stuffing box and casing head. Fluids were also observed near the well head with oil sheen and salt crystals near the well head. A TSS reading of 72,900 ppm was taken from the fluids pooled near the well head that we observed leaking.

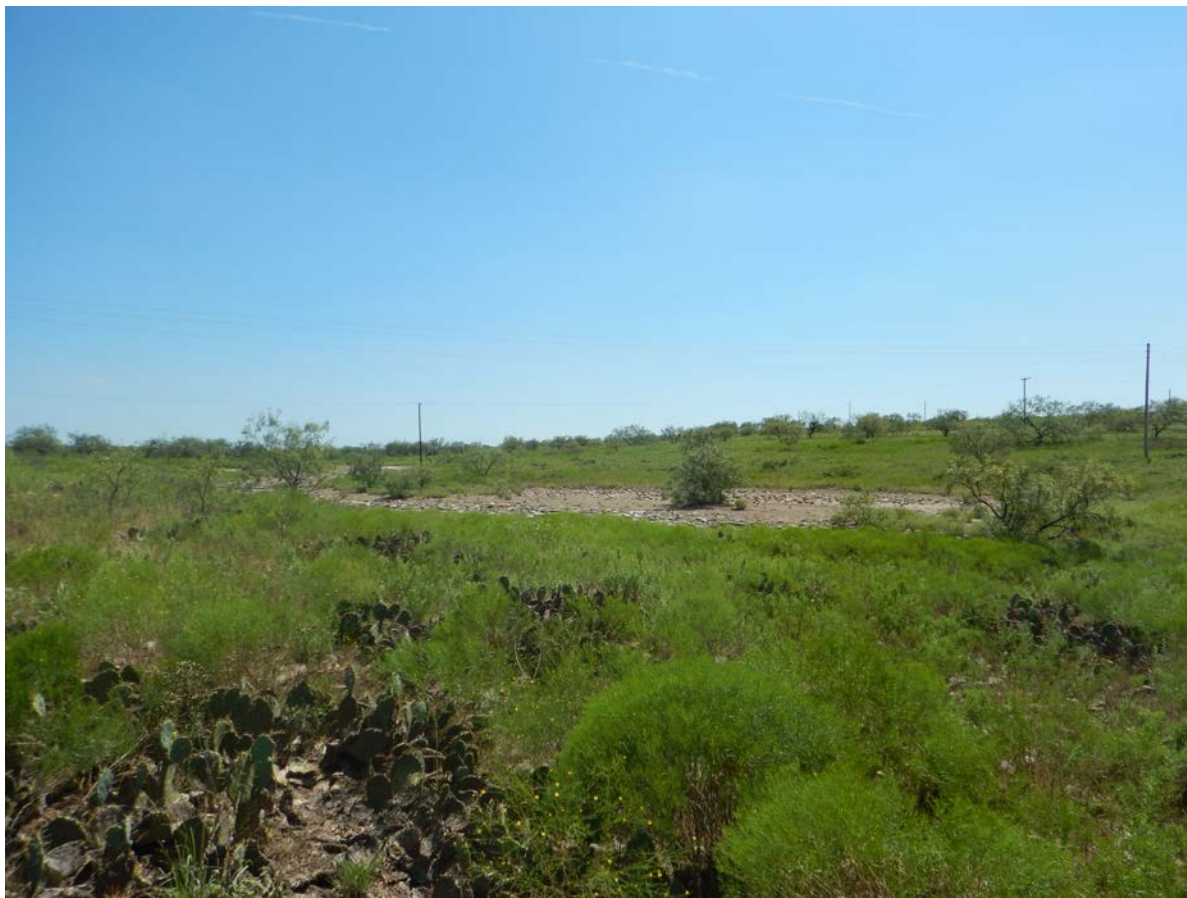
Photograph File Name: DSCN0857.JPG

Description: This image shows the dry flow path, downstream of the Novice Unit 8022 Battery Lease. We observed that the flow path merged with the tributary of the South Fork of the Jim Ned Creek and went north towards the South Fork of the Jim Ned Creek. We observed bed and bank along the tributary as well as a lack of vegetation along the flow path

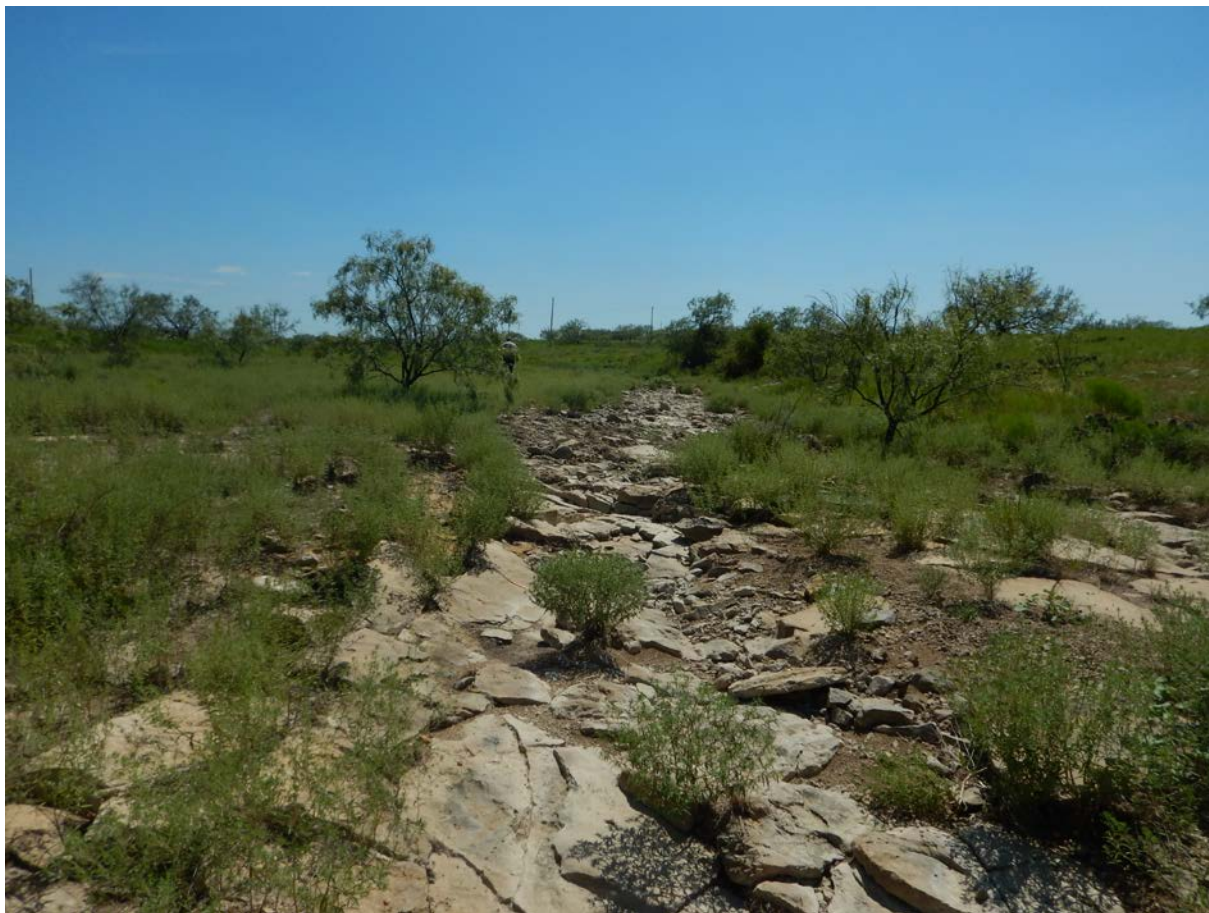
Photograph File Name: DSCN0854.JPG

Description: This image shows the dry flow path, downstream of the Novice Unit 8022 Battery Lease. We observed that the flow path merged with the tributary of the South Fork of the Jim Ned Creek and went north towards the South Fork of the Jim Ned Creek. We observed bed and bank along the tributary, including visible rock bottom and bank on the west side of the tributary.

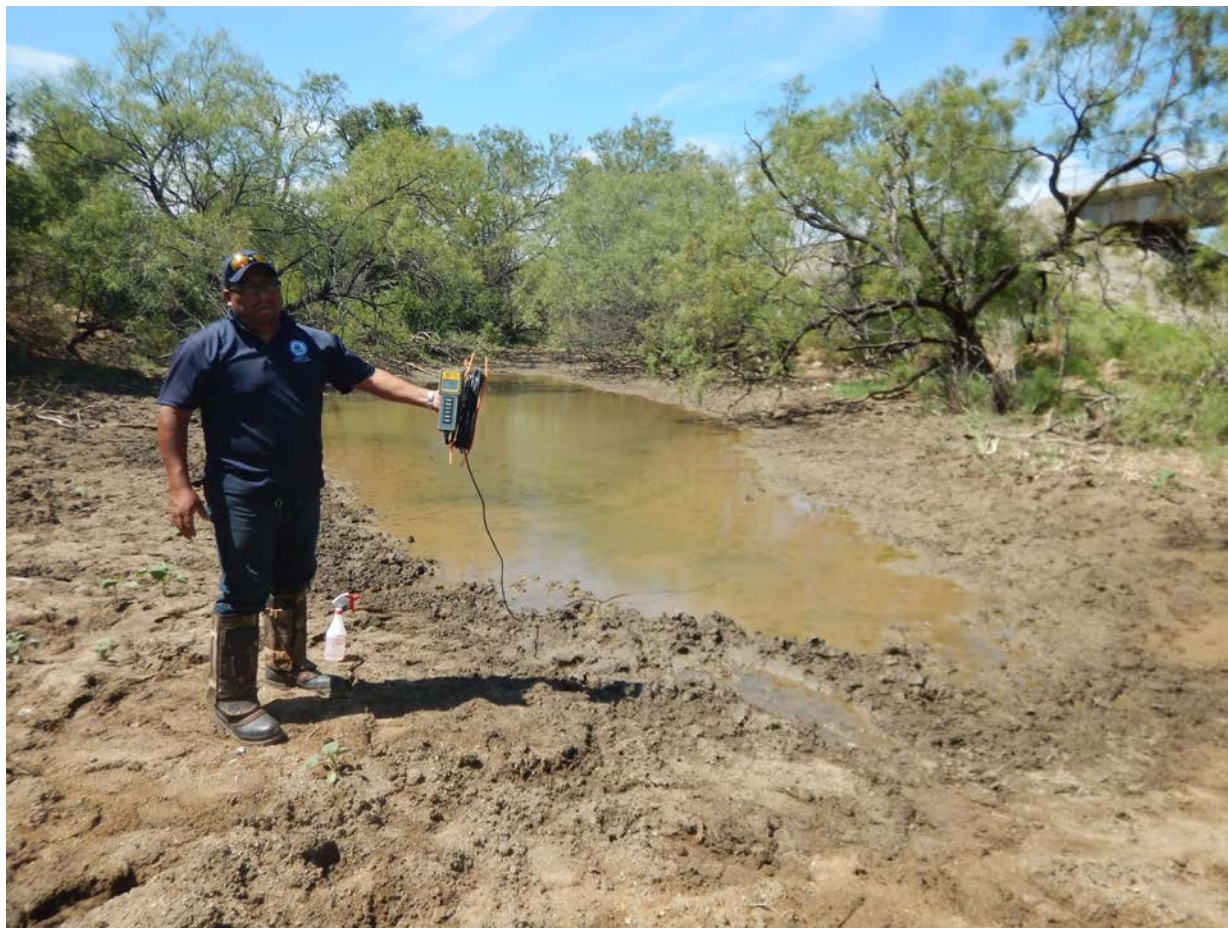
Photograph File Name: DSCN0856.JPG

Description: This image shows the dry flow path, downstream of the Novice Unit 8022 Battery Lease. We observed a dry flow path to a tributary of the South Fork of the Jim Ned Creek and ponded fluids. We took a TSS reading at the point of entry of the flow path from the tank battery, downstream along the tributary. We observed visible bed and bank as well as high water marks shown on the tributary at the time of the inspection.

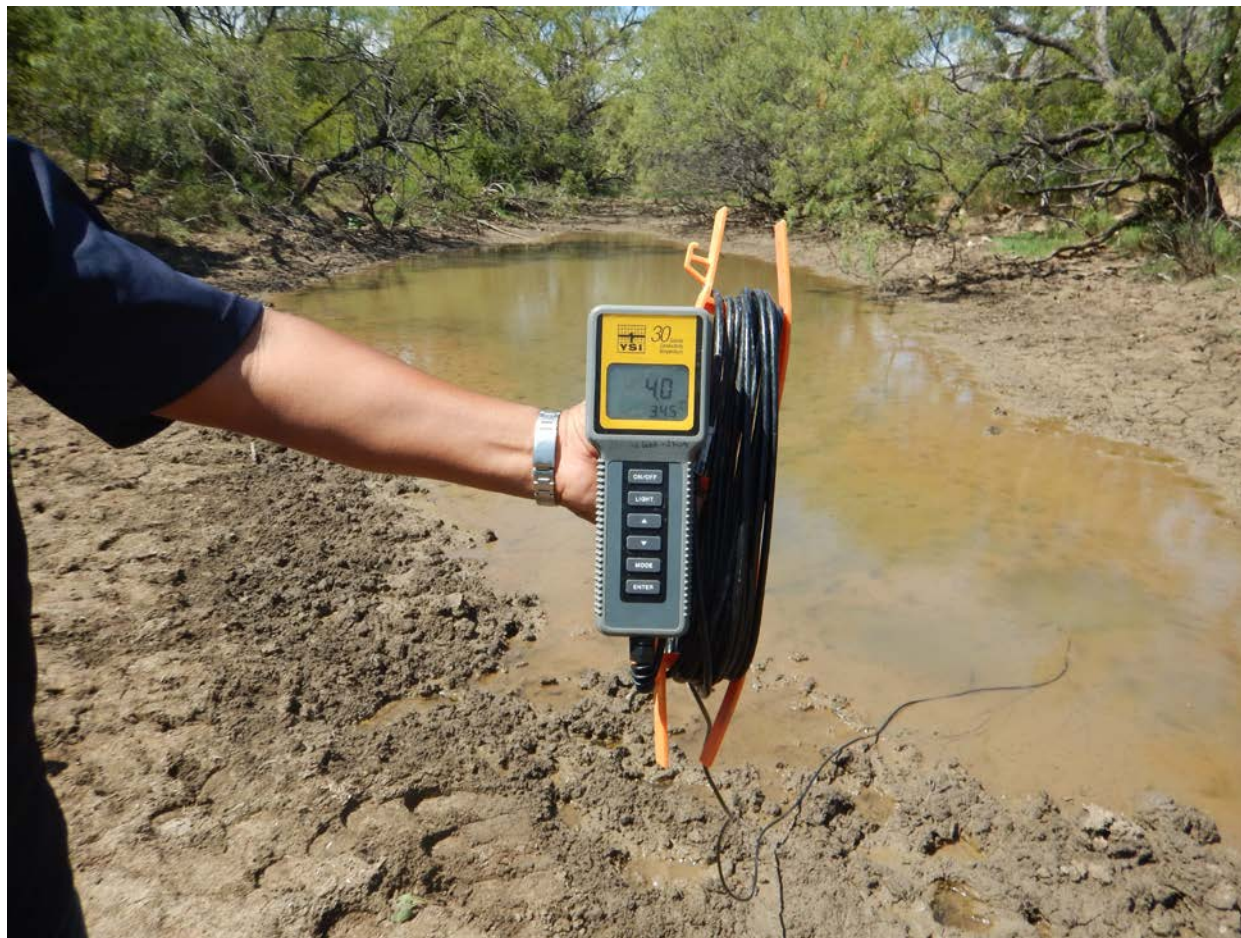
Photograph File Name: DSCN0855.JPG

Description: This image shows the dry flow path, downstream of the Novice Unit 8022 Battery Lease. We observed a dry flow path to a tributary of the South Fork of the Jim Ned Creek and ponded fluids. We took a TSS reading of 4,000 ppm at the point of entry of the flow path from the tank battery, downstream along the tributary.

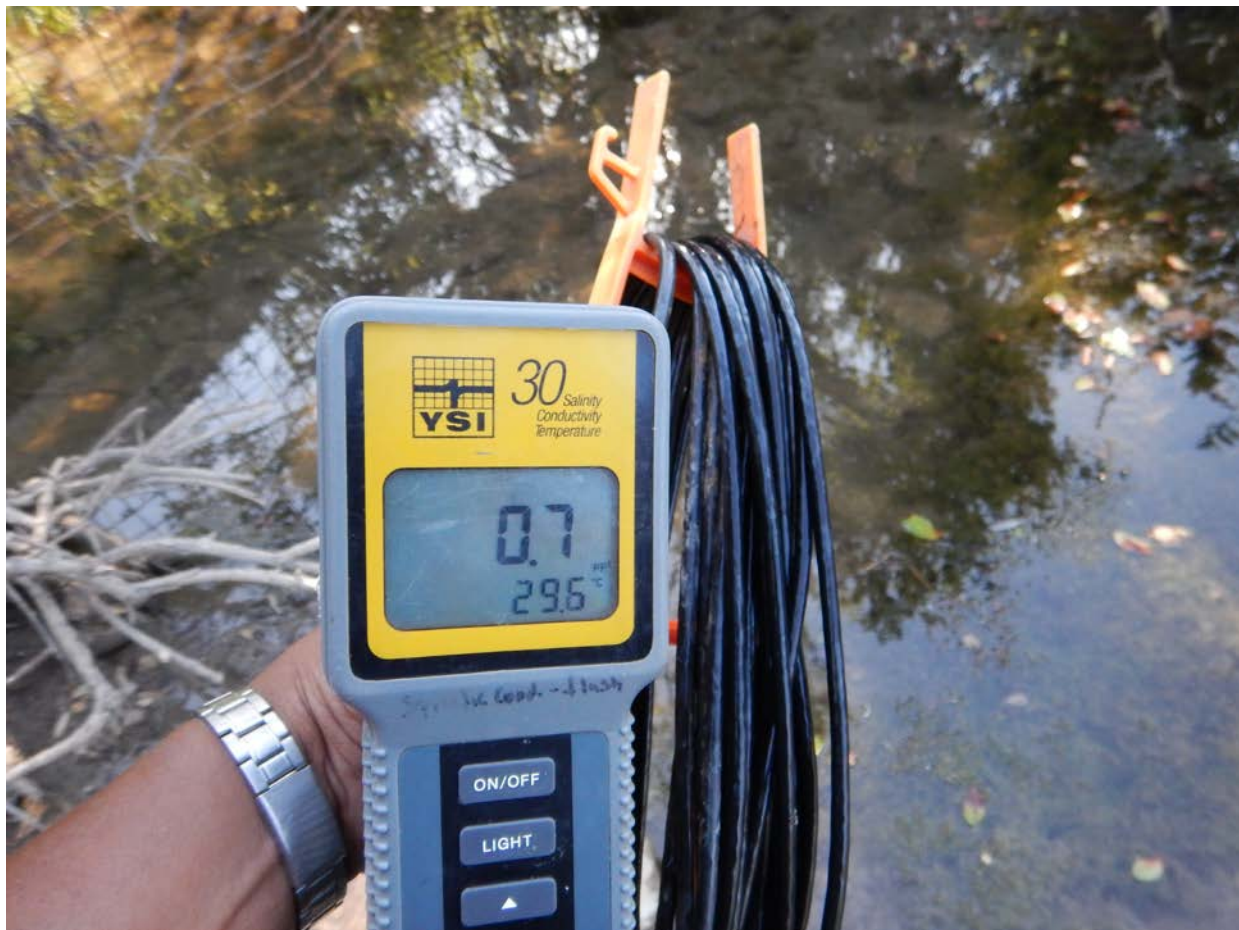
Photograph File Name: DSCN0909.JPG

Description: This image shows the South Fork of the Jim Ned Creek downstream from where the tributary coalesces with the South Fork of Jim Ned Creek. A TSS reading of 700 ppm was taken at this location. We observed riparian debris and vegetation at the time of inspection.

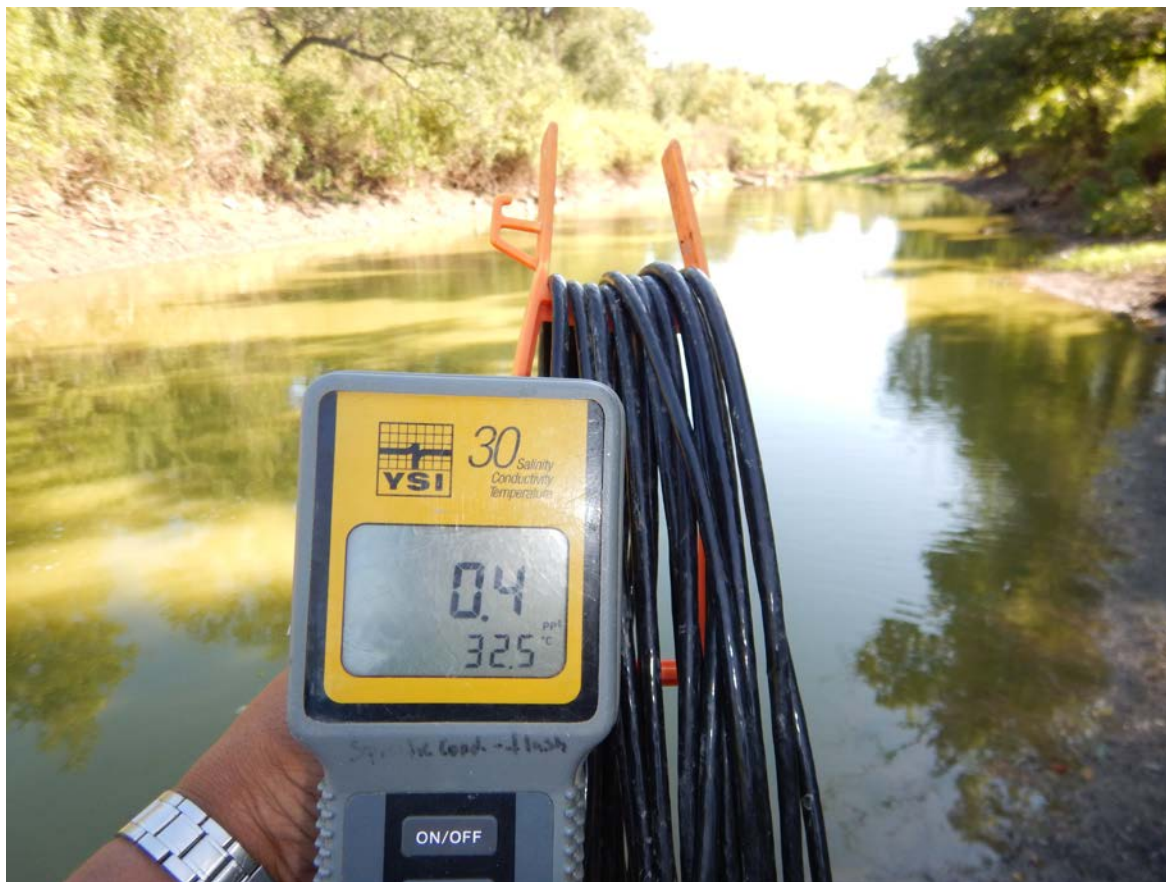
Photograph File Name: DSCN0908.JPG

Description: This image shows the South Fork of the Jim Ned Creek upstream approximately 100 feet from where the tributary coalesces with the South Fork of Jim Ned Creek. A TSS reading of 400 ppm was taken at this location as a background measurement. We observed that the South Fork of Jim Ned Creek, which can be seen in the back ground of Photo No. 26, has bed and bank characteristics similar to a riparian environment.

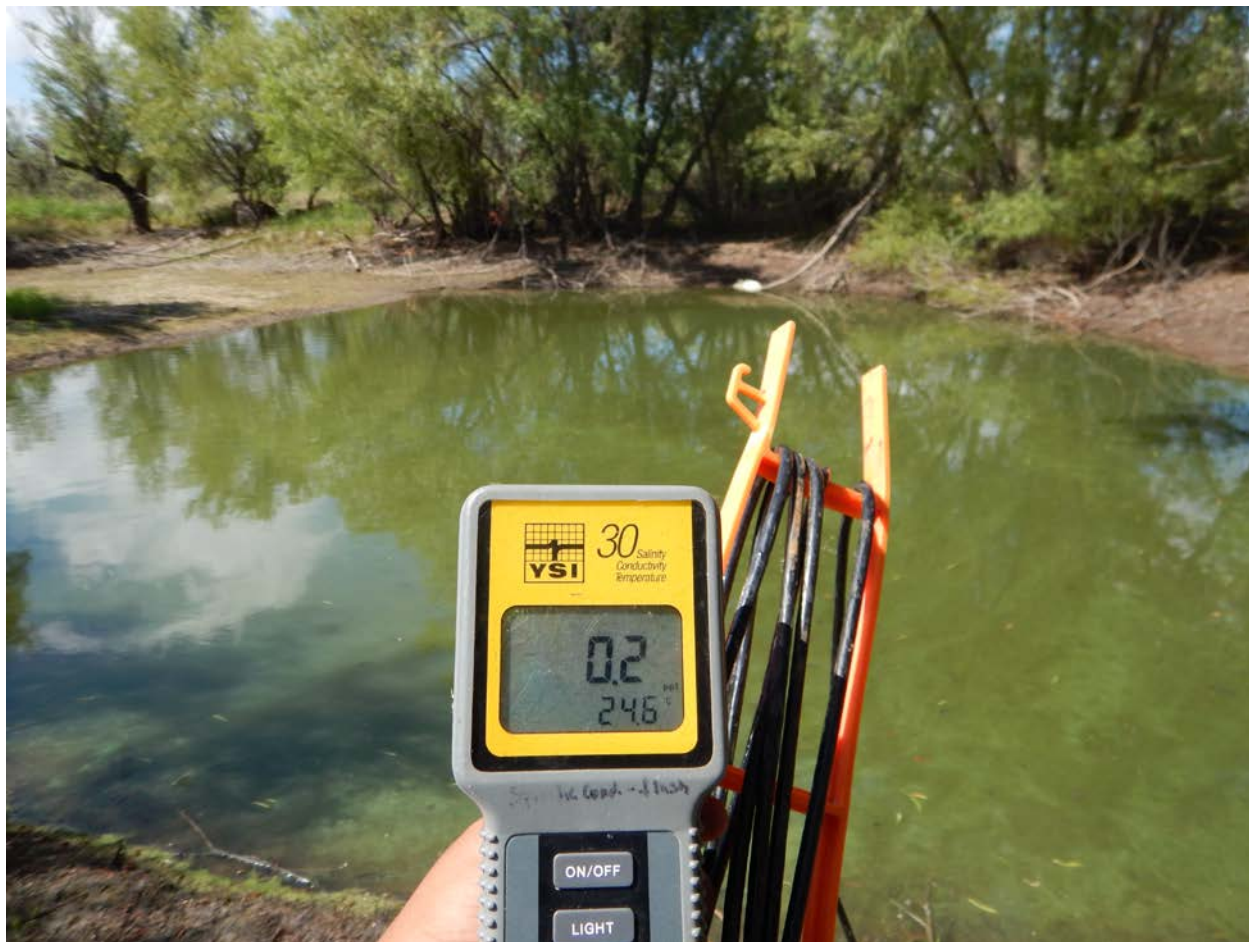
Photograph File Name: DSCN0939.JPG

Description: This image shows an additional background TSS reading of 200 ppm taken upstream along the tributary of the South Fork of the Jim Ned Creek. We observed visible aquatic life at the time of the inspection at the ponded area, as seen in this photo.
