SUMMARY OF SPECIAL C-8 SAMPLING PROJECT

Jennifer Nichols  
Environmental Lab LSE

9-16-97

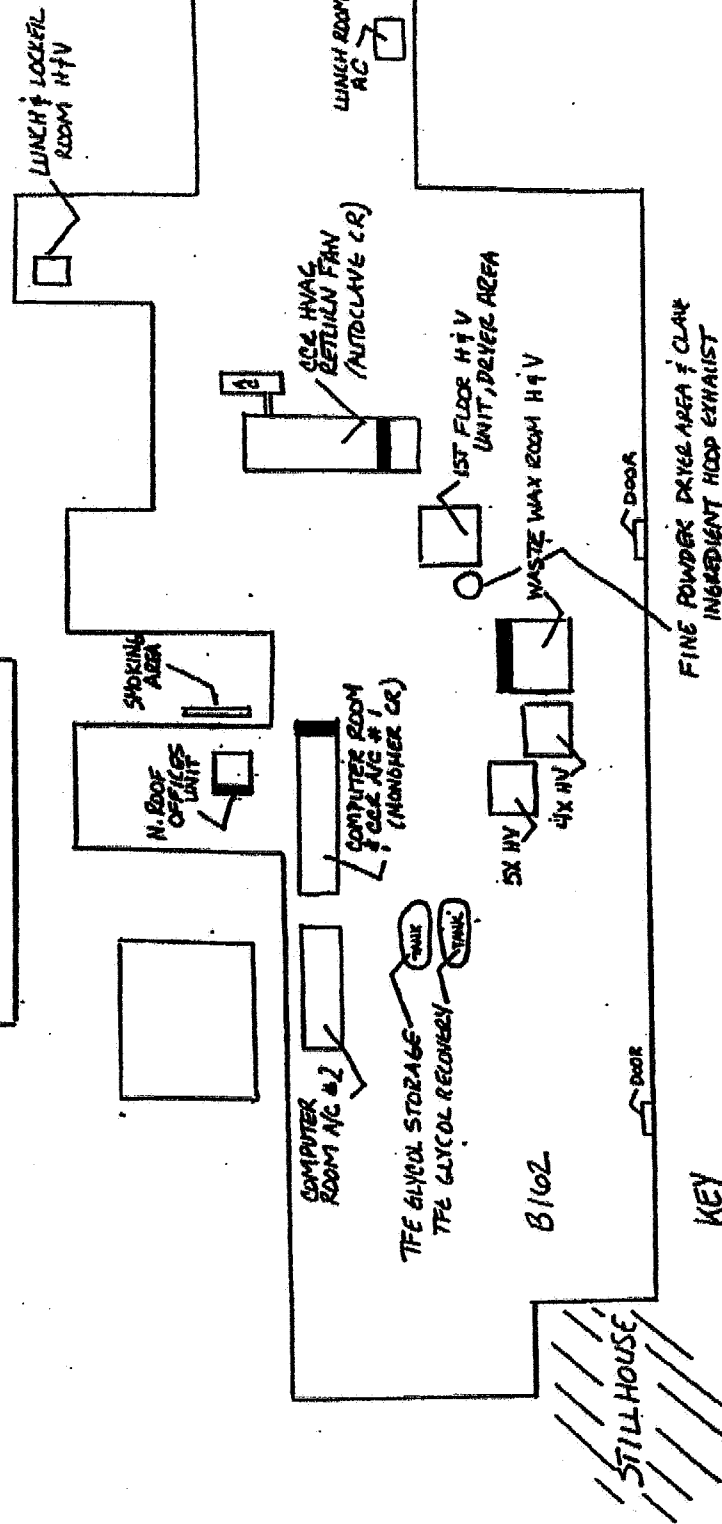
THIS CR'S SYSTEM IS LOCATED ON THE ROOF (FIG. 1). THE INTAKE IS LOCATED ON TOP OF THE RETURN FAN SYSTEM (AC UNIT IS CONNECTED TO THIS).

THERE IS AN OUTSIDE DOOR WHICH IS FREQUENTLY LEFT OPEN FOR VENTILATION BUT OCCASIONALLY ITS BEEN SHUT. THE HVAC UNIT IS LOCATED ON THE ROOF (FIG. 1).

THIS UNIT IS ON THE SAME LEVEL AS OTHERS BUT, APPEARS TO SIT LOWER BECAUSE IT IS FLUSH WITH THE GROUND. IT IS CLOSEST TO THE C-8 STACK (FIG. 1).

THERE IS A ROOF UNIT MARKED CCR AND COMPUTER #1 UNIT. A SECOND UNIT, WEST OF IT, IS MARKED COMPUTER #2 UNIT. THESE ARE DIRECTLY ACROSS FROM THE C-8 STACK (FIG. 1).

C-8 STACK

- \* THE ROOF SAMPLES DEMONSTRATE A NEED FOR BETTER CONTROLS ON THE C-8 STACK EMISSIONS AND/OR LIMITING THE TIME SPENT (WITHOUT A RESPIRATOR) ON THE ROOF. LOCATIONS CLOSEST TO THE STACK SHOWED LOWER LEVELS THAN THOSE TO THE SOUTH (FIGURE 4) DEMONSTRATING A LOOPING EFFECT OF THE EMISSION. AS STATED BEFORE, ON SEVERAL OCCASIONS WHEN I WAS ON THE ROOF I WITNESSED THE EMISSION LOOPING EFFECT (DEPENDING ON THE WEATHER). FOLLOW-UP SAMPLING CAMPAIGN SUGGESTED AFTER REMEDIATION.
