**Region 6 Compliance Assurance and Enforcement Division  
INSPECTION REPORT**

| Company Name: | <b>Diamond 3S, LLC</b> | | |
| Facility Name: | <b><i>Kennedy</i></b> | | |
| Identification/Permit Number: | OKU000867 | | |

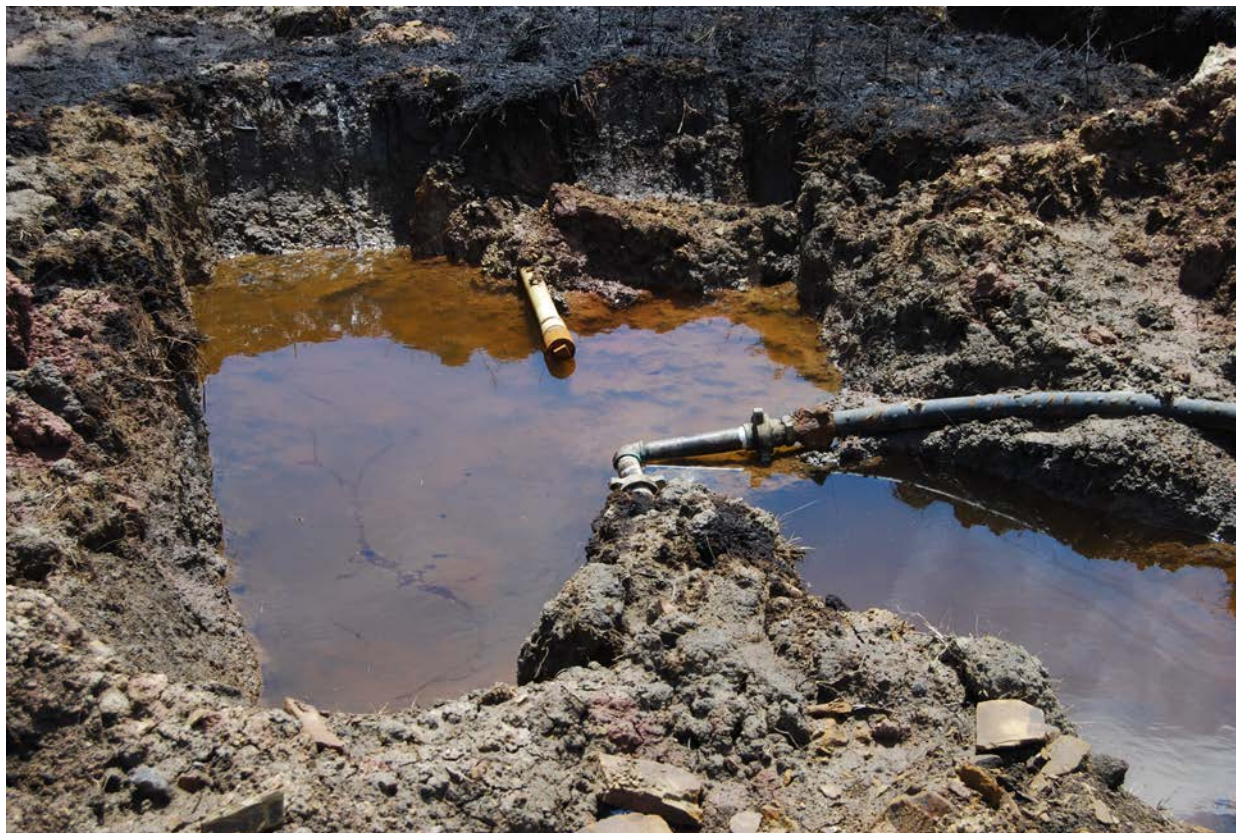
Photo No. 1

I arrived at the Diamond 3S, LLC, Kennedy lease at about 1:00 pm on April 26, 2018. Photo 1 indicated that the injection line that leaked brine and some oil into the tributary of Daniel's Run Creek had not been moved. Photo 2 shows the ongoing damage to the hillside where the flow path of brine occurred on the surface and subsurface from a previous leak that occurred in March 2018. The ground was still saturated with brine near the tributary (Photo 3). The brine was seeping into the creek (Photo 4). A Specific Conductance field reading was taken with a calibrated YSI 30 Conductivity Meter at the point of entry and was 67.4 milliSiemens (mS), which was converted to 43,810 milligrams/Liter (mg/L) Total Dissolved Solids (TDS) as shown in Appendix 2 (Photo 5 in Appendix 1). The tributary was full after a recent rainfall event (Photo 6). Dam 1 had water and brine running through a pipe and downstream along the tributary of Daniel's Run Creek during the inspection. There was some foam observed on the surface of the tributary. (Photo 7). A Specific Conductance field reading taken at Dam 1 was 65.9 mS, which was converted to 42,835 mg/L TDS as shown in Appendix 2 (Photo 8 in Appendix 1). Dam 2 was full and running over and flowing downstream during the inspection (Photo 9). A dead crayfish was present at the Dam 2 location (Photo 10). A Specific Conductance field reading taken at Dam 2 was 26.55 mS, which was converted to 17,257 mg/L TDS as shown in Appendix 2 (Photo 11 in Appendix 1). I observed that water and brine were also running through Dam 3 during the inspection and flowing south, downstream, as shown in Photos 12 and 13. A Specific Conductance field reading taken at Dam 3

Description: This photo shows where a previous discharge originated from an injection well line located, which was a few yards from Kennedy #3 injection well.

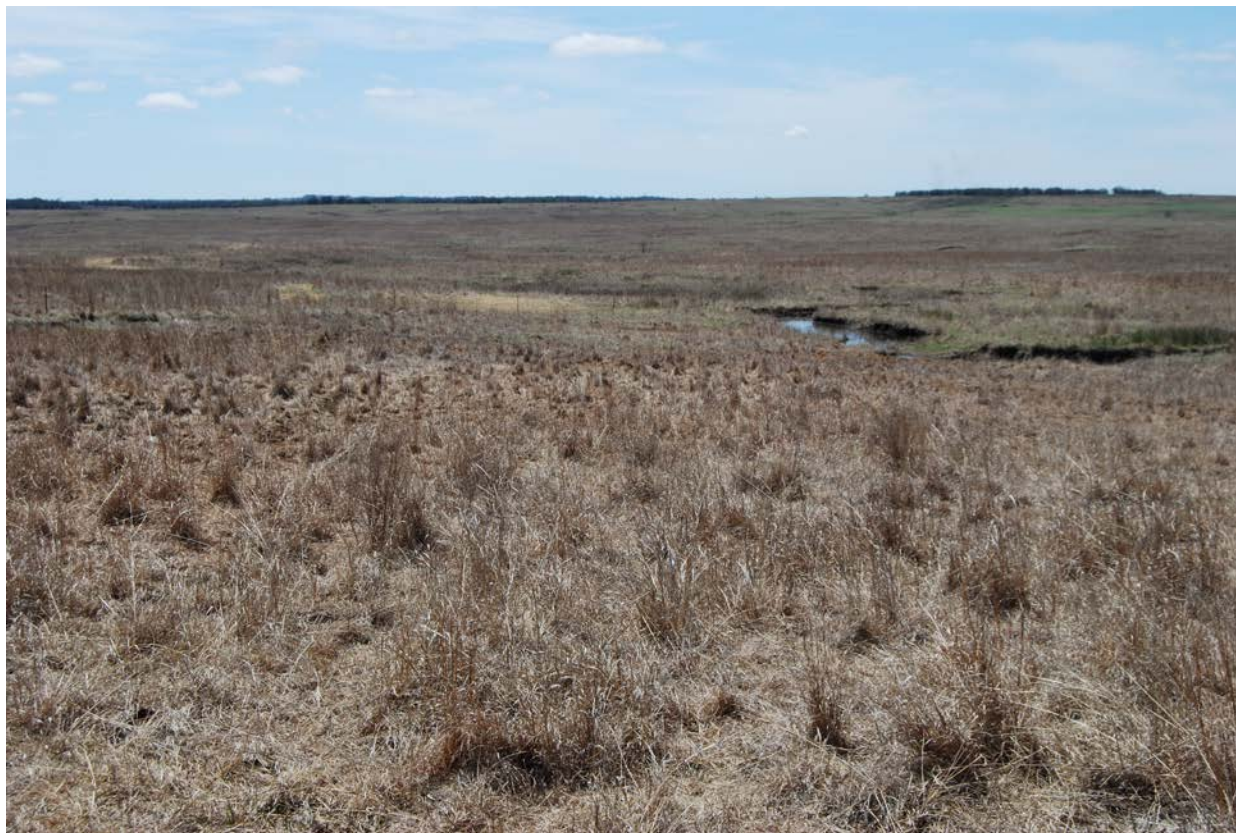
Photo No. 2

Description: The hillside southwest of the point of discharge was dead and saturated with brine during the inspection. The brine was seeping from the contaminated hillside into the tributary of Daniel's Run Creek.

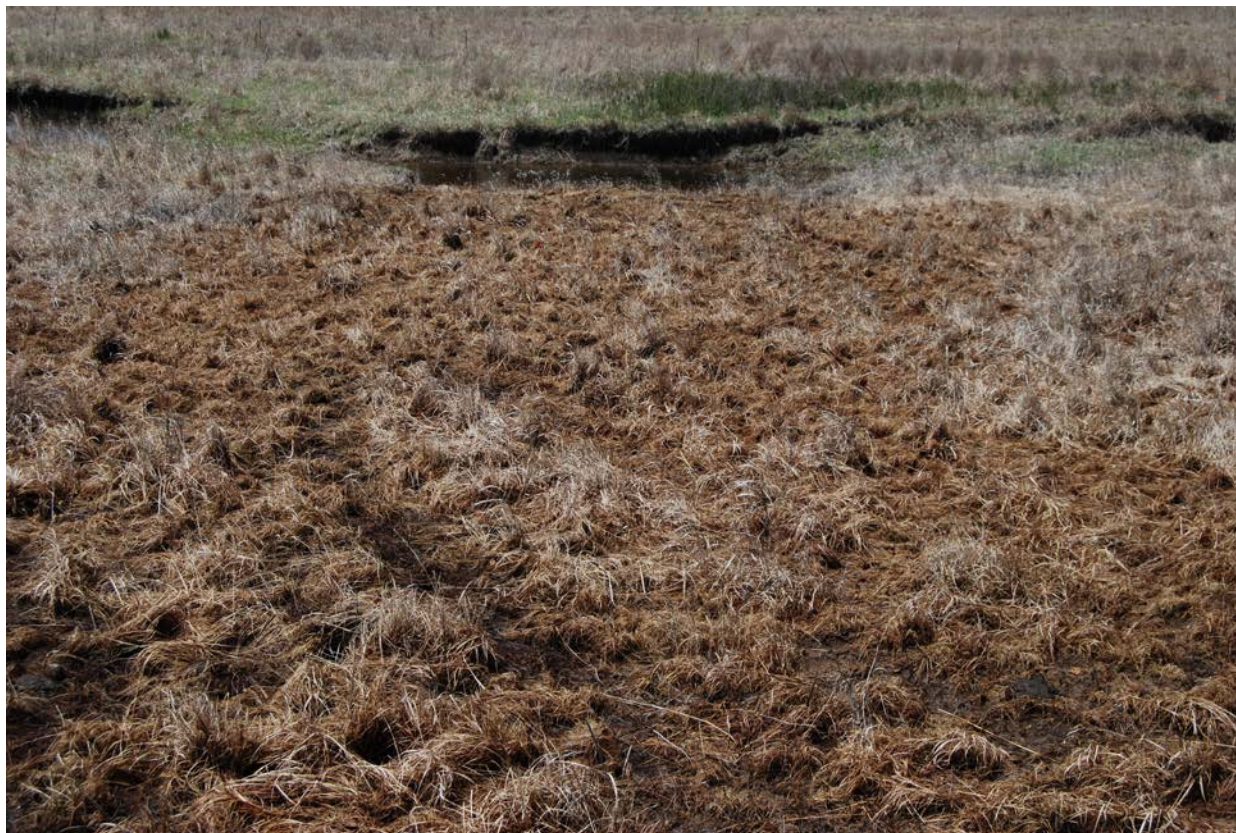
Photo No. 3

Description: The ground next to the tributary was saturated with brine and flowed to the point of entry to the tributary of Daniel's Run Creek.

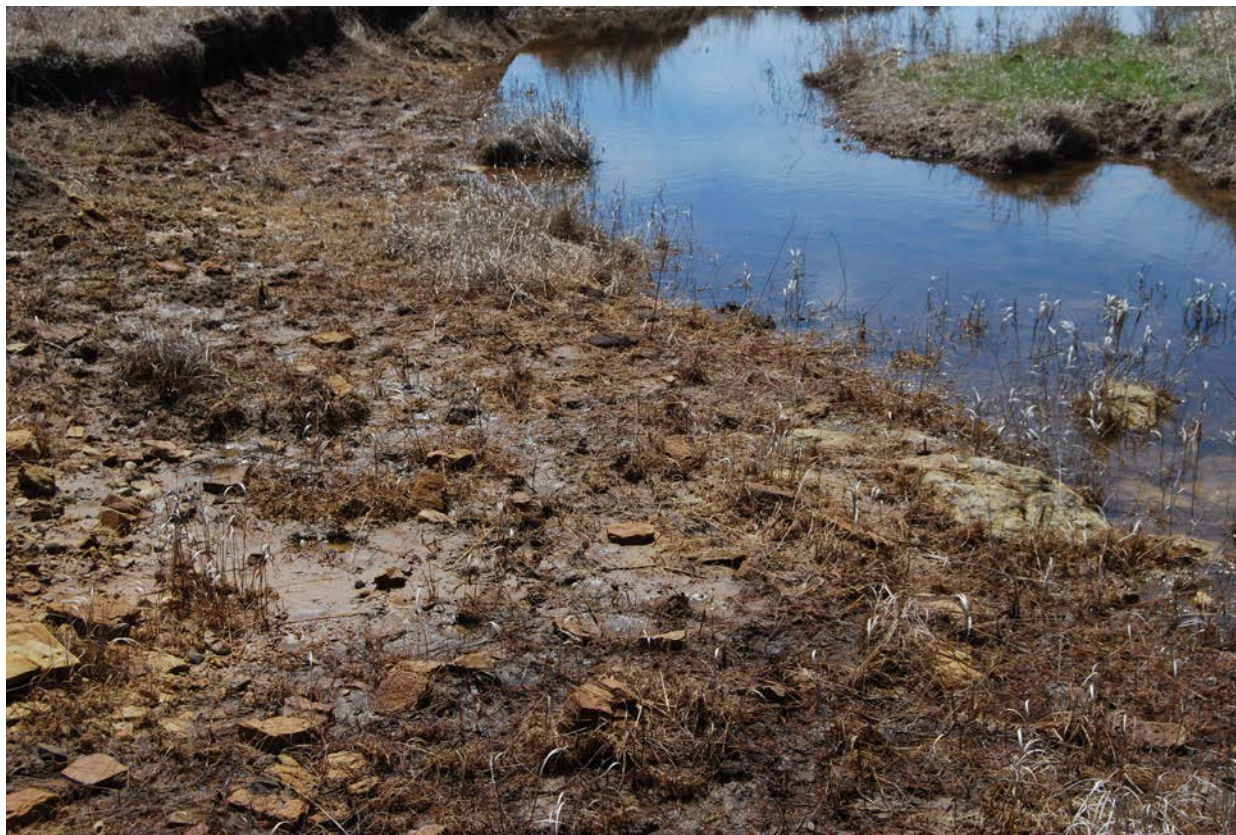
Photo No. 4

Description: The brine enters the tributary of Daniel's Run Creek here from the large saturated area uphill from the point of entry.

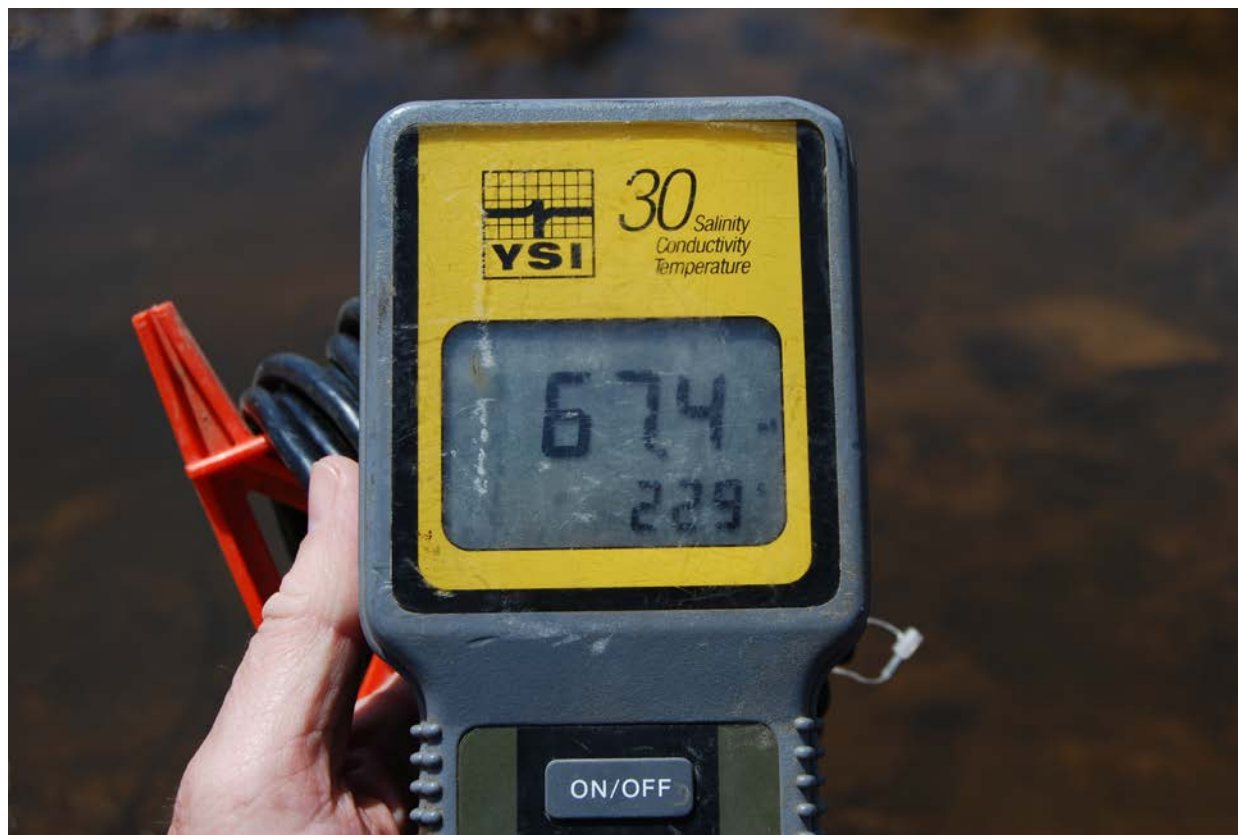
Description: A Specific Conductance field reading was taken with a calibrated YSI 30 Conductivity Meter at the point of entry was 67.4 milliSiemens (mS), which was converted to 43,810 milligrams/Liter (mg/L) Total Dissolved Solids (TDS) as shown in Appendix 2.

| Inspection Report<br>Photo No. | Specific Conductance<br>Reading (mS) | Specific Conductance<br>(uS) | Converted Total<br>Dissolved Solids (mg/L)* |
|---|---|---|---|
| Photo No. 5 | 67.4 mS | 67,400 uS | 43,810 mg/L |

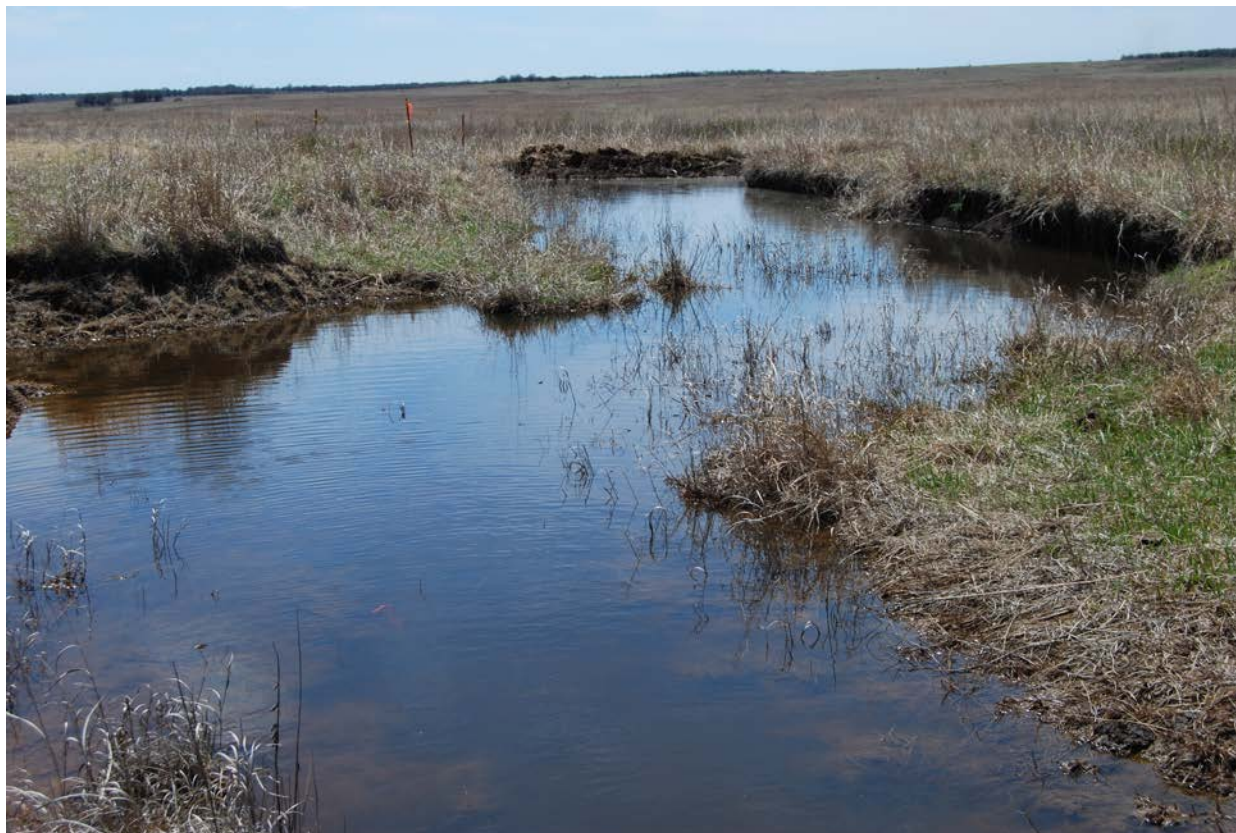
Photo No. 6

Description: The tributary was shown here backed up behind the first temporary dam, or Dam 1. I observed some bed, bank and riparian vegetation.

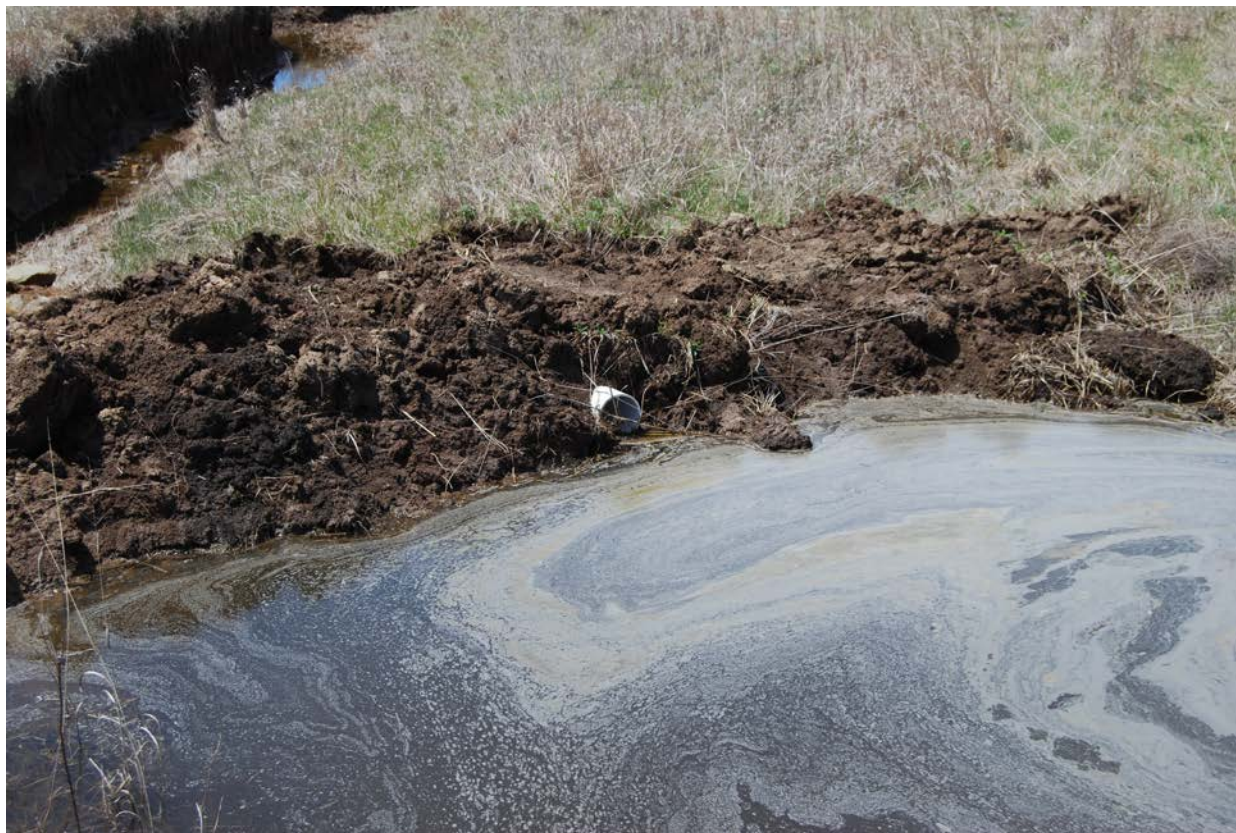
Photo No. 7

Description: Dam 1 is shown here and water and brine were running through the pipe and downstream along the tributary of Daniel's Run Creek during the inspection. There was some foam observed on the surface of the tributary.

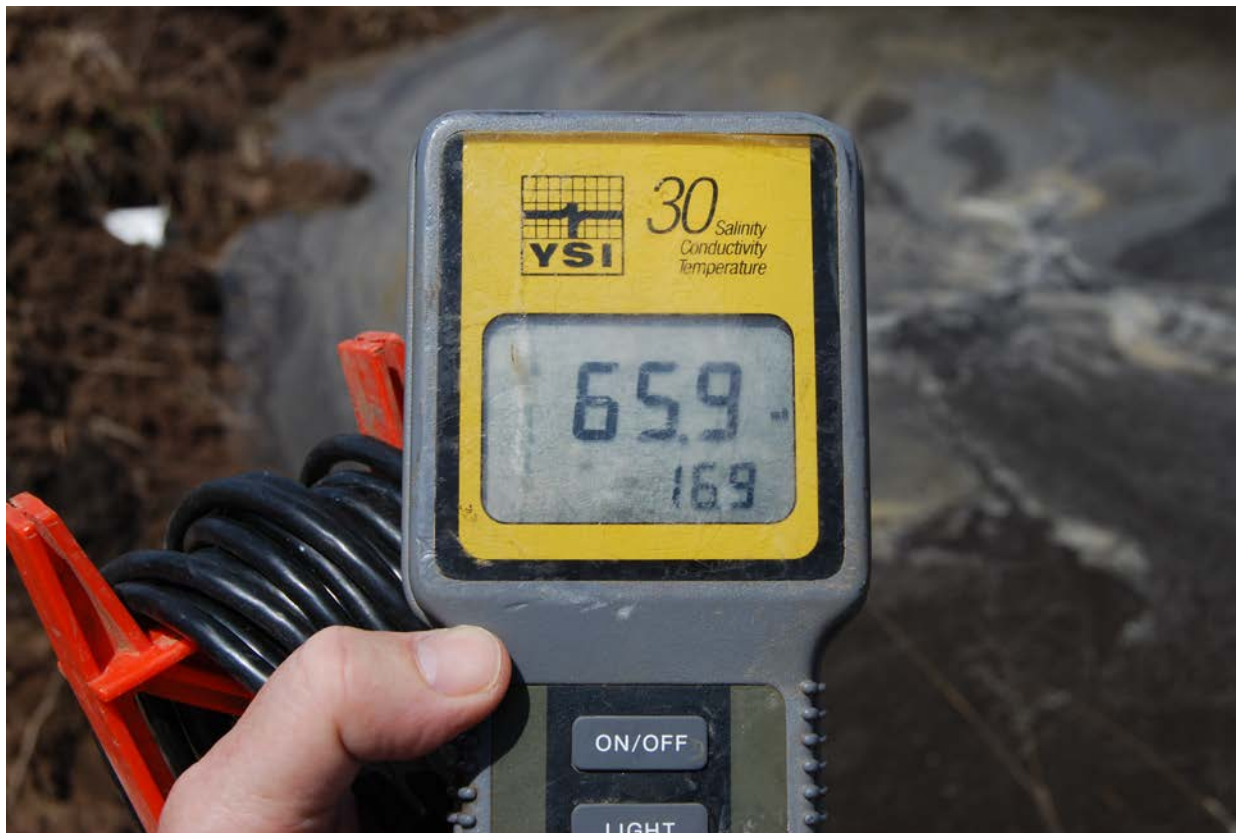
Description: A Specific Conductance field reading taken at Dam 1 was 65.9 mS, which was converted to 42,835 mg/L TDS as shown in Appendix 2.

| Inspection Report<br>Photo No. | Specific Conductance<br>Reading (mS) | Specific Conductance<br>(uS) | Converted Total<br>Dissolved Solids (mg/L)* |
|---|---|---|---|
| Photo No. 8 | 65.9 mS | 65,900 uS | 42,835 mg/L |

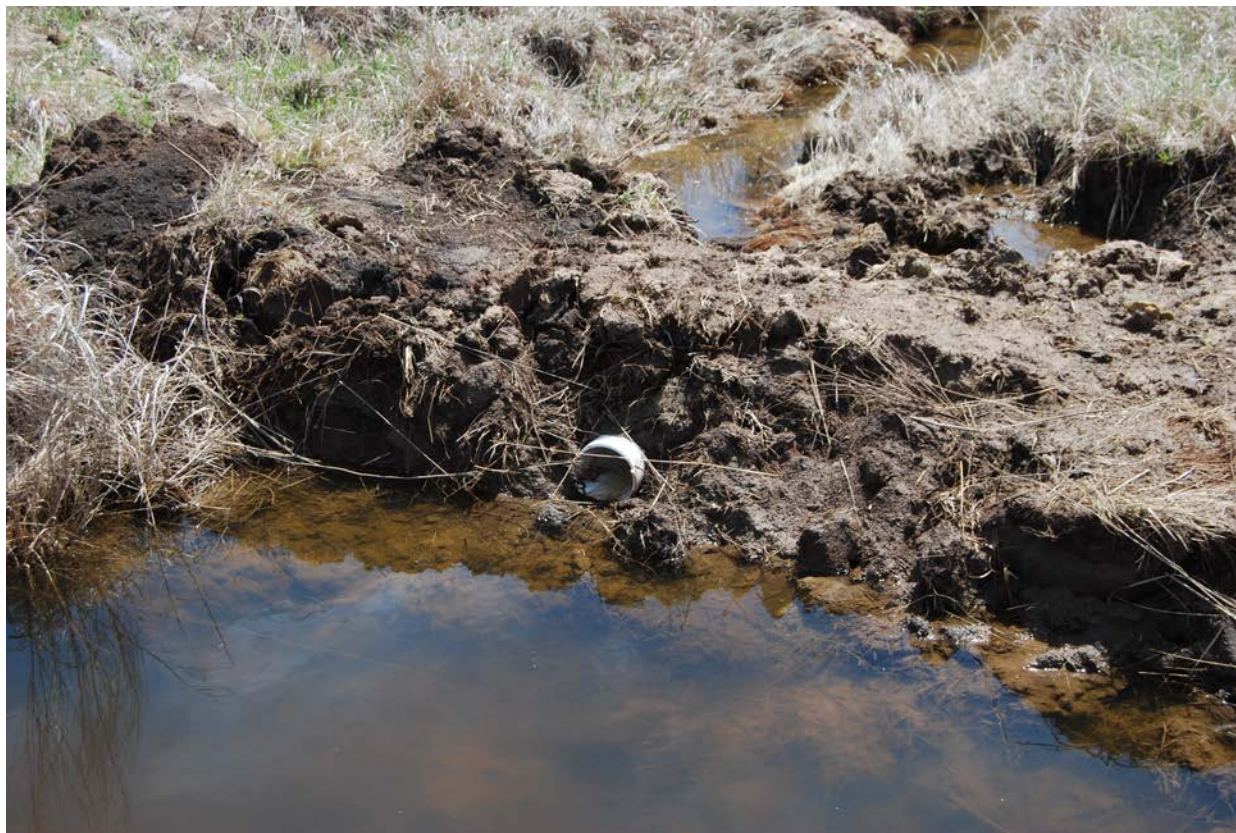
Photo No. 9

Description: This photo shows the second temporary dam, or Dam 2. Water and brine were also flowing over the dam and flowing downstream in the tributary of Daniel's Run Creek.

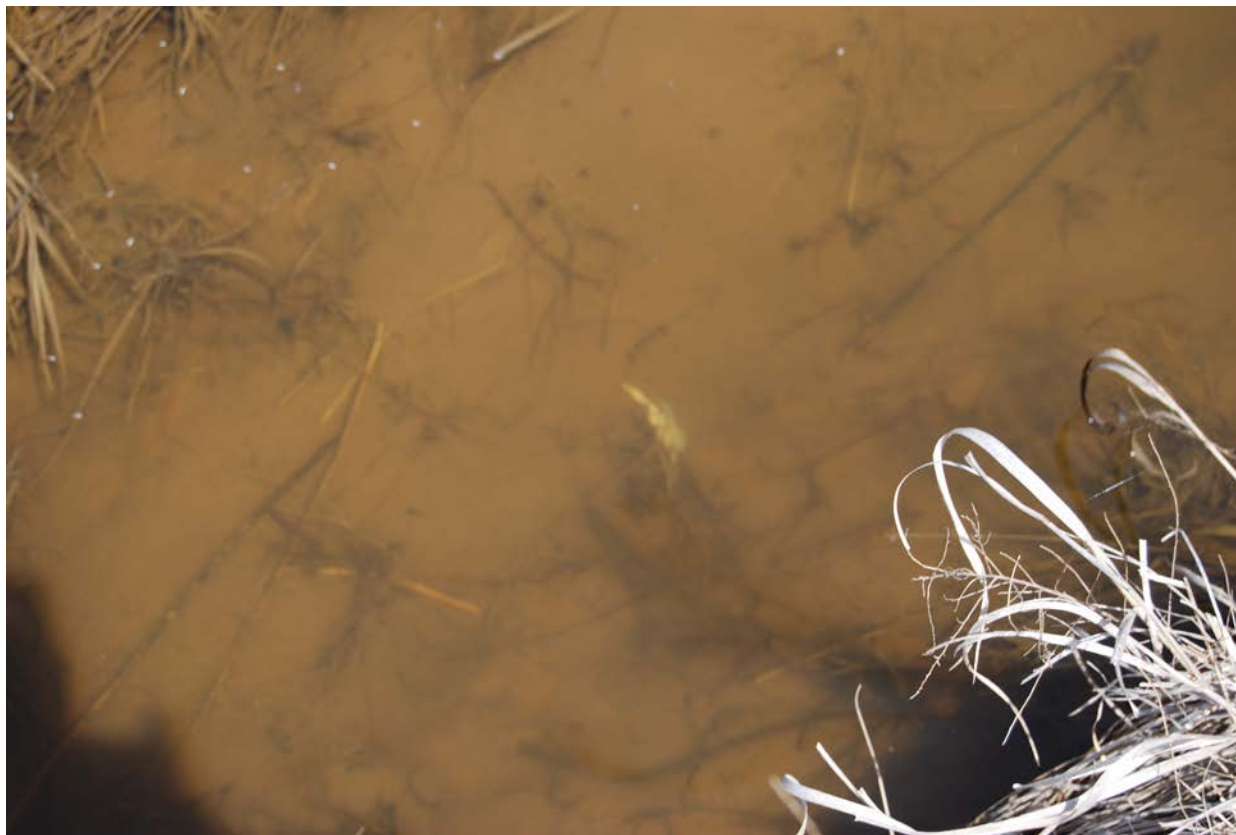
Photo No. 10

Description: I observed a dead crayfish in the tributary at Dam 2.

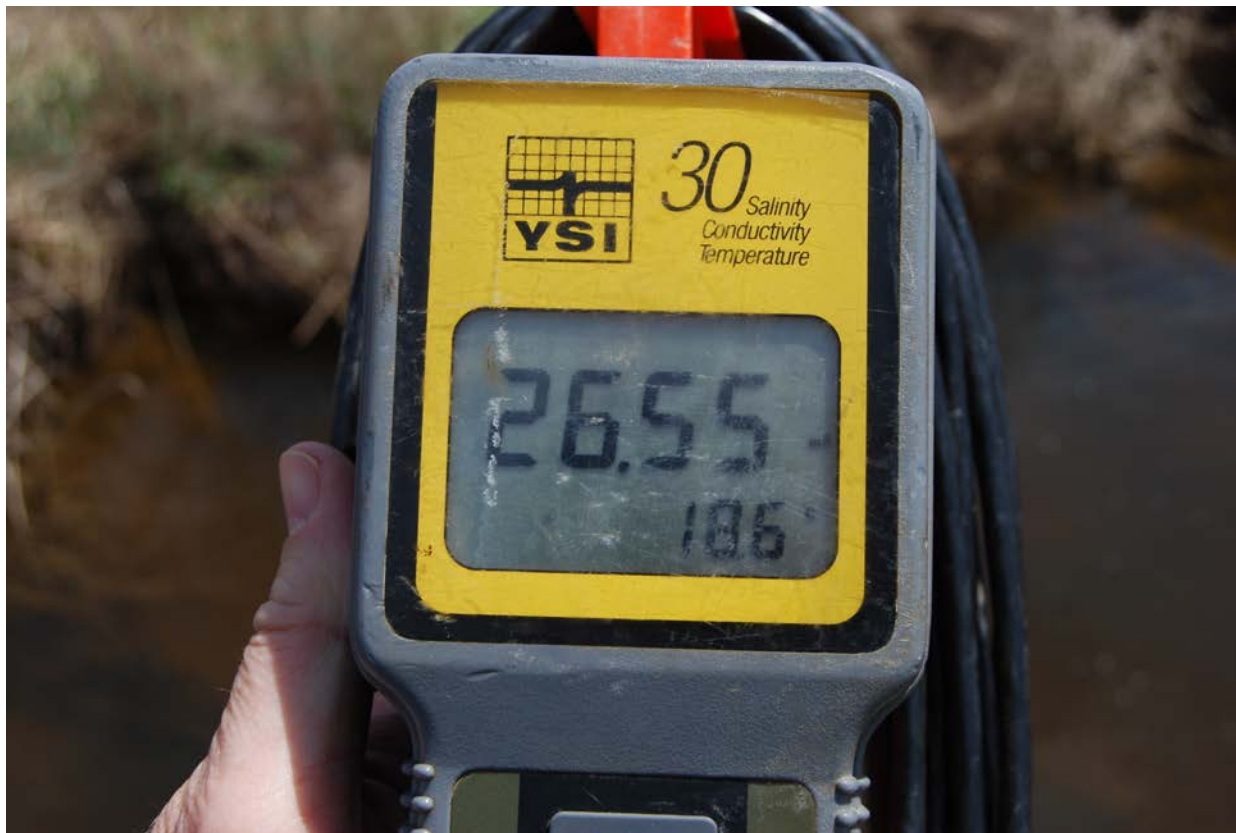
Description: A Specific Conductance field reading taken at Dam 2 was 26.55 mS, which was converted to 17,257 mg/L TDS as shown in Appendix 2.

| Inspection Report<br>Photo No. | Specific Conductance<br>Reading (mS) | Specific Conductance<br>(uS) | Converted Total<br>Dissolved Solids (mg/L)* |
|---|---|---|---|
| Photo No. 11 | 26.55 mS | 26,550 uS | 17,257.5 mg/L |

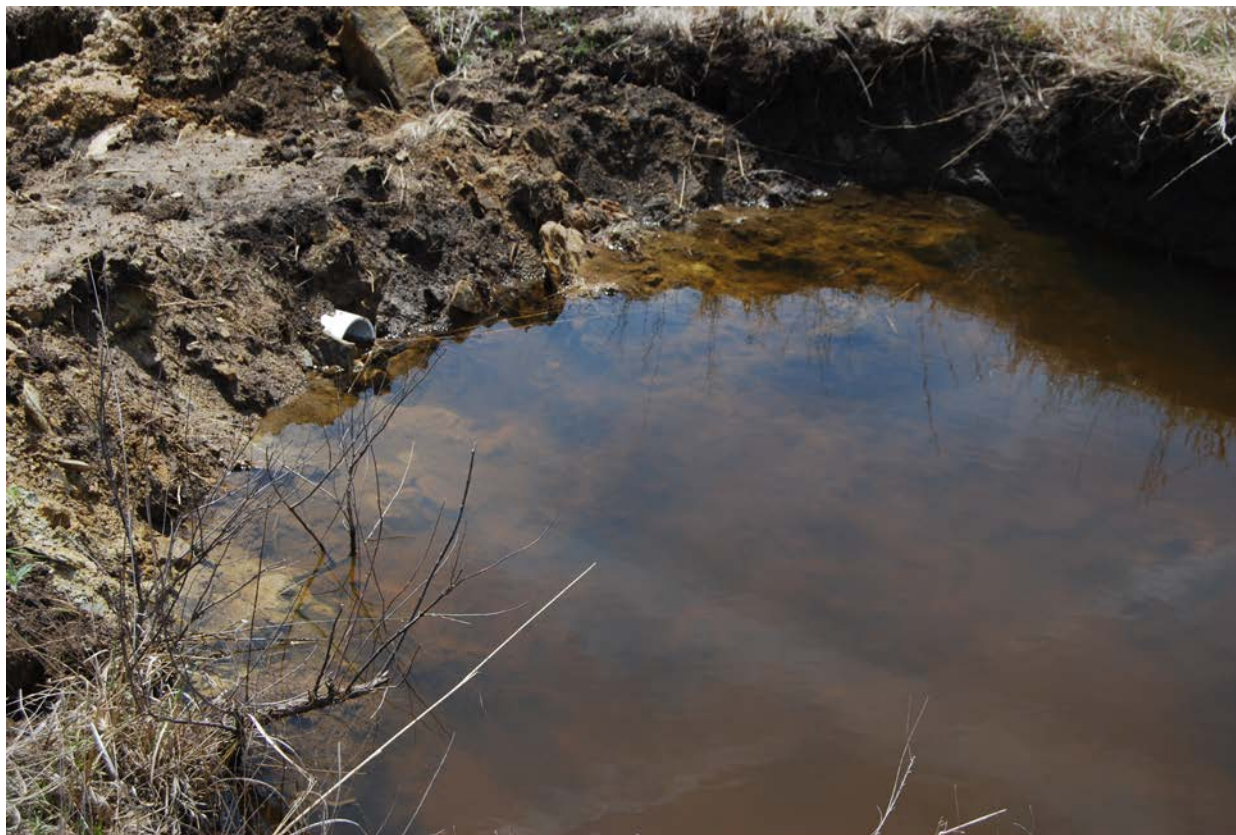
Photo No. 12

Description: This photo shows a third temporary dam, or Dam 3.

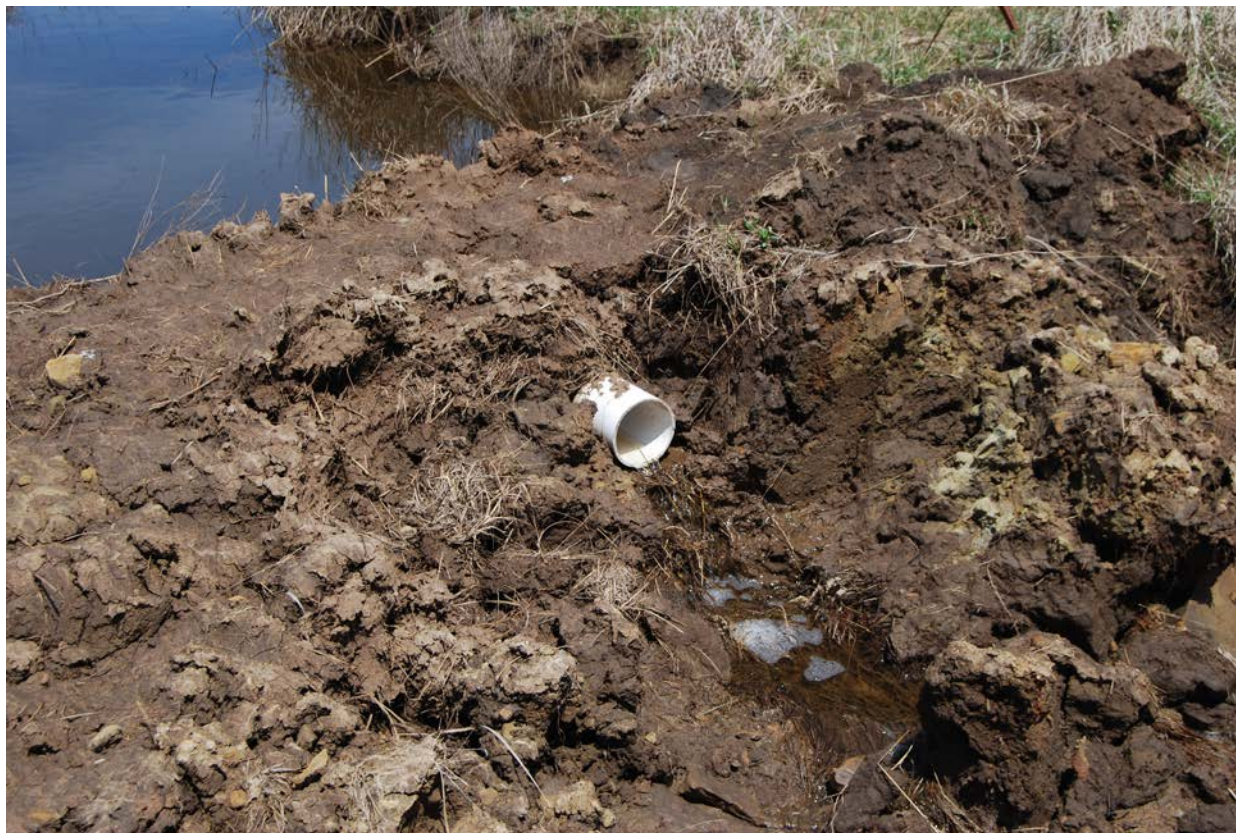
Photo No. 13

Description: I observed that water and brine were also running through the Dam 3 during the inspection and flowing south, downstream.

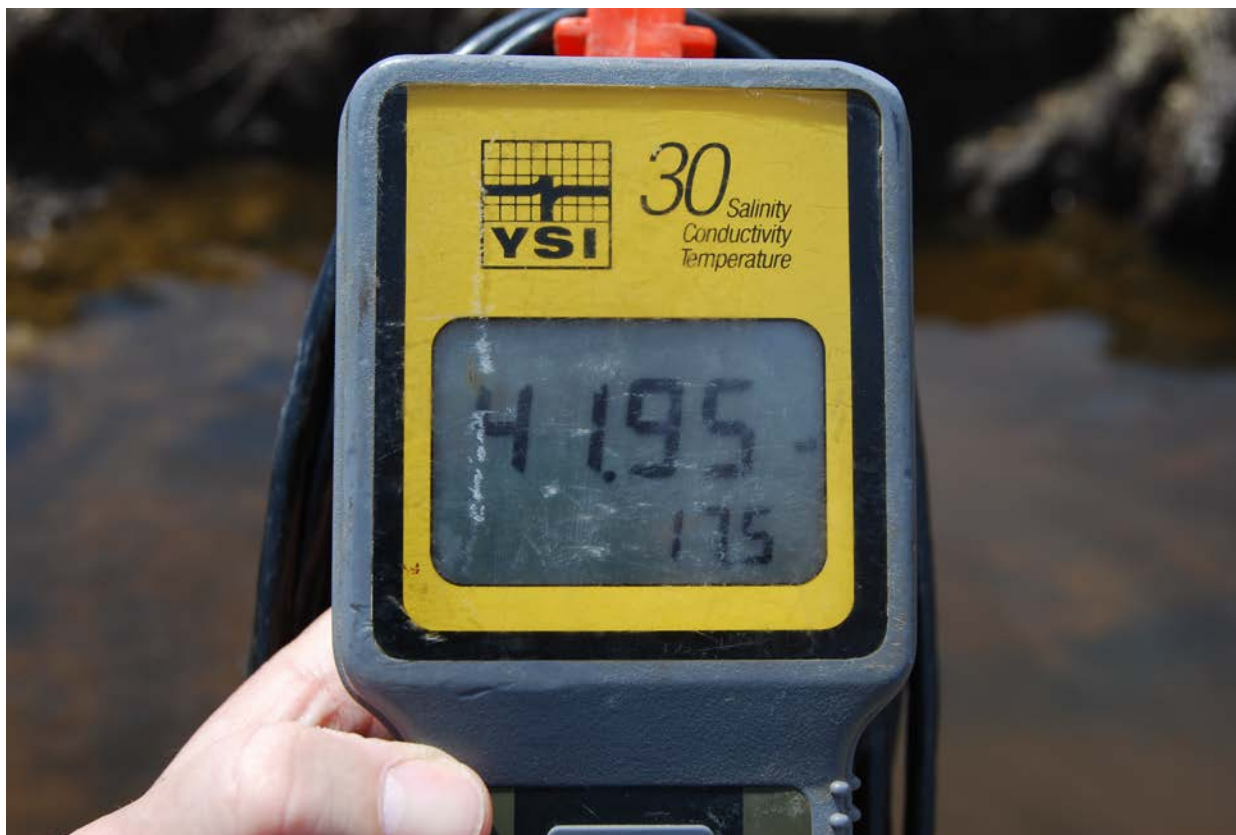
was 41.95 mS, which was converted to 27,267 mg/L TDS as shown in Appendix 2 (Photo 14 in Appendix 1). I observed livestock tracks, including cattle tracks, that indicate cattle were at the tributary between Dam 2 and Dam 3 (Photo 15). Photo 16 shows a 4<sup>th</sup> dam that was built downstream of Dam 3. Water and brine were also running over the dam and flowing south in Daniel's Run Creek. A Specific Conductance field reading taken at Dam 4 was 6.44 mS, which was converted to 4,186 mg/L TDS as shown in Appendix 2 (Photo 17 in Appendix 1). Photo 18 shows the unaffected portion of the tributary of Daniel's Run Creek upstream of the discharge point of entry. A Specific Conductance field reading taken upstream in the tributary and was 749 microSiemens (uS), which was converted to 486 mg/L TDS as shown in Appendix 2 (Photo 19 in Appendix 1).

Description: A Specific Conductance field reading taken at Dam 3 was 41.95 mS, which was converted to 27,267 mg/L TDS as shown in Appendix 2.

| Inspection Report<br>Photo No. | Specific Conductance<br>Reading (mS) | Specific Conductance<br>(uS) | Converted Total<br>Dissolved Solids (mg/L)* |
|---|---|---|---|
| Photo No. 14 | 41.95 mS | 41,950 uS | 27,267.5 mg/L |

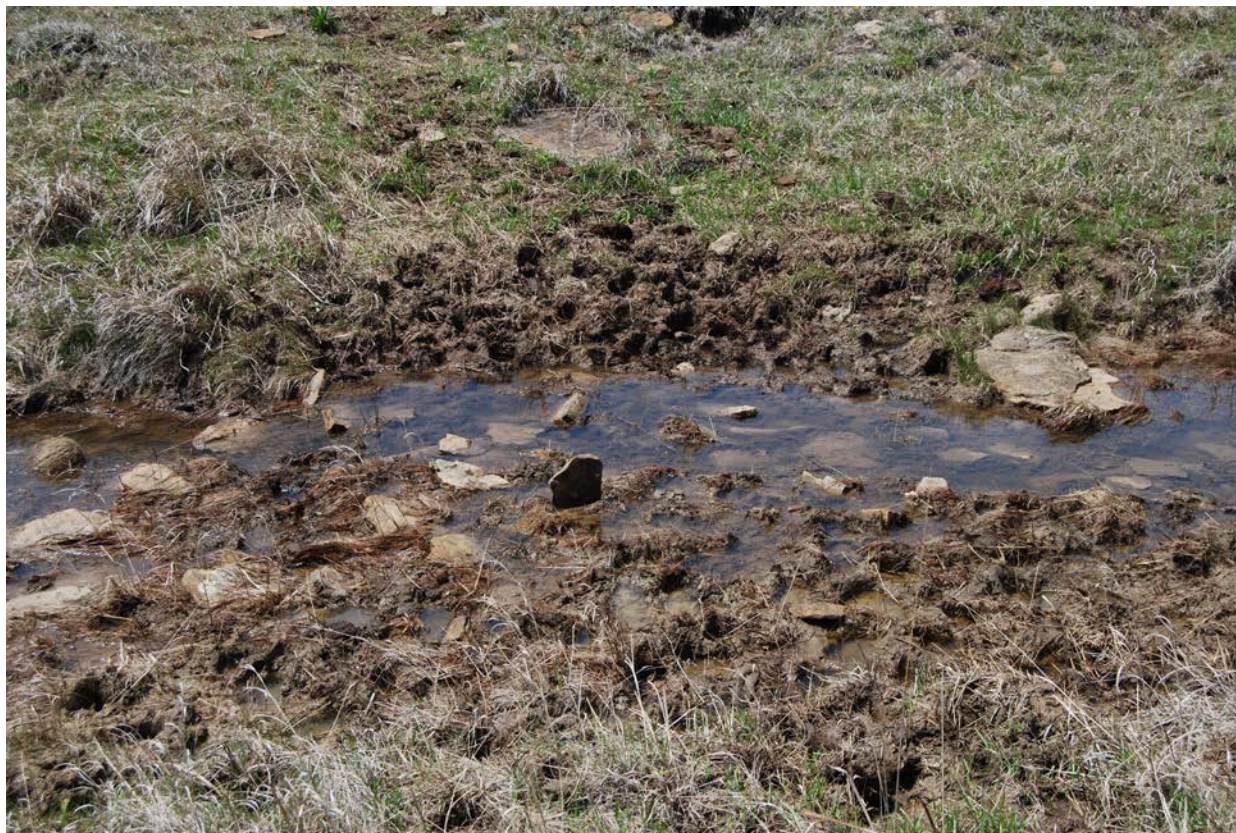
Photo No. 15

Description: I observed livestock tracks, including cattle tracks, that indicate cattle were at the tributary at this location here, between Dam 2 and Dam 3.

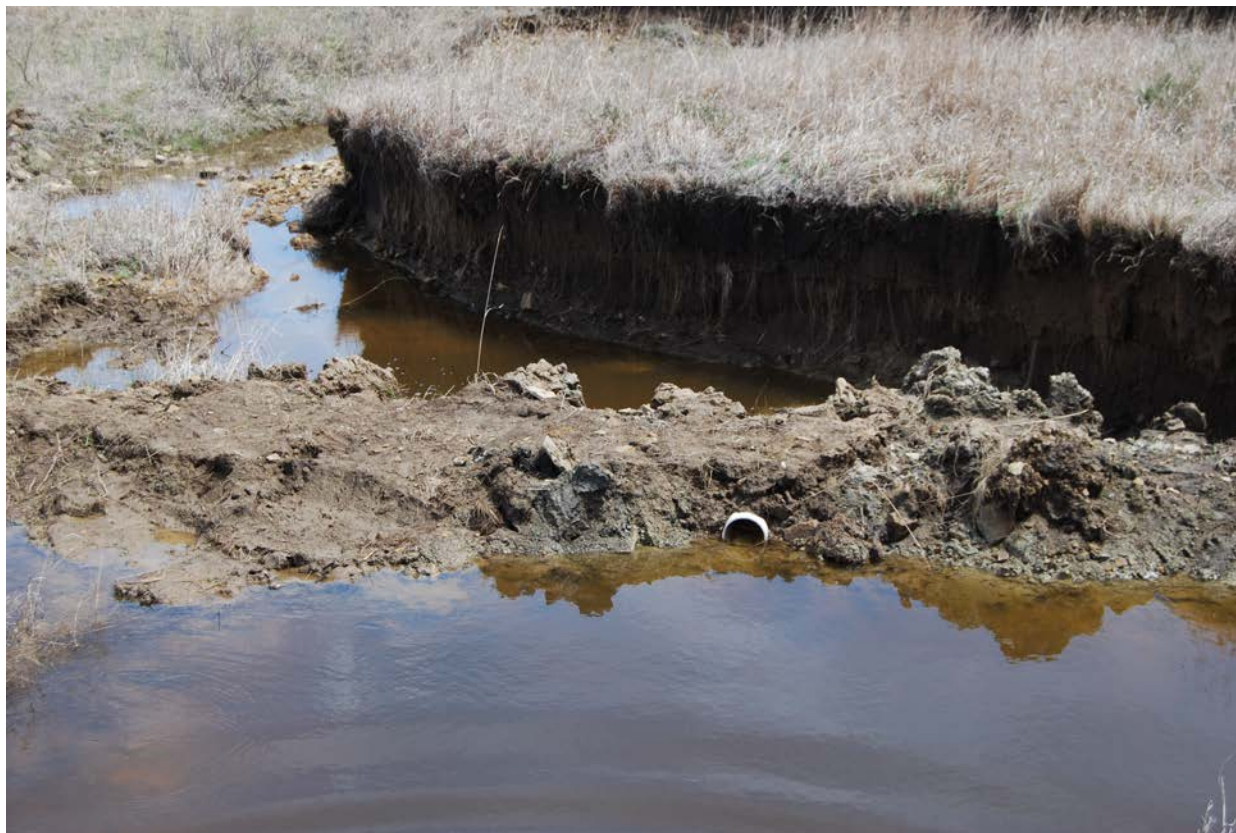
Photo No. 16

Description: A fourth Dam has been built as shown here, or Dam 4. Water and brine were flowing through the dam at the time of the inspection.

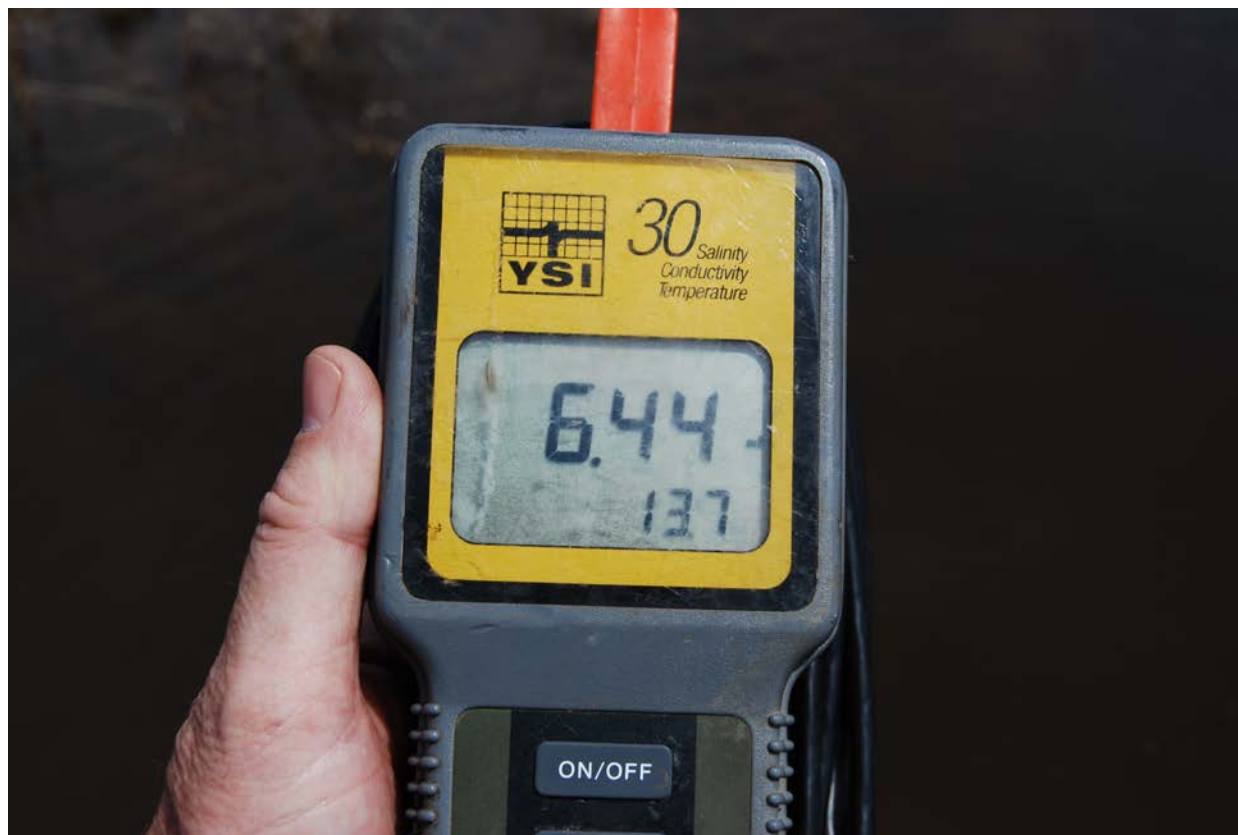
Description: A Specific Conductance field reading taken at Dam 4 was 6.44 mS, which was converted to 4,186 mg/L TDS as shown in Appendix 2.

| Inspection Report<br>Photo No. | Specific Conductance<br>Reading (mS) | Specific Conductance<br>(uS) | Converted Total<br>Dissolved Solids (mg/L)* |
|---|---|---|---|
| Photo No. 17 | 6.44 mS | 6,440 uS | 4,186 mg/L |

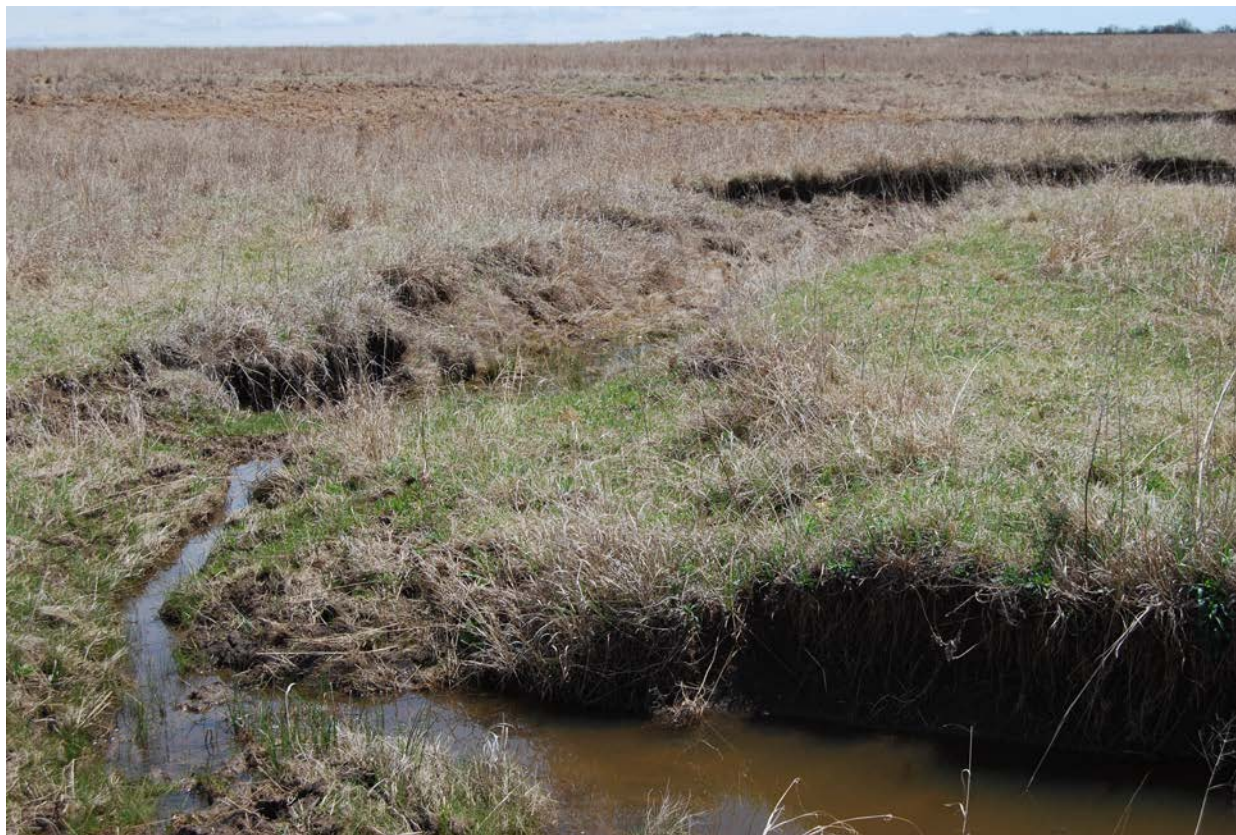
Photo No. 18

Description: I observed the tributary of Daniel's Run Creek upstream of the discharge point of entry at this location.

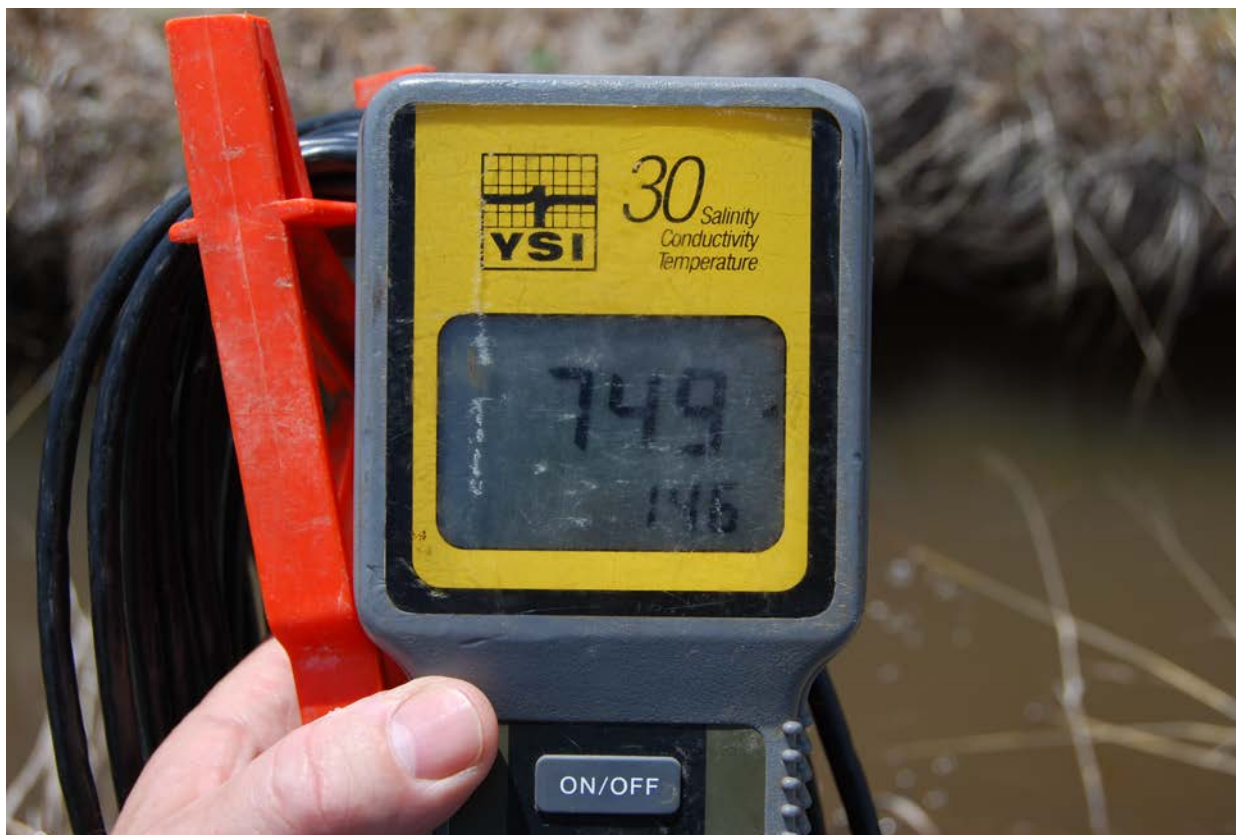
Description: A Specific Conductance field reading taken upstream in the tributary and was 749 microSiemens (uS), which was converted to 486 mg/L TDS as shown in Appendix 2.

| Inspection Report<br>Photo No. | Specific Conductance<br>Reading (mS) | Specific Conductance<br>(uS) | Converted Total<br>Dissolved Solids (mg/L)* |
|---|---|---|---|
| Photo No. 19 | N/A | 749 uS | 486.8 mg/L |
