EMISSION INVESTIGATION

Date of Incident: March 8, 1972 4:00 A.M. and 6:00 A.M.

Location: Dept. 246, Distillation Column

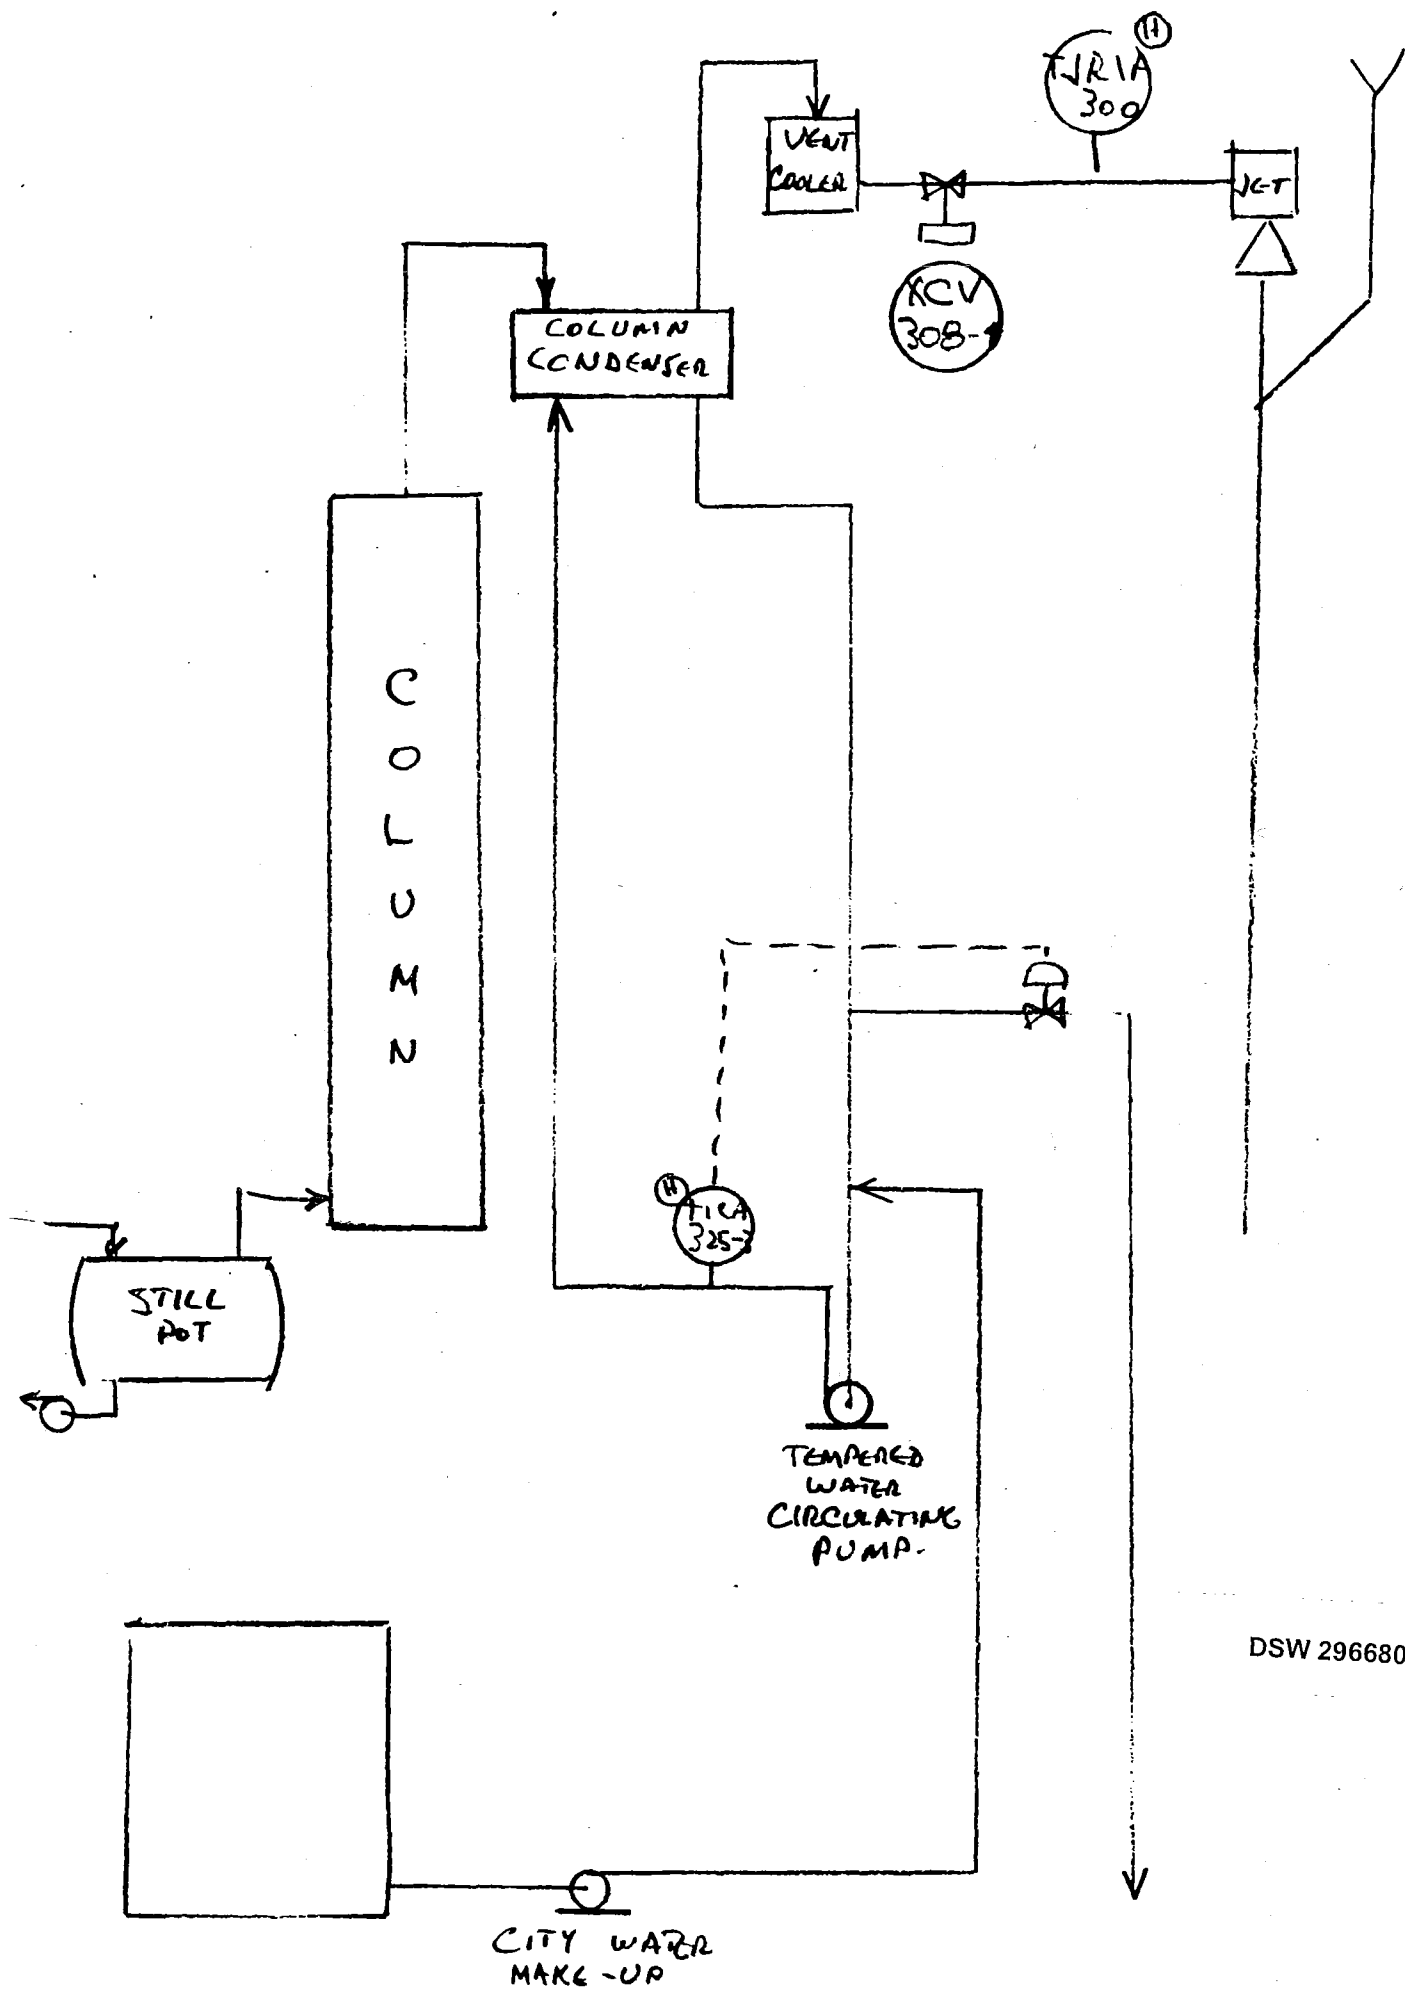
The emission was caused by a loss of cooling water at the column condenser. There will be a continued generation of vapors after the external source of heat has been discontinued because the column itself is a heat sink, and when refluxing stops there will be a further decrease in pressure which will promote boiling. Without cooling water on the condenser some vapors will pass uncondensed through the condenser, the vent cooler, the jets and into the atmosphere. Although there is a valve in the vent line it currently fails in the open position on electrical failure, and there is no way to immediately stop the vapors during an electrical failure. See sketch.

The emissions can be stopped by closing the valve between the vent cooler and the jet. This can be done with minor electrical changes to permit the valve to fail in the closed position on electrical failure. This can be done safely and was reviewed with Dale Schillinger and Walter Howard of CED.

1. Alter the vent valve (XV 308-4) to close on electrical failure.  
(TSD & Maintenance EDC 4/1/72)
2. Install "open-close" switch for vent valve (XV 308-4) in the control room so operator can accuate when needed. To be interlocked with the furnace such that when closed the fires will be out.  
(TSD & Maintenance EDC 4/1/72)
3. Write specific procedure to be followed by operator when power failure occurs. Include nitrogen addition at Still Pot to reduce pressure.  
(Production EDC 4/1/72)
4. Install alarm in control room on city water make-up pump that supplies column tempered water circulating system.  
(TSD & Maintenance EDC 4/1/72)
5. Check and reset alarm and interlock on vent cooler outlet (TJR 1A-300)  
(Production EDC 4/1/72)
