**Region 6 - Enforcement & Compliance Assurance Division**  
**INSPECTION REPORT**

| <b>Inspection Date(s):</b> | 02/26/2025 | |
| <b>Company Name:</b> | <b>New Mexico State University (NMSU)</b> | |
| <b>Facility Name:</b> | <b>NMSU Water System</b> | |

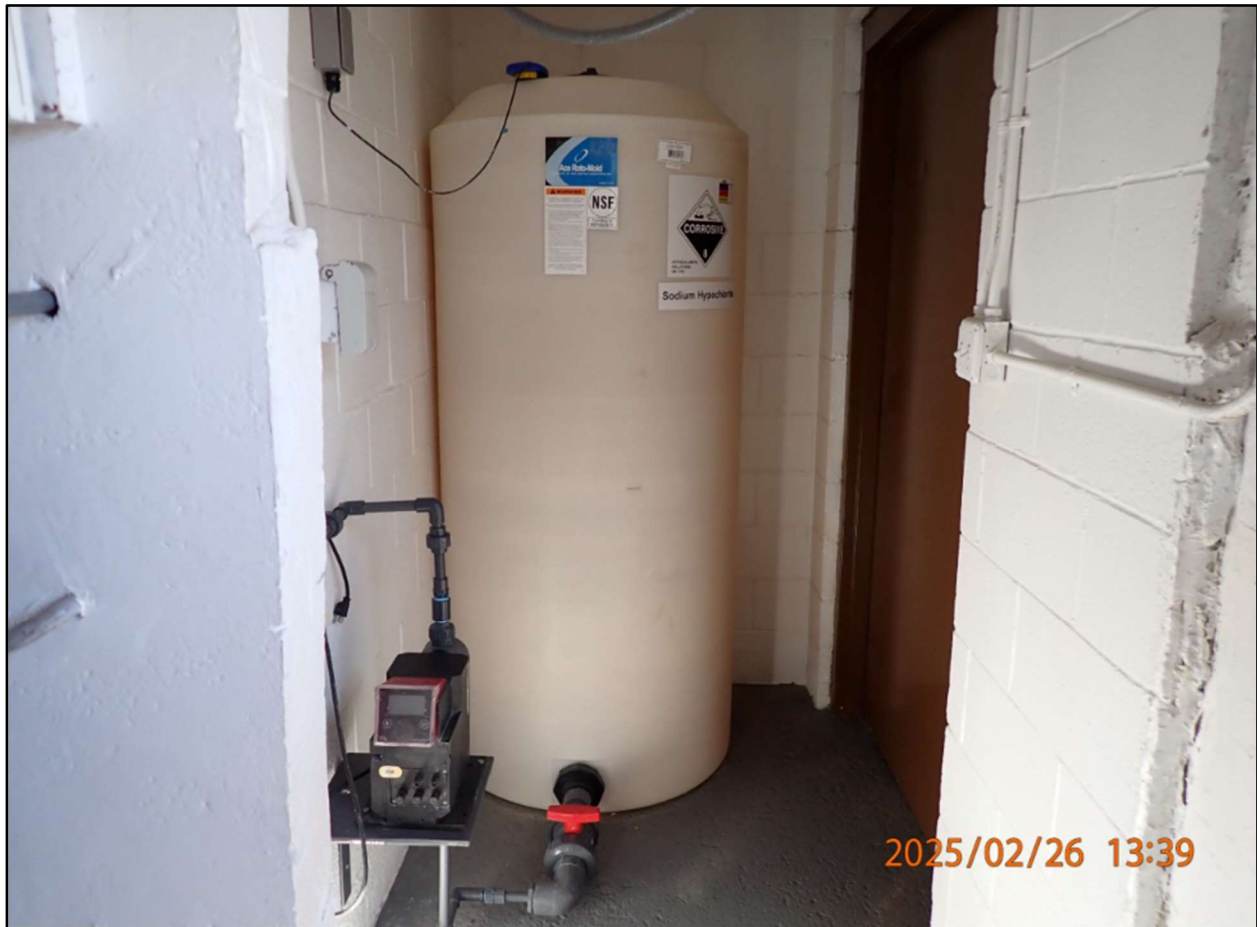
**Photograph 1. 02/26/2025 13:39 P2260411.JPG**

Description: Sodium hypochlorite storage at Well #10 without secondary containment.

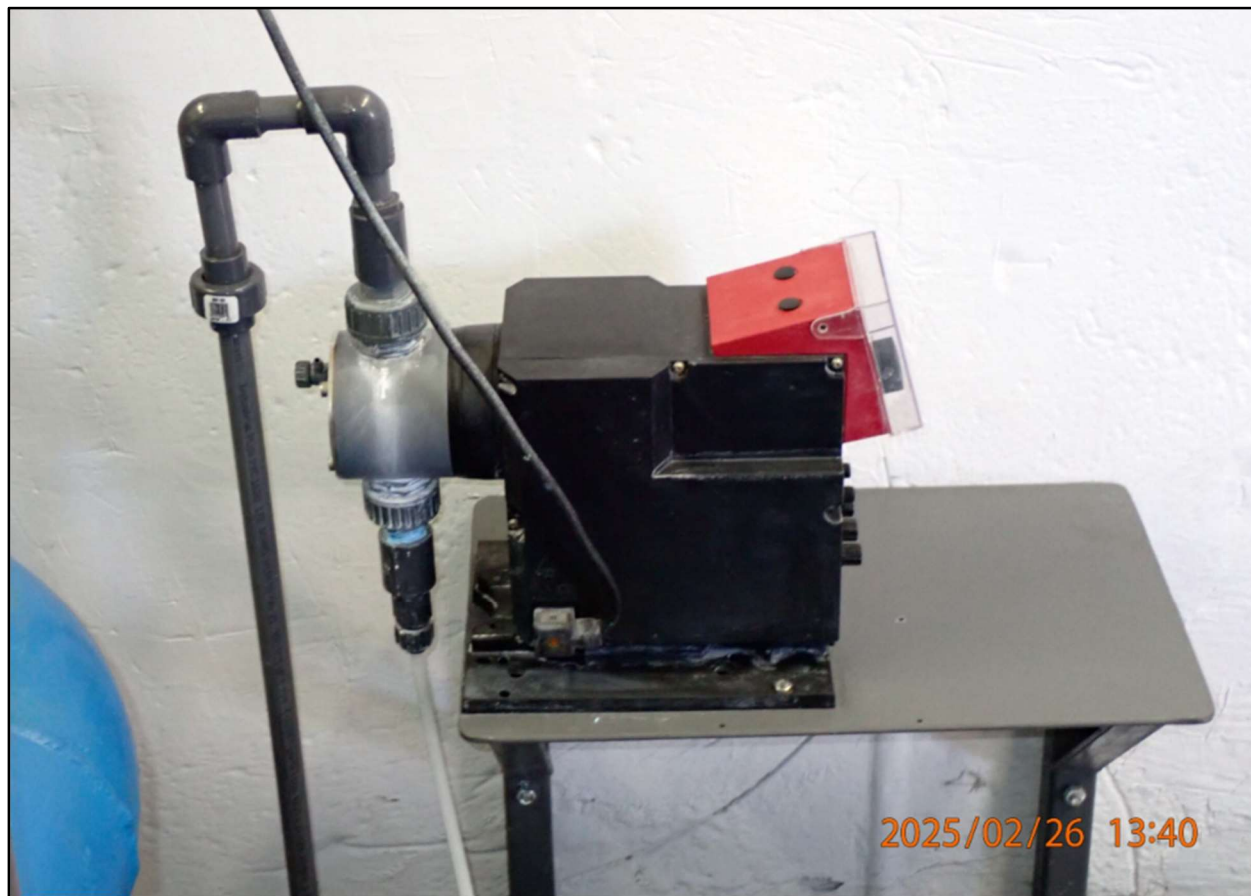
**Photograph 2. 02/26/2025 13:40 P2260413.JPG**

Description: Chemical feed equipment at Well #10 (representative of all chemical feed equipment throughout the System) without anti-siphon valves.

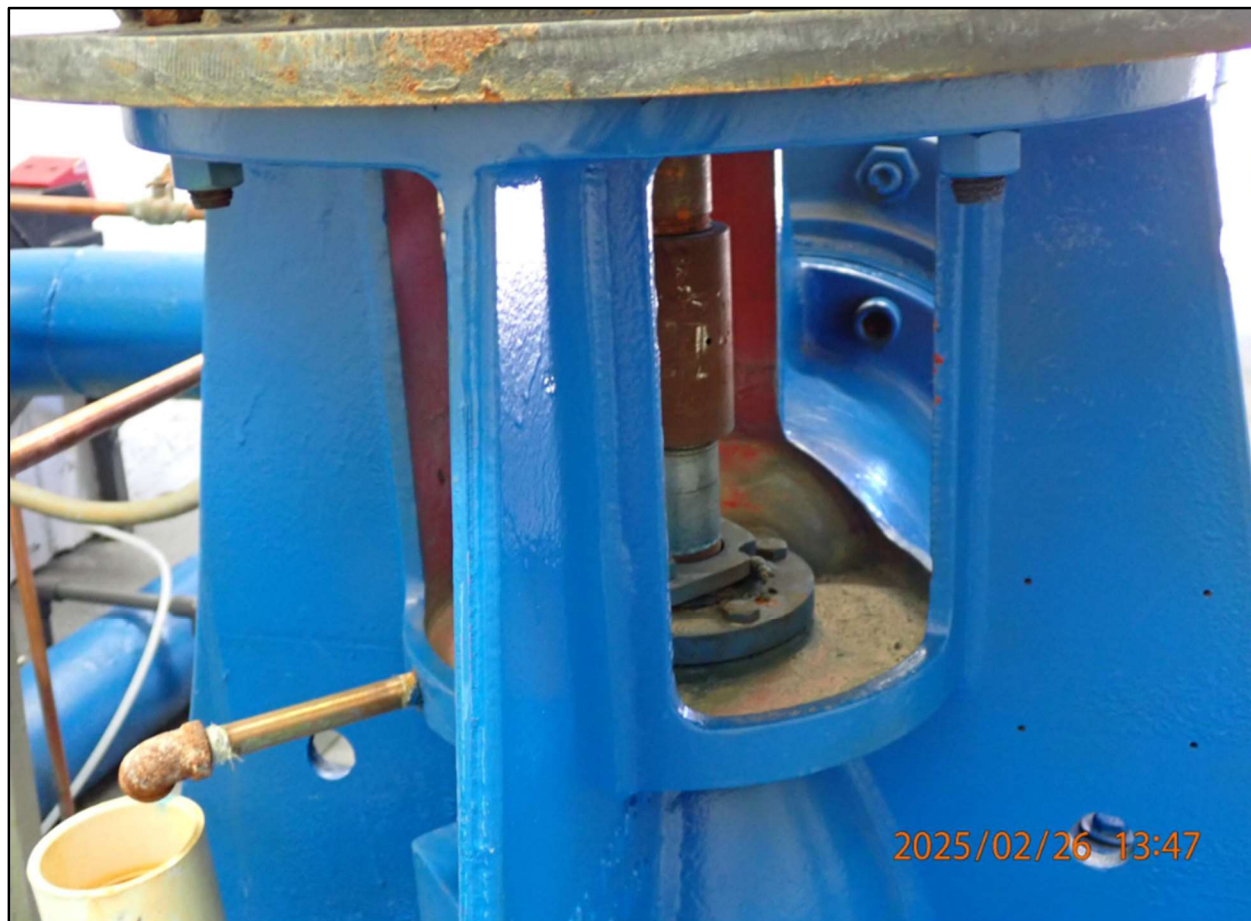
**Photograph 3. 02/26/2025 13:47 P2260418.JPG**

Description: Well #10 rotating pump shaft without protective guard.

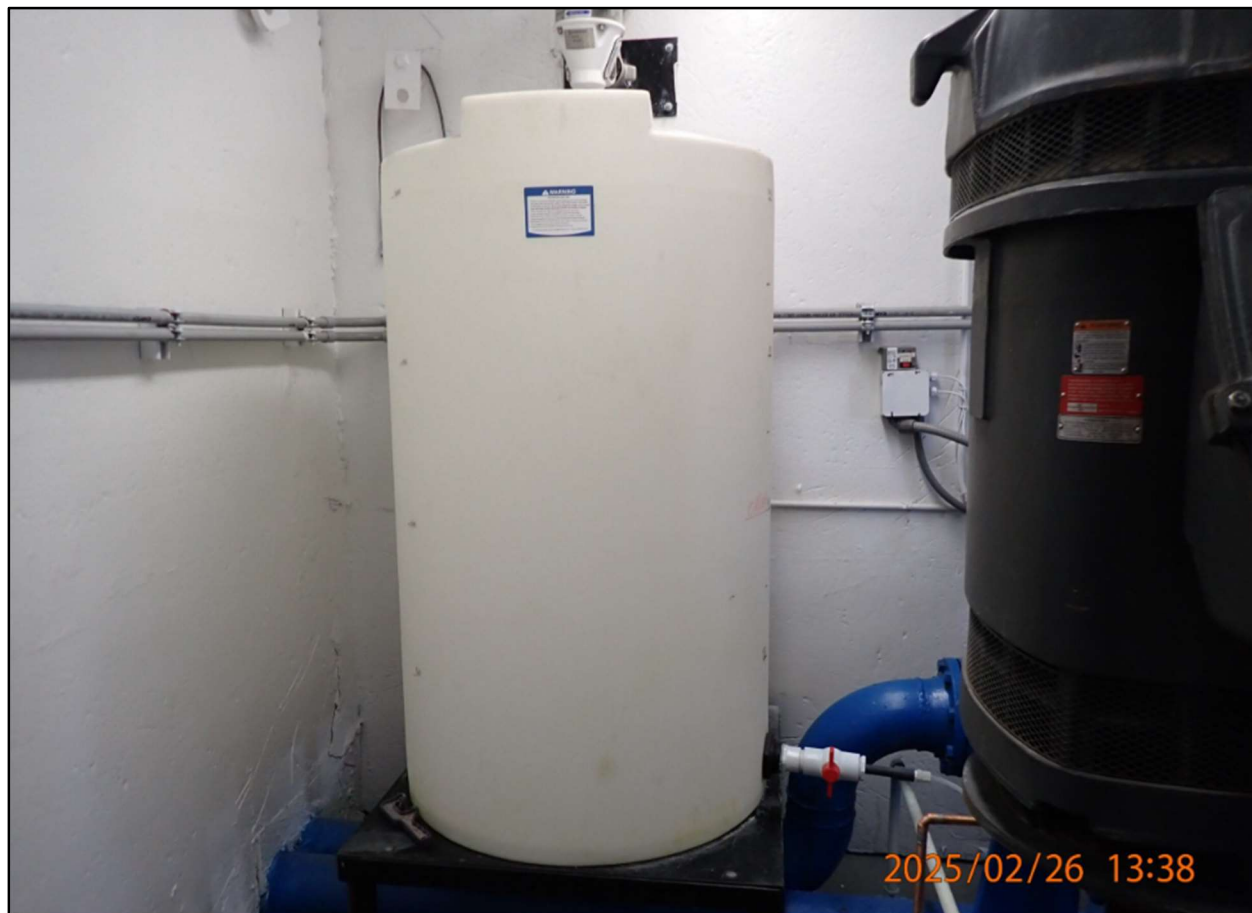
**Photograph 4. 02/26/2025 13:38 P2260410.JPG**

Description: Polyphosphate chemical storage at Well #10 without secondary containment.

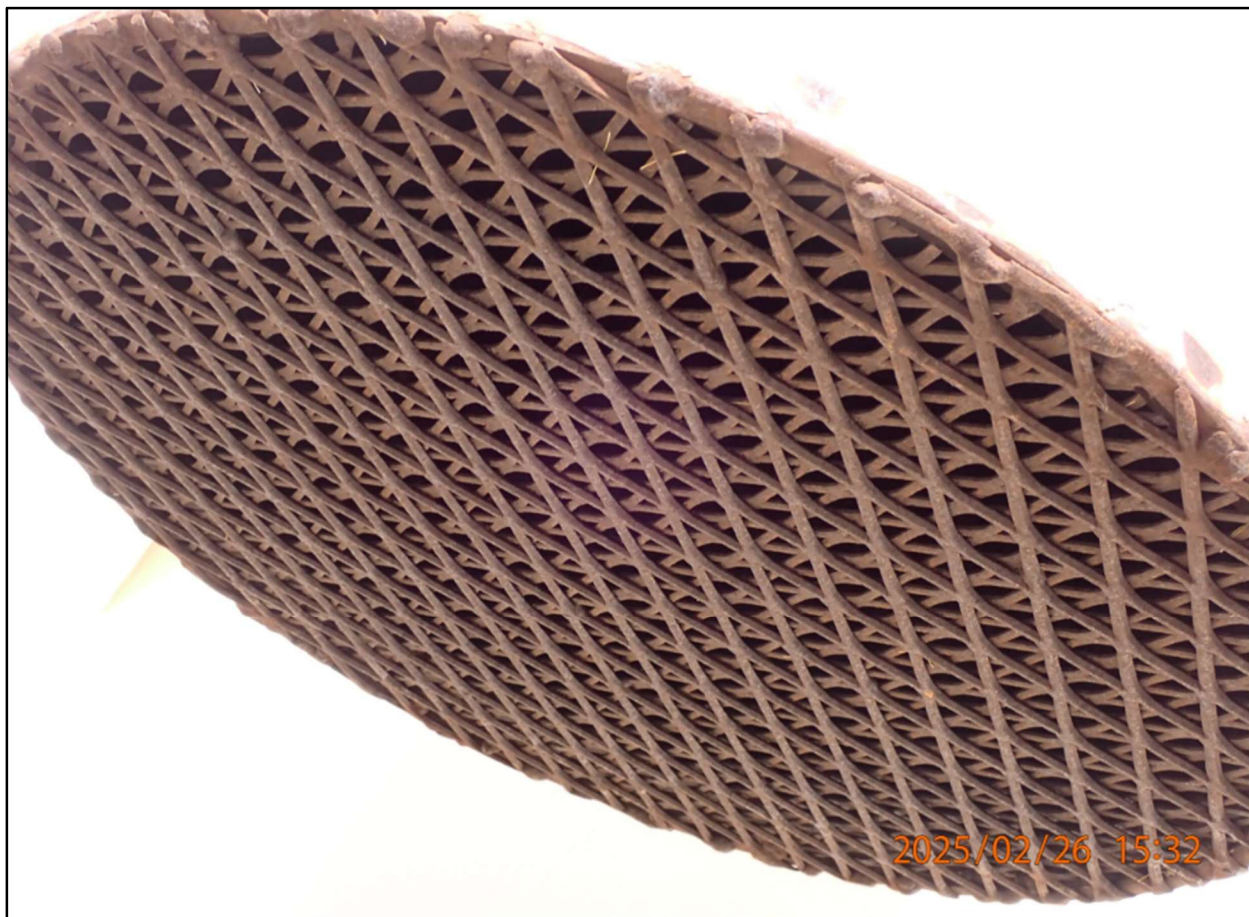
**Photograph 5. 02/26/2025 15:32 P2260555.JPG**

Description: 5-MG Storage Tank overflow with coarse screen.

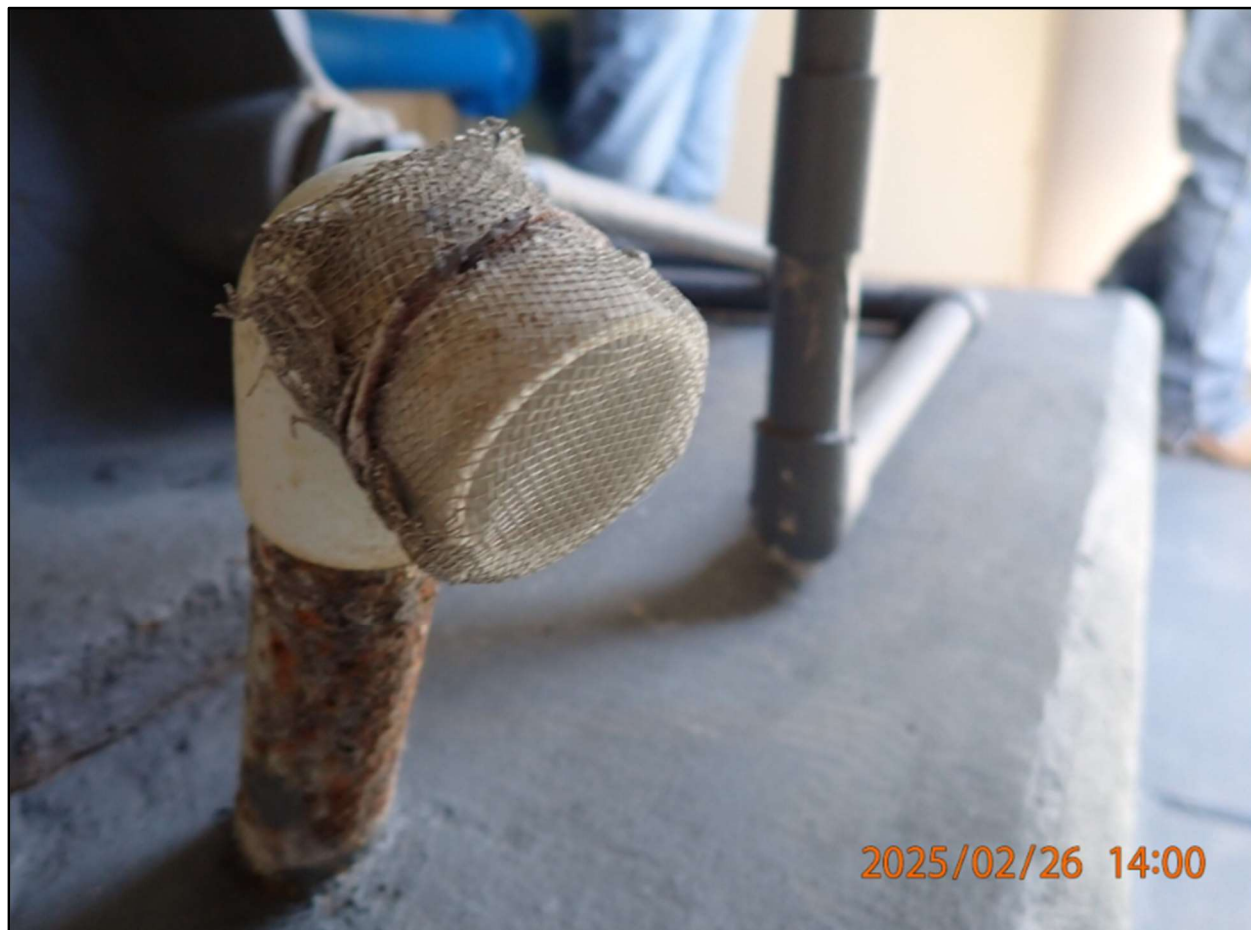
**Photograph 6. 02/26/2025 14:00 P2260433.JPG**

Description: Well #17 air relief port with fine mesh.

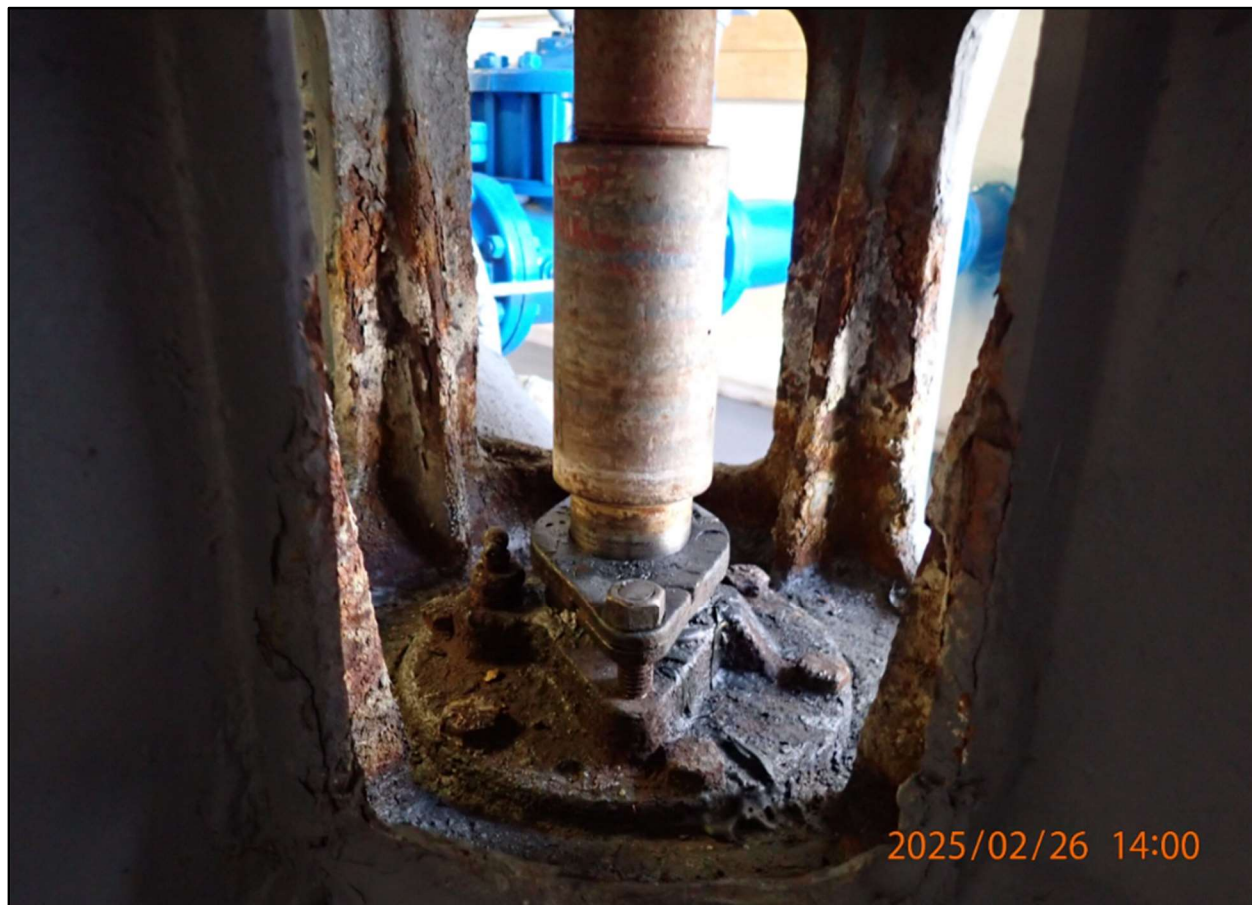
**Photograph 7. 02/26/2025 14:00 P2260435.JPG**

Description: Well #17 rotating pump shaft without protective guard.

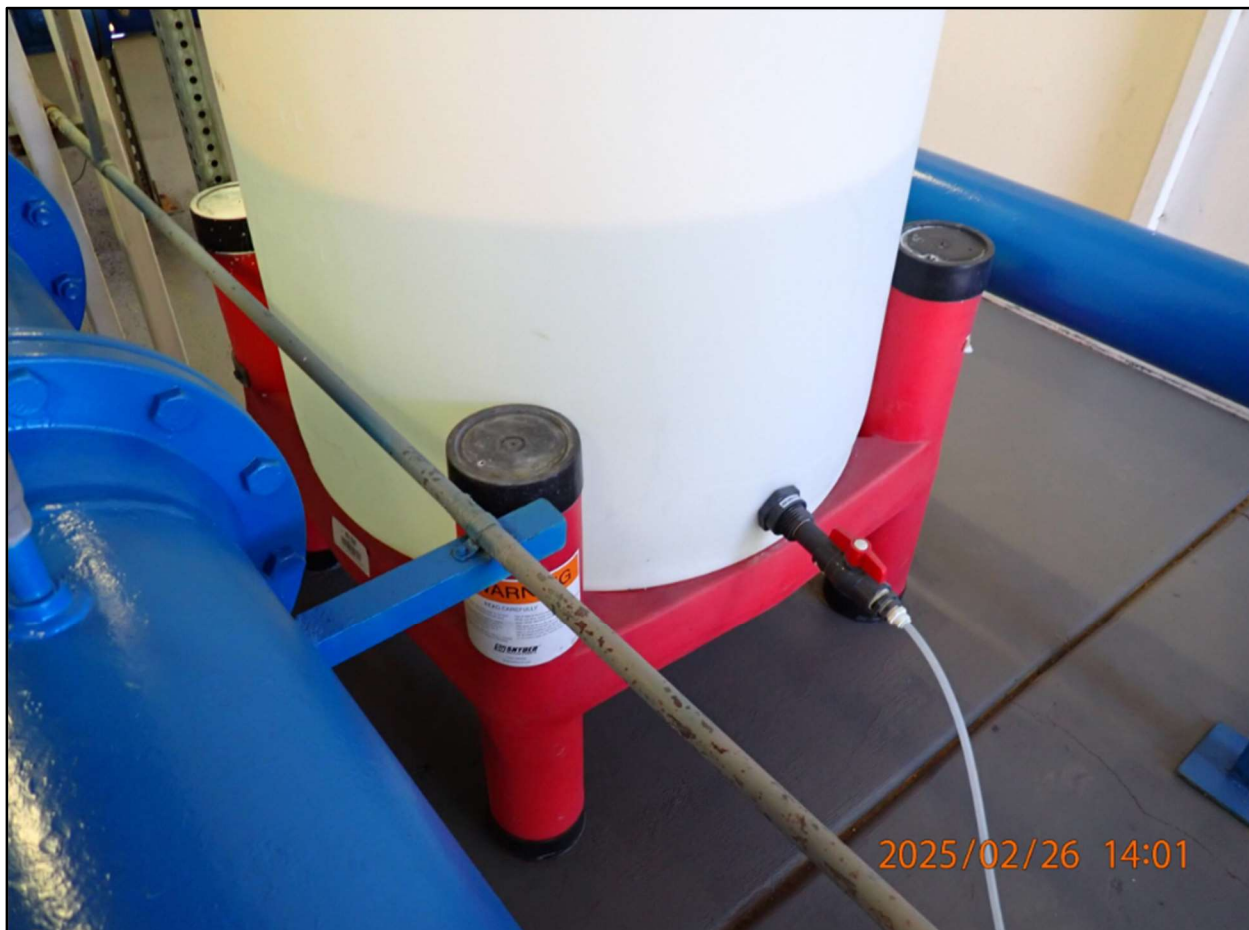
**Photograph 8. 02/26/2025 14:01 P2260440.JPG**

Description: Polyphosphate storage at Well #17 without secondary containment.

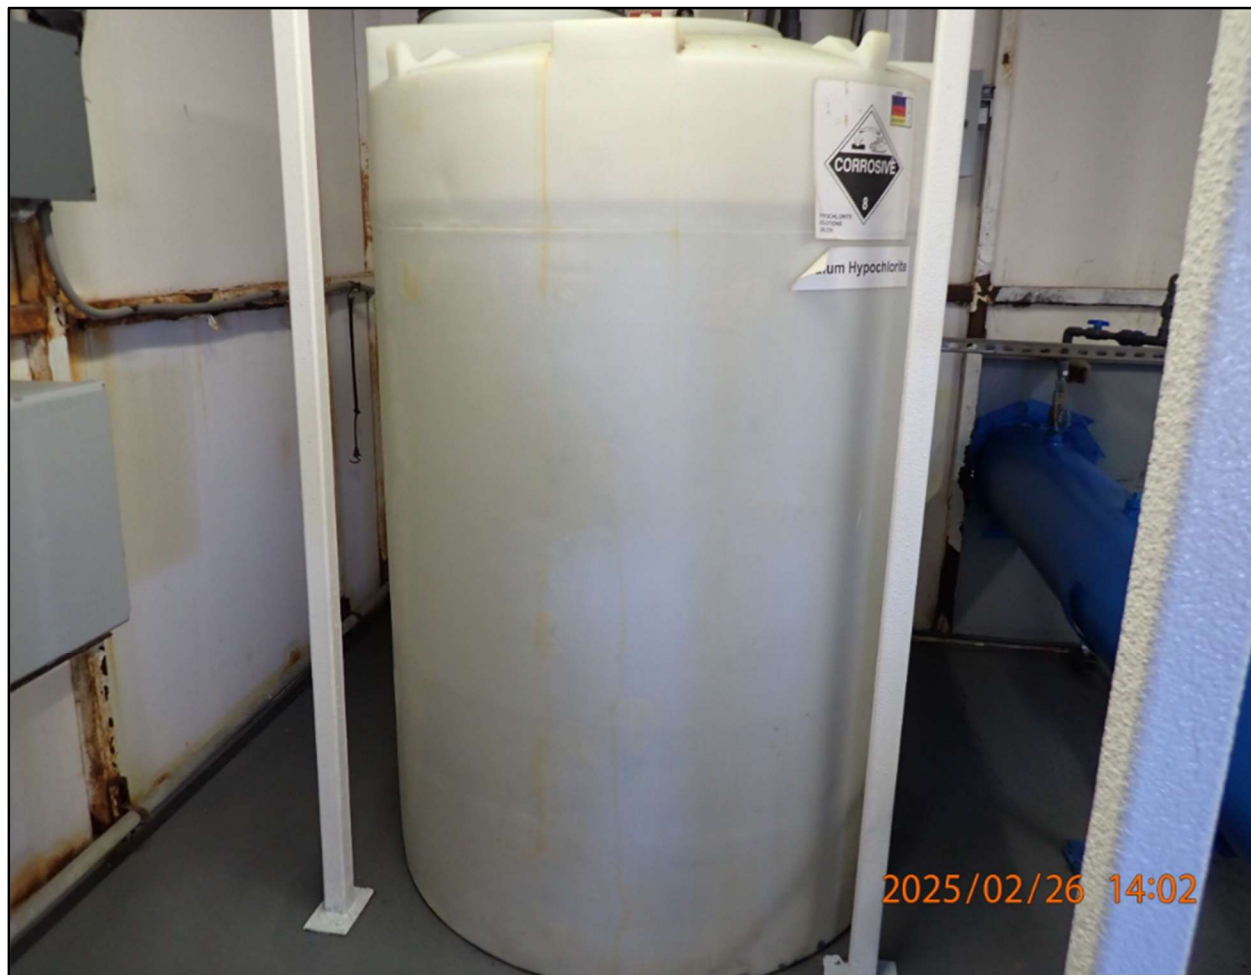
**Photograph 9. 02/26/2025 14:02 P2260442.JPG**

Description: Sodium hypochlorite storage at Well #17 without secondary containment.

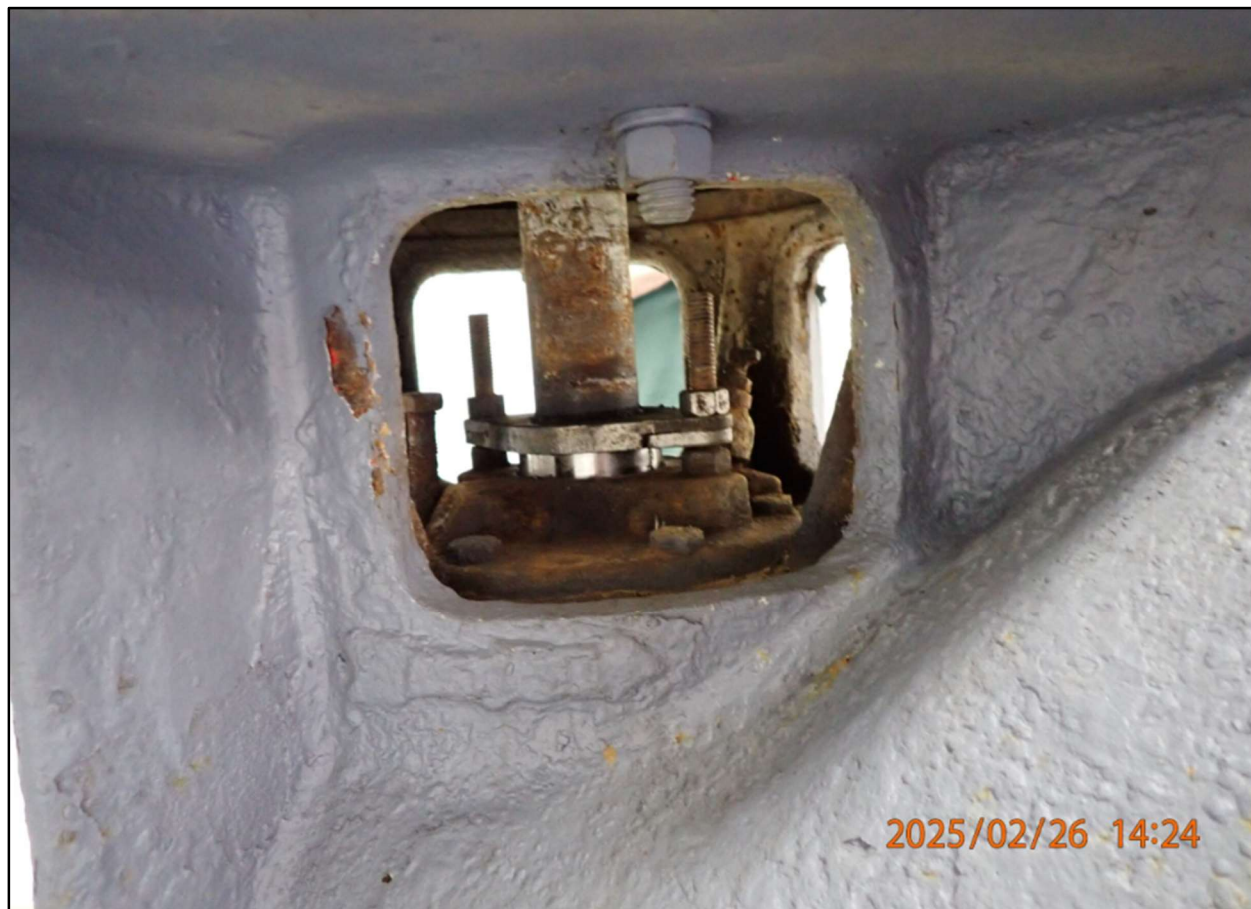
**Photograph 10. 02/26/2025 14:24 P2260469.JPG**

Description: Well #14 rotating pump shaft without protective guard.

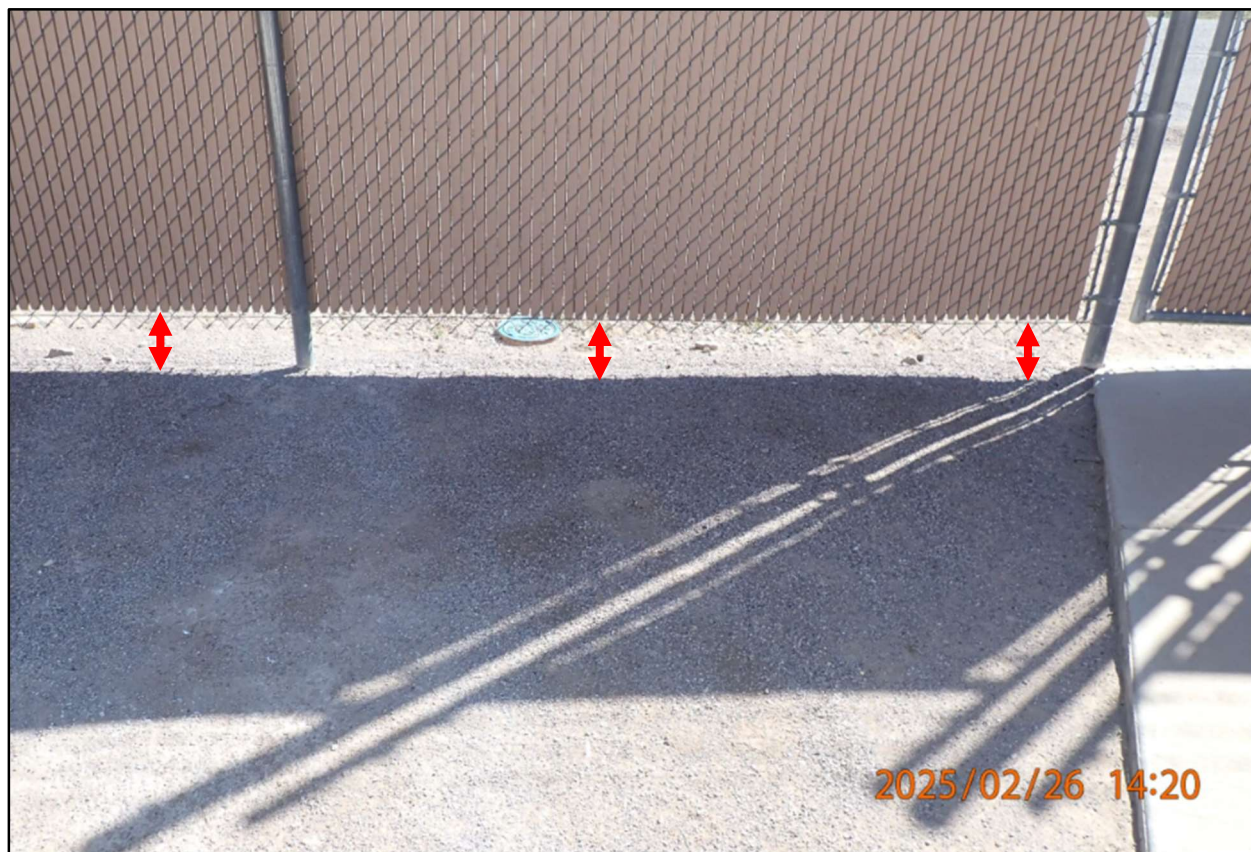
**Photograph 11. 02/26/2025 14:20 P2260453.JPG**

Description: Gap underneath the fencing around Well #14 large enough for unauthorized access.

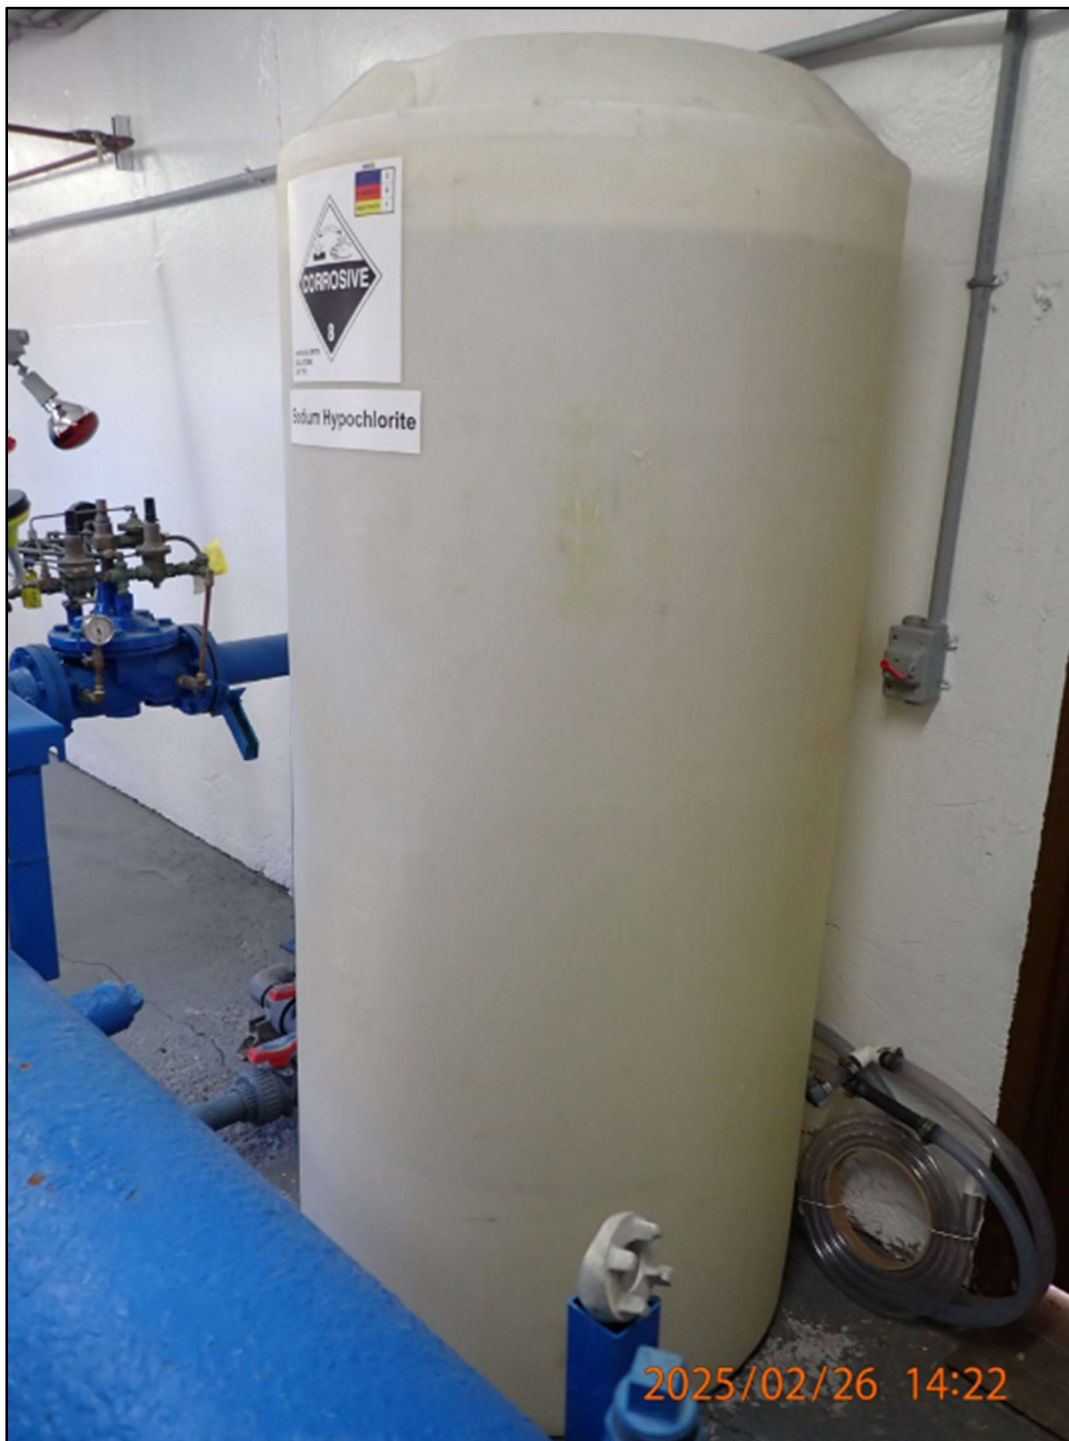
**Photograph 12. 02/26/2025 14:22 P2260459.JPG**

Description: Sodium hypochlorite storage at Well #14 without secondary containment.

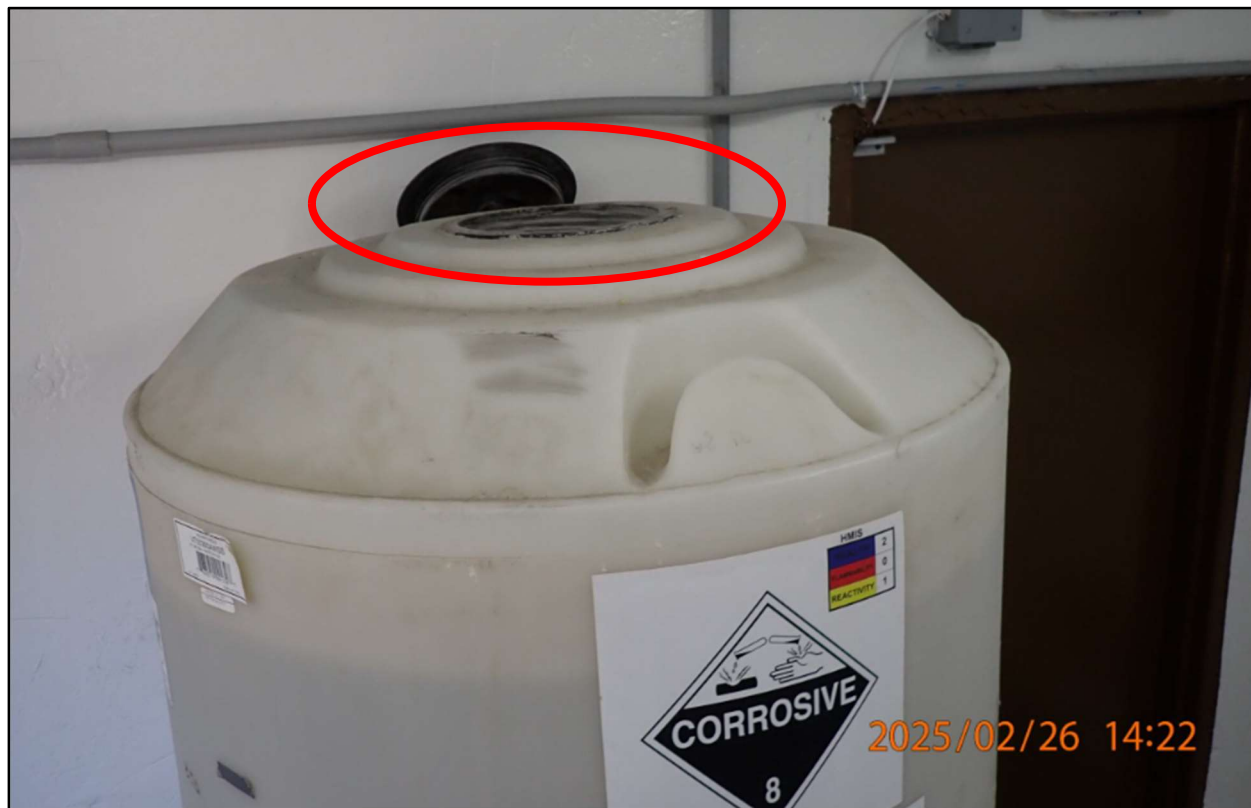
**Photograph 13. 02/26/2025 14:22 P2260463.JPG**

Description: Sodium hypochlorite storage at Well #14 with displaced lid.

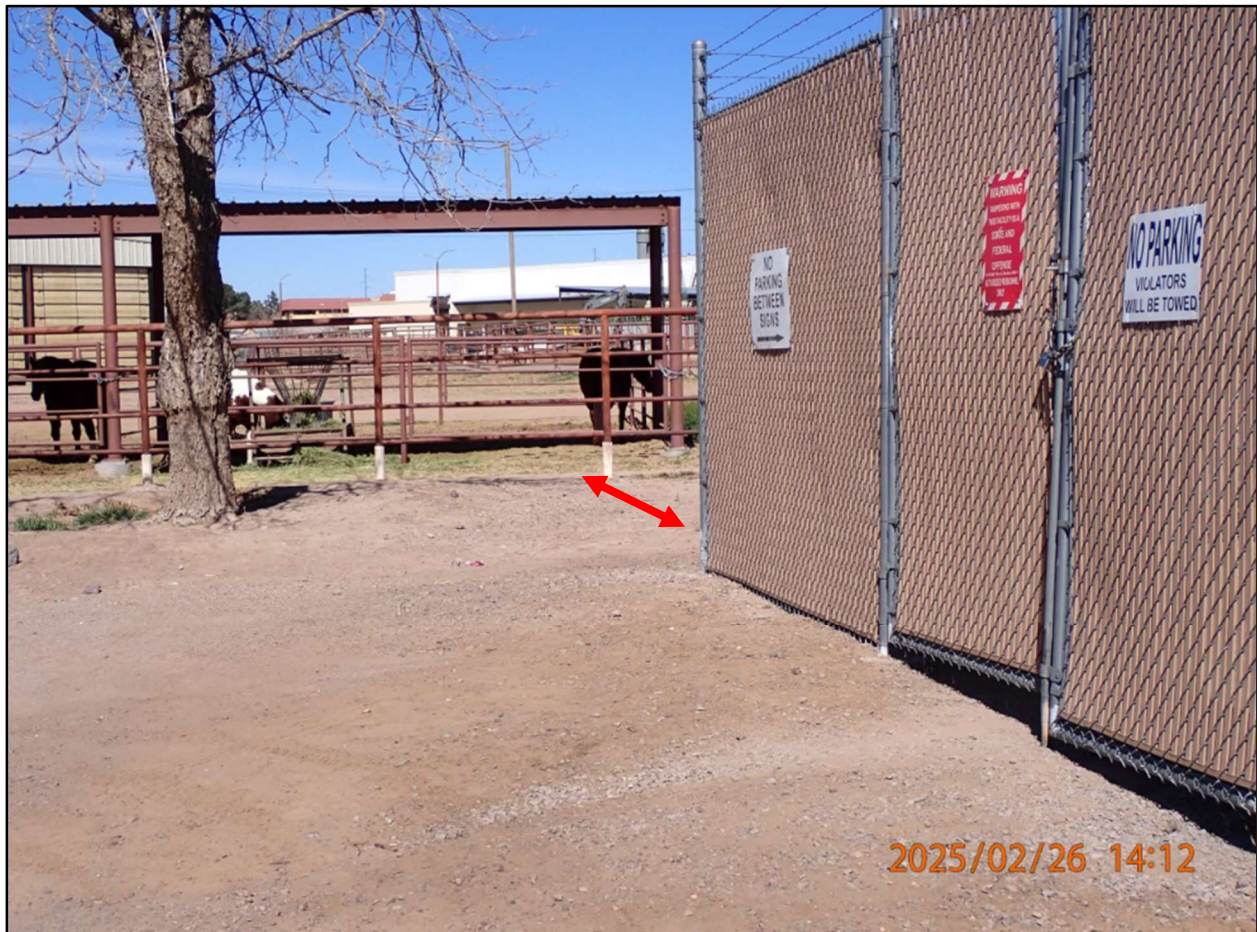
**Photograph 14. 02/26/2025 14:12 P2260450.JPG**

Description: Animal feed lots located within 1000 feet of Well #17. Fence surrounds well house.

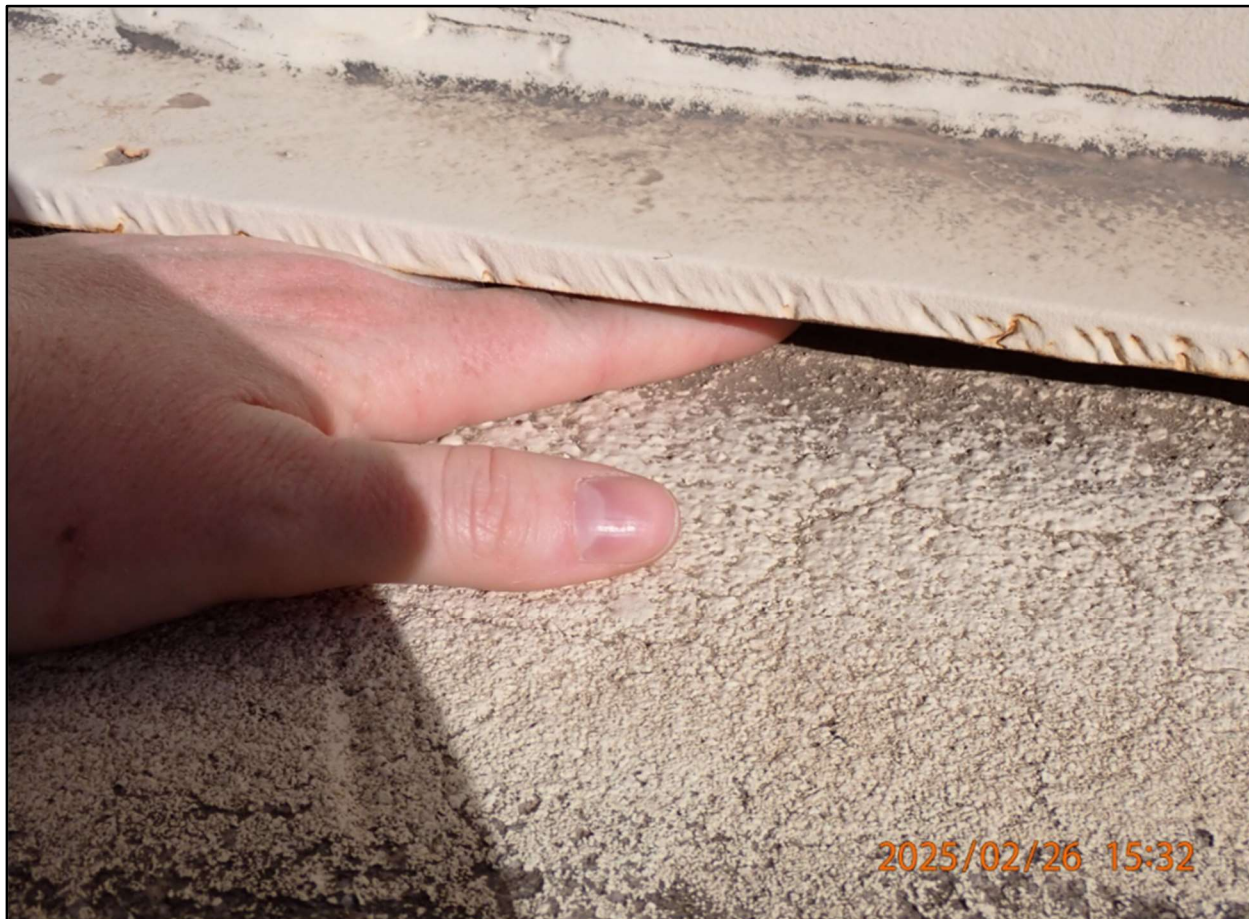
**Photograph 15. 02/26/2025 15:32 P2260558.JPG**

Description: 5-MG Storage Tank overflow with missing foundation seal.

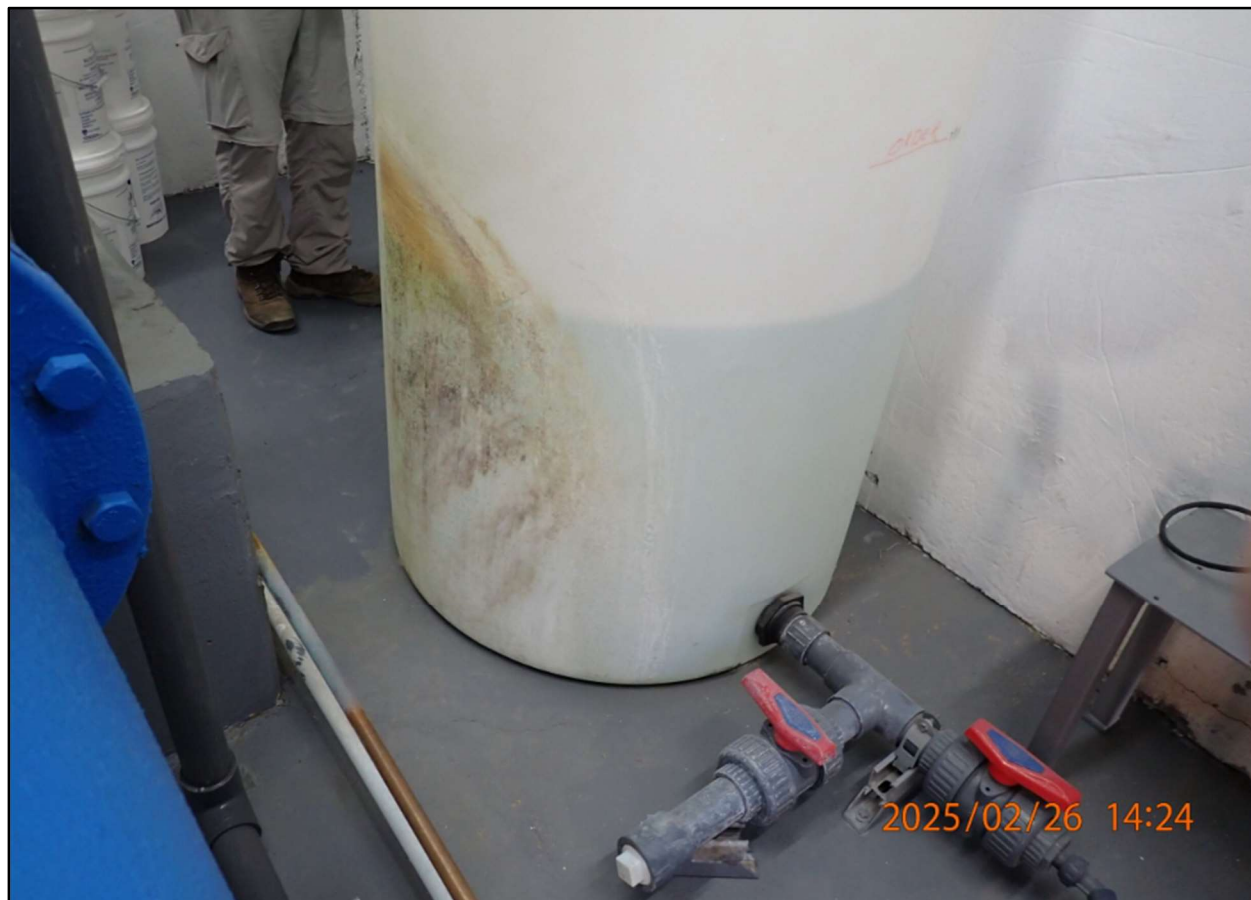
**Photograph 16. 02/26/2025 14:24 P2260467.JPG**

Description: Polyphosphate storage tank at Well #14 without secondary containment.

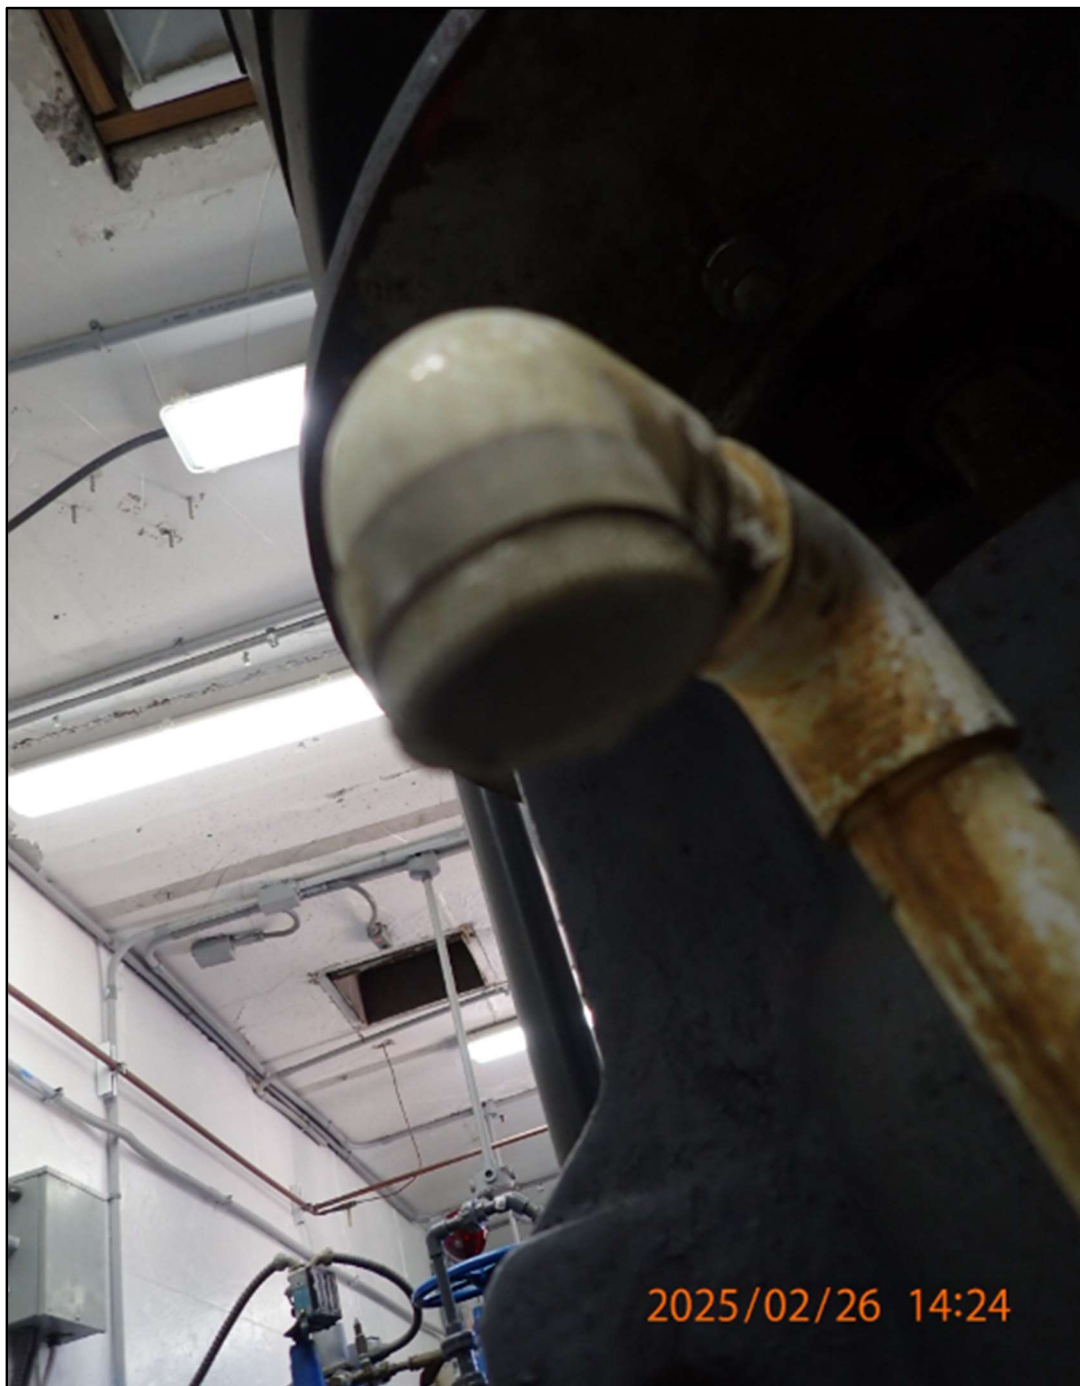
**Photograph 17. 02/26/2025 14:24 P2260470.JPG**

Description: Well #14 vent with fine mesh.

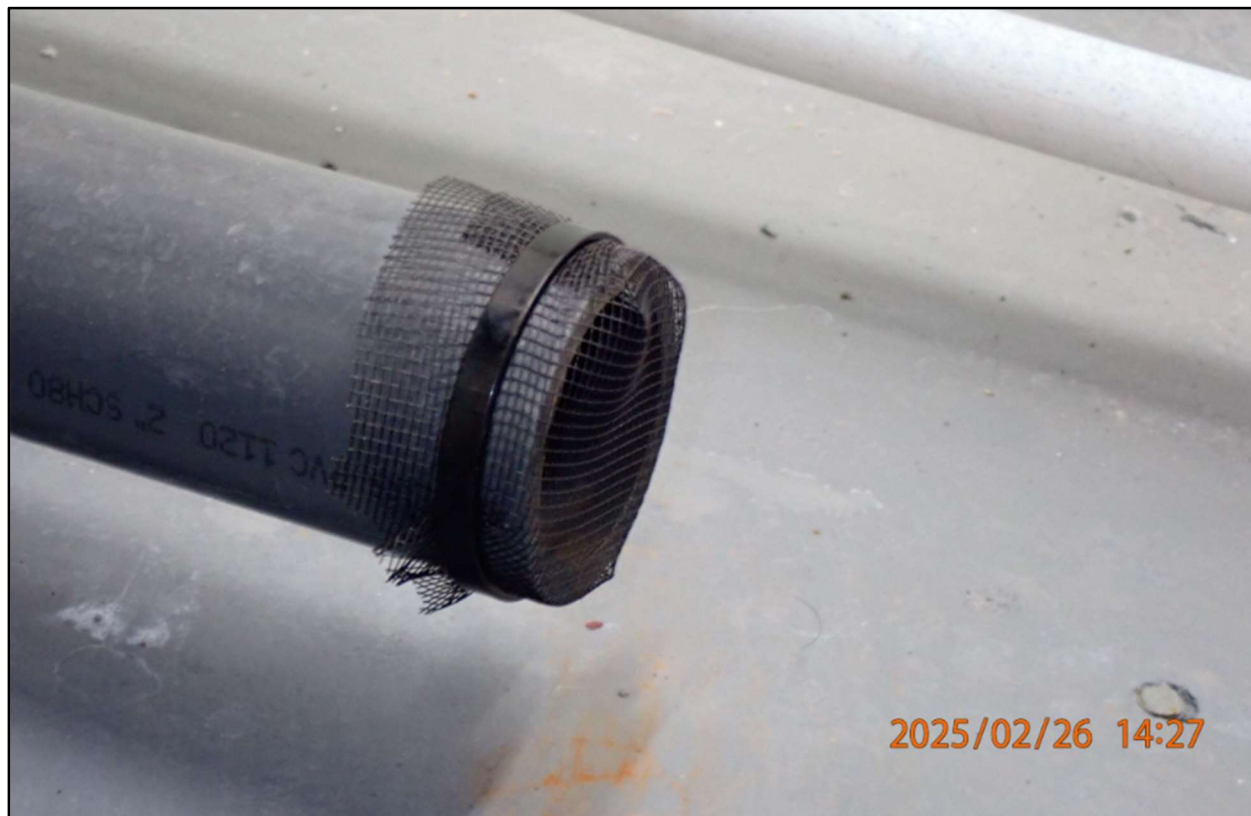
**Photograph 18. 02/26/2025 14:27 P2260473.JPG**

Description: Well #14 vent line with a screen larger than #24-mesh.

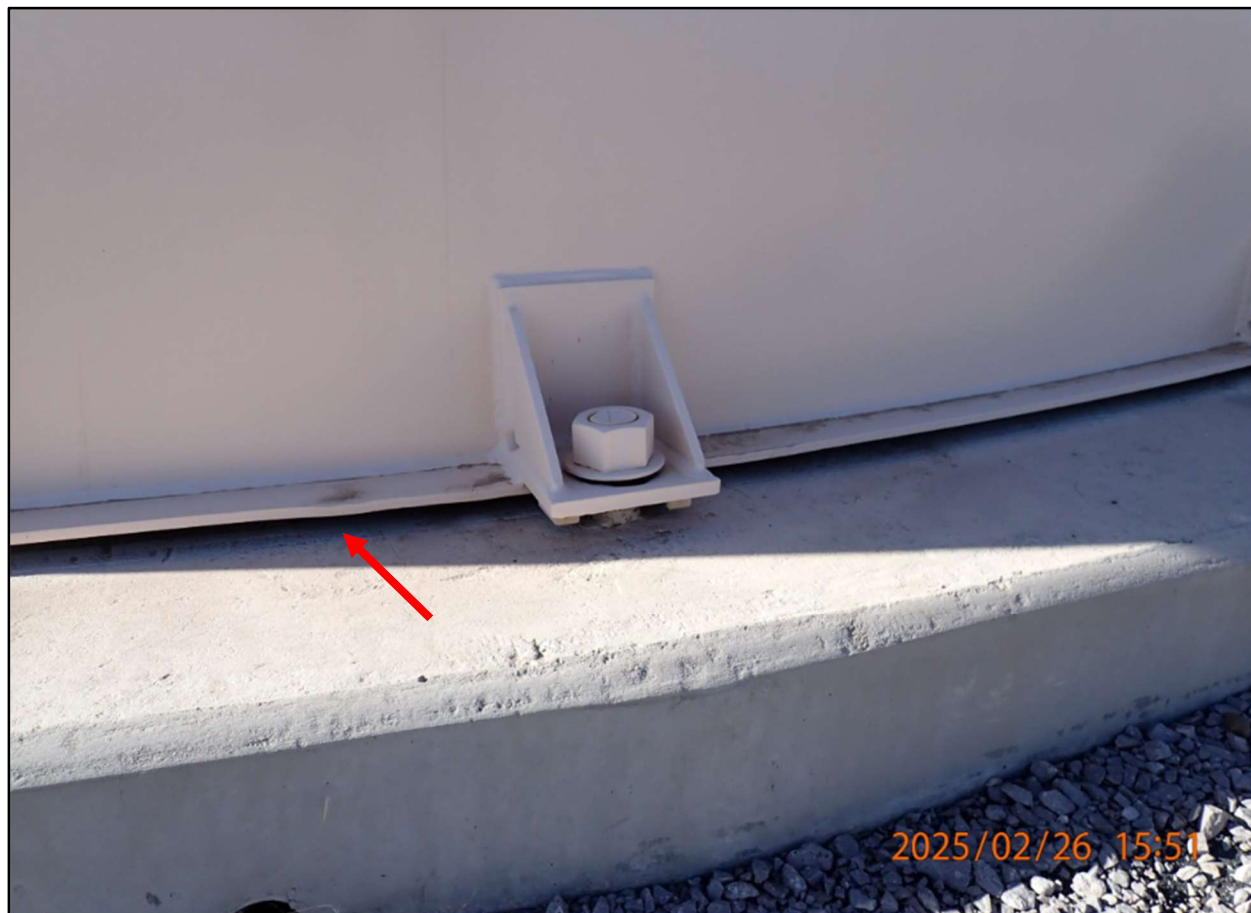
**Photograph 19. 02/26/2025 15:51 P2260566.JPG**

Description: 250,000-Gallon Storage Tank with gaps in foundation seal.
