**Region 6 - Enforcement & Compliance Assurance Division**  
**INSPECTION REPORT**

| <b>Inspection Date(s):</b> | 02/26/2025 | |
| <b>Company Name:</b> | <b>New Mexico State University (NMSU)</b> | |
| <b>Facility Name:</b> | <b>NMSU Water System</b> | |

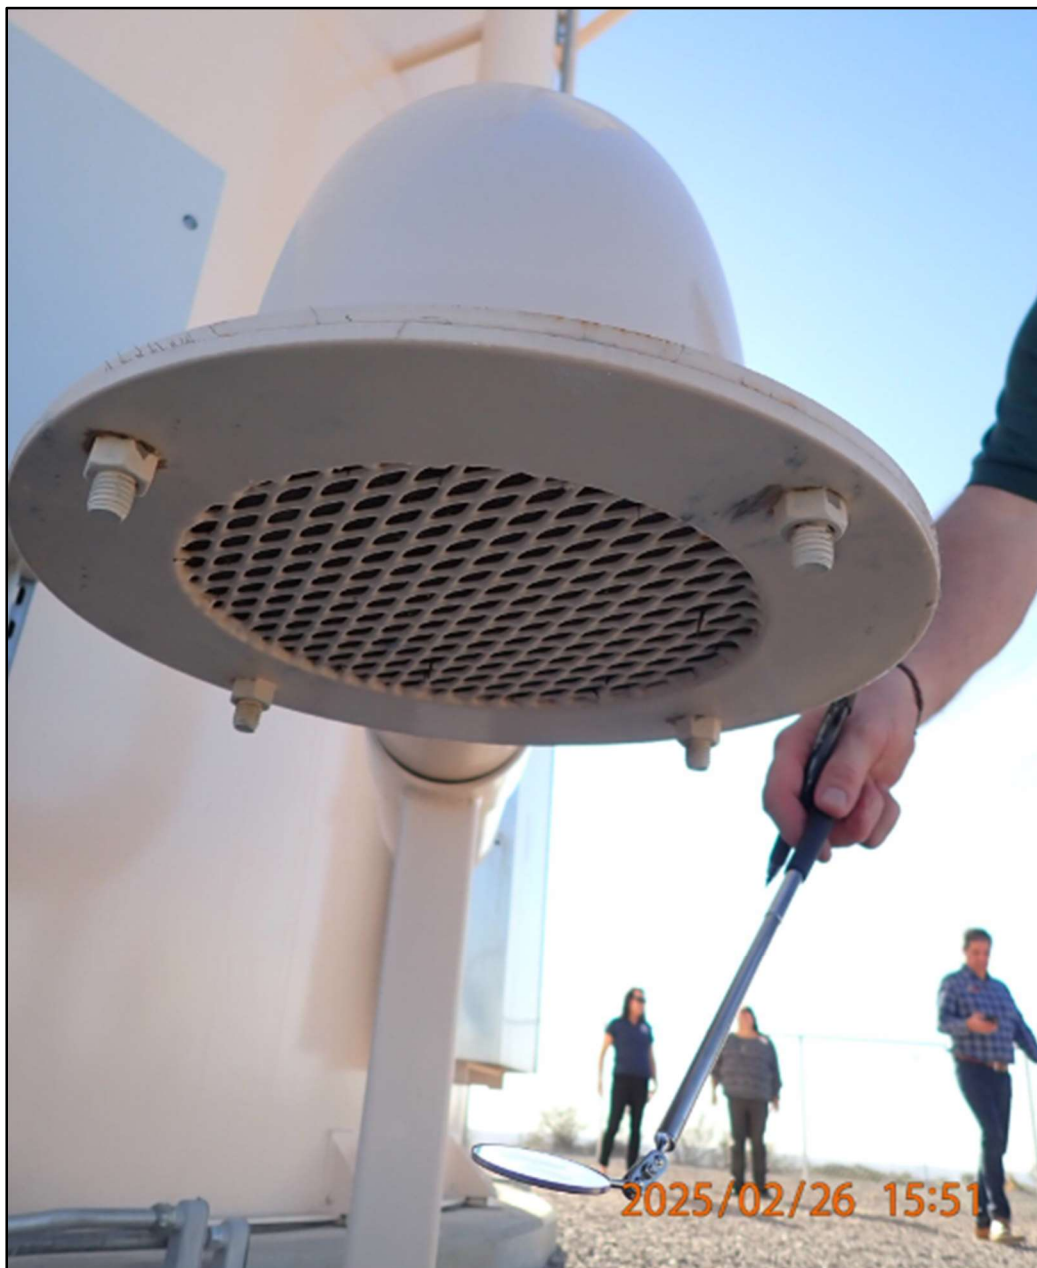
**Photograph 20. 02/26/2025 15:51 P2260567.JPG**

Description: 250,000 Gallon Storage Tank overflow with coarse screen.

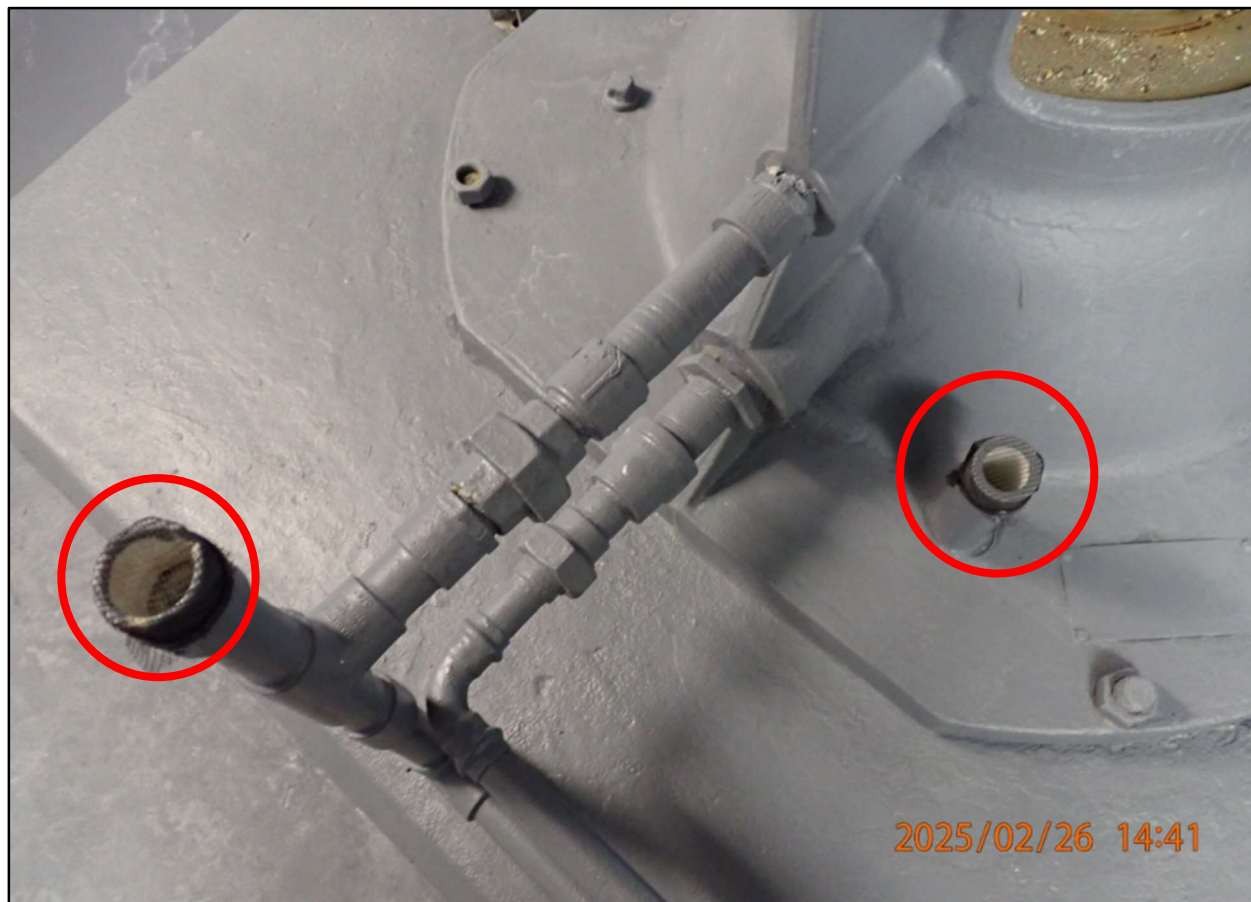
**Photograph 21. 02/26/2025 14:41 P2260488.JPG**

Description: Well #16 drain vent with a screen larger than #24-mesh.

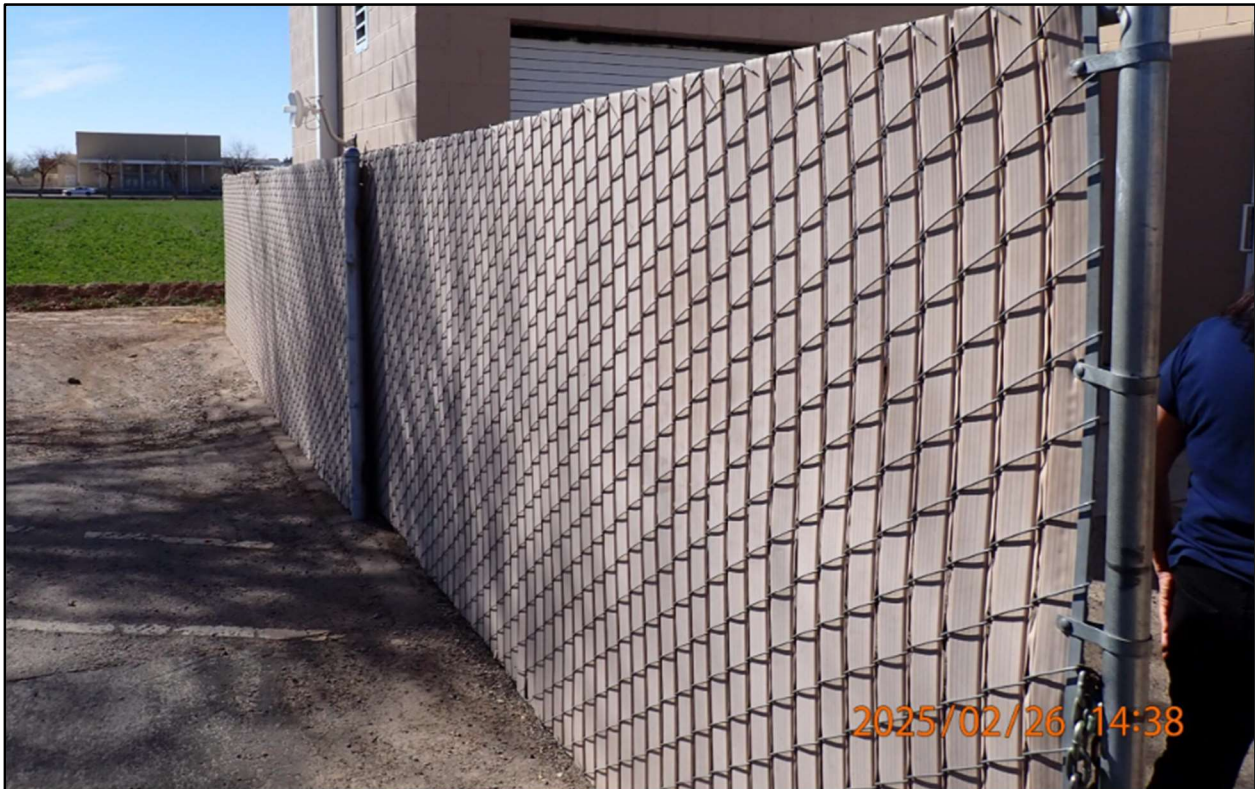
**Photograph 22. 02/26/2025 14:38 P2260478.JPG**

Description: Short fence without barbed wire surrounding Well #16.

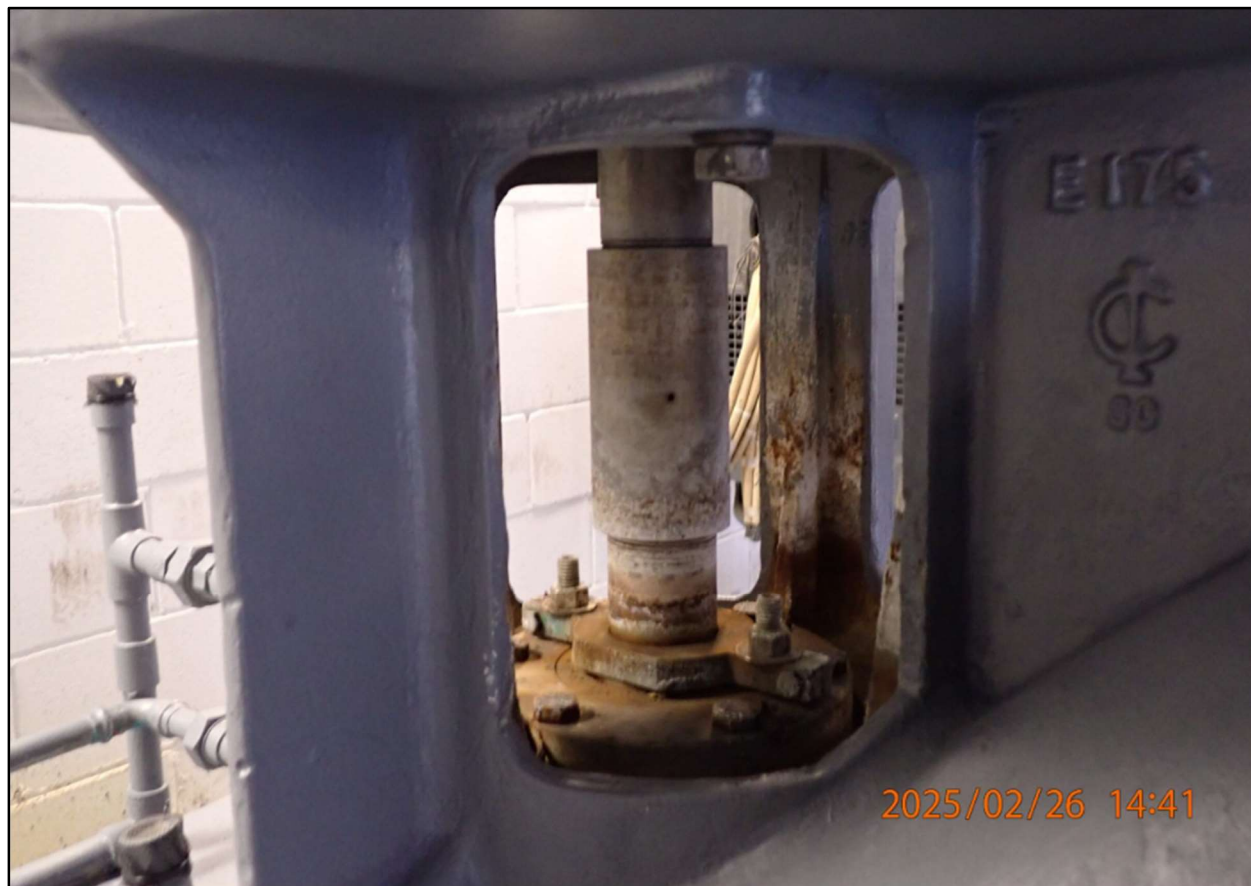
**Photograph 23. 02/26/2025 14:41 P2260487.JPG**

Description: Well #16 rotating pump shaft without protective guard.

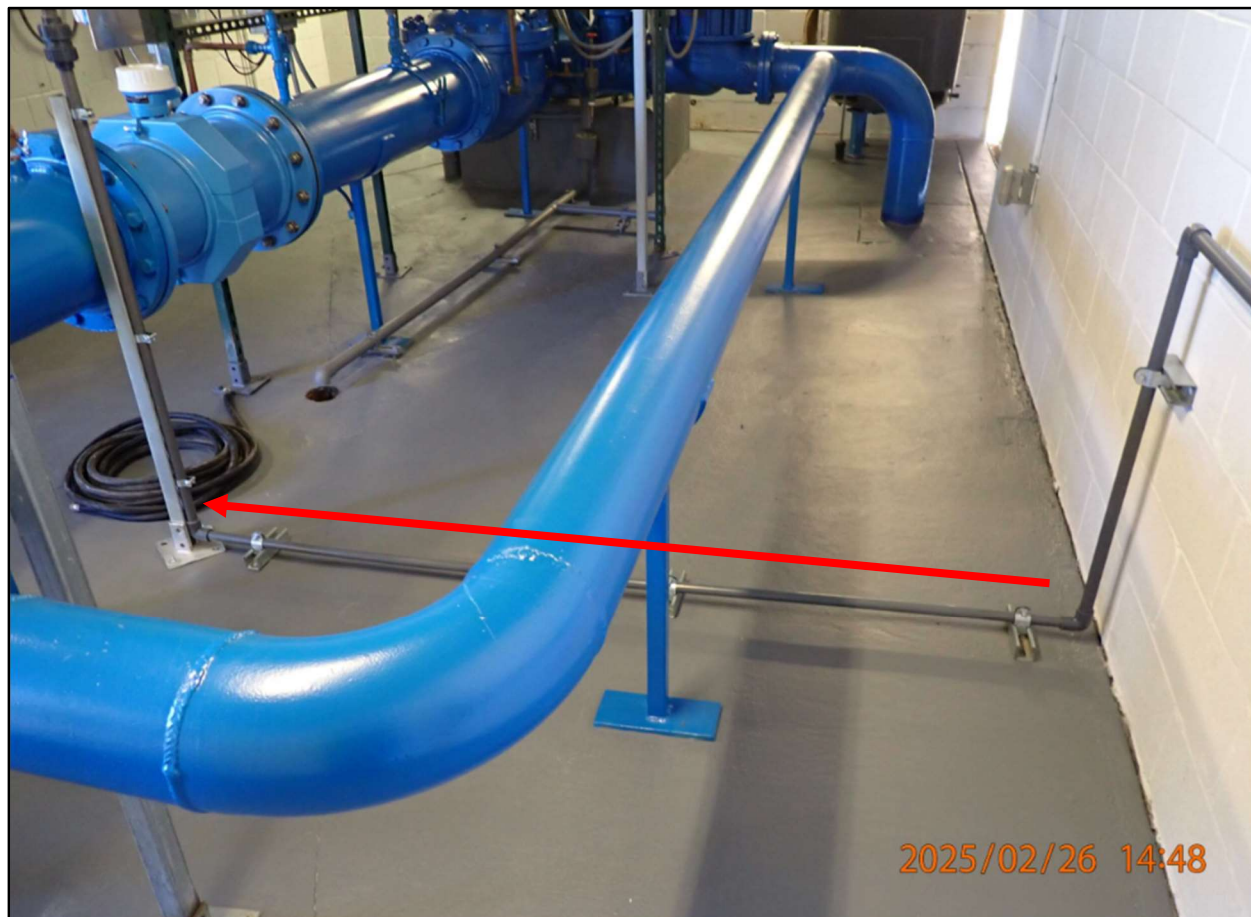
**Photograph 24. 02/26/2025 14:48 P2260492.JPG**

Description: Unlabeled chemical feed line plumbed across the floor of Well #16.

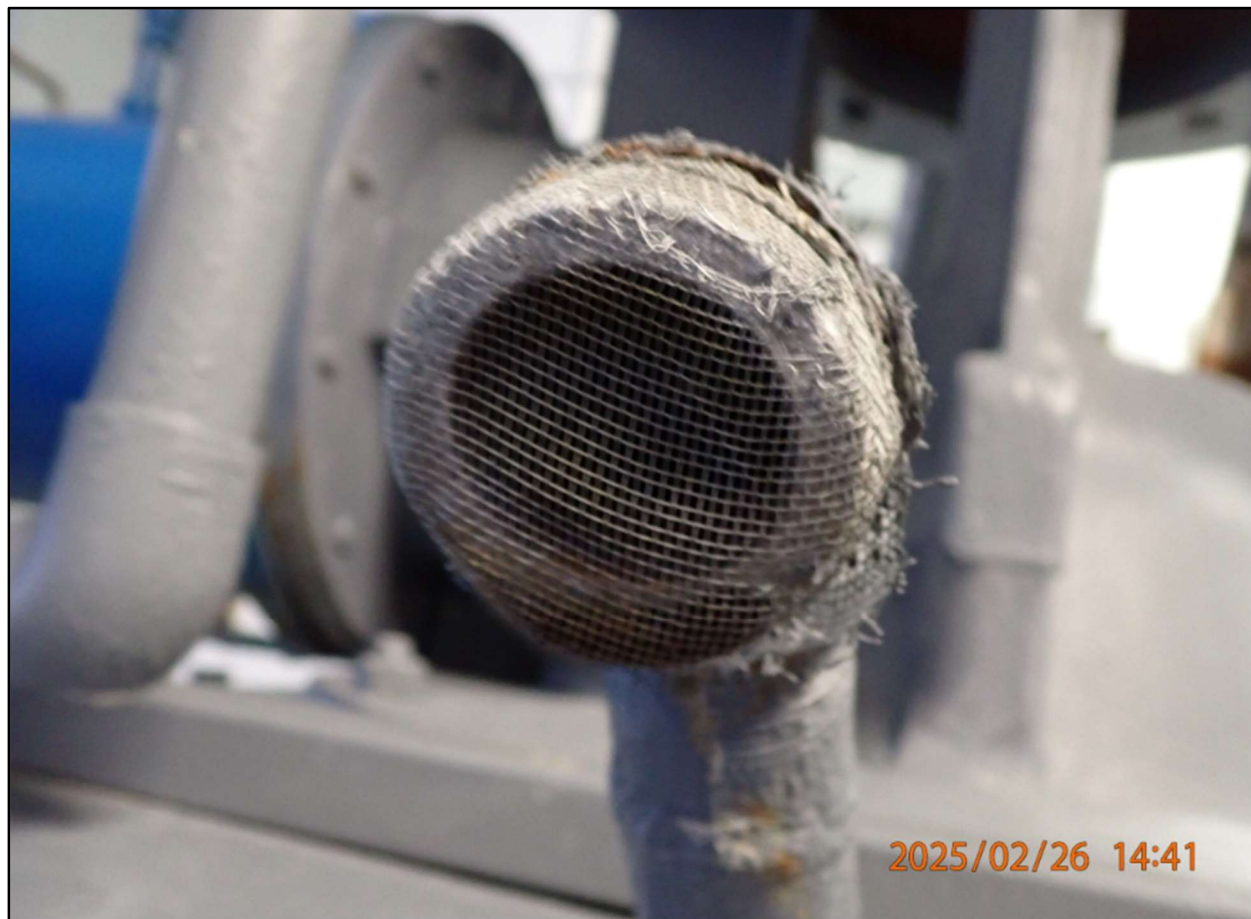
**Photograph 25. 02/26/2025 14:41 P2260489.JPG**

Description: Well #16 vent with a screen larger than #24-mesh.

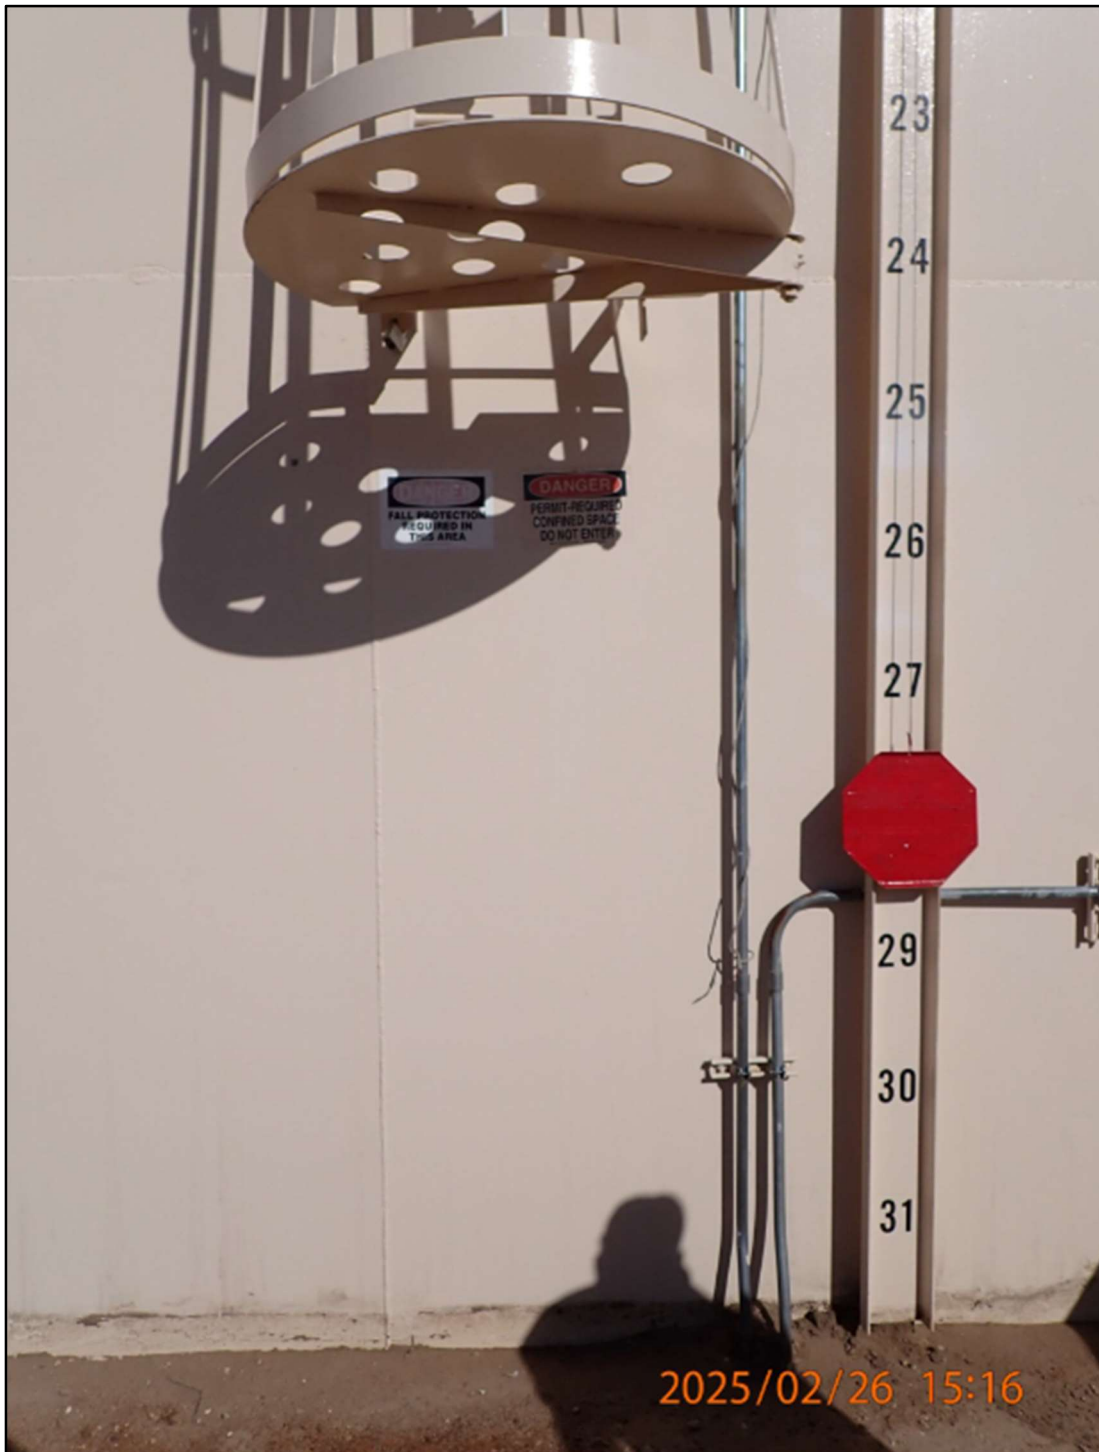
**Photograph 28. 02/26/2025 15:16 P2260532.JPG**

Description: First ladder rung at the 4-MG Storage Tank 7 feet off the ground.

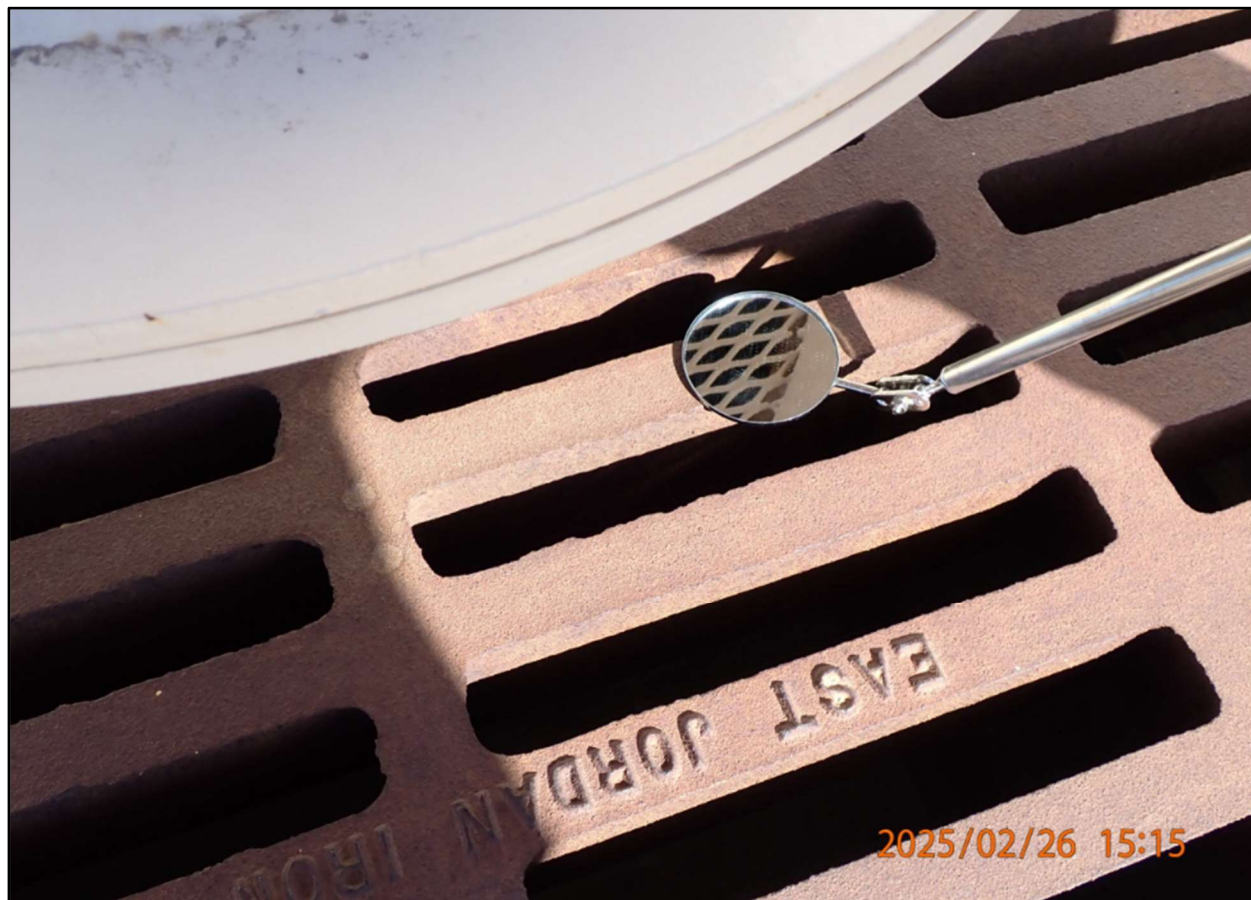
**Photograph 29. 02/26/2025 15:15 P2260527.JPG**

Description: Overflow of the 4-MG Storage Tank with coarse screen (shown in mirror).

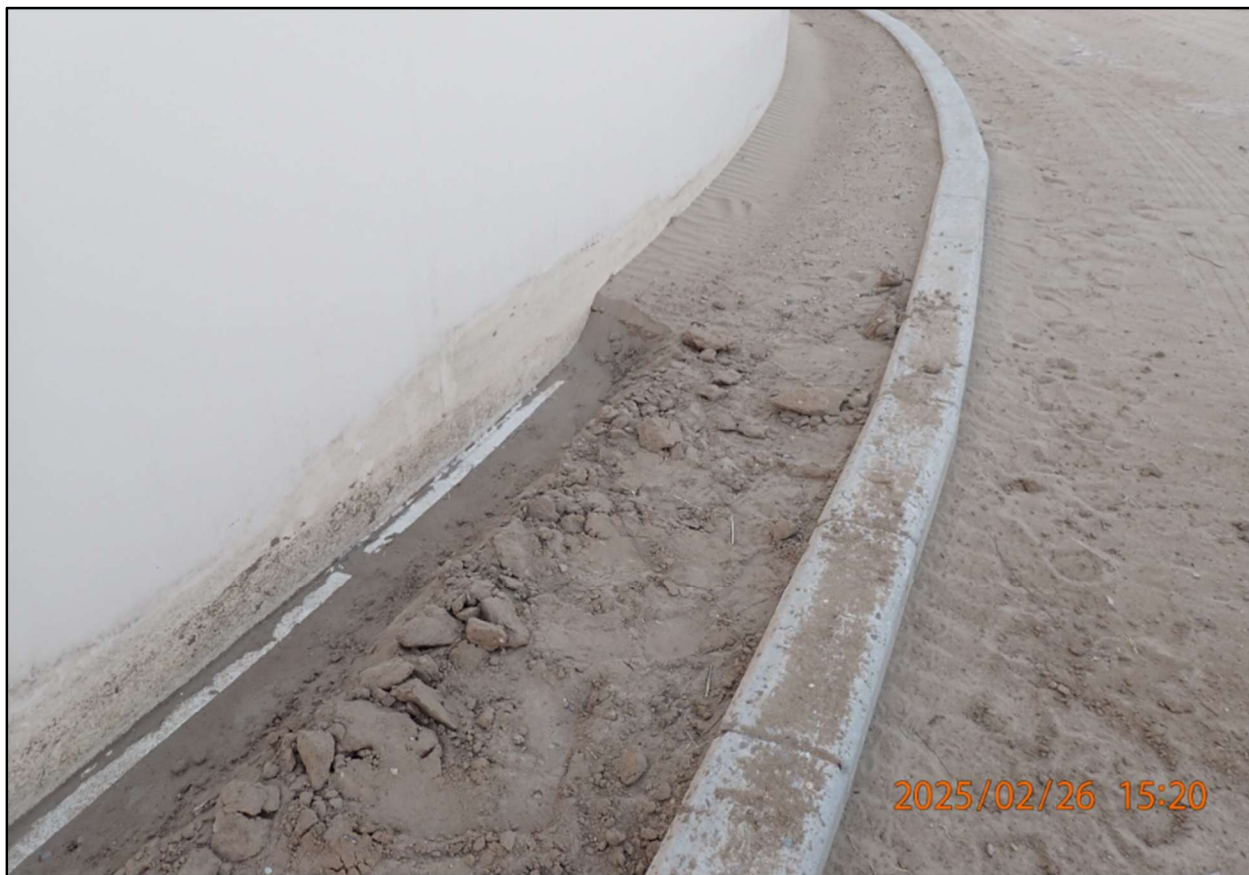
**Photograph 30. 02/26/2025 15:20 P2260535.JPG**

Description: Dirt and sand collected around the foundation of the 4-MG Storage Tank, clogging foundation ring drains.

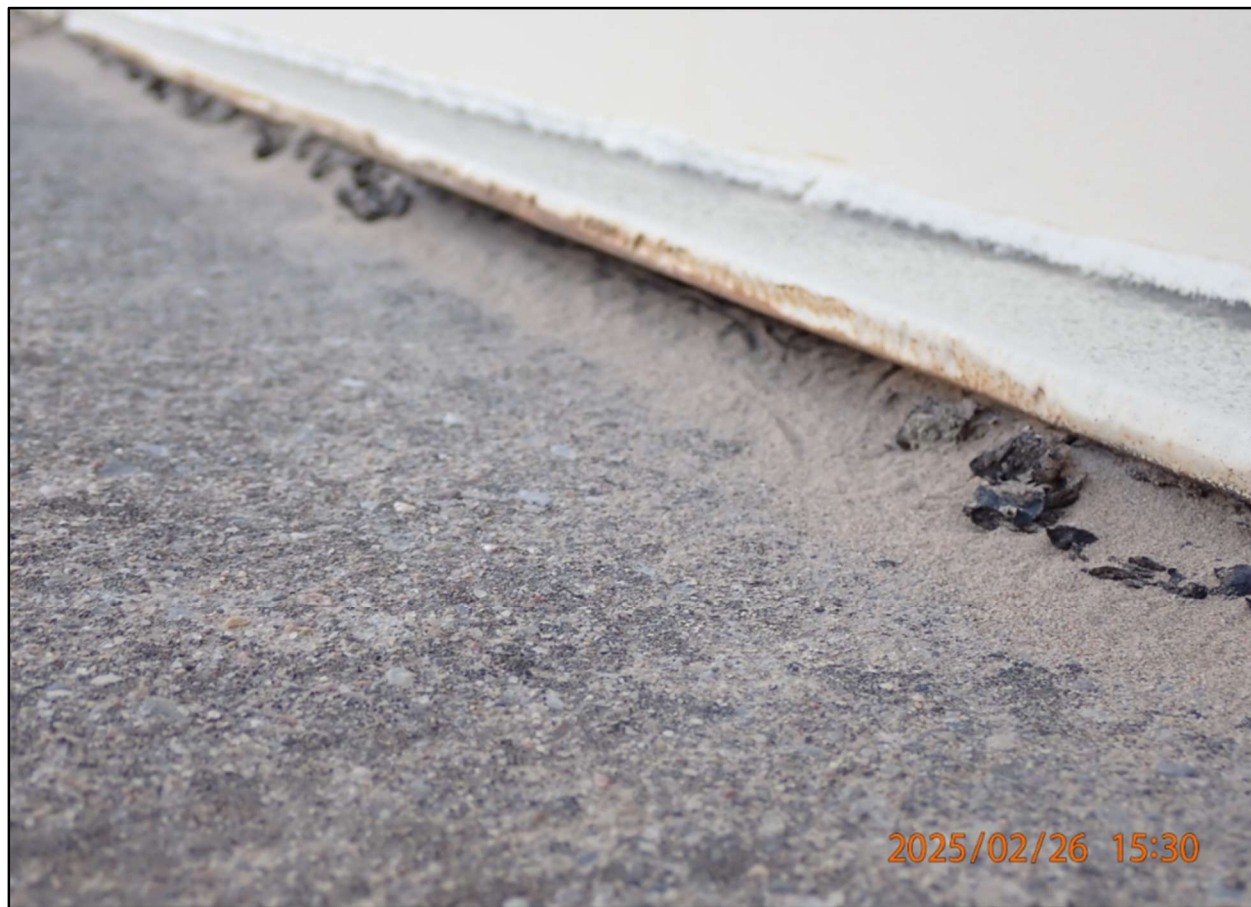
**Photograph 31. 02/26/2025 15:30 P2260551.JPG**

Description: 5-MG Storage Tank foundation with brittle and missing seal.

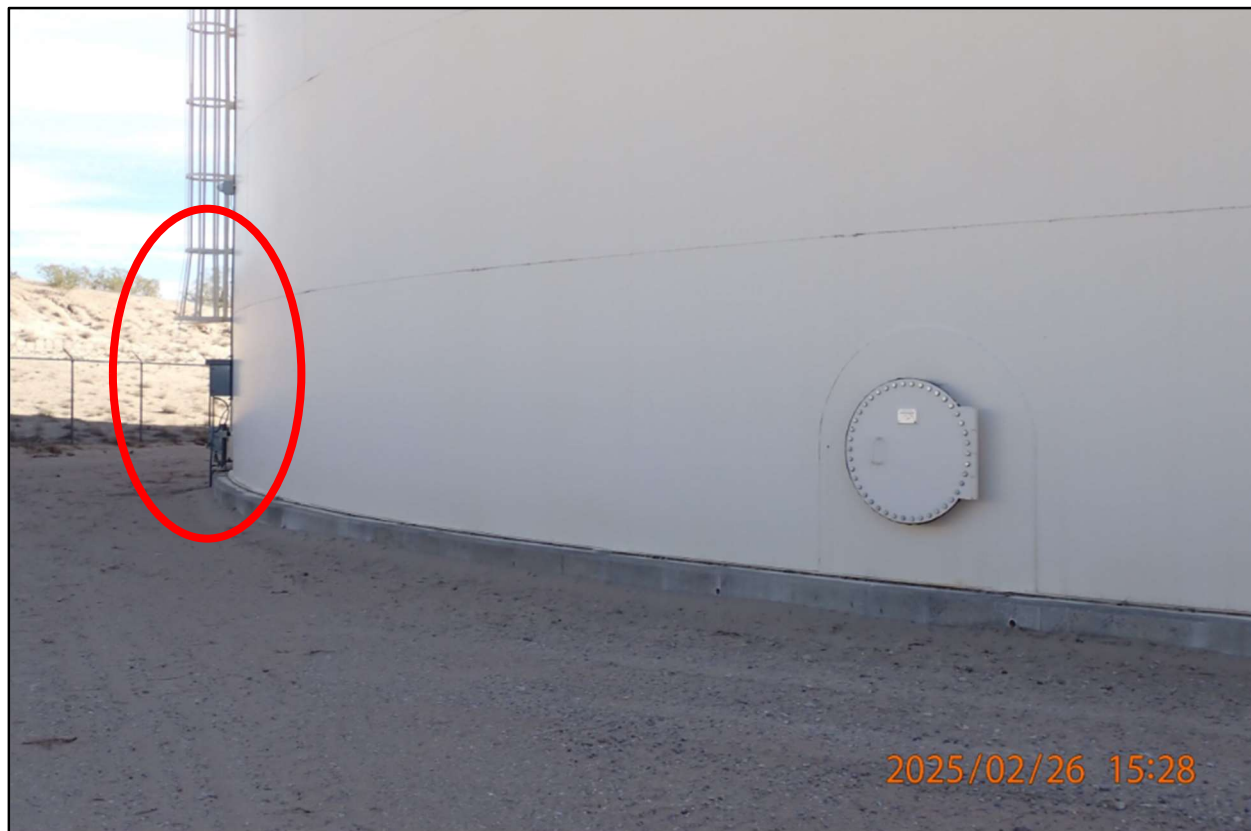
**Photograph 32. 02/26/2025 15:28 P2260547.JPG**

Description: First ladder rung at the 5-MG Storage Tank 9 feet off the ground.
