**UNITED STATES ENVIRONMENTAL PROTECTION AGENCY, REGION 2**  
**Enforcement and Compliance Assurance Division Water**  
**Compliance Branch**

| <b>Clean Water Act (CWA) Inspection</b><br><b>Report Program:</b> Industrial Stormwater | <b>Inspection Type:</b> Compliance Evaluation Inspection |
| <b>Site Name:</b> Curran Renewable Energy LLC<br>(Does not have a permit) | <b>NPDES/ICIS No.:</b> NYU065324 |

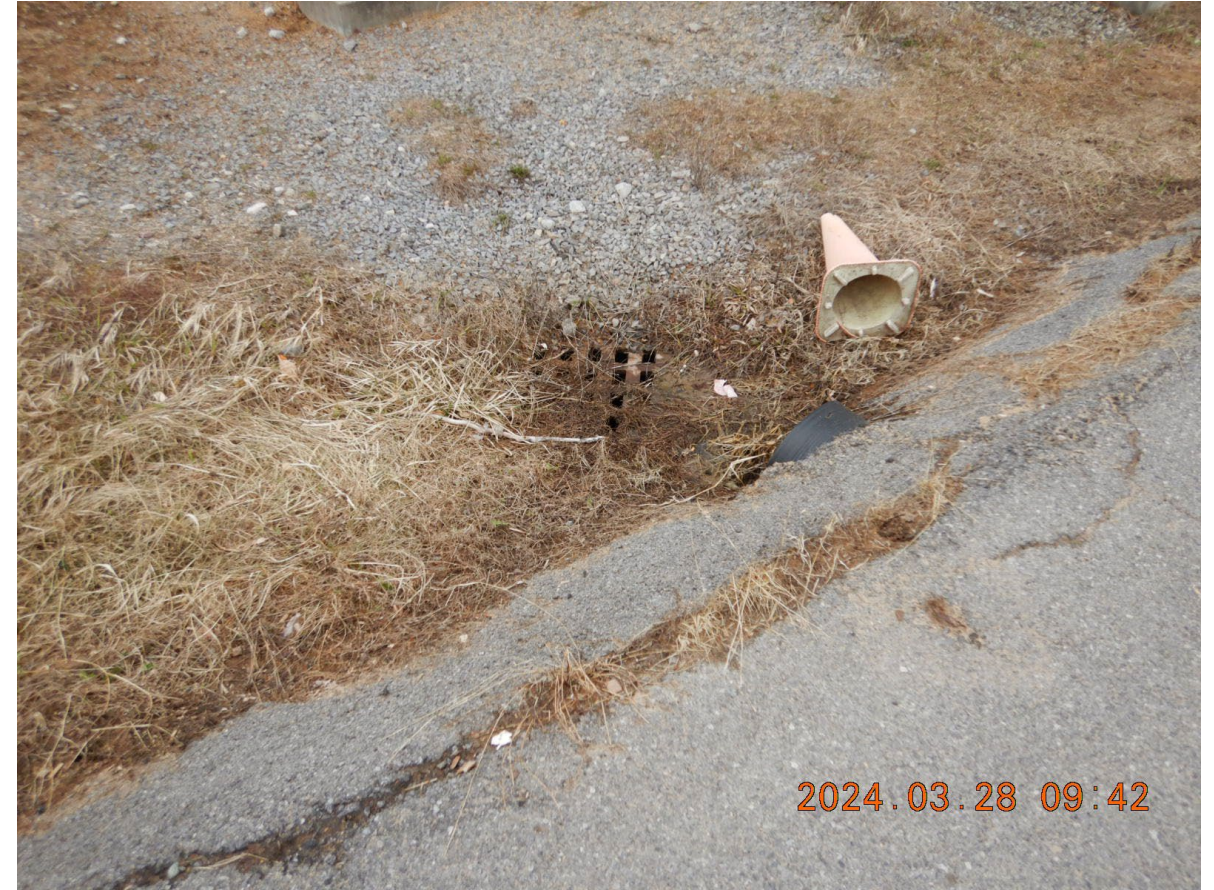
DSCN2661 - Stormwater channel that enters a pipe and flows downslope W towards storm drainage along rail line

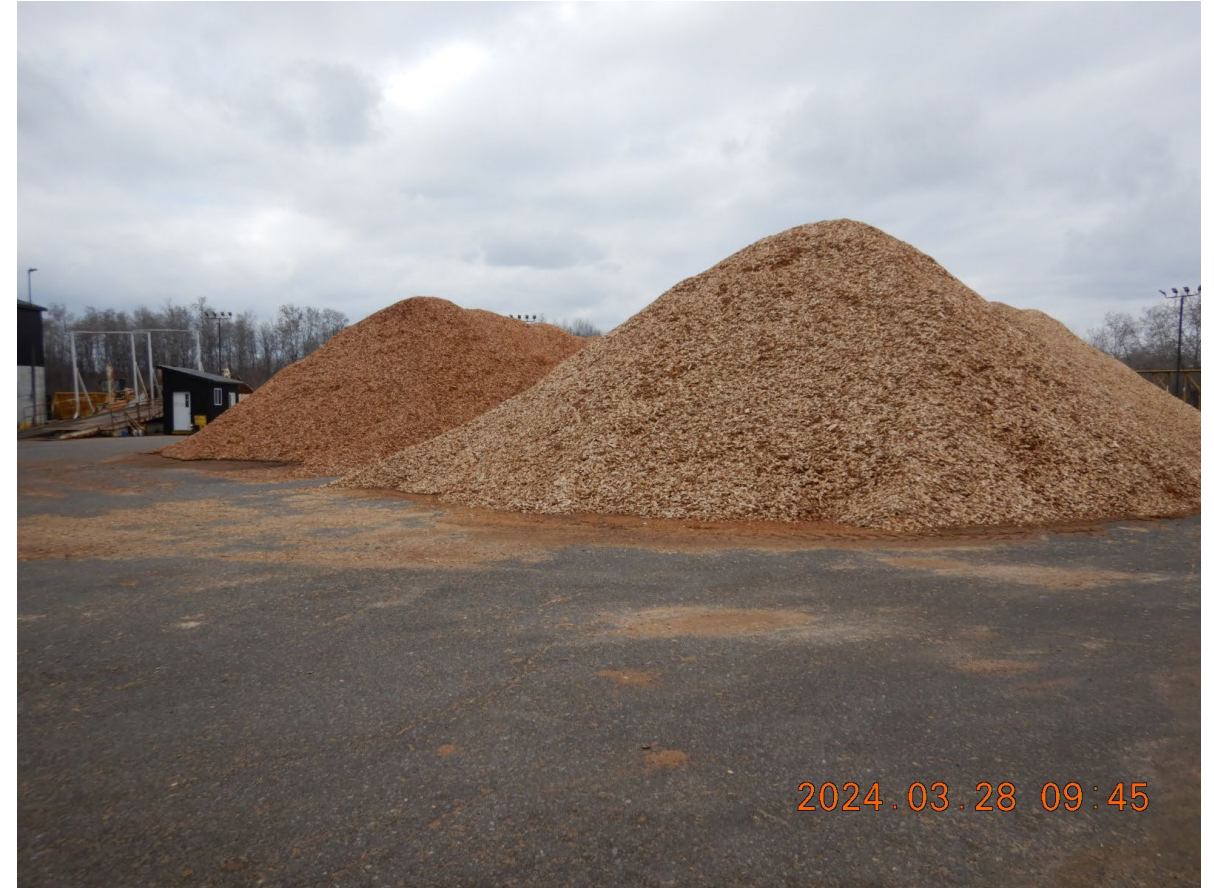
- a. At the time of the CEI, EPA observed an uncovered dumpster and materials, scrap and waste exposed to stormwater (Attachment 1; DSCN2664, DSCN2680 and DSCN2686).

DSCN2664 - Uncovered dumpster on the S side of the packaging warehouse

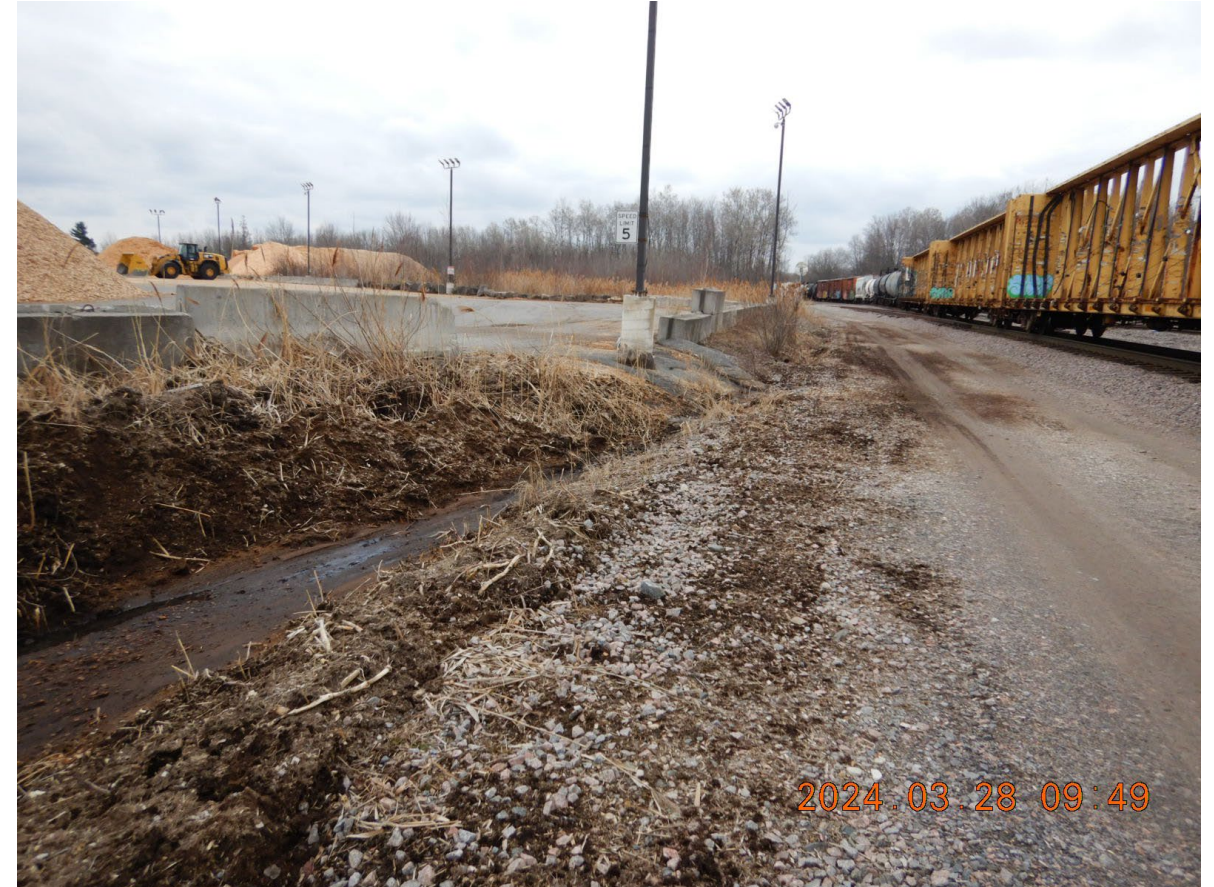
2. Part II.A.3 of the Permit states that the owner or operator must minimize pollutant discharges and achieve the effluent limitations in this permit, all industrial equipment and systems and control measures must be maintained in effective operating condition. EPA observed catch basins in need of maintenance. For example, photo 2754 shows a storm inlet with a large amount of wood chips and mulch within it, and photo 2662 shows a storm inlet partially blocked with vegetation (Attachment 1; DSCN2662, DSCN2671, DSCN2753, DSCN2754, DSCN2756).

DSCN2671 - Stormwater outfall on the W edge of Site; Stormwater from Catch Basin #1 located near the S corner of the packaging warehouse. The outfall is not visible (and needs to be cleaned)

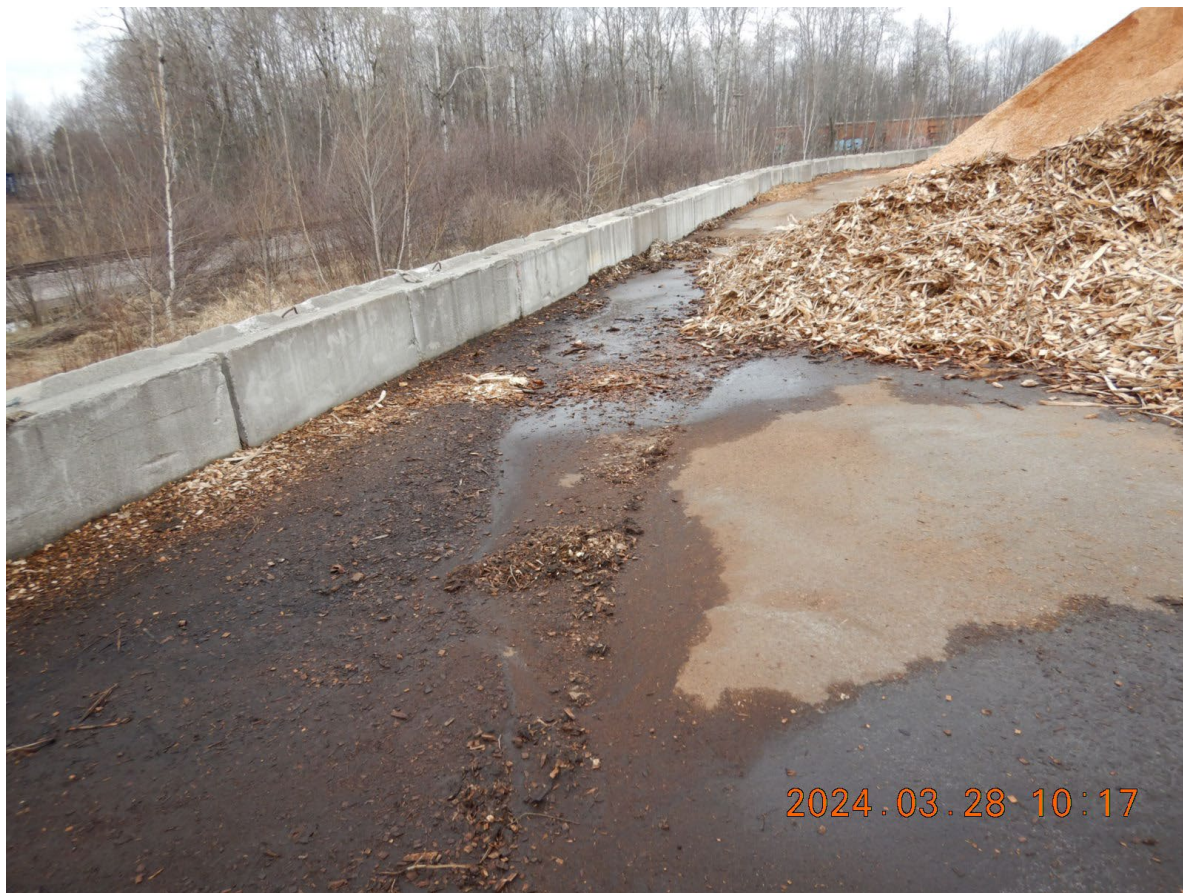
gaps in the concrete block wall in certain locations and piping that allow stormwater associated with industrial activities to reach stormwater channels (Attachment 1; DSCN2703, DSCN2707, DSCN2708, DSCN2709, and DSCN2716).

DSCN2707 - Stormwater runoff on S lot of Site. There are small gaps in the block wall where stormwater could flow out of.

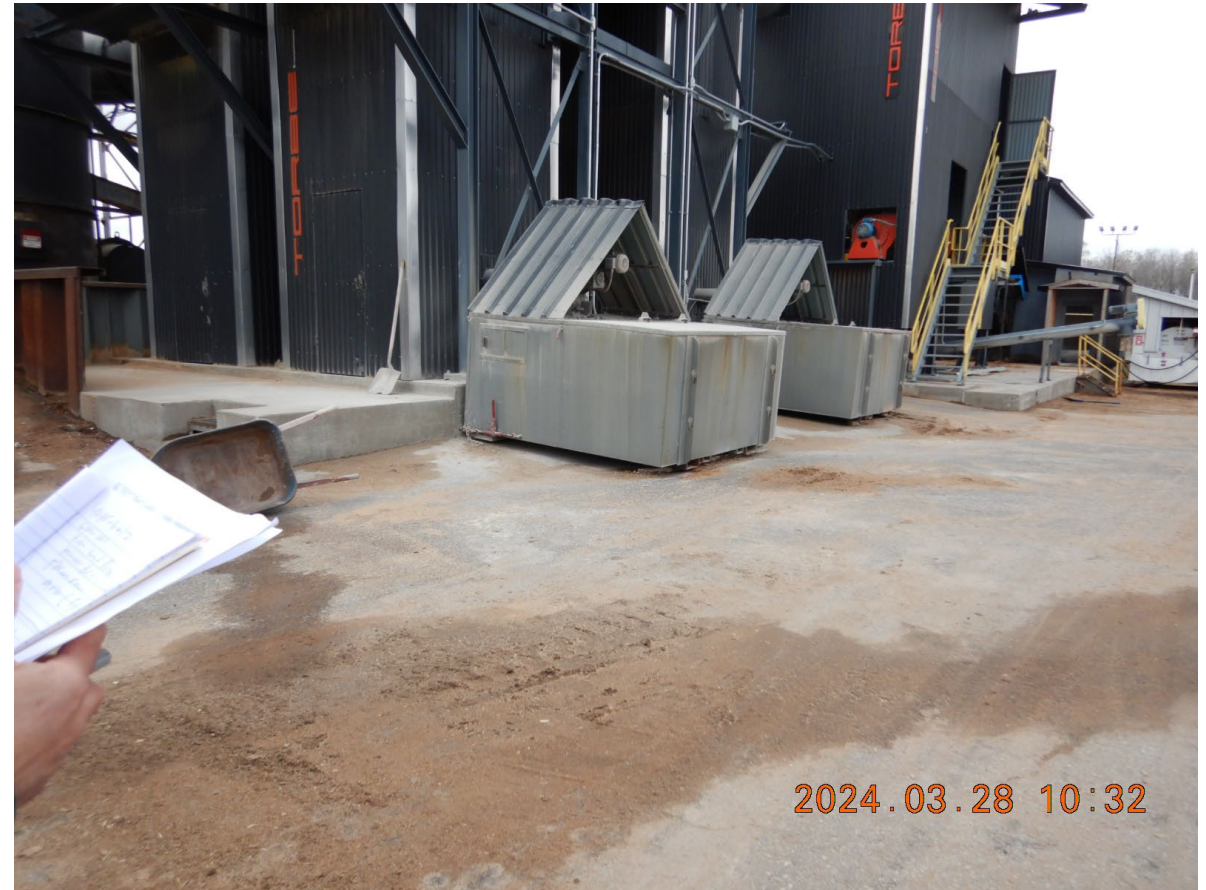
3. As shown in photo DSCN2722, the Facility has a 2,000-gallon tank for off road diesel fuel, which is used for fueling equipment. The facility representative said that they have a Spill Prevention Control and Countermeasures ("SPCC") Plan required by 40 CFR 112. EPA requests to be provided a copy of the SPCC plan.

DSCN2722 - Diesel Tank located near woodchip unloading and loading in central area of Site

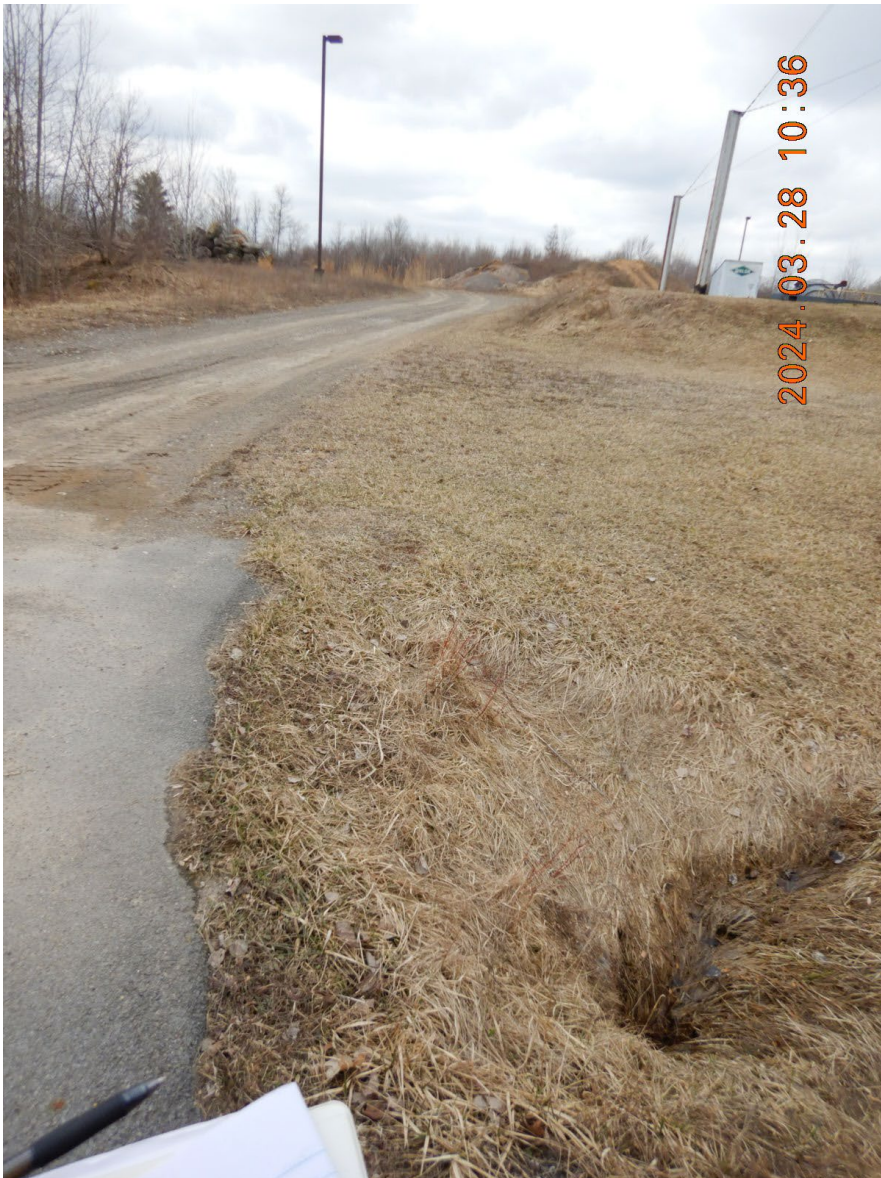
DSCN2724 - Two containers that collect waste ash during pellet manufacturing with loose material seen on the ground near them

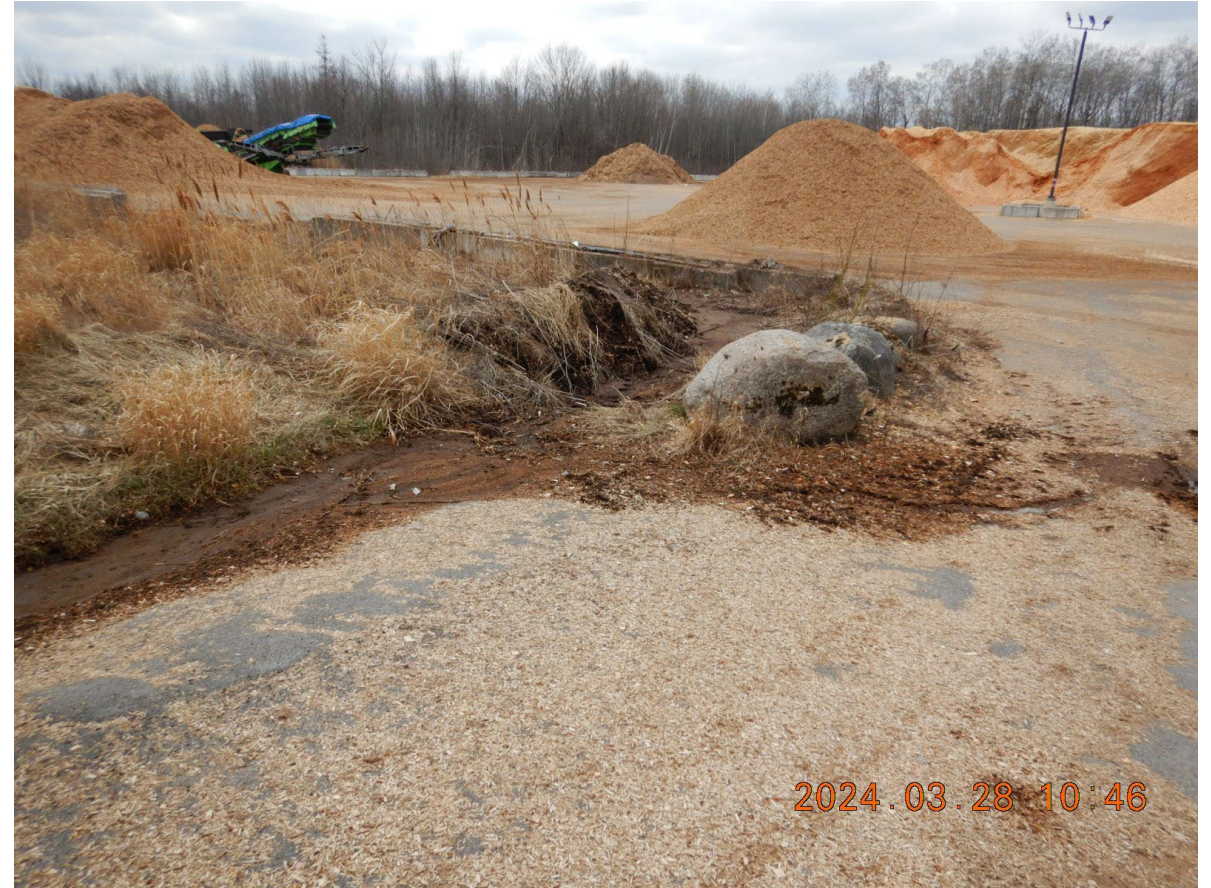
- c. Runoff of condensate from the Facility equipment towards a stormwater channel (Attachment 1; DSCN2751, DSCN2749, DSCN2750, and DSCN2748). Part I.B.2 of the MSGP does not authorize non-stormwater discharges of condensate of gas streams (except for uncontaminated steam or air conditioning condensate) as cited in 6 NYCRR 750-1.2(a)(29)(vi).

DSCN2749 - Condensate runoff from manufacturing process

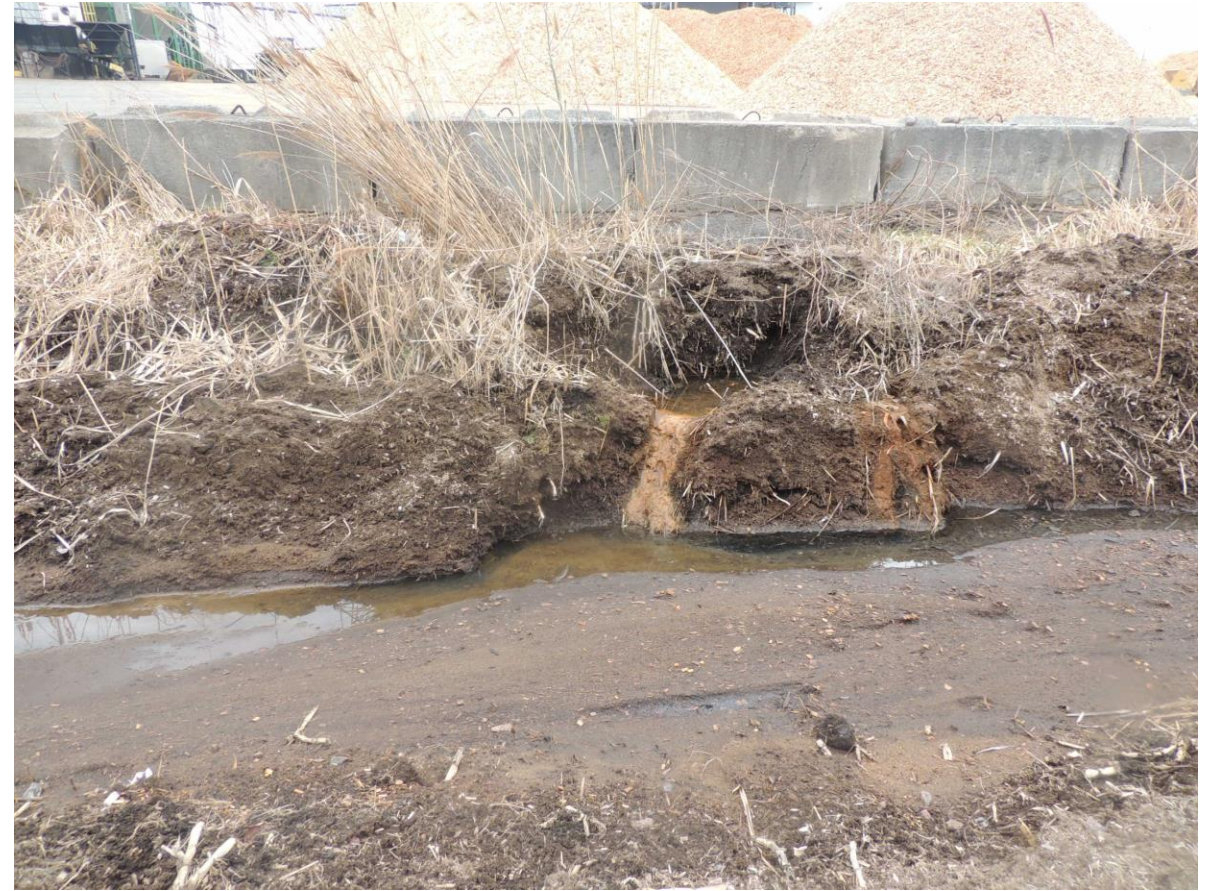
DSCN3994 - Stormwater outfall on the West of Site near CSX tracks; Stormwater from catch basin located near the South corner of the packaging warehouse. The outfall is not visible (and needs to be cleaned). Channel for stormwater flow also seen

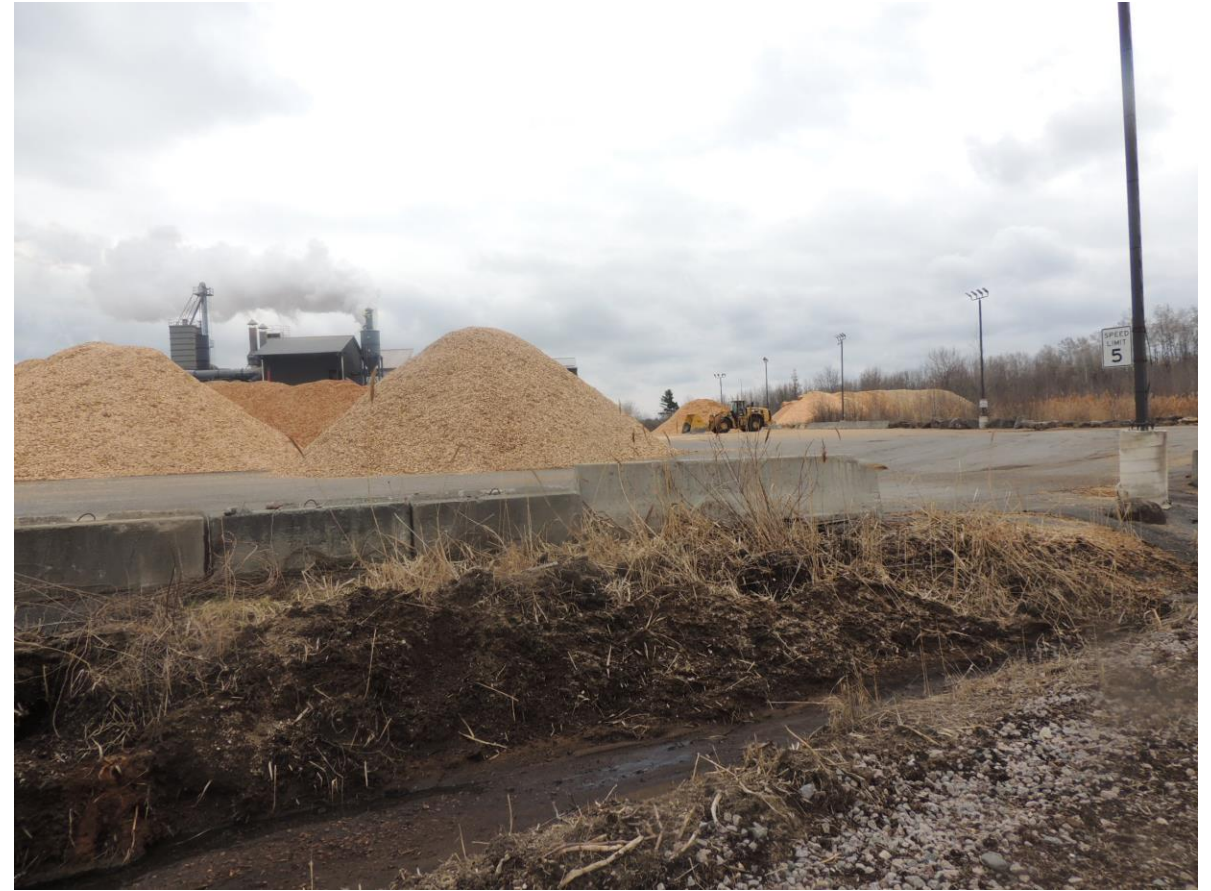
DSCN3996 – Storm channel along western portion of the Site adjacent to the CSX rail line and a break in block wall that would allow stormwater flow off the site.

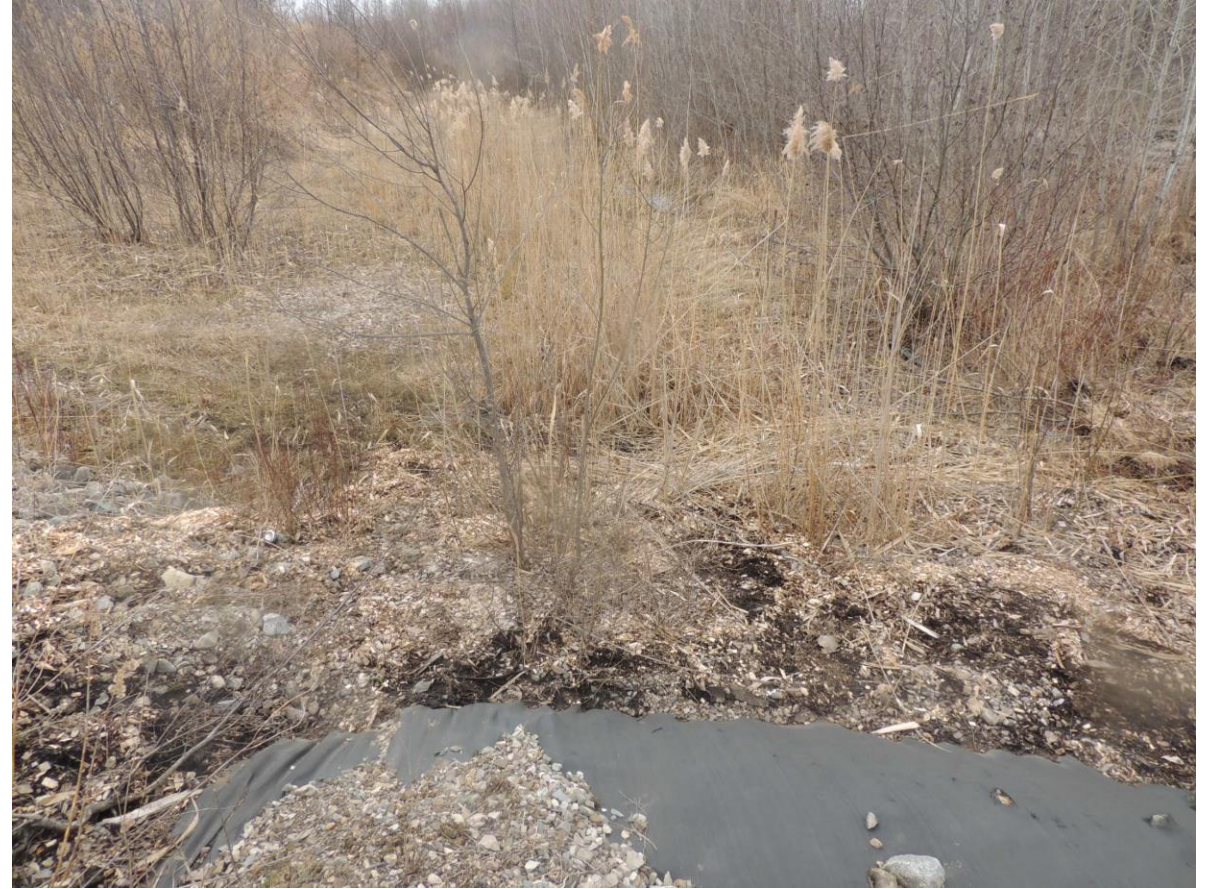
DSCN4020 – Drainage pathway for stormwater to flow from woodchip piles through the block walls on the southeast portion of the Site, area is wet

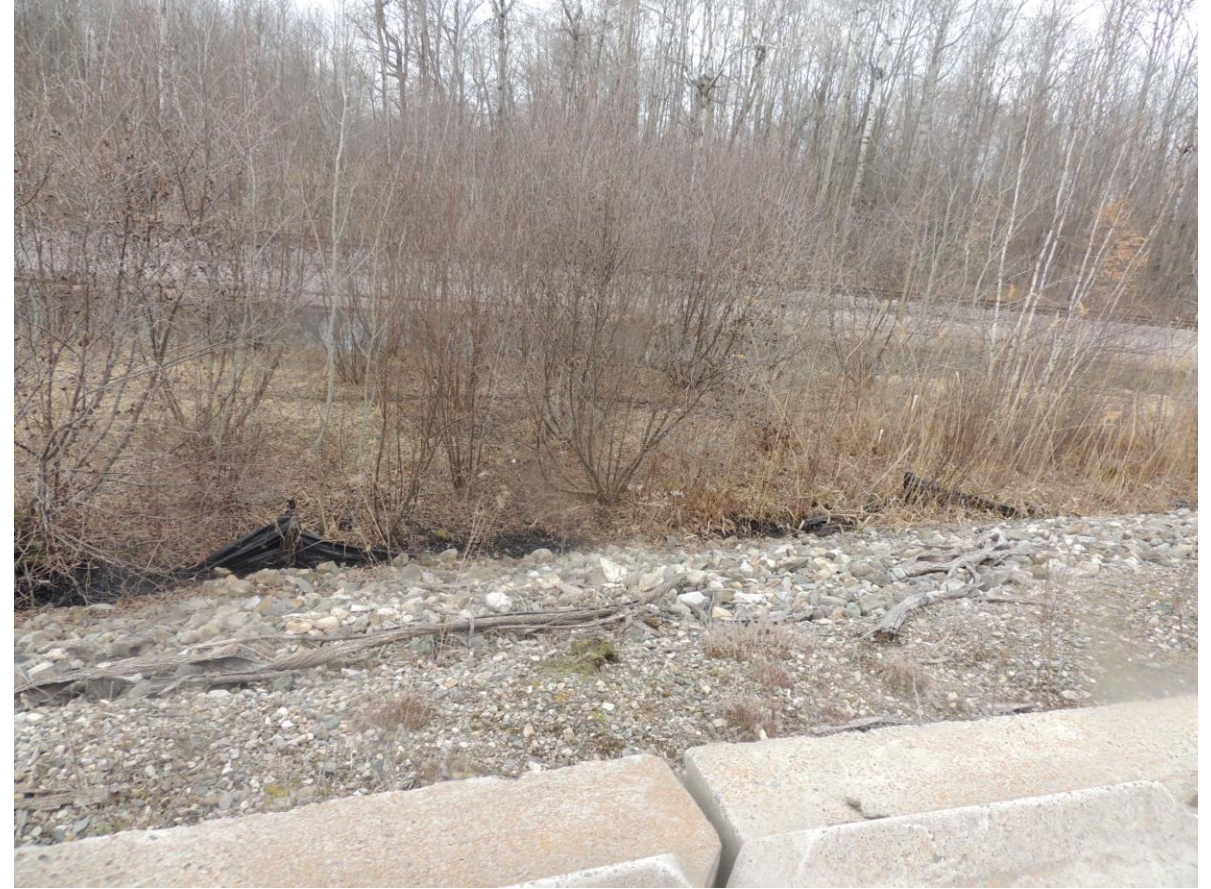
DSCN4026 – Gaps in the block wall around the facility  
southwest corner of Site

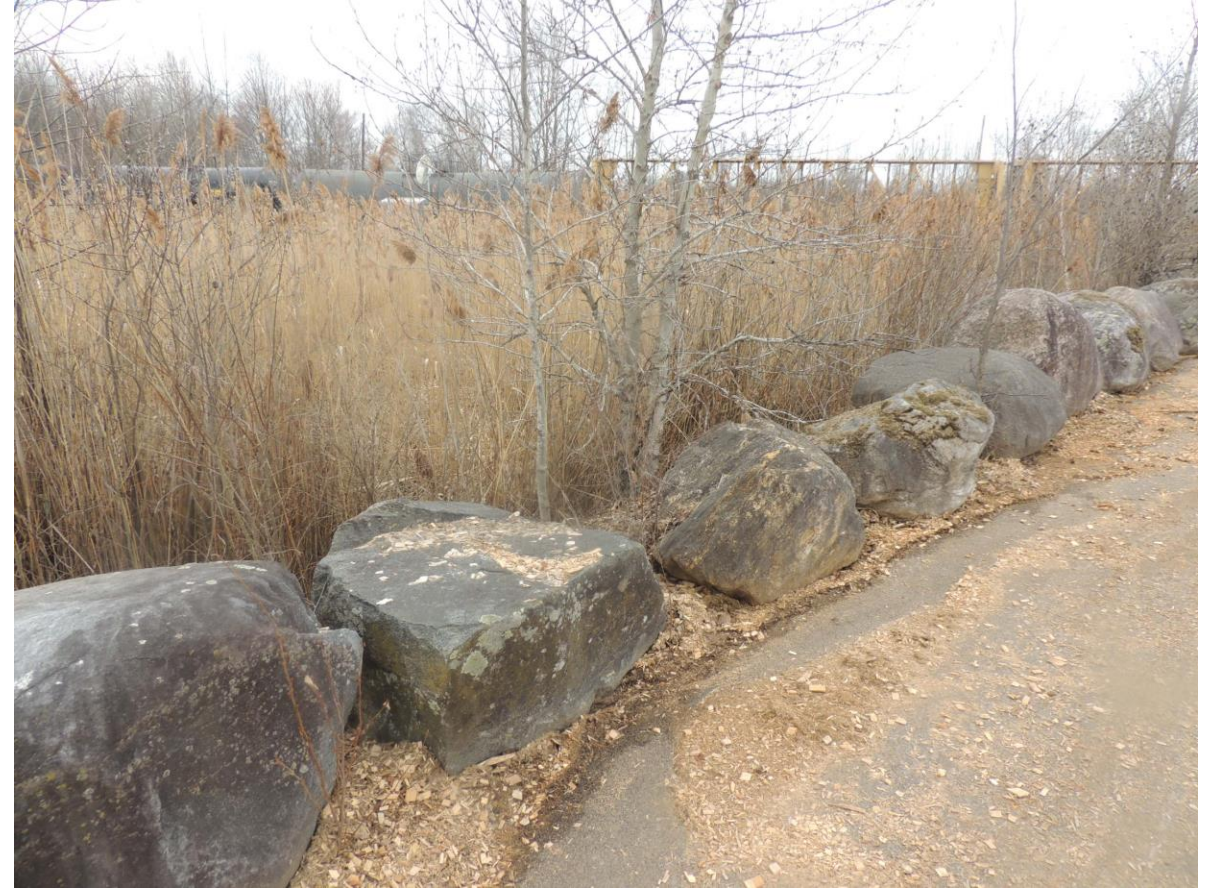
DSCN4036 - Gap in block wall on the southwest portion of the Site – woodchip accumulation

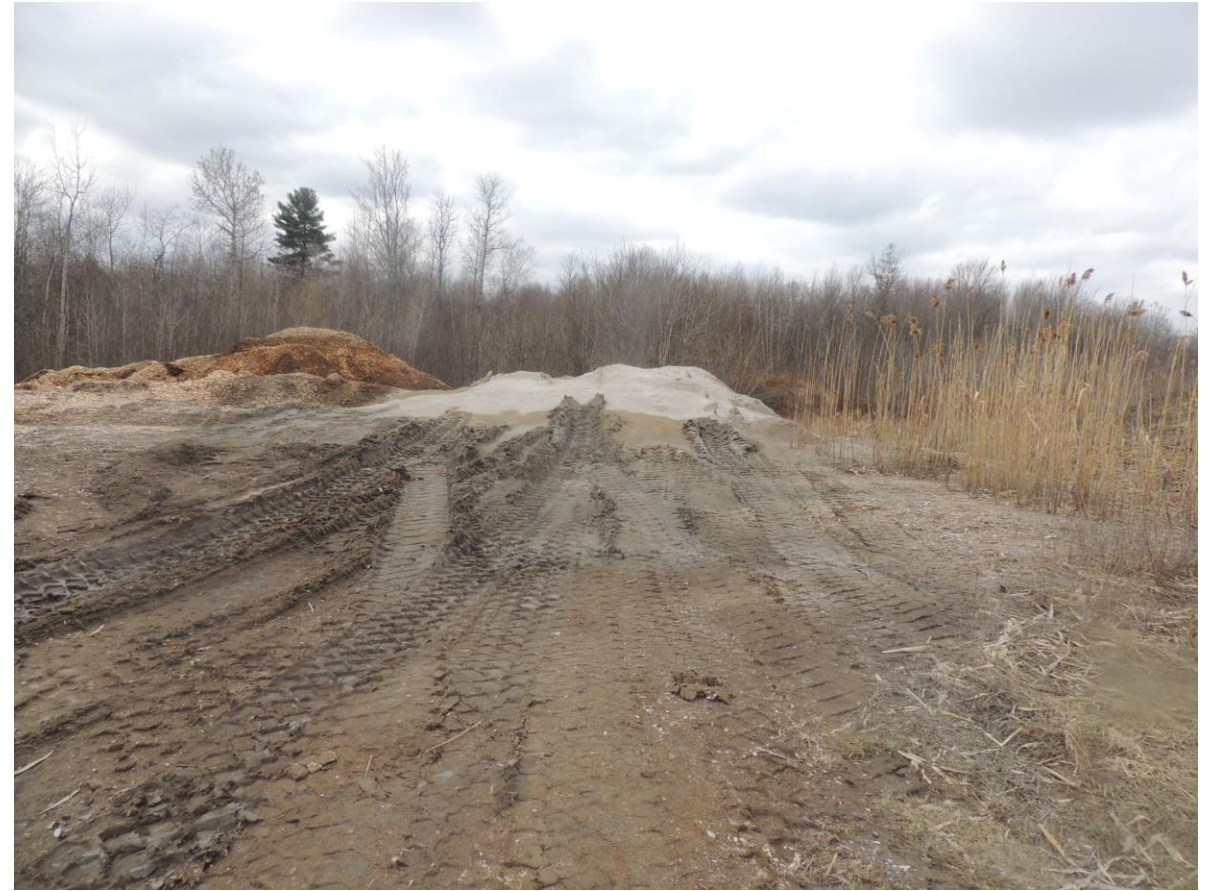
DSCN4046 – Boiler ash storage pile (uncovered), no BMPs in place

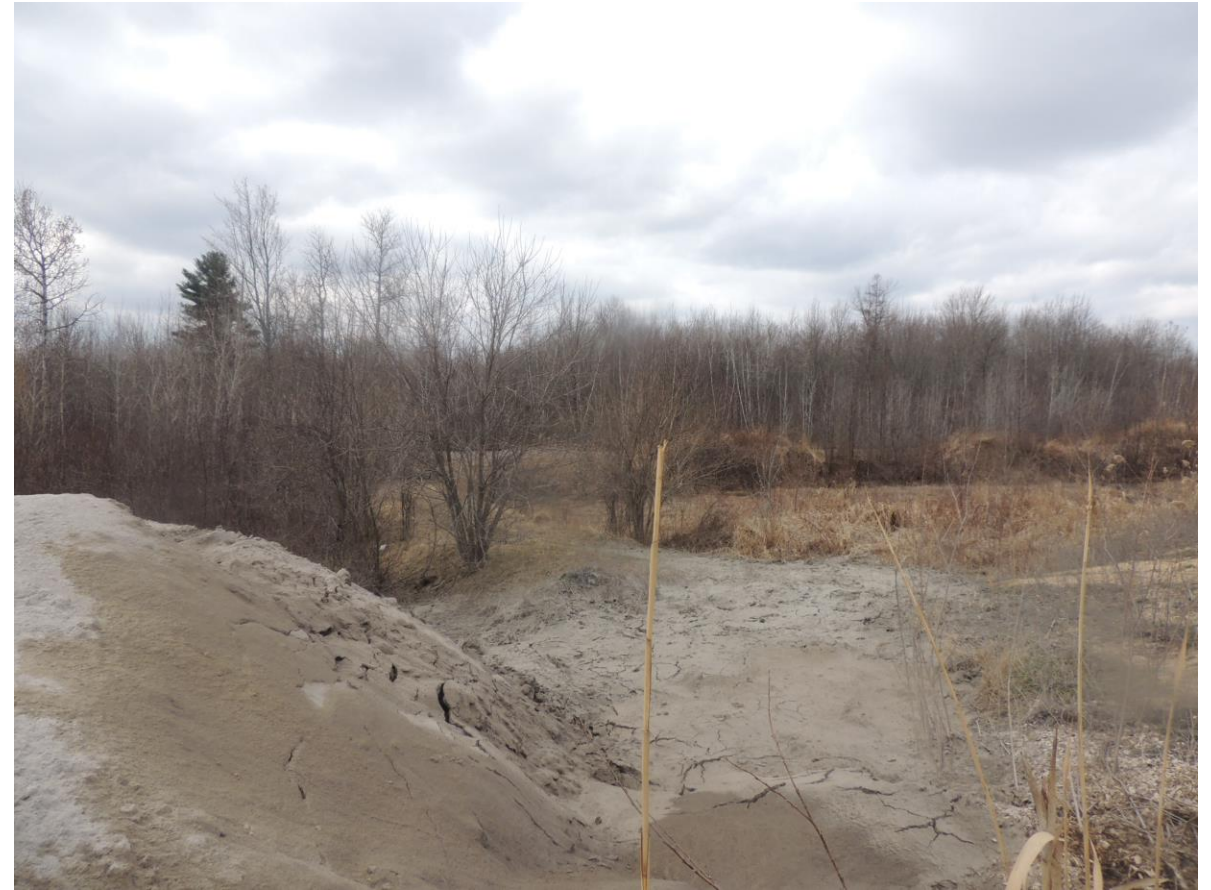
DSCN4047 – Boiler ash storage pile (uncovered), no BMPs in place

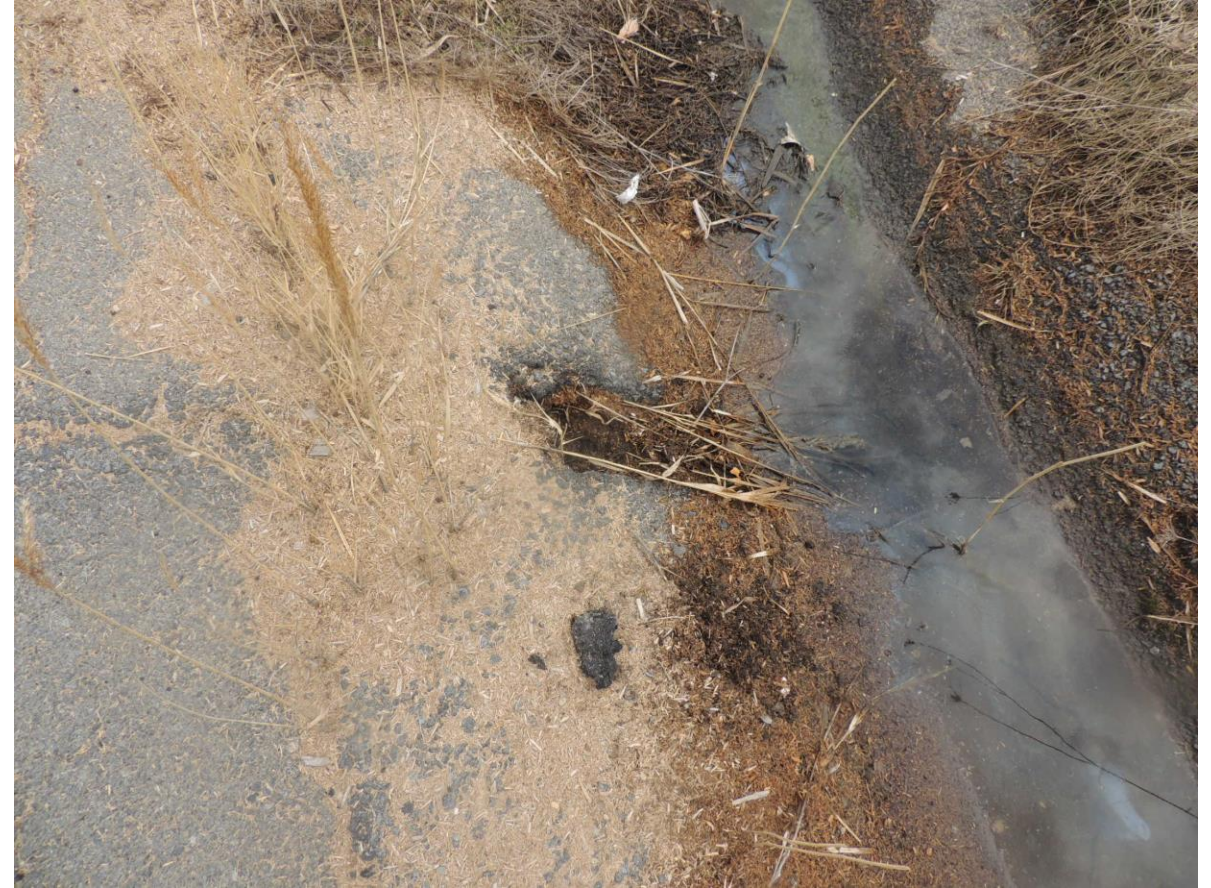
DSCN4061 – Dry weather/condensate flow into channel. Material Storage piles - exposed

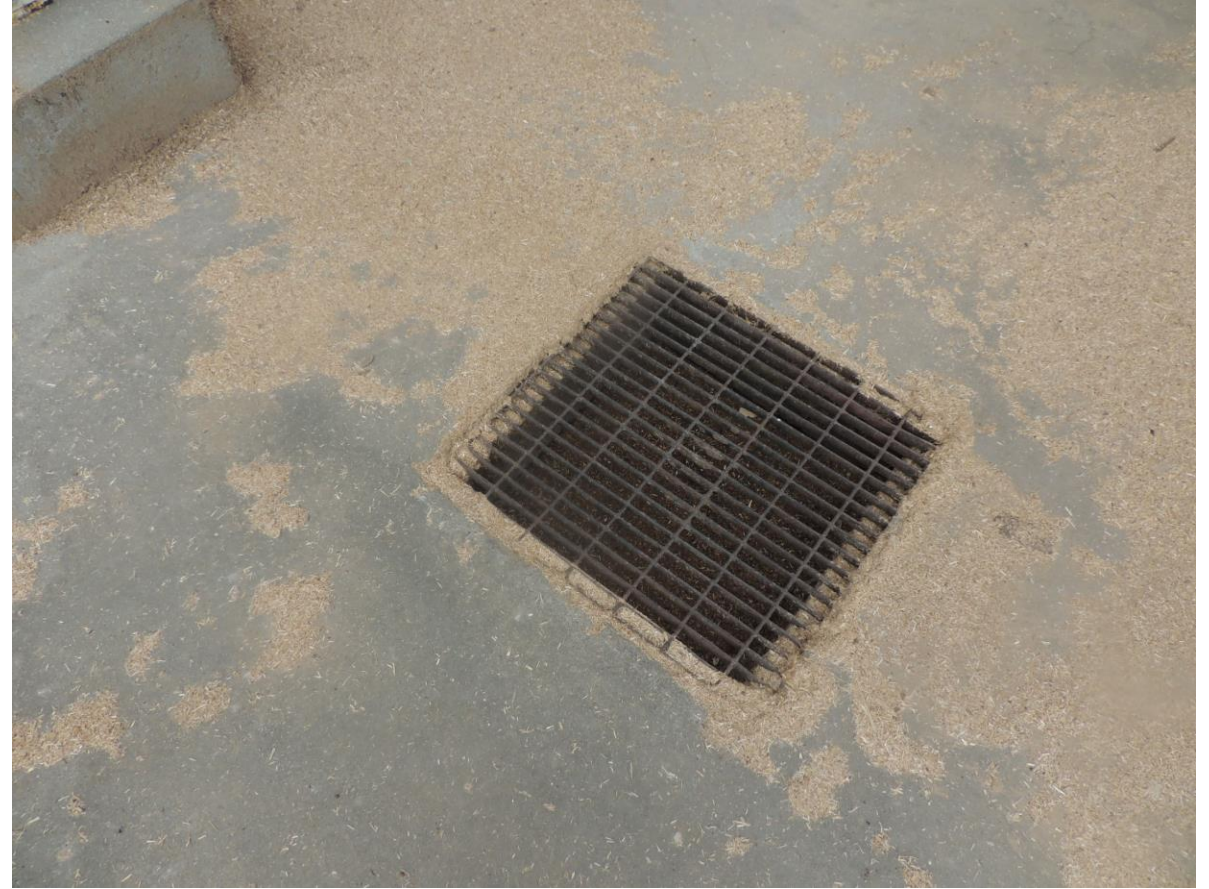
DSCN4064 – Catch basin with woodchip material in it
