REGARDING: Industrial Hygiene Summary Report for the Asbestos Identification Survey at Acustar Inc., Trenton Chemical Division, 5437 West Jefferson, Trenton, Michigan

**INDUSTRIAL HYGIENE SUMMARY REPORT****OF****THE ASBESTOS IDENTIFICATION SURVEY**

**ACUSTAR INC.  
TRENTON CHEMICAL DIVISION  
5437 WEST JEFFERSON  
TRENTON, MICHIGAN**

**PROJECT NO. 2088**

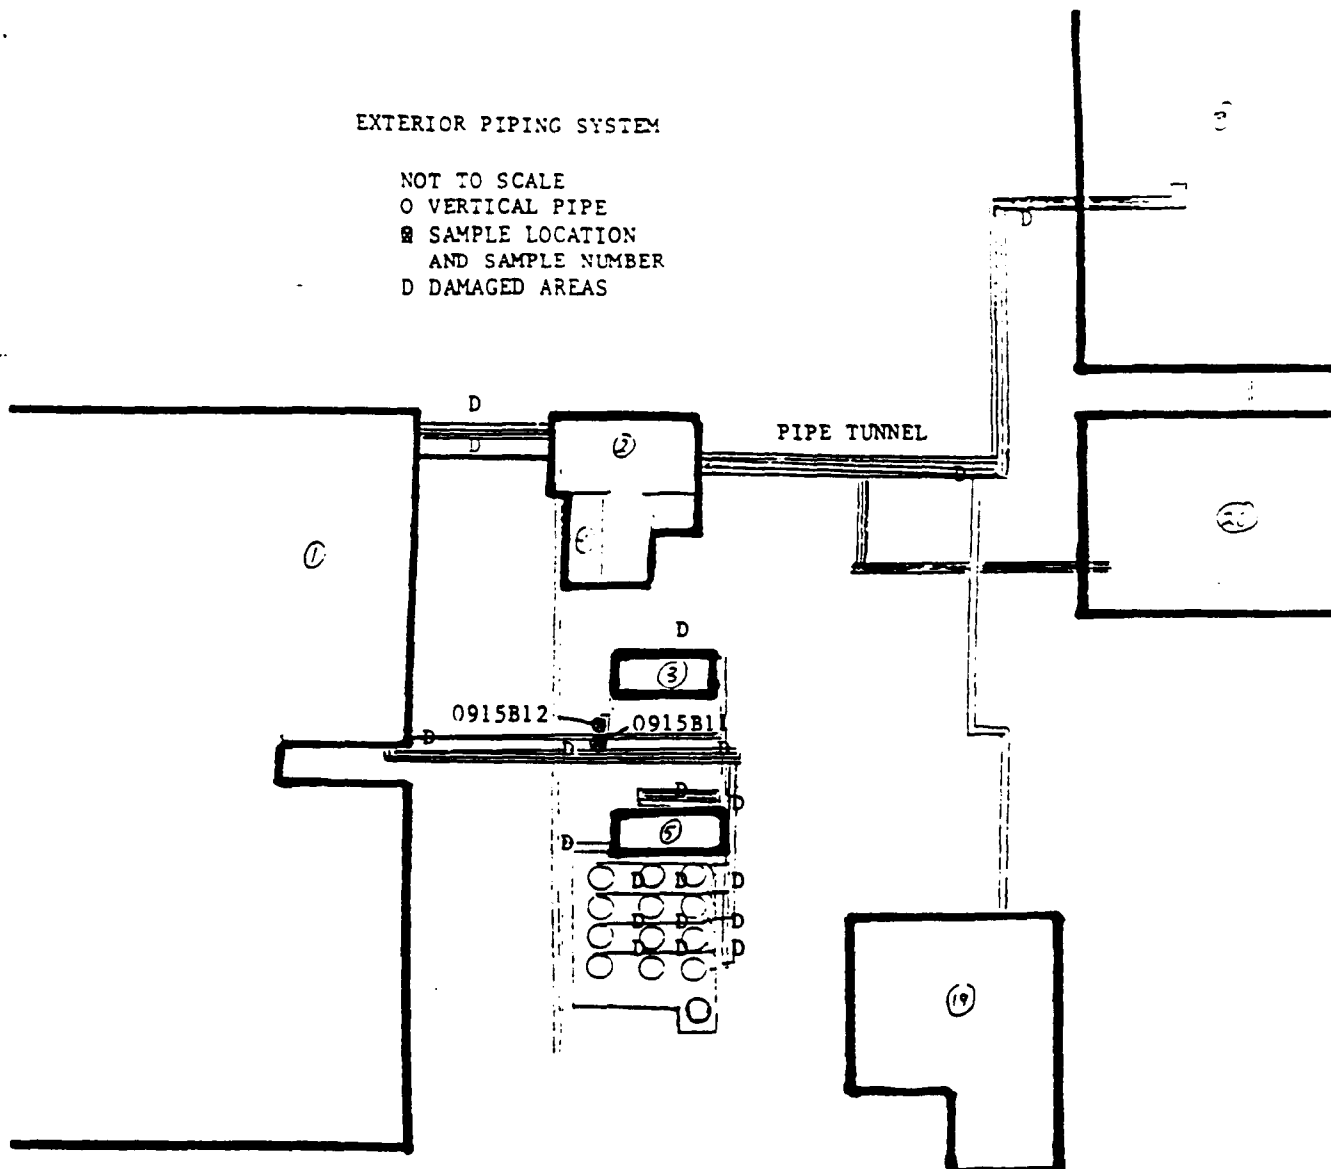
# EXTERIOR PIPING SYSTEM

Three hundred linear feet of piping and approximately 150 elbows are ACM. All fibrous glass lines, except elbows, are free of ACM.

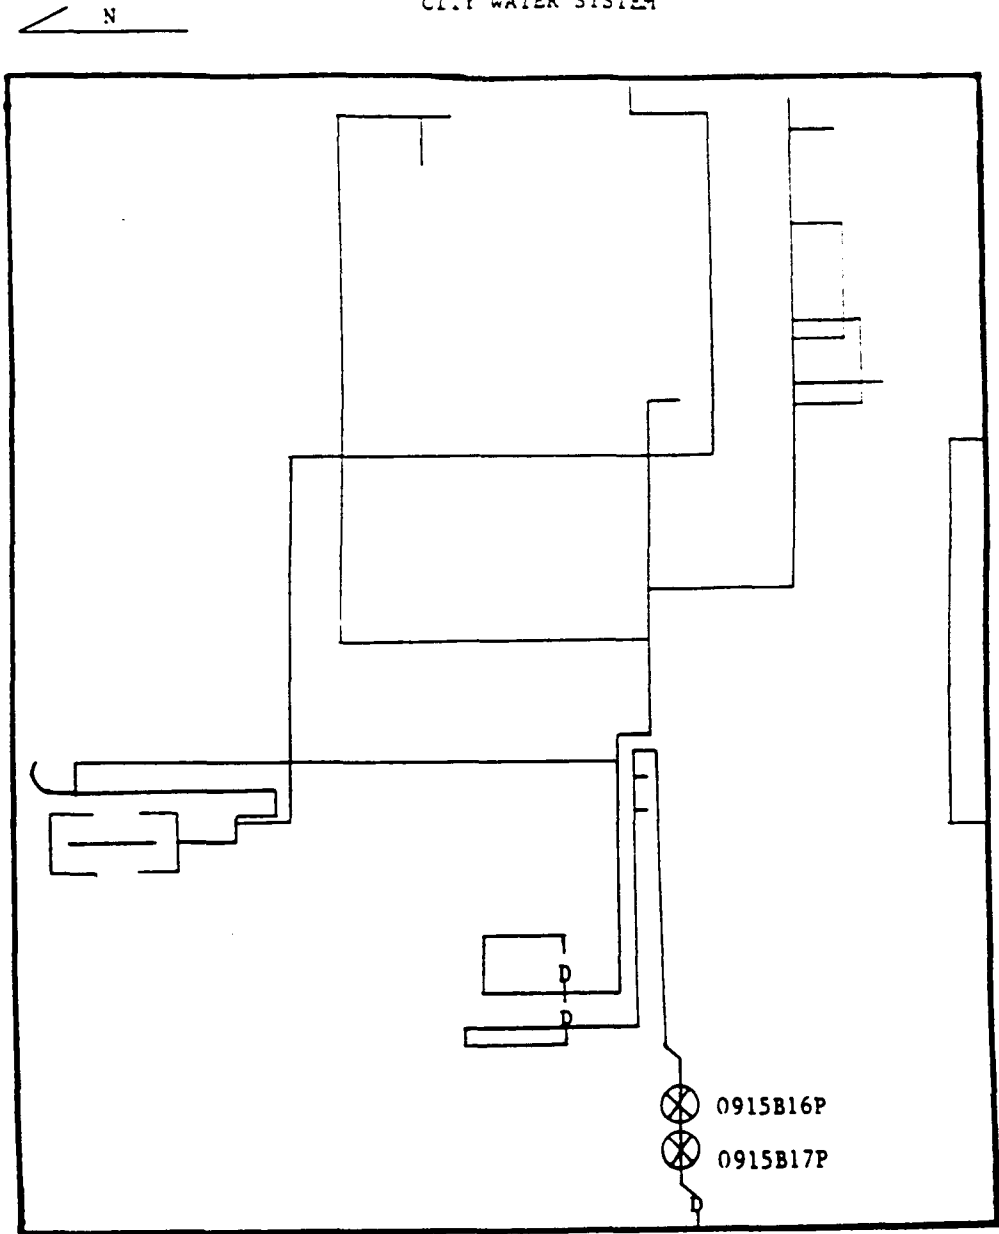
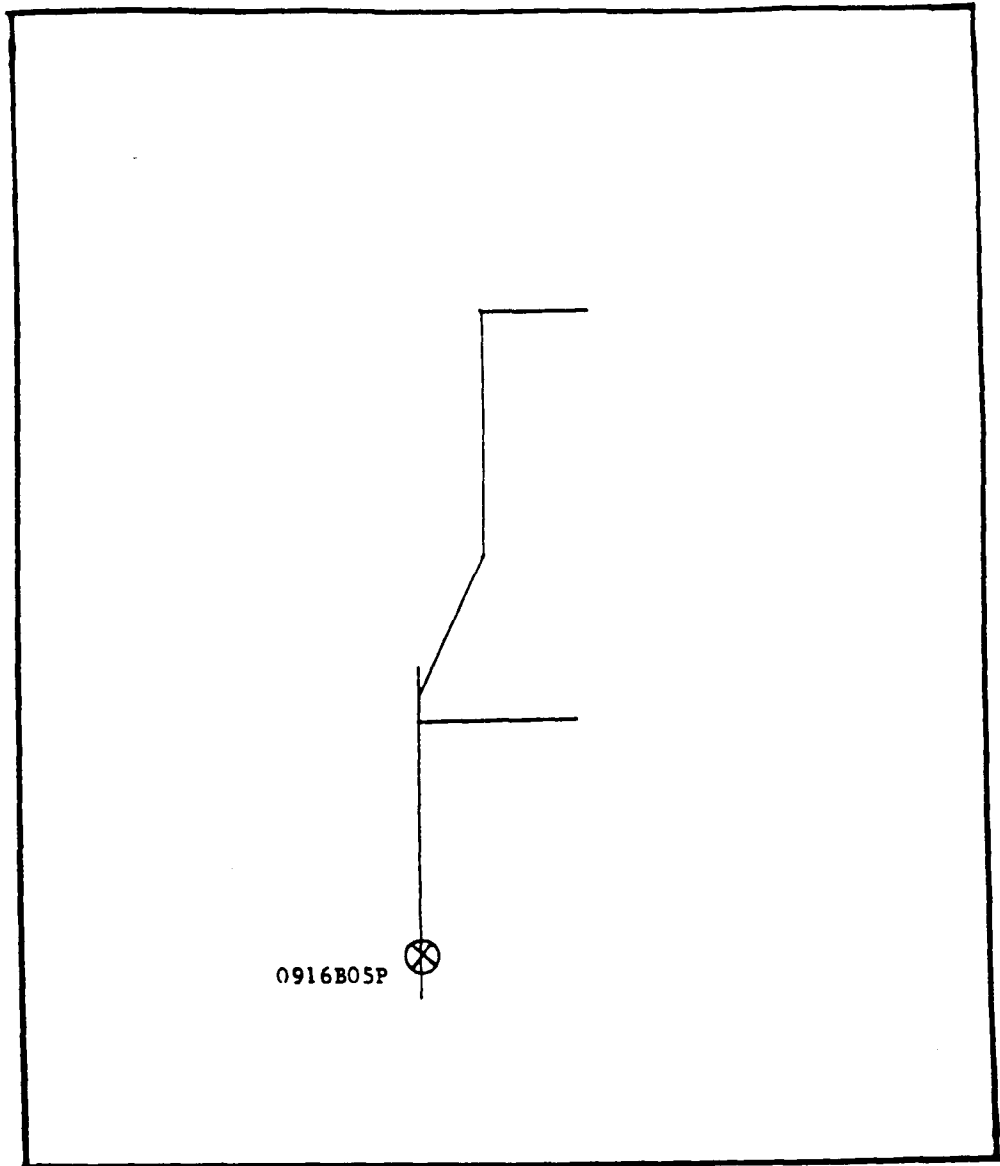
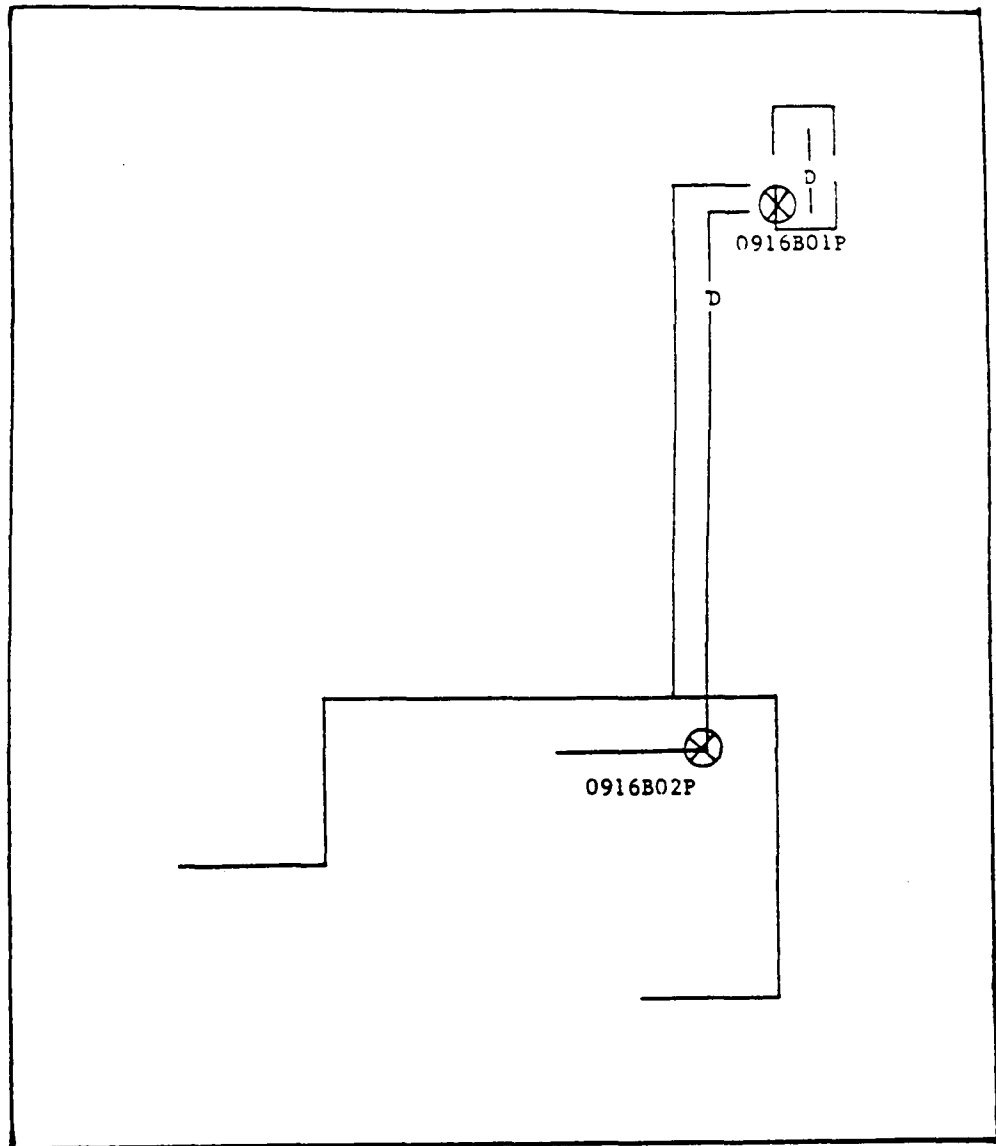
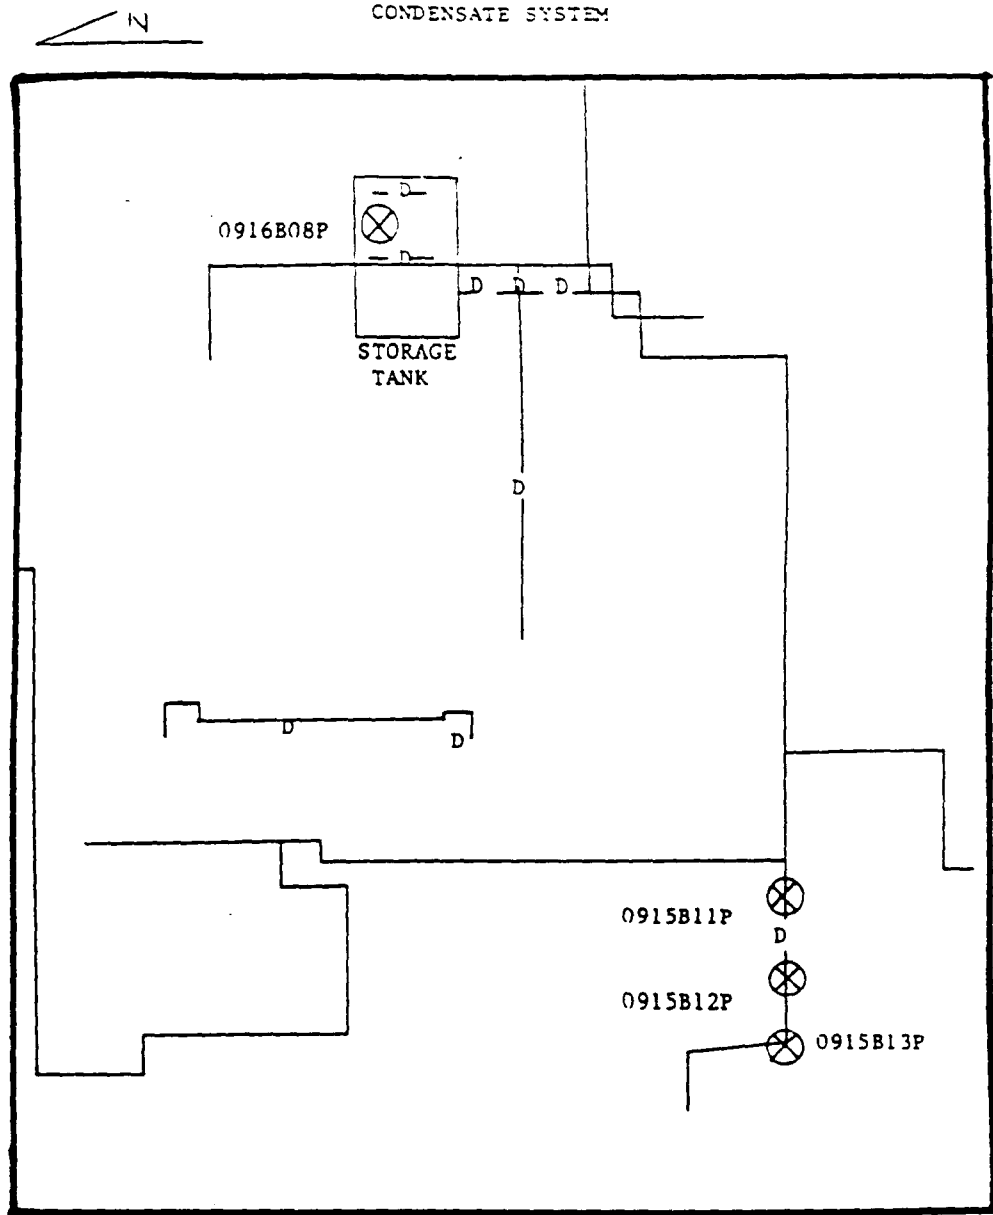
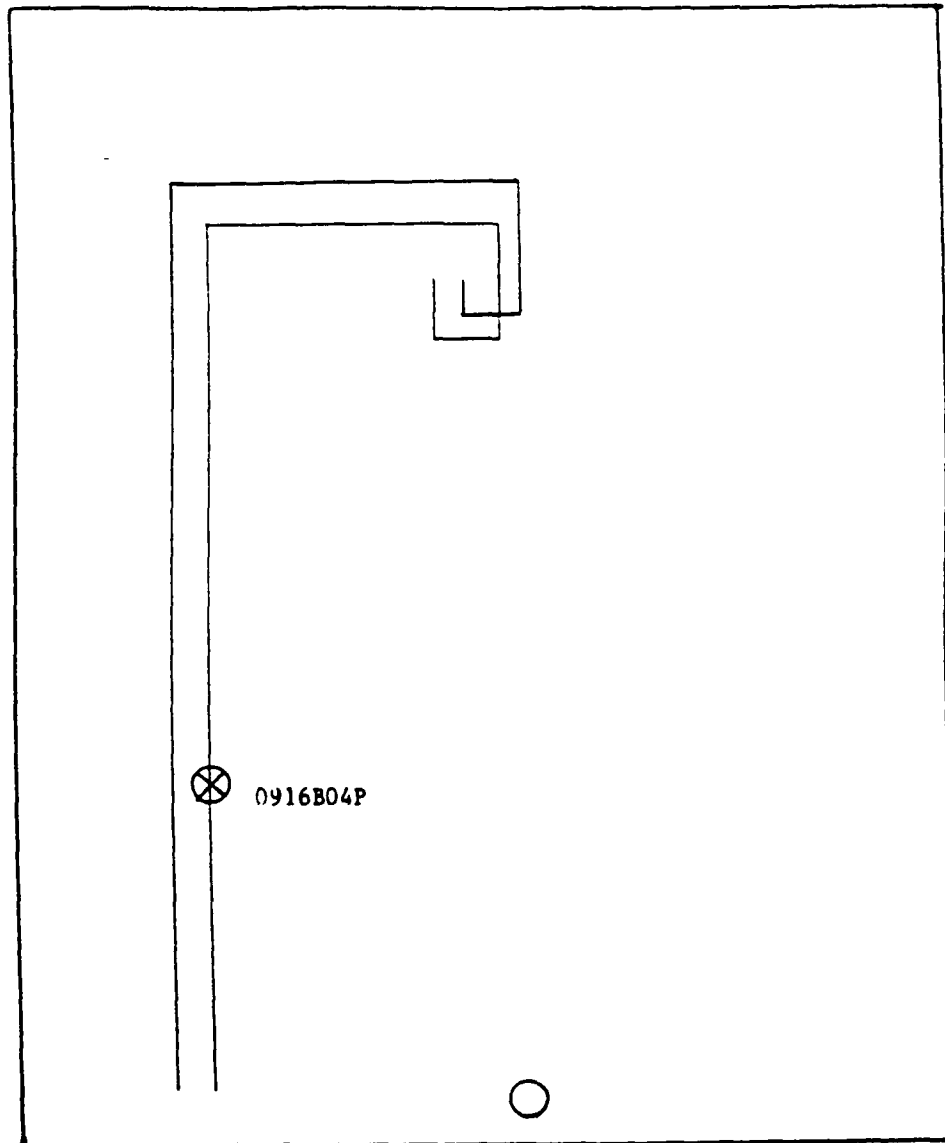
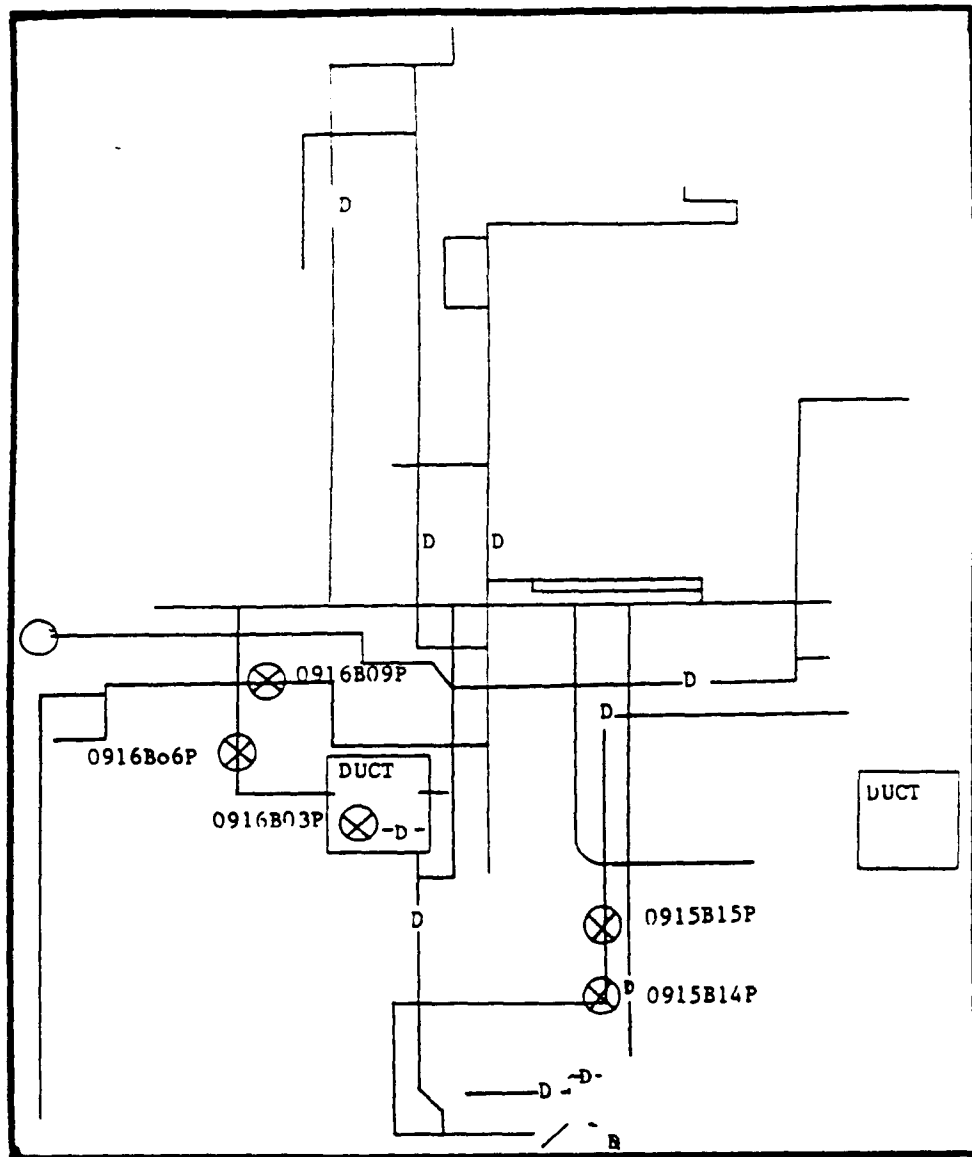
Piping - All piping except 8" outside diameter city water runs, joints, and fibrous glass lines without a mud wrap coating have ACM. Piping condition is mostly Class 1 with few scattered Class 2 within system. See pipe system drawings for damage locations. See pipe system drawings for damage locations.

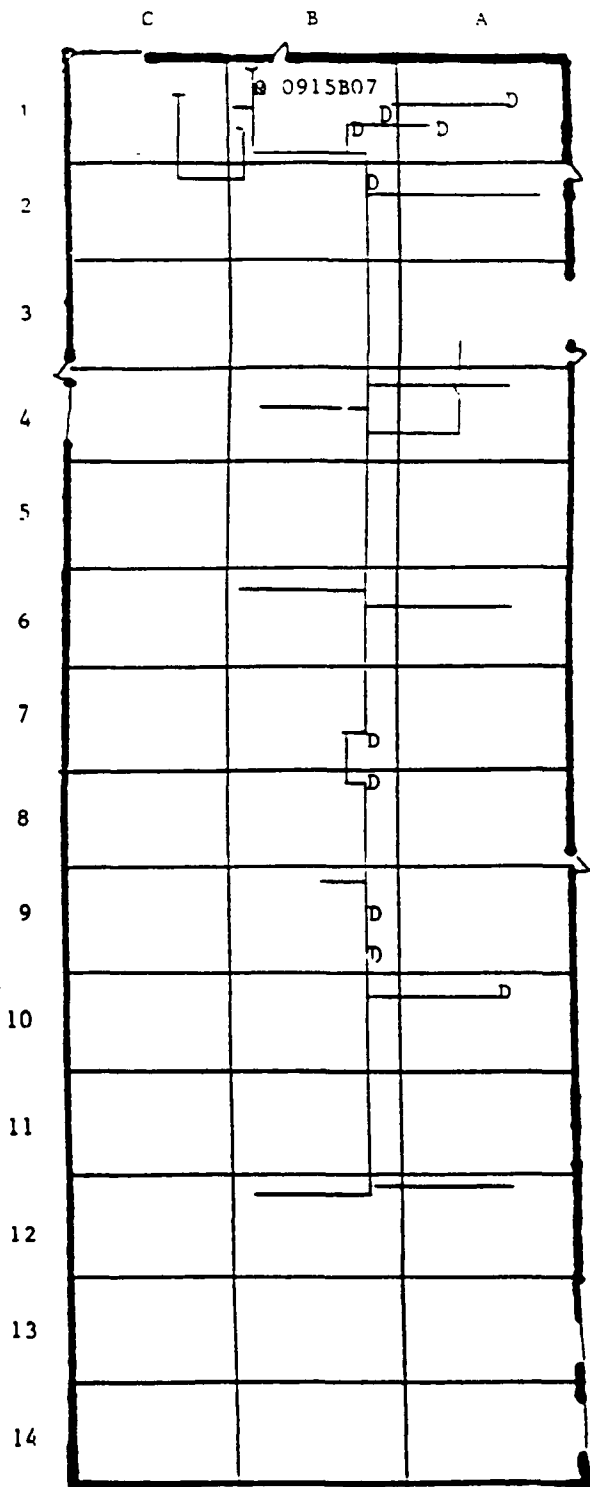
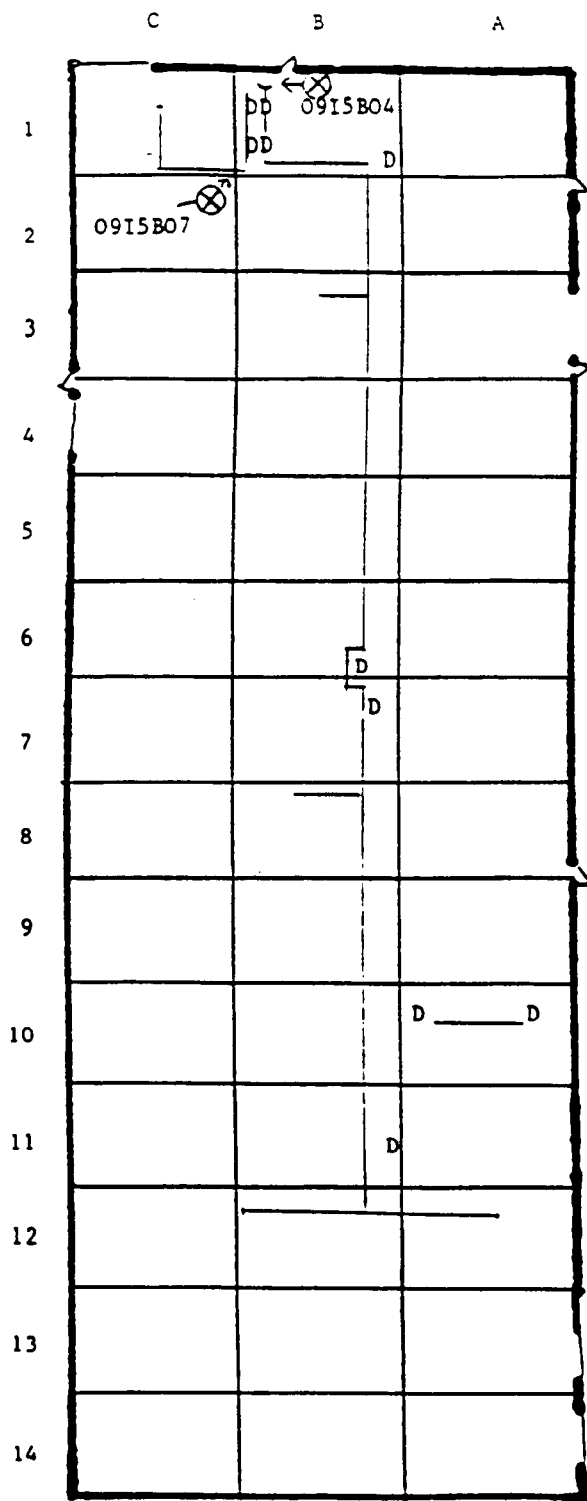
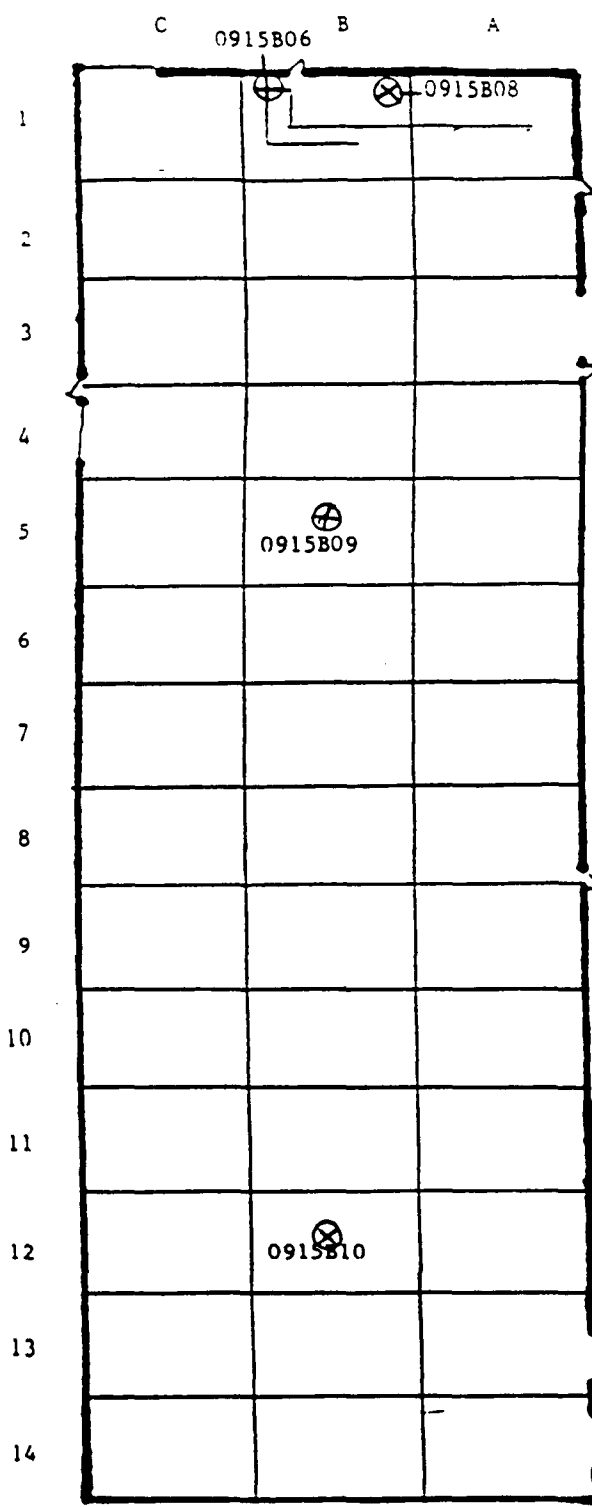
Piping - All steam and condensate lines have ACM in Class 1 condition and some scattered Class 2 sections of pipe.

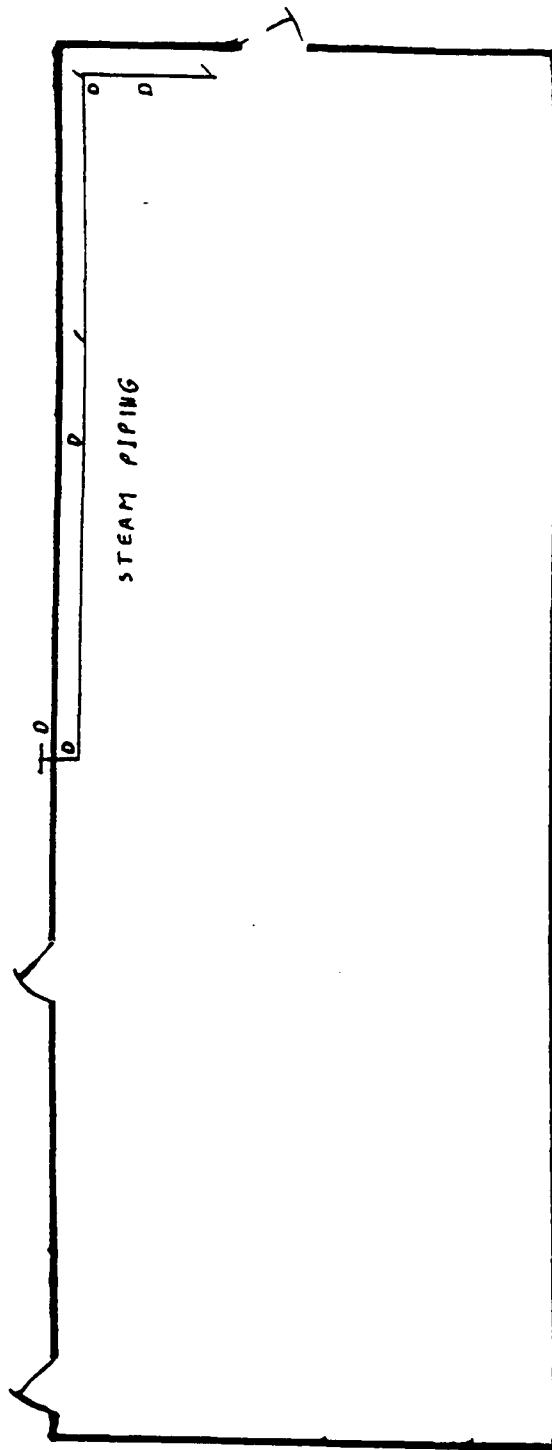
Piping - There is thirty-eight feet of steam pipe in Class 3 condition.

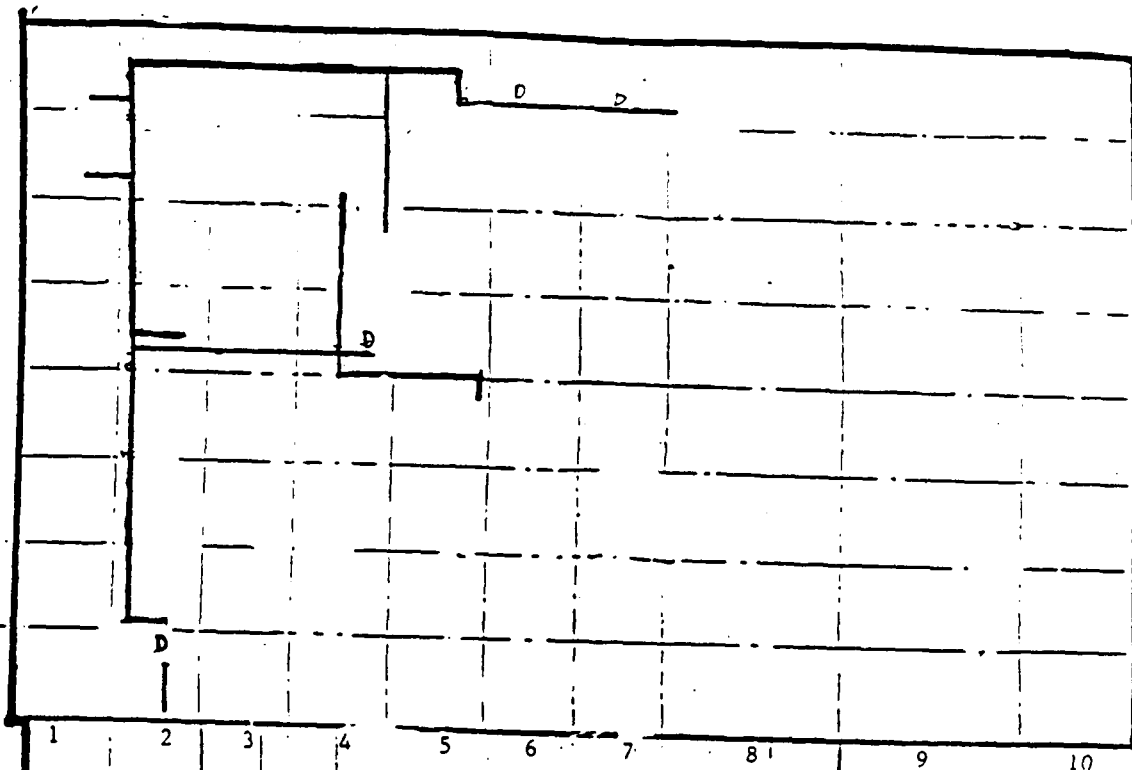
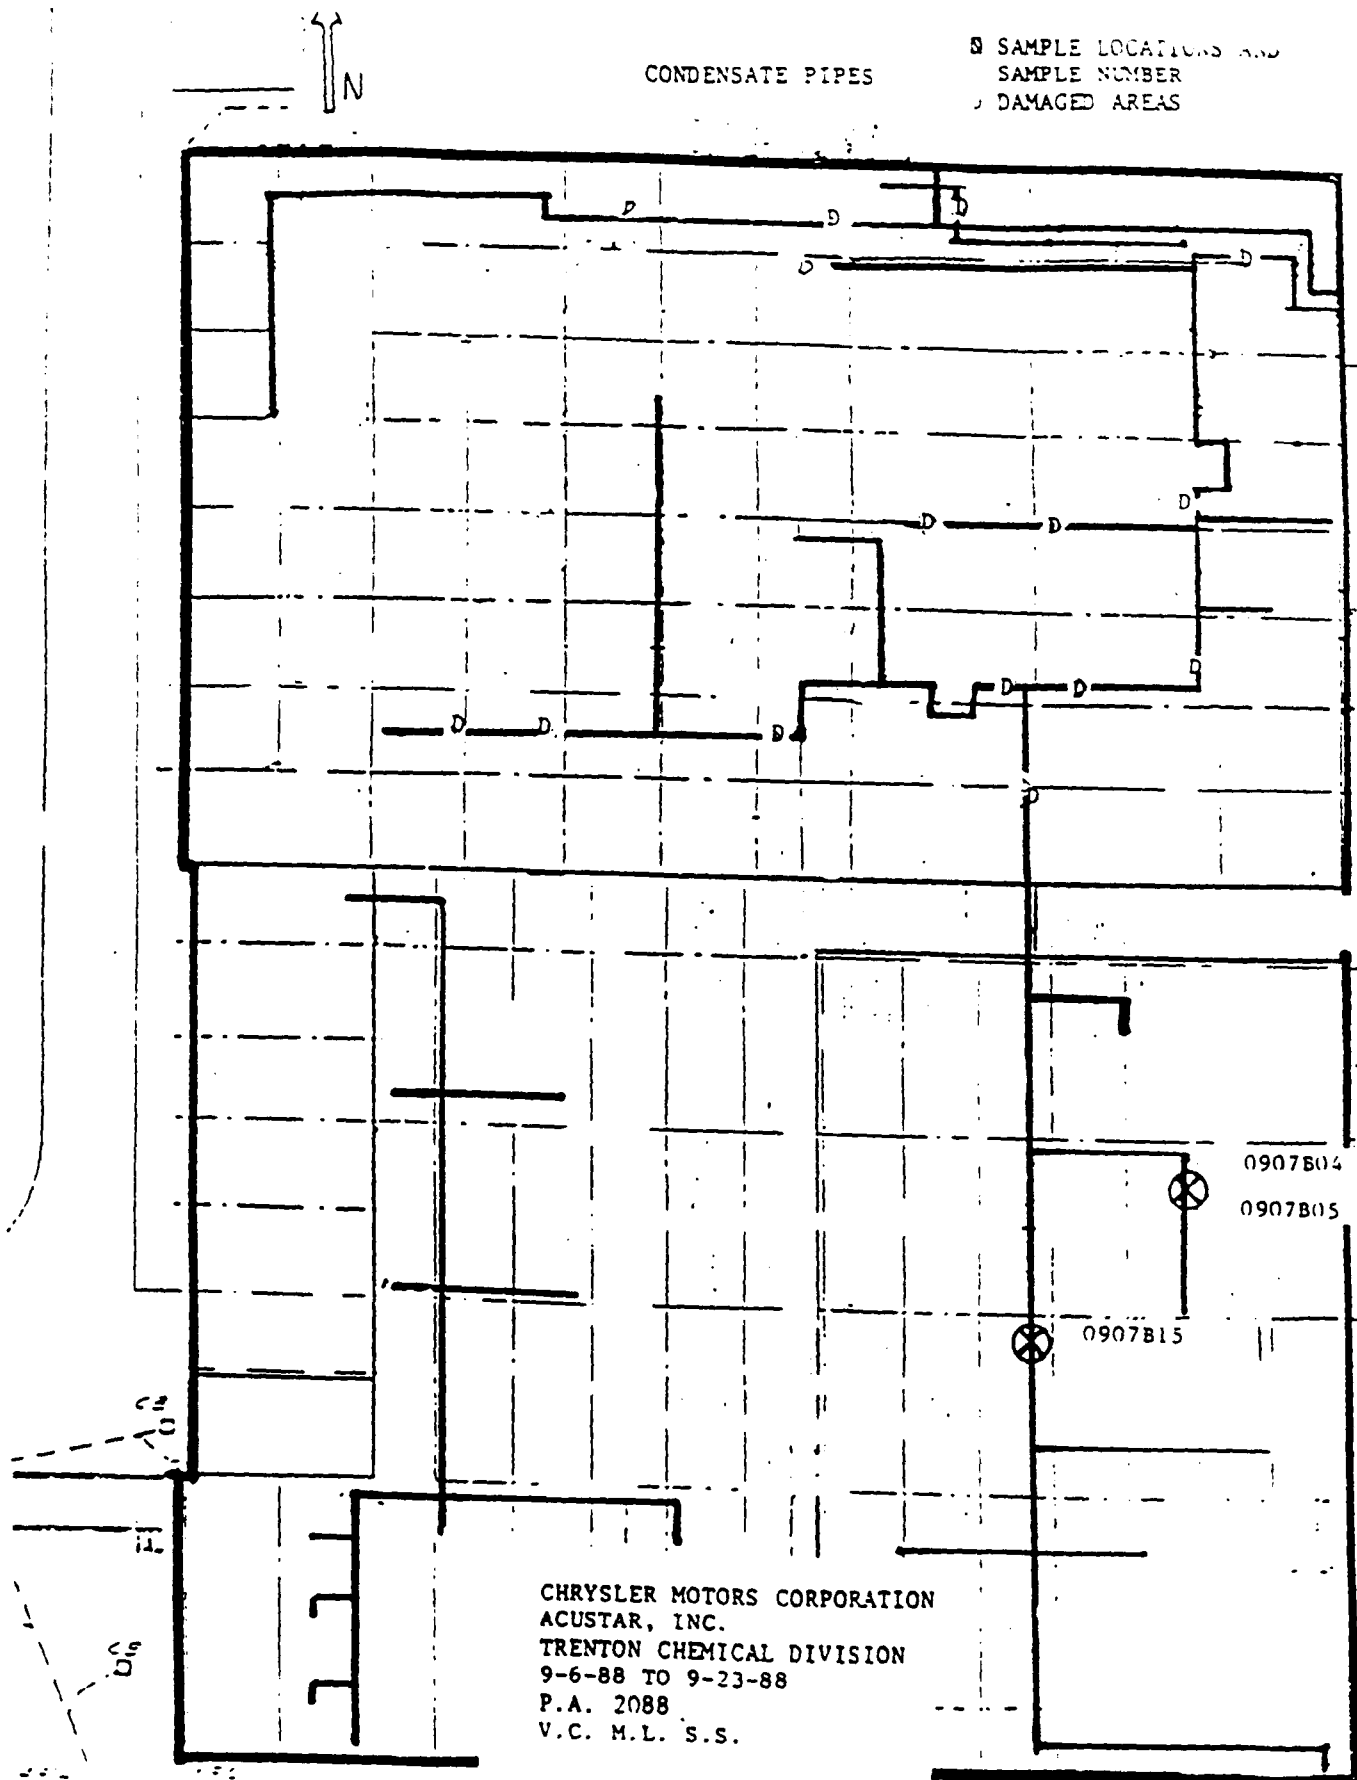
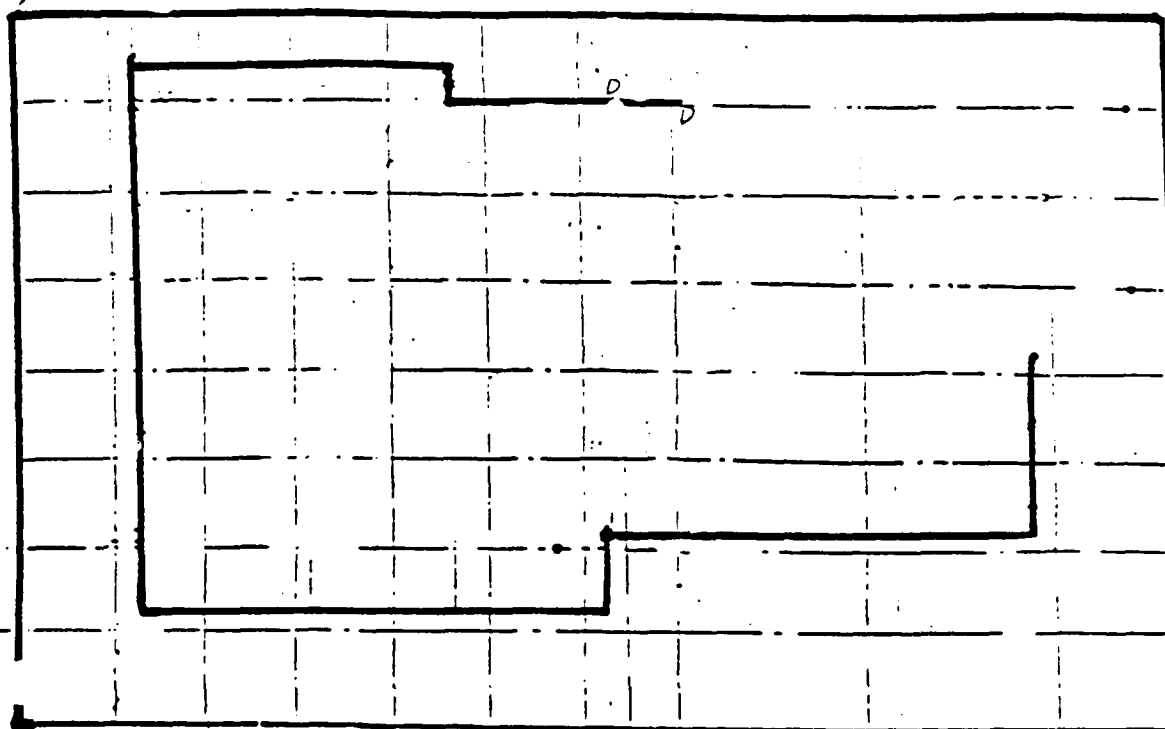
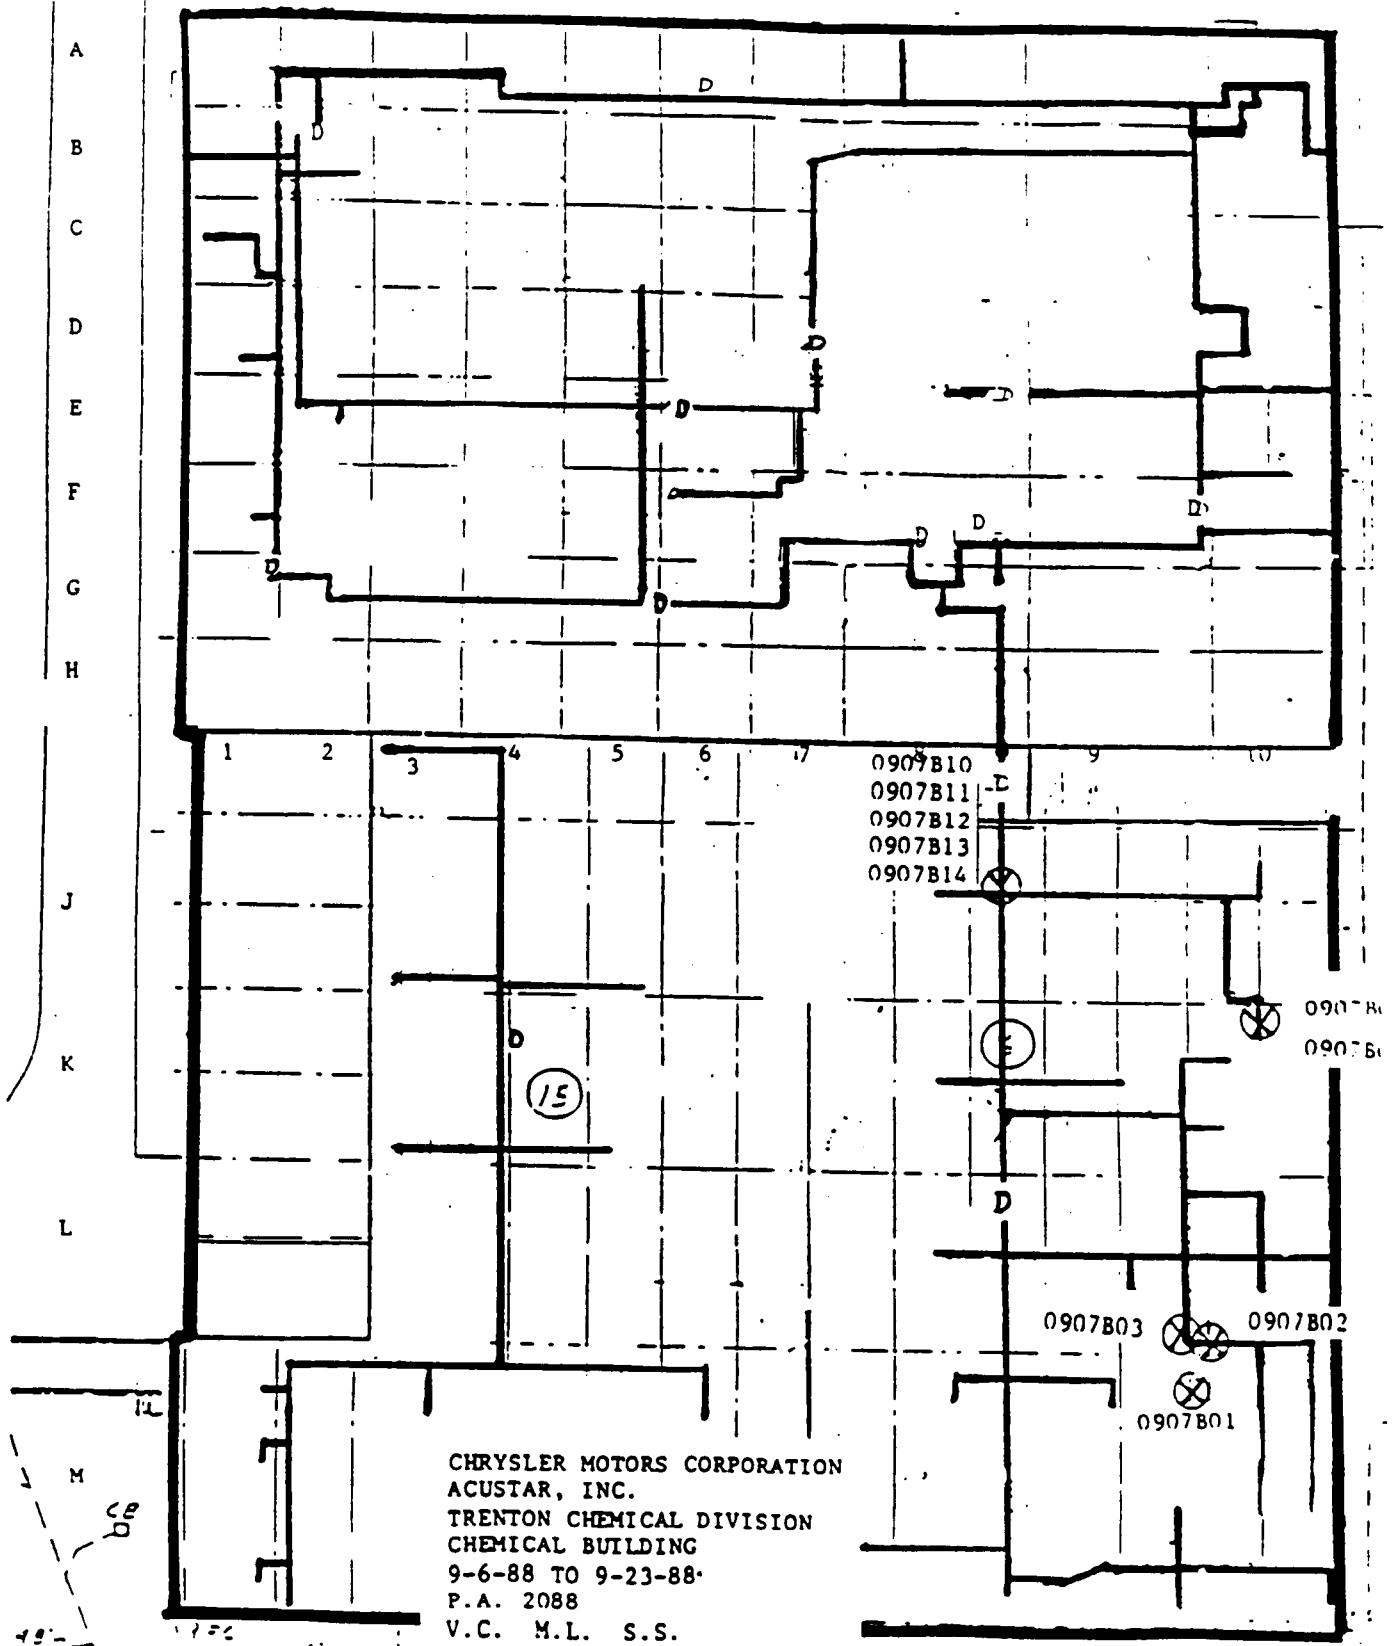
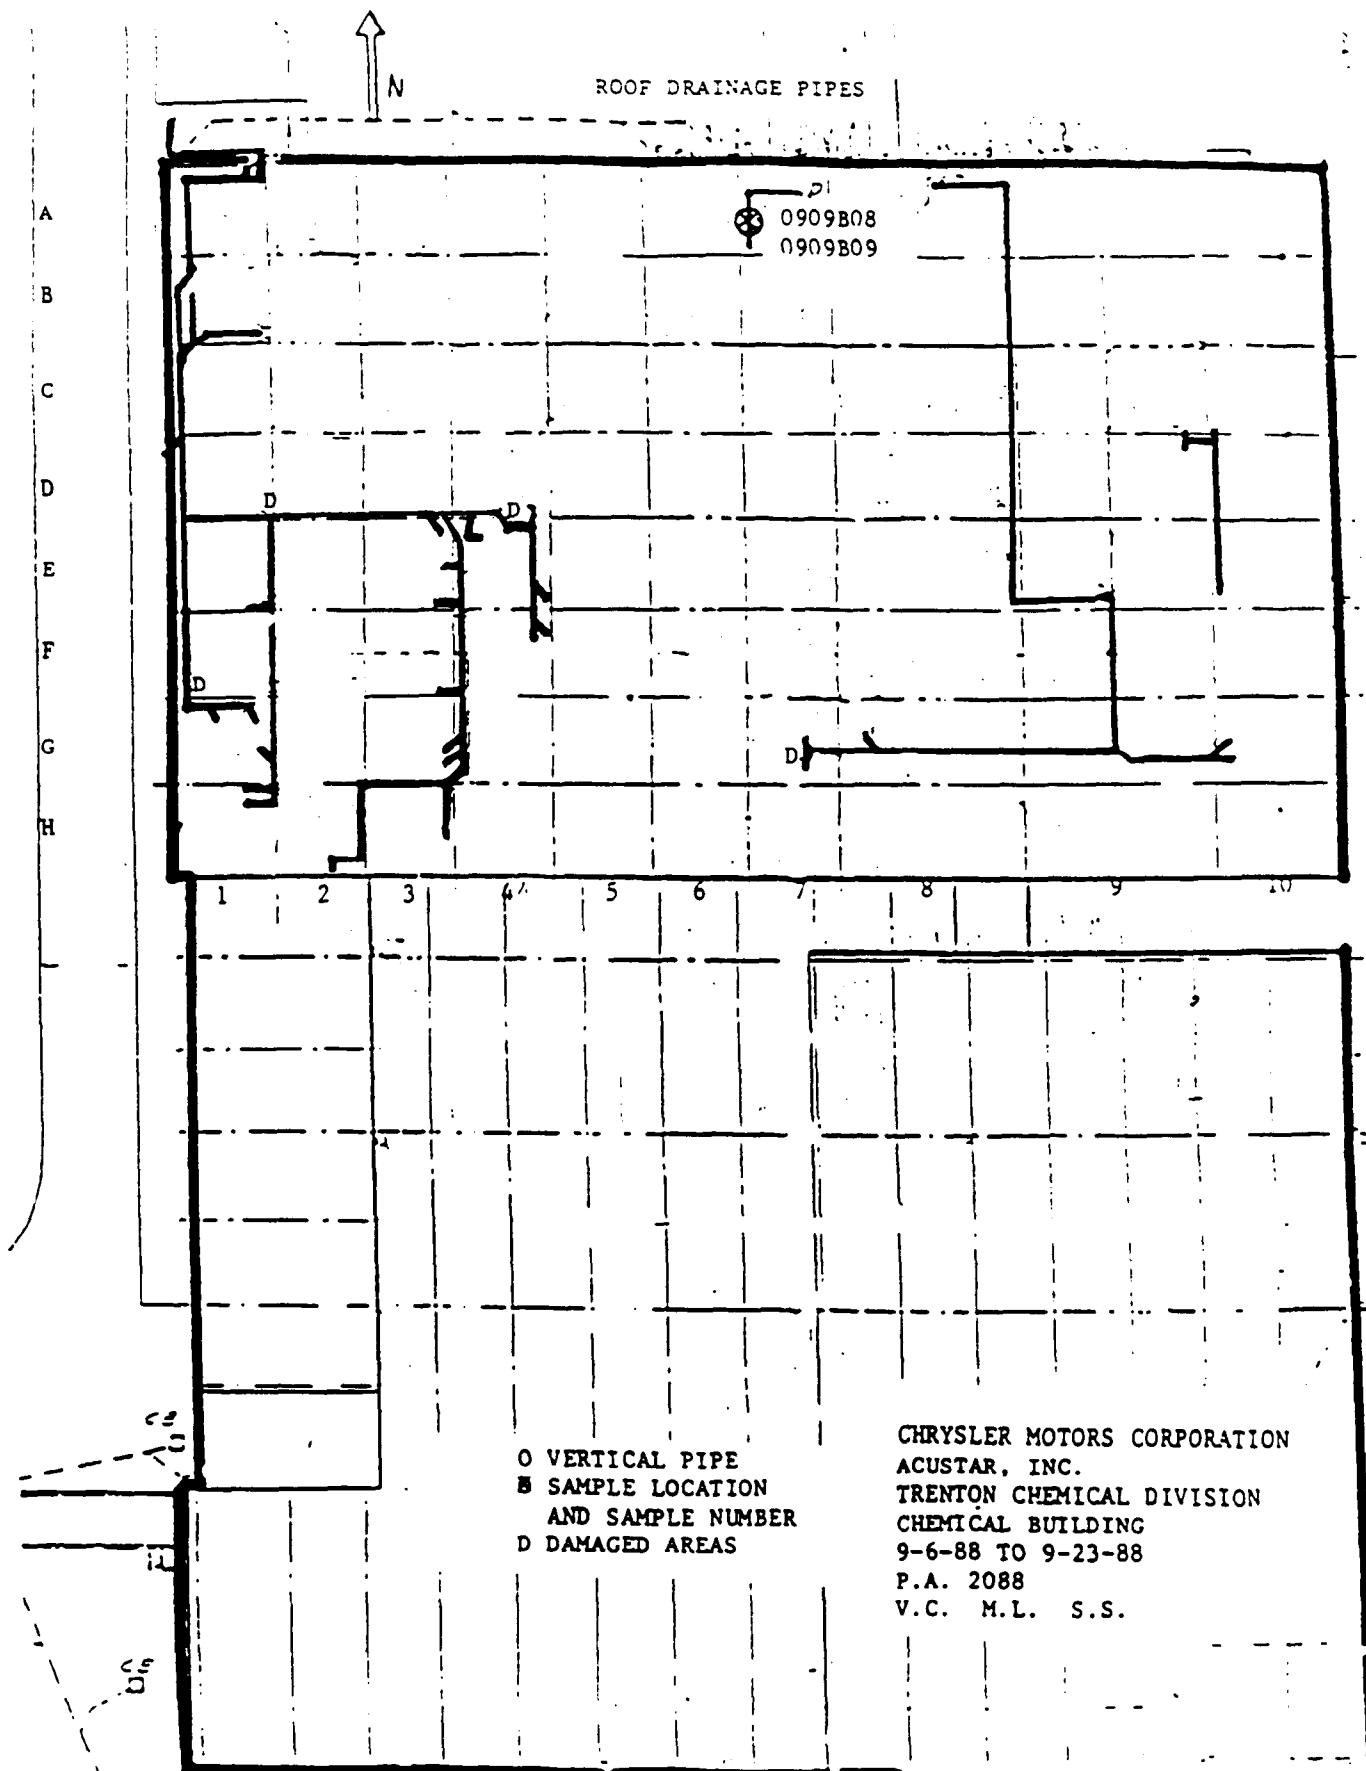
Most piping located in the Chemical Building and the Chemical Building storage areas are Class 1 and 2. Damage due primarily to storage fork lift traffic. Areas of Class 3 damage is restricted to mezzanine piping valve header stations, and north Administration office mezzanine east/west pipe chase. See drawing section for pipe system locations of severely damaged areas.
