REGARDING: Industrial Hygiene Summary Report for the Asbestos Identification Survey at Acustar Inc., Trenton Chemical Division, 5437 West Jefferson, Trenton, Michigan

**INDUSTRIAL HYGIENE SUMMARY REPORT****OF****THE ASBESTOS IDENTIFICATION SURVEY**

**ACUSTAR INC.  
TRENTON CHEMICAL DIVISION  
5437 WEST JEFFERSON  
TRENTON, MICHIGAN**

**PROJECT NO. 2088**

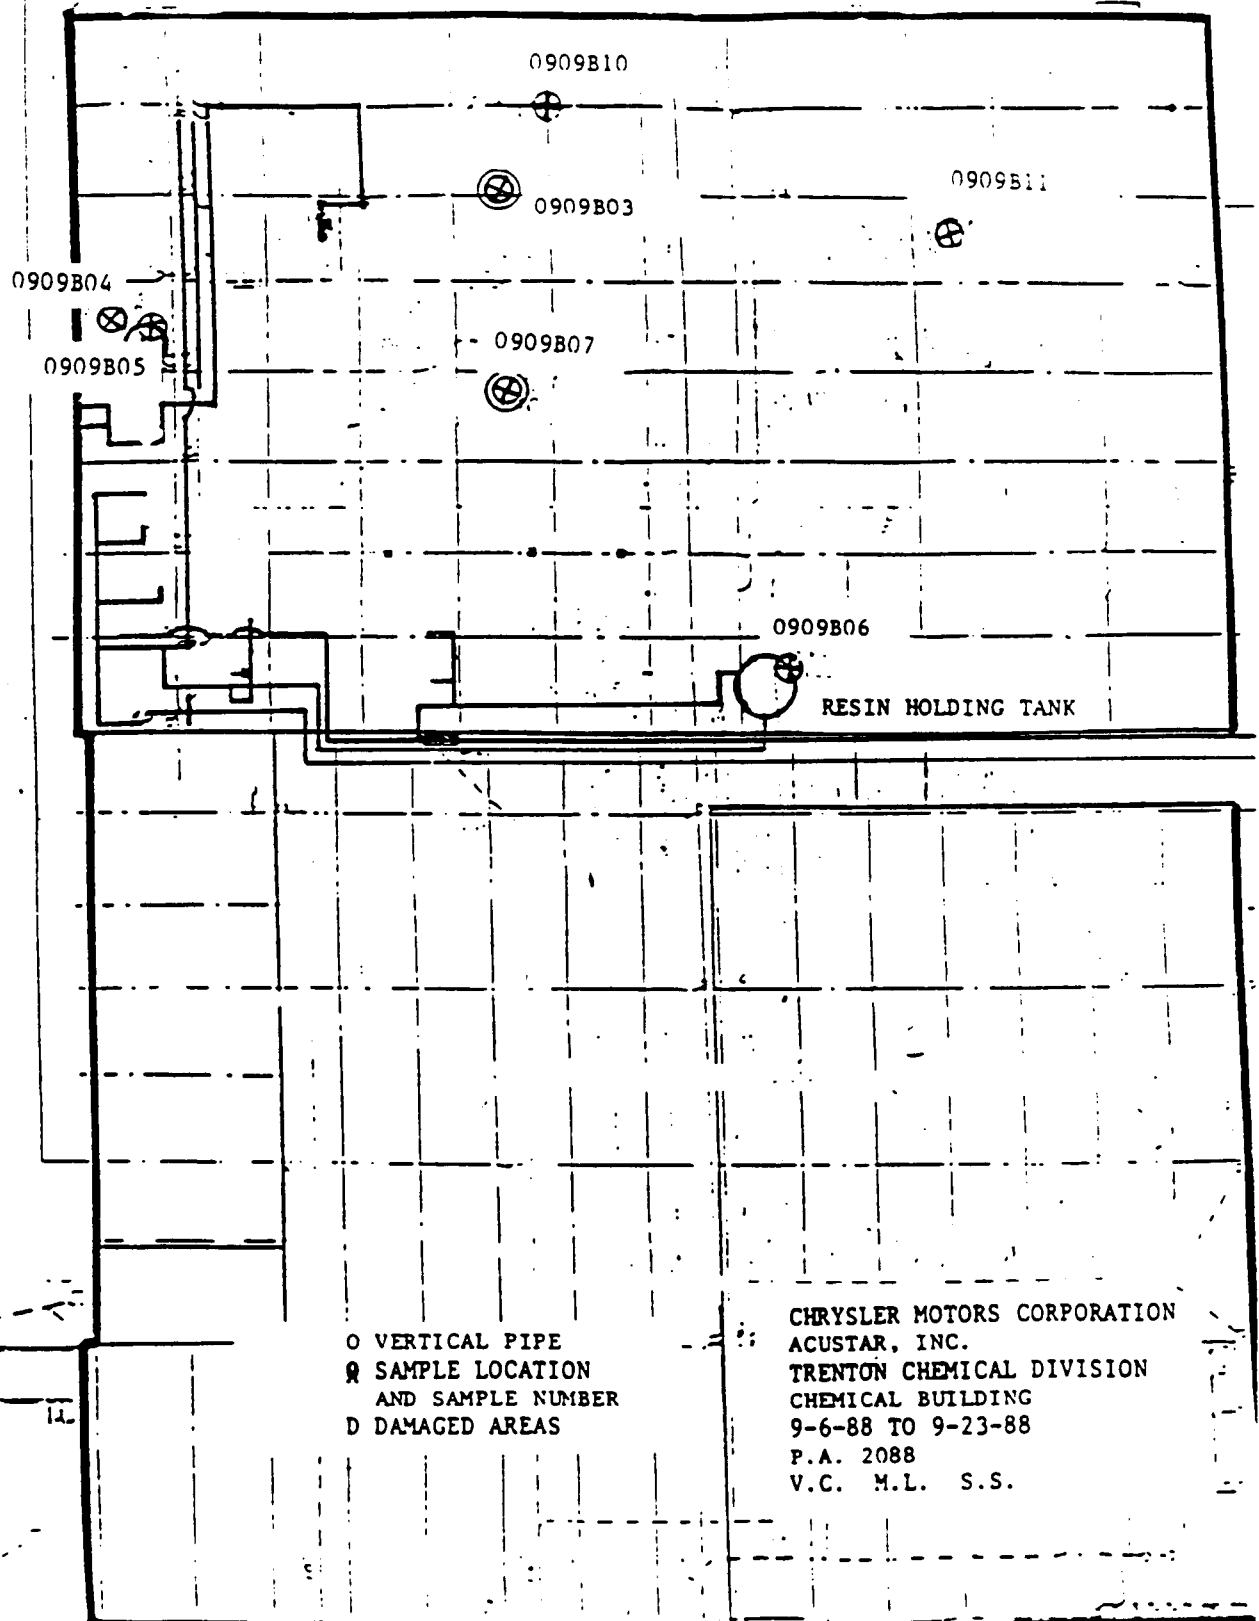
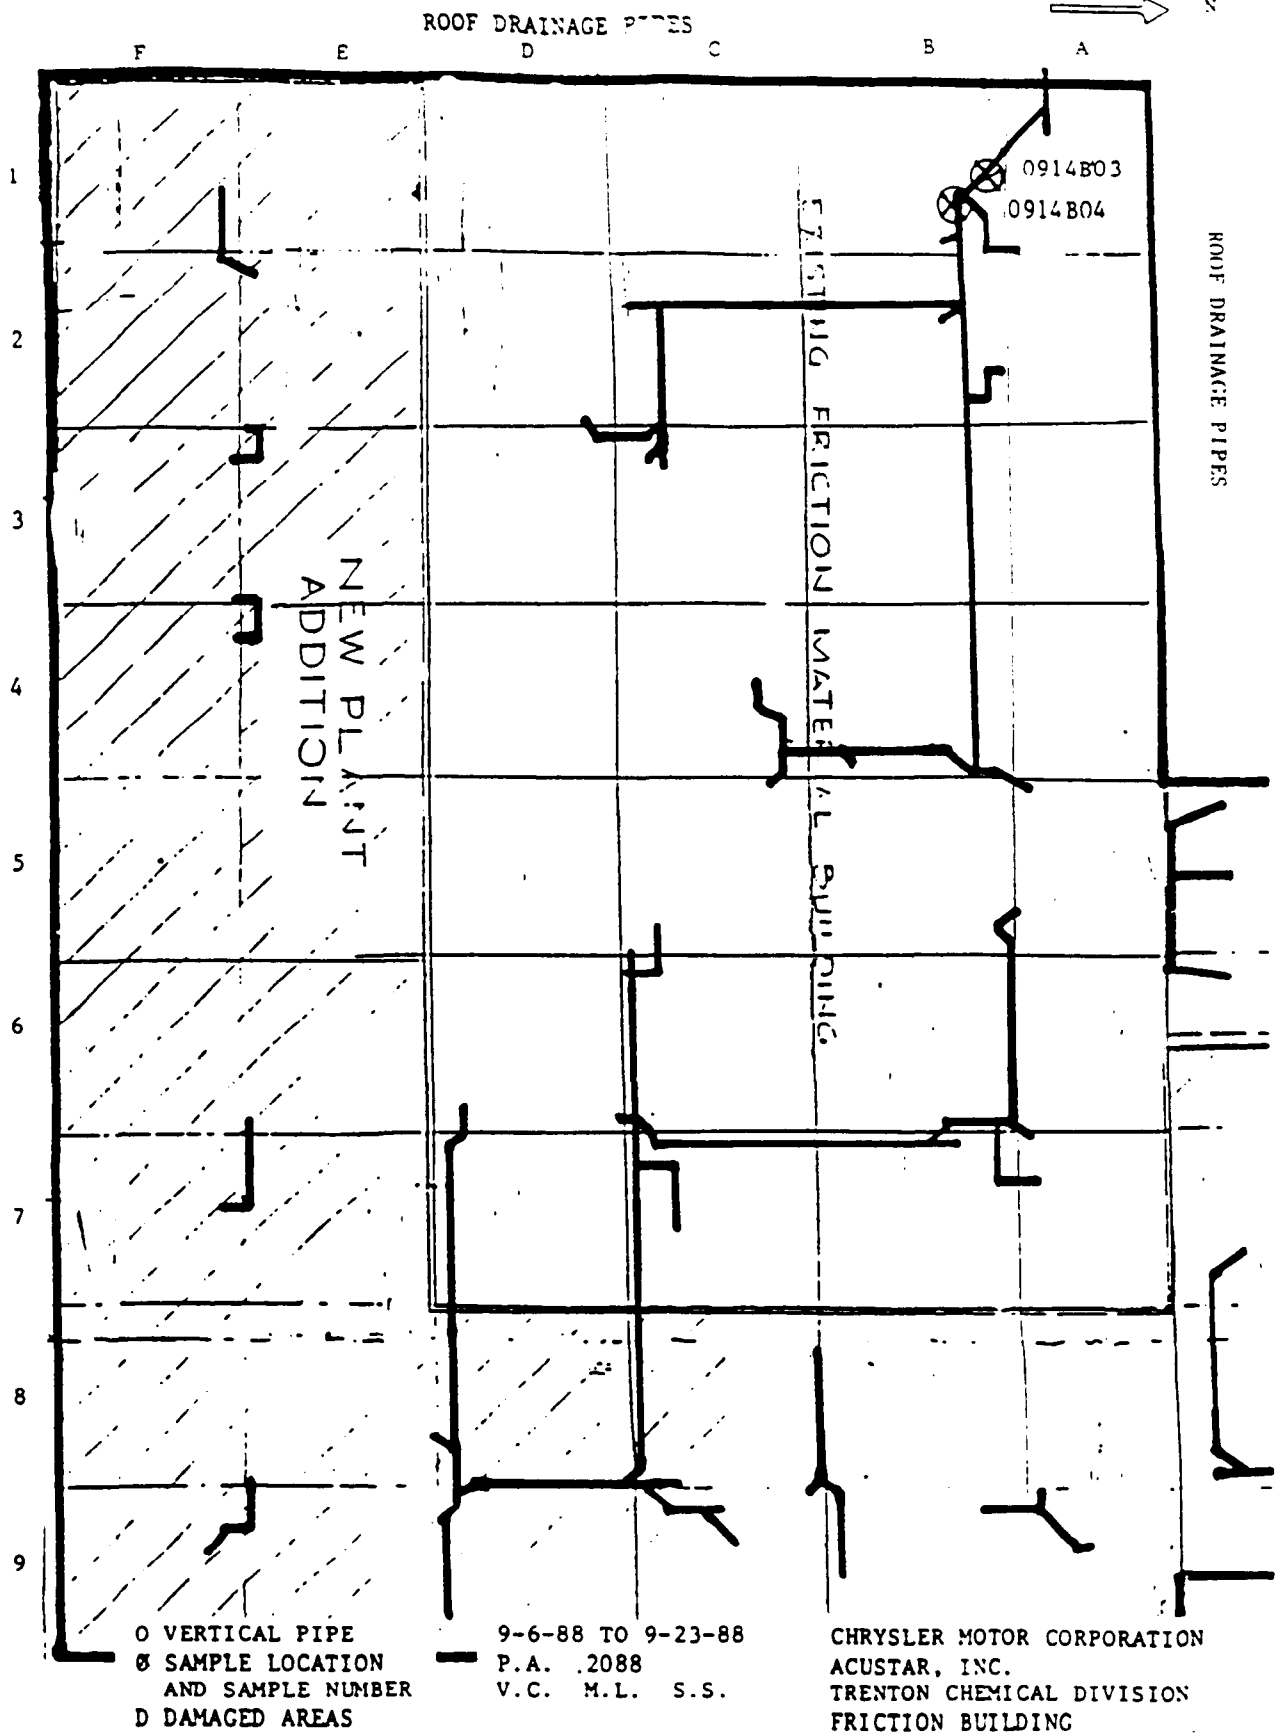
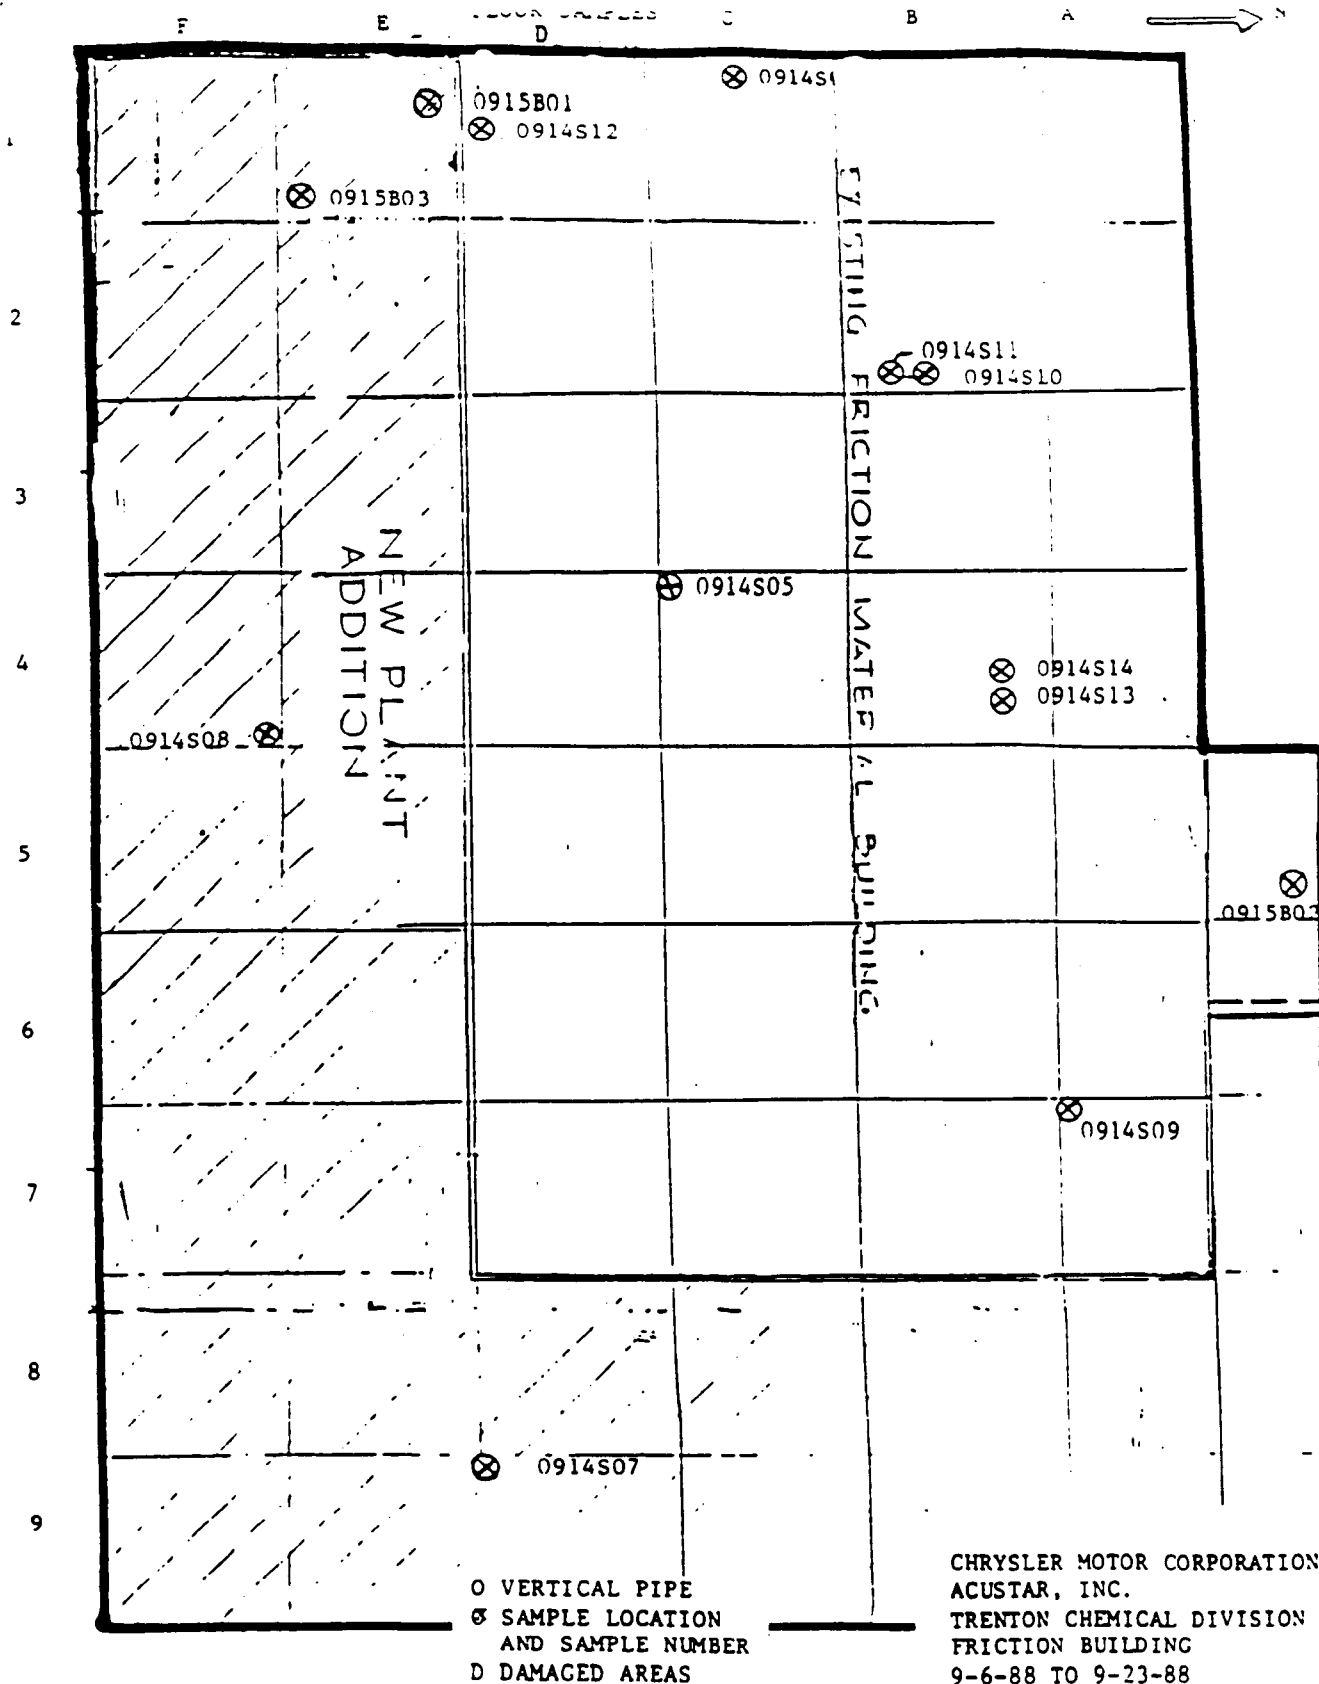
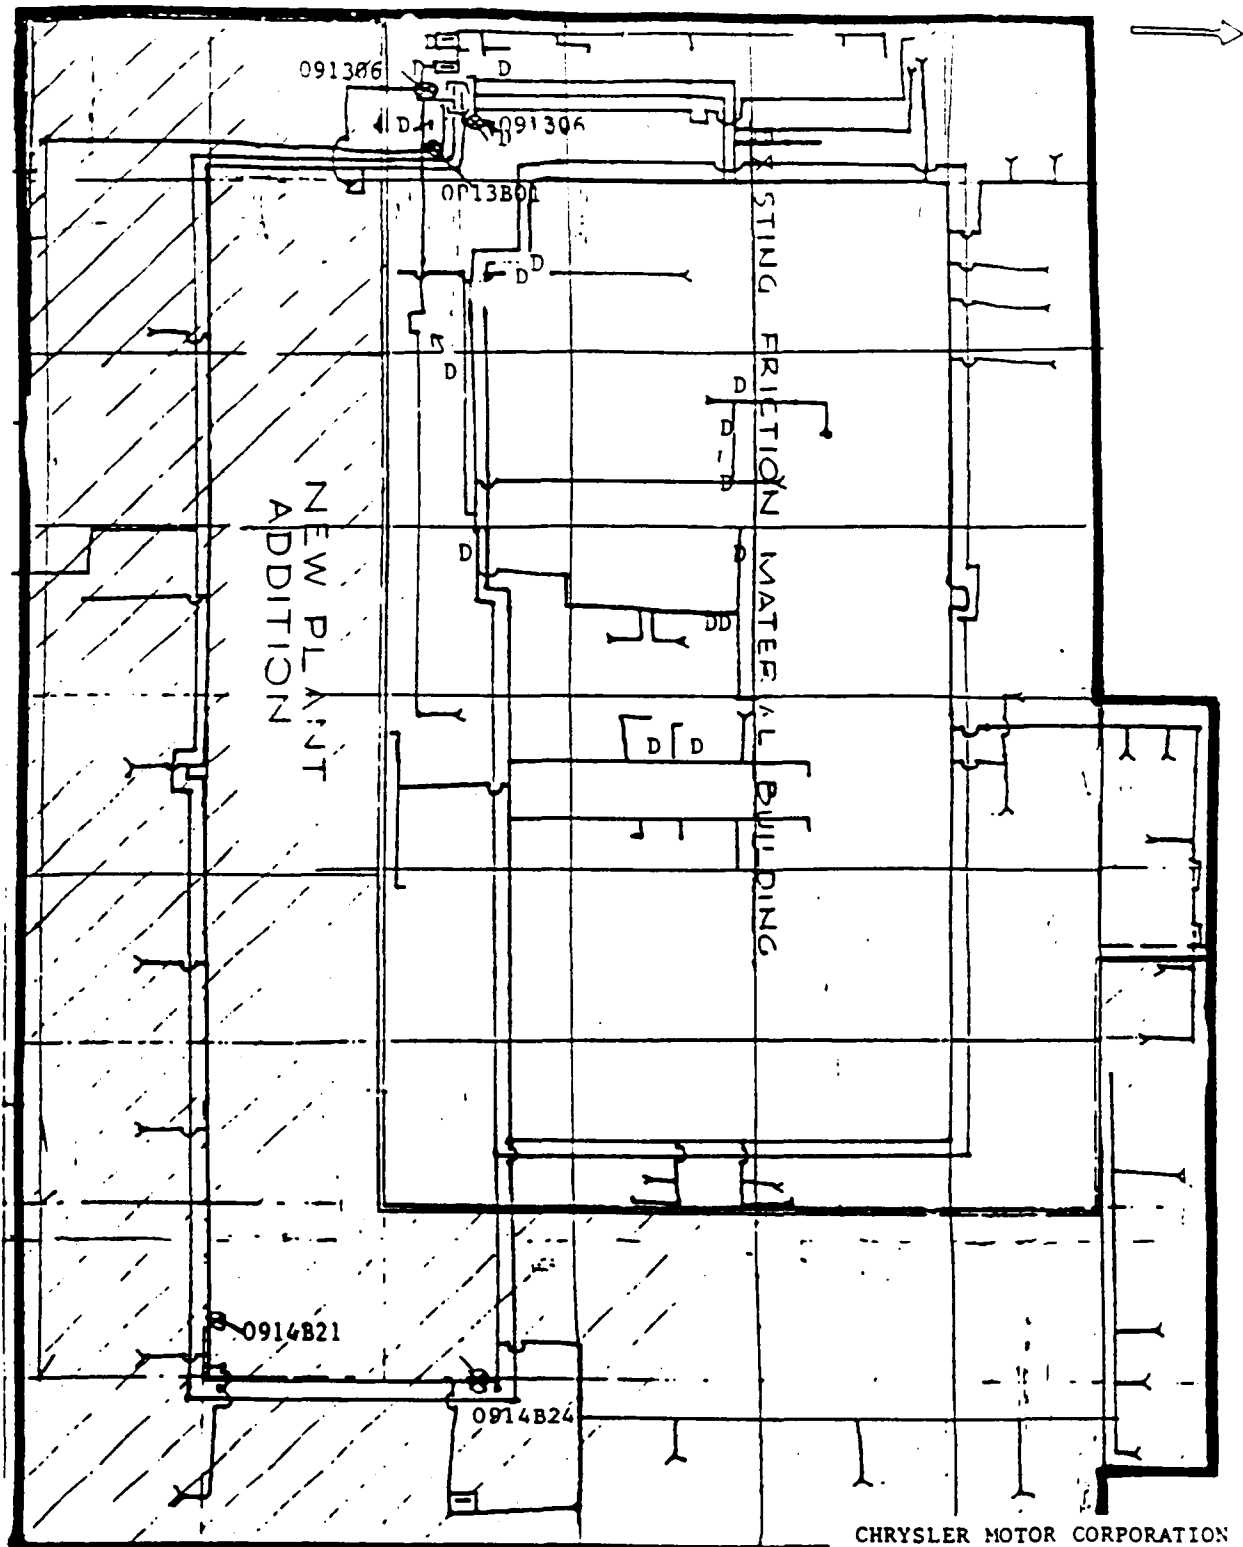
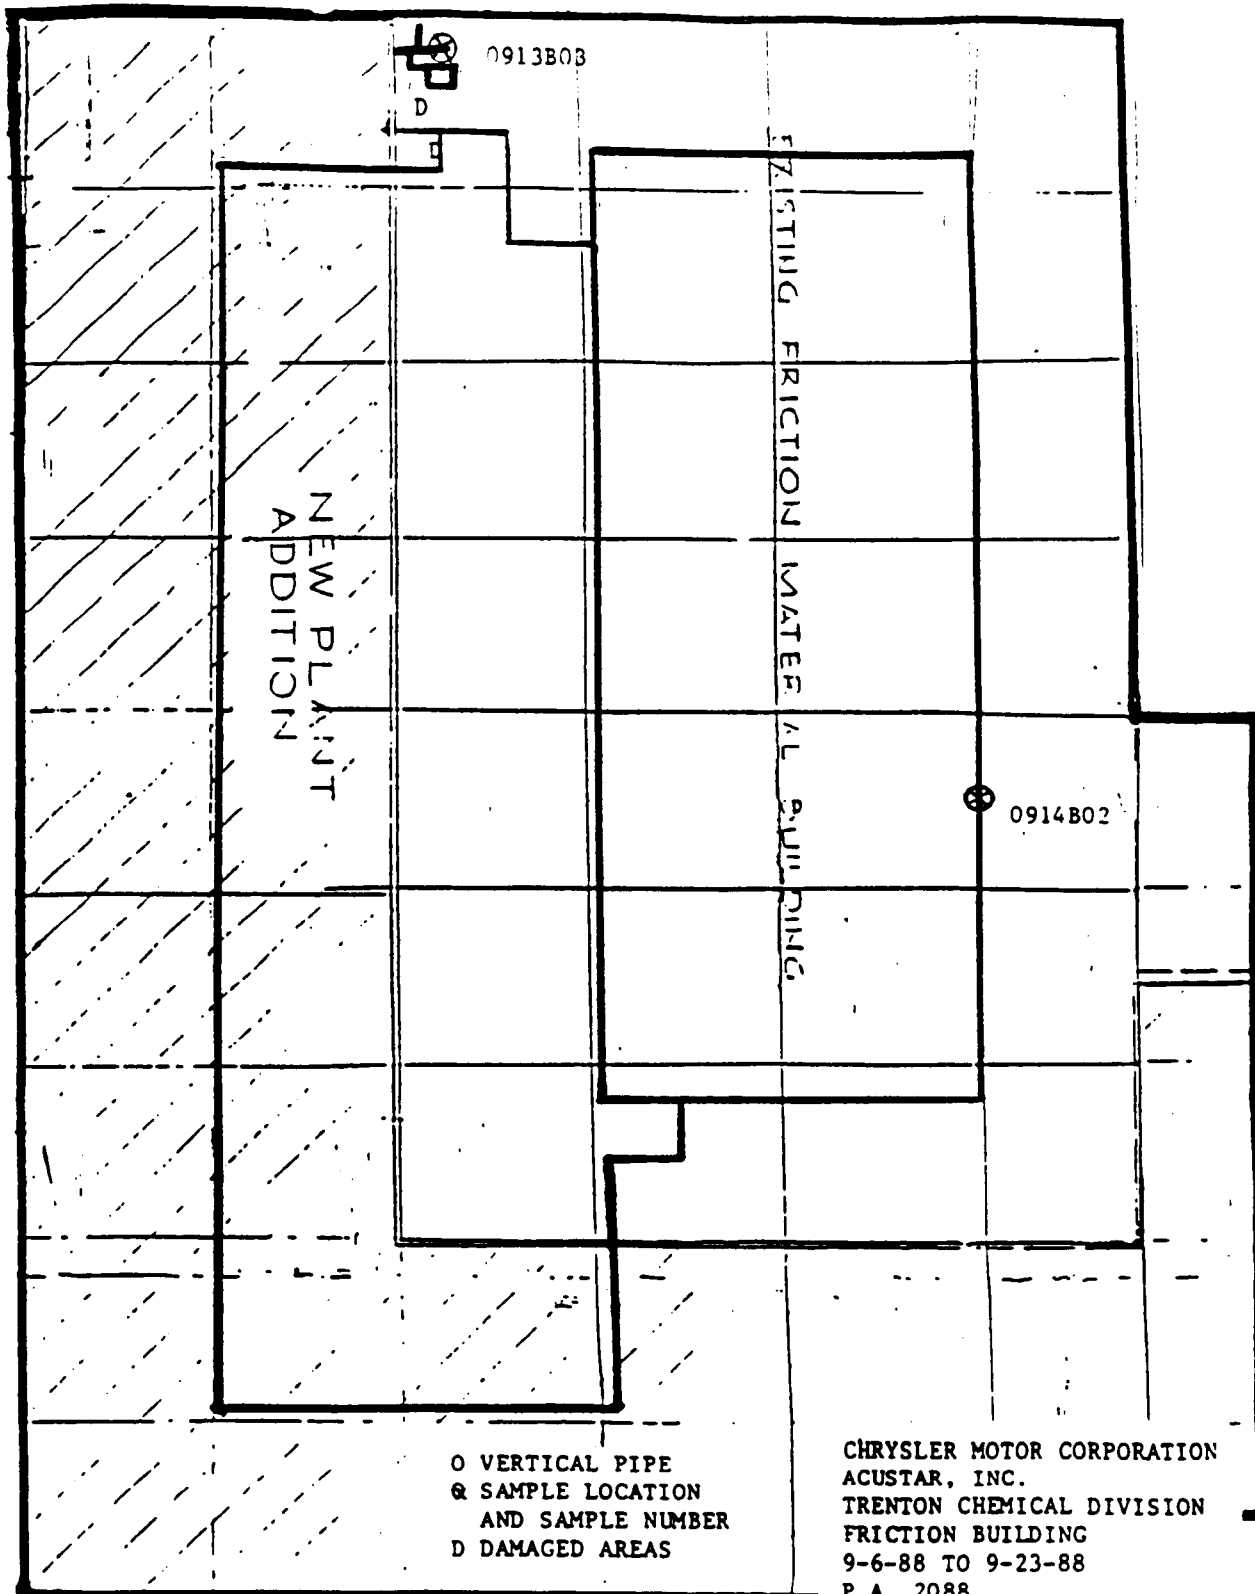
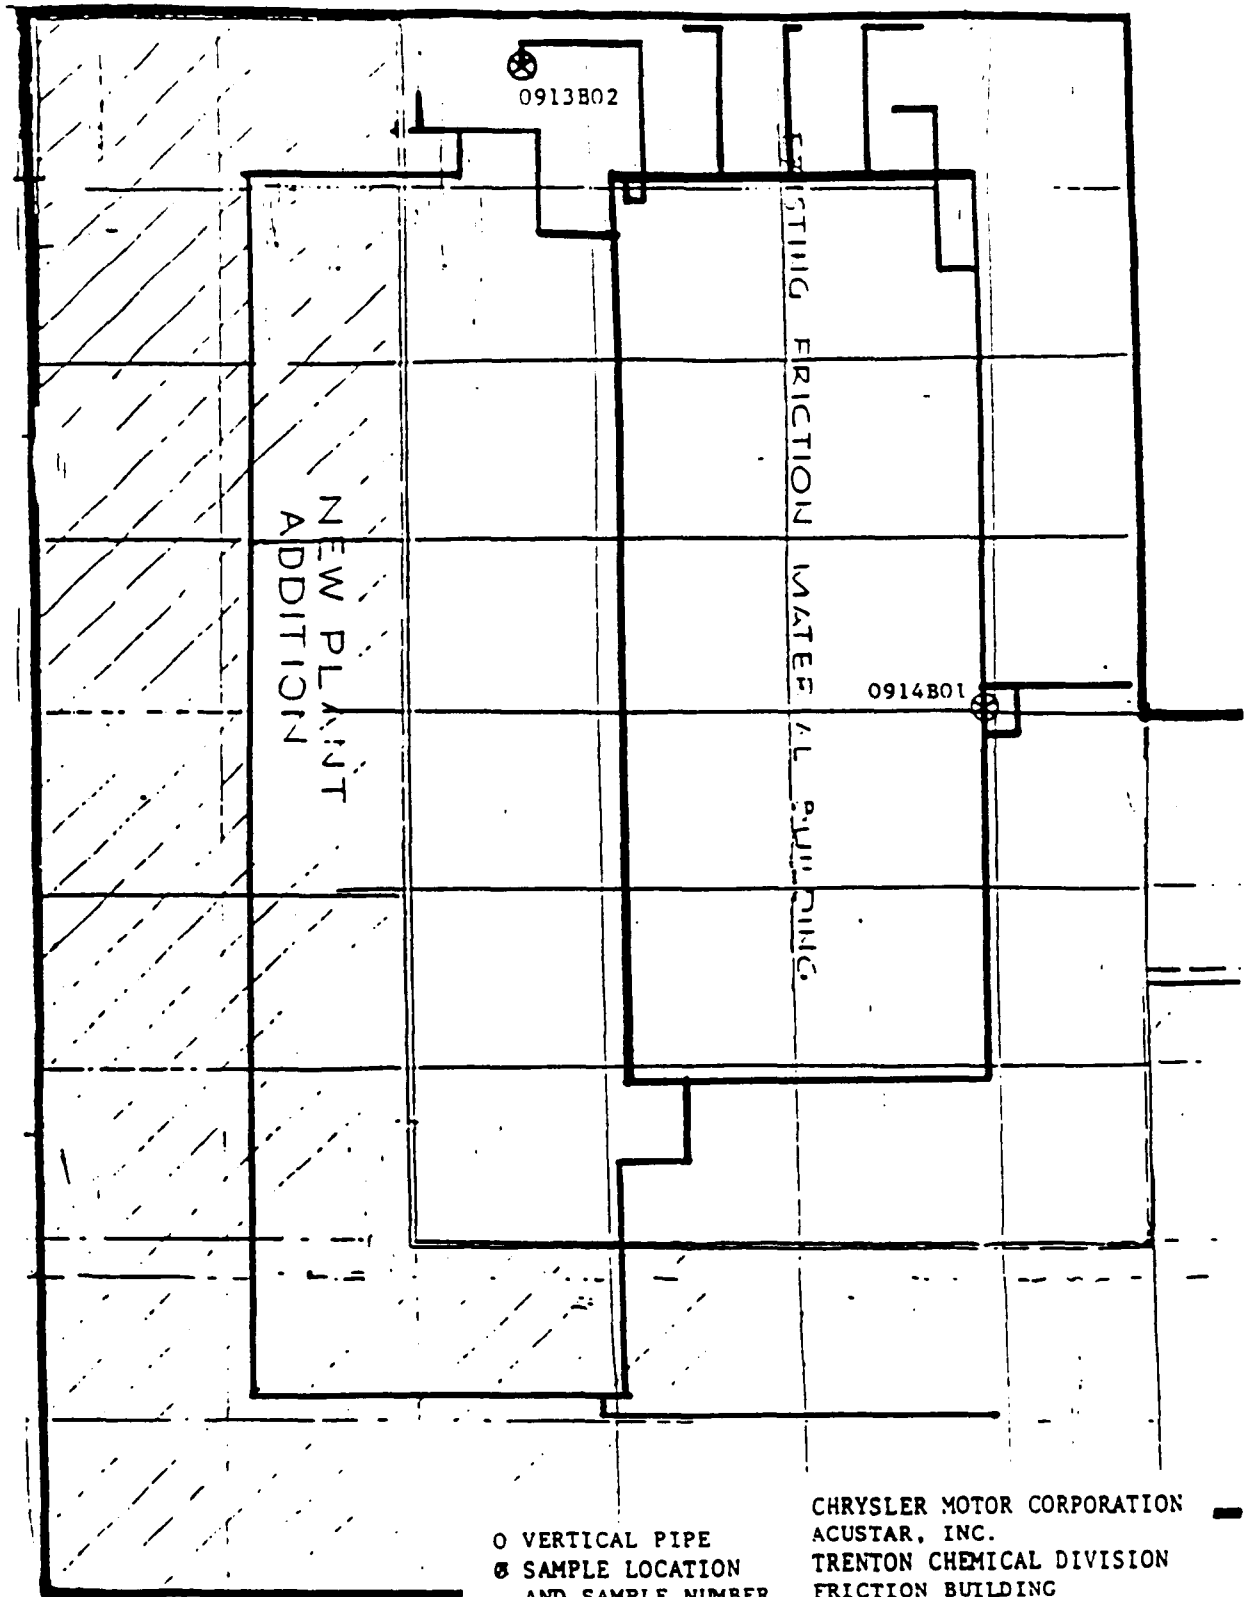
Piping - All piping that is wrapped with insulation other than fibrous glass has asbestos-containing materials (ACM). This includes all mudded joints, tees, and elbows. The condition of ACM ranges from Class 1 (Good Condition - Raw or Friable ACM is not exposed and no repair is needed) to Class 2 (material is torn, ripped, opened, or damaged to a degree which is repaired or can be encapsulated). The exception is the area above the west mezzanine (Bay F-1 and G-1). Much of this piping is Class 3 (material is damaged so severely that complete removal is required) due to moisture damage from steam and condensate leaks. There are also many isolated Class 3 damaged areas throughout the Friction Building that need immediate attention. These areas are indicated in the section of building system drawings of this report. The damaged areas are noted on the drawings by the letter Q.

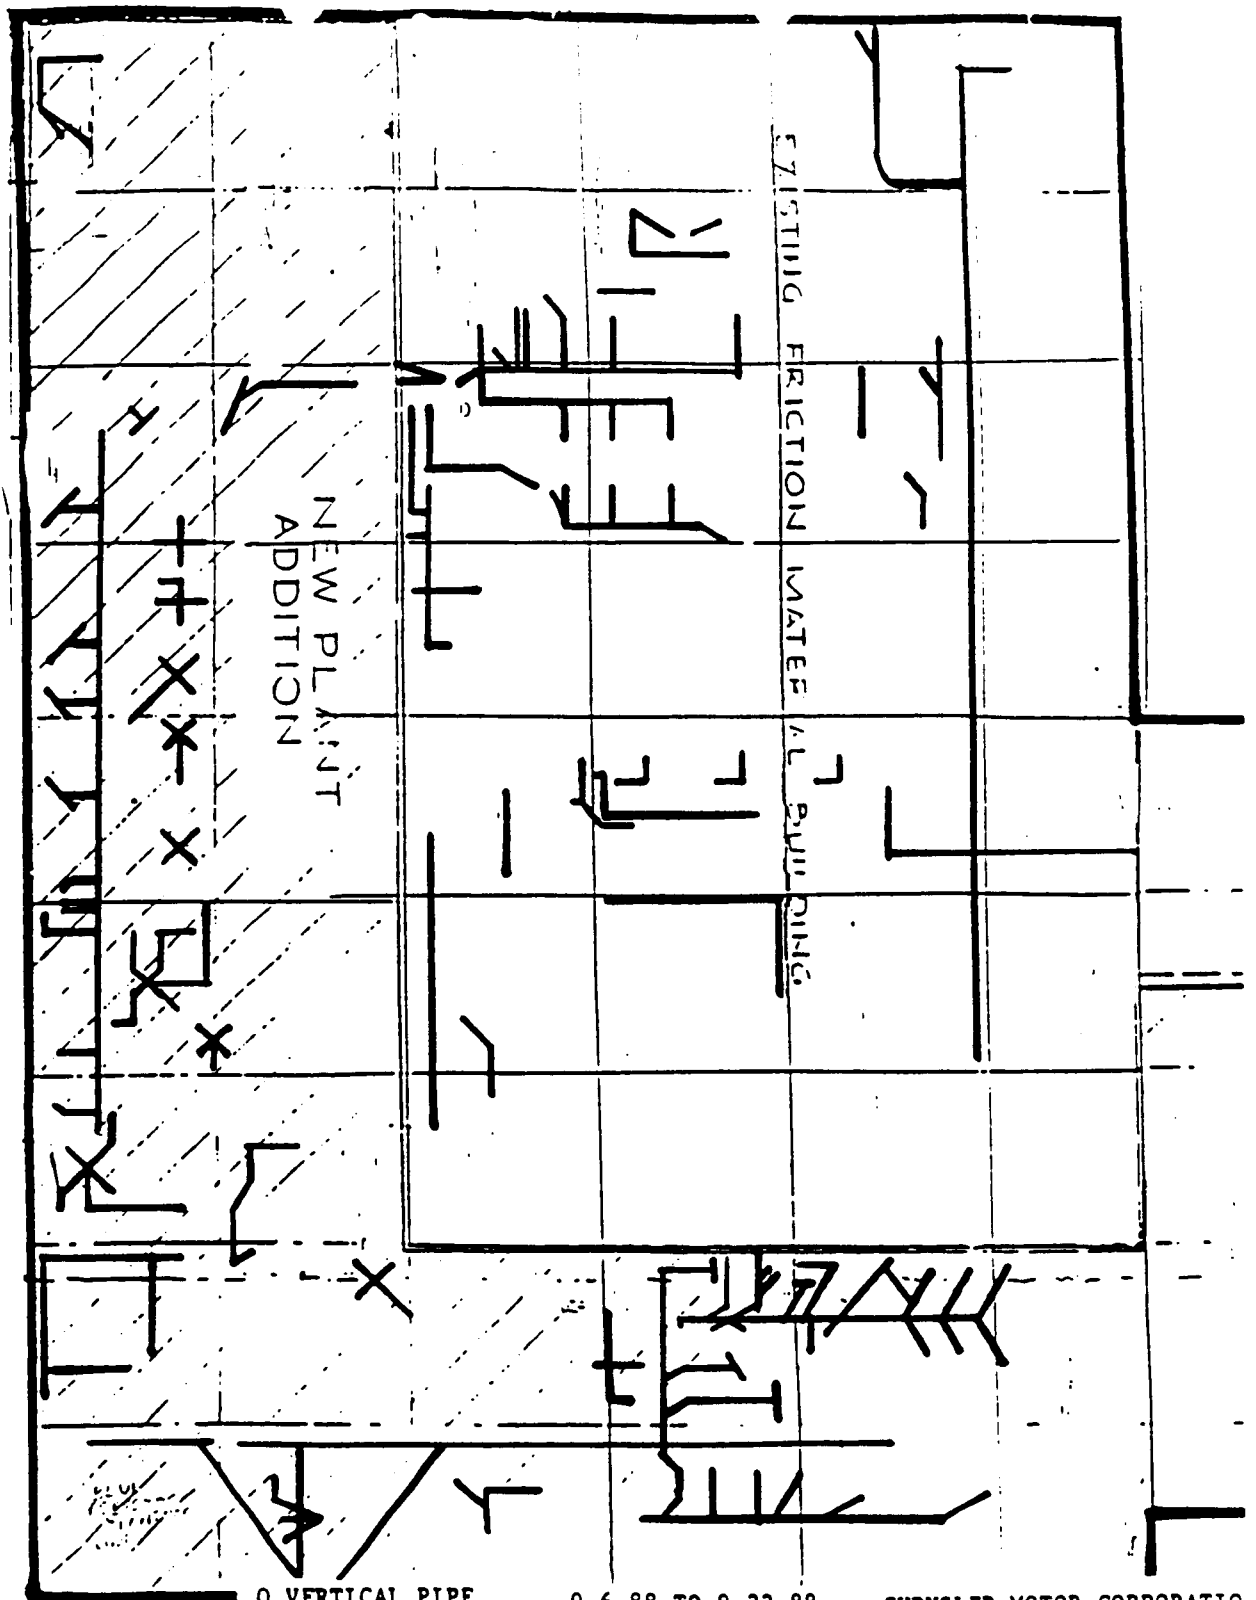
DUCT WORK WITHIN FRICTION BUILDING

Vents and Bag Housing - Approximately 12,000 square feet of duct work and 35,400 square feet of the bag house area was grossly contaminated with ACM. Extreme caution should be used when removing or entering access panels.
