**Region 6 - Enforcement & Compliance Assurance Division**  
**INSPECTION REPORT**

| Regulatory Program: | Water (CWA) Brine Program (Oil & Gas inspection) | |
| Company Name: | LBOC, LLC | |
| Facility Name: | Reynolds Lease Tank Battery | |

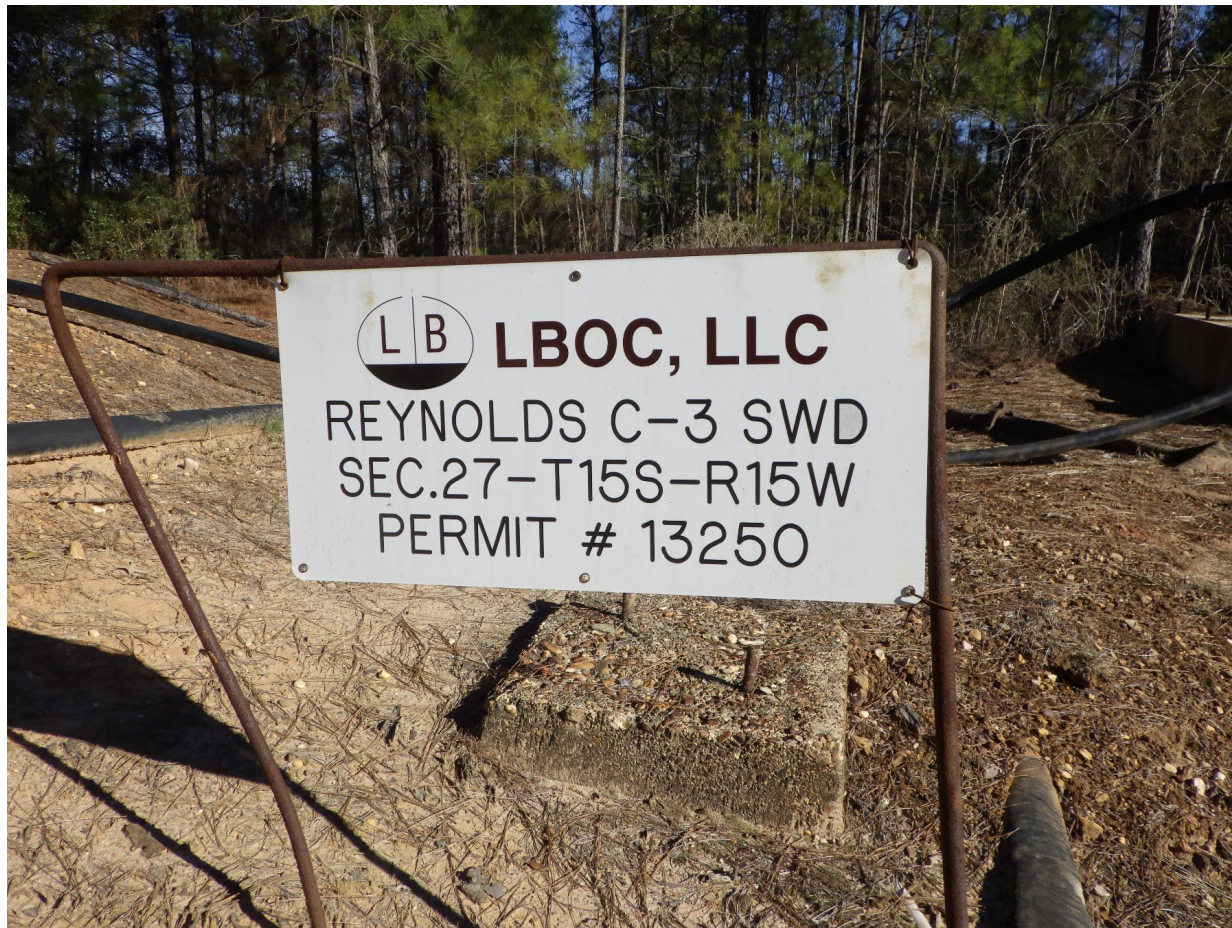
Photo No. 1

| Description: | Looking SW, this photo shows the signage for the Reynolds Lease Tank Battery ("facility"). | | |

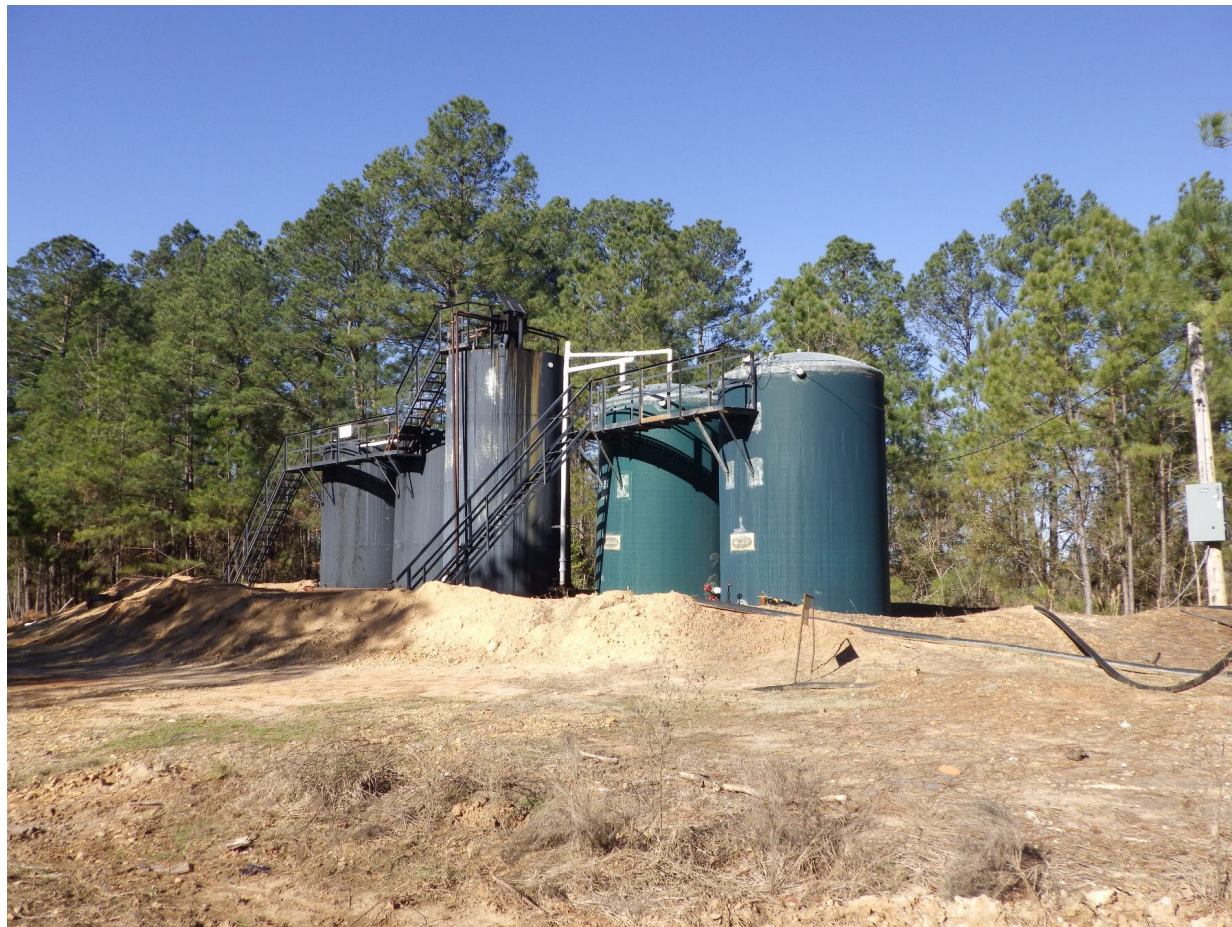
Photo No. 2

| Description: | Looking SW, this photo shows an overview of the facility. | | |

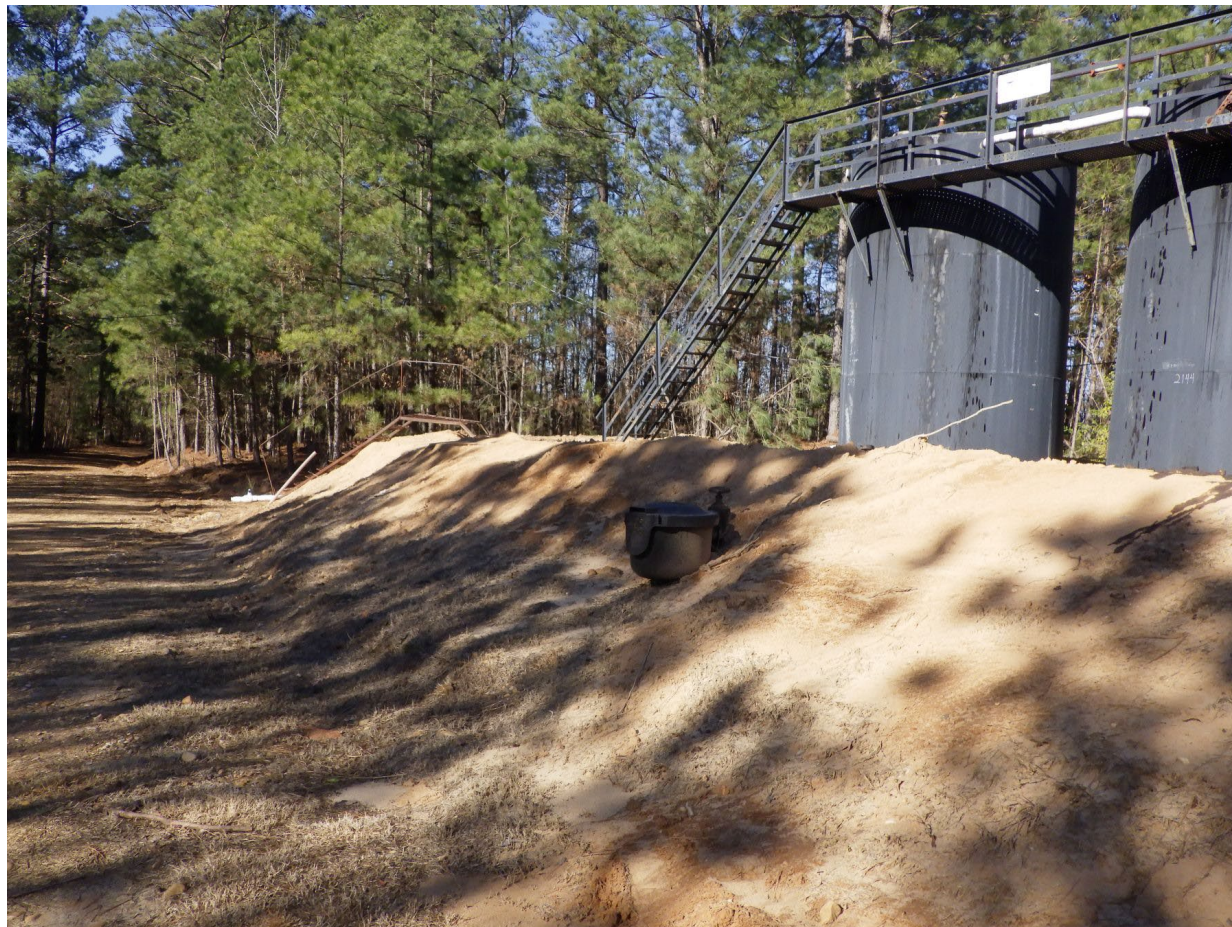
Photo No. 3

I observed the loading line for the tank battery with a catchment bucket, see Photo No. 3.

| Description: | Looking SW, this photo shows a transfer line with secondary containment in place. | | |

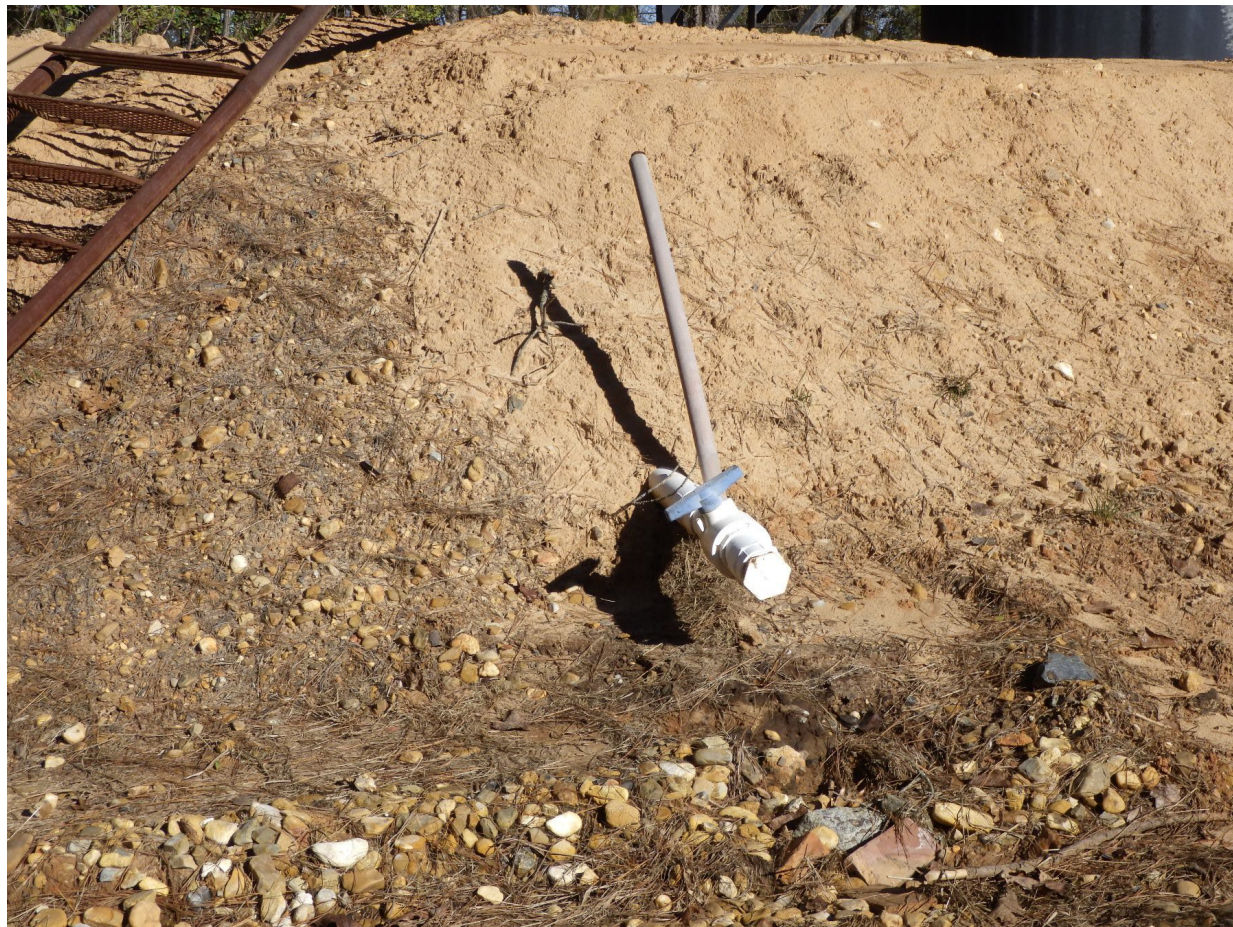
Photo No. 4

I observed the drainpipe for the tank battery with a valve and cap, see Photo No. 4.

| Description: | Looking SW, this photo shows the drainpipe for the tank battery. | | |

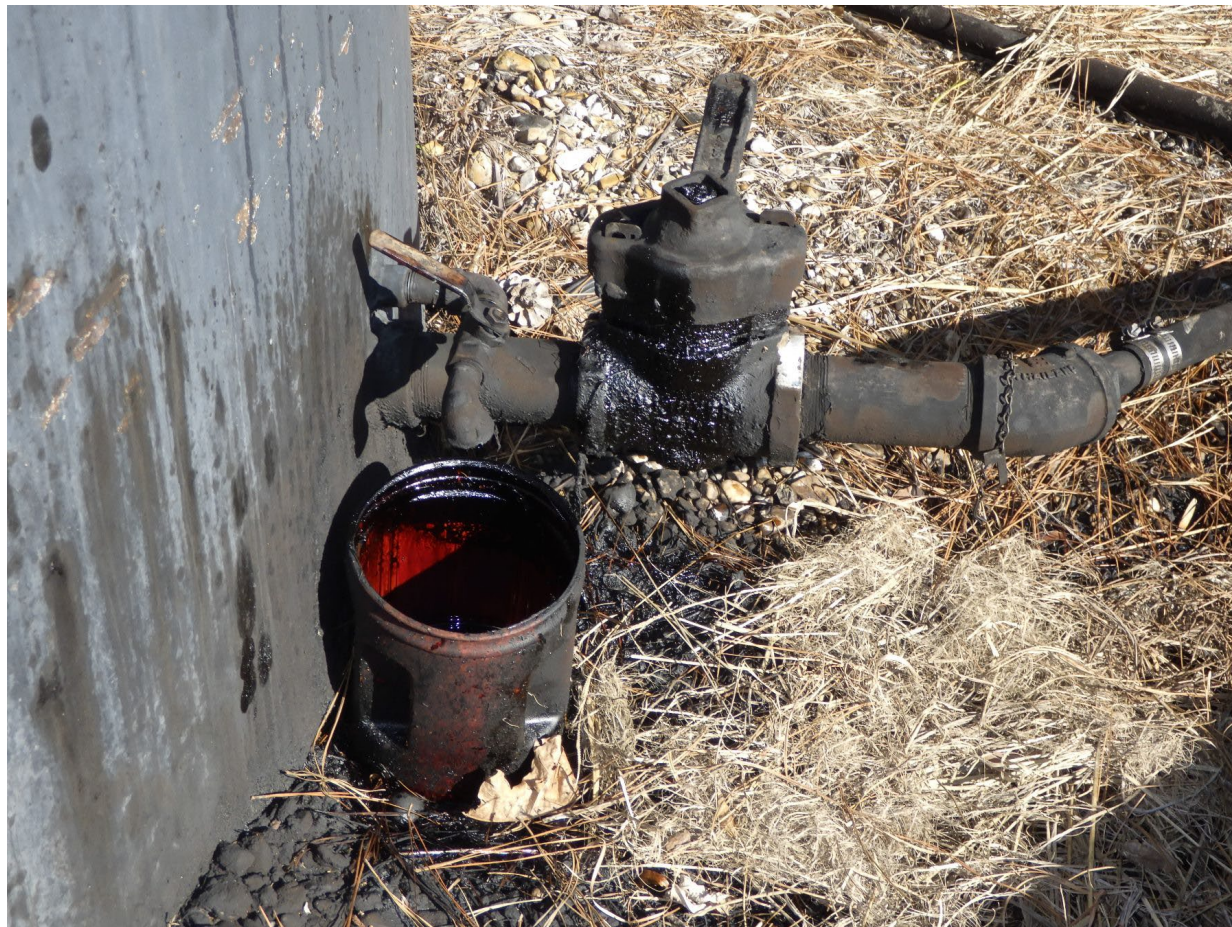
Photo No. 5

I observed a sample port with an open-top catchment bucket inside the tank battery, see Photo No. 5.

I observed active leaks of crude oil and saltwater inside secondary containment, see Photos No. 5 through No. 8.

- Active oil and saltwater leaks at valves/couplings inside the tank battery, 40 CFR 112.9(b)(1) (Photos No. 5 through No. 8).

| Description: | Looking SW, this photo shows a sample port with an open-top catchment bucket. | | |

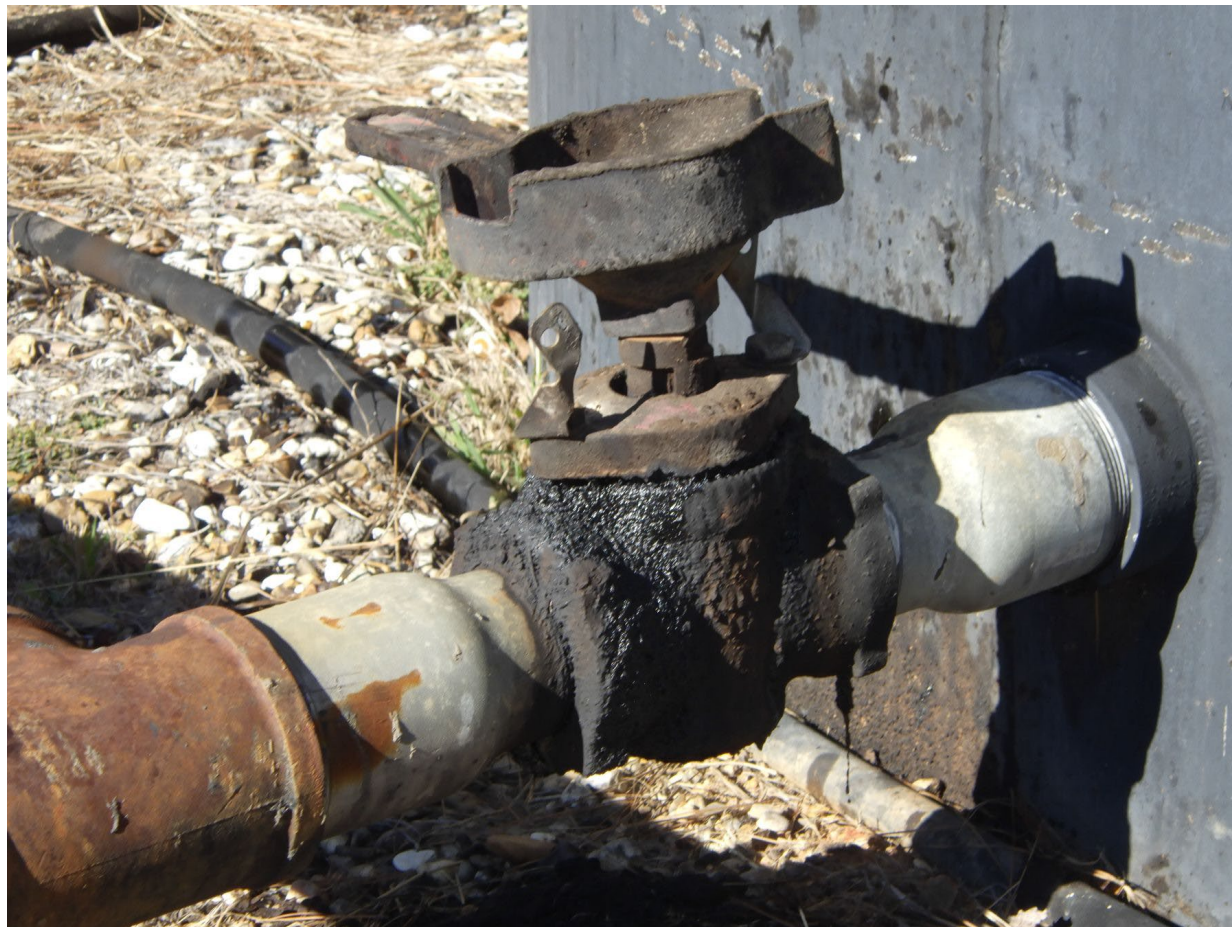
Photo No. 6

| Description: | Looking SW, this photo shows an active leak for a valve at a storage tank. | | |

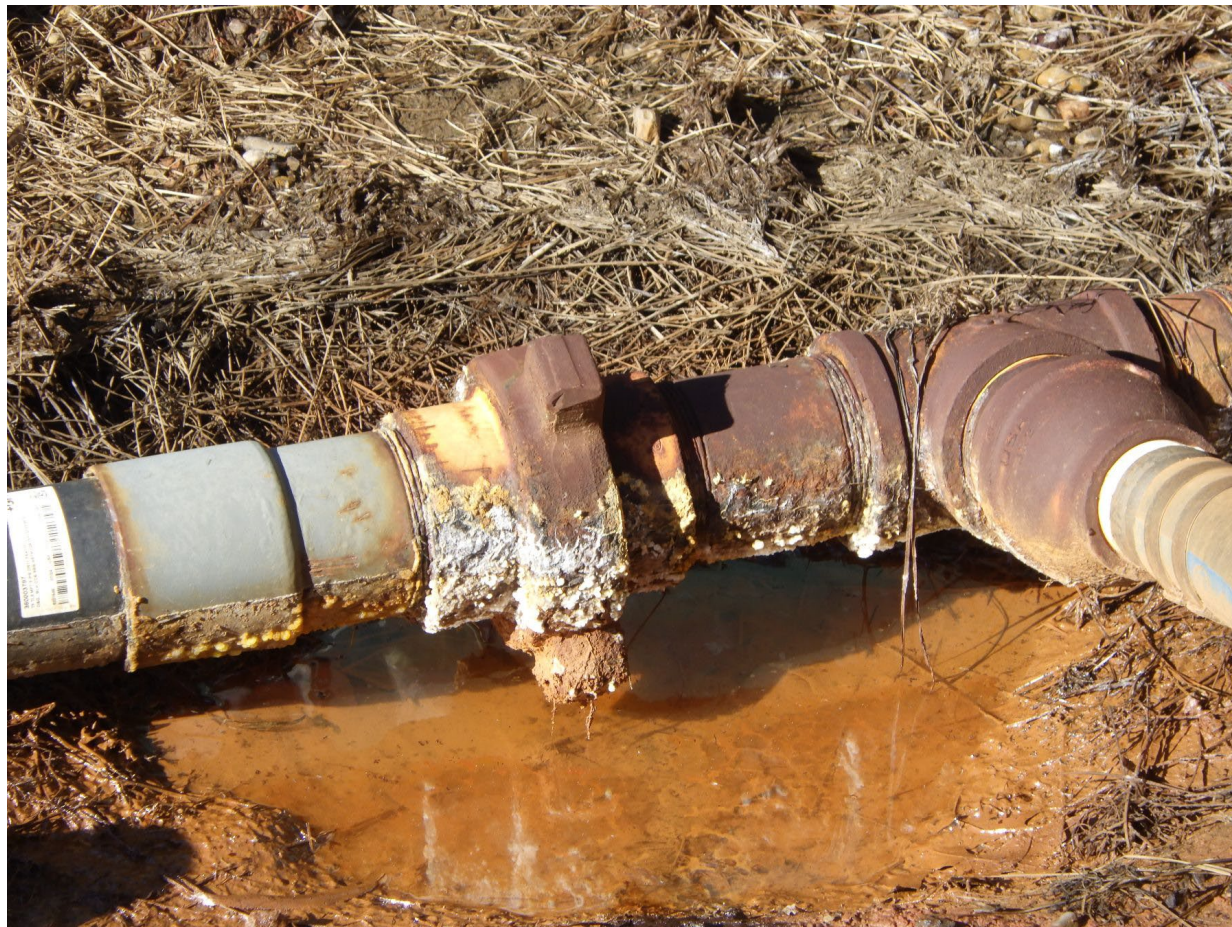
Photo No. 7

| Description: | Looking WSW, this photo shows an active leak of saltwater from a coupling for piping. | | |

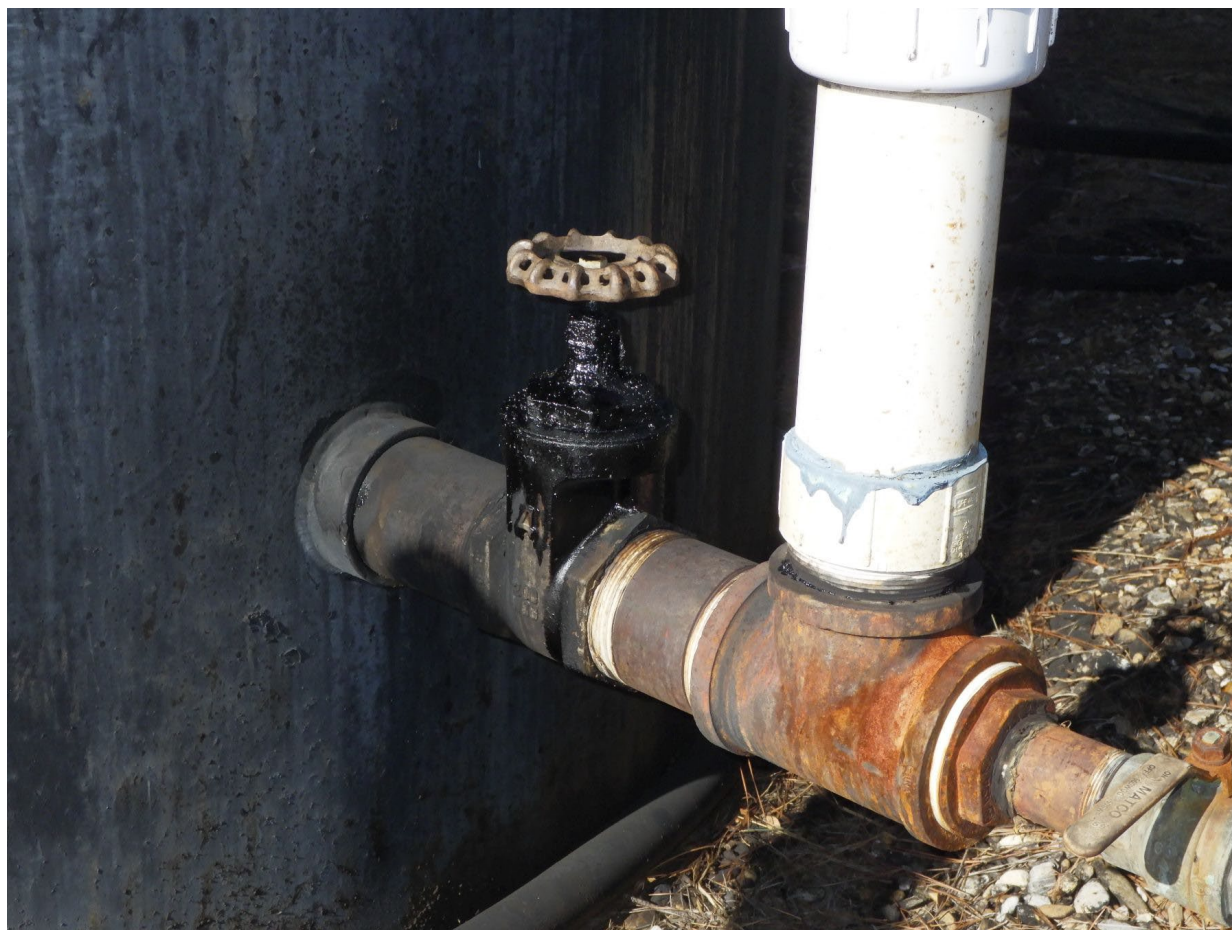
Photo No. 8

| Description: | Looking SW, this photo shows an active leak from a valve for a storage tank. | | |
