INSPECTION REPORT

| Type of Inspection | Compliance Evaluation Inspection | | |
| Permittee Name | Granite Excavation | | |
| Site Name | Kuna Mora Pit aka Blacks Creek Pit | | |

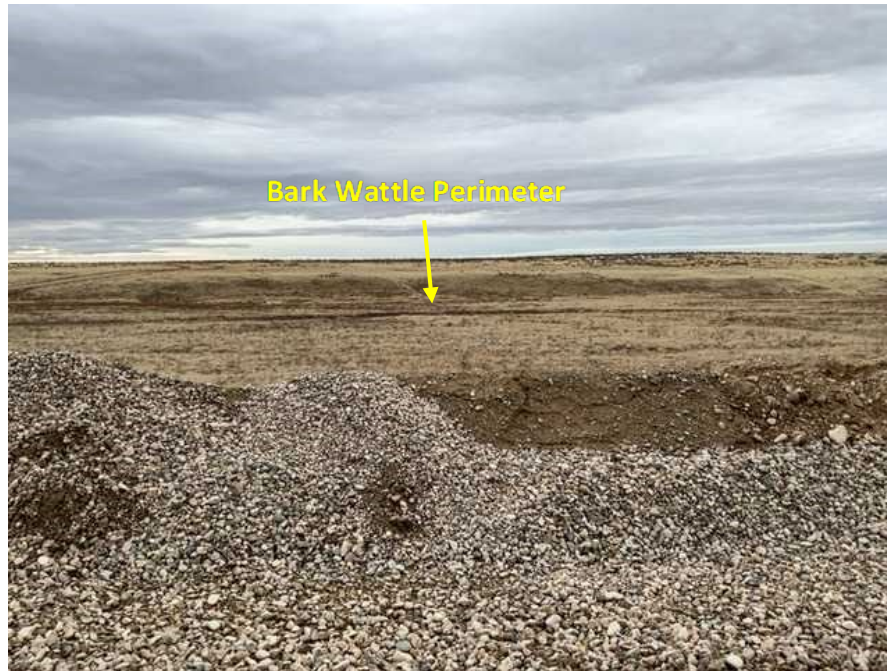
| Berm | | | IMG-202412180941444144138914.jpg |

| Active Site Perimeter Berm, Vegetated Buffer Zone, and Bark Wattle Delineating the Outer Boundary of the Site. | | | |

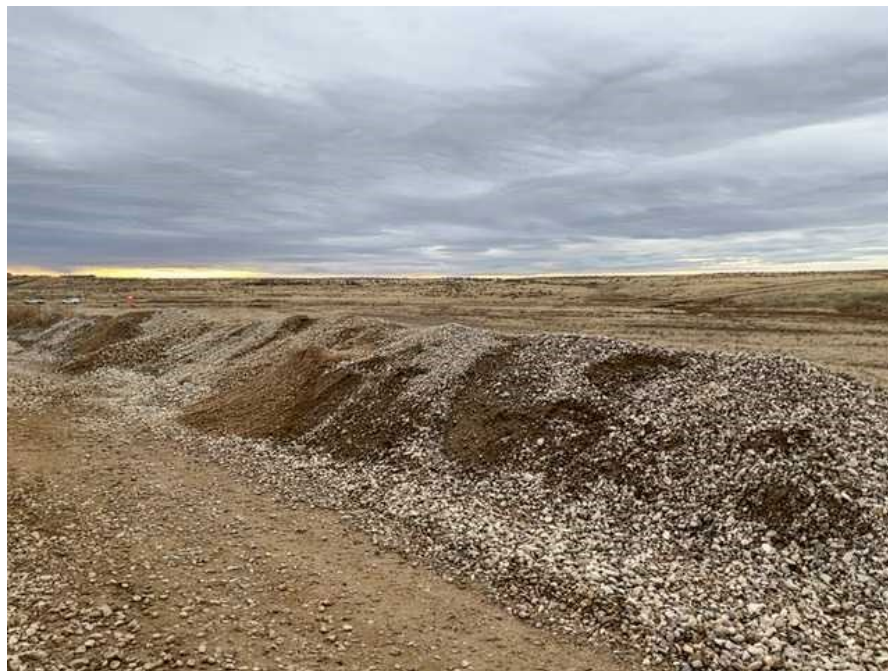
| Berm | | | IMG-202412180941474147130497.jpg |

| Active Site Perimeter Berm along Access Road, photo 1 | | | |

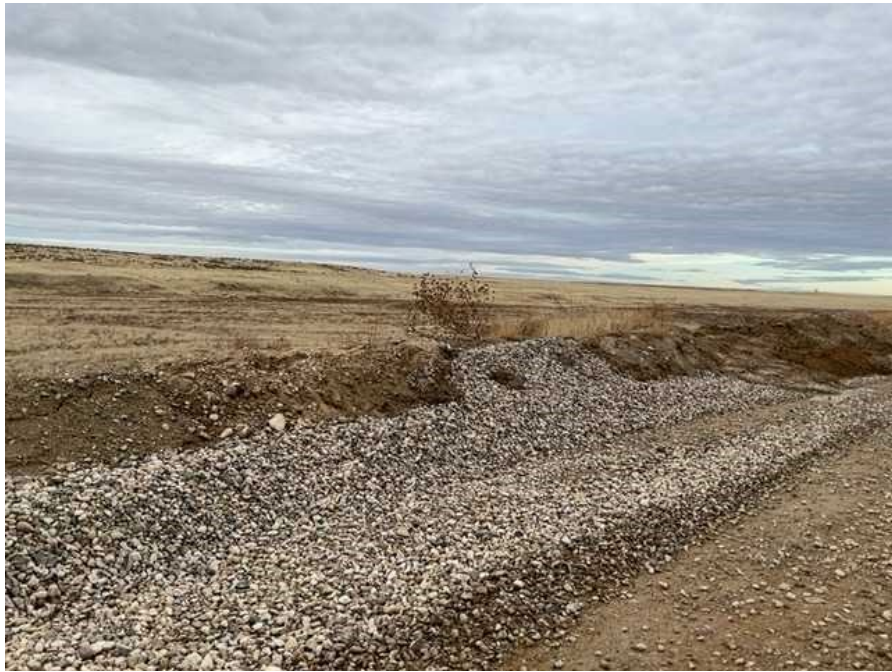
| Berm | | | IMG-202412180941514151135534.jpg |

| Active Site Perimeter Berm along Access Road, photo 2 | | | |

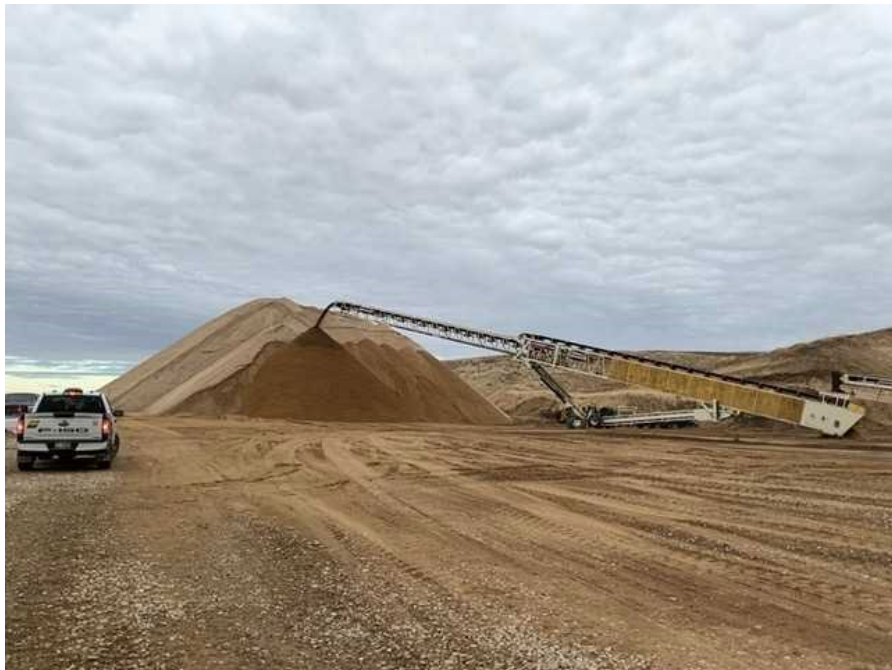
| Conveyor | | | IMG-20241218094312431287636.jpg |

| Conveyor piling sand | | | |

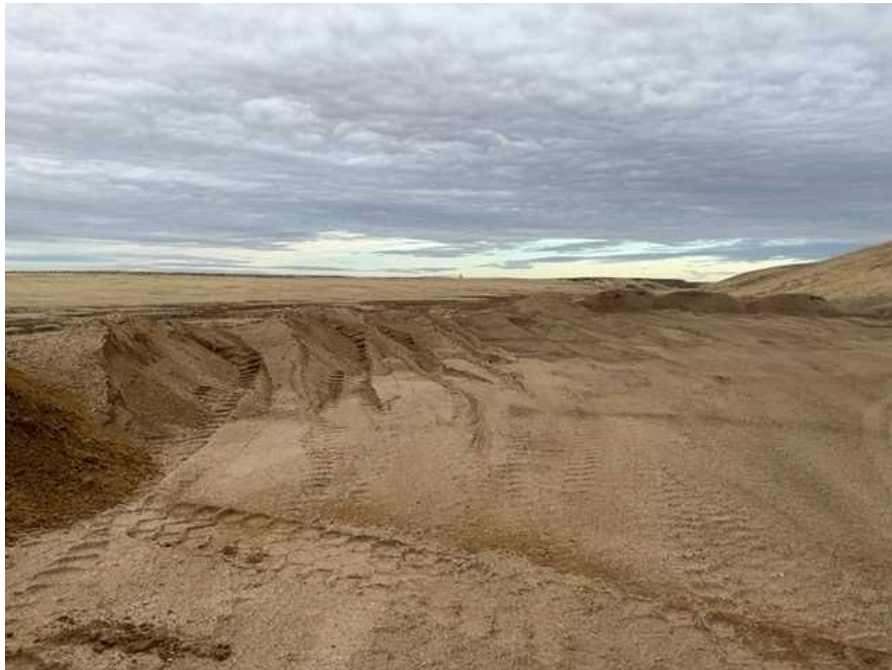
| Upper Site | | | IMG-20241218094642464293212.jpg |

| Site bounded by Hills, photo 1 | | | |

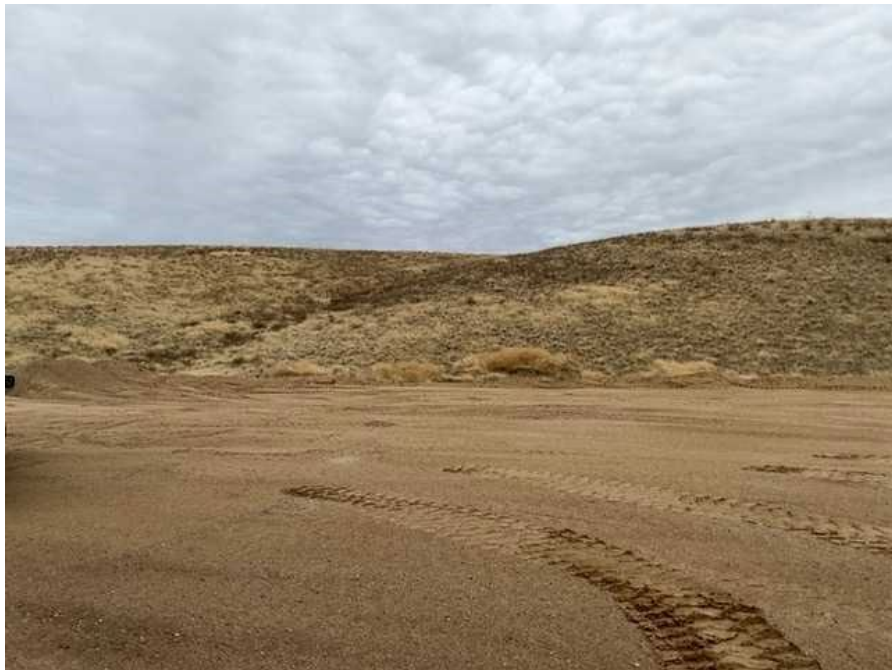
| Upper Site | | | IMG-20241218094651465193241.jpg |

| Site bounded by Hills, photo 2 | | | |

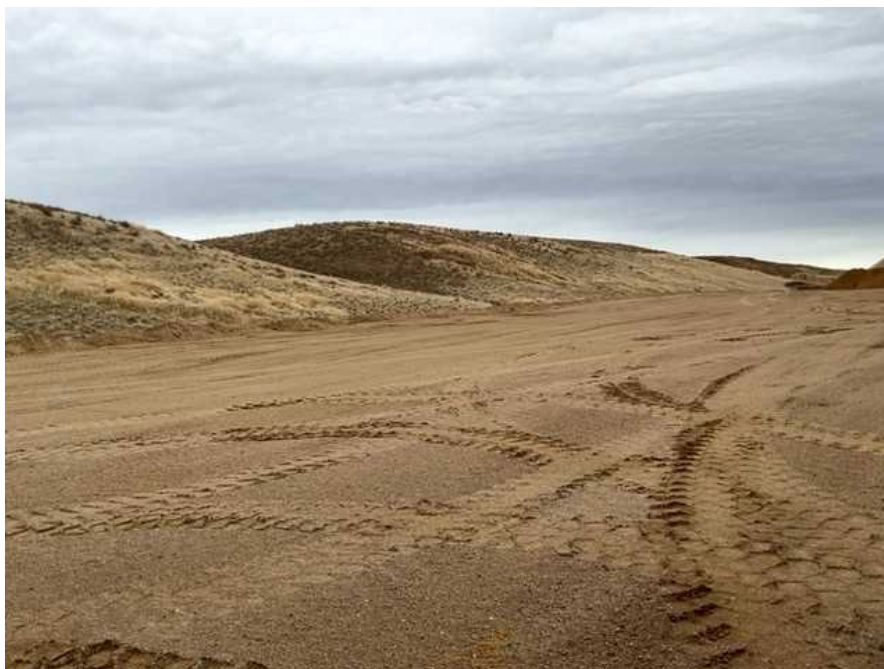
| Upper Site | | | IMG-20241218094658465897554.jpg |

| Site bounded by Hills, photo 3 | | | |

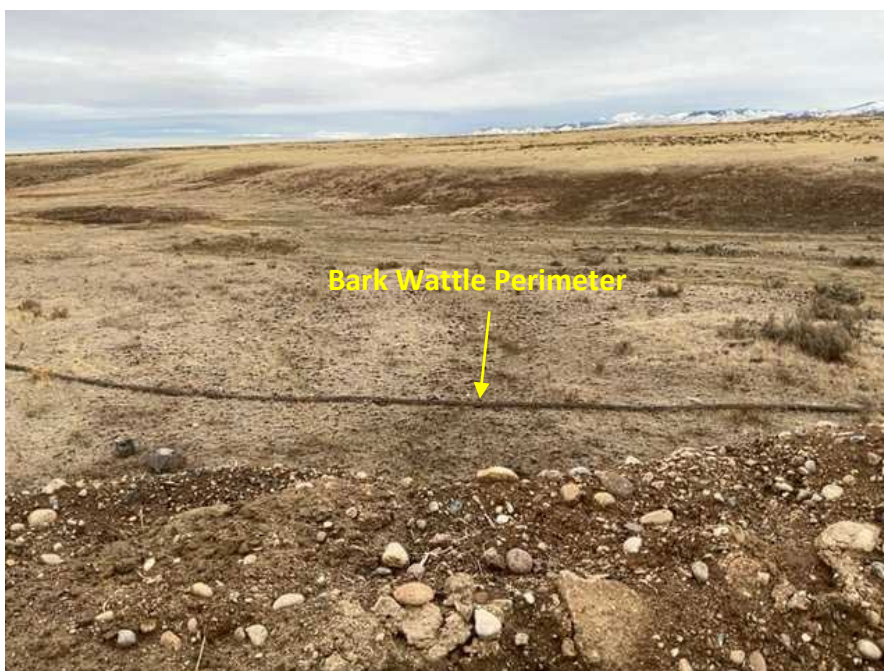
| Outer Site Boundary | | | IMG-202412180954485448148815.jpg |

| Bark wattle acting as limit of active site, photo 1 | | | |

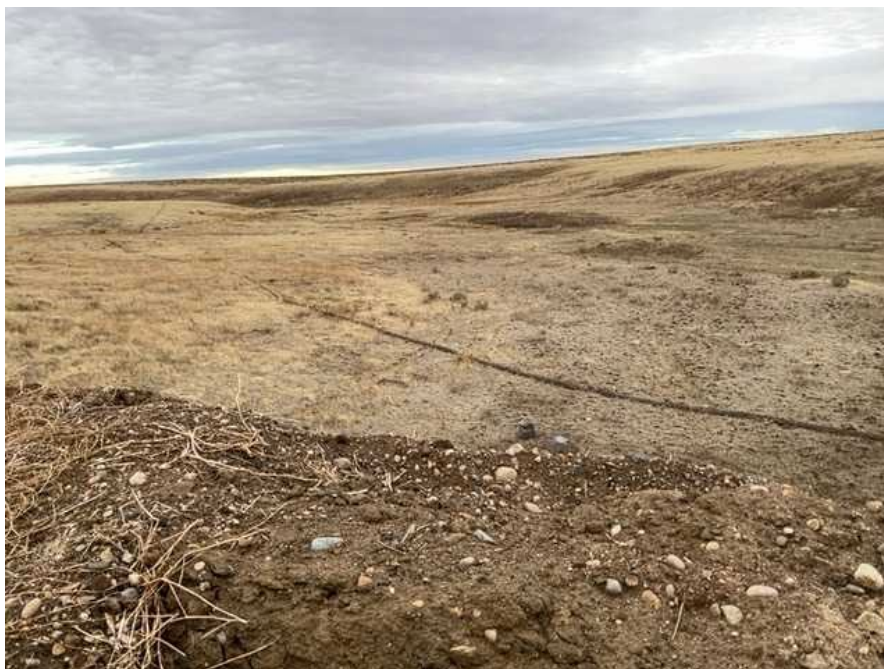
| Outer Site Boundary | | | IMG-202412180954505450137977.jpg |

| Bark wattle acting as limit of active site, photo 2 | | | |

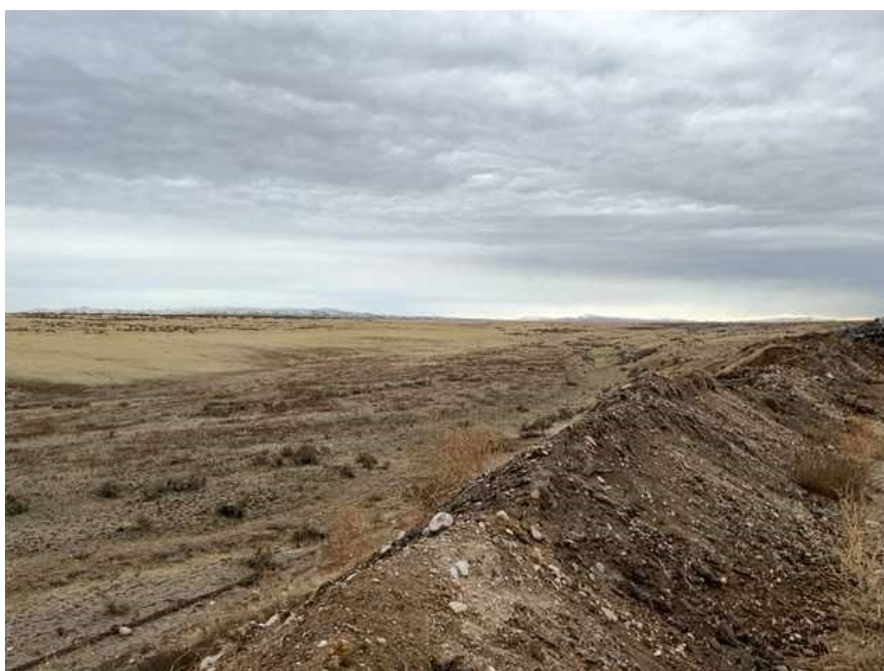
| Outer Site Boundary | | | IMG-202412180956455645101834.jpg |

| Active Site Perimeter Berm along Access Road, photo 3 | | | |

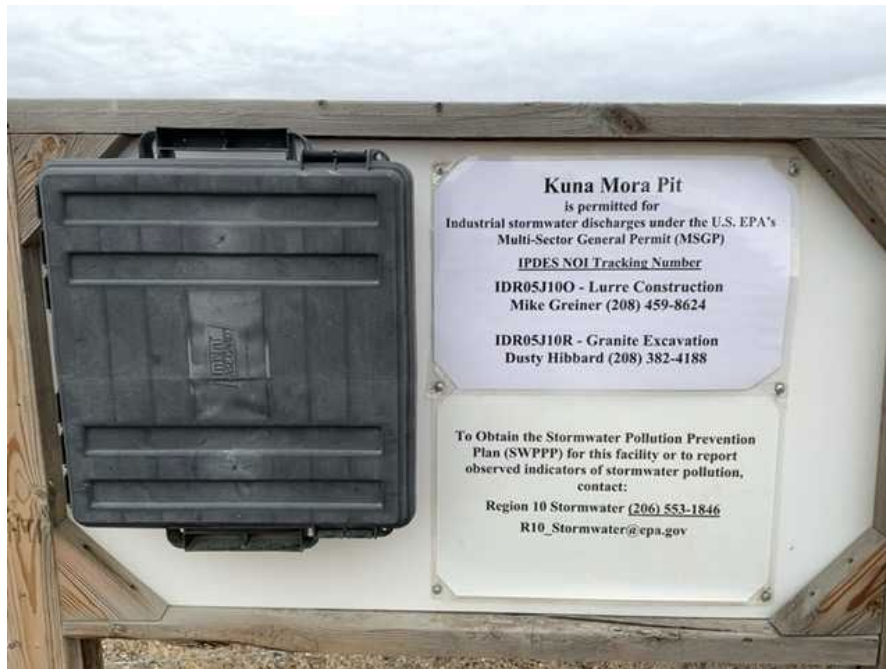
| Site Entrance Sign | | | IMG-2024121810081381383215.jpg |

| Site Entrance Sign with SWPPP, Photo 1 | | | |

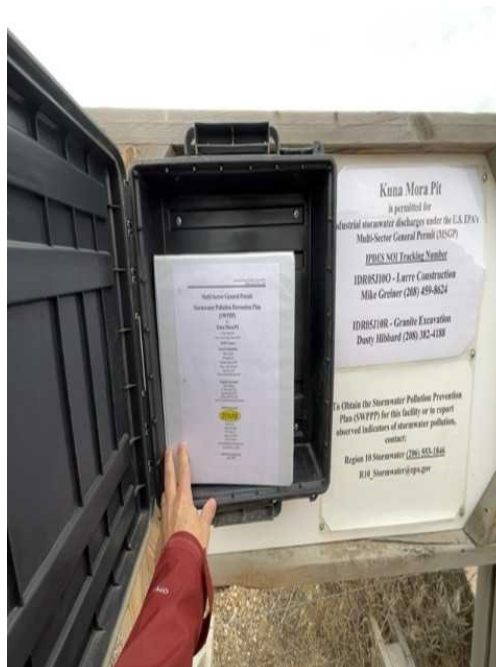
| Site Entrance Sign | | | IMG-2024121810083883866724.jpg |

| Site Entrance Sign with SWPPP, Photo 2 | | | |
