## NPDES Compliance Inspection Report

### A&K Railroad Materials, Inc.

NPDES Tracking # WAU000661

Inspection Date: February 16, 2021

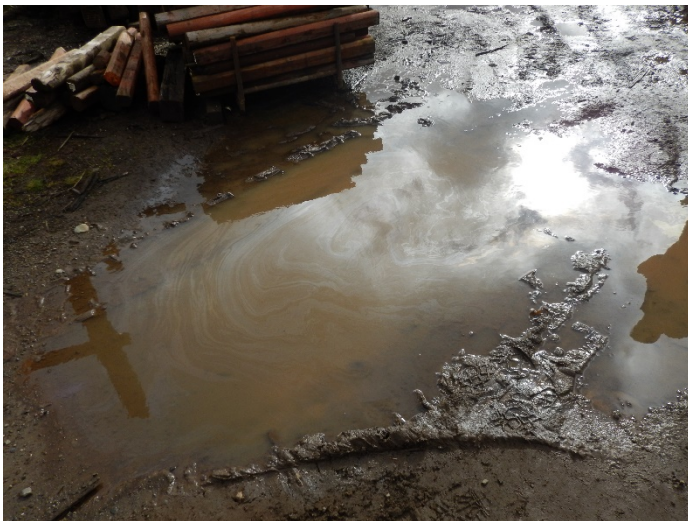
Photo #:07 (DSCN0661)

Description: Photo of pooled stormwater with visible oil sheen.

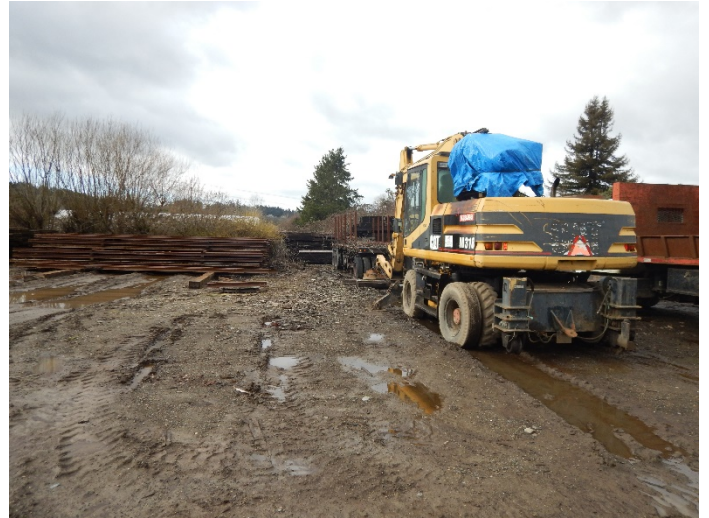
Photo #:10 (DSCN0664)

Description: Facing west, photo of railroad materials and equipment. Note the stormwater pooling.

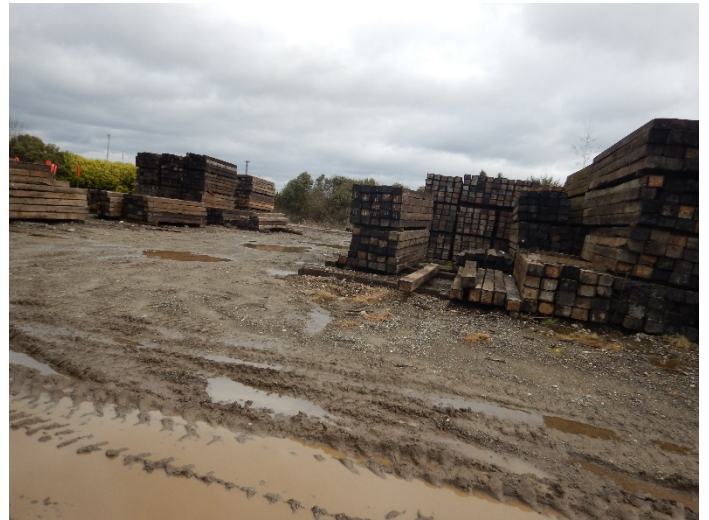
Photo #:12 (DSCN0666)

Description: Facing east, photo of stored railroad materials and pooling stormwater.

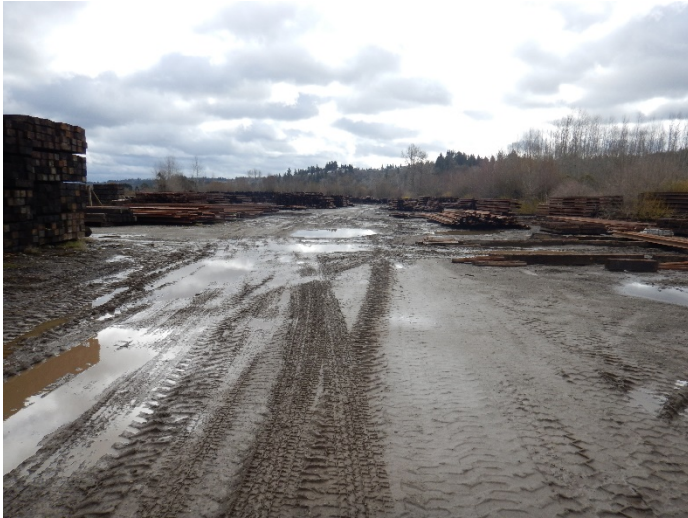
Photo #:13 (DSCN0667)

Description: Facing south, photo of stormwater pooling in the yard.

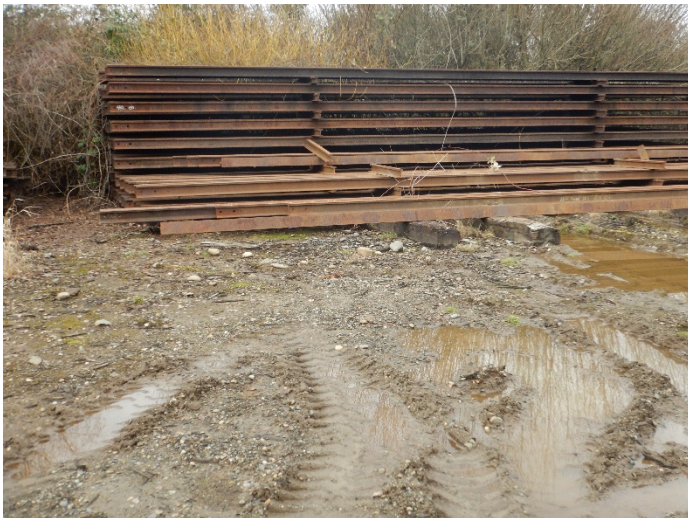
Photo #:15 (DSCN0669)

Description: Facing south, photo of stored railroad materials and pooling stormwater.

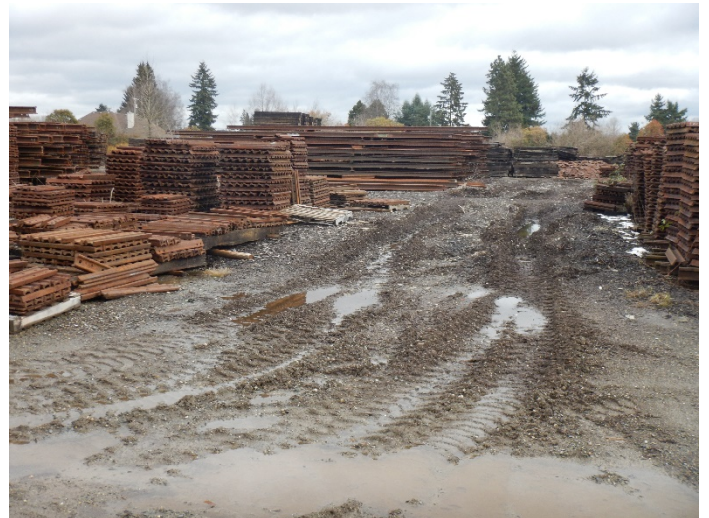
Photo #:16 (DSCN0670)

Description: Facing east, photo of stored railroad materials and pooling stormwater.

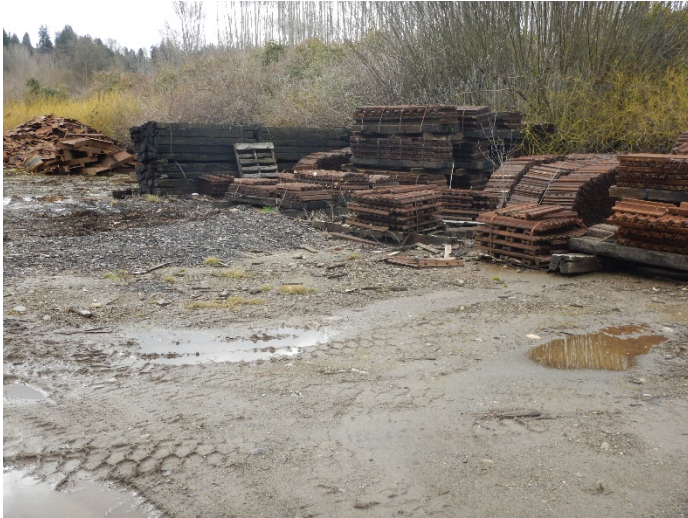
Photo #:17 (DSCN0671)

Description: Facing southeast, photo of stored railroad materials and pooling stormwater.

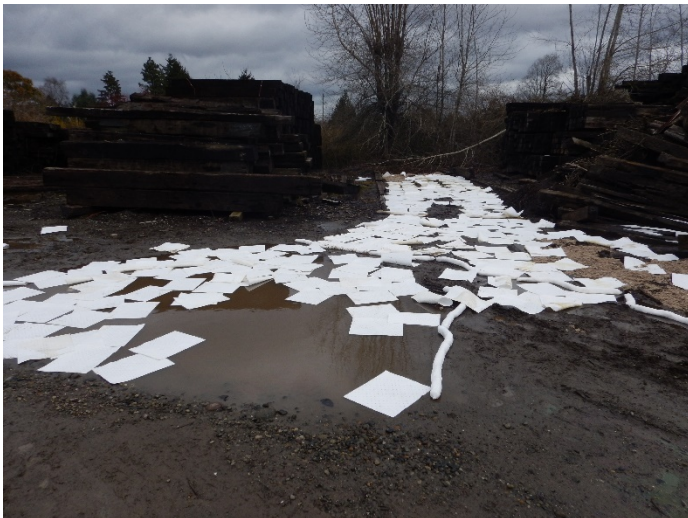
Photo #:19 (DSCN0673)

During my review of the facility at the time of the inspection, I noted an area where filter socks and absorbent pads were being used (**See Attachment B, Photo 19**). Mr. Hall explained that there had been an accidental spill last week involving a blown hydraulic hose. He stated that a hydraulic hose attachment had blown on one of the supply trucks on Friday (2/12/2021), causing a hydraulic fluid spill. After the spill occurred, he immediately began applying the filter socks, pads, etc. on the spill area as part of the initial cleanup process. He explained that the socks and filter pads that I observed during the inspection were part of the second round of cleanup.

Description: Facing east, photo of the hydraulic fluid spill area and associated cleanup. Note the absorbent pads and socks.

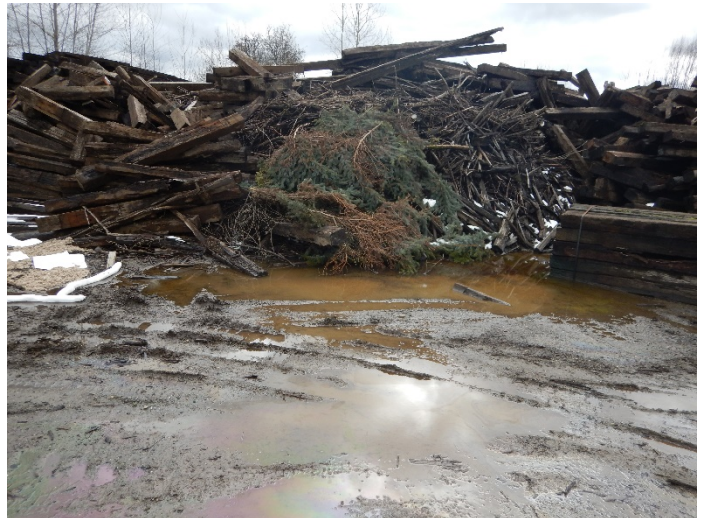
Photo #:20 (DSCN0674)

I observed visible sheen in areas surrounding the spill site, which I pointed out to Mr. Hall during the inspection (**See Attachment B, Photos 20 & 21**). I mentioned that the spill needed to be cleaned up further, given the presence of these sheen patches, and that acquiring larger or more absorbent pads/booms/socks might be helpful for future spill events. Mr. Hall indicated that he had attempted to find better spill cleanup equipment, but that the supply stores/companies did not offer any larger or better options at that time.

Description: Facing south, photo of the water pooled near the hydraulic fluid spill. Note the sheen present in some areas.

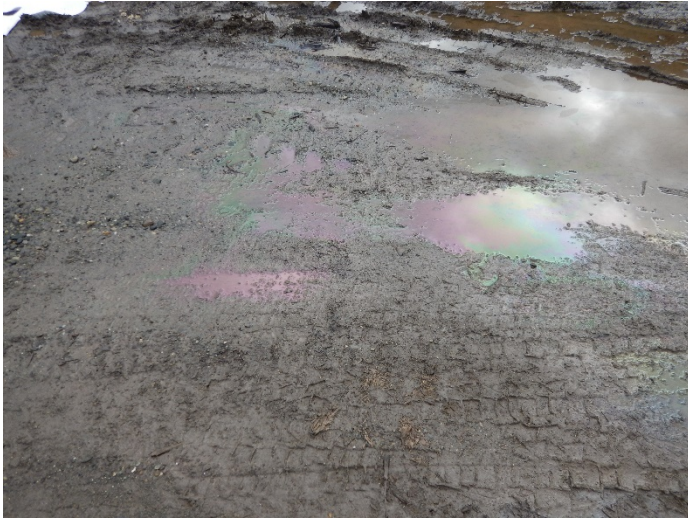
Photo #:21 (DSCN0675)

Description: Facing south, photo of the water pooled near the hydraulic fluid spill. Note the sheen present in some areas.

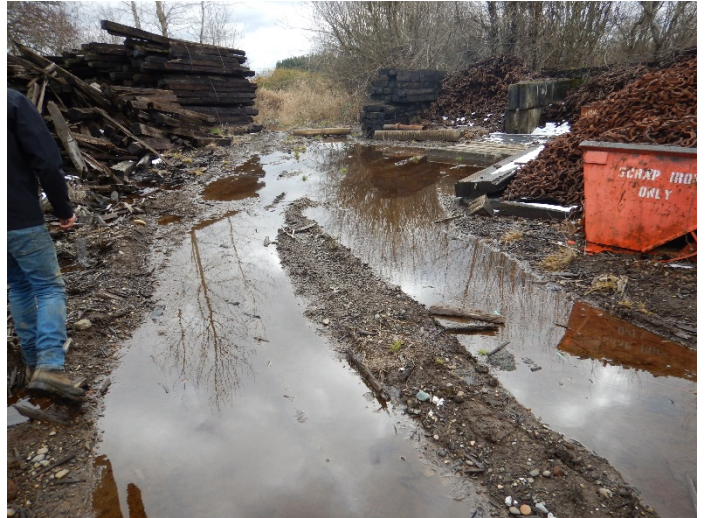
Photo #:22 (DSCN0676)

Description: Facing east, photo of water pooling near the holding pond at the rear of the facility.

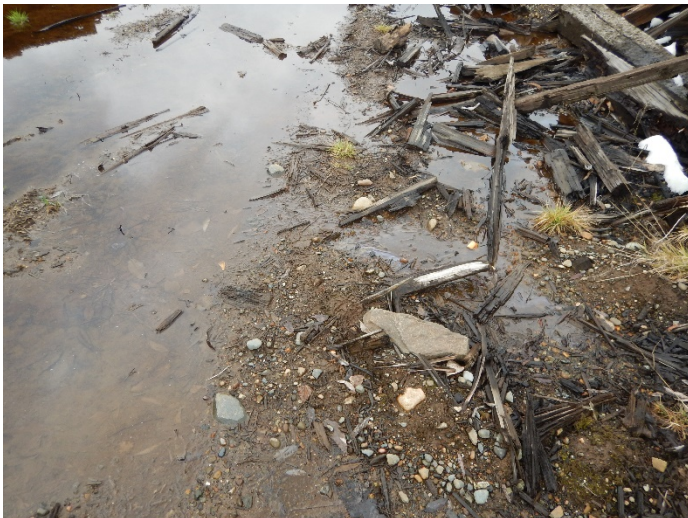
Photo #:23 (DSCN0677)

Description: Facing east, photo of water pooling near the holding pond at the rear of the facility.

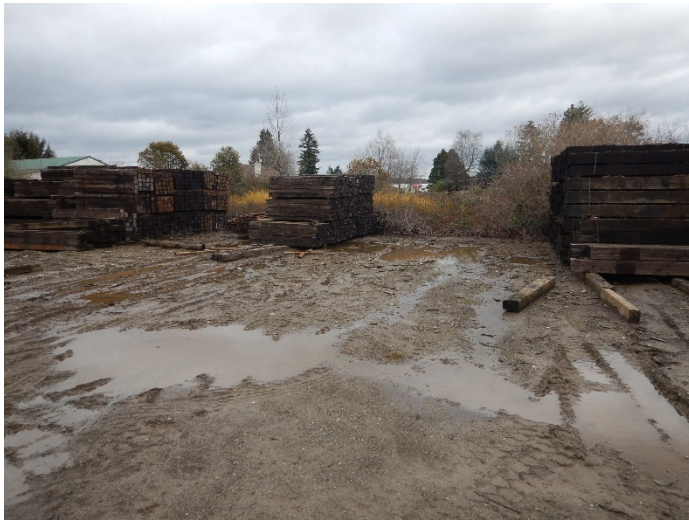
Photo #:29 (DSCN0683)

Description: Facing east, photo of pooling stormwater and stored materials.

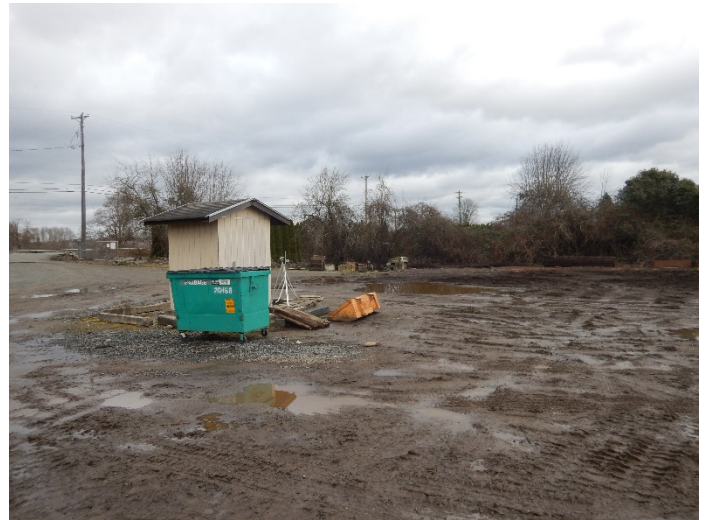
Photo #:30 (DSCN0684)

Description: Facing northeast, photo of dumpster, stormwater pooling, and old shed.
