INDUSTRIAL HYGIENE SURVEY

GENUINE PARTS COMPANY  
RAYLOC DIVISION  
ATLANTA, GEORGIA

August, 1972

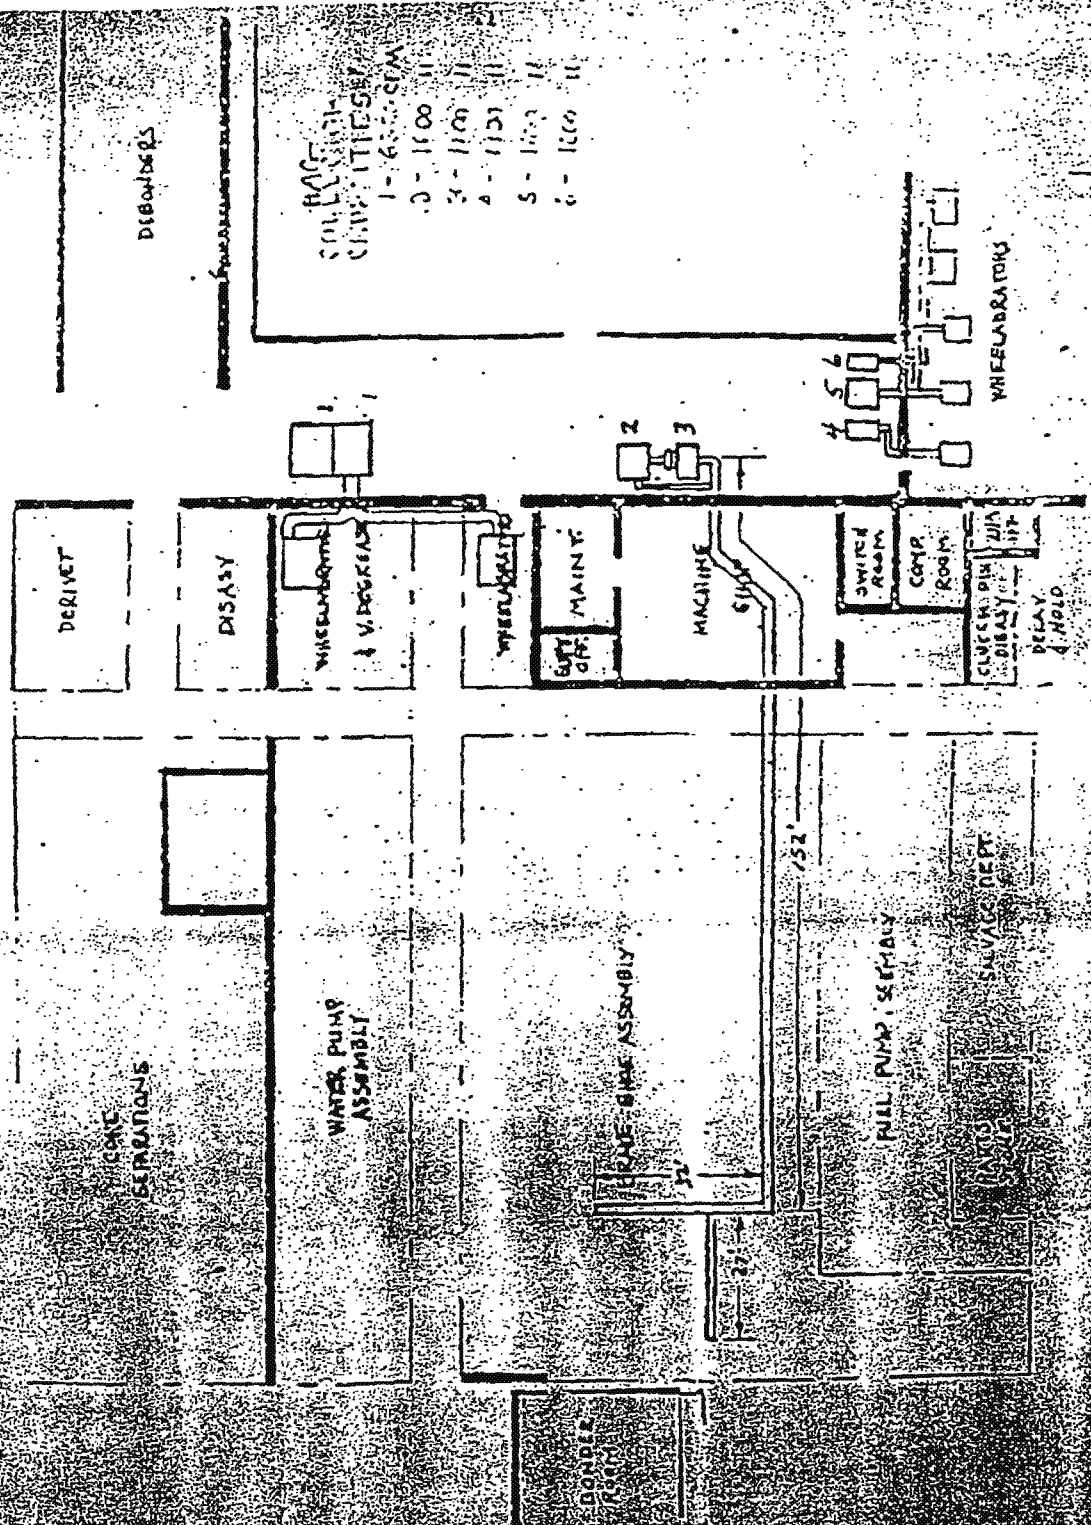
FIGURE 1: FRICTION PRODUCT LAYOUT WITH COLLECTORS

Figure 1 shows a layout of the friction products area of the plant along with locations of the dust collectors and their respective capacities.

Velocity measurements at the entrance to the grinder hoods showed velocities ranging from 600 fpm to 1100 fpm. No ventilation is provided at the clutch deriveting operation.
