**Region 6 - Enforcement & Compliance Assurance Division**  
**INSPECTION REPORT**

| Company Name: | McCann Resources, Inc | |
| Facility Name: | Dixon-Rock Lease | |
| Identification/Permit Number: | OKU002085 | |

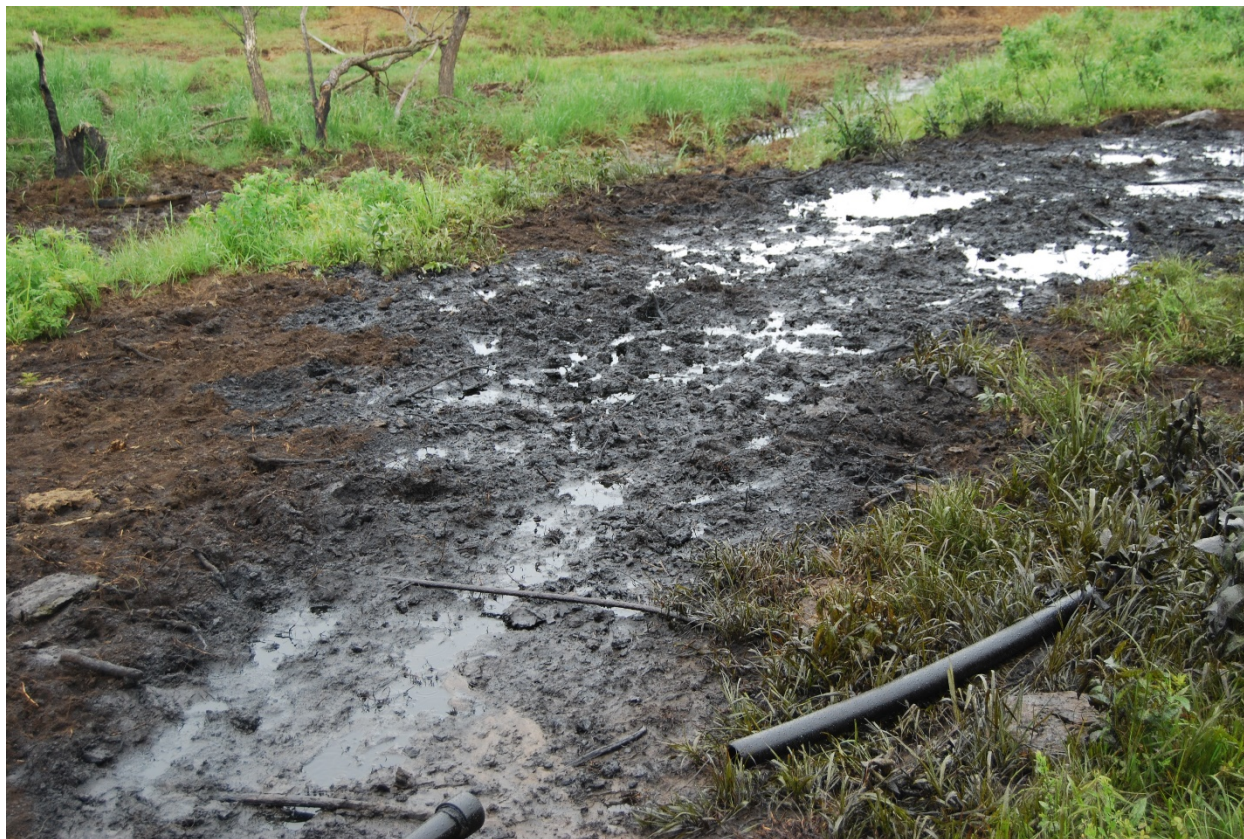
Photo No. 1

I observed the Release Point (GPS 36.893911, -96.126546) of the spill as seen in photo No. 1 of Appendix 1 (photo log). The release point was a point where the 2-inch diameter poly flowline carrying brine and oil from the Dixon-Rock tank battery to the Bowring tank battery pulled apart at a collar joint and spilled produced fluids onto the land. I observed impacted soil and vegetation beginning at the release point, then continued northwest along the flowpath, these impacted areas can be seen in photo No. 1 and No. 5. The spilled fluids flowed across the land approximately 75 feet before spilling into a nearby unnamed tributary of the Caney River/Hulah Lake. The Point of Entry (POE) (GPS 36.893982, -96.126775) into the main channel of the unnamed tributary is documented in photo No. 4. Using a properly calibrated YSI Pro 30 conductivity meter, I observed an elevated Total Dissolved Solids (TDS) field reading of 50,201 mg/L in the main channel of the tributary at the POE, this field reading was the highest level observed during the inspection and can be seen in photo No. 3. I observed a “background” TDS field reading of 204.4 mg/L approximately 20 feet upstream from the POE in a pool of water which was not impacted by the spill, this field reading can be seen in photo No. 2. I observed a significant amount of crude oil on the surface of the tributary which can be seen in photos No. 7, 9, 11, and 12. As the inspection continued downstream from the POE, I observed elevated TDS field readings of 28,233 mg/L (photo No. 8), 22,970 mg/L (photo No. 10), and 759 mg/L (photo No. 13). The TDS field reading of 759 mg/L taken at (GPS 36.899665, -96.125167) was the furthest downstream measurement taken where spill impacts were

**Description:** This was the Release Point of the spill, a 2-inch diameter poly flowline which was pulled apart at the collar connection. Oil and saltwater which were present on the soil and vegetation were also shown in the picture.

EPA Region 6 Inspector, Matthew Allen, conducted a phone conference with Mark McCann, owner/operator of McCann Resources, Inc. at the conclusion of the inspection. During the call I conveyed my primary areas of concern which were to capture and remove waters with TDS levels above the observed "background" level, as well as the capture and removal of oil from the impacted tributary before further downstream migration could occur. I also noted the need to clean the flowpath from the Release Point of the spill to the Point of Entry into the tributary.

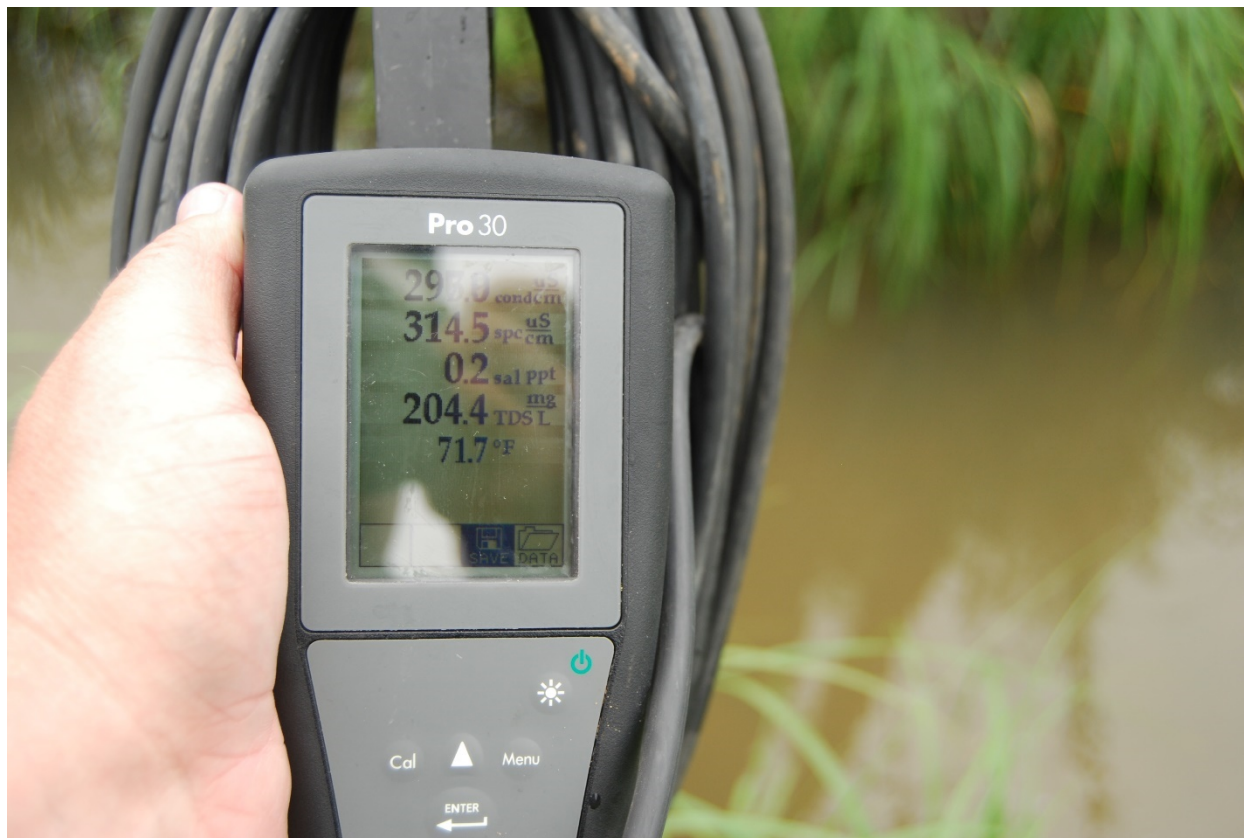
Photo No. 2

**Description:** This was a background TDS field reading of 204.4 mg/L taken along the impacted stream approximately 25 feet upstream from the Point of Entry (POE). This reading was taken in a pool of water which was not impacted by the spill.

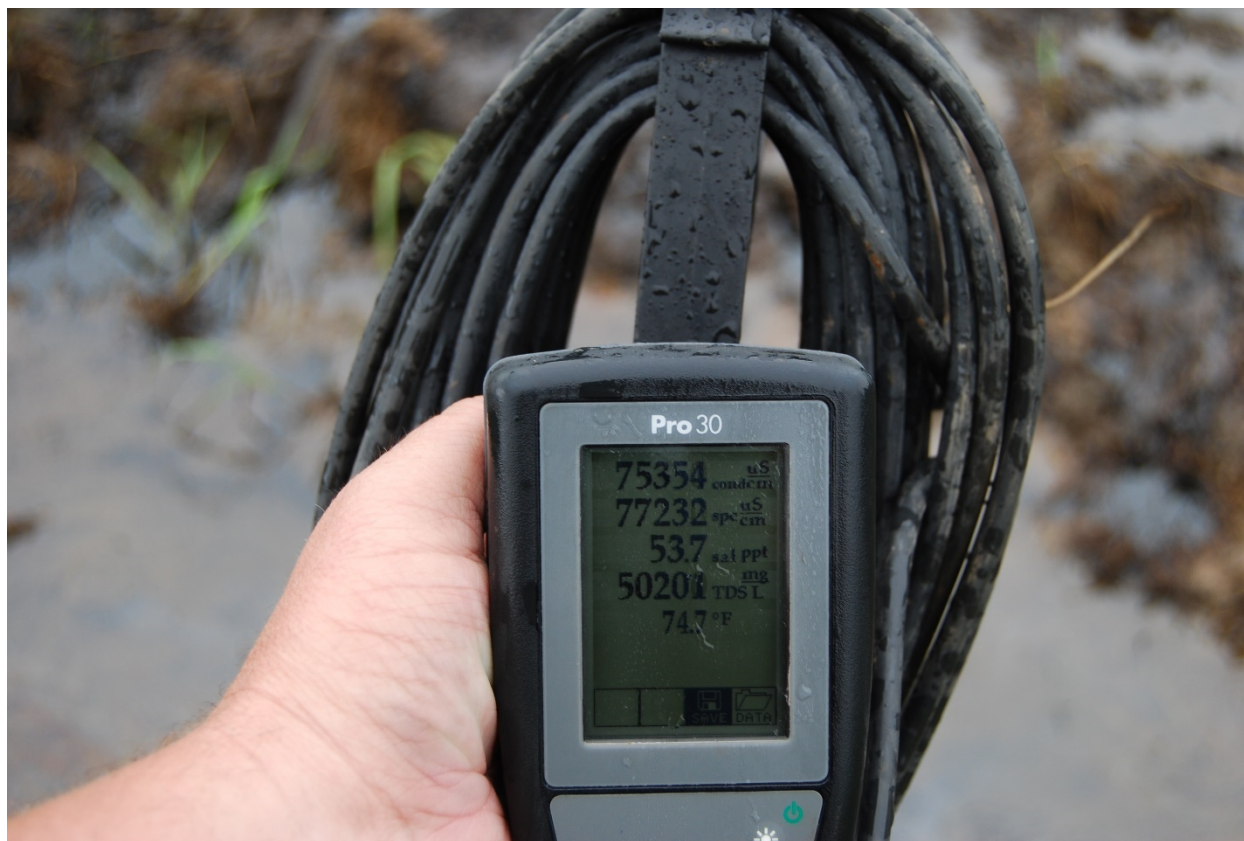
Photo No. 3

**Description:** This was an elevated TDS field reading of 50,201 mg/L taken at the POE into the impacted unnamed tributary. This measurement and all others taken during the inspection were taken with a properly calibrated YSI Pro 30 conductivity meter.

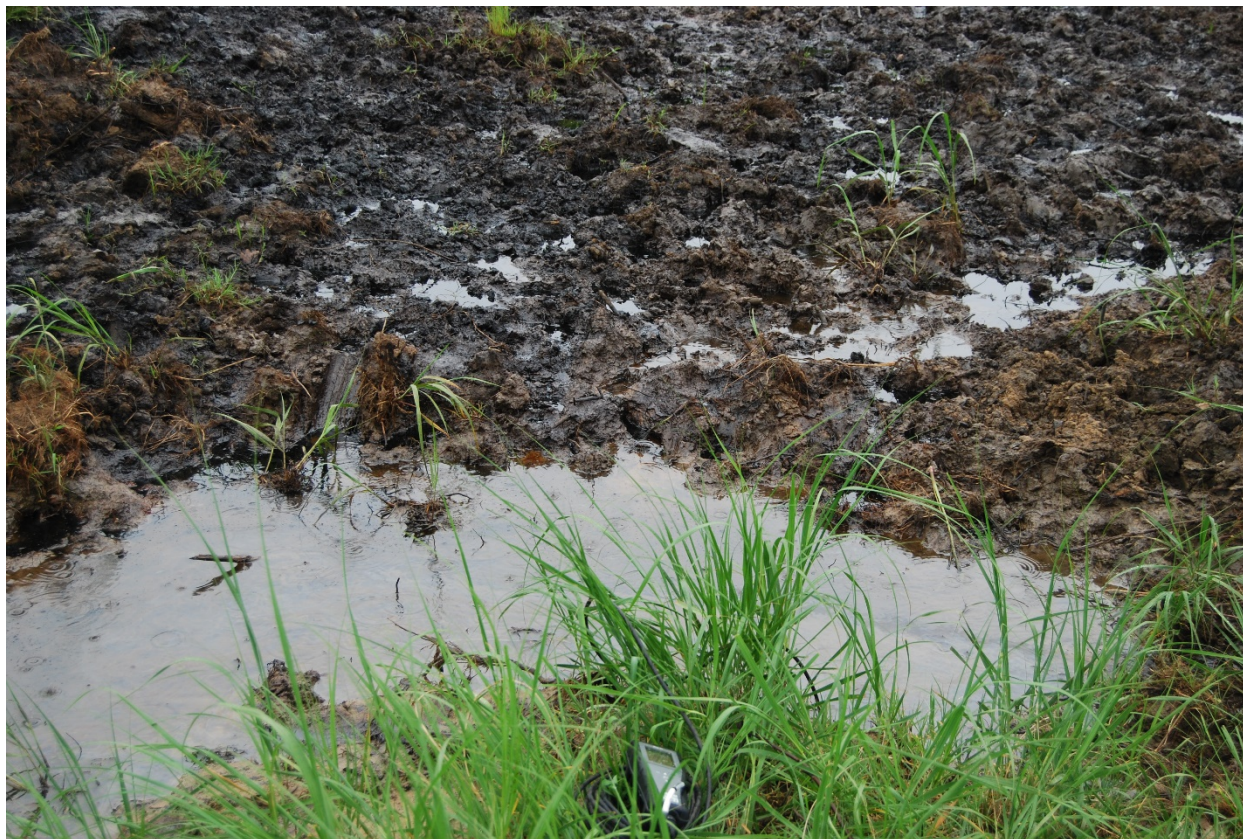
Photo No. 4

**Description:** This is the Point of Entry (POE) where saltwater and oil spilled into the impacted tributary. The TDS field reading at this location was 50,201 mg/L, which was the highest reading observed during the inspection.

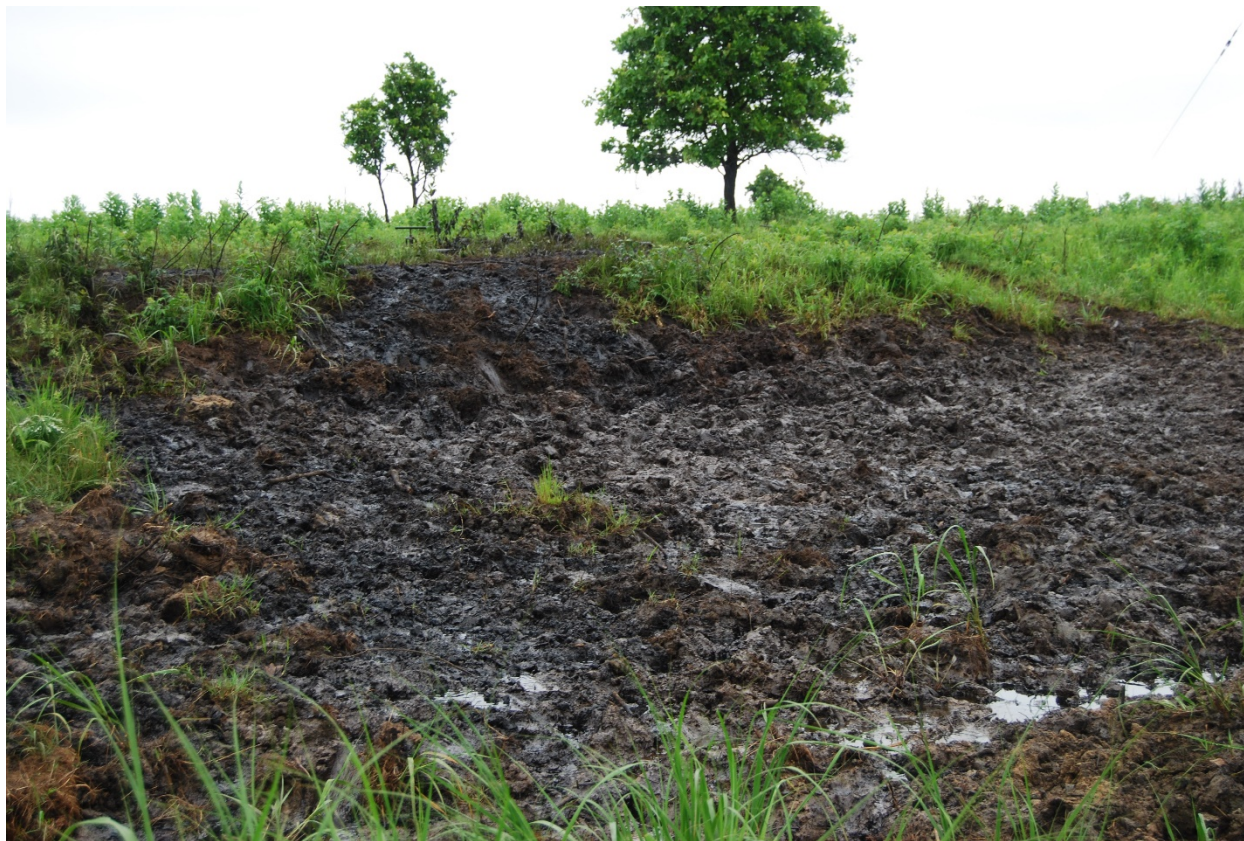
Photo No. 5

**Description:** This photo was taken standing at the POE into the tributary, looking East along the flowpath of the spill. The Release Point of the spill was located near the largest tree in the picture.

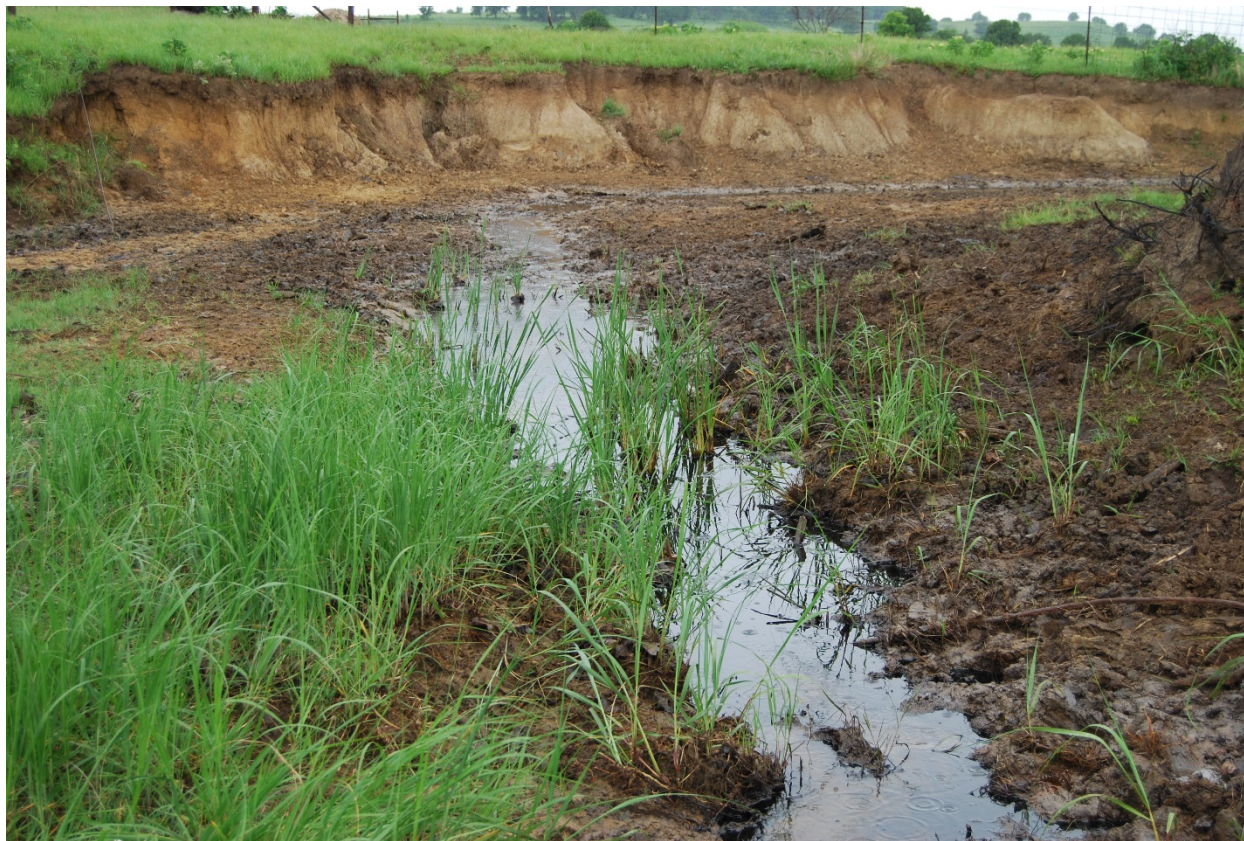
Photo No. 6

**Description:** This photo was taken from the POE into the tributary with a view looking downstream.

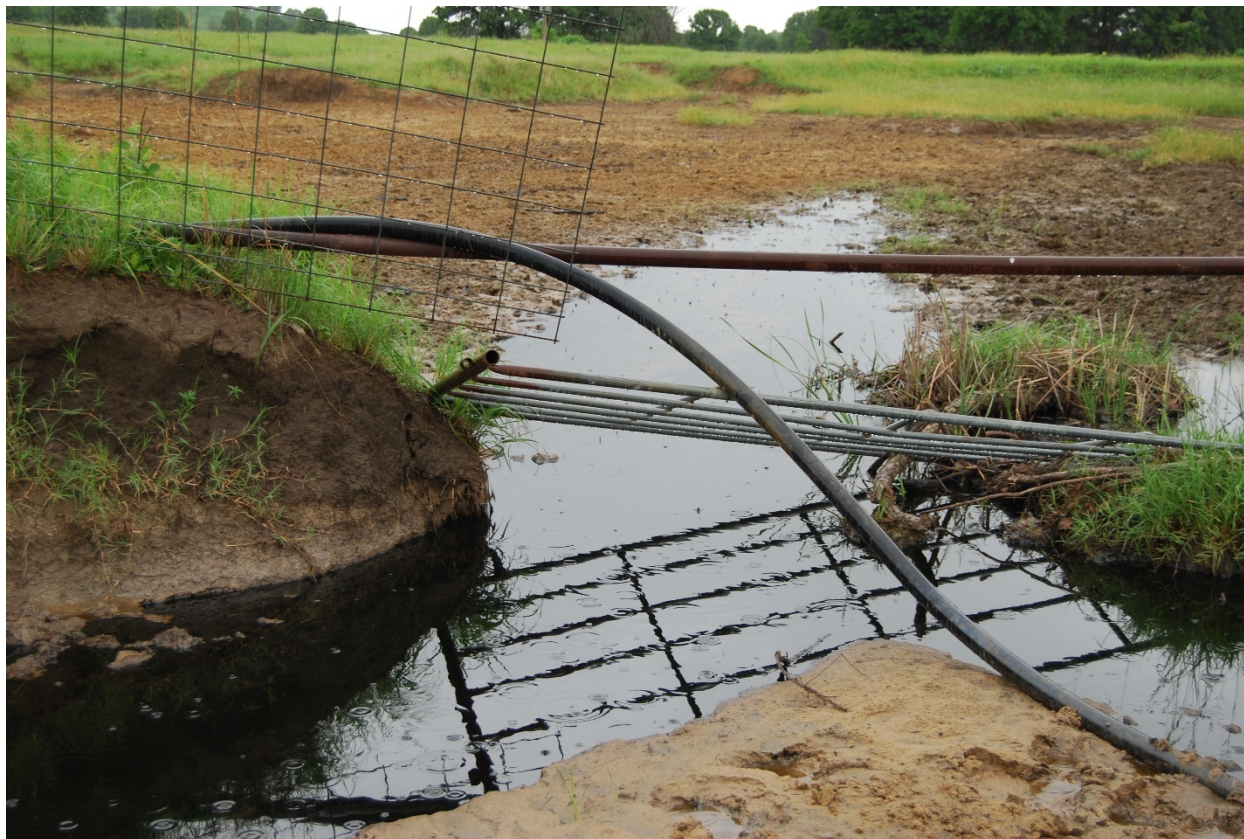
Photo No. 7

**Description:** This pool of water located approximately 30 yards downstream from the POE was covered with oil at the time of the inspection.

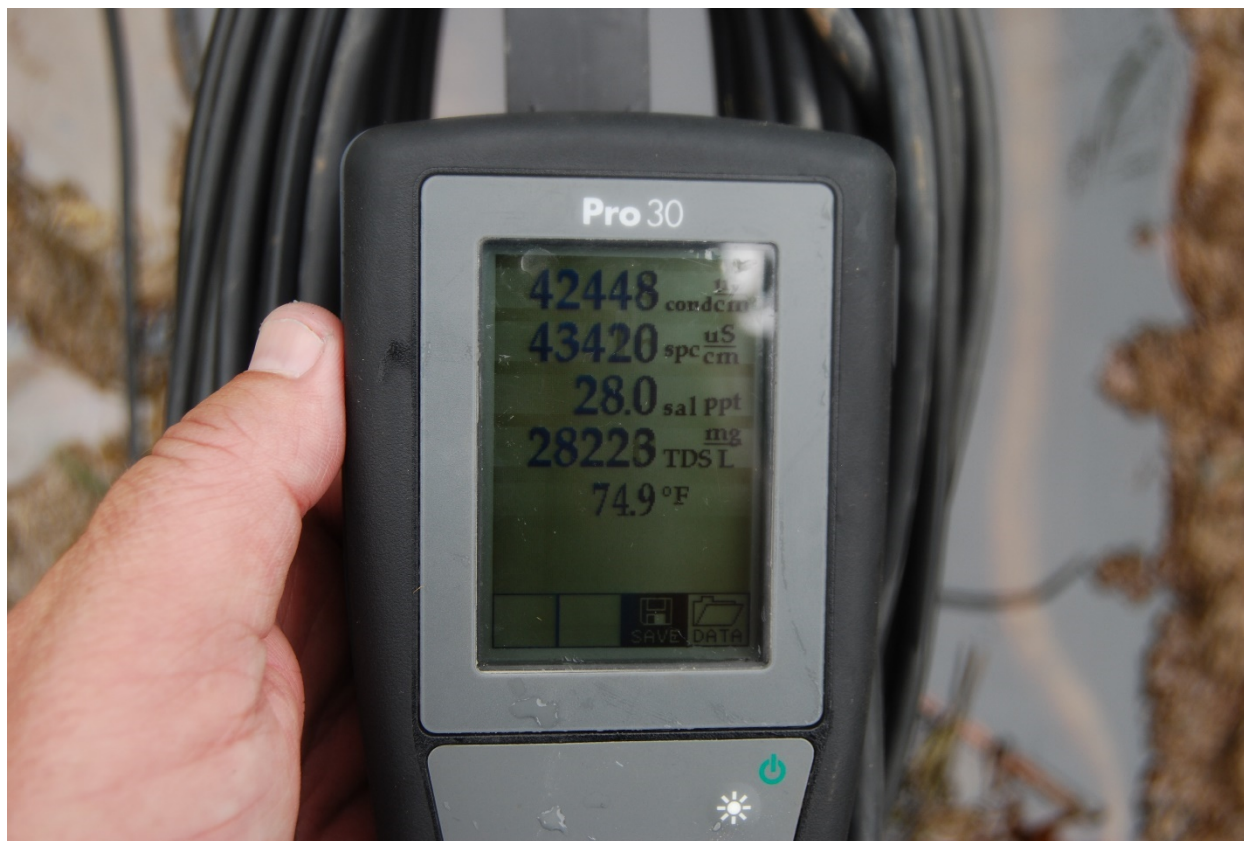
Photo No. 8

**Description:** This was an elevated TDS field reading of 28,223 mg/L taken along the impacted tributary.

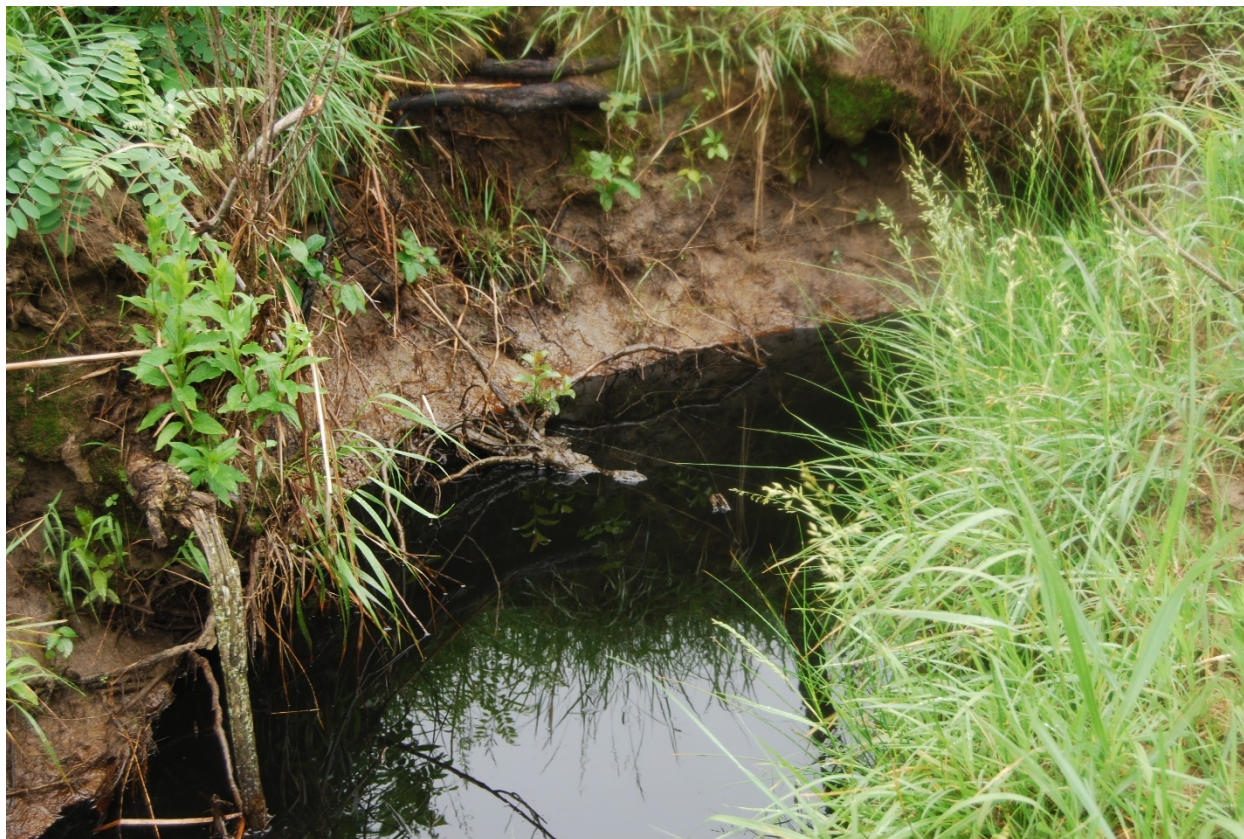
Photo No. 9

**Description:** This photo showed the defined streambed and bank features of the tributary. The tributary was completely covered in oil at this location. An elevated TDS field reading of 28,223 mg/L was taken at this location.

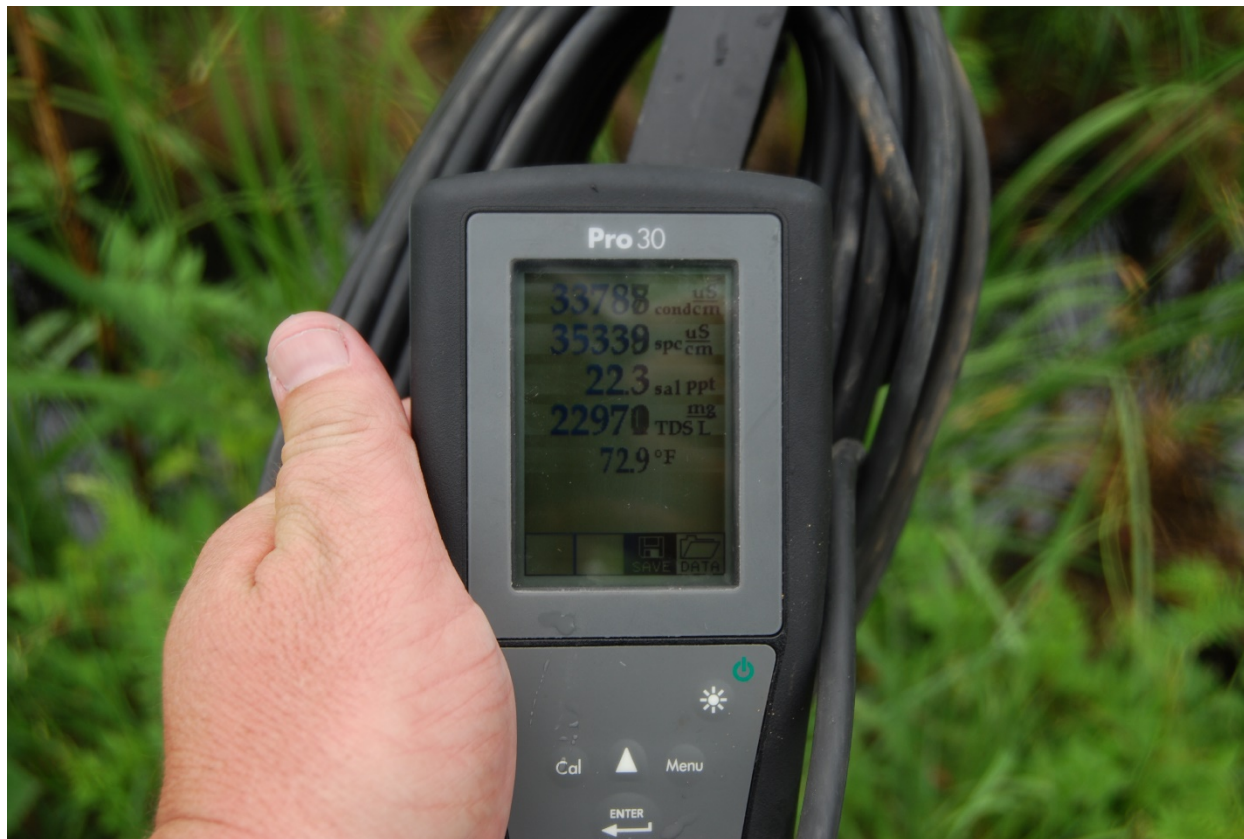
Photo No. 10

**Description:** This was an elevated TDS field reading of 22,970 mg/L taken along the impacted tributary.

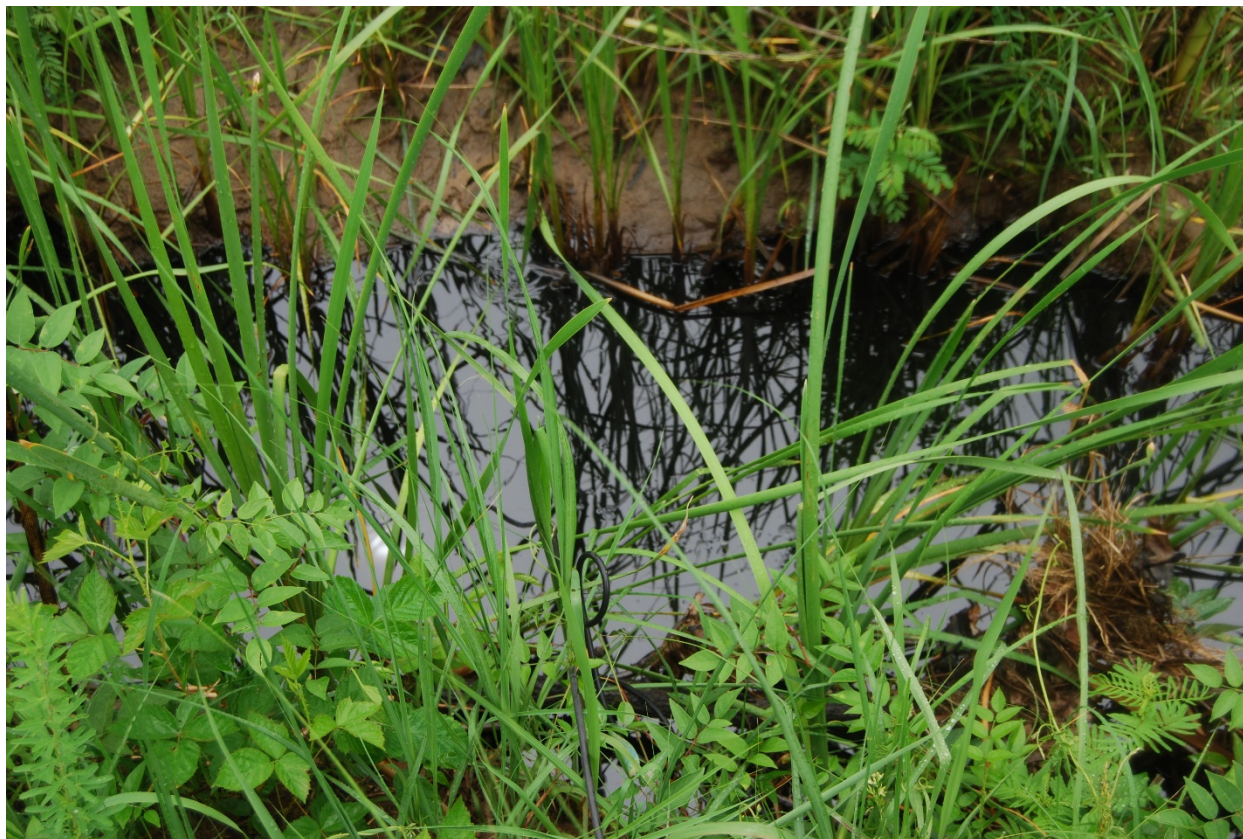
Photo No. 11

**Description:** This photo showed the location where an elevated TDS field reading of 22,970 mg/L was taken. The tributary was completely covered with oil at this location.

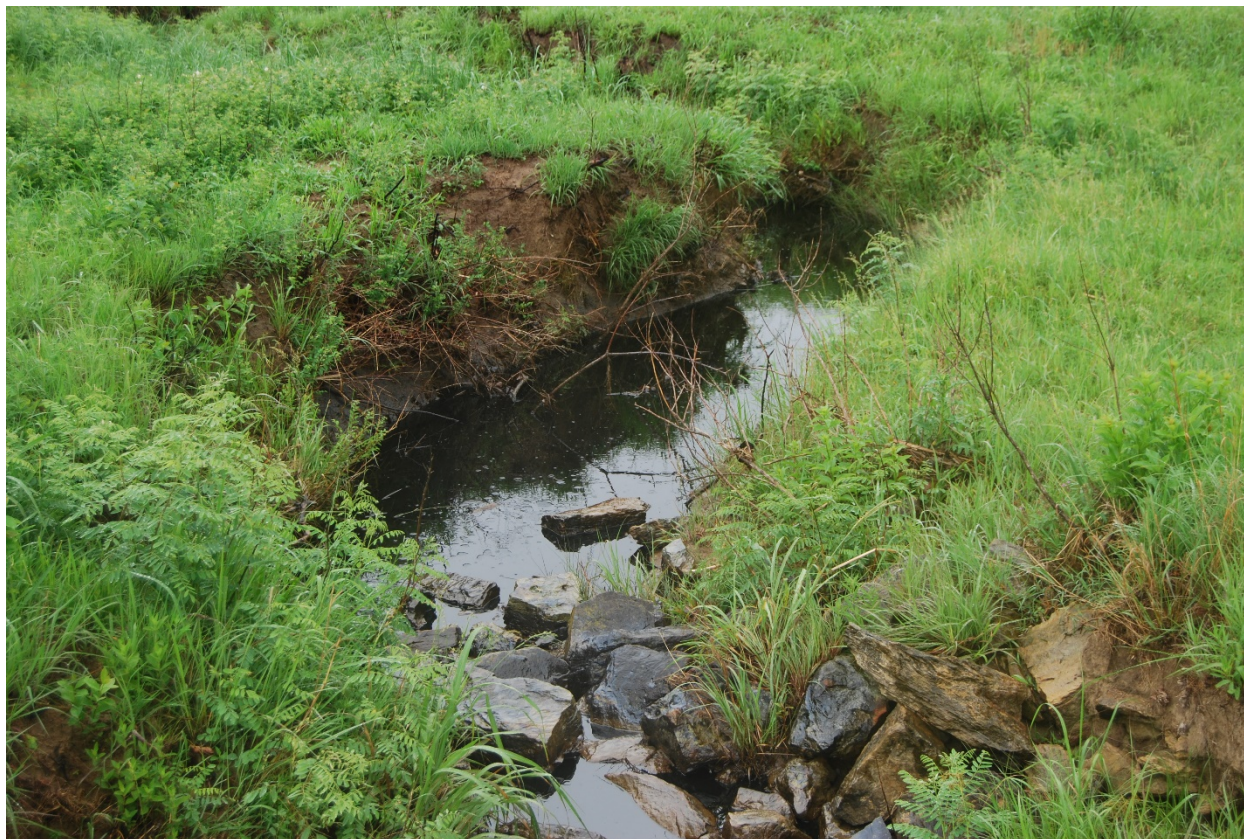
Photo No. 12

**Description:** This photo was taken approximately 0.35 miles downstream from the POE and showed the surface of the water was 100% covered with oil. Oil had impacted the banks, rocks, and vegetation along the tributary. The streambed and banks were well defined, this photo provided an accurate depiction of the physical size of the tributary.

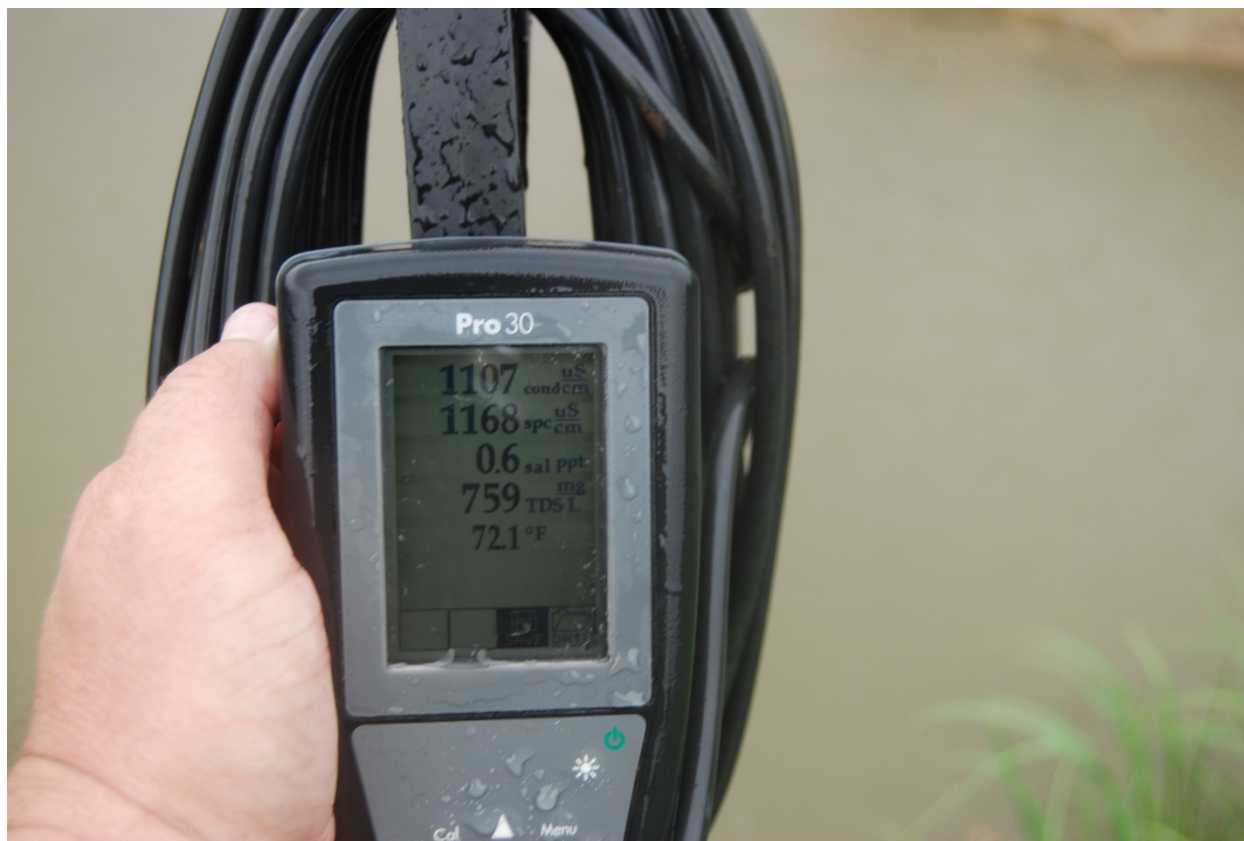
Photo No. 13

**Description:** This was an elevated TDS field reading of 759 mg/L which documented the furthest downstream impact observed during the inspection.

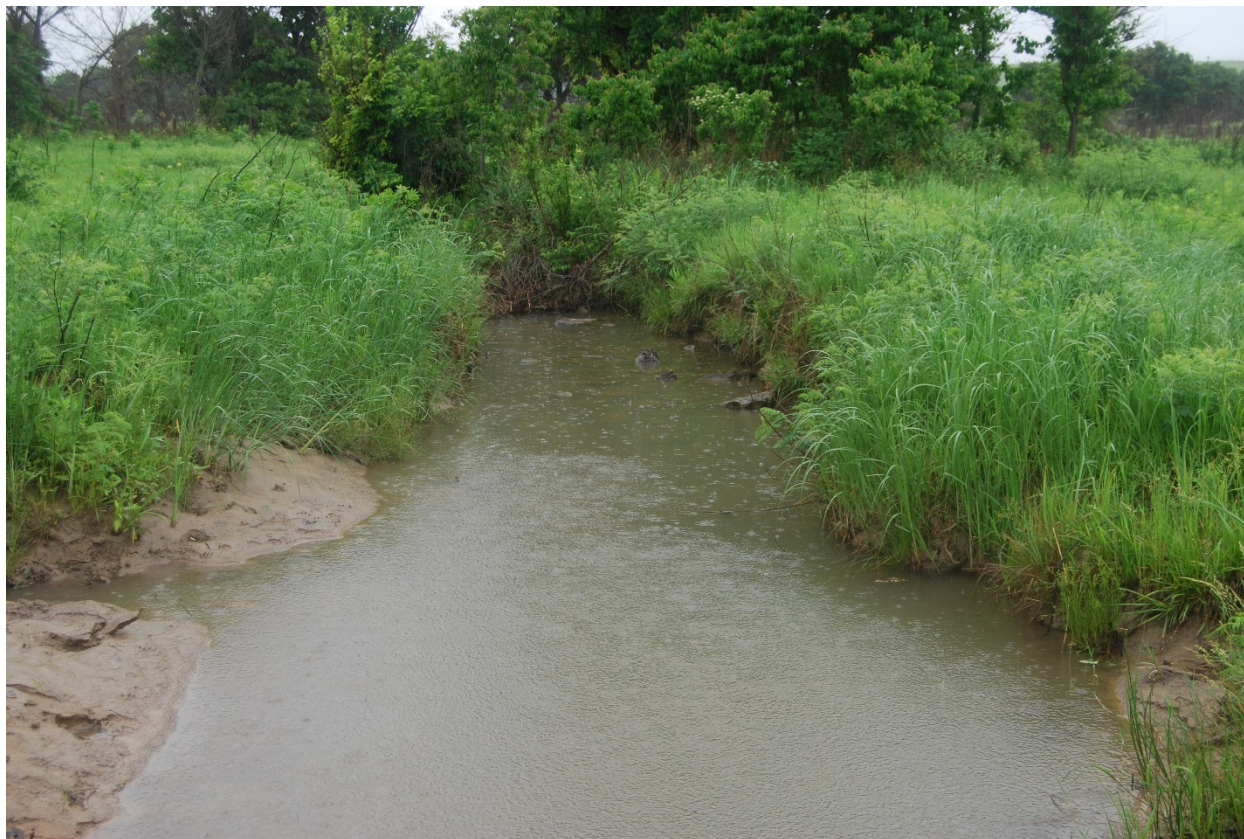
Photo No. 14

**Description:** This pool was the location of the last elevated TDS field reading observed during the inspection. This photo was taken from the downstream end of the pool with a view looking upstream.

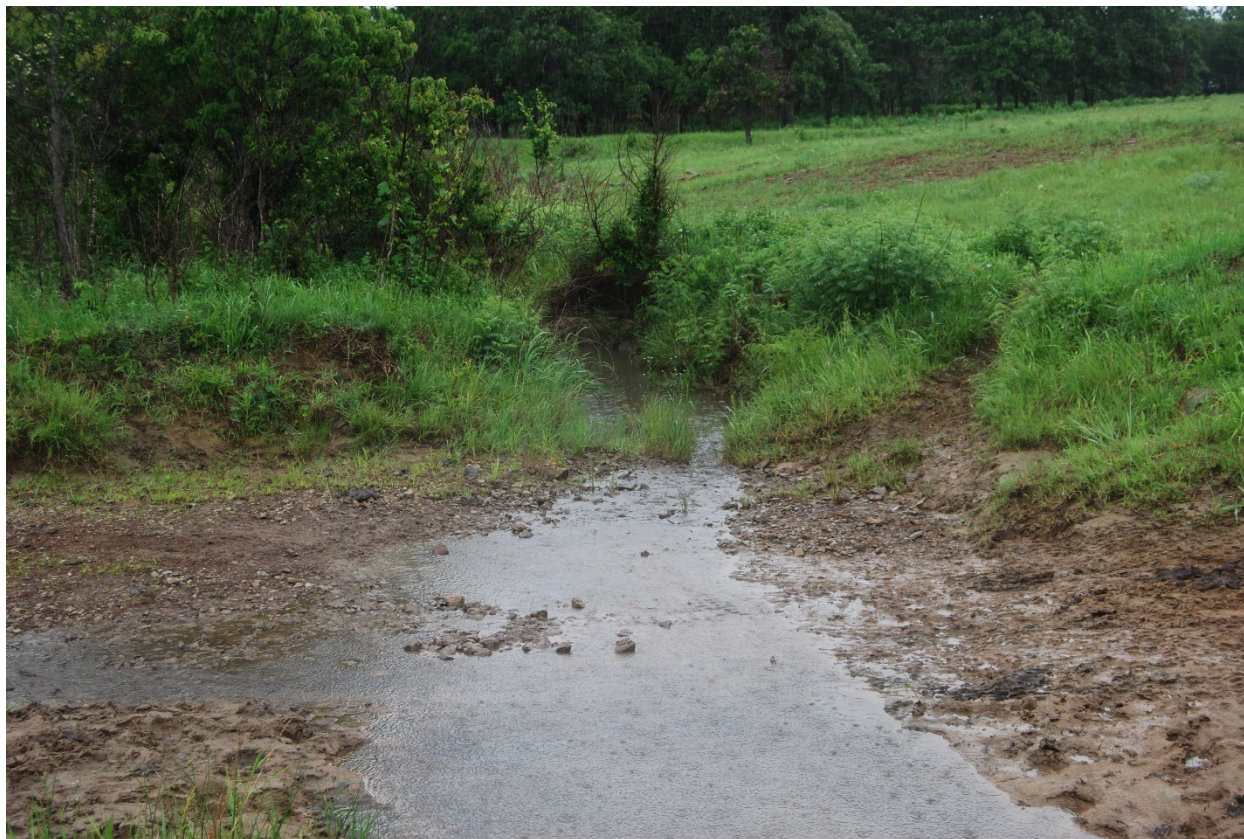
Photo No. 15

**Description:** This photo was taken at the last impacted pool in the tributary, looking downstream. This photo also captured a small tributary which was not impacted as its waters spilled into the impacted tributary, flowing from left to right in the bottom left corner of the photo. There was no containment structure to prevent further downstream migration of impacted waters at the time of the inspection.

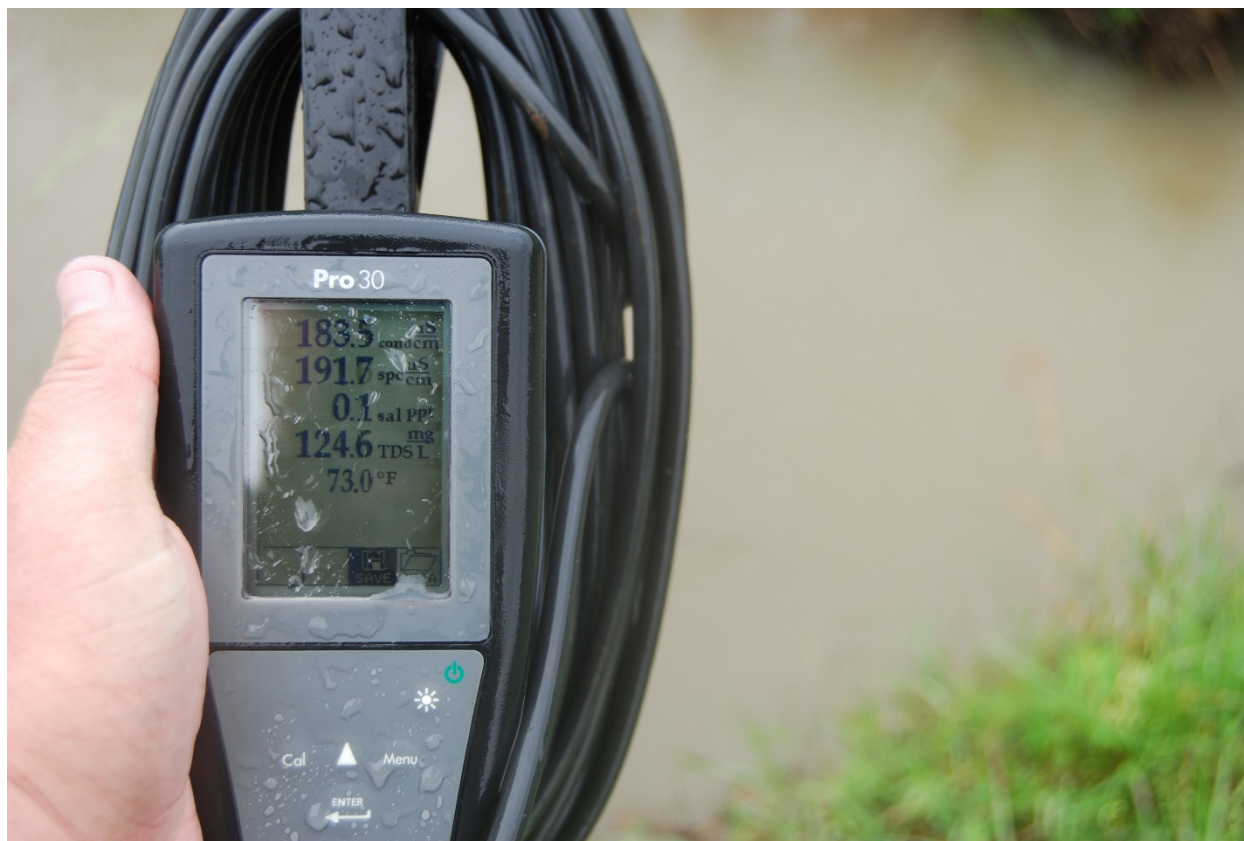
Photo No. 16

observed in the tributary during the inspection. Spill impacts were documented along approximately .5 miles of the tributary during the inspection. At the time of the inspection, there was a slow to moderate instream flow along the impacted tributary and light rainfall was ongoing throughout the inspection. At the time of the inspection, there were no temporary containment structures in place to prevent further downstream migration of the impacted waters. At the time of the inspection there was a floating, oil absorbent containment boom placed across the impacted tributary to prevent downstream migration of the crude oil. I observed an additional "background" TDS field of 124.6 mg/L (GPS 36.899694, -96.125182), this field reading was taken in the channel of a small tributary just before it flowed into the impacted tributary and can be seen in photo No. 16.

**Description:** This was a background TDS field reading of 124.6 mg/L taken in a small tributary just before it flowed into the impacted tributary. This tributary joined the impacted tributary at a point immediately downstream from the location where the last elevated TDS field reading was observed during the inspection.
