RCRA Compliance Branch  
INSPECTION REPORT

| Inspection Date(s): | 2/29/2024 | Inspection Announced: No |
| Facility or Site Name: | Kearny Steel Container Corporation | |
| Facility/Site Physical Location: | 401 South Street | |

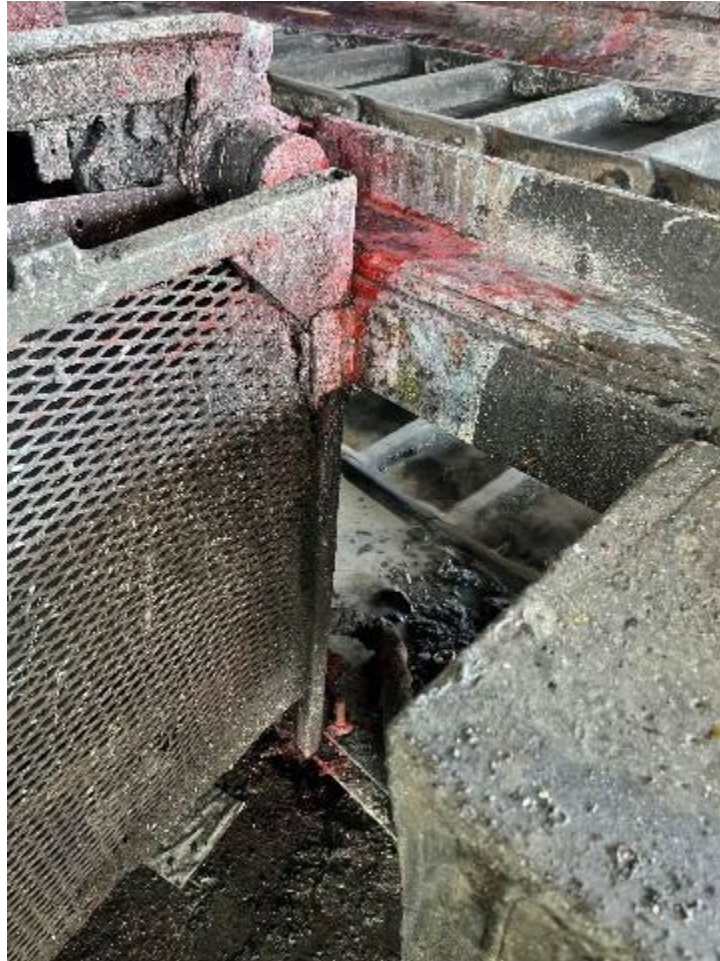
process, and looked inside several drums as they moved past, but did not observe any drums that appeared to contain liquids or other residuals. At the entrance to the furnace, the drums are turned upside down on the conveyor line. The inspection team observed some liquid residual and ash on and beneath the conveyor line, as shown in Photograph 15. The liquid residual may originate from drums that are turned upside-down on the line. Kearny Steel personnel could not say whether the material beneath the line is cleaned at a certain frequency.

View of liquids and solids collecting beneath the conveyor line that leads into the furnace.  
{Photograph 15, Attachment 1}

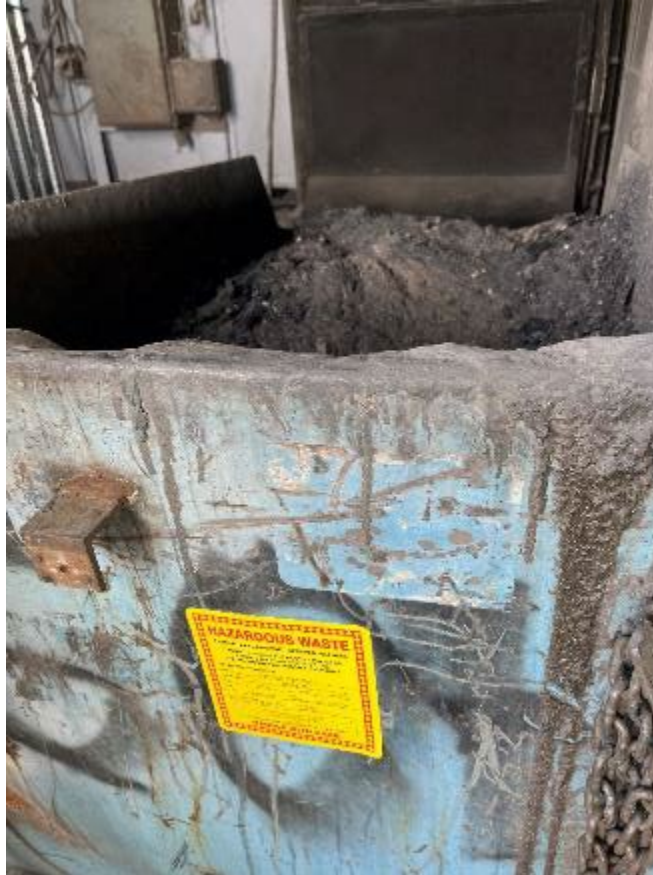
Adjacent to the furnace is an open-top hopper where furnace ash is collected from a baghouse. The hopper of furnace ash serves as a central accumulation area since the volume of the hopper is greater than 55 gallons. The hopper present during the walk-through was labeled as a hazardous waste with an accumulation start date of February 28, 2024, and with hazardous waste codes D001 (ignitability), F003 (spent non-halogenated solvents and solvent mixtures), and F005 (spent non-halogenated solvents). However, the potential hazard associated with the furnace ash is toxicity from chromium or lead. The hopper was not labeled with the correct

indication of the hazards of its contents. Analytical testing is performed to determine if each shipment of furnace ash is hazardous, but in the event that it is hazardous, this container would not be appropriately labeled.

View of furnace ash hopper located near the furnace. The hazardous waste label lists waste codes D001, F003, and F005, which are not accurate for the potential hazards for this waste stream. {Photograph 11, Attachment 1}

1. 40 CFR 265.173(a), as referenced by 40 CFR 262.34(a)(1)(i), states “a container holding hazardous waste must always be closed during storage, except when it is necessary to add or remove waste”. The inspection team observed a poly tote used to accumulate hazardous drum drainage waste on the balcony where steel drums are drained. The top of the poly tote was cut off, such that it was open even when waste was not actively being added or removed (see Photograph 23, Attachment 1). Additionally, the inspection team observed an open poly tote that was used to accumulate by gravity draining hazardous drum drainage waste outside of the poly container and off-spec steel drum processing building. The top of the poly tote was completely cut off, such that it was open even when waste was not actively being added or removed (see Photograph 19, Attachment 1). Also, the furnace ash hopper, which is the accumulation container of furnace ash prior to transfer to a roll-off container, was open-top (see Photograph 11, Attachment 1).

- a. 40 CFR 262.17(a)(5)(i)(B) states that “a large quantity generator must mark or label its containers with... an indication of the hazards of the contents...”. The inspection team observed a hopper of furnace ash that was not labeled with the correct indication of the hazards of its contents. The label on the drum showed hazardous waste codes D001 (ignitability), F003 (spent non-halogenated solvents and solvent mixtures), and F005 (non-halogenated solvent mixtures) (see Photograph 11, Attachment 1). However, based on statements from facility personnel about how this waste was historically manifested and the labeling on other furnace ash containers, the potential hazard associated with this waste is toxicity from chromium and lead.

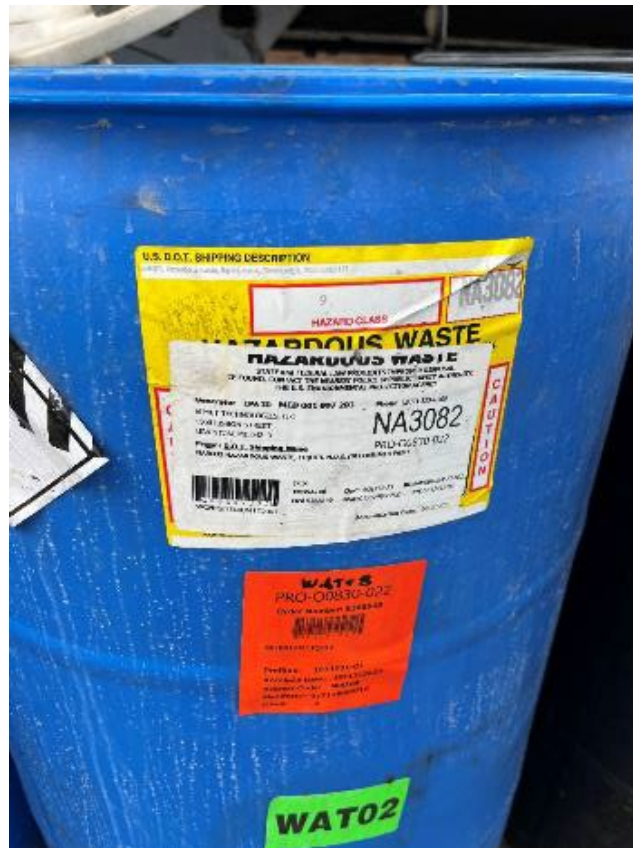
One blue 55-gallon drum was labeled as “Hazardous Waste Liquid, N.O.S. (Selenium), Generator Name “Elmet Technologies””, with drum number “PRO-O0830-022” (Photograph 6, Attachment 1). The drum felt heavy, and upon opening the lid, liquid was observed in the drum, and it was not RCRA-empty (Photograph 5, Attachment 1). Additional information on this drum was provided after the inspection by the facility and it is discussed further in the document review section of this report.

View of 55-gallon drum stored in the unloading area. The label Hazardous Waste Liquid, N.O.S. (Selenium), Generator Name “Elmet Technologies””. The label indicated that hazardous waste was stored in the container and the drum was not RCRA-empty. {Photograph 6, Attachment 1}

**Testing for Containers Observed During Inspection:** The inspection team observed three containers from customers during the site inspection that did not appear to be RCRA empty and were labeled to indicate that the contents could be hazardous. In response to a request from the inspection team, Kearny Steel provided additional information on these containers. The facility stated that each of the three containers had been brought to the site within five days of the inspection, however, additional information or a means to document the timing was not provided. Kearny Steel confirmed that one drum labeled as “Alcohol” was truly RCRA-empty, and that the container appeared to be full due to staining on the drum. For two other containers that were labeled as hazardous waste and were not RCRA-empty, Kearny Steel tested the contents of each container for RCRA metals, pH and ignitability. Although these two containers were not RCRA-empty, these tests indicated that the materials were not hazardous. Each container was reportedly triple-rinsed and shredded. The test results and other information from Kearny Steel on these three drums are provided as Attachment 12.

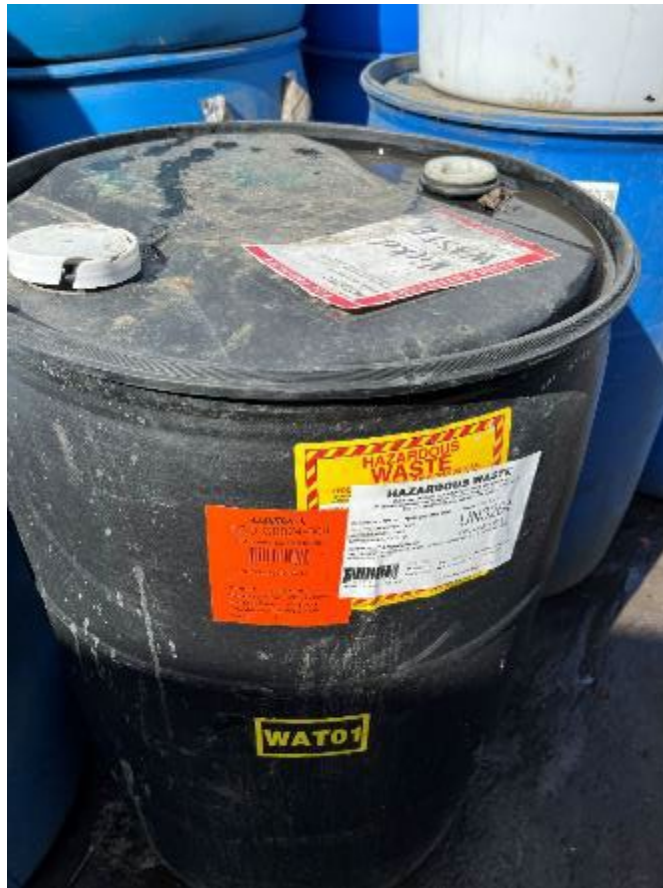
One black 55-gallon plastic drum was observed that was labeled as a corrosive and toxic hazardous waste containing hydrochloric acid and lead, with drum number “PRO-O8874-003”

(Photograph 9, Attachment 1). The drum was very heavy when it was pushed, indicating that the container was not RCRA-empty. Additional information on this drum was provided after the inspection by the facility and it is discussed further in the document review section of this report.

View of 55-gallon drum in the drum unloading area that was labeled as hazardous waste. When the container was pushed, it felt heavy, indicating that it was not RCRA-empty. {Photograph 9, Attachment 1}

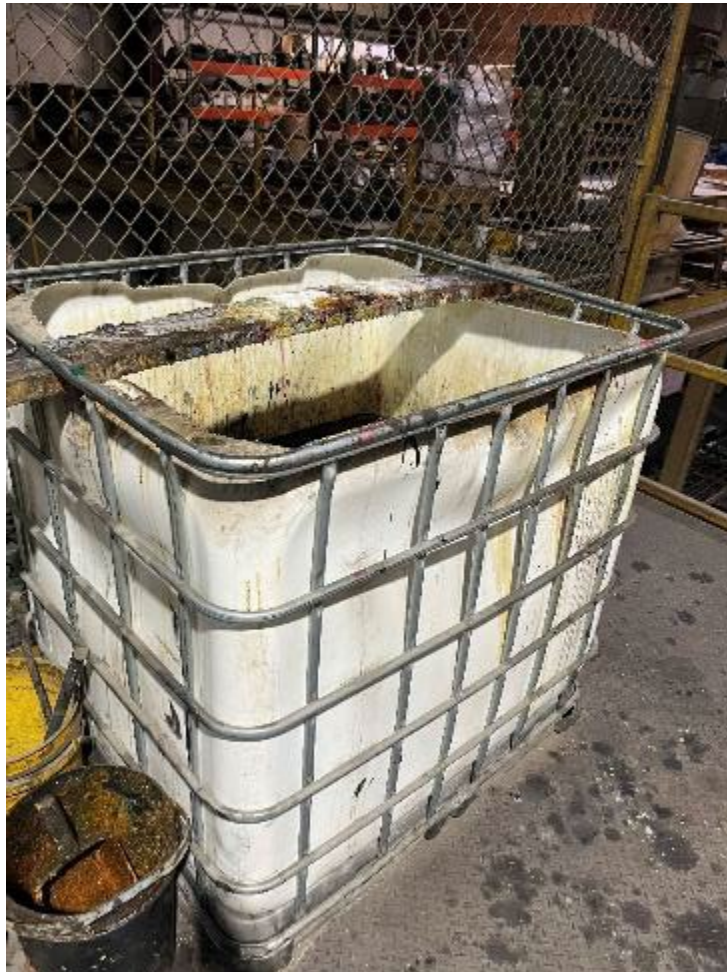
the balcony, an additional poly tote accumulating hazardous waste was observed (Photograph 23, Attachment 1). The tote was used to drain buckets or smaller containers of drainage material. The tote was not labeled as hazardous waste or with an indication of the hazards. Additionally, the container was not actively being filled, but the container was open.

View of accumulation container for hazardous drum drainage waste. The container was not labeled as hazardous waste and was open, despite no active loading occurring.

{Photograph 23, Attachment 1}

2. Pursuant to 40 CFR 262.34(a)(3), while being accumulated on-site, each container and tank must be clearly labeled or marked with the words “Hazardous Waste”. The inspection team observed a poly tote used to accumulate hazardous drum drainage waste on the balcony where steel drums are drained. The tote was not labeled as “hazardous waste” (see Photograph 23, Attachment 1).

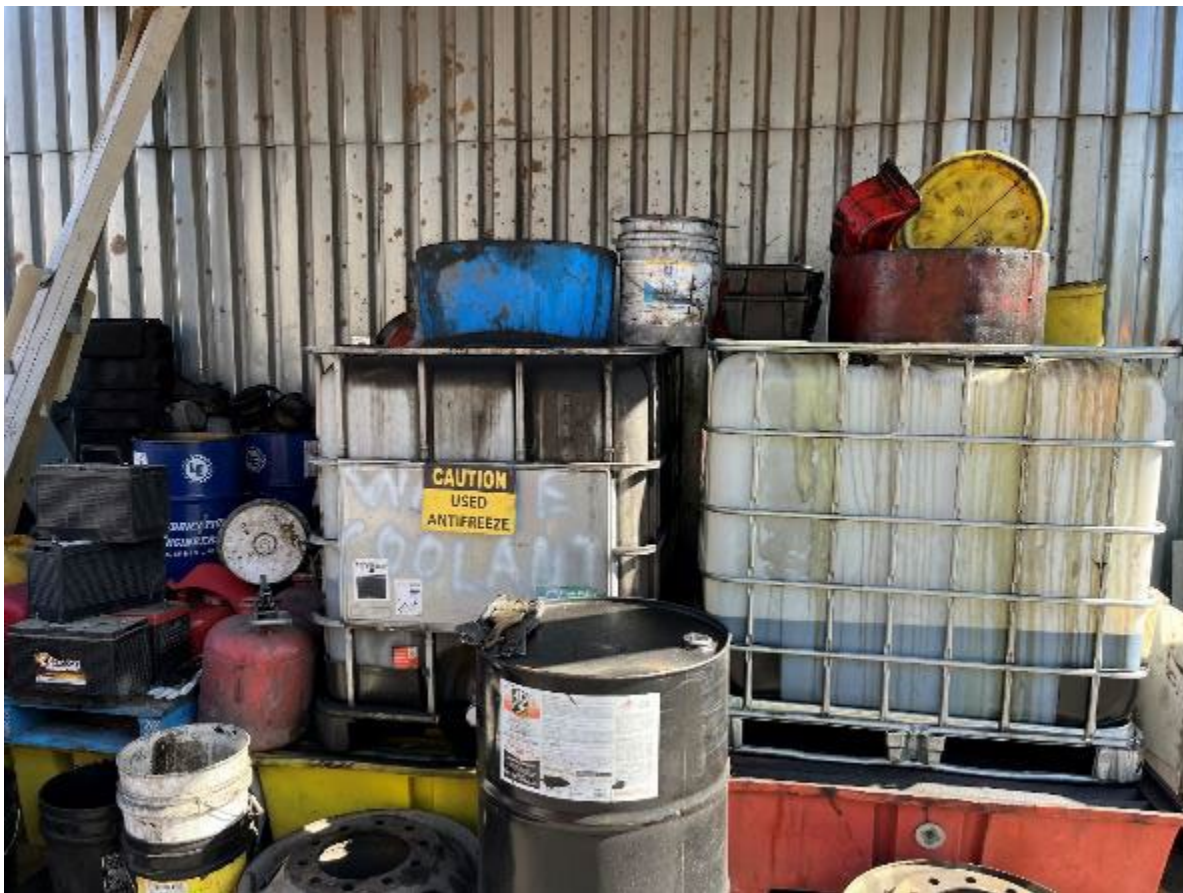
The inspection team observed the maintenance shop, where minor maintenance is performed on delivery trucks and other mobile equipment. Outside of the maintenance shop, one used oil and one used antifreeze tote was observed. Both totes were labeled as to their contents. Adjacent to the used antifreeze tote was at least four used lead-acid batteries, which were not properly labeled (Photograph 29, Attachment 1).

View of used antifreeze, used oil and used batteries, stored adjacent to the maintenance shop.  
The used batteries are not labeled.  
{Photograph 29, Attachment 1}

3. 40 CFR 273.14 states that “universal waste batteries (i.e., each battery), or a container in which the batteries are contained, must be labeled or marked clearly with any of the

following phrases: “Universal Waste – Battery(ies),” or “Waste Battery(ies),” or “Used Battery(ies)”. The inspection team observed waste batteries stored in an exterior area adjacent to the maintenance shop that were not properly labeled.
