ASBESTOS INSPECTION  
AT THE  
POWER HOUSE BLDG  
BASEMENT FLOOR  
UNITS 7, 6, 5, 4, 2 AND  
CIRCUIT PUMP # 3

ASARCO INCORPORATED  
P.O. BOX 1111  
El Paso, Texas 79999

SUN  
CITY  
ANALYTICAL  
INC.

AN ASBESTOS INSPECTION  
OF  
UNITS 7, 6, 5, 4, & 2  
AT THE POWER HOUSE BLDG  
FOR  
ASARCO INCORPORATED

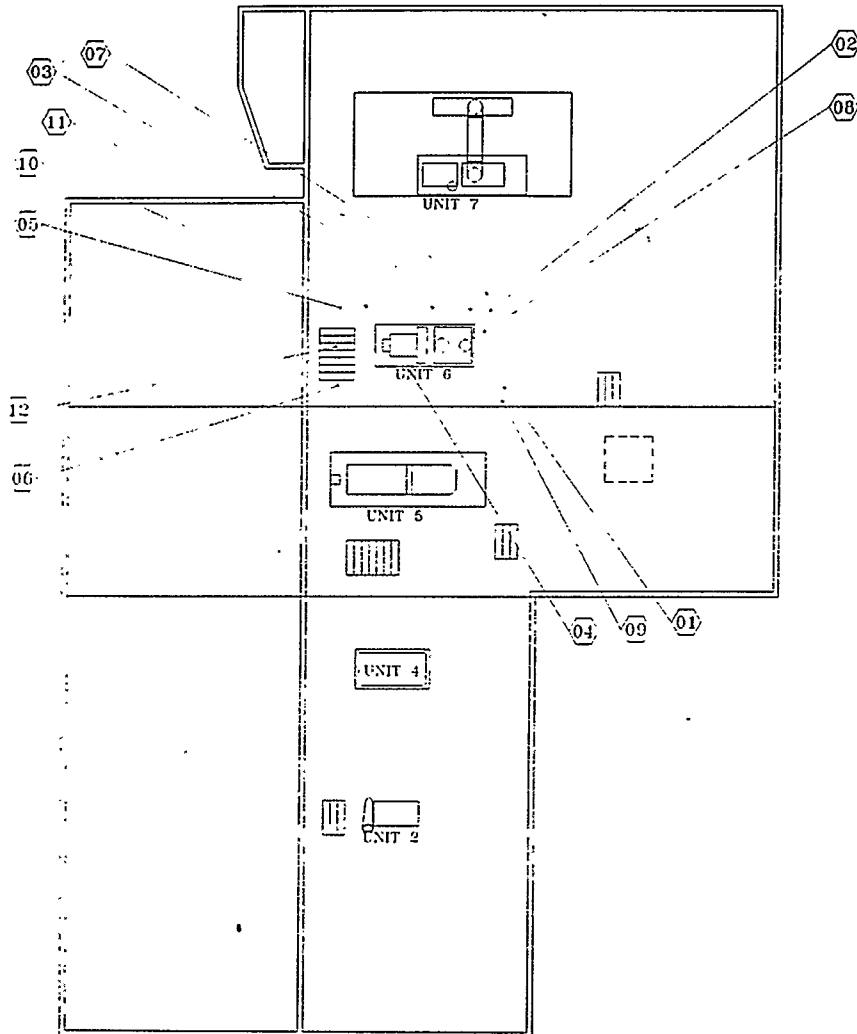
# INSPECTION DATA SERIES FL1021U6-

ELBO 01 Building No. PH  
Description: SMALL PIPE FITTING INSULATION

LOCATION(s): THROUGHOUT UNIT # 6 (SEE DRAWINGS  
FOR QUANTITIES)

Quantity: 0 EA  
Sample No(s): FL1021U6-09  
Result: CHRYSOTILE 5-10%

Damage - Deterioration (aging)  
Severity - Severe Damage  
Assessment - Damaged or significantly damaged  
thermal insulation materials.

Building No. PH  
Description: LARGE PIPE FITTING INSULATION

Quantity: 0 EA  
Sample No(s): FL1021U6-10  
Result: CHRY. 5-10% AMOSITE 15-20%

PIPE 01 Building No. PH  
Description: SMALL PIPE INSULATION

Quantity: 0 LF  
Sample No(s): FL1021U6-02  
Result: AMOSITE 10-15%

PIPE 02 Building No. PH  
Description: LARGE PIPE INSULATION

Quantity: 0 LF  
Sample No(s): FL1021U6-04  
Result: CHRY. 2-7% AMOSITE 10-15%

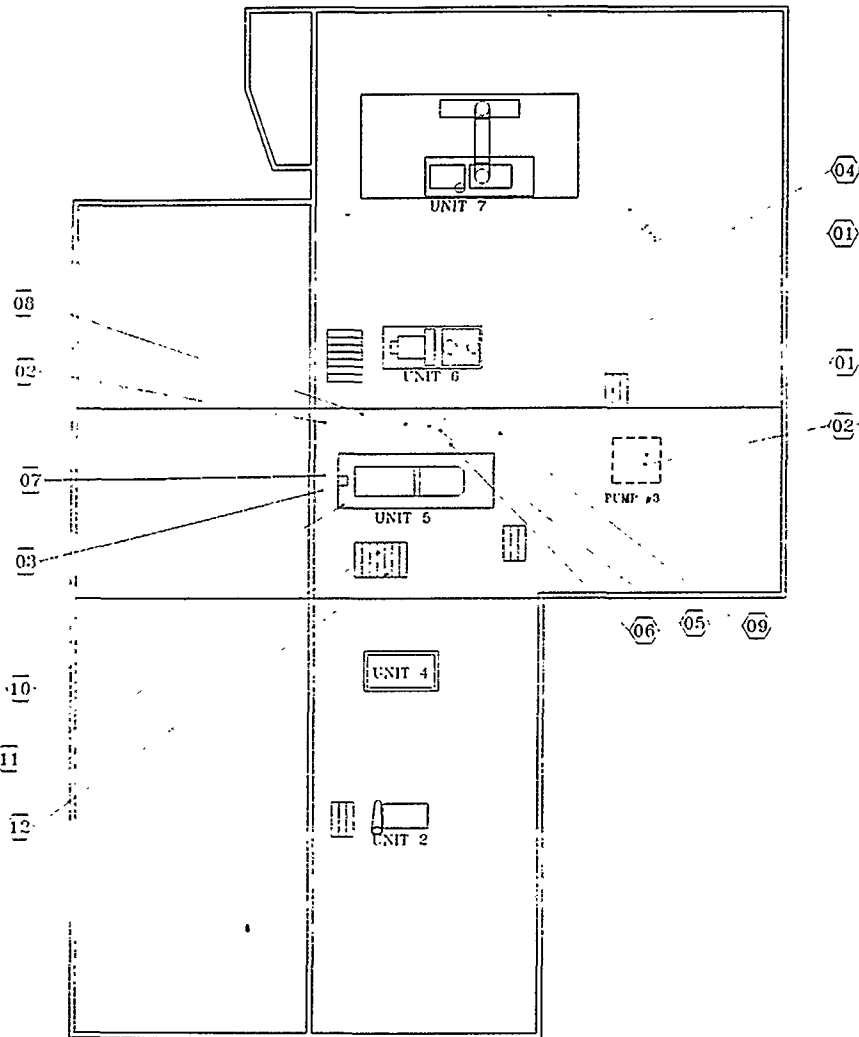
SERIES FL1021U5-  
FL1021P3-

ELBO 06 Building No.PH  
Description: PIPE FITTING INSULATION

LOCATION(s): THROUGHOUT CIRCUIT PUMP # 3 ( SEE  
DRAWINGS FOR QUANTITIES)

Quantity: 0 EA  
Sample No(s): FL1021P3-01  
Result: CHRYSOTILE 15-20%

Damage - Deterioration (aging)  
Severity - Minor Damage  
Assessment - Damaged or significantly damaged  
thermal insulation materials.

ELBO 07 Building No.PH  
Description: SMALL PIPE FITTING INSULATION

LOCATION(s): THROUGHOUT UNIT # 5 (SEE DRAWINGS  
FOR QUANTITIES)

Quantity: 0 EA  
Sample No(s): FL1021U5-01  
Result: CHRYSOTILE 15-20%

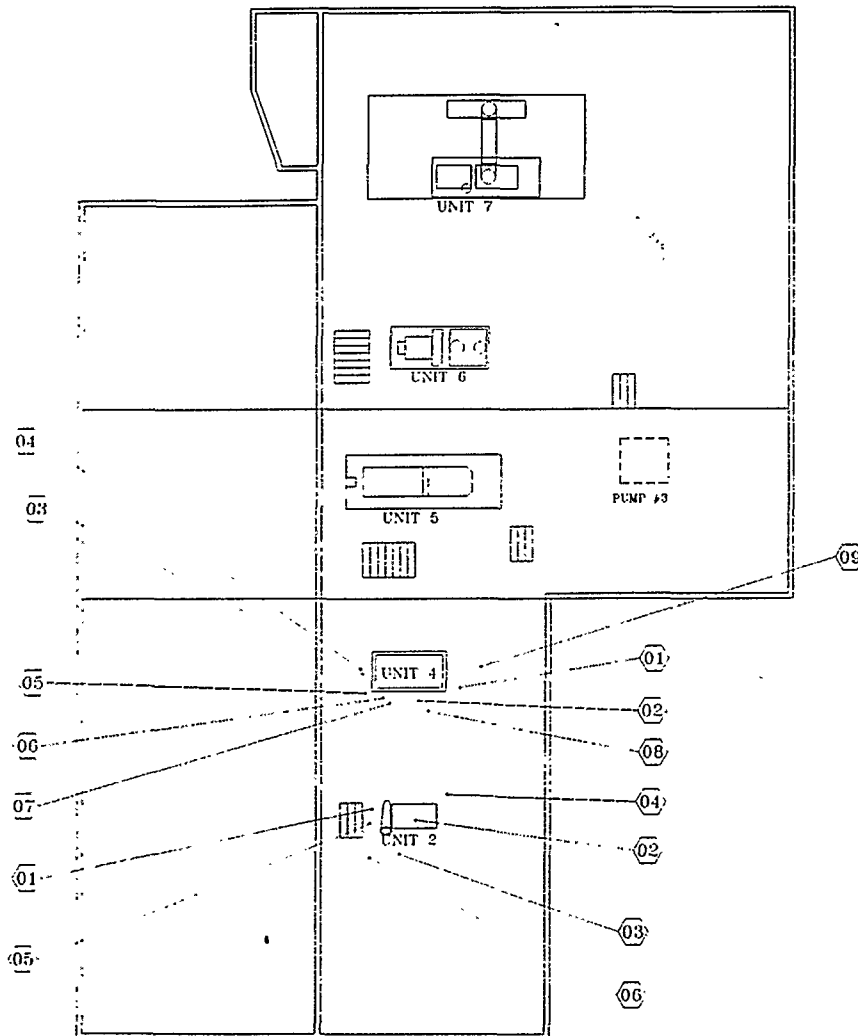
SERIES FL1021U4-  
FL1021U2-

ELBO 03 Building No.PH  
Description: PIPE FITTING INSULATION

LOCATION(s): THROUGHOUT UNIT # 2 (SEE DRAWINGS  
FOR QUANTITIES)

Quantity: 0 EA  
Sample No(s): FL1021U2-01  
Result: CHRYSOTILE 5-10%

Damage - Deterioration (aging)  
Severity - Minor Damage  
Assessment - Damaged or significantly damaged  
thermal insulation materials.

Building No.PH  
Description: SMALL PIPE FITTING INSULATION

Quantity: 0 LF  
Sample No(s): FL1021U4-02  
Result: CHRYSOTILE 30-35%

ELBO 05 Building No.PH  
Description: LARGE PIPE FITTING INSULATION

Quantity: 0 LF  
Sample No(s): FL1021U4-04  
Result: CHRYSOTILE 7-12%

PIPE 03 Building No.PH  
Description: PIPE INSULATION (AIRCELL)

Quantity: 0 LF  
Sample No(s): FL1021U2-04  
Result: CHRYSOTILE 30-35%

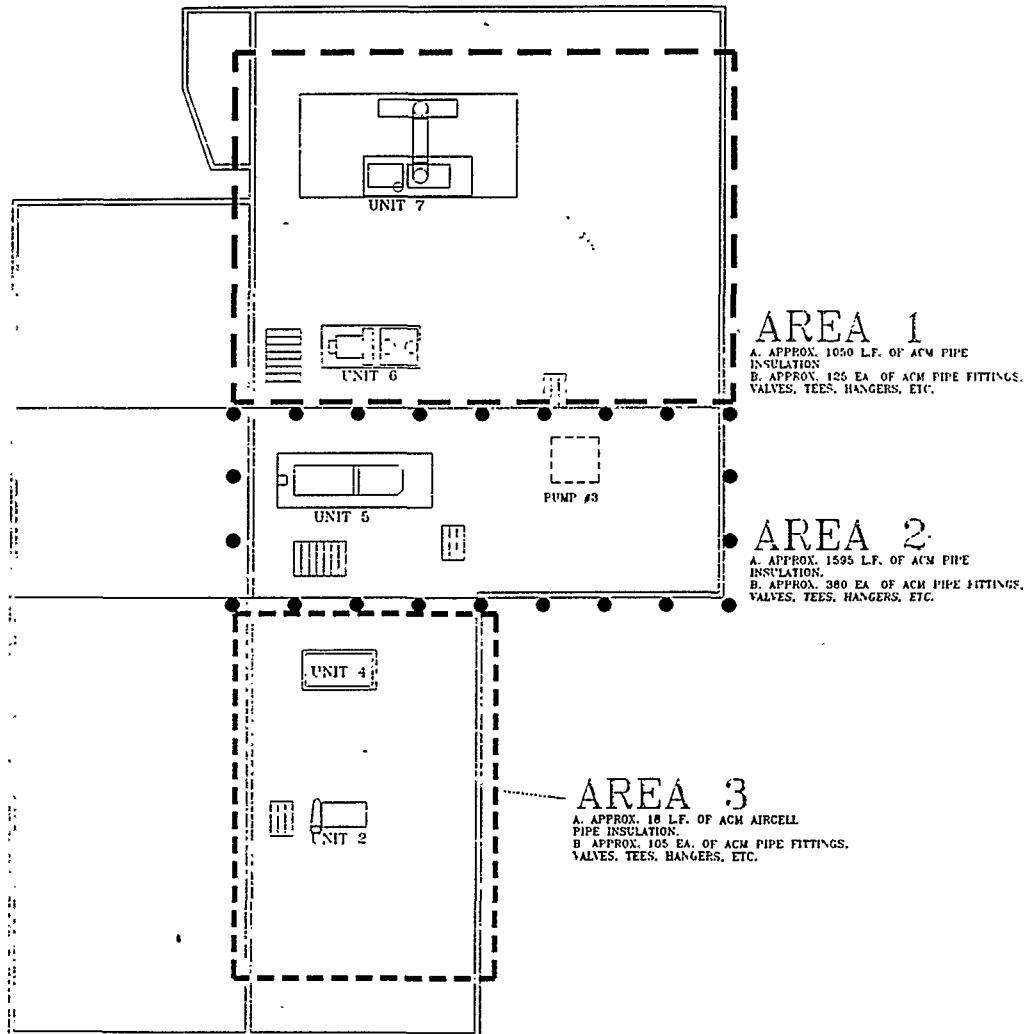
# ACM AREAS

SCAI inspectors took various samples of the thermal insulation materials located on the units surveyed. The materials found to contain asbestos were the pipe fittings, hangers, valves, tees, etc. and pipe insulation.

The ACM thermal insulation located on units 7, 6, 5, 4 & 2 has moderate damage and is classified by EPA under the National Emission Standards for Hazardous Air Pollutants (NESHAP) as Regulated Asbestos Containing Material (RACM) friable material. This means that the material when dry will become friable if renovation/demolition activities are performed. If the removal of these materials becomes necessary then the method of removal to be used should take the NESHAP regulations into account. SCAI recommends that this materials be removed prior to renovation/demolition activities on the units by a licensed asbestos abatement contractor. The owner should also contract a licensed asbestos consultant to prepare the abatement plan and oversee the abatement process.
